**EXCAVATIONS AT
230 ST MARY'S LANE, UPMINSTER
LONDON BOROUGH OF HAVERING, RM14 3DH**

An Archaeological Assessment Report

Site code: SMS16

Planning ref: PO811.14

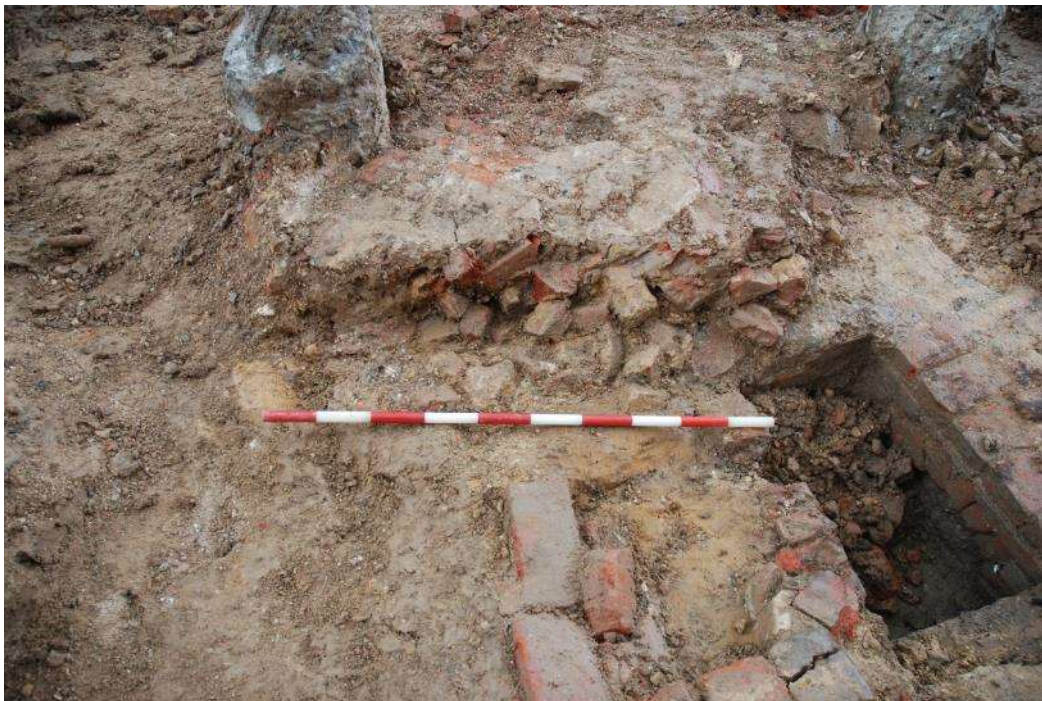
Figure 32: Partially excavated CBM brick and tile dump (46), which was overlying drain [47]. Facing WNW. Scale 1m.

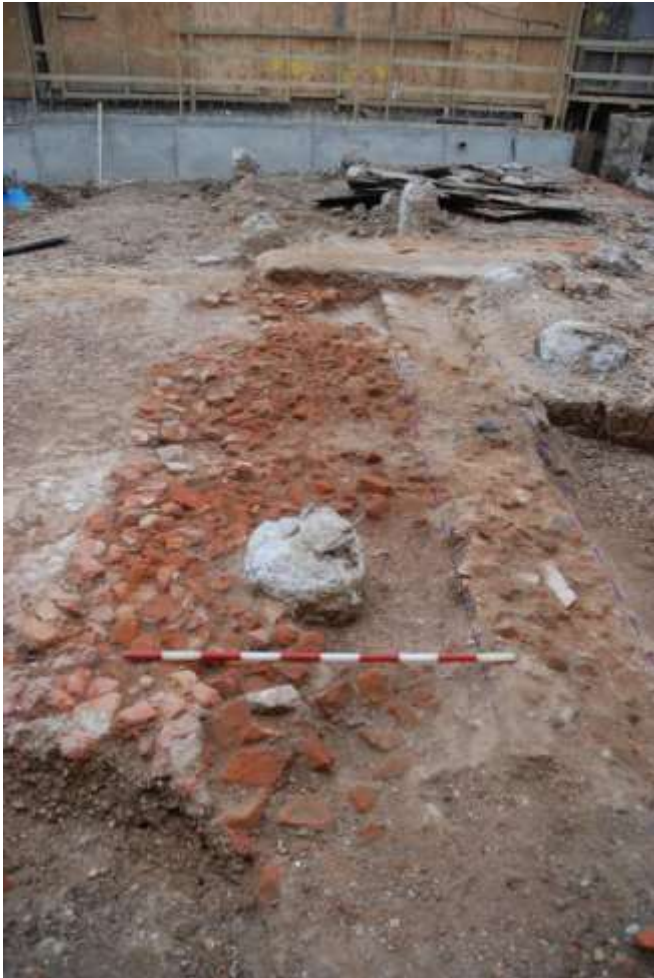
Figure 33: CBM abundant deposit (57) outlined in blue, overlying W[51]. The material is taken to be demolition rubble backfilled into the cut of the wall. Facing W. Scale 1m.

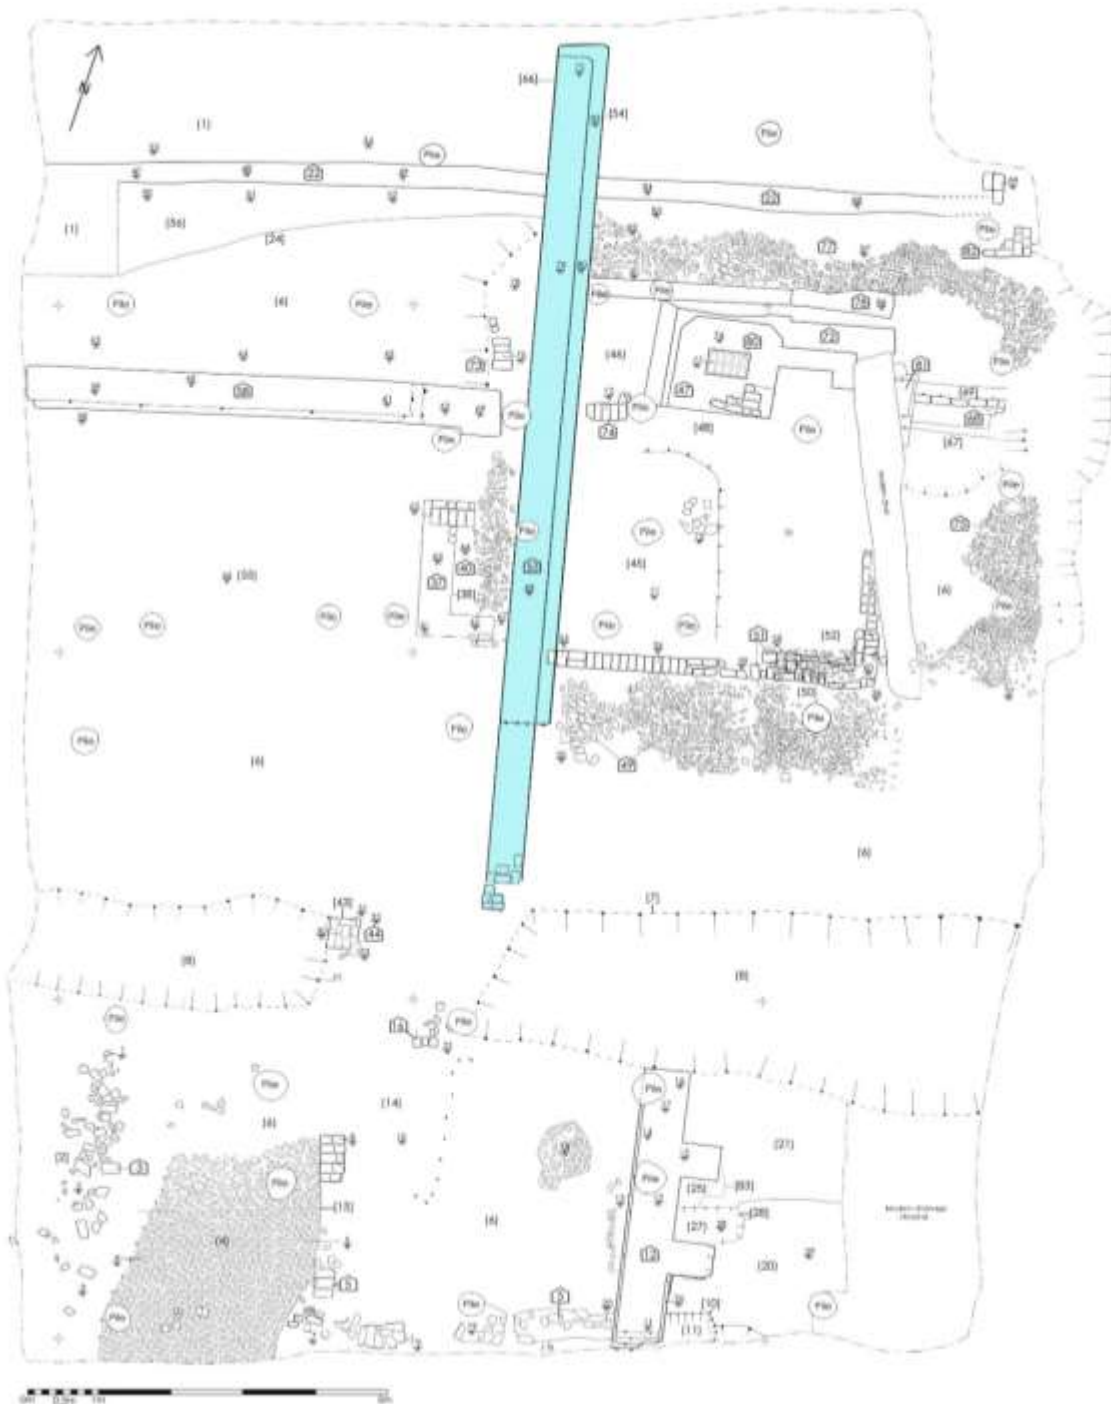
Figure 34: Wall W[53], which appears to have been constructed, demolished to foundation level and backfilled within a relatively short period of time. Original drawn at 1:20.

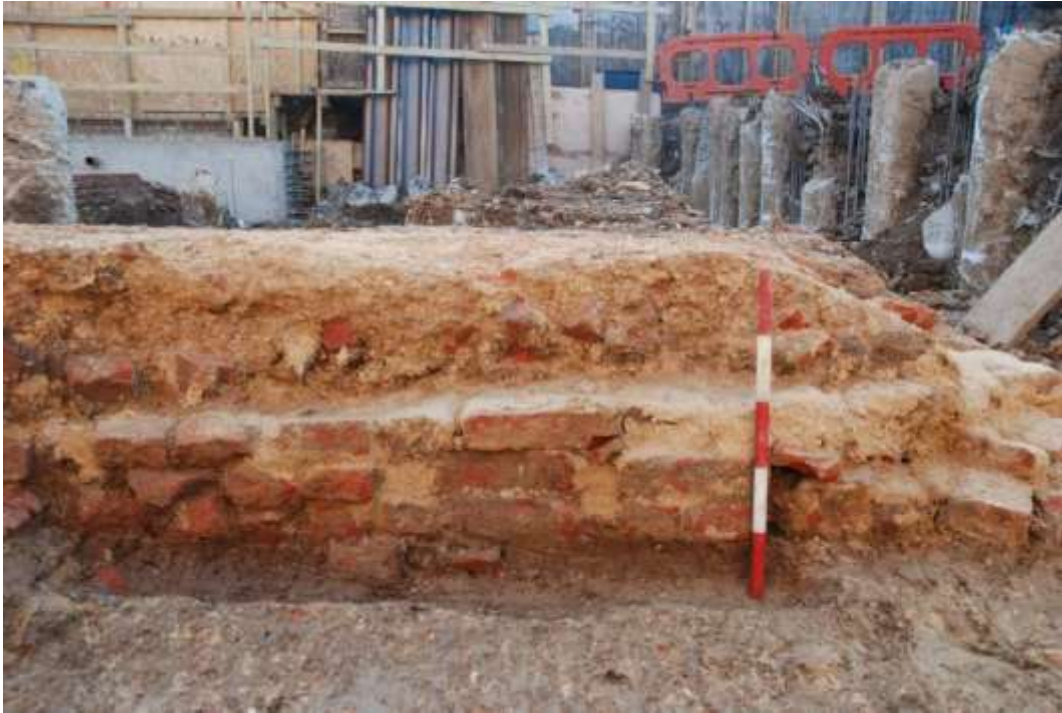
Figure 35: Northern end of wall W[53] showing three courses of surviving brickwork below demolition mortar and rubble. Facing W. Scale 0.5m.

- 7.6.3** The structure measured 12.5m in length x 0.55 – 0.75m in width x a maximum of 0.3m in height, with the bricks measuring 230 x 110 x 60mm. The three foundation courses remained relatively intact, with some deformation observed towards the northern end (fig.35).

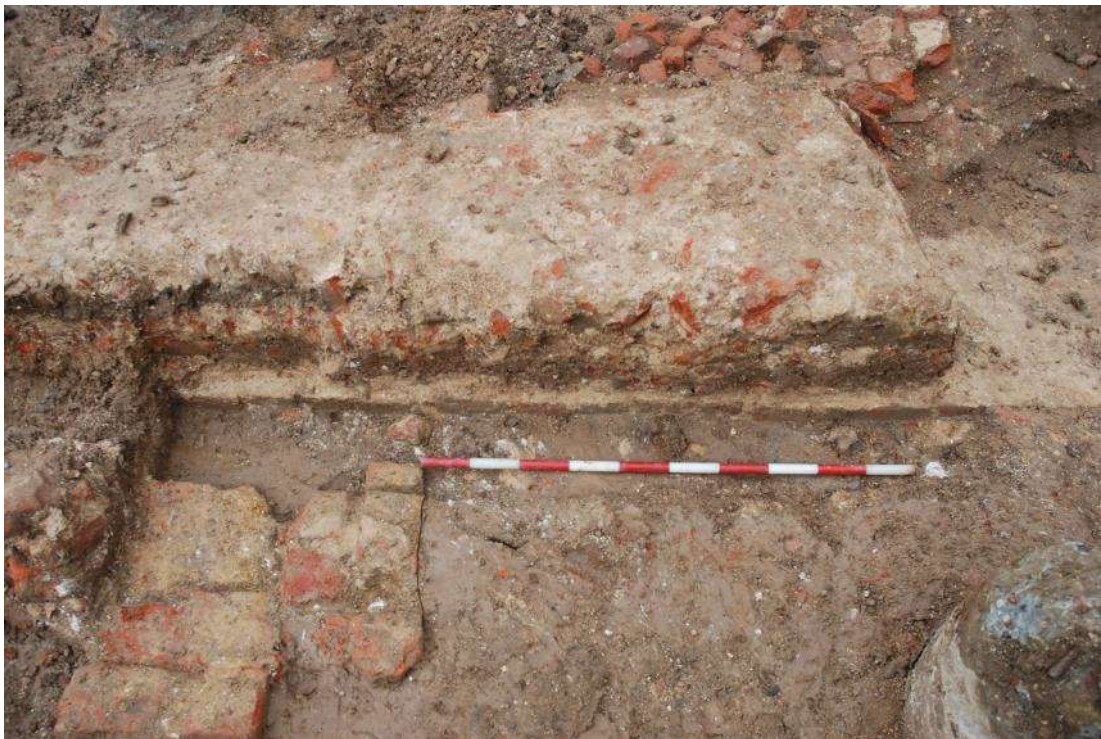
Figure 36: Truncation of [37] by [53]. The bands of mortar and brick redeposited demolition material can be seen, with the surviving wall at the base, above the scale. Facing E. Scale 1m.

- 7.6.4** When the wall fell out of use it was demolished to this foundation level, observed as a messy linear cut [66] varying in width between 0.4 and 0.65m. The cut was subsequently backfilled in four alternating bands of fine brick rubble and mortar demolition material, and more soil abundant backfill (62) – (65) (fig.36).

Although some commingling between the four layers was noted, the banding would suggest a staggered backfill, or multiple episodes of backfilling, rather than one mixed dump of material being deposited.

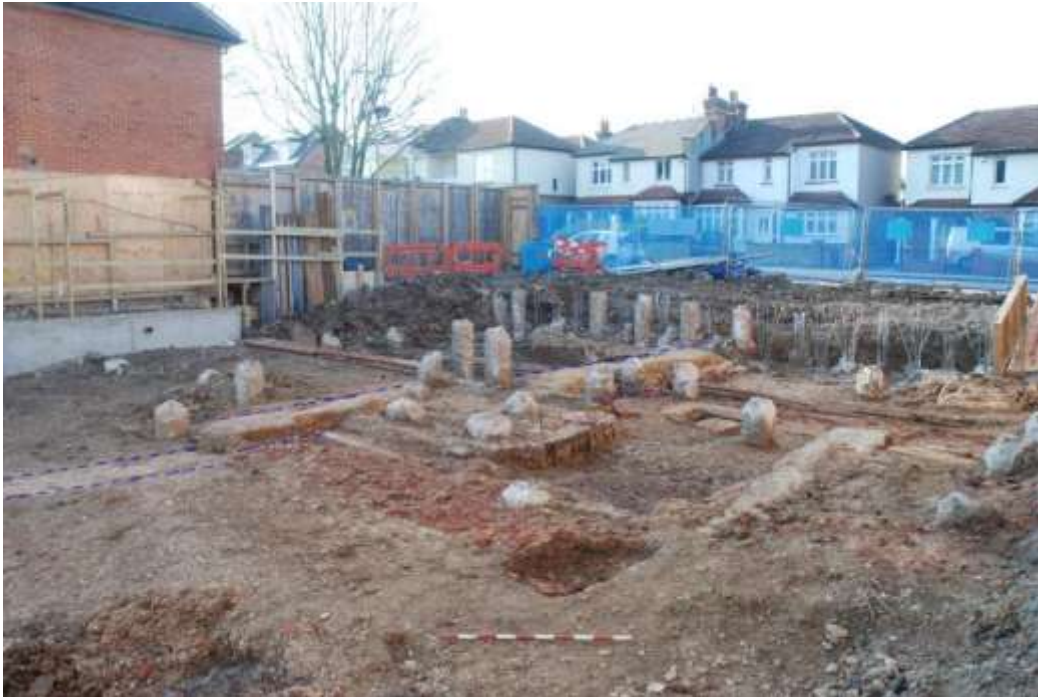
Figure 37: Wall [53] (marked in blue) seen running N-S through the centre of site. Facing NW. Scale 1m.

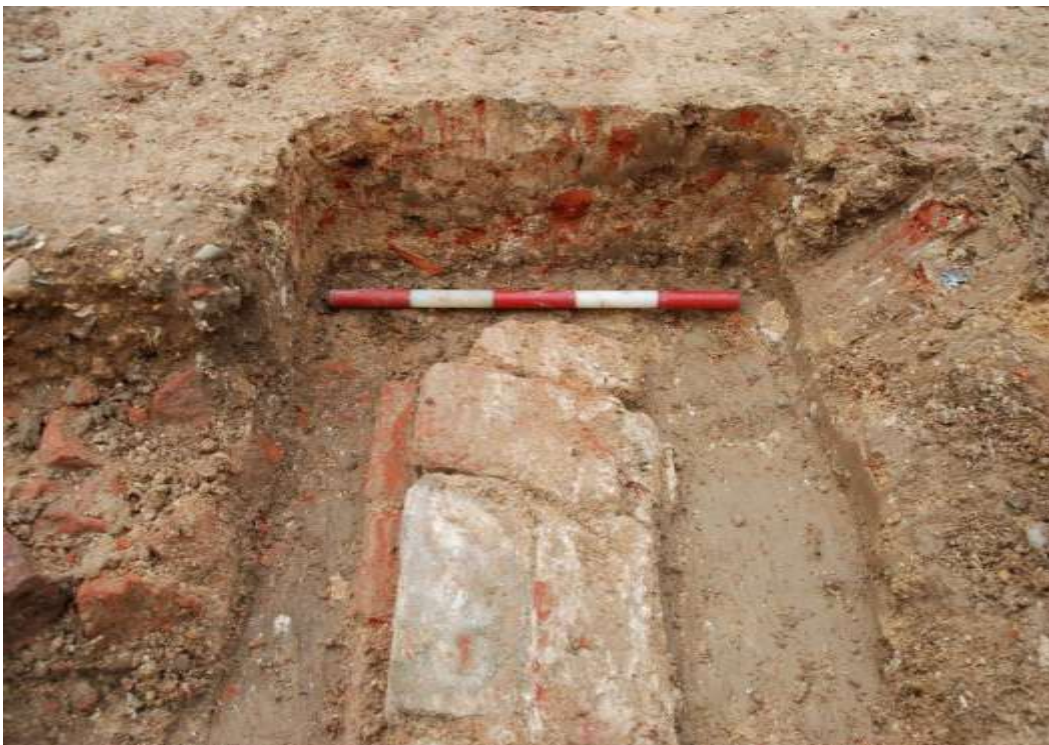
Figure 38: Eastern side of W[53] (opposite side to the above figure) showing the truncation of W[51]. Facing W. Scale 0.5m.

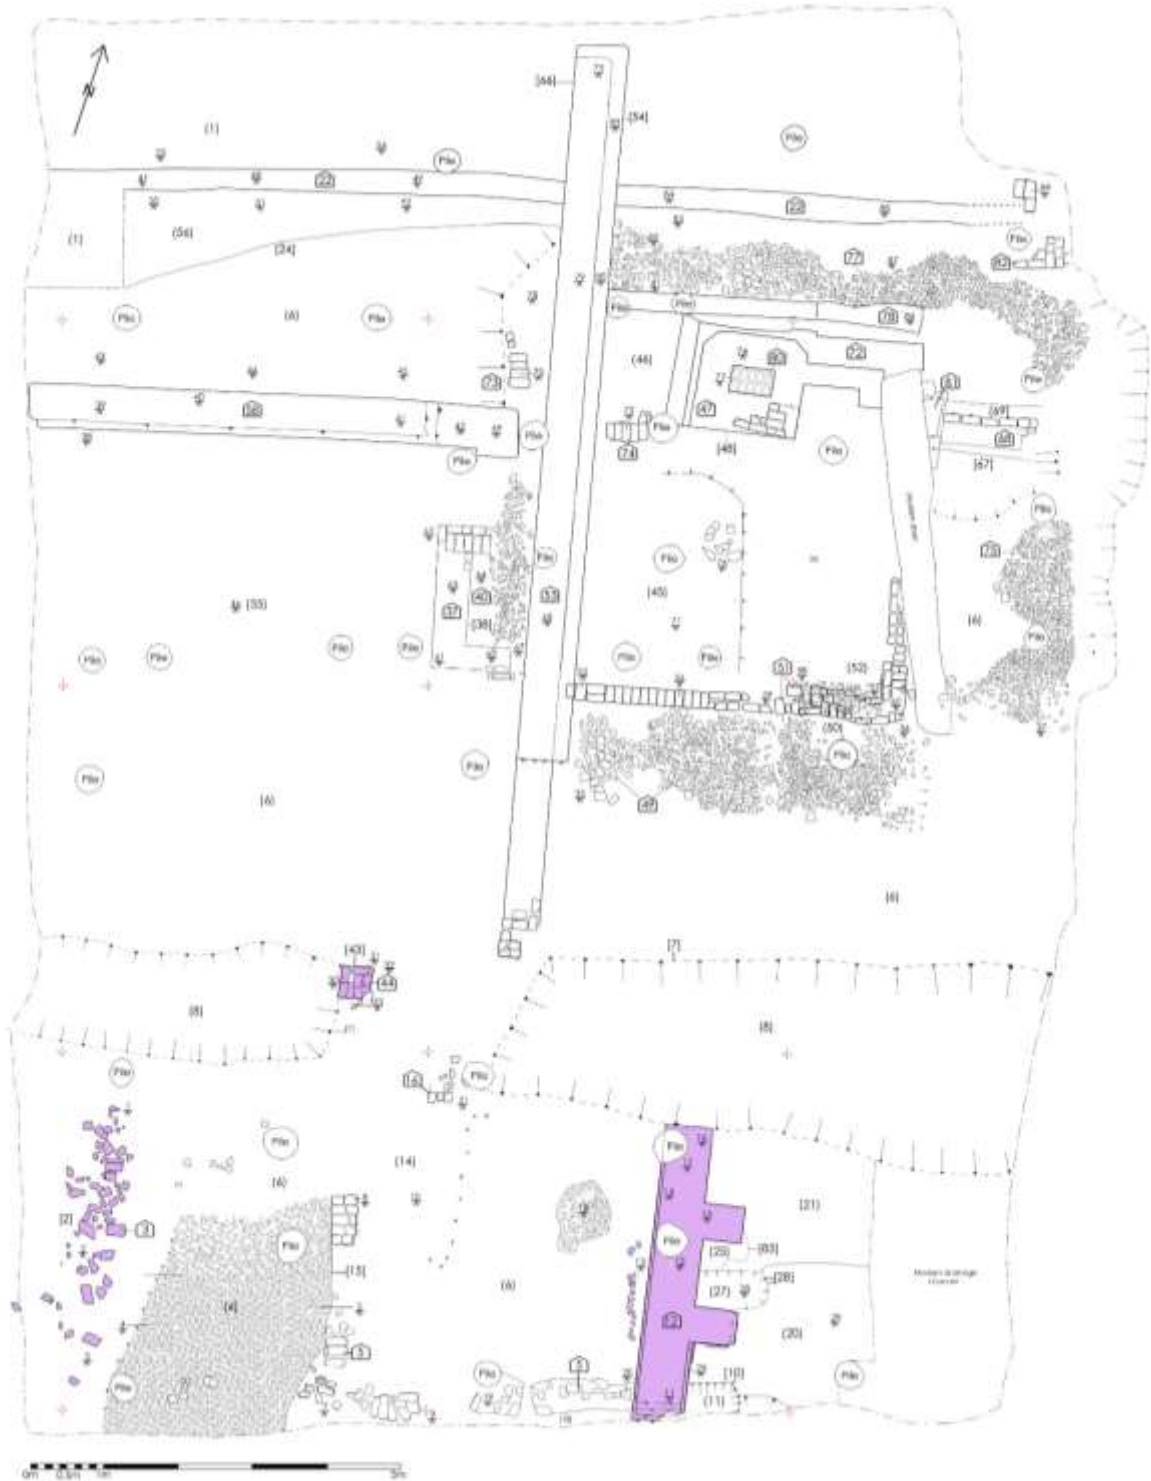
Figure 39: Western wall of the main central block of New Place [12] and western wall of Esdaile's ballroom [3]. Original drawn at 1:20.

7.7.2 The western end of the property was represented primarily by three walls, situated at the southern end of the excavation area. The walls were partially observed and recorded during the 2016 evaluation and archaeological monitoring of the pile capping and trenching (Compass Archaeology February 2017).

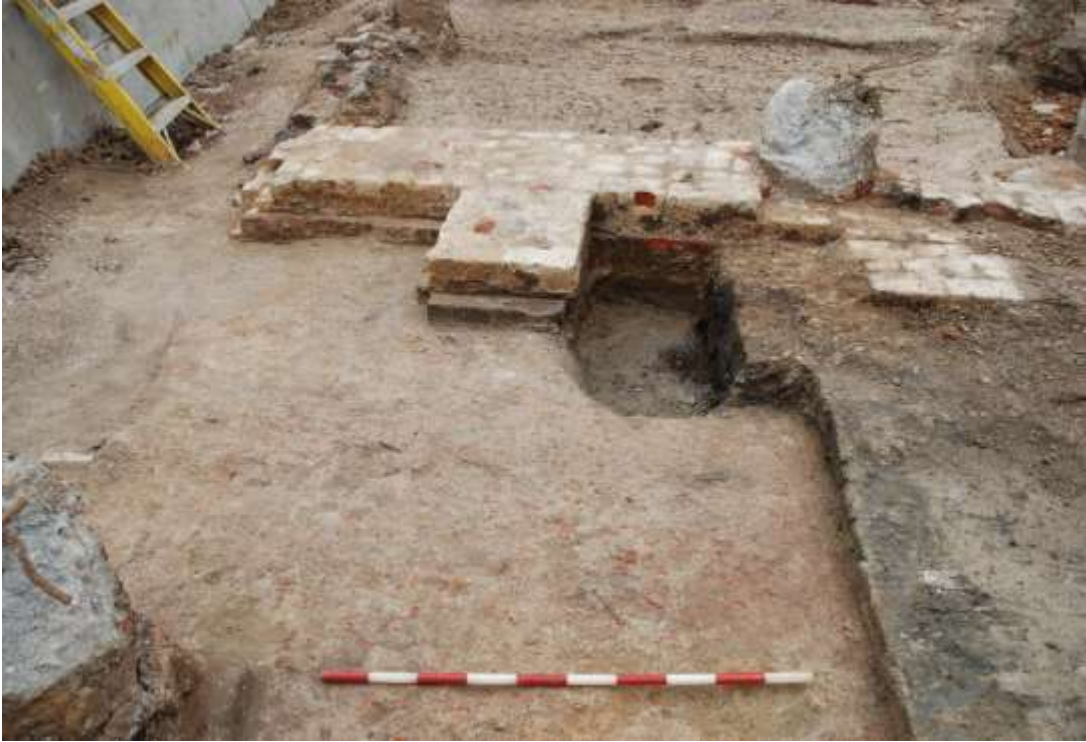
Figure 40: W[12], partially truncated by modern pile. Traces of render can be seen on the east face of the southernmost buttress. Facing W. Scale 1m.

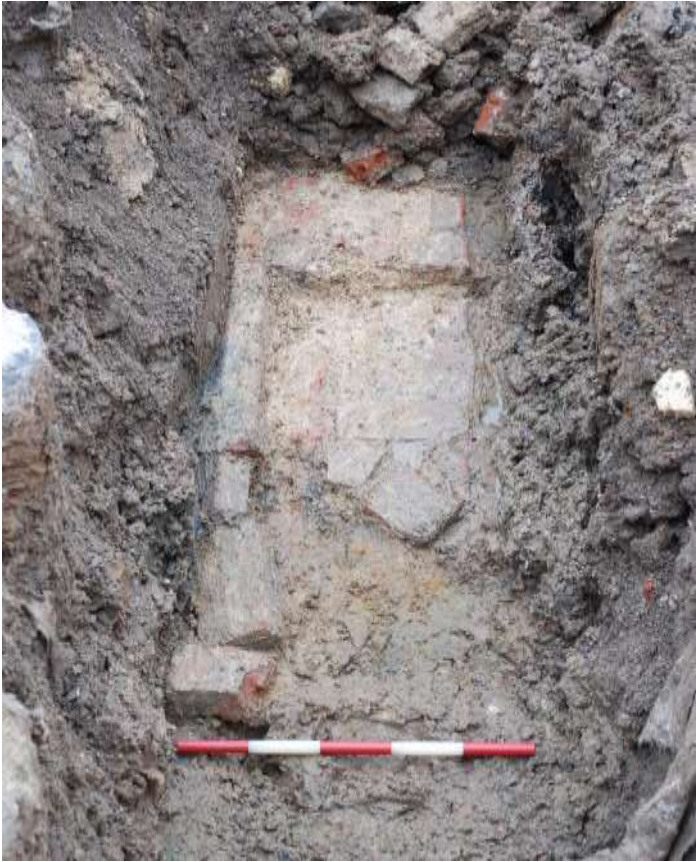
Figure 41: E-W return of W[12] observed during the pile cap trenching. Facing W. Scale 0.5m.

7.7.4 A return of this wall was observed further south, during monitoring of the pile cap trenching (February 2017). The recorded section was aligned approximately E-W, measuring 3.14m in length x 0.47m in width, surviving to a height of 0.34m (5 courses). The easternmost 0.54m was disturbed and partially missing, showing a considerable degree of truncation, with the wall not appearing to extend further eastwards after this point (fig.41).

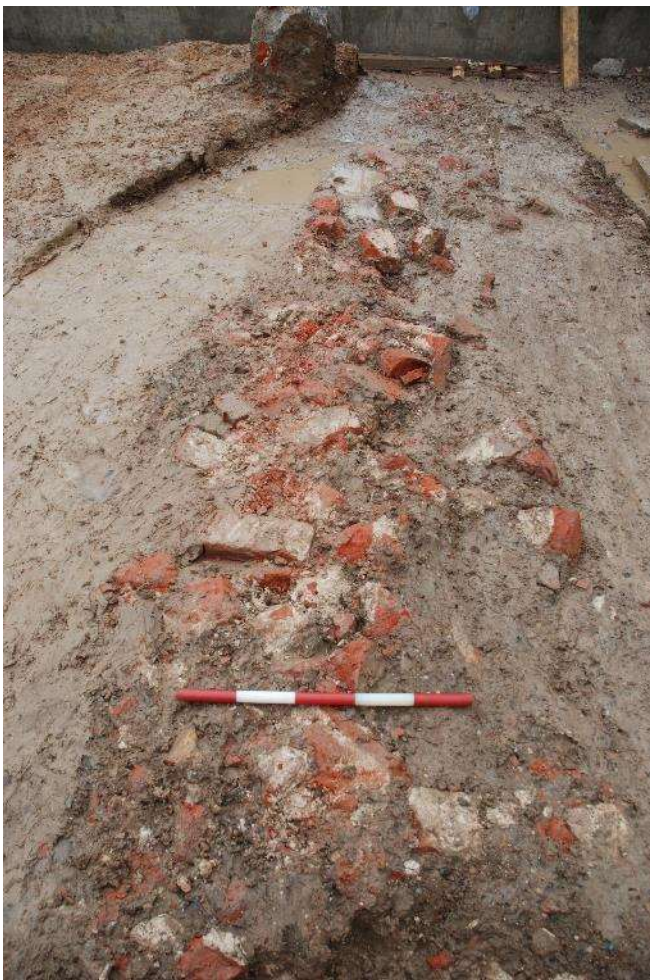
Figure 42: Wall W[3]. Facing S. Scale 0.5m.

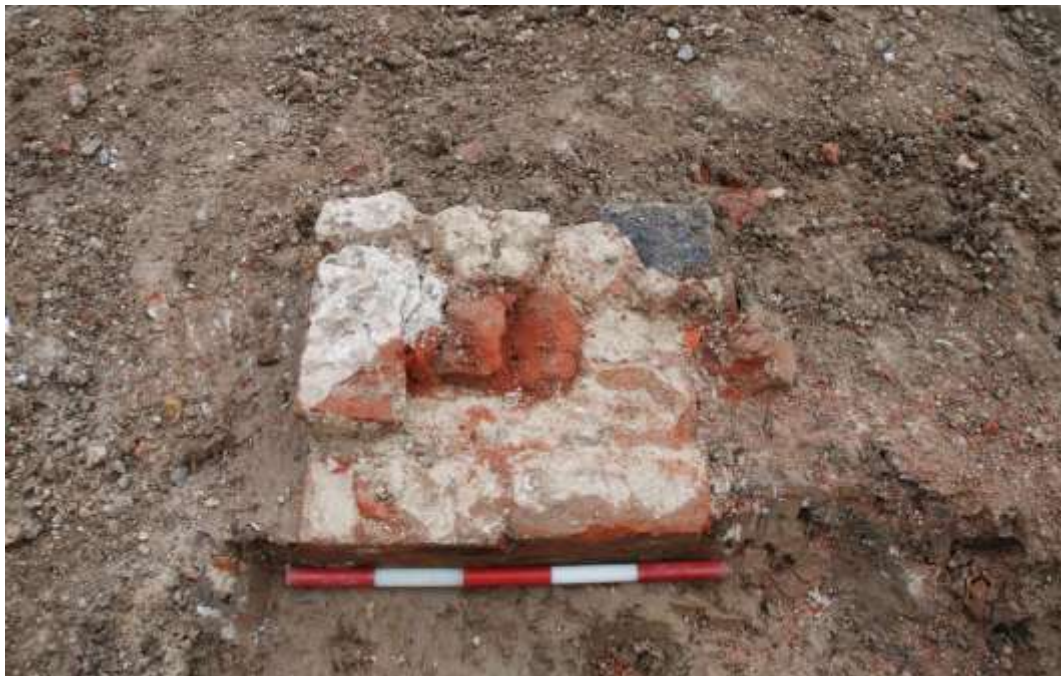
Figure 43: Brick pad [44]. Facing E. Scale 0.5m.

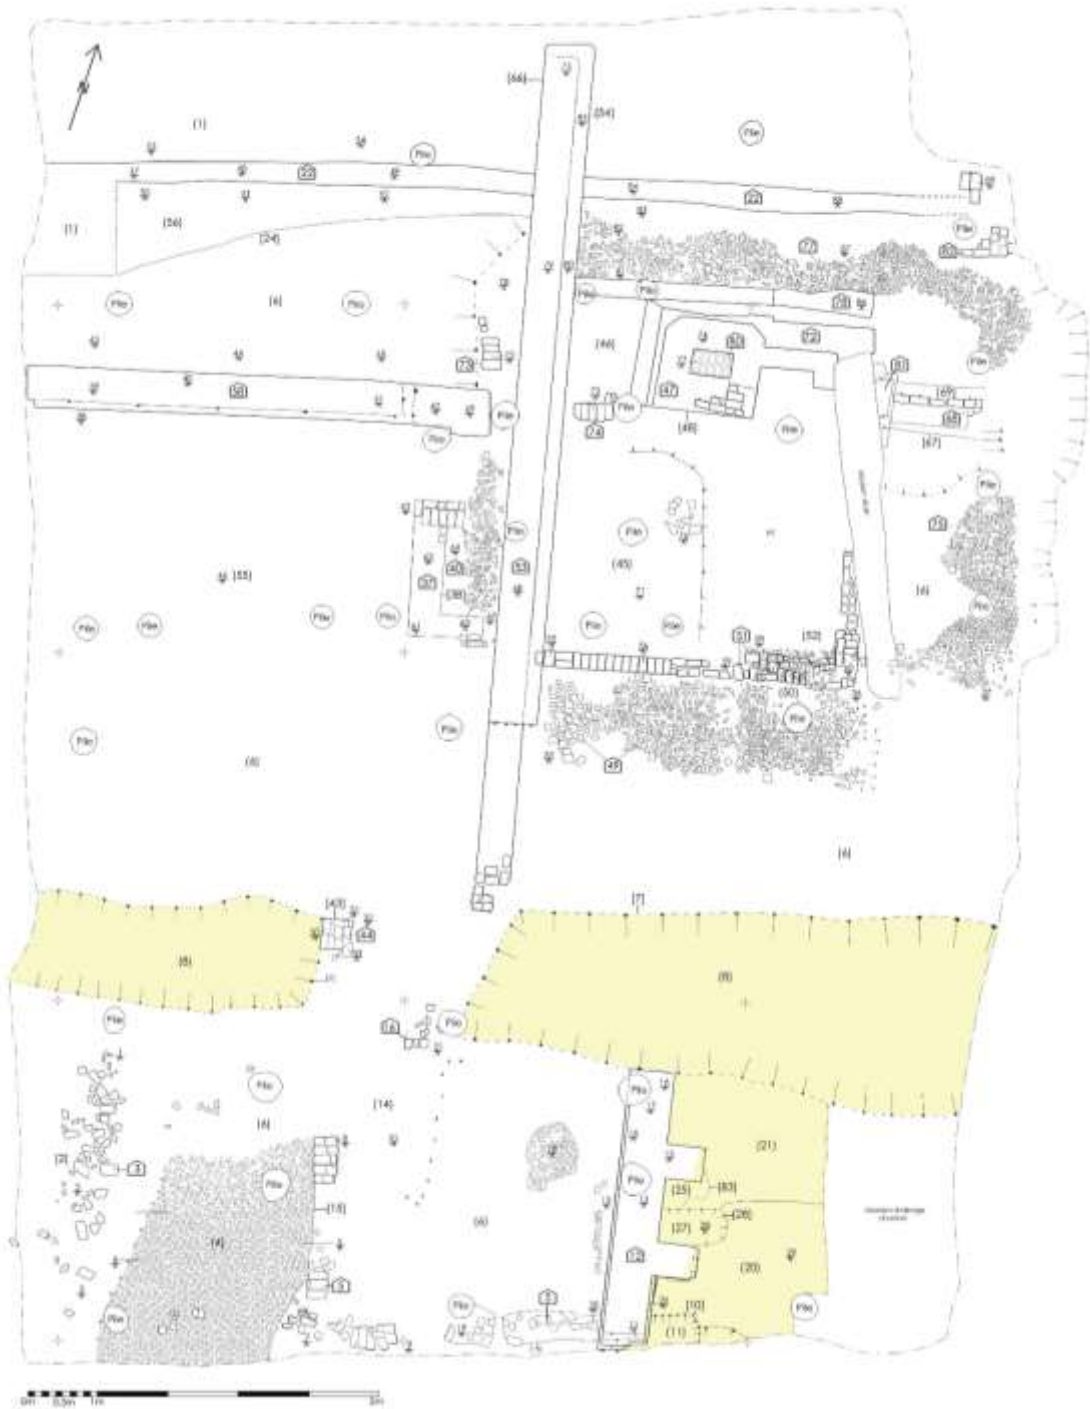
Figure 44: Plan of the site, showing the contexts associated with Phase 5 in yellow. Original drawn at 1:20.

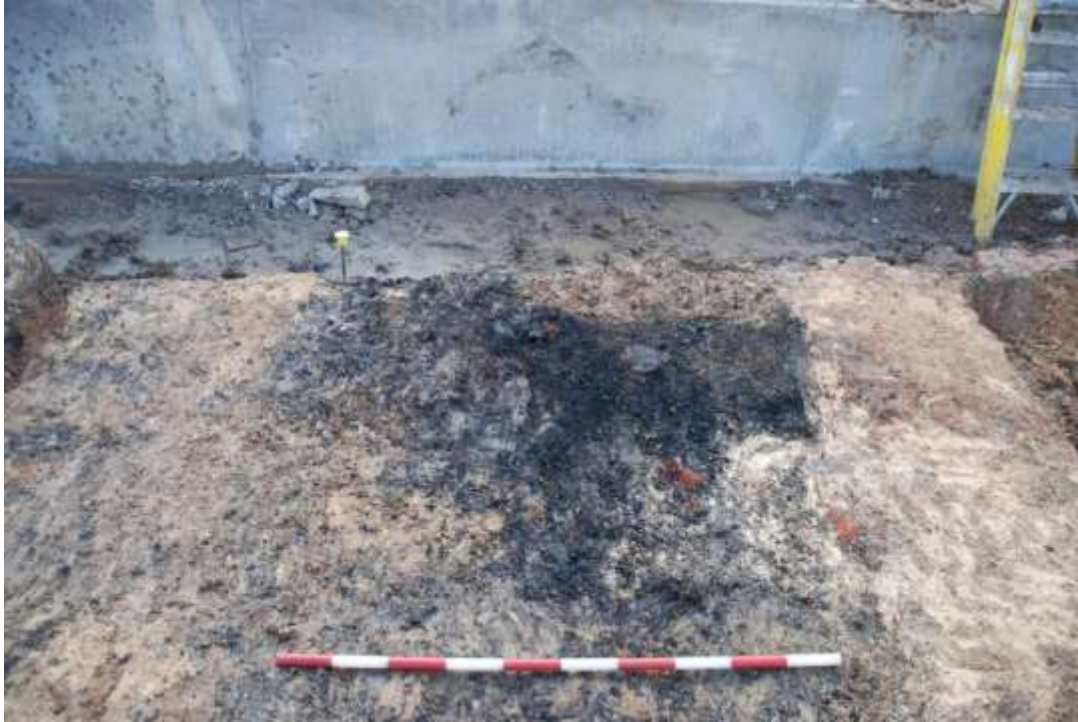
Figure 45: Ash deposit (9) observed overlying (19) and W[12]. The sub-rectangular cut and fill [10] / (11) can be seen towards the top of frame, slightly off-centre. Facing S. Scale 1m.

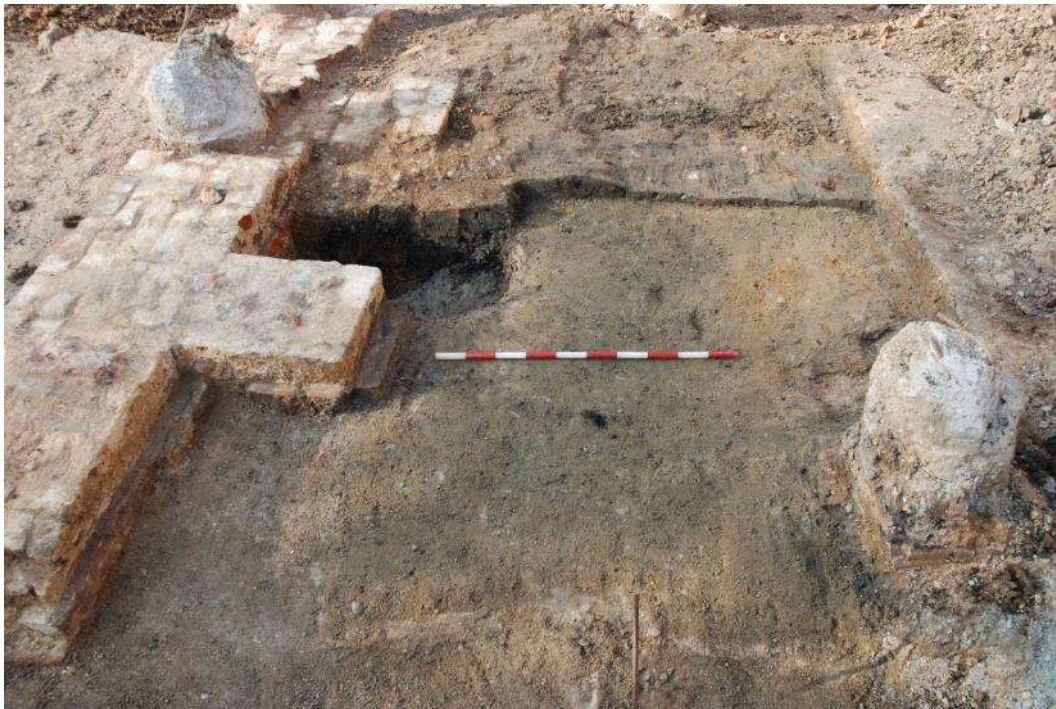
Figure 46: Southeastern corner of excavation, showing (83) after the partial removal of grey clay (21). Facing N. Scale 1m.

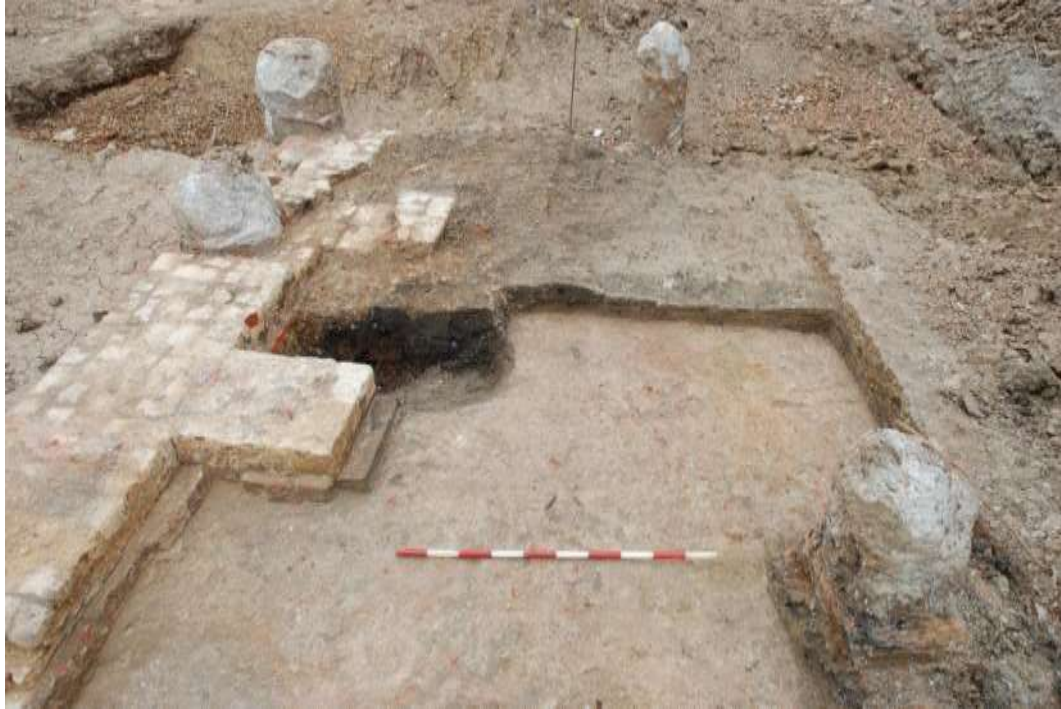
Figure 47: Completed excavation showing the light mortar trample (84) below (83) and (21). Facing N. Scale 1m.

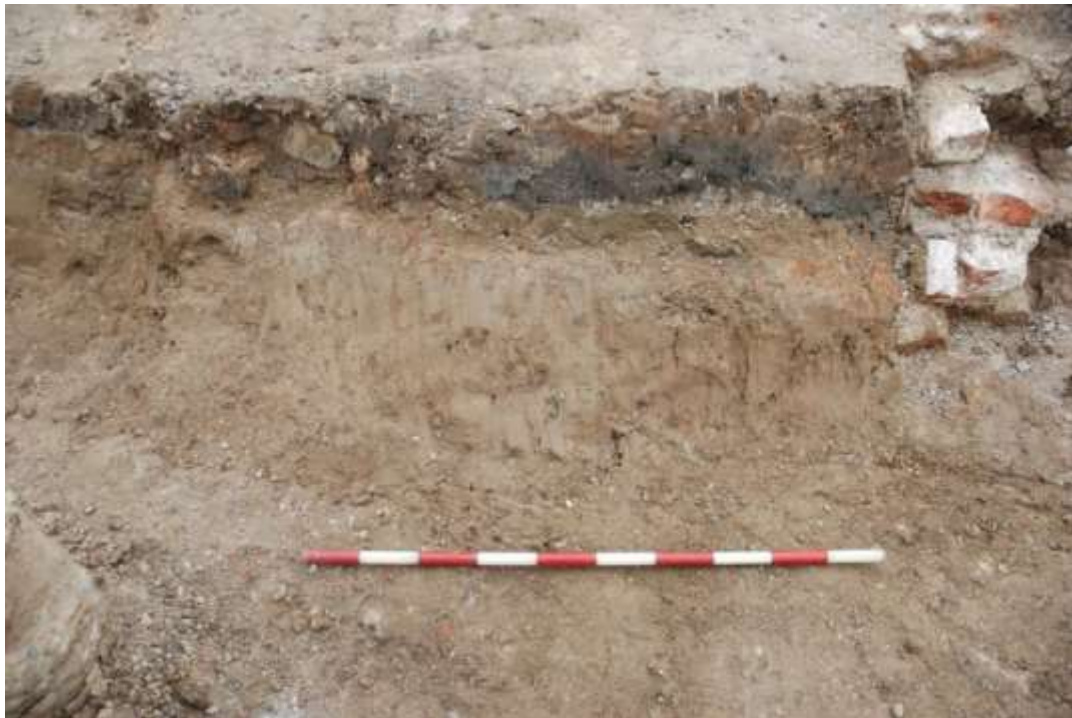
Figure 48: Stratigraphic sequence as observed in the southeastern corner of excavation. With the exception of the fill of the brick drain [47], this area provided the deepest and most comprehensive archaeological section. The truncation to W[12] is caused by the cut of drainage channel [7]. Facing S. Scale 1m.

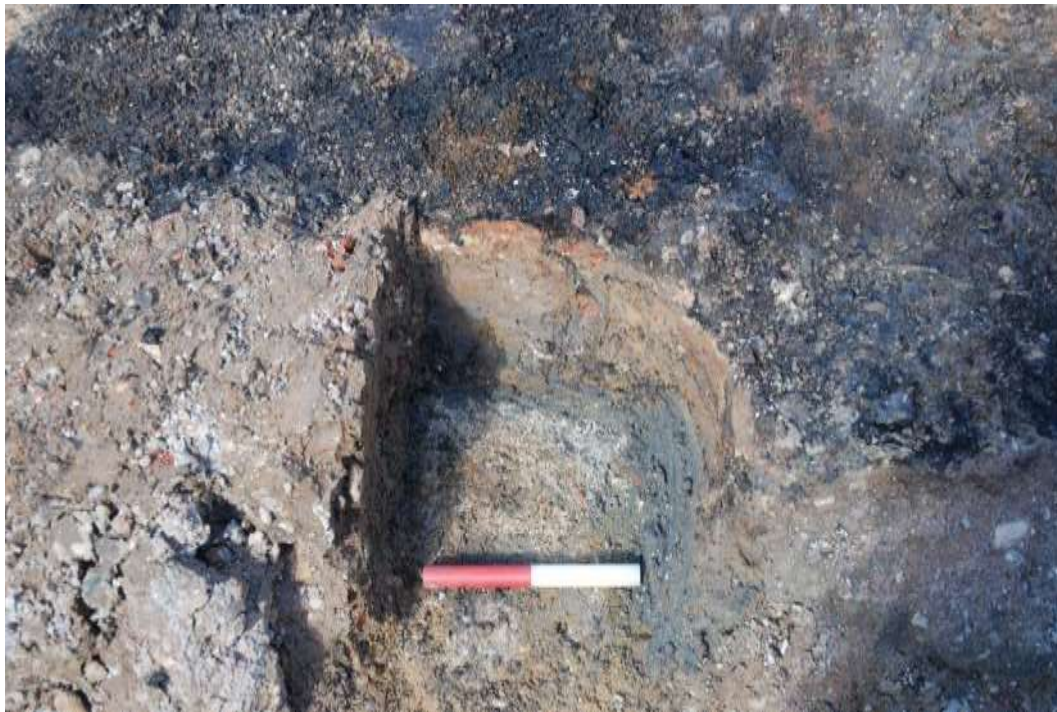
Figure 49: Pit [10] half-sectioned. The grey clay (21) and mortar trample (84) can be seen at the base of the small feature. Facing N. Scale 0.2m.

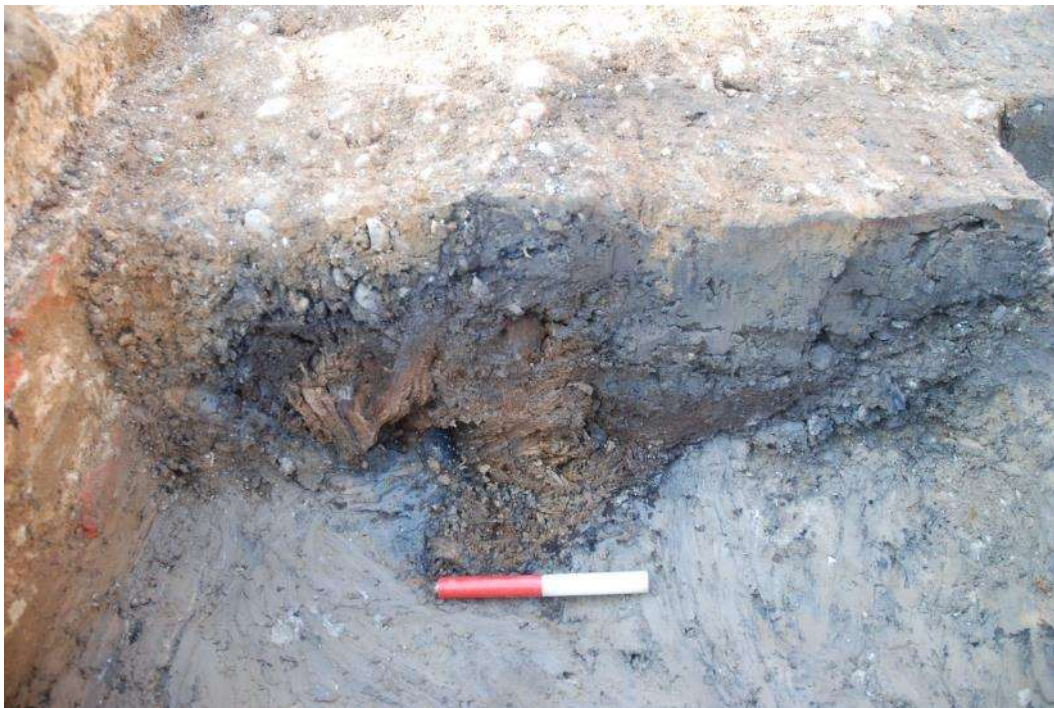
Figure 50: Pit [28], abutting W[12] to the left of frame. Cut [83] and fill (25) can be seen to the top left of [28]. Facing N. Scale 0.2m.

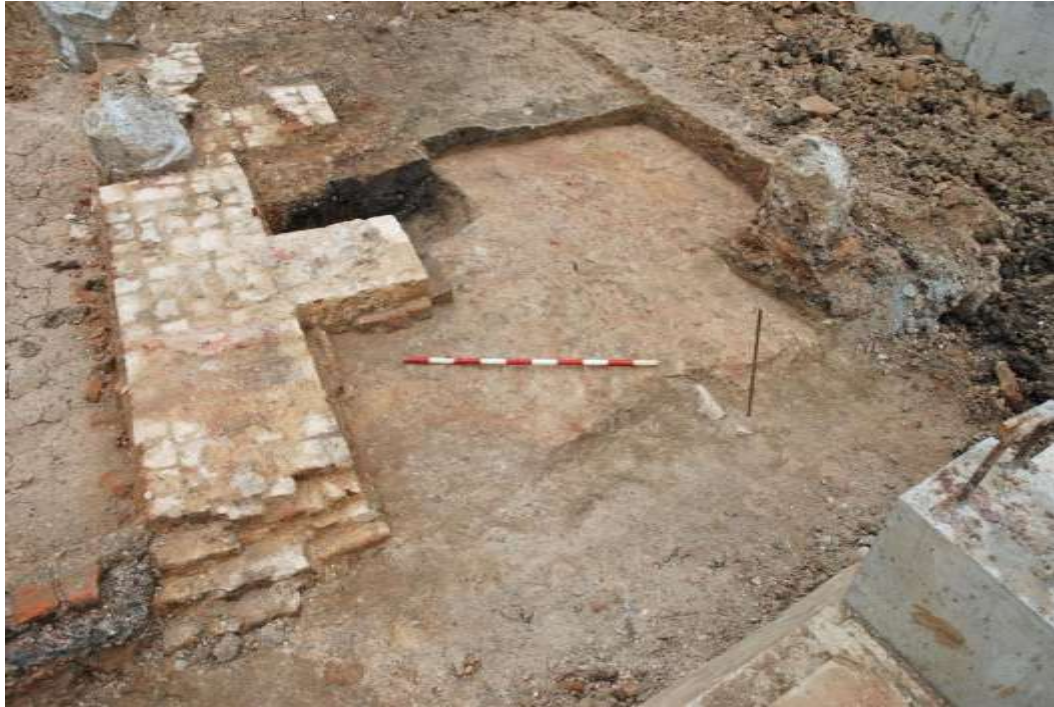
Figure 51: Southeastern corner of excavation showing wall W[12] (truncated by piling) and demolition stratigraphy to the east. Facing NE. Scale 1m.

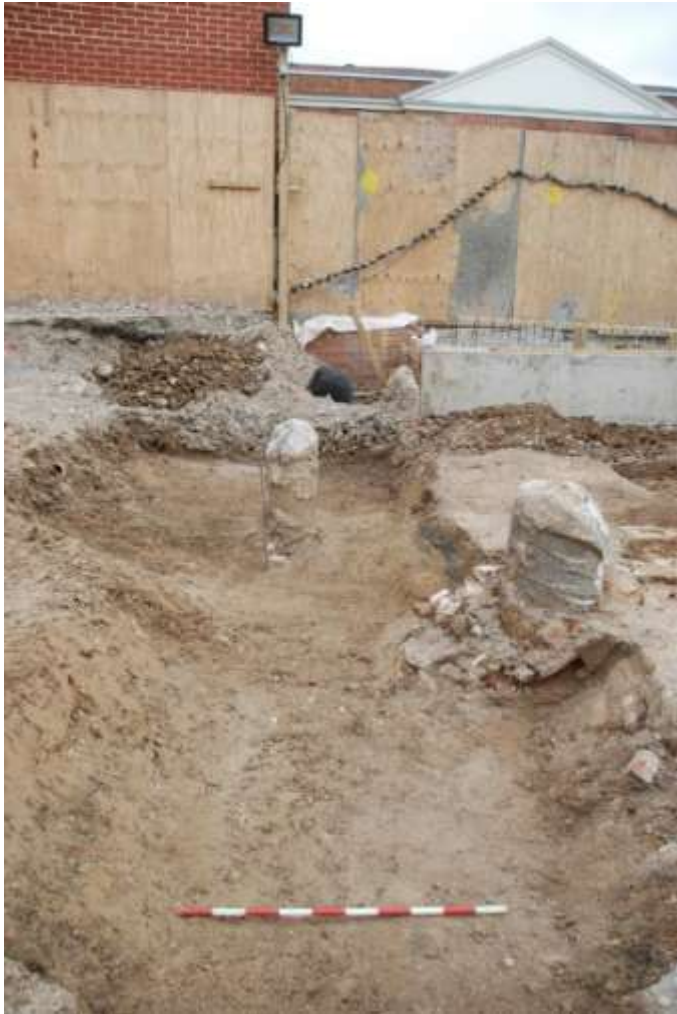
Figure 52: Eastern half of modern drainage channel [7] after removal of fill (8). The white pitched frontage of the Clock House, formerly the stable block to the post-1775 New Place can be seen towards the top of frame above the wooden hoarding. Facing E. Scale 1m.

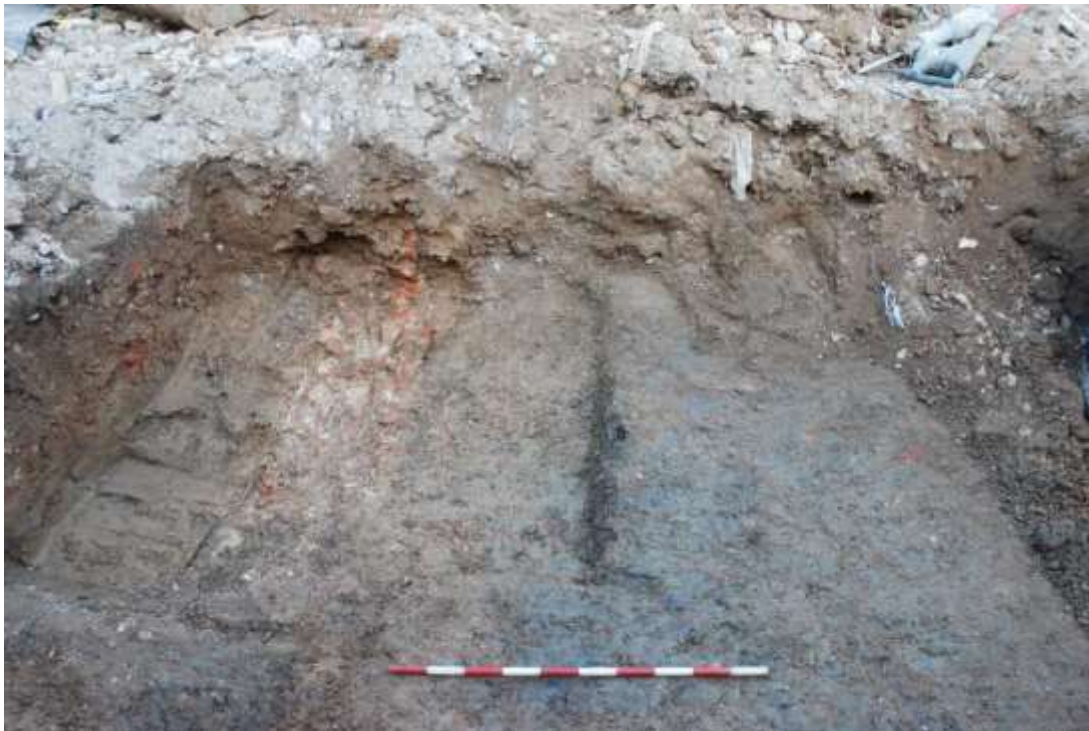
Figure 53: Completed ramp trench, showing modern construction debris overlying stained clay. The drain feature can be seen to the left of frame. Facing E. Scale 1m.

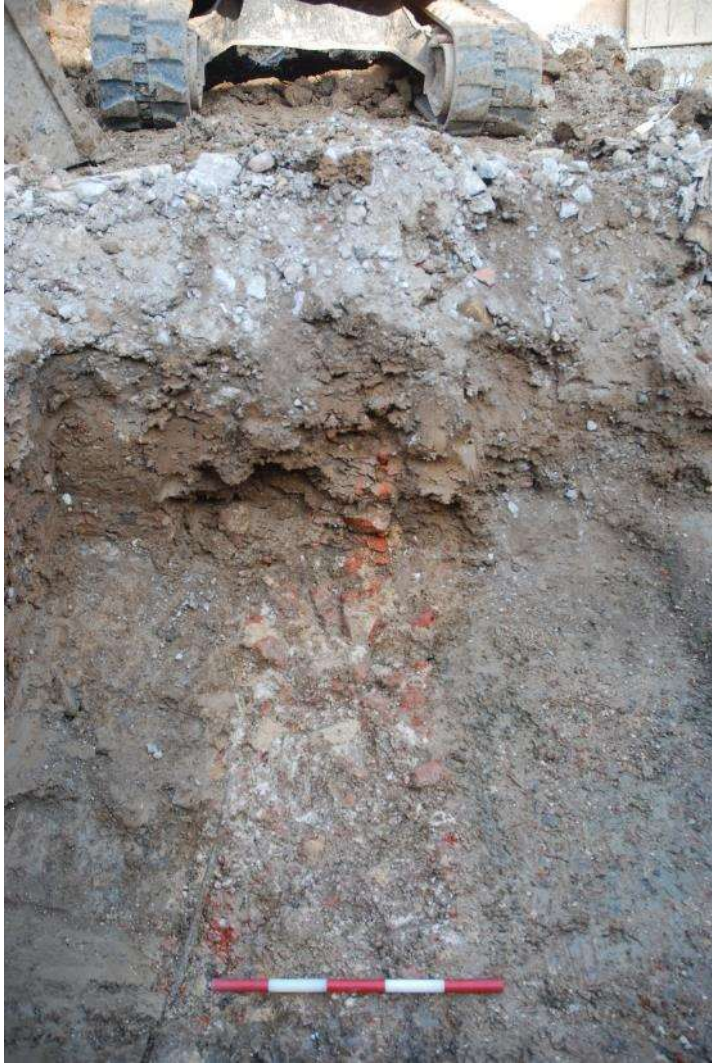
Figure 54: Detail of drain / culvert remains. Facing E. Scale 0.5m.

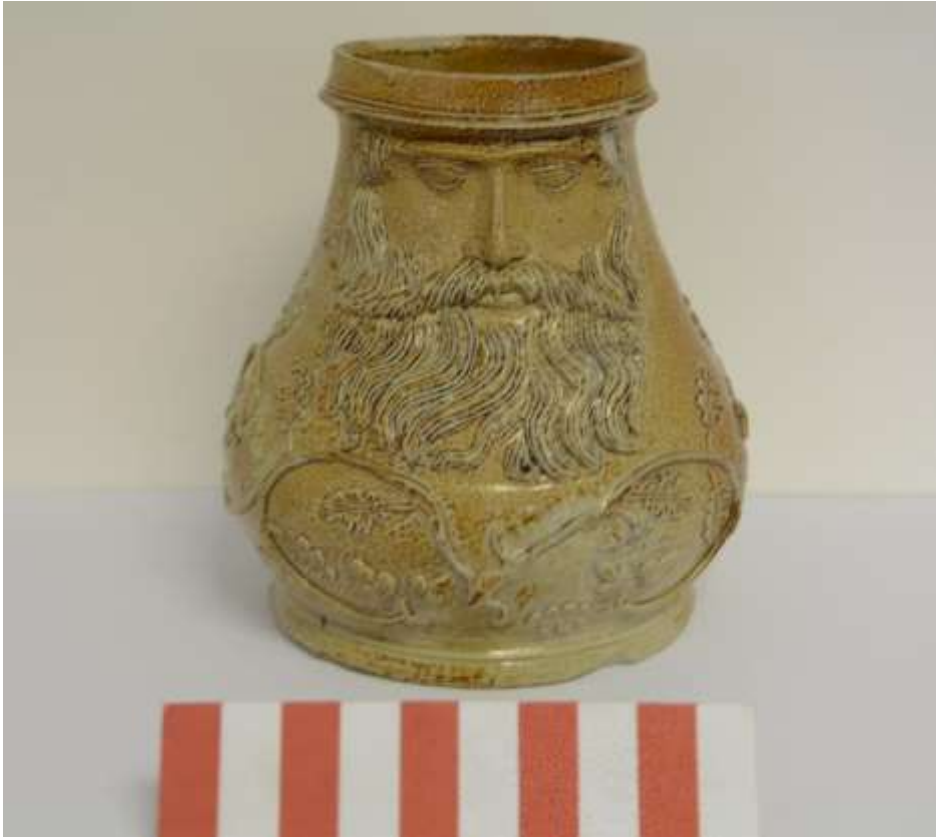
Figure 56: Front view of Cologne Stoneware mug recovered from context (79). Scale 10cm.

The assemblage from context 79 is somewhat curious. Most of the pottery (by sherd count) is 19th century, but it also contained a complete Cologne Stoneware mug with extremely high-quality decoration (figs.56-57), and a largely complete late medieval Colchester Ware jug (fig.58). The former is of extremely high quality, with a finely-detailed moulding in the form of an unusually life-like bearded facemask and oak-leaf-and-acorn decoration. Naturalist face-masks and oak-leaf-and-acorn decoration are hallmarks of the early years of Cologne Stoneware production, and so it seems this vessel is likely to date to the first half of the 16th century (Gaimster 1997, 192). This would fit with the chronology of the near-complete COLS jug from the same context, and suggests an earlier deposit was disturbed, although it is possible that they were curated vessels. Certainly, the mug would still have been usable when it was thrown away.

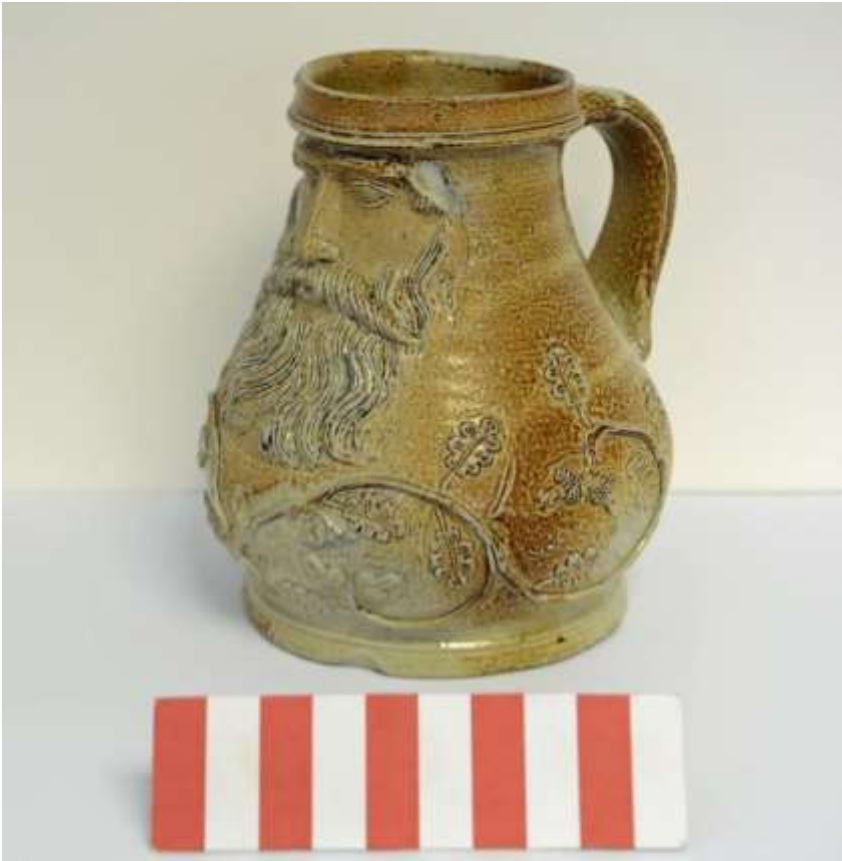
Figure 57: Side view of the mug showing handle. Scale 10cm.
