**EXCAVATIONS AT
230 ST MARY'S LANE, UPMINSTER
LONDON BOROUGH OF HAVERING, RM14 3DH**

An Archaeological Assessment Report

Site code: SMS16

Planning ref: PO811.14

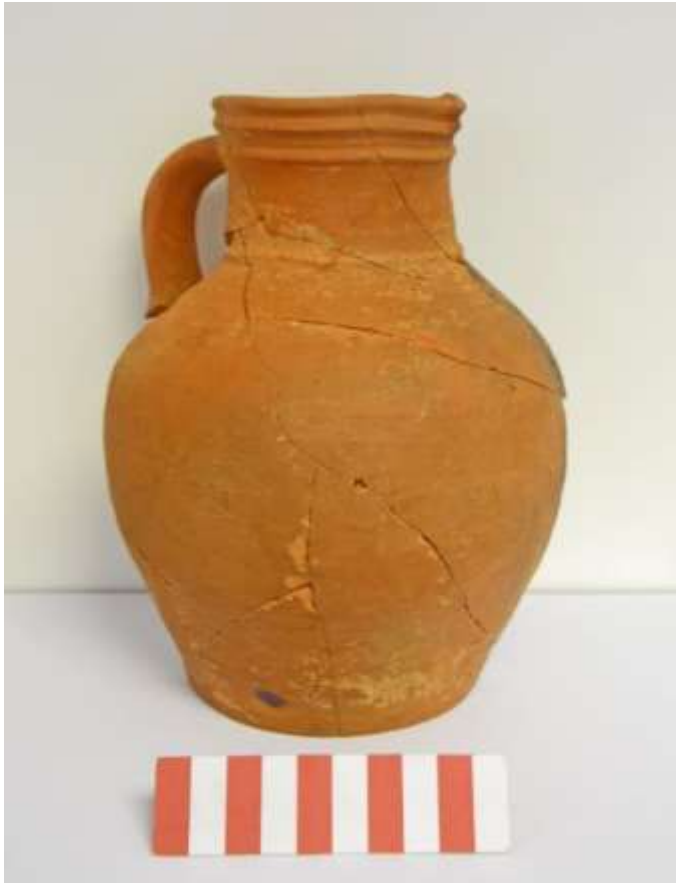
Figure 58: Colchester Ware jug, partially complete, showing handle and shaped rim. Scale 10cm.

The assemblage from context 79 is somewhat curious. Most of the pottery (by sherd count) is 19th century, but it also contained a complete Cologne Stoneware mug with extremely high-quality decoration (figs.56-57), and a largely complete late medieval Colchester Ware jug (fig.58). The former is of extremely high quality, with a finely-detailed moulding in the form of an unusually life-like bearded facemask and oak-leaf-and-acorn decoration. Naturalist face-masks and oak-leaf-and-acorn decoration are hallmarks of the early years of Cologne Stoneware production, and so it seems this vessel is likely to date to the first half of the 16th century (Gaimster 1997, 192). This would fit with the chronology of the near-complete COLS jug from the same context, and suggests an earlier deposit was disturbed, although it is possible that they were curated vessels. Certainly, the mug would still have been usable when it was thrown away.

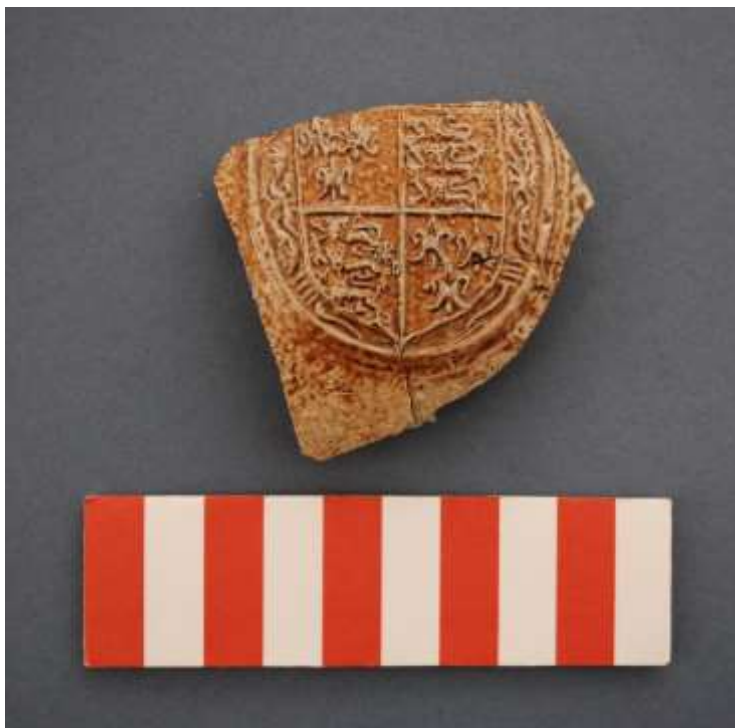
Figure 59: Fragment of Frechen stoneware from (79) with decorative coat of arms. Scale 10cm.

The sherd of Frechen stoneware from context 46 has a large fragment of moulded escutcheon portraying the arms of England (fig.59). Such decoration is well attested on mugs, bottles and pitchers of this type which were made specifically for the English market between the late 16th and mid-17th century (ibid., 210).

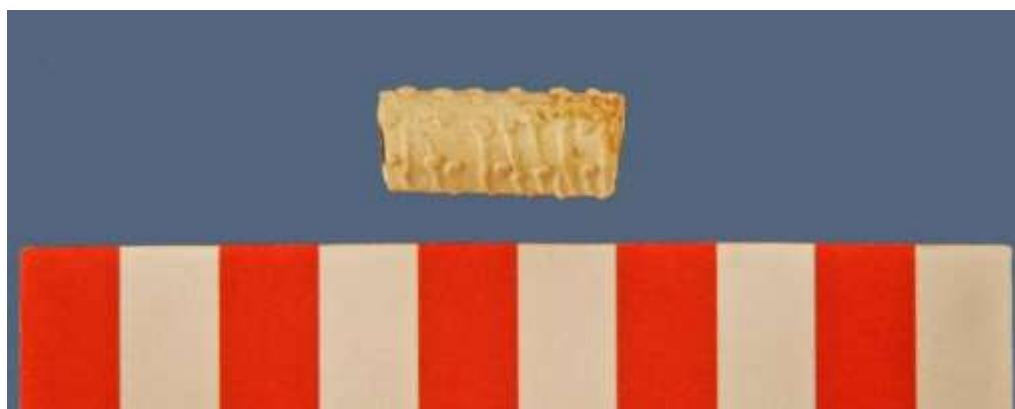
One stem fragment was decorated around each side with a moulded botanical pattern (fig.60).

Figure 60: Moulded botanical pattern on partial stem. Scale 10cm.

(56)	Partial stem	-	-	1	-	-	32	8	3	-
(46)	Partial bowl	21	1680-1710	1	UO	UO	-	-	3	-
(46)	Partial stem	-	-	1	-	-	22	10	3.5	Moulded botanical pattern RS- flower buds/grass around stem. Mild smoke staining around interior (fig. 60)

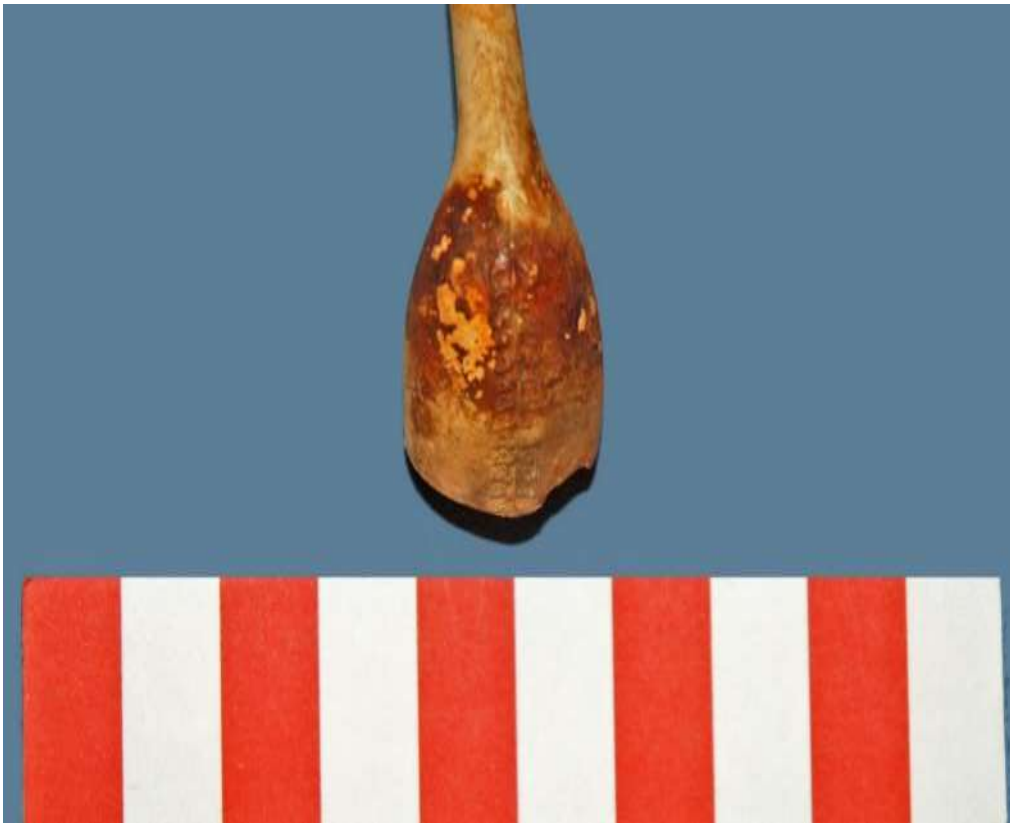
Five of the six later bowls were smoke stained, and four were decorated. The first consisted of a moulded leaf and flower garland up the back of the bowl, along the seam (fig.61). This pipe was rust stained.

Figure 61: Leaf and flower garland on back of pipe bowl, plus iron staining. Scale 10cm.

(79)	Bowl and partial stem	30	1850-1910	1	30	19	54	5	1.5	Stained yellow/brown all over. Smoke staining in bowl. Moulded botanical pattern BA- leaf and flower garland up back seam (fig. 61)

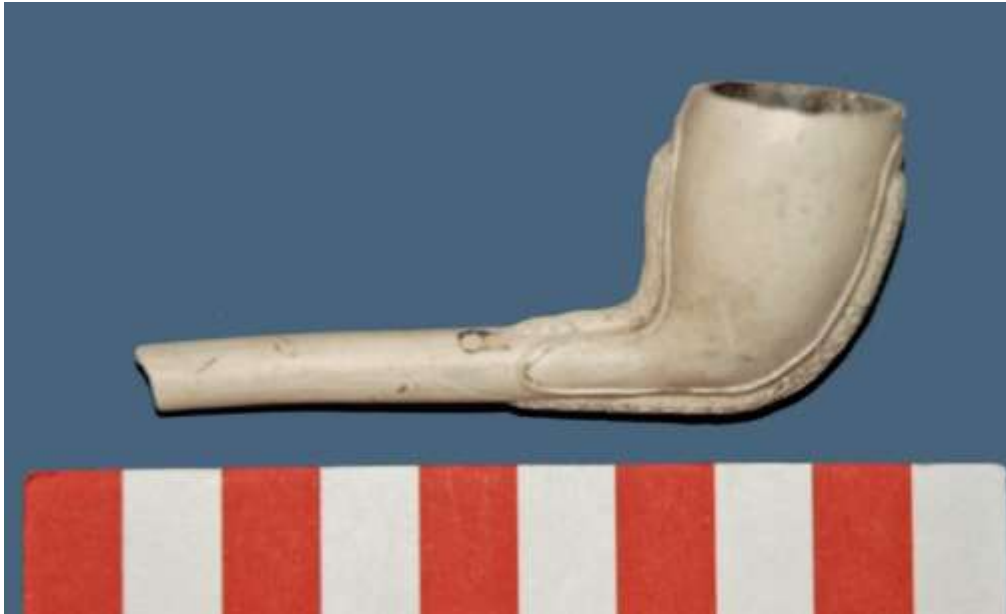
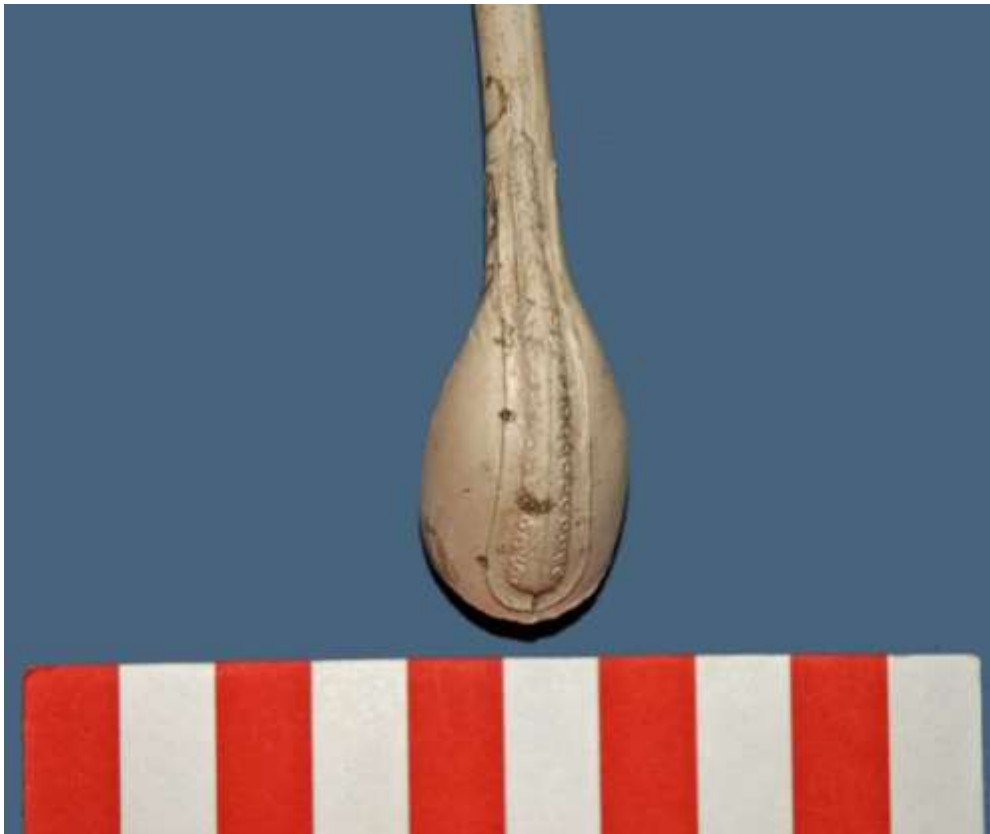
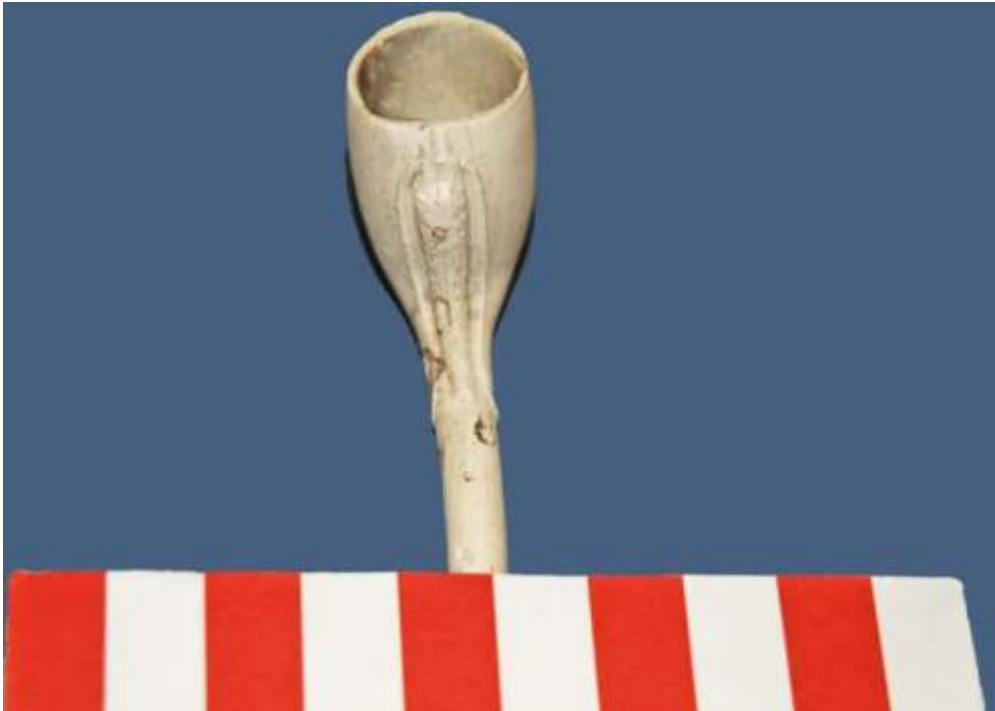
The second bowl was decorated with a more elaborate moulded leaf garland with a border (figs.62-64).

Figure 62: Leaf and garland border, right side of bowl. Scale 10cm.

Figure 63: Leaf and garland border, base of bowl. Scale 10cm.

Figure 64: Leaf and garland border, front of bowl. Scale 10cm.

(79)	Bowl and partial stem	6	1610-1640	1	24	15	45	8	3	Stamped geometric band BC.
(79)	Bowl and partial stem	30	1850-1910	1	32	20	50	6	1.5	Smoke stained inside bowl. Moulded botanical decoration BA, BB and BF-protruding leaf garland with simple line border (figs.62-64)

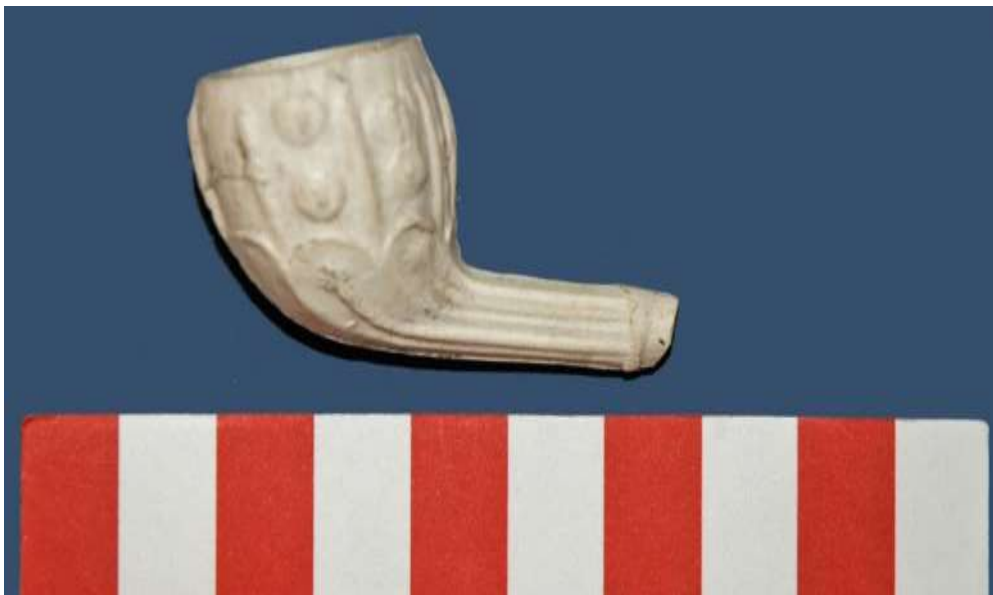
The third bowl was decorated with a moulded scalloped pattern (fig.65). The final decorated bowl was moulded on the sides of the spur, but the pattern was obscured by iron corrosion and staining. All the decorated bowls were the same style and therefore dated to the same period; 1850-1910.

Figure 65: Scallop pattern, left side of bowl. Scale 10cm.
