MITRE SQUARE DEVELOPMENT – PHASE TWO, DUKE’S PLACE, CITY OF LONDON, EC3

**AN ARCHAEOLOGICAL EVALUATION AND WATCHING
BRIEF**

Site Code: DUS 16
Approximate Site Centre: TQ 33460 81182

COMPASS ARCHAEOLOGY LIMITED
250 YORK ROAD
LONDON SW11 3SJ

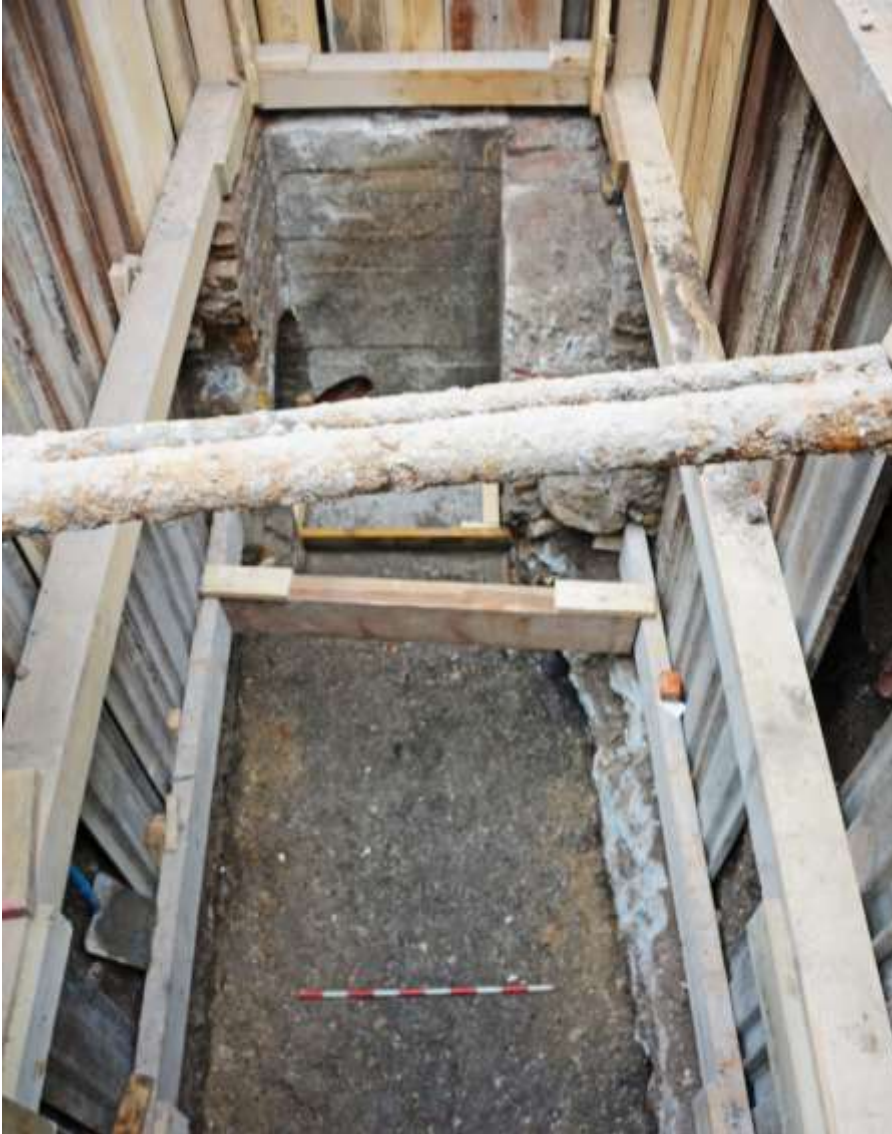
Figure 4: Base of drop shaft looking N. Scale 1m

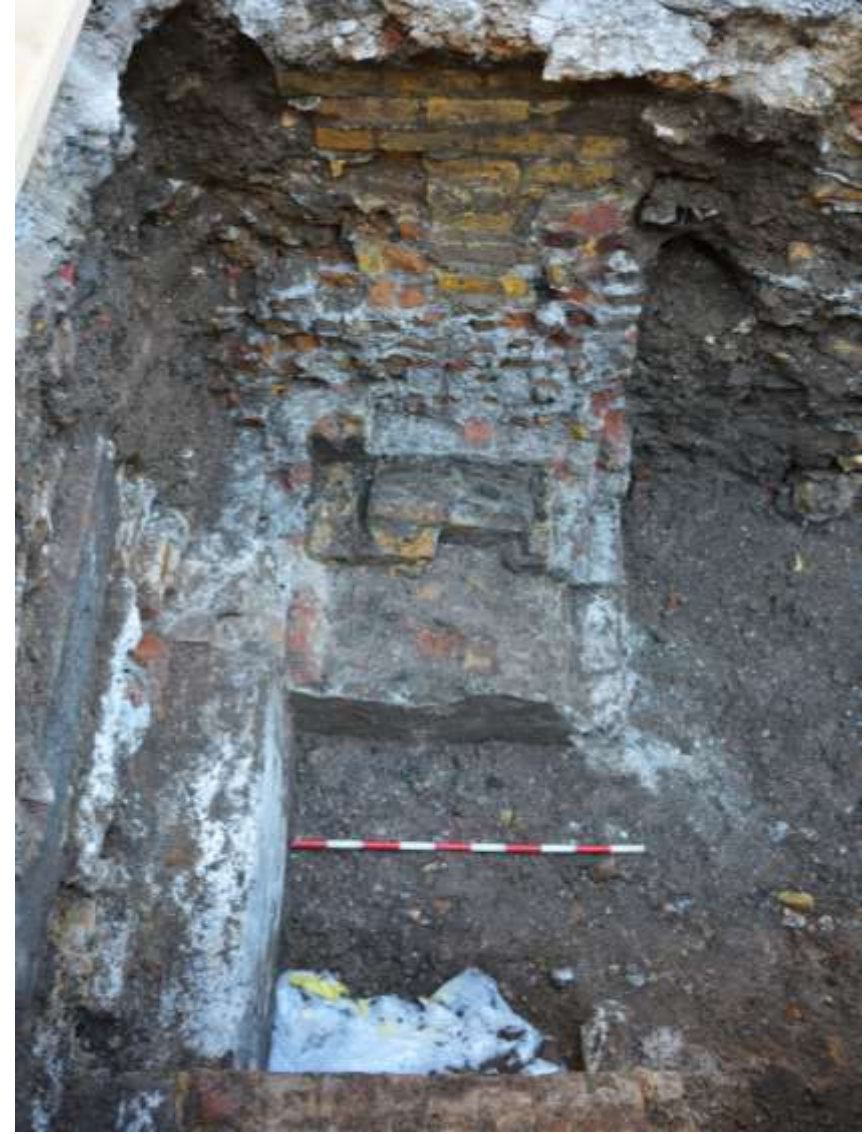
7.2.3 At the northern end of the drop shaft, an E-W oriented brick sewer and associated N-S aligned walkway, [50] were found (fig. 5). The post-medieval sewer was constructed of red and yellow brick, with later concrete alterations/reinforcements. The upper metre was formed of yellow stock bricks in a neat stretcher bond, bonded with gritty grey mortar. The lower meter was more jumbled, made of red brick headers and thick mortar. The brick tunnel was encased by a smoothed concrete cube. A concrete walkway extends southwards in to the trench. To the south of the sewer, a brick structure, [51] was excavated underneath (41). This measured approximately 1m² and was made of mostly yellow stock bricks, with red stock bricks forming the upper 2 courses. It was bonded with a thick, messy, whitish mortar. It has been interpreted as a post-medieval manhole or chamber (fig. 6).

Figure 5: The sewer [50], northern end of the drop shaft. Looking E. Scale 1m

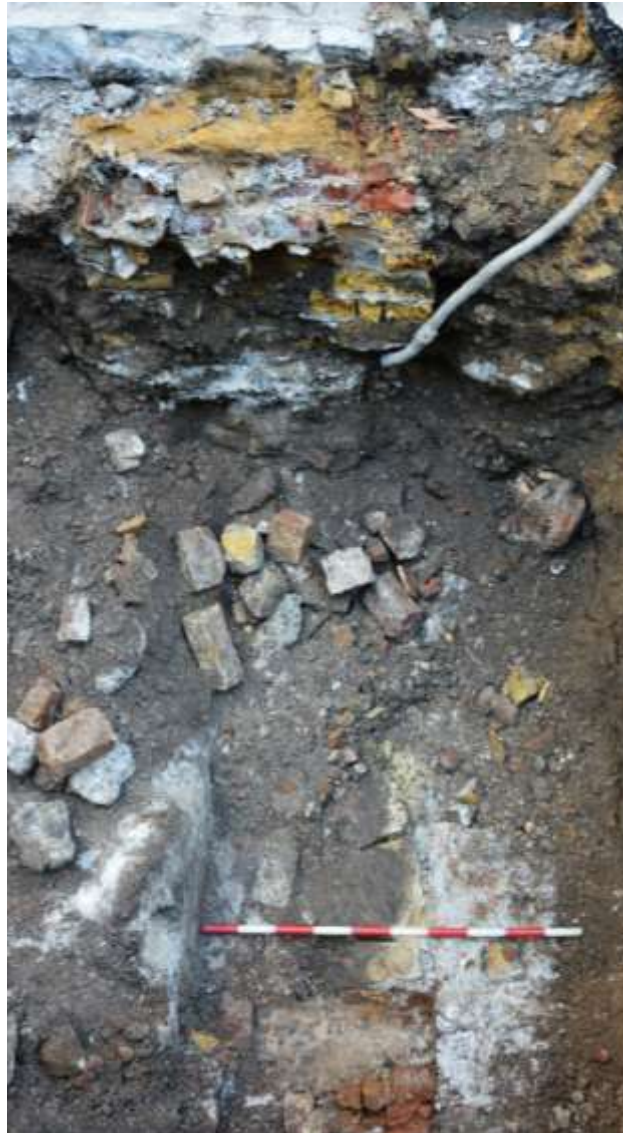
Figure 6: W facing section showing [51] and [55]. Looking E. Scale 1m

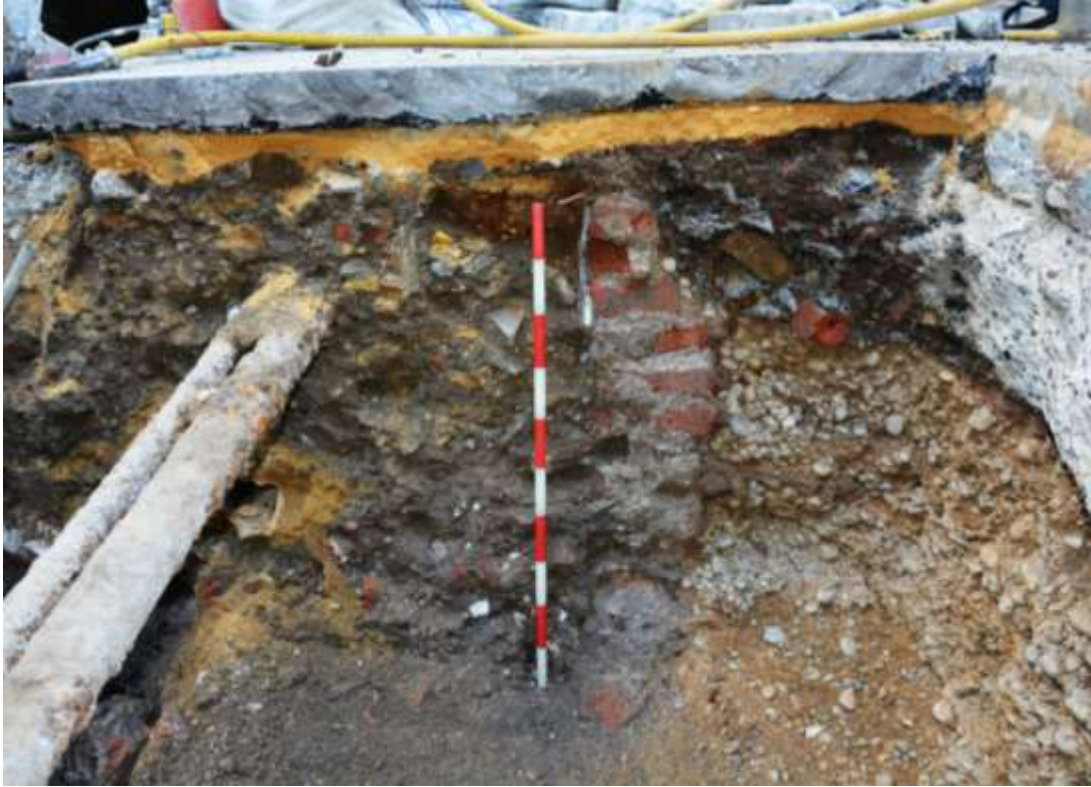
Figure 7: West facing section of south end of drop shaft, showing wall [46] with backfill (45) to the north. Looking E. Scale 1m.

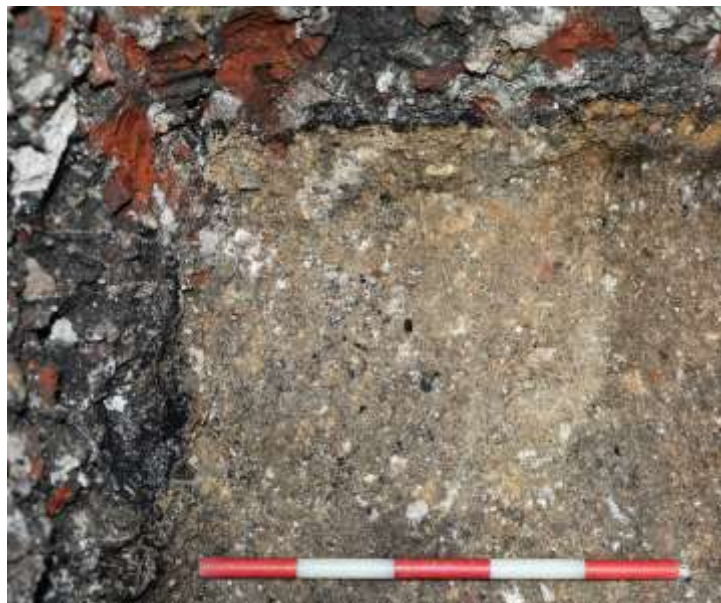
- 7.2.7** (60) and (61) were cut by several small, shallow pits and areas of localised burning that were half sectioned and excavated by hand.
- 7.2.8** [62] was a roughly circular pit in the SE corner of the trench. It measured 450mm x 340mm and was 140mm deep. It was filled with a pale mortar with frequent soil and CBM fragments, (63), indicating it was probably a small dump related to the larger post-medieval demolition event (fig. 8).

Figure 8: Pit [62] and fill (63). Scale 0.5m

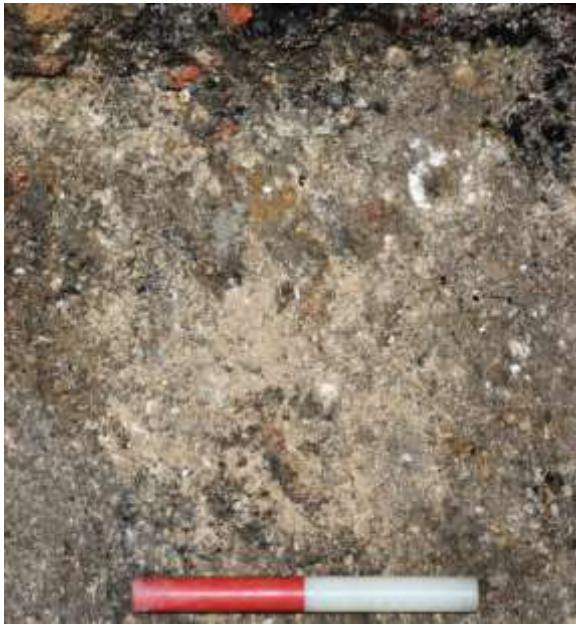
- 7.2.10** Another semi-circular pit, [66] measured 200mm x 1600mm and 20mm deep. It was filled with whitish mortar, (67) (fig. 10).
- 7.2.11** A sub-round cut observed in the SW corner of the trench, [68] measured 480mm x 80mm and 70mm deep (minimum). It was filled by charcoal and black silt, unburnt wood and large brick/stone fragments, (69). There was also some oyster shell recovered from (69), indicating this could have been the remains of a small campfire (fig. 11). Pot and CBM recovered from (69) have been dated as post-medieval.

Figure 10: Pit [66] and fill (67). Scale 0.2m

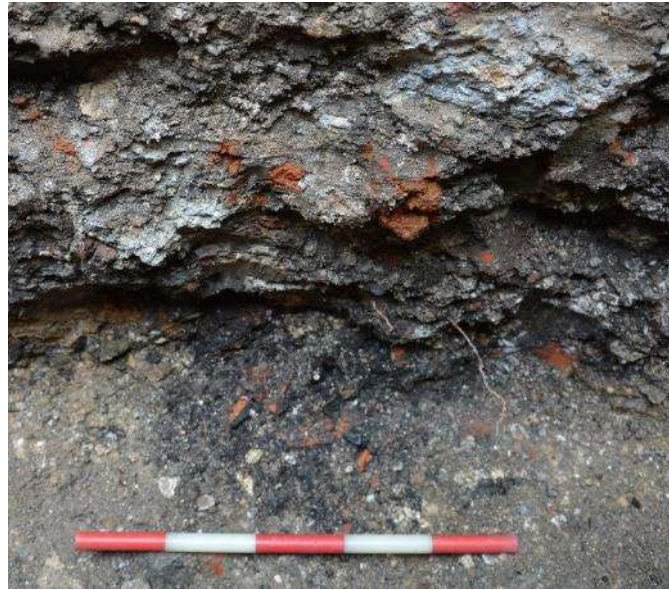
Figure 12: Pit [70] and fill (71). Scale 0.5m

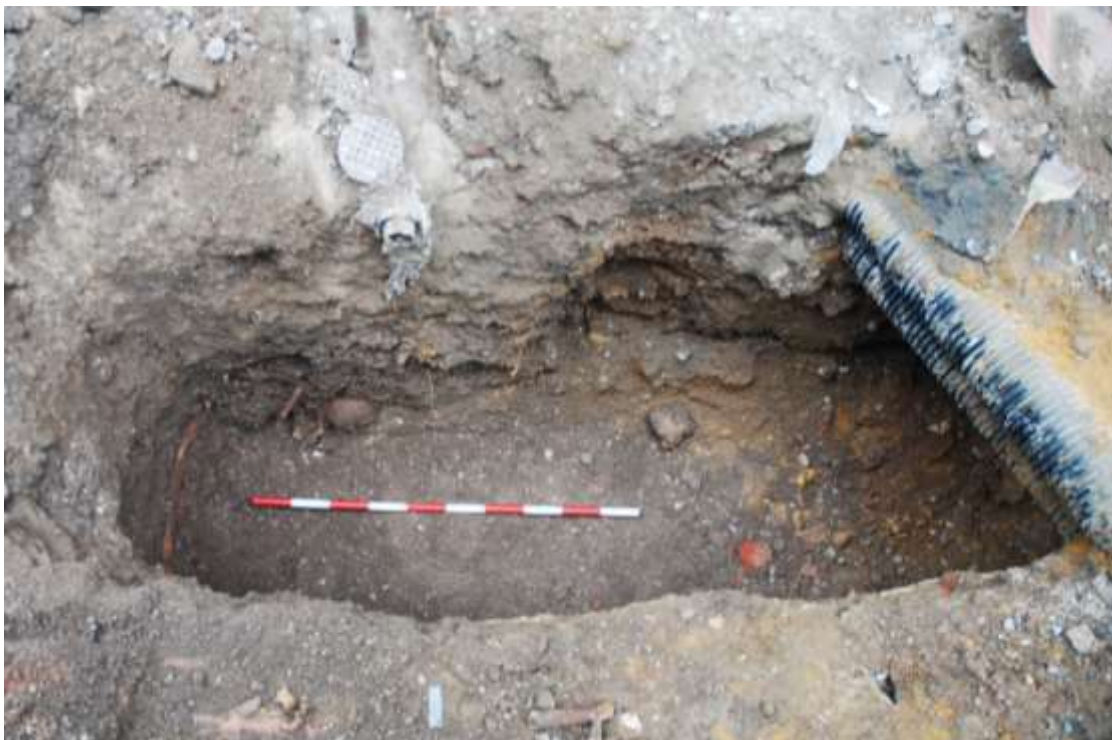
7.3.2 The stratigraphy in this trench comprised of paving slabs, (75) c.70mm thick overlying concrete/mortar bedding, (76) c.100mm thick. Underlying this was a pale grey, fairly compacted gravelly soil, (77) which was c.0.8m thick. A dark brown, loosely compacted sandy soil, (81) lay under (77). This was provisionally 0.3m thick but extended beyond the limit of investigation. This layer contained frequent post-medieval inclusions of CBM, clay tobacco pipe (CTP), glass and pot, as well as a large amount of human remains; articulated and disarticulated, and some coffin remnants including iron nails and wood (fig. 14). (81) appeared only in the north-eastern end of the trench, not extending beyond a NW-SE aligned wall, [82] found at the south-western end of the trench.

Figure 14: Section of trench 1 showing (77) (light grey) overlying (81) (darker brown). Some human remains are visible in upper left side of the trench. Looking NW. Scale 1m

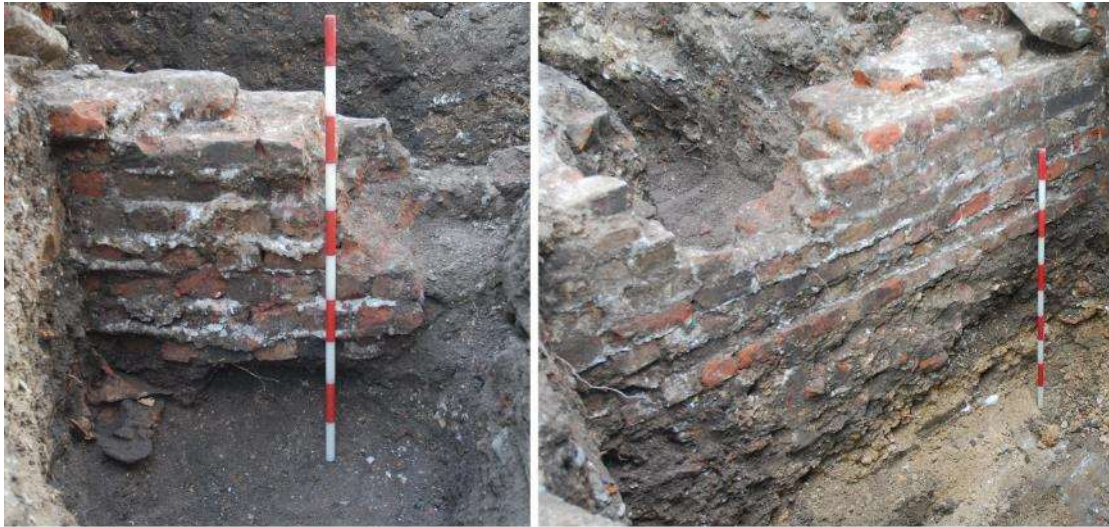
7.3.3 [82] was a red brick wall, consisting of eight courses bonded with hard, whitish mortar. It was found at a depth of 0.58m from the surface level. The wall was roughly faced on the eastern side and much smoother on the western side, indicating it was probably the external wall of a basement (fig. 15).

Figure 15: Wall [82] showing E (left) and W (right) sides. Note difference in bond. Scale 1m

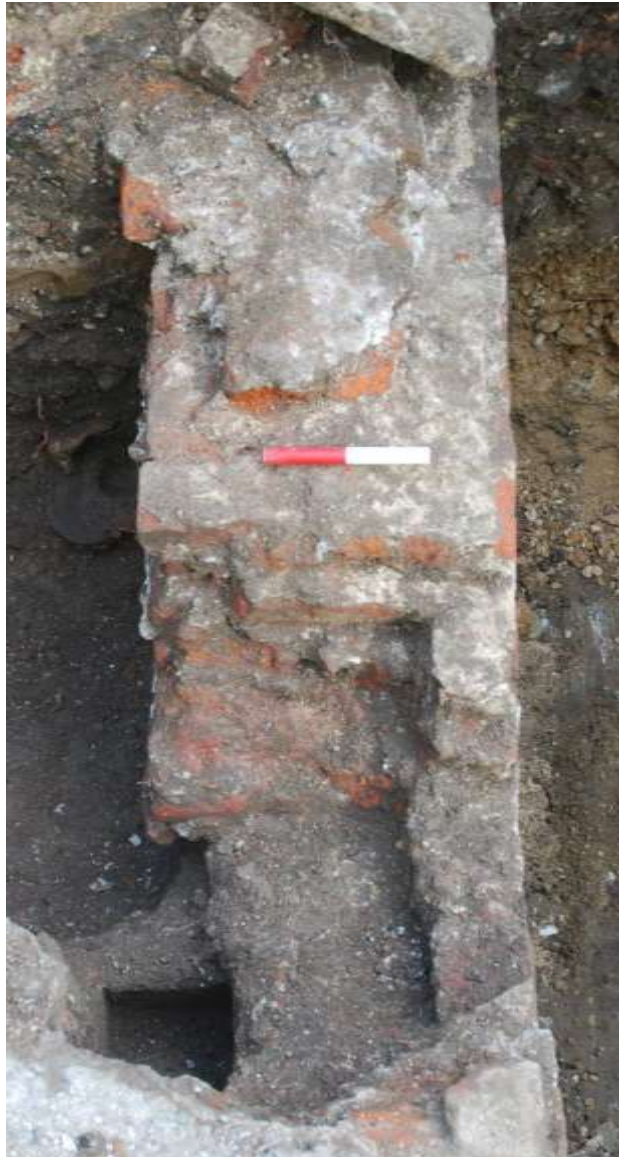
7.3.4 A square posthole, [86] was found at the northern end of [82], measuring roughly 0.2m², and c.0.4m deep (fig. 16). The sides of the posthole were vertical and smoothed, indicating that (87) was not its original fill. (87) comprised a very loose brownish-grey silty soil visible mainly at the base of the posthole, with some surrounding the four worked stones that were loosely packed in at the top. These stones were rectangular, measuring, on average, c.0.2m x 0.1m x 0.07m. (87) was backfill, introduced into the posthole when the original solid post had either rotted or been removed.

Figure 16: Top of [82] showing the posthole in bottom left corner. Scale 0.2m

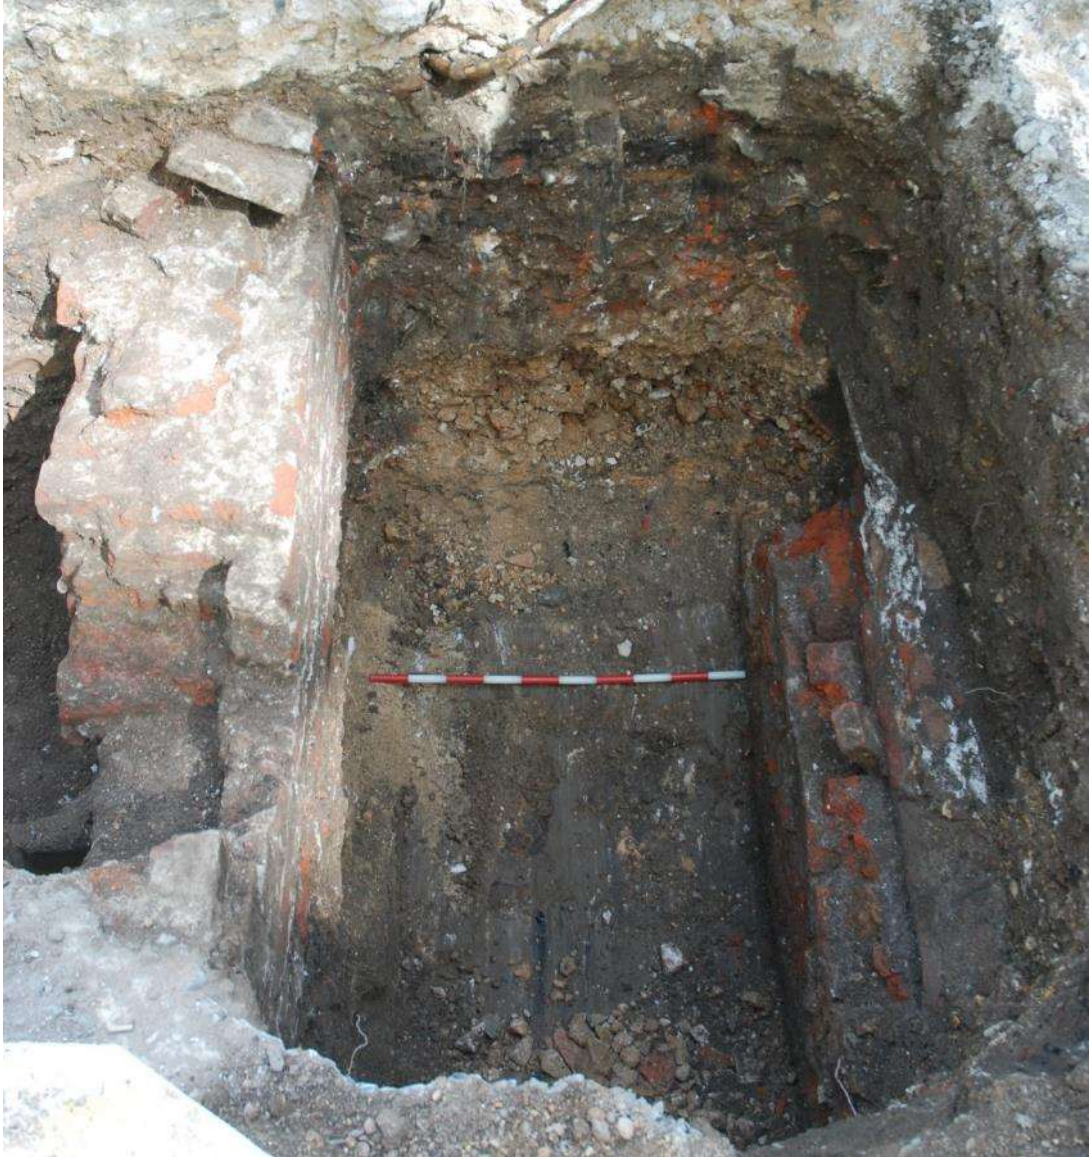
- 7.3.6** The stratigraphy between [82] and [84] differed from the rest of the trench (fig. 17). Underlying (75), (76) and (77) was a layer of fairly compacted, dark brown silt soil, (88) with frequent inclusions of CBM. It contained several patches of dark grey staining, potentially burnt spots. The layer was c.1.1m thick. It overlay another fairly compact layer of pale yellow demolition rubble, (89), c. 0.4m thick. This consisted of degraded mortar with frequent inclusions of building materials and CBM. It was interpreted as post-medieval demolition rubble, possibly from when the buildings that lay on that area were demolished. Underlying (89) was a compact, mid-brown redeposited clay, (90) with no inclusions. This layer extended beyond the limit of investigation.

Figure 17: [82] (left) and [84] (right). Showing stratigraphy between them- (77) top, overlying (88) (dark brown) which overlies (89) (yellow) and (90) (mid-brown). Looking SW. Scale 1m.

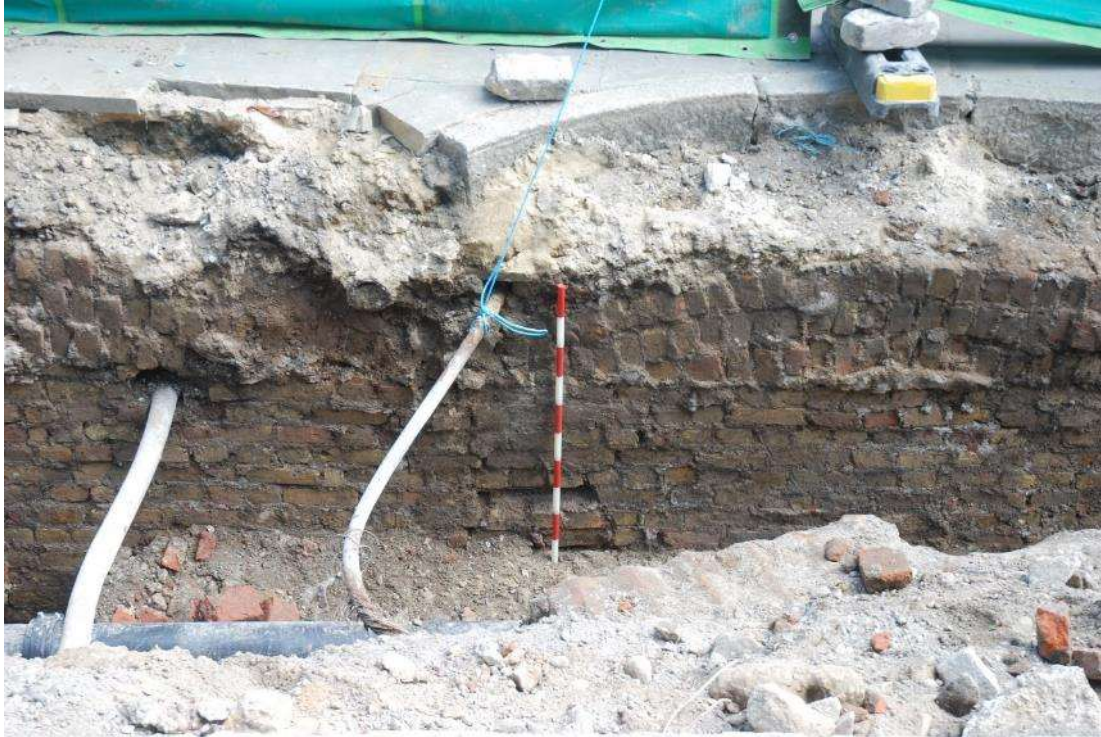
- 7.3.7** At the northeast end of the trench, along the north facing section ran a wall, [78]. It consisted of eight courses of red bricks bonded with a thick, crumbly mortar, with three courses of yellow stock brick forming a slight arch, bonded with a hard, whitish mortar above that (fig. 18). The wall measured 1.2m tall and c.0.36m thick. It was 10m+ long. This has been interpreted as the basement wall belonging to the Horner & Sons chemical warehouse (fig. 13). It was found 0.42m below the surface level.

Figure 18: Wall [78] showing arched pattern of bricks. Looking N. Scale 1m.

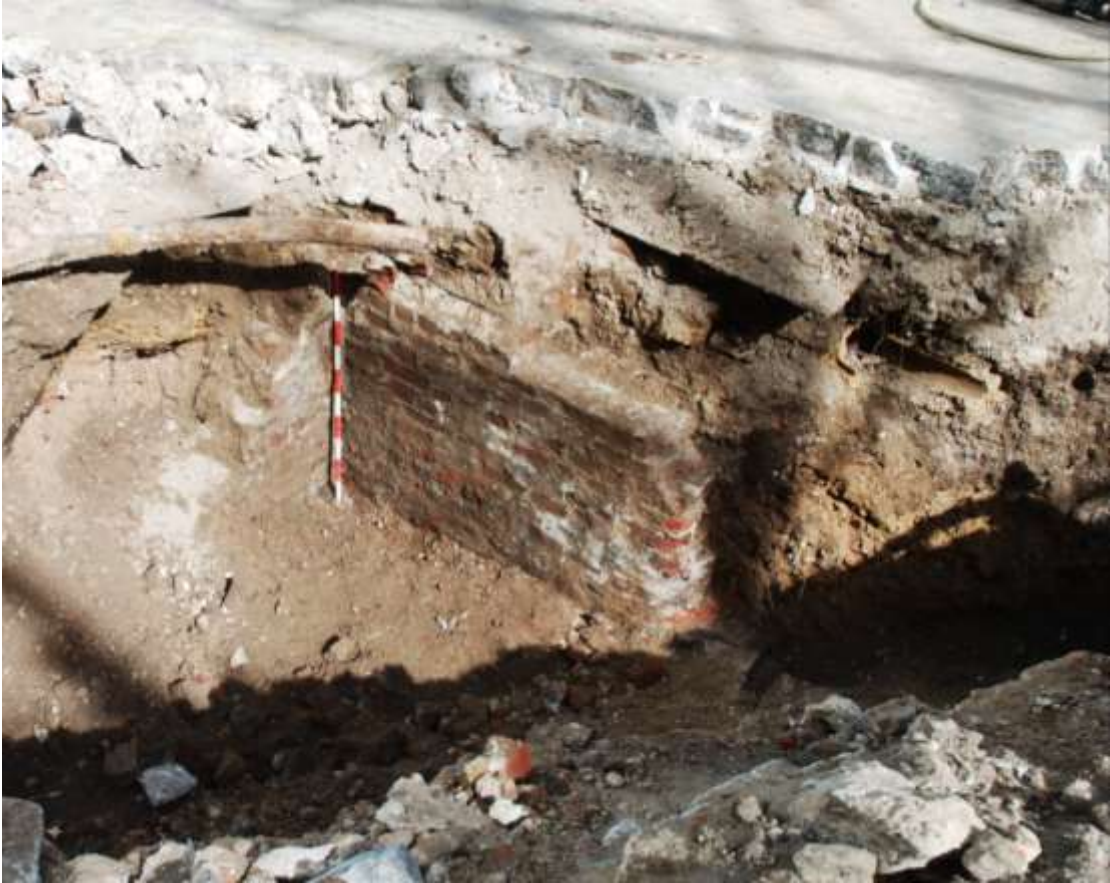
7.4.3 A post-medieval structure was observed at the western end of the trench, [102], consisting of two walls forming a corner (fig. 20). There were traces of a western wall and evidence of a vaulted ceiling. The wall was constructed of red brick, bonded with

a gritty grey mortar with alternating rows of headers and stretchers. There were possible traces of render or limewash. The easternmost N-S aligned wall measured 2.5m long, and the E-W return measured 1.1m long. The third possible section lay to the west, aligned N-S. The structure was 1.2m high and there was evidence of the spring of an arch on the eastern N-S wall. This has been interpreted as a small cellar, though the western part has been heavily truncated. If it did form a room, it would have been very narrow; c.1.4m wide, possibly more of a passage.

Figure 19: Walls [102] in trench 1 extension. Facing E. Scale 1m.

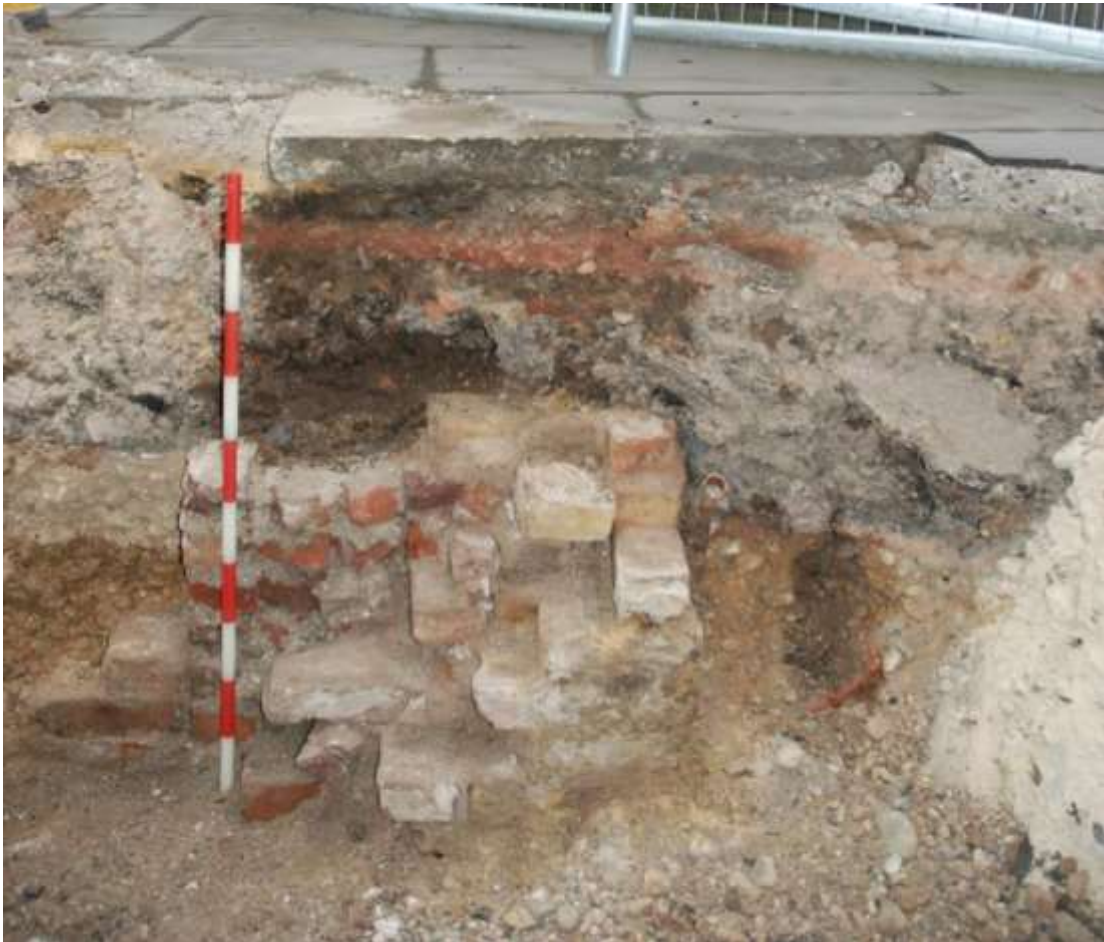
7.5.3 A linear cut, [93] aligned E-W was observed in section. It measured 0.6m high and minimum of 1.4m wide. The cut was surrounded by (95) and filled with a wall, [94]. [94] was constructed of mixed red and yellow bricks; the red bricks were crumbly whereas the yellow ones were still solid. It consisted of eight courses, bonded with a

thick crumbly concrete mortar (fig. 19). The wall was observed at a depth of 0.42m below the surface. It measured 1m wide and 0.7m high. It extended 0.36m westwards into the trench. There was some evidence of a corner, turning northwards. The upper part of the wall was truncated by modern groundworks. Initially thought to have been a continuation of [78] due to the similar depth at which they were found, a closer inspection of the Goad Insurance plan (fig. 13) would suggest that the basement wall does not continue that far across the square. Instead the wall might have been a part of the basement of one of the buildings fronting Mitre Street, contemporary with [82] and [46].

Figure 20: Wall [94] in section. Looking W. Scale 1m.

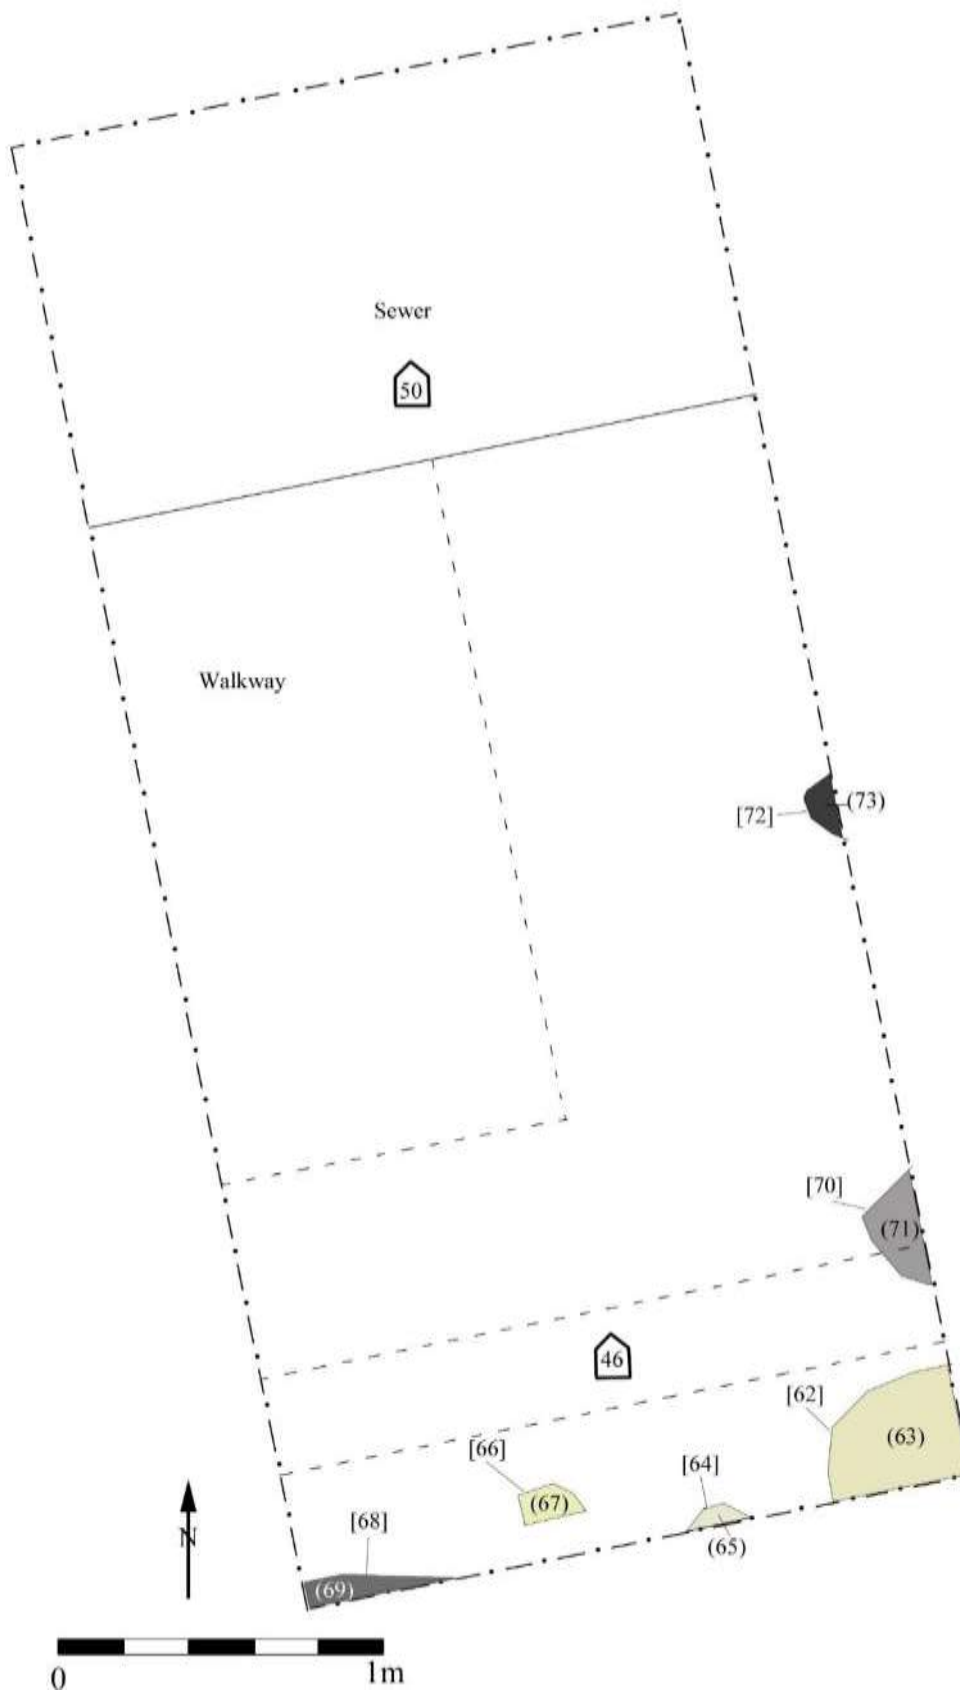
Figure 22: Plan of the base of the drop shaft, showing the pits and projected location of [46]. Original drawn at 1:20.

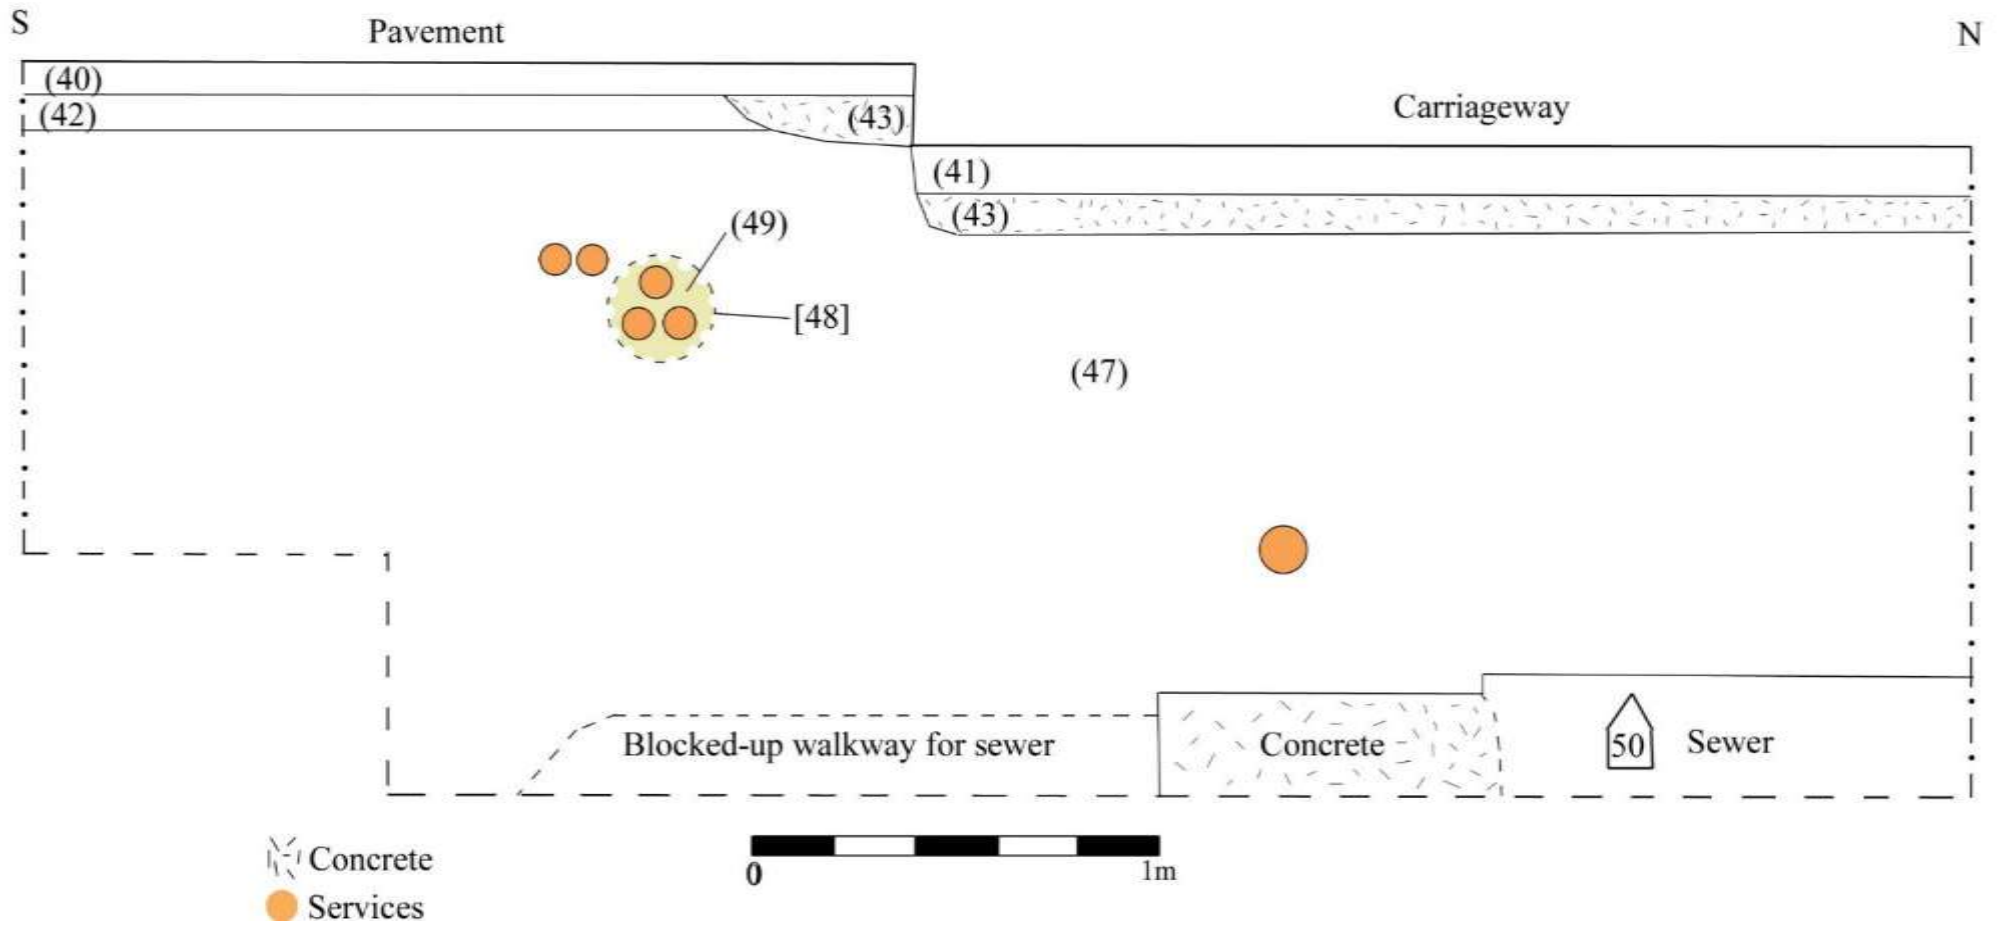
Figure 23: E facing section, centre of drop shaft, upper 1.8m. Original drawn at 1:20.

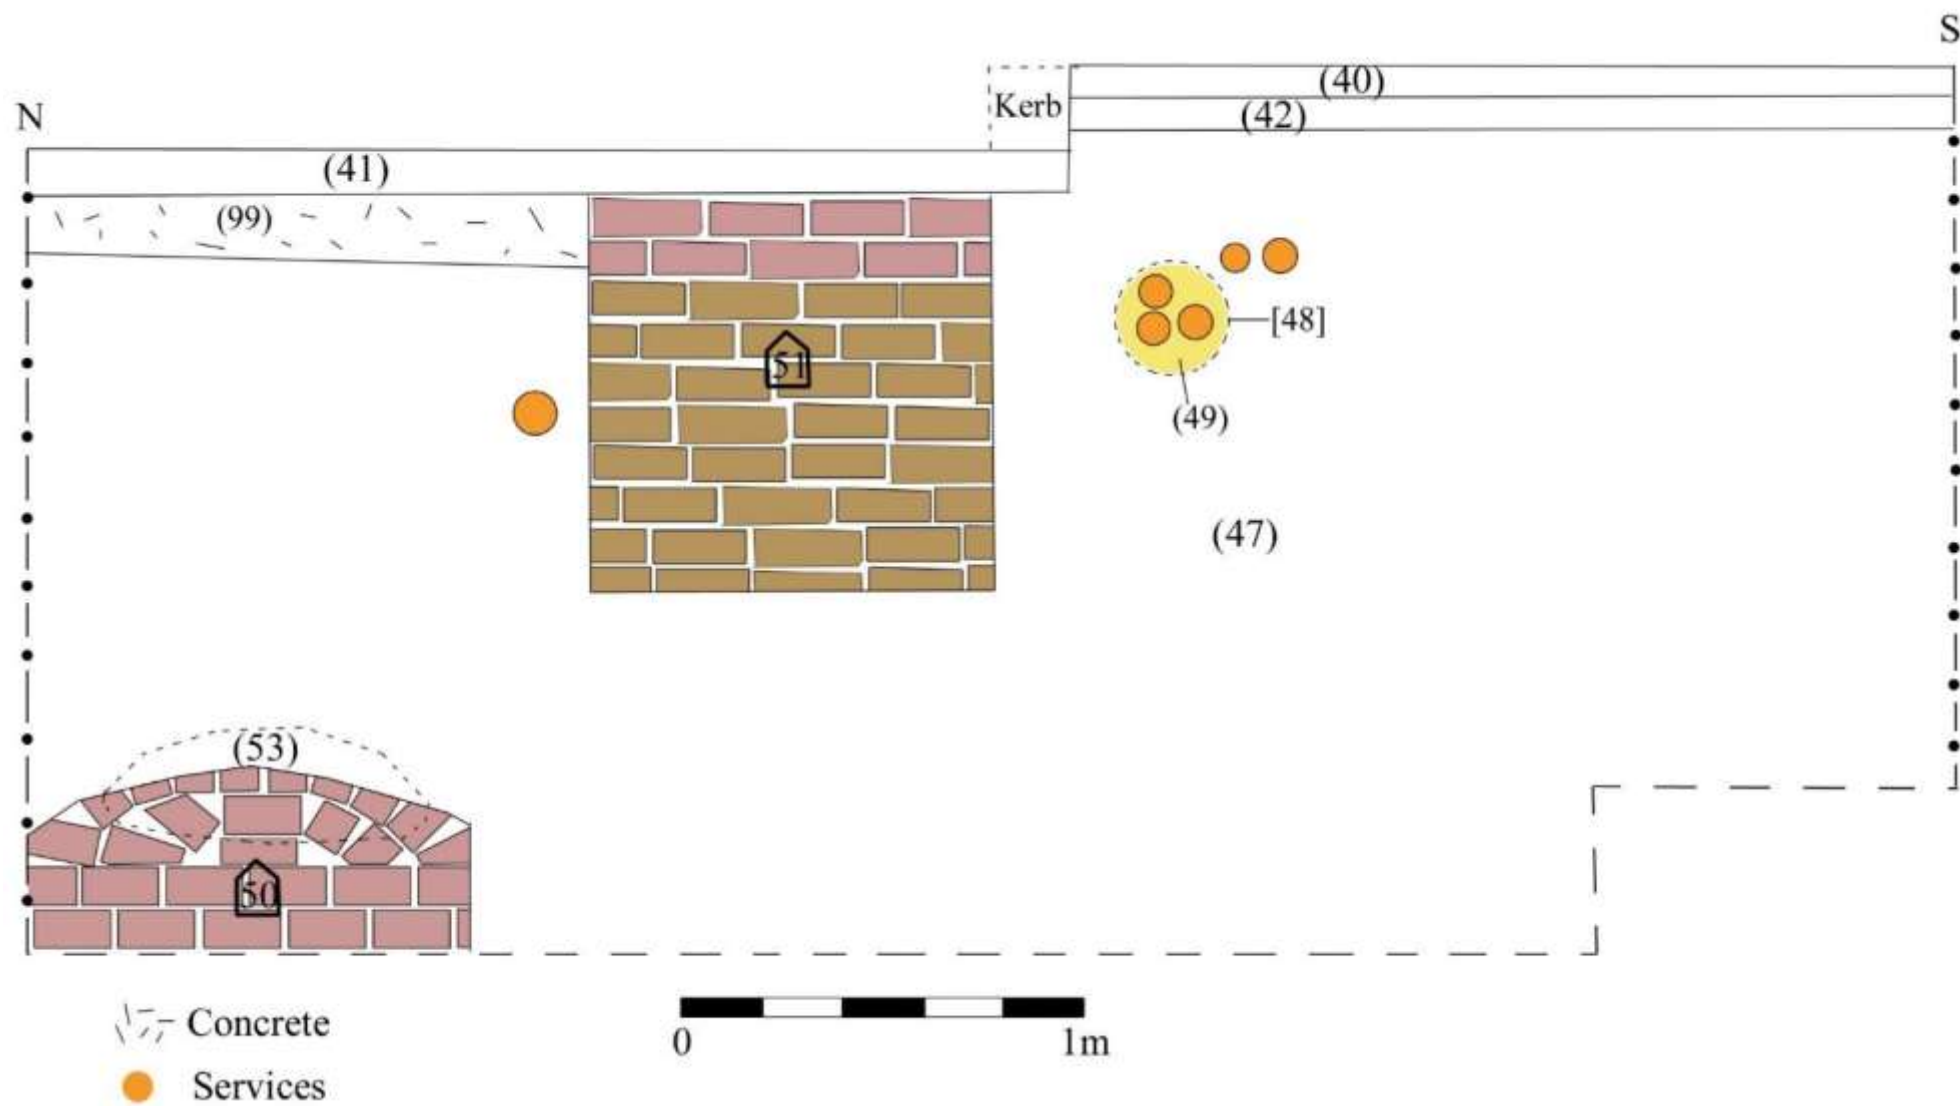
Figure 25: W facing section, centre of drop shaft, upper 2.1m. Original drawn at 1:20.

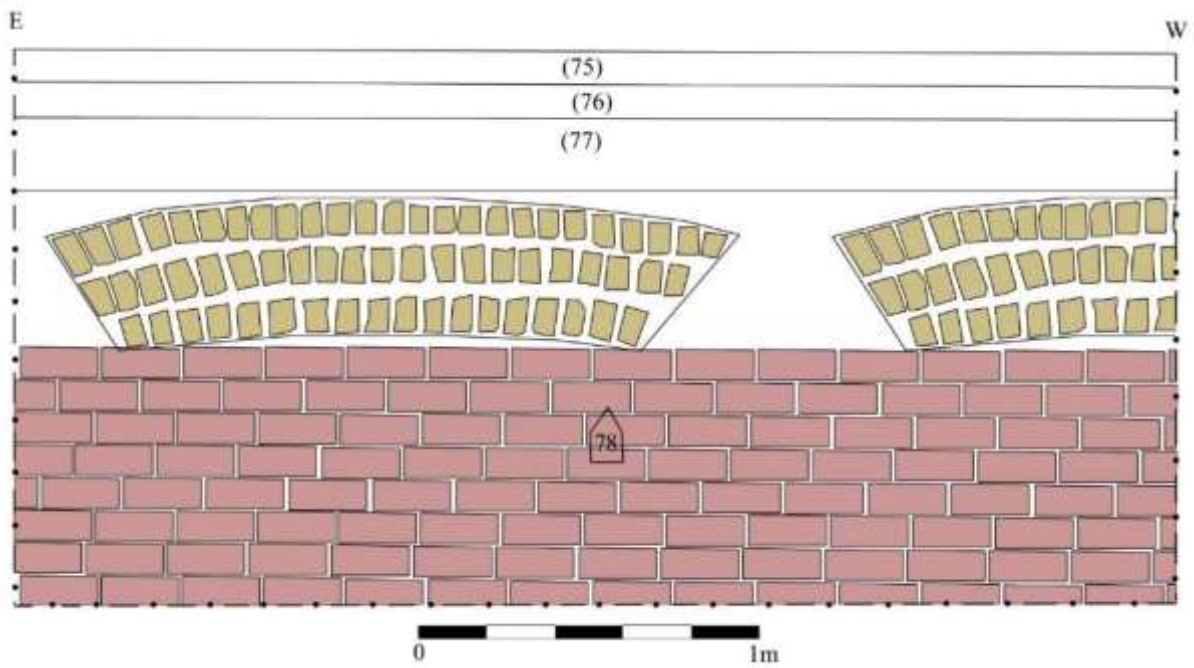
Figure 30: N facing section of E end of trench 1. Original drawn at 1:20.

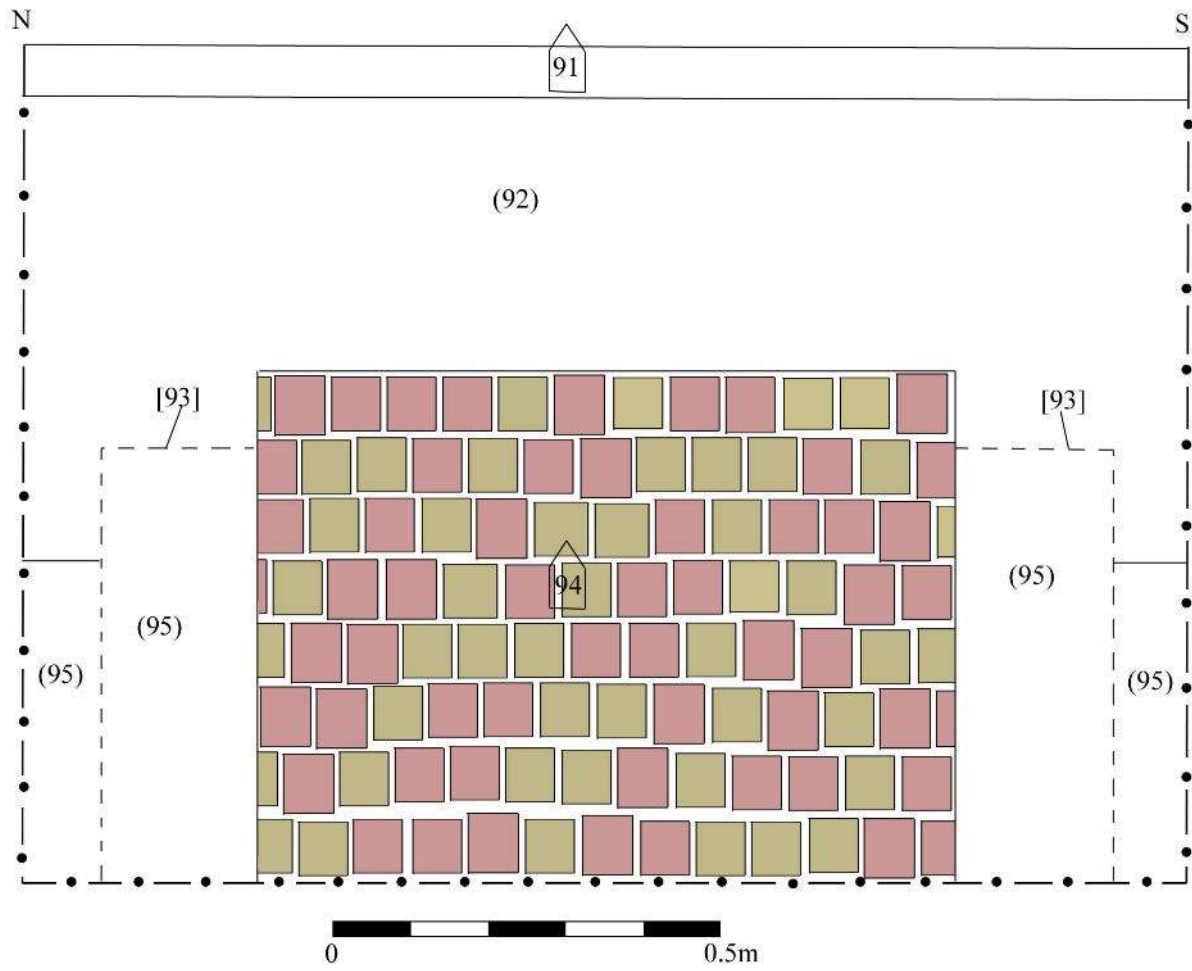
Figure 32: W facing section of trench 2. Original drawn at 1:10.

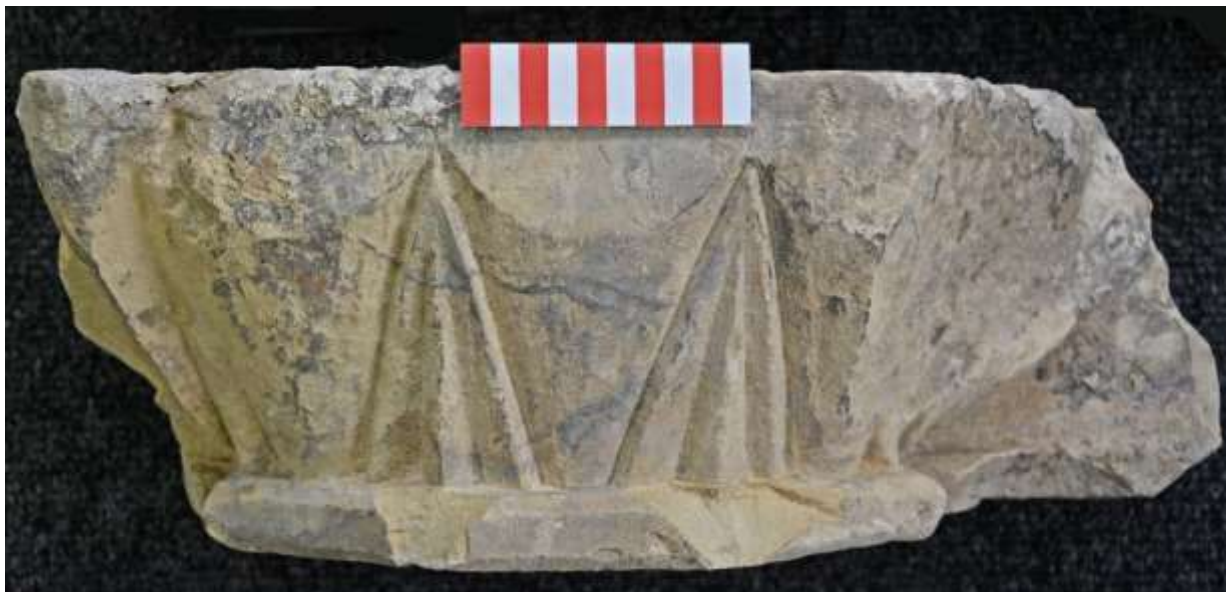
The most important item in this group is a scalloped capital (A), of which all parts are represented despite historic and recent damage (figs. 33-37). This was a respond capital which rested on a narrow fluted respond shaft; the capital was in its turn capped by an abacus (missing). A vault springing rested on the abacus.

Figure 33: (A) – front of worked stone, showing scalloping. Scale 0.1m

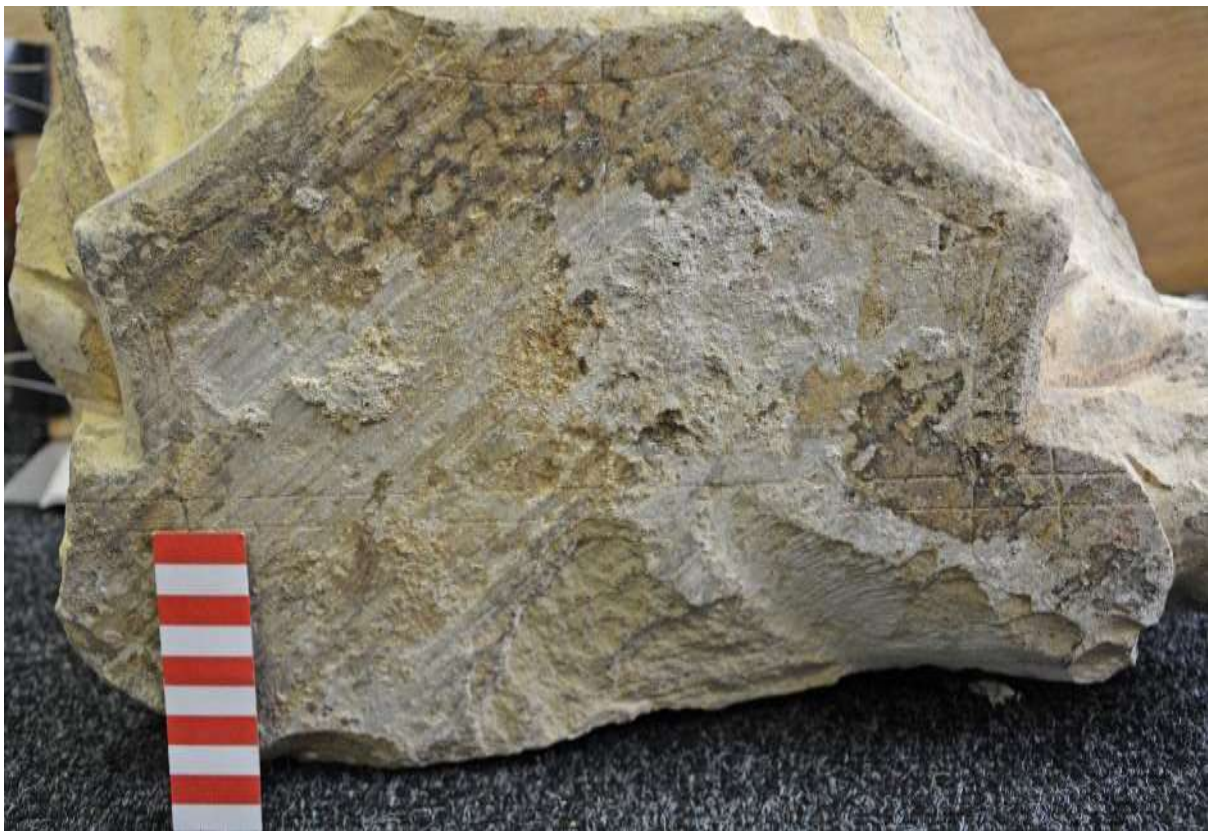
Figure 34: (A) – base of stone showing incised border. Scale 0.1m
