MITRE SQUARE DEVELOPMENT – PHASE TWO, DUKE’S PLACE, CITY OF LONDON, EC3

**AN ARCHAEOLOGICAL EVALUATION AND WATCHING
BRIEF**

Site Code: DUS 16
Approximate Site Centre: TQ 33460 81182

COMPASS ARCHAEOLOGY LIMITED
250 YORK ROAD
LONDON SW11 3SJ

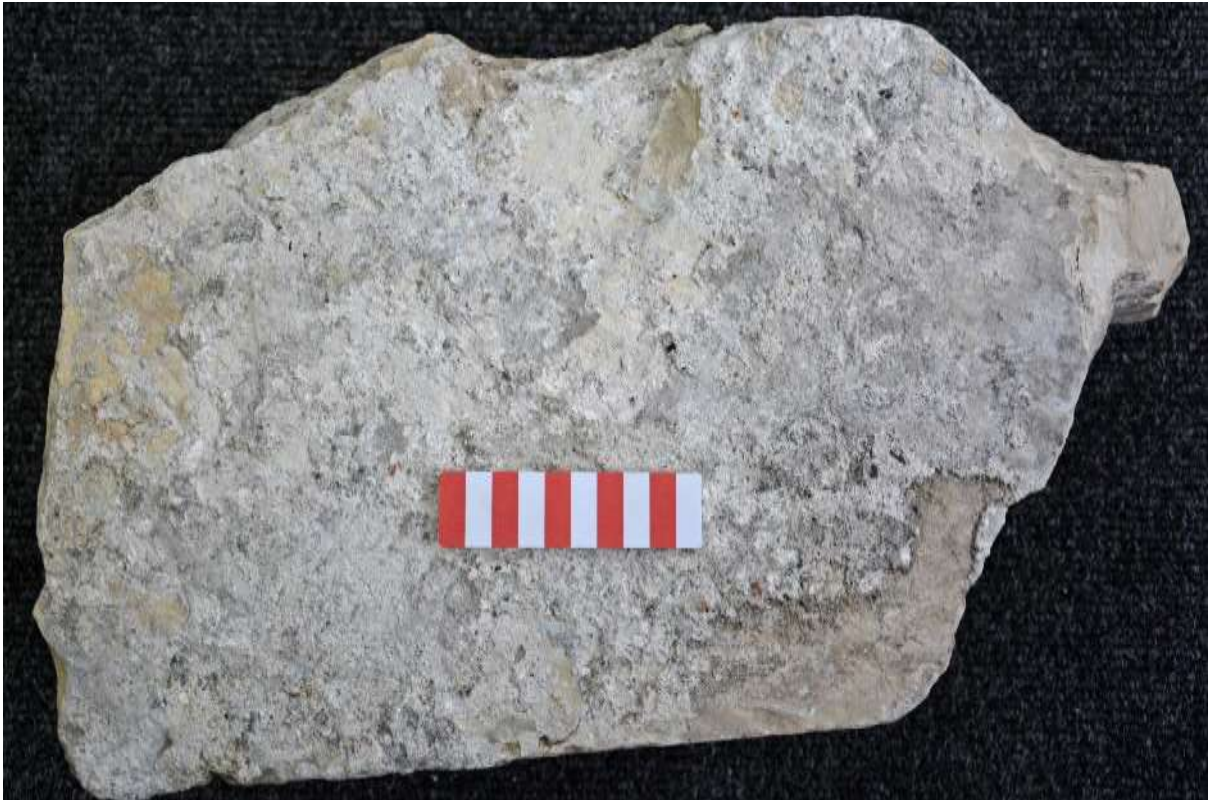
Figure 35: (A) – top of stone, showing remnants of mortar used in bonding stone into sewer, [50] construction. Scale 0.1m

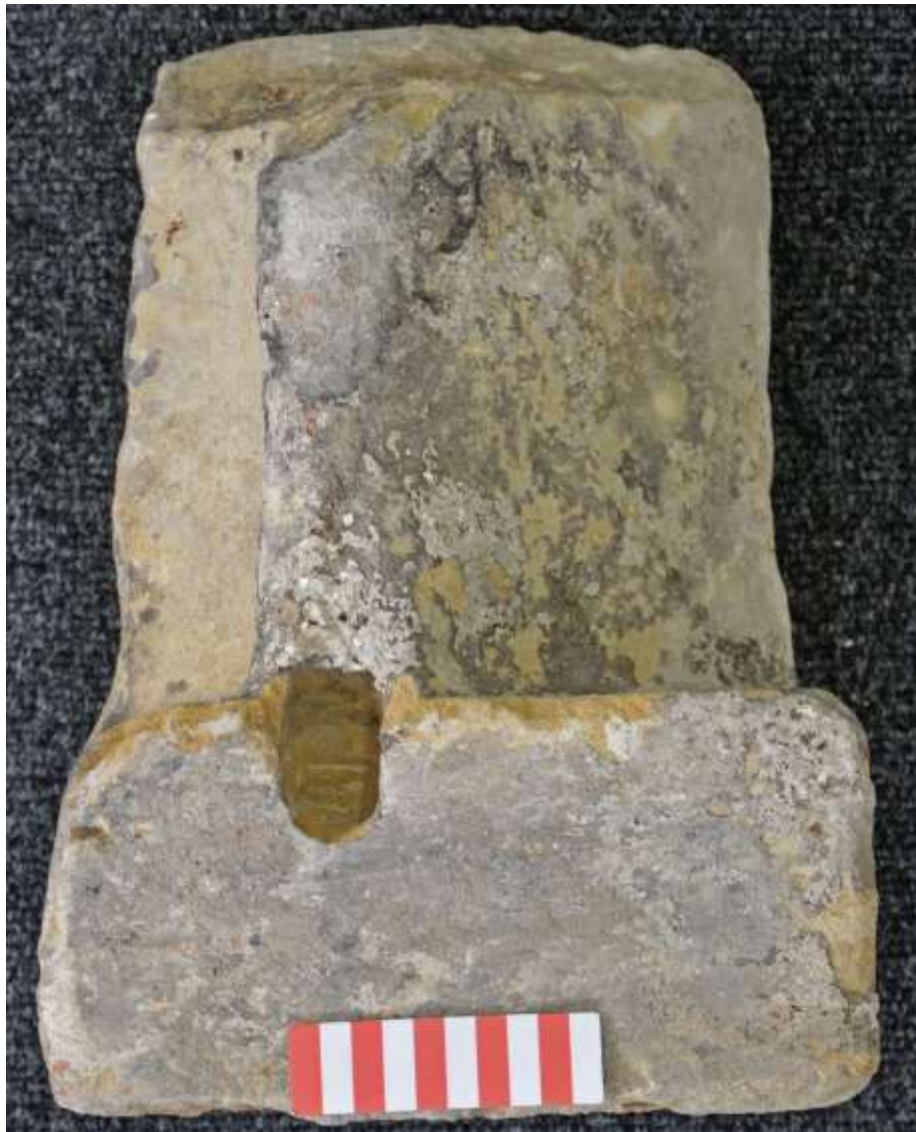
A heavily-weathered coping stone was recognized (B; figs. 38-44). It may have represented the end of a run of crenellation as one end develops a plain wall face. An iron clamp (missing) held the coping in place against the wall. The block was later removed and trimmed to form a facing block (ashlar). It was in effect turned through ninety degrees so that the bed became the wall face (indicating yet more recycling of the worked stone). Well-dated Ketton stone copings were recorded at the Leadenhall Garner (1444 +; Samuel 1989) a few hundred metres away. Association with the Priory is likely, but such copings were employed in late medieval and Tudor buildings throughout the City.

Figure 38: (B) – top of stone. Scale 0.1m

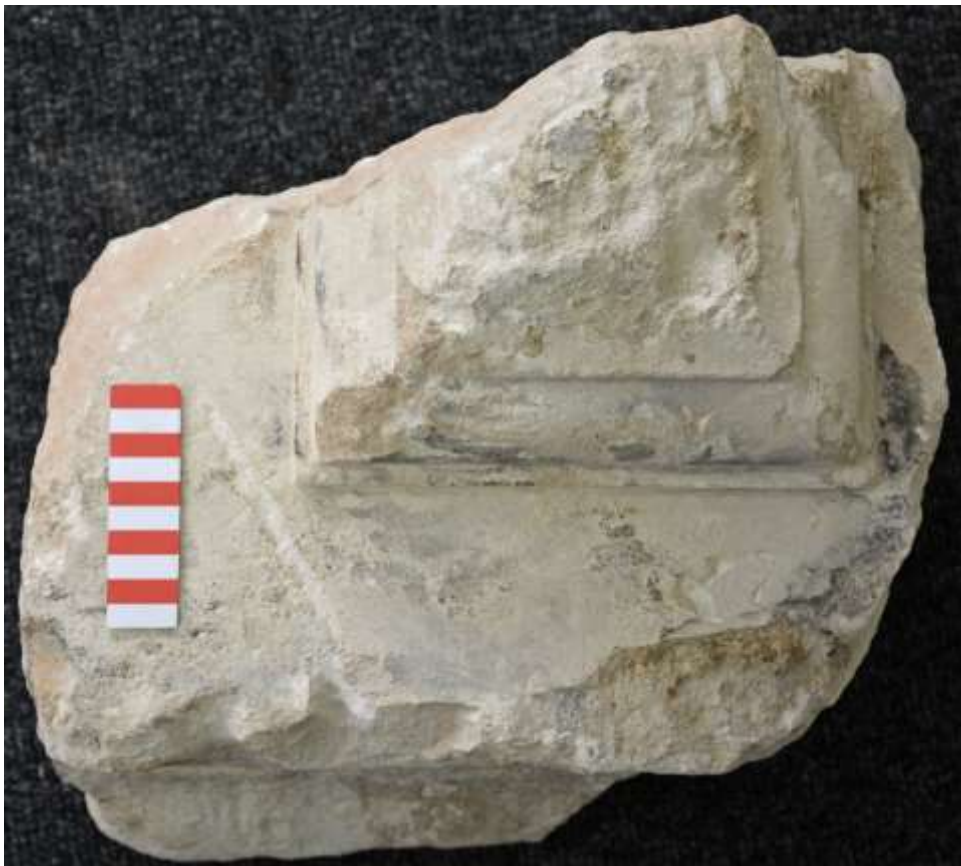
A third block (C) can be identified as part of a cornice (figs. 45-49), remotely deriving from classical Ionic models, as shown by the ovolo-moulded consoles. These hanging consoles adopt the moulding more normally used in the lower order of the cornice. The scale of cantilever illustrates a large classical building. The building must have existed for many years because the exposed lip was heavily weathered before demolition. A church may be represented; but the relative wealth represented by the fragment is hard to associate with St James Duke Place (demolished 1874); the 'lost' church in the area. This church was built by and for poor folk and was of plain design (Huelin 1996, 42). The fine gateway of the Aldgate Ward Watch house next to St Catherine Cree (Schofield 2005, fig. 165) has been relocated since its construction in 1631. The use of cornices with consoles does however show the sort of architectural context the fragment may have occupied. A comparison would be of interest.

Figure 45: (C) – top of stone. Scale 0.1m

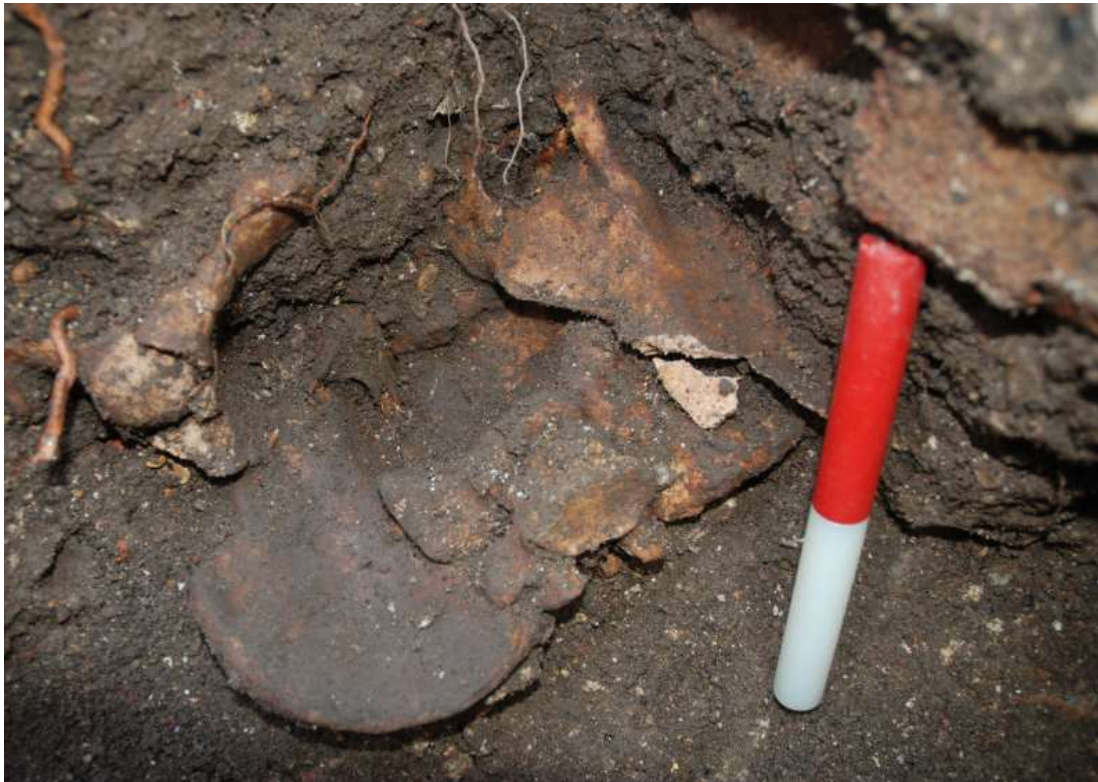
[SK2] was recovered with another burial, [SK 3] from next to, and partially under wall [82]. Both of the burials consisted of pelvic girdles with femurs articulated. The burials were in a supine, extended position, and oriented N-S. The pelvises were stacked on top of one another indicating that they had been buried in the same grave cut, though the cut was not visible (fig. 53). There were also two right lower arms placed over the pelvises, with the majority of a left and right hand. It is unclear which of the bones belong to which individual, particularly the os coxae and sacrum, though the distal humerus, ulna and radius articulate, as do the other ulna and radius. The hands also articulate, but the left is more robust than the right potentially indicating that they either belong to different individuals, or that it is evidence of handedness or occupation (fig. 54).

Figure 53: Burials [SK 2] and [SK 3] in situ. Wall [82] in top right corner. Scale 0.2m

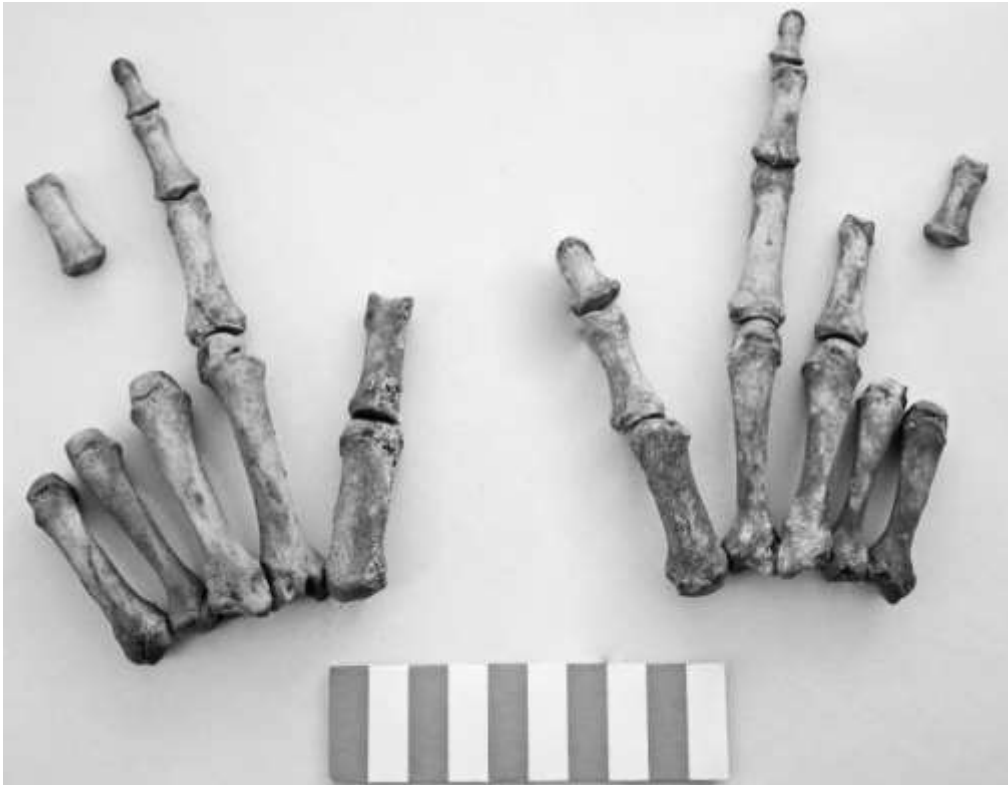
Figure 54: Showing robusticity of left hand in comparison with right. Scale 0.1m

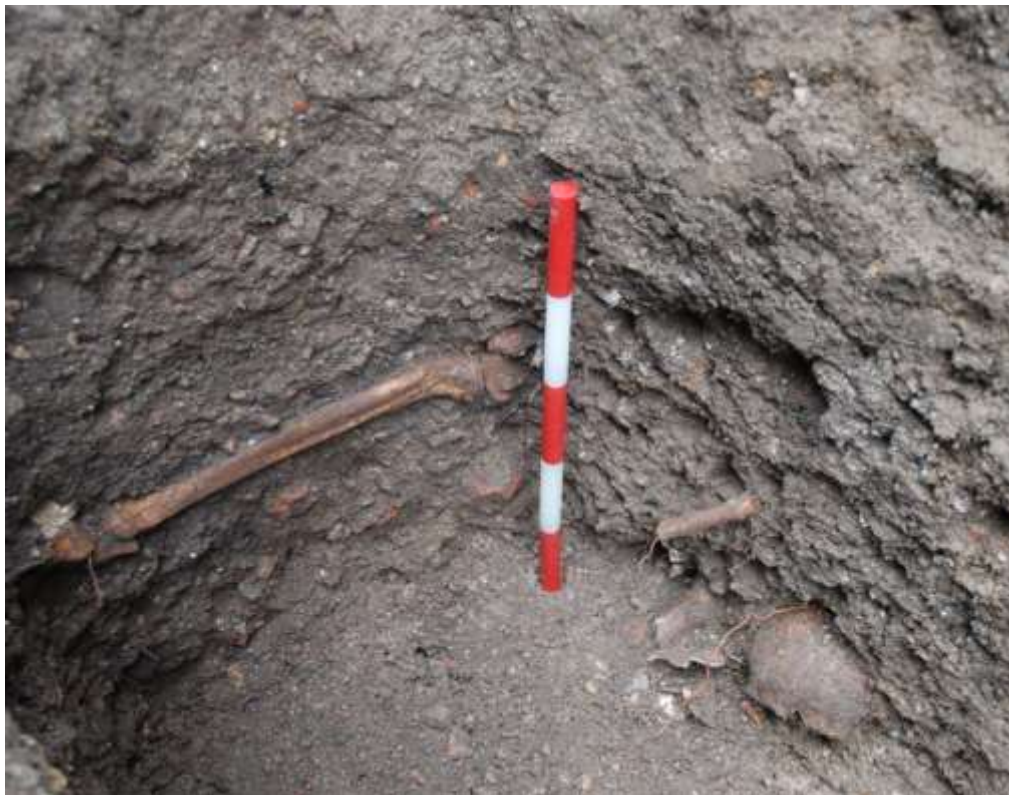
Figure 57: Cranium B in the section wall with other disarticulated fragments. Left leg of [SK 1] is visible to the left. Scale 0.5m.

Cranium (B) was also highly fragmented and disarticulated (fig. 57). It consisted of a cranial vault with no facial bones present. The orientation and position of the burial is unknown. The

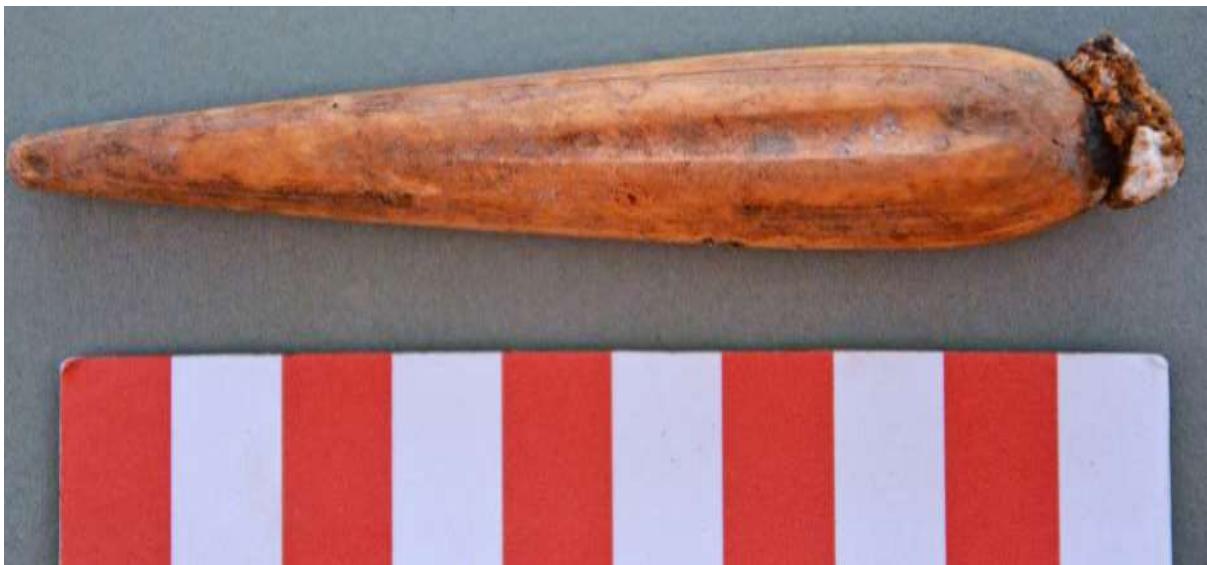
Figure 64: Bone handle recovered from (53). See remnants of metal fixing on right end. Scale 0.1m

Context (53) was a small deposit of a mid- to dark brown silty soil with infrequent stone inclusions. The deposit was observed at the north end of the drop shaft, overlying the brick arch of the sewer, [50]. It contained a worked bone handle, possibly for a knife or other cutlery (fig. 64). The handle is somewhat cracked, with one side broken. The handle is 105mm long and 19mm wide, it tapers at one end to 5mm wide. A lump of corroded metal is on the other end, probably the remains of the knife blade/other fixture.
