CAMDEN LOCK VILLAGE REDEVELOPMENT

HAWLEY WHARF: LAND BOUNDED BY CHALK FARM ROAD, CASTLEHAVEN ROAD, HAWLEY ROAD, KENTISH TOWN ROAD & REGENT'S CANAL

AN ARCHAEOLOGICAL POST-EXCAVATION ASSESSMENT

SITE CODE: CLV15
APPROXIMATE SITE CENTRE NGR: TQ 2881 8422
PLANNING APPLICATION REF: 2012/4628/P

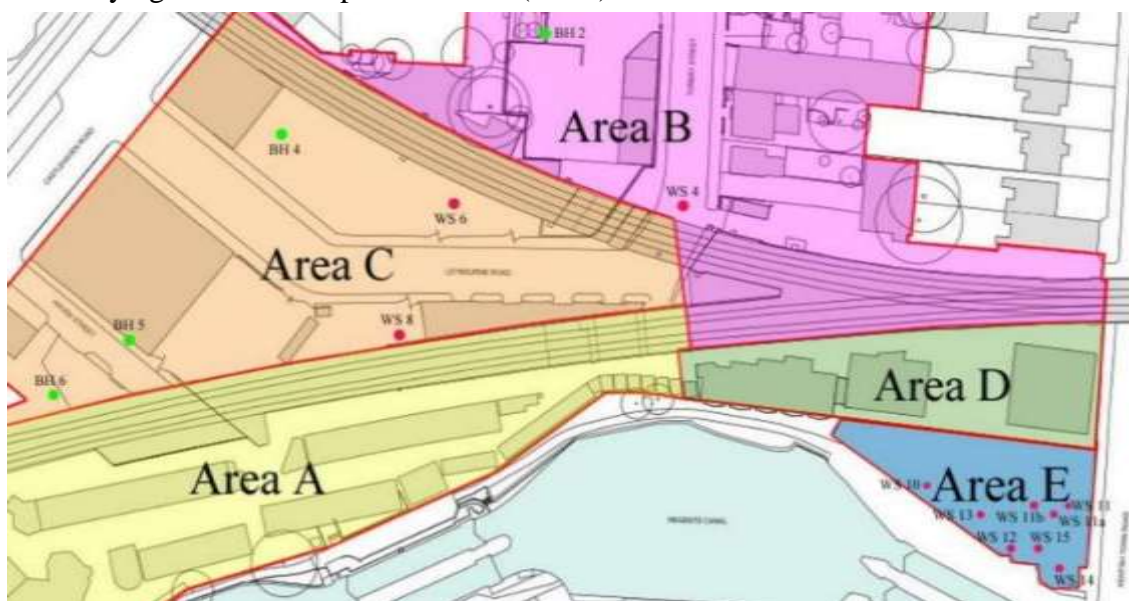
Figure 4: Site plan showing location of boreholes (green) and window samples (pink).

3.4 Prior to the commencement of groundworks, a series of geotechnical boreholes and window samples were taken across the site (fig. 4; Appendix IX), all showing deposits of made ground up to 1.5m thick (24.29mOD), overlying weathered natural London Clay where the lowest recorded level was 16.06mOD, with undisturbed London Clay underlying that. The deepest borehole (BH 5) measured -12.14mOD.

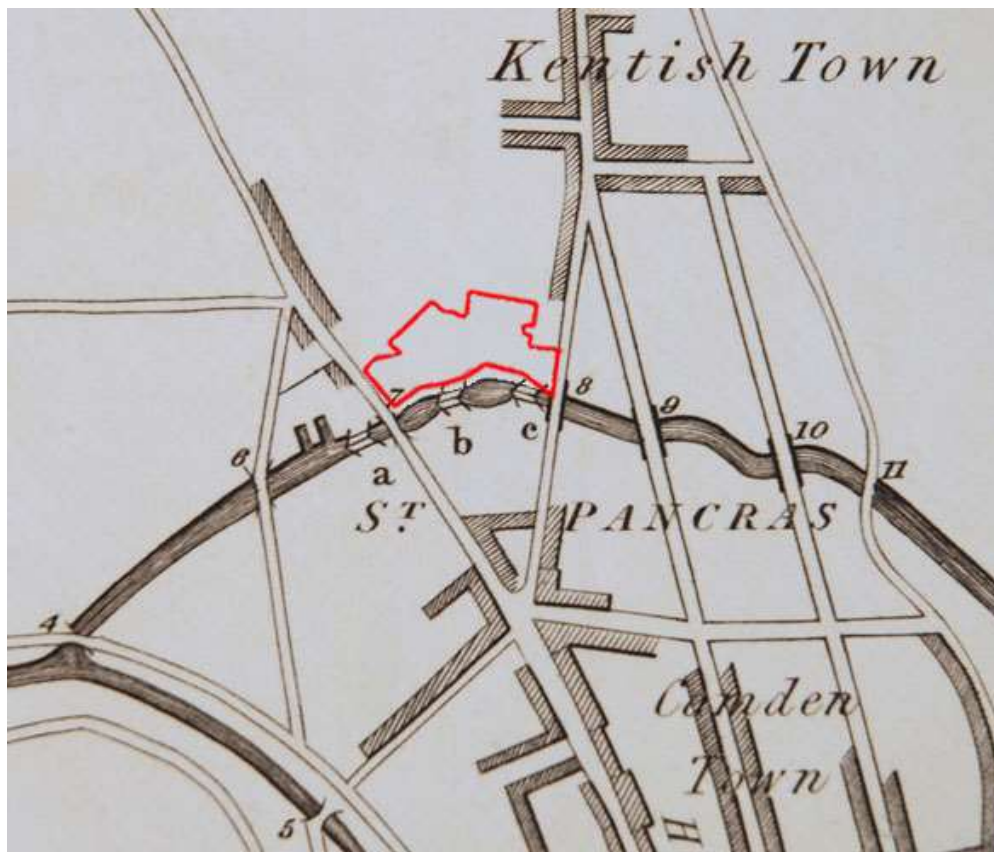
Figure 8: Extract from the Regent's Canal Plan, site in red (1820)

The site still appears to be undeveloped, aside from the Regent's Canal that has been constructed along the southern boundary of the site. The course of the River Fleet has not been included on this plan.

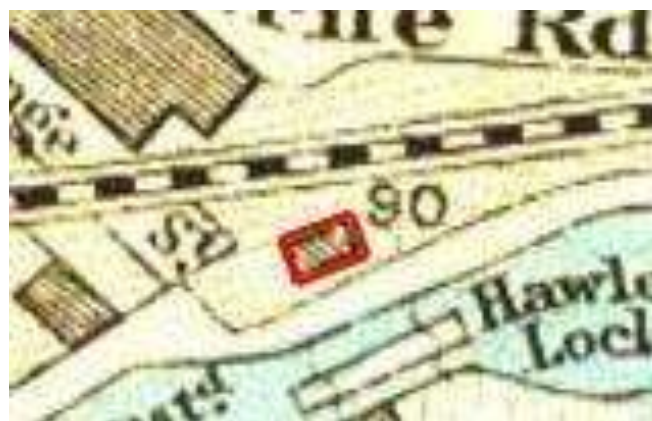
Figure 18: Extract from Stanford's map, showing cottage (red) (1862)

The cottage appears still as a single building, though slightly changed from the previous plan but this could be due to cartographic differences rather than a reflection of physical alteration. A census from 1861 lists one family living at Hawley Lock; James and Mary Lash, aged 39 and 35 respectively.

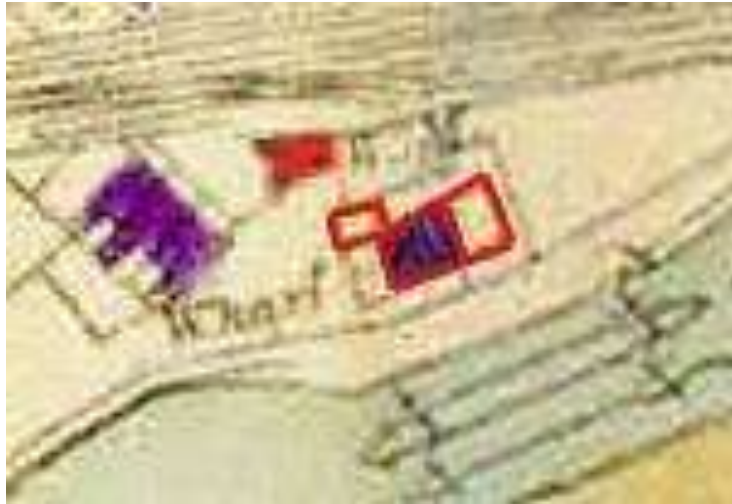
Figure 23: Extract from the LCC bomb damage map, cottage in red (1945)

In this map we can see the damage that was caused by flying bombs during the blitz. The western side of the building was 'damaged beyond repair' (purple colour; fig. 15) and it is likely that in the post-war clearance, the whole structure was torn down.

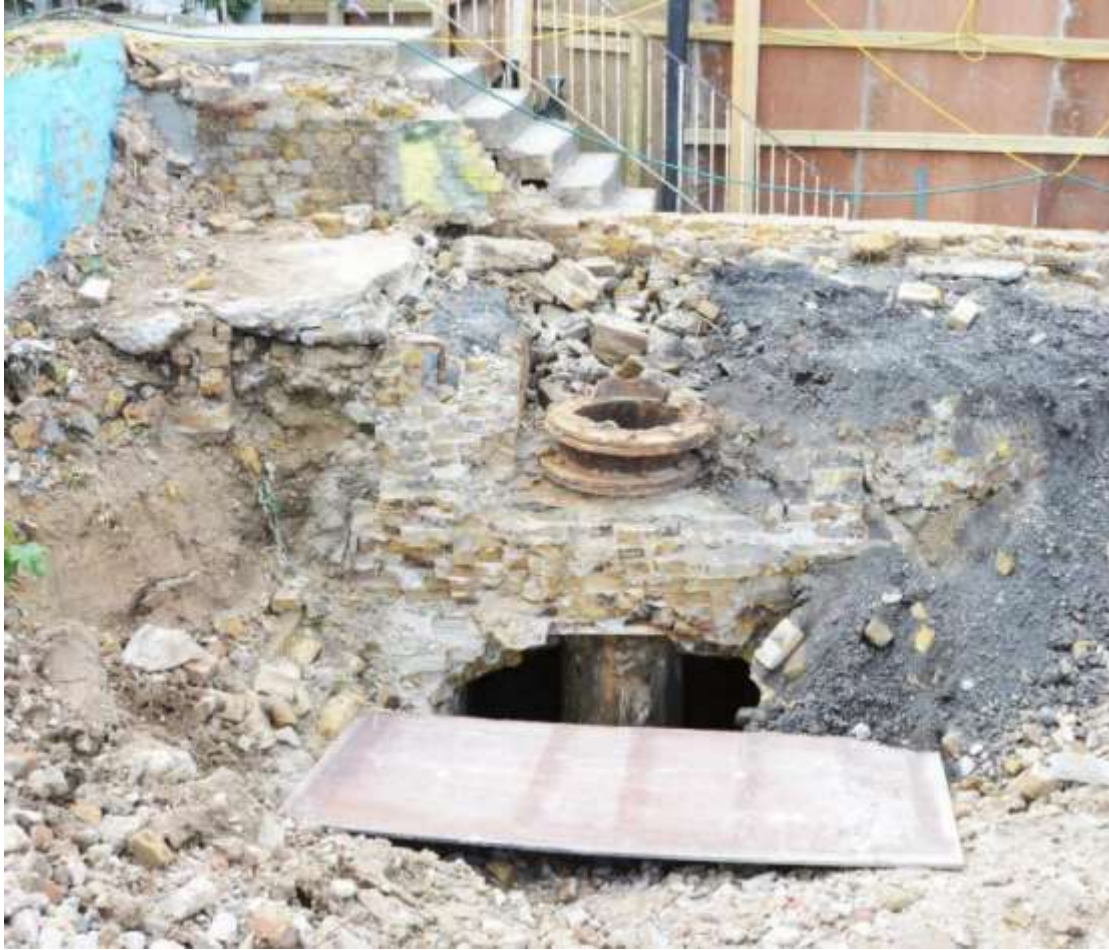
Figure 26: View of the chamber with capping removed. The standing walls of the old pump-house are visible to the left and rear of the chamber (partially demolished during works). Looking S. No scale.

- 7.2.2** A brick-built chamber, constructed with yellow stock bricks was visible only 200mm below the present ground level (fig. 26). The uppermost courses of brick were observed from 25.06mAOD. Its internal measurements were 1.7m² and the walls of the chamber were c.600mm thick, though the southern and northern walls were not fully exposed. The ceiling of the chamber was arched with a shallow rise of c.300mm from the springing point to the apex.

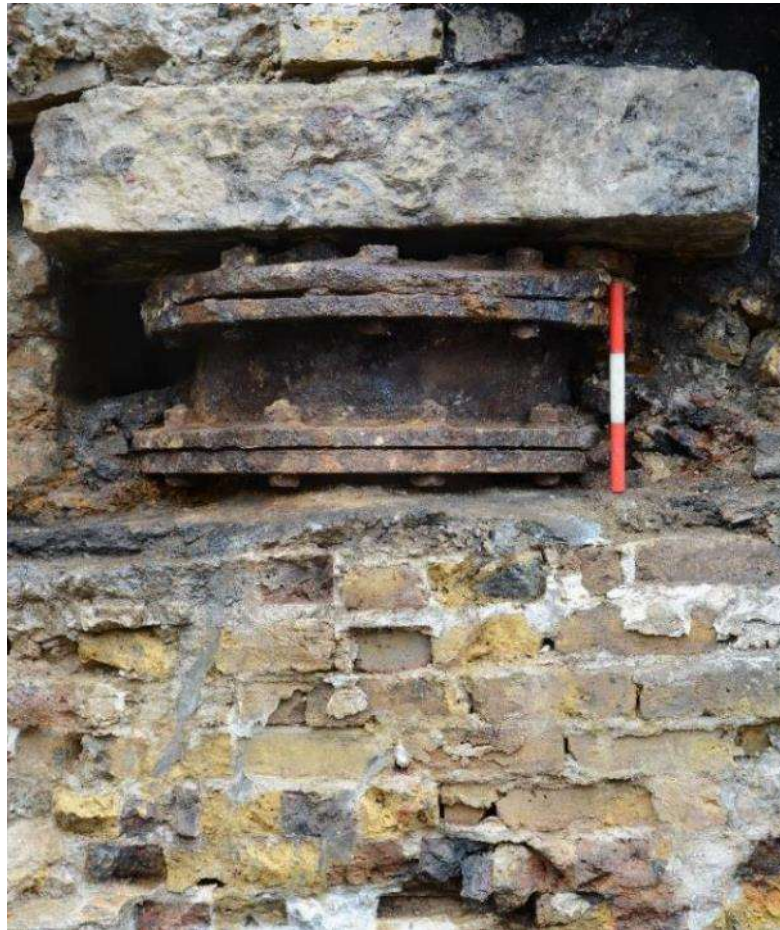
Figure 27: Detail of flanged separator section of pipe with NW twist. Concrete capping above and remainder of pipe extending into chamber below. Facing S. Scale 0.3m

- 7.2.4** Inside the chamber was a centrally-positioned, vertical cast-iron pipe, measuring 600mm diameter. The pipe extended through the ceiling of the chamber, continuing for 780mm before emerging from the roof of the structure, ending with a flanged head. This was attached to another section of pipe 250mm tall with a slight NW twist, fitted with square-headed nuts and bolts (fig. 27). This pipe was then attached by a similarly flanged head to an upper section of pipe which had been broken off 100mm from the base. The whole thing was capped with a concrete block. The upper portions of the pipework were enclosed by yellow stock brick walls, creating a mini chamber above the main one.

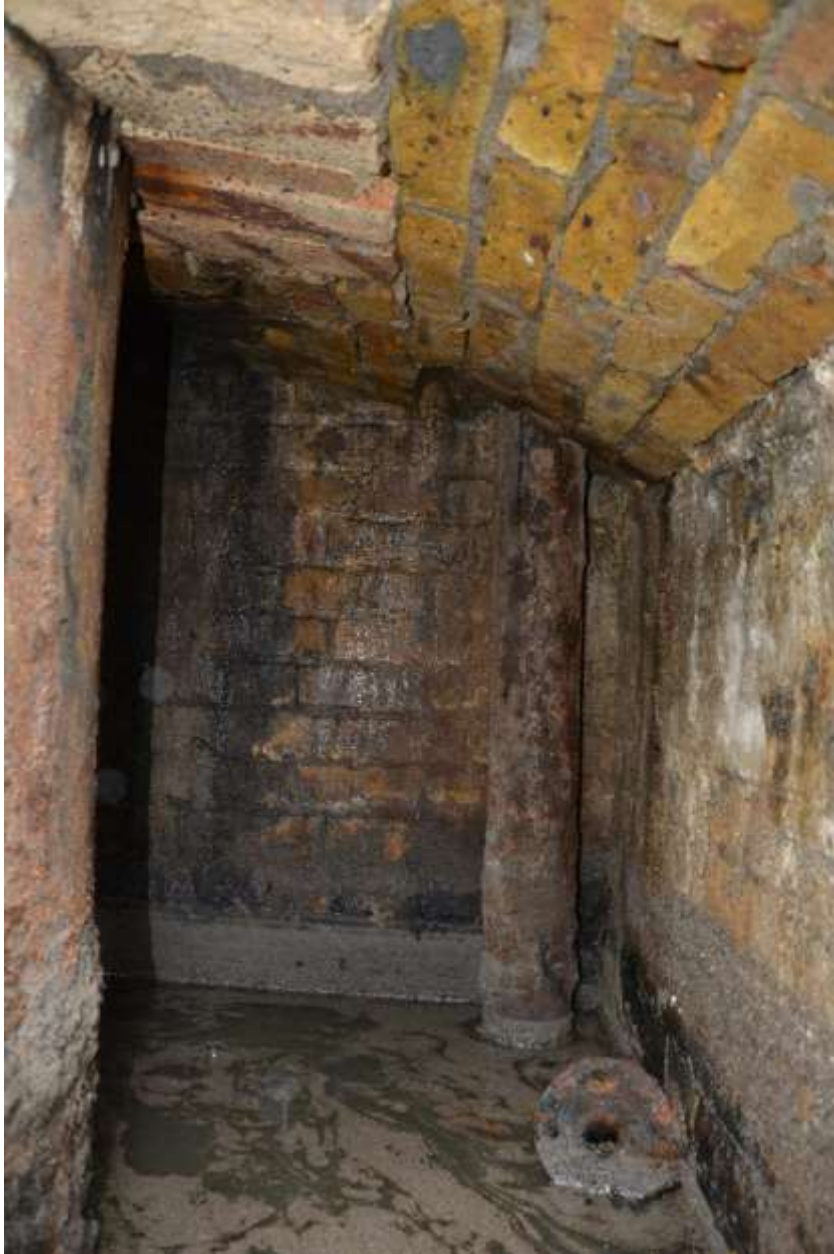
Figure 28: Interior southwest corner of chamber showing secondary downpipe and pump head. Arched ceiling and standing water visible. Facing S. No scale.

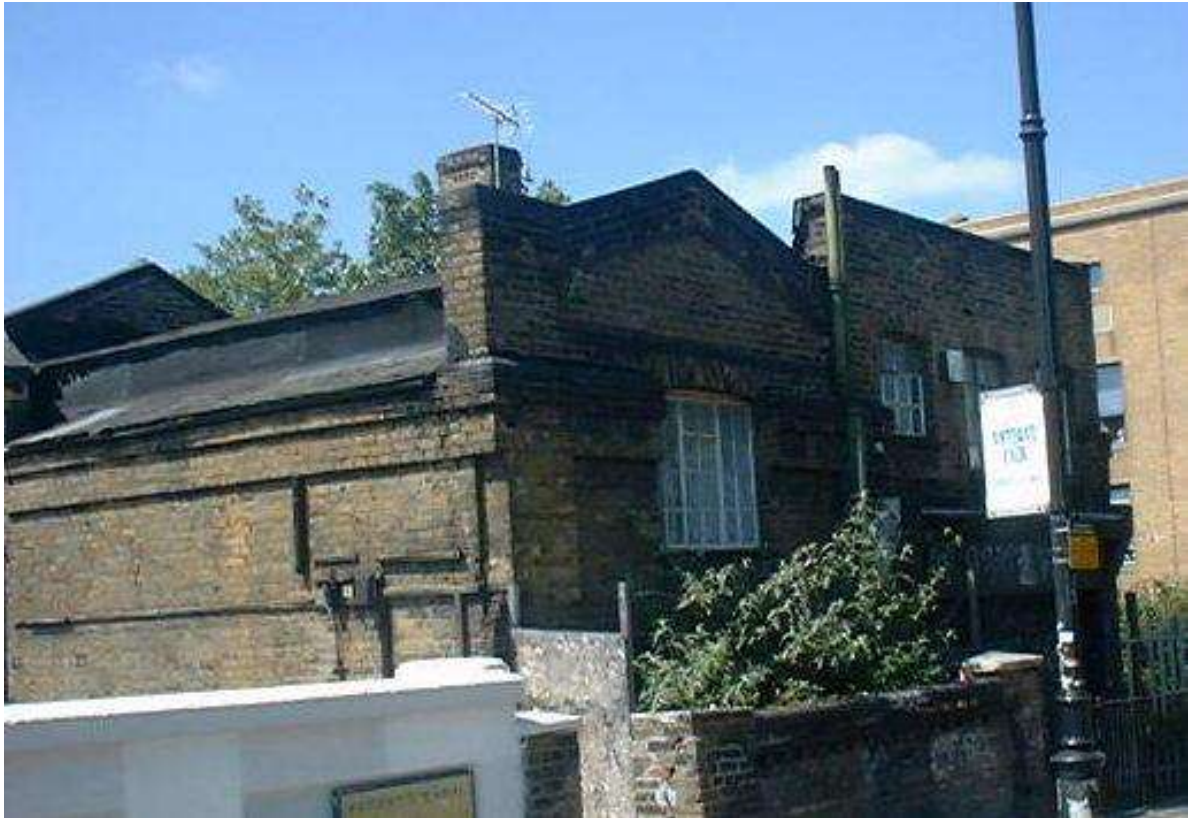
Figure 29: View of the steam pumping station, Kentish Town lock. Looking NW. (2000)

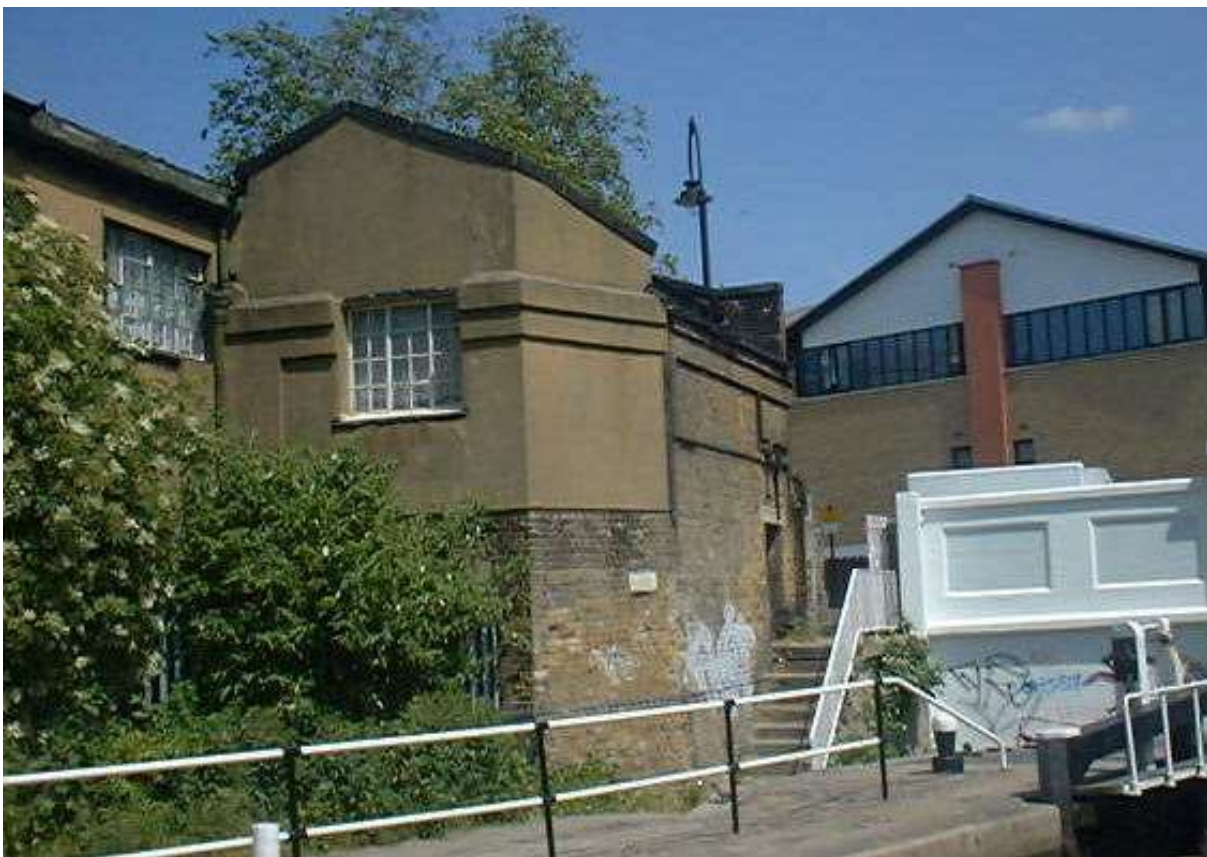
Figure 30: View of the steam pumping house, Kentish Town lock. Looking NE (2000)

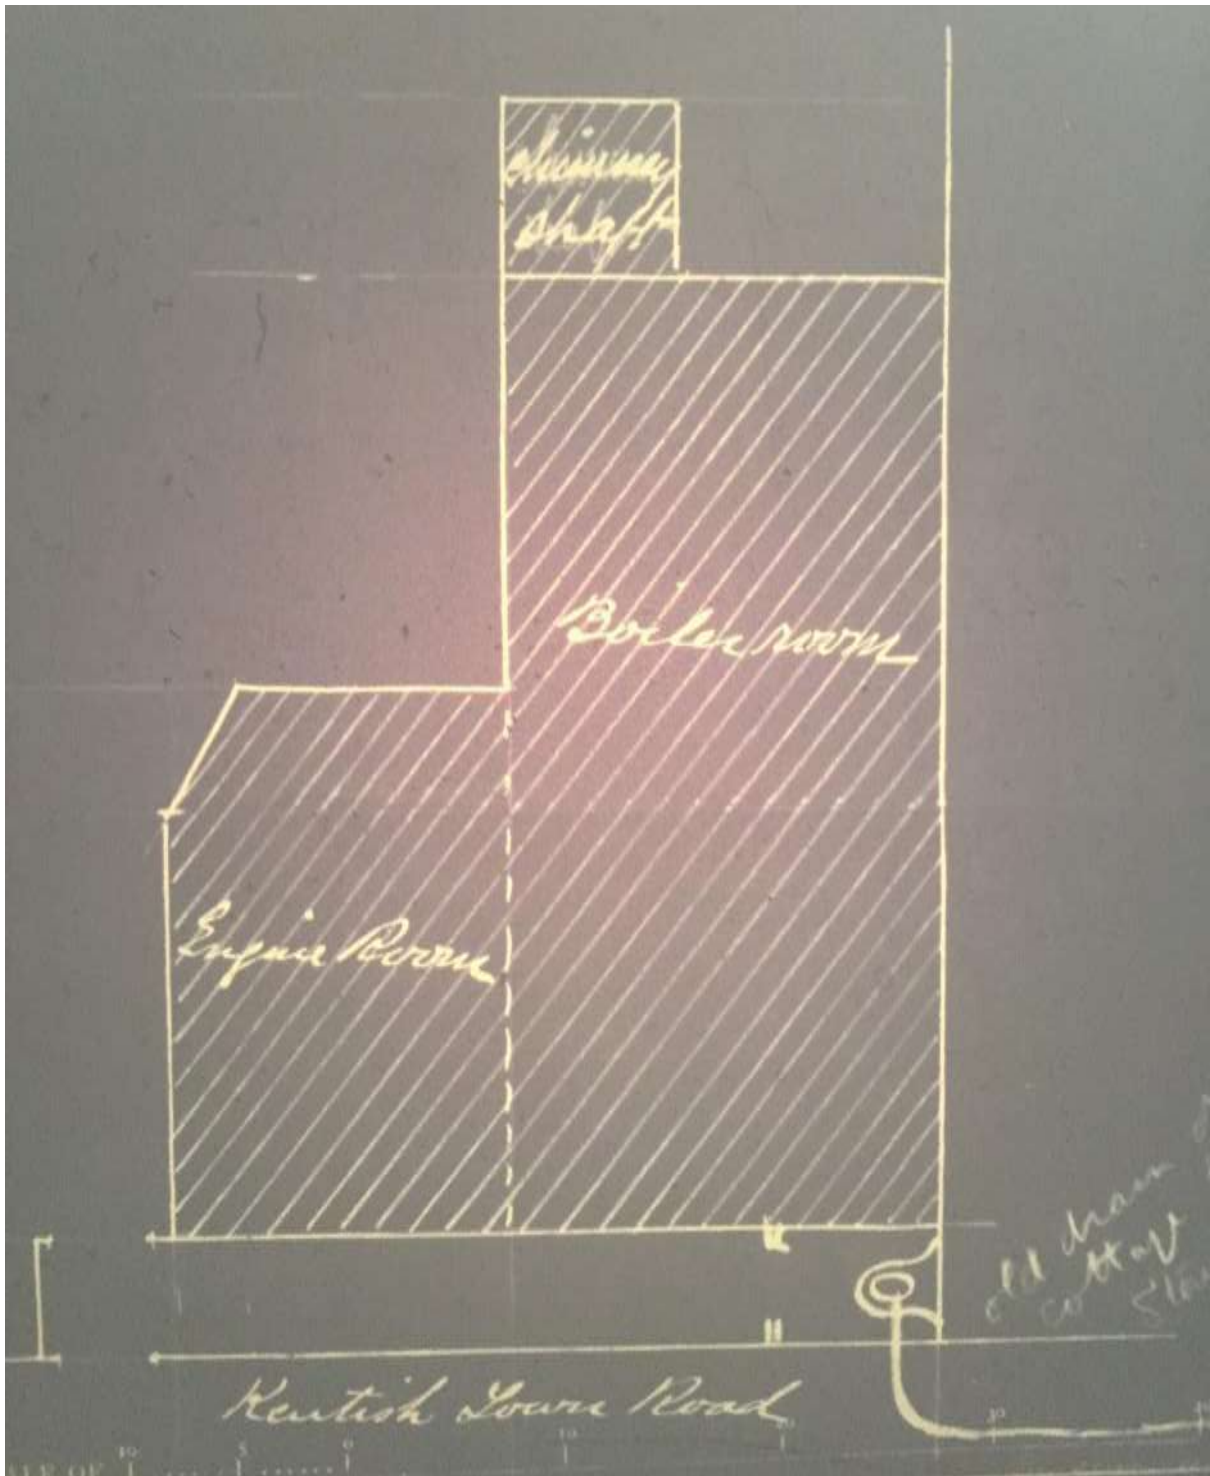
Figure 31: Plan of the steam pumping house. Regent's Canal on the left. (Taken from planning application, 1926)

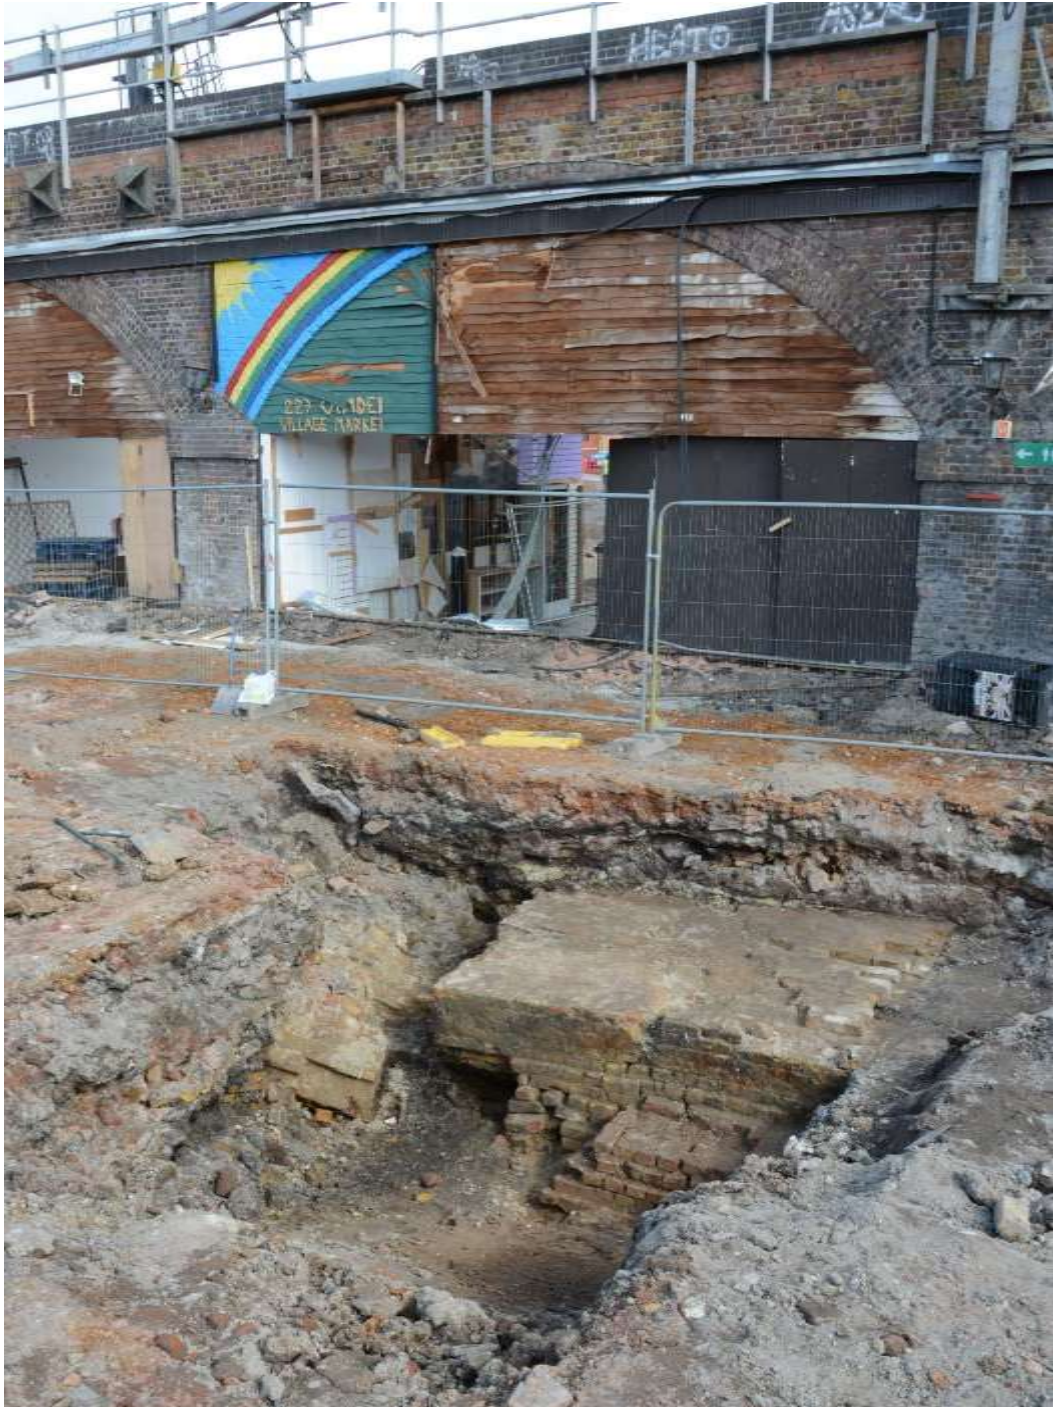
Figure 35: Working shot of the railway associated structures [1], [2] & [4], showing proximity to present-day viaduct. Looking NW.

7.3.3.1 This feature comprised several brick structures and lay to the northeast of the lock-keeps cottage, just south of the present viaduct location (fig. 32 & 35). [1], a yellow stock brick structure made up of at least 12 courses (on the S side) of alternating headers and stretchers lay just below the ground level, at av. 28.24mOD. The structure was roughly rectangular, measuring 2.8m by 2.4m and at least 700mm high (fig. 36). It was bonded with a hard mortar, different to that used to bond structure [2], to the south of [1].

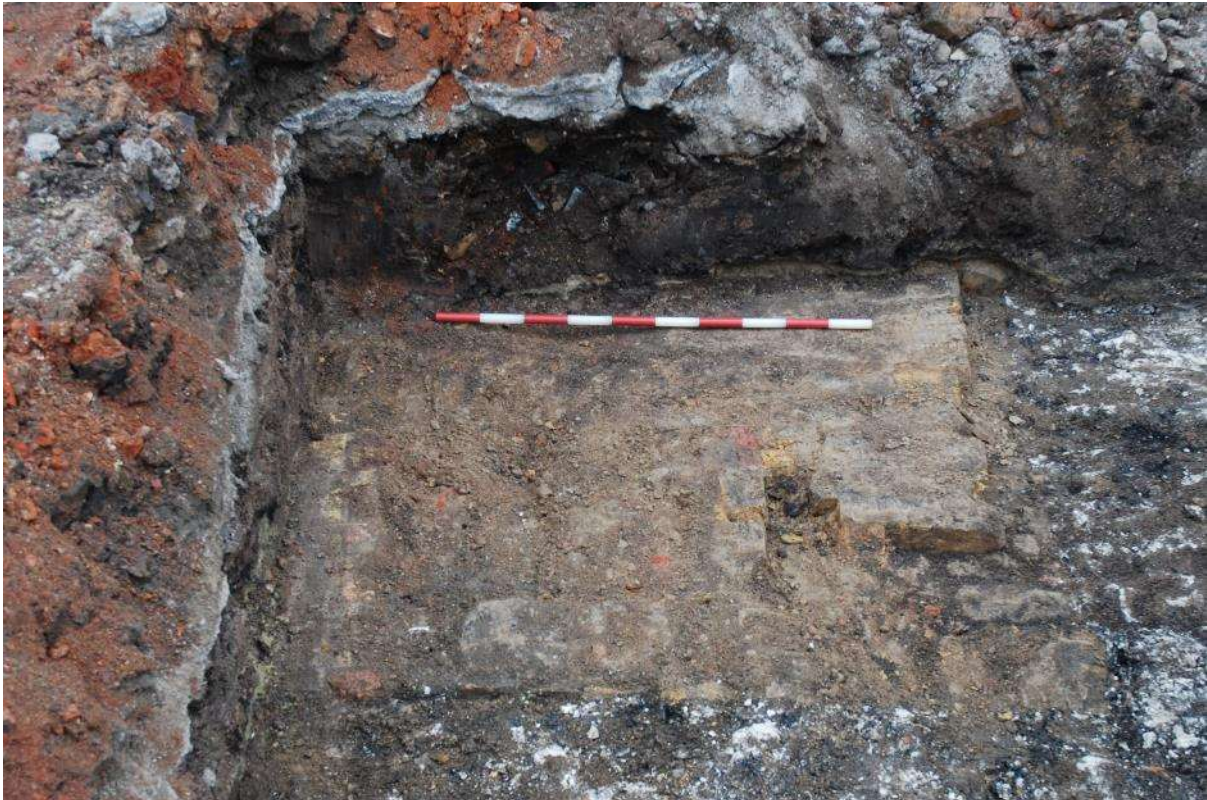
Figure 36: Top of [1]. Looking E. Scale 1m

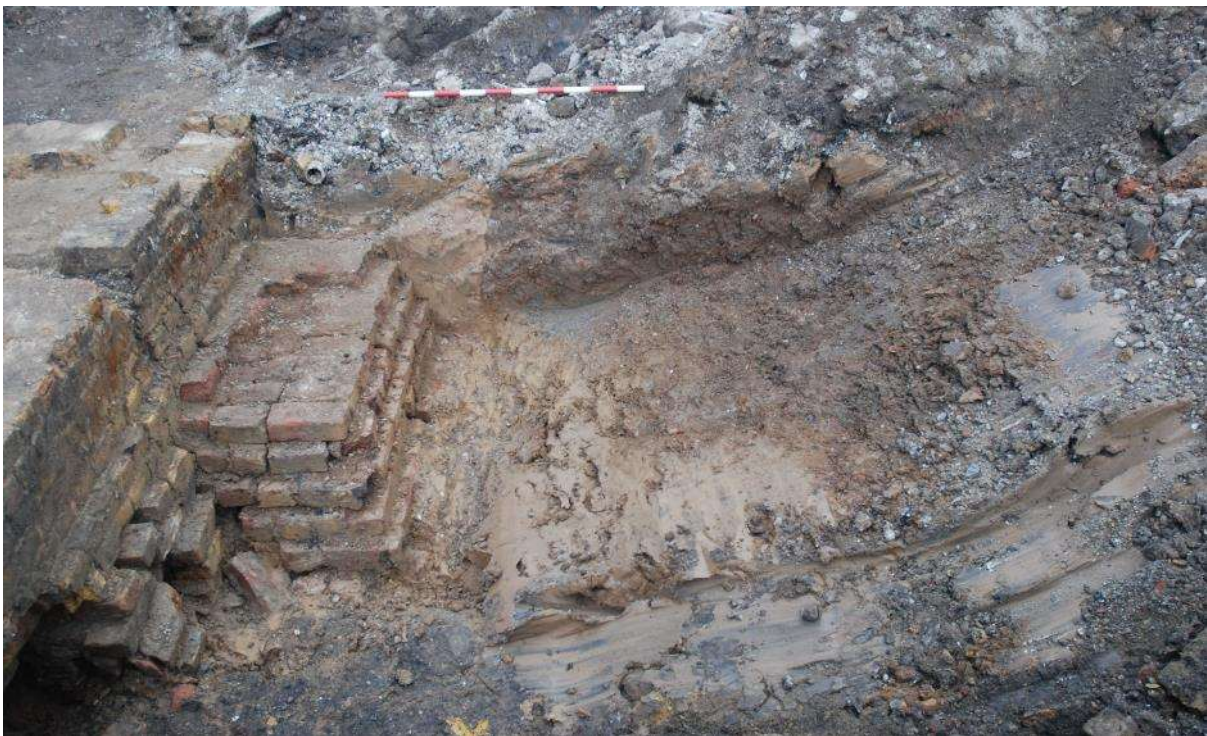
Figure 37: S side of [1], [2] and pit [5] with dark brown fill, (3) cut into natural clay. Looking E. Scale 1m

7.3.3.2 Structure [2] comprised 6 courses of stepped red brick aligned N-S, measuring 0.8m by 1.3m (fig. 37). [2] appeared to extend beneath [1] and the difference in mortar used ([2]'s mortar was loose and sandy) would indicate two phases of building. Structure [2] lies on a similar alignment to the present day viaduct arch pillar, indicating it may have been part of the earlier railway architecture.

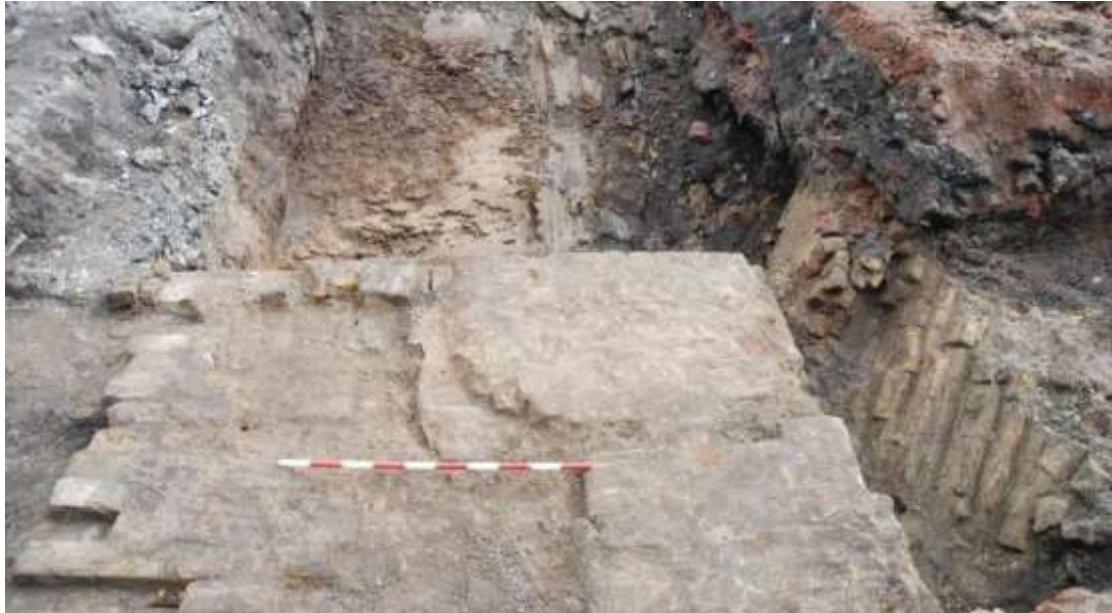
Figure 38: Top of [1] and [4] (right). Looking SSE. Scale 1m

7.3.3.3 Further to the south of [2], a sub-circular pit, [5] was visible, measuring 1.7m by 1.2m and 0.56m deep, cut into the natural clay (fig. 38; 26.54mOD). It was filled with (3), a compacted dark brown silty clay with no inclusions.

7.3.3.4 To the west of [1] lay [4], a collapsed structure (possibly an arch/vault) made of yellow stock brick with several courses visible (fig. 37). It measured 1.4m by 0.9m and was bonded with hard mortar, similar to [1], indicating that [1] and [4] were probably contemporary.

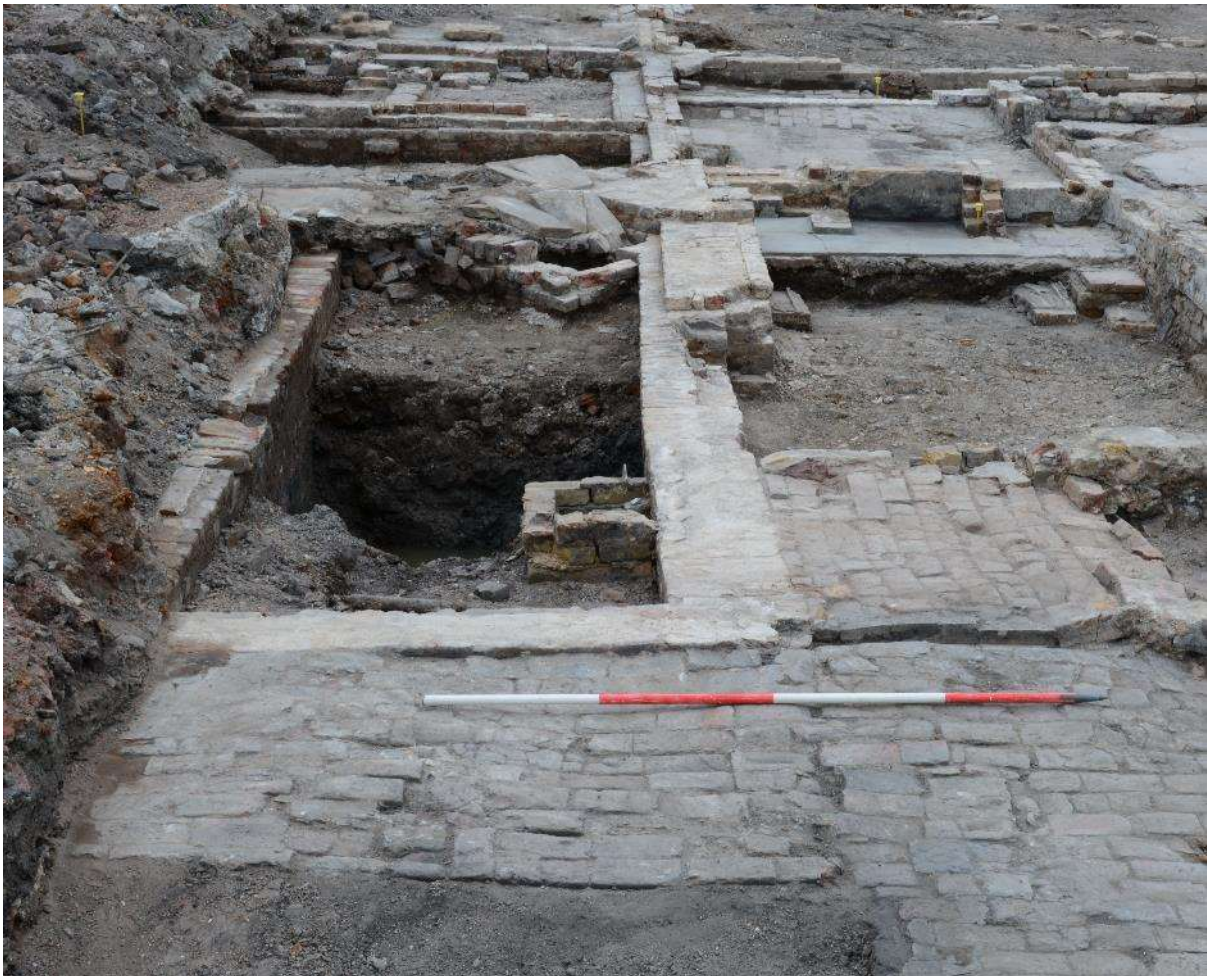
Figure 40: Walls [65] (front left), [24] (centre) and [23] (left) and [22] (back left). Looking W. Scale 2m.

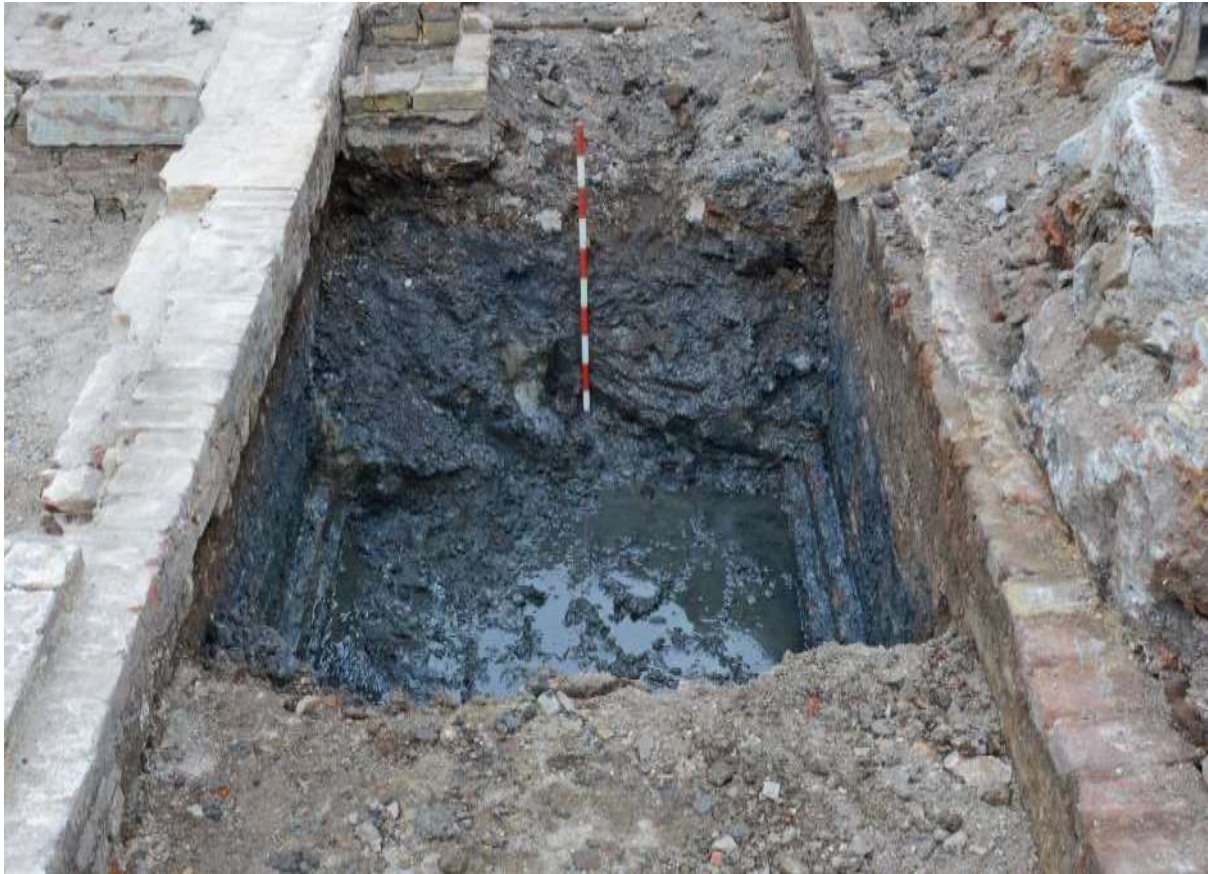
Figure 41: Deep excavation showing foundations of [23] (right) and [24] (left), and, top down: fills (57), (58) and (59). Looking E. Scale 1m.

a wall of five visible courses of stretchers (the full extent was not excavated). It measured c.8m long by 0.24m wide, aligned approximately ENE-WSW. It was truncated by a modern concrete slab at 8m so its original length is unknown but it was probably similar to the length of [24]. The easternmost wall of the original cottage was [65], made up of five visible courses of alternating rows of headers and stretchers. It measured c.4m long by 0.35m wide and was aligned NW-SE (parallel to [22]). The final external wall of the original cottage was [24]. It ran parallel to [60], aligned ENE-WSW. Measuring 9.2m long and 0.32m wide at the ends, widening to c.0.5m in the centre with three courses visible. A small area of further excavation revealed the foundations of [24]. They were very deep, laid on what is assumed to have been the pre-existing land surface level which was subsequently raised with a layer of made ground, 12 courses below what was visible at the surface level (>1m deep, 26.59mOD). The bottom two courses at the base of the wall were stepped out nearly a full bricks-

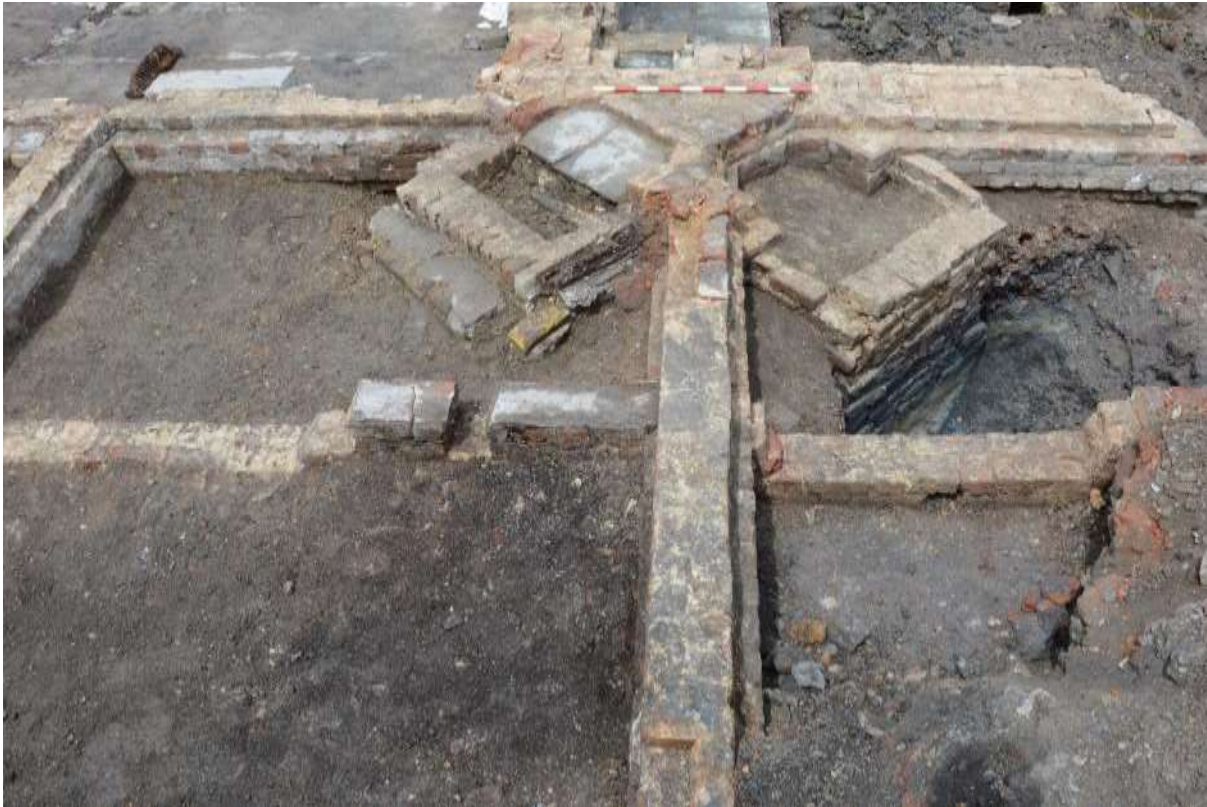
Figure 42: Walls (clockwise from left): [22], [24], [23] and [26] (centre), showing step in second course for suspended floor, and fireplaces [27] and [28]. Looking ENE. Scale 1m.

7.3.4.3 There were three internal walls, one, [23] ran through the centre of the cottage parallel to [24] and [60], one, [62] which ran parallel to [22] and [65], extending between [23] and [60] in the south-eastern corner. The final internal wall, [26] also ran parallel to [22] and [65] at the southwest end, extending between [24] and [60]. The internal walls were made of red brick (av. 230mm x 110mm) and bonded with yellow-white mortar, similar to that seen in the external walls. [23] comprised between 2-5 courses of visible headers, however further excavation revealed very deep foundations, c.15 courses (>1m deep, 26.51mOD). The bottom two courses were stepped out by a brick width, creating two steps at the wall base, similar to what was seen at the base of wall [24] (fig. 41). It measured 5.8m long by 0.25m wide, aligned ENE-WSW. Two fragments of pottery were found mortared into the wall, both have been dated to 1700-1900 which would indicate the wall was probably part of the original cottage, rather than the extension of phase 2 (Appendix V). [62] was much shorter, measuring 1.6m long by 0.24m wide, orientated NW-SE. [62] was of similar construction to [22], being two stretchers wide on the first course and four wide below. It measured c.2.2m long and 0.3m wide, aligned NW-SE. It has been theorised that wall [23] was actually a joist to support a suspended timber floor across the interior of the cottage. This theory also provides an explanation for the step in the second course visible in the exterior walls, [24], [22] and [60], as well as the interior wall [26], which also most likely divided the property into two rooms (fig. 42).

7.3.4.4 Wall [26] abutted two brick structures, [27] and [28], positioned either side to the west and east respectively, and south of [24] (fig. 42). They have been interpreted as fireplaces or stove-bases, both sharing a flue/chimney to the north; the chimney base overlay [24]. [27] lay to the west of [26], and comprised a dark red brick diamond-shaped foundation with a shaped, slightly hollow interior, recessed at the NE end (fig. 43). It was aligned NW-SE and measured 0.9m wide (E-W) and 1.3m long. It was 0.3m high, approximately four or five visible courses, but its foundations were not fully investigated. The hollow interior space measured 0.5m by 0.35m, and was partially covered with two slabs of flagged stone at the NE end. The bricks were arranged with a row of vertical headers along the SW edge (the ‘front’ of the structure, facing into the room), and along both sides, underneath which were rows of stretchers, all bonded with a gritty grey mortar. There were two more flagged stone slabs placed at the base of the structure, along the SW edge. These were mortared to a layer of bricks underneath, forming a hearth or step. It is possible that [27] was a later addition to the room, constructed to match [28], in phase 2 when the cottage was extended and redeveloped. The foundation level of [27] would have helped to establish this but it was not excavated due to time constraints. The style of construction of [27] and [28] differed slightly indicating that they were not built at the same time, but the fact they shared a chimney flue could possibly indicate otherwise (see 7.4.3.5).

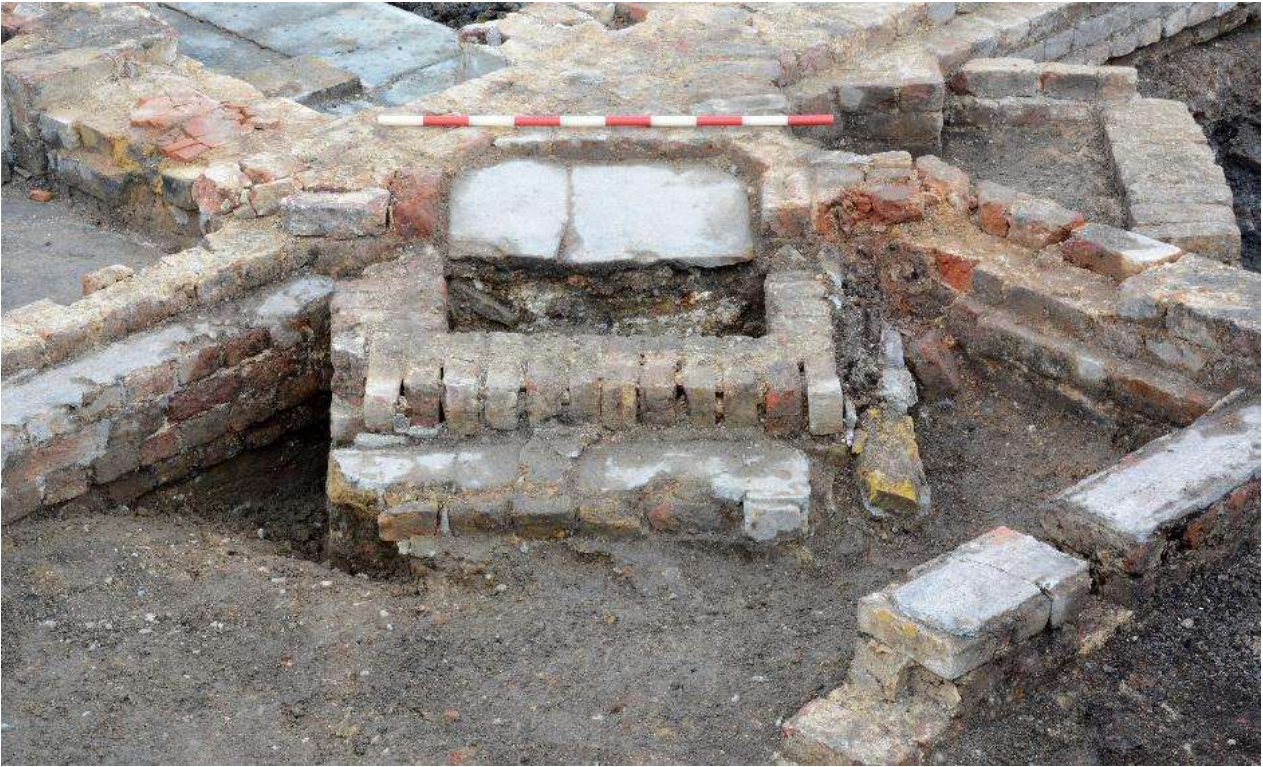
Figure 43: Structure [27]. Facing NW. Scale 1m.

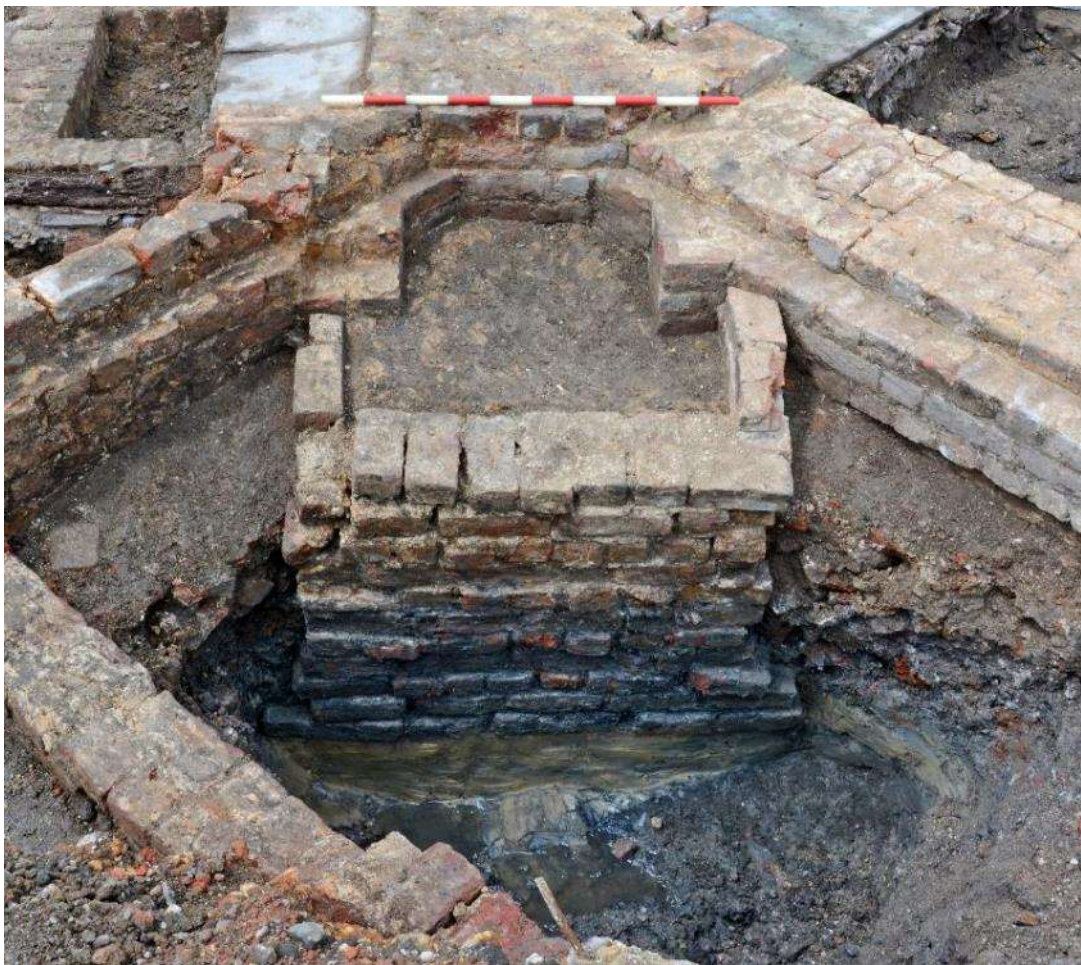
Figure 44: Structure [28] showing depth of foundations. Facing NE. Scale 1m

7.3.4.5 [28] was very similar to [27], also comprising a dark red brick, diamond-shaped foundation with hollowed interior, recessed at the NW end. It was aligned NW-SE and measured 0.9m wide by 1m long. The front of the structure was excavated to a deeper level and revealed the foundations continuing below surface level to cut into the natural clay. It measured c.0.65m high, with 11 courses visible, though only 2 of these were visible at the level of the original floor surface (fig. 44). There were no interior flagged stones or hearthstones as seen in [27], and it was either missing the top course of bricks, or was constructed slightly differently. The first course of [28] was made of horizontal headers along the SW edge with stretchers laid end-to-end down either side, one brick-width wide. Below these, along the SW edge were rows of stretchers, down the sides the same end-to-end layout was repeated. Brick samples taken from [28] were dated to 1650-1900. Its foundation level was 26.81mOD, slightly higher than the level seen for walls [24] and [23] but as it is cut into the natural clay as seen elsewhere, this difference in level may have been due to a natural rise in the ground level of the time.

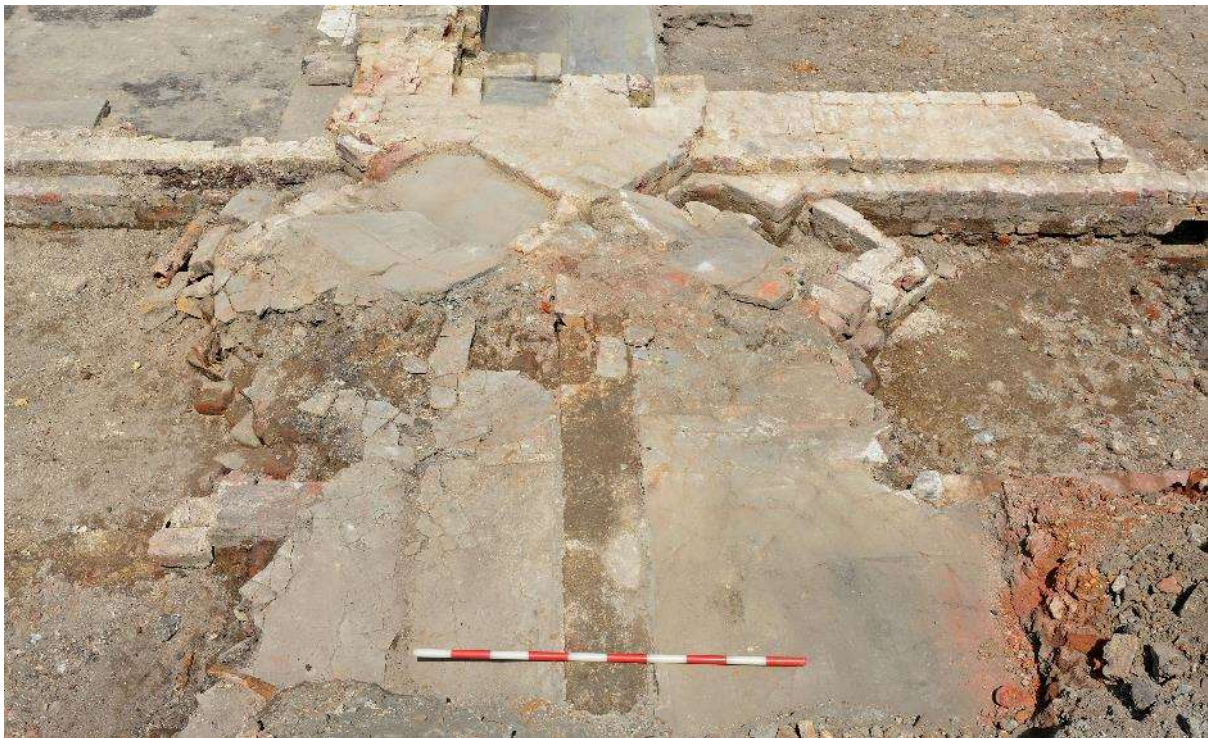
Figure 45: Surface [25] overlaying [27] and [28], cut by [26]. Looking ENE. Scale 1m

7.3.4.6 A surface, [25], made up of disturbed stone flags, cement and some bricks partially overlay [27] and [28], extending south, either side of [26] (fig. 45). It measured (at its greatest extent) 2.4m N-S by 2.1m E-W. [25] also overlay [23] and was possibly the result of works to reinforce the floor in that area. It is also possible that it wasn't laid down until the second phase of building but this cannot be verified. A coin was found on the surface of [25], though fairly obscured it has been dated to post-1915 (Appendix VI). Due to the residual nature of the find it cannot be used to date the floors construction.
