CAMDEN LOCK VILLAGE REDEVELOPMENT

HAWLEY WHARF: LAND BOUNDED BY CHALK FARM ROAD, CASTLEHAVEN ROAD, HAWLEY ROAD, KENTISH TOWN ROAD & REGENT'S CANAL

AN ARCHAEOLOGICAL POST-EXCAVATION ASSESSMENT

SITE CODE: CLV15
APPROXIMATE SITE CENTRE NGR: TQ 2881 8422
PLANNING APPLICATION REF: 2012/4628/P

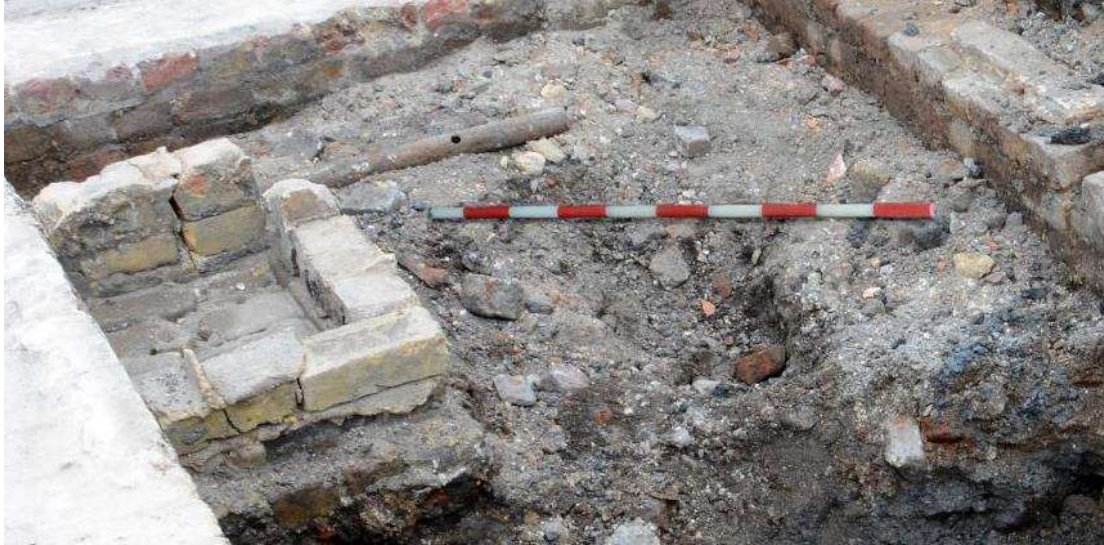
7.3.4.7 A more ambiguous brick structure was visible at the eastern end of [24]. [34] comprised four courses of yellow stock stretchers, laid out in a rectangular shape. It measured 0.75m by 0.5m and abutted [24]. The walls of the structure were 0.11m wide, and had a hollow in the centre roughly two courses deep (c.0.2m). Traces of render covered the bricks (fig. 46).

Figure 46: Structure [34], abutting [24]. Looking SE. Scale 1m.

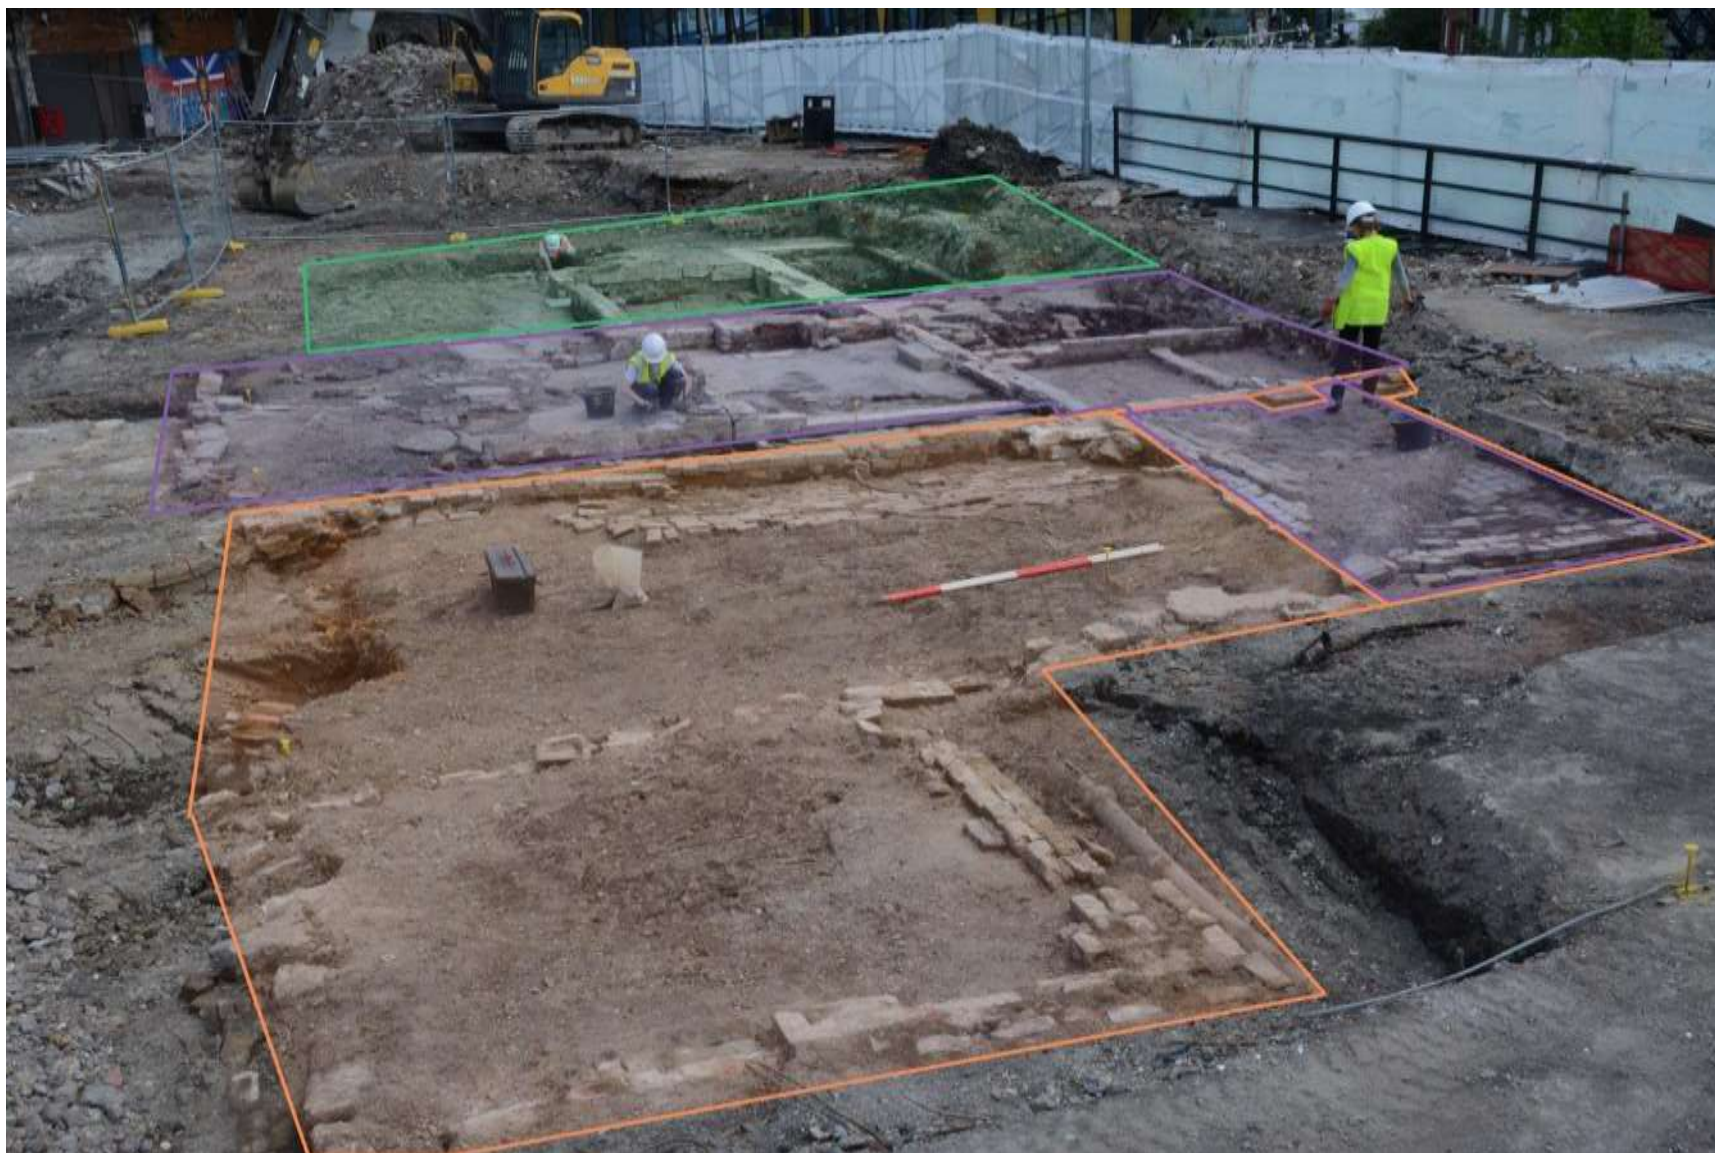
Figure 49: Site working shot, divided into dwellings as Fig. 44. Green=dwelling 1, purple= dwelling 2, orange= dwelling 3. Looking SE. Scale 2m.

- 7.3.5.1** The footprint of dwelling 1 lies half over the original cottage (fig. 47; 49). Orientated NW-SE, the dwelling appears to have consisted of two rooms plus a small outside yard and outhouse to the east, and a larger yard to the north. Its footprint measured c.6m E-W by c.11m N-S (including the northern yard area).

7.3.6.1 Dwelling 2 lay over the remainder of the original cottage, but the majority of its footprint lay on erstwhile open land. Orientated NW-SE, it measured 13.7m long (including the northern yard) and 6m wide (fig. 47; 49). It appears to have consisted of two rooms, a front and a back, with an outdoor space to the north. There was the remains of an outhouse to the north of the yard, and what appears to be a corridor or similar space to the west of the yard and the back room. It is unclear whether this was an outdoor space or what function it might have served.

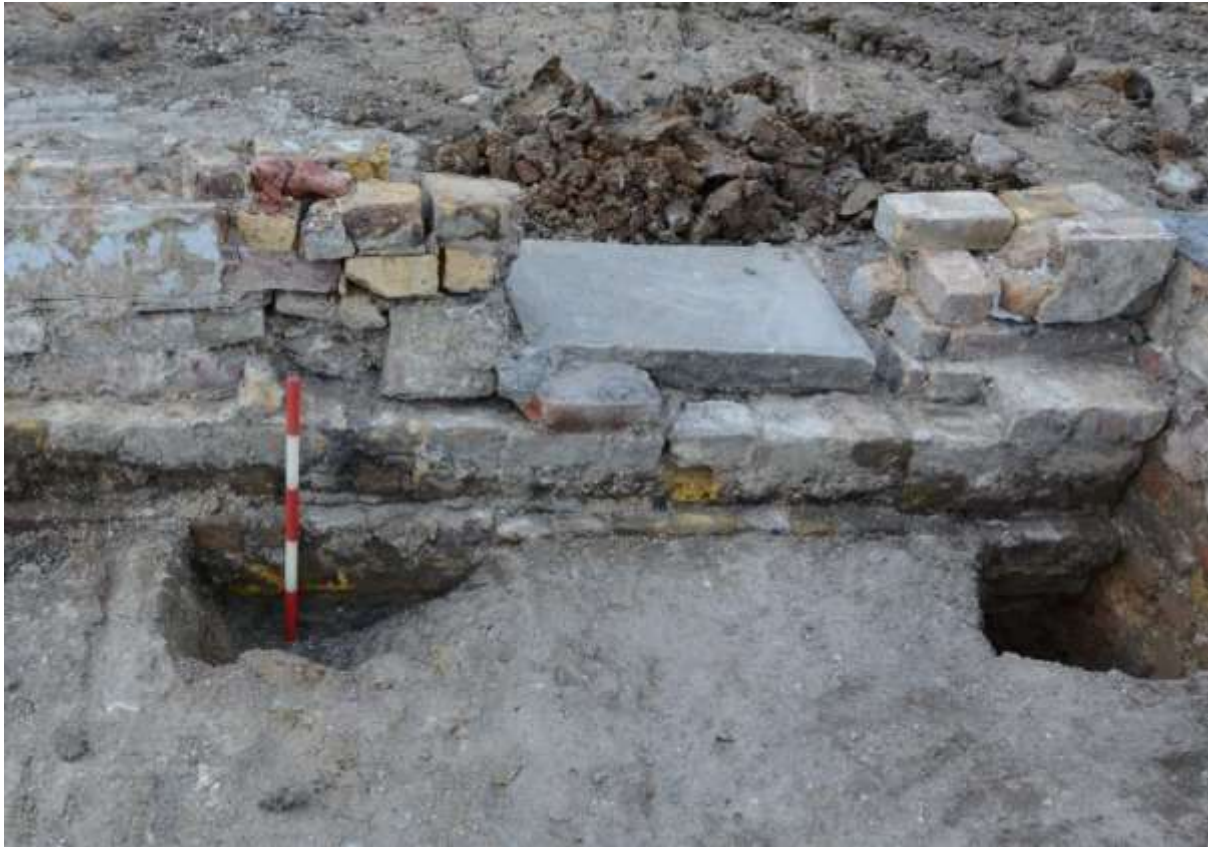
Figure 50: Foundation level of [30], and threshold [37]. Looking NW. Scale 0.5m

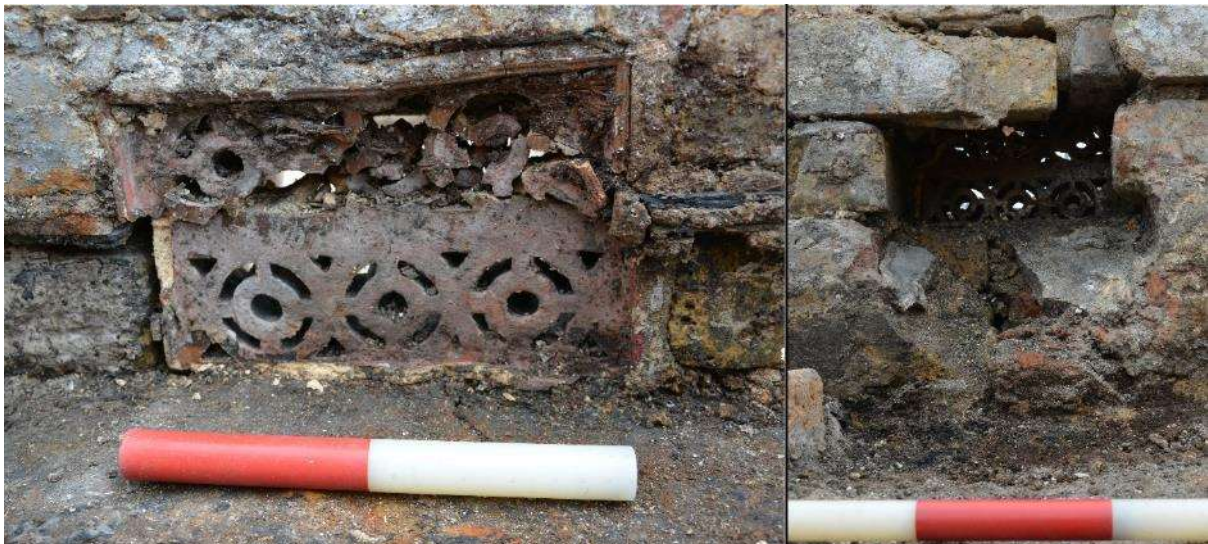
Figure 51: Ceramic grilles set in to [30]. Left: facing SE, scale 0.2m; Right: facing NW, scale 0.1m

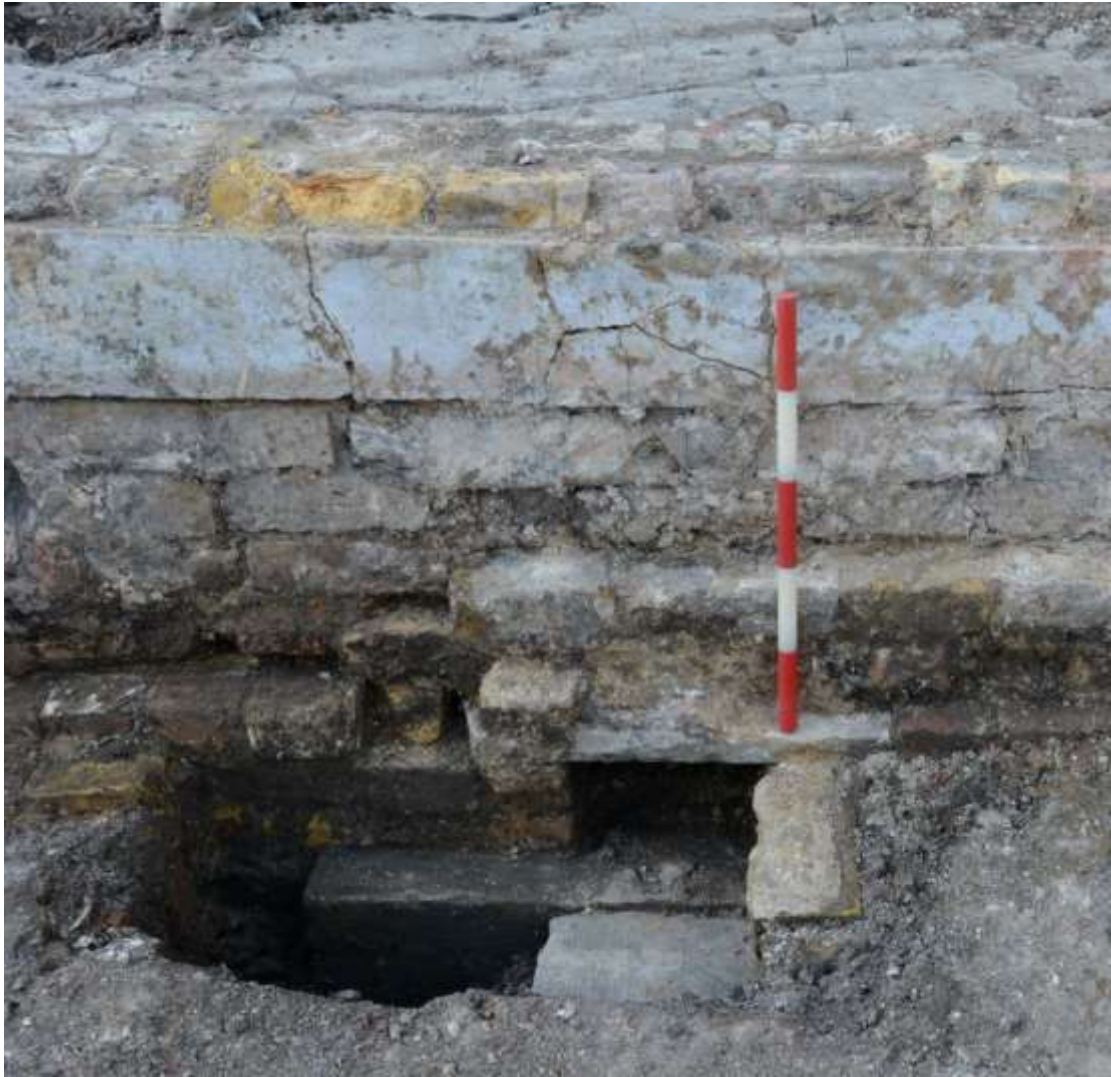
Figure 52: Stone-lined feature at base of [30], presumed to be a drain. Note render on courses 2 and 3. Looking NW. Scale 0.5m

- 7.3.5.3** Structure [30] makes up the northern external wall. Measuring approximately 11m long in total, it is shared with the cottage next door. It is 0.25m wide and made of seven visible courses of red and yellow bricks, bonded by mortar in alternating rows of headers and stretchers. The second and third course down were covered in render, possibly indicating the floor level within the room (fig. 52). The foundation level of [30] was far shallower than [24]; c.0.25m below the surface level (27.21mOD), making it clear they were not contemporary (fig. 50). A stone paving slab was excavated c.0.25m from the east end of [30]. Measuring 0.42m by 0.62m and aligned E-W, it was interpreted as a threshold or step from the outside yard (N of [30]) into the cottage interior (fig. 50). West of [37], a ceramic grille was set into [30] to provide ventilation. Two more ventilation grilles were set into [30], one on top of the other further west along the wall (fig. 51). The ceramic ventilator grilles have been dated to 1860-1940 and all three show evidence of having been painted several times on one face. This could indicate that the whole exterior of the back wall (at least) had been painted up to three or four different colours (Appendix IV). It is more likely though that the walls of the cottage were white-washed (7.3.5; fig. 48) and the ventilators were painted with subsequent varying shades of red as a decoration. Approximately 2m from the east end of [30] was a possible drain or a more crude ventilation structure. It was constructed from a large stone slab placed under the foundation of [30], with brick either side, topped by another, slightly smaller and much thinner stone slab creating a square hole in the wall. The base stone measured approximately 0.55m long, its full width and thickness was unknown due to excavation constraints. The hole measured c.0.24m long by 0.12m high. Its depth was unrecorded (fig. 52).

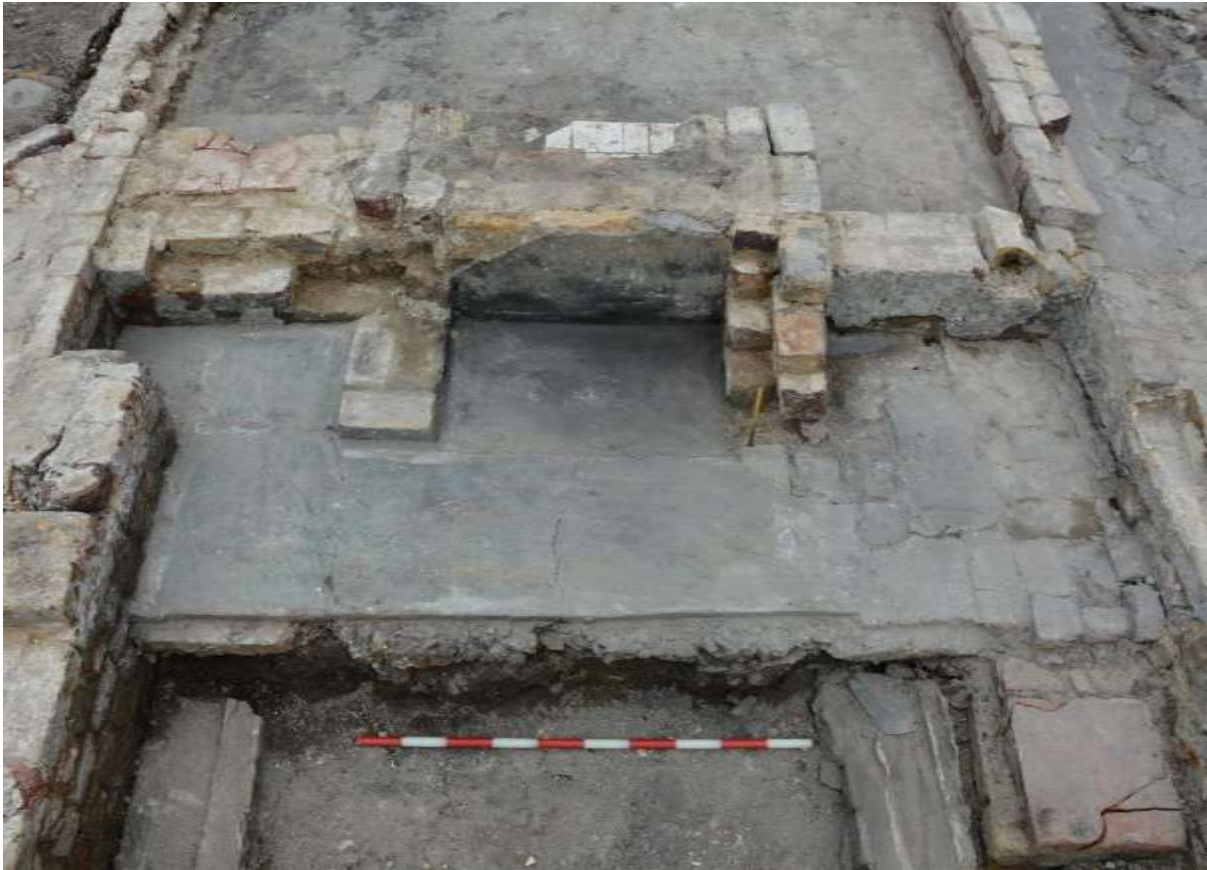
Figure 53: Fireplace [33] (centre) with wall [31] (right), floor surfaces (67) and [68]. Large tile in front of [68] (bottom right) was sampled, dated to 1750-1950. Looking SW. Scale 1m.

7.3.5.4 Abutting [30] was a N-S aligned wall, [31] that provided the western boundary of the cottage north of the fireplace [33]. It measured 0.66m long by 0.23m wide, made of three courses of red and yellow brick in a stretcher bond, bonded with mortar. The east face of [31] (facing into cottage 1) was rendered (fig. 53). [31] also abutted the chimney foundations of fireplaces [32] and [33]. [33] was associated with cottage 1, constructed of brick with a worked slab of sandstone making the hearth. The fireplace measured 0.84m N-S by 0.45m E-W at its full extent. The brick portion was two brick stretchers wide either side of the sandstone hearth, three fragmentary courses on the northern side and one course on the southern side. The area in front and to the sides of the fireplace was covered with a concrete layer, (67), similar to (49). This layer was damaged north of [33], exposing a brick floor underneath, [68]. A large fragment of brick floor-tile was recovered from in front of [68] and dated to 1700-1900. (67) ended in a neat edge, perhaps implying the floor beyond the hearth was constructed from a different material, most likely wood (fig. 53).

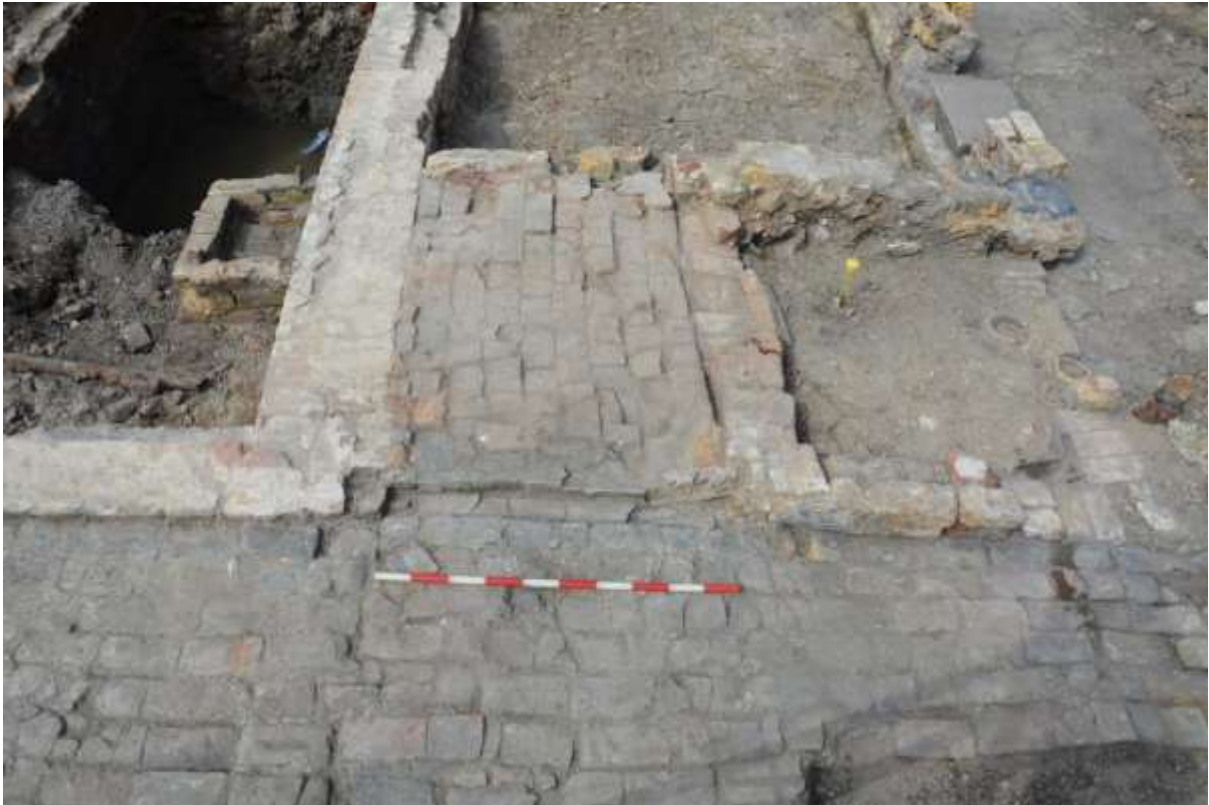
Figure 54: Yard [43] (centre), yard [42] (front) and beam cut [41] between them. Structure [40] and [38] (right). Looking SW. Scale 1m.

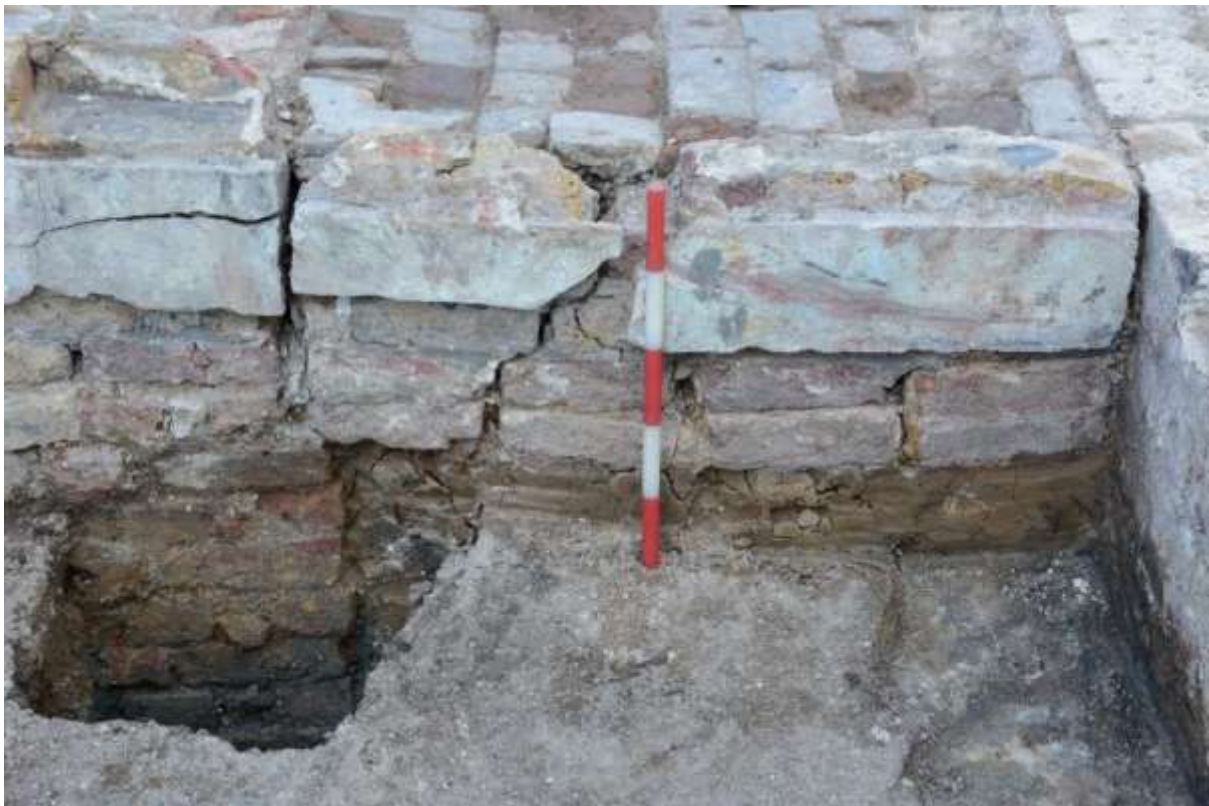
Figure 55: Change in foundation levels between [40] (left) and [39] (right). Note render on courses 2 and 3, and lack on secure bonding to wall [24] (far right) and [40]. Looking NE. Scale 0.5m

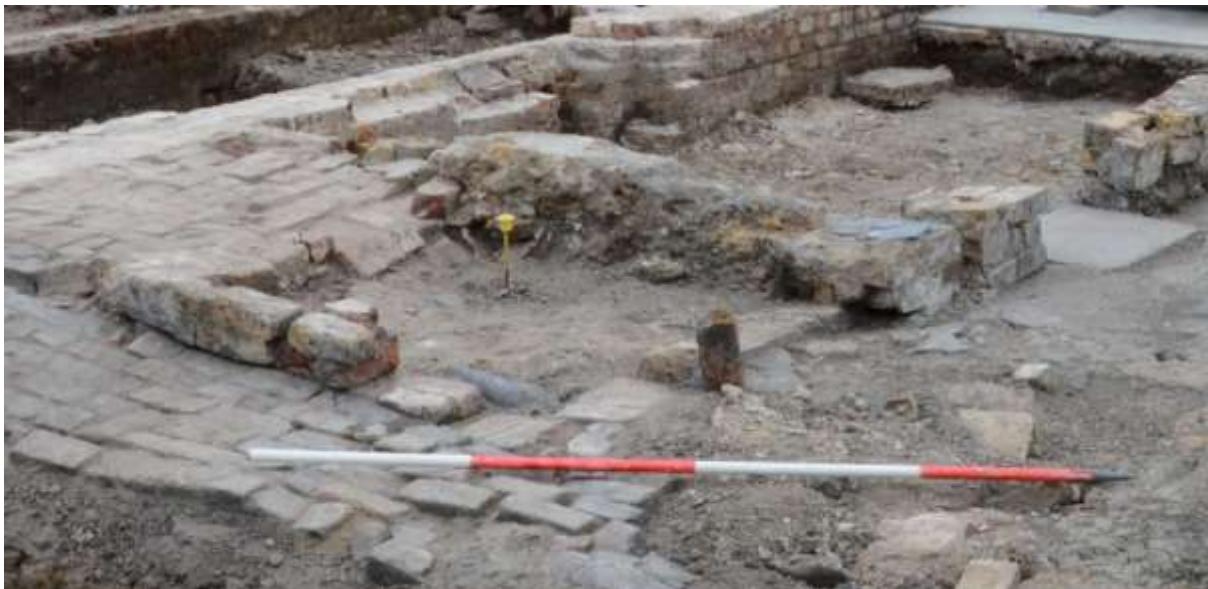
Figure 56: Overview of [40] and [38] with yard [43]. Looking SW. Scale 2m.

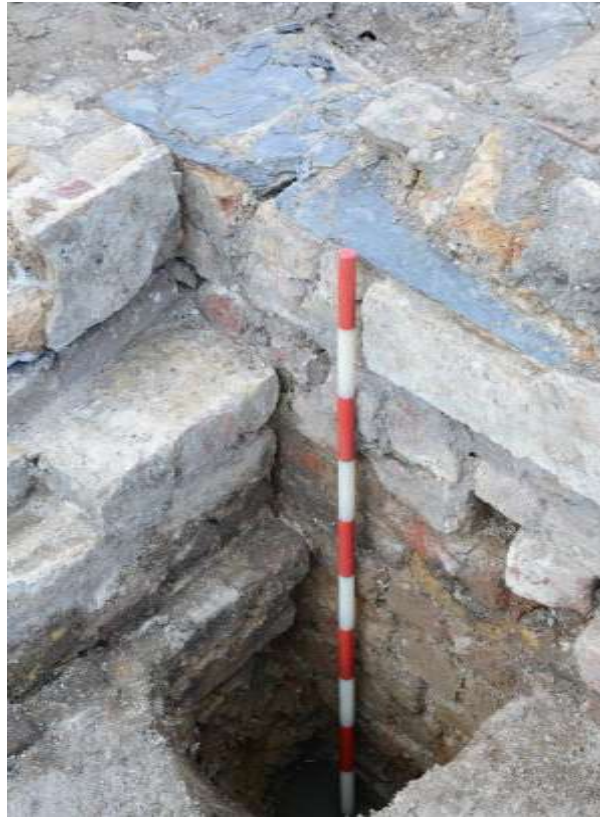
Figure 57: Showing insecure bond and foundation difference between [30] (left) and [40]. Note course of slates as damp proofing in [40]. Looking N. Scale 1m.

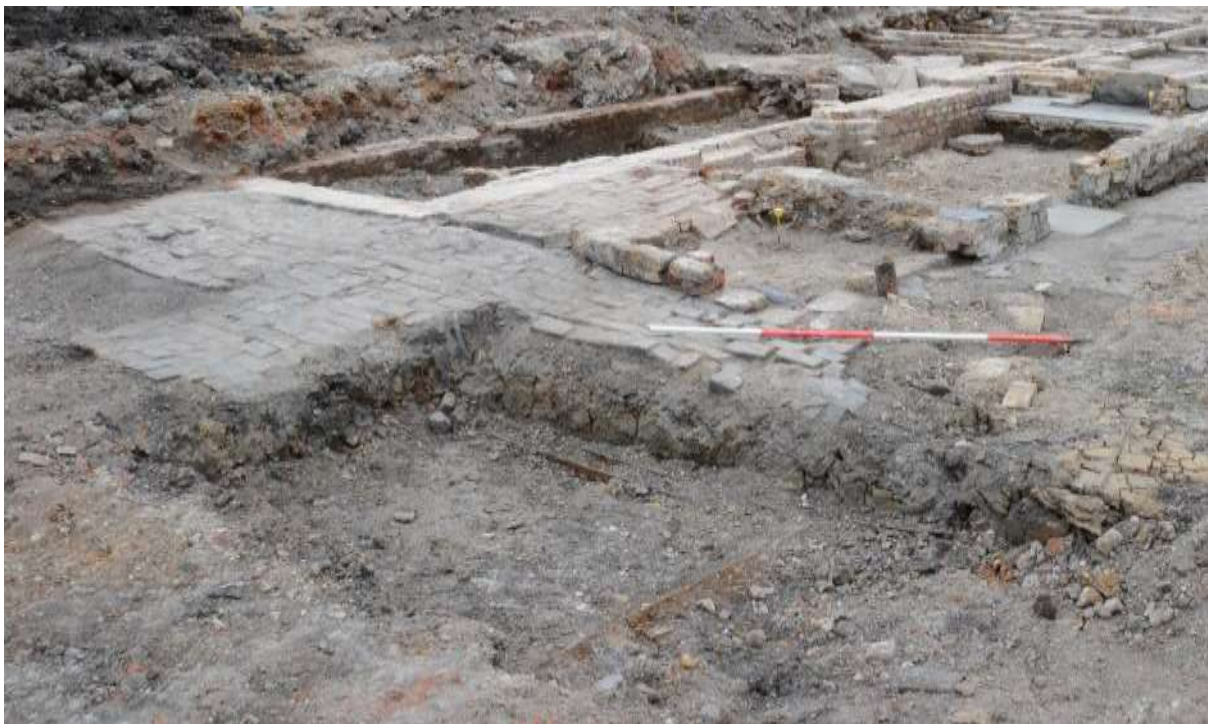
Figure 58: Floor [42] and unexcavated tracks (55) (foreground). Looking SW. Scale 2m.

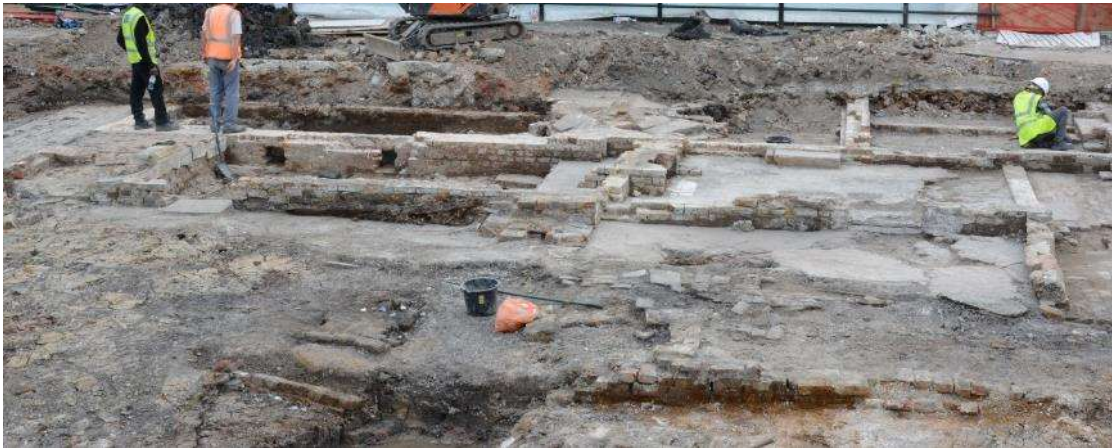
Figure 59: Working shot of back yard with concrete surface (45). Structure [47] visible unexcavated in the foreground. Looking SE. No scale.

7.3.5.8 The north of the cottage was characterised by a fragmented concrete surface, (45) which was interpreted as an outdoor yard. It covered the area to the north of both cottages, c.9.3m wide by 2.7m long, extending in patches from [53] to [38] (fig. 59). The surface was indented with two narrow linear drains near [30], aligned NE-SW. These were interpreted as drainage channels, both leading to a brick drainage system, [44] with an iron grate at its centre (fig. 60). Measuring 0.6m by 0.8m, [44] consisted of one stone slab to the east, with a brick wall 5 horizontal headers wide beside it. To the south of the grate was a course of stretchers laid end-to-end, to the west was two courses of brick; stretchers overlying headers. The north side of the grate was truncated. To the north of (45) was a small area of fragmented and disturbed brick surface, [46]. It was made of red brick bonded with mortar, measuring 1.1m by 0.4m aligned NW-SE. It was at a level of 27.49mOD, below that of (45) indicating that it may have been the original yard surface which was partially cleared and overlaid by (45). Further north of [46] was a short section of wall [48], which continued to just north of [53]. It comprised red and yellow brick in alternating rows of headers and stretchers bonded with mortar. It measured 6.05m by 0.24m, though somewhat truncated along its length; a c.1.4m gap between two sections. The section above [46] measured c.0.85m long.

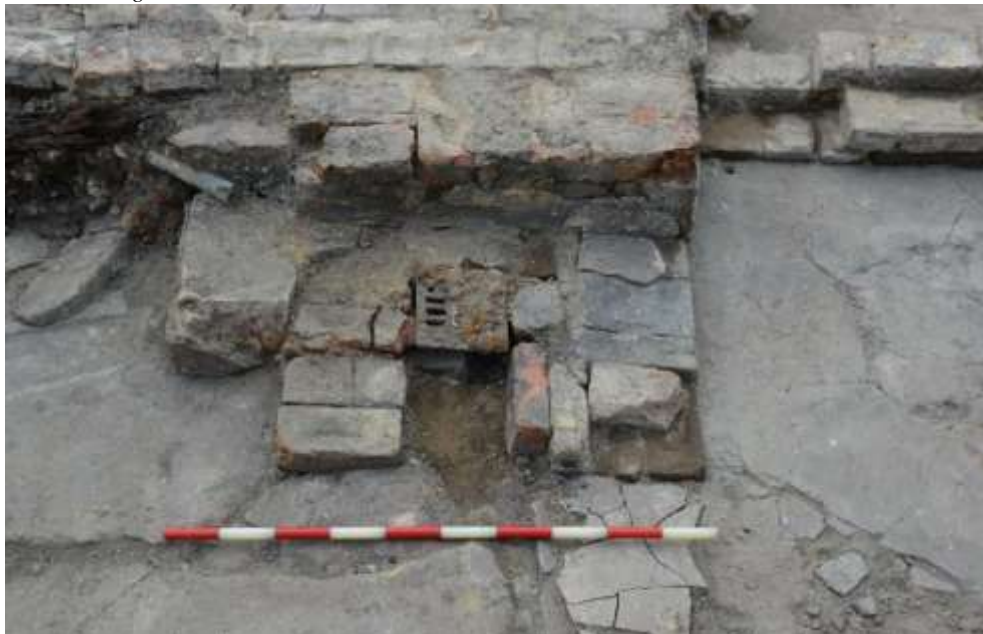
Figure 60: Drain [44] surrounded by (45) showing indentations in its surface. Looking SE. Scale 1m.

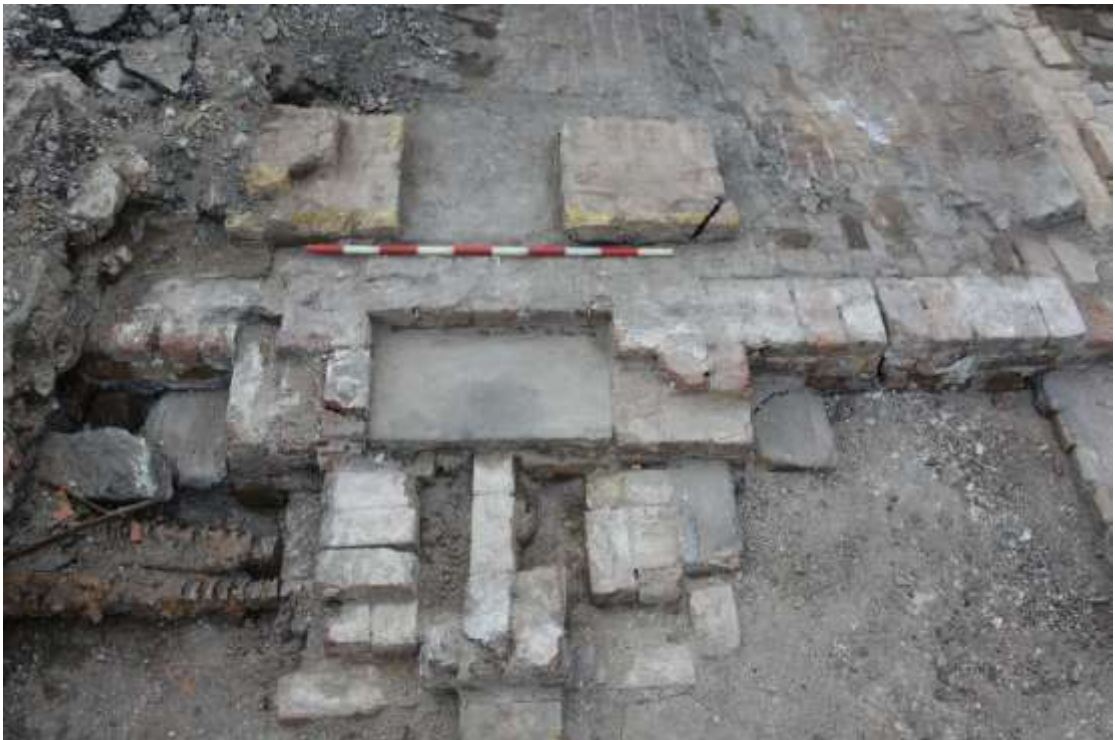
Figure 61: Threshold/fireplace [19] (foreground), with brick surface [12] behind it, wall [29] to the right and in situ metal items to left. Later brick pads [13] overlying [12]. Looking SW. Scale 1m.

7.3.6.2 This cottage shared two party walls with dwelling 1 to the east; [26] and [31], and [30] and [60] ran the length of both cottages, north and south. The western external wall of the cottage comprised two walls, [29] to the south and [53] to the north, joined by a small section of [64] and [20]. [29] was constructed from red brick, four courses in a stretcher bond, measuring c.4.3m long by 0.26m wide, aligned NW-SE. It was cut in approximately the middle by [19], a brick and stone slab structure that has been interpreted as a possible threshold for the entrance to the cottage, or a fireplace (fig. 61). It measured 1.14m long and 0.36m wide, on the same alignment as [29]. It comprised a large, worked stone slab surrounded either side by three-header-wide red brick walls, three courses high.

To the west of the slab (external face) the bricks were obscured by mortar, but appeared to be in a header bond, lain side-by-side, and nine bricks wide. The number of courses on this side is unknown as the top of it was on the same level as surface [12]. The eastern face (internal) saw a single row of headers bonded end-to-end coming from the centre of the slab, three bricks long, extending to wall [21]. Either side of this were two sections of brick, the southernmost made up of two courses of headers and stretchers. The northern section comprised one course of stretchers. Some metal objects were

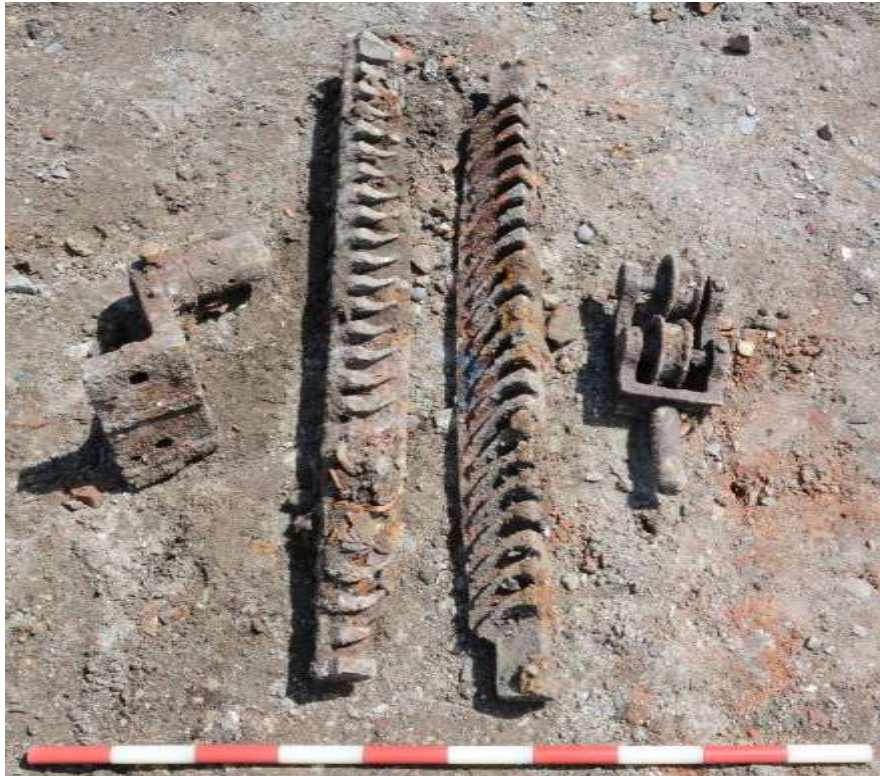
Figure 62: Metal objects found by [19]. Scale 1m.

found to the west of [19], partially underneath [60] (fig. 62). These items are industrial in appearance but their intended use is unclear. They are perhaps connected with the sawmill to the west of the cottages, rather than the canal. A floor tile was also recovered from this context, made by *The Campbell Brick and Tile Company* it was dated to 1876-1882 (Appendix IV; fig. 63). Brick surface [12] lay to the west of [29]. It measured 4.5m by 2.9m (truncated). It was constructed from red brick with two rows of cobblestones along wall [14], possibly indicating some repair attempt after the later wall was built. There appeared to be two wheel ruts in the centre of the floor, leading to the interpretation that it was an outdoor yard, connected to the cottage by [19] (fig. 64).

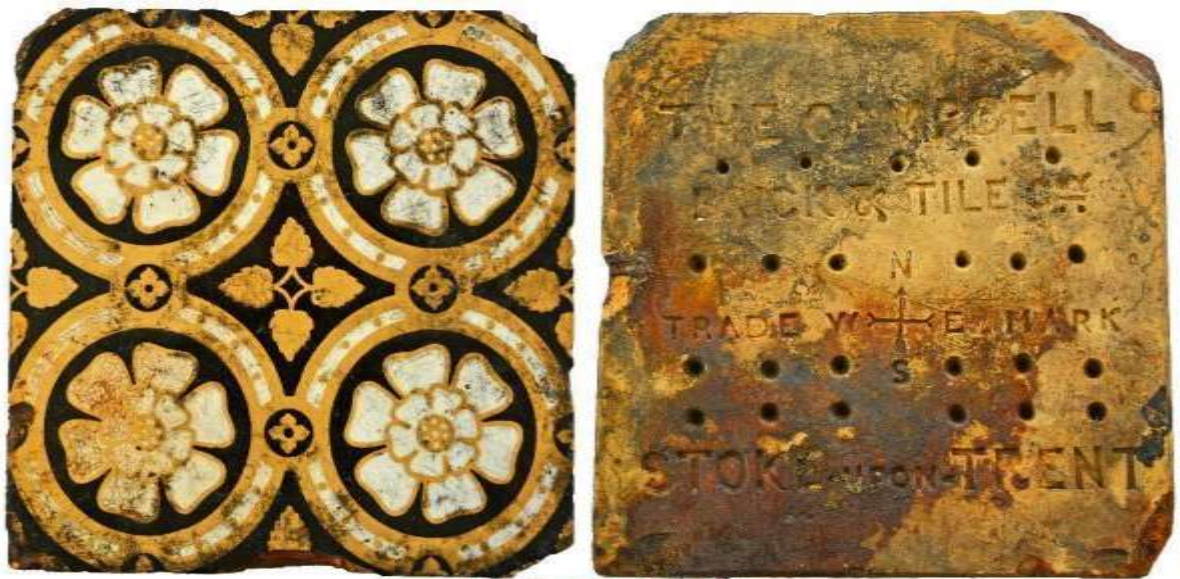
Figure 63: Encaustic floor tile from beside [19]. Dated to 1876-1882. Scale 0.1m.

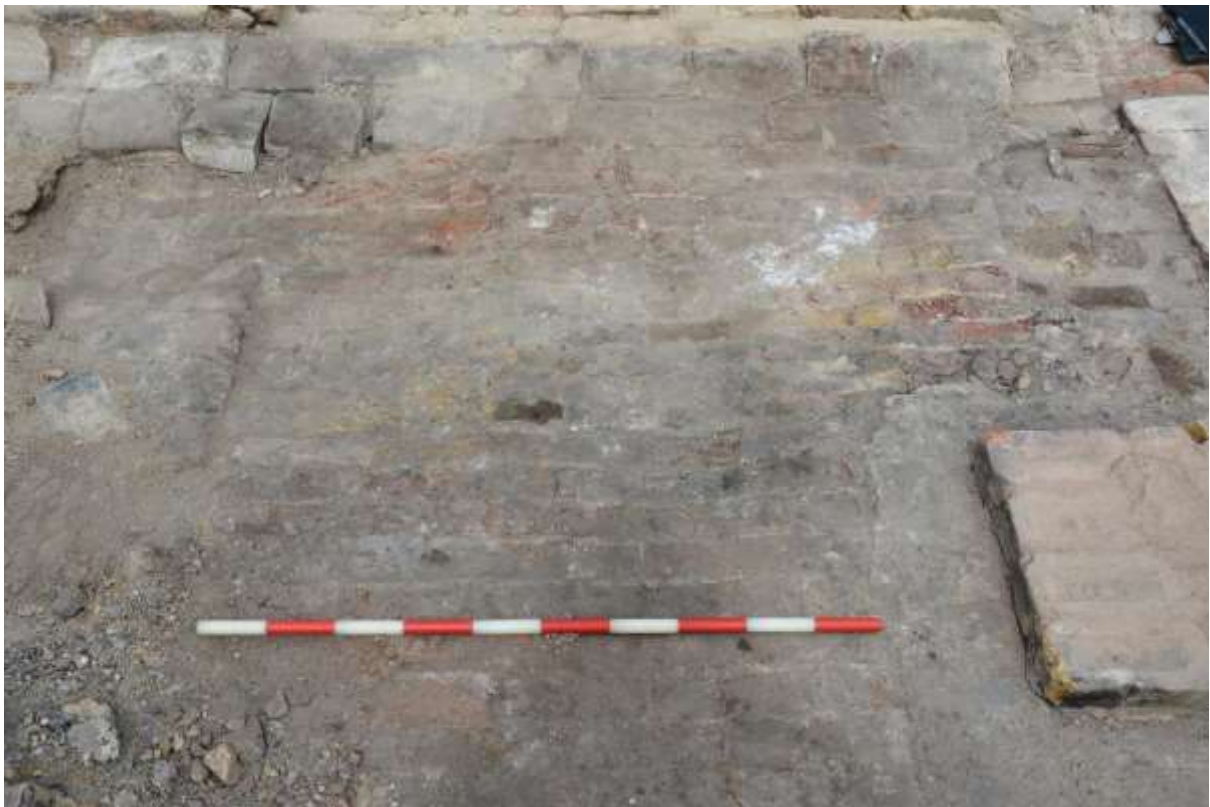
Figure 64: Floor [12] with wheel ruts (centre). Overlain by [13] (right). Looking WNW. Scale 1m.

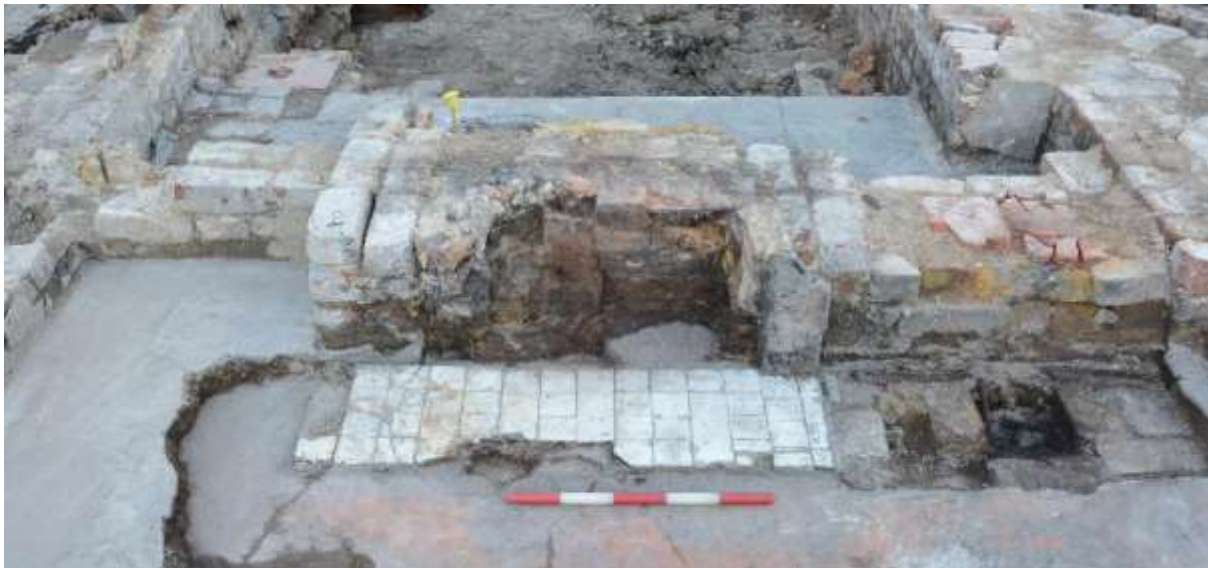
Figure 65: Fireplace [32] with glazed tile hearth and concrete floor (49). Looking NE. Scale 0.5m.

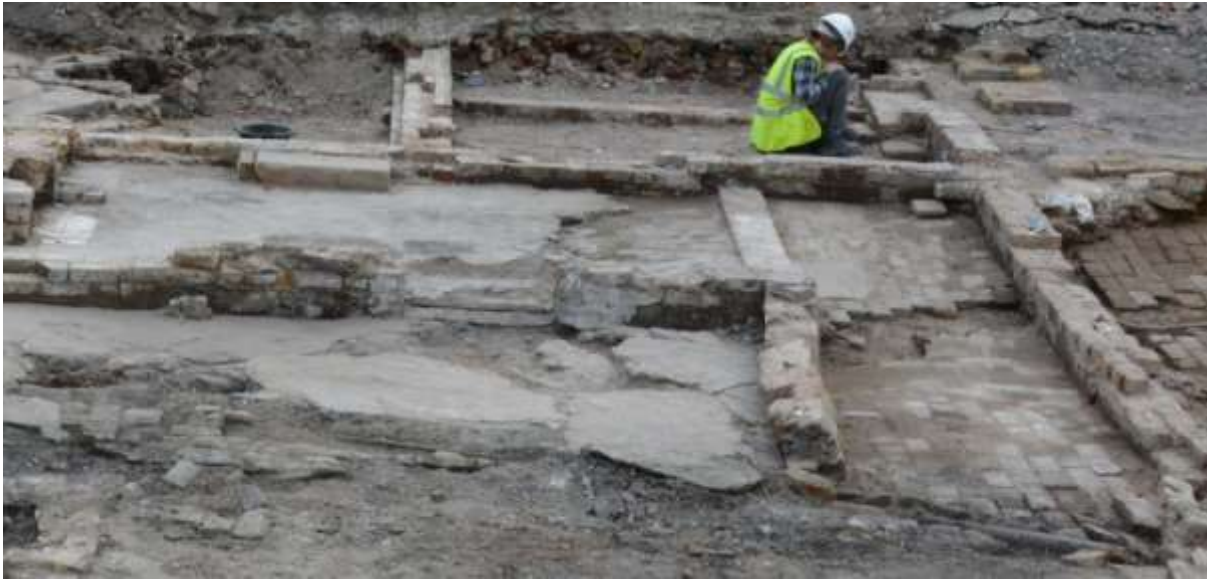
Figure 66: Working shot of floor [50] (inside back room, centre), and [52] (between walls [15] and [53], right). Step [36] visible in back- (left). Looking ESE. No scale.

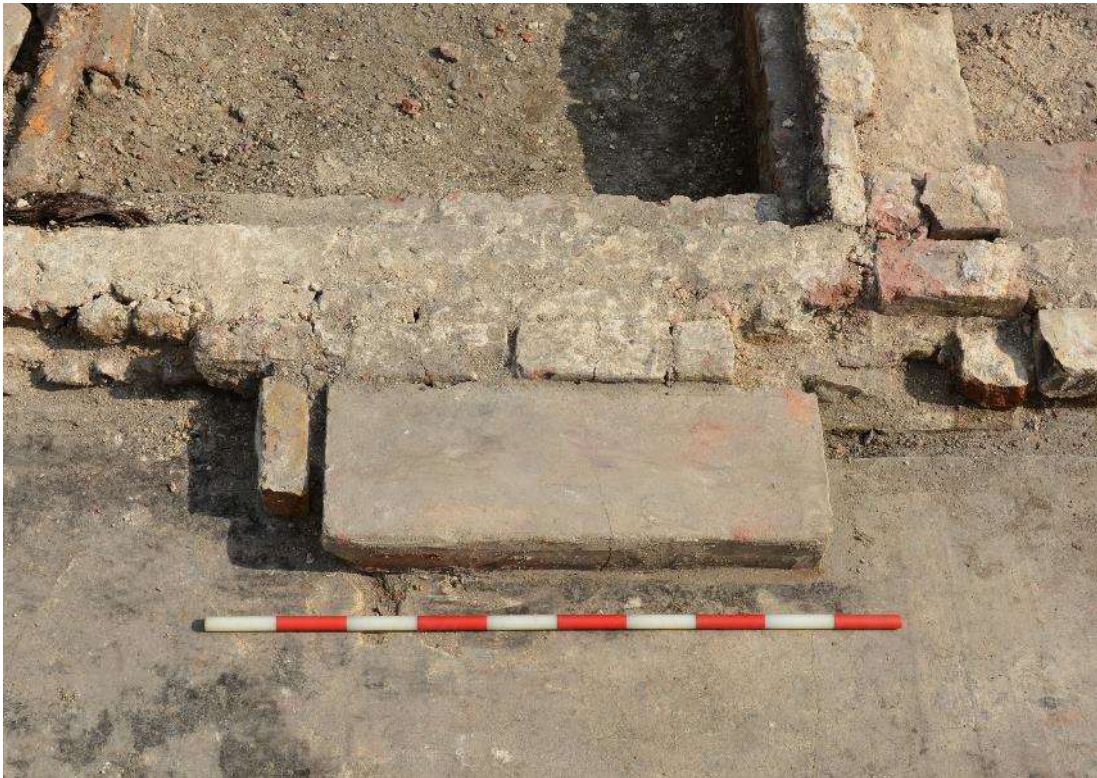
Figure 67: Step [36] butting wall [24] with floor (49). Looking ESE. Scale 1m.

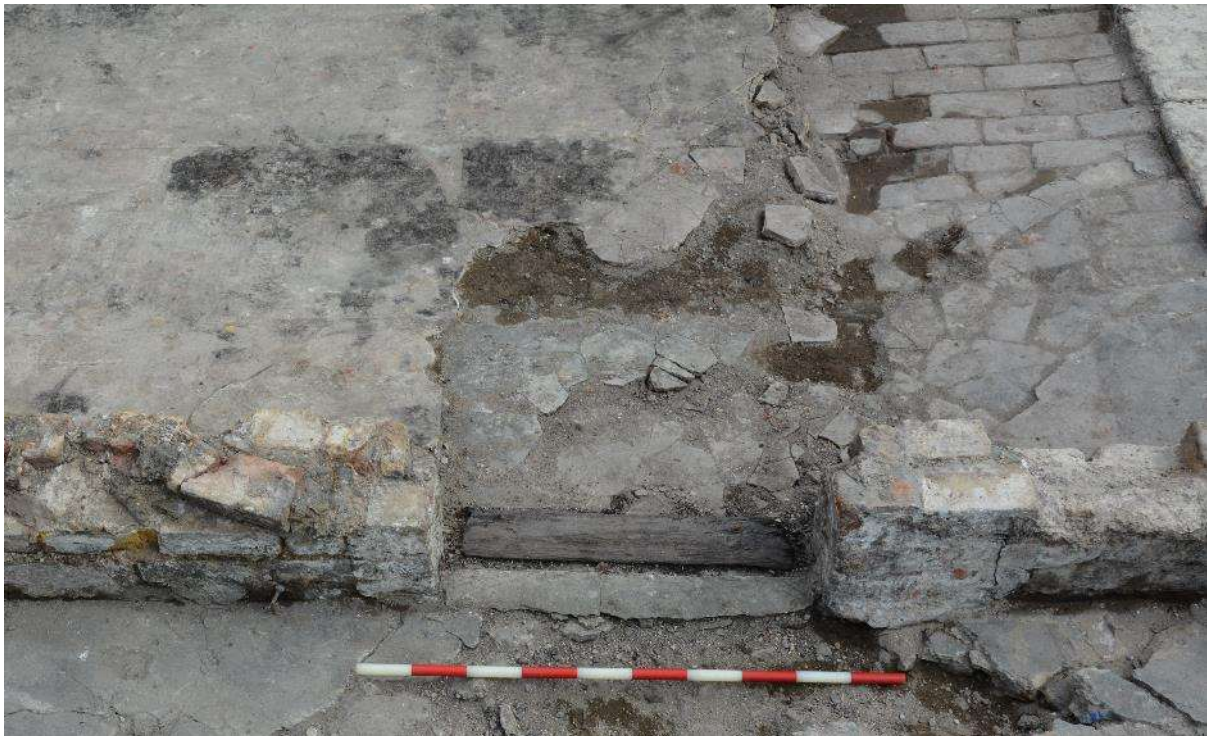
Figure 68: Threshold [35] in wall [30]. Floor [50] (right) underlying (49). Looking ESE. Scale 1m.

7.3.6.5 Another feature that was interpreted as a threshold was [35], located in the western end of [30] it comprised a render slab with a timber plank (fig. 68). The slab measured 0.6m by 0.4m and the plank measured 0.48m by 0.14m, aligned NE-SW. This threshold enabled access between the back room of the cottage and the outdoor yard. The yard was, like the space next door, surfaced with (45), a concrete layer that contained some indentations. Several finds lay on top of this surface at the western end, including a stack of unused, small, square tiles that have been dated to 1890-1940, and some children's toys. The toys included a couple of figurines from a set of Disney's 'Snow White and the Seven Dwarfs', produced by William Britain Ltd in 1939 (Appendices V & VII; fig. 69). Underlying (45) was a brick surface, [54], comprising brick and stone

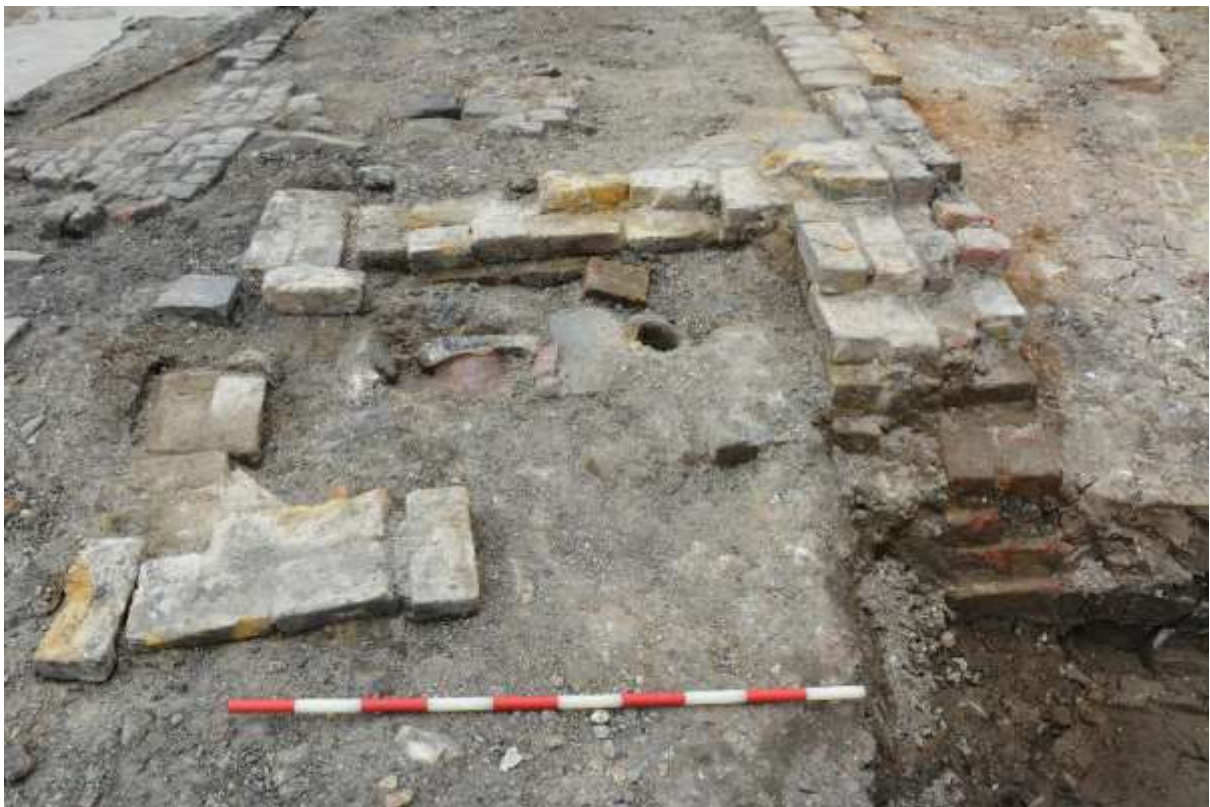
Figure 70: Structure [47] with wall [48] running back (right). Patches of brick floor [54] outside [47]. Looking SW. Scale 1m.
