CAMDEN LOCK VILLAGE REDEVELOPMENT

HAWLEY WHARF: LAND BOUNDED BY CHALK FARM ROAD, CASTLEHAVEN ROAD, HAWLEY ROAD, KENTISH TOWN ROAD & REGENT'S CANAL

AN ARCHAEOLOGICAL POST-EXCAVATION ASSESSMENT

SITE CODE: CLV15
APPROXIMATE SITE CENTRE NGR: TQ 2881 8422
PLANNING APPLICATION REF: 2012/4628/P

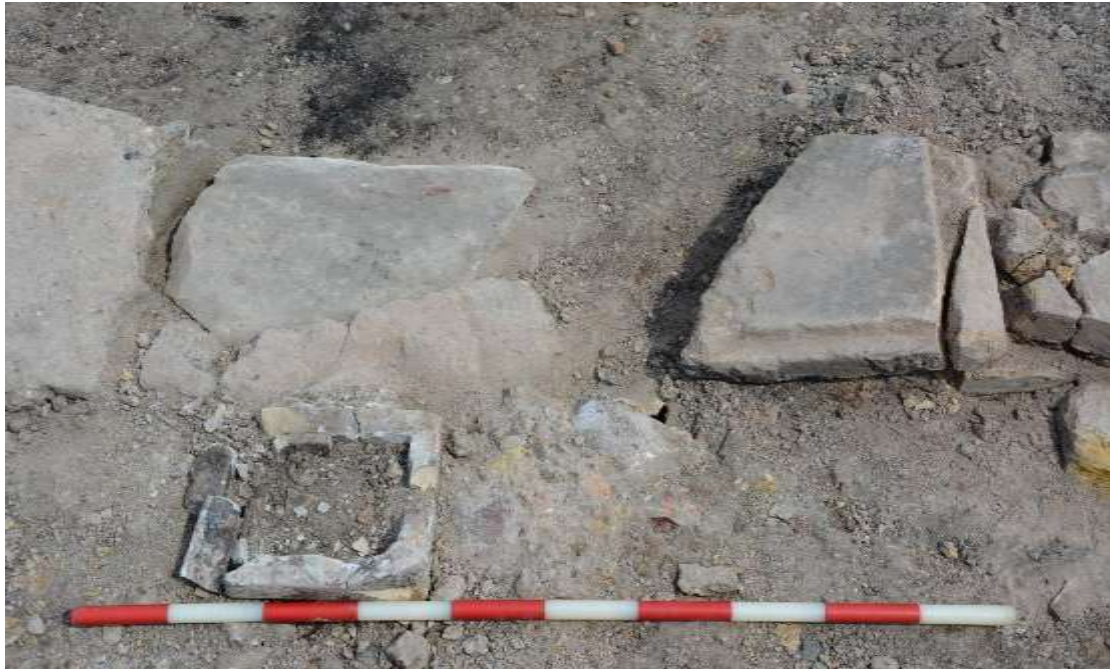
Figure 71: Threshold [10] between walls [9] and [11]. Looking NE. Scale 1m.

7.3.7.2 Bordering [12] to the west was [9], a wall that consisted of two visible courses of stretchers of differing sizes. It measured 2.1m by 0.57m and aligned NW-SE. [9] was unusually wide for this site, potentially indicating that it acted as foundations for an object, rather than serving as a wall. [9] was abutted at its northern end by [10], two pieces of worked stone that have been interpreted as a threshold (fig. 71). The larger fragment lay to the north and measured 0.4m by 0.3m, and the smaller, southern fragment measured 0.3m². If [9] was not a wall then it is unlikely that [10] acted as a threshold, but it is difficult to interpret. The southern fragment of stone has a worked border down one side, something that is not seen on the other fragment potentially indicating that they are not part of the same feature and instead are residual objects from the heavy truncation of the site. North of [10] was [11], a sub-square brick wall structure that extended west. It was constructed from red and yellow brick in a stretcher bond, with one course visible (fig. 72). The walls were all 0.23m wide, the southern NE-SW axis measured 3m long, the eastern NW-SE axis was 3.2m long and the western axis was 3.5m long. The northern axis was heavily disturbed and ephemeral and was therefore not measured but can be assumed to have been a similar length to the southern axis. The centre of the structure was not excavated due to time constraints. A 19th century lead pipe, (7) and cut, [8] were excavated southwest of [11], measuring c.2.15m by 0.18m and 0.25m deep, orientated NE-SW, parallel to the southern axis of [11].

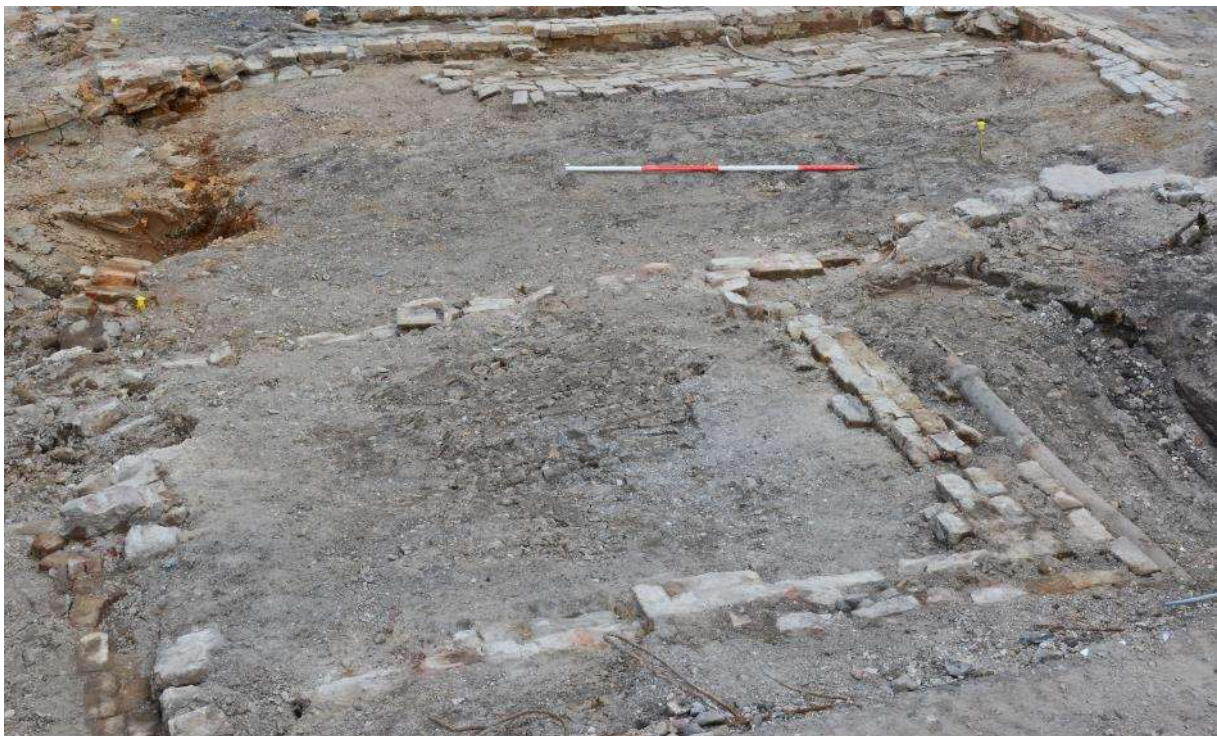
Figure 72: Structure [11] with lead pipe (7) (right). Looking E. Scale 2m.

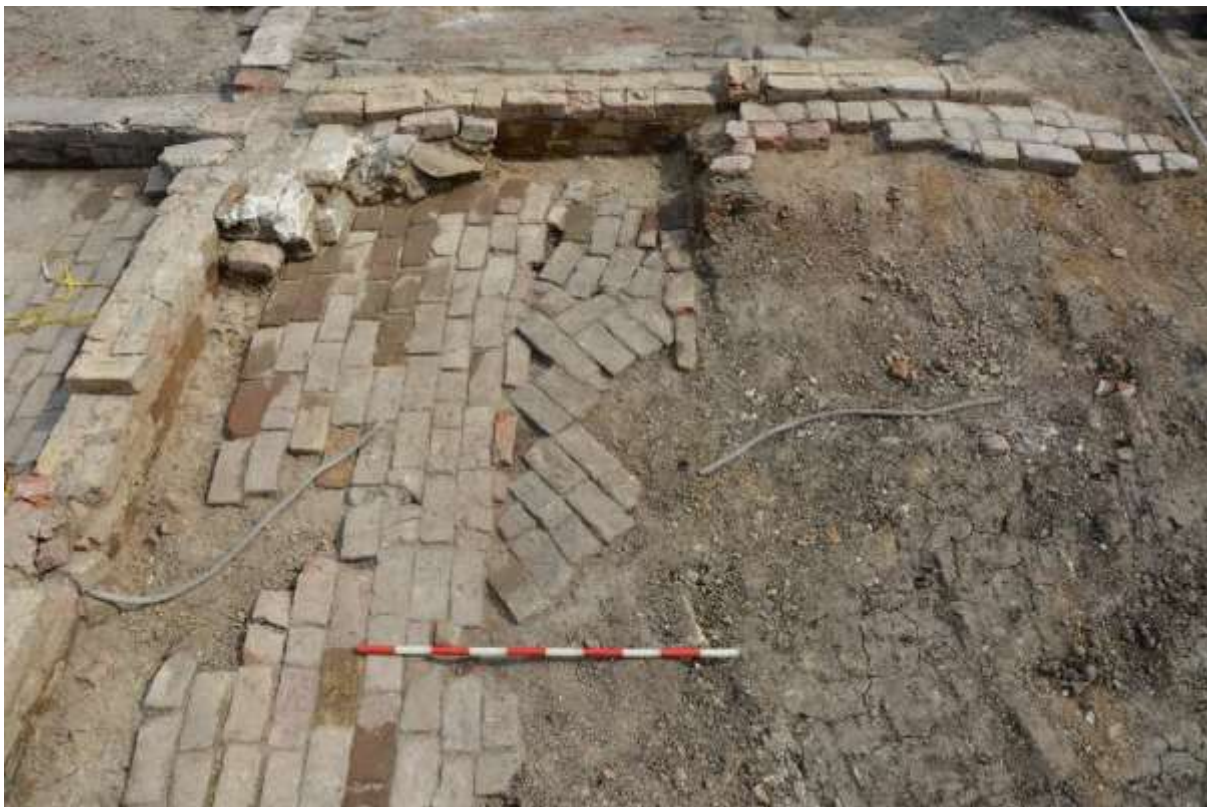
Figure 73: Floor surface [18], overlain by (17) and [16] (top right). Bounded by walls [15] (left) and [14]. Note the pipe that truncated [18], [15] and [52]. Looking SSE. Scale 1m.

7.3.7.3 North of [14] were several layers of floor surface. [16] was found at the highest level (27.94mOD), consisting of very fragmentary red brick bonded with mortar. It measured c.2m by 0.4m, orientated NE-SW (fig. 73). It appeared on a similar level as the western end of [14] (27.94mOD), implying it could have been a continuation of [12], cut by [14]. Due to the fragmentary nature of [16], this was unverifiable. Underlying [16] was (17), a compact silty grey/brown gravel that measured c.1.03m by 0.34m. (17) overlay [18], another brick surface measuring 4.5m by 1.55m wide, orientated NW-SE. The bricks were laid out in an intermittent herringbone pattern, interspersed with straight

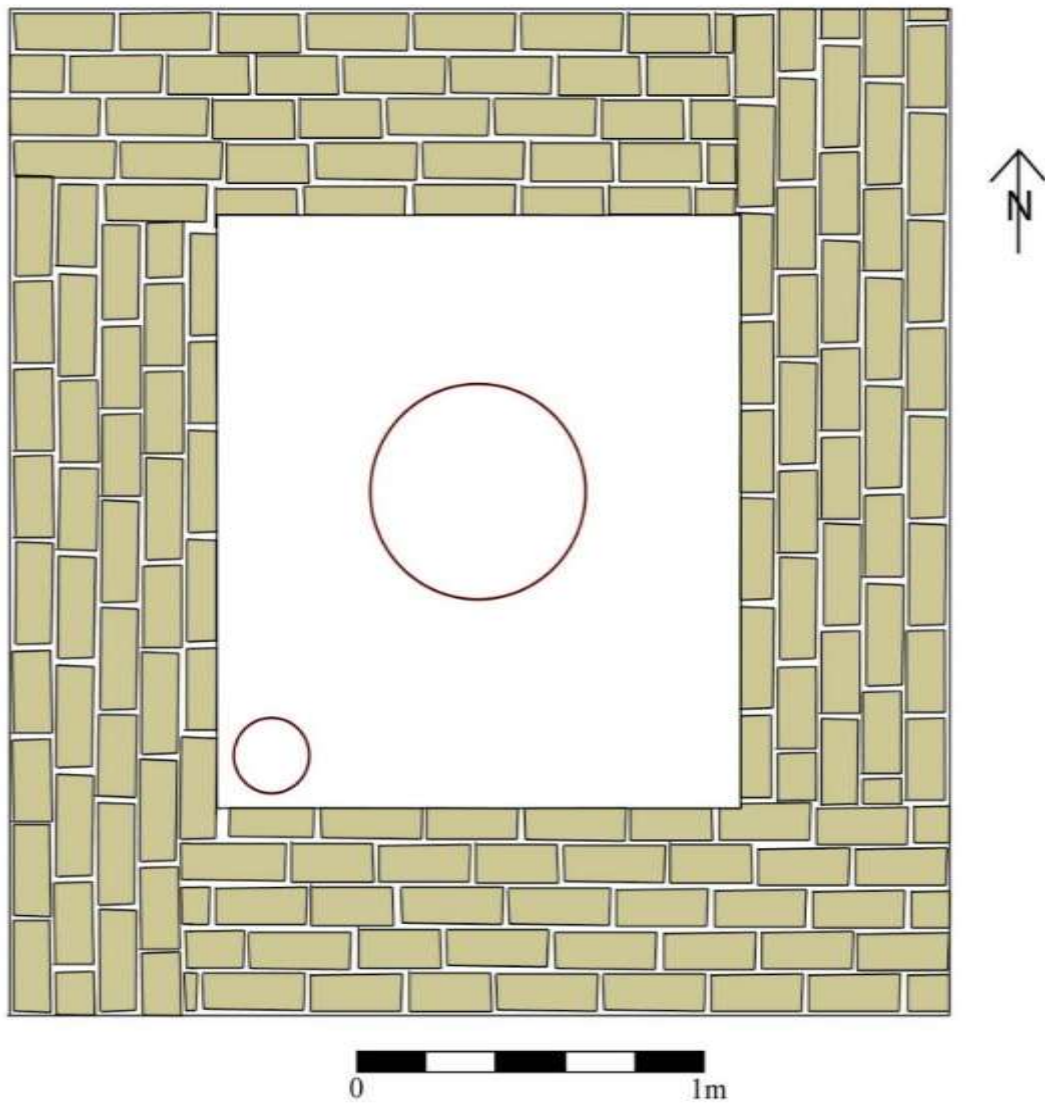
Figure 75: Plan of pump-chamber with pipe in centre and SW corner. Original drawn at 1:10.

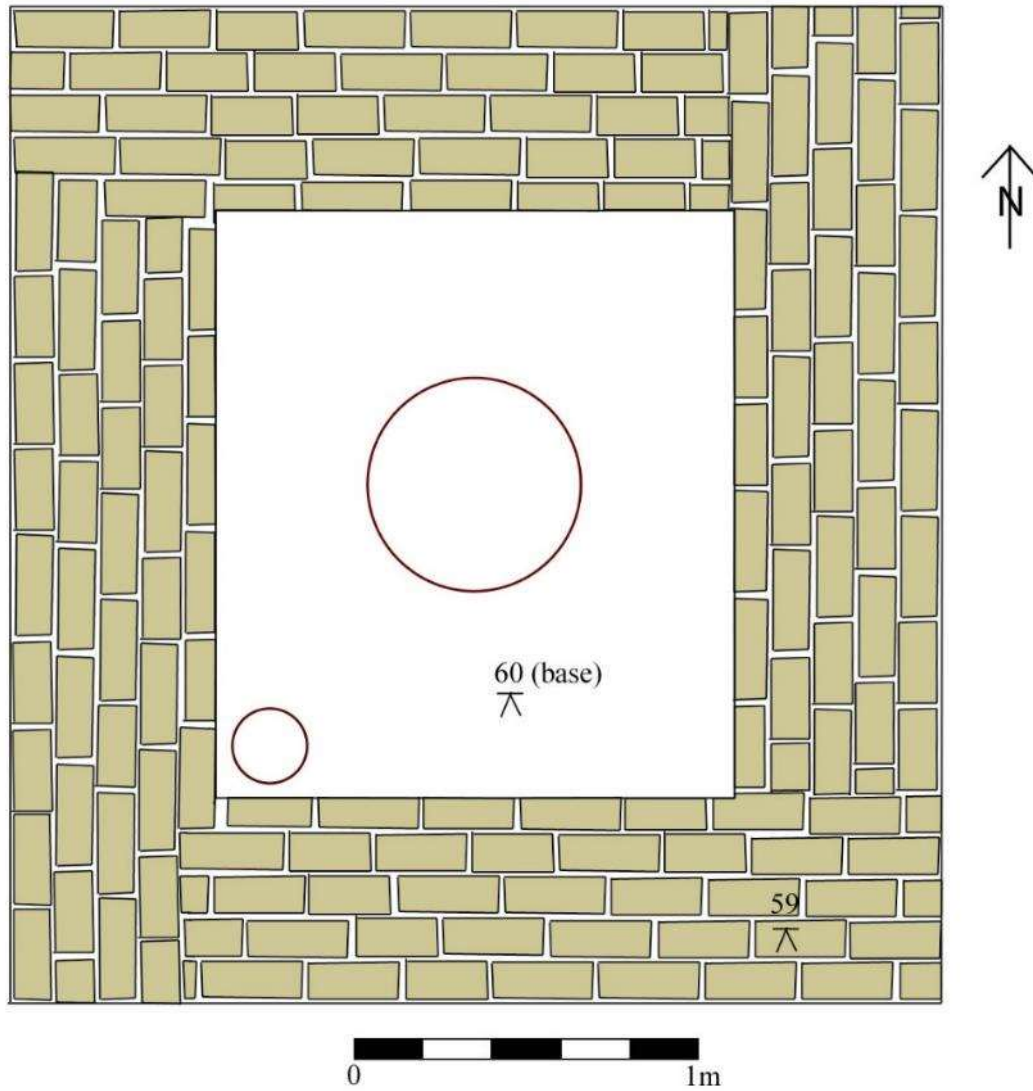
Figure 78: Plan of levels taken on pump chamber.

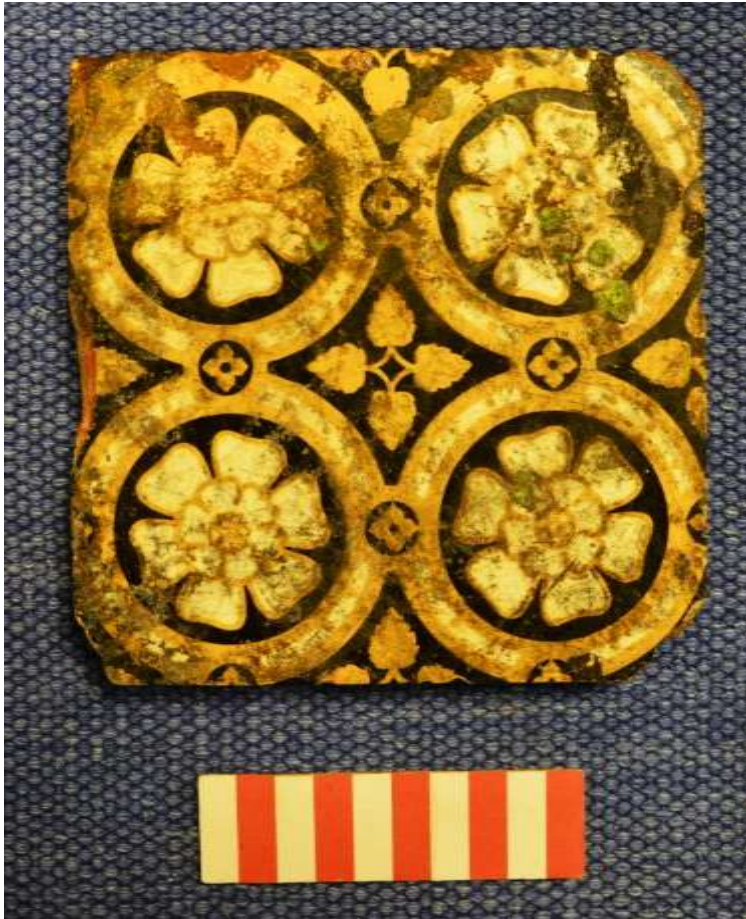
Figure 81: Encaustic floor tile from near threshold/fireplace [19]. Scale 0.1m

The other CBM recovered from site demonstrated a variety of forms and styles, with one or two fine examples. These included a single surviving encaustic glazed floor tile, (fig. 81), bearing a Tudor Rose quadrant design in yellow and white on a black background. The tile may have originally been from a church setting and later reused. It bore a stamp on the reverse for Campbell Brick and Tile Company, Stoke-Upon-Trent, and as such can be accurately dated to between 1876 and 1882. The tile had later been splashed by a mid-green paint presumably during some interior decorating project. Another interesting find was a group of 53 small, square, wall tiles glazed in either white, yellow-brown or green, stacked neatly on top of concrete floor (45) in the north of the building, context (66). Some of the darker-green glazed tiles had a stylised flower design, (fig. 82). These tiles may have represented an aborted renovation project or simply excess material from a similar project.

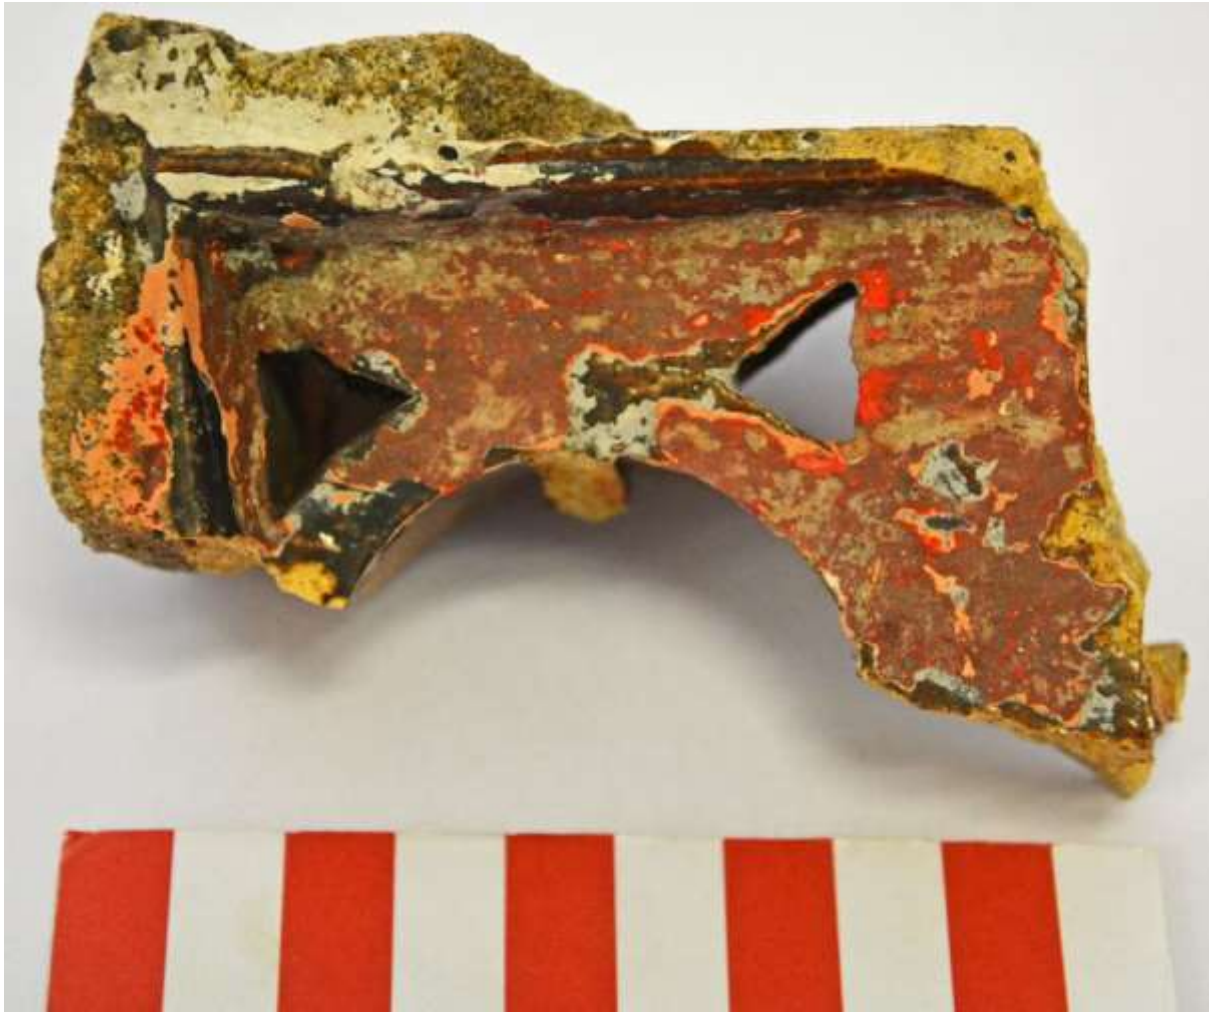
Figure 83: Fragment of ceramic ventilator showing layers of paint over the original brown glaze. Scale 0.1m

The three ceramic ventilators found in wall [30] showed evidence of layers of varying shades of red/brown paint on the external face (fig. 83). This was most likely an attempt at featuring the ventilators as decoration on the external, white-washed walls of the cottages.

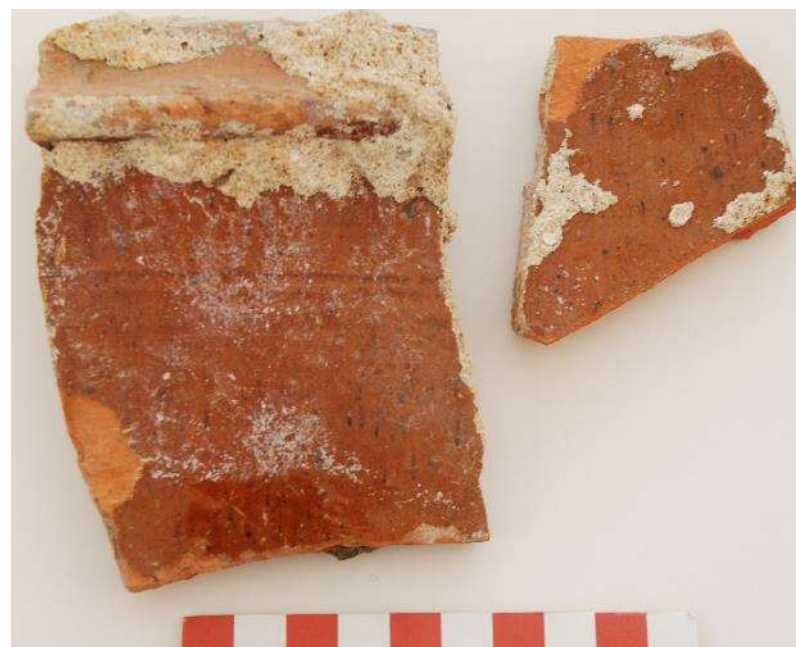
Figure 85: Post-medieval redware found mortared in to wall [23]. Scale 0.1m

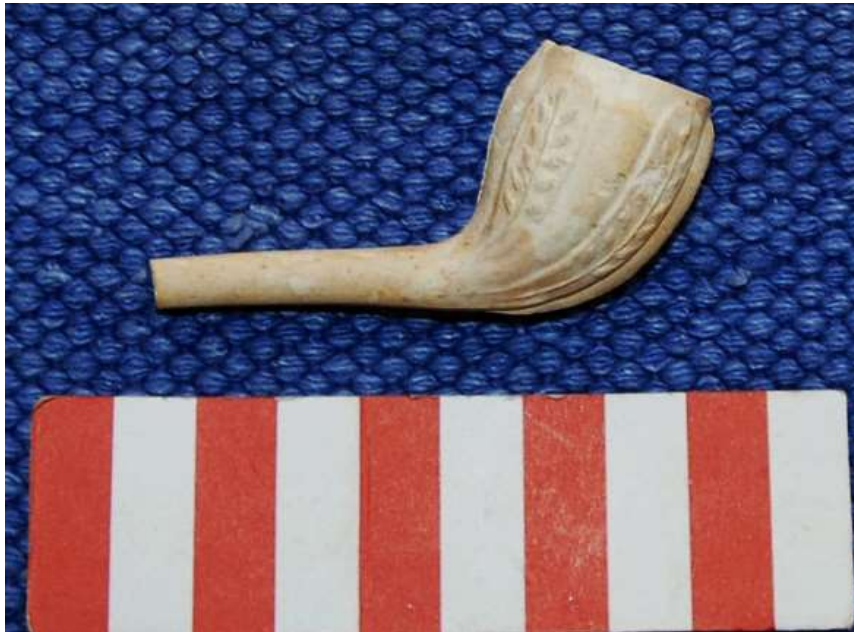
Figure 86: Clay pipe bowl from (6). Scale 0.1m

The dateable bowl was recovered from (6), which was the general overburden seen across the site, and was dated to 1850-1910 (fig. 86). The bowl was decorated with a leaf or branch botanical moulded design on the bowl.

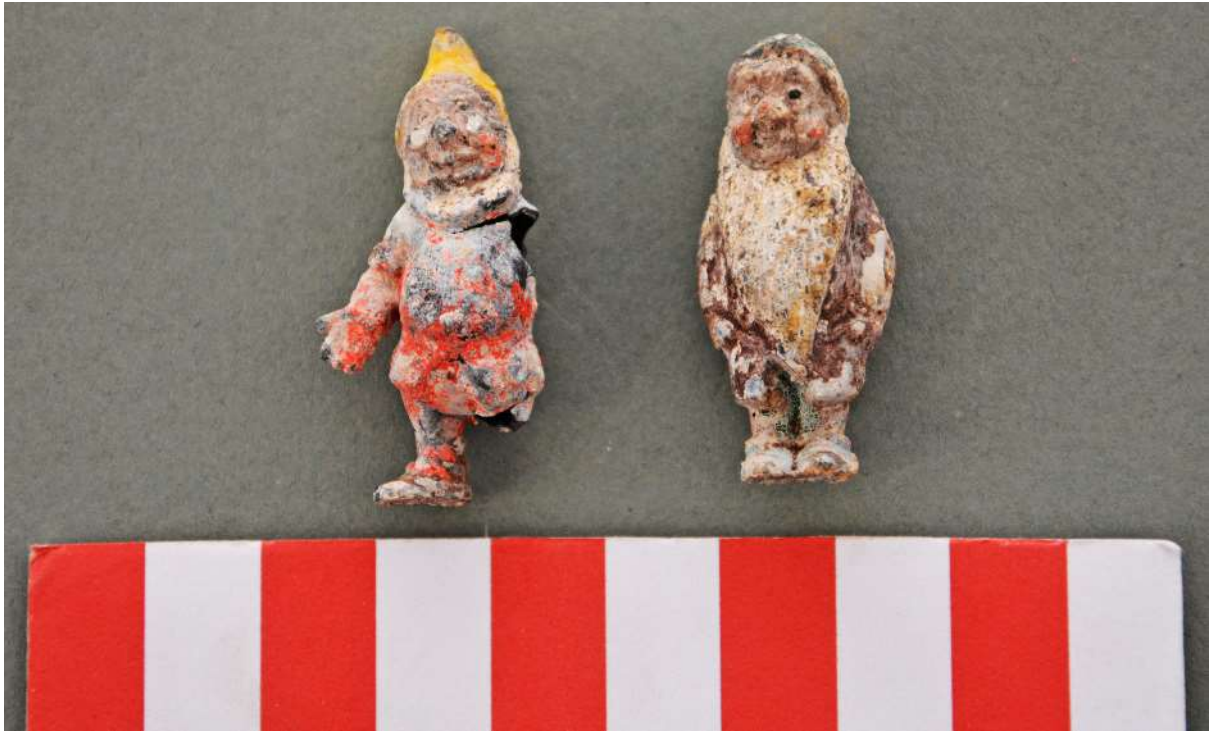
Figure 87: Dwarf hollowcast figurines found on (45). Doc (left) and bashful (right). Scale 0.1m

A small assemblage of children's toys were recovered from the top of concrete surface (45), by walls [30] and [51] (fig. 87-89). Two figurines were part of a 'Snow White and the Seven Dwarfs' set that was produced by William Britain Ltd. in 1939 (fig. 87). The other figure is unidentifiable but also made of cast lead.

Context	Form	Count	Weight (g)	Comments
(45)	Marble	1	10	Clear glass outer layer with striped multi-coloured centre.
(45)	Marble	3	6	Each marble is a different shade of blue glass with white swirls around outside.
(45)	Doll figurine	1	8	Lead miniature of a figure in a seated position with bent knees. Remains of paint- orange on the body and limbs (possibly undercoat), red mouth, white boots and yellow hair. The figure is wearing a belted robe, a neck scarf and boots over trousers.
(45)	Dwarf figurine	2	16	Hollowcast lead miniatures of 2 dwarfs (probably Snow White's dwarfs). 1= pointed yellow hat with a short white beard and red cheeks, glasses. A red top belted around the middle and red trousers. Long white shoes. Probably 'Doc'. 2= floppy green hat with a long white beard. Long brown coat with green trousers and shoes. Probably 'Bashful'. Made in 1939 by William Britain Ltd (Britains).

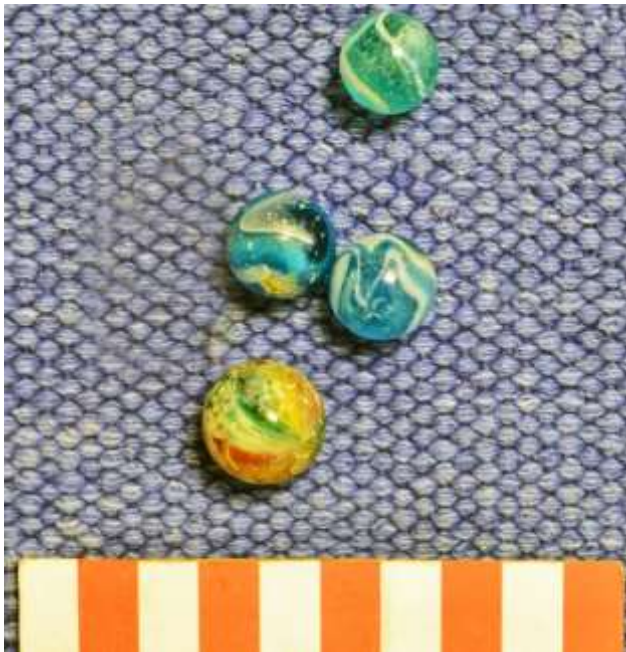
Figure 88: Marbles found on (45). Scale 0.1m

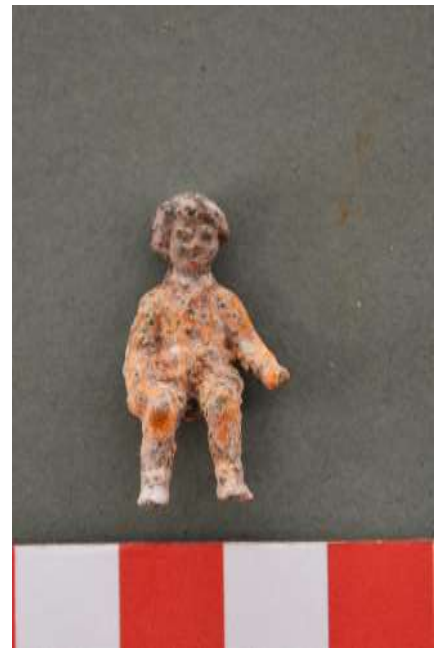
Figure 89: Lead figurine found on (45). Scale 0.04m

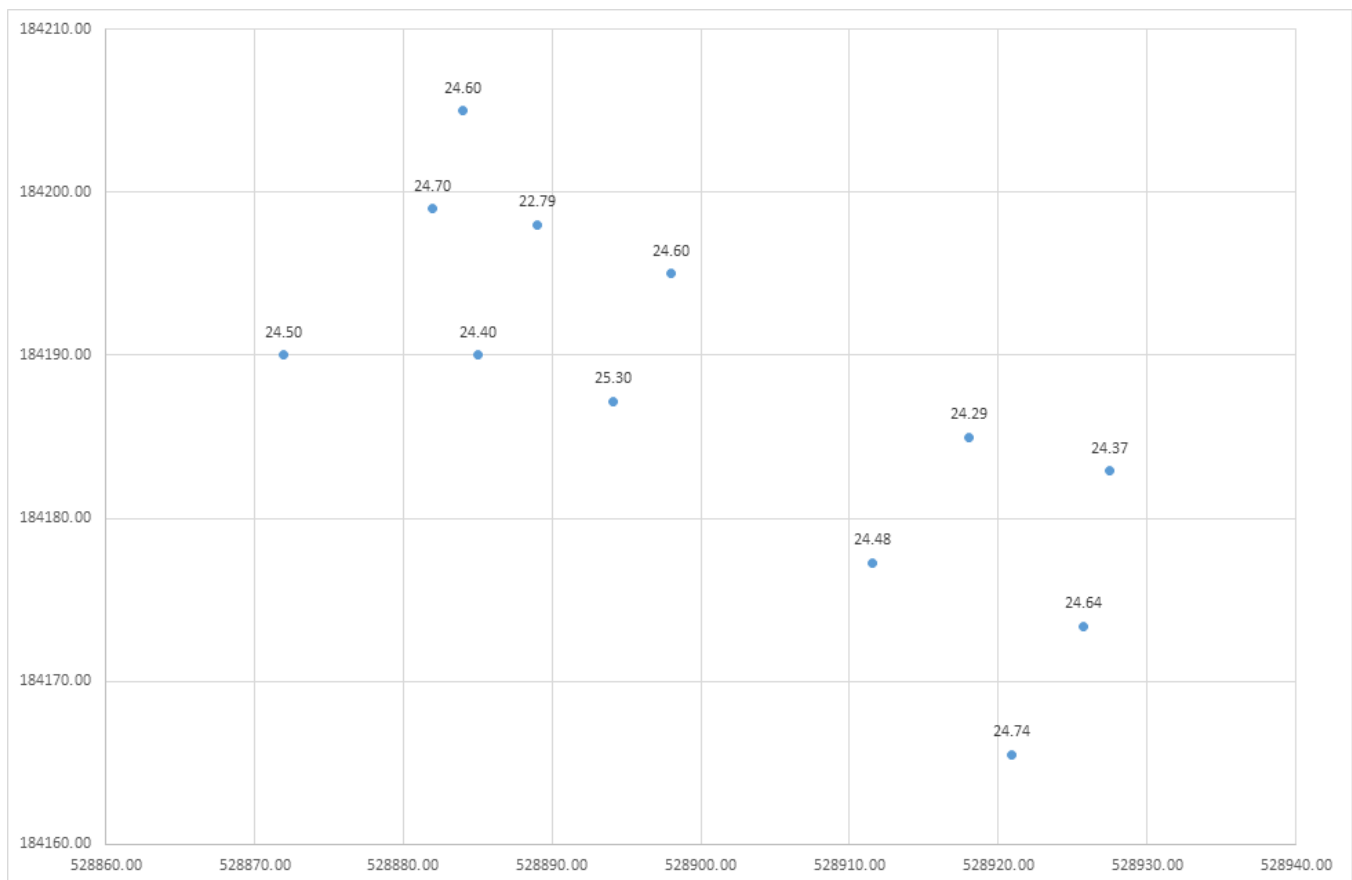
Figure 90: Showing the surface elevation of the bedrock across the site in mOD. Drawing provided by QUEST (2017).
