ALL SAINTS PARISH CHURCH CARSHALTON
LONDON BOROUGH OF SUTTON
AN ARCHAEOLOGICAL WATCHING BRIEF

SITE CODE: ASZ07

This report details the results of an archaeological watching brief carried out during drainage installation works at All Saints Parish Church, Carshalton, London Borough of Sutton between May and June 2007.

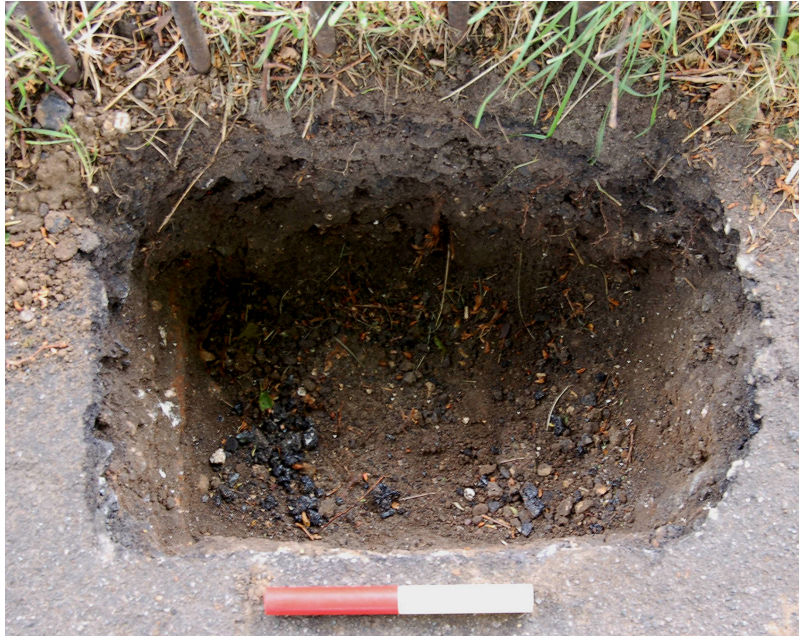
Fig 3: Trench 1 (0.2m scale)

Trench 1 was recorded at 0.4m (north-south) by 0.5m (east-west) and excavated to a depth of 0.3m below the current ground level. The tarmac constituting the existing path surface was supported by a thin layer of concrete hardcore. A mixed mid-brown silty deposit was observed below this, containing numerous pebble, flint, concrete and CBM inclusions. This deposit is considered to represent a shallow rubble base, associated with the most recent period of path makeup and relaying (Fig 3)

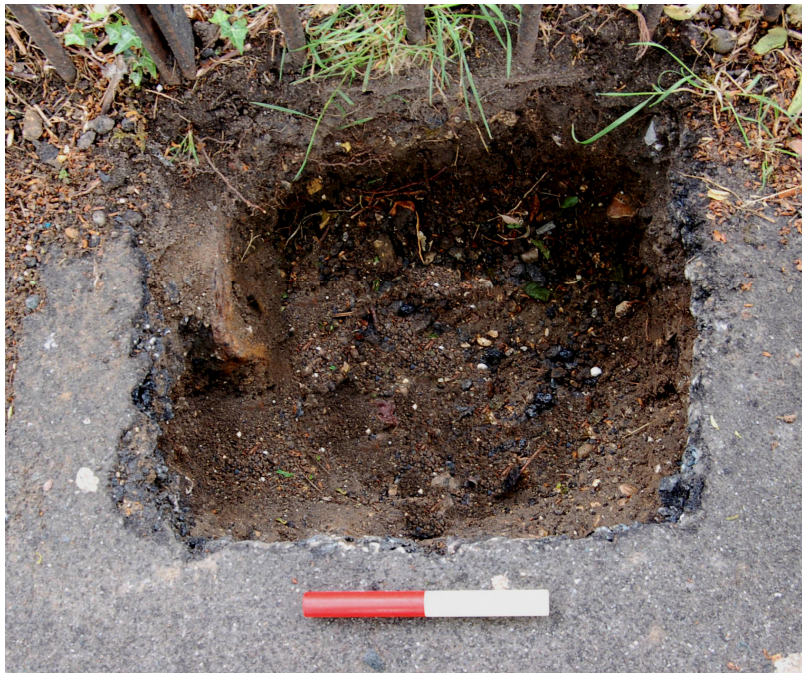
Fig 4: Trench 2 (0.2m scale)

Trench 2 presented a similar makeup and was measured at the same dimensions, but located further east towards the north-east corner of the church (Fig 4)

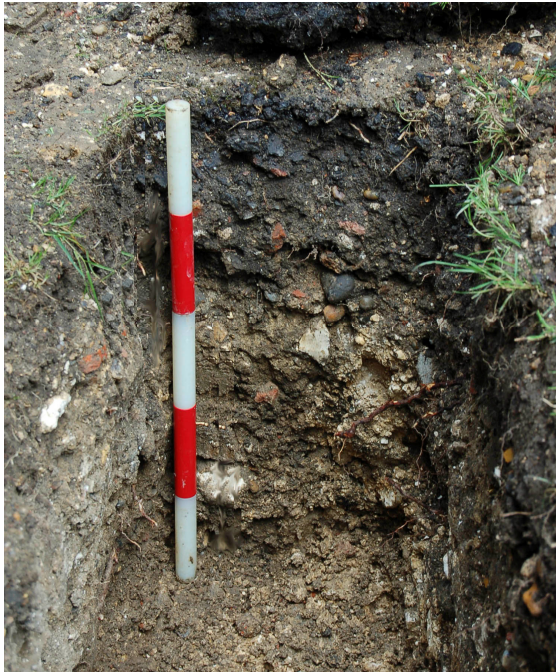
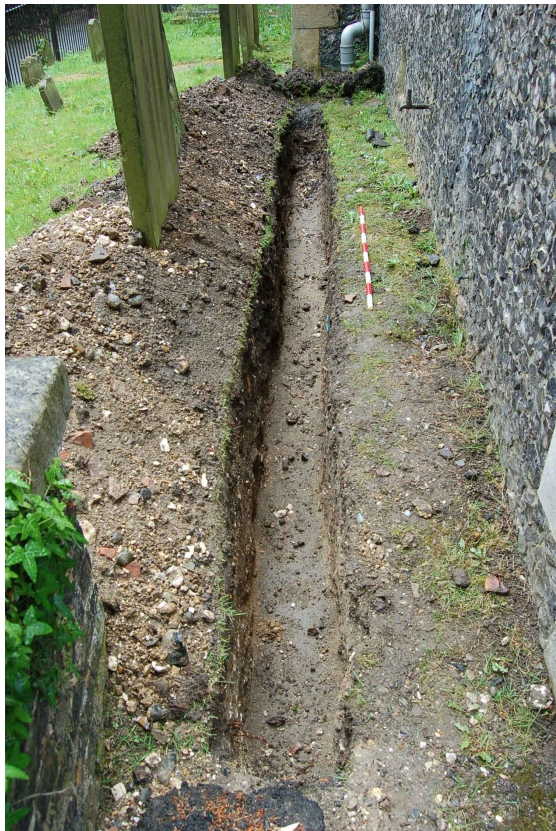
The location of the trench is clearly indicative of the deposits recorded therein; to the west, the eastern extension of the church and replaced nave and north aisle (1880's –1914) consists of flint faced walls and tiled roof, to the east a line of gravestones stands on a ridge which then slopes sharply down to the footpath. The tile and frequent flint inclusions are clearly representative of the development of the early 20th century, which are likely to have disturbed the existing graveyard deposits. The small number of abraded human bone fragments is further testament to this process (Figs 6 and 7).

Fig 6: Trench 3, south facing section

Fig 7: Trench 3 looking south

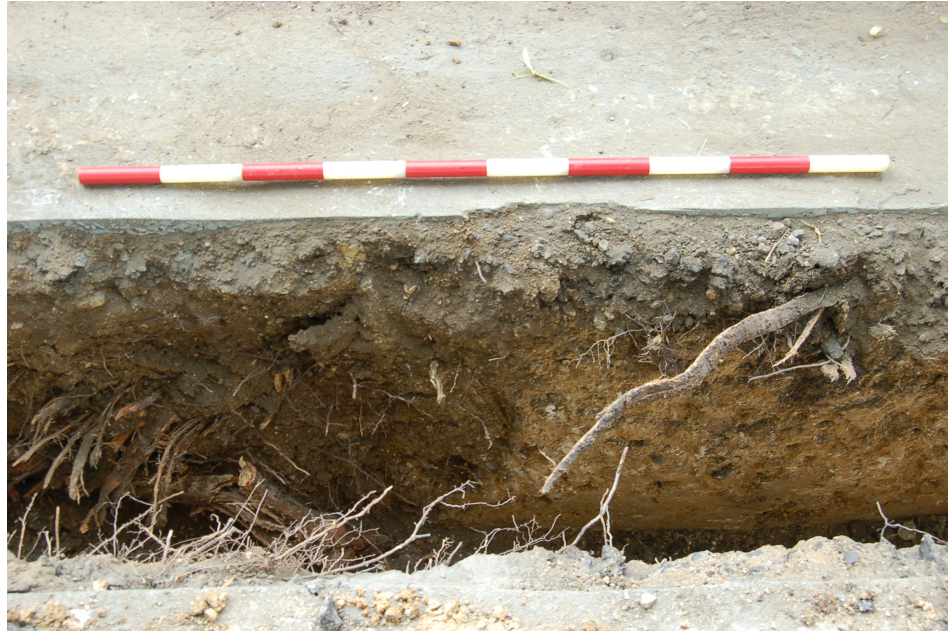
The existing ground surface is represented by tarmac and a relatively shallow layer of concrete/rubble makeup [6]. On removal this exposed a highly disturbed deposit [7] that was observed for the full length of the trench and overlay natural deposits of chalk [10] and gravels [8]. (See Figs 8, 9 and 10)

The chalk bedrock [10] observed in the western end of the trench was first observed in section approximately 8m east of the western extent of the trench, at a level of 37.96m OD. Some 2m of degraded chalk and silt [9] preceded [10] to the east. These contexts are clearly part of the natural geological makeup of the site, situated as it is on a junction between the North Downs chalk and River Terrace gravels. The junction between the mixed deposit [7] and chalk/degraded chalk [9] [10] was a sharp, vertical line transition. Whether this transition represents a natural outcropping of a chalk or a man-made cut into the bedrock is unclear. The related degraded chalk and silt [9] would indicate the latter, but the original purpose/nature of the cut was not determinable. It may have been an earlier grave-cut (supported by the human remains found in [7]) but its location in the centre of the historic footpath would seem to belie this assertion, unless the cut belonged to a much earlier period, prior to the establishment of the footpath. The presence of Dame Duffins Cottage in this area of the church yard (demolished in 1836 and possible an earlier Medieval Chantry Chapel), may also provide an explanation for cut features in the vicinity, also the exact nature of the feature if this solution is accepted remains unclear.

Fig 9: North facing section of Trench 4 showing degraded chalk-outcropping

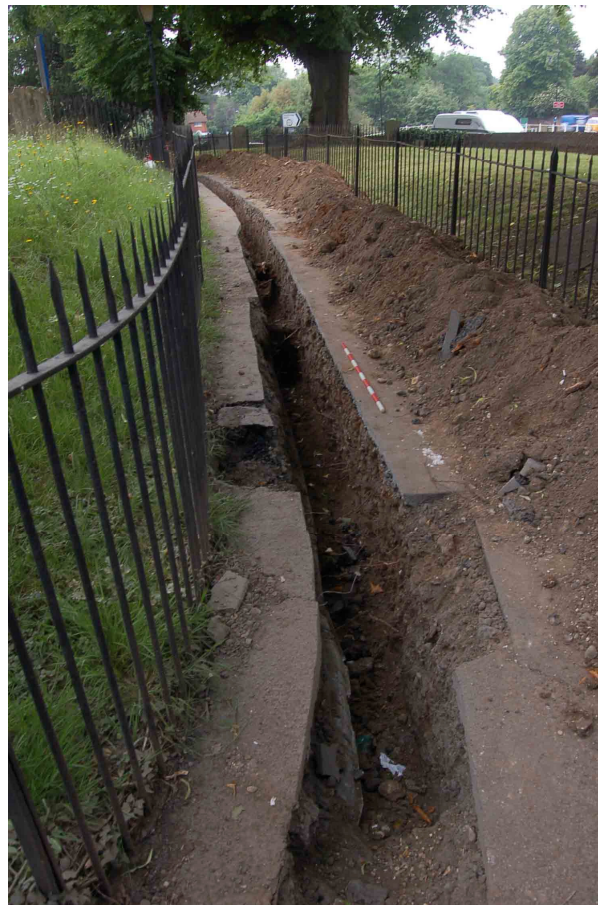
A significant amount of disarticulated human bone was recovered from this context, all of which was bagged in biodegradable packaging and reburied below the drainage pipe within the same trench. A section of *in-situ* articulated skeleton was recorded in the south-facing section, approximately 4m west of the eastern limit of the trench. The skeleton was highly truncated, consisting of a partial vertebral column, abraded pelvic lobe, four ribs and the proximal head of the humerus. As the skeleton posed no obstruction to the laying of services or continued excavation it was left *in-situ*. A further possible area of surviving articulated remains was recorded approximately 12m west of the eastern extent of the trench, again in the south facing section. A partially exposed skull was exposed and orientated in the correct manner to signify *in-situ* remains. However, as with the previous remains, the skull posed no obstruction to further work and was thus not excavated further or removed for reburial.

Fig 10: View of Trench 4 looking west

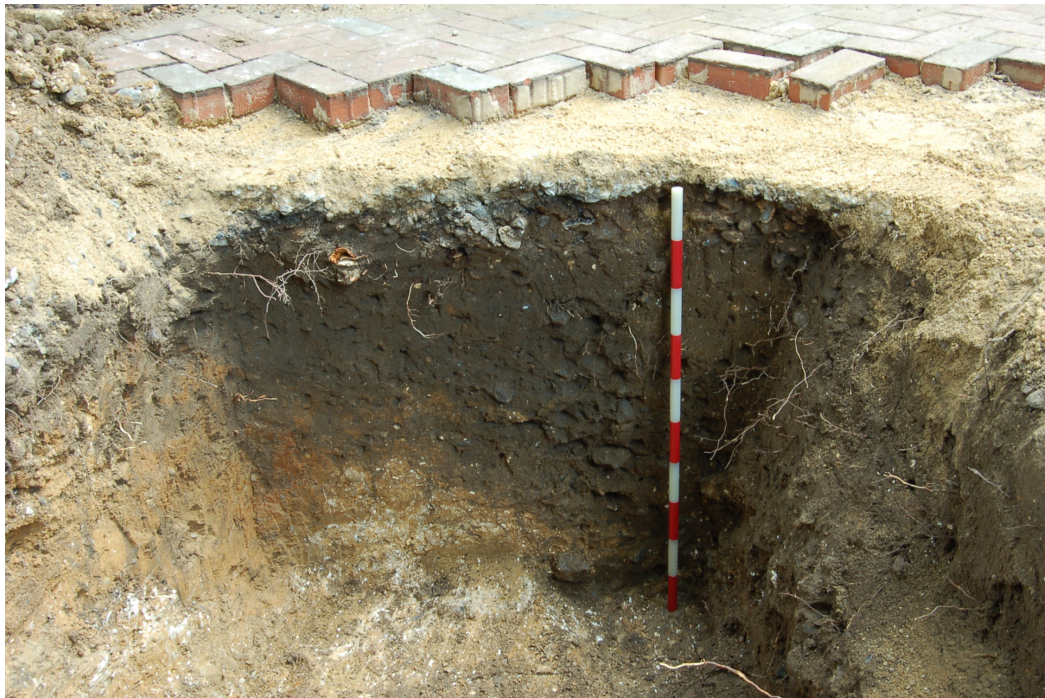
Modern ground surfaces and makeup layers were represented by brick-herringbone paving [11] in a basic sand-bedding overlying 0.2m of concrete hardcore [12]. (See Figs 11 and 12).

Below the modern makeup the same mixed silt-soil deposit [13] as observed in Trench 4 [7] was recorded. Both deposits were of the same silty composition, relatively loose compaction with frequent pebble and flint inclusions. However, a significant difference between the two was the absence of disarticulated human bone in Trench 5, nor the recovery of any other finds.

Mottled orange clay [14] and chalk [15] both appear to be natural deposits. Natural chalk bedrock was observed at 37.90m OD, slightly deeper than that observed in Trench 4, suggesting the level of natural chalk rises to the west.

Fig 12: West facing section of Trench 5

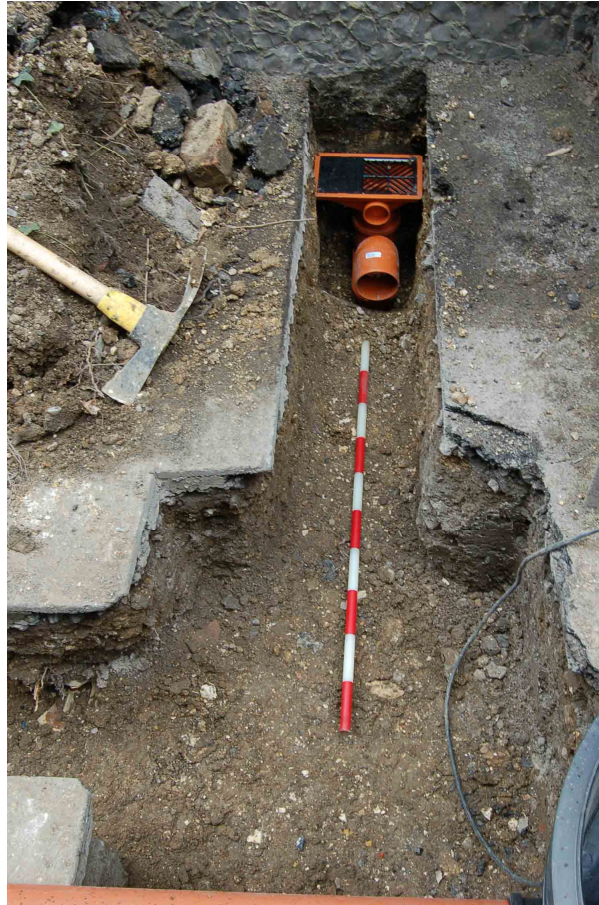
Modern activity in Trench 6 was represented by tarmac [16] and shallow concrete makeup [17] to a depth of 0.3m.

Mixed deposits below the present ground surface [18] contained numerous flint and CBM inclusions. These deposits are likely to be associated with the construction and related activity of the north aisle, and northeast extension between 1880's and 1912. The flint-facing on the church walls is a useful explanation for the quantities of flint pieces in this deposit.

The natural geology was not exposed in this trench, being excavated to just 0.5m below the current ground surface. (See Figs 13 and 14).

Fig 14: North-south section of Trench 6, looking south.
