**THAMES WATER
MAINS REHABILITATION WORKS,
VANBRUGH PARK ROAD, GREENWICH SE3 7NJ
DMA ZOXLWD13**

An Archaeological Watching Brief

Site code: VPR17

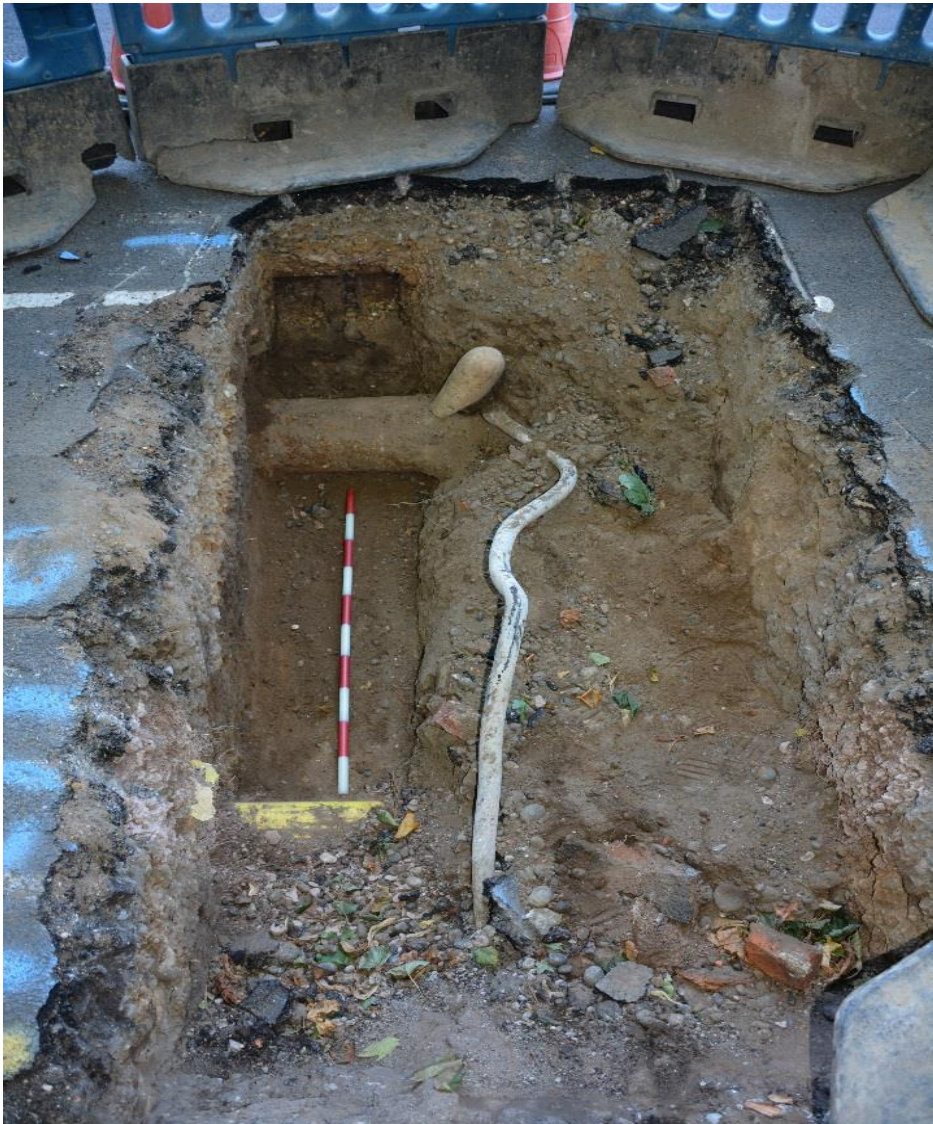
7.2.1 The first trench was located towards the centre of Vanbrugh Park Road, aligned east-west straddling the carriageway and pavement adjacent to Nos.1-8 Fentons Apartments. The trench was rectangular in plan, measuring 5.6m in length x 0.6 – 1.2m in width x 0.4 – 0.85m in depth (fig.6).

Figure 6: Western part of the trench, within the carriageway. Facing W. Scale 1m.

7.2.2 The stratigraphy within the carriageway comprised 100mm - 160mm of well compacted asphalt (1) overlying 200mm - 350mm of moderately well compacted light brown gravel (5), above 380mm - 700mm of a mid-brown sandy soil (3) and a minimum of 100mm of orange sand (4), continuing below the level of excavation. The orange sand (4) is taken to be the natural geology.

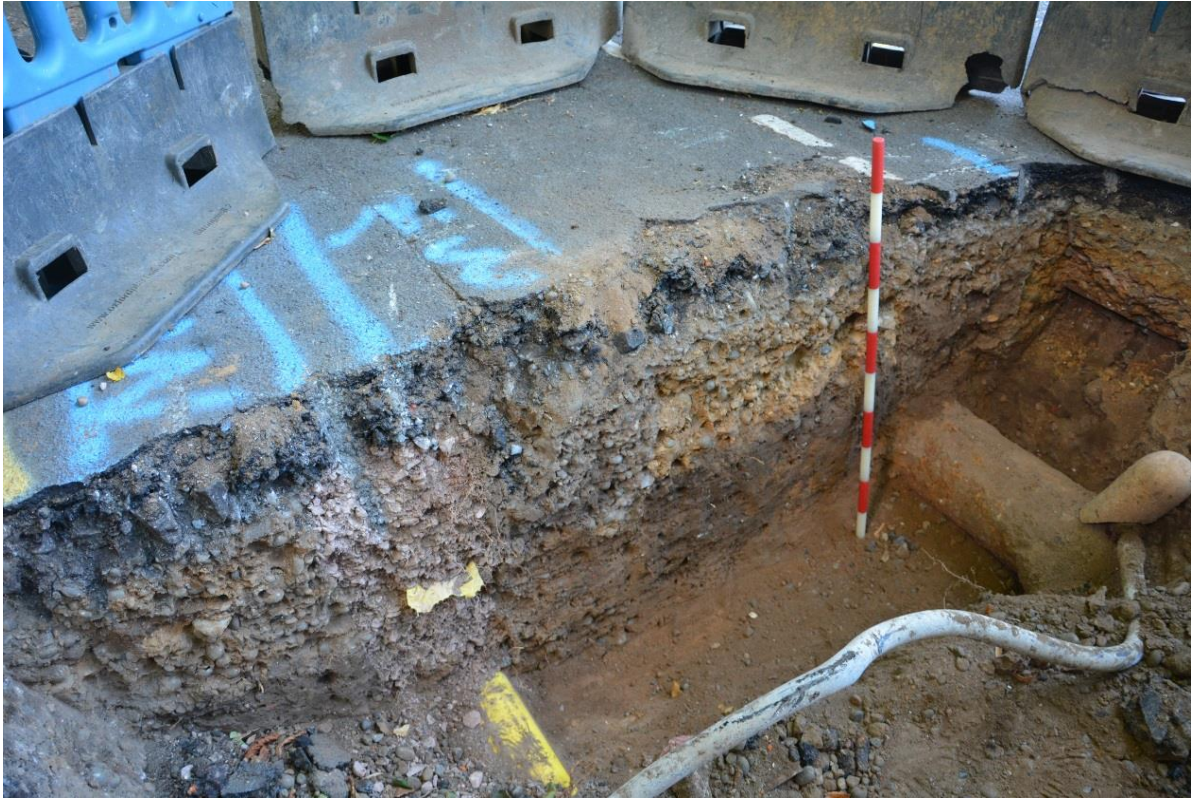
7.2.3 At the eastern end of the trench, contexts (3), (4) and (5) were truncated by a linear service cut, [7], measuring 250mm in width. This cut contained a plastic PE pipe and was backfilled with a homogenous deposit of light pink MOT Type 1 (8) (fig.7).

Figure 7: North facing section of Trench 1, showing the gravels and light sandy soil below the road surface. Orange sand can be seen towards the base of the section, with service cut [7] to the left of frame. Facing SW. Scale 1m.

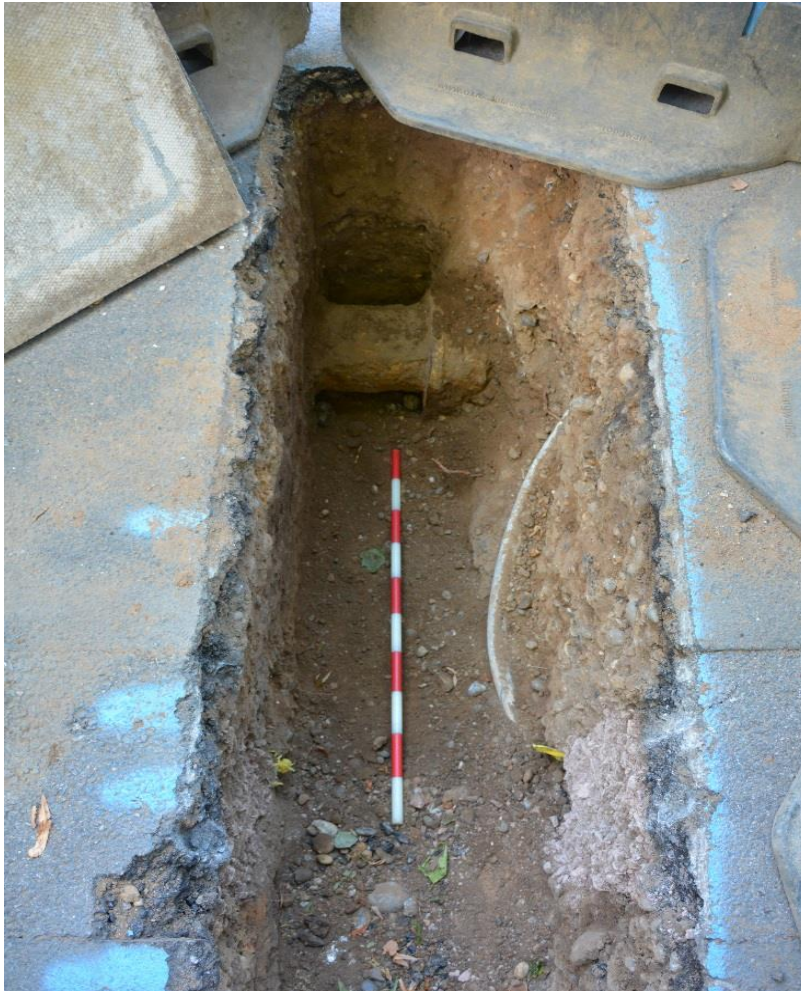
7.3.1 The second trench was located to the north of the first, aligned east-west, adjacent to Nos. 9-16 Fentons Apartments, again straddling the carriageway and pavement. This trench measured a total of 5.6m in length by 0.5m – 0.65m in width by 0.7m - 0.9m in depth (fig.8).

Figure 8: Western part of Trench 2. The continuation of the main can be seen towards the top of the frame, and service cut [7] towards the bottom. Facing W. Scale 1m.

7.3.2 The stratigraphy recorded in this trench was similar to Trench 1 above, comprising 120mm of asphalt (1) overlying 170mm of compact gravel within a light-brown sandy matrix (5), above 470mm of light-brown, moderately loose, sandy-soil (3), The orange sand (4) recorded in Trench 1 however was not observed.

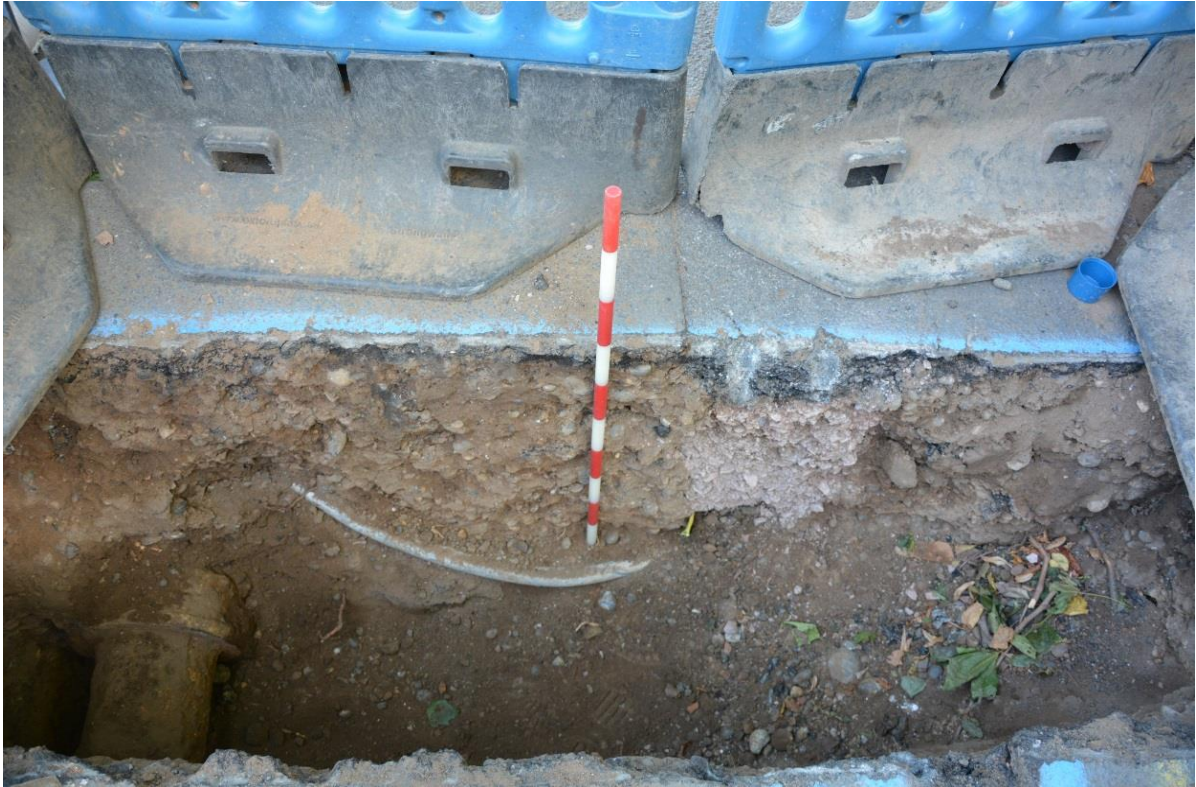
7.3.3 Similarly, the stratigraphy was interrupted at the eastern end of the trench by service cut [7], backfilled with MOT Type 1 (8), which measured 300mm in width. A lead pipe was also visible in the south facing section, however there was no distinct cut and fill noticed for this feature (fig.9).

Figure 9: South facing section of Trench 2, showing made ground and services below the road surface. Facing N. Scale 1m.

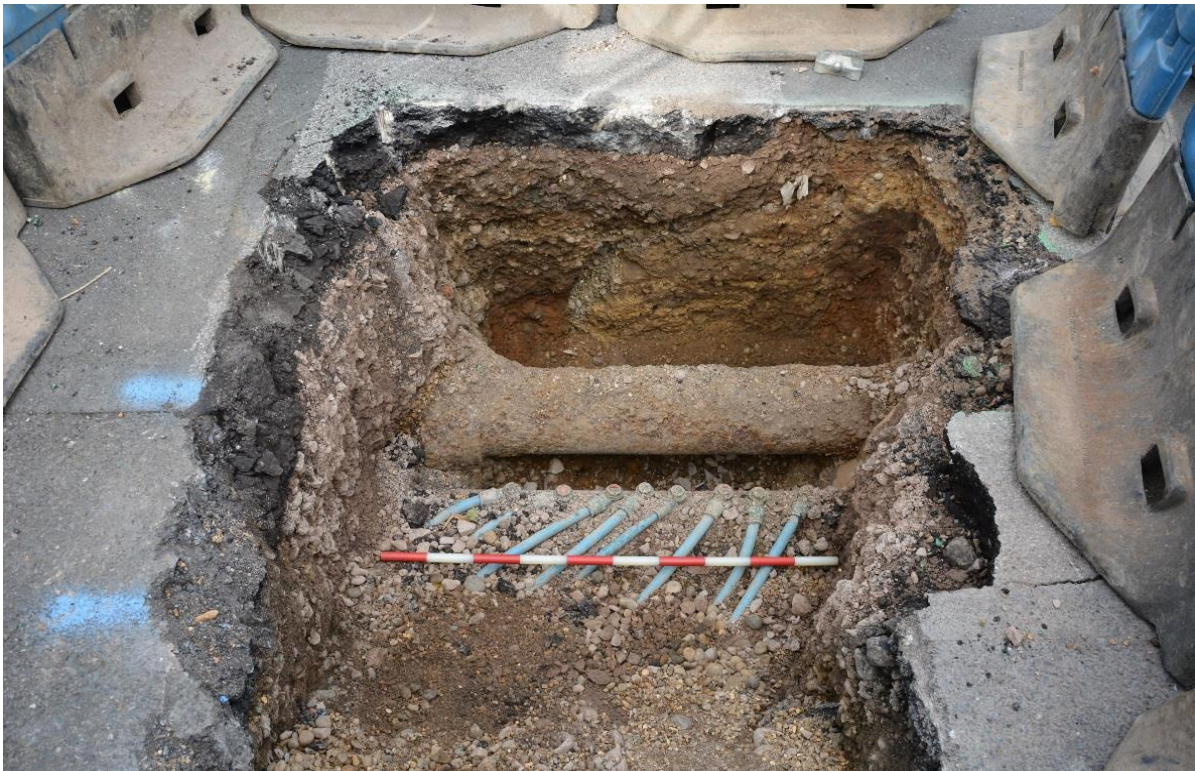
7.4.1 The third trench undertaken was located towards the northern end of Vanbrugh Park Road, on the eastern side of the carriageway opposite garages belonging to Nos. 9-12 Vanbrugh Park Road. The trench was located wholly within the carriageway, with the eastern edge abutting the existing kerb, measuring 2.5m in length, (east-west) by 1.5m in width and up to 0.9m in depth, (fig.10).

Figure 10: Trench 3, located within the existing carriageway. Facing W. Scale 1m.

7.4.2 The stratigraphy observed in this trench differed from Trenches 1 and 2 as much of the ground was heavily truncated by a large service cut. The eastern 1.6m of the trench was comprised wholly of loose shingle, only partially excavated, sloping down westwards to overlay a large N-S service.

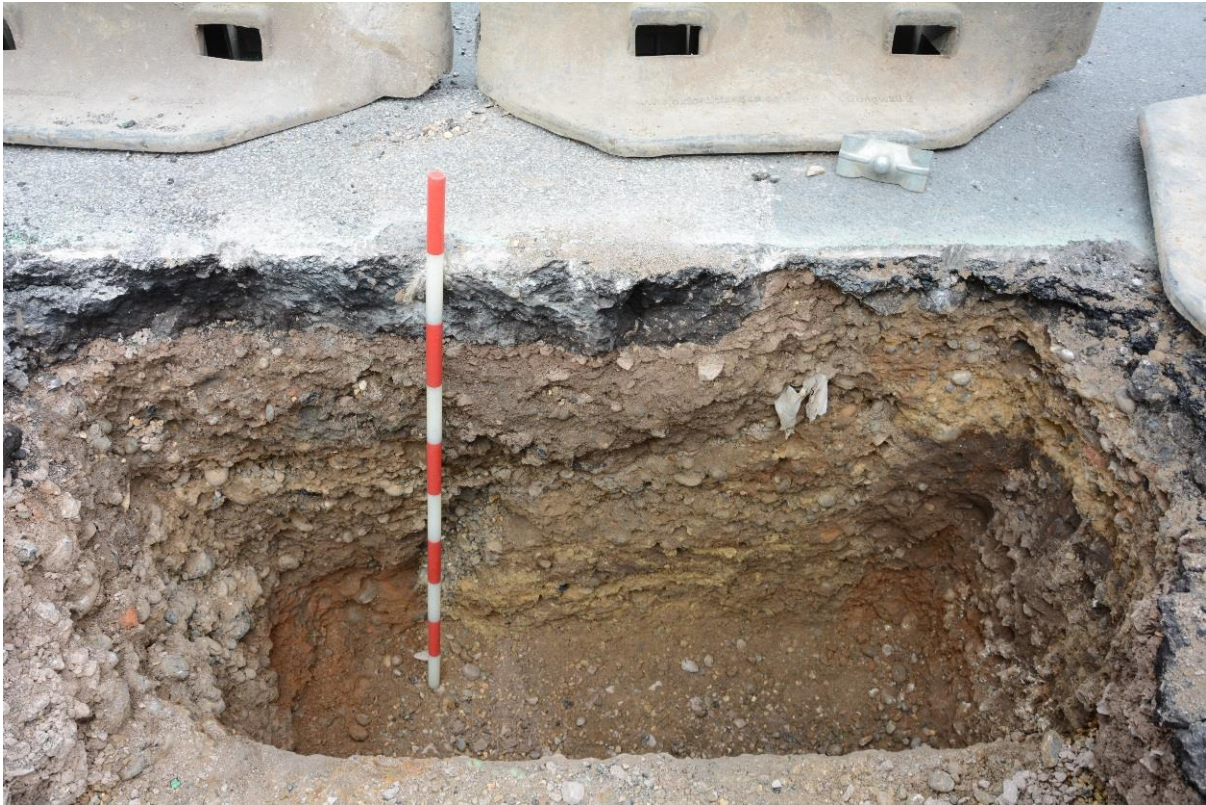
7.4.3 Made ground was visible in the east facing section, consisting of 200mm - 220mm of asphalt road surface (1) overlying a ground of tipped backfills (6). These deposits measured up to 740mm in thickness, and were characterised by a mixture of gravels, soil and sand, with some shingle, (fig.11).

Figure 11: Trench 3, east facing section. What is taken to be a series of modern backfills can be seen tipping downwards towards the scale bar, with some darker deposits of sand and soil seen towards the trench base. Facing W. Scale 1m.

- 7.4.4** Two deposits of very dark orange sand were seen in the corners of this section and may represent natural geology, truncated by made ground in the centre, however, as only a small portion was exposed this is inconclusive.
- 7.4.5** The majority of the remainder of the trench was disturbed by a large north-south service cut, [10], which had vertical sloping sides measuring approximately 1m in width, and was again filled by a homogenous deposit of MOT Type 1 (11) and sealed by a thick layer of asphalt (1).
- 7.4.6** No finds of archaeological interest were recovered, and with the exception of the variations in the made ground, no further features were recorded.

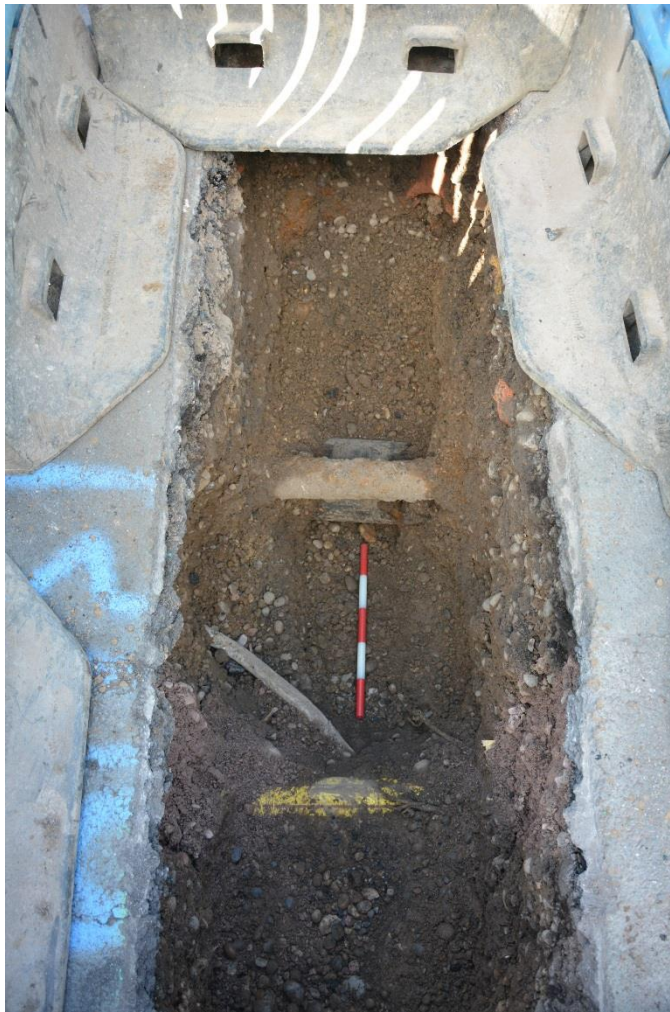
7.5.1 The final trench to be recorded during the watching brief was located at the northern end of Vanbrugh Park Road, within the eastern side of the carriageway, situated opposite the junction with Combe Avenue. The trench measured approximately 2.2m in length, (E-W), by 0.64m in width and 0.6m - 1.1m in depth, becoming deeper towards the west (fig.12).

Figure 12: Trench 4, showing N-S services below modern made ground. The remains of a ceramic drain can be seen towards the top right of the trench. Facing W. Scale 0.5m.

7.5.2 The stratigraphy recorded in this trench comprised 90mm of the asphalt road surface (1) overlying a coarse gravel abundant with red and yellow brick rubble (12), measuring up to 220 mm in thickness. This sealed 500mm - 850mm of gravelly backfill (5), as seen in Trenches 1-3. No orange natural sand was observed.

7.5.3 Again, the made ground was truncated by an N-S service cut [7], measuring 300mm in width and filled by MOT Type 1 (8). No cut was visible for the second set of services, seen towards the top of frame in fig.12 above.

7.5.4 The brick rubble appeared to be a backfill deposit, rather than a bedding layer for the road surface and most likely originated from bomb debris material from the Victorian villas damaged by a Second World War V1 flying bomb.
