**THAMES WATER
MAINS REHABILITATION WORKS,
DMA: ZSTHFL05
MUNFORD DRIVE, SWANSCOMBE, DA10 0BX**

An Archaeological Watching Brief

October 2017

Site code: MFD17
Approximate site centre: NGR TQ 60485 73833

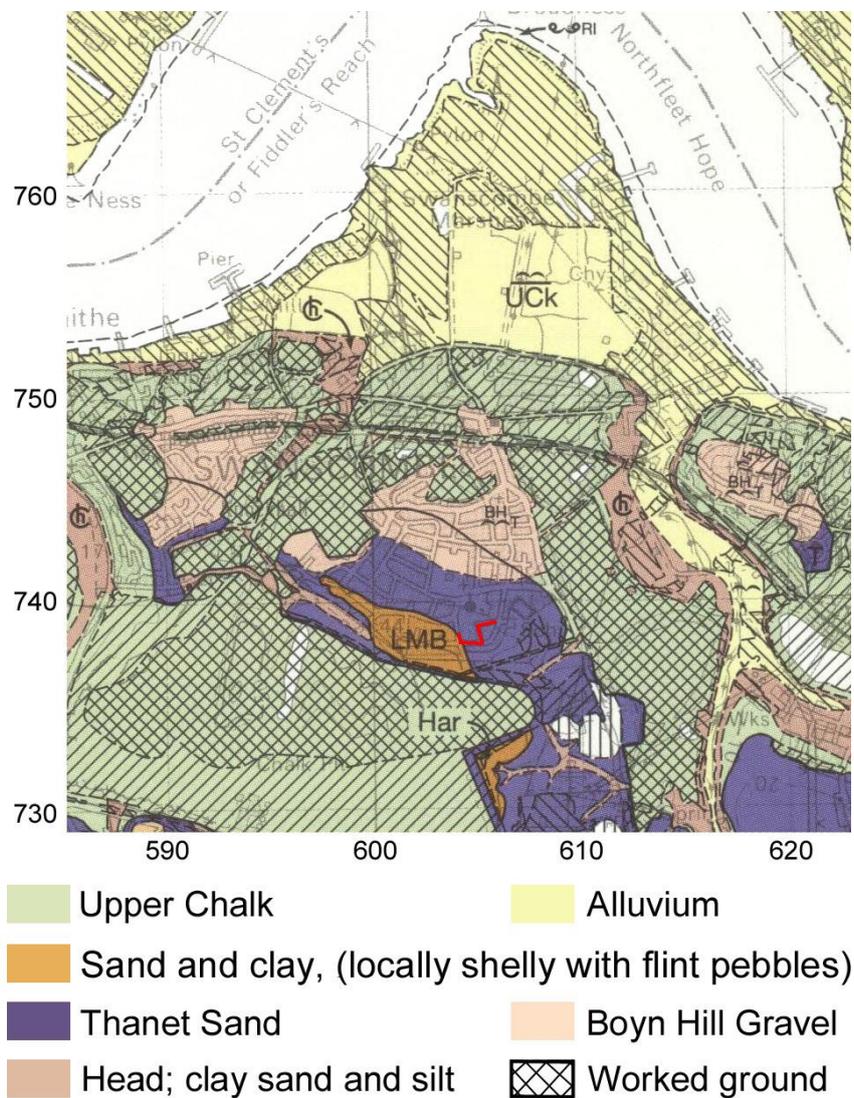
Fig.2: Site plan, (red line), in relation to the underlying geology

3.2 The British Geological Survey, Sheet 271: Dartford, indicates that the site lies on an outcrop of Thanet Sand, close to a pocket of shelly sand and clay. Head predominates as the ground slopes down to the north as part of a colluvial process; the underlying geology is chalk, albeit largely disturbed and worked over.

3.3 The site rises quite steeply from northeast to southwest, from c39mOD on Swanscombe Street and 44mOD on Keary Road.

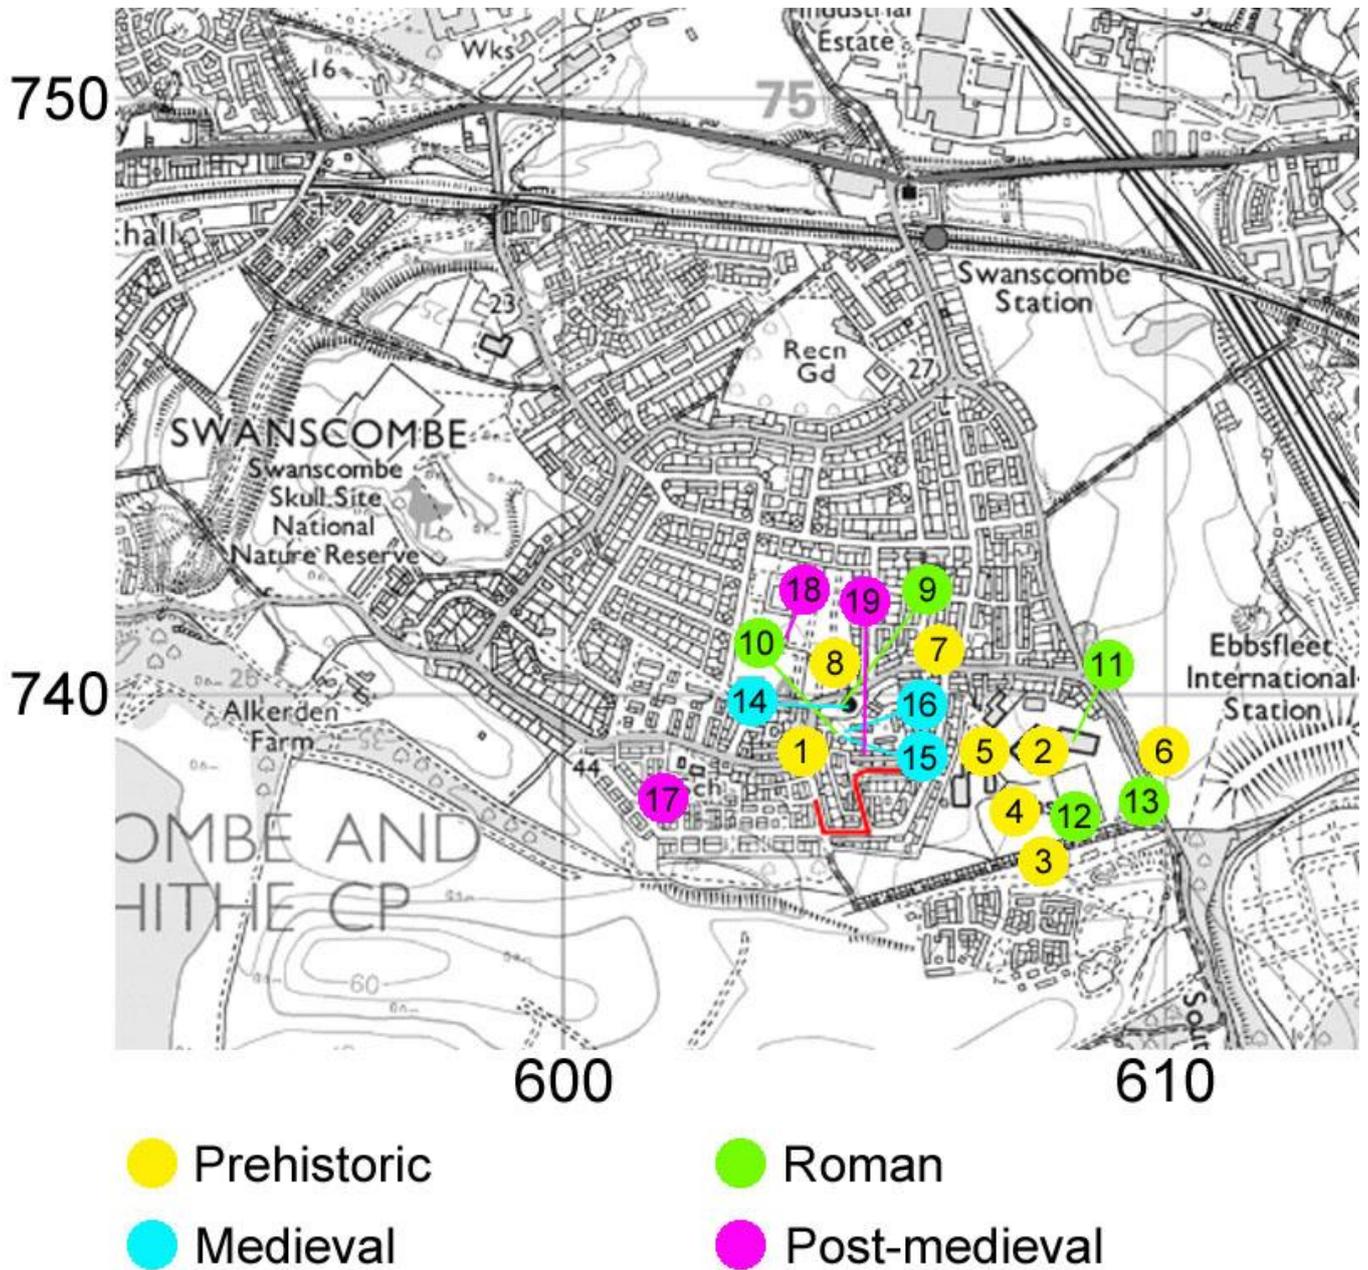
Fig.3: The works zone, (red line), in relation to relevant KHER entries

4.1 Included here is a summary of the archaeological and historical background of the site. This is, in part, based upon a search of the Kent Historic Environment Record, (KHER), via the Heritage Gateway website, up to 1km around TQ 60485 72837, (see fig.3 below).

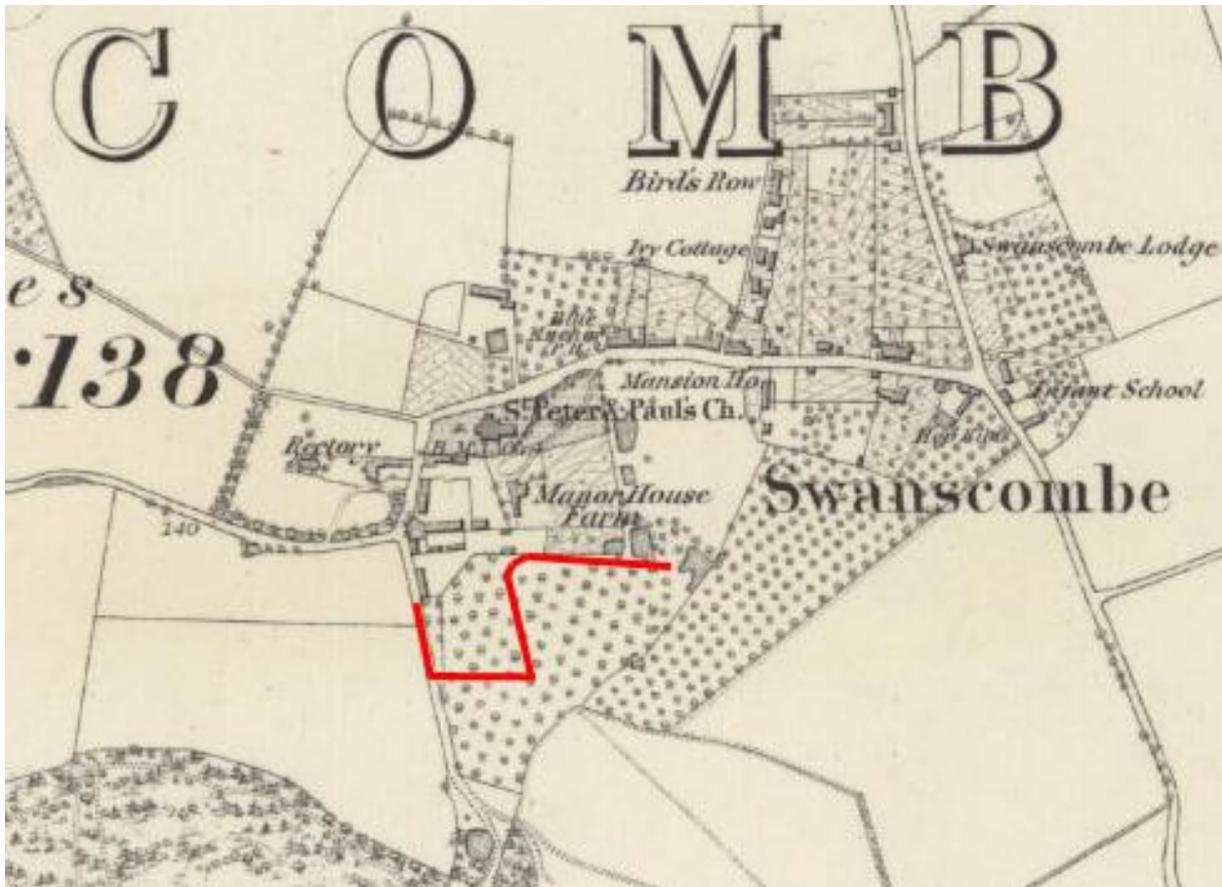
Fig.4: Extract from the First Edition 1869 OS map

House immediately to the east formed the focal points of the community; the works zone being situated further south in amongst orchards, (see fig.4). The wider landscape retained its agricultural characteristics well into the 20th century, and it was not until the 1960s that the works zone was subjected to any large scale development.

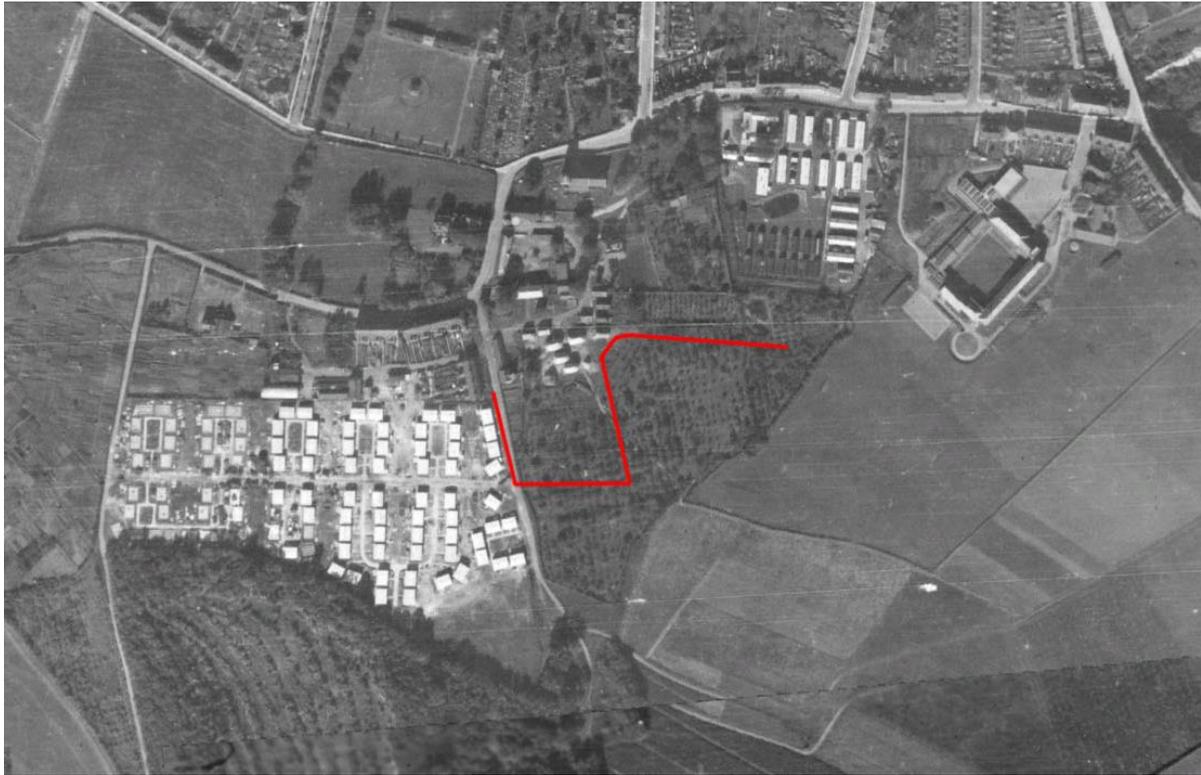
Fig.5: *Extract from an aerial view of the site c1945*

4.5.2 In the late 1940s and 1950s the area immediately to the north of the works zone was built upon to house prisoners of war. It was during this period that the estate to the west of Betsham Road was also first developed.

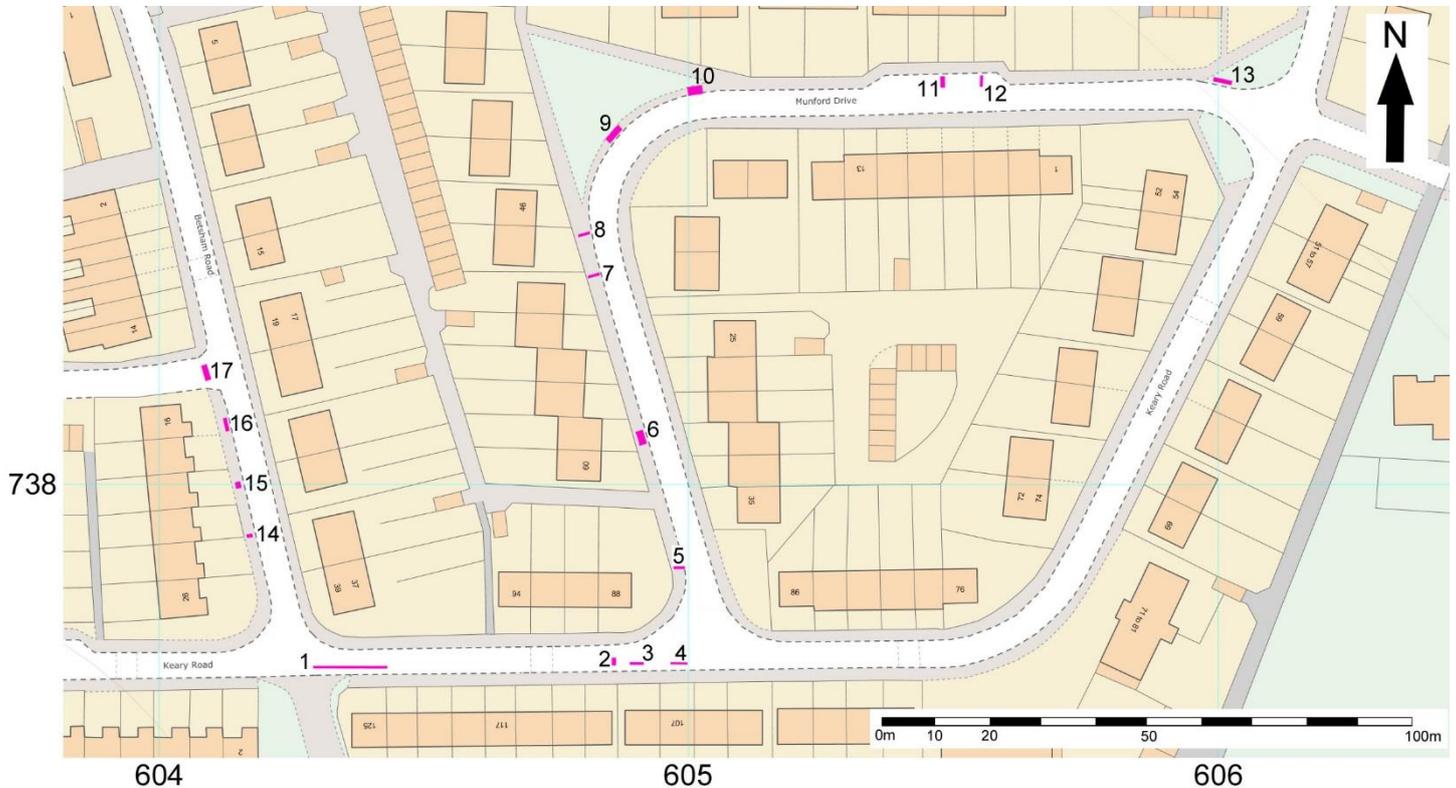
Fig.6: Plan of observed trench works during the watching brief

- 6.2.1** The fieldwork entailed the monitoring of 17 trenches located along Munford Drive, the southern arm of Keary Road and Betsham Road. The trenches were located within the main carriageway, on the pavements and on one occasion the verge. The trenches measured between 0.90m and 3.45m long, 0.60m and 1.20m wide, and a maximum of 1.25m deep, (see fig.6).

7.2 The watching brief was conducted over the course of four site visits between the 21st September and 18th October 2017. The results will be discussed in the context of these visits. Observed trenches are shown on fig.6 above and should be referred to throughout.

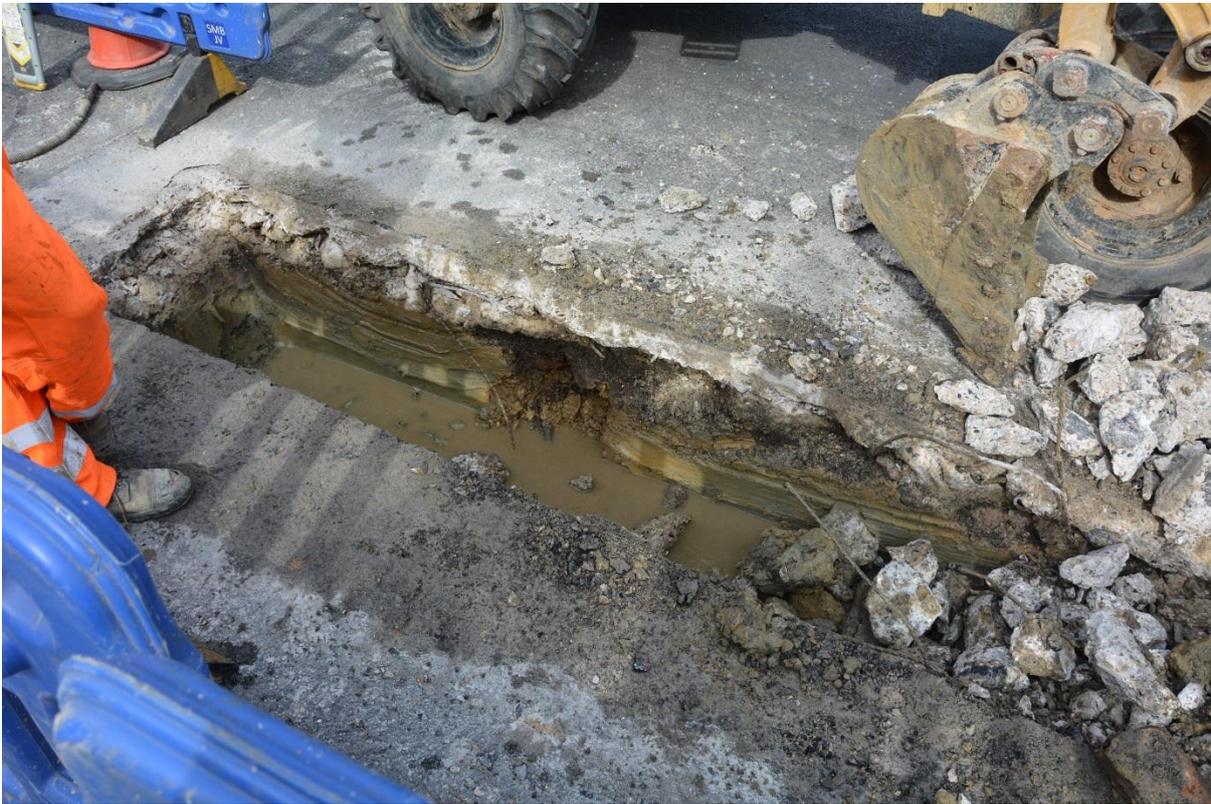
Fig.7: Trench 4 working shot, facing NE

7.3.3 Trench 4, (fig.7), was observed in its initial stages, whilst still being dug. The natural clay was observed from 300mm below ground level and was pale-brown / yellow in colour, sterile and compact. This was sealed below a layer of reinforced concrete road base and then capped with the existing tarmac road base. Water ingress began at 600mm below ground level, presumably ground water.

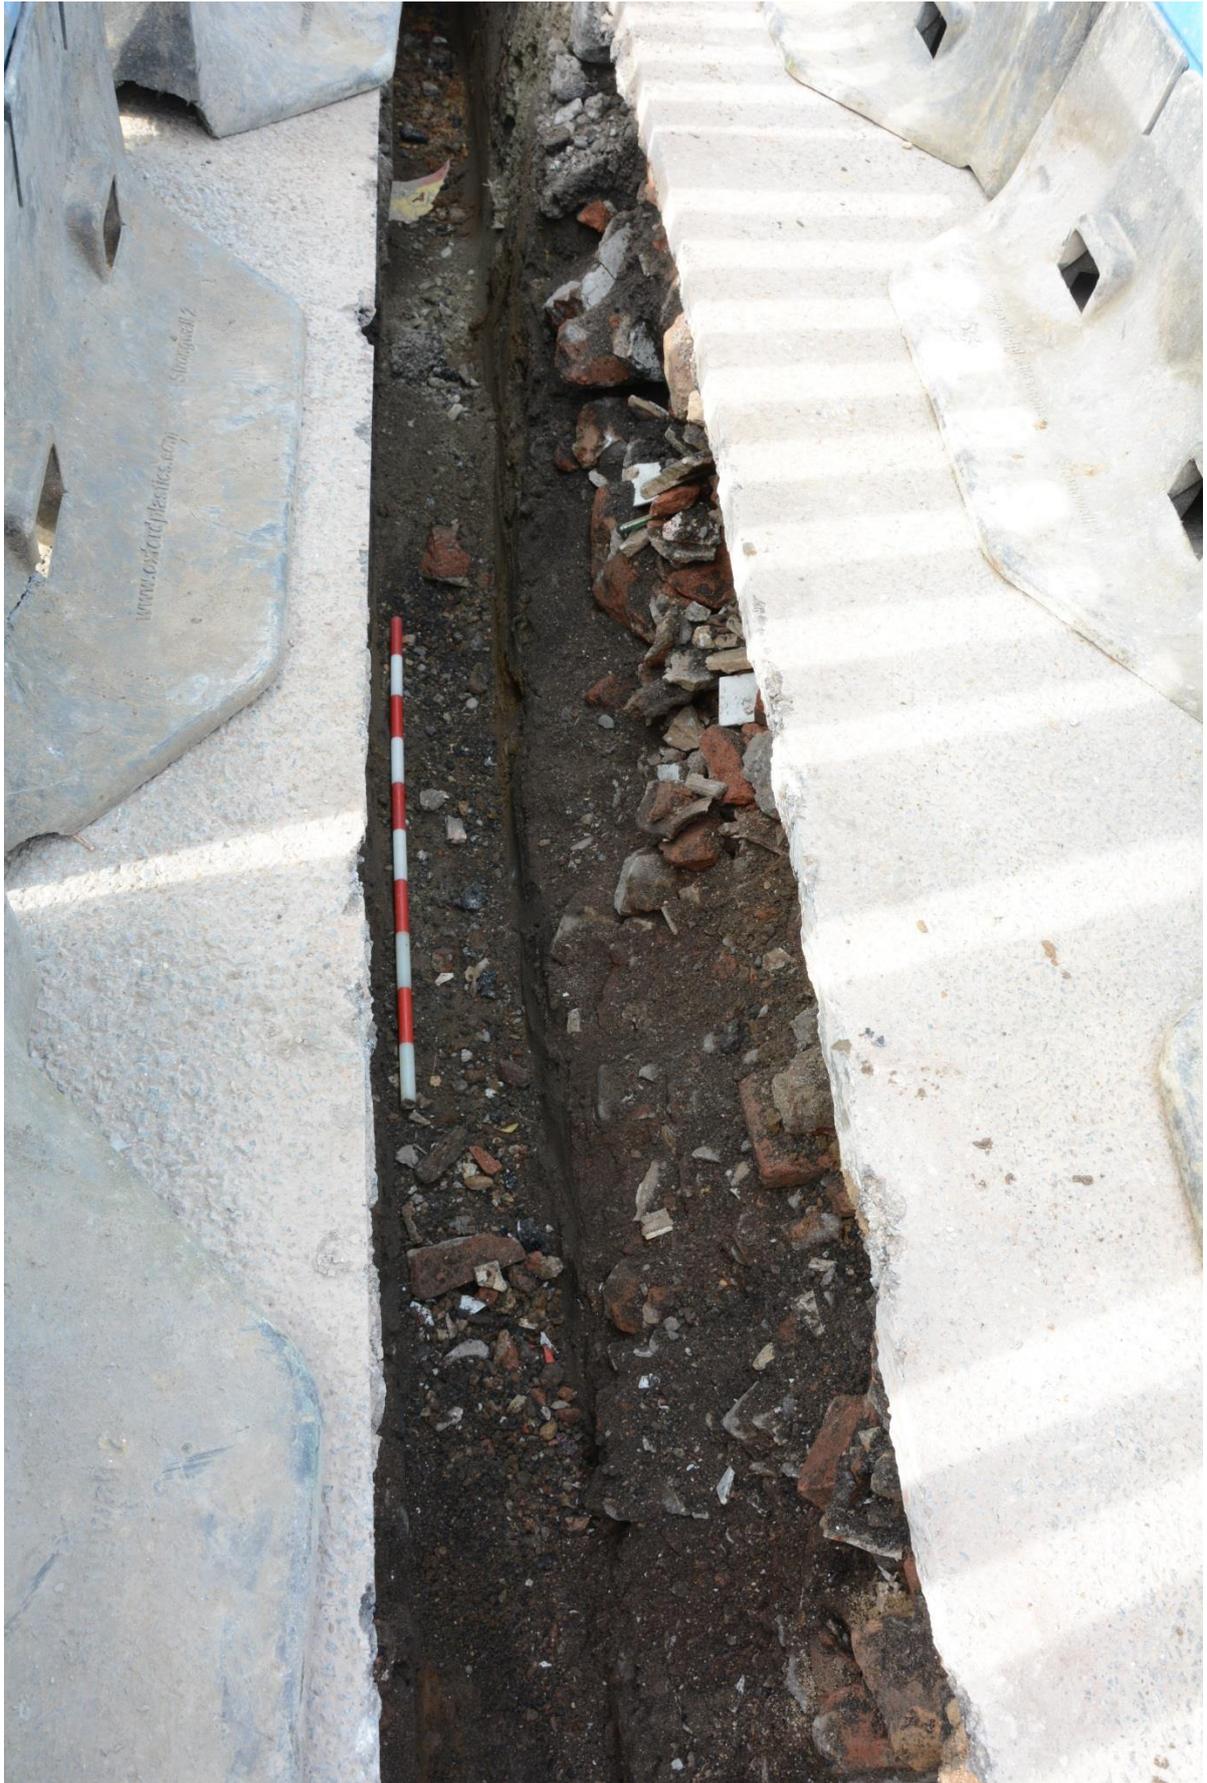
7.3.4 Trench 1 was the most interesting stratigraphy-wise with natural geology, (pale yellow clay), exposed at 700mm below ground level at the eastern end of the trench. Although present at the western end of the trench it is largely truncated in the upper levels by 830mm of brown silt containing brick / tile and modern 20th century rubble, (fig.8). This was then occasionally sealed below a hardcore-based road-bed below the existing tarmac road surface.

Fig.8: Trench 1, facing NW with modern intrusion seen in section, 1m scale

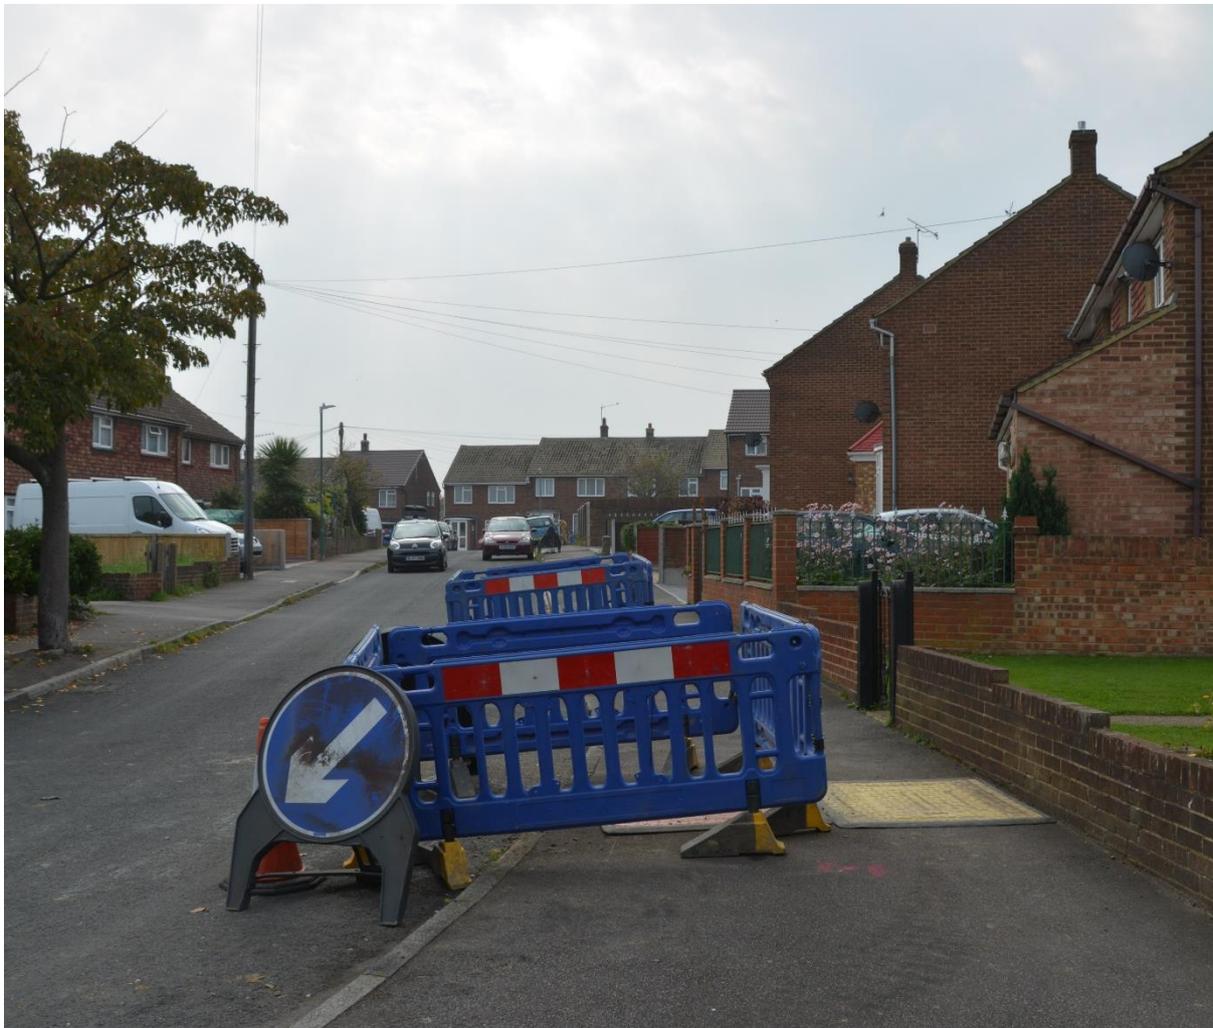
7.4.2 Trenches 5, 7 and 8, (fig.9), were connection trenches and did not expose any archaeologically significant deposits, only backfill associated with the extant pipework.

Fig.9: Connection trenches 8 and 7 on the west side of Munford Drive, facing S

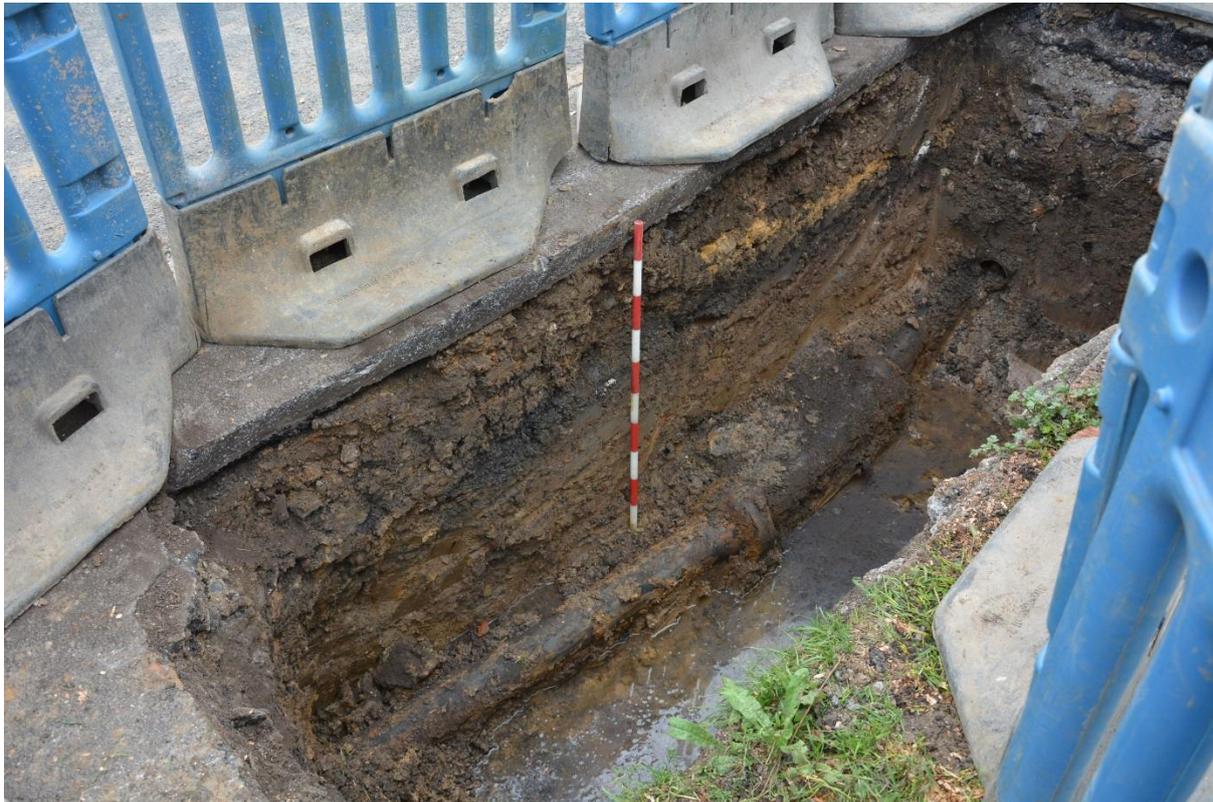
Fig.10: Trial trench 9, facing SW, 1m scale

7.4.4 Trench 9, (fig.10), was dug on the pavement as the road curves round to the east, and exposed sterile natural clay from as little as 700mm below ground level. This was overlain by 350mm of grey-brown clay-silt containing rare 20th century brick and tile debris, probably representing some form of buried subsoil. This in turn was overlain by 120mm of dark-brown / black silty-clay, which may represent a buried land surface. This buried land surface was present below 90mm of rubble-base and the extant tarmac surface. Both sections were also disturbed by existing services so even the observed stratigraphy has been somewhat disturbed.

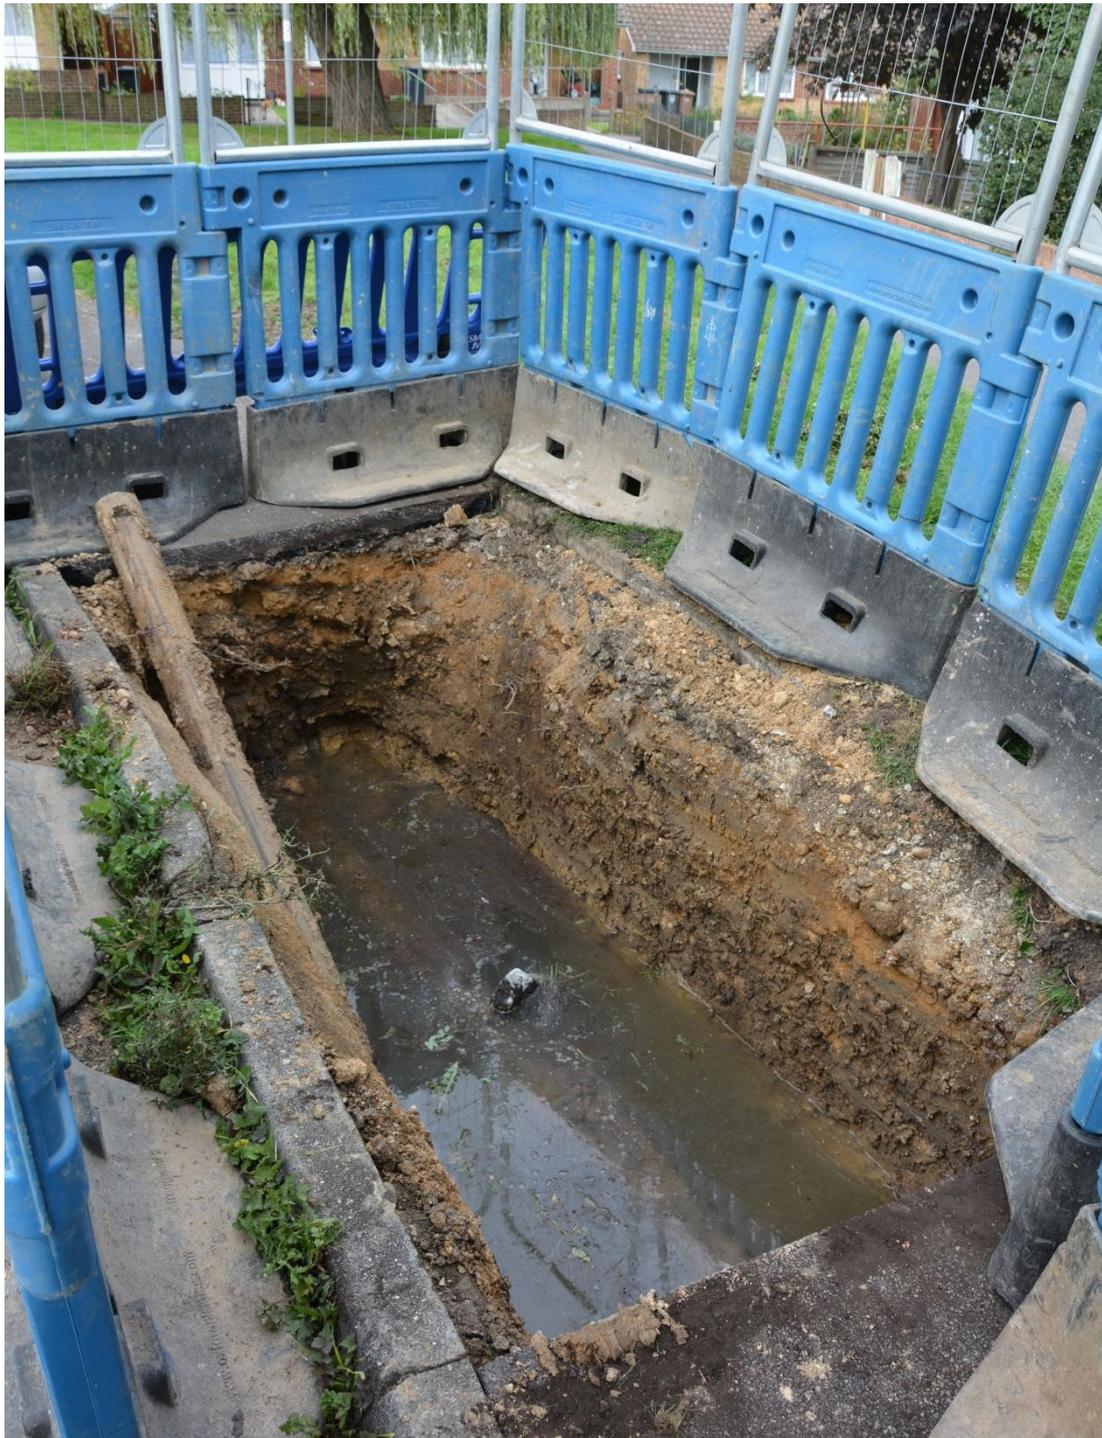
7.5.3 The westernmost trench exposed similar stratigraphy as Trench 9 on the previous visit. Pit 10 exposed sterile, pale-brown / yellow, clay 650mm below ground overlain by

450mm of dark-brown / grey clay-silt with occasional stones and rounded pebbles. This in turn was sealed by 300mm of rubble road base and extant tarmac pavement, (fig.11).

Fig.11: Trench 10, facing NW. Water ingress, from groundwater

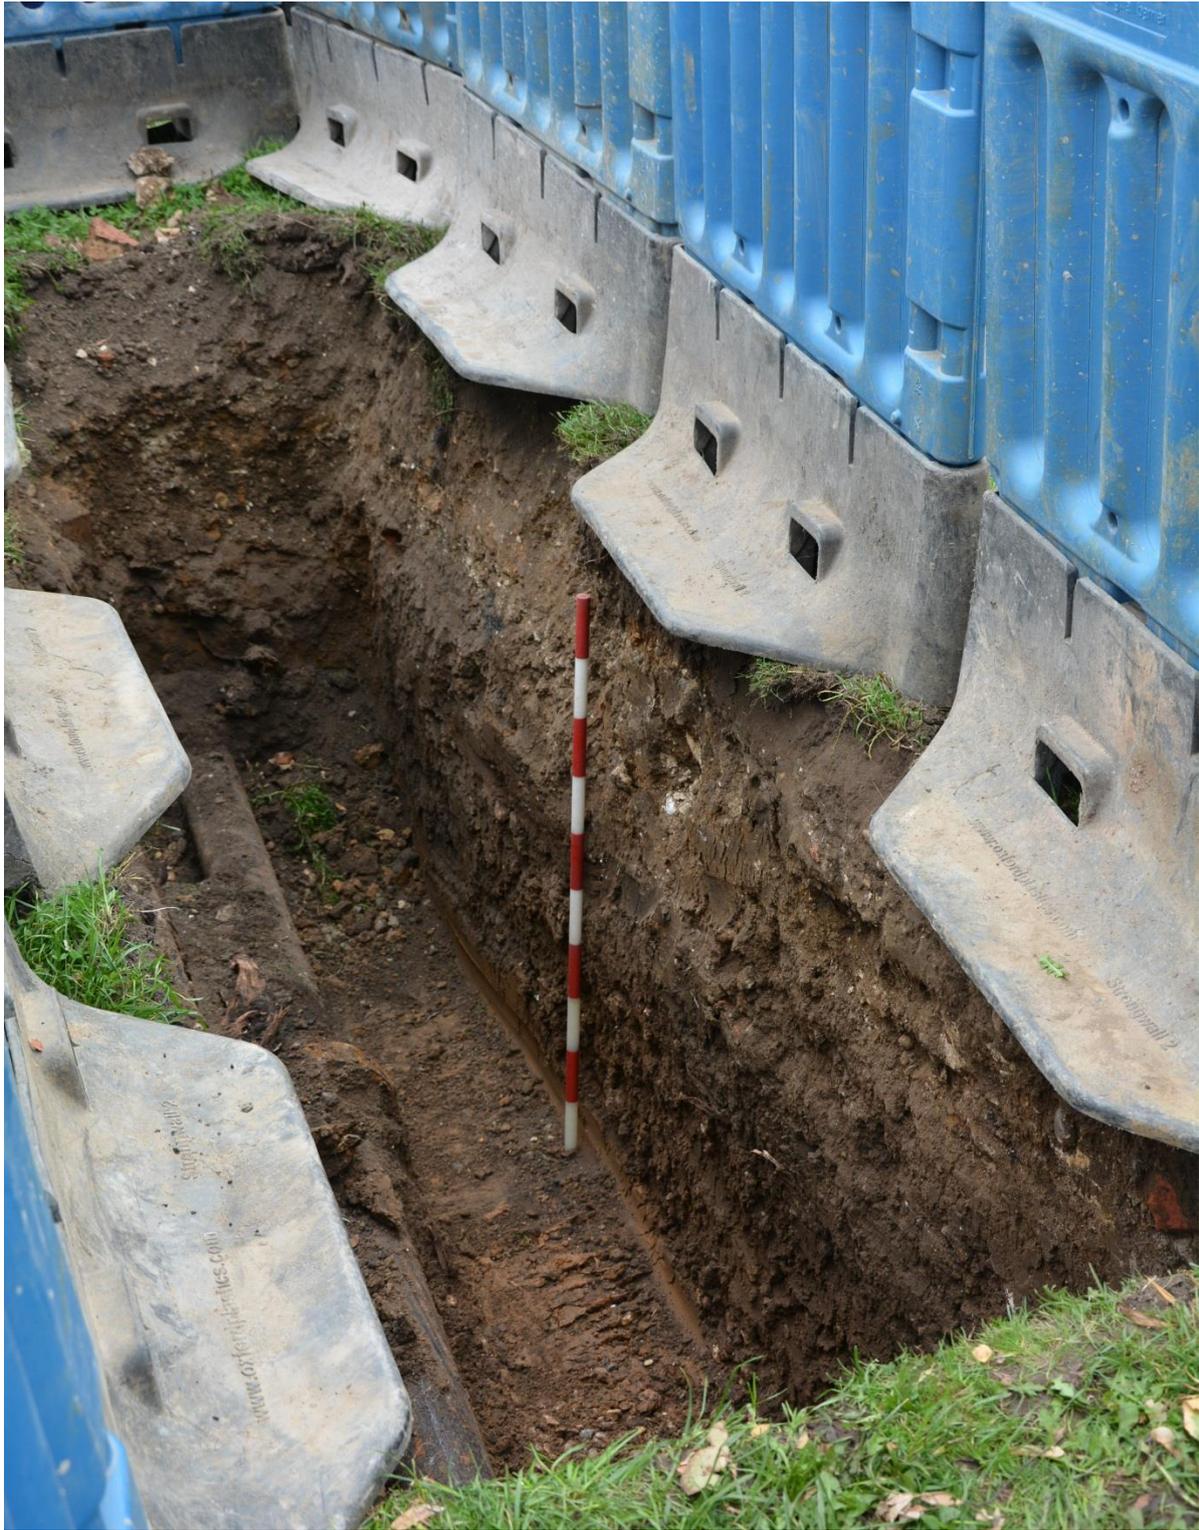
- 7.5.4** Trench 13 exposed natural geology 1.16m below ground level sealed below 600mm of dense, brown, silty-clay, and 340mm of rubbly silty-clay. The latter deposit may represent demolition derived rubble from post-war development of the estate. These deposits were sealed below the 220mm of existing loamy topsoil, (fig.12).

Fig.12: Trench 13 at the east end of Munford Drive, facing SE, 1m scale

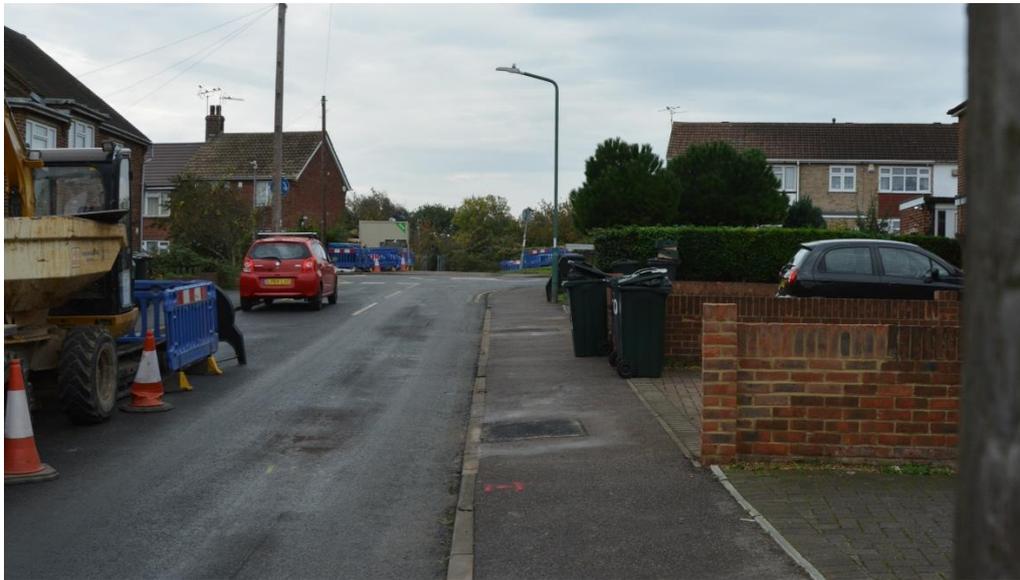
7.6.1 A final four test pits were observed during the final visit, along Betsham Road. However, pits 14 and 15 were already backfilled, and pits 16 and 17 were covered by metal road plates which could not be lifted to fully expose the trenches. Only depths could be measured.

Fig.13: Pits 14 and 15 facing S along Betsham Road towards the junction with Keary Road

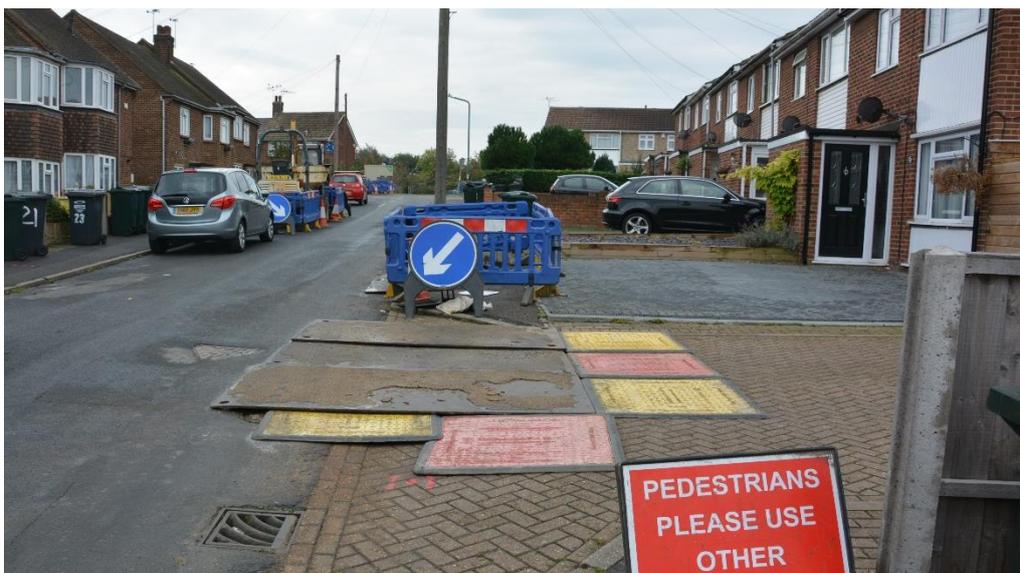
Fig.14: Pit 17 under the road plates, and 16 behind blue fencing, east side of Betsham Road, facing S
