**LEVEL 2 HISTORIC BUILDING RECORD &
TRIAL TRENCHING
ON THE SITE OF THE FORMER 'RETREAT',
MARKET PLACE, ABRIDGE,
ESSEX, RM4 1UA**

LEVEL 2 HISTORIC BUILDING RECORD &
TRIAL TRENCHING
ON THE SITE OF THE FORMER 'RETREAT',
MARKET PLACE, ABRIDGE,
ESSEX, RM4 1UA

Principal Author: James Aaronson
with contributions from
Geoff Potter and Miranda Fulbright

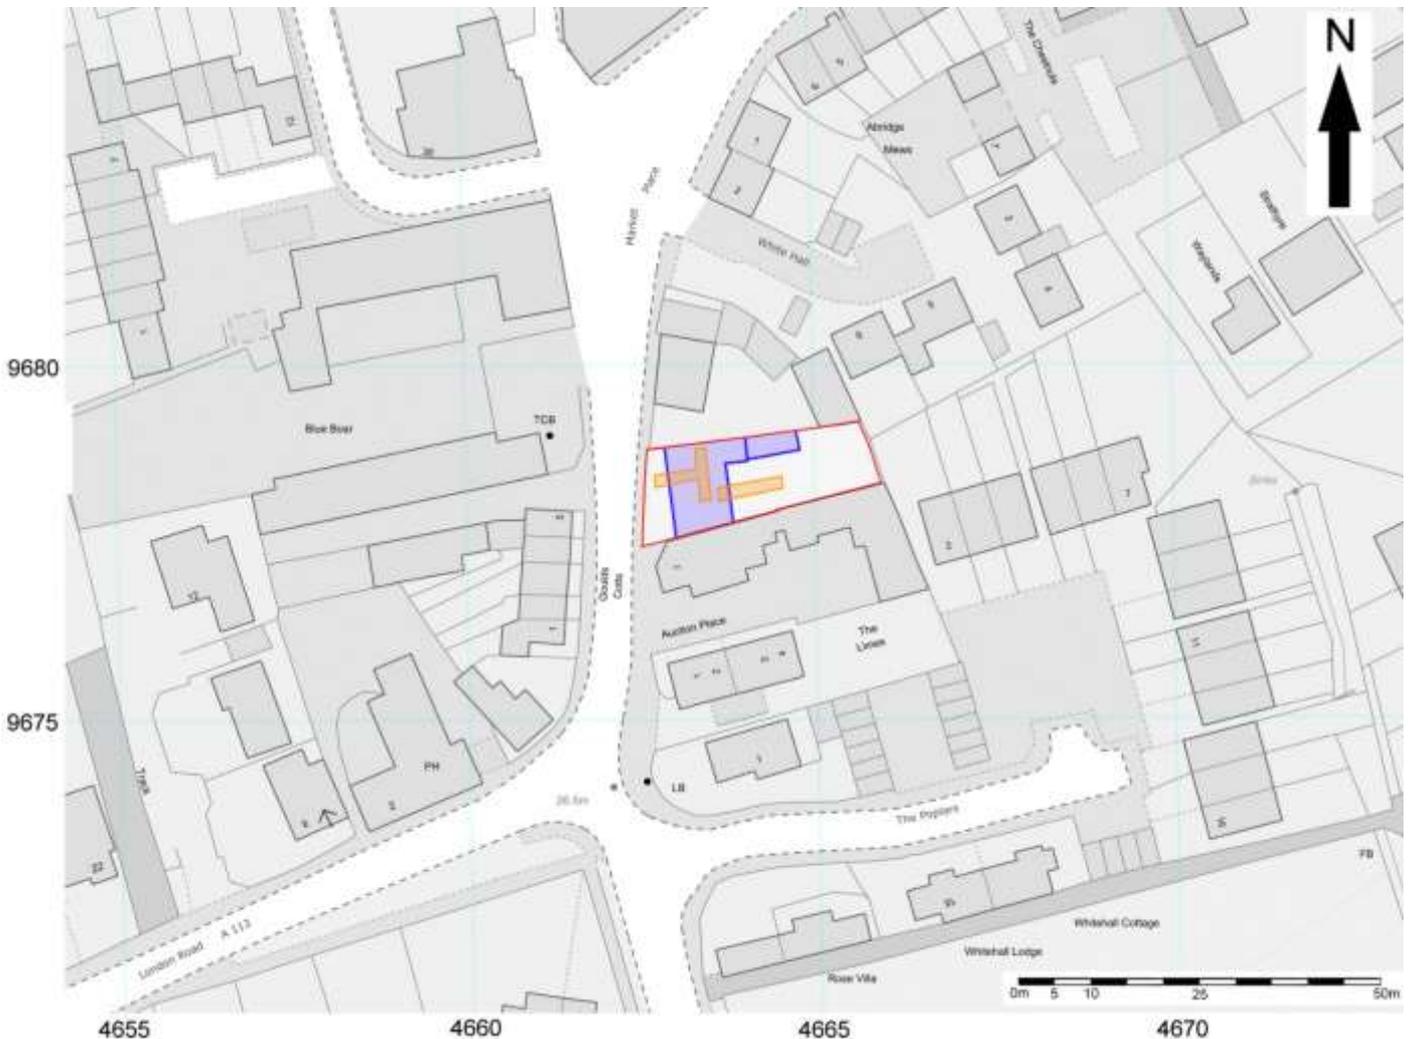
Fig.3: Site location, showing the former Retreat and outbuildings prior to demolition

- 3.1.1** The previous building, known as The Retreat, had two storeys plus a small disused cellar, and was mainly timber-framed and weather-boarded. The main body of the structure was shown to be of mid to later-19th century date, although there have been a number of later alterations and additions. The whole building was at the time derelict and in a very poor state of repair, with much of the internal walling and ceilings stripped back to the bare frames. To the rear there was a fairly small and heavily overgrown garden, with one dilapidated timber outhouse on the northern side. Plans showed that the latter was once linked to the main building by a further structure that had since disappeared.

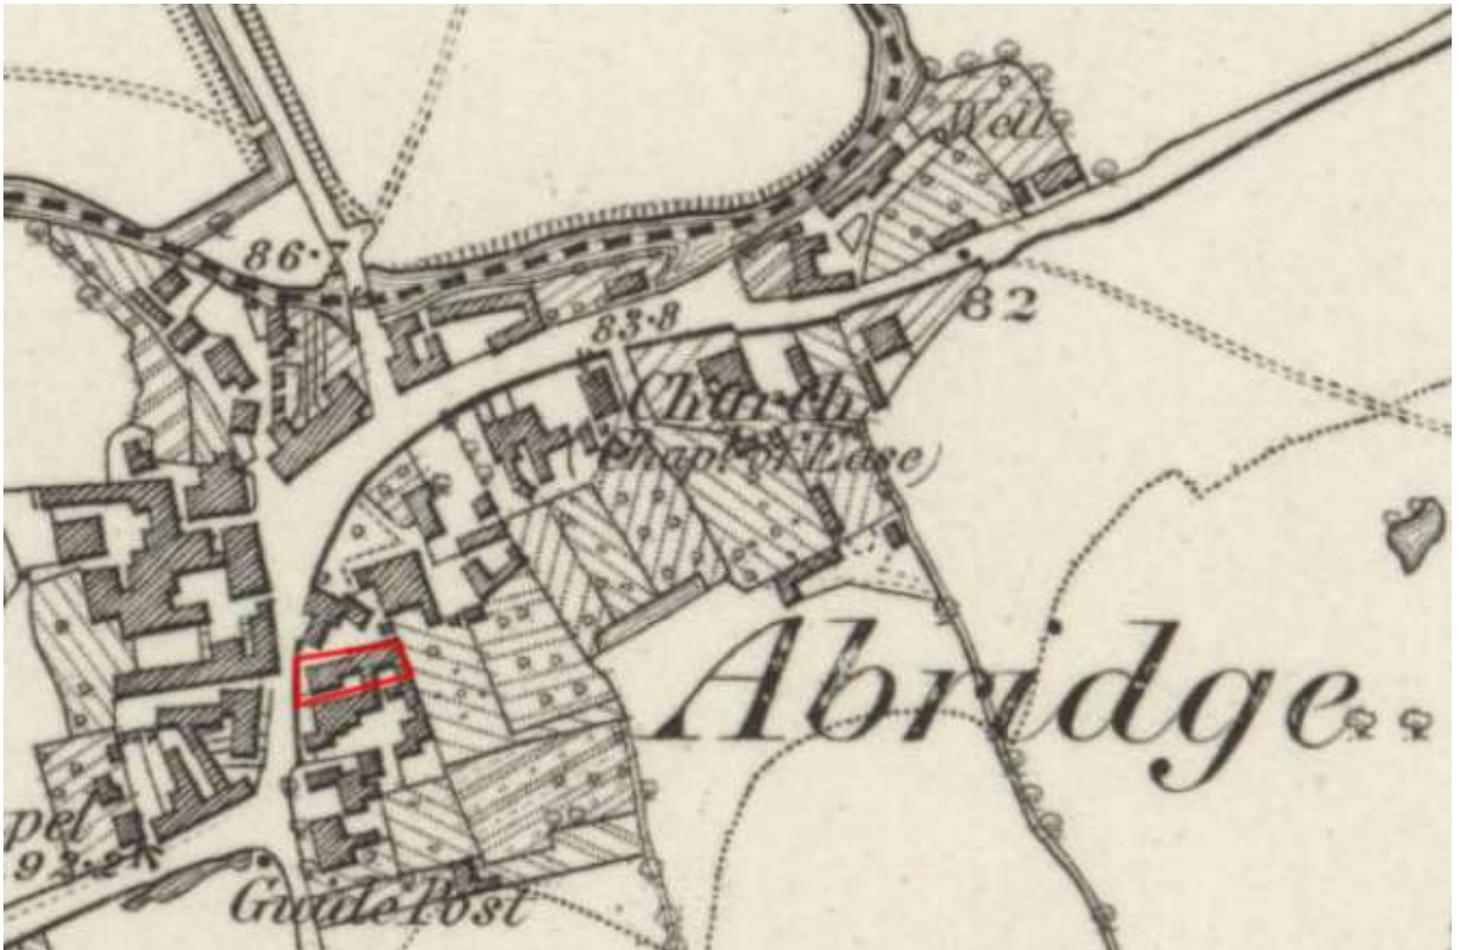
4.6.5 By the time of the First Edition 25inch OS map (1880; fig.5), the site of ‘The Retreat’ is occupied by an arrangement of buildings with a squat frontage and eastern extension to the rear. Two further buildings span the northern half and width of the plot beyond the main street frontage with two small yards to the south. There is the possibility that the building facing the street is not the same as exists today, as the frontage of the building seems to be slightly stepped back from the street and the building appears to have a much squatter footprint. This may account for the small size of the existing cellar in the building today; in that it belonged to an earlier and smaller building that was demolished and rebuilt as the present structure.

Fig.5: Site location in relation to the 1880 Ordnance Survey map. It is possible that this shows an earlier building than that recorded in the building survey

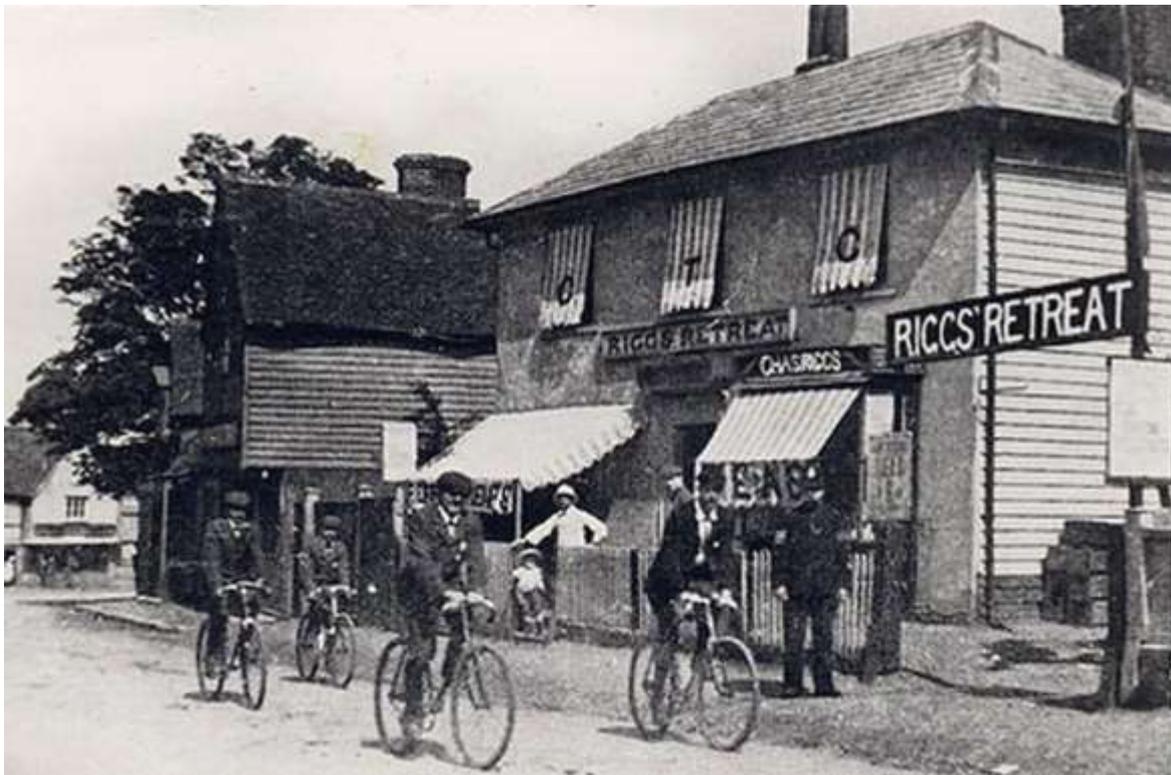
4.6.6 Similar buildings occupy the site into the early-20th century, (see fig.6, the 1921 OS map). A photograph taken in the early-20th century, (fig.7), shows the west-front and southern side of the property; the former rendered, and the latter weather-boarded. The building has a wooden fence facing the street, and is named Rigg’s Retreat. The name derives from the local individual who founded the company in 1879; John Riggs. The name above the window names Charles Riggs as proprietor so must be another member of the Riggs family. The establishment was linked with the Temperance movement and was renowned for its afternoon teas and non-alcoholic refreshments. Several similar establishments were set up in the surrounding villages.

Fig.7: Probable early-20th century view of the building. The frontage appears to be rendered here, unlike the present day and indeed other historic photos

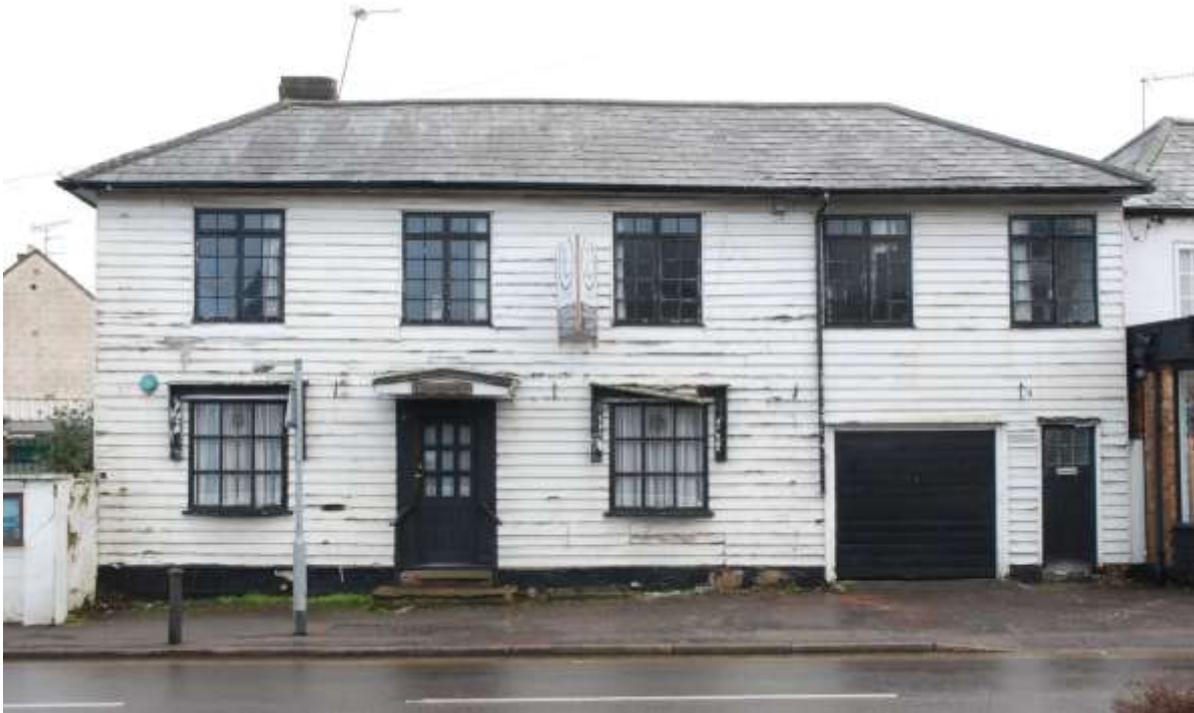
Fig.10: *The western elevation, street frontage, of 'The Retreat', facing east from the western side of Market Place*

6.3.1.1.2 The ground sloped gradually down to the north and so the front door was raised up from pavement level by a set of two steps with wooden hand rails on either-side, and a pitched roof porch overhead projecting 0.95m from the frontage, (fig.11). The slope in ground meant that the property was raised higher at the northern end, but rested at ground level at the far southern end, (see fig.10 above).

6.3.1.1.6 In an attempt to unify the two halves the roof had been re-modelled, and the extension weather boarded to match the original. The weatherboarding was in a relatively poor condition, and the paintwork was also flaking.

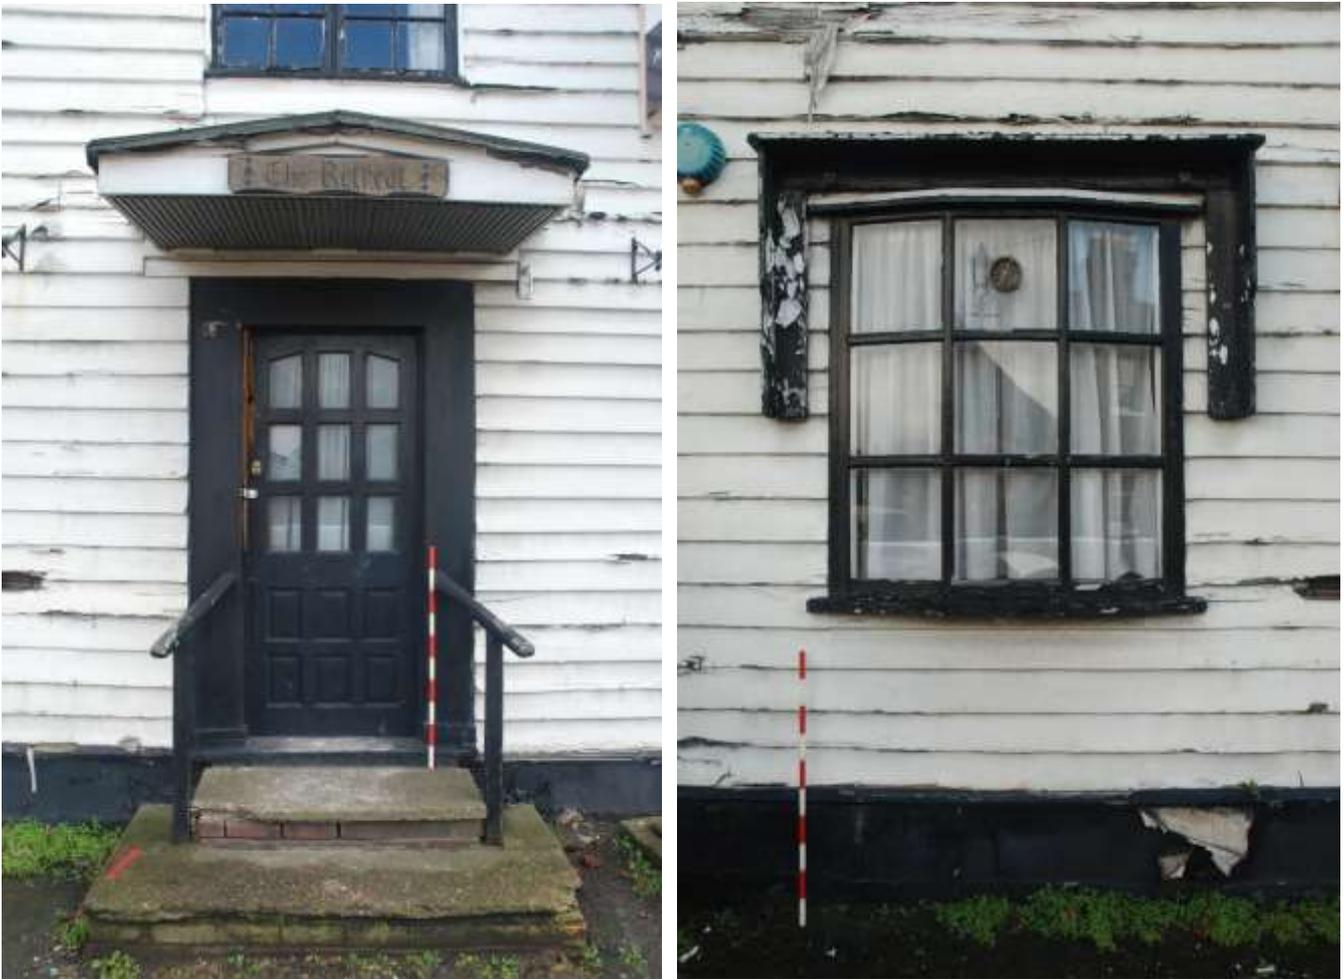
Fig.11: *Detail of the front door and northernmost window in west elevation, 1m scale*

6.3.1.1.4 The original frontage comprised the central doorway flanked by a single three-sided box-window to the north and south with decorative wooden rainhoods, and circular air vents in the uppermost central pane at ground floor level, (fig.11). A further three casement windows mirroring the arrangement at ground floor level are situated at first floor level, but are modern additions, put in at the same time as the southern extension. The original frontage would have measured approximately 9.3m long.

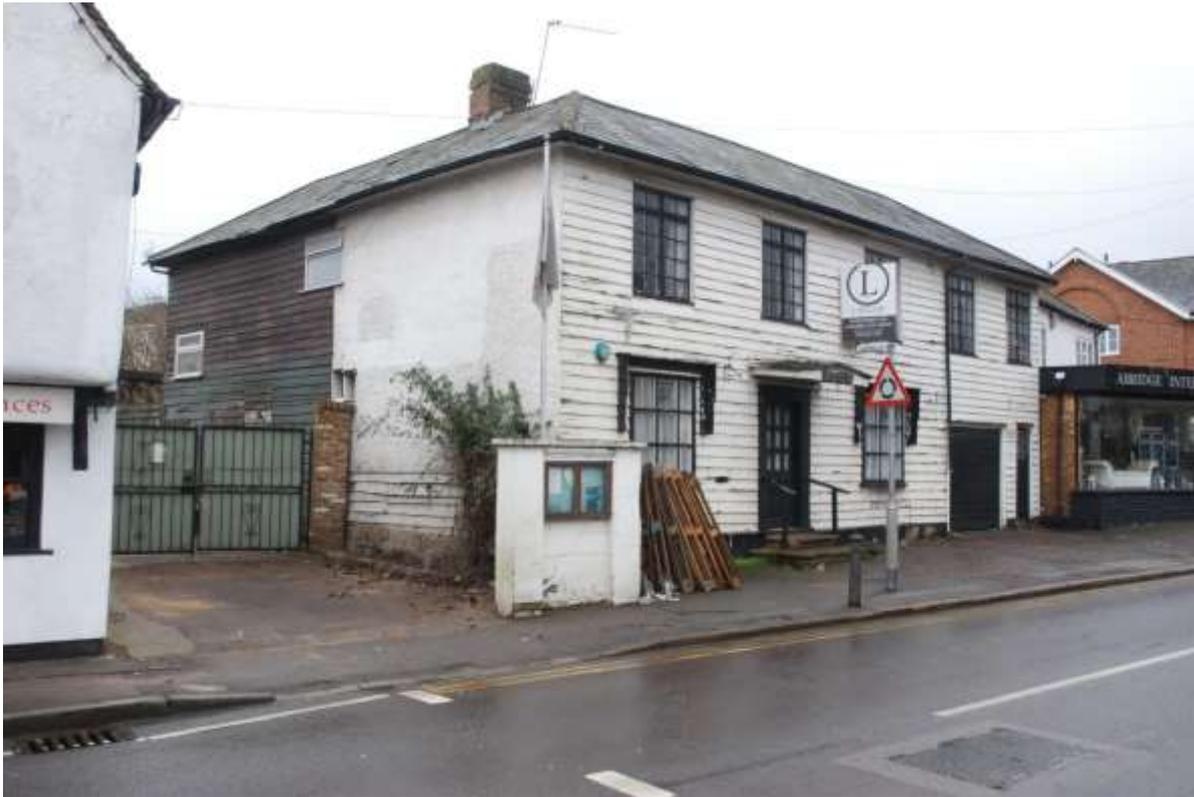
Fig.13: Northern elevation facing SE

- 6.3.1.2.1** The northern elevation could also be divided into two, with the western half corresponding with the original core block of the property, and the eastern remodelling as seen inside the property, (see 6.3.3)

- 6.3.1.2.2** The western end of the north elevation was exposed brickwork at the bottom 0.50m above which it was partially weather boarded for a further 0.70m and from here to the eaves the weatherboarding had been covered with a pebble-dash render.

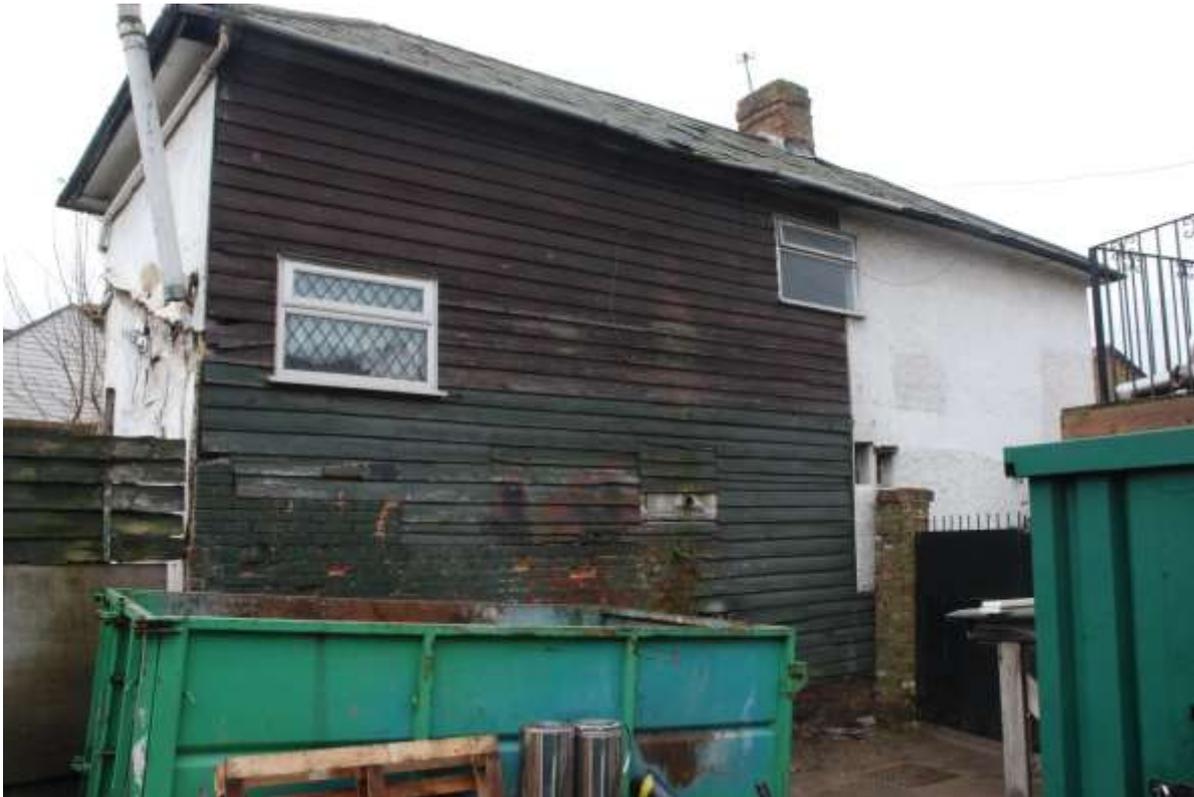
- 6.3.1.2.3** The western half of the northern elevation included an area of exposed brickwork at ground floor level, (fig.15), which would probably have formed an earlier boundary wall with the adjoining property to the north, but which later formed the lower part of a rear extension / remodelling of 'The Retreat', (see 6.3.3.4). Above and to the west of this the elevation was weather boarded and stained a mixture of mossy green and dark-brown, (fig.14). Why this was part of the property escaped pebble-dashing like the western half is not clear.

Fig.14: Northern elevation, facing SSW

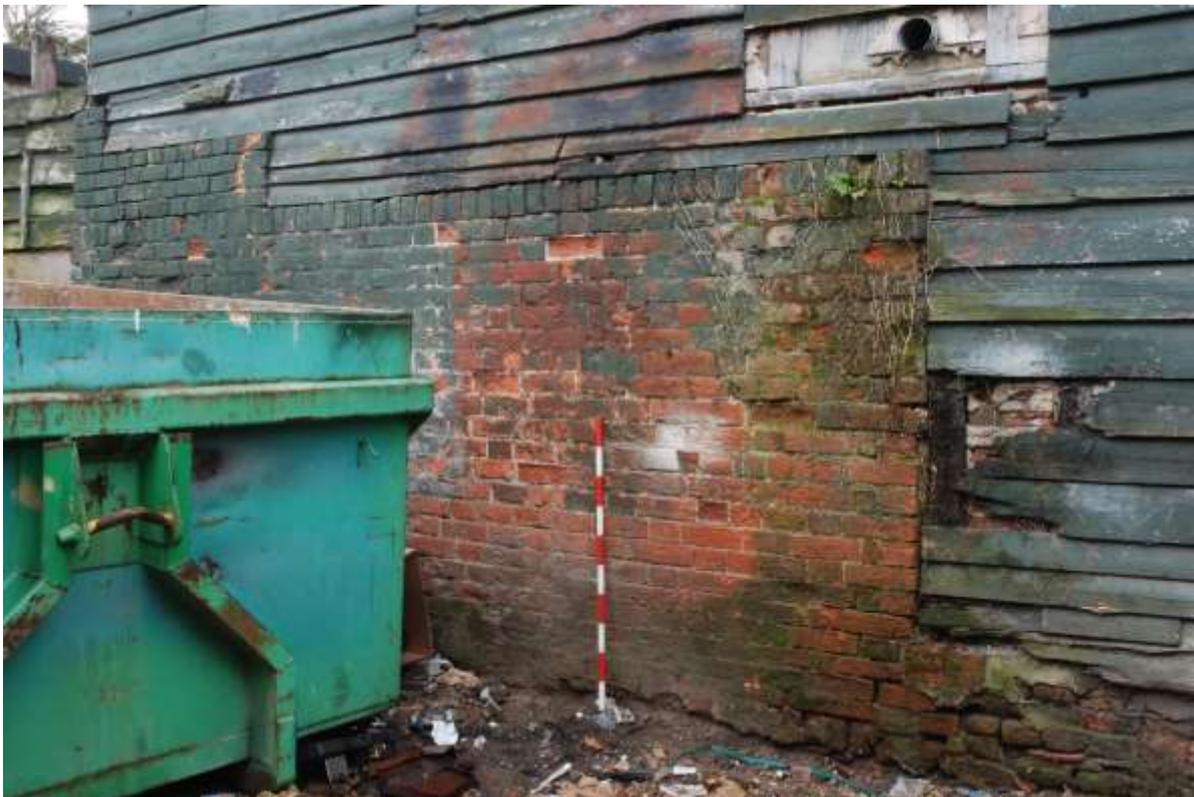
Fig.15: Northern elevation, eastern end, solid brickwork also visible in room G4, facing SE, 1m scale. The brickwork probably formed part of an original boundary wall, later utilised in the eastern extension / remodelling of the property

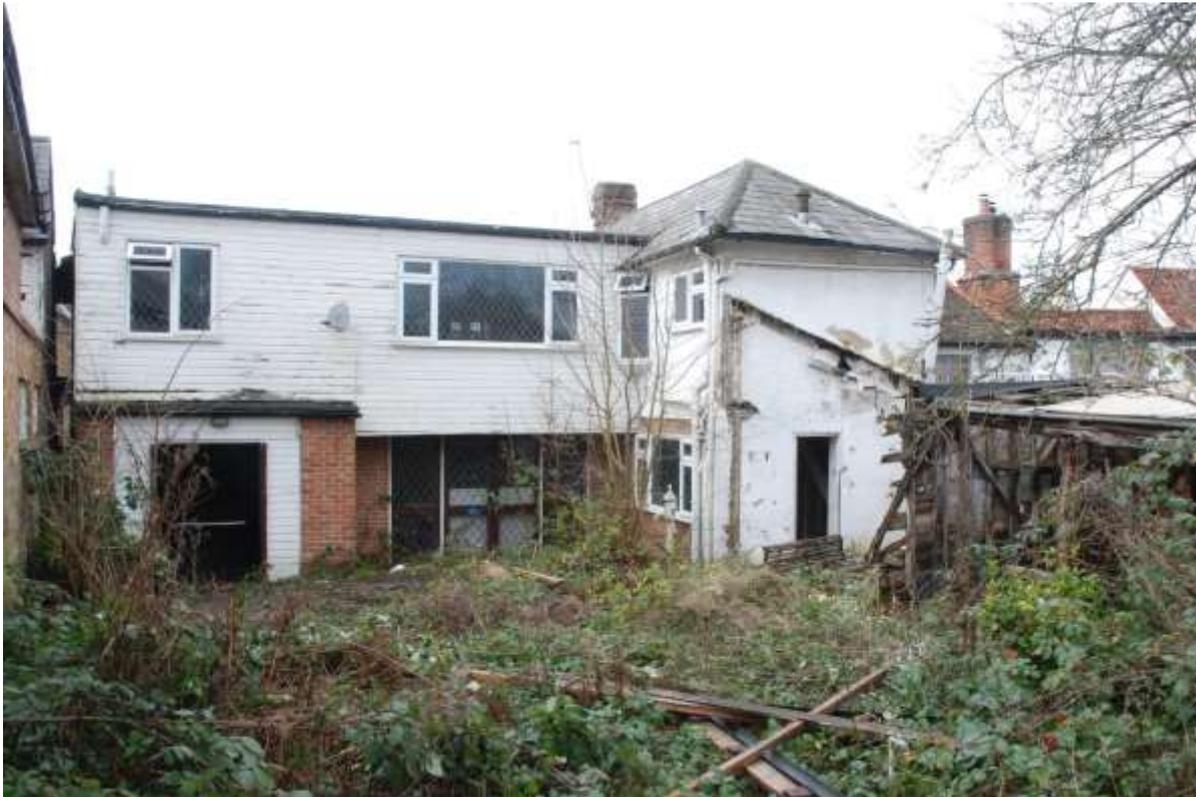
Fig.16: *The eastern / rear, elevation of the property as viewed from the garden, facing WNW*

6.3.1.3.1 The rear elevation of the property was like the rest of ‘The Retreat’ a mixture of old and new. The north-eastern corner of the building represented an early extension / remodelling of the property in the 19th century, whilst the southern / main elevation was of a thoroughly modern nature, with uPVC framed windows, and brick-faced blockwork. The upper floor of the southern half had been weather boarded like the main frontage.

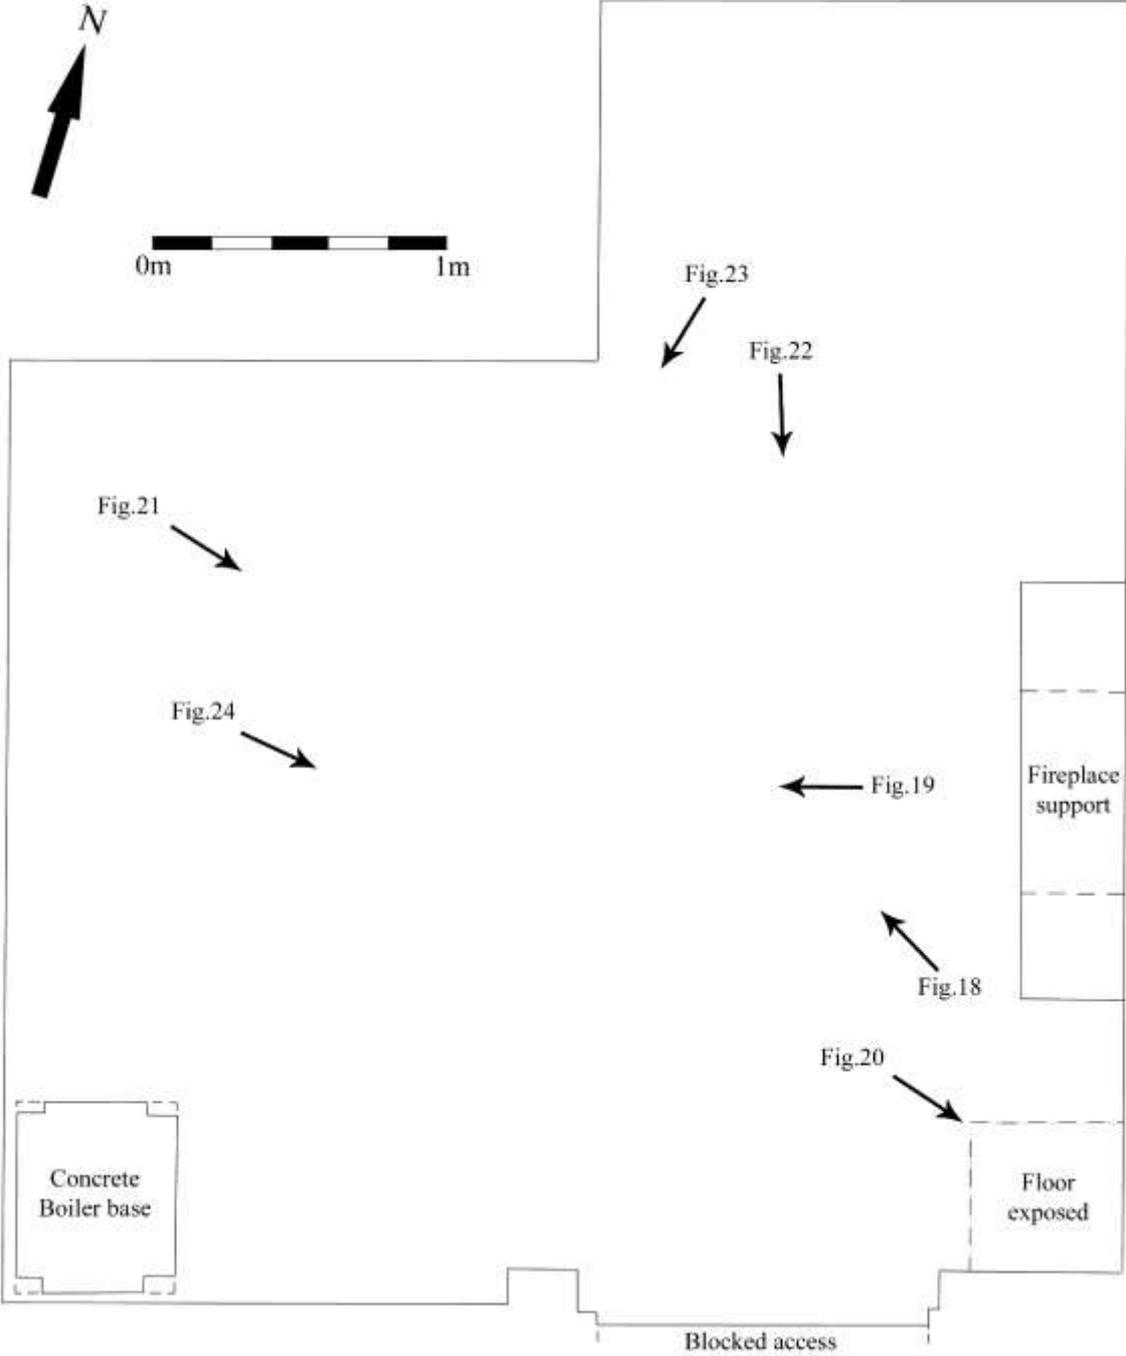
Fig.17: Plan of the cellar

6.3.2.1 The cellar was located below the southwest corner of the property. The main area of the cellar was rectangular in plan, measuring c3.83m (E-W), by 2.57m (N-S), with an additional 1.87m wide (E-W) by 1.08m (N-S) projection in the northeast corner.

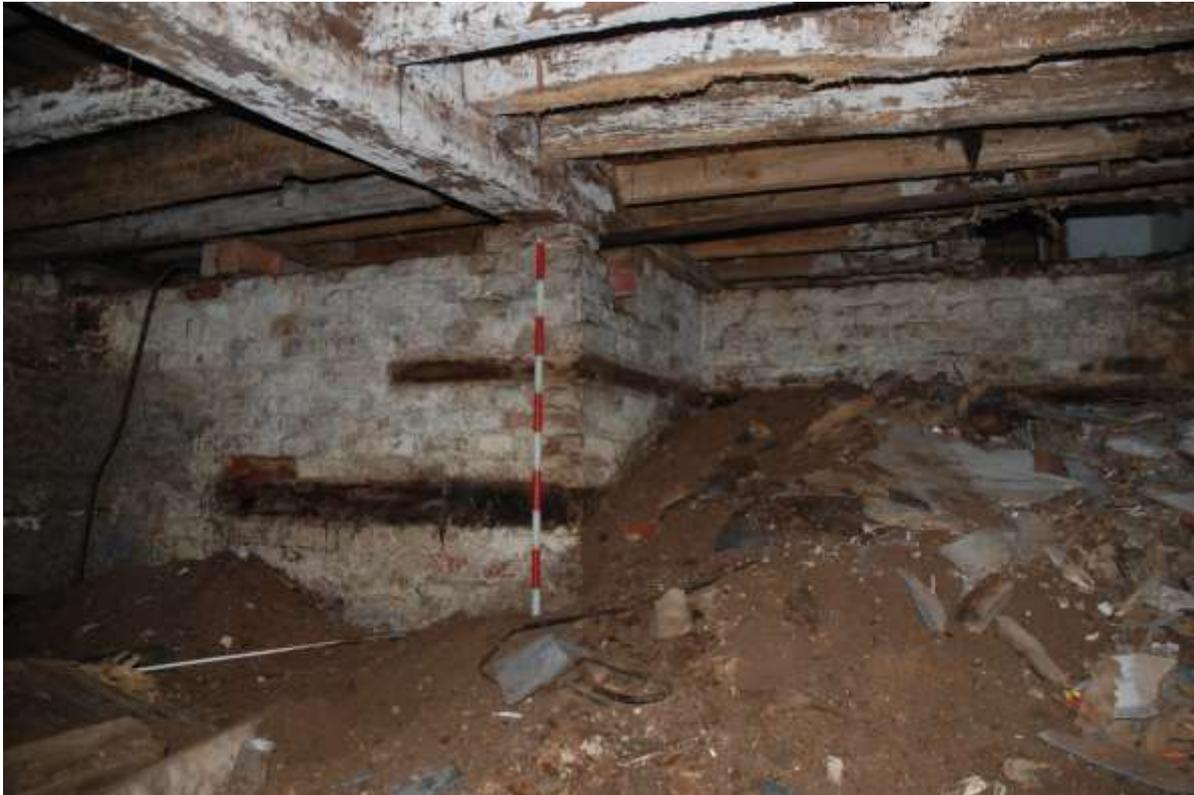
6.3.2.2 The main construction of the cellar walls was brick, laid in irregular bond and whitewashed against the damp. The north wall, northeast projection, and the eastern wall also included bond timbers between 60mm and 120mm thick. These timbers worked into the fabric of the walls were used throughout the 18th century and up until the middle of the 19th century to add strength and stability to the structures, where it was deemed necessary³. Brick samples taken from the walls and floor support an early-18th century date for the construction of the cellar⁴, which in turn identifies the cellar as an earlier feature, probably preceding the main structure overhead.

Fig.18: North wall of the cellar with projection and bond timbers, facing NNW, 1m scale

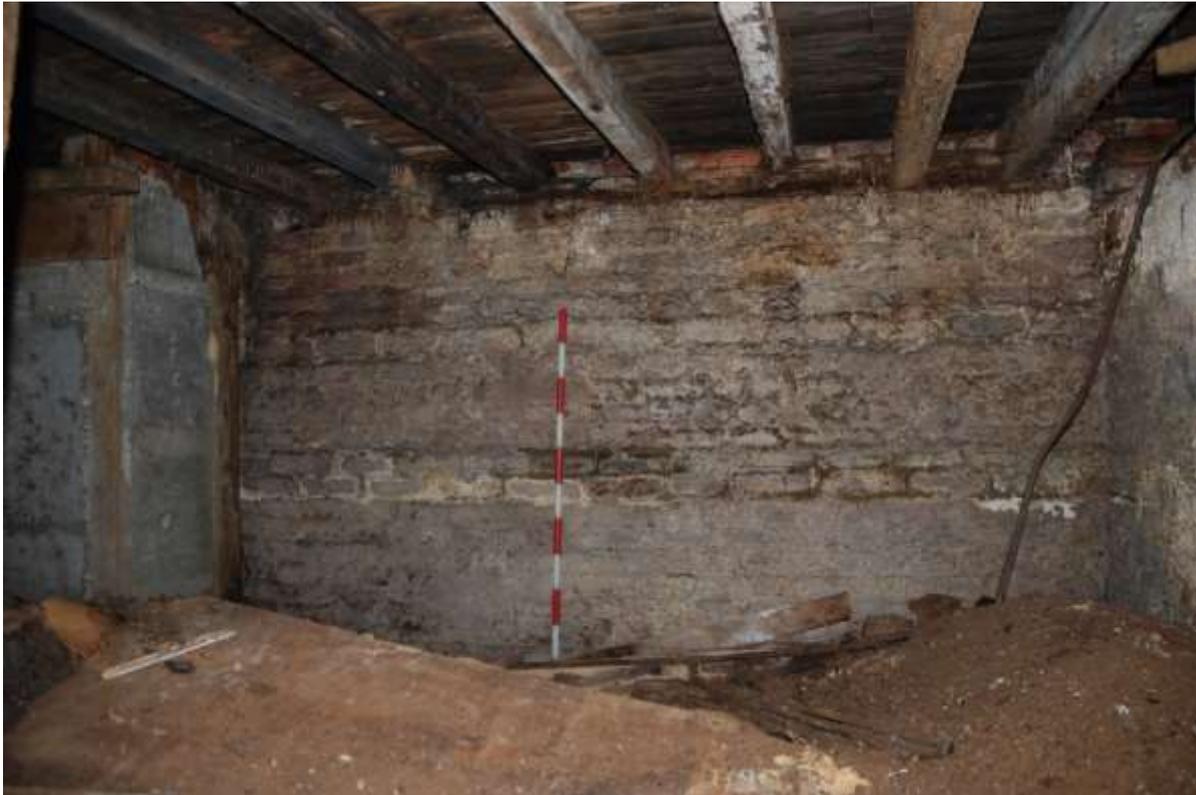
Fig.19: West wall of the cellar, facing WSW, 1m scale, concrete boiler base to left of frame

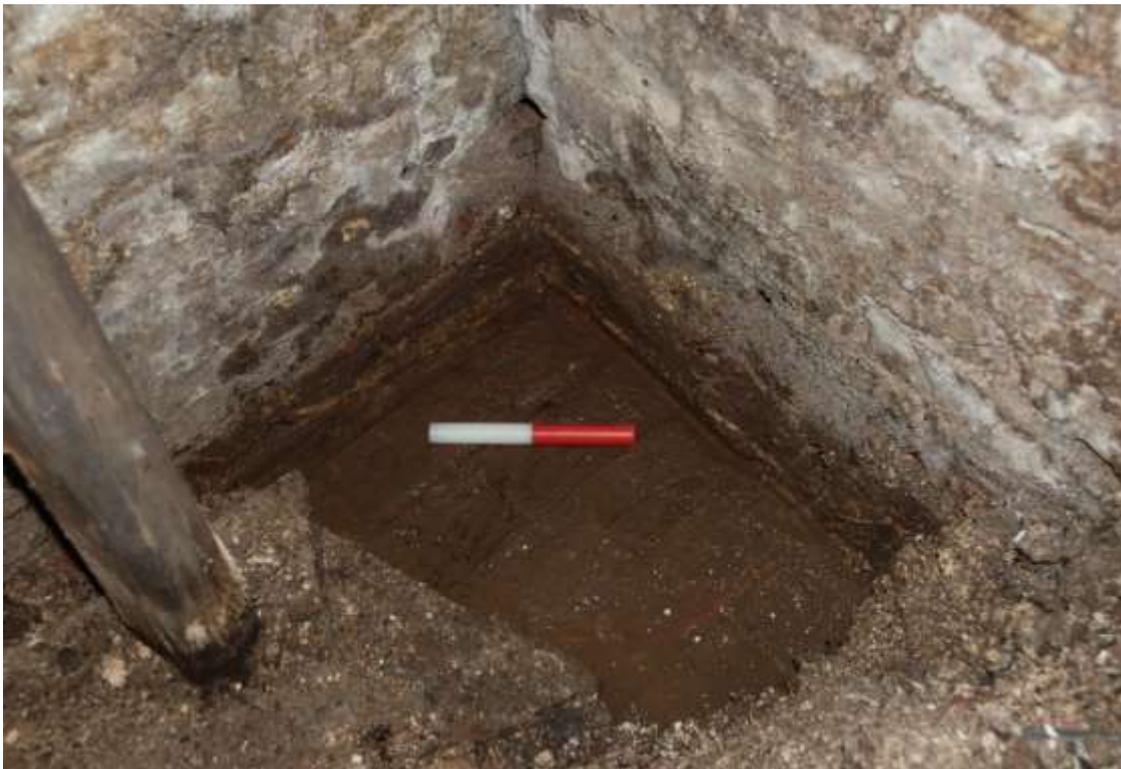
Fig.20: Exposed brick floor in SE corner, 0.20m scale

6.3.2.3 The floor of the cellar, as inferred above, was also brick-built with unfroged bricks dry-laid as a single course over natural gravels, (fig.20). The floor was only exposed in the southeast corner of the cellar below a considerable build-up of backfilled material.

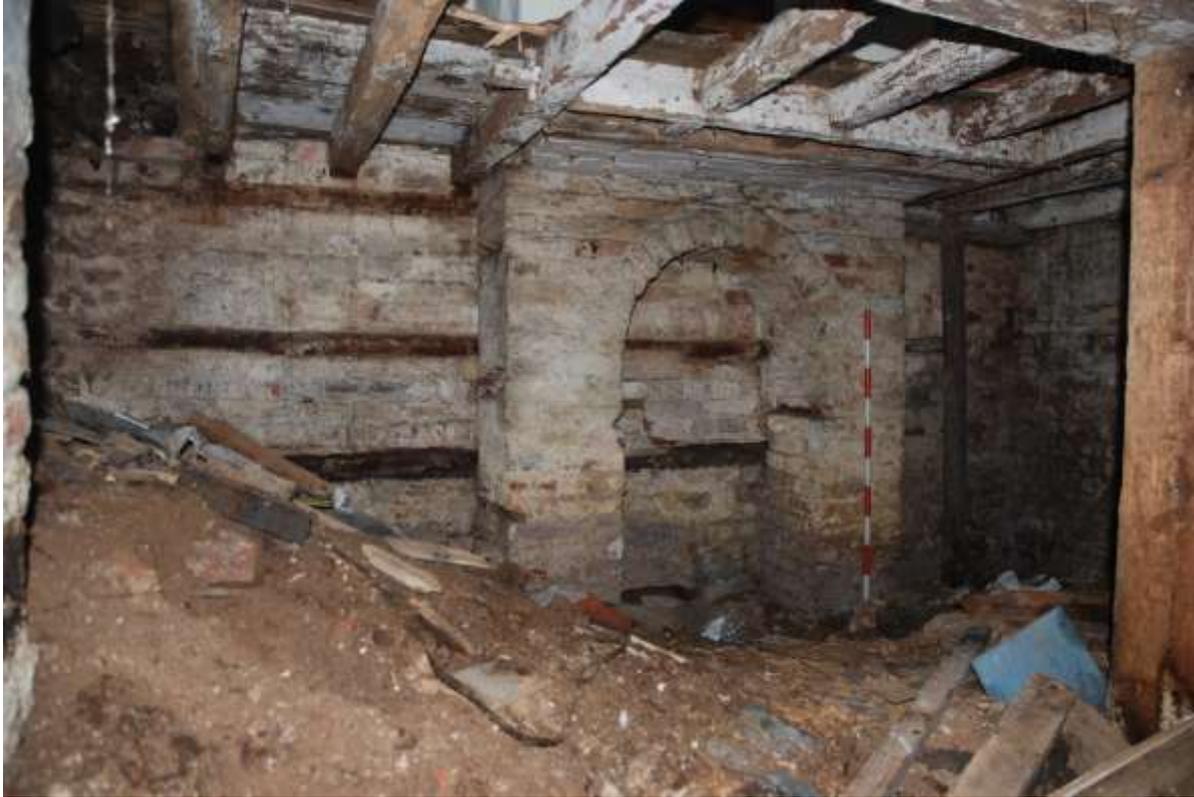
Fig.21: East wall of the cellar, facing SE, 1m scale. Note the brick support for the southern fireplace in room G1 above

6.3.2.4 Other features within the cellar included the supporting brickwork for the southern fireplace in Room G1 above. The brickwork was built up against the eastern wall, not bonded into the brickwork itself, and formed an arch with an external span of 1.43m, supported on columns projecting 0.35m into the cellar. The fact that the two elements were not bonded indicates the fireplace foundations are a later insertion.

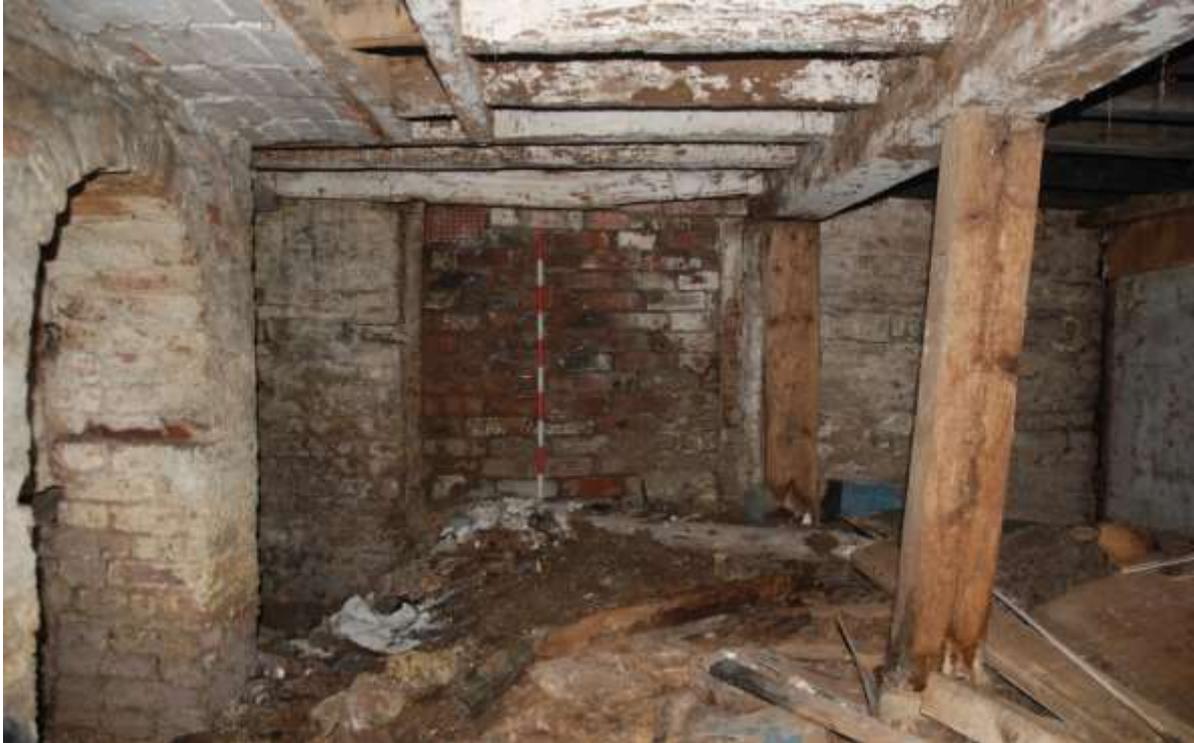
Fig.22: South wall facing S, showing the brick-up access point. 1m scale

6.3.2.5 The southern wall showed signs of once having been pierced by an earlier access point, 1.13m wide, with chamfered brickwork either side of the opening. This access point had later been blocked up with modern brickwork, including air-bricks to aid air circulation, (fig.22). This episode probably occurred simultaneously as a prerequisite to construction of the southern garage extension in the 1960s.

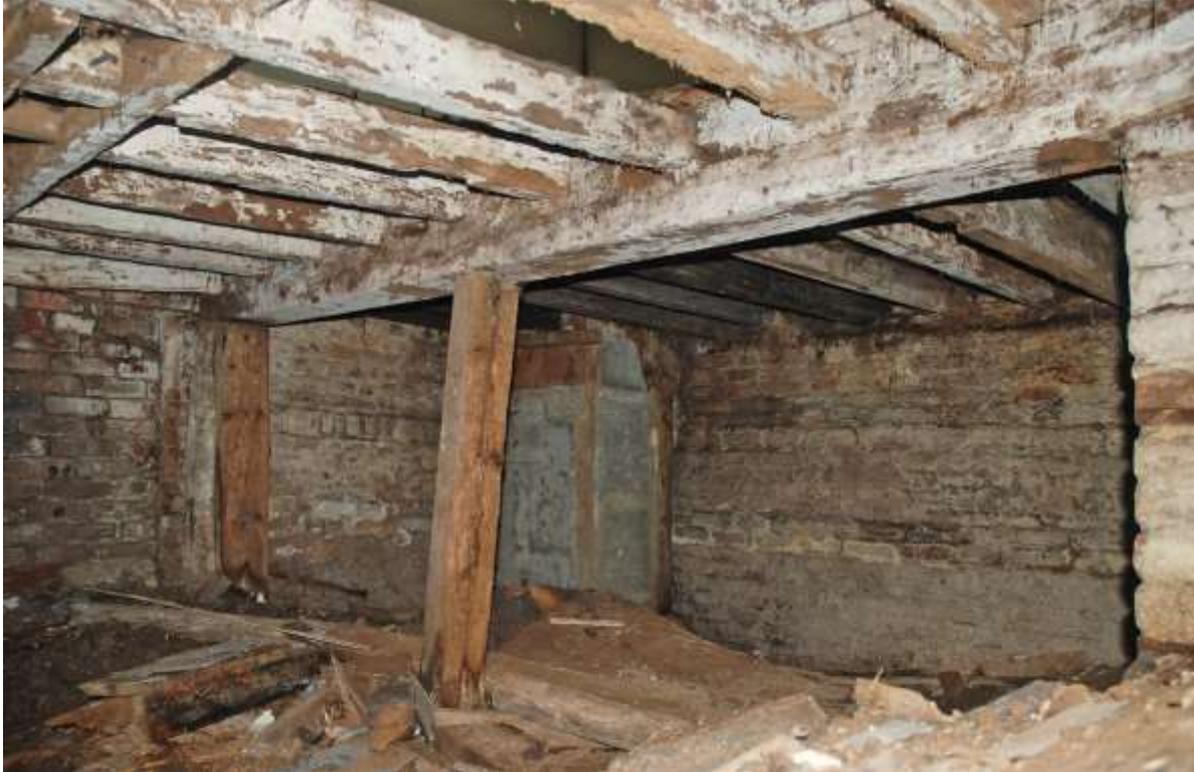
Fig.23: Southwest corner of the cellar showing concrete block base for boiler. Facing SW

6.3.2.6 A modern intrusion in the southwest corner of the cellar took the form of a rectangular block of solid concrete from floor to ceiling height, 0.54m (E-W) by 0.66m (N-S), which was interpreted as the base for a large, heavy boiler at ground floor level. The corners of the block showed signs of rotted out wooden supports for surrounding box work. The ceiling of the cellar in this corner and floor in the room above had been broken through to allow construction of the block.

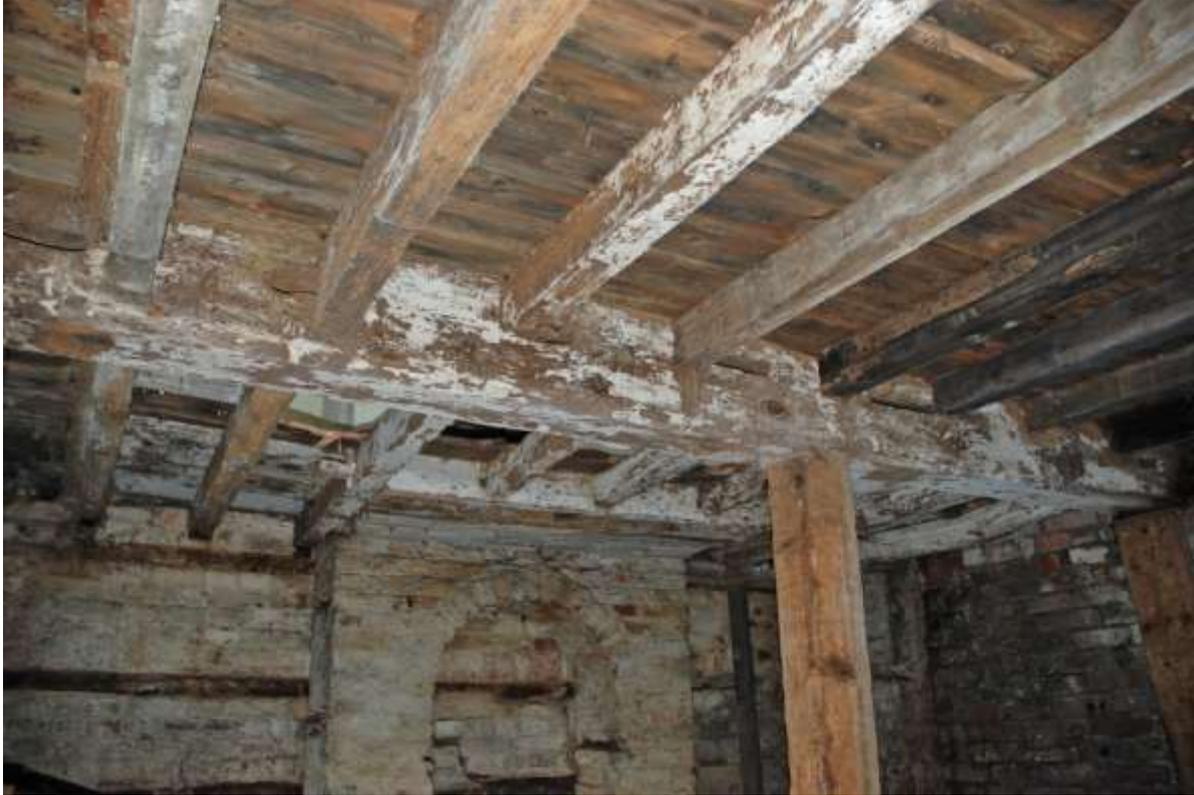
6.3.2.7 The ceiling of the cellar was largely of modern construction with machine cut wooden joists and floorboards, although there main E-W beam was of earlier date, with empty mortices where the original floor joists would have sat. The height from floor to the underside of the joists was 1.60m in the southeast corner and 1.83m along the east side, two-courses higher from east to west.

Fig.24: Detail of the cellar ceiling. Facing towards the SE corner. Note the earlier beam with empty mortices compared to the extant modern, machine cut joists and boards

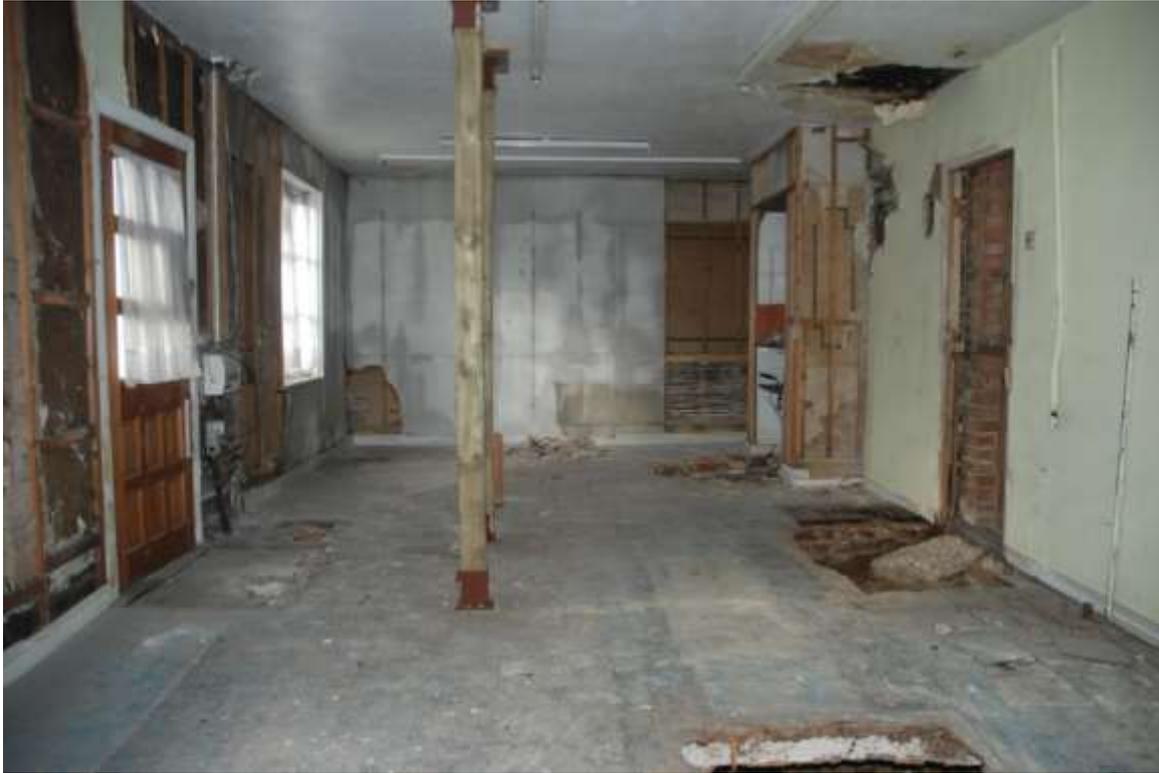
6.3.3.1.1 The front room of the property at the time of survey was a large, open-plan space measuring 8.85m long, (N-S), by 4.01 to 4.11m wide, (E-W), being wider in the south compared to the north. The floor to ceiling height was approximately 2.48m.

Fig.26: Room G1 facing N, front door to left of frame, holes to cellar in floor

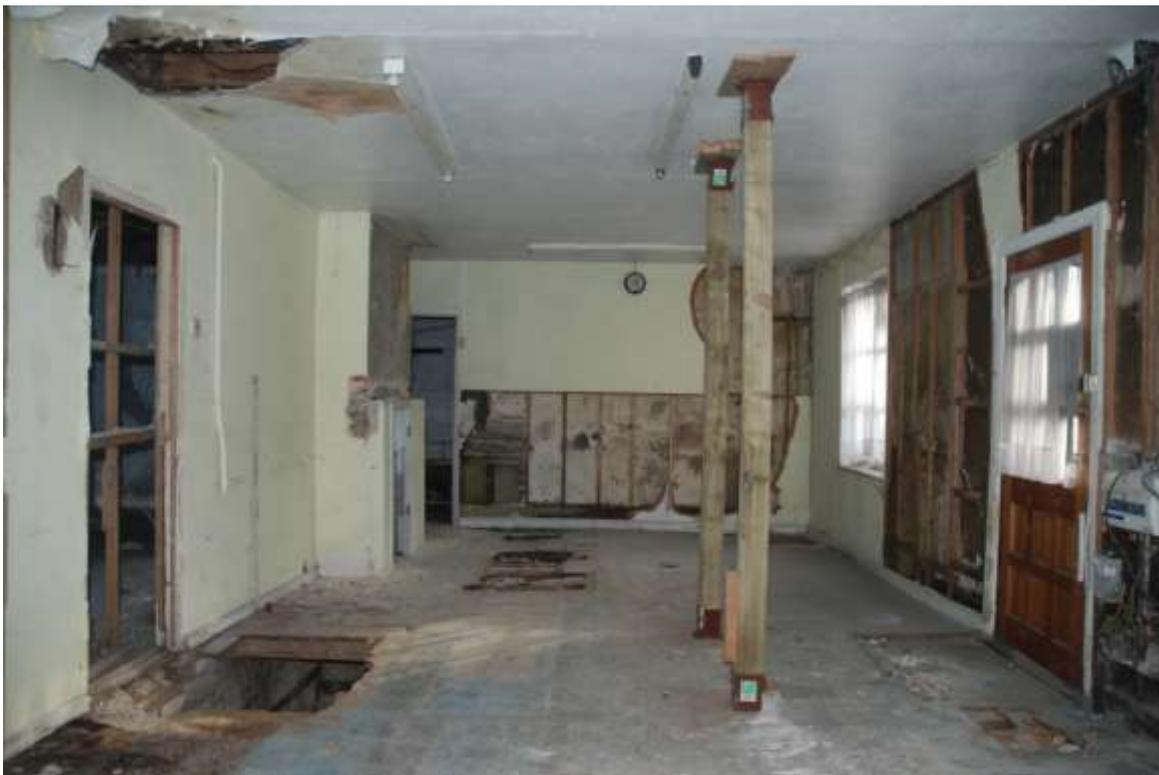
Fig.27: Room G1 facing S, eastern cellar walls just visible in left foreground. 'Scars' of former hallway walls also visible as slightly raised lines in the ceiling
