**LEVEL 2 HISTORIC BUILDING RECORD &
TRIAL TRENCHING
ON THE SITE OF THE FORMER 'RETREAT',
MARKET PLACE, ABRIDGE,
ESSEX, RM4 1UA**

LEVEL 2 HISTORIC BUILDING RECORD &
TRIAL TRENCHING
ON THE SITE OF THE FORMER 'RETREAT',
MARKET PLACE, ABRIDGE,
ESSEX, RM4 1UA

Principal Author: James Aaronson
with contributions from
Geoff Potter and Miranda Fulbright

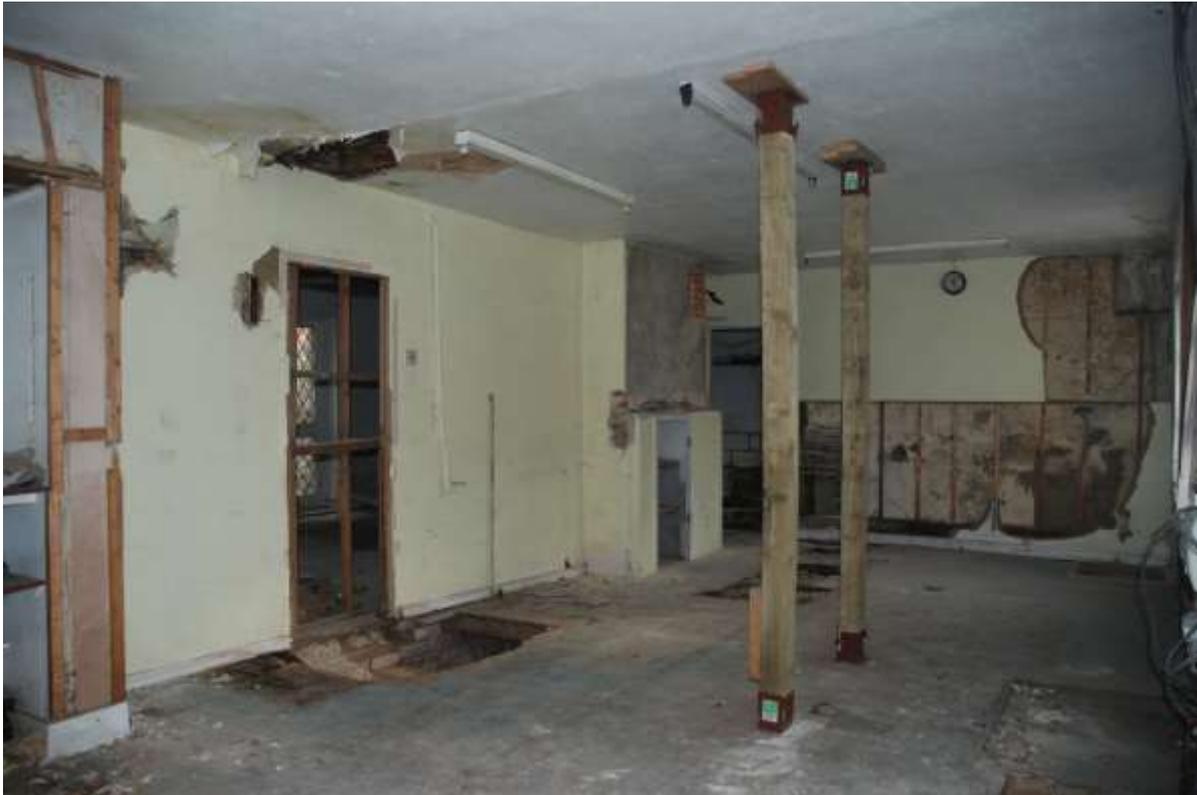
Fig.28: Room G1, facing SE, showing north fireplace / cupboard in left of frame. Southern fireplace / cupboard in background. View down into cellar and into back room in centre

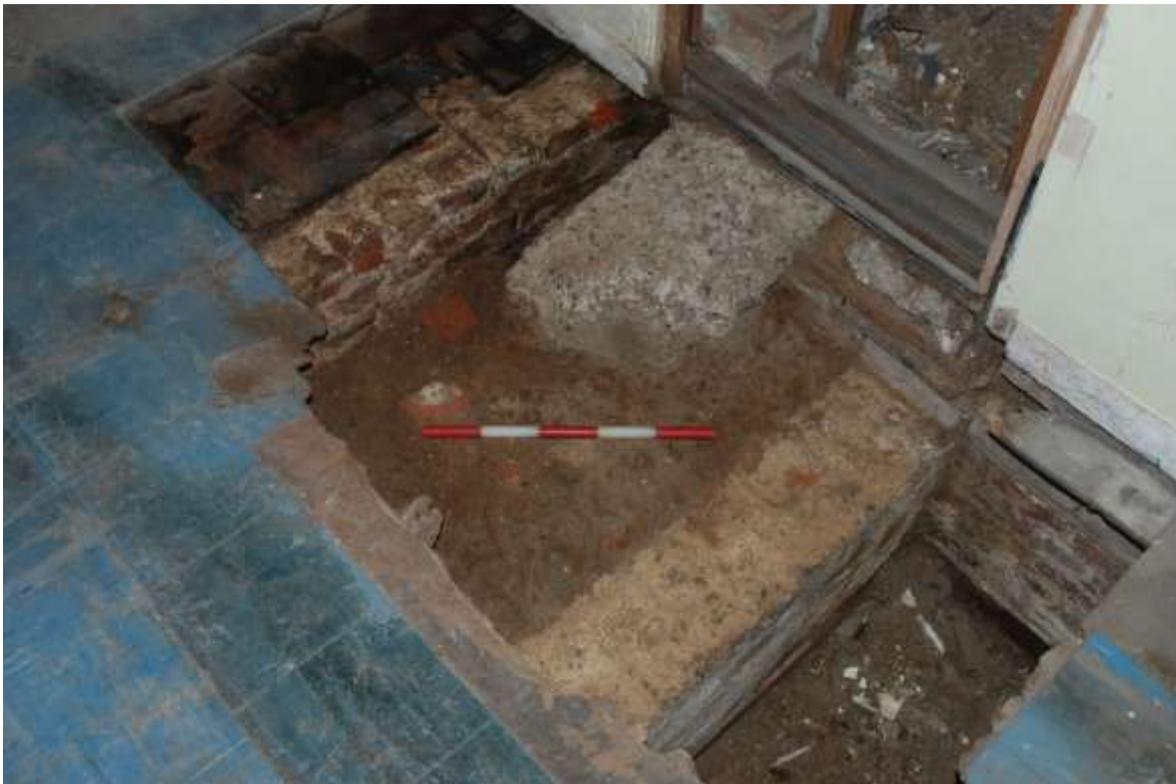
6.3.3.1.3 The central hallway was represented by a wall footing exposed north of the extant cellar entrance lining up with ‘scars’ of former walls visible in the ceiling, and in the western wall of the room, (figs.29 and 30). A corresponding southern ‘scar’ was also visible representing the southern extent of the hallway. The line of the southern side of the hallway mirrored the main northern wall of the cellar, meaning that the small projection in the northeast corner of the cellar probably represents an access point to the cellar from the hallway, perhaps via some form of trapdoor no longer existing. The hallway would have measured 1.76m wide, (N-S), by 4.05m long, (E-W).

Fig.30: Northeast corner of cellar in foreground and northern footing of central hallway in background. Facing NE, 0.5m scale

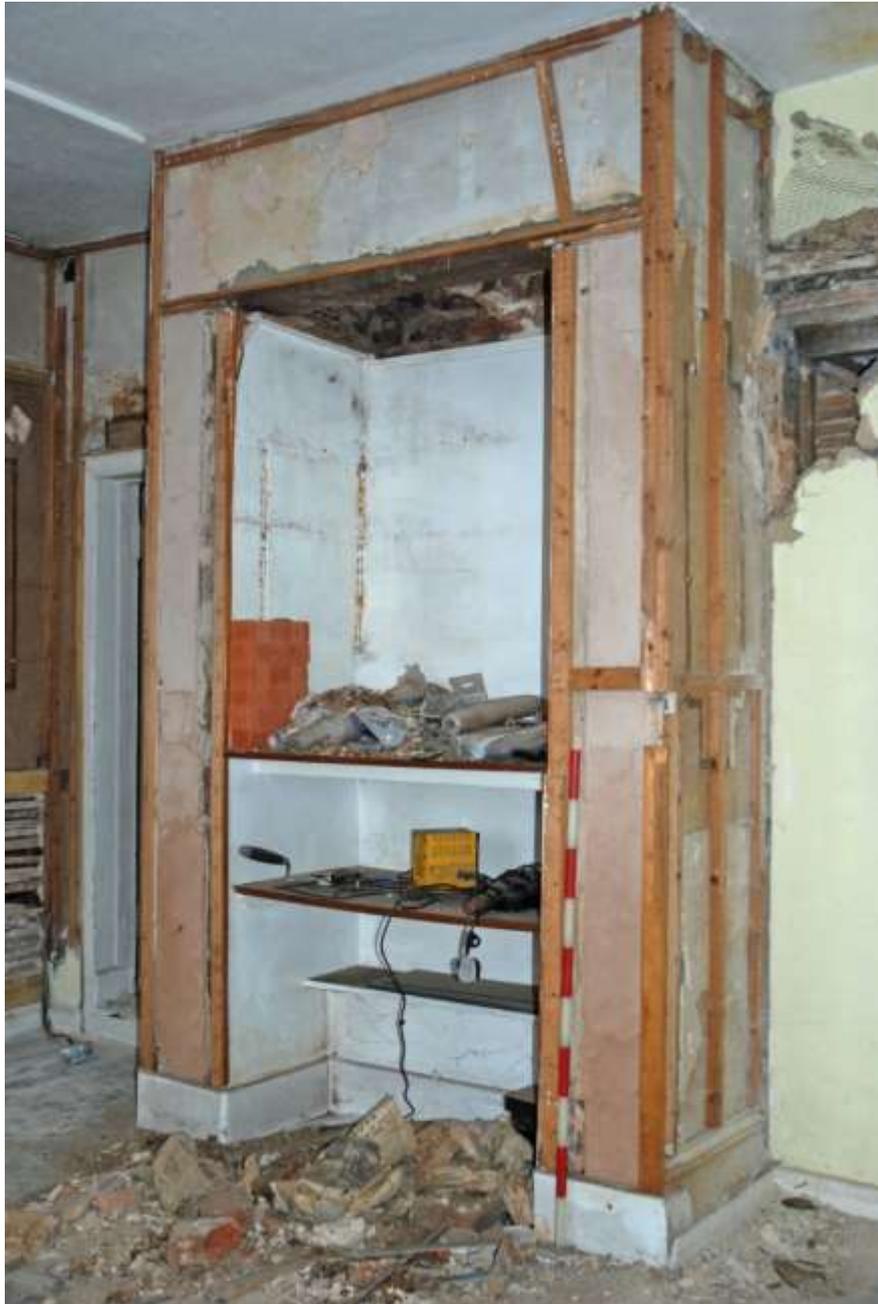
6.3.3.1.4 The room to the north of the hallway would have measured 3.44m wide, (N-S), by 4.01m (E-W). A centrally placed window pierced the west wall, measuring 1.16m wide by 1.48m high. A fireplace in the centre of the eastern wall had been partially converted into a cupboard space with the lower part of the chimney stack / overmantle and the mantelpiece removed. The chimney stack / flue survived in the ceiling of the cupboard, as a double flue; the southern of which was blocked by brick rubble, whilst the northern was still open and retaining evidence of thick sooting, (fig.33). Bricks from the structure of the chimney and wall base suggest a 17th to 18th century date, but are likely to have been re-used⁵. A door in the northeast corner of the room led to the rear rooms of the original property.

Fig.32: Former fireplace in northeastern corner of room G1, facing NE, 1m scale

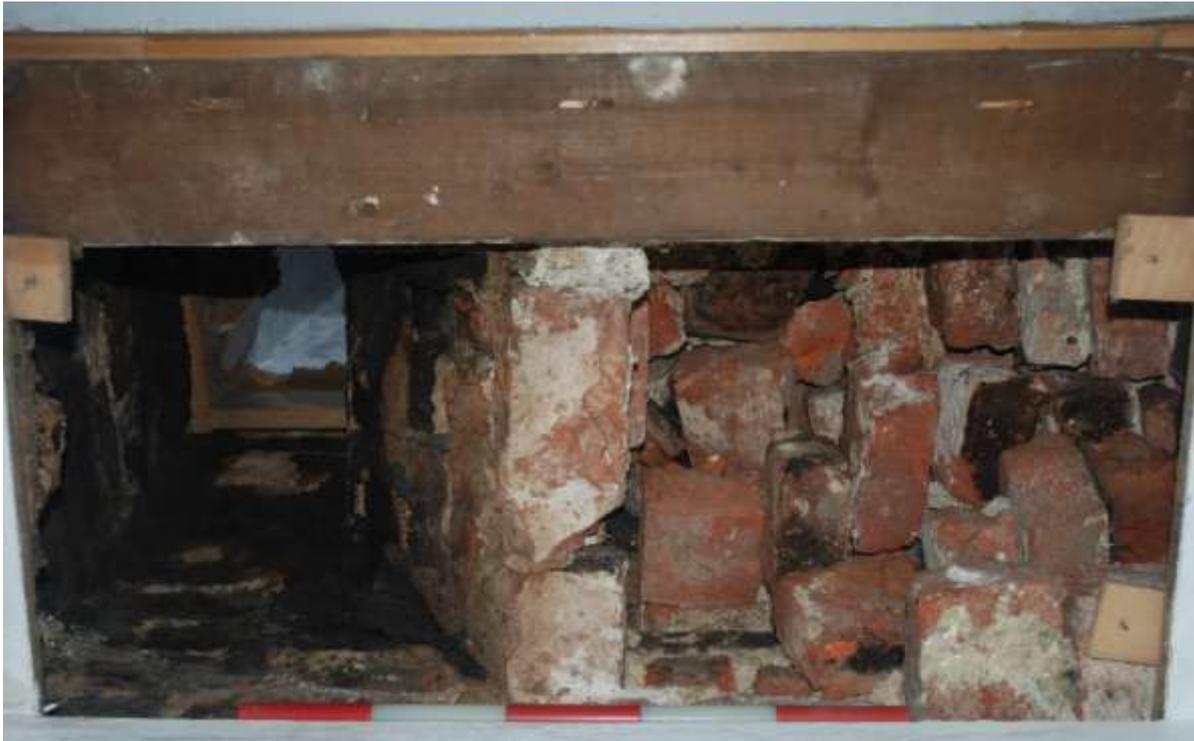
Fig.33: Interior of former flue above fireplace in the northeastern corner of room G1. North to left of frame. 0.50m scale

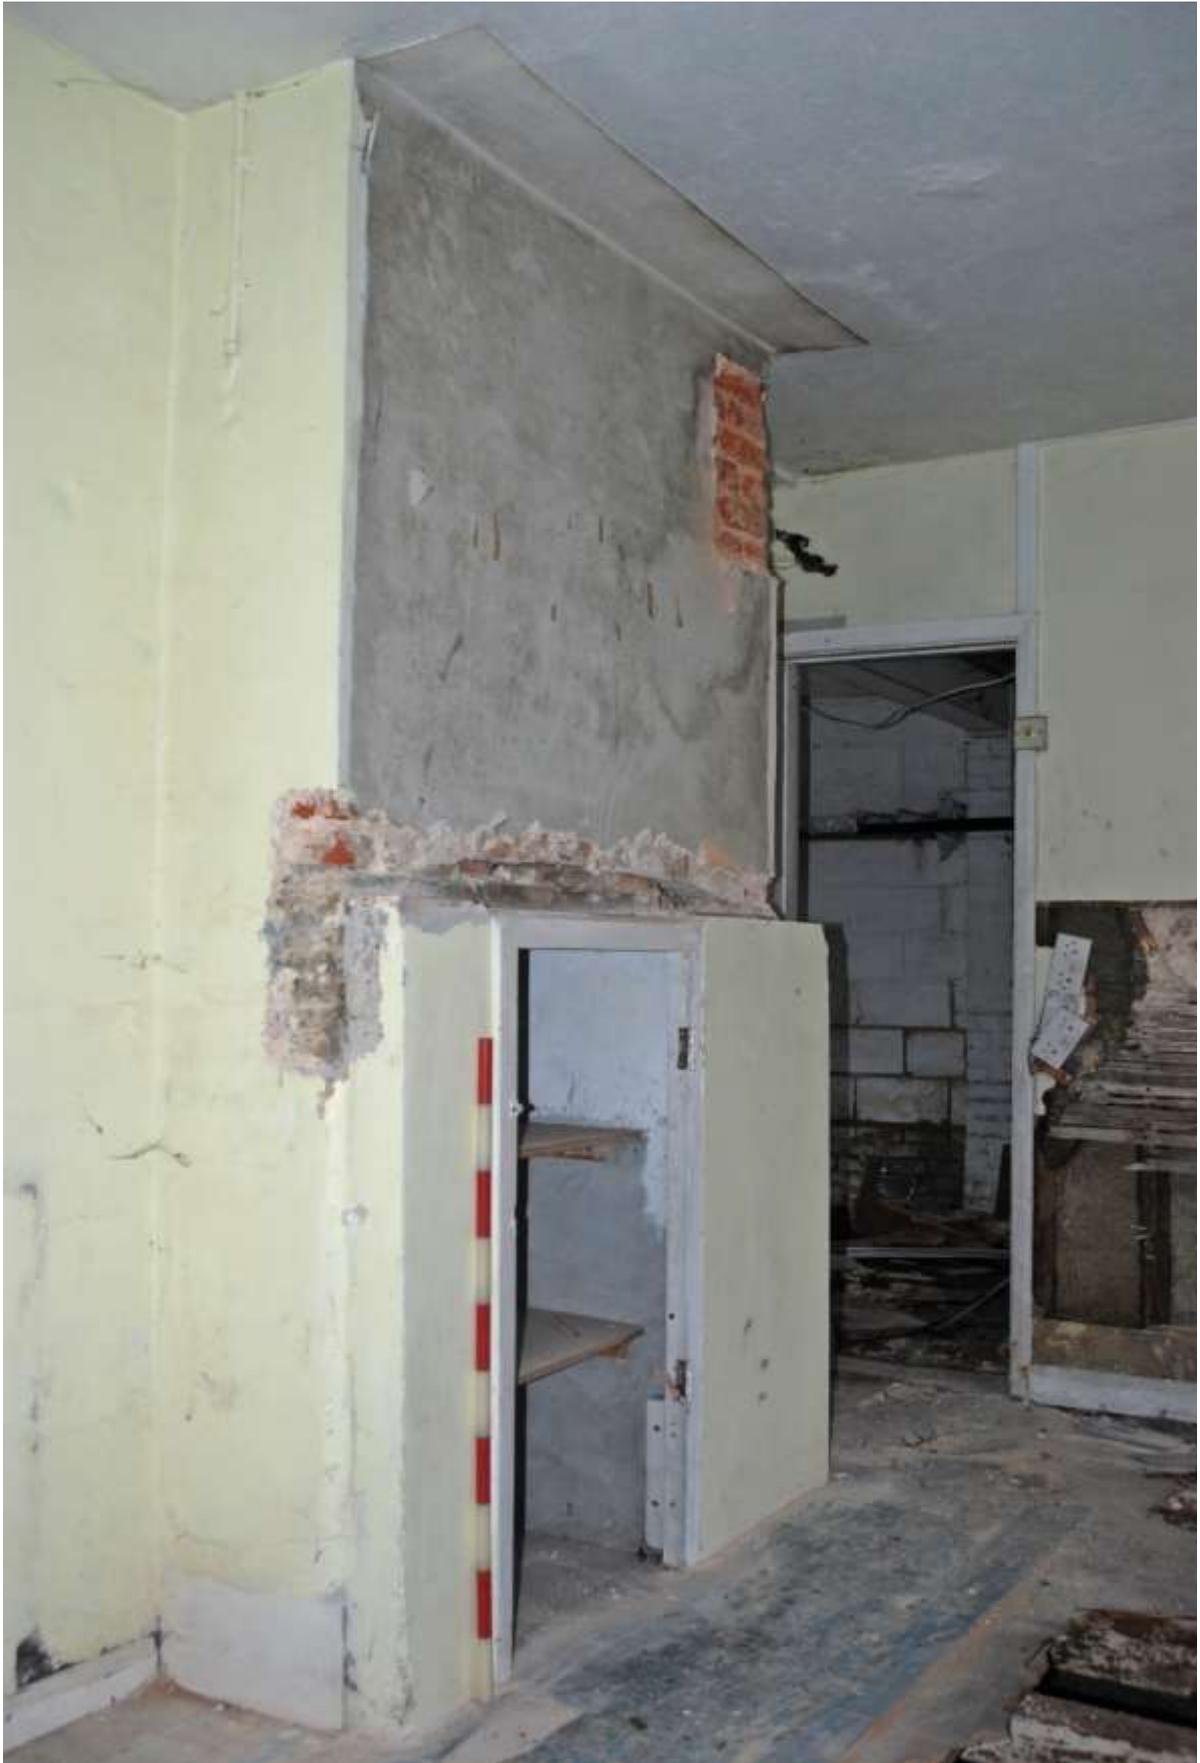
Fig.34: Former fireplace in the southeast corner of room G1, since converted into a cupboard and safe, facing SE, 1m scale. Note the exposed original brickwork in the upper portion.

6.3.3.1.5 The original southern room would have been 3.33m wide, (N-S), by 4.11m long, (E-W). Like the northern room, a centrally placed window pierced the western wall, and measured 1.16m wide by 1.48m high. The centrally located fireplace in the eastern wall had its firebox partially blocked and a small cupboard created. The southern side of the surrounding structure had been used to house a safe, probably when the property served as the local shop / post office, bearing the makers plate; ‘Thomas Wastell, Maker, 341 Kingsland Road, London’, (figs.35 and 36). It appears that Thomas was listed in the 1871 census. The southwest corner of the room housed the metal floorplate for a boiler, fixed to the concrete block seen in the cellar, (see **6.3.2.6**).

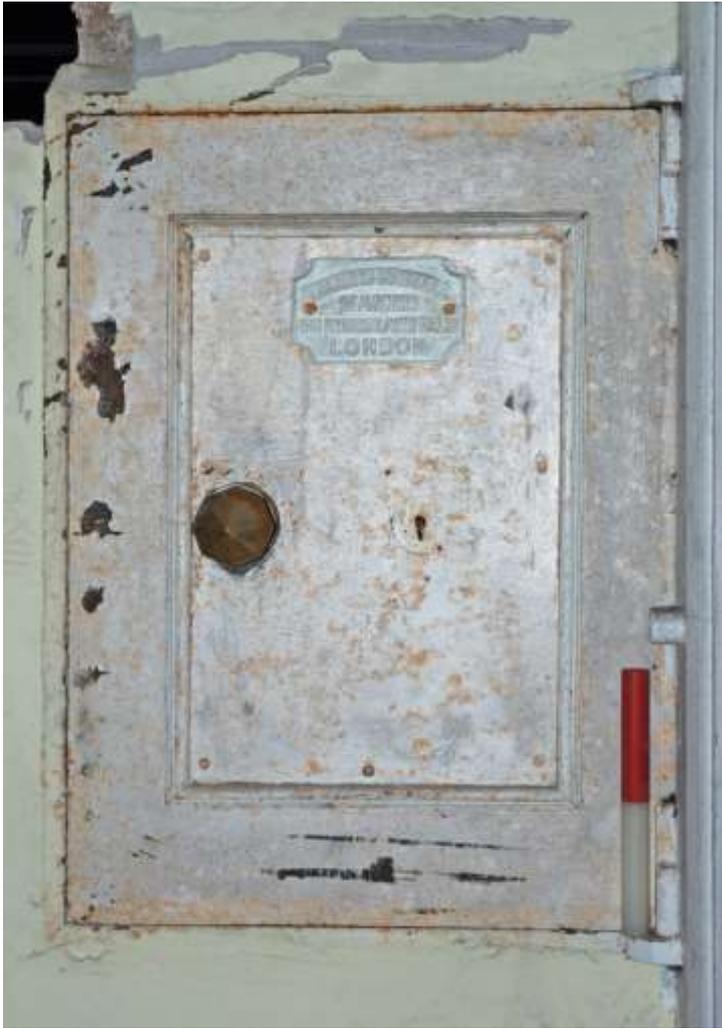
Fig.35: Safe built into the southern face of the fireplace in south of room G1, facing N, 0.20m scale

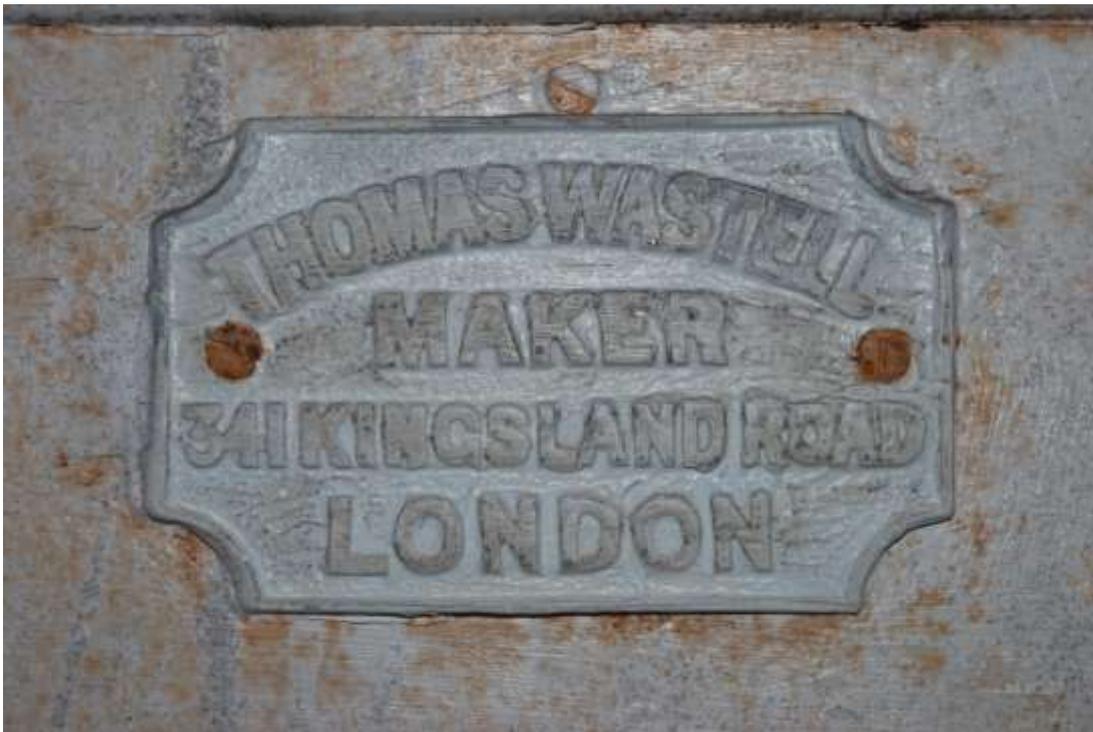
Fig.36: Makers plate of Thomas Wastell on the door of the safe built into the southeastern fireplace

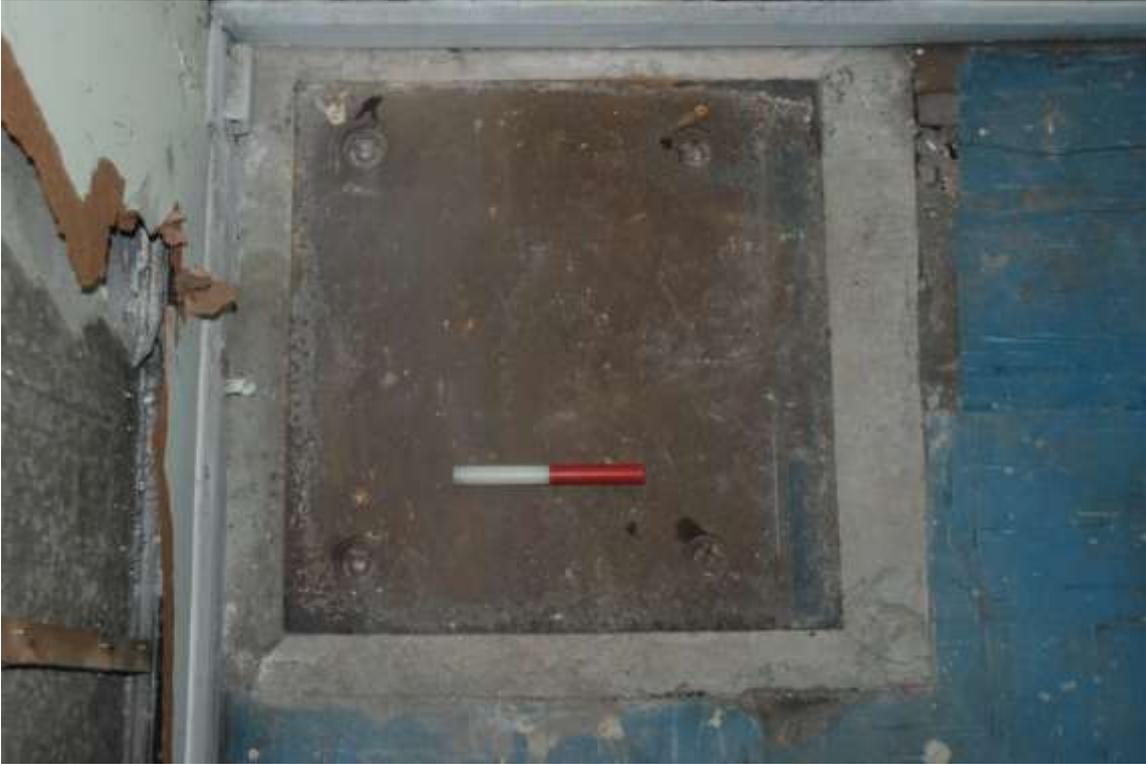
Fig.37: Floorplate for the boiler in the southwest corner of room G1, facing W, 0.20m scale

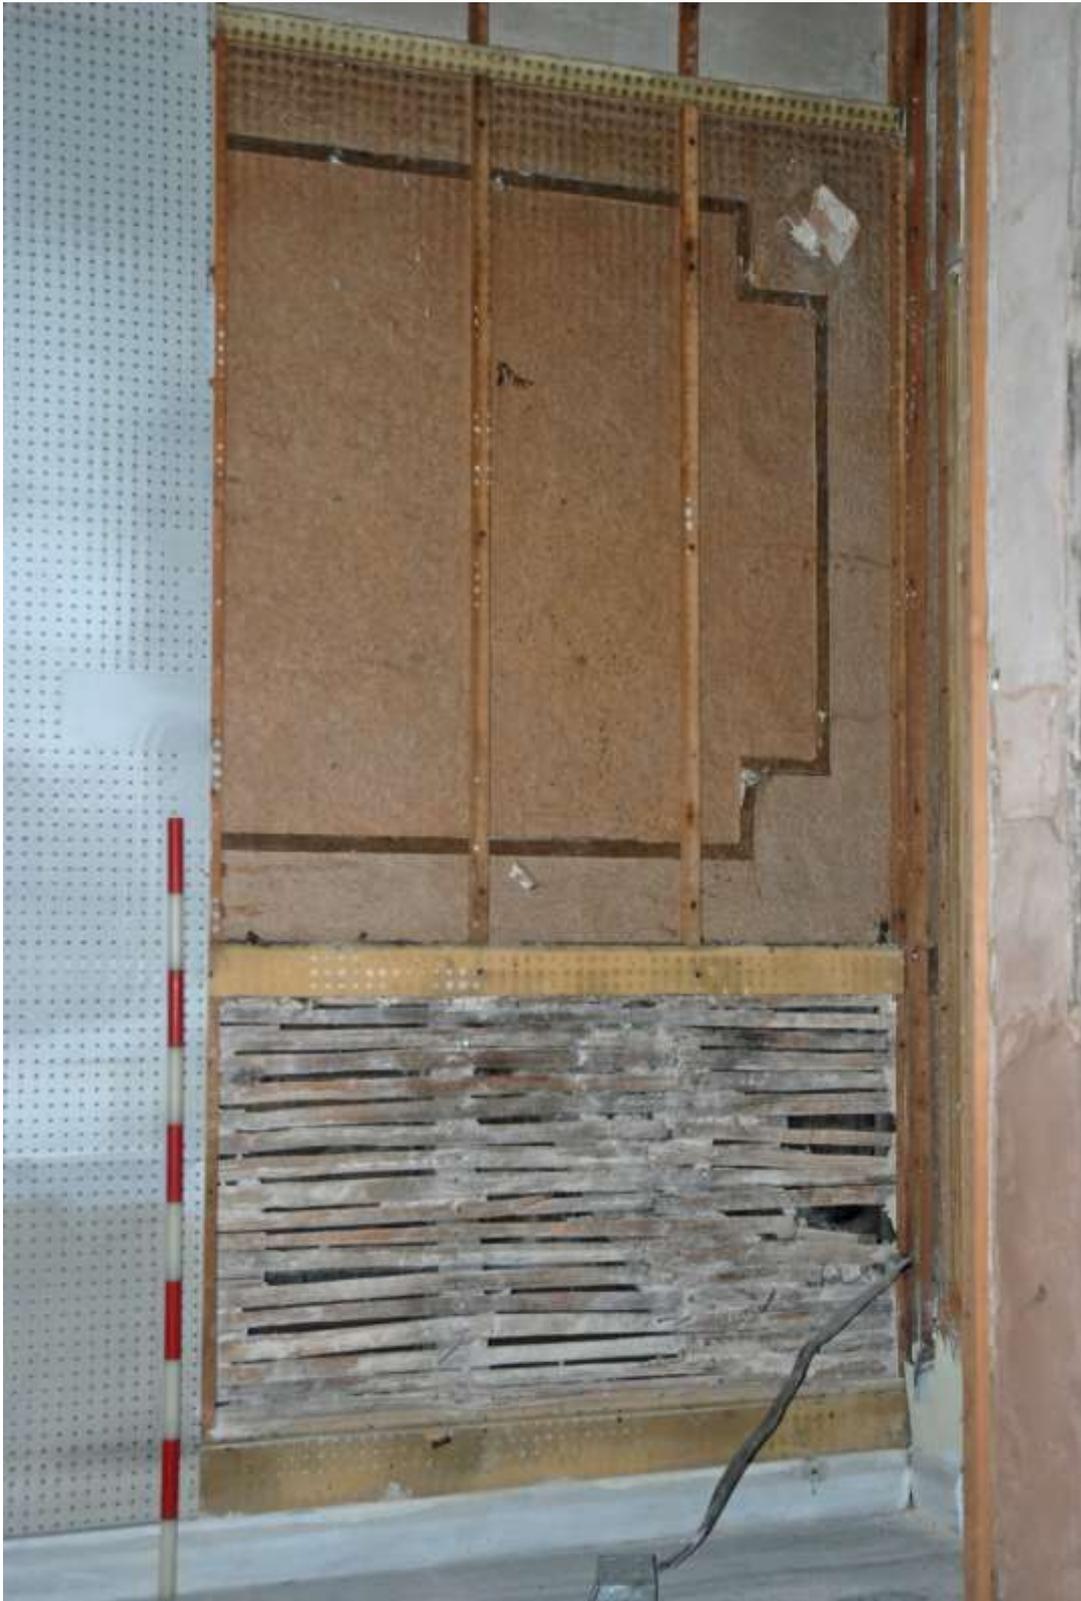
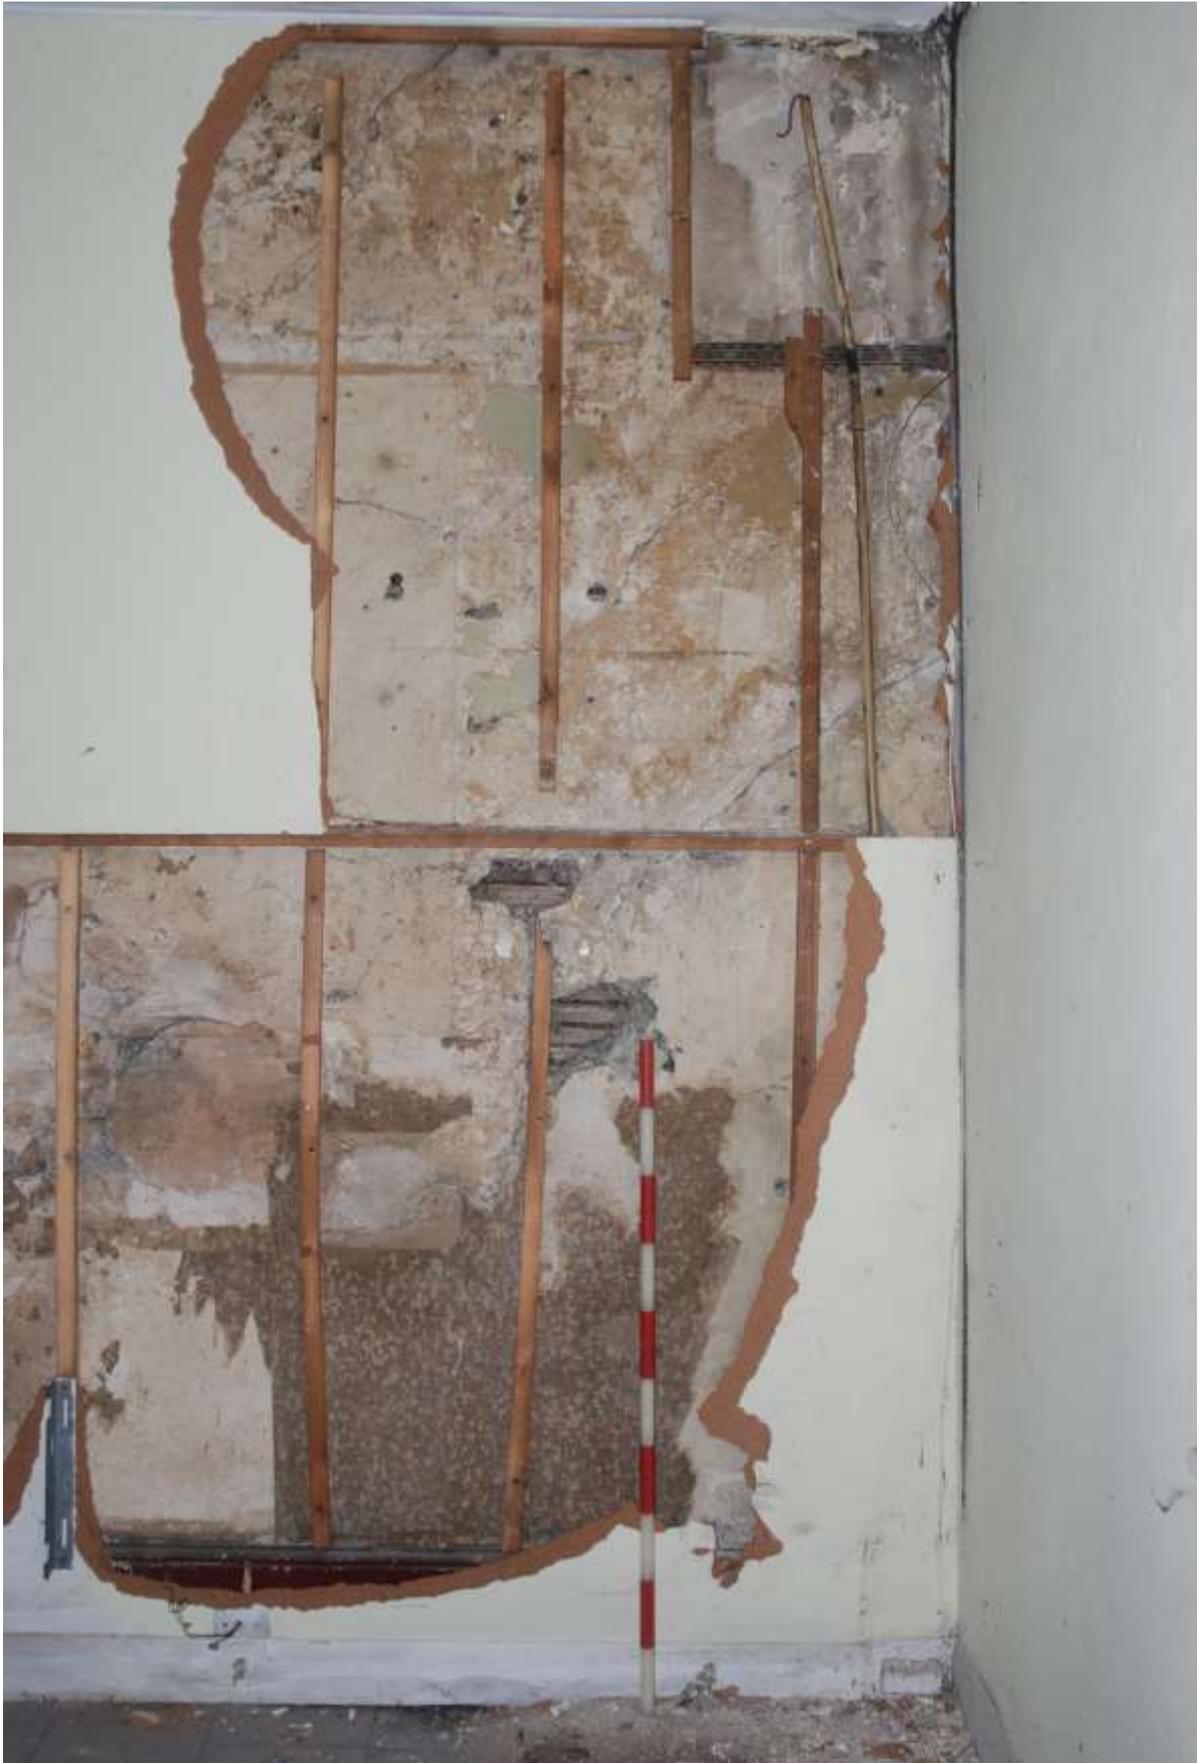
6.3.3.1.6 The walls of the room were timber-framed with panelling of lath and plaster, later covered by modern plasterboard. Details of previous decorative schemes survived behind the panels, (figs.38 and 39).

Fig.38: Northeast corner of room G1, facing N, 1m scale. Detail of former decorative schemes and lath and plasterwork construction visible

Fig.39: Southwest corner of room G1, facing SSE, 1m scale. Detail of former decorative schemes and lath and plaster construction

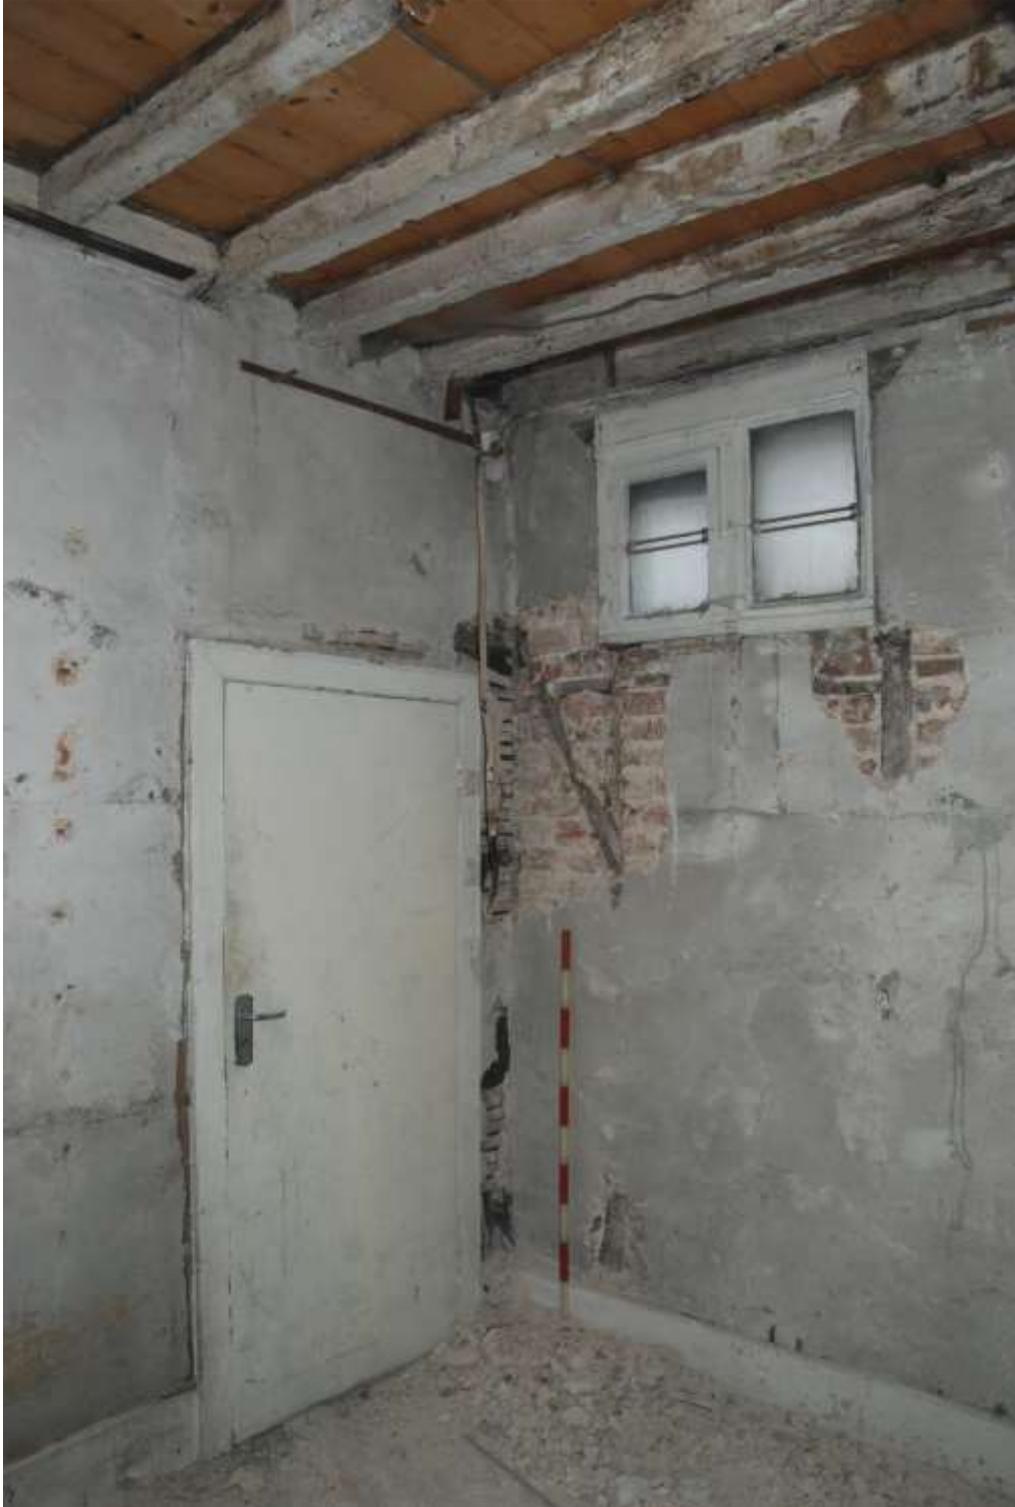
6.3.3.2.1 Leading off of the northeast corner of room G1 was a rectangular room; 2.37m wide, (N-S), by 1.95m long, (E-W), with a floor to ceiling joist height of 2.43m. The northwestern wall was pierced by a high level window 0.74m wide and 0.60m high.

Fig.40: Room G2 facing NW, 1m scale

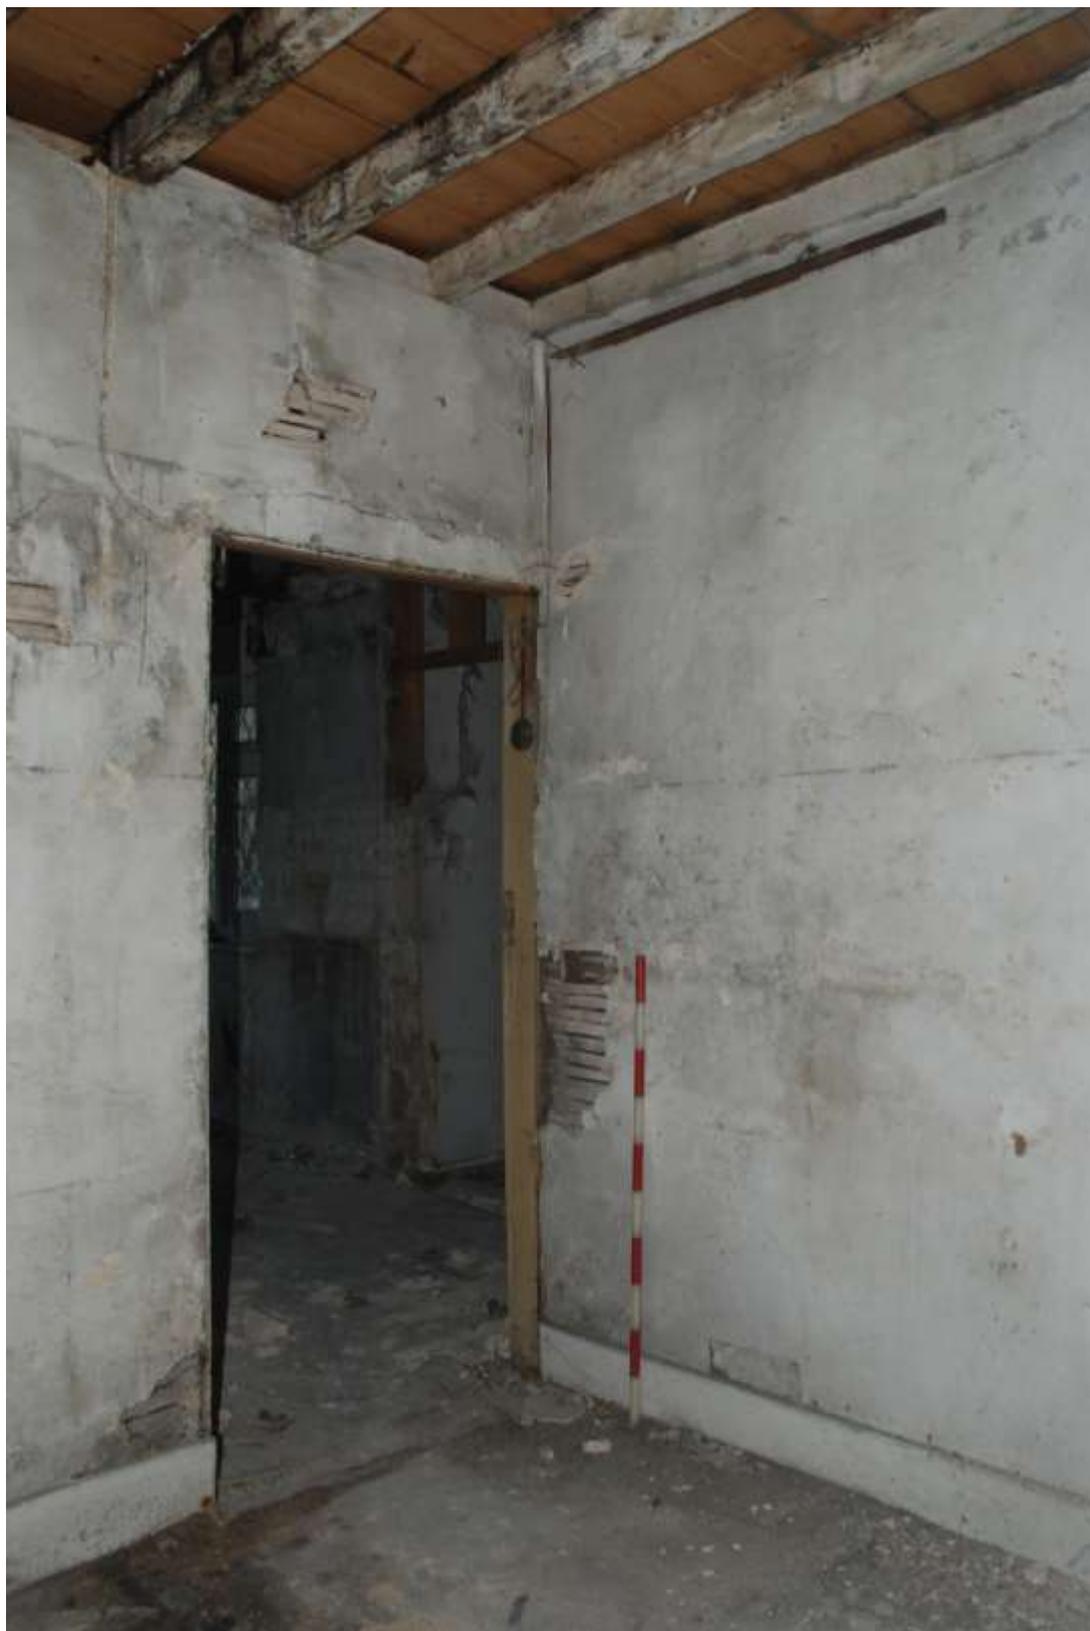
6.3.3.2.2 The door from room G1 opened in the northwest corner of G2 and a second door opened in the southeastern corner of the G2 into room G4 at the rear of the property.

Fig.41: Room G2 facing SE with room G4 beyond, 1m scale

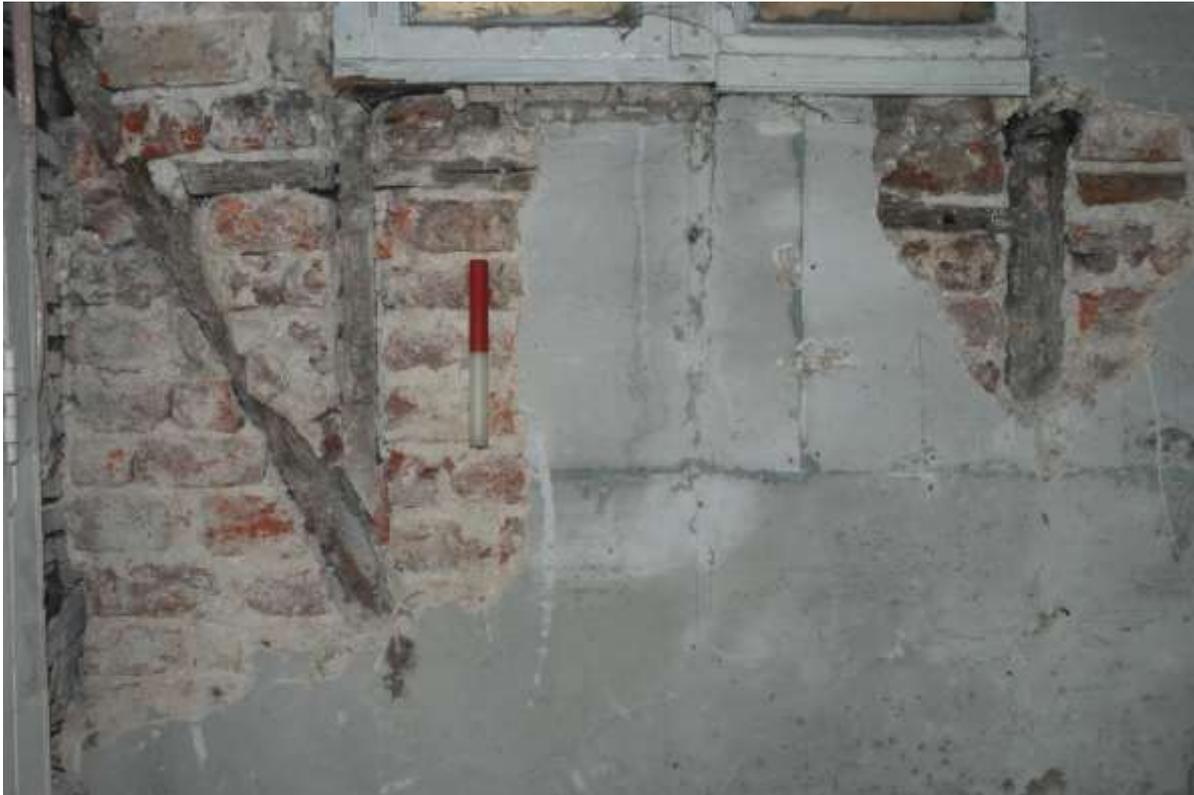
6.3.3.2.4 The northern wall of G2 abutted and directly overlay the lath and plasterwork of the western wall, as seen in the NW corner of the room, (fig.42). The wall was built of brickwork infill within a timber frame, with the brickwork crudely fitted and bonded with a liberally applied lime-mortar, (fig.43). The internal face had then been given a plaster finish, which continued east; beyond the confines of the room and into room G4, (fig.44).

Fig.43: *Detail of north wall showing timber framework, brick infill and plaster finish. 0.20m scale*

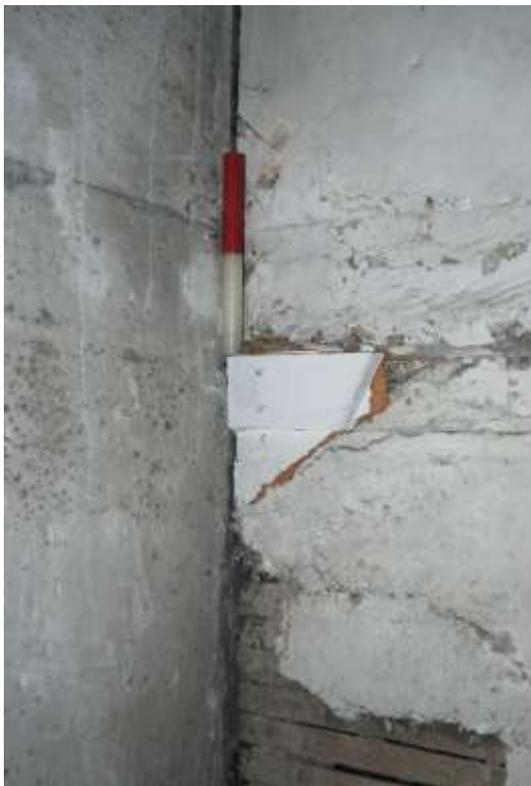
6.3.3.2.5 The plasterwork of the northern wall was therefore abutted / overlain by the eastern wall, (fig.44), which was of lath and plaster construction and appeared to be part of the same build as the southern wall, which was also of lath and plaster, and abutted the brickwork if the western wall.

Fig.44: *Northeast corner of room G2, facing NE, 0.20m scale. Note gap between abutting east wall and plasterwork of north wall continuing beyond into room G4*

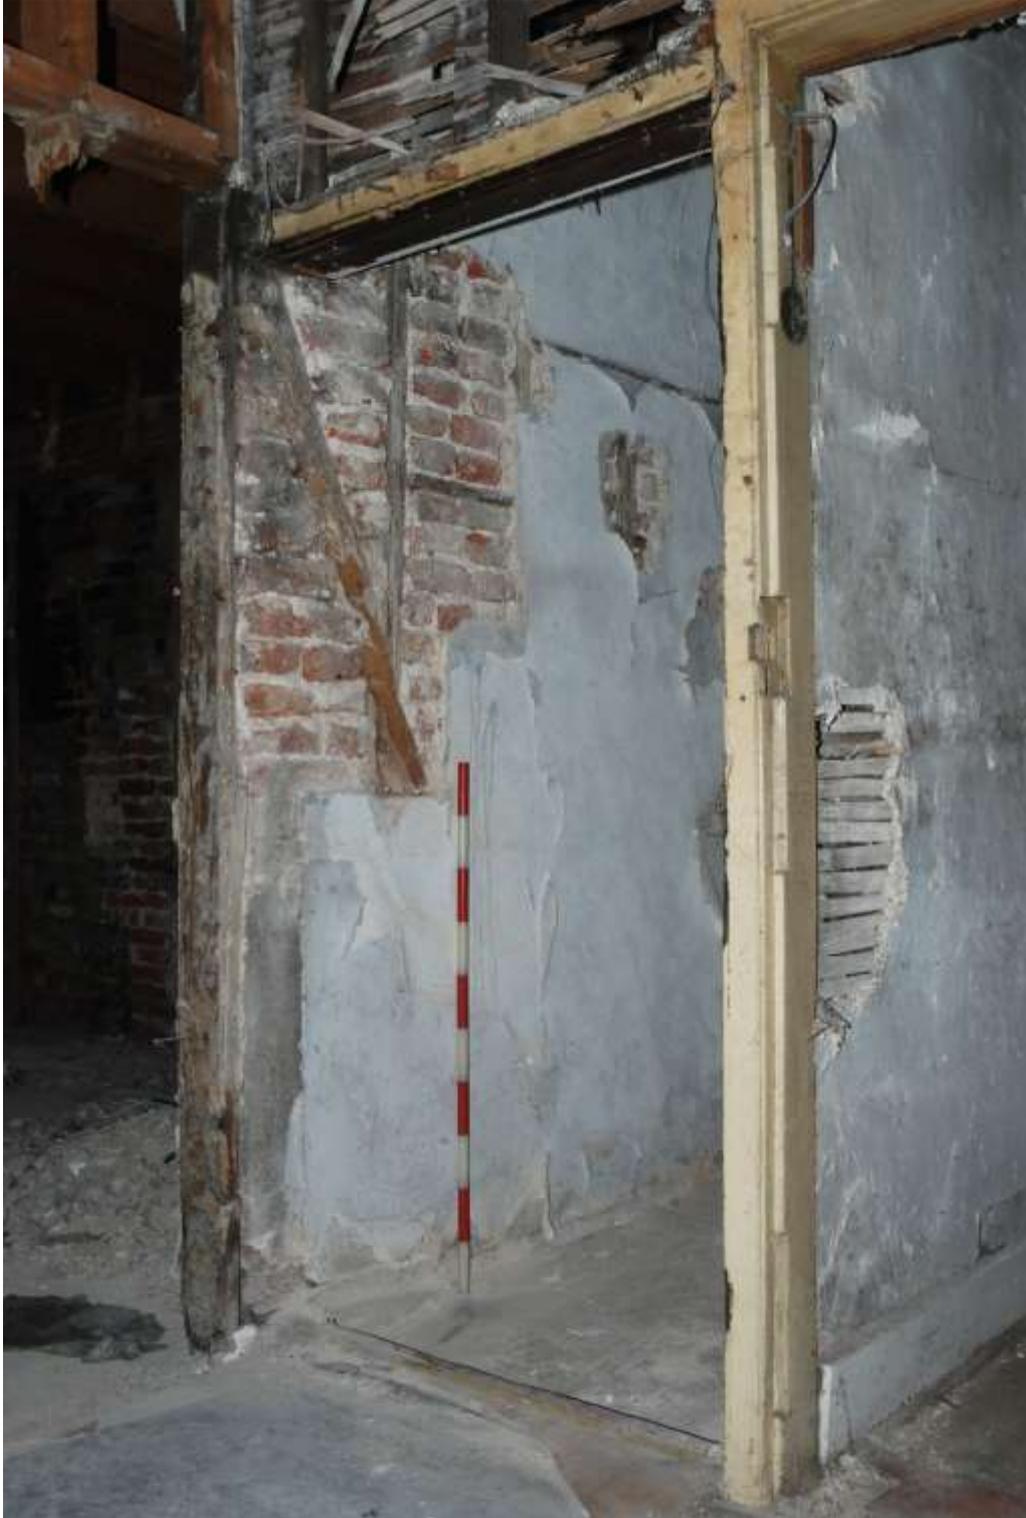
6.3.3.3.1 Room G3 was a small cupboard space created by the addition of the northern and southern walls to the original external, (easternmost), face of G1. The space created measured 0.87m wide, (N-S), by 2.10m long, (E-W). Height from floor to underside of ceiling joists measured 2.51m.

Fig.46: Room G3, facing SW, 1m scale

6.3.3.3.2 The northern wall was provided by the southern wall of room G2 to the north, and was of lath and plaster over a timber frame abutting the brickwork of G1. The southern wall was similar in form and construction technique as the northern wall of G2, namely of a timber frame infilled with bricks, (fig.46). For this reason it is believed to have been contiguous to the said northern wall in rooms G2 and G4, and the two walls perhaps once formed a much larger rear room of a single build, which was later subdivided by the construction of the lath and plaster walls.

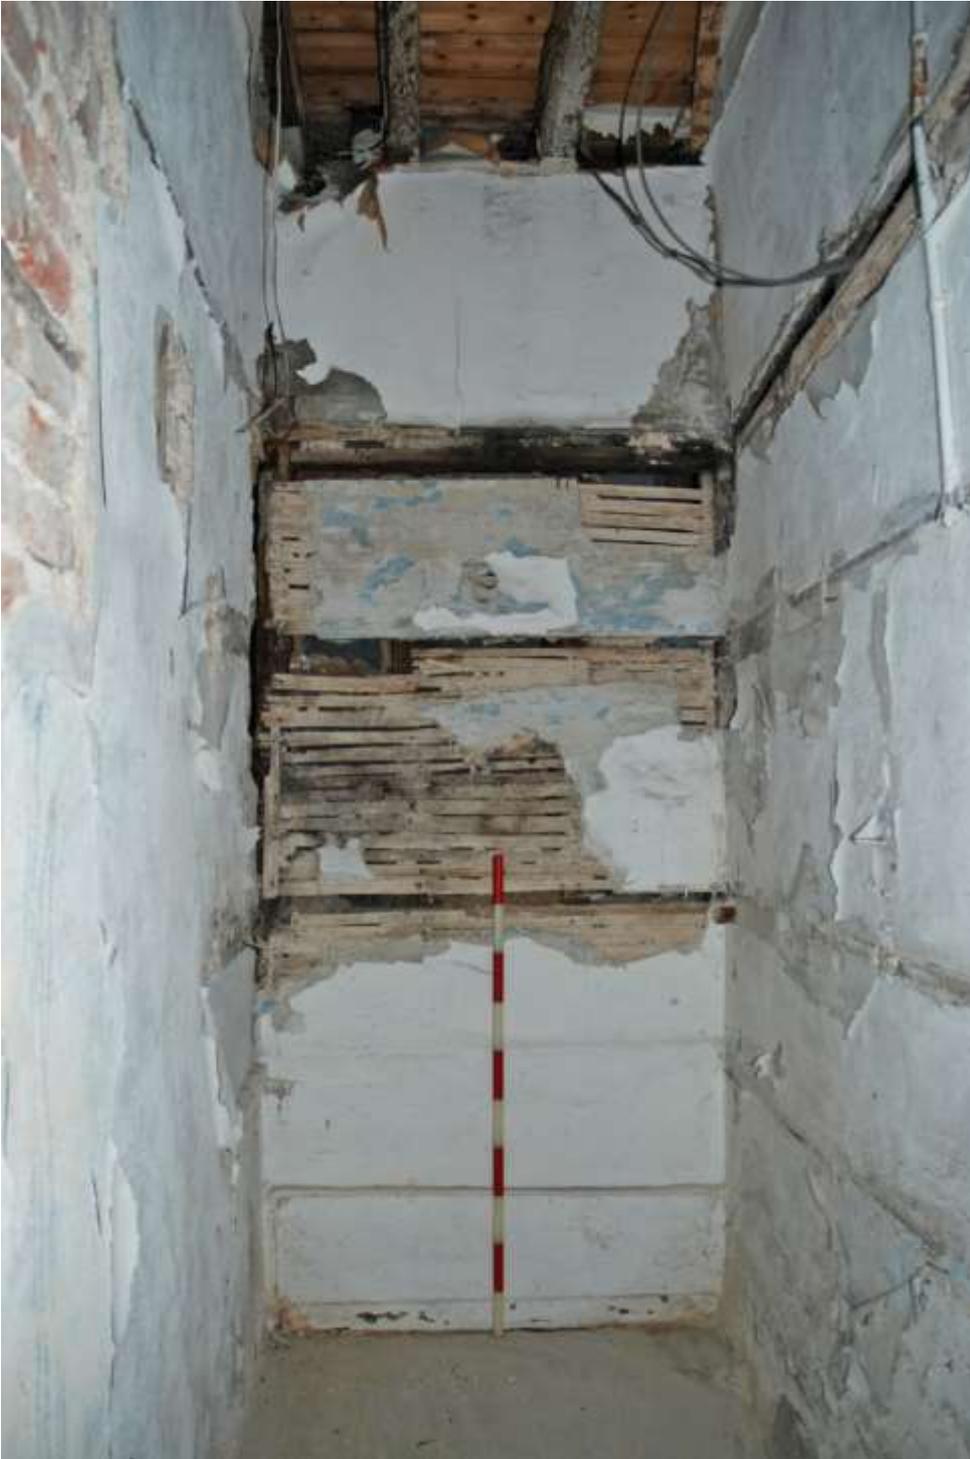
Fig.47: Cupboard room G3, facing W, 1m scale. Note the lath and plaster construction of the west and north walls and timber / brickwork of southern wall

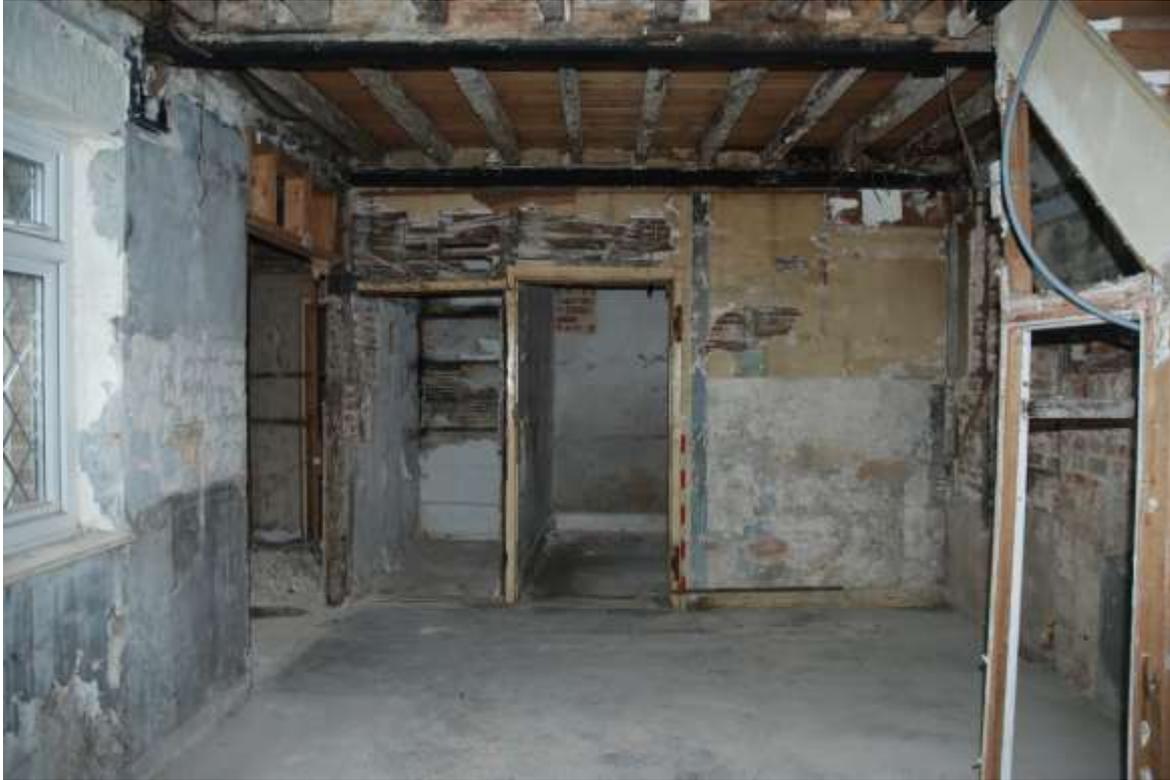
6.3.3.4.2 The room was accessed via the southeastern door in G2, (fig.50), and through the northwestern doors in G6. The eastern wall contained a door leading out into the garden. The southern wall was pierced by a large window 2.35m wide by 1.19m high. The room also contained the staircase leading up to the first floor situated in the northeastern corner.

Fig.50: Room G4 facing W, 1m scale. Room G2 through door by scale, room G3 to left of this
