**LEVEL 2 HISTORIC BUILDING RECORD &
TRIAL TRENCHING
ON THE SITE OF THE FORMER 'RETREAT',
MARKET PLACE, ABRIDGE,
ESSEX, RM4 1UA**

LEVEL 2 HISTORIC BUILDING RECORD &
TRIAL TRENCHING
ON THE SITE OF THE FORMER 'RETREAT',
MARKET PLACE, ABRIDGE,
ESSEX, RM4 1UA

Principal Author: James Aaronson
with contributions from
Geoff Potter and Miranda Fulbright

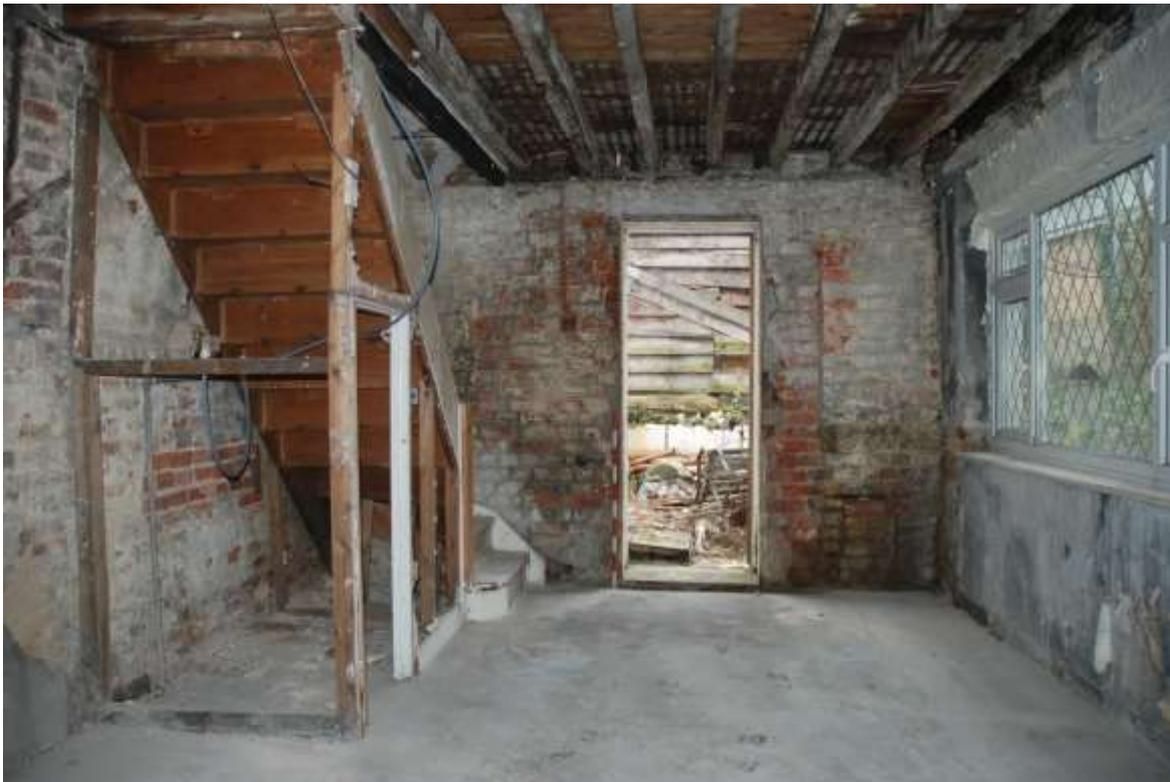
Fig.51: Room G4 facing E, 1m scale

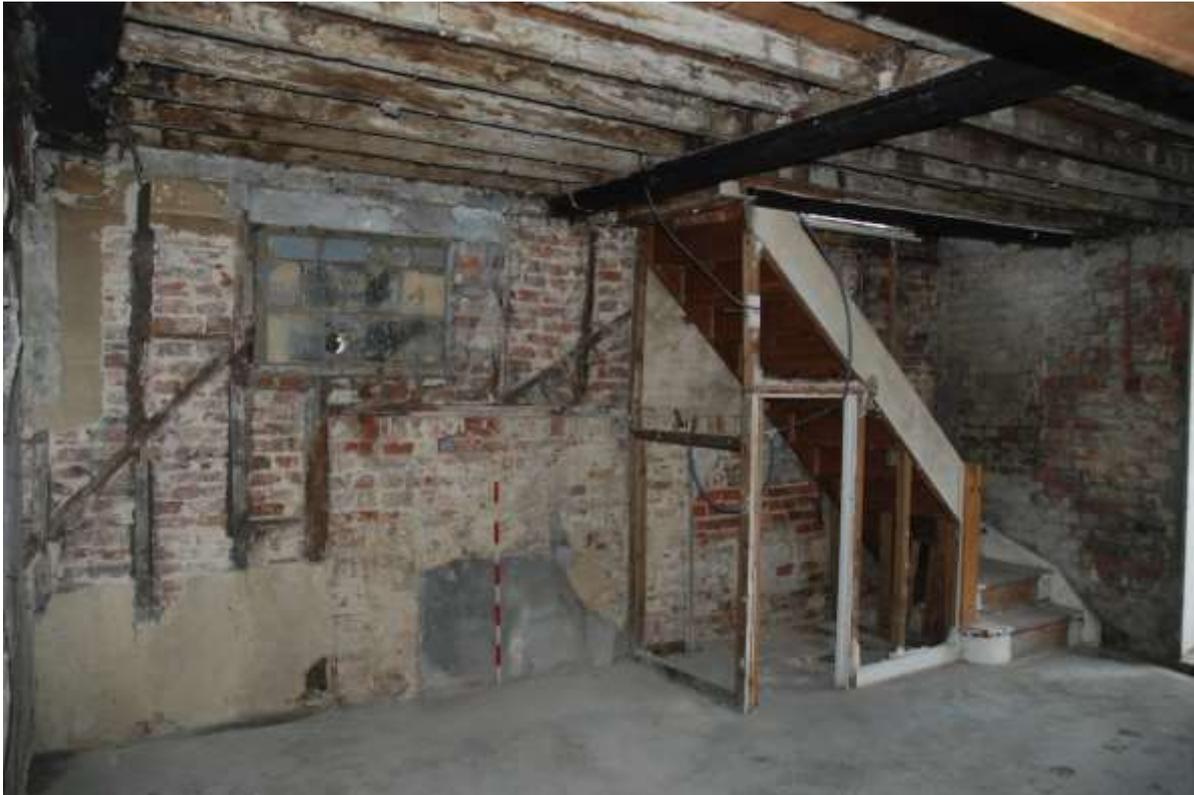
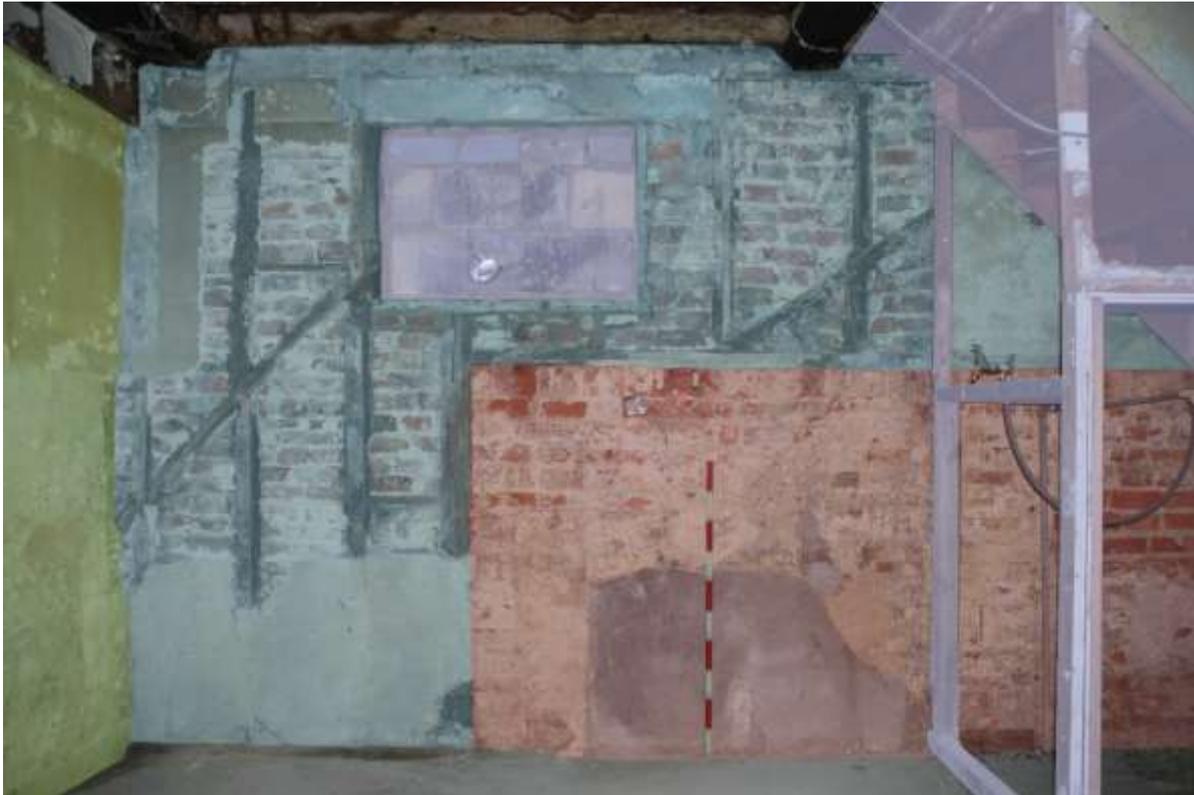
Fig.52: *The northern (external) wall of room G4 facing NE, 1m scale*

6.3.3.4.3 The northern, (exterior), wall of the room was very complex and appeared to have undergone several phases of rebuild / repair work, (fig.52 and 53). The first phase was represented by the lower 1.31m, (16 courses), of brickwork, from the centre of the wall to the far eastern end, measuring *c*4.20m wide. The uppermost course was set as a soldier course, indicating a maximum height. This solid brickwork would appear to be 19th century date judging by the bonding material. The second phase of build was represented by up to seven courses of brickwork at the far eastern end of the wall overlying the solid, lower coursing. This may have simply been a repair to the existing structure or may have been an abortive attempt to heighten the wall, later superceded by the final phase discussed below. The upper part of the wall and the first 1.22m at the western end of the elevation formed the final phase of rebuild. It was constructed around a timber-frame infilled with bricks, as seen in the northern wall of G2 and southern wall of G3 and probably represent the same phase. Brick samples taken from the infilling date from anywhere between the 16th to the late-19th century with the earlier material having almost certainly been reused. The construction is provisionally dated to the mid-19th century. This phase of build also contained a high-level window, 0.87m wide by 0.60m high, positioned 1.56m from floor level. The window had later been infilled with breeze-blocks.

Fig.53: *Marked up photo of the north wall, facing N, 1m scale. Green earlier phase of building, Red first phase of brickwork, blue secondary phase with the infilled timber framing. Purple represents modern intrusions, infilling of window and stairs*

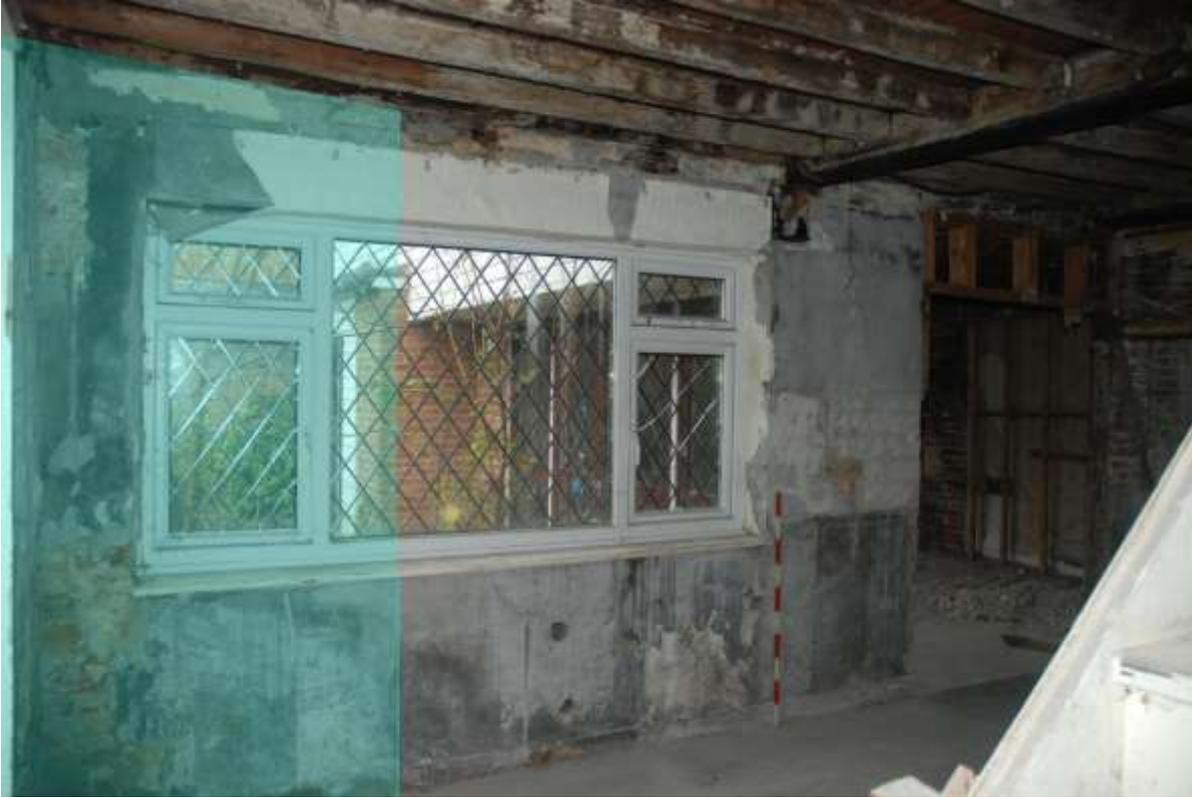
6.3.3.4.6 The eastern wall and adjacent north and south walls have been whitewashed and not plastered or rendered over like the western ends. The whitewashed sections of wall wood have created a space 1.09m wide, (E-W), at the eastern end of the room and may have indicated an original subdivision in the room, for a scullery / larder, hence the whitewash against dampness.

Fig.56: Indicated subdivision of the rear room with scullery highlighted blue. Room G4 facing SW, 1m scale

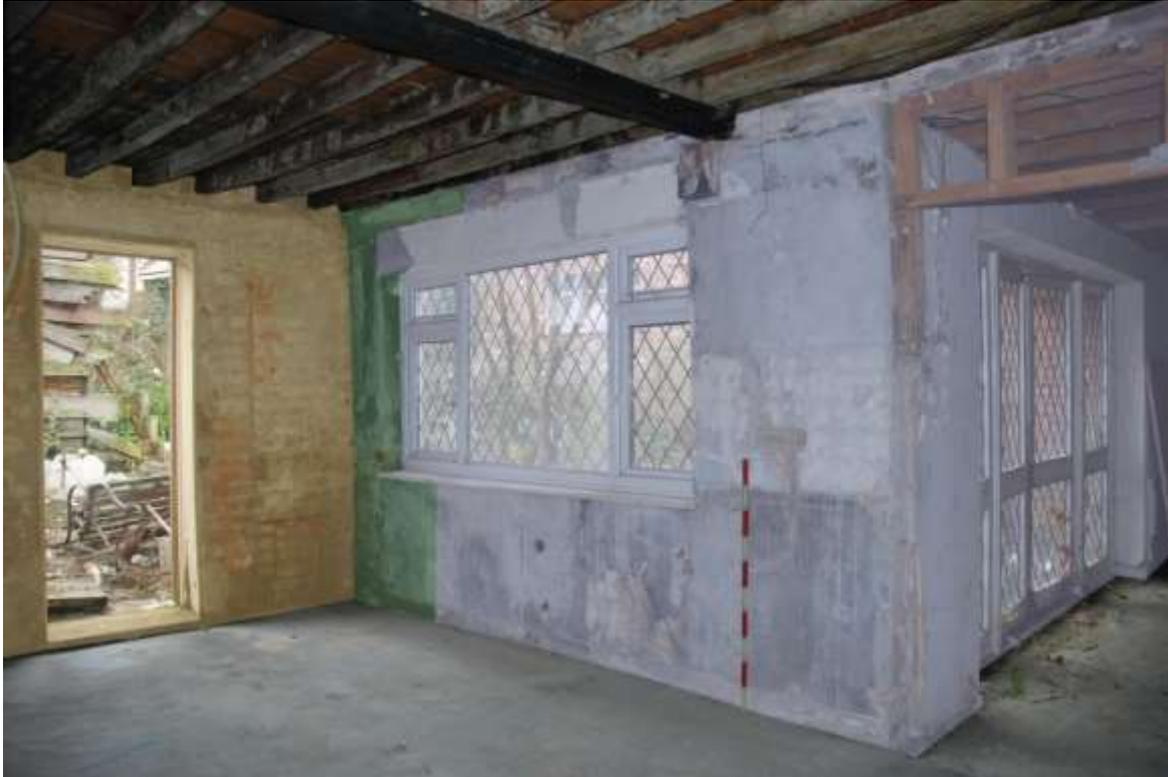
6.3.3.4.7 The southern wall of room G4, was formed of the brick stub described above, (6.3.3.3.4), and the rest of the wall was of rendered breeze-block and contained a large uPVC framed window, (fig.56 and 57). This part of the room was built as part of the extension to the south, rooms G5 and G6. The use of breeze blocks also indicates that the infilling of the window in the north wall, (6.3.3.4.3), also occurred at this time.

Fig.57: Room G4 facing SE, 1m scale. Earliest phase in green, second in orange, third in purple

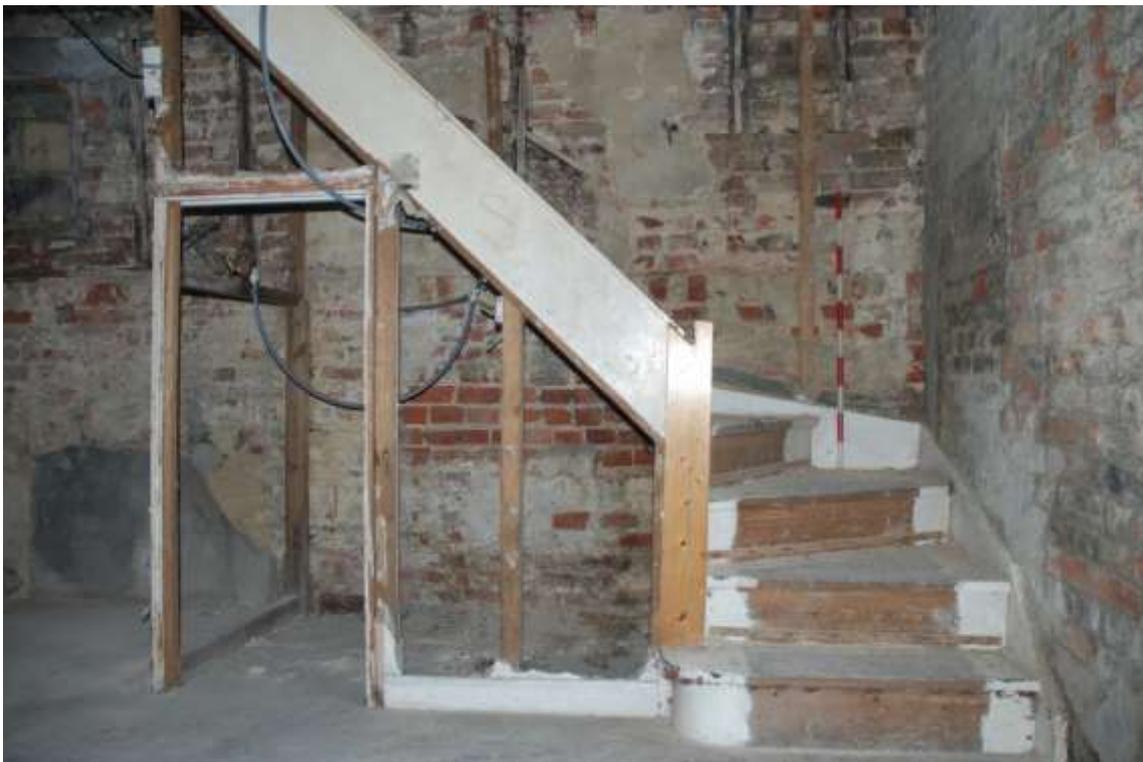
6.3.3.4.8 The room also included the staircase to the first floor, built in the northeast corner of the room. It is of modern, machine-cut, timbers with a right-angle turn from north to west, totalling 12 risers. The underside of the staircase was boxed in to provide additional storage space, (fig.58).

Fig.58: Staircase in the NE corner of the room, facing N, 1m scale

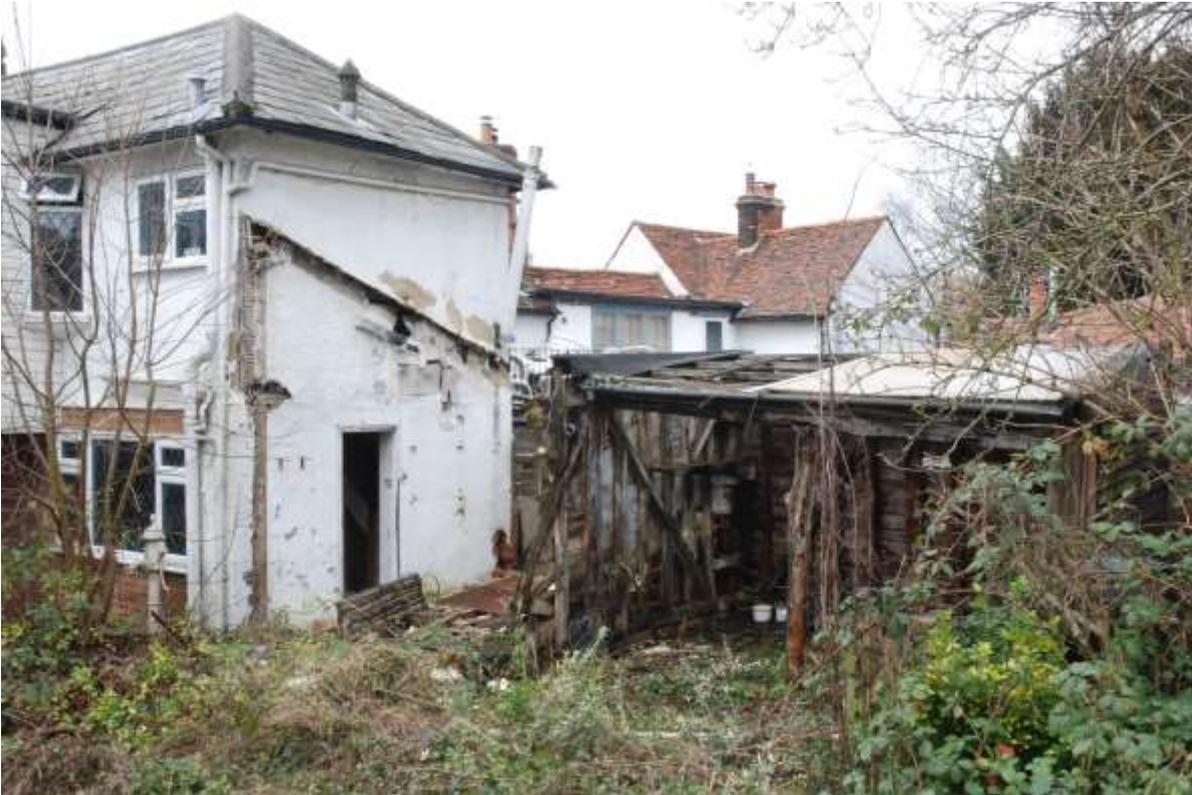
6.3.3.5.1 The doorway in the rearmost room of the property, G4, opened up onto the garden, however, according to the ground floor plans provided during the survey it originally opened into a final single-storey room. The only sign of this room was a 'scar' of the sloping roof-line, sloping down from south to north, and of the north wall, the timber framework of the structure and the very base of a plasterwork wall on the eastern side, (figs.60 and 106). The room would have measured 3.42m wide, (N-S), and 2.60m long, (E-W).

Fig.60: *Exterior of eastern elevation, note the 'scar' of the sloping roof of room G5*

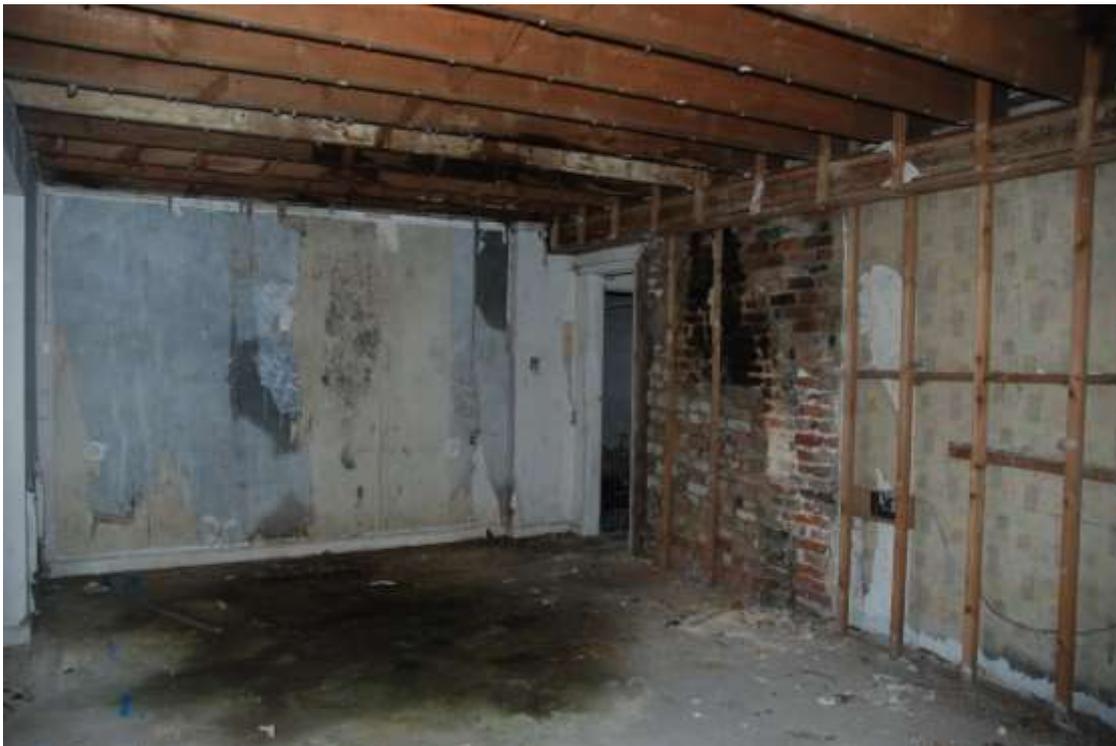
Fig.62: Room G6 facing SW showing door to room G1 in the corner of the room and sooting of former fireplace. The southern wall is breeze block behind the plasterwork

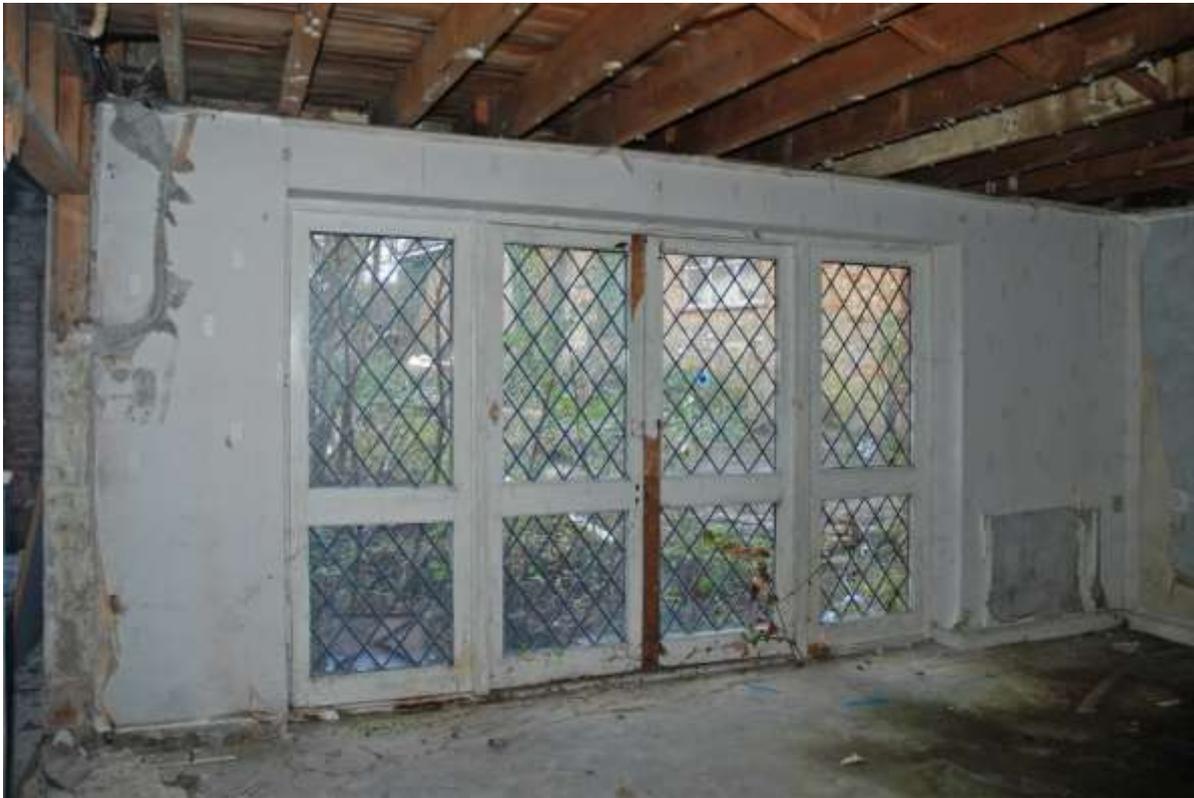
6.3.3.6.2 The eastern and southern wall were built of breeze-blocks, covered in plasterboard. The eastern wall was pierced by a set of French doors 3.32m wide by 2.12m high, leading to the rear garden, (fig.63). The room was accessed via a door in the southwestern corner stepping down into room G1, and also from a double-door opening in the northeast corner linking room G6 and room G4. The floor stepped up by 70mm into G6. The latter had since been removed. The extension shared its northeastern wall with the southern wall of cupboard G3, and the western wall with the eastern wall of G1.

Fig.63: East wall of room G6, facing SE, showing the French doors

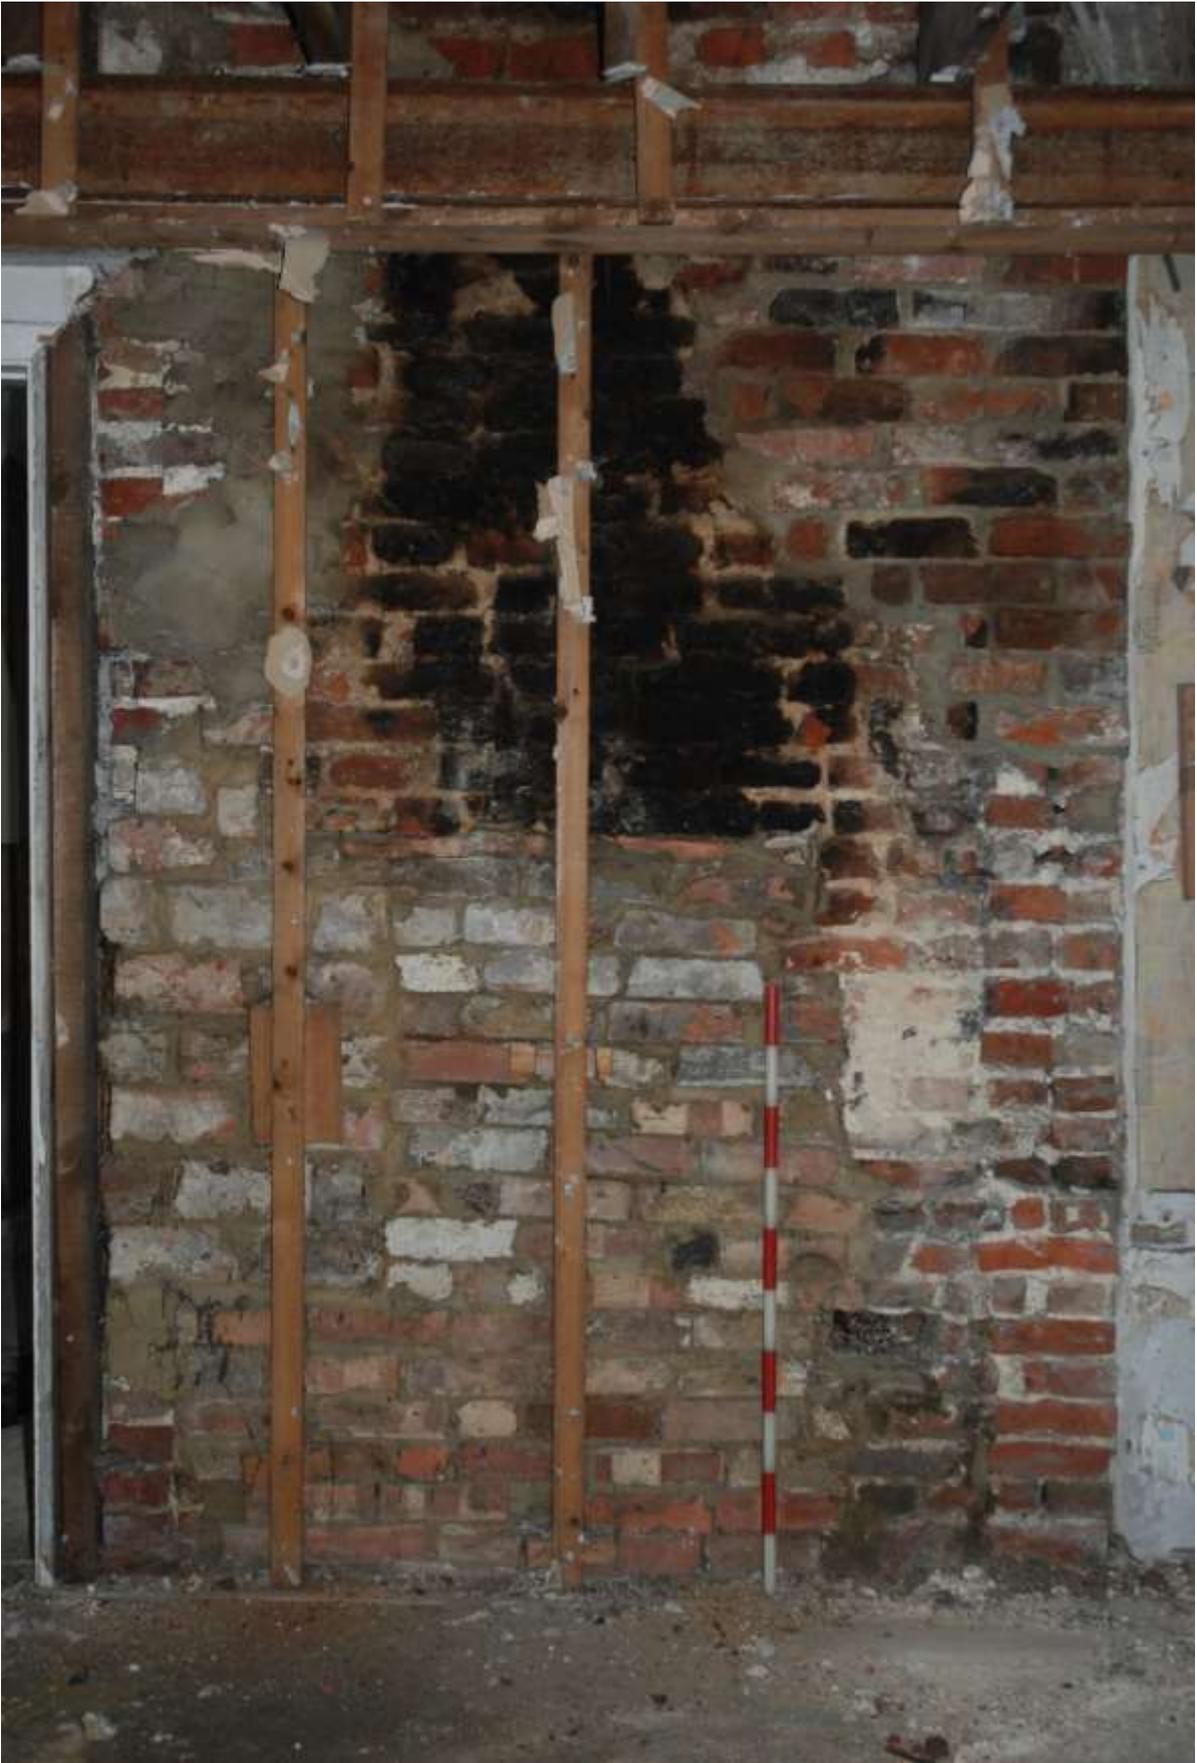
Fig.64: *Detail of former fireplace, facing W, 1m scale*

6.3.3.6.3 The western wall of room G6 showed the scar of a former fireplace, through a large patch of sooting, 0.78m wide, towards the top of the wall, along with fragmentary broken brickwork on the northern side 0.26m wide, (fig.64). This fireplace would presumably have been a mirror image to the fireplace in the south of room G1. The presence of this feature suggests that there would have been an earlier room in this area preceding the modern extension works, but that it had been completely demolished with no other trace of the former structure.

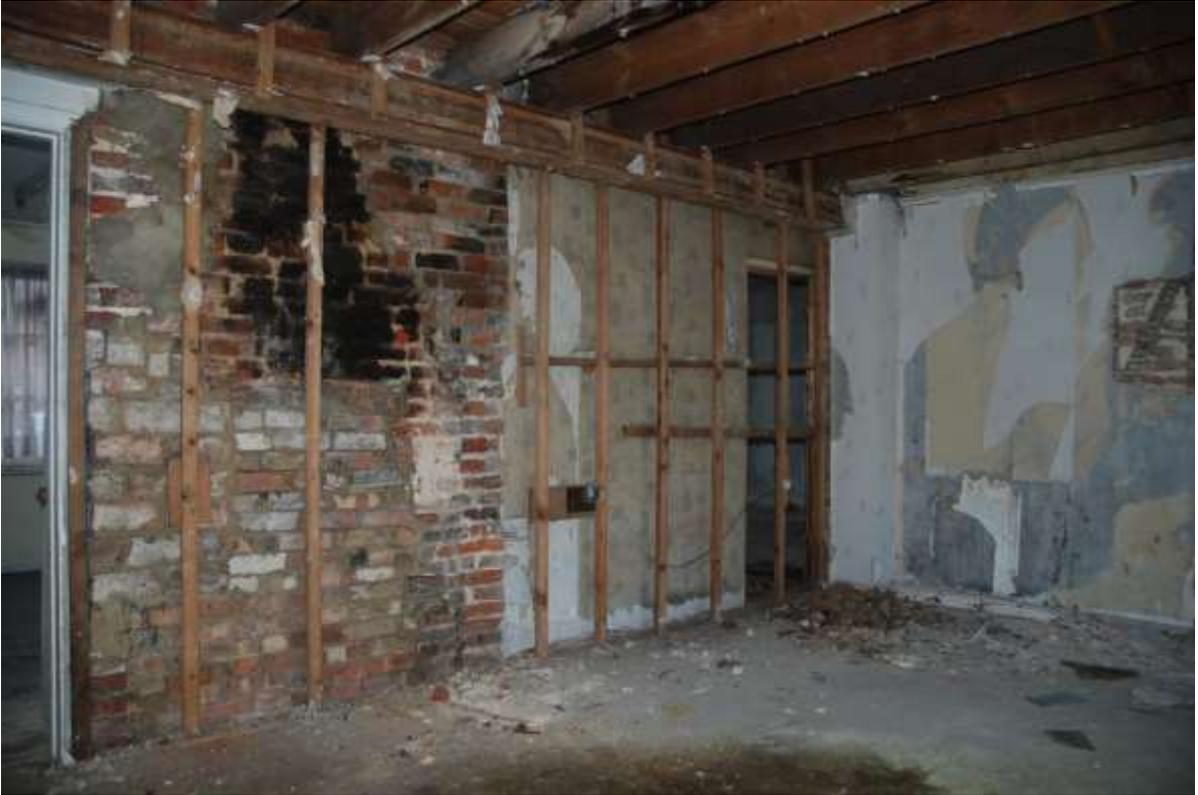
Fig.65: West wall of room G6, facing NW showing the sooting of former fireplace

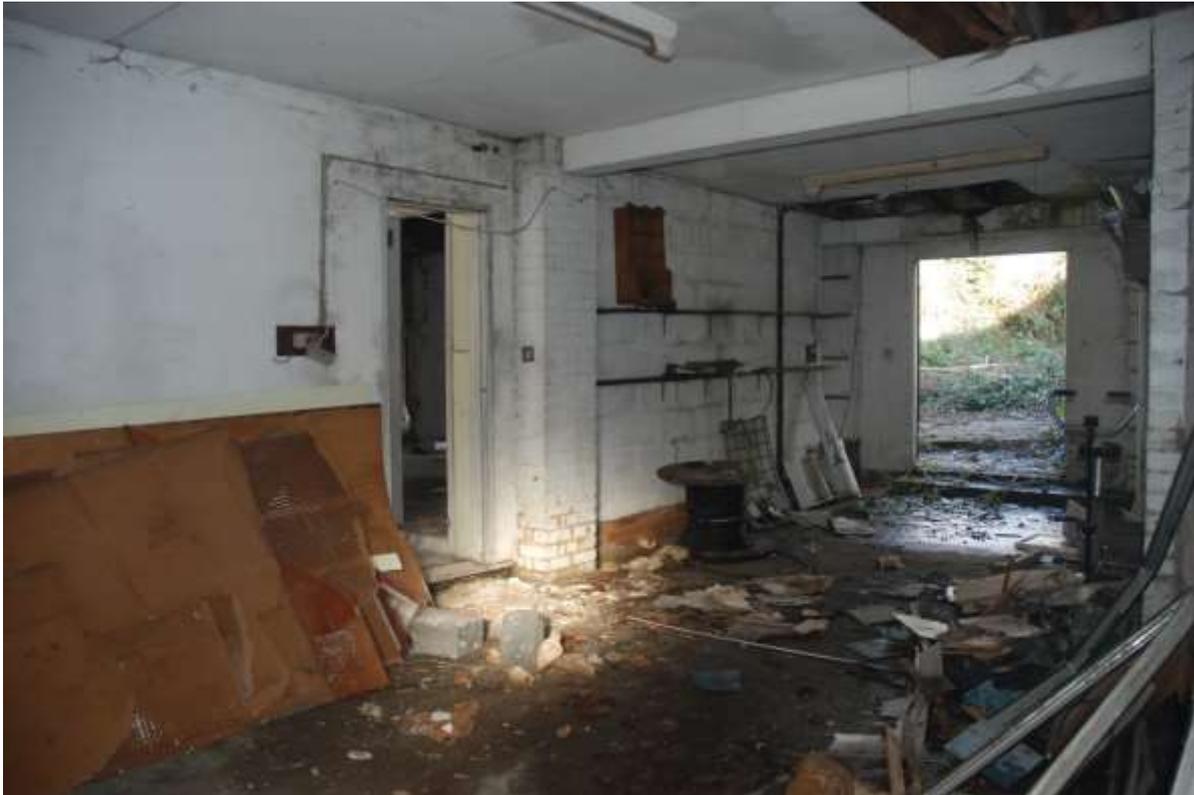
Fig.67: Garage space facing NE, access to GI in centre left of frame and door to garden in background. Note the breeze-block construction in NE corner and the northwest original external wall

6.3.3.7.3 As part of the construction a new door had been broken through into the southern wall of G1, above and close to the original external access to the cellar. The eastern wall was pierced by a wide door providing access to the garden, (fig.67).

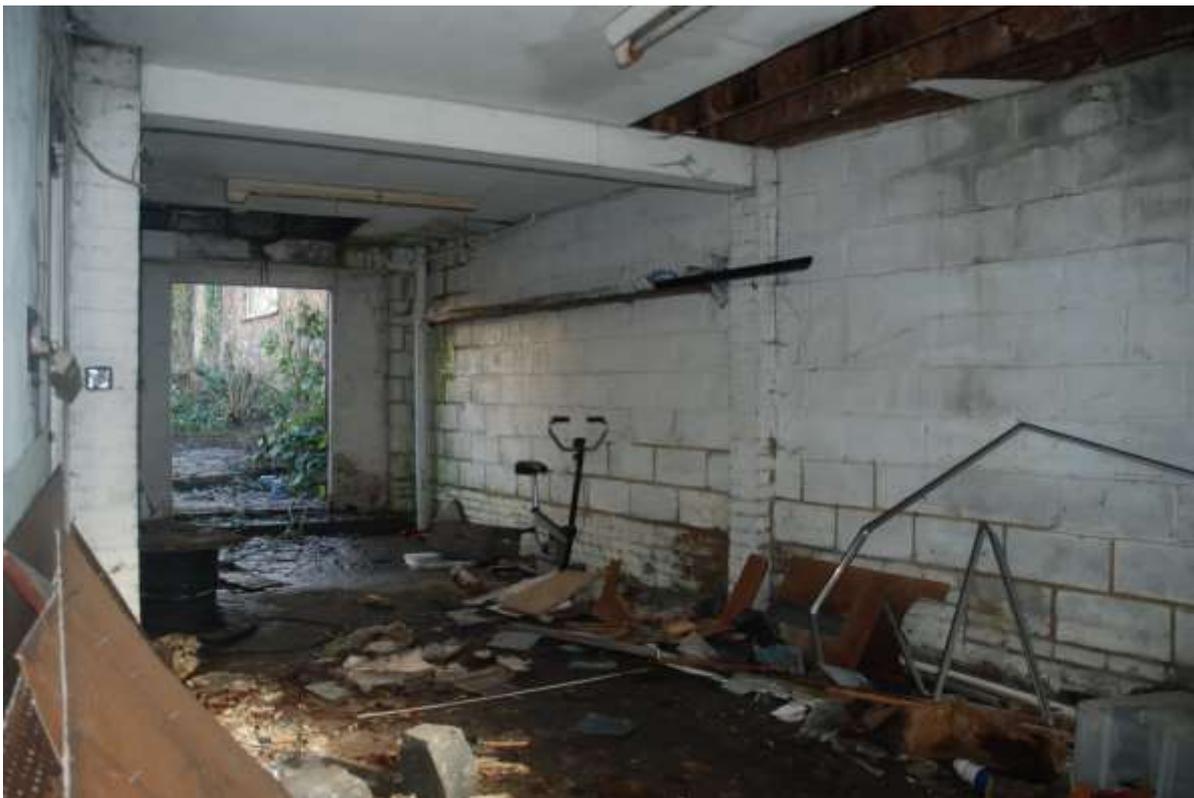
6.3.3.7.2 The structure was primarily built of breeze-blocks on a low brick footing of four or five courses, (figs.67 and 68). The northwestern wall of the room utilised the southern wall of G1, which would have formed the external wall of the property. It was during the construction of this space that the external access to the cellar was blocked.

Fig.68: Garage facing SE, note the breeze-block construction

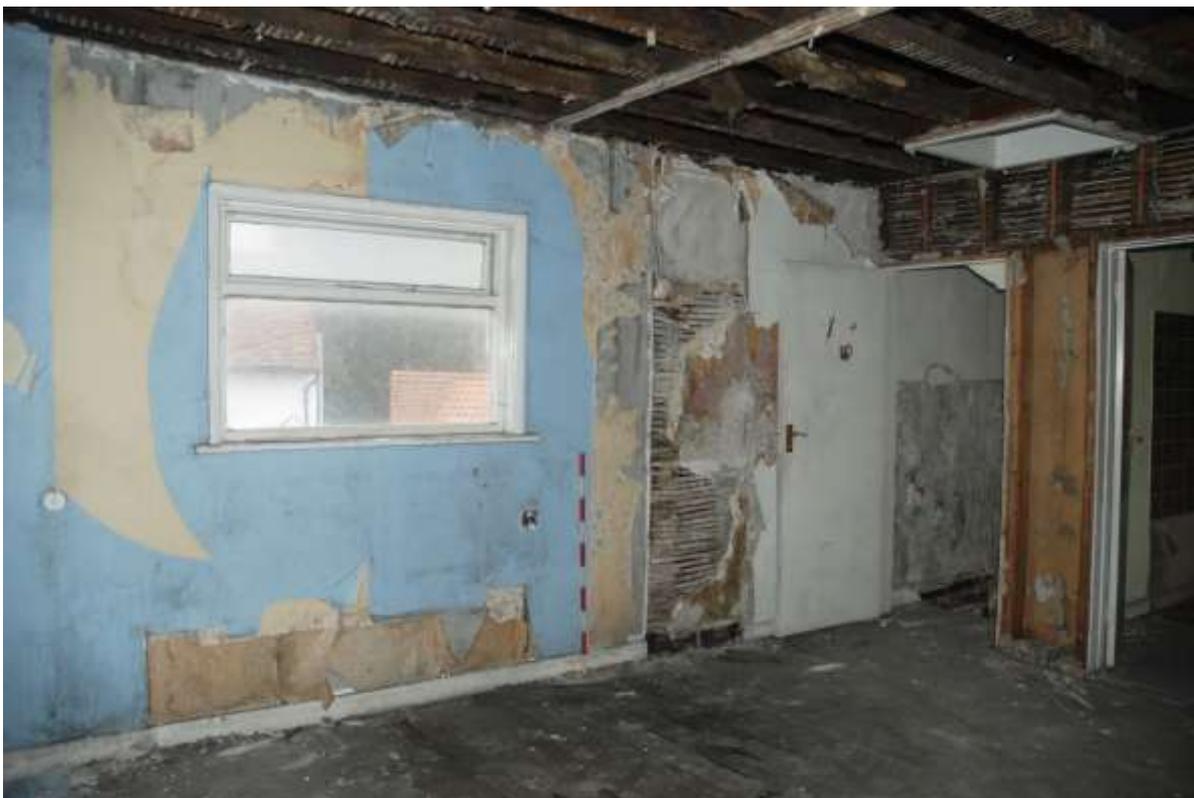
6.3.4.1.2 The room was formed of timber frame and lath and plaster walls to the north, (external wall), and west. The position of the eastern wall is inferred by the presence of a thin N-S orientated timber attached to the underside of the ceiling joists and a change in decor along the northern wall, (figs.72, and 73). No sign of the southern wall survived. The missing walls are presumed to have been of similar construction to those surviving. The room would have measured c2.50m wide, (N-S), by approximately 3.00m long, (E-W). The height from floor to ceiling joists was 2.40m.

Fig.72: Room F1 eastern extent indicated by the lighter timber in the ceiling and end of blue wallpaper, facing NE, 1m scale

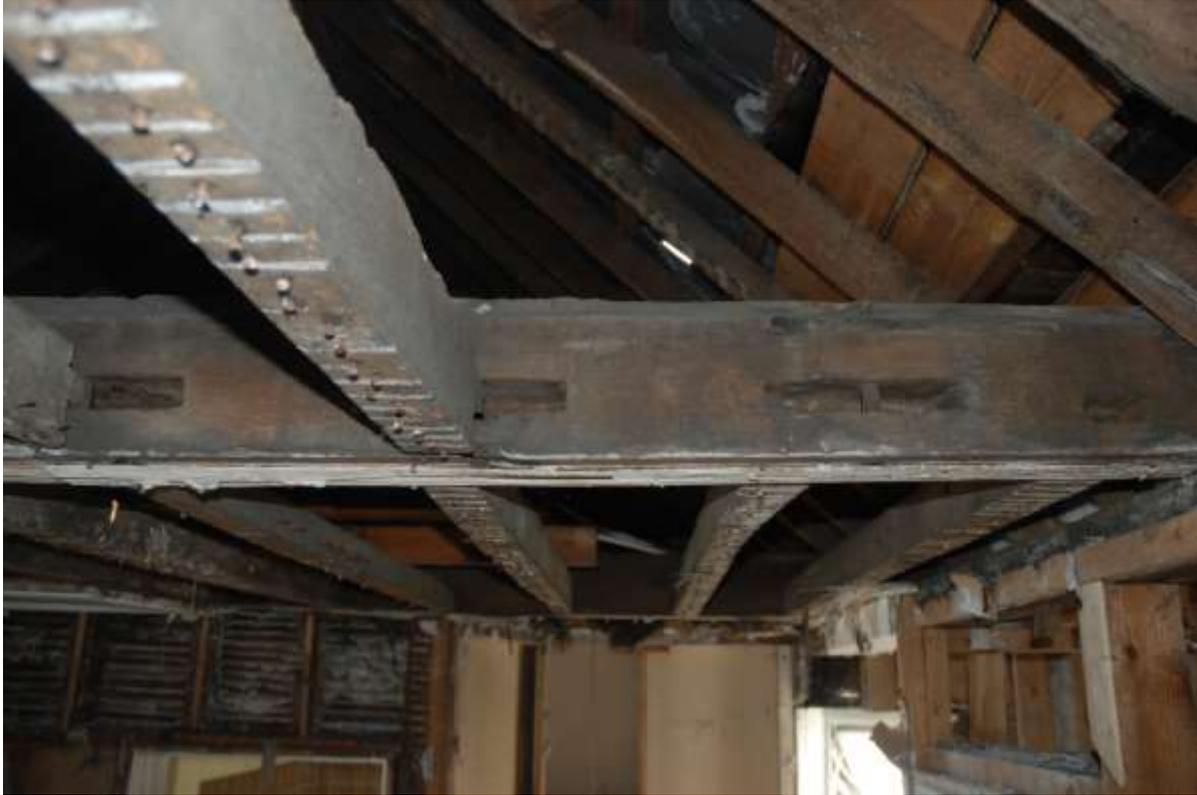
6.3.4.1.3 The central ceiling beam is approximately 3.64m long, (N-S), by 0.13m wide, (E-W), and 0.13m thick, and shows obvious signs of having been reused. The beam contained 9 blocked mortices in the west face with some numbered II-VIII, the eastern face contained 7 empty cut-outs with pegs / dowels still present which mirrored the west face, (figs.75 and 105).

Fig.75: Detail of the eastern face of ceiling beam in room F1, towards southern wall and valley of roof showing the empty cut outs / mortices. The one on the right retains a peg / dowel

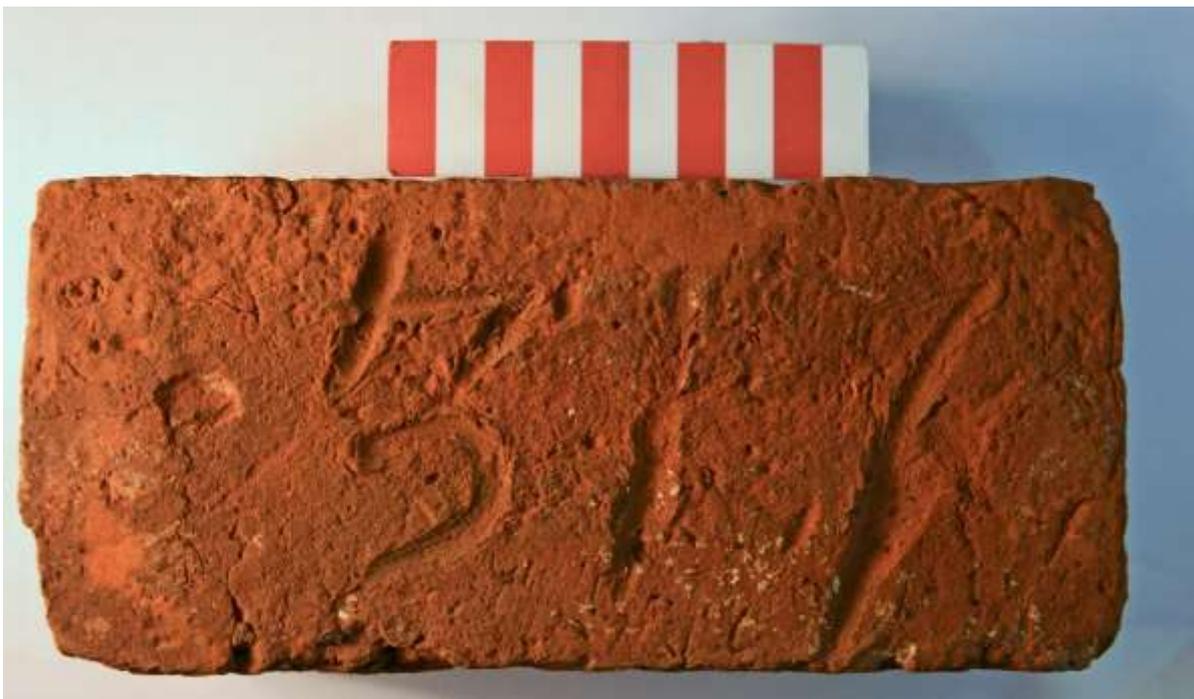
6.3.4.3.2 The western, (external), wall of the room is pierced by a casement window, 1.12m wide by 1.41m high. The eastern wall of the room contained an open-fronted double cupboard which measured 0.55m deep, (E-W), and 2.35m wide, (N-S). The southern of the cupboards occupied the footprint of the northern chimney stack as seen in G1, but with the remaining upper portion of the chimney still intact over the cupboard. Therefore the central portion of the chimney stack is missing, but the base and top survive, (fig.78). Bricks from this space were dated to the late-18th to mid-19th century and included distinctive pressure marks on the stretcher faces, perhaps indicating a maker's mark for piecework⁶. One of the bricks also included the graffiti '317' roughly traced with a finger in the frogged face, (fig.79).

Fig.79: Brick taken from the northern chimneystack showing graffiti, 10cm scale

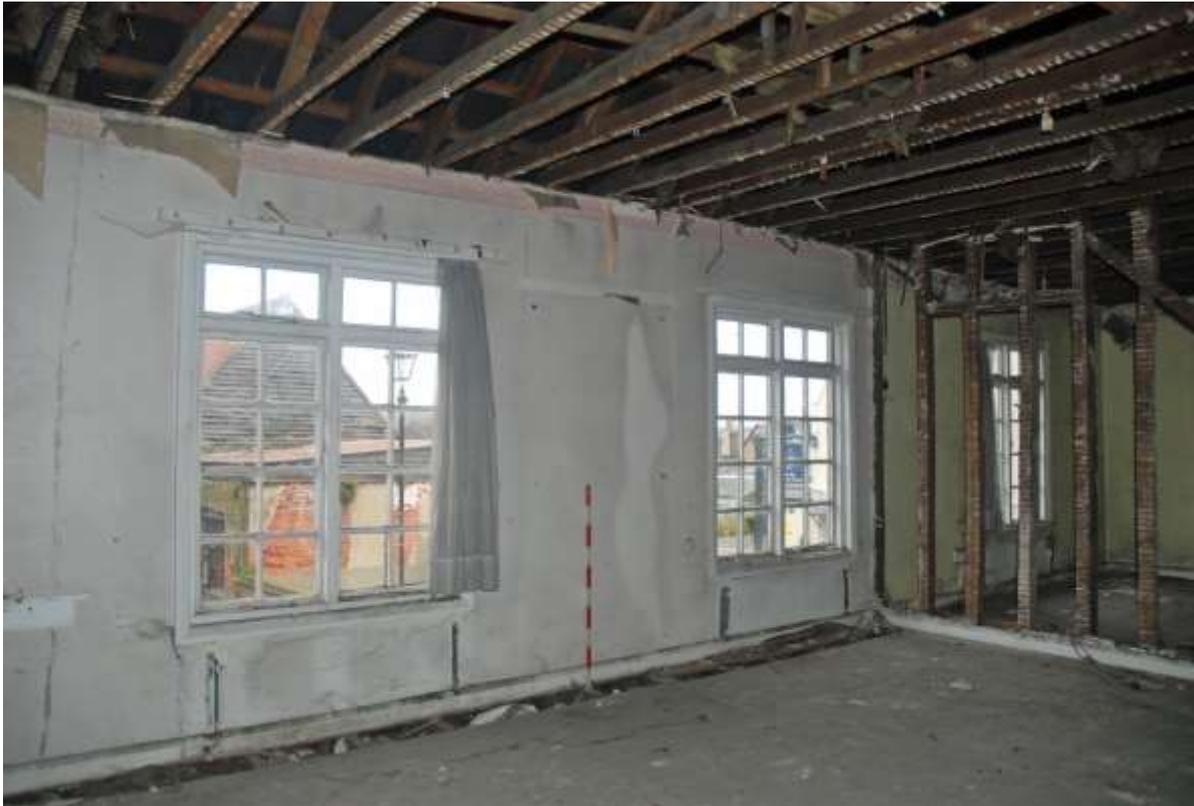
- 6.3.4.4.3** The western, street frontage, wall was pierced by two casement windows measuring 1.12m wide by 1.41m high and which are modern insertions to give the frontage a unified look in accordance with the modern extension works to the south, (fig.86). A single door, as mentioned above, provided access to the northeastern corner of the room from the modern hallway, but would appear to be a later alteration.

Fig.86: Room F4, western, street frontage, facing NW, 1m scale

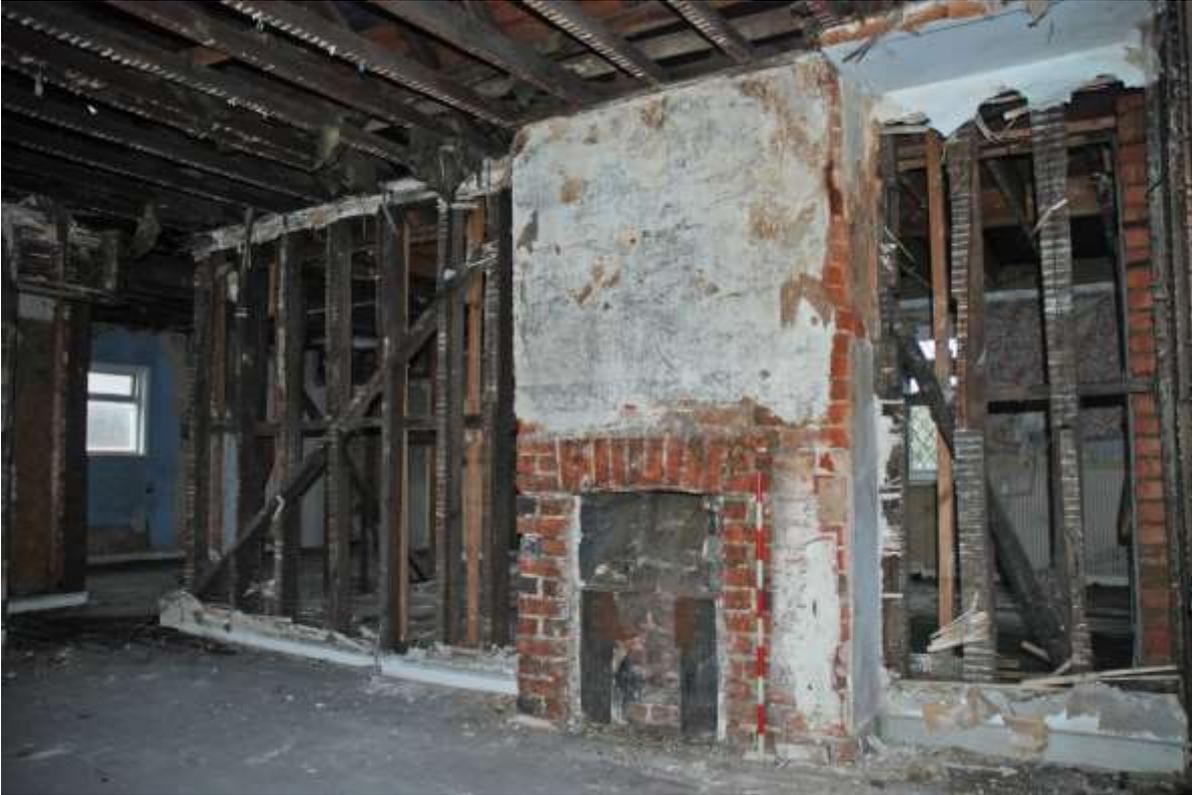
6.3.4.4.4 The eastern wall of the room housed the southern fireplace, and was the only surviving fireplace still open. The fireplace measured 1.37m wide, (N-S), and was 0.36m deep, (E-W). The central firebox was 0.68m wide, and contained a cast-iron hob grate with the central grate broken off but the decorative side panels still in place, (fig.88). The thin central flue was also still clearly visible and showed signs of thick sooting suggesting extensive use. The upper portion of the chimney stack above the mantel was plastered over and whitewashed. Bricks taken from the southern fireplace showed the same finger imprinted pressure marks as seen on bricks taken from the northern fireplace suggesting they came from the same batch / same construction phase.

Fig.87: Room F4, facing NE, 1m scale, southern chimney stack

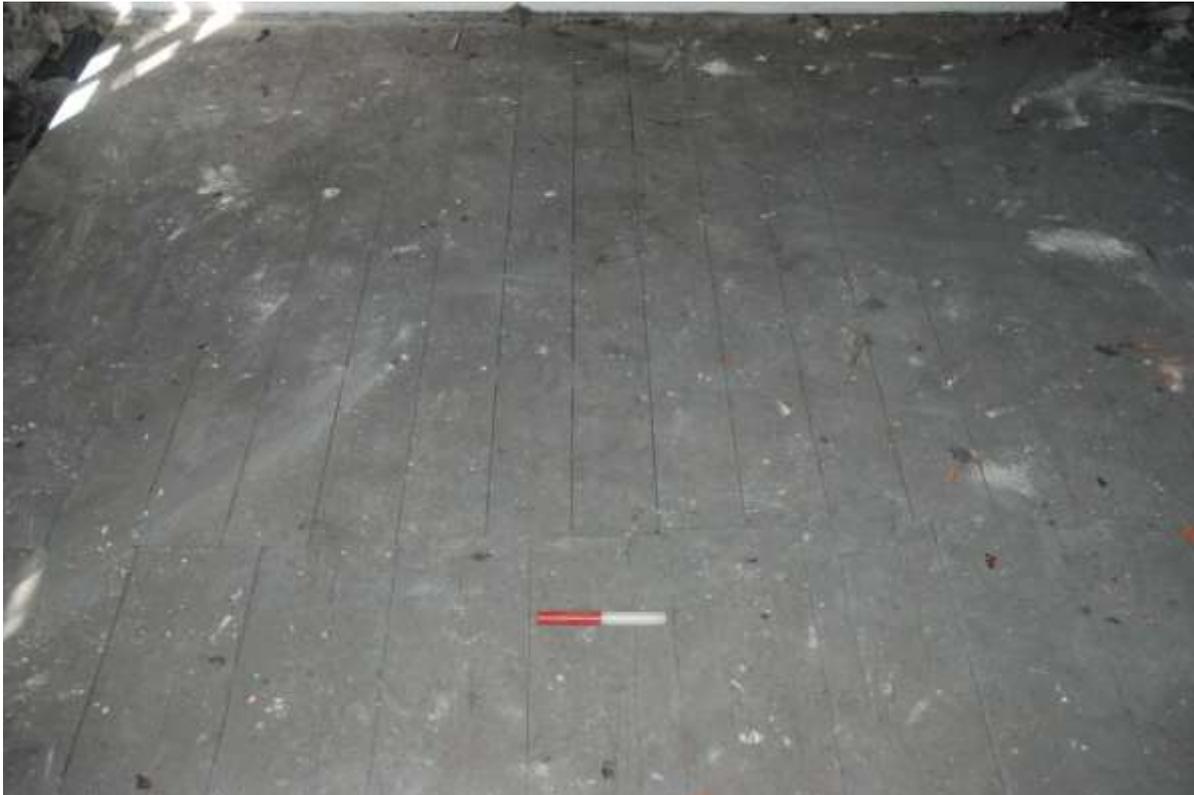
Fig.89: *Detail of the change in floorboards over the area of the hypothetical original staircase, facing N, 0.20m scale*

6.3.4.4.5 Of particular interest was the alteration in the use of floorboards in this room. The northernmost 1.93m of the room had N-S oriented planks measuring 143mm wide, those to the south were also orientated N-S but offset and measured 215mm wide, (fig.89). The change in floorboards also coincided with a small 35mm step back in the eastern wall, and the presence of a double joist in the ceiling. This would suggest an alteration having taken place within the space. It is suggested that the position of the alteration corresponds closely to the position of the original hallway at ground floor level, (see room G1, **6.3.3.1.3**), and that the small planks represent the infilling of the original staircase. It is suggested that the staircase would have occupied one side of the hallway at ground floor level, rising west to east, with the open space underneath to accommodate the internal entrance to the cellar. The staircase would have terminated in a small landing from which doors to the north and south opened into rooms F3 and F4 respectively. The presence of this staircase and landing would have created a much more symmetrical first floor plan and the fireplace in room F4 would then have been more centrally located within a smaller room rather than towards the southern end of the room as existed in its later formation.
