**LEVEL 2 HISTORIC BUILDING RECORD &
TRIAL TRENCHING
ON THE SITE OF THE FORMER 'RETREAT',
MARKET PLACE, ABRIDGE,
ESSEX, RM4 1UA**

LEVEL 2 HISTORIC BUILDING RECORD &
TRIAL TRENCHING
ON THE SITE OF THE FORMER 'RETREAT',
MARKET PLACE, ABRIDGE,
ESSEX, RM4 1UA

Principal Author: James Aaronson
with contributions from
Geoff Potter and Miranda Fulbright

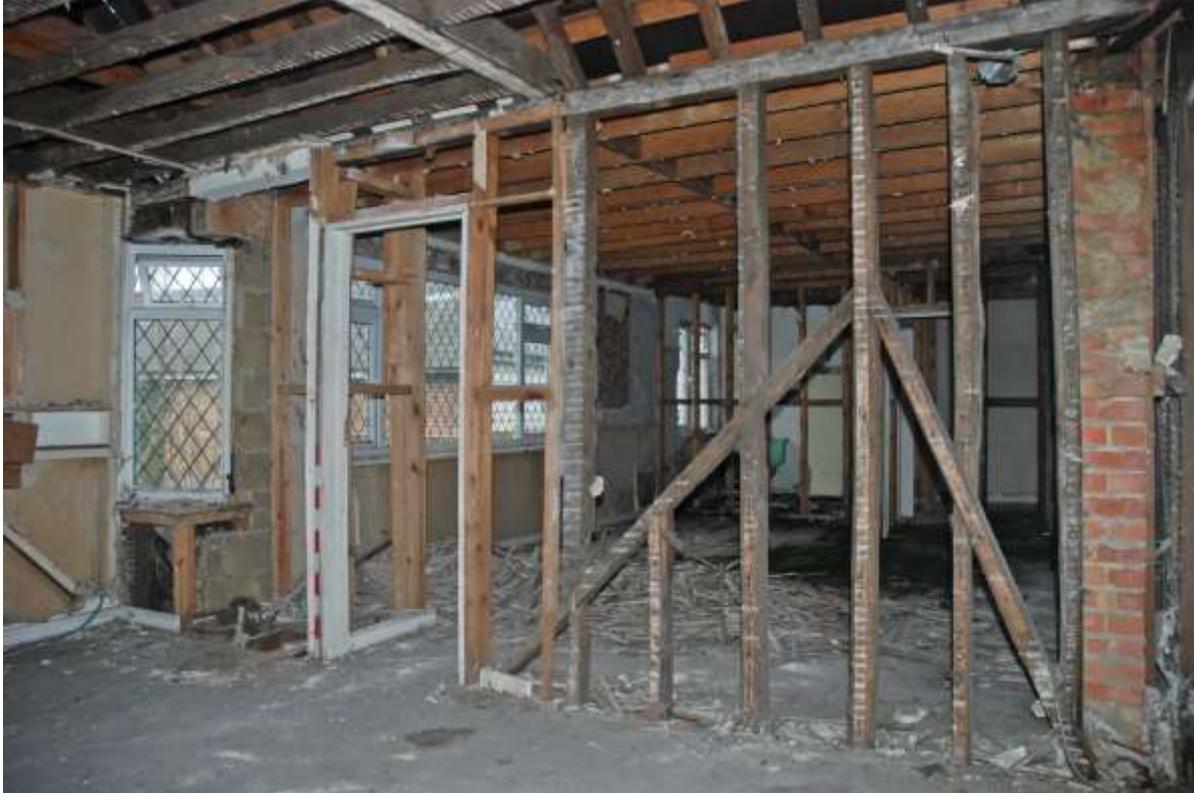
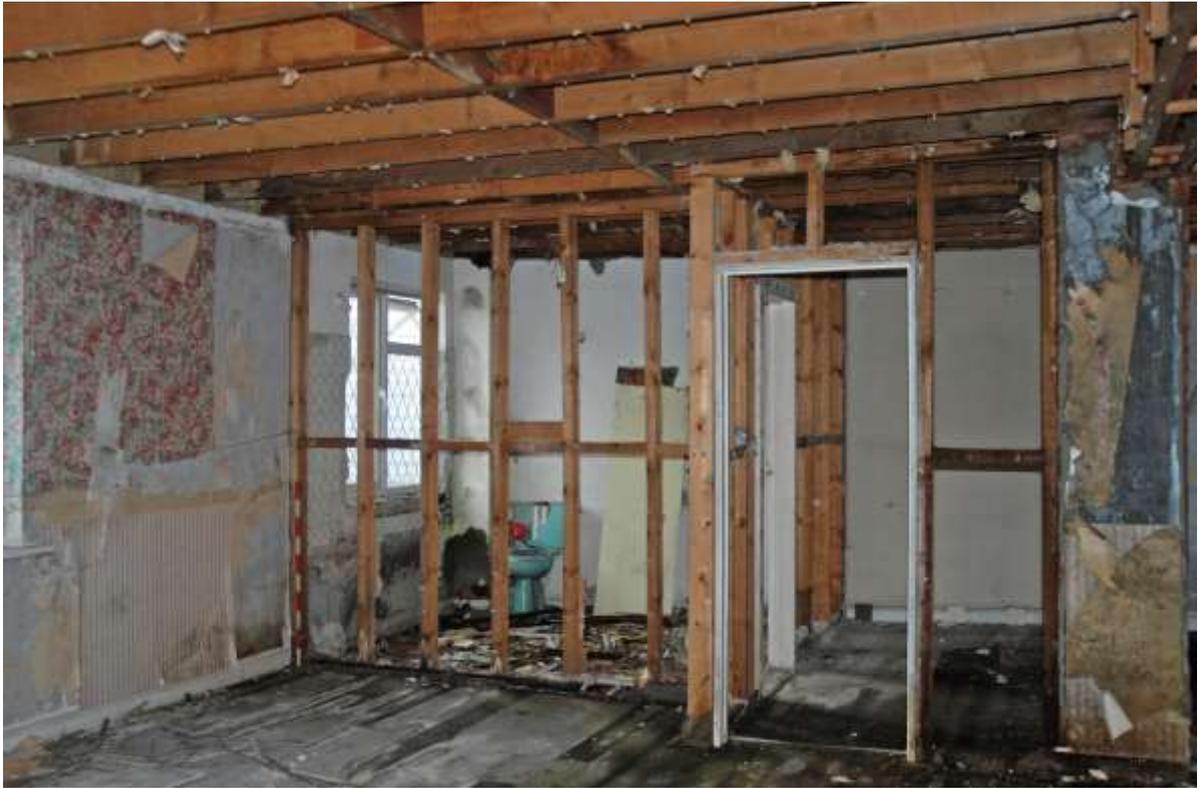
Fig.90: Room F5 facing SE, from the hallway, 1m scale

6.3.4.5.2 The northern wall of the room is part of an earlier phase of timber framework, showing impressions of the laths, and stud nails. The southern wall is comprised of fresher looking machine cut timbers reflecting the more recent construction, (figs.90 and 91 for comparison).

Fig.91: Room F5, facing SE, 1m scale. Door to F6 and toilet in the background

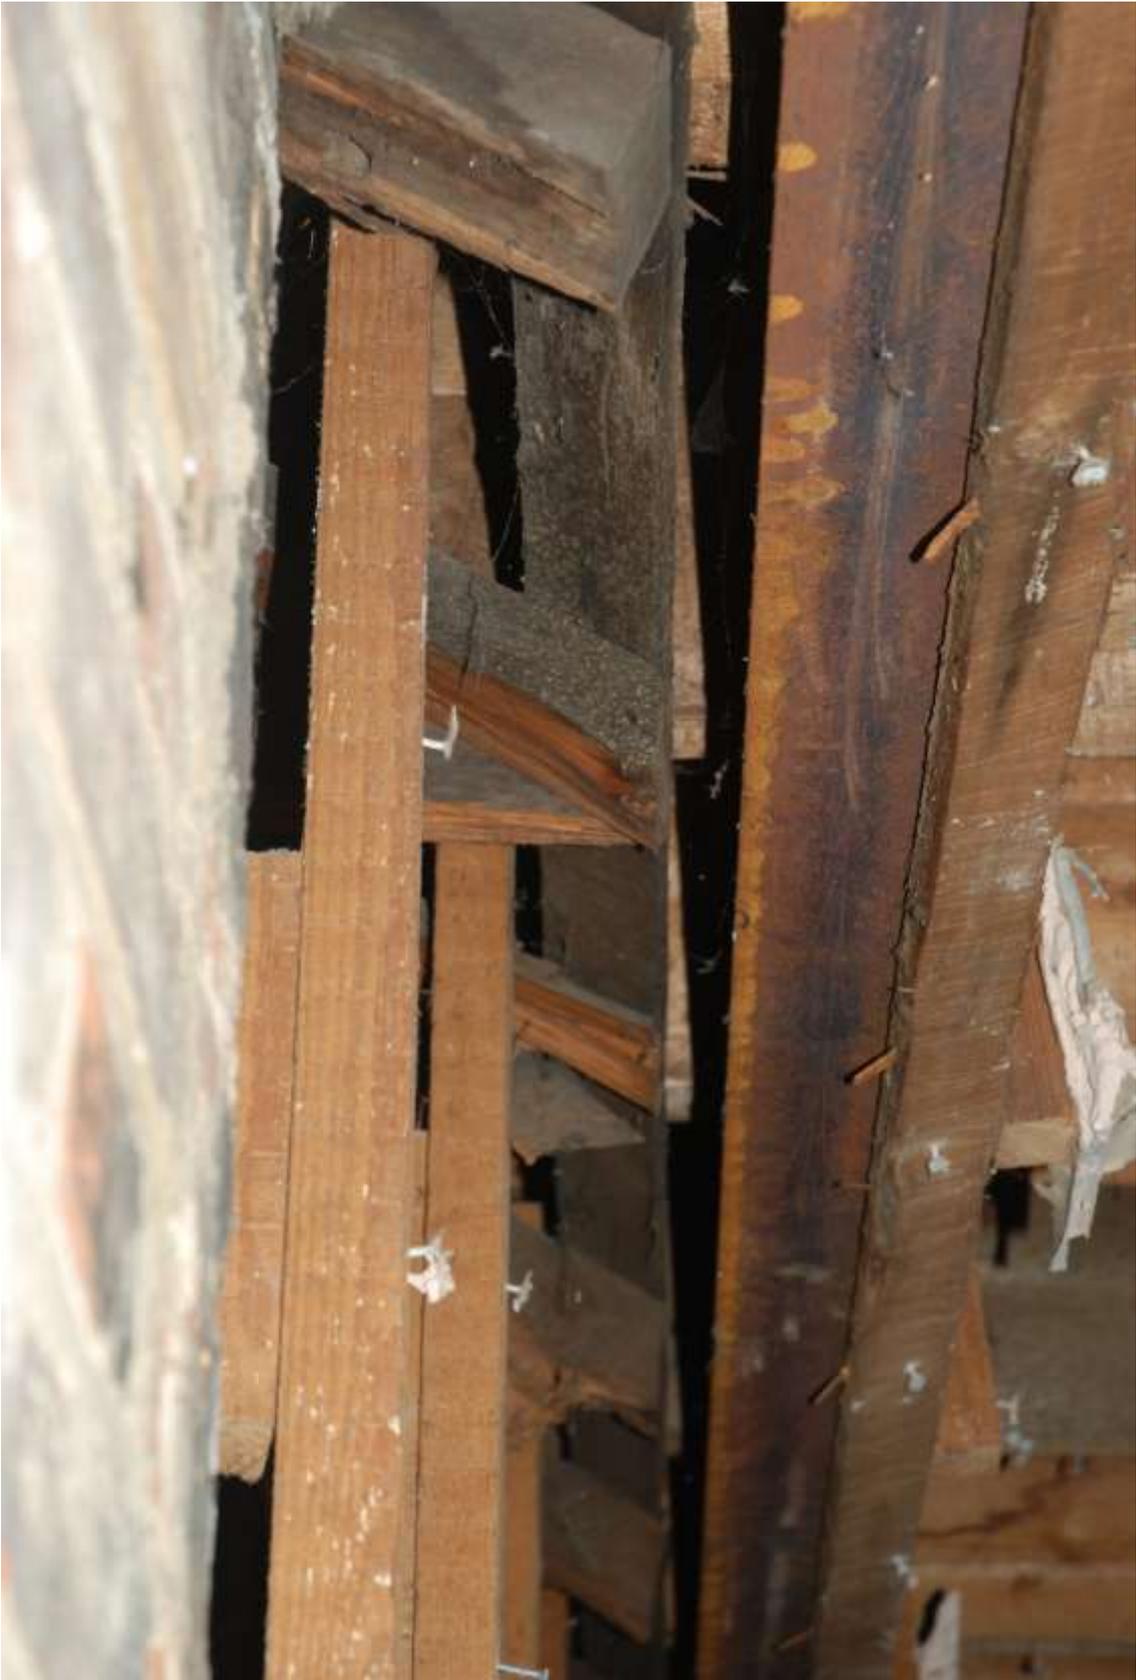
Fig.94: Original roof rafters at rear of property, (room F5), having been cut back to fit RSJ. Looking up from north side of chimneystack

6.3.4.5.4 In front of the chimney stack a rolled steel joist, (RSJ), has presumably replaced an earlier timber / been inserted to support the new roof structure above the eastern and southern extensions. To accommodate the RSJ the original rafters of the hipped roof have been cut back by approximately 0.20m to the west, (fig.94).

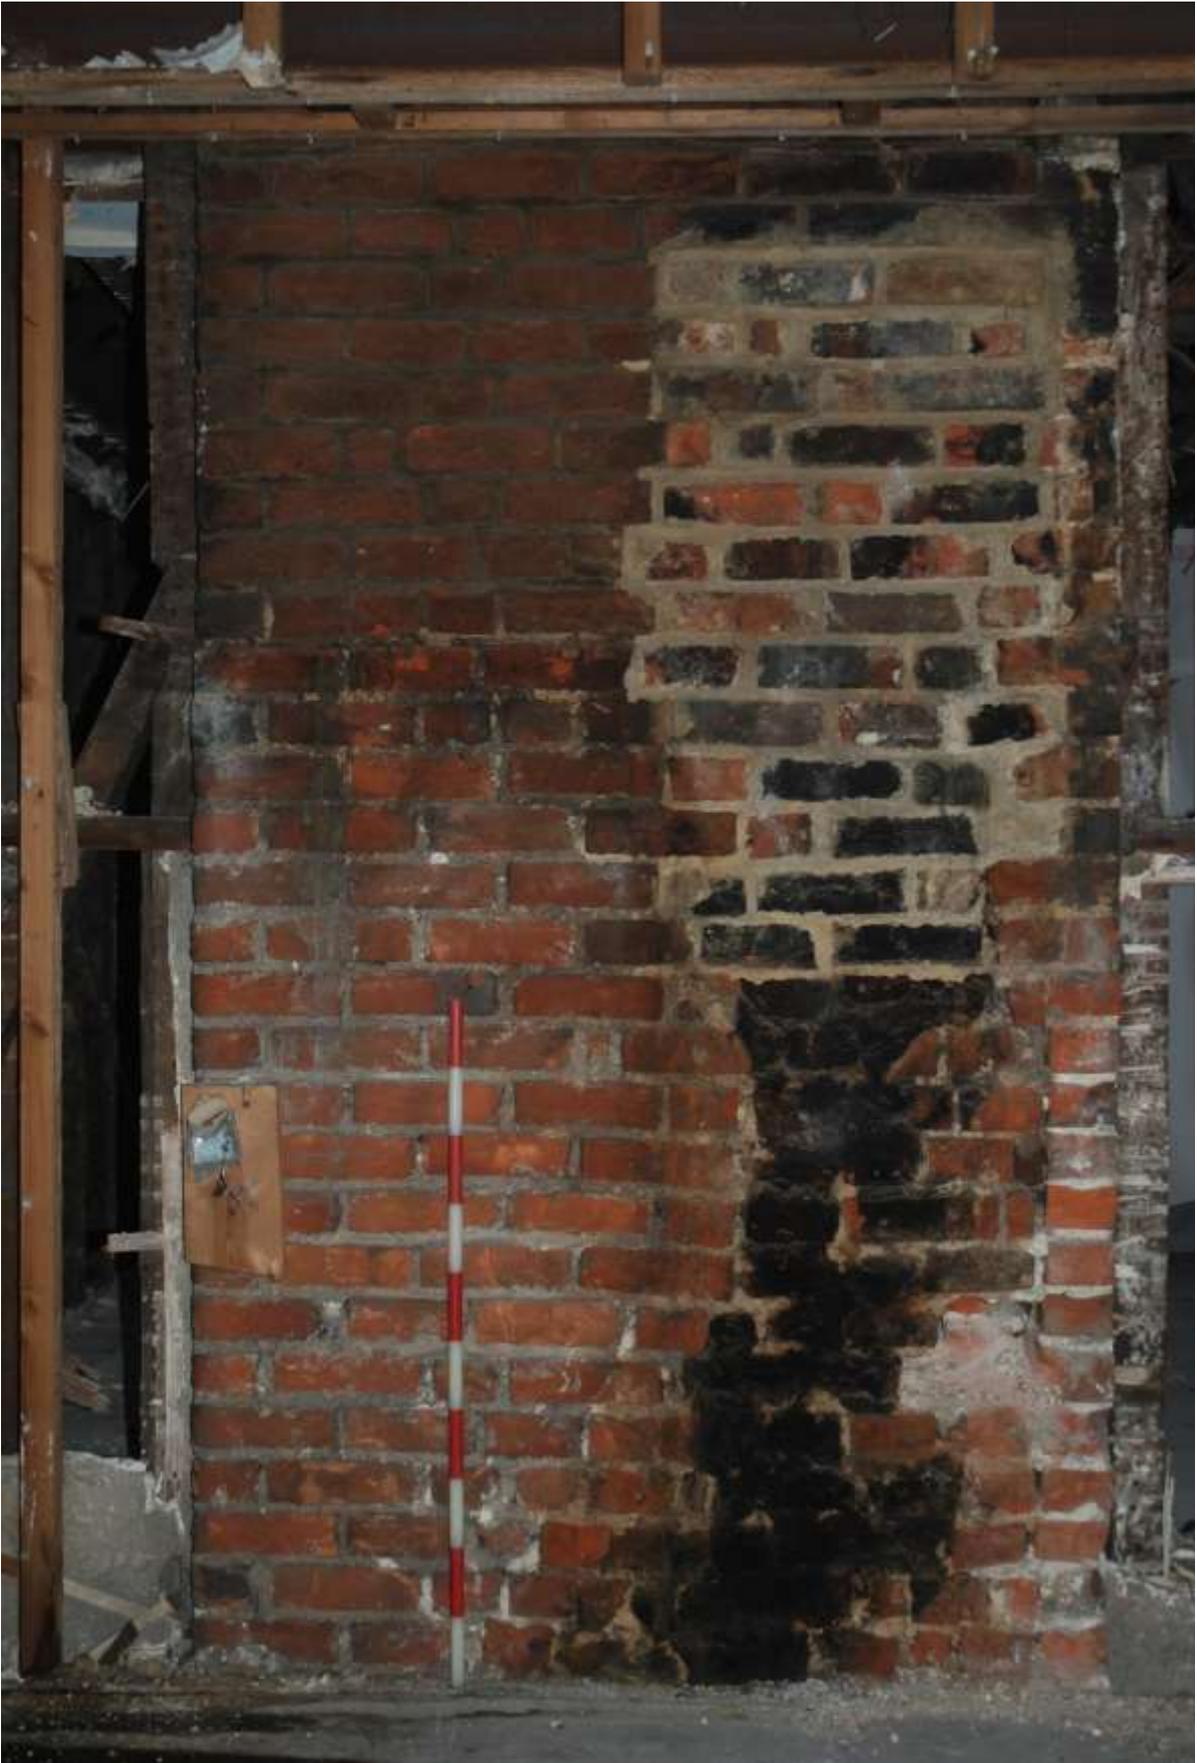
6.3.4.5.3 The western wall of the room showed the original timber frame of the front room, with the fresher cut timbers of the western wall of room F5 fixed against these. The western wall also shows the eastern face of the southern chimney stack, and like the wall western wall in ground floor room G6, shows signs of sooting indicating the position of an earlier fireplace / flue, (figs.93 and 95).

Fig.95: Eastern side of chimney stack, 1m scale

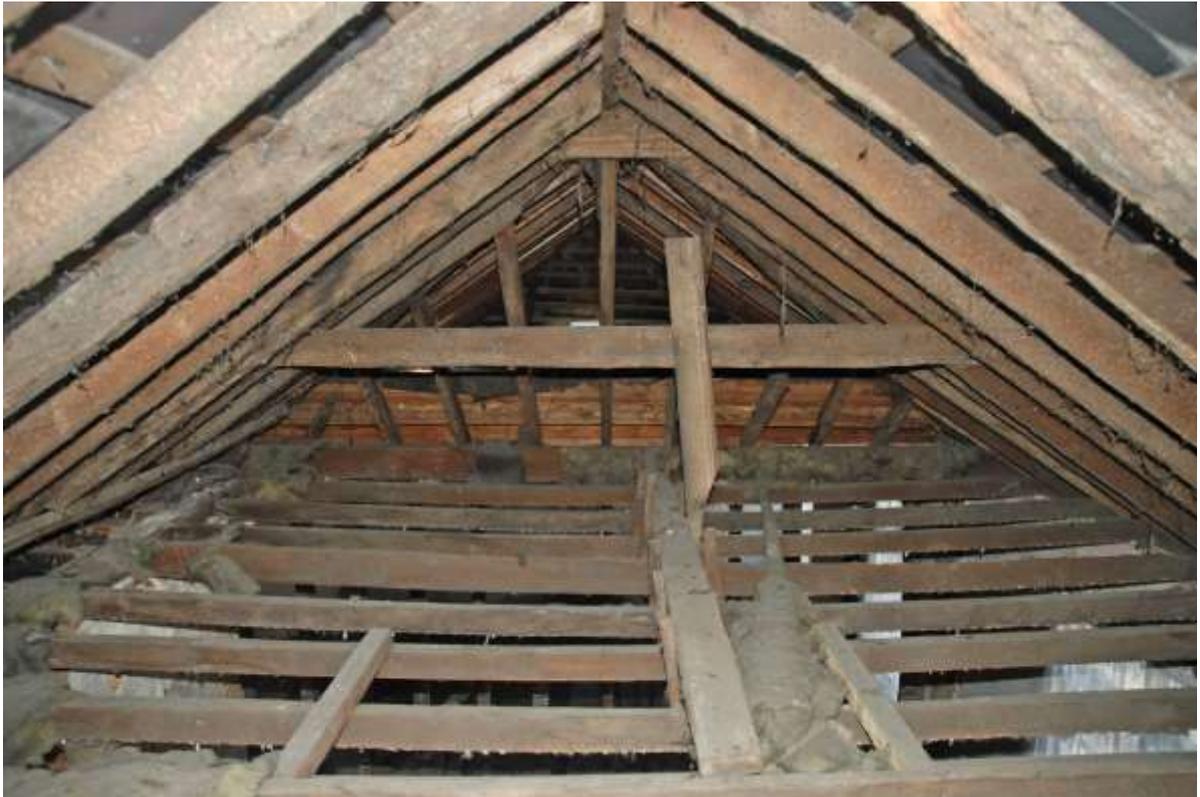
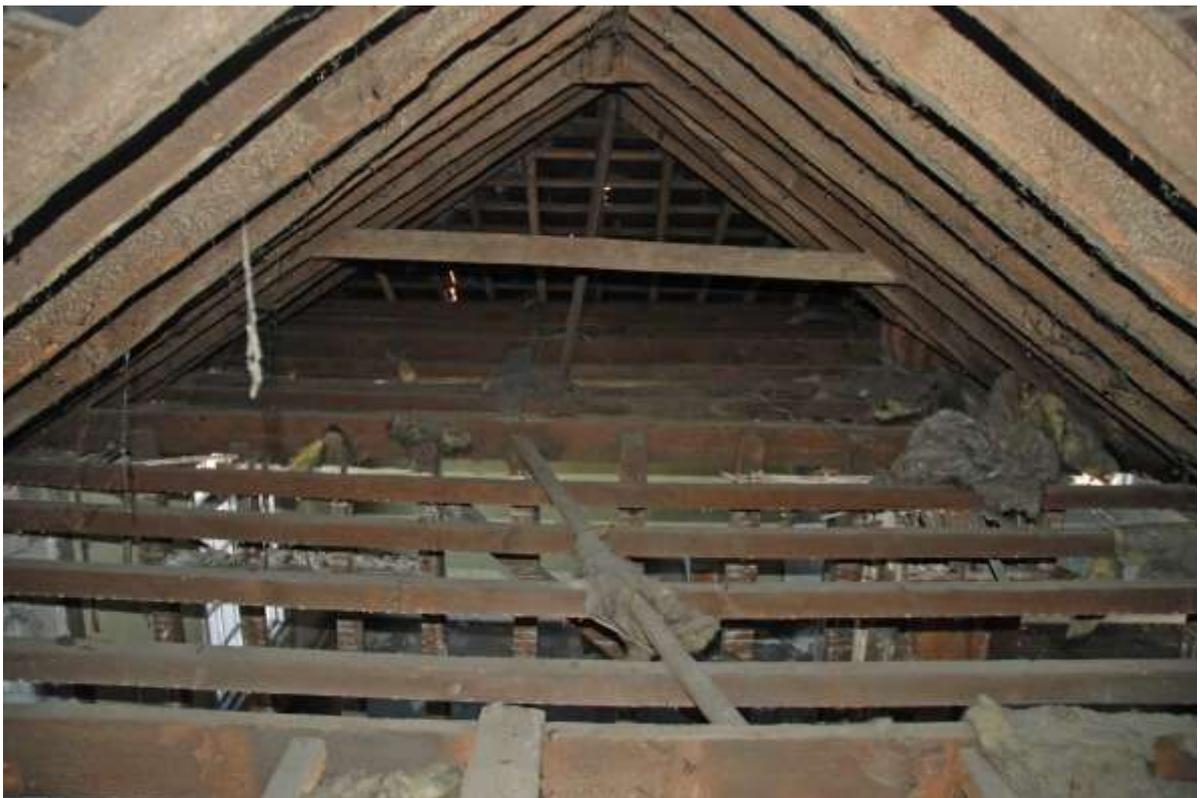
6.3.5.1 The main roof construction could be broken down into two phases, extensively rebuilt: the original hipped roof covering the front two rooms, F3 and F4; and the remodelling to accommodate later southern and eastern extensions to the property over rooms, F1, F2, F5 and F6, to create the later cross-hipped roof.

Fig.100: *Roof space over room F4, facing S towards original hipped end of roof, and to southern extension beyond*

Fig.101: *Roof space over room F4 facing N, showing sloping end of original hipped roof line*

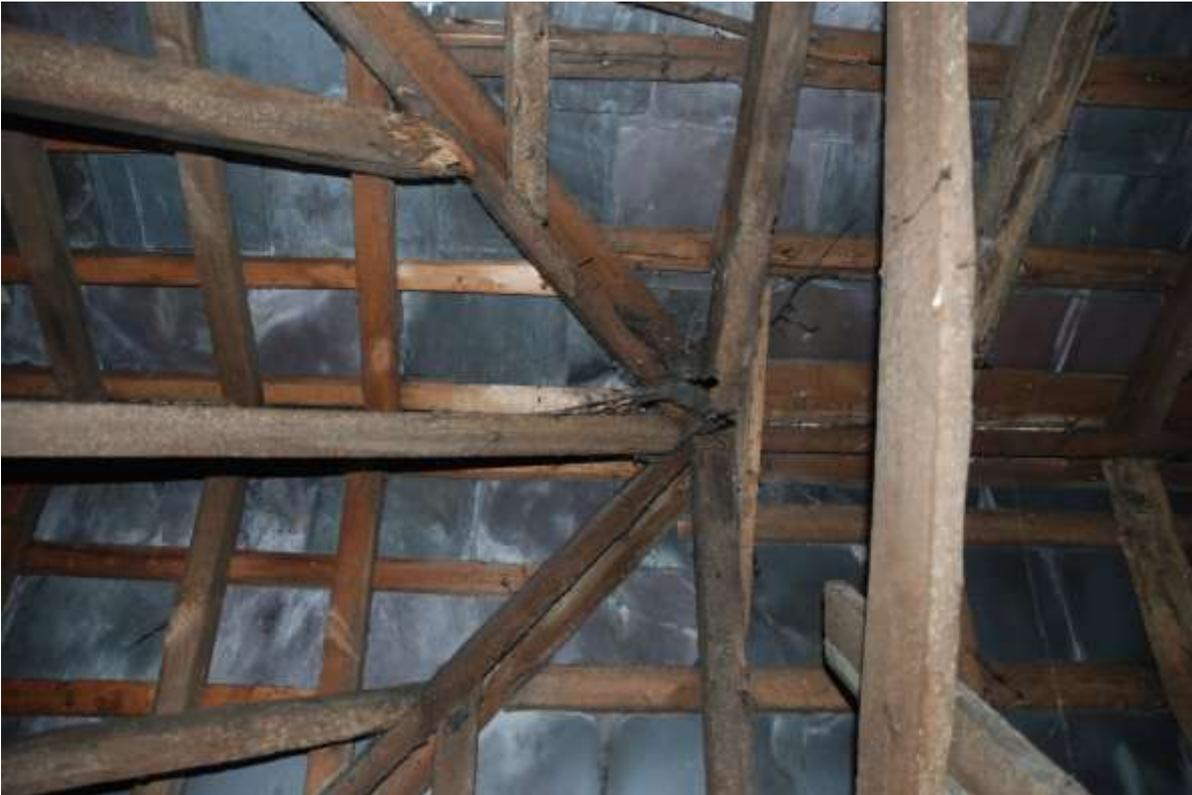
Fig.102: Roof space over room F4. Southern end looking directly up at original hipped end of roof, since remodelled to accommodate southern extension, (see fresher timbers on left of frame)

- 6.3.5.3** When the house was extended east and south extensive alterations were made to create the cross-hipped roof, with a large proportion of timbers in these sections showing signs of re-use or being new additions of machine-cut and treated wood of more uniform size and shape. The original southern end of the hipped roof was simple built over and masked by the southern extension, and the whole roof was re-felting and re-tiled.

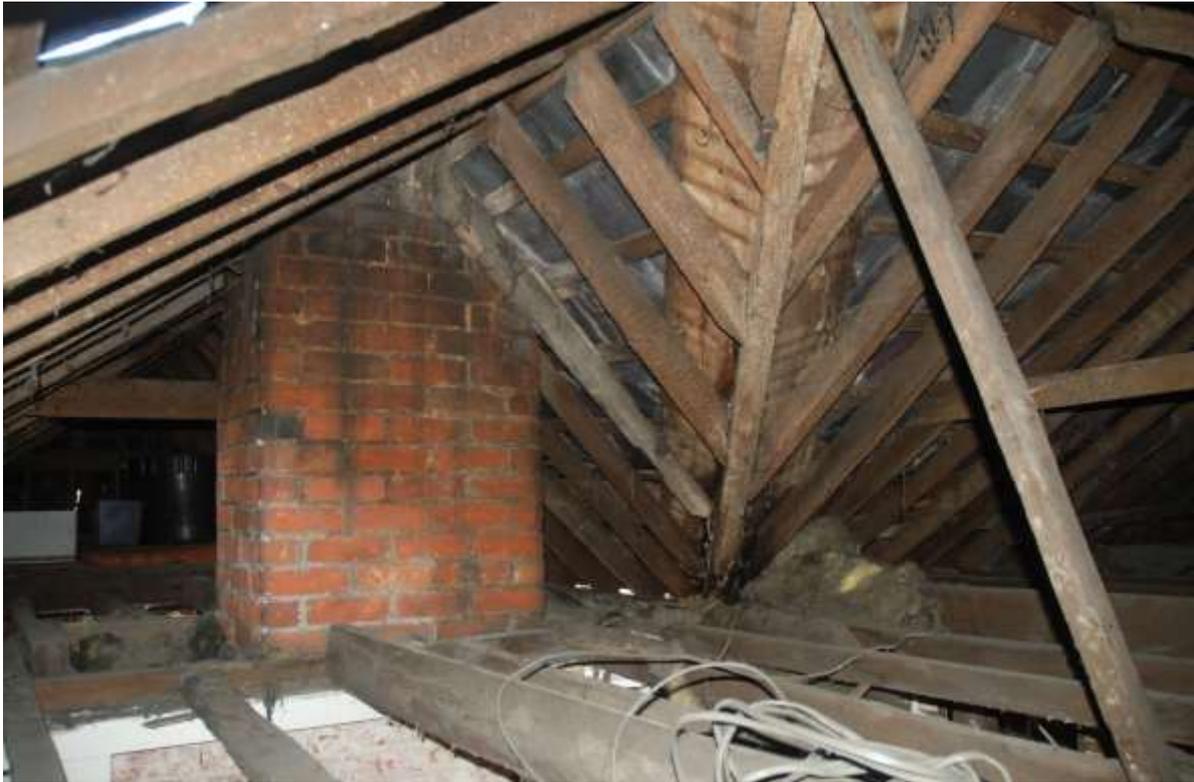
Fig.103: Roof space over room F3, facing ESE. View of the northern chimney stack and valley between the N-S and E-W hipped roofs. Water butt over eastern room F2 in background

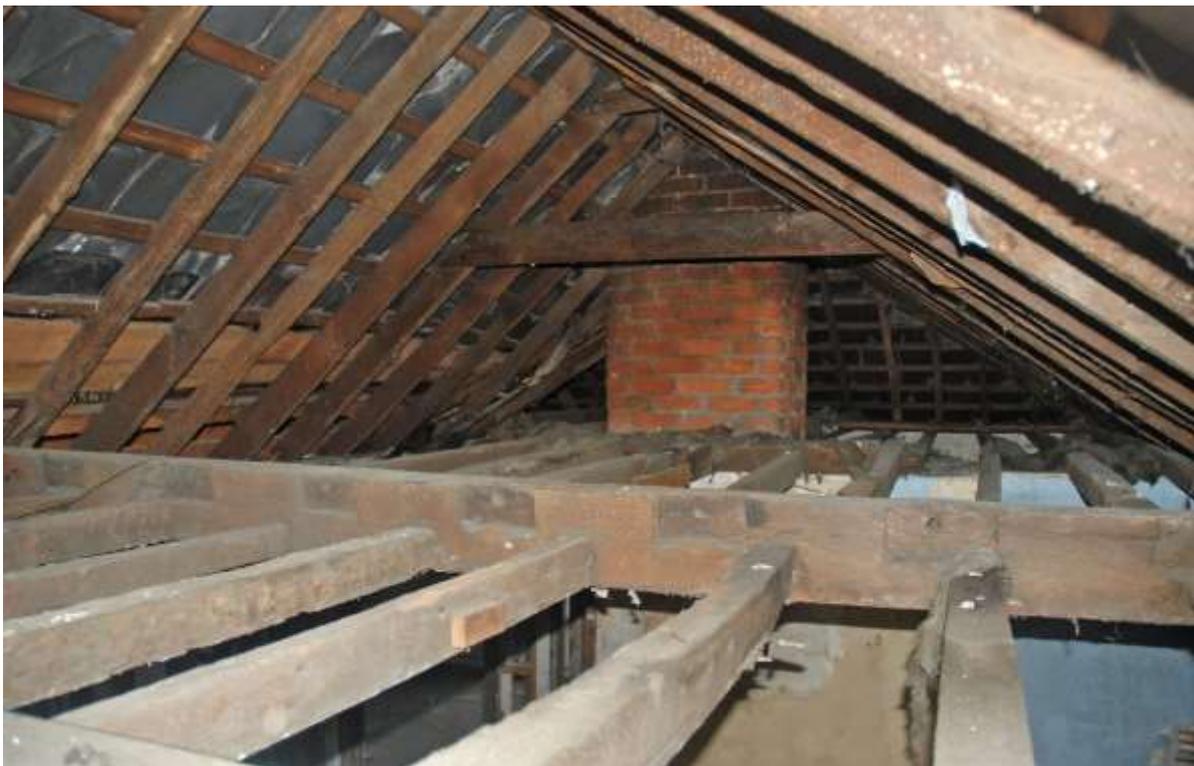
Fig.104: Roof space over room F1, facing WSW towards chimneystack and room F3

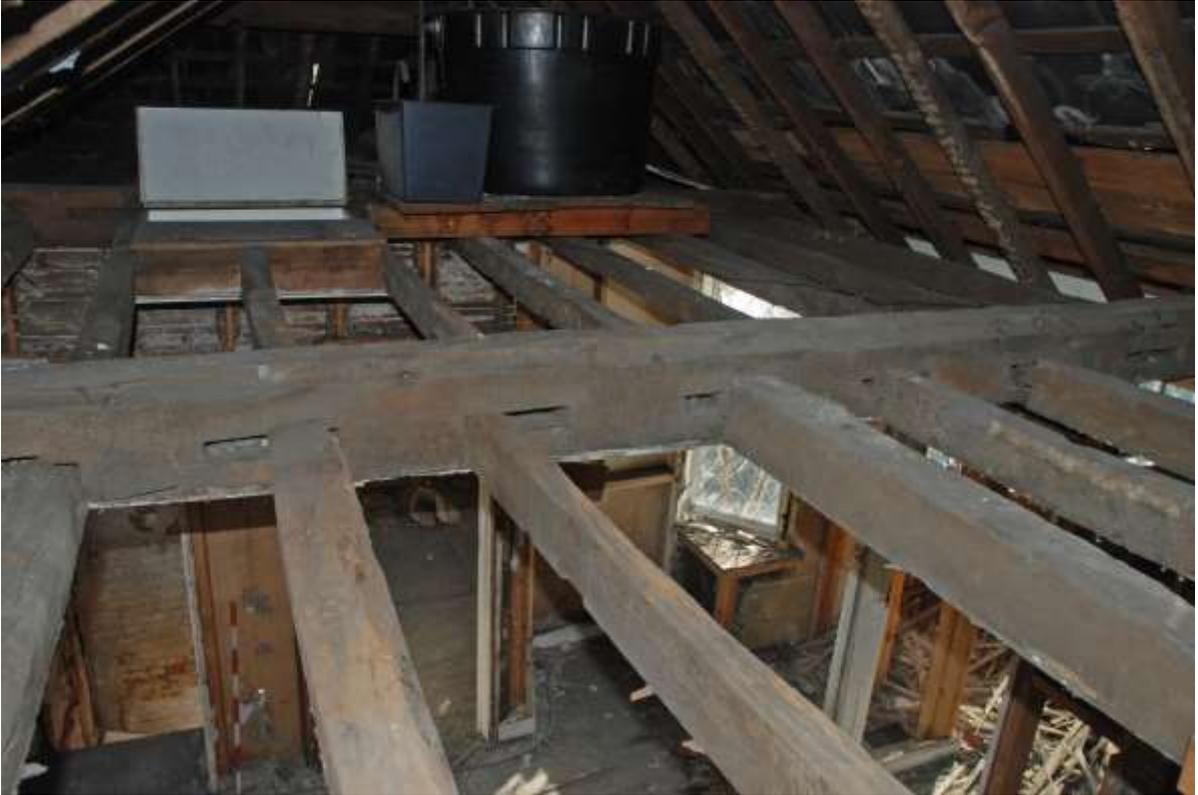
Fig.105: Roof space over room F1, facing ESE, towards eastern end and water butt over room F2, (bathroom). Note reused central beam with empty mortices and cut outs

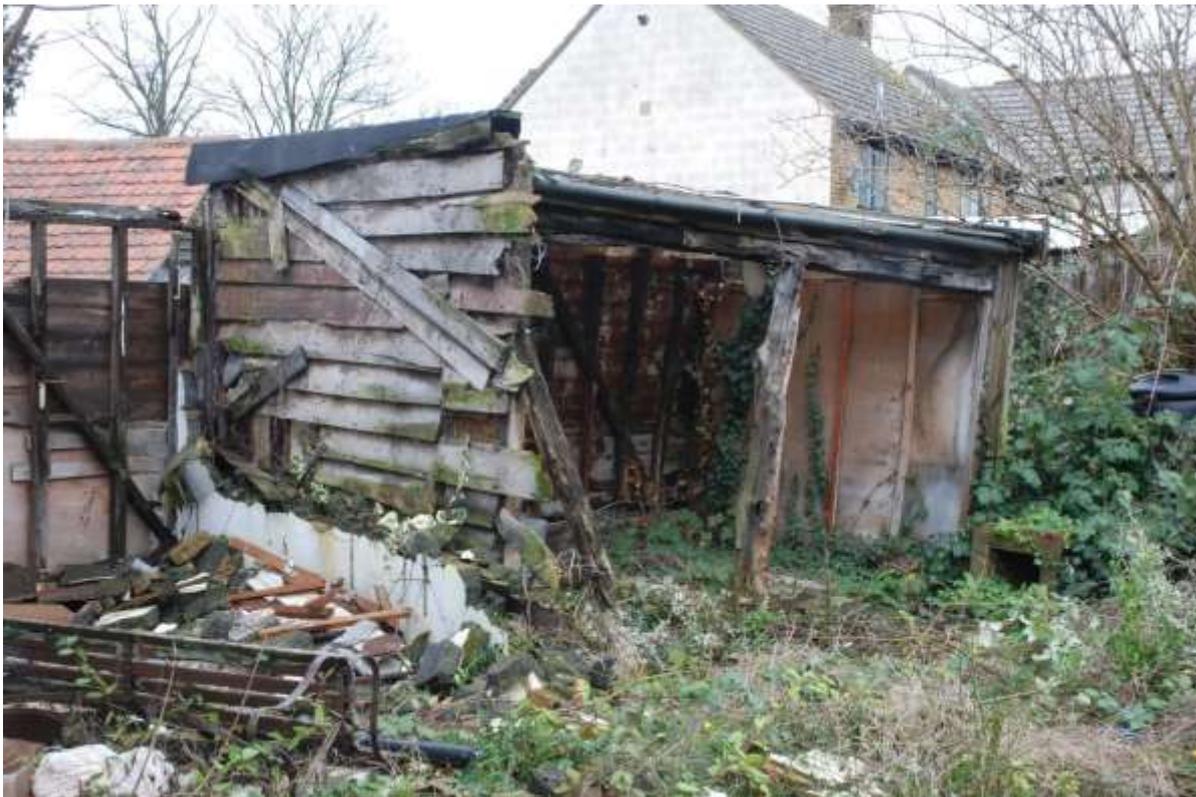
6.3.6.1 A single wooden structure survived in a very run-down state behind the eastern room of the main property. The structure measured 2.55m wide, (N-S), by 3.90m long, (E-W), along its rear northern side, and 4.02m on its southern frontage. The shed was open-fronted, with a central support post. The building had a shallow-sloping felt roof from north to south, (figs.106 and 107).

Fig.106: *Shed facing NE*

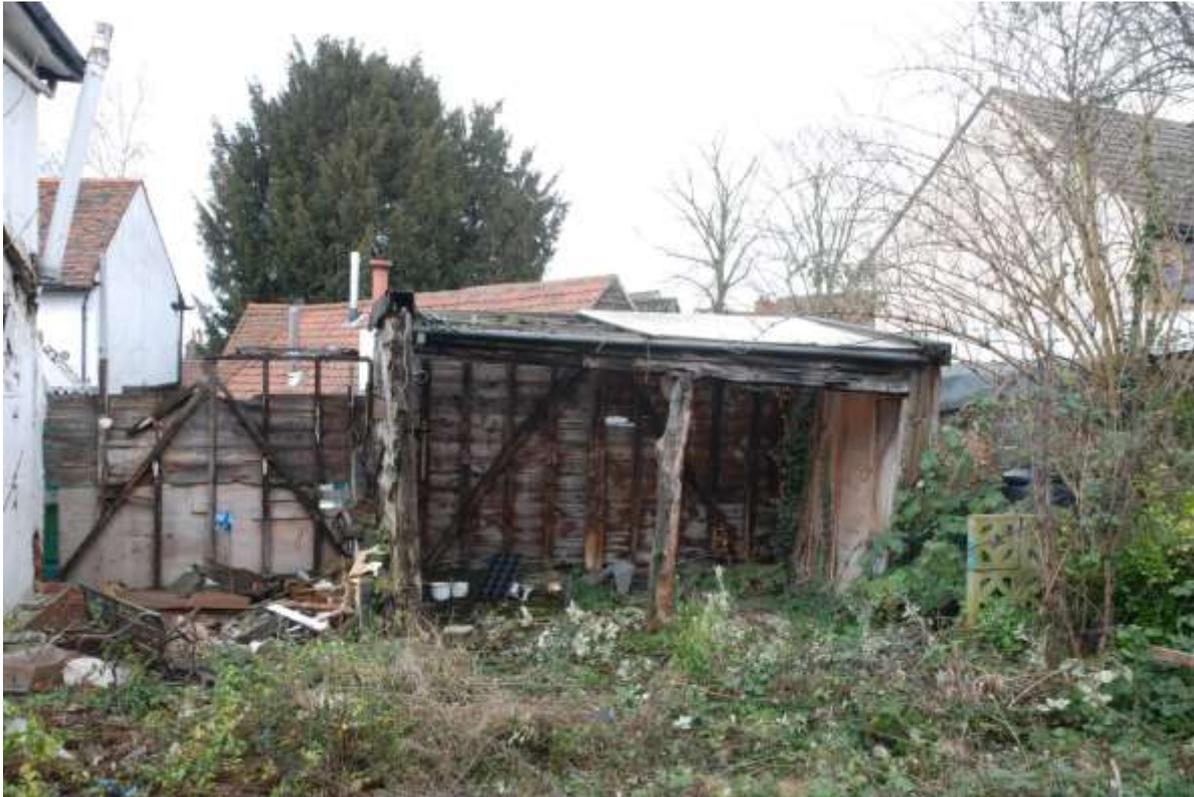
Fig.107: *Shed facing N, with timber frame of room G5 in left of frame*

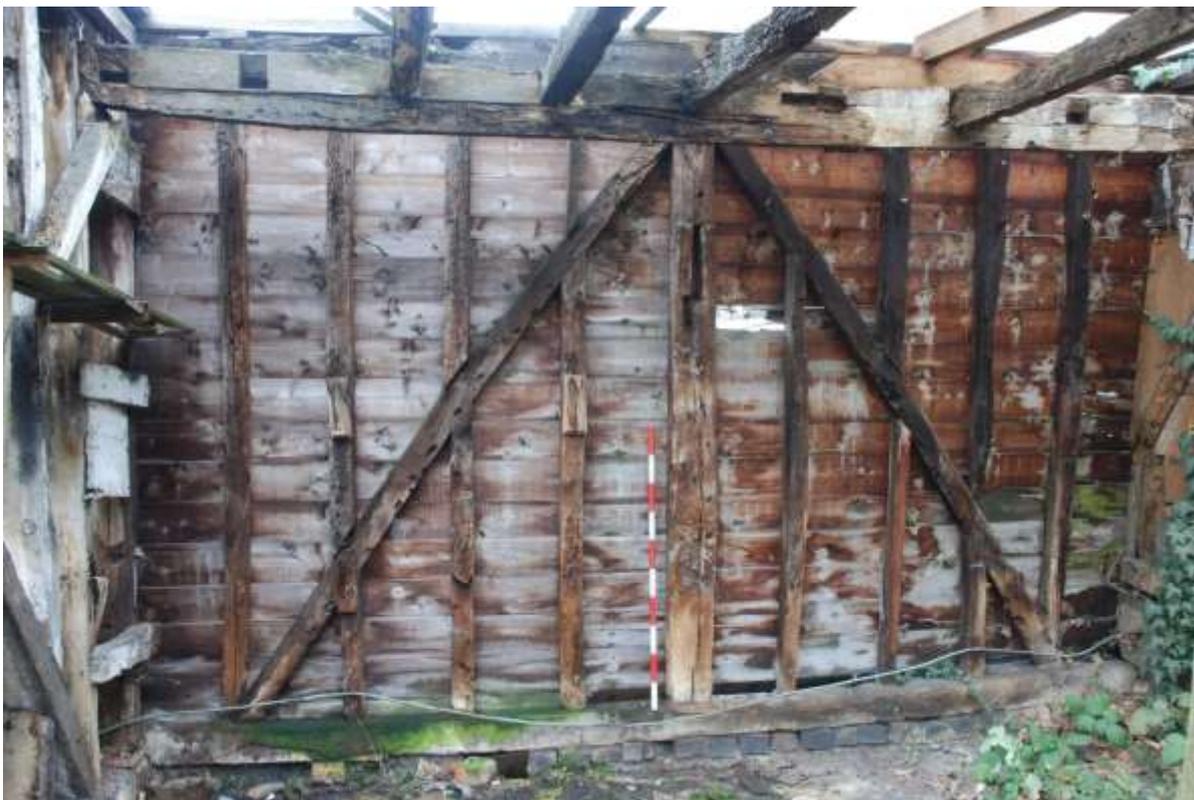
6.3.6.2 The building was ramshackle and appeared to be created from randomly collected materials, including what looked like weatherboarding, and large timbers containing empty mortices and peg holes; perhaps from the original building partly demolished during the modern extension works. The whole structure was raised off of the ground on a single bricks depth footing, (fig.108).

Fig.108: *Detail of the shed framework facing N, 1m scale*

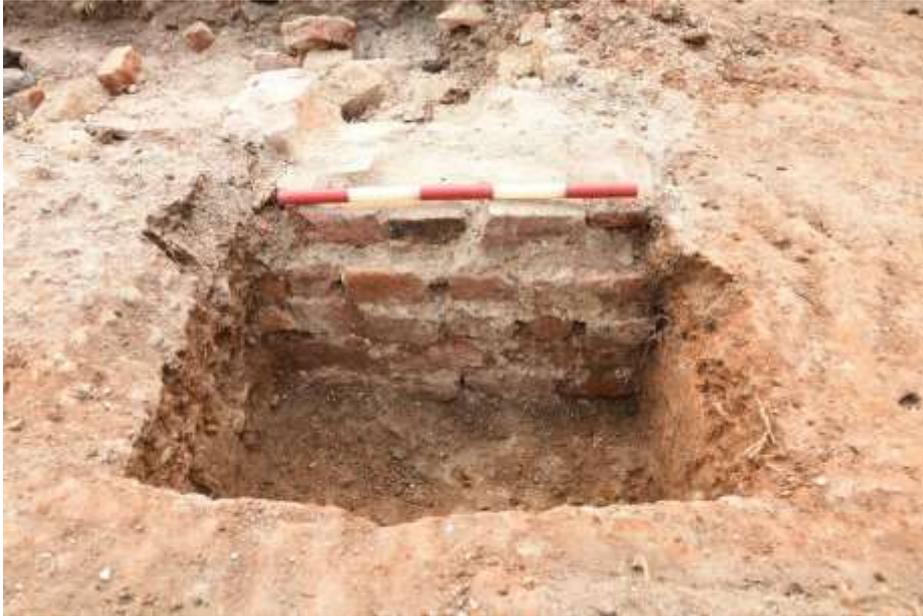
7.2.3 Natural was cut by [106], 0.50m from the eastern end of the trench and extended 2.70m south, the cut extended nearly the full width of the trench at 1.50m and continued

southwards, beyond the limit of excavation. The cut was vertical sided and filled with (108); a compacted orange-brown gravel and sand matrix. The cut was excavated to a depth of 0.38m to establish an indication of its profile. This feature formed an ‘overcut’ into which the cellar, [105], to ‘The Retreat’ was built.

Fig.110: *External face of cellar wall as exposed in cut [106], facing S, 0.50m scale*

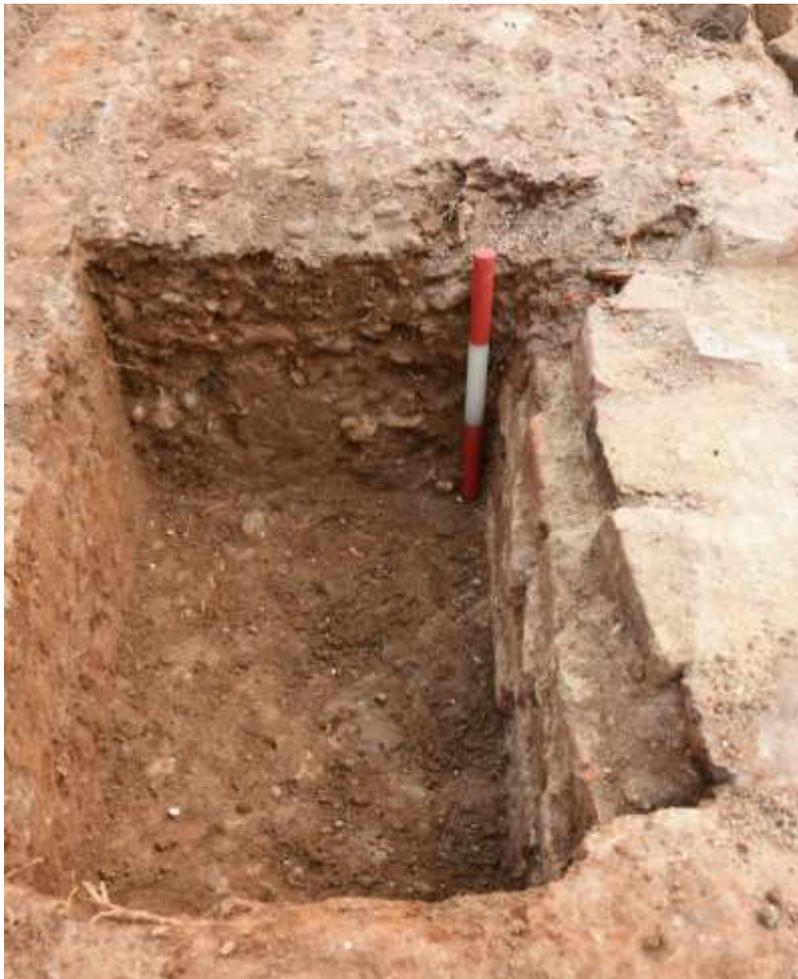
Fig.111: *Northwest corner of cut [106] facing E, 0.30m scale*

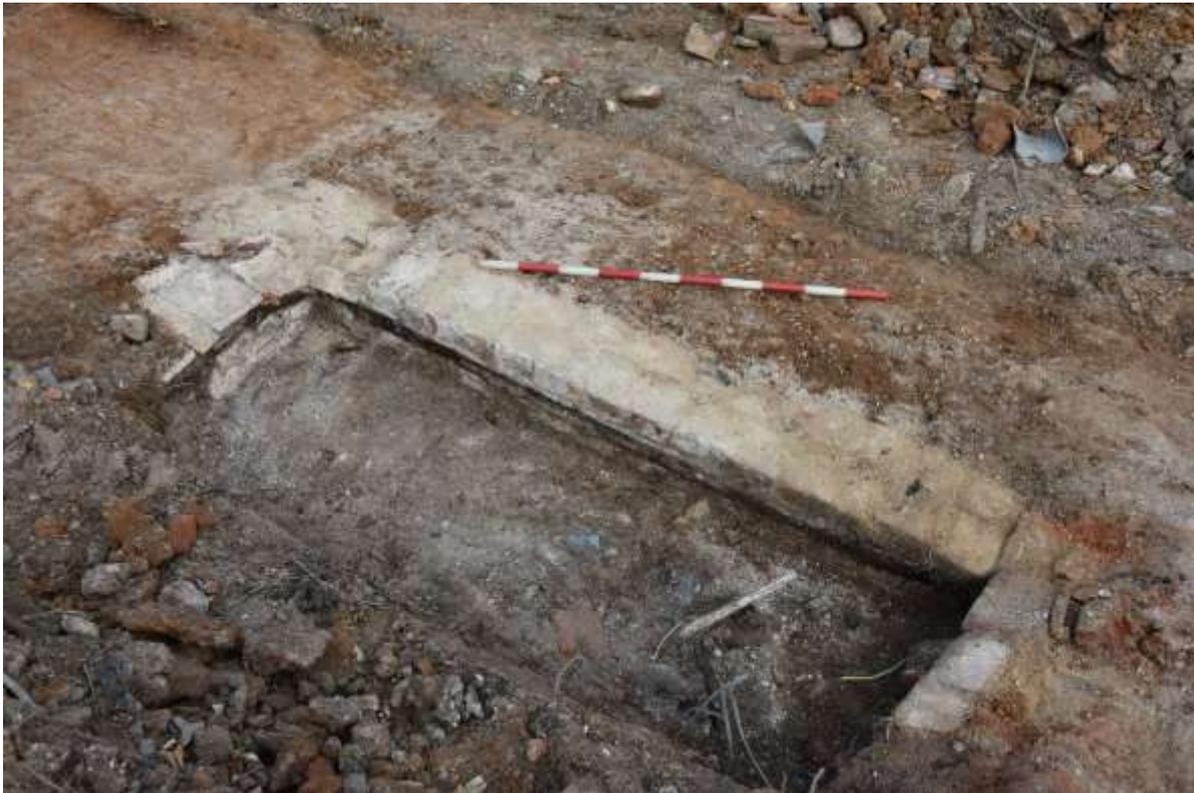
7.2.4 Cellar [105], was recorded more extensively during the building survey and so was only cleaned up during the evaluation. The walls exposed in Trench 1 represented the northwestern corner of the cellar. The backfill of the cellar, (104), was derived from the demolition of the standing property in late-2015, and was therefore of little archaeological value. Exposed brickwork of the cellar showed the same white-washed surface along with infrequent tile coursing in the western extent, and timber bracing along the northern face, (fig.112). Brick samples are dated to the late-18th century to early 19th century. Comparing the brickwork to the photos taken during the building survey shows that the walls had been reduced by up to five courses, the equivalent of approximately 0.30m during demolition of the site.

Fig.112: *Northeastern corner of the cellar facing NW, 1m scale*

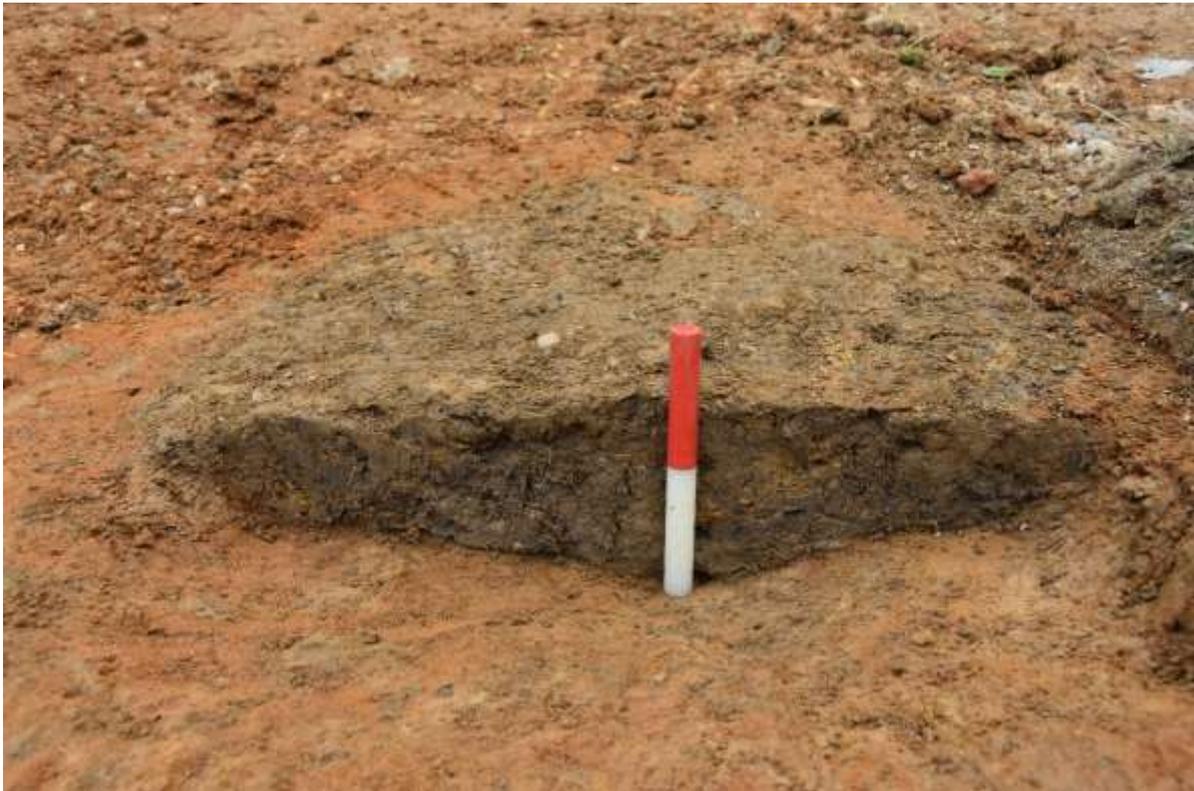
- 7.3.3** The second feature in the trench, [205], was a sub-circular cut on the western side of the trench close to the junction with Trench 1. The cut measured 0.70m wide, by up 0.11m deep, and had a shallow bowl-shaped profile. The fill, (204), was a mid-grey-brown compacted clayey-silt with frequent flinty inclusions, (fig.114). It would appear to have been a tree-throw or some relatively natural feature and produced no evidence of direct human agency.

Fig.114: Section through feature [205], facing SW, 0.20m scale

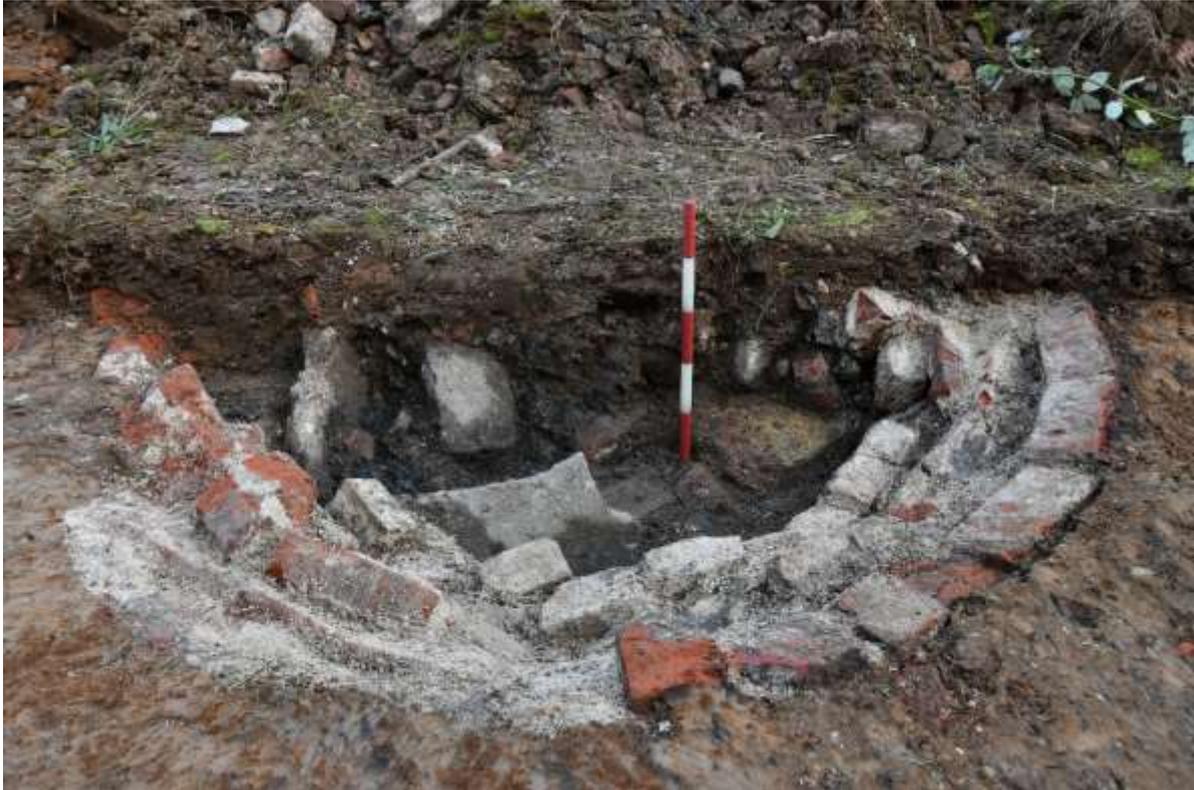
Fig.117: Soakaway [305], facing north, 0.50m scale

7.4.3 The natural was cut by a linear ceramic drain, [303], aligned approximately SSW-NNE across the trench. The northern end of the drain converged with the western edge of [305], a brick-built soakaway, exposed in the northern section of the trench. Soakaway [305] was brick-built, a single brick's width thick, bonded with a coarse white lime-mortar. The uppermost courses of brickwork exposed formed the springing point for what would have been a domed roof for the soakaway, (figs.117 and 118). The inner face of the soakaway had been lined by a thin cement render. The upper four courses of the dome had collapsed into the structure itself, forming part of the backfill of the structure (304). Probing with a road pin reached the base of the structure at c1.00m below dome level, the feature itself had external dimensions of around 1.80m in diameter, and internal of approximately 1.60m. Bricks taken from the structure were dated to pre-18th century, so probably represents an early feature on the site, or at least pre-dates the main structure of the previous standing building. The backfill of [305] included brick rubble, fragmentary concrete slabs, rotten wood, and more recent material such as plastic cabling and crisp packets. This would indicate that the truncation of the top of the soakaway and its backfilling occurred quite recently, probably during demolition of 'The Retreat'.

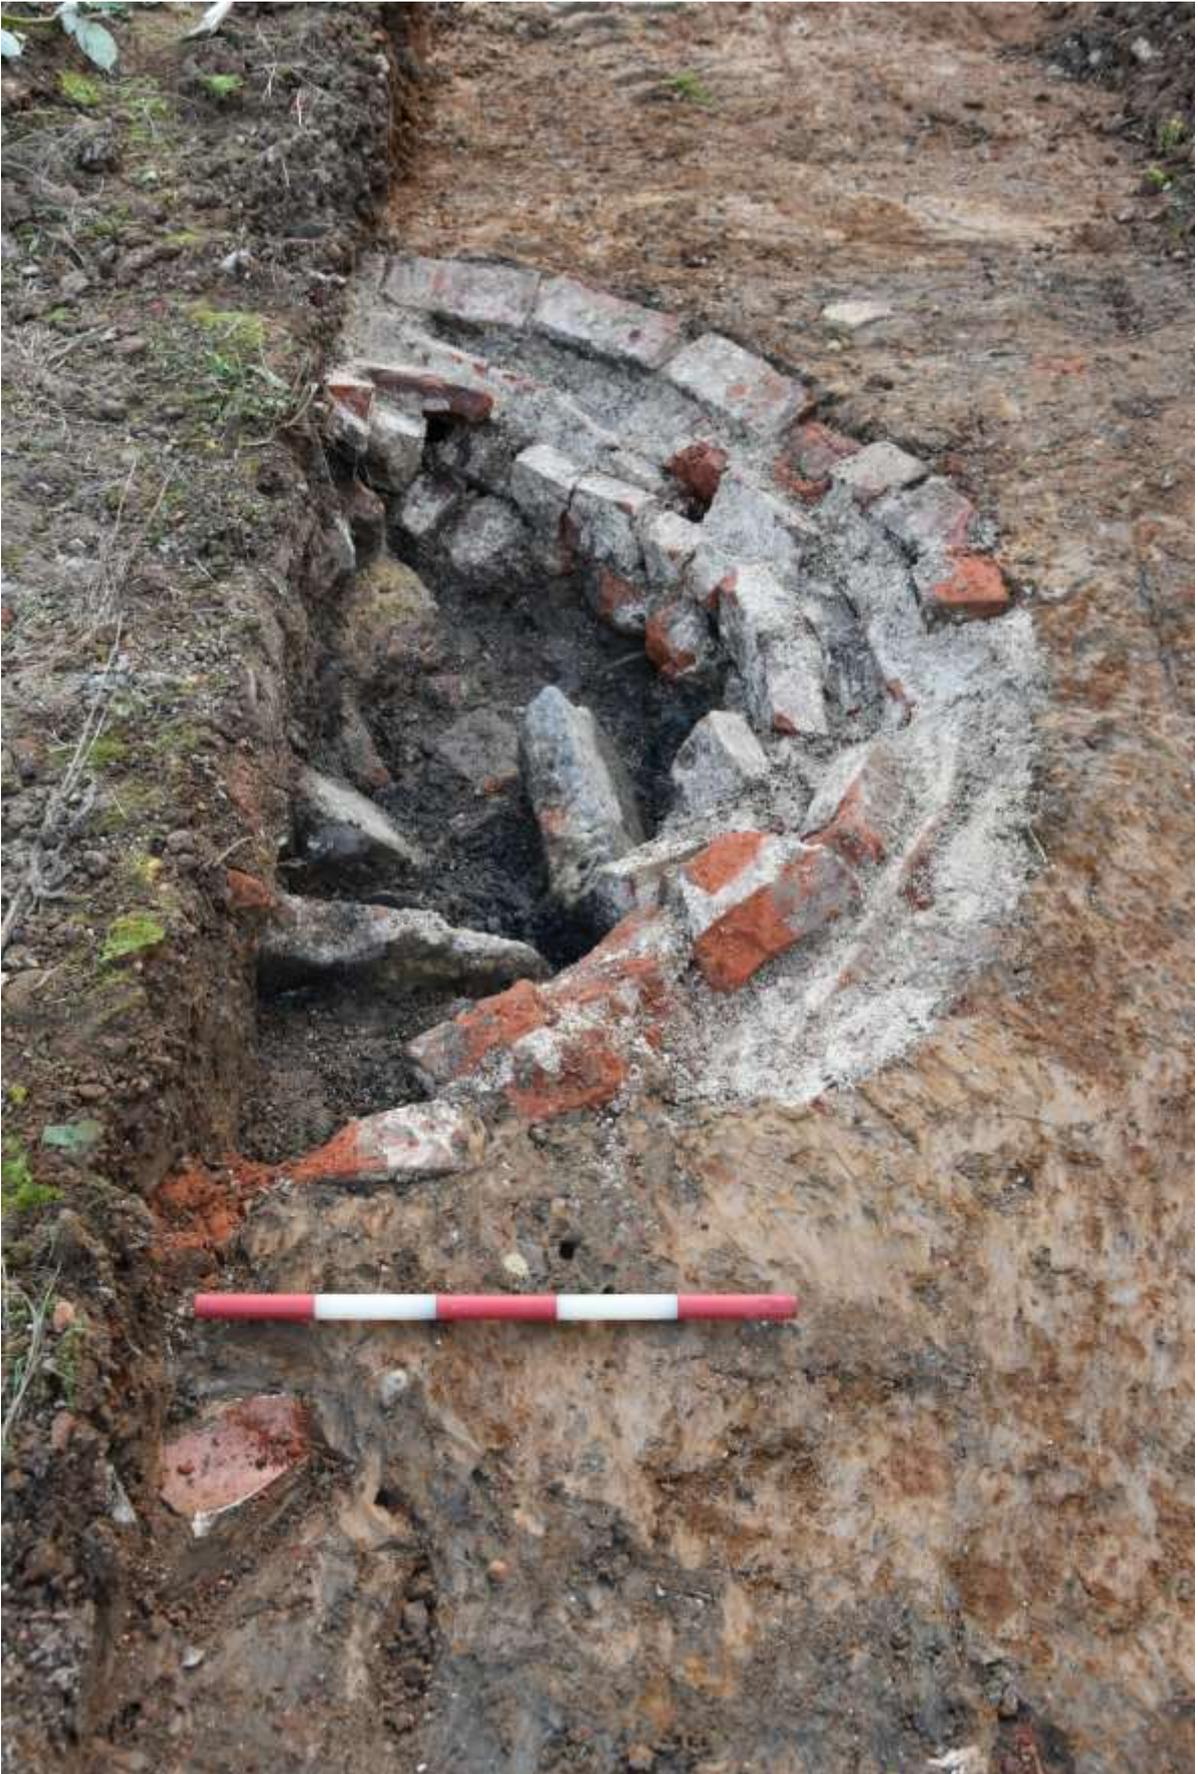
Fig.118: Soakaway [305], facing east, 0.50m scale

7.4.4 The soakaway, drain, and natural were all sealed below the same demolition derived levelling deposits, (301), as observed elsewhere on site.
