**THAMES WATER
MAINS REHABILITATION WORKS,
WATERMILL WAY, SOUTH DARENTH, DARTFORD
DA4 9BB**

An Archaeological Watching Brief

Site code: WMW17
Approximate site centre: NGR TQ 5599 6947
Scheme 1004

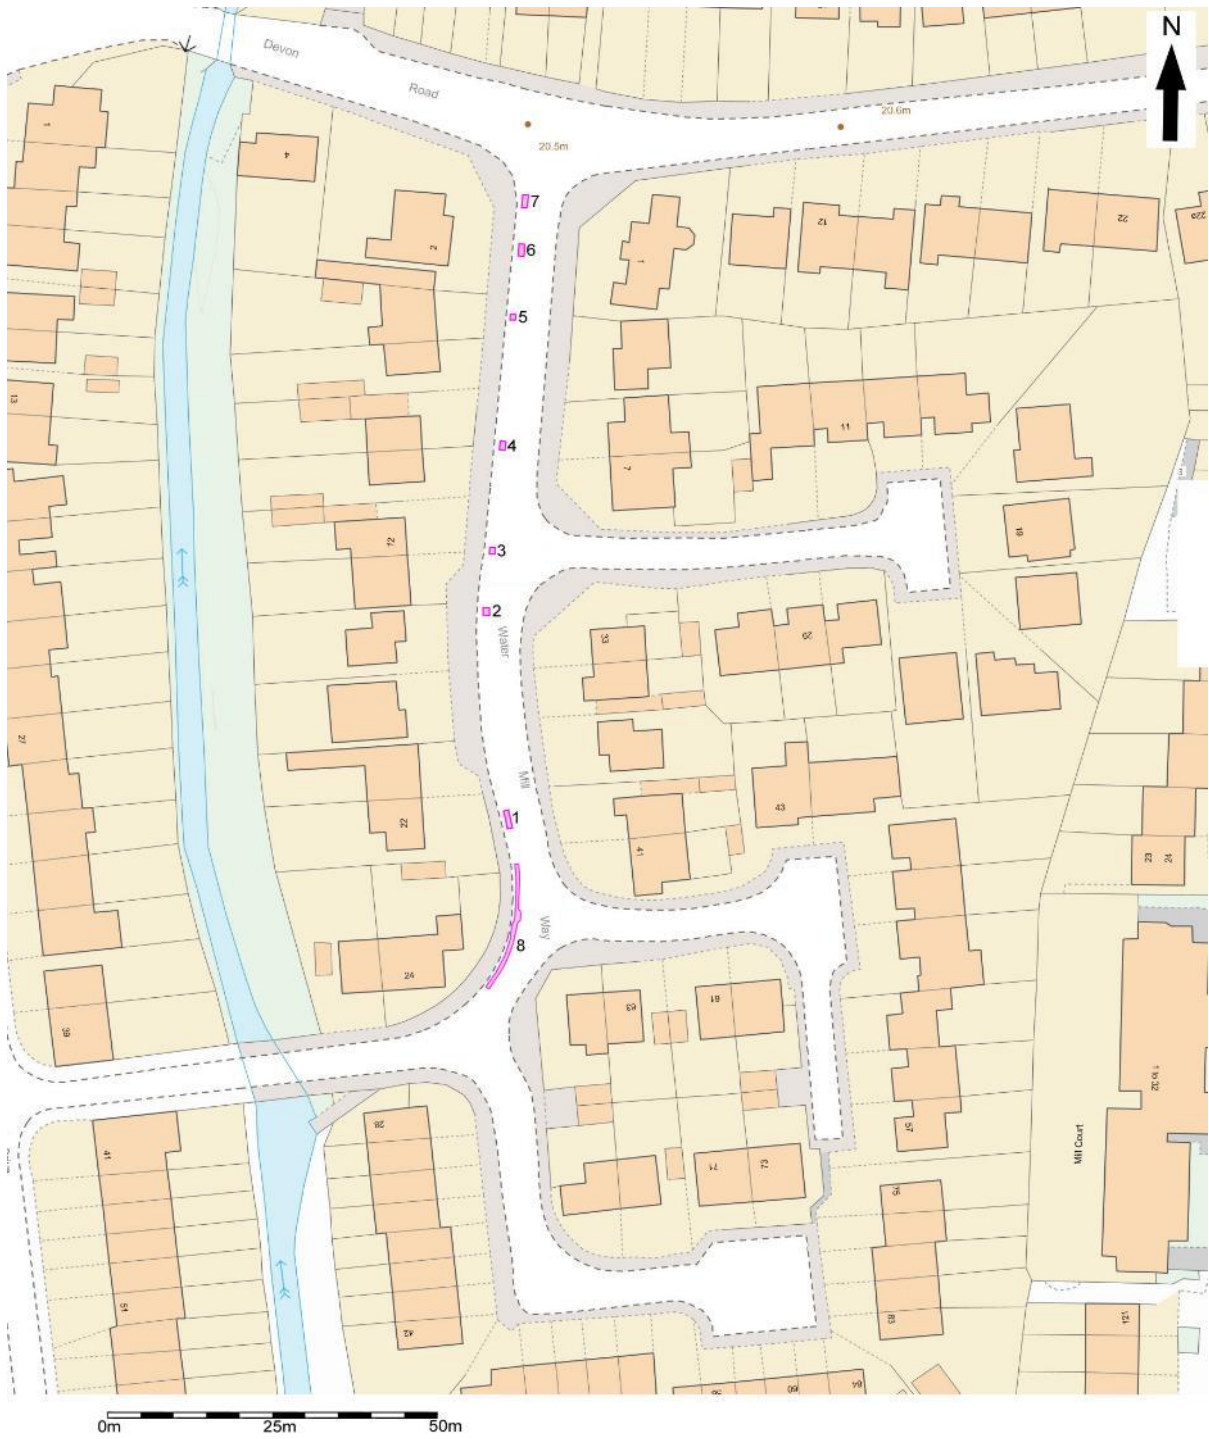
Figure 5: Trench locations, marked in pink. Map base adapted from the City of London Geocortex Viewer.

7.2 The watching brief was conducted over the course of two site visits between the 28th September and 24th October 2017. The results will be discussed in the context of these visits. Observed trenches are shown on fig.5 below and should be referred to throughout.

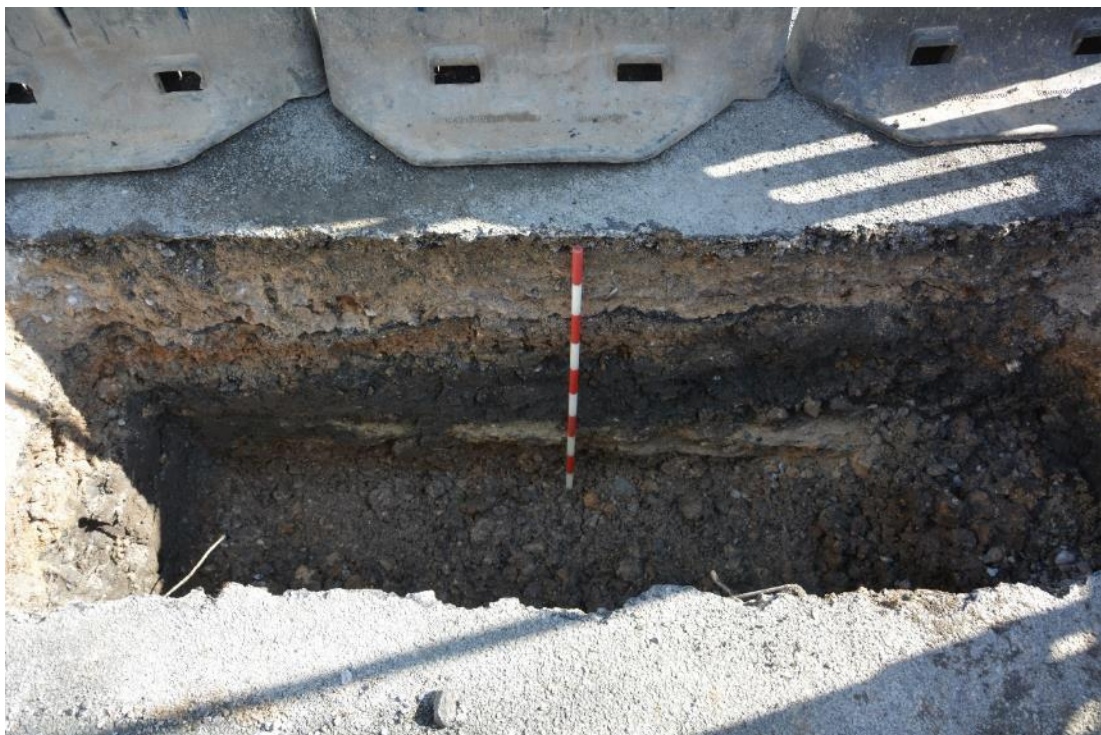
7.3.2 The stratigraphy observed across all seven trenches was broadly similar, comprising 30mm of the existing black asphalt road surface (1) overlying 370mm of brick and tile rubble, and gravel hardcore road base (2) (fig.6).

Figure 6: Trench 1. Gravels (3) and (4) below road surface and make up (1) - (2). Facing E. Scale 1m.

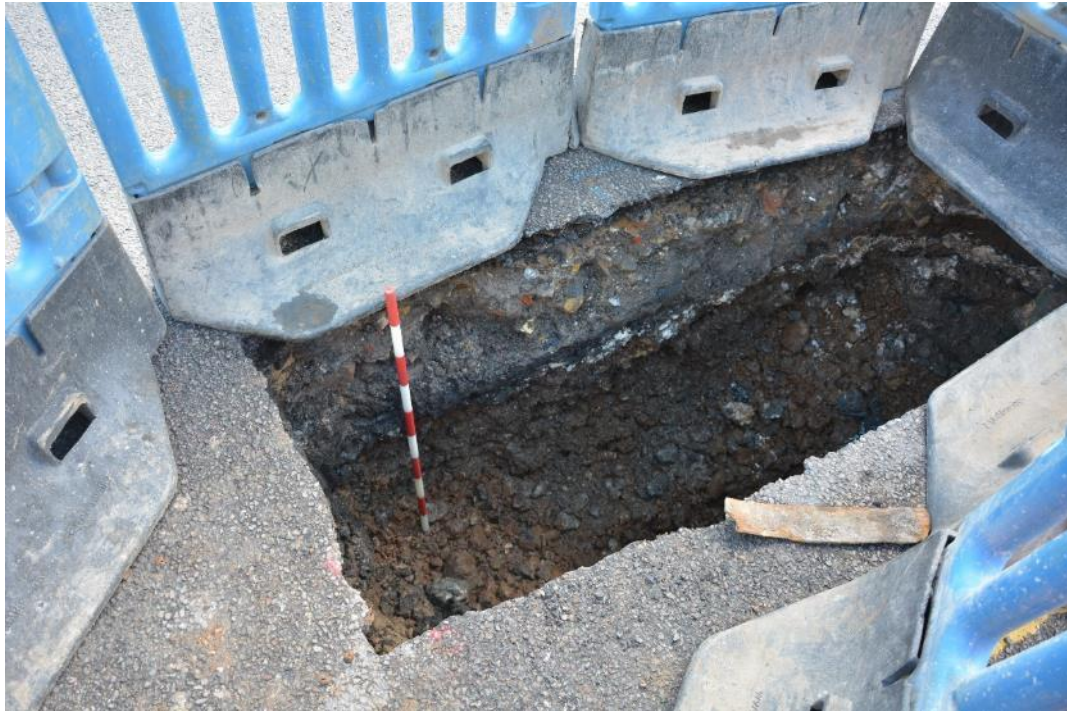
7.3.3 Below the rubble road base a 140mm lens of black gravels was observed in all seven trenches, stretching across the trench entirety (3). This sealed at least two slightly different types of coarse gravels, orange-brown and grey-brown in colour (4) taken to continue below the level of excavation (fig.7).

Figure 7: Trench 6. Dark orange gravels (4) can be seen below a thin black lens (3) and rubble abundant road make up (2). Facing SE. Scale 1m.

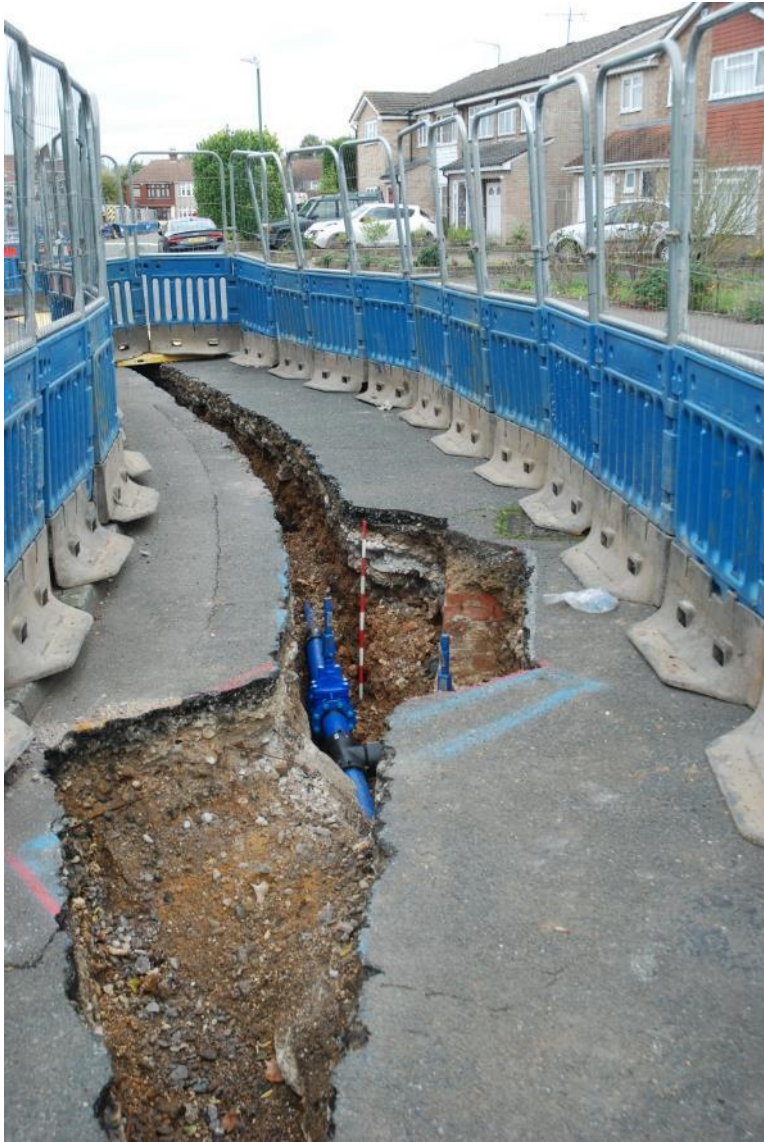
7.4.3 The observed stratigraphy was broadly similar to trenches 1-7, comprising 80mm of compact black asphalt road surface (1) overlying 200mm of concrete and rubble (5), taken to be a bedding layer. This overlay a 170mm thick black gravel lens (3), as observed in trenches 1-7, above a further 330mm of orange gravels (4) (fig.8).

Figure 8: Trench 8. Road make up and gravel layers, (5) and (4). Facing NNE. Scale 1m.

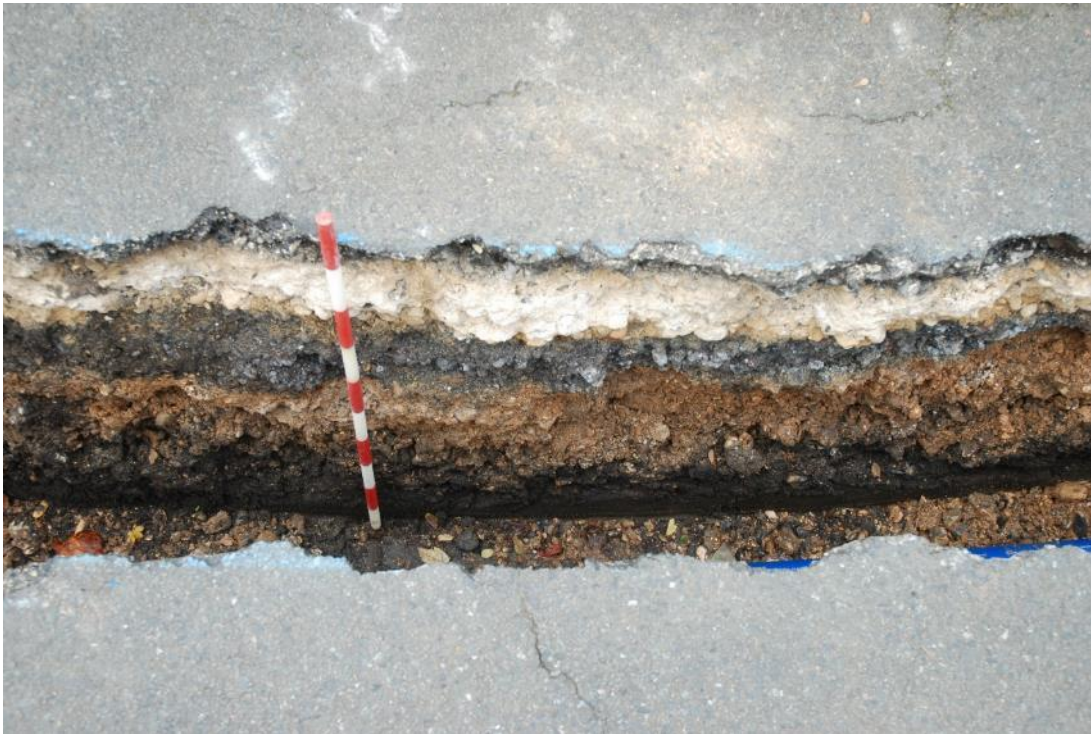
7.4.4 The gravel layers described above sealed at least 320mm of dark grey-black moderately wet silty clay (6), taken to continue below the level of excavation (figs 9-11).

Figure 9: Darker silty clay (6) seen towards the trench base. Facing NW. Scale 1m.

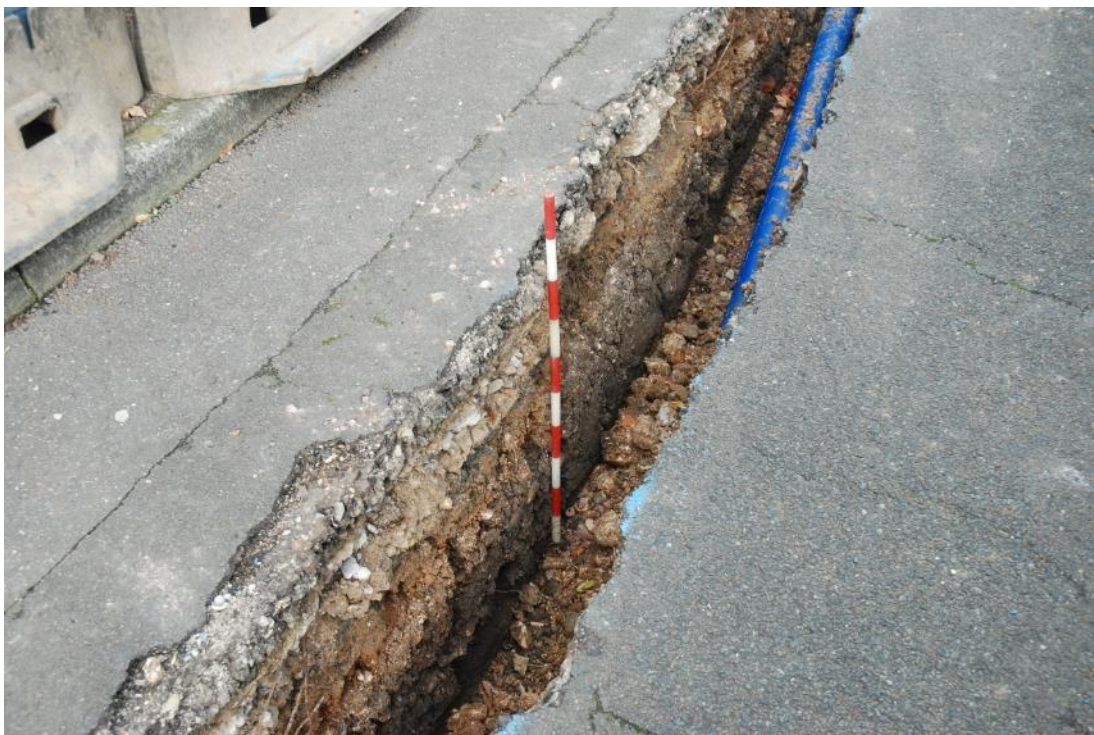
Figure 10: A similar stratigraphy of road make up and gravels overlying a darker, wetter clay was seen throughout Trench 8. Facing NW. Scale 1m.

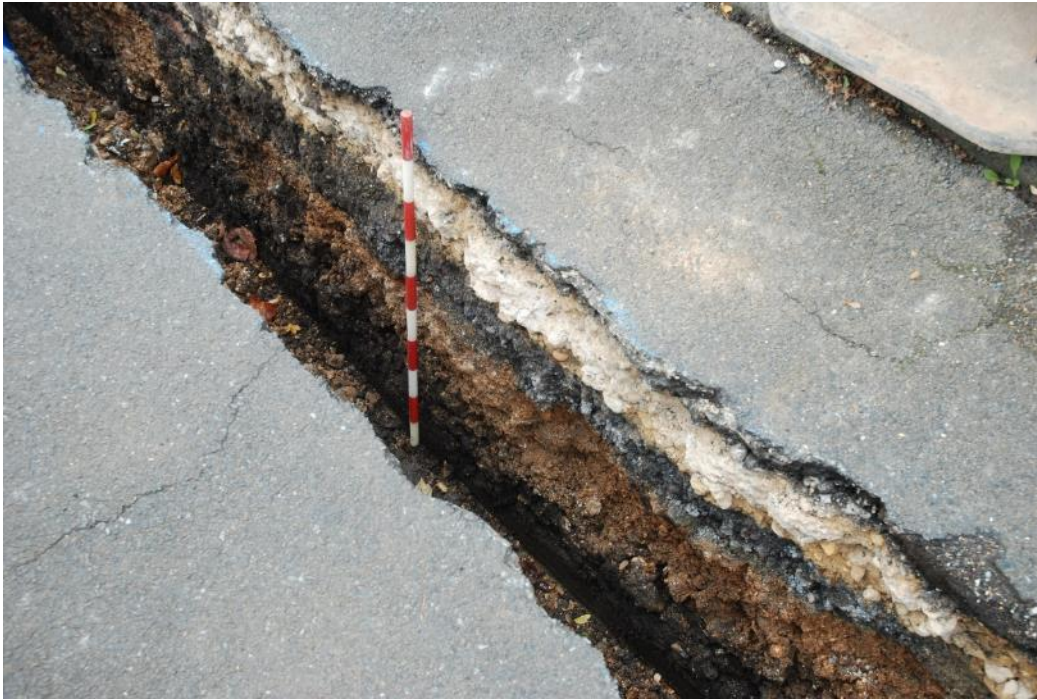
Figure 11: Detail of the concrete bedding layer (5) for the asphalt road surface (1) observed in Trench 8. Facing SW. Scale 1m.
