**H582 EUSTON WATER MAIN
DIVERSION –
TRIAL WORKS IN LONDON ZOO (ZSL),
GLOUCESTER SLIPS CAR PARK,
REGENT’S PARK NW1 4RY**

An Archaeological Watching Brief

January 2018

Site code: ZSL17

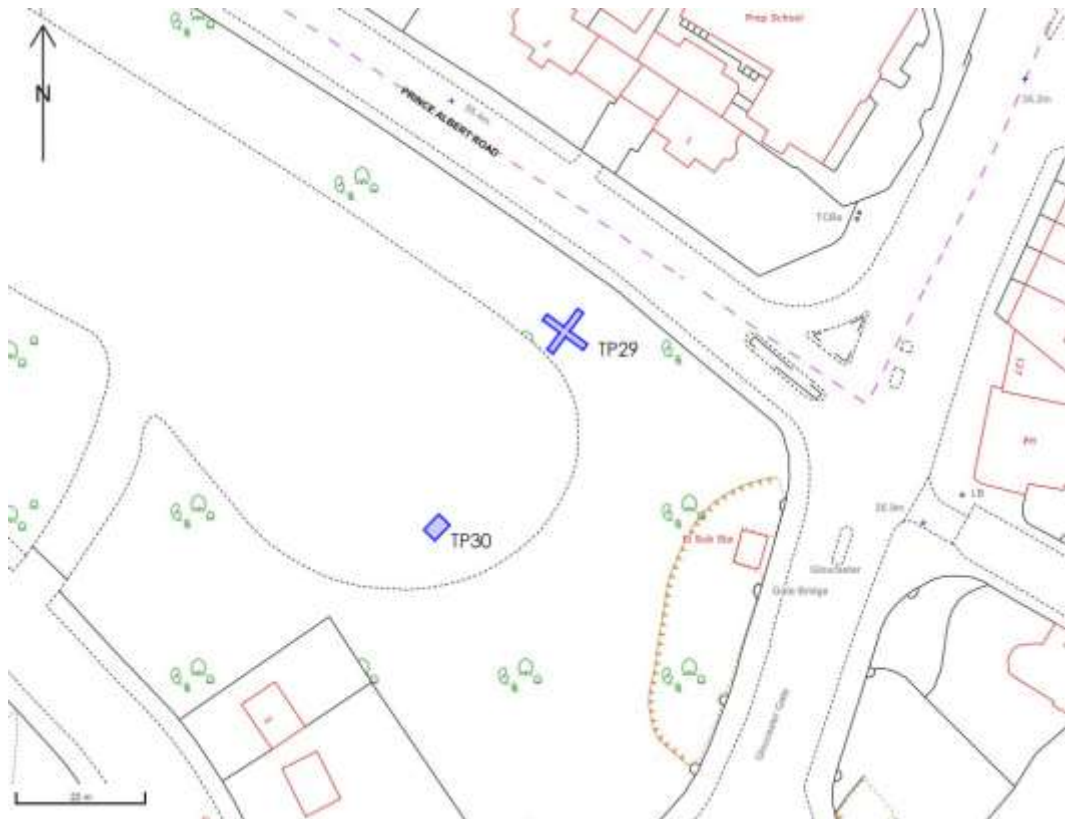
Figure 7: Locations of Trial pits 29 and 30 marked in blue.

- 4.6.1** Between the 21st February and 28th February 2017 Compass Archaeology conducted a watching brief of two trial trenches, located at the eastern end of Gloucester Slips Car Park, undertaken to establish the practicalities of re-routing the mains water supply ahead of the construction of the HS2 rail line (fig.7).

- 4.6.3** The stratigraphy recorded in both trenches was consistent with the known archaeological sequence of the area: in TP30 a large deposit of post-Second World War bomb debris was recorded, overlying siltier layers; TP29 recorded a less well defined layer of rubble cutting into natural London Clay. The rubble observed in both trenches was taken to be the result of a large scale infilling event which took place between 1941 and 1943, after the canal fell out of use (figs.8 - 9).

- 4.6.4** No features consistent with the canal construction were identified, nor were any traces of earlier activity. Natural London Clay was recorded in TP29 only, at a depth of 0.7m (34.76mOD), sloping southwards to 1.1m (34.36mOD).

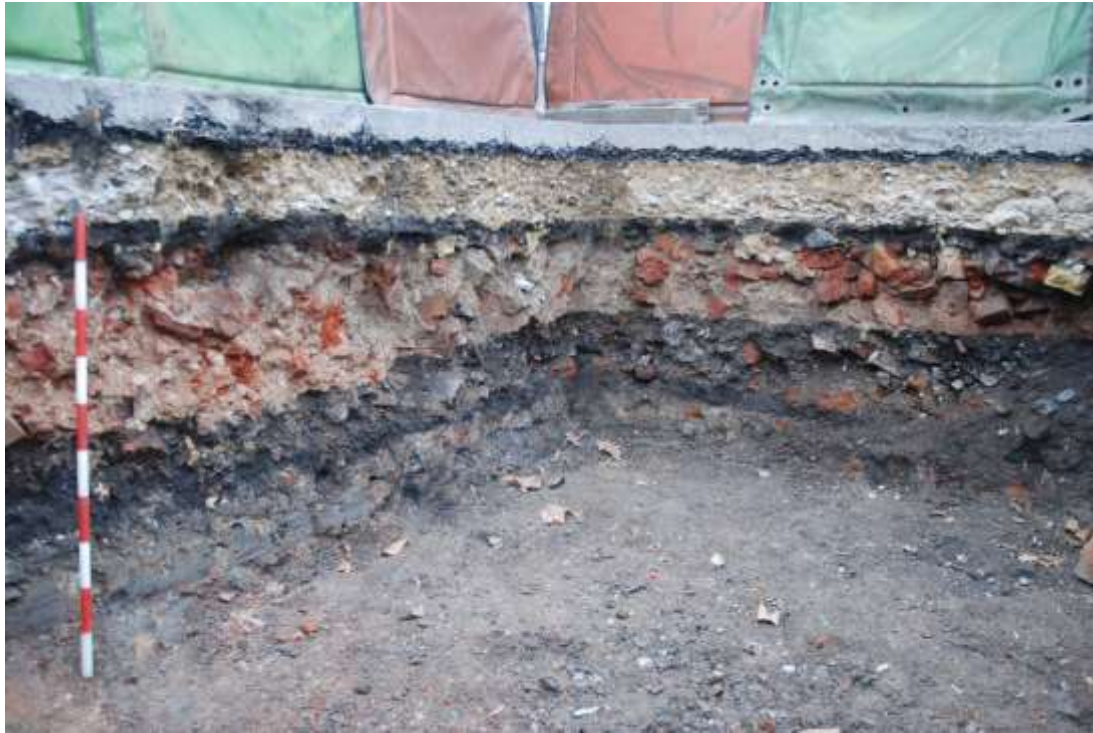
Figure 8: Extended and completed trench, showing the northeast and northwest facing sections. Facing approximately S. Scale 1m.

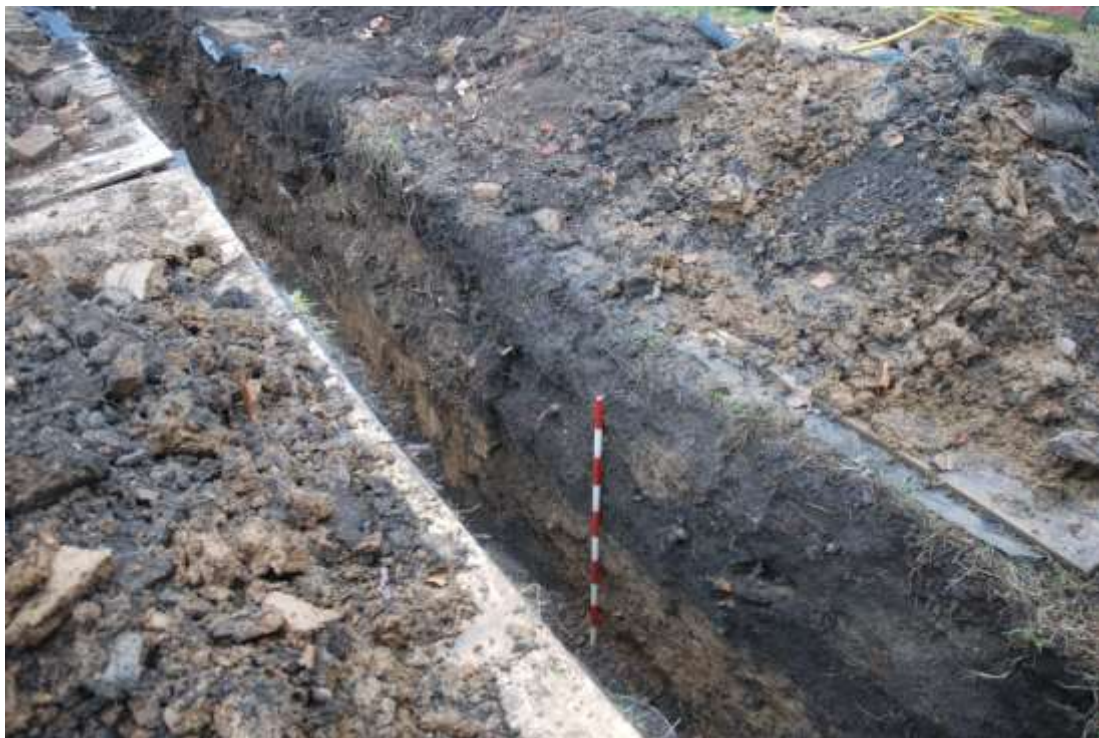
Figure 9: View of TP29 from the northern end, showing topsoil (8) overlying natural clay (11) to the right of the scale, and the beginning of the rubble (10) to the left, with the natural clay sloping downwards towards the canal. Facing approximately SW. Scale 1m.

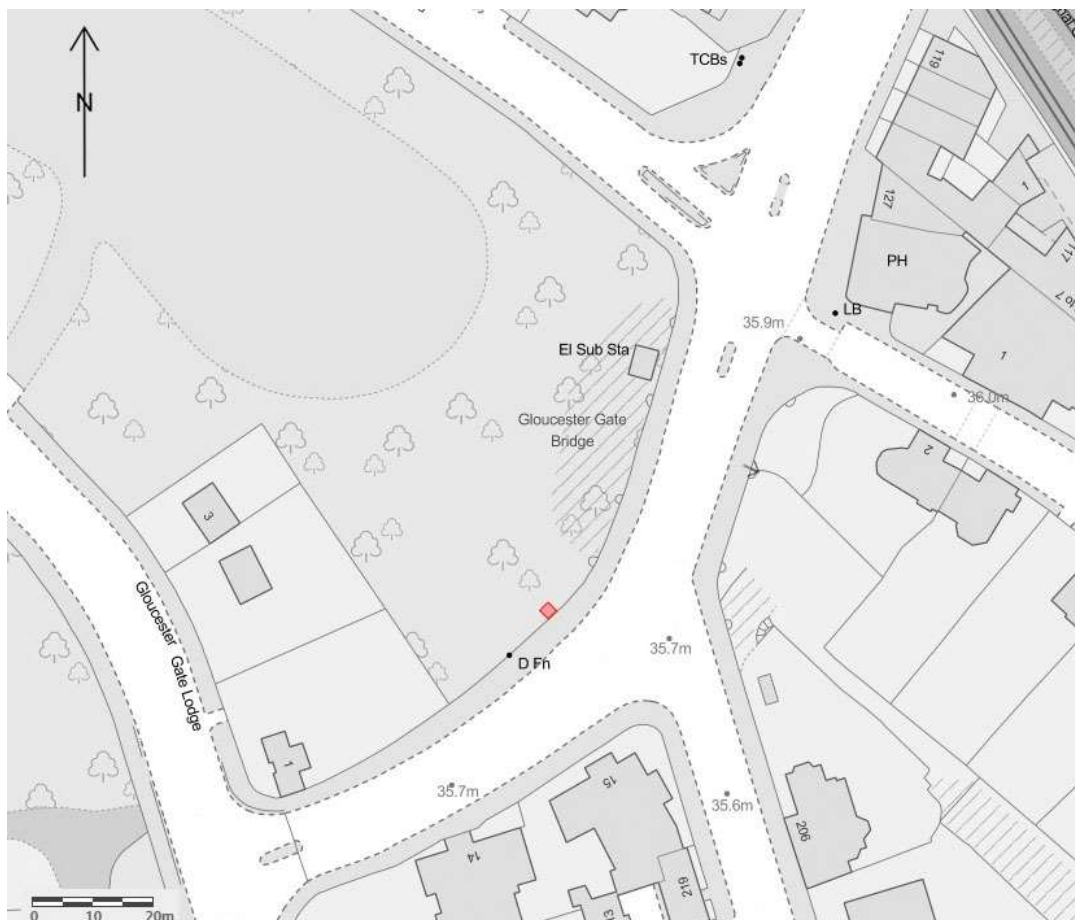
Figure 10: Trench location, marked in red.

- 5.1 The groundworks entailed the completion of a single trench located against Gloucester Gate Lodge wall, at the south-eastern end of the ZSL Gloucester Slips Car Park. (fig.10). The trench was aligned north-west – south-east, measuring 2.5m in length x 2.5m in width x 1.2m in depth. A small sondage was dug on the southeastern side abutting the exposed wall foundations to a depth of c1.4m (33.78mOD).

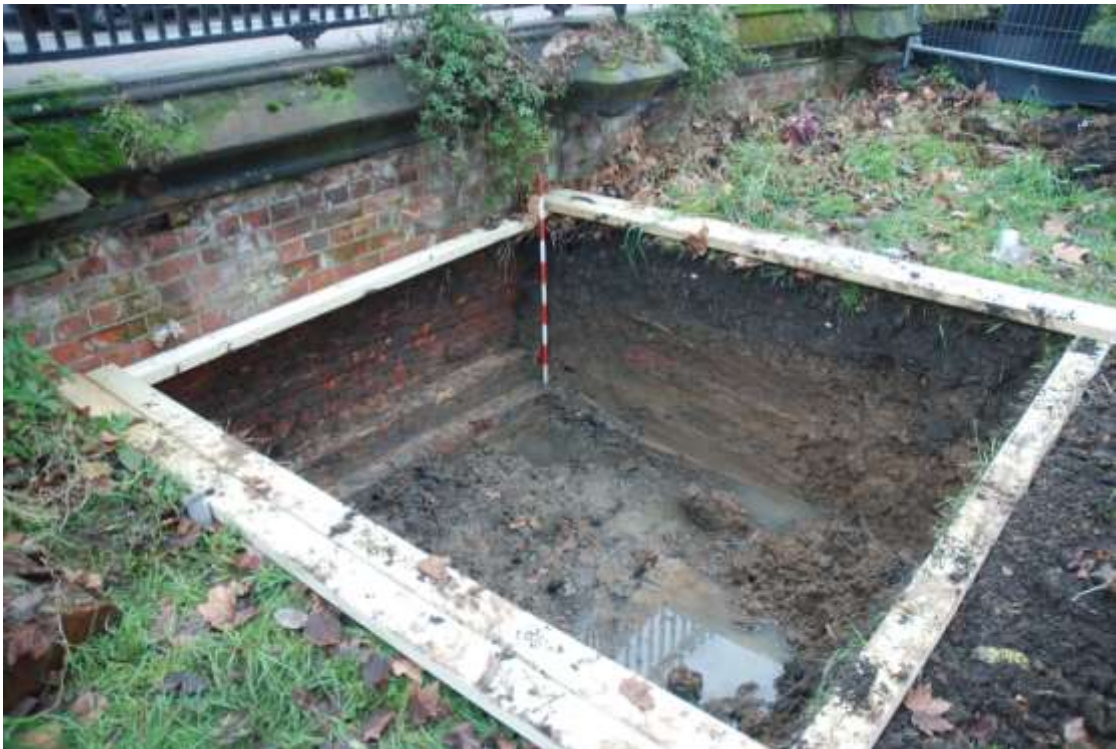
Figure 11: Trench, at a depth of 1.0m. The stepped foundations of the wall can be seen to the left of the scale. Facing S. Scale 1m.

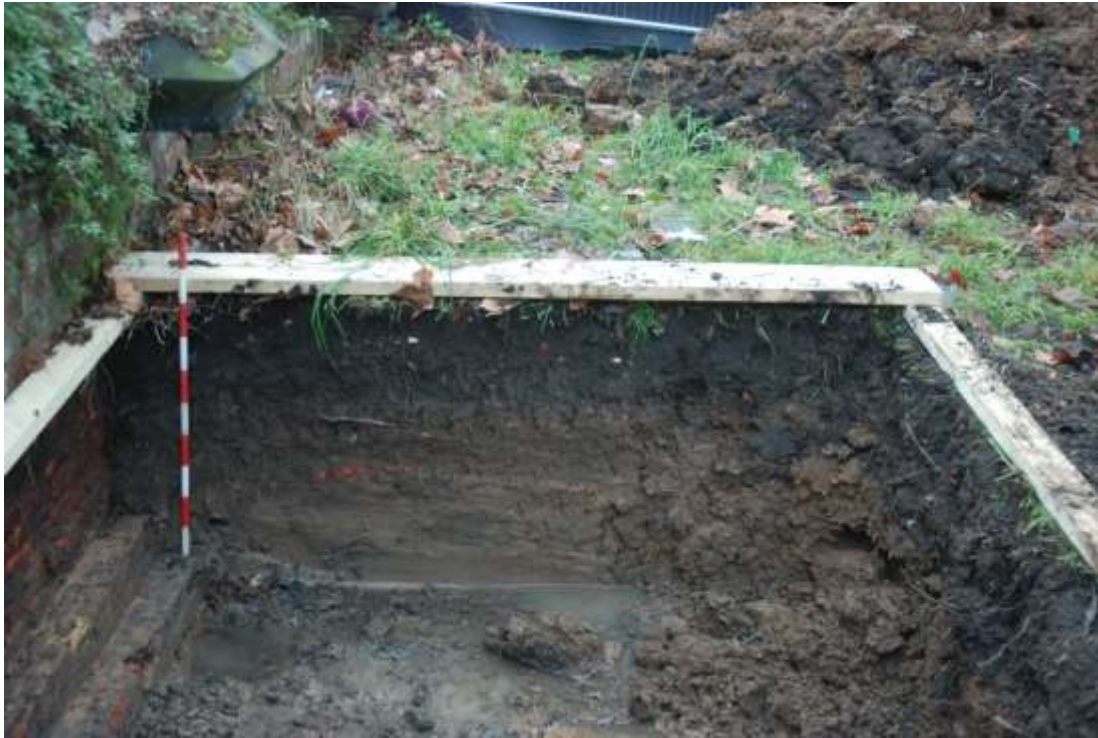
- 7.3 The stratigraphy comprised 100mm of very dark brown loamy topsoil (1), abundant with roots, small fragments of brick and general modern detritus – including pens, cans, bottles, litter etc. This overlay 300-500mm of homogenous mid to dark brown silty subsoil (2) observed across the trench entirety. The layer was moderately abundant with roots and contained relatively infrequent gravels and fragments of Ceramic Building Material (CBM).
- 7.4 Natural geology was encountered at a uniform depth of 400mm below ground (34.7mOD). The layer (3) comprised mid to light brown-orange sticky clay, with frequent grey patches and charcoal flecks and infrequent large tree roots. The clay is taken to continue below the trench base, which was reached at 33.78mOD (fig.12).

Figure 12: North-east section showing topsoil (1) and subsoil (2) overlying natural clay (3) and existing wall foundations [4]. Facing SW. Scale 1m.

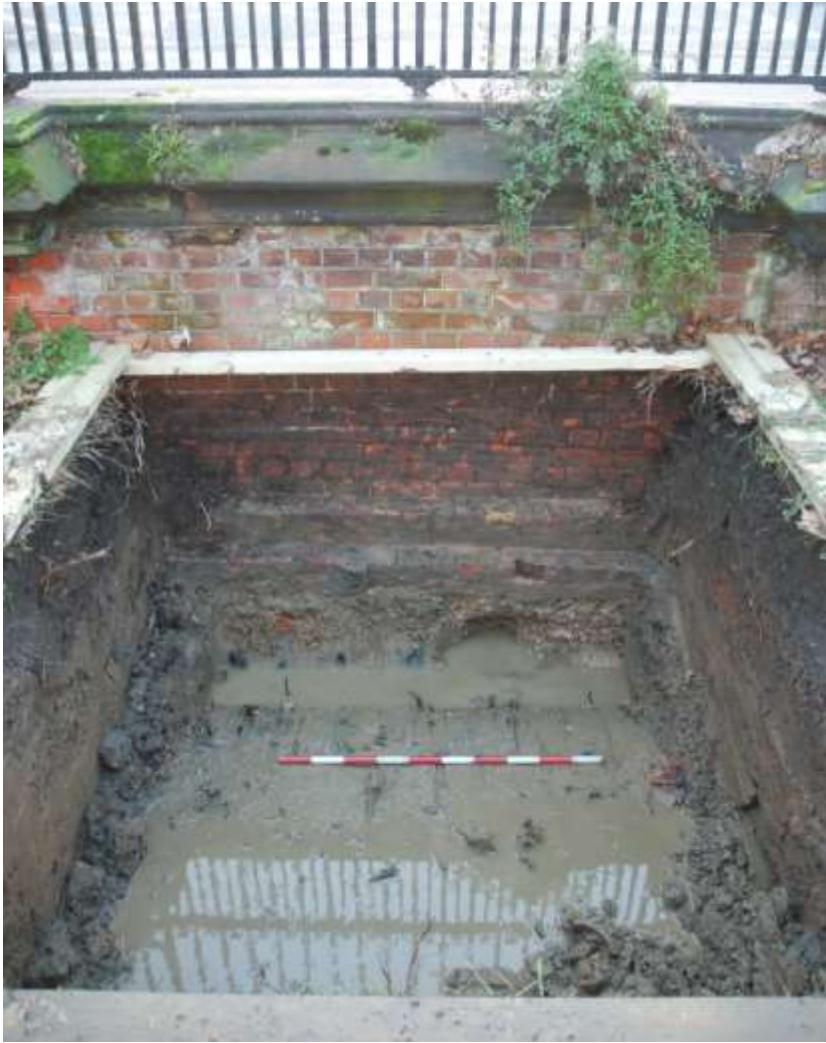
- 7.7** At a depth of 0.6m the wall stepped out northwards into the trench by 110mm, marking the first of two foundation courses. The upper course comprised headers measuring a total of c180mm in thickness, with the second row below extending a further 120mm into the trench x c180mm in thickness. The base of the wall was encountered at 34.028mOD (fig.13).

Figure 13: Completed trench, showing foundations of wall [4], water ingress from gravel (5) and natural clay (3). Facing SE. Scale 1m.

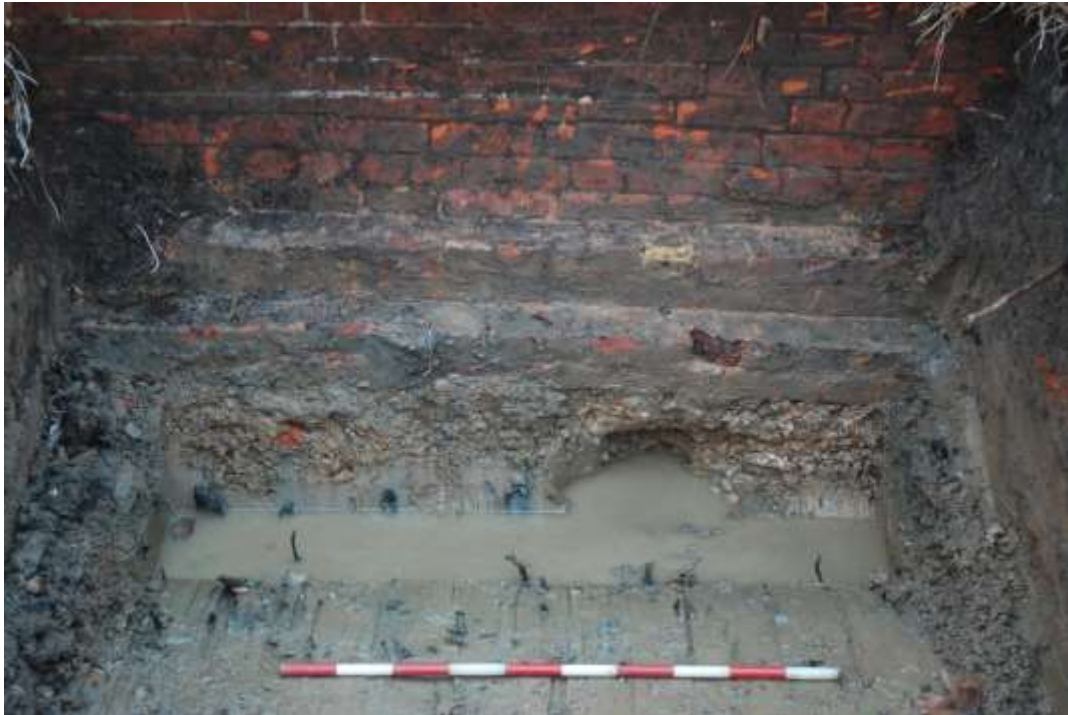
- 7.8** Below the wall a layer of compact orange-brown gravels were observed (5), measuring a minimum of 300mm in thickness (fig.14). Moderate water ingress was observed permeating through this layer.

Figure 14: Detail of wall foundation [4] and gravel (5), overlying natural clay (3). Facing SE. Scale 1m.

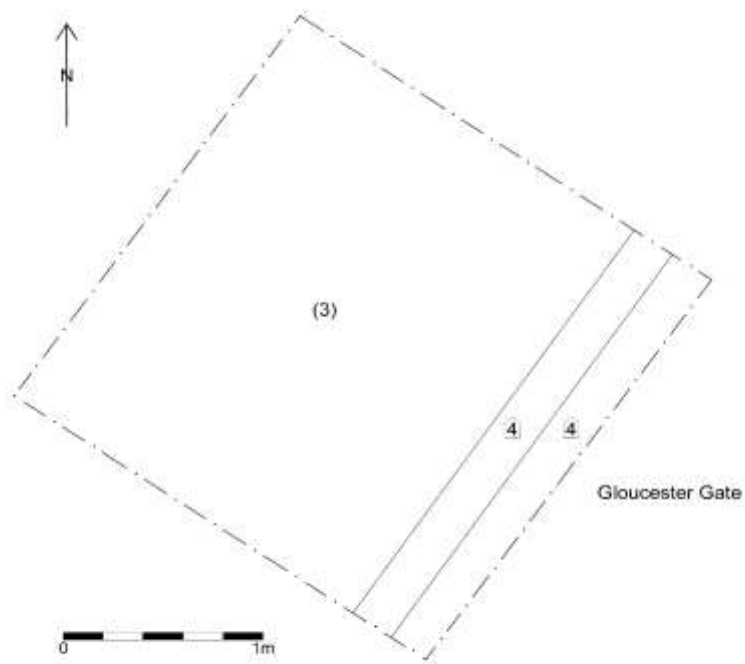
Figure 2: Trench Plan. Original drawn at 1:20.

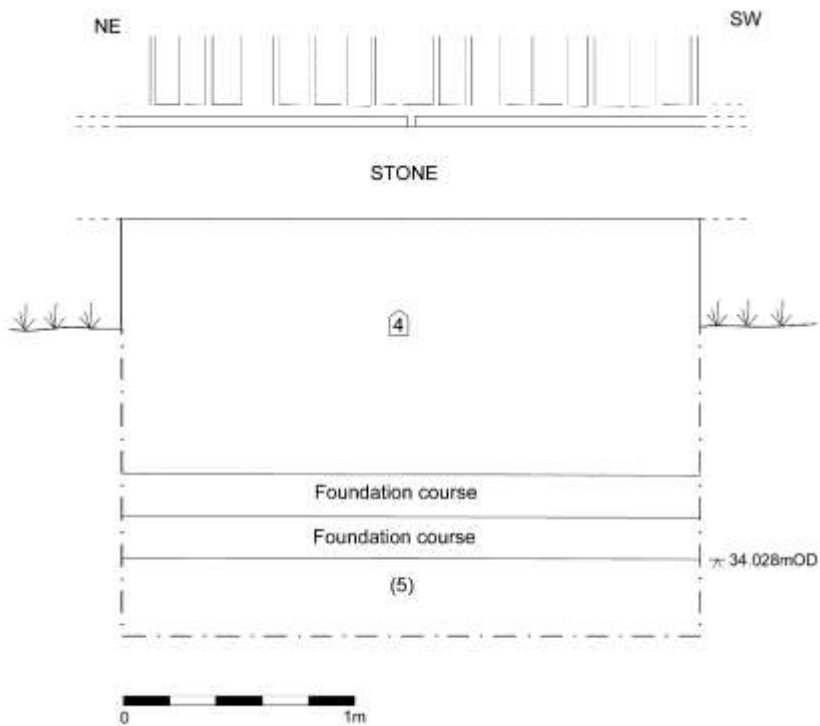
- 7.5** The wall [4], was observed in the north-west facing section. The above ground section comprised 6 rows in an approximate English Dutch Corner bond, measuring 0.45m in height. This bond continued below ground, comprising 4 rows of alternating headers and stretchers above a single course of half bricks (which were full size at the southern end and narrowed to half the thickness at the northern), followed by a further 3 rows of alternating headers and stretchers.

Figure 3: NW facing section of trench, showing metal railings, wall [4] and gravels (5). Original drawn at 1:10.
