**HIGHWAY IMPROVEMENT WORKS
THE MALL/HORSE GUARDS ROAD, CITY OF
WESTMINSTER, SW1A 2WH**

AN ARCHAEOLOGICAL WATCHING BRIEF

Site code: HGU18
Site Location NGR: TQ 29812 80198

e-mail: mail@compassarchaeology.co.uk
Author: Heidi Archer
March 2018

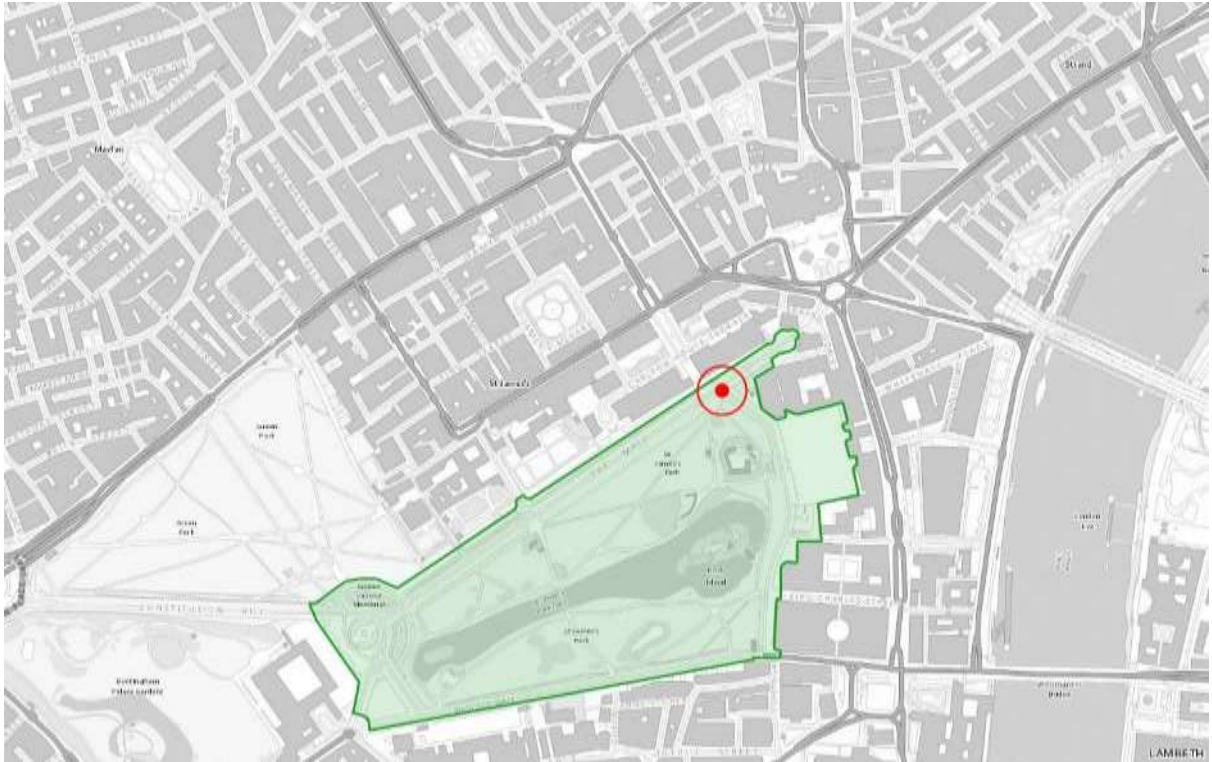
Figure 4: Site location (red) in relation to St James's Park, Registered Historic Park and Garden (Grade I). Adapted from the City of Westminster Council's Online Map (2018).

In addition, the proposed works are located within the Grade I Registered Historic Park and Garden of *St James's Park*, as designated by Historic England (fig.4).

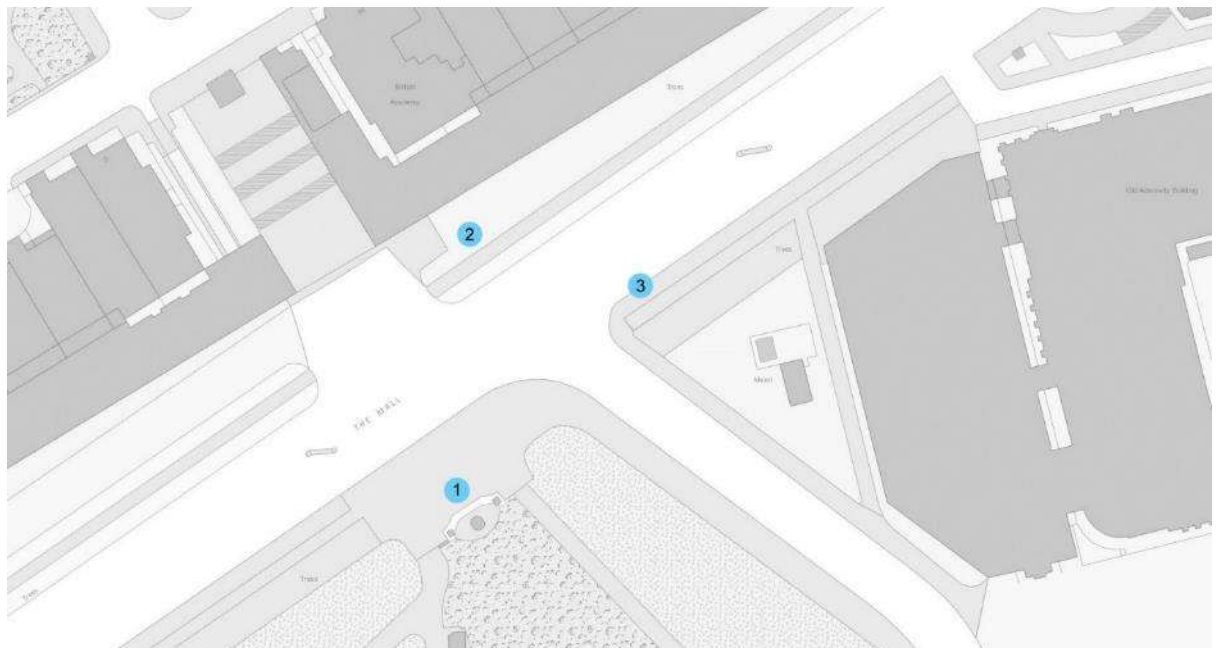
Figure 5: Map showing the Listed Buildings in the immediate vicinity of Horse Guards Road / The Mall: 1) Royal Artillery Memorial of the South African War (Grade II*: UID 1273903); 2) 33 lamp standards lining footpaths and ride on north side (Grade II: UID 1273938); 3) 44 lamp standards lining road and circus in front of palace (Grade II: UID 1239084).

1239084: Grade II) and 33 *Lamp Standards lining Footpaths and Ride on north side* (UID 1273938: Grade II), as designated by Historic England (fig.5).

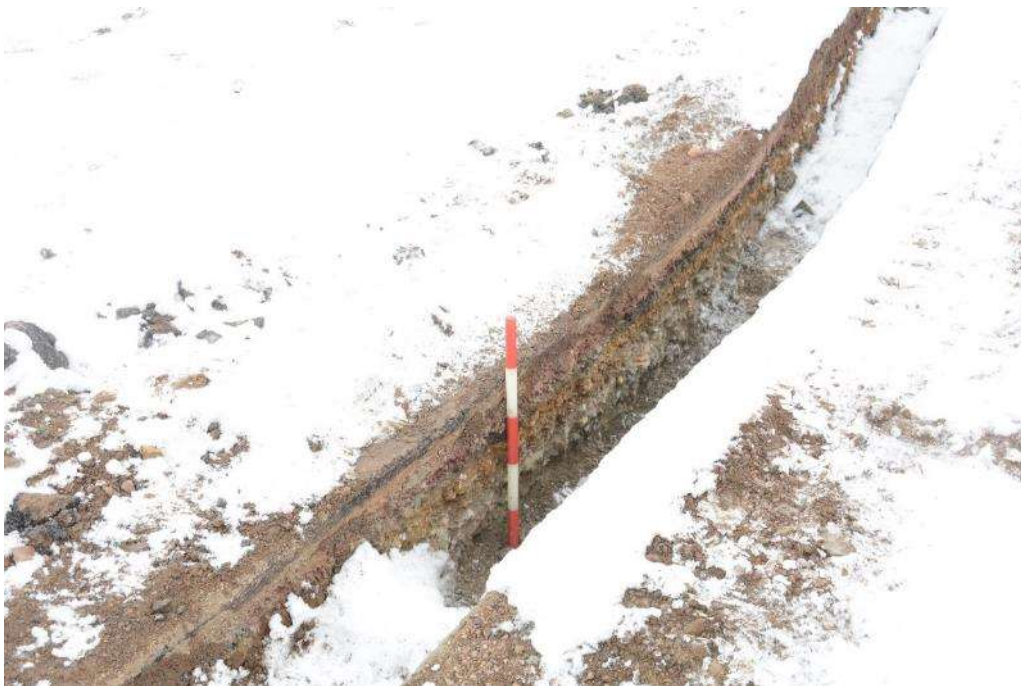
7.3 The stratigraphy observed on the western side of South Horse Ride comprised 50mm of black tarmac (3) overlying a further 80mm of red and grey bedding gravel (2), above 40mm of orange gravel (13) and coarse grey rubbly concrete (14), measuring at least 180mm in thickness, continuing below the level of excavation at c.6.49mOD (fig.10).

Figure 10: Stratigraphy observed in a section of ducting running east-west along South Horse Ride. Facing NE. Scale 0.5m

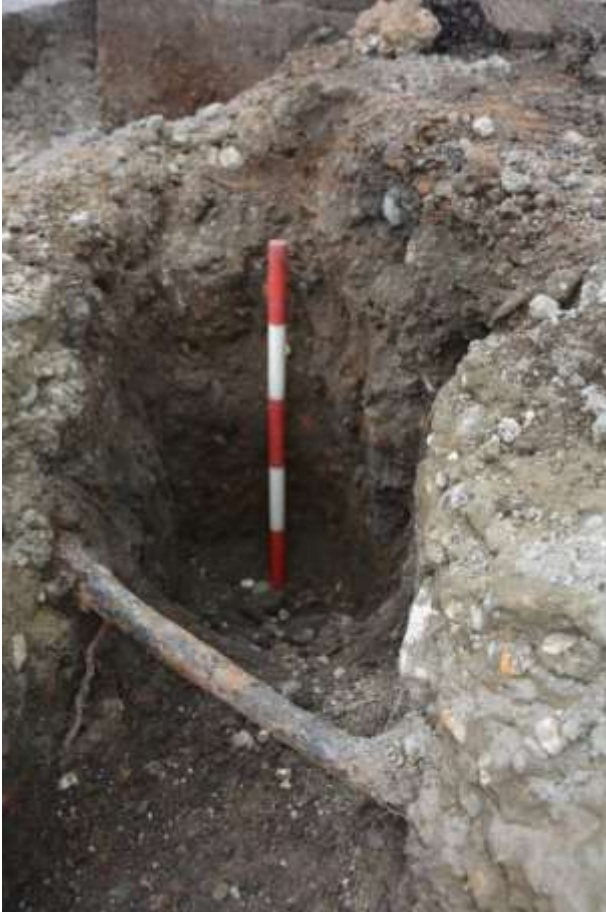
- 7.4** On the eastern side of South Horse Ride a similar sequence was observed, albeit to a lesser extent, comprising very loosely compacted stony rubble make-up (15) measuring c400mm in thickness, with patches of a more homogenous mid brown soil containing frequent small fragments of Ceramic Building Material (CBM) (16), measuring up to 600mm in thickness (fig.11).

Figure 11: Context (16), observed at the northeastern end of a 12m trench completed on the east side of South Horse Ride. Facing NE. Scale 0.5m

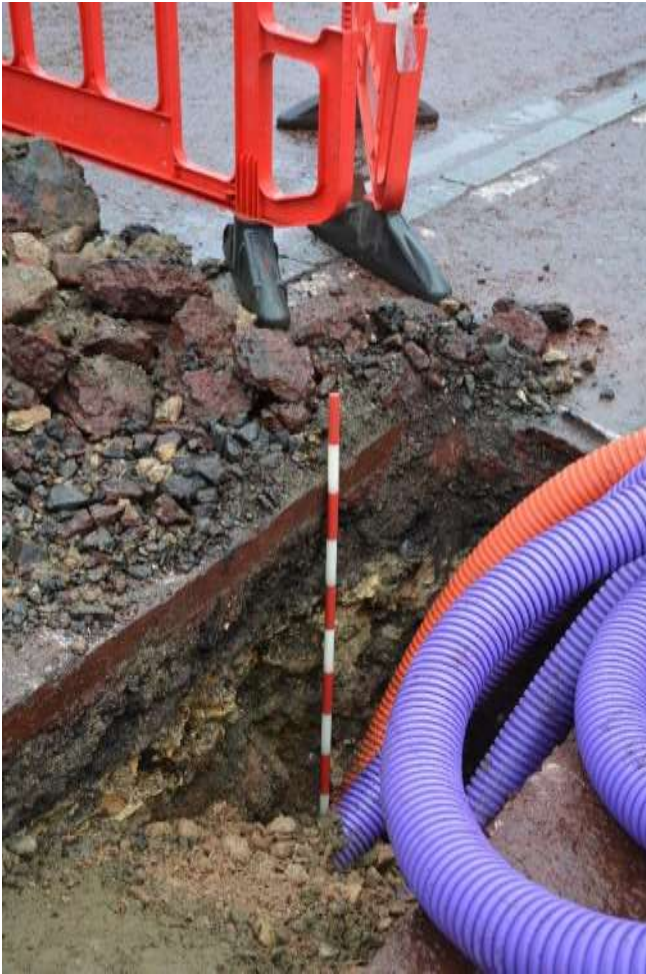
- 7.5** Two parallel northeast-southwest trenches were dug across the width of Horse Guards Road, at the northern end, to connect the two trenches described above. Both trenches measured 0.65m in width x 0.80 – 1.0m in depth (c5.3-5.45mOD), excavated by machine (fig.12).

Figure 12: South facing section of east-west trenching across Horse Guards Road, showing post-medieval / modern backfill below modern road make-up layers. Facing NE. Scale 1m.

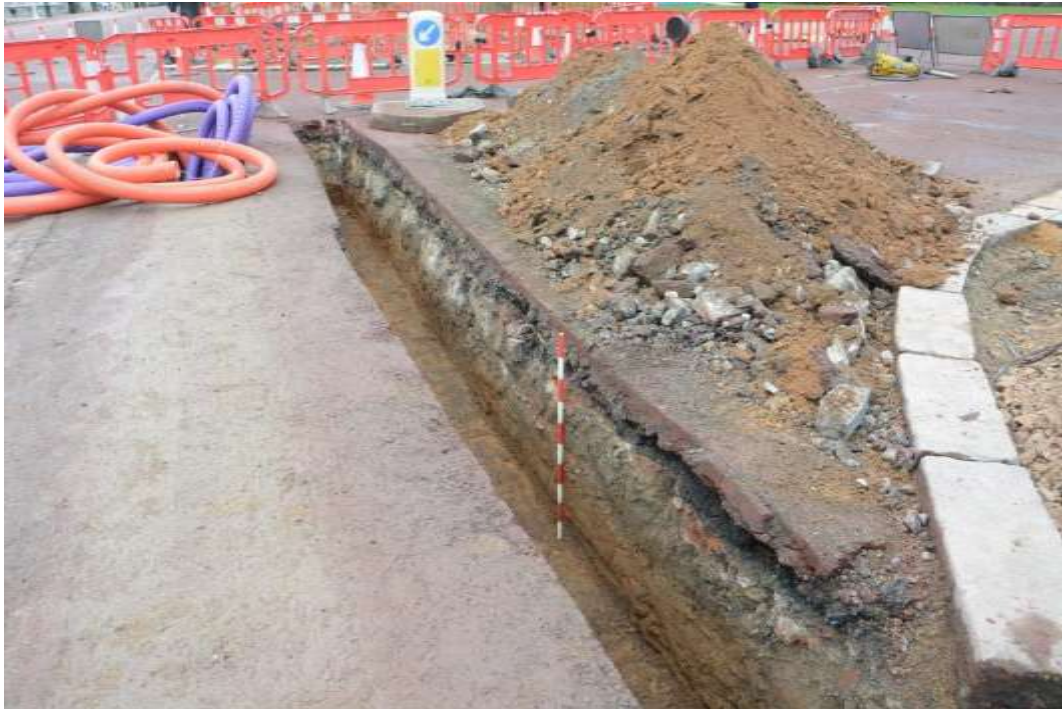
At the south-western end of the trench the thin skim of concrete (4) sealed a single course of bricks, bordered by a single large stone at the eastern end (18). The bricks were badly battered and the stone did not appear to be *in situ*, however, the uniformity of the layer would suggest it was deliberately laid, and possibly represents a post-medieval or modern surface (fig.13).

Figure 13: Southernmost east-west trench across Horse Guards Road, showing road make-up and brick rubble overlying natural clean sand. Facing E. Scale 1m.

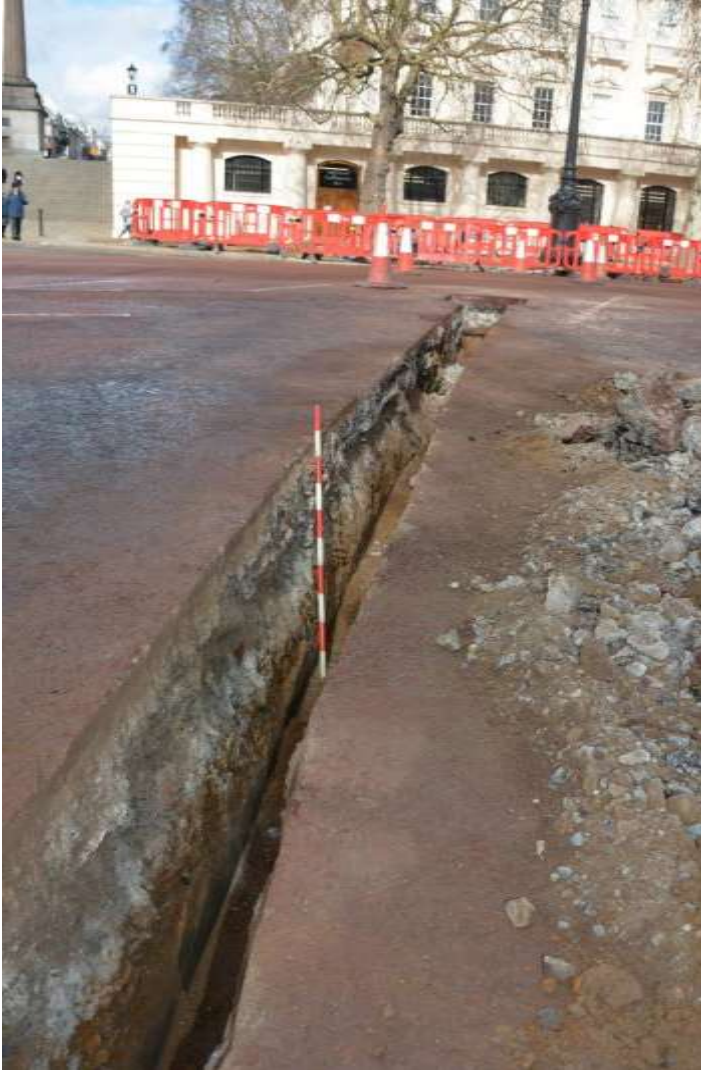
- 7.8** Three sections were observed and recorded crossing the width of The Mall in a northwest-southeast direction. The westernmost and centre sections, located adjacent to the Royal Artillery Boer War Memorial, measuring 8.0m in length x 0.4m in width x 0.7m in depth (c5.7mOD) (fig.14).

Figure 14: NE-SW trench crossing The Mall. Facing approximately NNE. Scale 1m.

The stratigraphy in these areas comprised 70mm of red tarmac (1) above 70mm of red gravel bedding (2) and 90mm of black tarmac (3). These overlay 100-220 of light grey concrete (19), forming a bedding layer for the road. The concrete sealed 120mm of orange gravel (13) above a minimum of 130mm of firm orange-brown natural sand (7), continuing below the level of excavation.

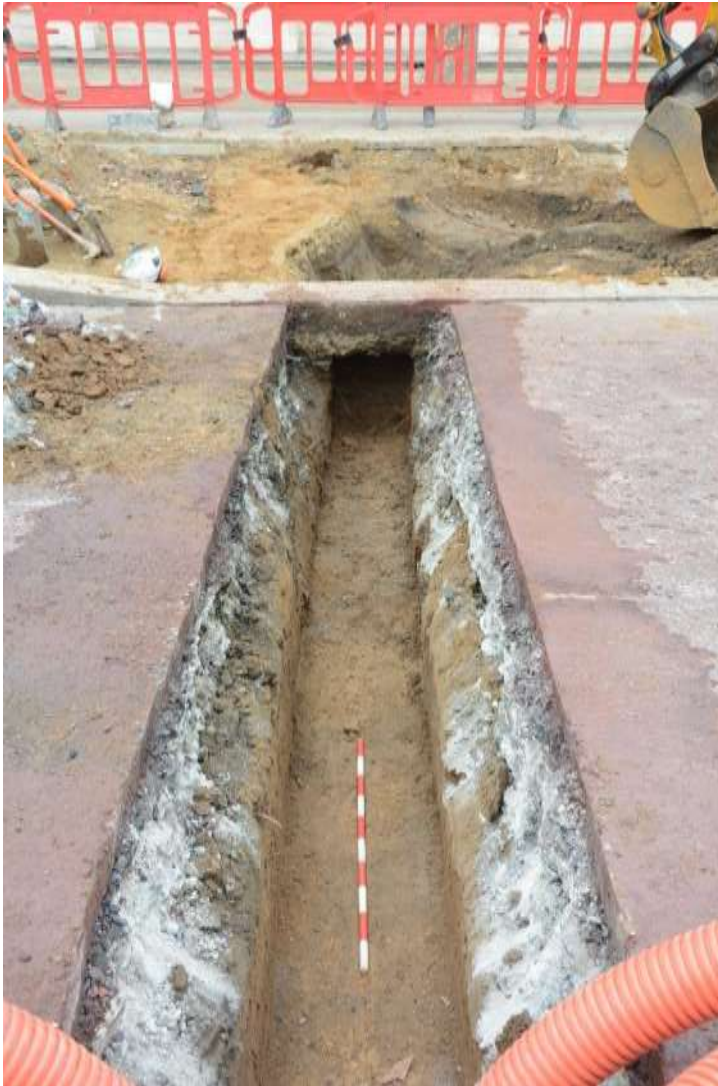
The easternmost trench was located on the eastern side of the junction, adjacent to the National Police Memorial, measuring 20m in length x 0.9m in width x 0.85m in depth (c6mOD) (fig.15).

Figure 15: Northwestern end of eastern trench (looking towards Carlton Terrace) showing the groundworks below the road and North Horse Ride. Facing NW. Scale 1m.

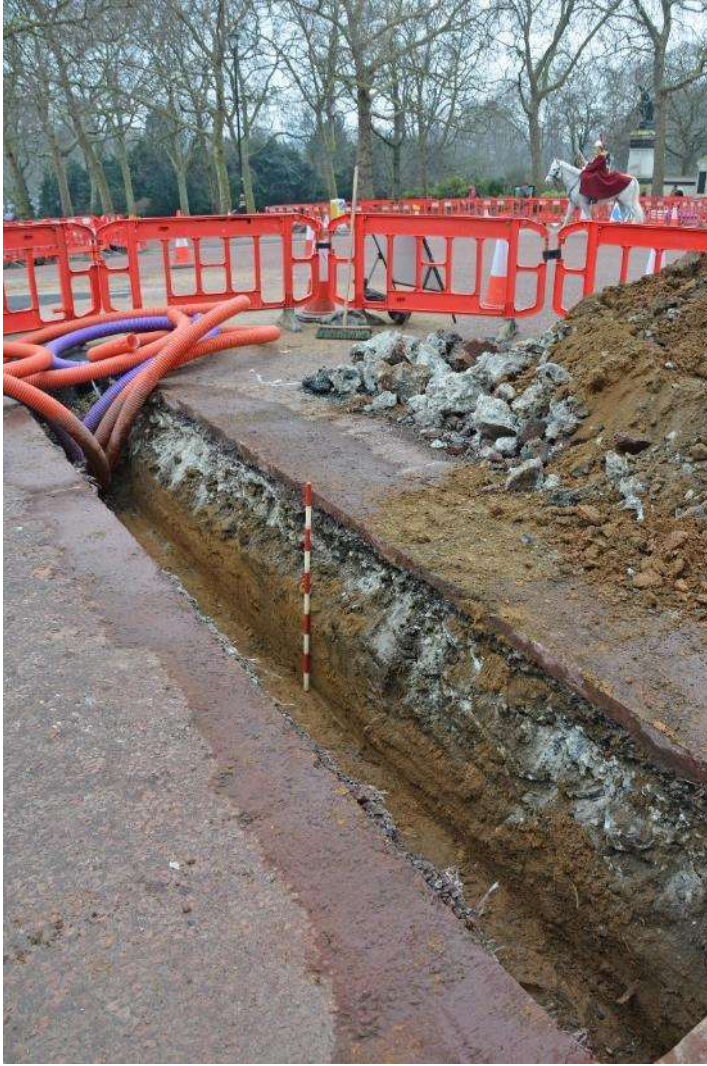
The stratigraphy comprised 100mm of red tarmac (1) above 50mm of bedding (2), overlying 170mm of very light grey powdery concrete (19). This sealed a homogenous clean deposit of orange-brown natural sand (7), measuring 460mm in thickness, continuing below the level of excavation (fig.16).

Figure 16: Southeastern end of trench, showing sand below road make-up. Facing S. Scale 1m.

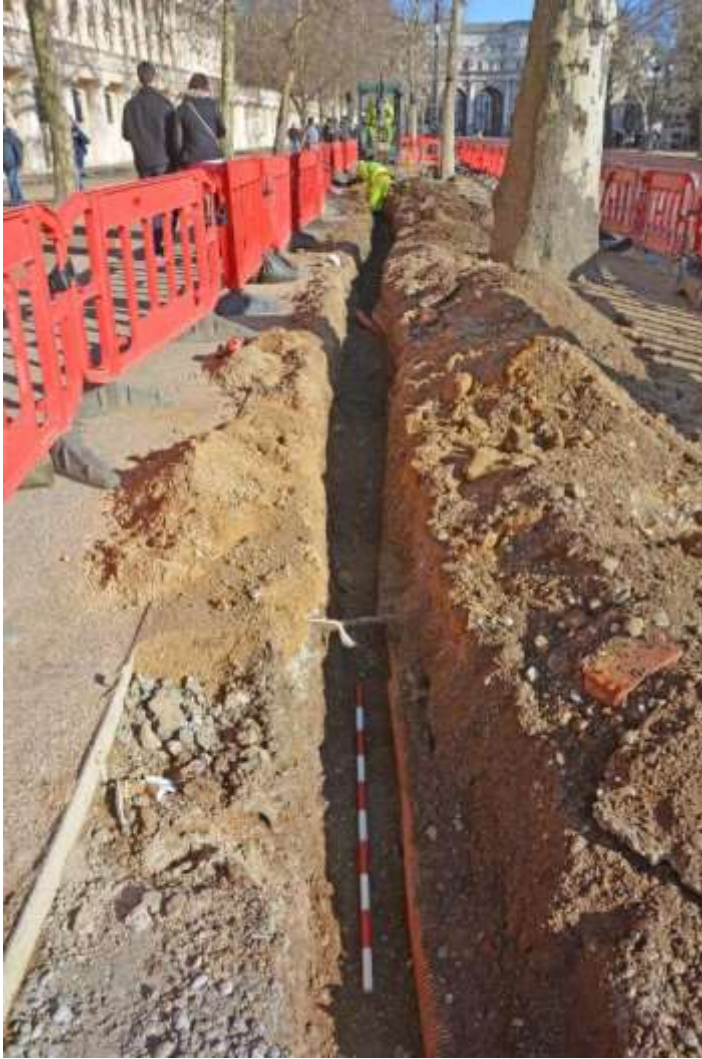
- 7.9** The final section of trenching to be monitored was located on the southern side of North Horse Ride, running in a northeast-southwest direction. A 50m section was observed, measuring 0.35-0.4m in width x 0.4m in depth (c6.4-6.0mOD) (fig.17).

Figure 17: Ducting trenching in North Horse Ride. Facing NE. Scale 1m.

As a result of the presence of a previous duct (seen on the right side of the trench in fig.17 above) the deposits consisted of already disturbed, modern made ground and as such no archaeological finds or features were observed.

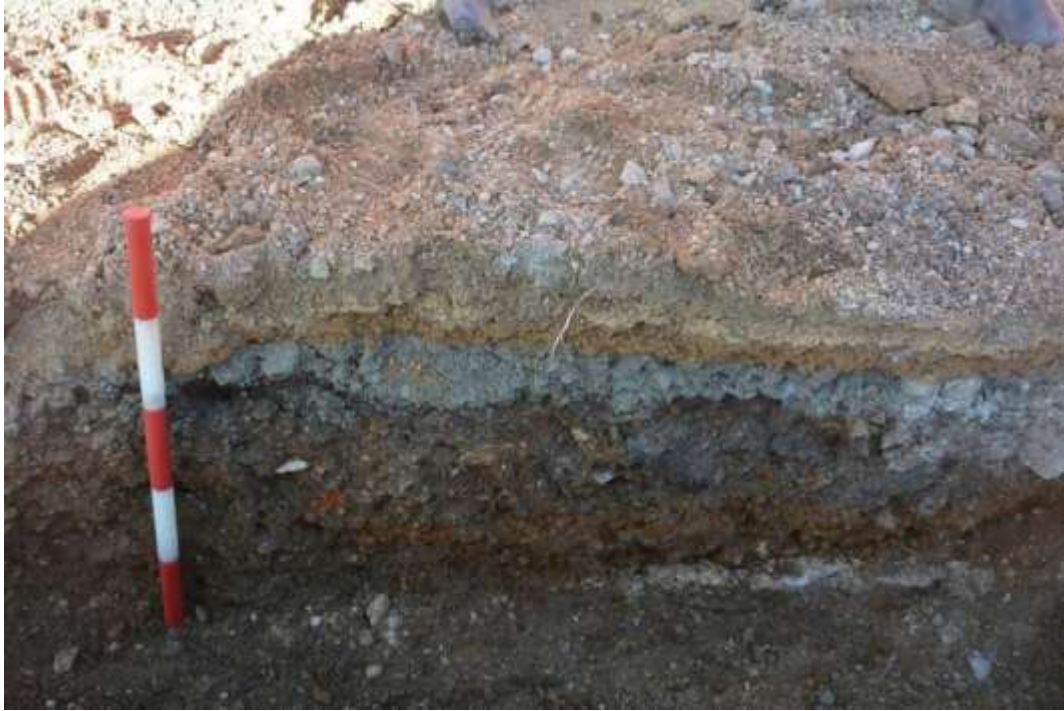
The stratigraphy along the full 50m length was relatively uniform, however a number of more silty patches were observed. This is taken to be a result of variation in modern groundworks rather than of archaeological intervention. The stratigraphy comprised 80mm of sharp sand (20) above 60mm of a gravel bedding layer (21), overlying 340mm of light brown soil, abundant with stone, mortar, concrete and fragments of CBM (fig.18).

Figure 18: Modern backfill / make-up observed on North Horse Ride. Facing NW. Scale 0.5m.
