**THAMES WATER MAINS REHABILITATION
WORKS – CROUCH HILL 57, HUGGIN HILL,
LONDON EC4V 4AY**

An Archaeological Watching Brief

Site code: HGN18
Approximate site centre: NGR TQ 32271 80864
SMC ref: S00188849

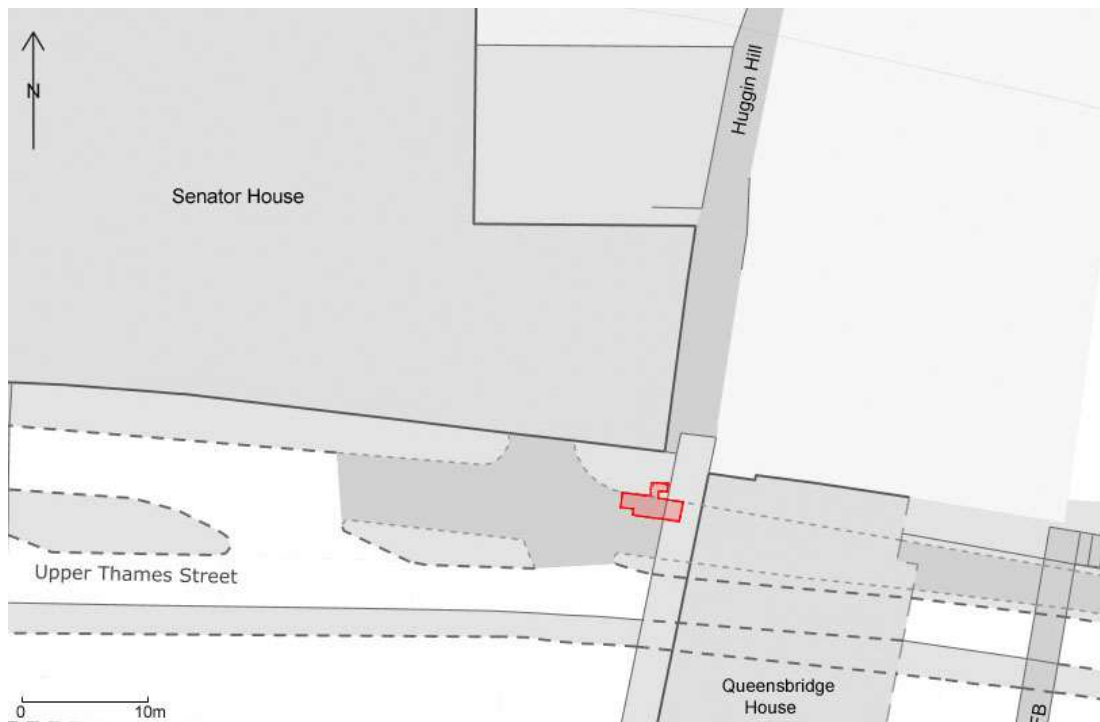
- 5.1 The groundworks entailed the completion of a single trench located at the southern end of Huggin Hill. The trench measured c6m in length x 2m in width x 0.5-1.0m in depth (c6mOD), aligned east-west. The majority of the trench was located within the cycle path, with a small section extending northwards into the existing footpath. This latter section was re-excavated in April 2018 to enable the fourth connection to be made (fig.5).

Figure 5: Trench location, marked in red.

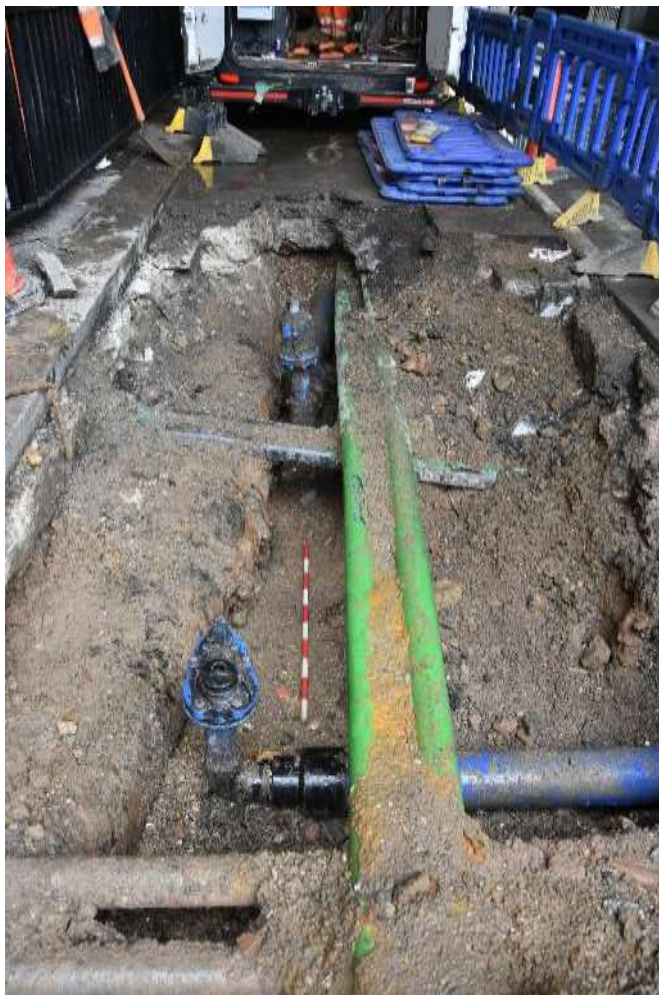
- 7.1 The following forms a written description of observations made during the watching brief. The works are discussed in chronological order, covering the main trench and subsequent re-cut. Deposits are shown as (x), cuts and structures as [x]. The text is supplemented with illustrative photographs. For a full context list refer to Appendix I.
- 7.2 The trench was located on the northern side of Upper Thames Street, within the cycle way adjacent to Huggin Hill. The trench was rectangular in plan with an additional spur on the northern side, in total measuring approximately 6m in length x 2m in width x 0.5-1.0m in depth (c6.5-6mOD) (figs.6-7).

Figure 6: View of the completed trench, showing multiple services cutting made ground. Facing E. Scale 1m.

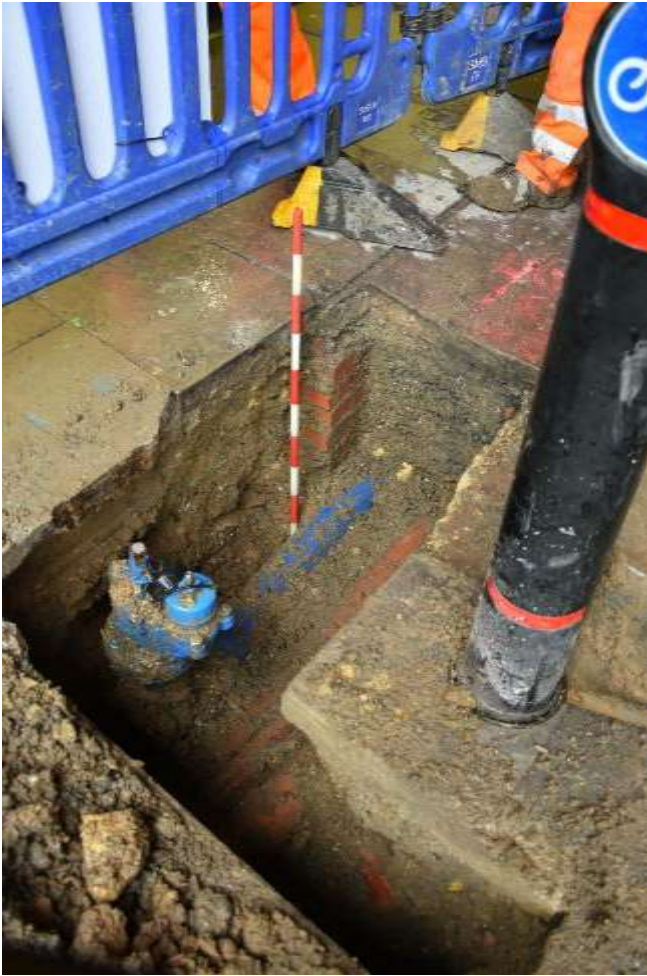
Figure 7: Additional spur on the northern side of the main trench, showing east-west water main and services [14] / (15). Facing approximately NE. Scale 1m.

- 7.6** The fourth main was situated within a small spur on the northern side of the trench, overlying a group of services, [14] / (15), aligned east-west.

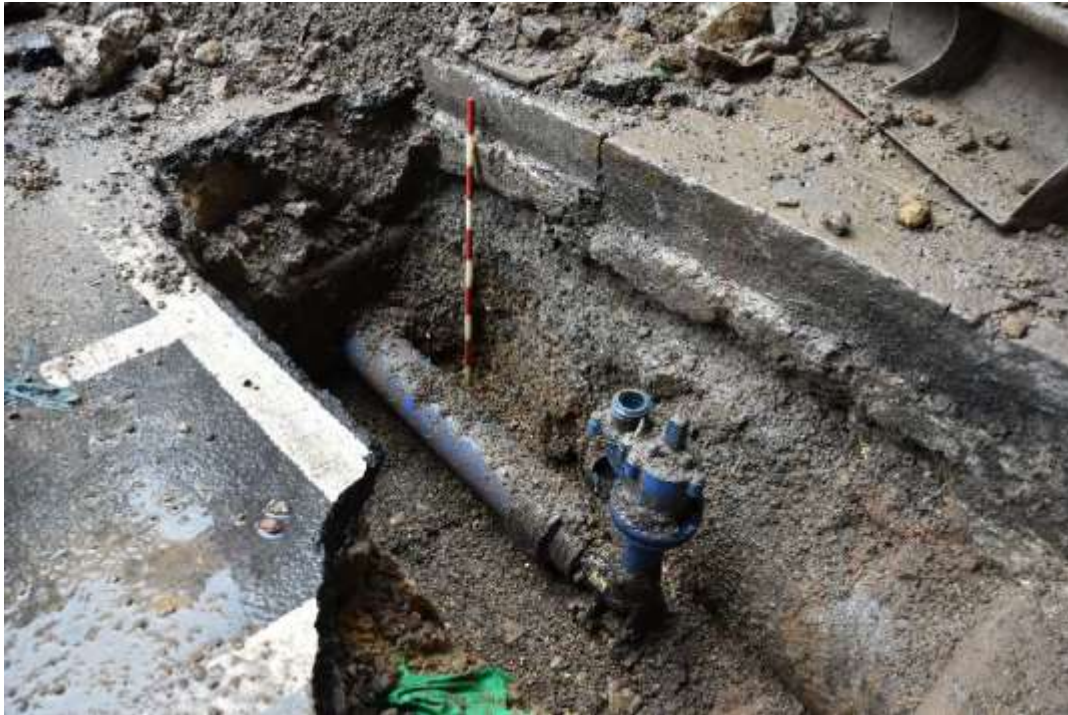
- 7.3** The stratigraphy comprised 60mm of black tarmac (1) above c350mm of coarse mix compact concrete (2). This existing surface and bedding layer overlay a homogenous deposit of post-medieval made ground (3), measuring up to 600mm in thickness. The context consisted of a mix of dark brown soil, hardcore, stones, MOT Type 1 and fragments of modern building rubble (fig.8).

Figure 8: South facing section of trench, showing existing cycle way surface and bedding above made ground. The large gas main [4] / (5) can be seen to the right of frame. Facing NW. Scale 1m.

- 7.5** In the main part of the trench a large post-medieval cast iron gas main was observed running east-west along the northern section, [4], surrounded by a fill, (5), similar in composition to (3). This was overlain on the western side of the trench by a north-south running service, [16] / (17), and again on the eastern side, [18] / (19). The highest service observed, two electricity cables, ran east-west through the centre of the trench surrounded by an orange sharp sand fill, [20] / (21). Three of the four Thames Water mains to be connected together were located in this main part.

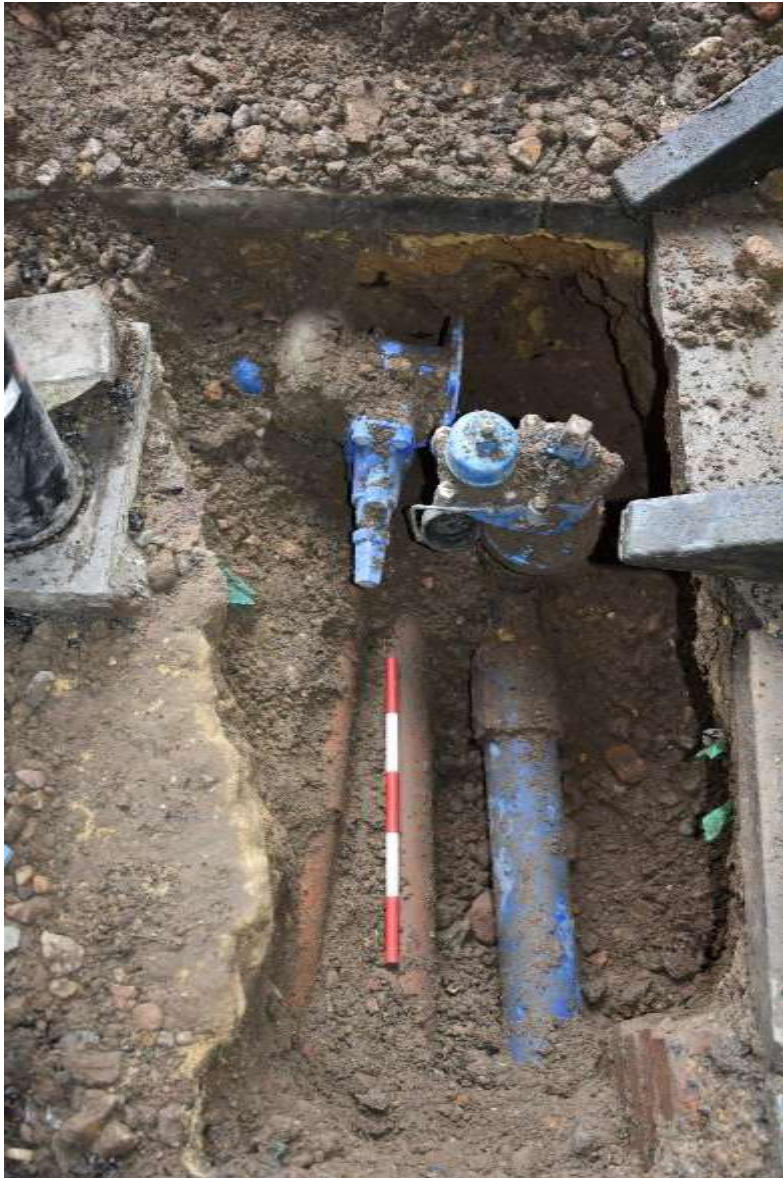
- 7.7** This spur was re-excavated on the 30th April to allow for the fourth connection to be made. No features of archaeological interest were observed (fig.9).

Figure 9: Re-excavated spur, showing TW main and valve and orange coloured services [14] / (15). Facing W. Scale 0.5m.
