**THAMES WATER MAINS REHABILITATION
WORKS, SEAFORD ROAD, LONDON BOROUGH OF
EALING, W13 9HS**

An Archaeological Watching Brief

Site code: SED18
Approximate site centre: NGR TQ 16677 80126

COMPASS ARCHAEOLOGY LIMITED
250 YORK ROAD
LONDON SW11 3SJ

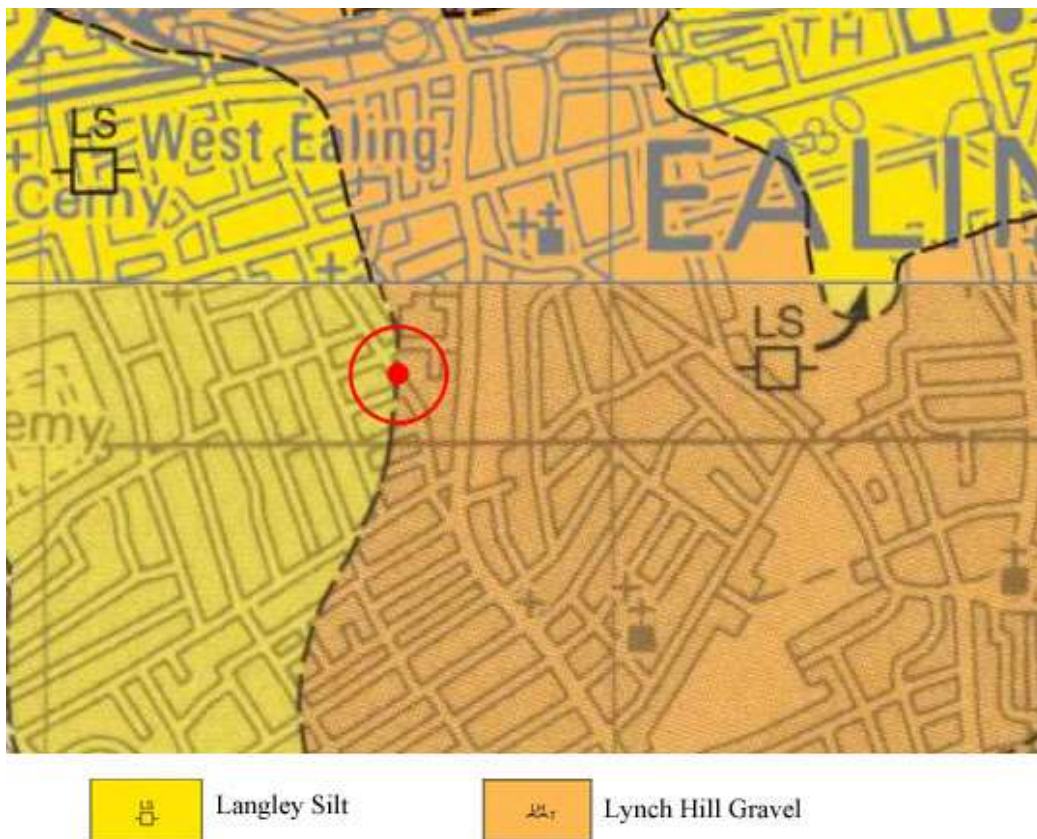
Figure 2: Extract from the British Geological Survey (sheets 256 and 270), with site location marked in red.

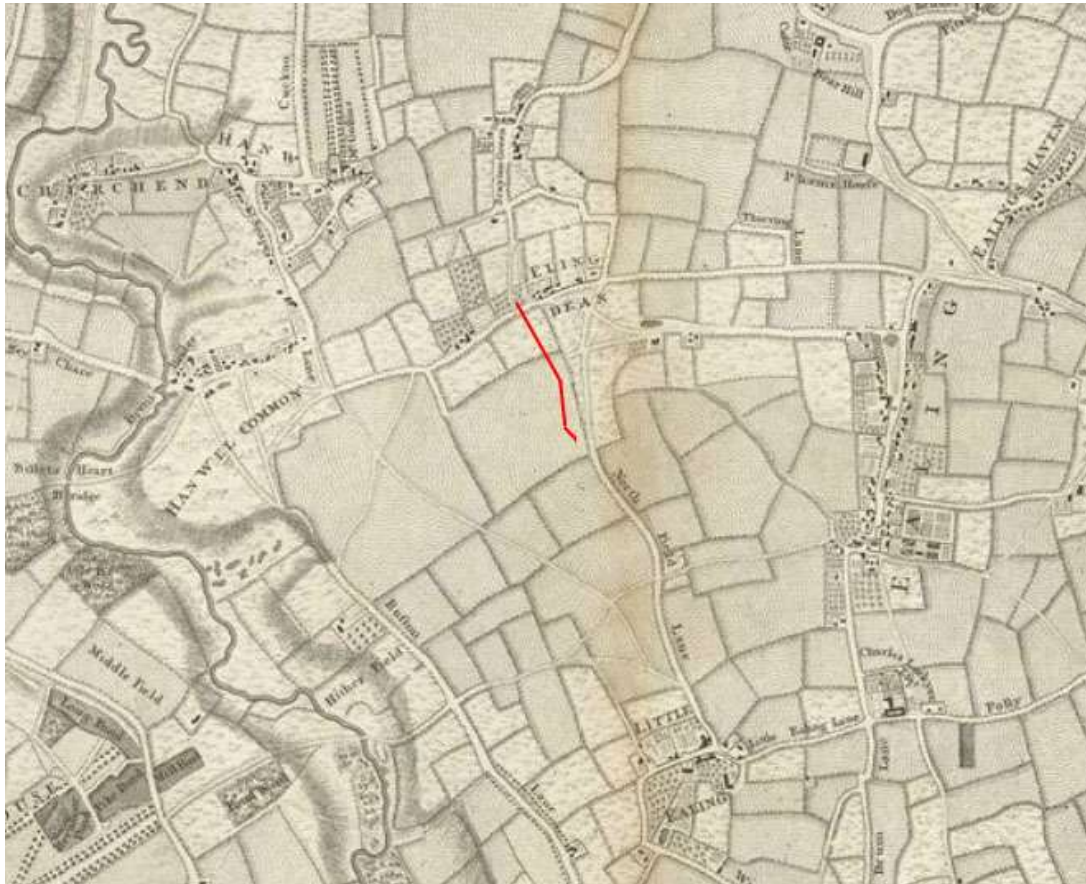
Figure 4: Extract from Rocque's Map of London (1746) with approximate location of Seaford Road marked in red.

The above extract from Rocque's Map of London shows Ealing in the mid-18th century as a sparsely developed ribbon settlement surrounded by open farmland. There is a fairly extensive road network linking the various hamlets together. St Mary's Road is the most developed, with buildings on both sides surrounded by more formally drawn gardens, potentially market gardens as well. Northfield Road is present, annotated as North Field Lane, running north-south between Ealing Dean and Little Ealing. Due to the fact that the road is named it is probable that it is significantly older, perhaps with medieval or Saxon origins. Seaford Road itself has yet to be constructed, with the Thames Water scheme lying over open fields, crossing one boundary.

Ealing remained a rural settlement, with development scattered along the main roads of St Mary's Road and Uxbridge Road until well into the mid-19th century (fig.4).

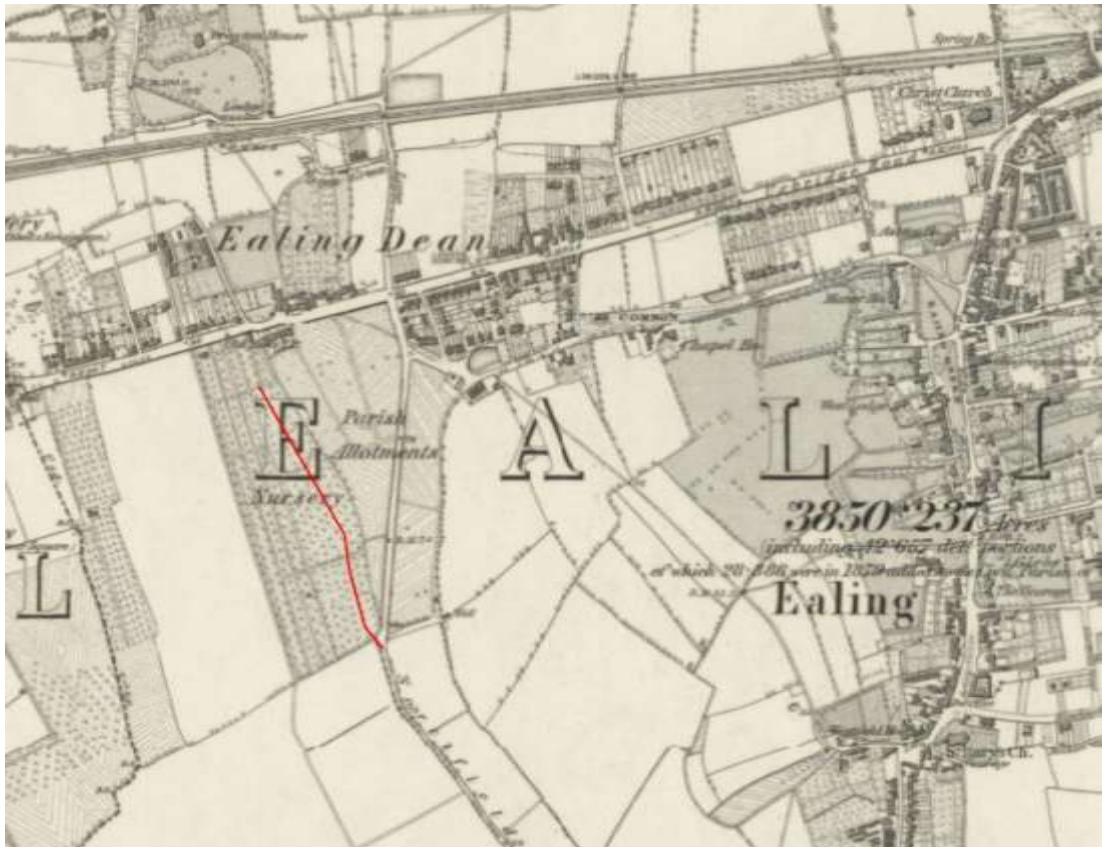
Figure 6: Extract from the OS 6-inch map (1864-6) with Seaford Road marked in red.

The opening of the Great Western Railway in the 1830s contributed significantly to the changes that can be seen in the 1860s map. A station was opened at Ealing Broadway in 1838 causing a large amount of speculative building work to take place throughout the mid-1800s. These developments were mostly semi-detached residences, examples of which can be seen north of the site on Uxbridge Road. Further development in Ealing itself is beginning to obscure the countryside. Seaford Road remains open ground, though now annotated as a Nursey and drawn in detail, suggesting formal rows of planting.

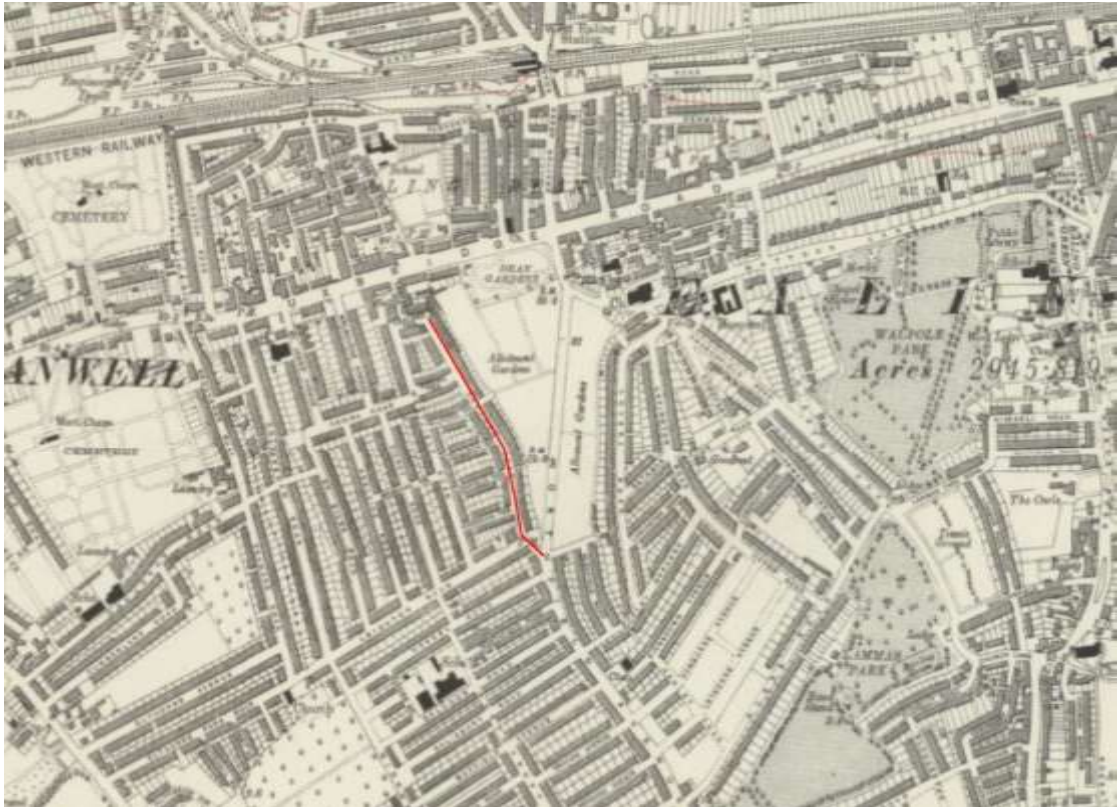
Figure 7: Extract from the OS 6-inch map (1912) with Seaford Road marked in red.

In the early-20th century development was prolific. Charles Jones, Borough Surveyor from 1863-1913 was responsible for turning Ealing into a town, with the creation of new roads, utilities, schools and public buildings, as well as large housing estates. The countryside is much depleted, appearing only in the large parks such as Walpole and Lammas. Seaford Road is part of large estate that was constructed between 1894 and 1912, with rows of terraced housing named after Australian streets and cities.

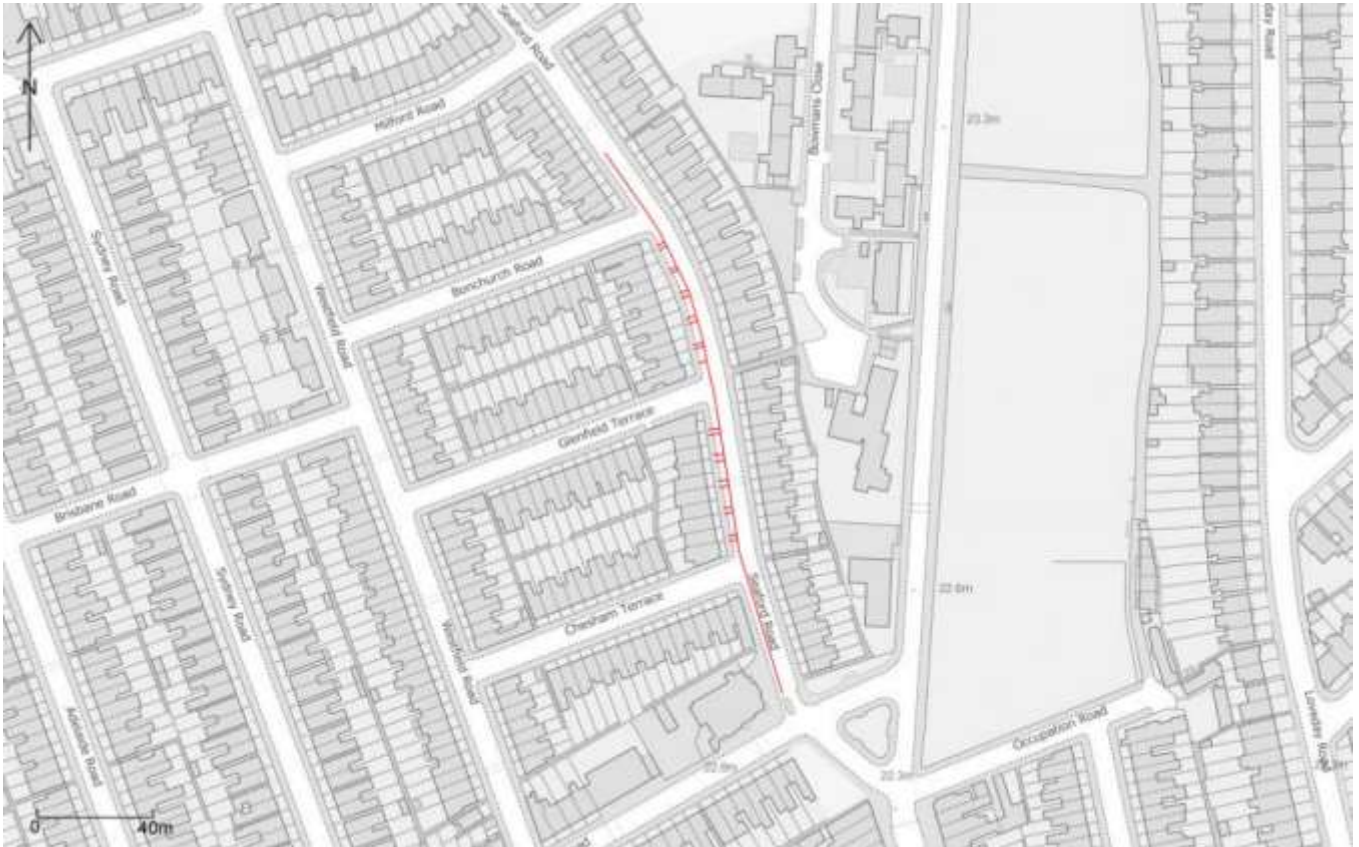
Figure 8: OS plan showing the scope of works monitored (red).

- 5.1 The groundworks entailed the completion of over 200 metres of open-cut trenching along the western side of the main north-south carriageway. Shorter east-west sections were opened on the western side, linking the new network to the existing residential properties along the length of Seaford Road. The trenching measured an average of 0.4-0.5m in width x 0.8 – 1.1m in depth (c21.5 - 21.2mOD) (fig.8).

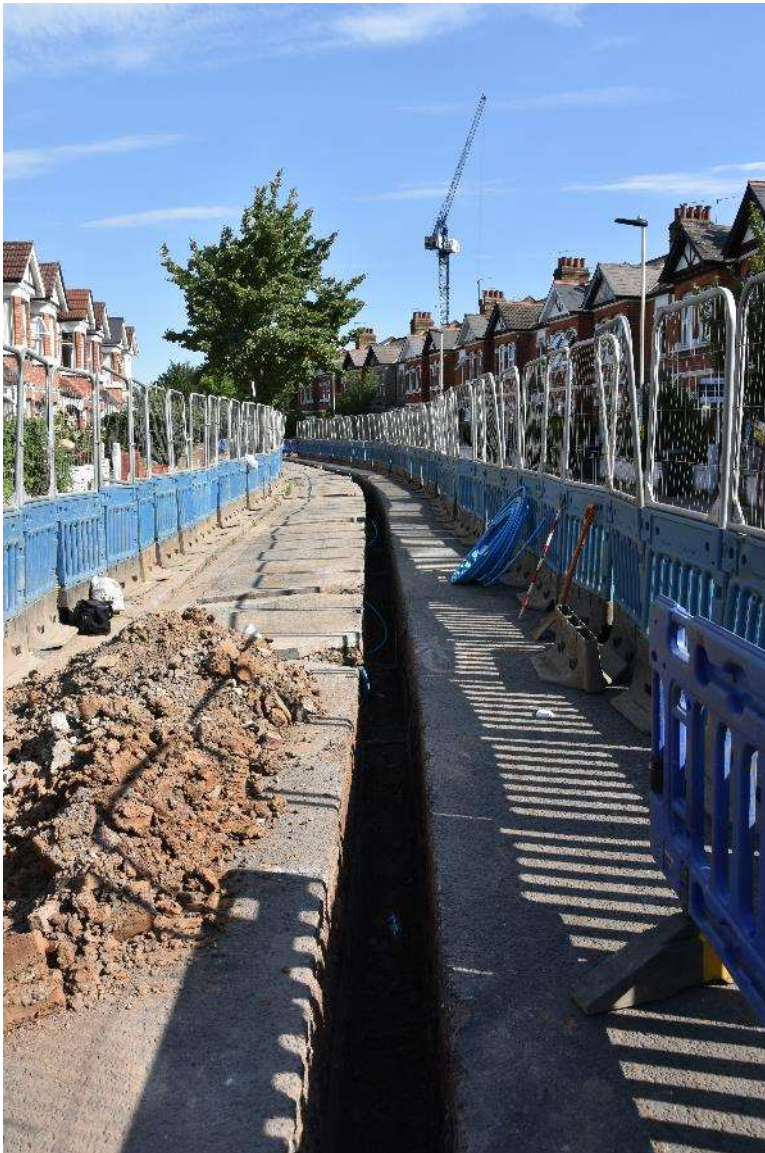
Figure 9: Working shot, showing the main trunk trench with spurs seen to the left of frame. Facing approximately N. No Scale.

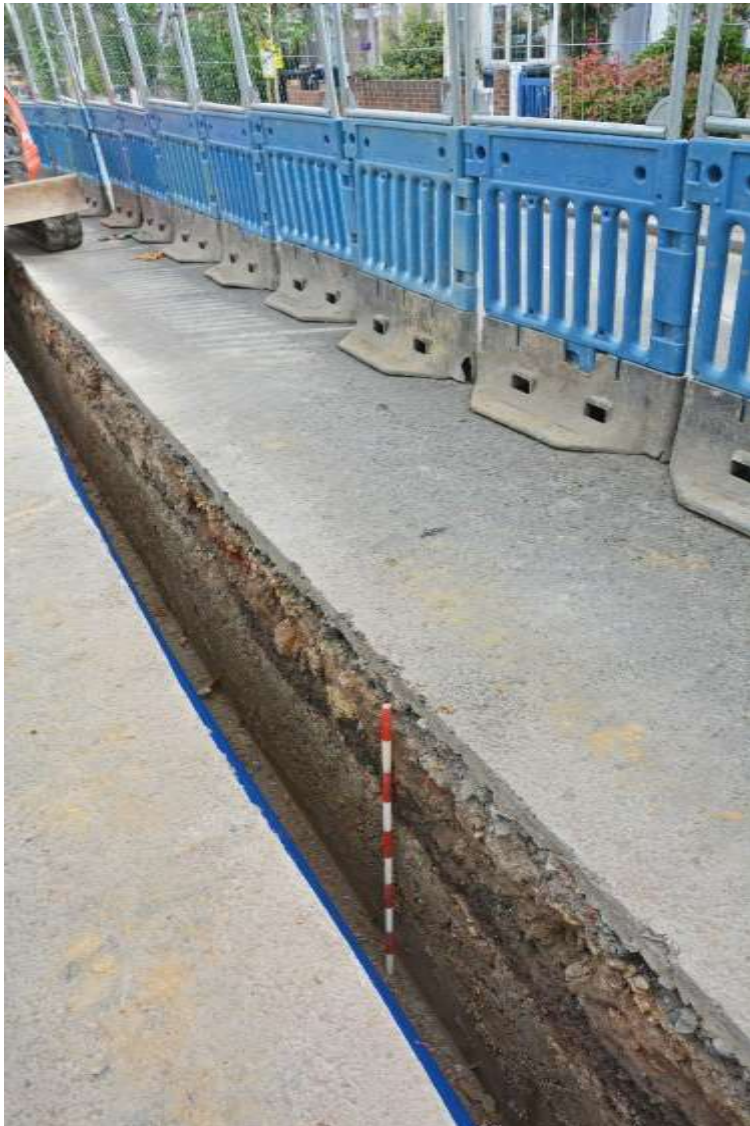
7.3 The stratigraphy was uniform throughout all observable sections, comprising 160mm of the existing black tarmac road surface and bedding layer (1) overlying 210mm of loosely compacted post-medieval brick rubble (2). The rubble overlay 150mm of a loose black asphalt layer (3). Context (3) overlay a well compacted orange clay / silt, taken to be the natural geology (4), which measured a minimum of 370mm in thickness, continuing below the level of excavation (figs.10-13).

Figure 10: Stratigraphy observed at the southern end of Seaford Road. Approximately 0.4m of post-medieval and modern stratigraphy can be seen above natural clay. Facing NNE-NE. Scale 1m.

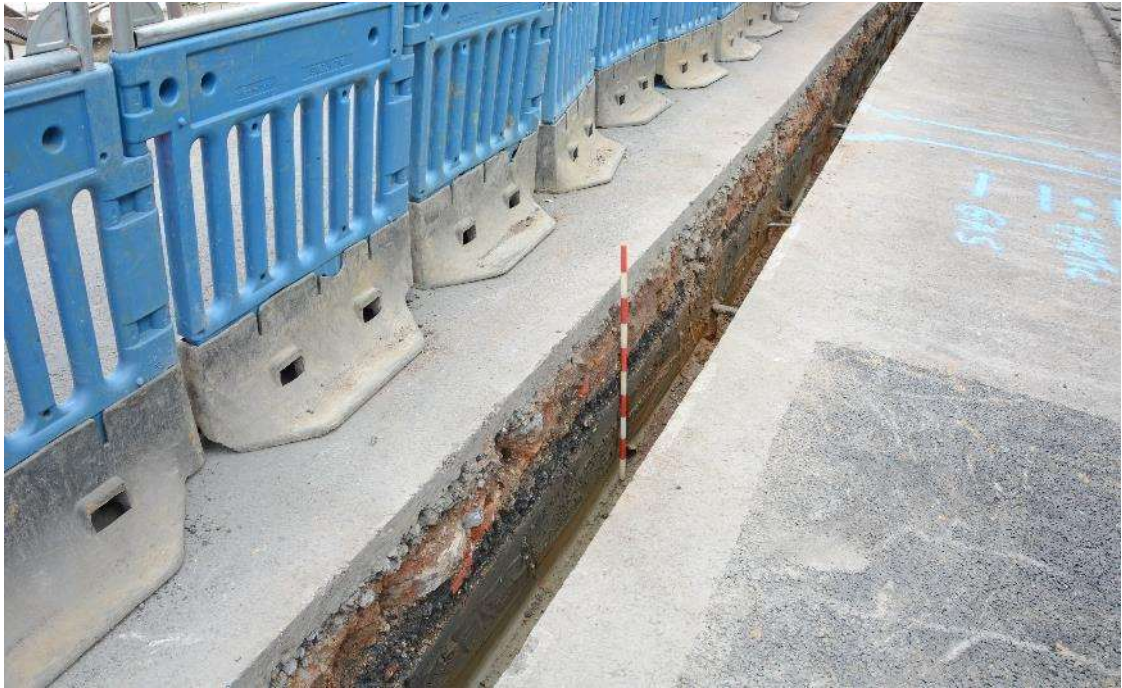
Figure 11: Stratigraphy observed adjacent to Glenfield Terrace. Facing SE. Scale 1m.

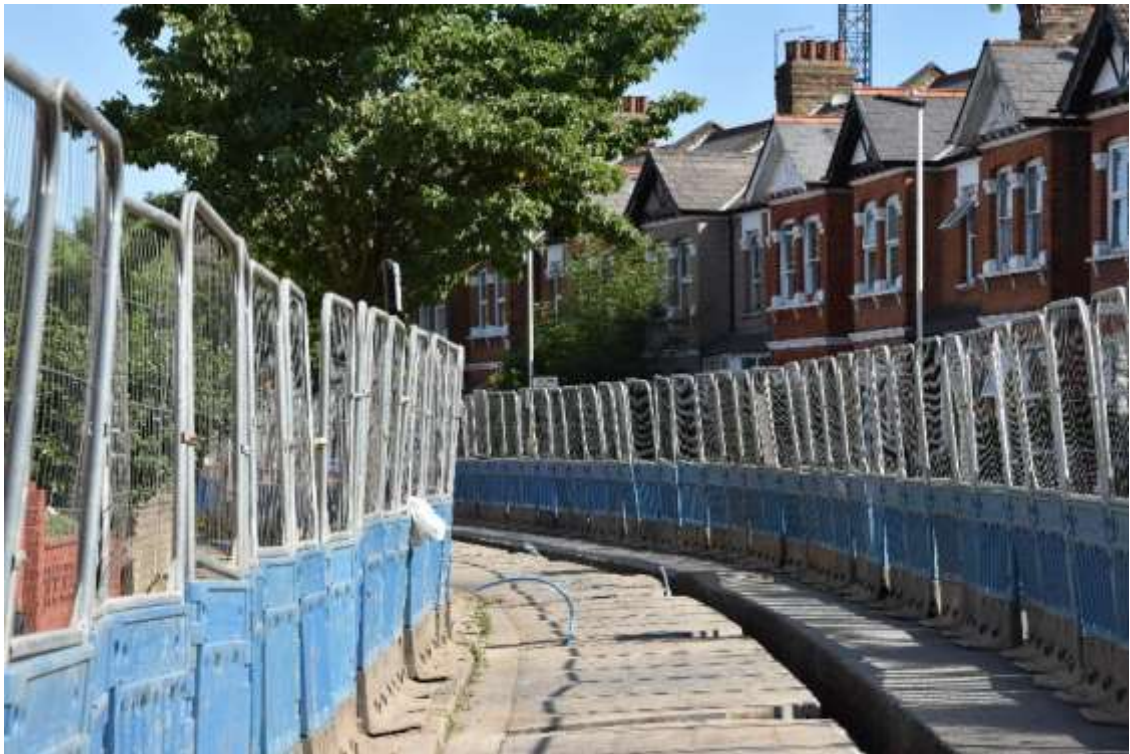
Figure 12: Working shot, looking towards Bonchurch Road. Facing NNE. No scale.

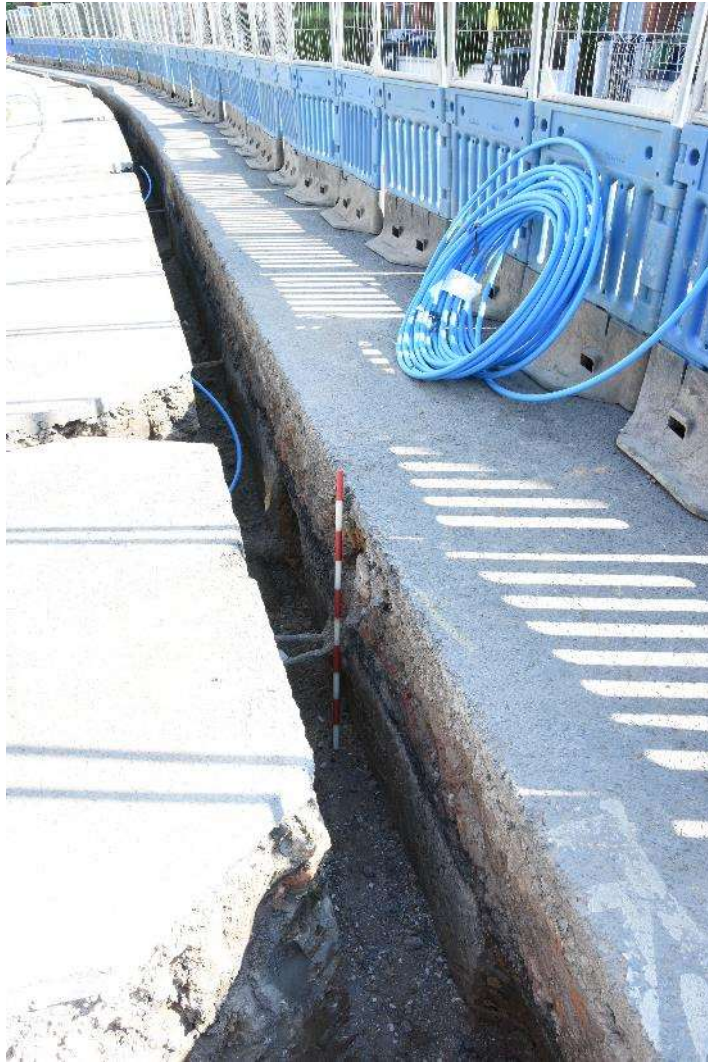
Figure 13: Stratigraphy observed between Glenfield Terrace, looking towards Bonchurch Road and Milford Road. Facing N. Scale 1m.
