**THAMES WATER  
MAINS INSTALLATION WORKS,  
LAND ADJACENT TO 4 PRIORY ROAD,  
DARTFORD, DA1 2BL**

An Archaeological Watching Brief

Site Code: PIY18

COMPASS ARCHAEOLOGY LIMITED  
250 YORK ROAD  
LONDON SW11 3SJ

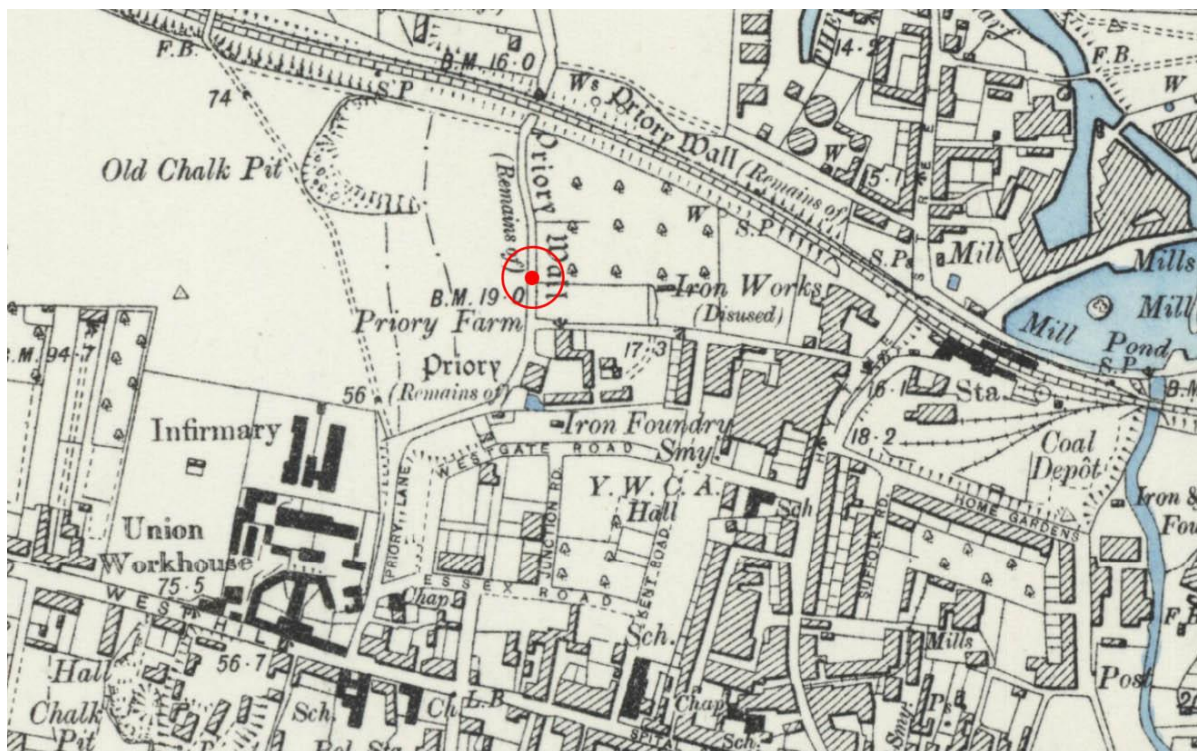
Figure 5: Extract from the Ordnance Survey 6-inch map (1895), with site location marked in red. The area is predominantly industrial in nature, incorporating the Priory Manor House into its grounds, with the surrounding land comprising open fields.

- 4.5.3 Dartford continued in a similar manner, expanding and adapting as the needs of the town grew (Figs.5-8). Renewed activity began in the post-war period and the previously open landscape of the Priory and its land was transformed into a residential and industrial hub, with the site itself being finished in the post-1960s.

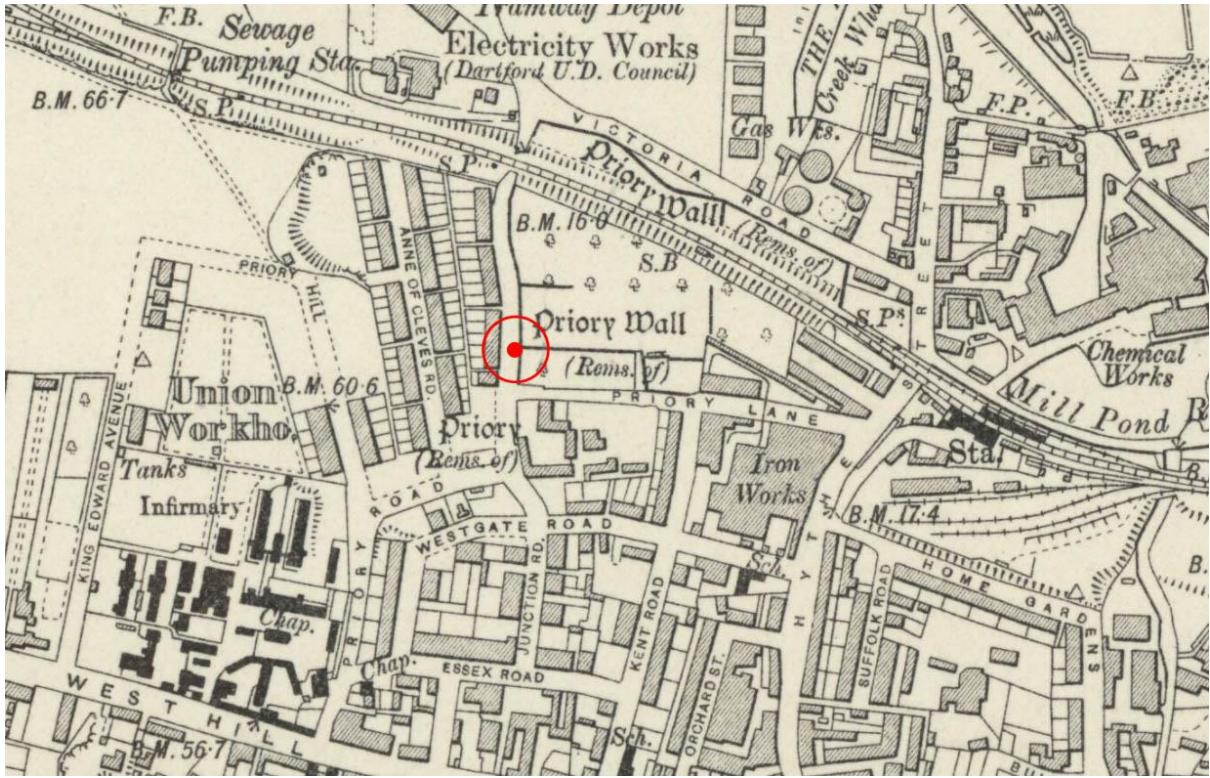
Figure 6: Extract from the Ordnance Survey 6-inch map (1907), with site location marked in red. The manor house can still be seen, however much of the previously open land to the west of Priory Lane has been laid out as terraced housing

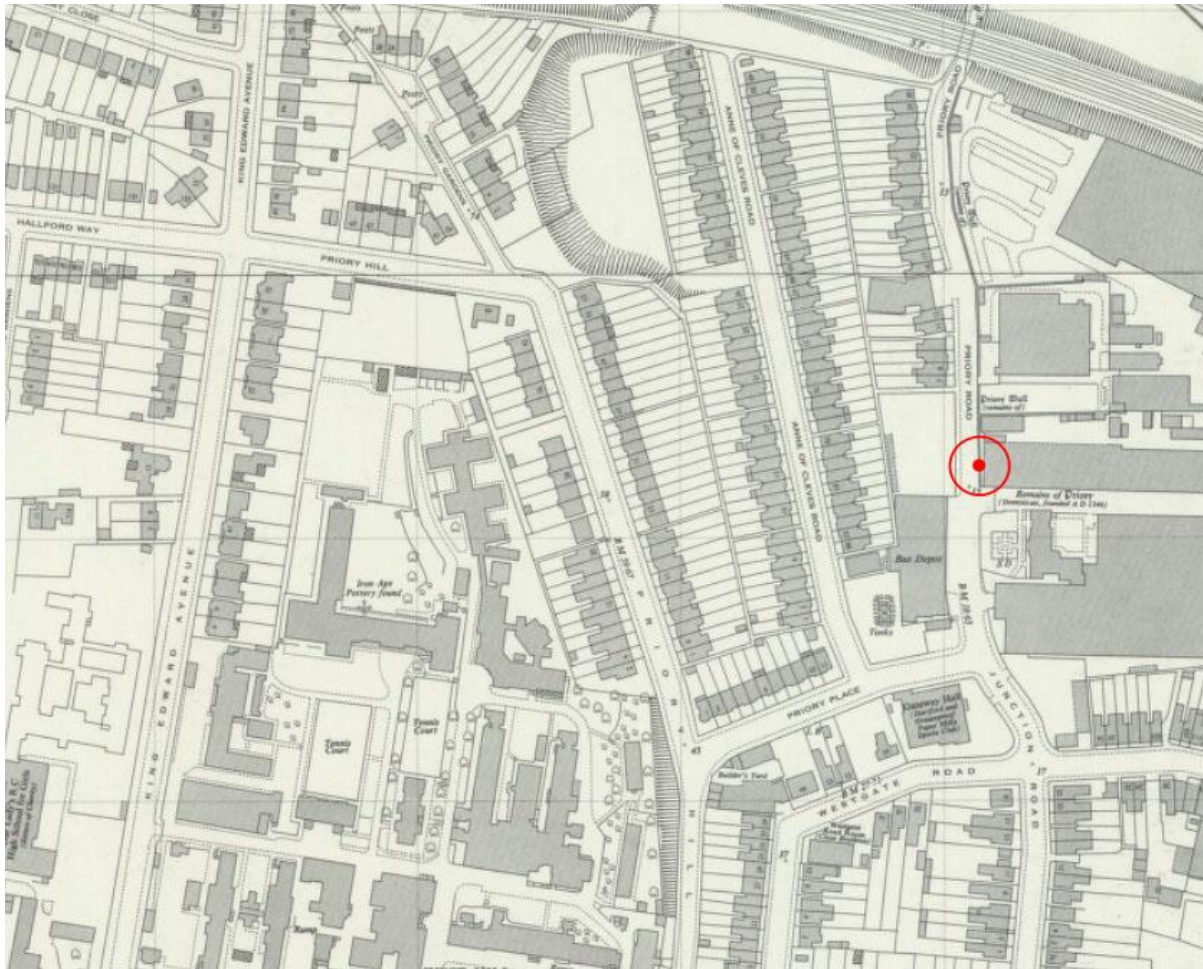
Figure 8: Extract from the Ordnance Survey 1:1250 map, TQ5274-5374-A (1962), with site location marked in red. Several of the terraces adjacent to the site have been cleared and the Engineering Works has expanded, abutting the Manor House. The previously open fields are now almost entirely built over.

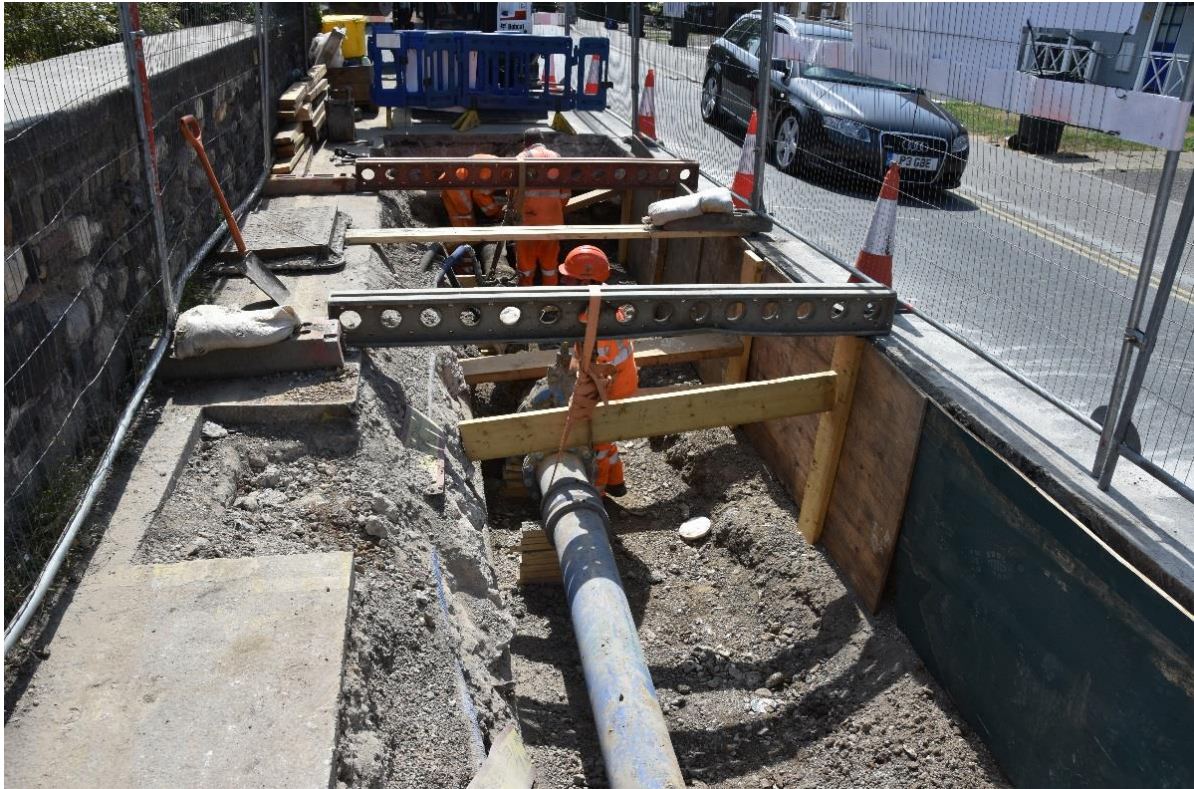
Figure 11: General shot of the excavated trench, facing SW; the water main is shown in the centre of photograph

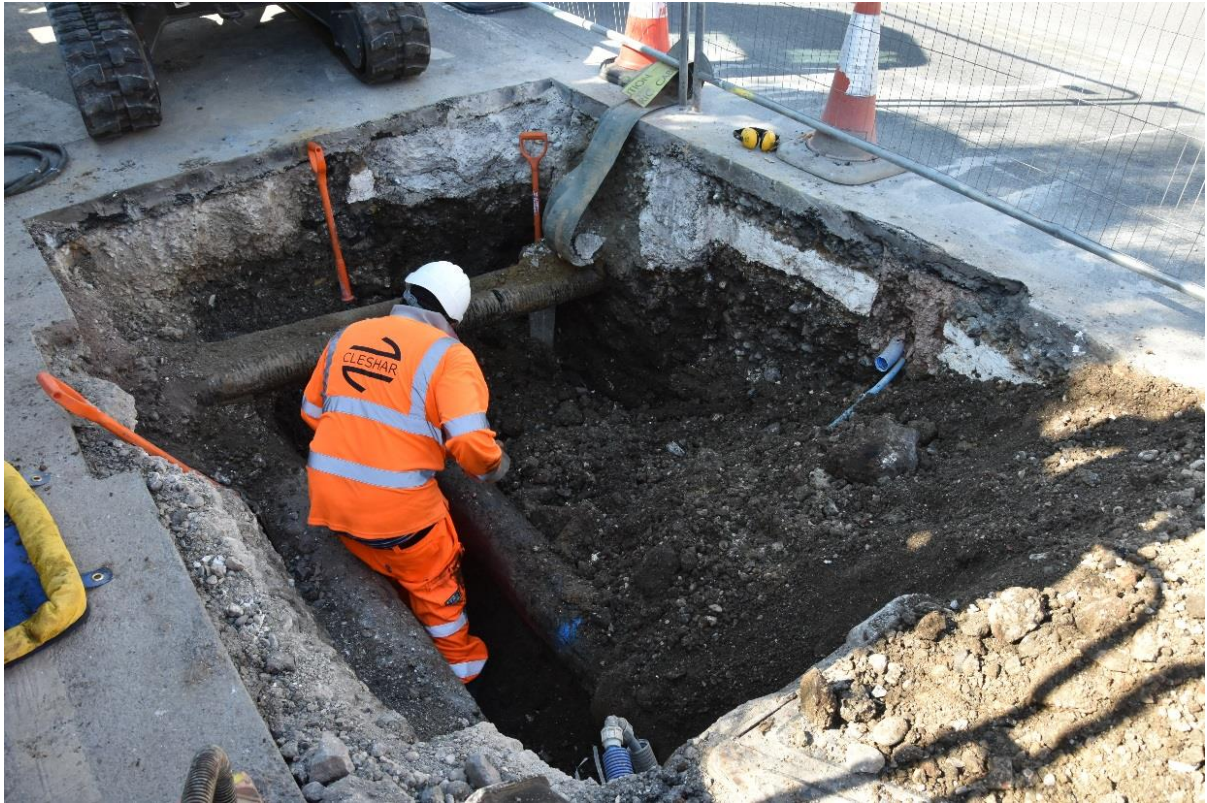
**7.3** The stratigraphy was recorded in two stages, in order to coincide with the anticipated exposure of archaeological deposits and remains during excavation at either end of the trench (Fig.11). The east-facing section in the southern portion of the trench was recorded first (*Section 1*, Fig.10) followed by the south-facing section in the northern end of the trench (*Section 2*, Fig.10). It was decided to target sections fixed at either end of the trench in order to investigate and compare a range of deposits. It is important to note, however, that the material within the trench was heavily disturbed by modern services running through the trench in the eastern and southern parts (Figs.12-13).

*Figure 12: Detail of trench, facing SW, highlighting extensive disturbance caused by modern services*

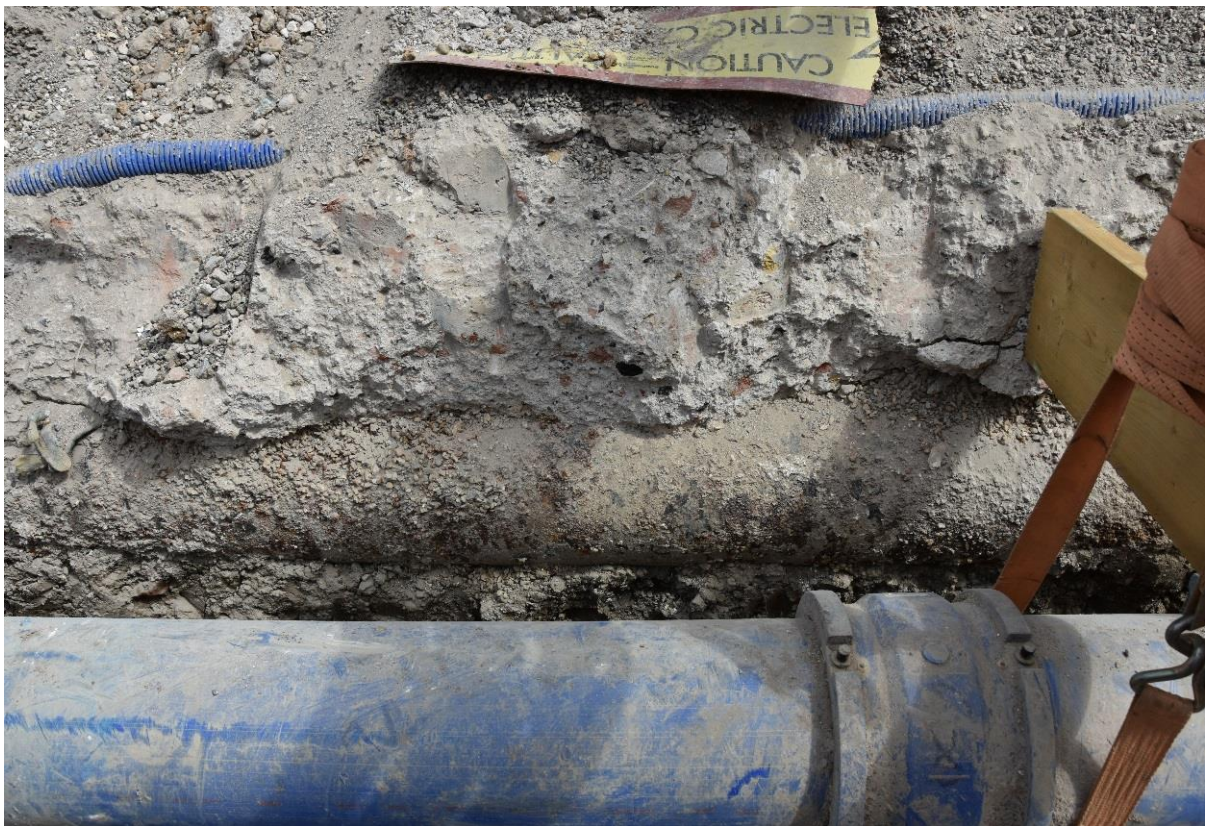
*Figure 13: Detail of disturbance caused by water main (below) and unknown service pipe (above), both running N-S, in west-facing section*

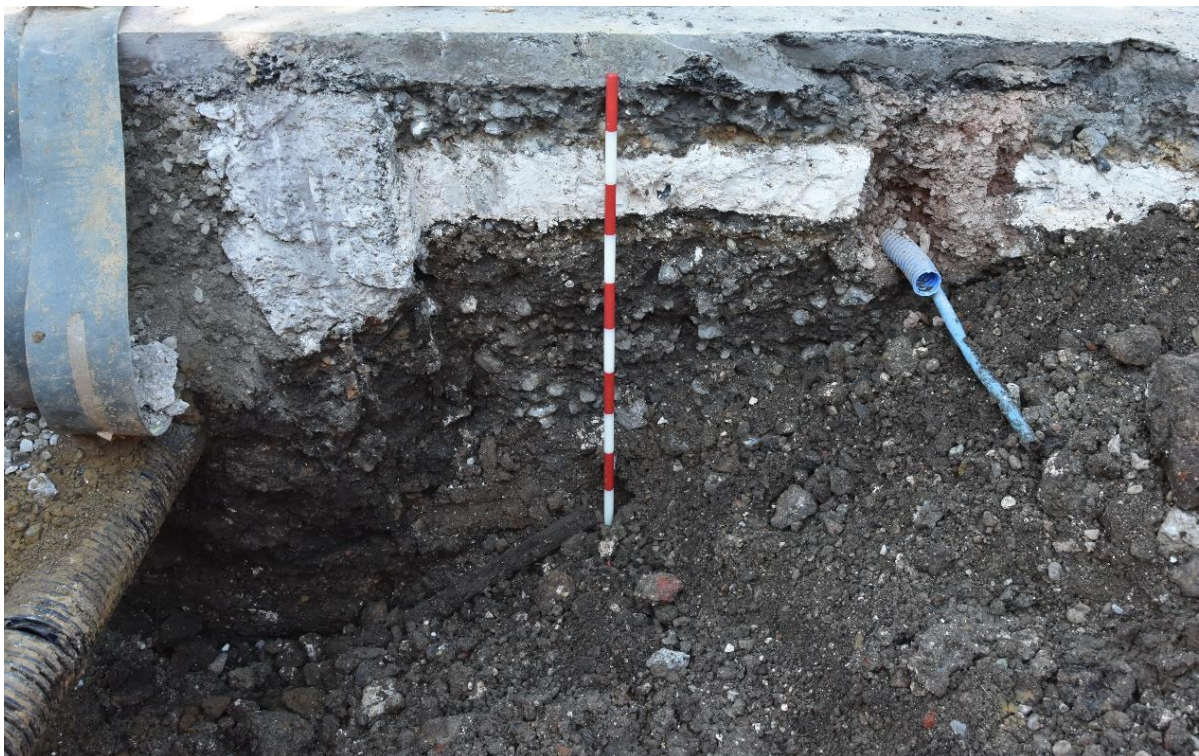
- 7.4.1** The stratigraphy in the southern part of the trench was observed in *Section 1* (Fig.14) and comprised an upper layer of tarmac (1), 0.15m thick, which forms the modern road surface. This overlies a clean, compact layer of chalk (2), measuring at 0.15m thick, extending along the trench section at a uniform level. Below the chalk, a layer of very compact flint rubble (3) was observed at 0.30m below ground surface, extending down to 0.90m below ground surface (0.60m thick). A lower layer of made-ground (4) consisting of a dark grey-brown silty dumped material was recorded 0.90m below ground level, extending down to the trench base, 1.27m below ground level. The made-ground contained frequent gravel and small stony inclusions, as well as a single brick fragment dated to the 18<sup>th</sup>/19<sup>th</sup> century (Appendix III).

- 7.4.2** The chalk, flint and made-ground layers were truncated by the cuts of two modern services [5], [7], both running east-west across the trench, clearly illustrated in the east-facing section (Fig.14). Most of the material in this area of the trench consisted of loose backfill (6) and (8), associated with these modern cuts.

- 7.4.3** Natural geology was not exposed in this southern portion of the trench.

Figure 14: Detail of east-facing section (*Section 1*), in southern end of trench (1m scale); illustrating truncation caused by service pipe [5] (bottom left), and compacted layers of chalk (2) (0.15m down from scale top) and flint rubble (3) (0.40m down from scale top)

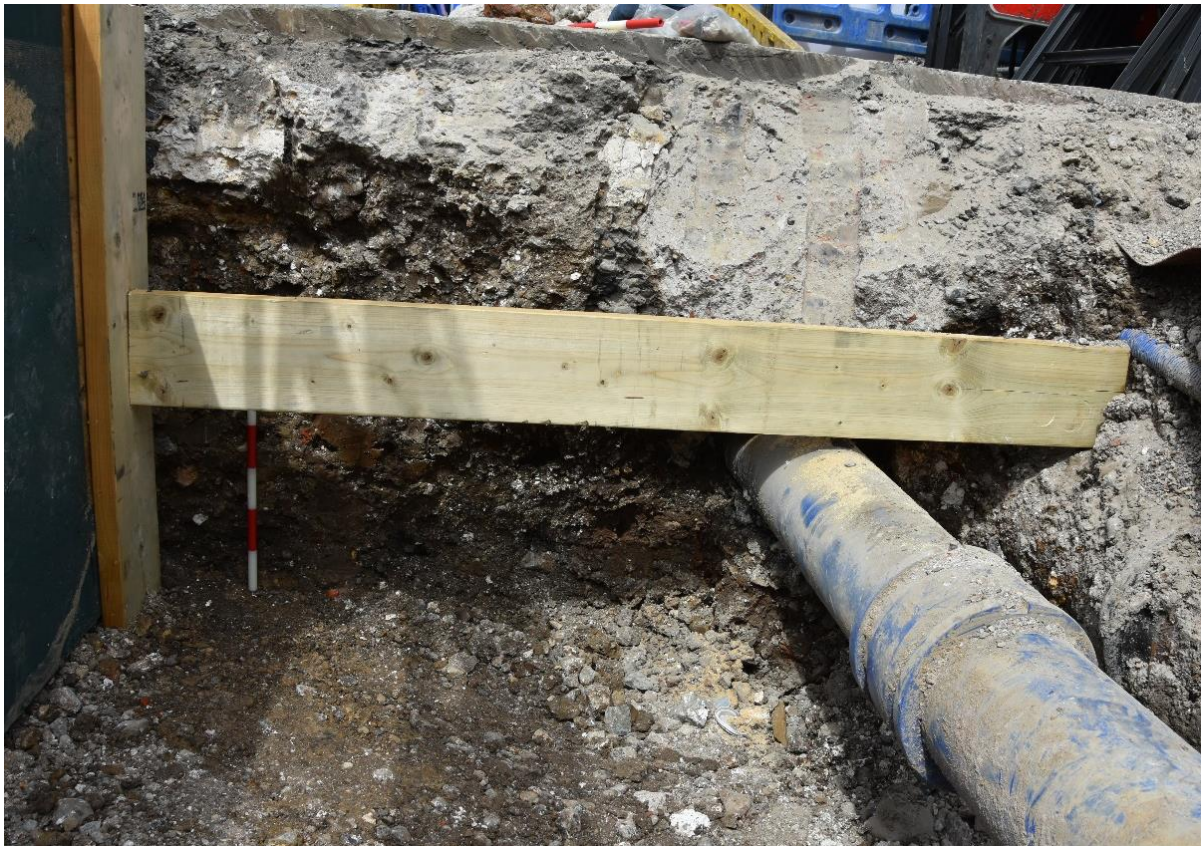
- 7.5.1** The stratigraphy in the northern part of the trench was recorded from the south-facing *Section 2* (Fig.15). Unfortunately work had already been undertaken to support the trench sides with timber shoring, which partially reduced the visibility of the section (Fig. 16).

- 7.5.2** Despite this, it was possible to record the stratigraphy of the section. Below the tarmac of the current road surface (9), measuring 90mm thick, was a substantial layer of pale concrete (10) associated with the backfilling of the original water mains cut [11]. Below the concrete was a series of dirty, mixed deposits of sandy and silty clay (12), (13), (14), extending down to 1.27m below ground surface, interpreted as post-medieval made-ground. These layers were observed to contain frequent small gravelly flint inclusions, as well as small pieces of chalk and chalk dust. A small number of post-medieval brick samples were retrieved from these lower layers of made-ground, which were subsequently dated to the 18<sup>th</sup>-19<sup>th</sup> centuries. Two examples of 15<sup>th</sup>/16<sup>th</sup> century brick were also identified, probably residual fragments of material associated with the Dominican Priory which once stood to the east of the study site (Appendix III).

- 7.5.3** The lower made-ground layer sealed approximately 60mm of compact orange-yellow, sandy clay (15), which sloped downwards from west to east, continuing into the trench base at 1.33m below ground level. This was taken to be the natural geology.

*Figure 15: Detail of south-facing section (Section 2), in northern end of trench (0.5m scale); illustrating water main (blue) [11] and unknown service pipe (far right), backfilled with concrete (10), truncating dark layers of made-ground (12), (13), (14) (left)*

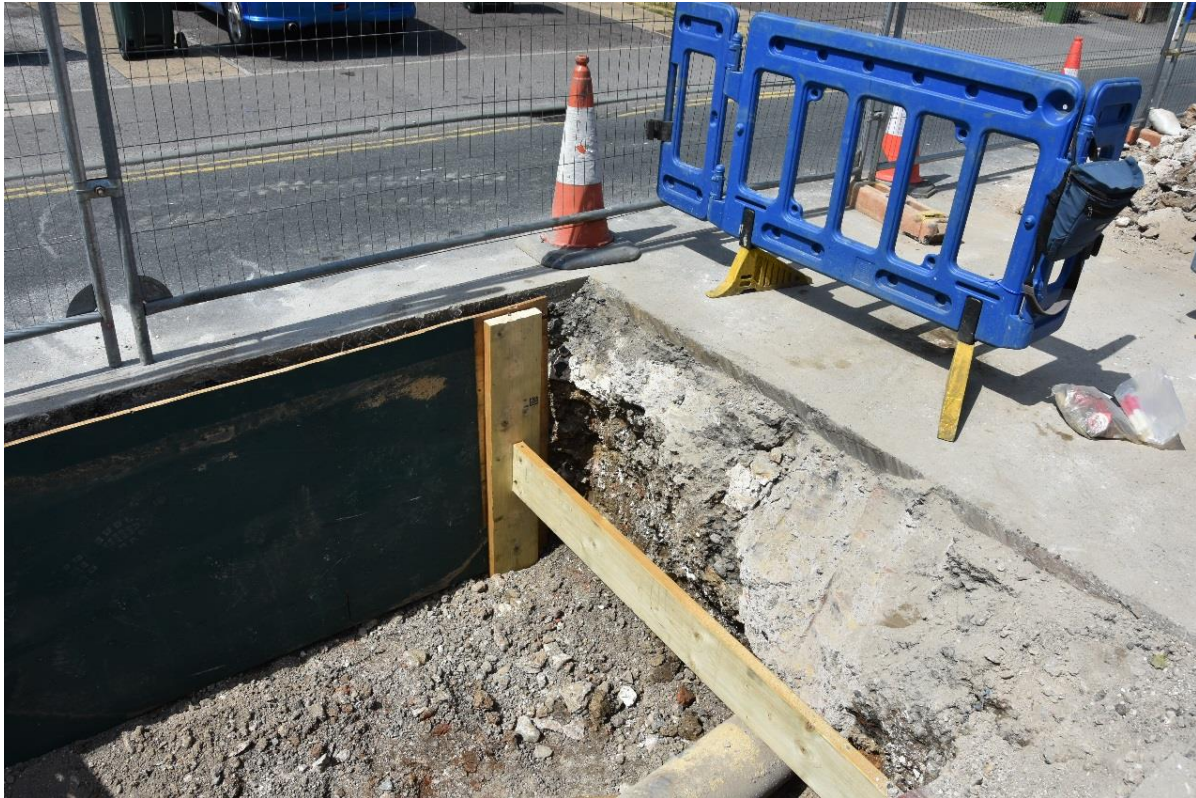
*Figure 16: View of timber shoring supporting trench sides, facing NW*
