## 11. THE EXTERNAL GROUNDWORKS

A number of areas adjacent to and outside the building were subject to excavation, variously for building foundations, drainage and other garden works (principally terracing). The principal groundworks are illustrated below (Fig.315, A-G) and described in detail in the following text and illustrations.

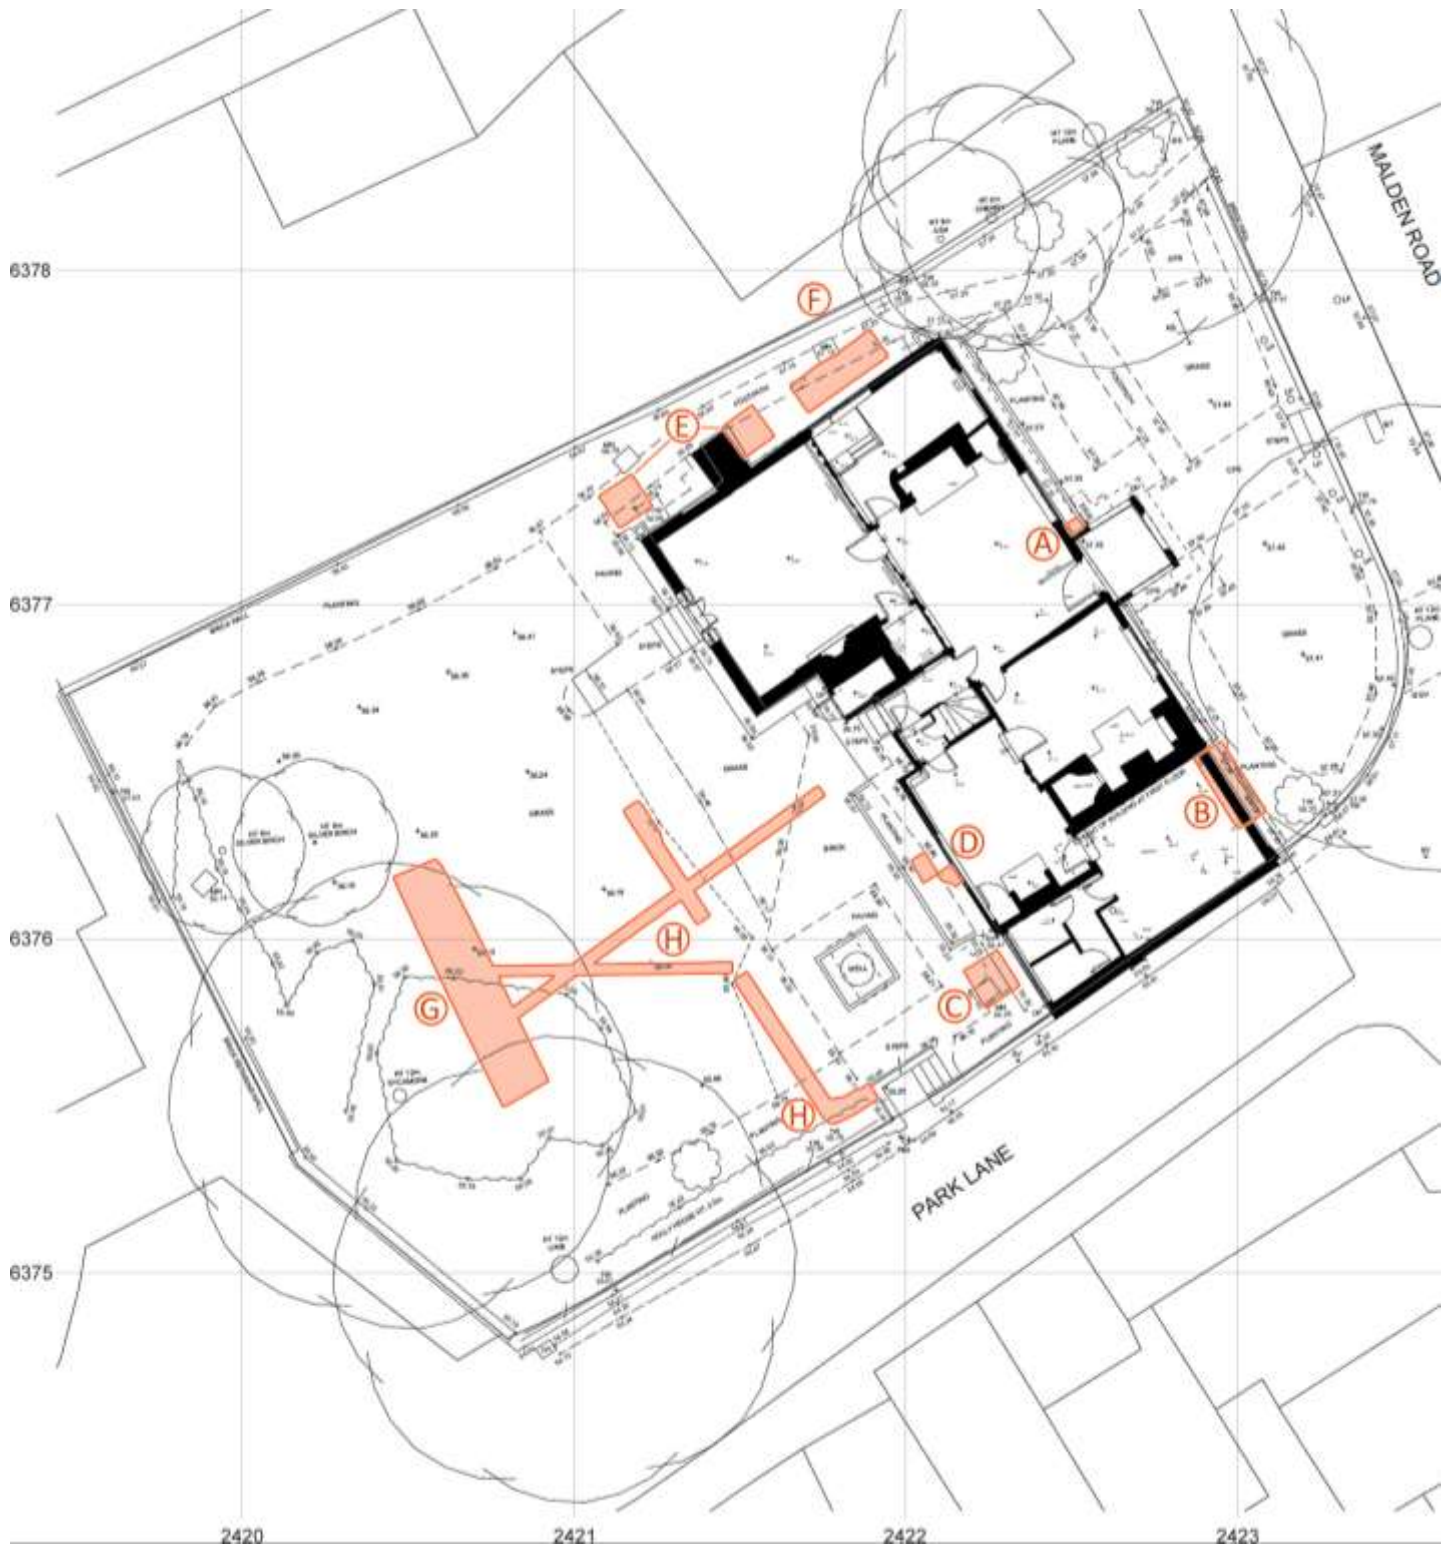
Fig.315: Principal areas of external excavation (A-G). Based on an original drawing by Curl la Tourelle Head Architecture. Drg. No. 957 100

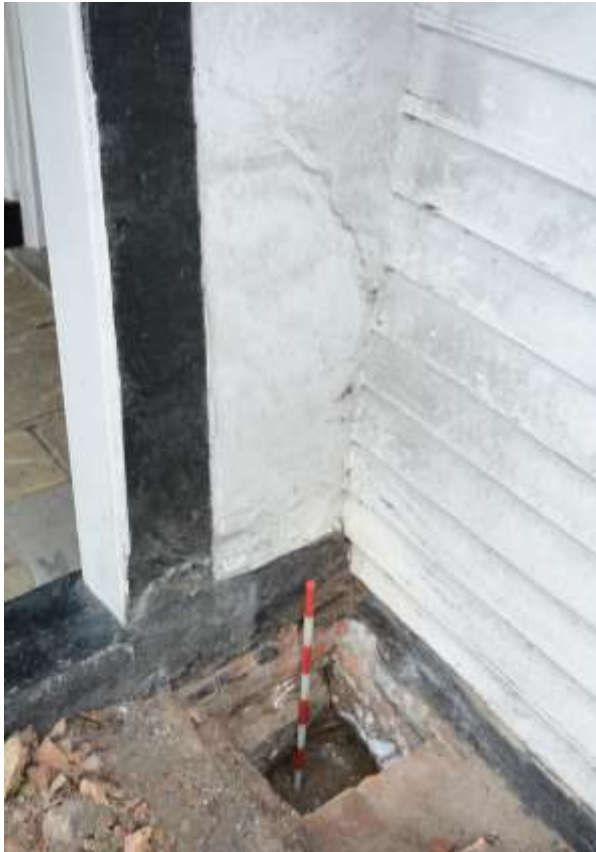
A single test pit c 650mm deep was excavated on the northern side of the junction between the front wall and porch. This indicated that the porch base (at least at its lower level) had been built against the main footing, although the upper brickwork may represent part of later rebuild/consolidation. Natural (16) was exposed at the base.

Fig.316: *General view of the test pit, looking south (0.8m scale)*

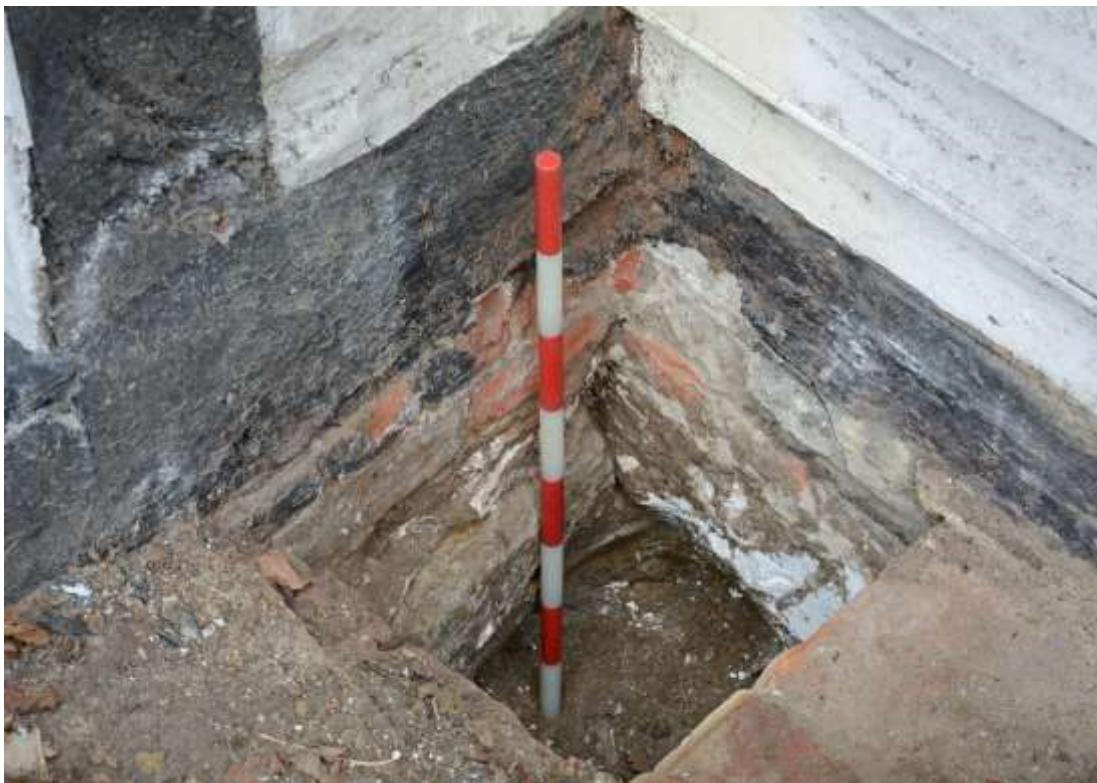
Fig.317 (below): *Detail of the above*

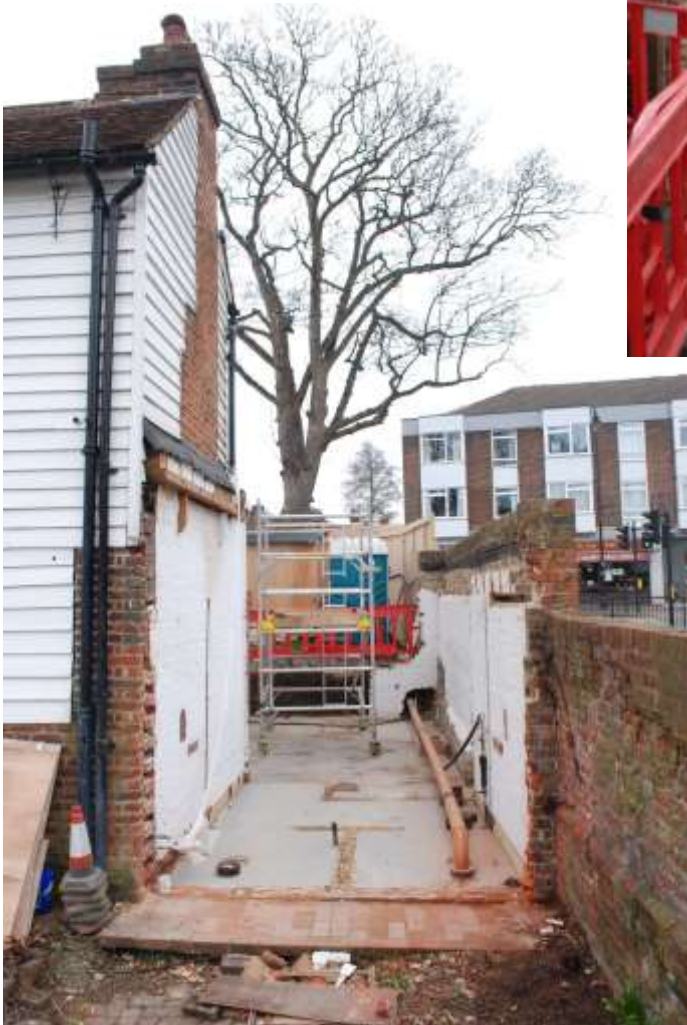
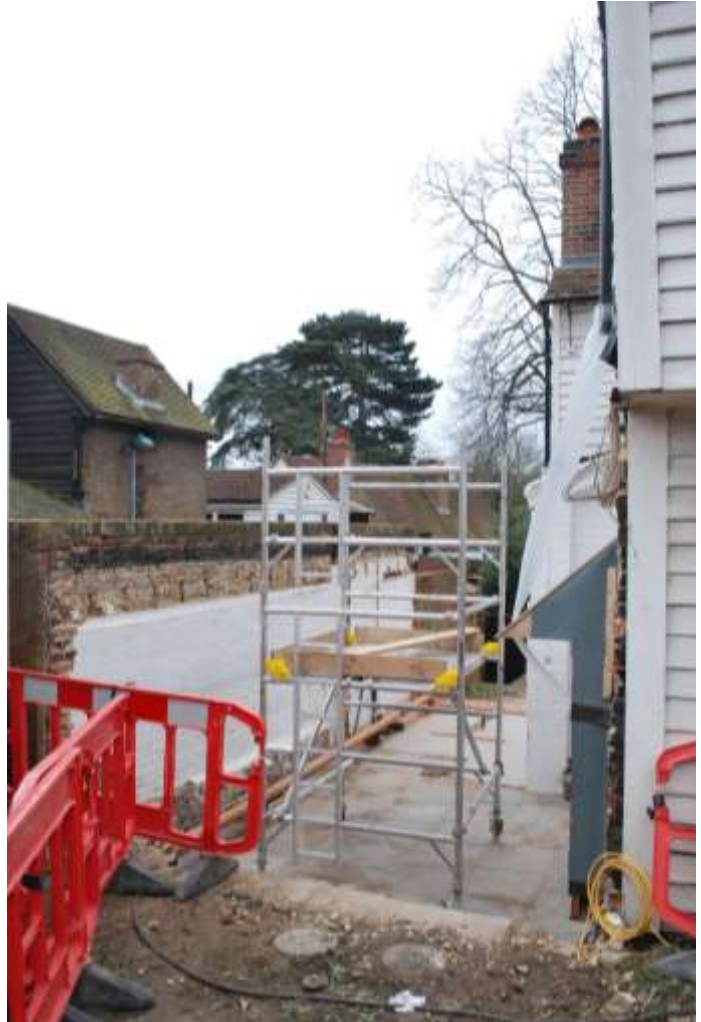
Fig.318: *The southern end of Whitehall after demolition of the Roy Smith Gallery, view looking southwest (front to back)*

Fig.319: *The opposite view to the above, looking from the rear towards Malden Road*

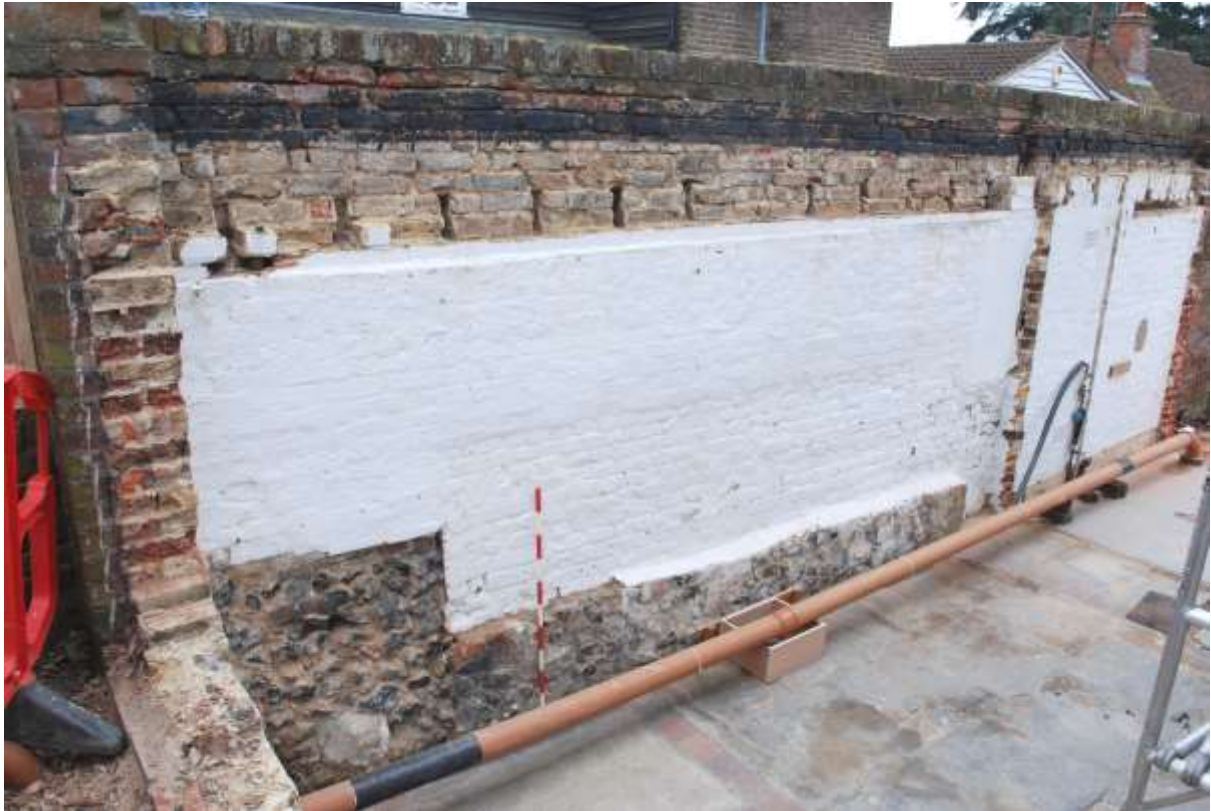
Fig.320: *The internal face of the southern boundary wall after demolition of the Roy Smith Gallery – the main part of the structure possibly of early 19<sup>th</sup> century date (1.0m scale)*

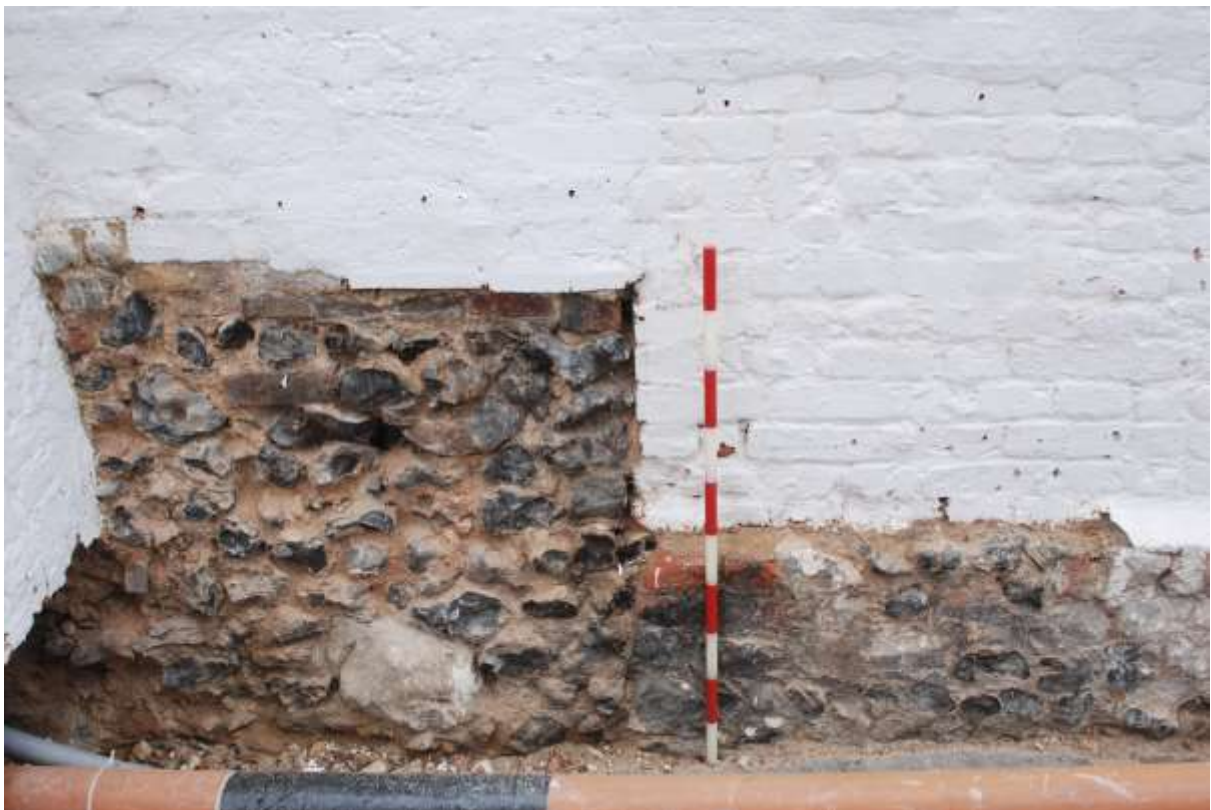
Fig.321: *Detail of the above showing part of the mainly flint base to the wall – possibly part of an earlier phase, predating the extension that appears on the 1808 Enclosure map*

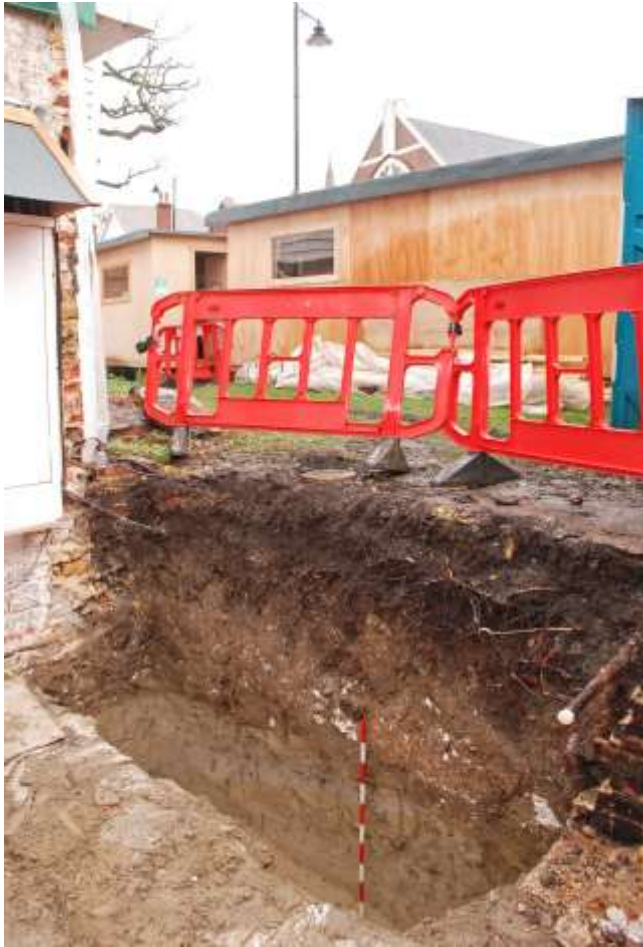
Fig.322: *View of the new foundation trench looking north towards Malden Road (1m scale)*

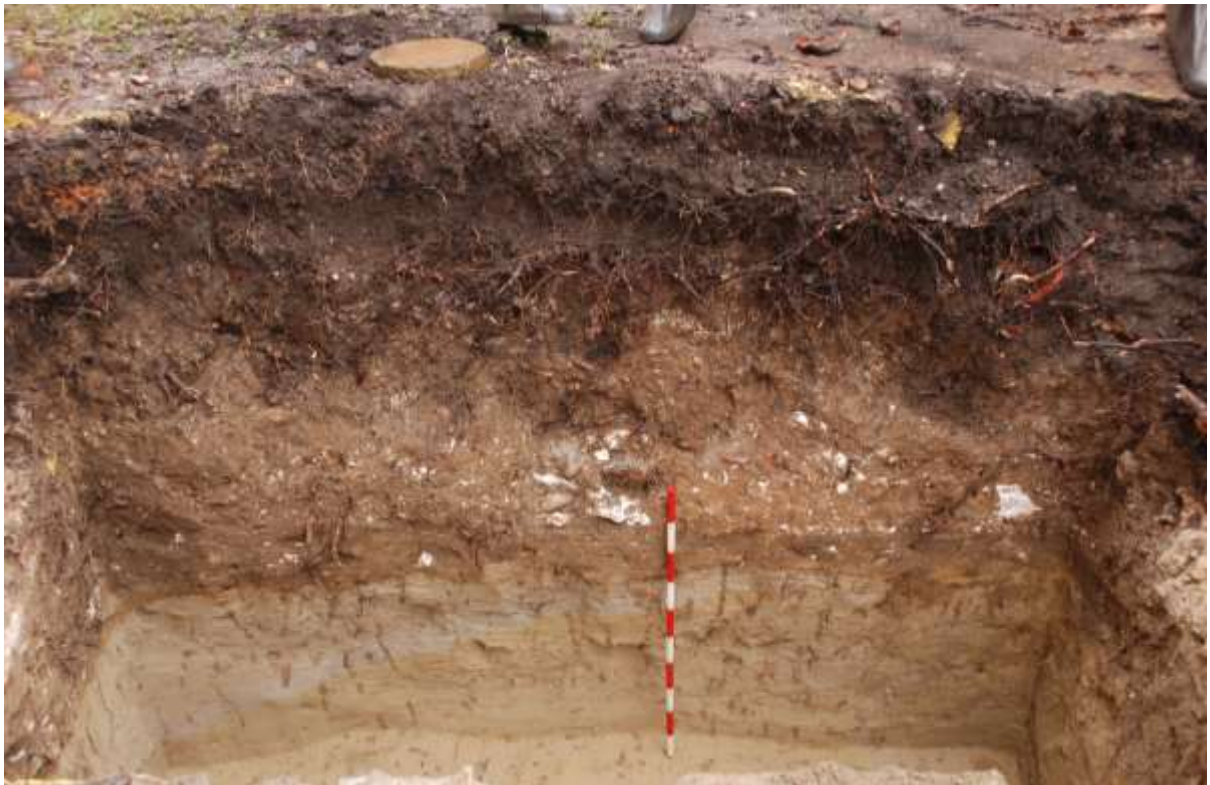
Fig.323: *Detailed view of the above looking northeast; see also section drawing overleaf*

The new foundation trench was approximately 2.6m by 1.05m in plan, and a maximum of 2.06m deep to the east – the ground to the west having already been substantially reduced by the previous development(s). As can be seen the groundworks exposed a series of deposits over the natural surface (16), some of which is presumably made ground, as well as a possible post pit (2). However, there were no significant features and the dating evidence was limited to fragments of ceramic building material (*cf.* Appendix I).

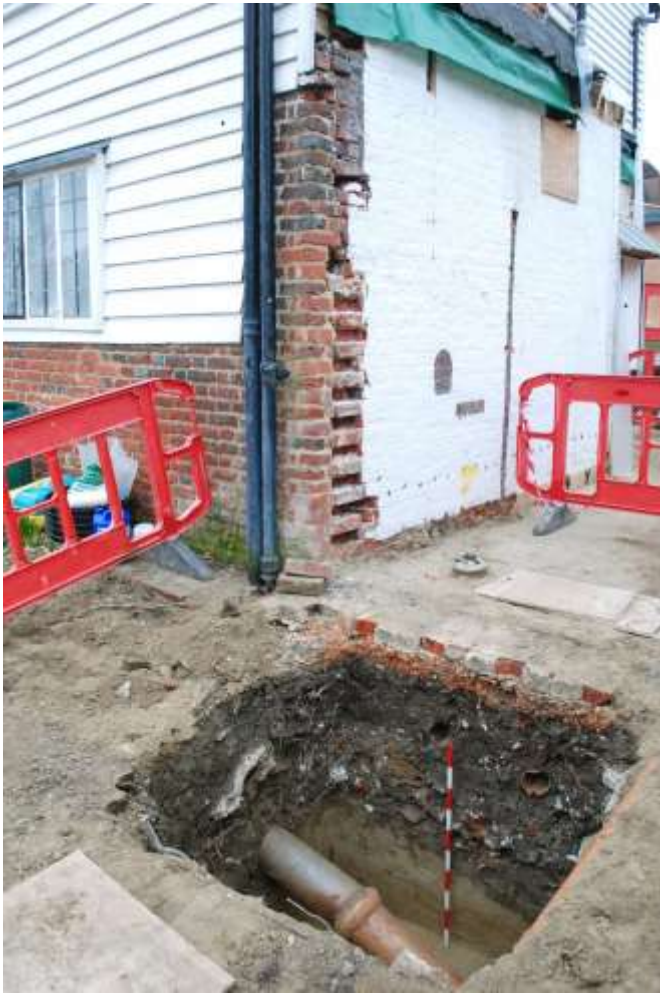
Fig.325: *General view of Area C excavation pit, looking north (1.0m scale)*

The excavation in Area C comprised a pit approximately 1.25m square in plan, and between *c* 1.25m and 1.46m deep. It was located within an area that was already largely disturbed by services – including a brick-lined inspection chamber, almost all of which was removed by the excavation (the surviving western edge can be seen in Fig.326).

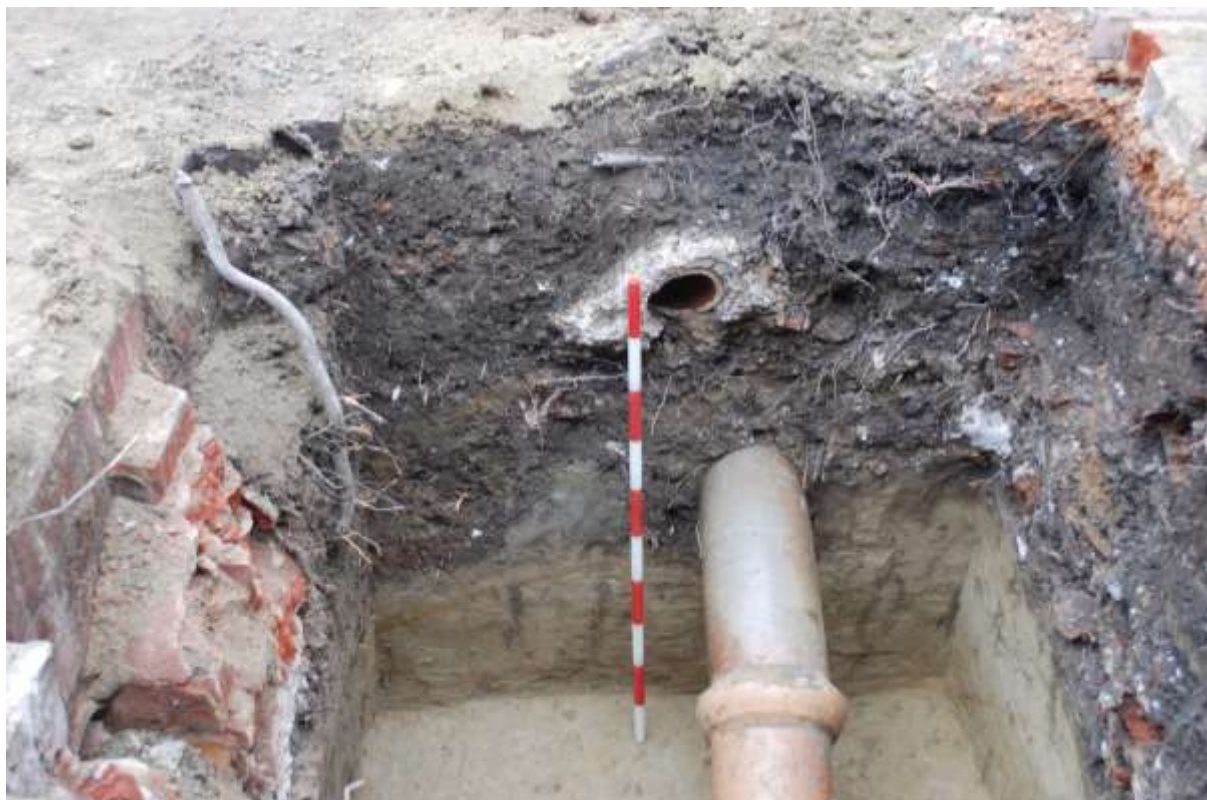
Fig.326 (below): *Detailed view of the northern section of the pit. The dark brown deposit cutting into natural sand to the left of the 1.0m scale may represent backfill within the 1979-80 excavation (Nail nd.)*

In the northwest corner of the pit was a slightly deeper cut into the natural sand, with a dark brownish fill (also Fig.326). This may represent backfill within (& perhaps the edge of) the 1979-80 archaeological excavation (Nail *nd.*): its location lies just outside the line of the well construction cut, which appears to have been thoroughly excavated (and which produced a large assemblage of medieval pottery, in particular 14<sup>th</sup> century Cheam white ware.).

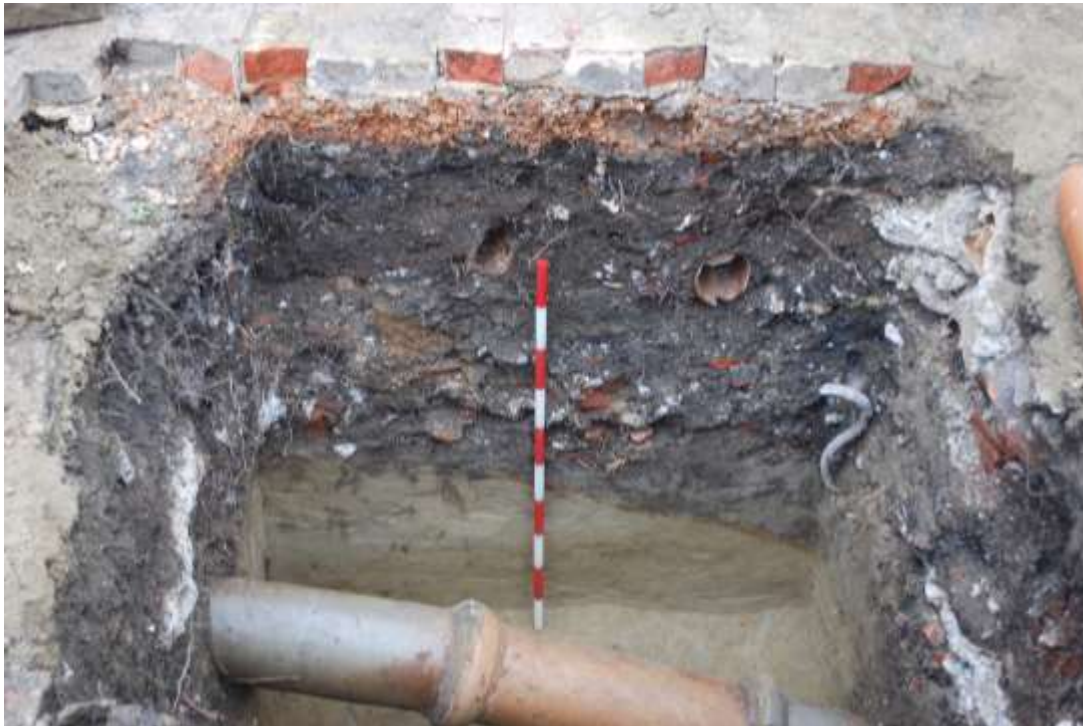
Fig.327: The eastern section of pit (C), showing made ground and backfill deposits over natural (1m scale)

However, the present excavation (contexts 10 & 11) did not produce many finds – there was some medieval/post-medieval ceramic building material, and a few potsherds of post-medieval date plus one of medieval Kingston-type ware (*cf.* Appendices I & II).

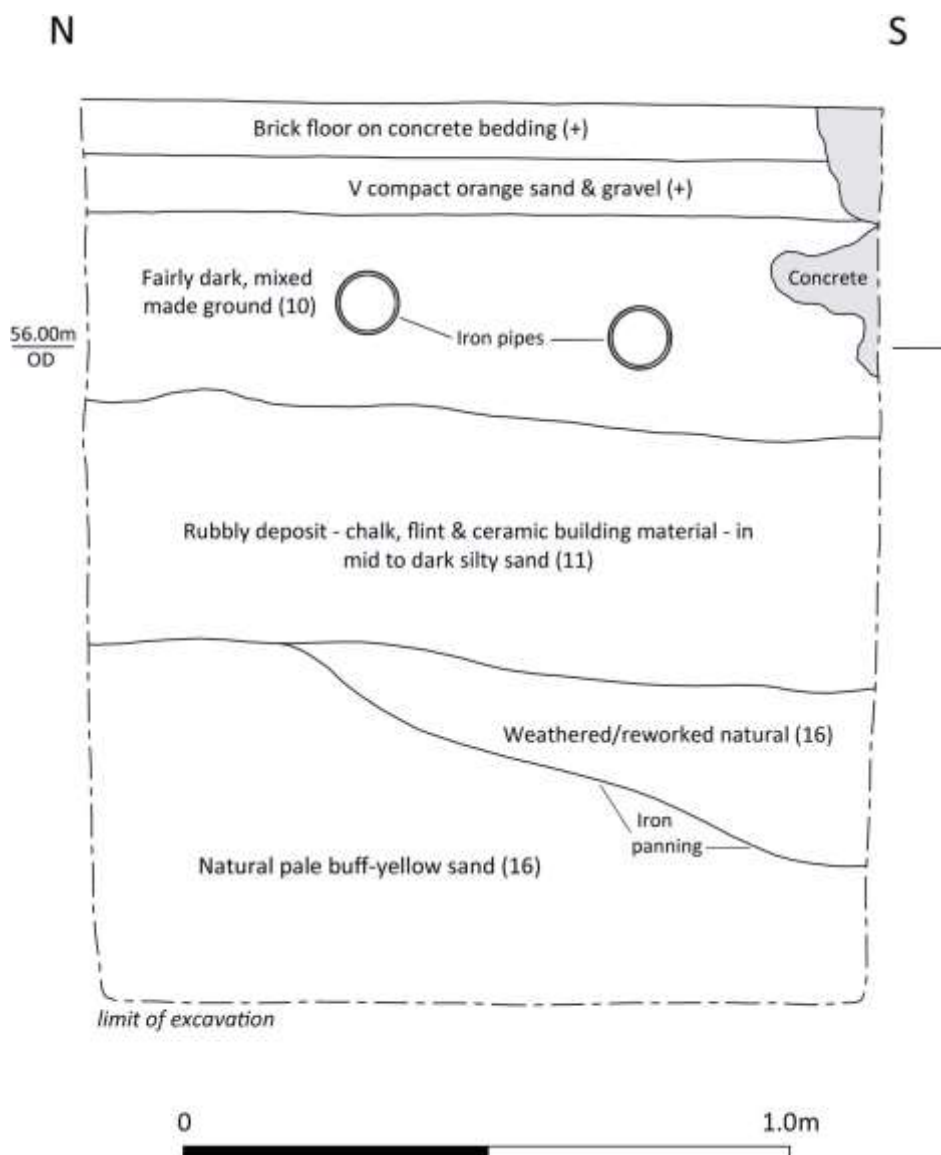
Fig.328: Drawing of the above section

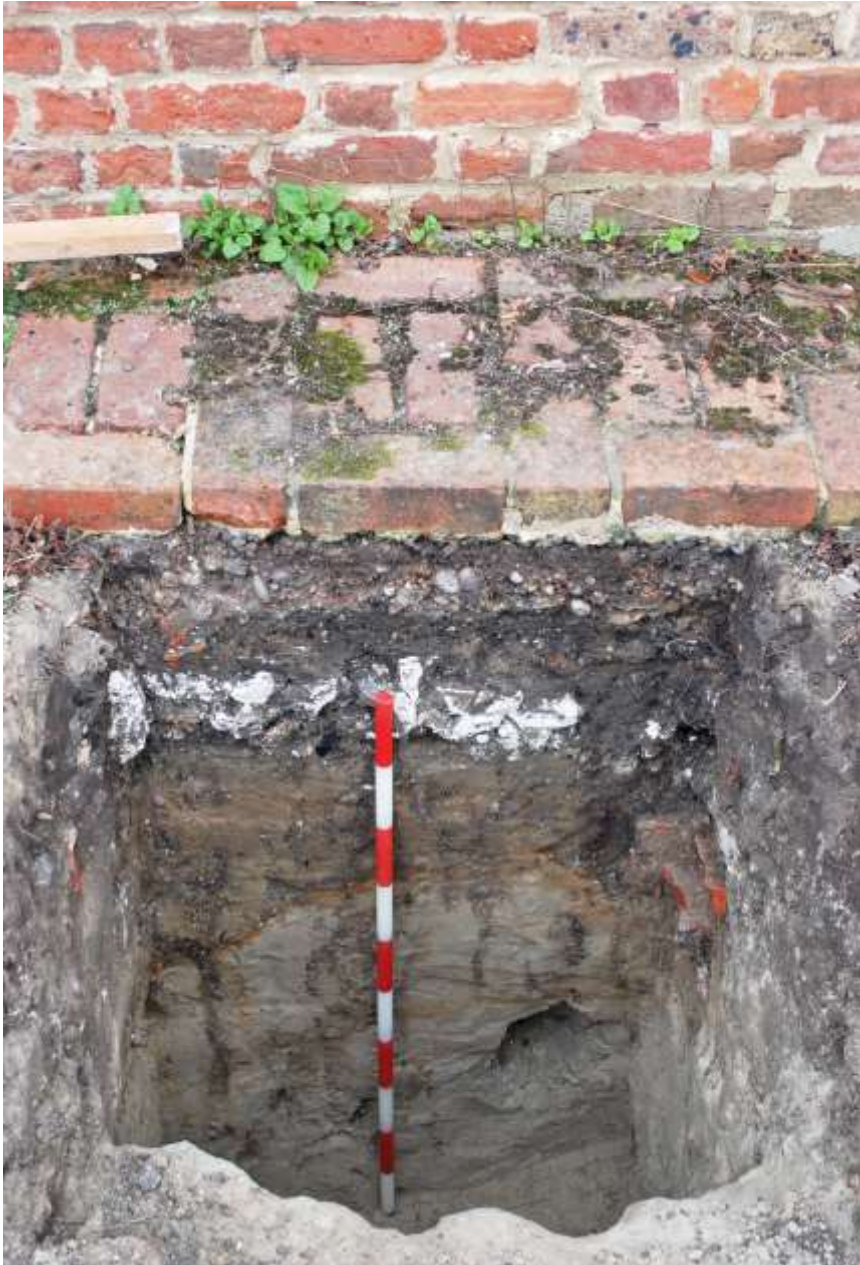
Fig.329: *The eastern section of the test pit (1.0m scale). See also section drawing overleaf*

The test pit (Figs.329 & 330) measured c 0.5m by 0.8m in plan, by up to 1.26m deep. It exposed a fairly simple sequence of made ground and probable reworked natural, overlying the clean – though somewhat root-disturbed – Thanet Sand.

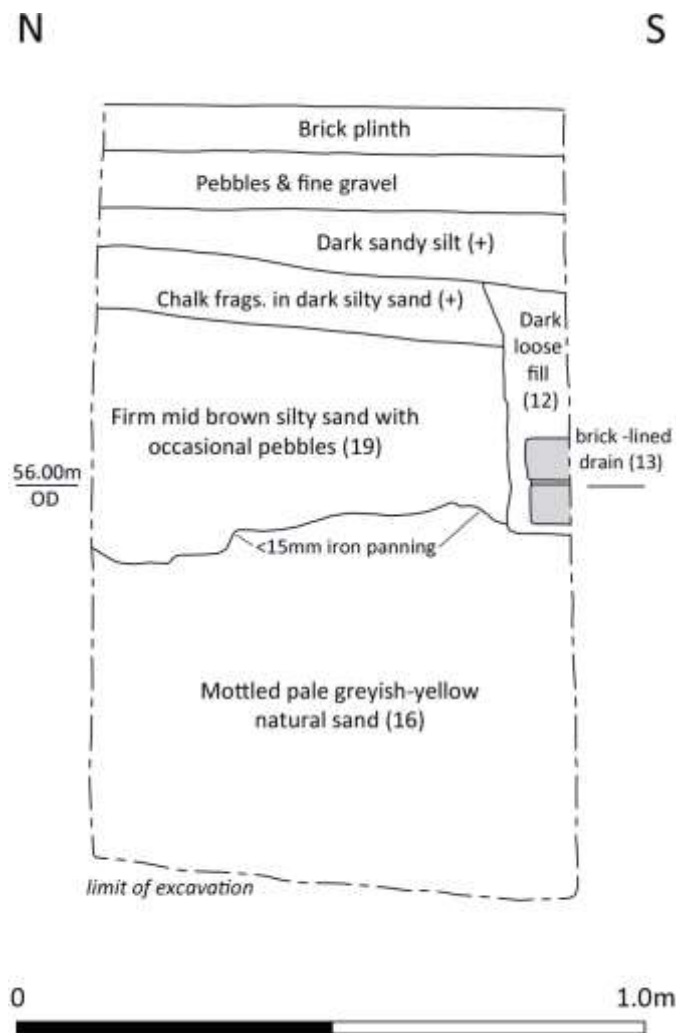
Fig.330: Drawing of the eastern section of the test pit, as seen in Fig.329

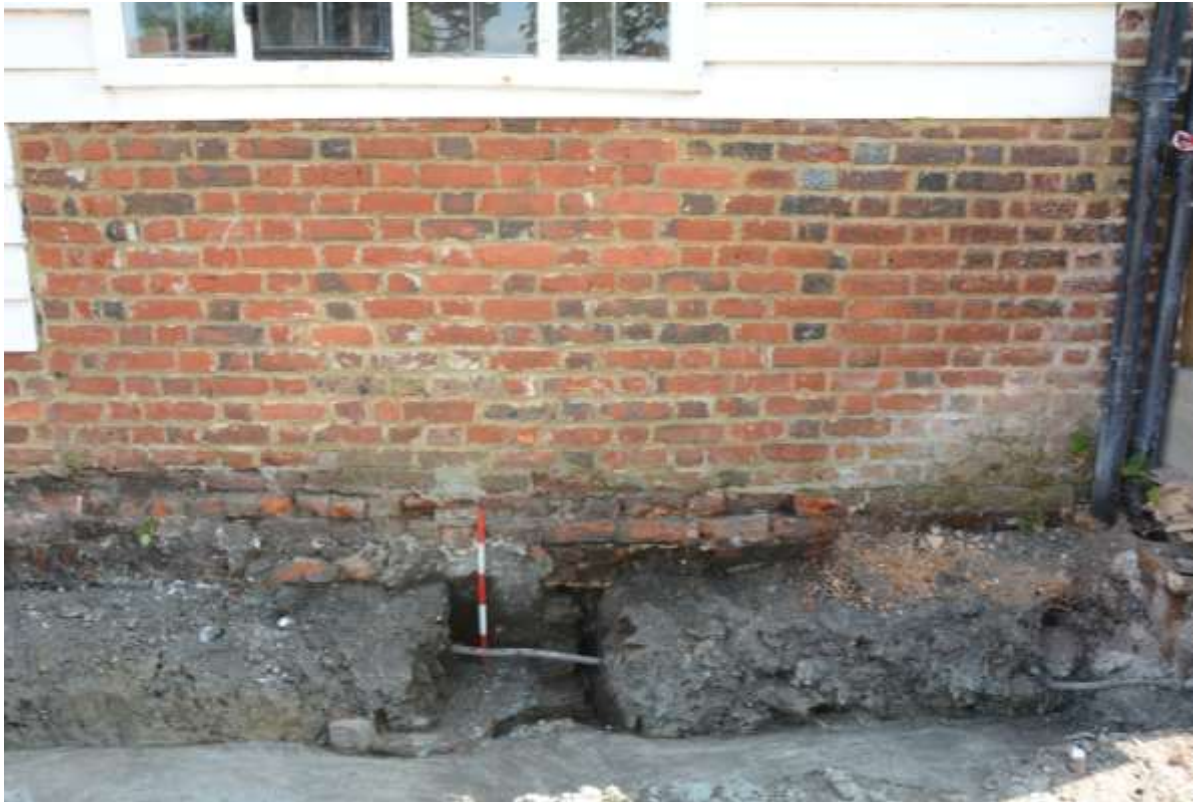
Fig.331: *General view of the surviving drain box (13) looking northeast, with a new dwarf wall foundation laid in the foreground*

**11.3.1** The southern edge of the above section was broken by cut containing a dark fill over mortared brickwork (contexts 12 & 13). Subsequently – after extension of the test pit north and south to form a new foundation trench - this was more fully exposed. The brickwork formed a partly demolished drain box, built against (and possibly contemporary with) the wall of Room G-04. Most of the base survived, plus parts of both side walls and just enough of the outer northwest corner to establish the internal dimensions – c 460mm square. Overall width was about 750mm and all internal faces had been rendered, including the exposed brickwork of the adjacent building.

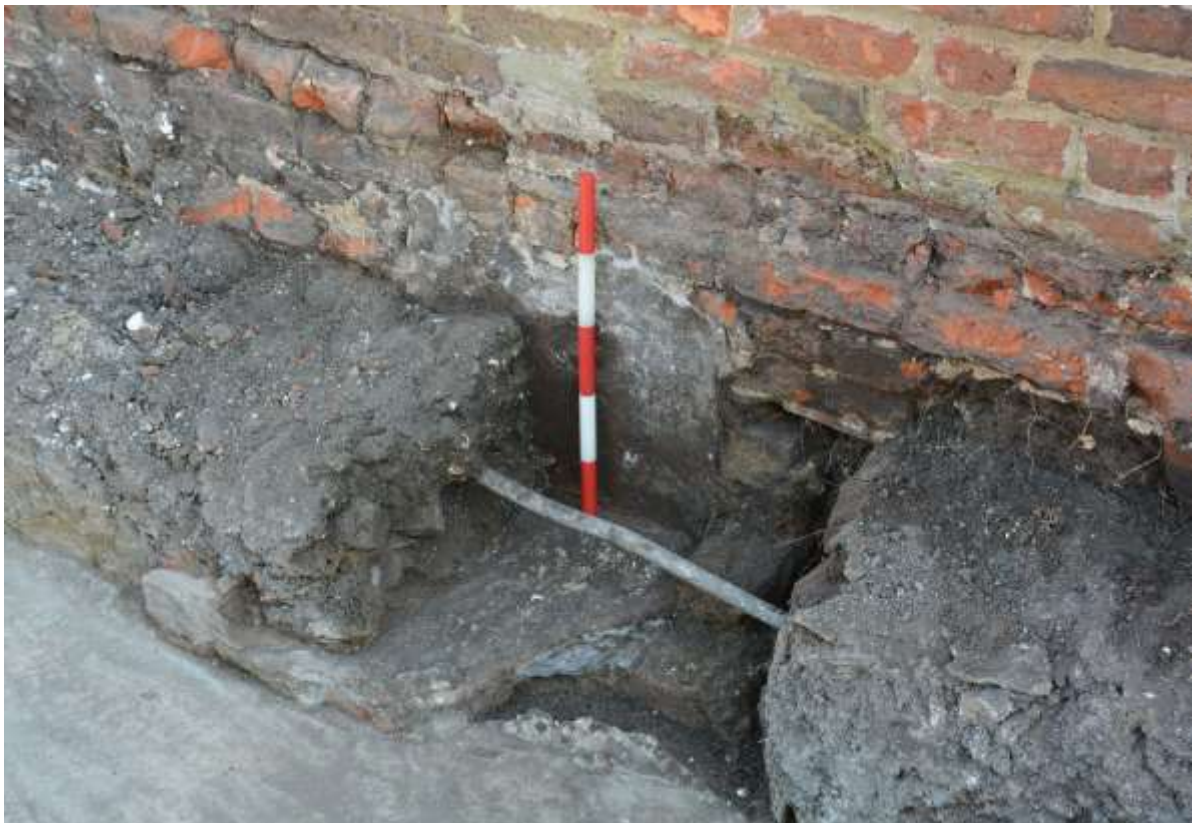
Fig.332: *Detail of the surviving drain box (0.5m scale)*

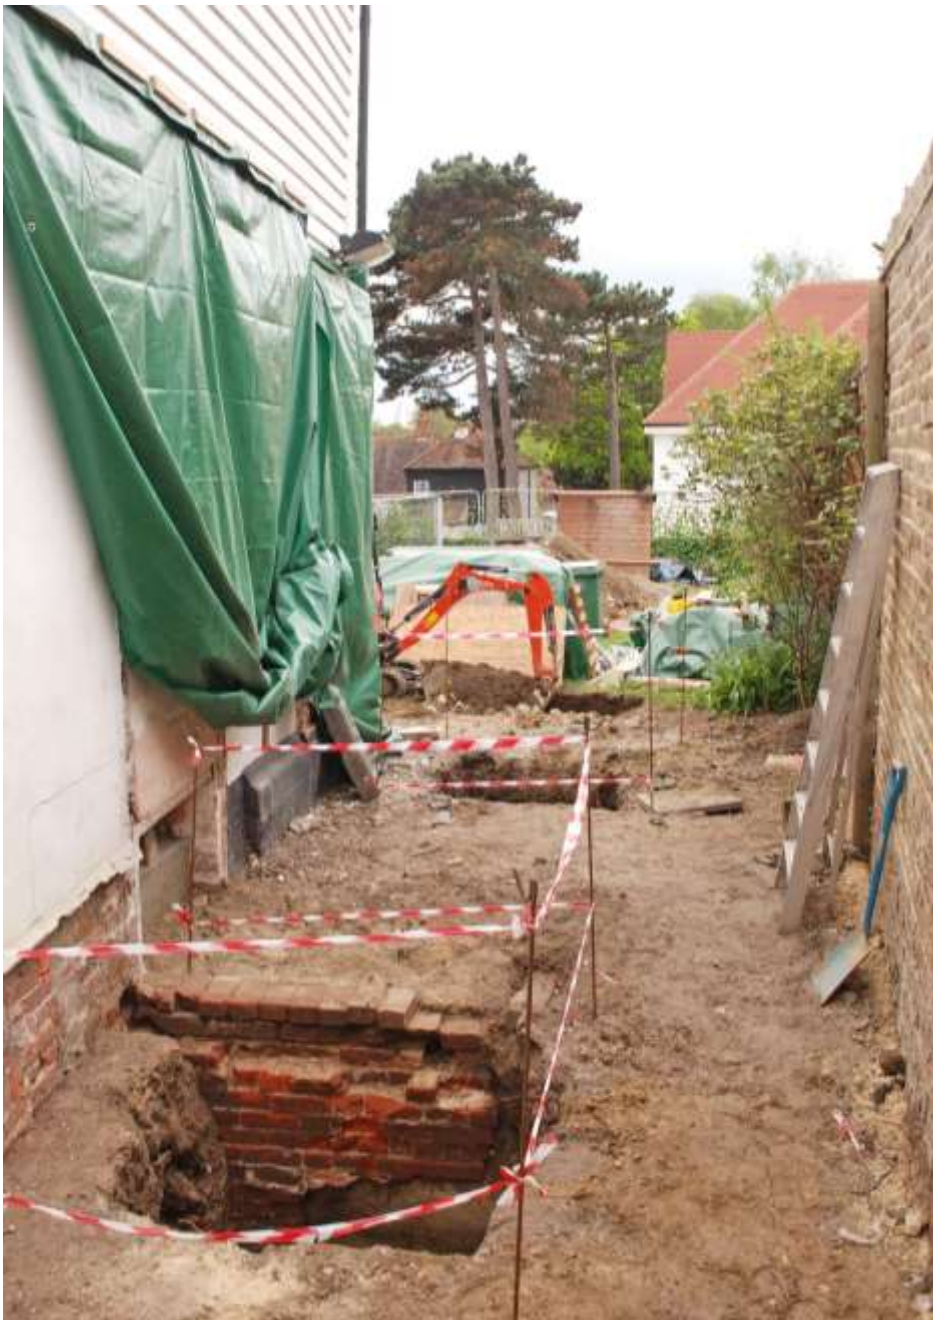
Fig.333: *General view of the northern extension foundation pits, looking southwest*

Two more or less square foundation pits were excavated on the northern side of Whitehall, following blocking and backfilling of the previous external cellar access and prior to casting of the overall slab for the new extension. Each pit measured approximately 1.15m square in plan, and was c 1.45m deep.

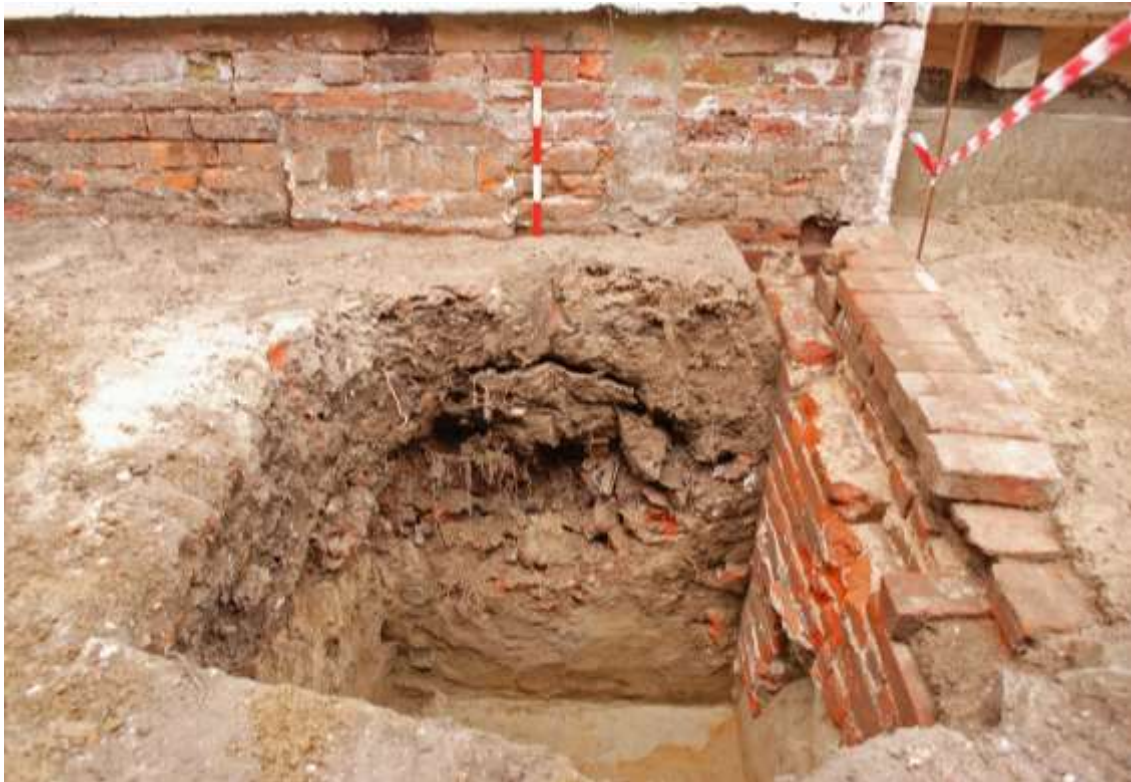
Fig.334 (above): *The southern side of the eastern foundation pit (see also section drawing, Fig.64)*

The easternmost pit exposed the outside face of the eastern flank wall to the cellar entrance (context 18), as seen in the foreground of Fig.334 below and detailed further in Section 8.2. There were no other notable features or features in either pit, and both revealed extensive modern disturbance that extended to (and clearly truncated) the natural sand: this is also illustrated in the section drawing that forms part of Fig.64.

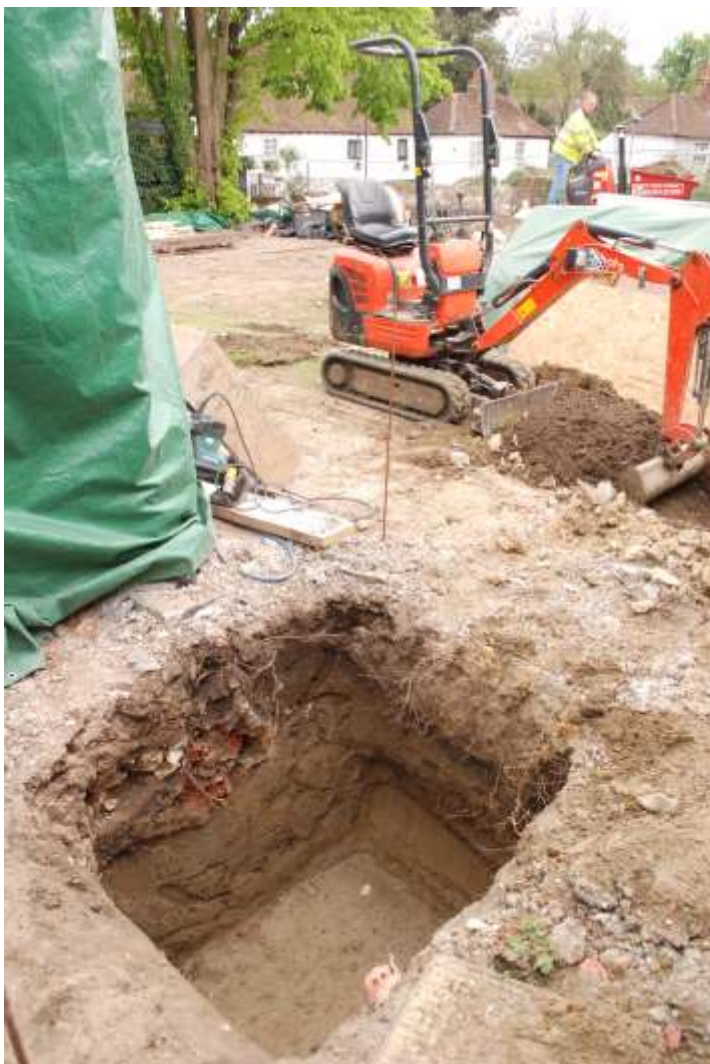
Fig.335: *The southern side and corner of the western foundation pit. Truncated natural sand appears at least 600mm below the present ground surface*

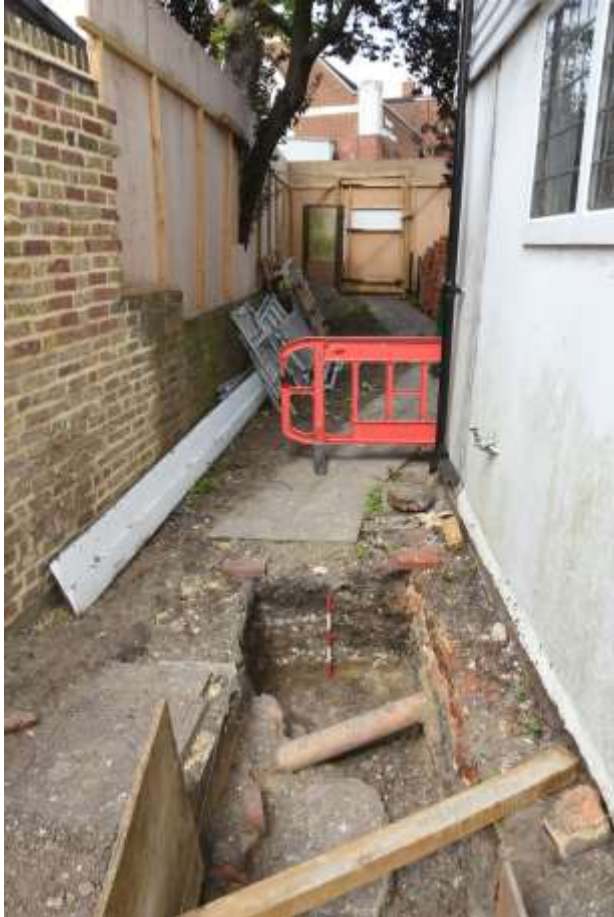
Fig.336: *View of the new foundation trench, looking northeast towards Malden Road*

This area was also heavily disturbed by modern services, although with a fairly intact section present to the east. A shallow soil overlay compact silty sand with frequent chalk and occasional ceramic fragments, and thence natural sand, as shown below.

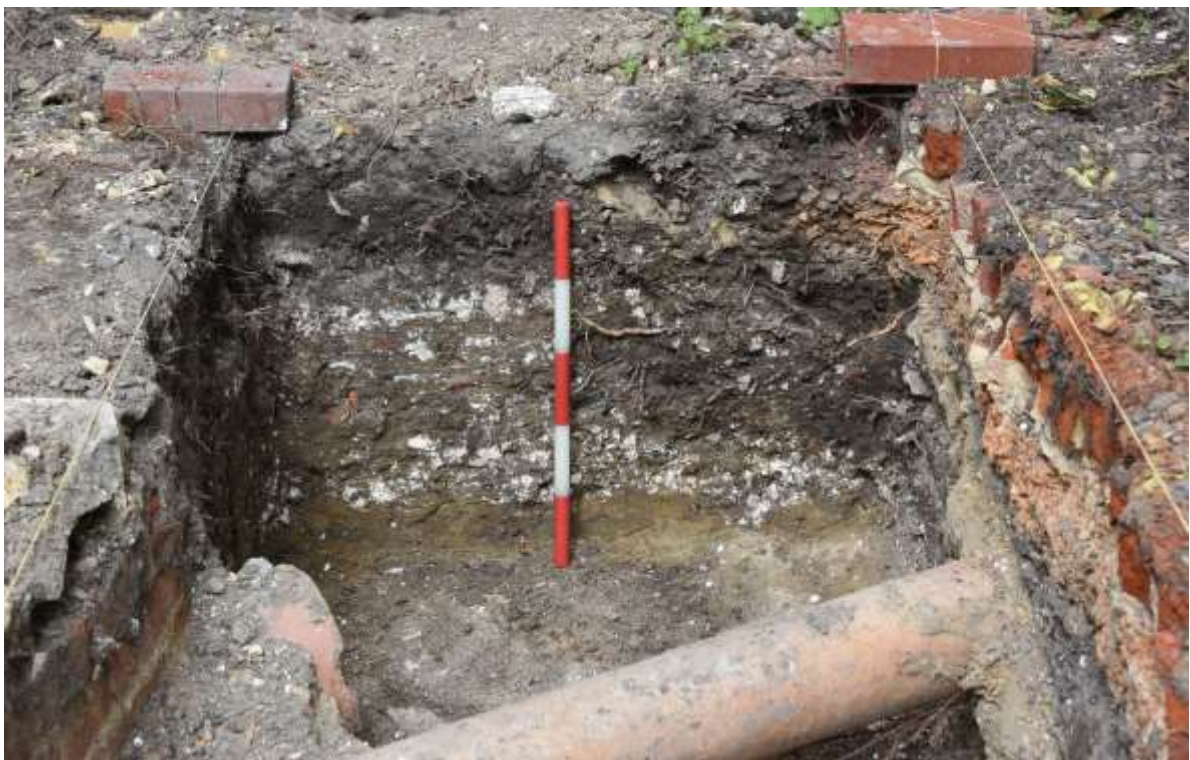
Fig.337 (below): *Detail of the eastern end section (0.5m scale)*

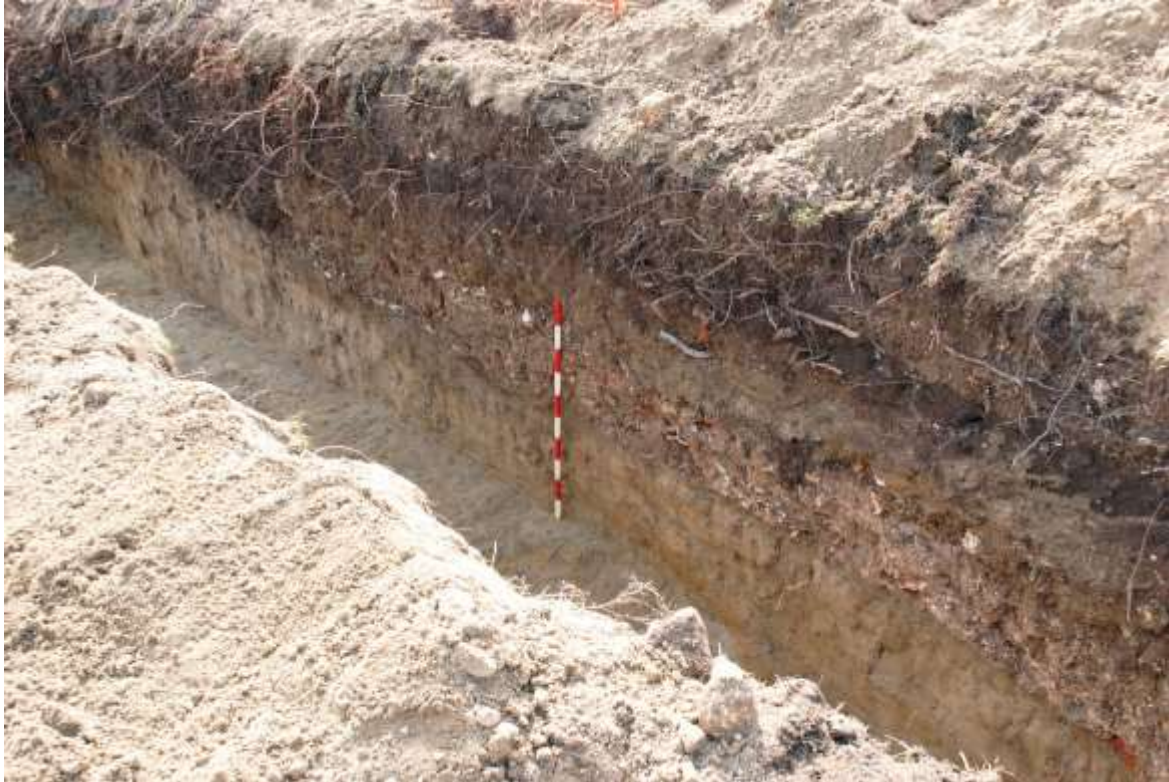
Fig.338: *Oblique view to show the full length of the western section (1.0m scale)*

In March 2107 a large soakaway was excavated towards the rear of the garden. This measured some 7.6m in length by 1.35m to 1.6m in width (narrowing slightly to the north), and was cut to a depth of *c* 1.4m to 1.65m.
