## 11. THE EXTERNAL GROUNDWORKS

A number of areas adjacent to and outside the building were subject to excavation, variously for building foundations, drainage and other garden works (principally terracing). The principal groundworks are illustrated below (Fig.315, A-G) and described in detail in the following text and illustrations.

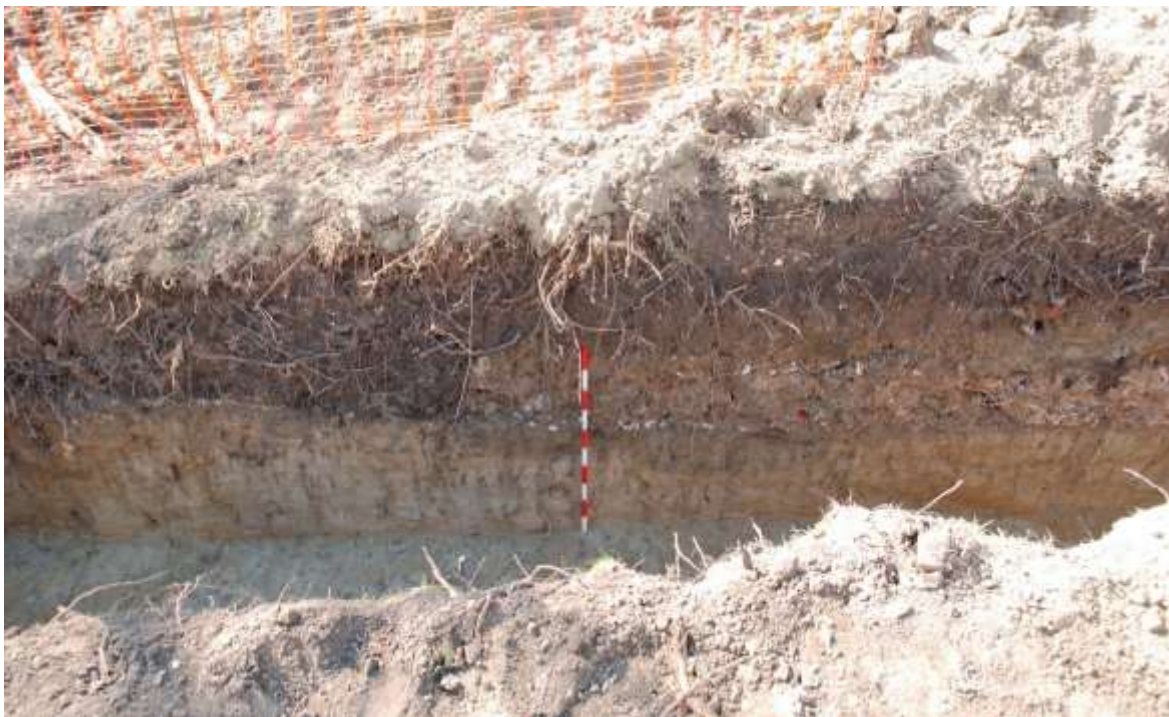
Fig. 339: *The central part of the western section of the soakaway*

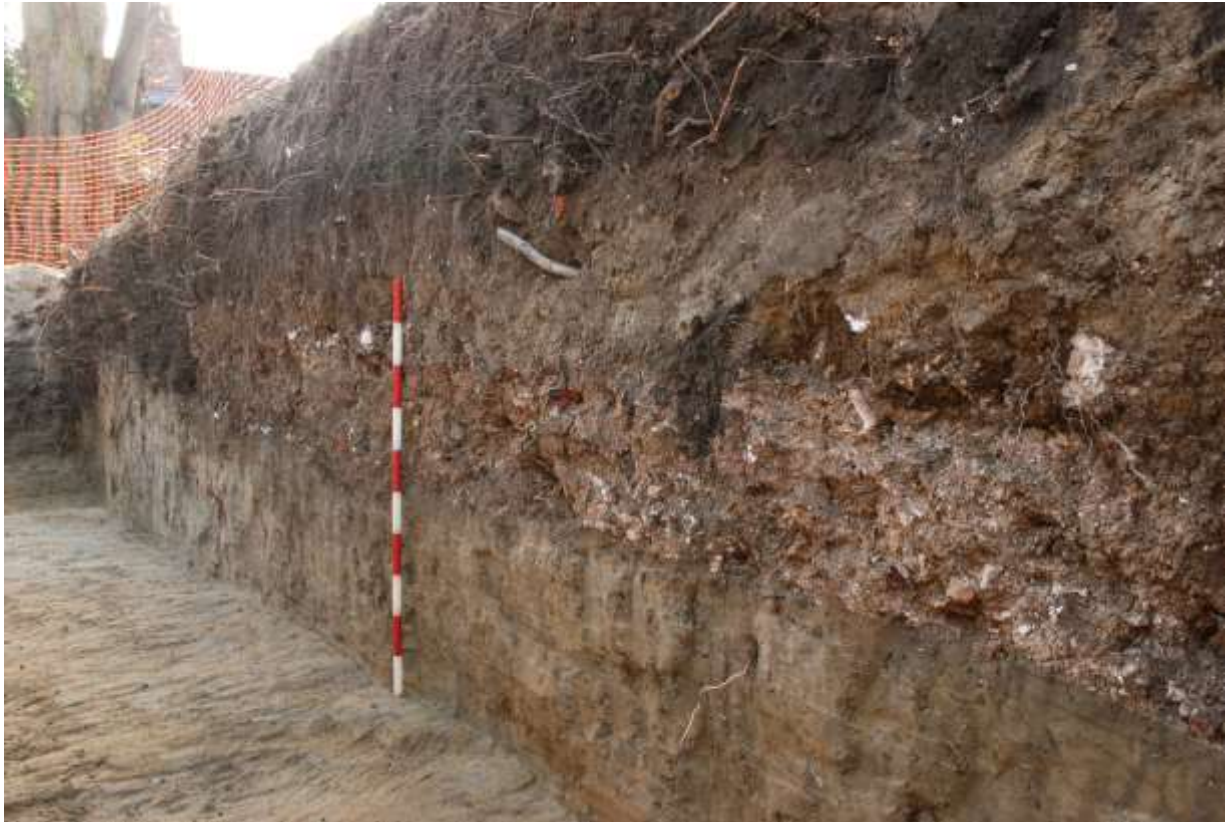
Fig.341: *Oblique view of the western section, looking south from within the excavated soakaway (1.0m scale)*

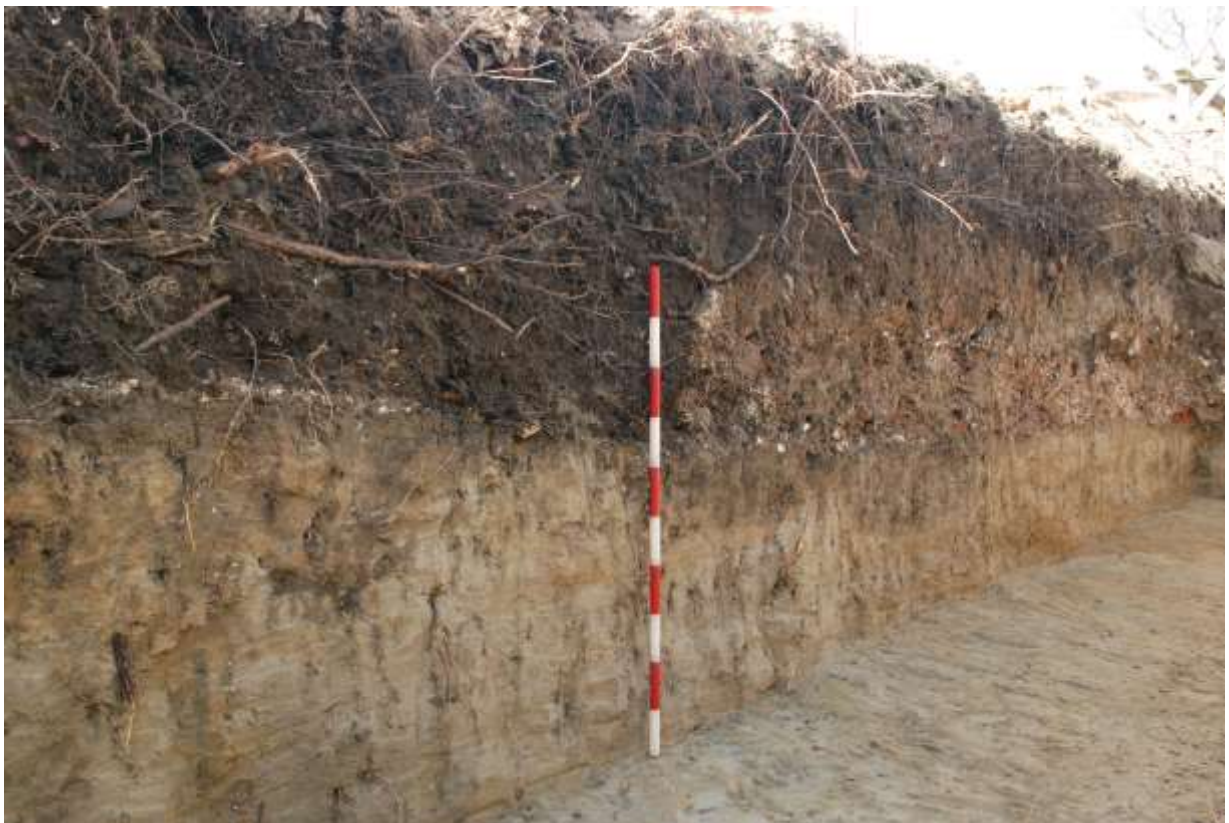
Fig.342: *Oblique view of the western section, looking northwest (1.0m scale)*

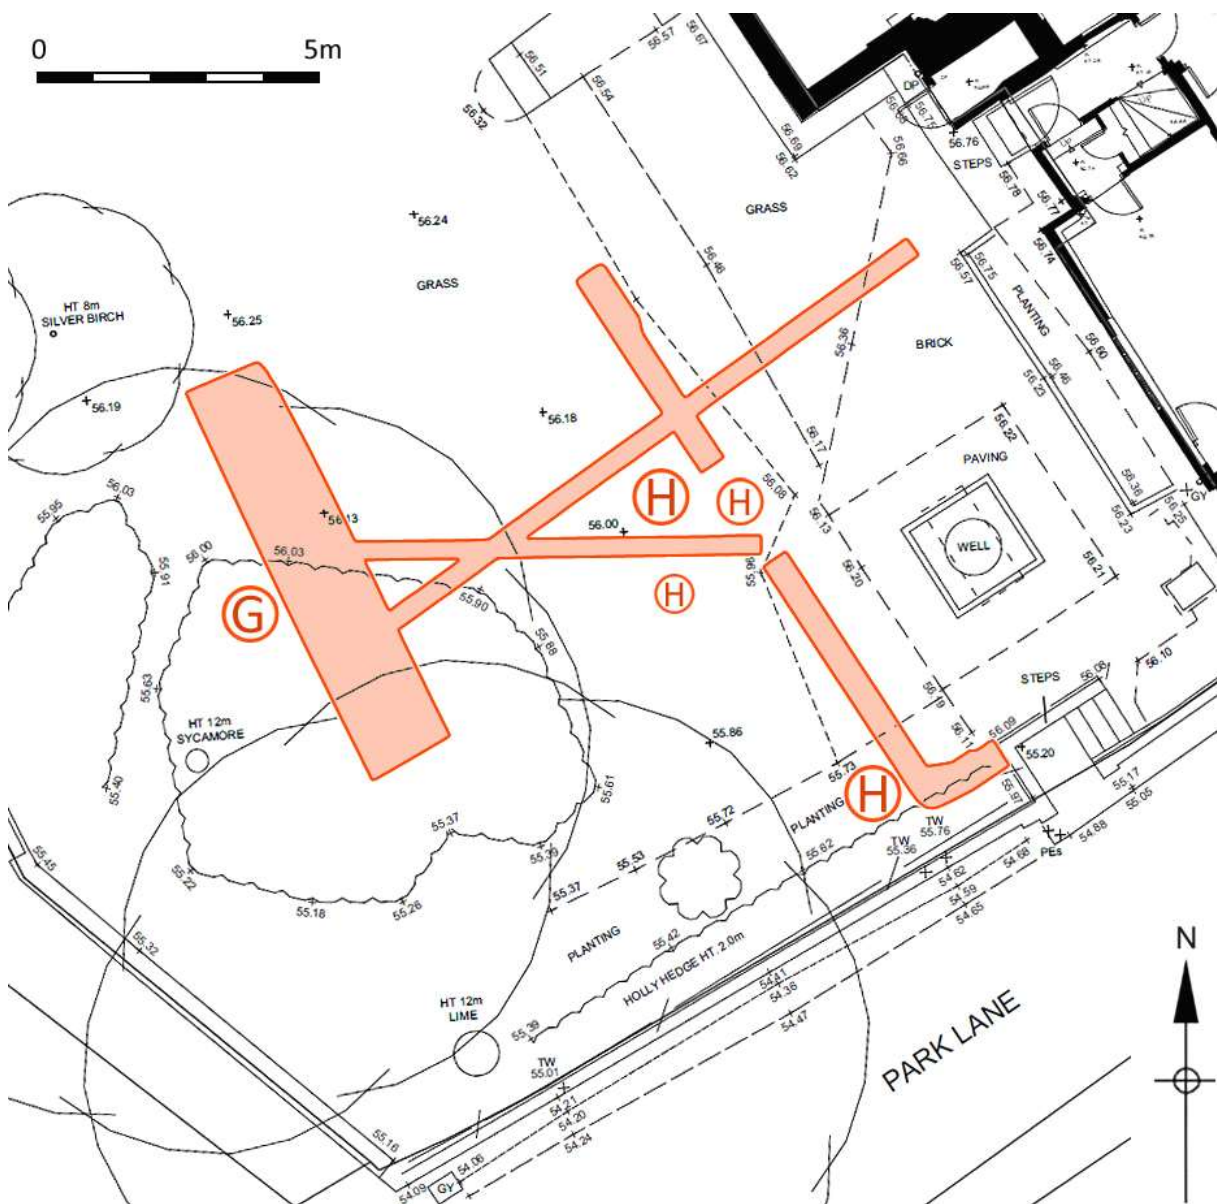
Fig.343: Enlarged plan of the area of drain trenches and wall footings shown in Figs.344 to 354

These trenches revealed a generally fairly shallow and straightforward sequence of deposits, typically coming down onto the natural sand at a depth of between 350mm and 500mm. It is likely that the area has been subject to past landscaping and levelling, and has also extensively disturbed – particularly the area closer to the house – by the archaeological investigations of 1978-80 (Nail nd.).

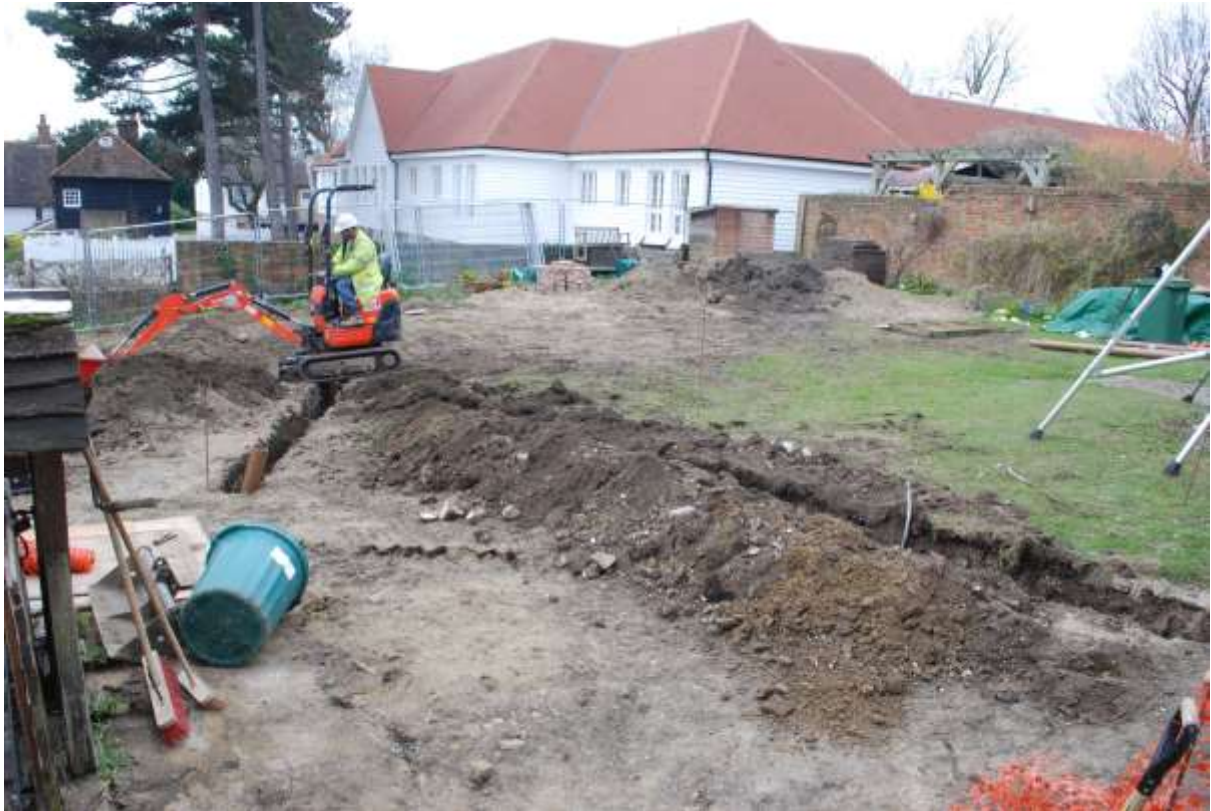
Fig.344: *General view of drain trenching towards the soakaway, looking approximately west*

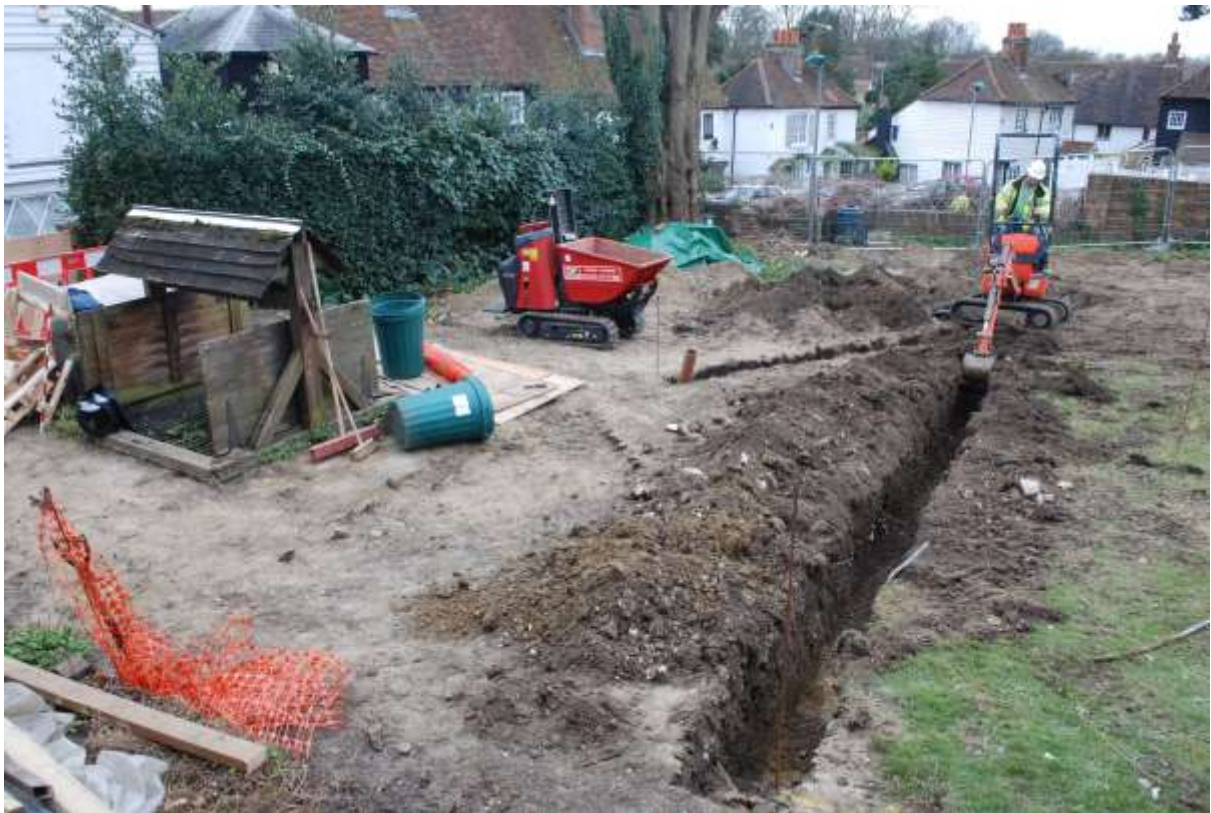
Fig.345: *As above, looking southwest with the well to the left*

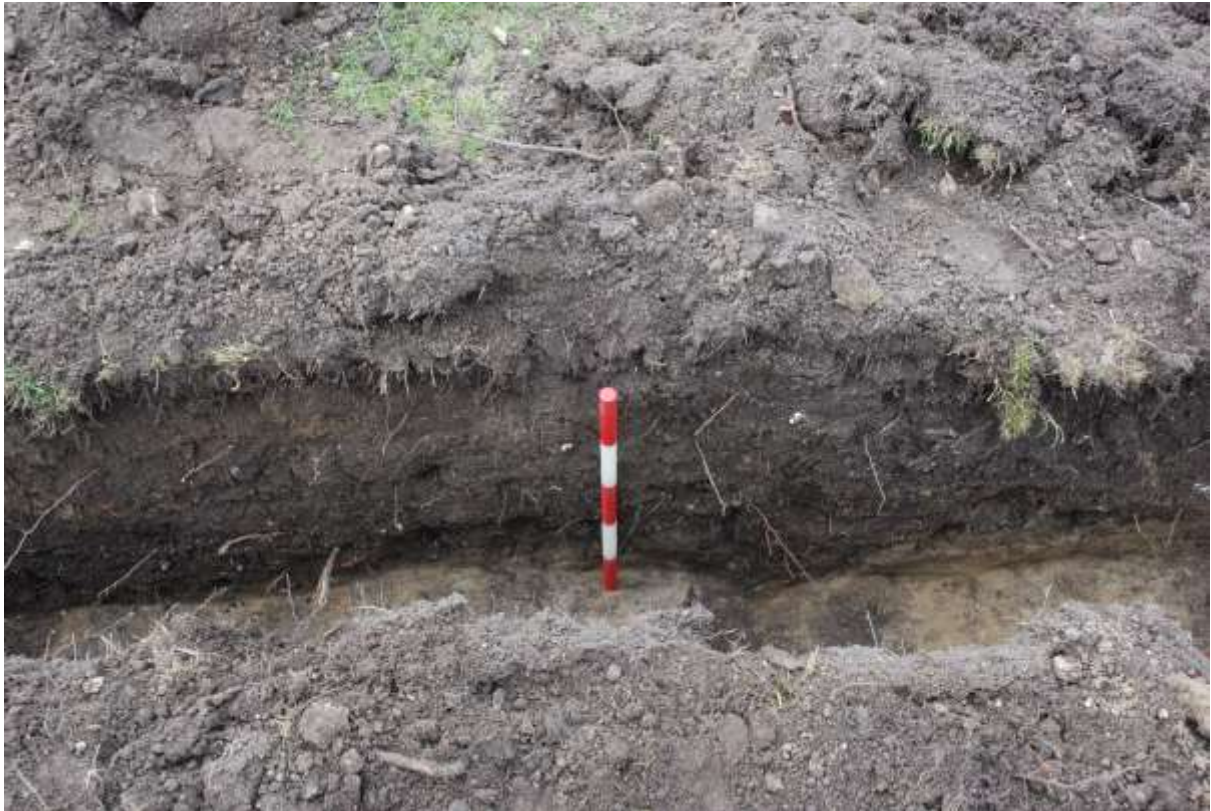
Fig.346: *Detail of drain trench, looking northwest (0.5m scale)*

In some areas topsoil overlay a lighter, more stony/chalky horizon that may well represent made ground (*cf.* Fig.348): elsewhere the uppermost layer itself appears to have been deposited over an apparently earlier (& somewhat darker/more friable) soil profile (Fig.350).

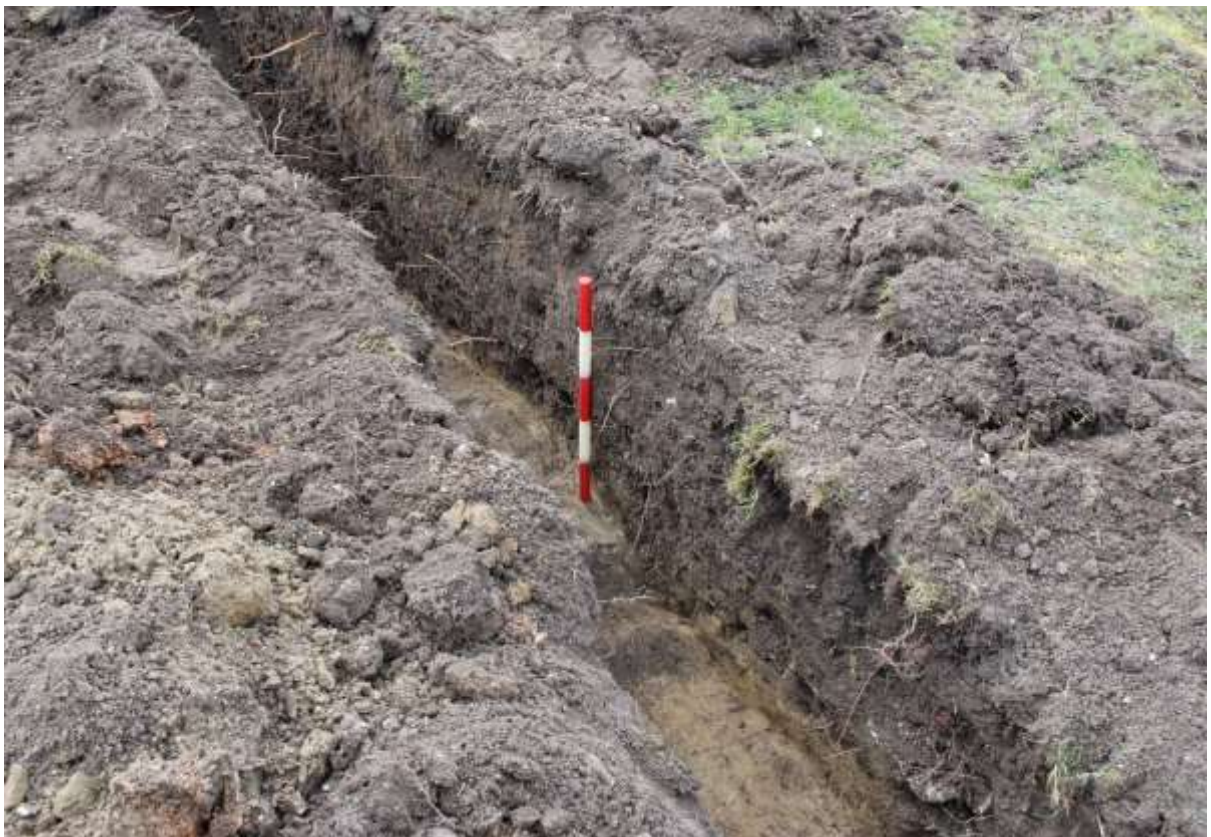
Fig.347: *Roughly the same area as above, looking west. The natural sand is exposed more or less at the limit of excavation*

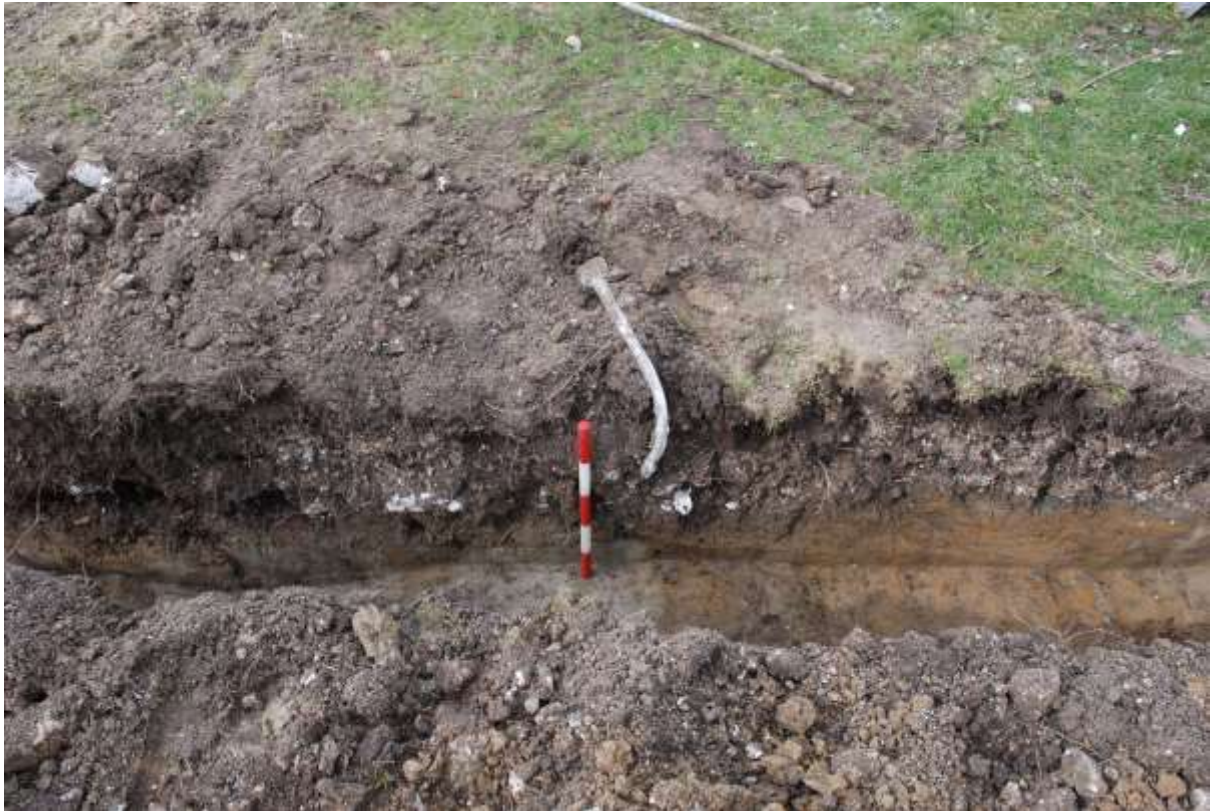
Fig.348: *Detail of drain trench, looking northwest (0.5m scale)*

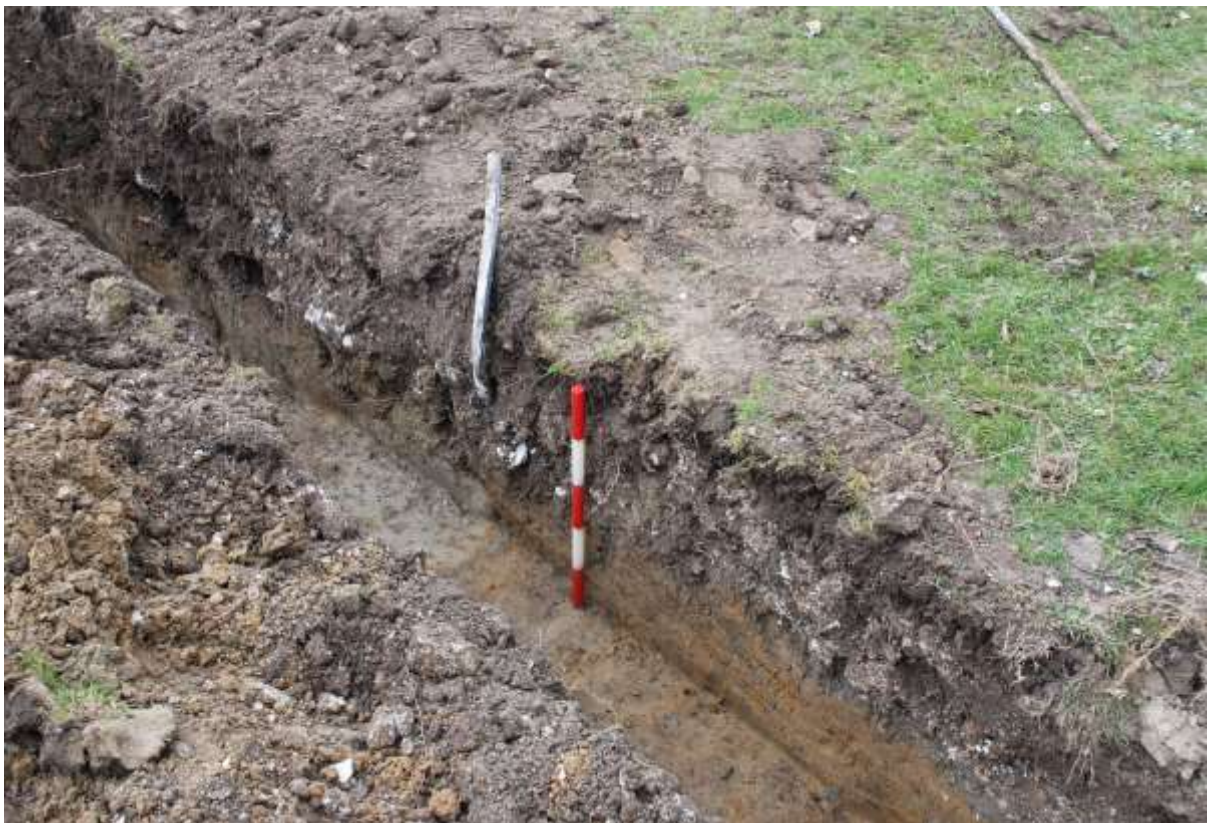
Fig.349: *The same area as above, looking west. In contrast to Figs.346-47 the topsoil here is shallow, over a lighter and much more mixed/stony horizon*

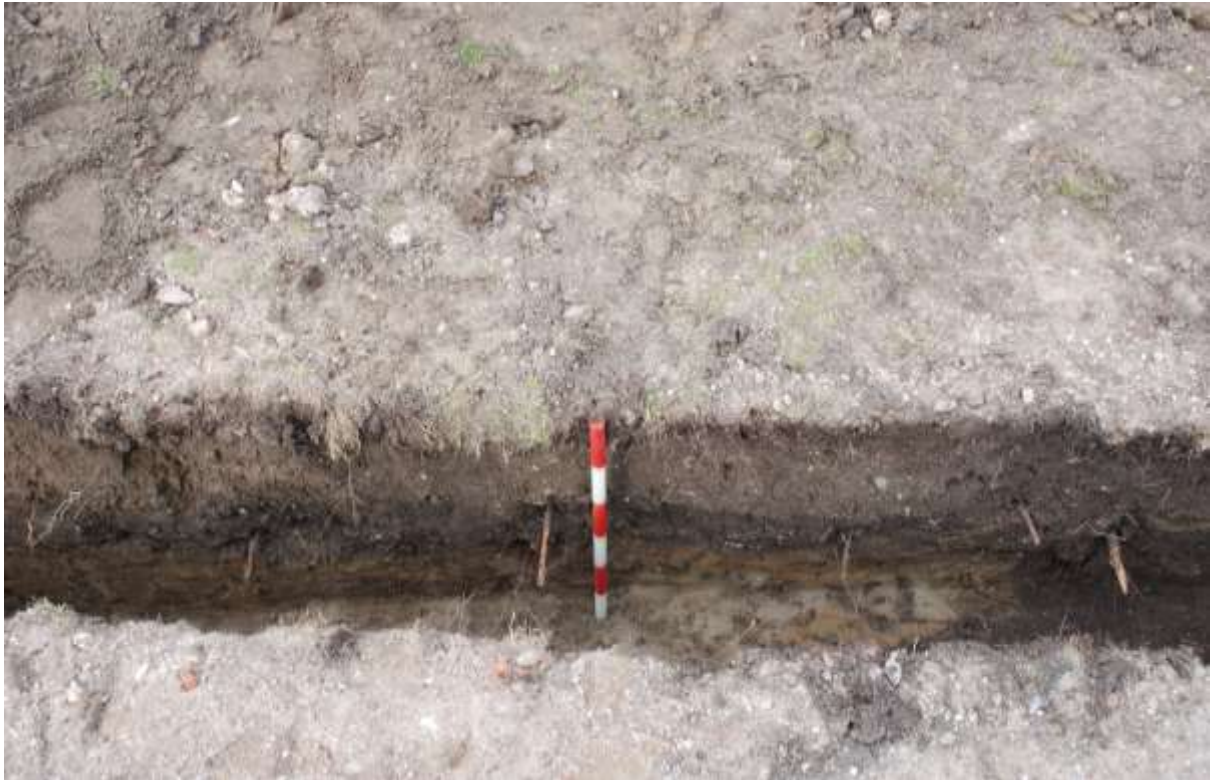
Fig.350: *Detail of drain trench, looking north (0.6m scale)*

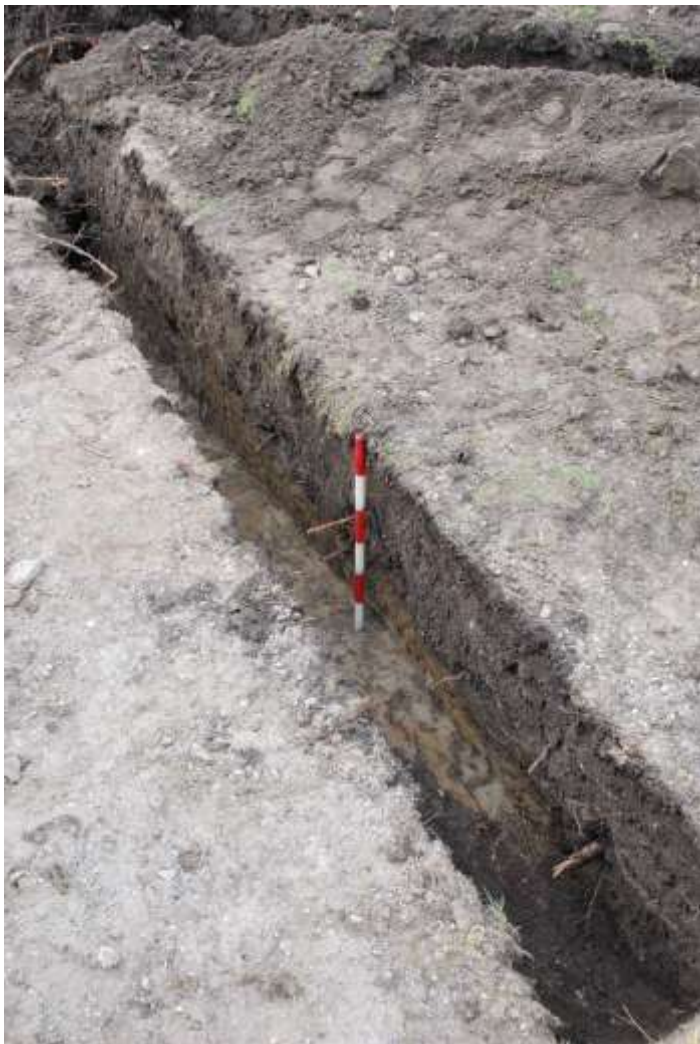
Fig.351: *The same area as above, looking northwest. The dark deposit in the foreground & continuing beyond the limit of excavation may represent backfill within the 1979-80 excavation (Nail nd.)*

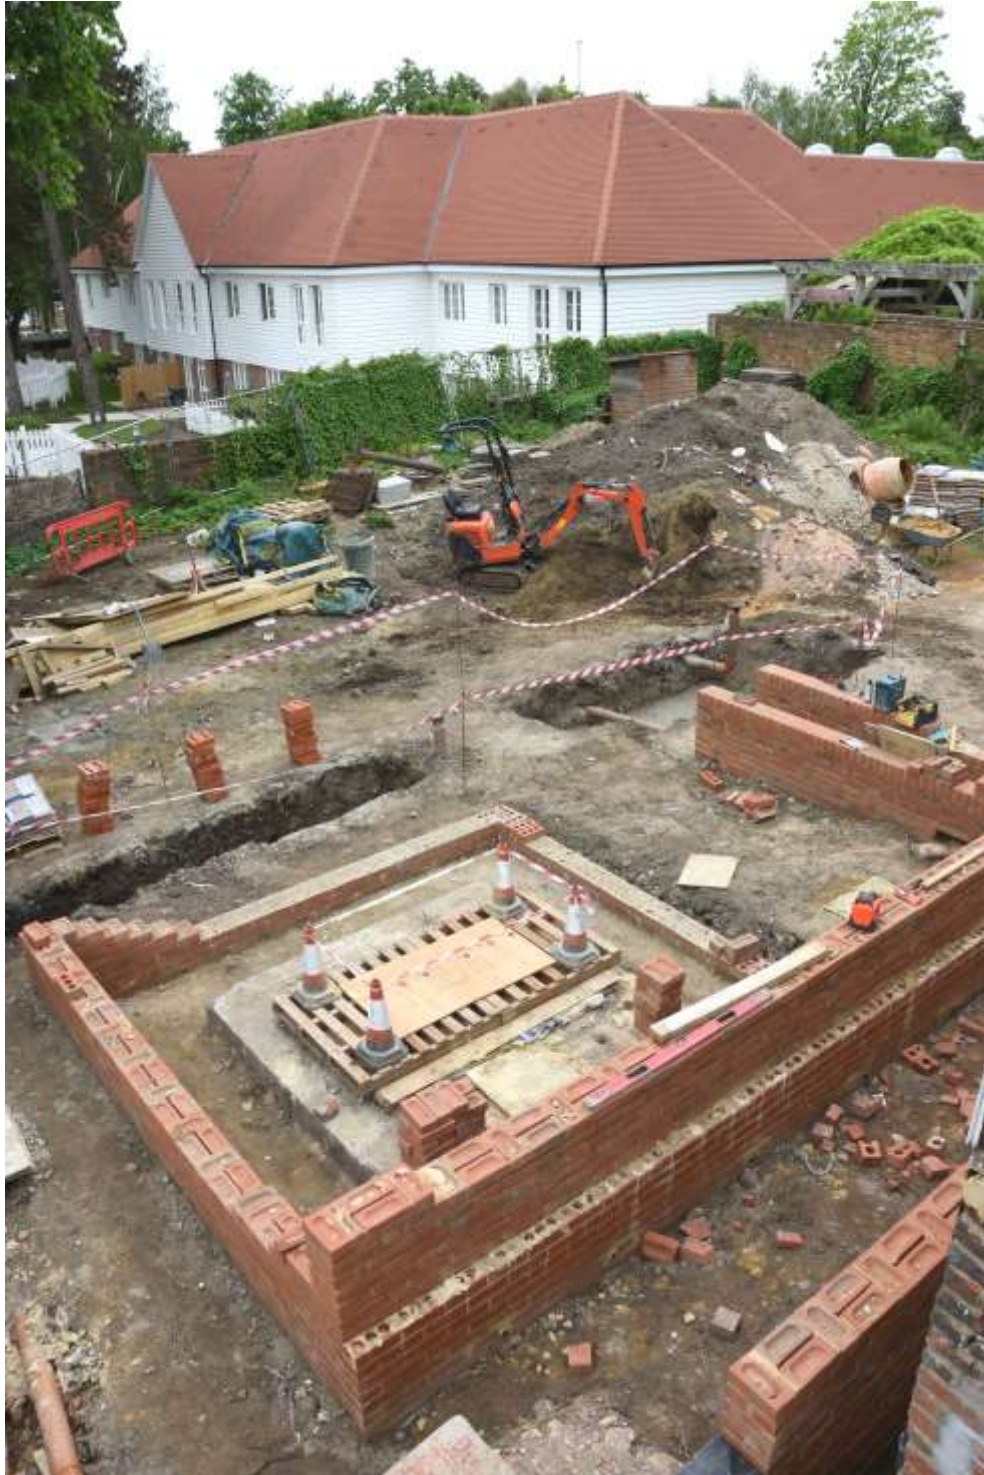
Fig.352: General view of the garden works from the house, looking roughly west

The drainage works were followed by development of the new garden layout, with a series of dwarf brick walls, *etc.*, as indicated below. The completed walls in the foreground very largely overlie areas around the well that were archaeologically excavated between 1979-80 (Nail nd.): this point is also illustrated overleaf, in relation to the two open trenches seen in the background of Figure 352.

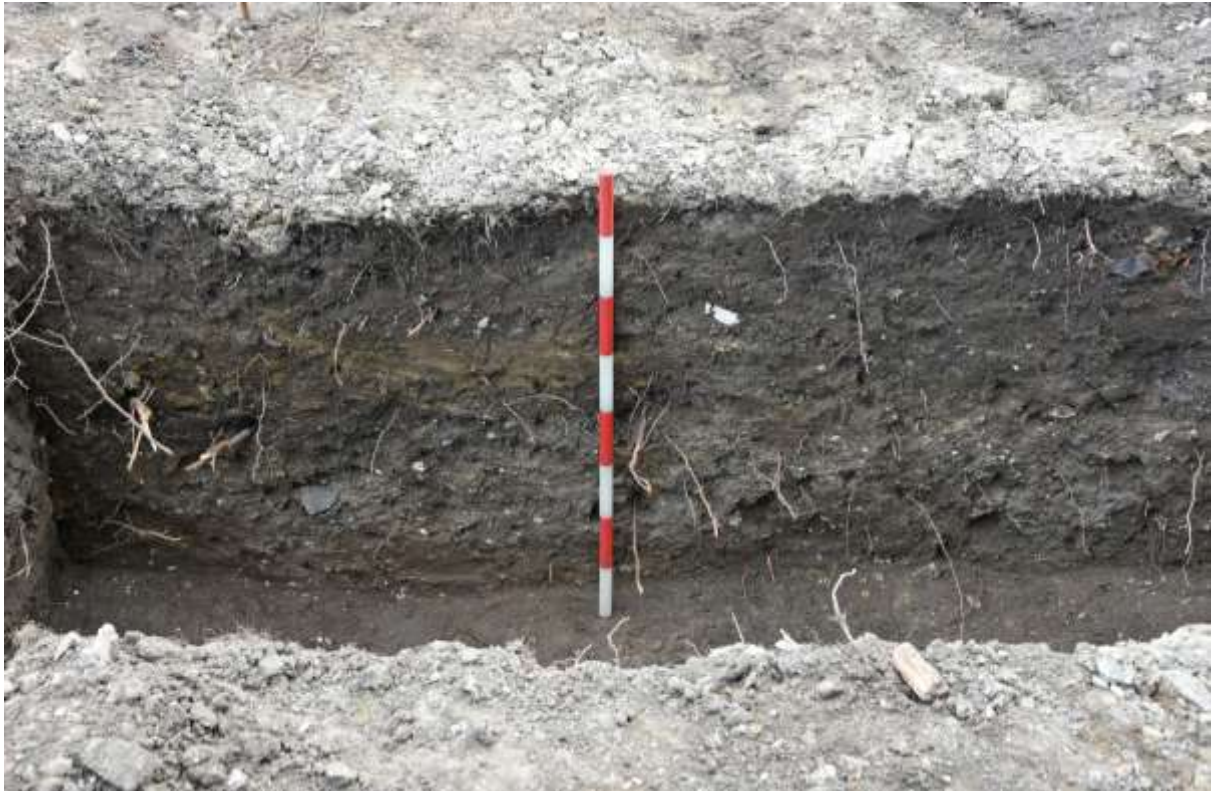
Fig.353: Wall foundation trench just to the west of the well, looking northeast. The deposits visible here are may well represent backfill within the 1979-80 excavation (0.8m scale)

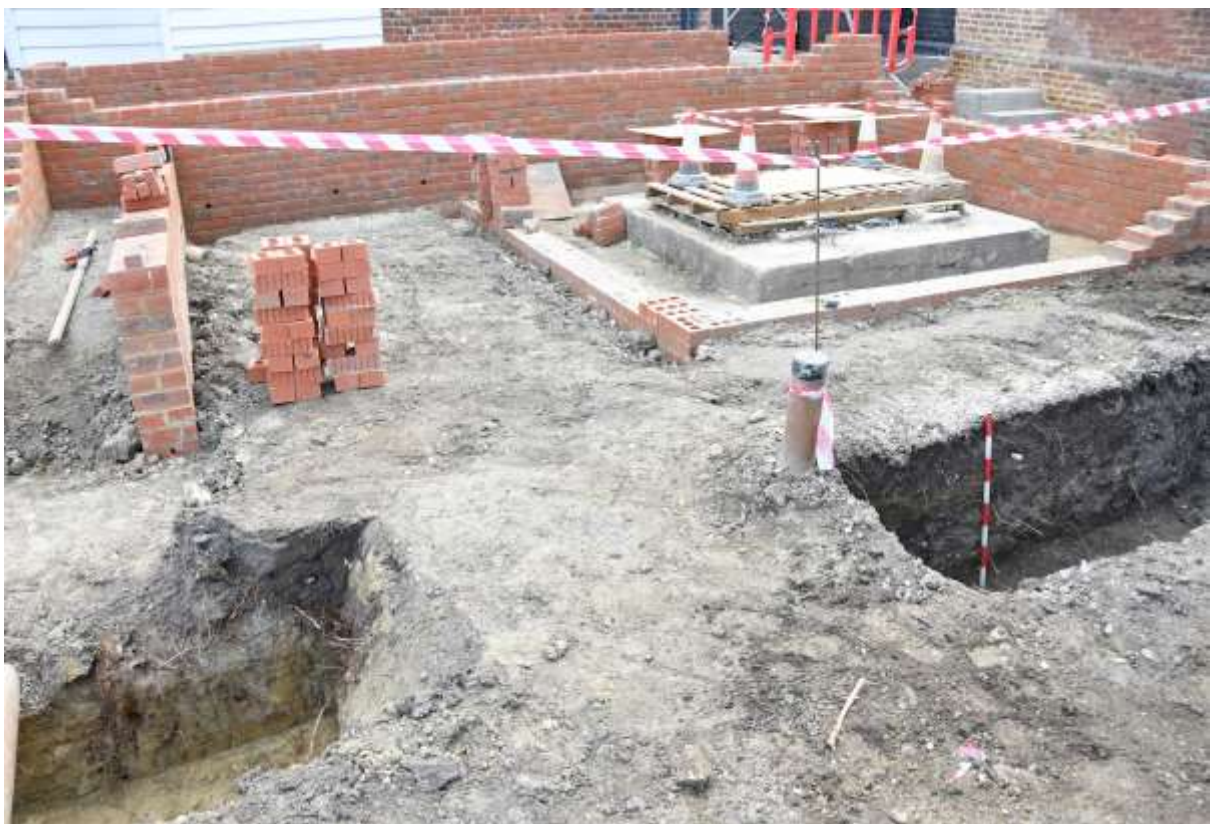
Fig.354: View looking east towards the well, with the trench in Fig.353 on the right and its continuation – with natural sand occupying most of the exposed section – on the left

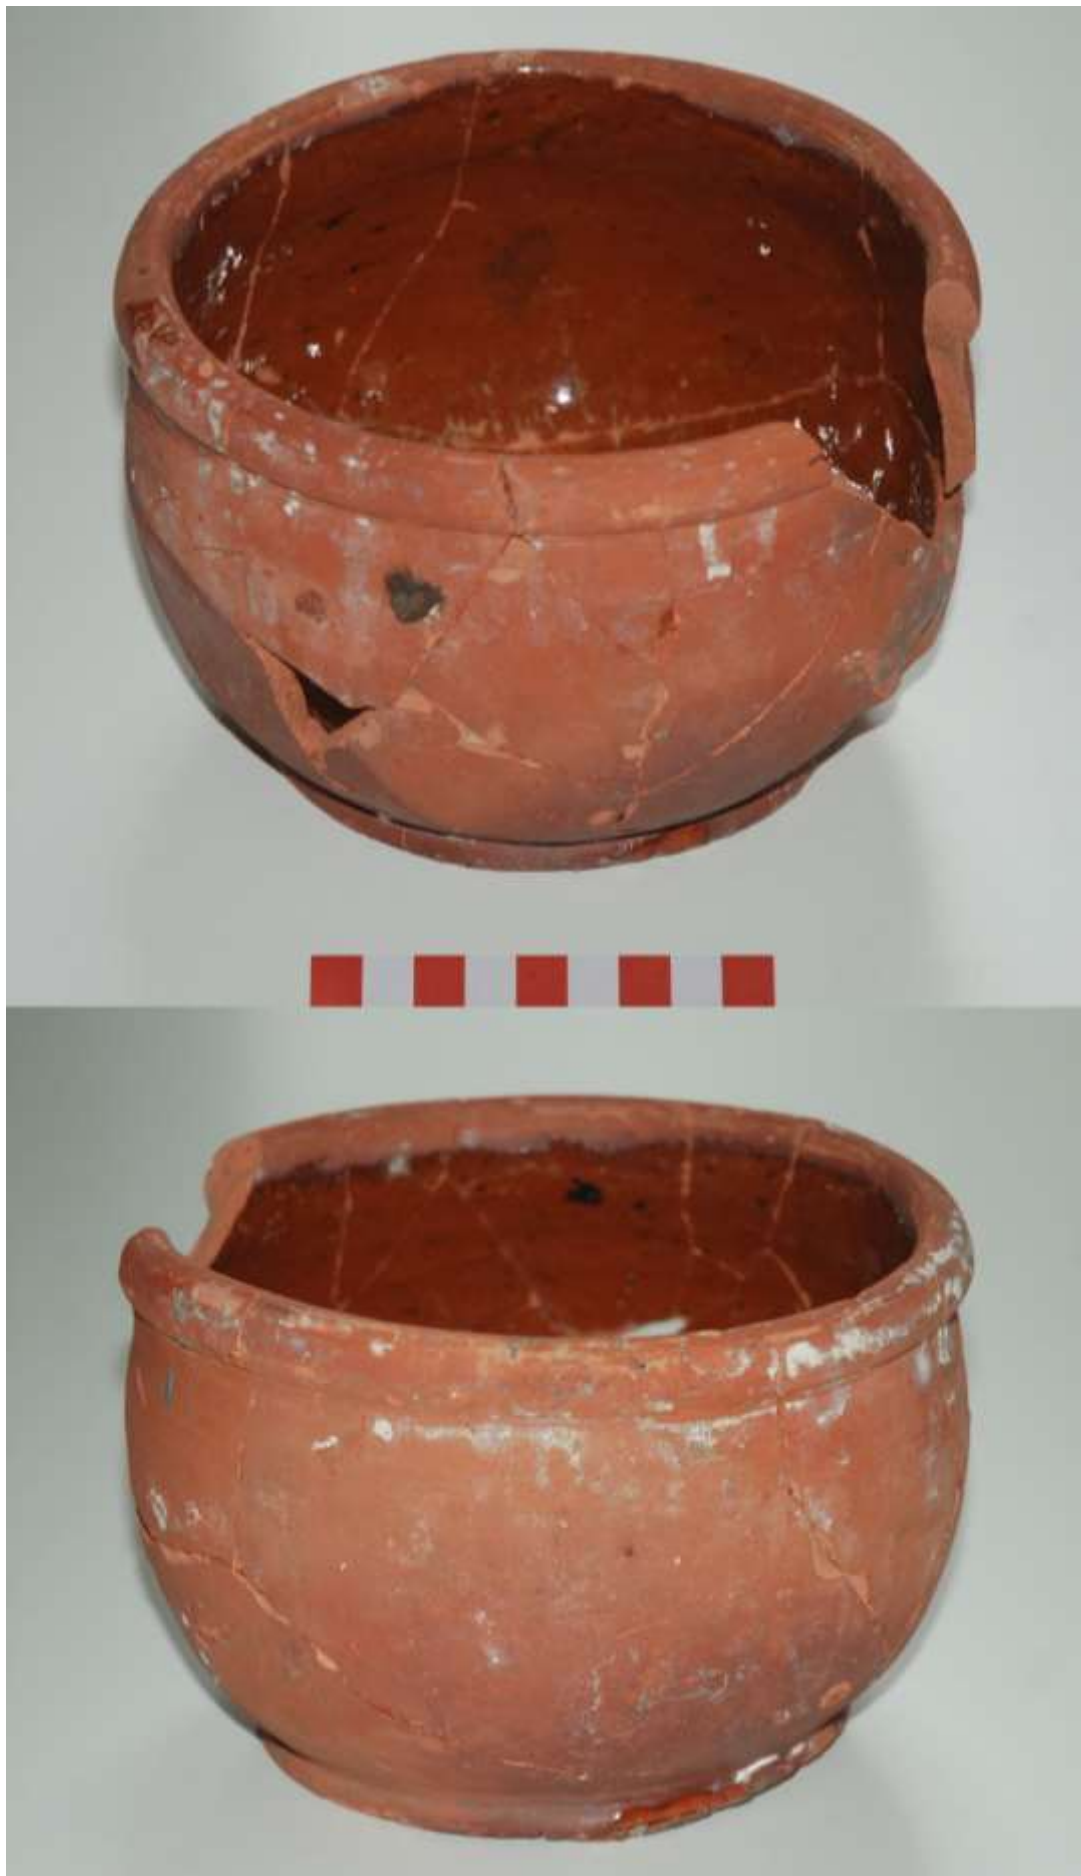
Fig.355: *Almost complete post-medieval redware pot from drain context (12). Scale 100mm*

This feature was given further significance by the discovery within the backfill (12) of a broken but largely complete Post-medieval Redware chamber pot (*cf.* Appendix II; Fig.355).

2. The pottery occurrence by number and weight of sherds per context by fabric type is shown in Table 3. Each date should be regarded as a *terminus post quem*. The range of fabric types is typical of sites in the region. The assemblage is generally in good condition, and appears reliably stratified.
3. The medieval sherds comprised fragments of glazed jugs, which is typical of their respective traditions. The post-medieval assemblage mostly consisted of fragments of internally glazed PMR vessels, mostly bowls (*cf.* Figs.358-59 overleaf), other than a near-complete chamber pot in the same fabric from context (12): external diameter of this latter was *c* 173mm and height 115mm (Fig.355).

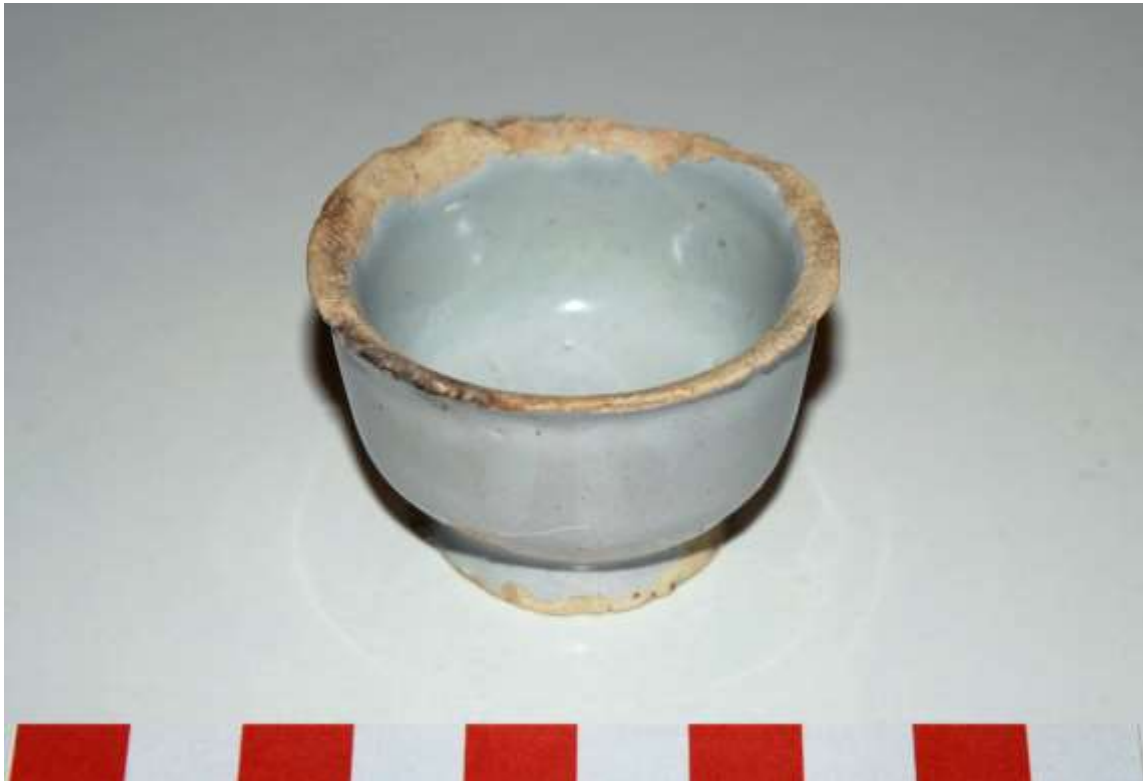
Fig.356: A 17<sup>th</sup> century miniature tin-glazed ware “ointment pot” from context (17) Scale 100mm

The fragment of CHPO is from the rim of a tea-bowl. Both the pieces of TGW had a plain, pale blue glaze. The item from context (17) is a complete, miniature tin-glazed ware “ointment pot”. It is 31mm high, and has a rim diameter of 46.5mm (Fig.356 overleaf).

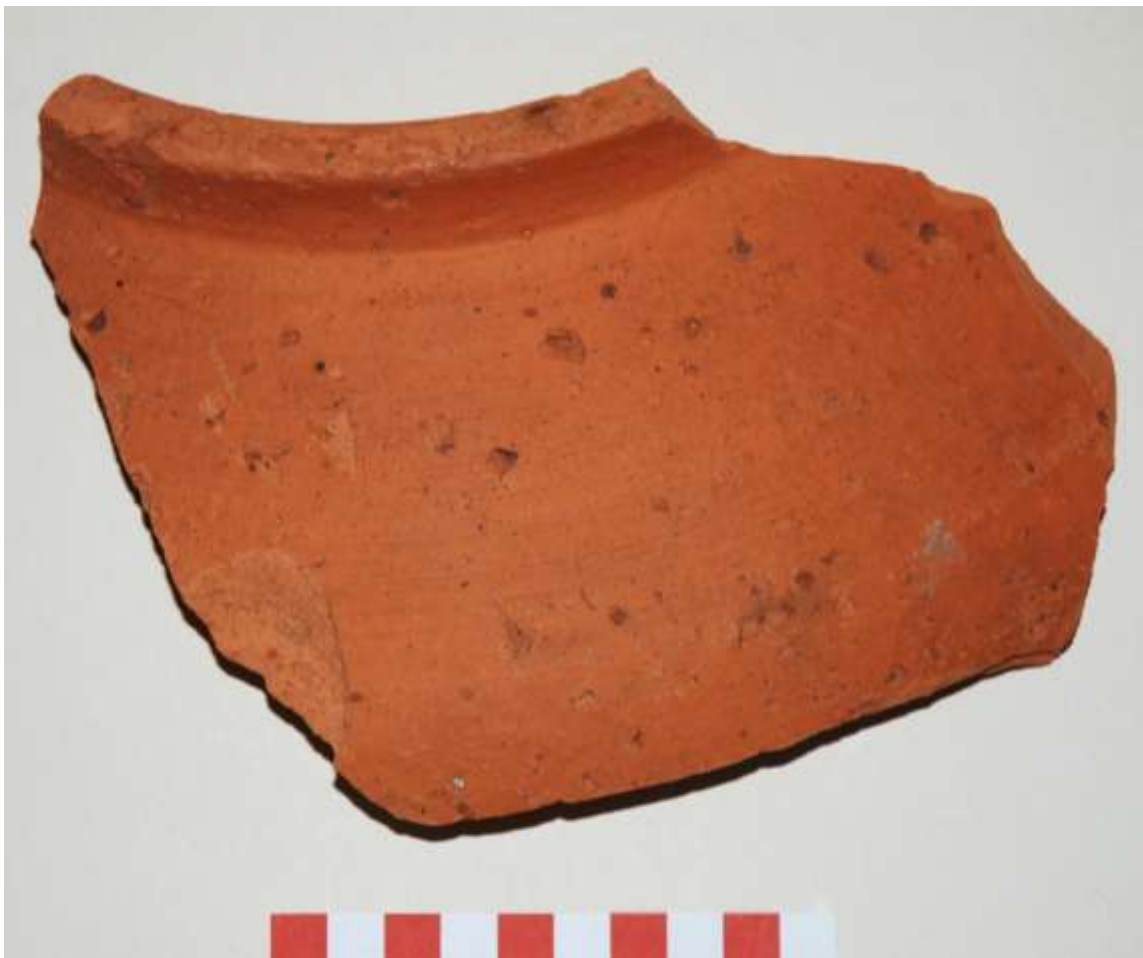
Fig.357: Rim & body sherd from a large unglazed post-medieval redware vessel, context (10)

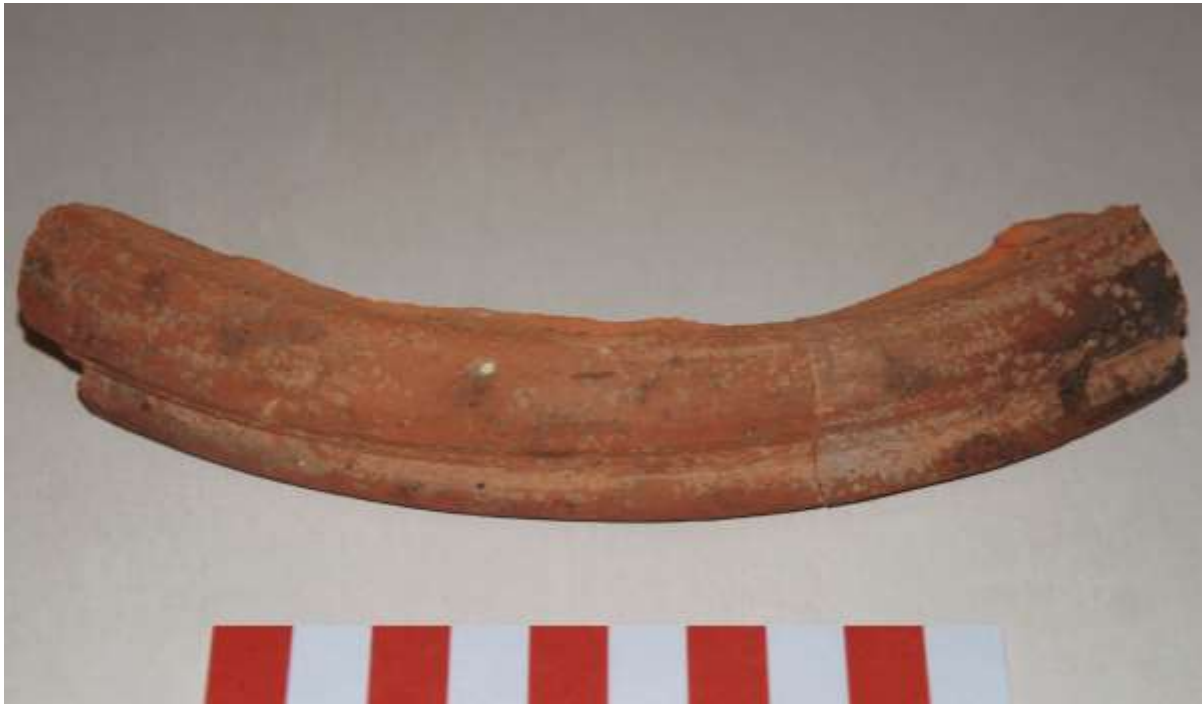
Fig.358: *Rim sherds from a post-medieval redware bowl, context (11). Scale 100mm*

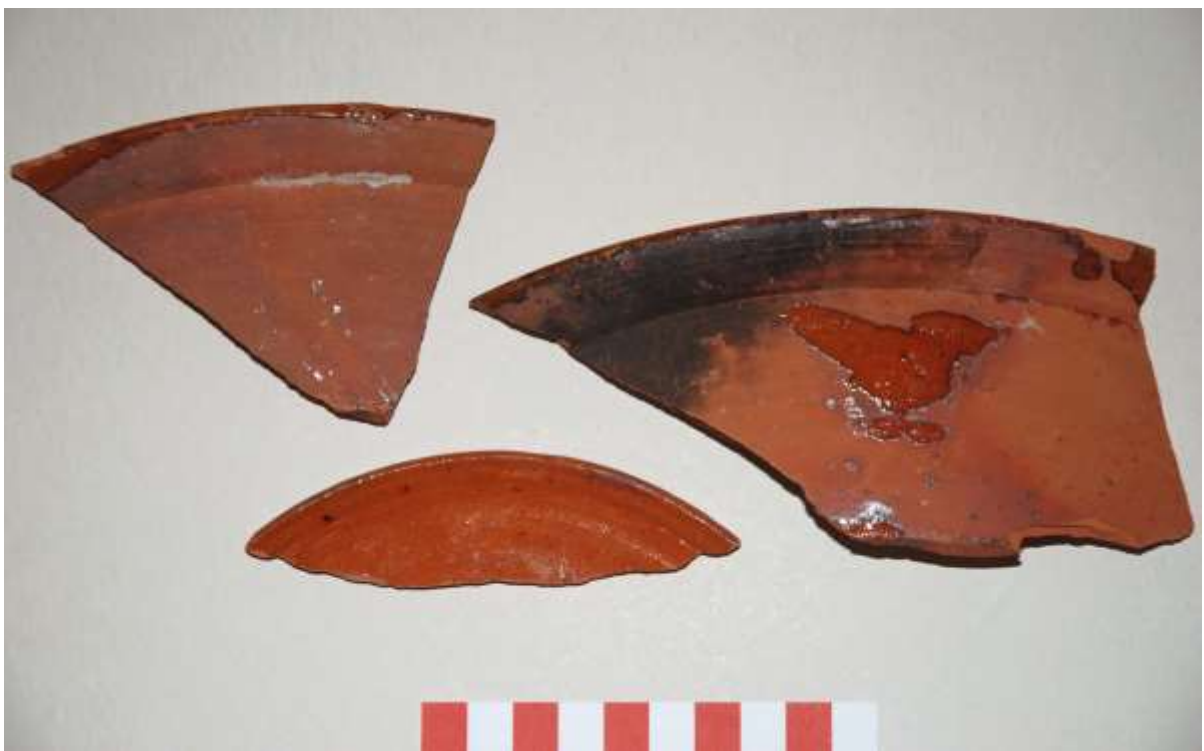
Fig.359: *Further post-medieval redware body & rim sherds from context (15)*
