## 11. THE EXTERNAL GROUNDWORKS

A number of areas adjacent to and outside the building were subject to excavation, variously for building foundations, drainage and other garden works (principally terracing). The principal groundworks are illustrated below (Fig.315, A-G) and described in detail in the following text and illustrations.

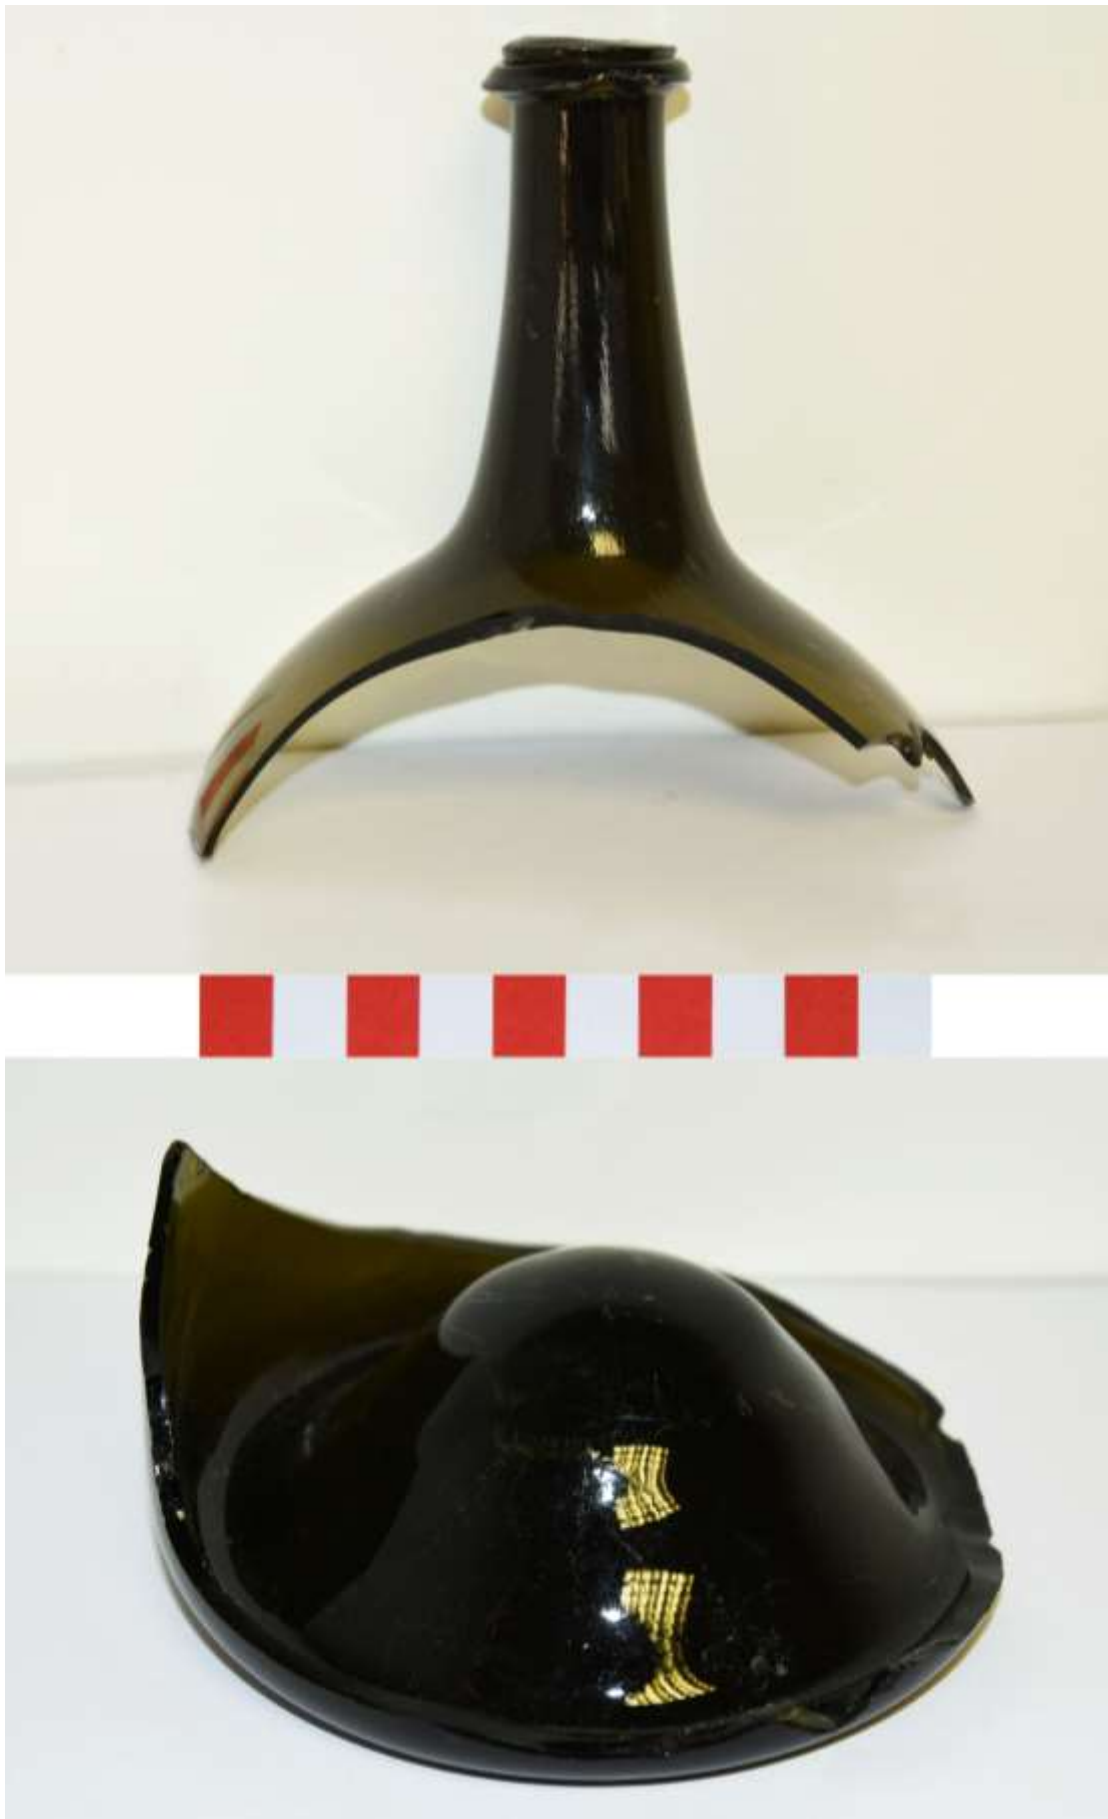
Fig.360: *Fragments of possible 17<sup>th</sup> century glass bottle from context (15). Scale 100mm*

Context	Form	Count	Weight (gm)	Comments
6	Fragment	1	6	Clear glass, fairly modern, probably pane glass or similar.
15	Bottle base fragment	2	302	Dark green, frequent bubbles inside. Bottle with deep kick at base.
15	Bottle base & partial sides	3	314	Dark green, some small bubbles. Body has even thickness, medium kick at base.
15	Bottle base	1	456	Dark brown-green, frequent bubbles. Very broad diameter – 130mm approx. Deep kick.
15	Body fragment	1	16	Olive-green, frequent bubbles. Mould seam visible.
15	Bottle neck (cf. Fig.360)	1	138	Olive-green, frequent bubbles. Hand blown-stretch marks visible on neck and elongated bubbles.

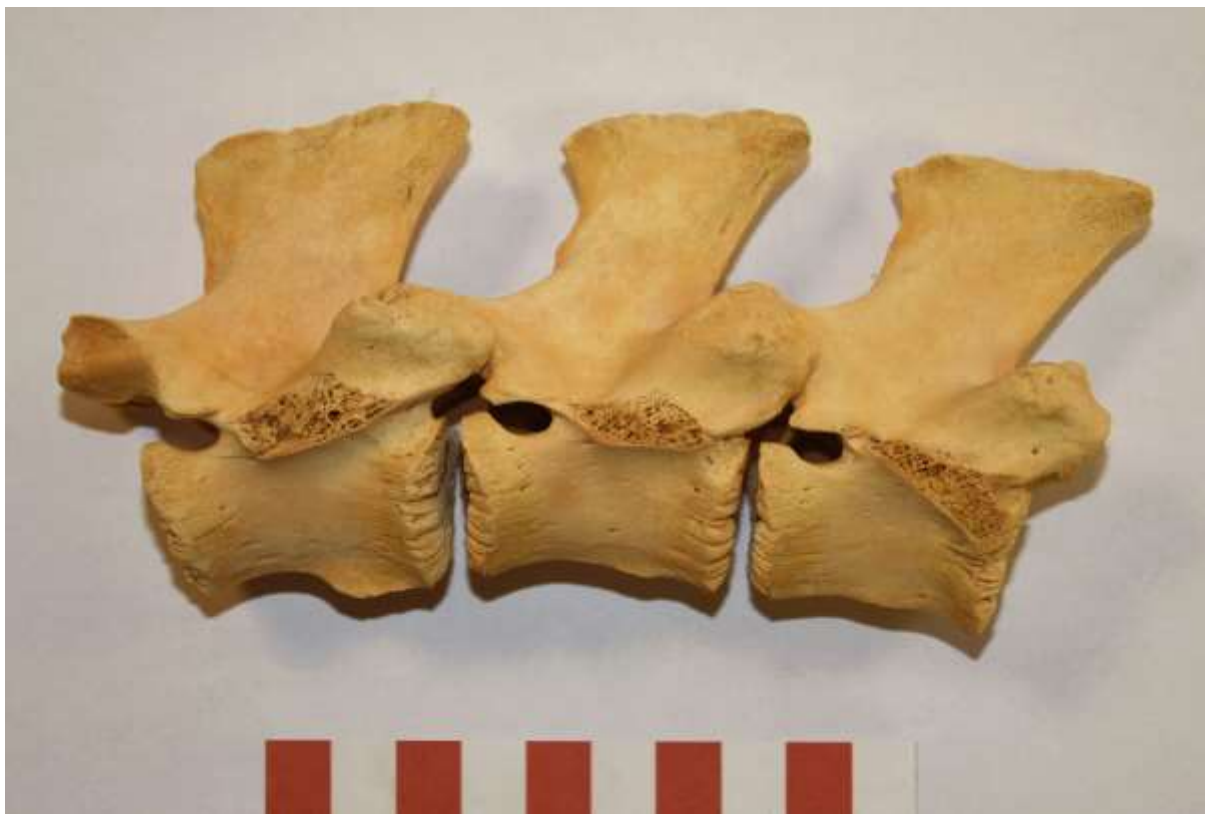
Fig.361: *Articulated sheep lumbar vertebrae from context (15)*

Context	Species	Bone	Side	Fusion	Completeness	Comments
11	Cos	Humerus	R	UO	Partial shaft (distal end)	Fairly weathered, possible evidence of butchery at either end: slight iron staining.
15	Sheep	Lumbar vertebra	-	Fused	Complete bar transverse processes	All three articulated, patch of burnt damage between joint of two. No butchery marks
15	Sheep	Lumbar vertebra	-	Fused	Complete bar transverse processes	
15	Sheep	Lumbar vertebra	-	Fused	Complete bar transverse processes

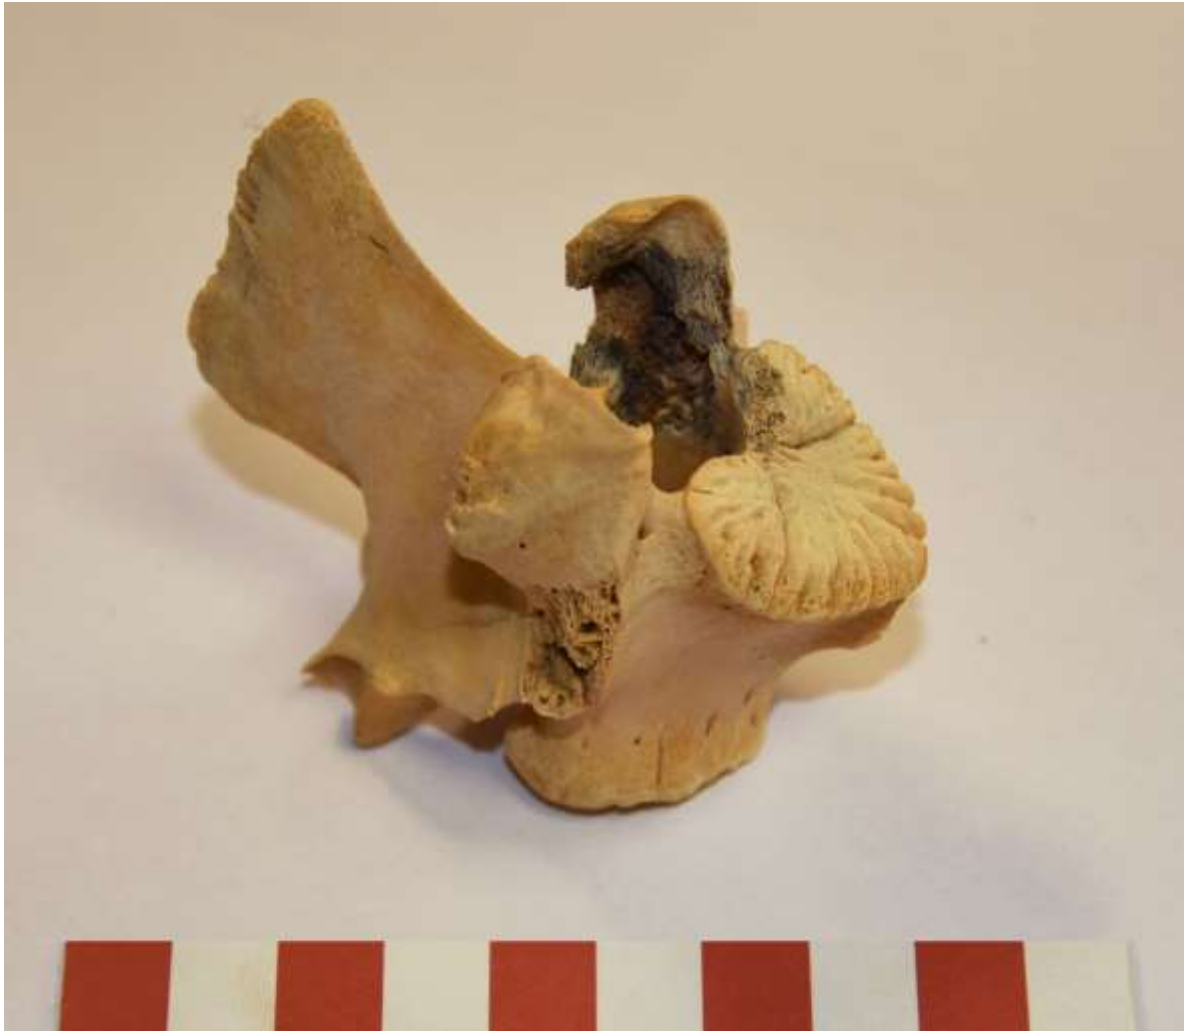
Fig.362: *Detail of a single vertebra, showing area of damage to top right*

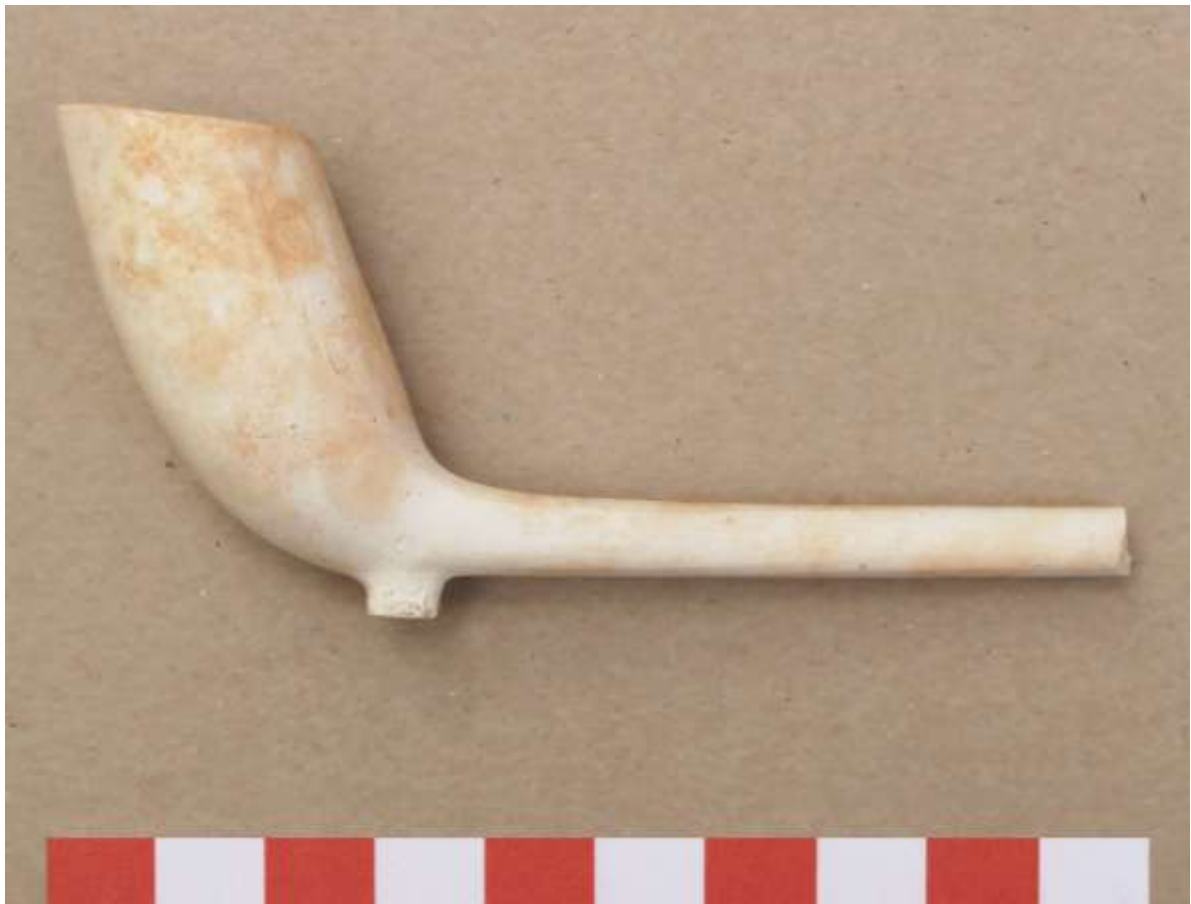
Fig.363: Clay pipe bowl and partial stem of probable earlier 18<sup>th</sup> century date, from context (15). Scale 100mm

1. Only one clay tobacco pipe was found, in deposits forming context (15) – below the floor of the short passageway between the stair turret and northwest extension (area G-11).
2. The pipe comprised an intact bowl and some 60mm of adjoining stem (Fig.363). The form is comparable to No.12 in Oswald's general typology (Oswald 1975, Fig. 3G): a tall upright bowl, relatively thin-walled with a fairly wide mouth, and is thus dated to c 1730-1780.

The pipe was quite plain apart from the maker's initials **IG** either side of the foot (the first of these visible in Fig.363). There are a number of recorded makers with these initials, although combining the evidence of date and geography the most likely candidate would seem to John Goodyer of Guildford, who is mentioned in the Surrey Apprentice Records of 1717.
