SECTION 278 DRAINAGE WORKS, 52-64 LIME STREET, CITY OF LONDON EC3A

AN ARCHAEOLOGICAL WATCHING BRIEF REPORT

TQ ref: 33243 81145 (centre)
Site code: LMT18

November 2018

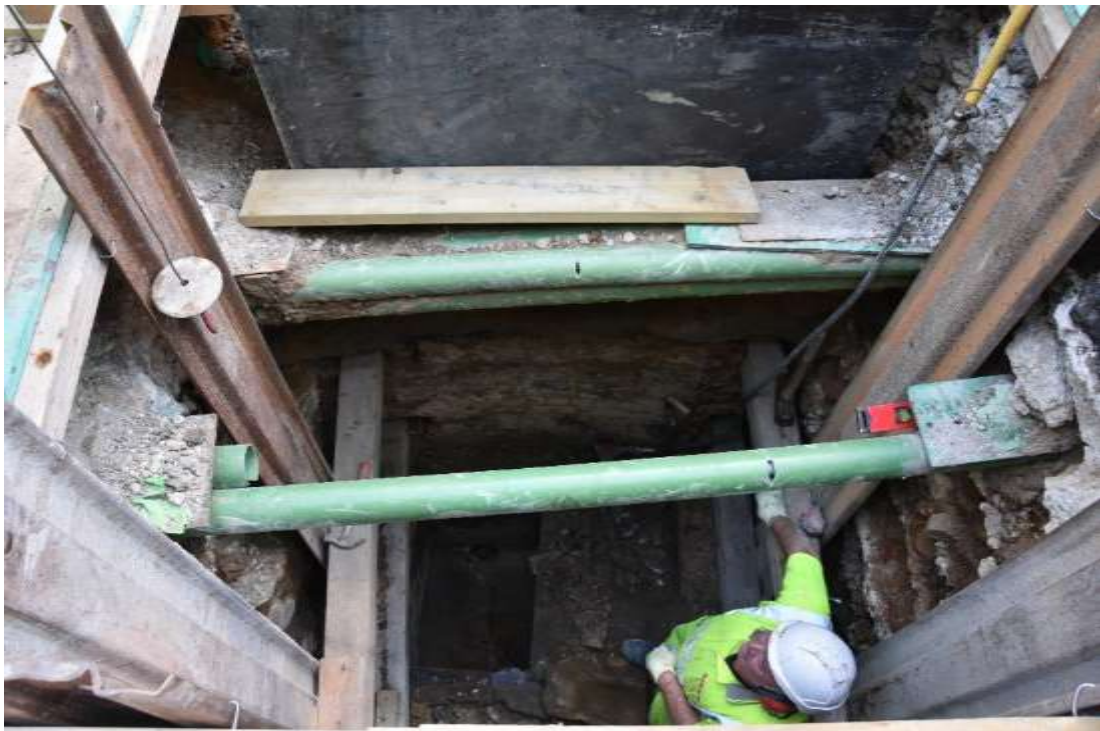
- 7.1 The following forms a written description of observations made during the watching brief. The works are discussed in chronological order, covering the main trench and subsequent re-cut. Deposits are shown as (x), cuts and structures as [x]. The text is supplemented with illustrative photographs. For a full context list refer to Appendix I.
- 7.2 The trench was located on the southern side of the carriageway, immediately outside 52 Lime Street. The drop shaft was square in plan, measuring 2m x 2m, and dug to a depth of between 4 and 4.5m (12.3 – 11.8mOD) (fig.4).

Figure 4: Working shot of completed drop shaft, showing the remains of a brick coal cellar in the northern section and drain in the trench base. Facing N, no scale.

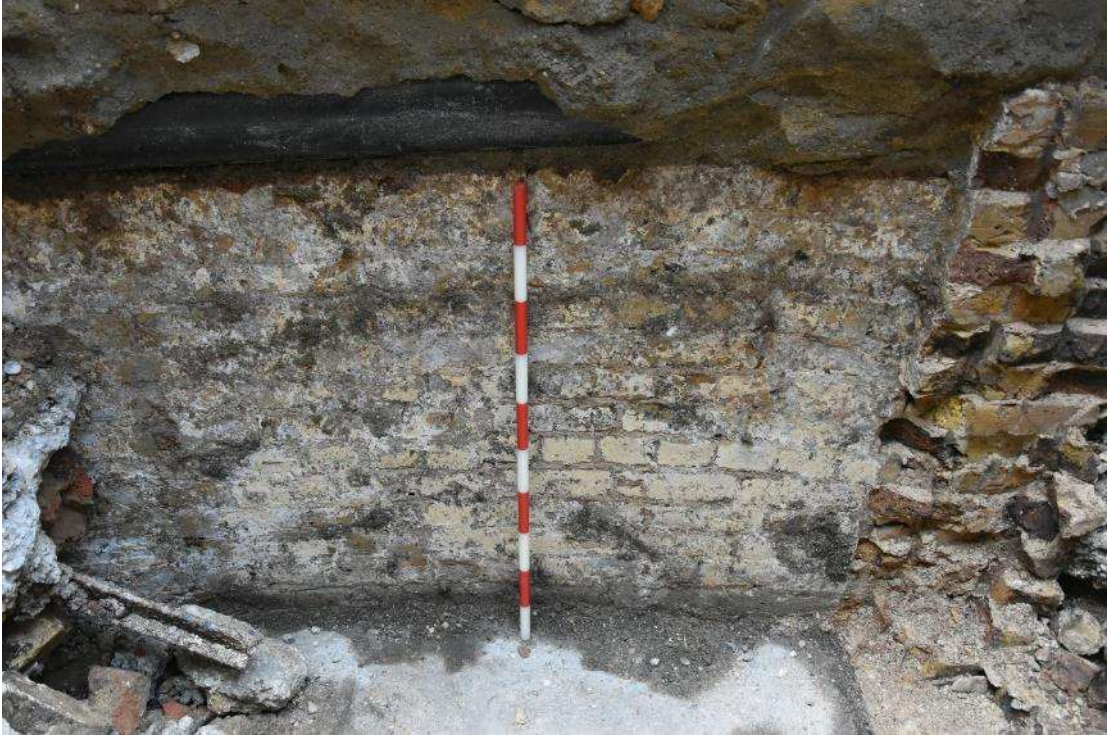
- 7.3 The stratigraphy in the upper two metres of the drop shaft comprised modern made ground. 100mm of compact black asphalt (1) forming the existing carriageway surface overlay up to 300mm of light grey coarse concrete (2), taken to be a bedding layer for (1). The modern carriageway surfacing overlay a series of east-west aligned service ducts [3], backfilled with orange sand (4).
- 7.4 The modern services directly overlay approximately 1.8m of solid, fairly dry mix, light grey concrete, observed across the trench entirety (5). Some brick rubble was observed throughout the deposit, particularly in the east and west sections.
- 7.5 At a depth of 1.8m (14.5mOD) the remains of a yellow stock brick coal cellar was observed in the northern section, wall [6] (fig.5).

Figure 5: Post-medieval coal cellar observed in the northern section. Facing N, scale 1m.

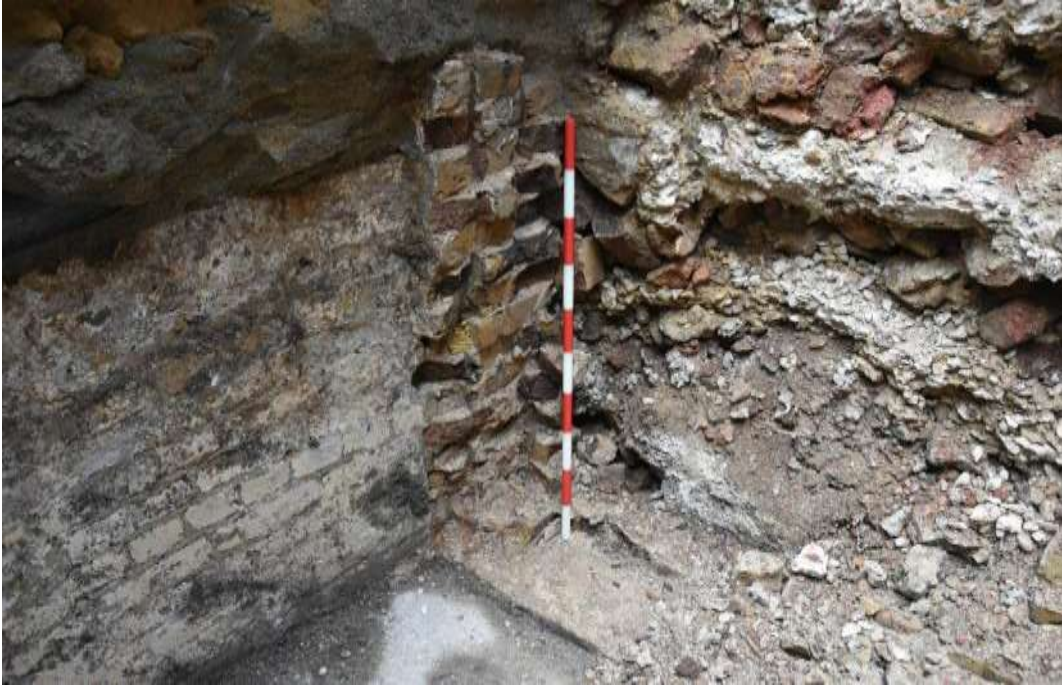
- 7.6** The observable section was truncated at the top by modern services, but survived to a height of 1.0m, with thirteen courses visible. The structure was built predominantly in alternating rows of headers and stretchers, with some variation throughout, bonded with a thick light grey mortar and finished with a cream / pale yellow paint. In keeping with the form of post-medieval coal cellars built during the 19th century, the wall has a slightly concave profile.
- 7.7** A return of the concave east-west wall was seen on the eastern side of the drop shaft, running north-south. The wall measured 0.3m in width, totalling three courses. It ran southwards for two metres, continuing beyond the extent of excavation in the southern section (figs.6-7).

Figure 6: North-south return of the coal cellar wall, observed in the eastern section. Facing NE, scale 1m.

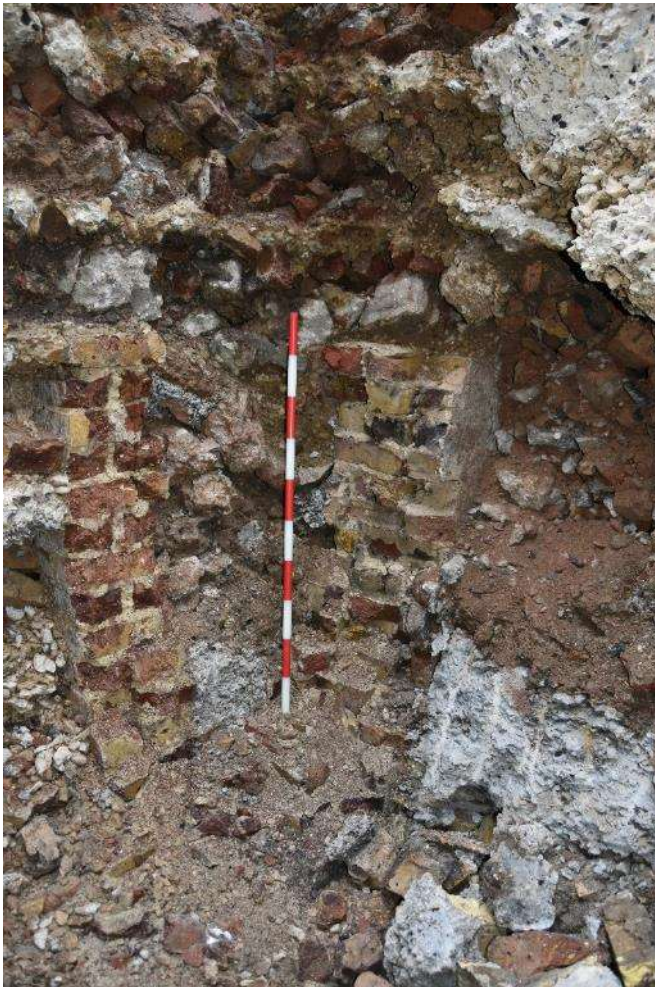
Figure 7: Continuation of wall [6] seen to the right of the scale, and an east-west adjoining spur to the left. Facing SE, scale 1m.

- 7.8** Due to truncation of the feature it is unclear if the east-west and north-south walls seen in figure 7 joined to form a corner. The presence of a white limewash seen on the northern face of the east-west section (to the left of the scale in figure 7) and western face of the north-south section (to the right) would suggest they were two internal faces and did indeed join.
- 7.9** The floor of the coal cellar was constructed from York stone slabs (7), encountered at a depth of 2.8m (13.5mOD). Much of the western part of the floor was cut away to accommodate a metal cover for a brick-built inspection chamber [8], (fig.8). The remainder of the floor was removed to expose the chamber fully.

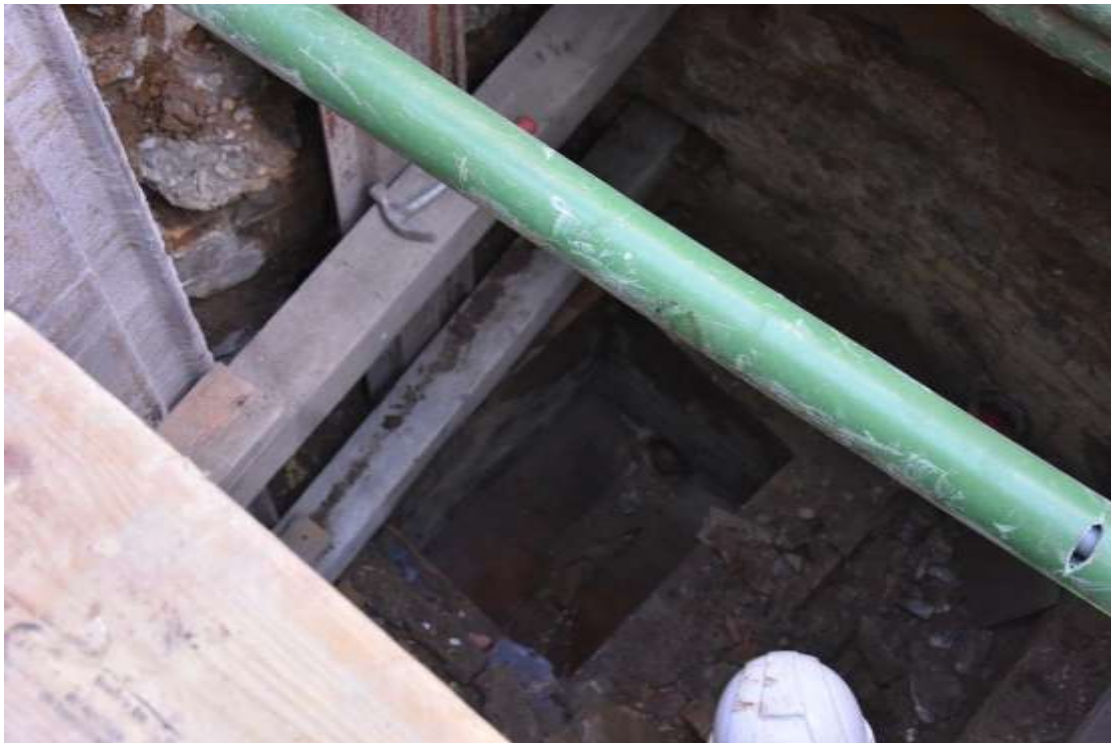
Figure 8: Working shot of the open inspection chamber to the south of the coal cellar [6], as seen from the top of the drop shaft. Facing NW, no scale.

- 7.10** The rectangular chamber was constructed from red and yellow bricks, aligned NNE-SSE. The structure measured 1.3m in length x 1.1m in width x 1m in height, with an internal space of 0.8 x 0.6m. The interior space sloped inwards to a narrow drain leading to the sewer. The drain was clear, with probing reaching approximately 5.5m before encountering resistance.

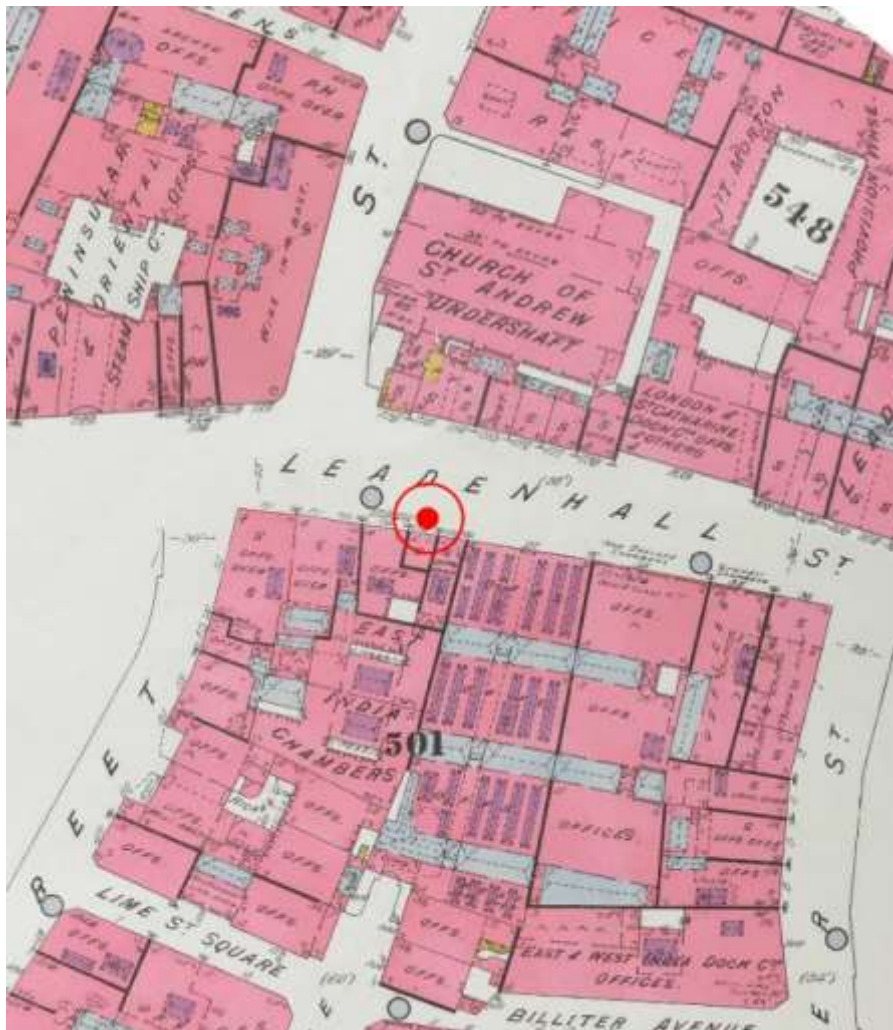
- 7.15** The earliest feature observed in the drop shaft was the post-medieval drain [8], connecting to the main sewer which runs east-west through the centre of Leadenhall Street. This was built into a 19th century coal cellar [6], the remains of which comprised a York stone floor and three sections of stock brick wall, recorded in the northern, eastern and southern sections of the trench. The wall was painted / limewashed on three surfaces. The coal cellar is likely to belong to the shop, shown on the Goad plan of 1887-9 (fig.9).

Figure 9: Extract from Goad's Insurance Plan vol.3 sheets 61, 67 and 68, with drop shaft location marked in red. The two easternmost blocks remained standing in the post-war period, with the central offices being cleared for the construction of Baltic House.

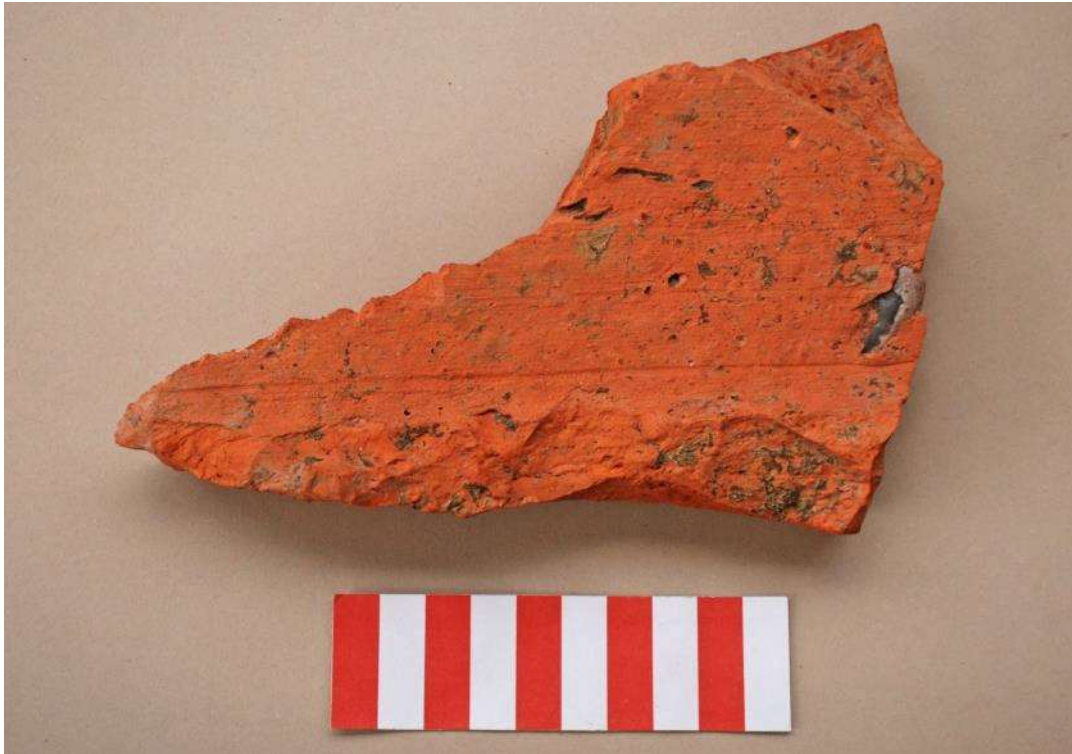
1 x fragment of Roman tegula roof tile. Base and partial edge. Coarse orange fabric, large flint inclusion. Visible moulding marks. Weight 392g. 1st – 4th century AD (fig.10).

Figure 10: Fragment of tegula recovered from context (9). Scale 10cm.

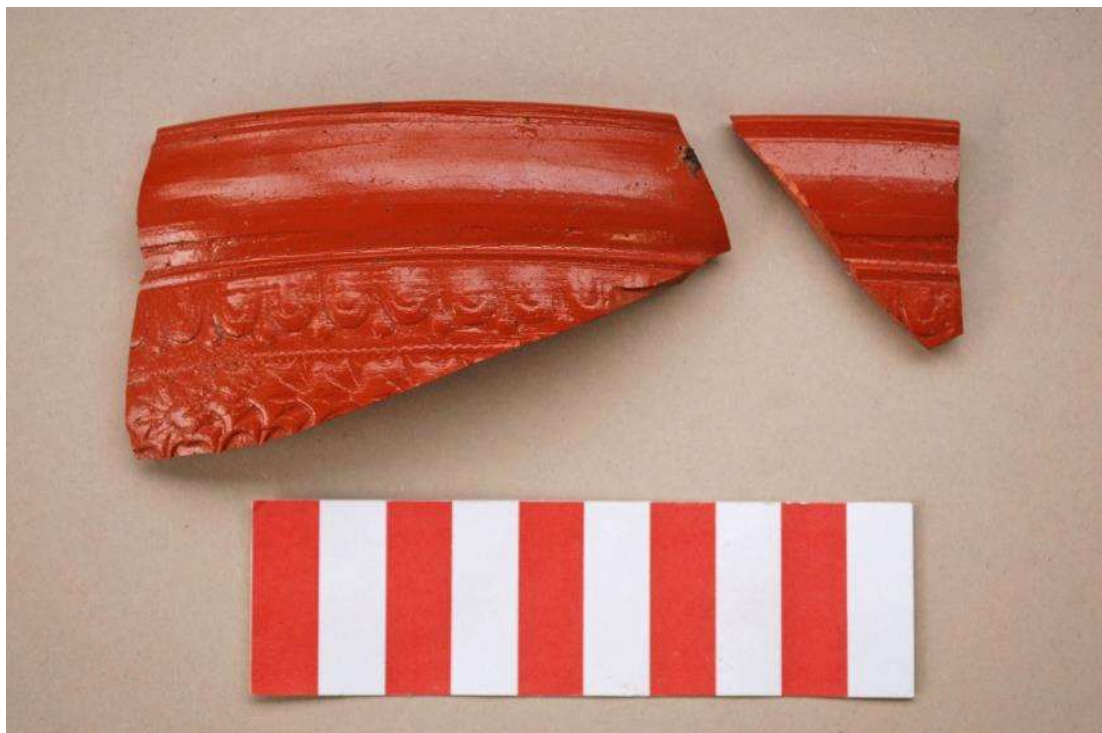
2 x fragments of samian ware. South Gaulish form 37, decorated bowl. 2 rim and wall sherds from the same vessel (not adjoining). Double bordered ovolo with a rosette-tipped tongue (badly blurred) above a wreath of overlapping leaves (Rogers group J¹), separated by a wavy line border A23. An early variant, cAD70-90 (fig.11).

Figure 11: 2 fragments from a samian bowl, recovered from context (9). Scale 10cm.
