ST ANNE'S CHURCH
KEW GREEN, KEW
LONDON BOROUGH OF RICHMOND

AN ARCHAEOLOGICAL WATCHING BRIEF

SITE CODE: ANK07
SITE CENTRE NGR: TQ 18964 77489

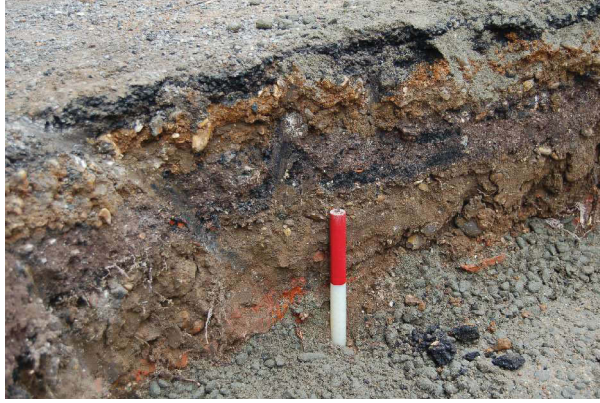
A – Section of gully excavation within tarmac forecourt (0.2m scale).

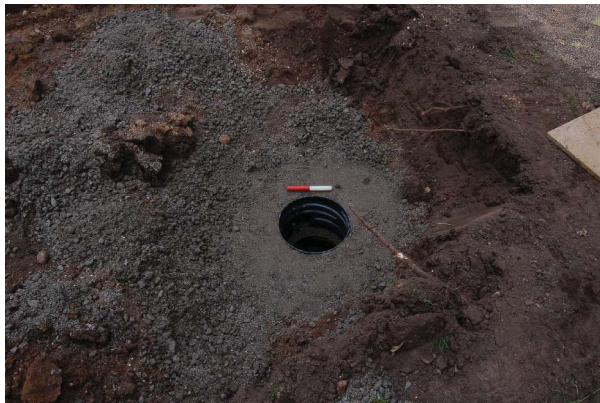
B – Section of gully excavation with turf area to west (0.2m scale).

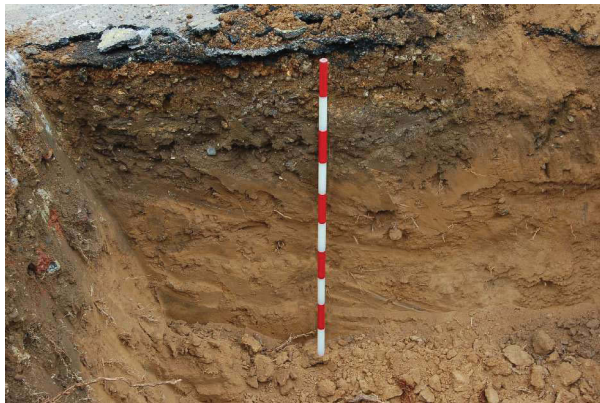
C - Section of new soakaway excavation showing shallow made-ground overlying clay natural (1m scale).

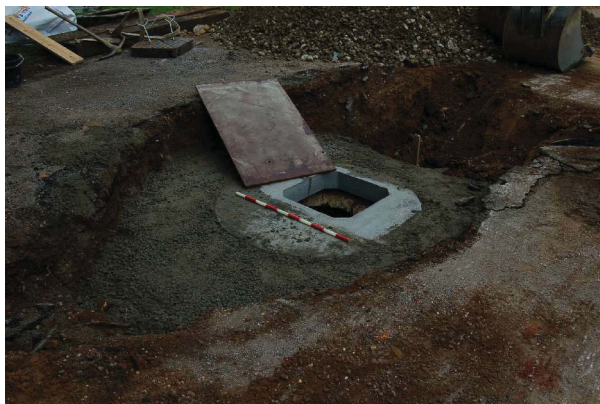
D – Old soakaway with concrete reinforcement (1m scale).

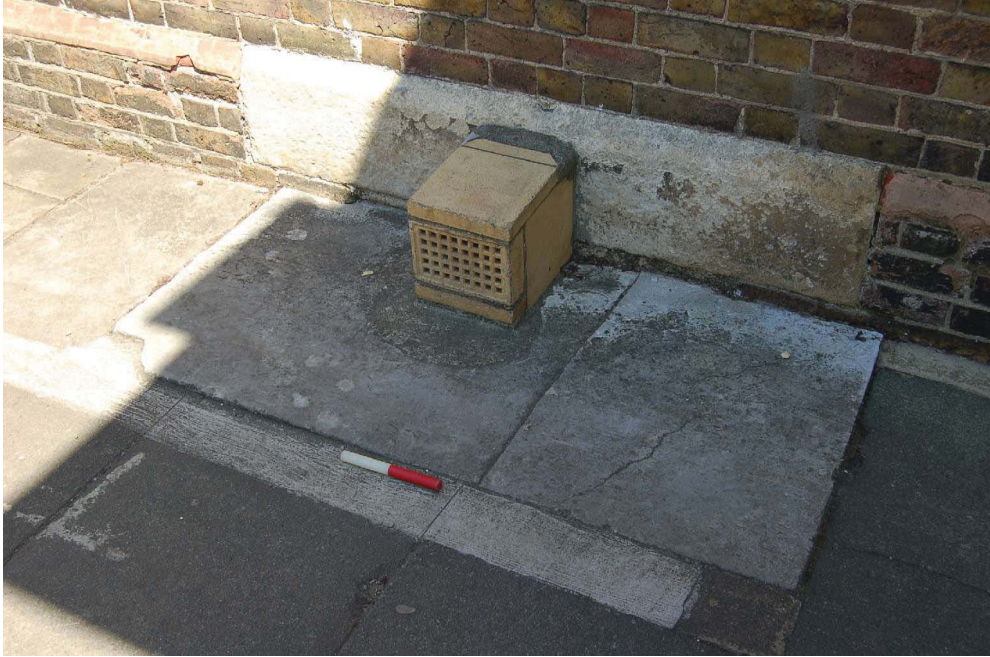
Three slabs were identified as grave slabs – the slab lain east-west in front of the southern most door is discussed in more detail below. A slab orientated north-south and lain adjacent to the west wall, north of the portico, was identified through characteristic molding. The upper left hand corner was cut and curved, as shown in Figure 7. Unfortunately, a vent was sunk through the centre of the slab, and a large section of concrete repair showed adjacent to a horizontal crack. What inscription survived was heavily abraded and unreadable. A further grave slab, measuring 2.1m in length by 0.9m in width was observed orientated east-west and laid adjacent to the west wall of the church (see Figure 8). However, while the grave slab showed no significant damage, the inscription was again heavily abraded. Only the first, uppermost, line of the inscription was legible, reading “*In Memory of*”. However, a survey of monumental inscriptions produced by the East Surrey Family History Society in 1988 provides further detail, presumably the inscription was less abraded at this time. The record from 1988 lists: “*A flat stone slab in pavement abutting west wall of church*” the inscription, again only partially legible, is listed as: *In Memory / of / (---) Ann Thomas / (---- --) / Edward (?) Thomas / ((Thomas Mrs Ann wife of Edward 18 Mch 18-8)).*”

Figure 7: Slab orientated north-south and lain adjacent to the west wall, showing curved upper left hand corner and significant damage including a vent cut through the slab.

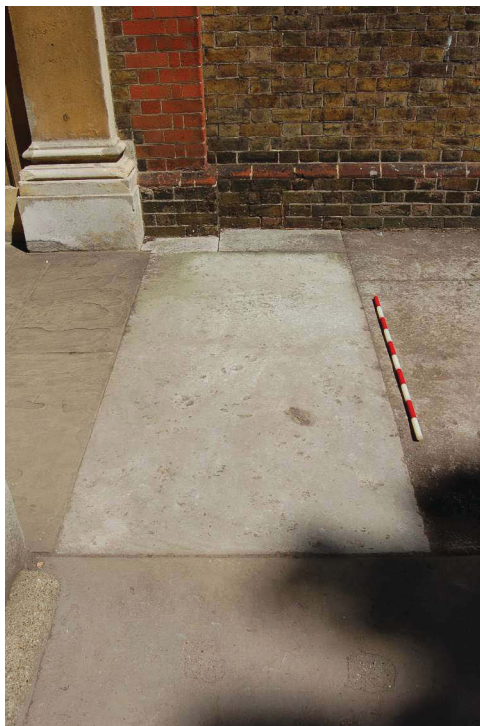
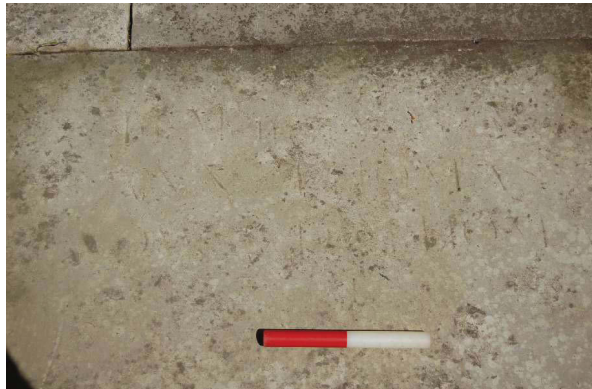
Figure 8: Slab orientated east-west adjacent to west wall of church, inset detail showing heavily worn inscription, slab supposedly references a Thomas family.

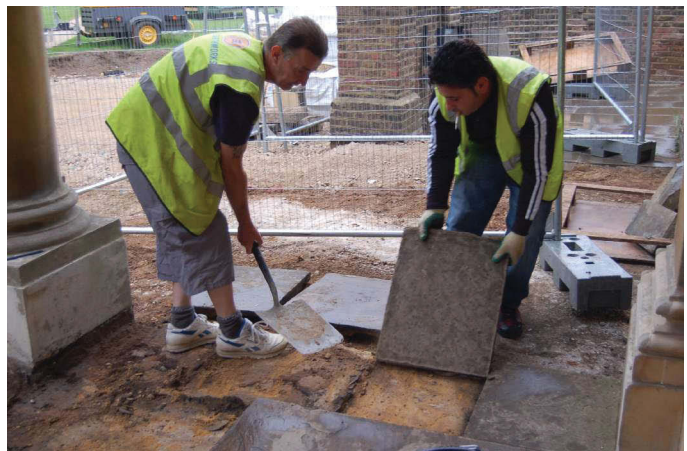
7.2.2 Where possible, the slabs were lifted by hand and retained or discarded as necessary. The bigger slabs were lifted using a vacuum suction machine attached to the arm of mechanical excavator. Slabs were wetted, the suction pads positioned, then the vacuum initiated and the slab lifted (see Figure 9).

On lifting, the slabs exposed shallow sand and gravel bedding, yellow-orange in colour and containing occasional brick and glass inclusions (see Figure 9). This makeup was exposed across the full length of the forecourt where slabs were removed, although more modern gravel was exposed beneath the isolated area of concrete slabs.

Figure 9: Slab lifting using a vacuum suction machine attached to the arm of a mechanical excavator and by hand, exposing shallow sand and gravel bedding below.

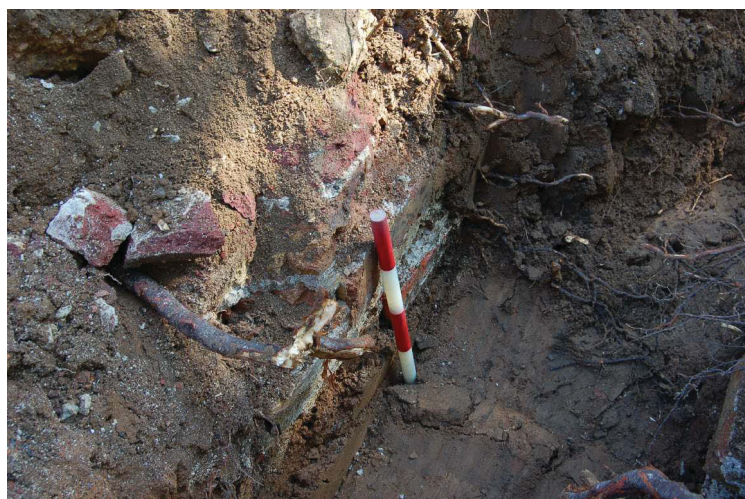
In both trenches shallow sand and gravel made ground was exposed (forming the base below the paving slabs), with a mixed mid-brown silty sub-soil below. Natural sterile clay was exposed in the base of both trenches. Sections of brick wall foundation were also exposed in both trenches, of the same fabric and construction as the existing boundary wall. In trench A the brickwork crossed the trench in alignment with the existing wall, exposed for a further 5 courses below the existing ground level and at the same width of *c* 0.5m (see Figure 11). In Trench B the opposing section was exposed, in the east facing section at the terminal of the trench. In this trench four courses of regular on-bed brickwork (of the same construction as the existing wall) were exposed, with a narrow step towards the base and a single course of bricks laid end-on (see Figure 12).

Figure 11: Section of brickwork exposed in Trench A, north facing section, 0.4m scale.

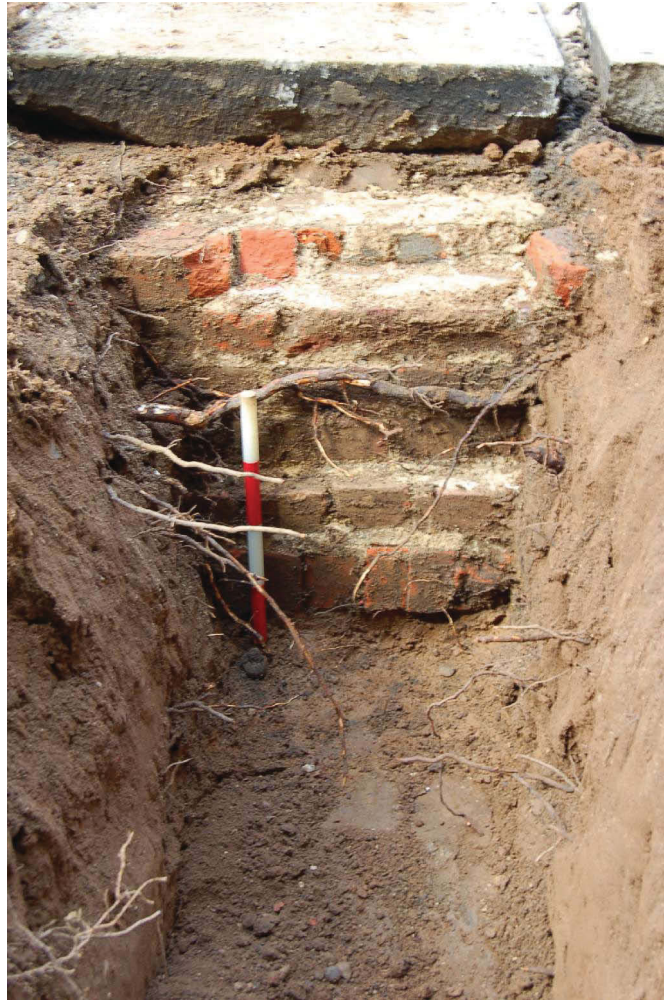
Figure 12: Section of brickwork exposed in east facing section of Trench B, 0.4m scale.

Both trenches appear to have exposed the same stretch of wall, which again appears to be the continuation, at foundation level, of the existing boundary wall. This suggests that the boundary wall would originally have continued on its present alignment, with a stretch of wall connecting the two existing terminals on the north and south sides of the portico, but presumably with an entrance into the churchyard. The present position of the portico, protruding from the main church building, was established in 1837 during a phase of extension and alteration to the church. Prints from the early 20th century show the boundary wall in its existing position and dimensions, but with wrought iron railings across the gap (see Figure 13). The exposed foundations therefore, suggest that the boundary wall extended further than it currently stands when originally constructed, presumably in 1837.

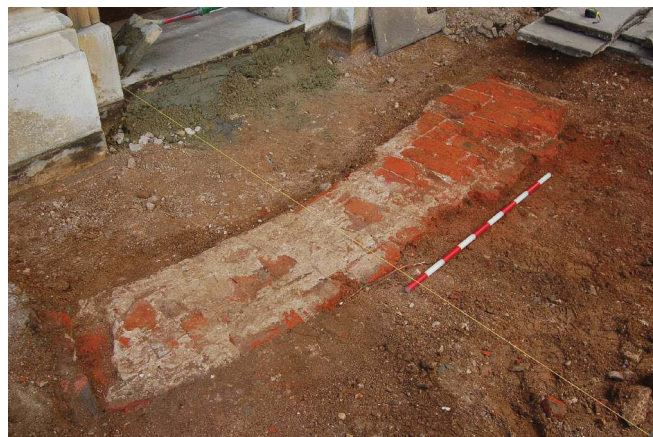
7.2.4 Beneath the slabs at the north end of the portico covered area, a 3.2m section of brick-wall foundation was exposed. The wall was orientated north-south, situated opposite the north entrance in the west wall of the church. The foundation survived to an average of 0.5m in width, and was exposed as a single course in plan and heavily abraded. The bricks were reddish orange in colour, unfrogged and very degraded, bonded with a grey-white chalky mortar and laid on-bed. In plan, the wall curved towards the north-east, similar to that of the existing boundary wall but further east (see Figure 14).

Figure 14: Photo and plan of brick foundations exposed outside north door.

The location of the wall, approximately 1m from the existing church wall, suggests it belongs to an earlier phase of the building. The current location of the portico (protruding significantly from the main building) was established in 1837, under the direction of Sir Jeffrey Wyattville. The exposed foundation then, must have been constructed prior to the extension of 1837, and was likely demolished at this time.

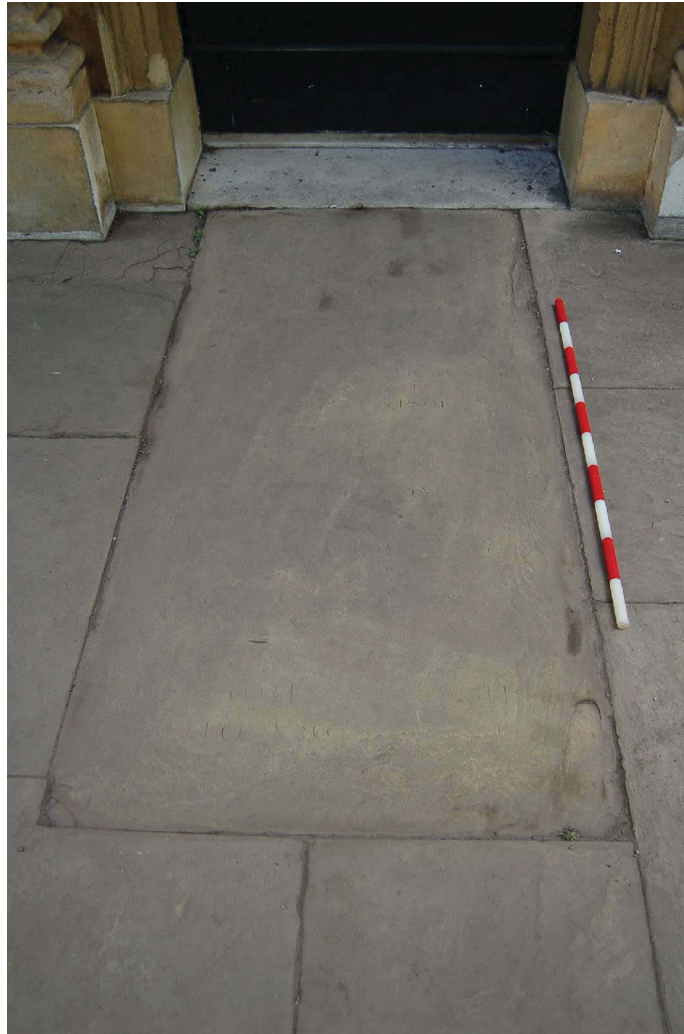
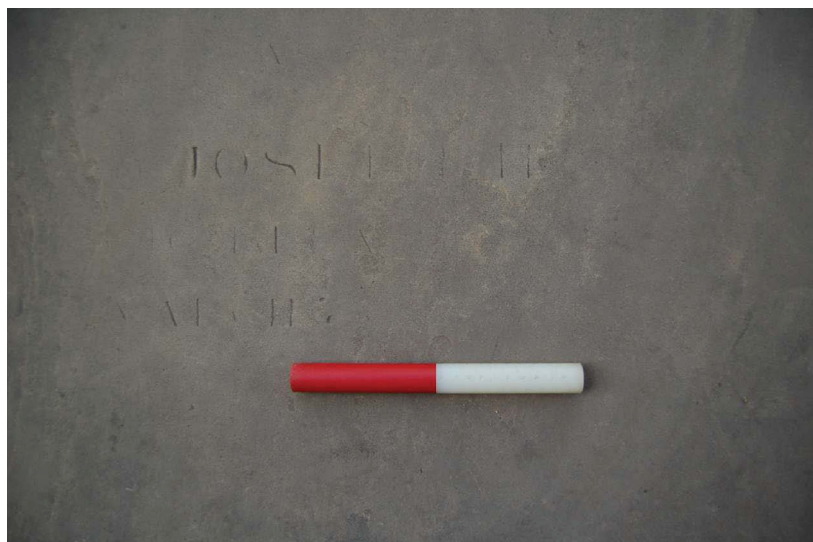
7.2.5 The slab marked in pink on Figure 6 measured 1.85m by 0.9m and was orientated east-west, lain directly in front of the southern most door beneath the portico. The stone was identified as a grave slab by the heavily abraded inscriptions surviving on its surface, which unfortunately were largely illegible (see Figure 16).

Figure 16: Photographs showing the grave slab sealing the burial vault *in-situ* and a sample of the heavily worn inscription.

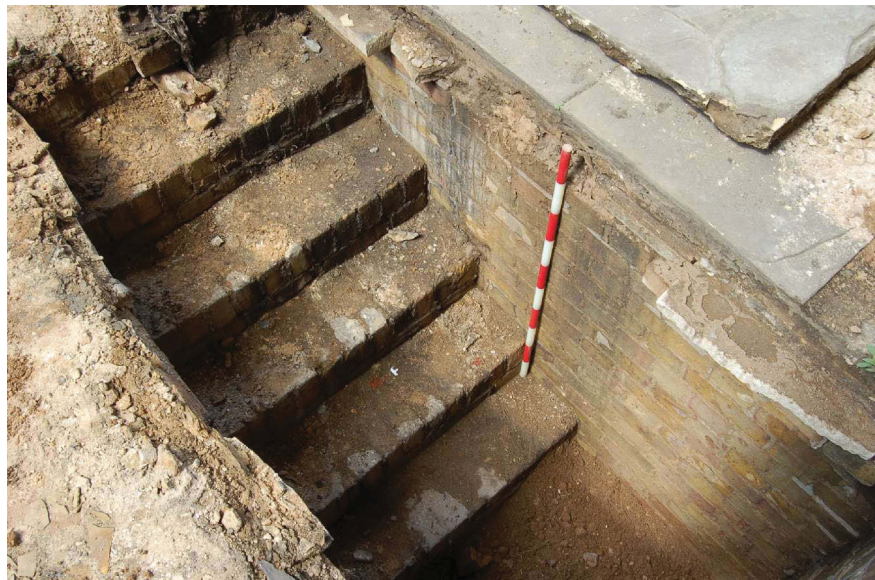
When lifted with vacuum suction, the slab was found to seal a set of brick-built steps leading to a bricked-up archway, situated almost directly below the southern doorway. Two bricks were removed from the bricked-up entrance to establish the presence and nature of the blocked structure. A brick-built burial vault was exposed behind the bricked archway, containing two intact lead coffins, one definite and one possible collapsed lead coffin, and a collapsed wooden coffin. The tomb had a vaulted ceiling, approximately 2m high and an estimated 3m in width and length. Due to the presence of lead coffins, the vault was not entered for health and safety reasons. Flash photography was used to capture images of the interior before the entrance was resealed and the empty stairwell backfilled with gravel.

Figure 18: Brick built steps exposed below grave slab, leading to bricked up archway entrance into burial vault.

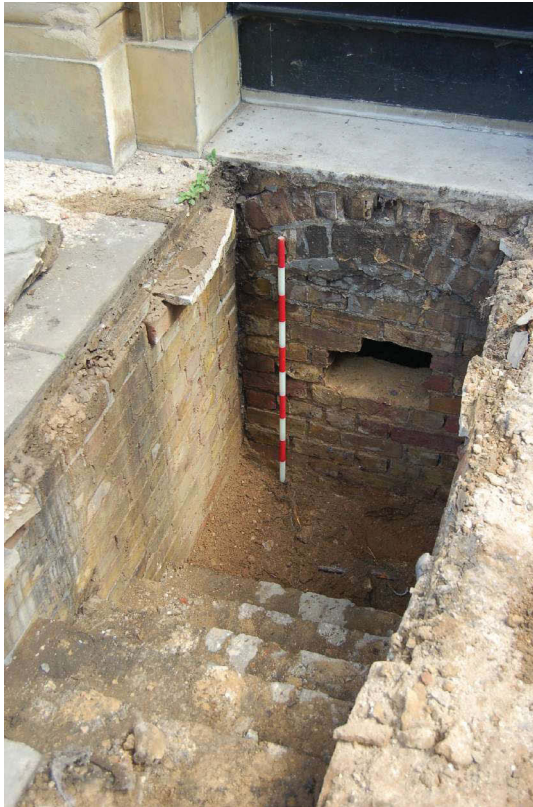
Figure 19: Views of the bricked up arched entrance into the burial vault below the southern door.

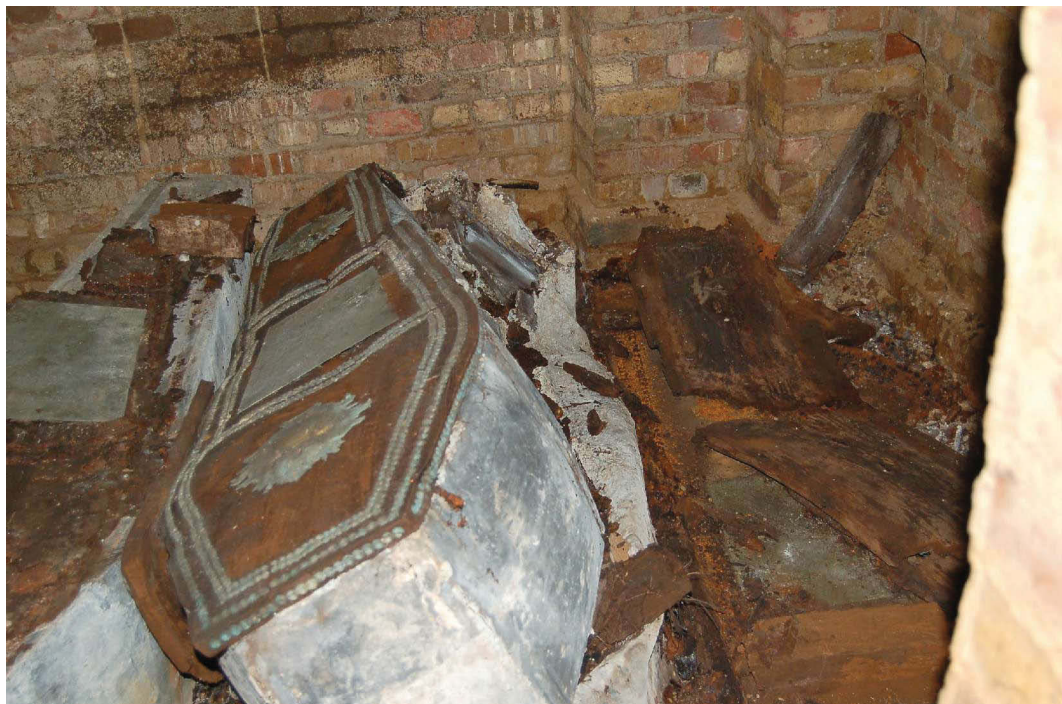
Figure 20: Inside the burial vault using flash photography, showing two intact lead coffins, collapsed coffins beneath and a partial wooden coffin to the right.

The resulting photographs, while hardly ideal, provided adequate information for an assessment of the vault and its contents. The coffins were orientated east-west, apparently in two stacks directly in front of the archway, with a single wooden coffin in the southern side. The two apparent stacks were both of lead coffins, and in both cases the lower coffins appeared to have collapsed beneath the weight of the upper. The two upper coffins were in good condition, were of adult dimensions and fairly elaborate in their decoration. The coffin directly in front of the archway was both the most visible and the best condition. Four rows of pins were inlaid around the edges of the lid and a flat plaque rested centrally, with two spurs of pins above and below. A crest or piece of elaborate decoration was visible at both the head and feet end of the coffin. The presence of lead coffins, and the degree of decoration and elaboration suggests that some considerable wealth must have belonged to the deceased. Interestingly, two bricks were visible within the vault which appeared to have been pushed in from the walls – suggesting that the vault had been accessed at a previous time.

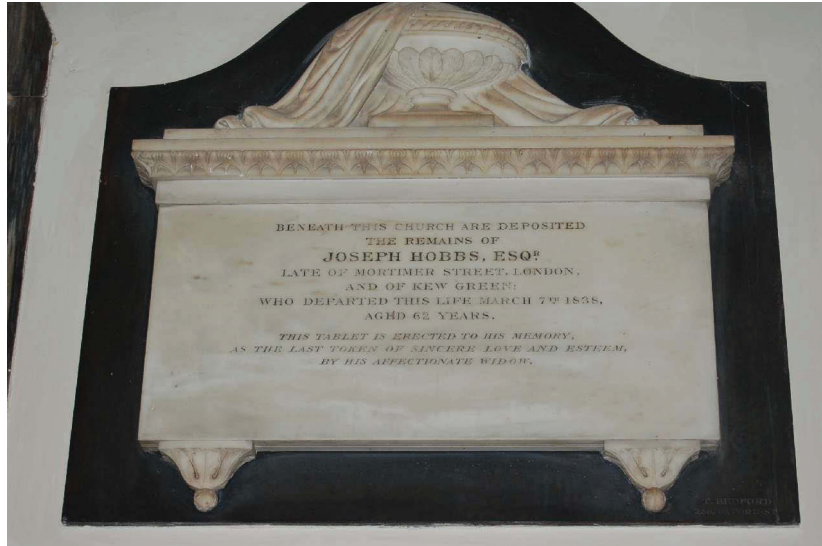
The survey also refers to a related plaque inscription inside the church (see Figure 21), “*South aisle, white marble & black slate wall tablet decorated with draped urn*”. This plaque is still within the church and reads:

*Beneath this church are deposited
 the remains of
 JOSEPH HOBBS Esqr
 Late of Mortimer Street, London
 and of Kew Green
 who departed this life March 7th 1838
 Aged 62 years
 This tablet is erected to his memory
 As the last token of sincere love and esteem
 By his affectionate widow*

Figure 21: Marble plaque on the wall of the south aisle in St Anne’s Church, referring to the remains of Joseph Hobbs.

The ‘Hobbs’ family, therefore, seem to be the general occupants of the exposed burial vault. A plan of the church from 1830, discussed above, gives the locations and family names of the major vaults. Vault F on the plan matches the position of the vault exposed during the slab lifting, the name provided being: *Mrs Mary Hobbs* and the date, *July 11th, 1813*. Whether or not this is the earliest burial within the vault is unclear, but it serves as a useful contemporary source in confirming the vault as belonging to the Hobbs family (Figure 22).

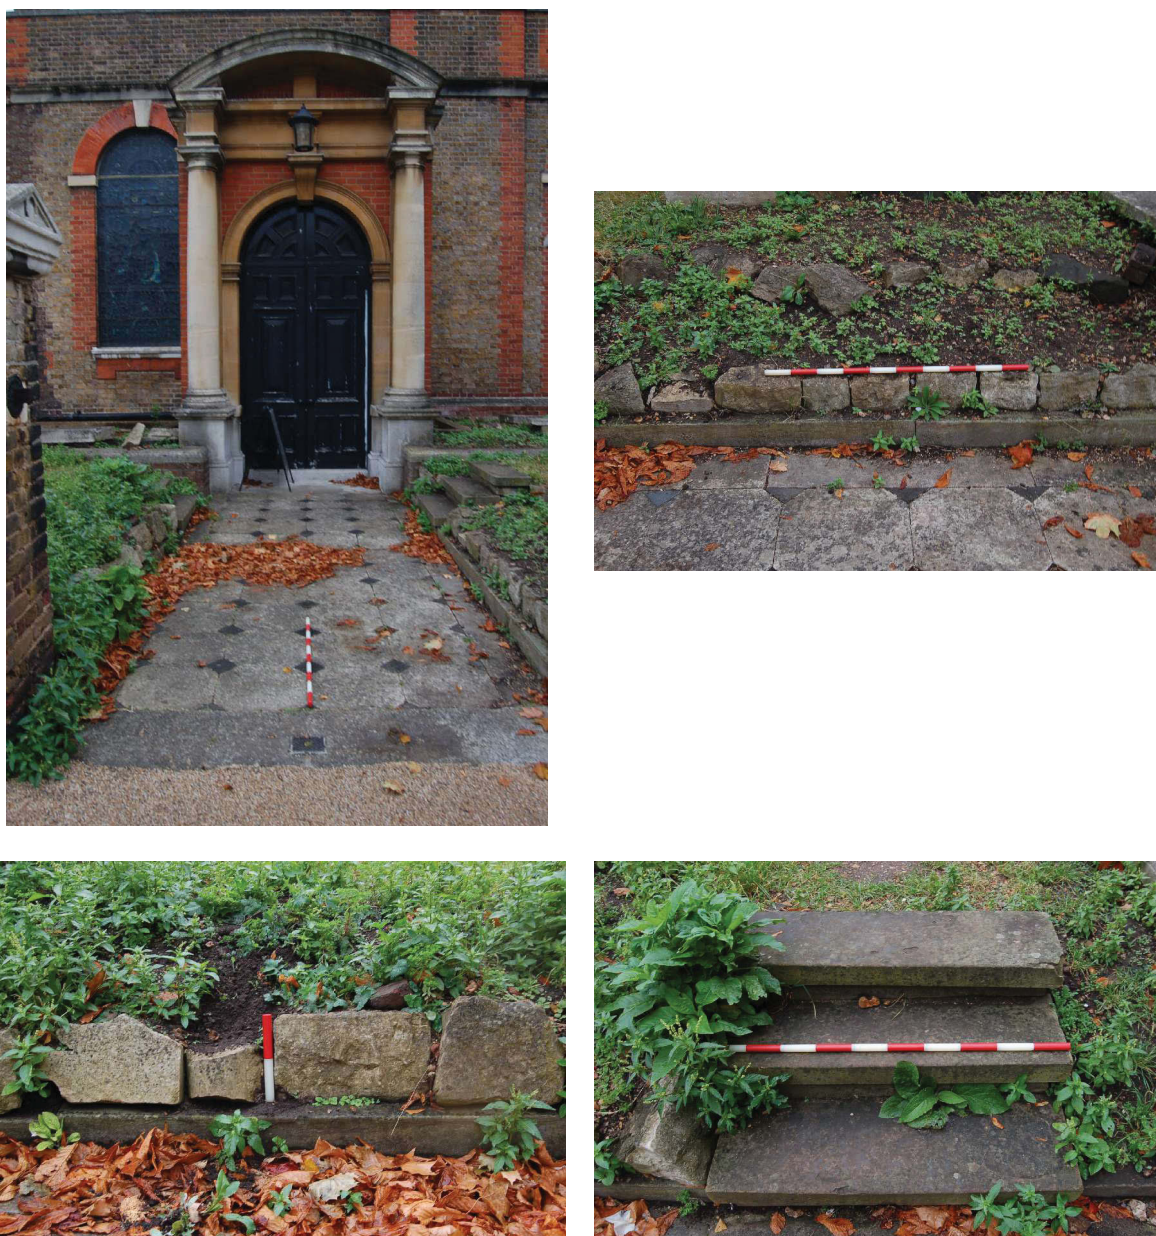
Prior to the commencement of works on the south porch a brief photographic survey was taken to record the paved footpath, steps and retaining wall. Various pieces of moulded, re-used stone were observed in the retaining wall, these are discussed in more detail below.

Figure 25: Images of the south porch, retaining walls and steps prior to refurbishment.

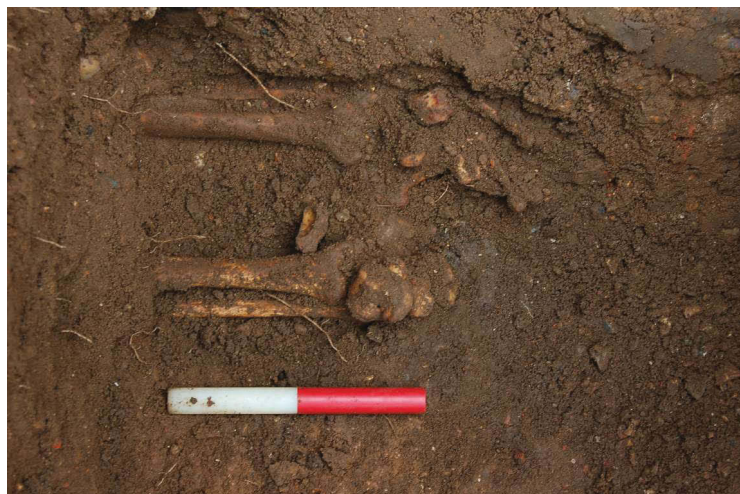
In the western trench, 0.87m below the cemetery level, *in-situ* human remains were exposed orientated east-west. The lower legs, ankles and feet of an adult were exposed protruding from the east facing section. These remains presented no obstacle to the construction of the retaining wall and were thus left undisturbed.

Figure 27: *in-situ* human remains in the western foundation trench.
