LAND TO THE REAR OF MILTON CRESCENT AND

THROUGH VALENTINES PARK

AN ARCHAEOLOGICAL WATCHING BRIEF

SITE CODE: MCV07

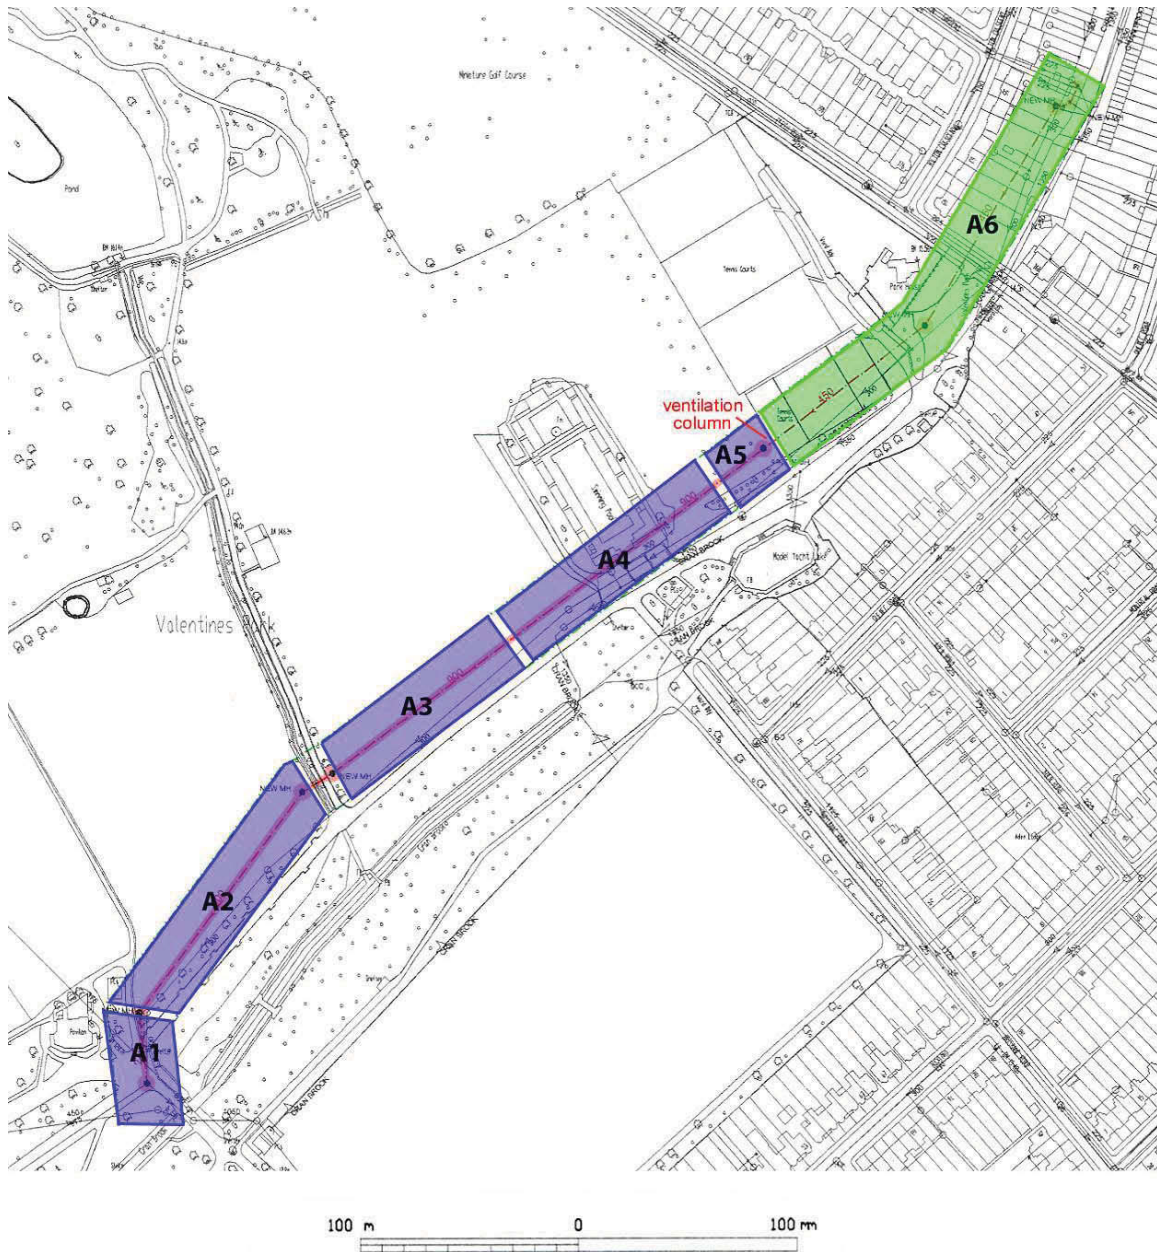
Figure 2: Areas of archaeological monitoring, based on WIA Notice Sewer Route drawing produced by Thames Water Utilities Engineering.

The results of the archaeological brief will be discussed by division into six separate areas, as defined in Figure 2 below. Areas 1-5 were within Valentines Park and constituted turf and topsoil stripping prior to open-cutting of the pipe trench. Area 6, through the northeast corner of the Park and to the rear of Milton Crescent, used micro-tunnelling and thus no land stripping or open cutting was required.

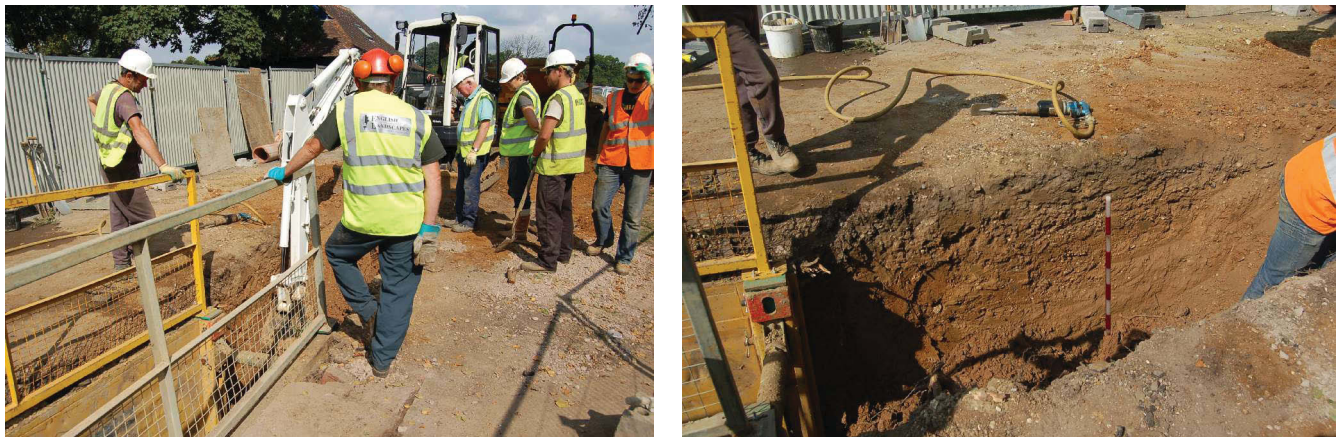
Area 1 was located within the tarmac area around the pavilion and café, north of the boating lake. The stripped area measured approximately 60m (north-south) by 32m (east-west), with a 2m wide pipe trench excavated within this area. The initial machine strip removed tarmac and shallow base to a depth of 0.21m, overlying dark-grey/brown ground makeup 0.35m in thickness. The pipe trench section exposed natural gravels beneath these deposits for the remaining depth. The pipe trench was excavated to 2.6m below the existing ground surface when observed and partially backfilled with shingle. No archaeological finds or features were exposed in this area.

Figure 3: Groundworks in Area 1, working shot and section (east facing).

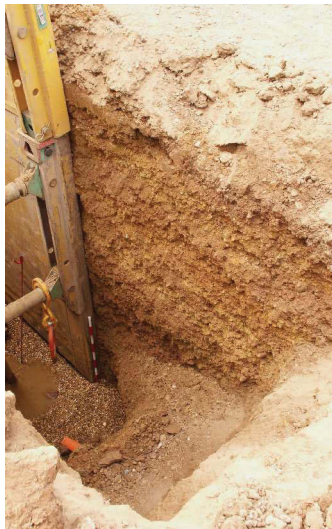
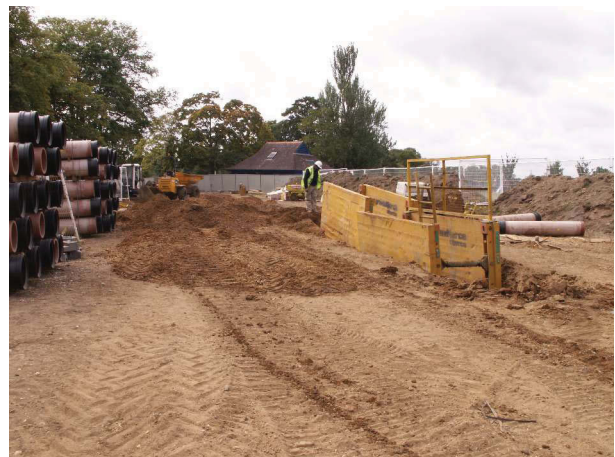
Area 2 measured approximately 130m (northeast-southwest) by 45m (northwest-southeast). Initial machine stripping removed topsoil and subsoil to a depth of 300-400mm below the turf level. A single pottery sherd was recovered from this context, identified as a fragment of a large stoneware bowl or planter, of 19th – 20th century date (pers. comm. Paul Blinkhorn: 2007). Natural Hackney gravels were exposed beneath these deposits. A section of the pipe trench excavated through this area measured 10m in length by 5m in width and was observed at a depth of 7m below the existing ground level. The gravels were very mobile, not compact and presented a possible danger of collapse. As such, metal siding was used to shore the sections and provide a safe working environment. Groundwater was visible in the base of this trench. No archaeological finds or features were observed in Area 2.

Figure 4: Ground works in Area 2, south facing section and stripped area.

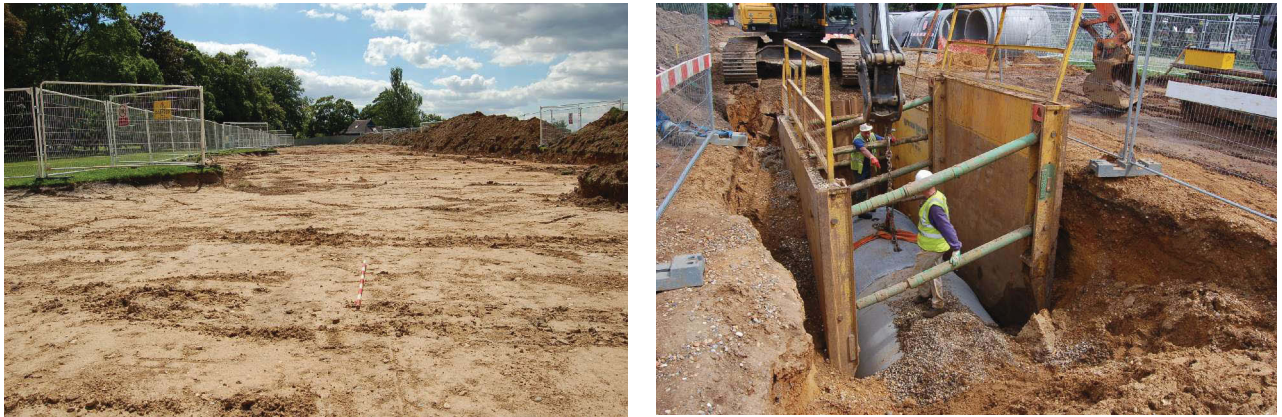
Area 3 measured approximately 110m by 40m and was located on the opposite side of a north-south hedgerow from Area 2. Topsoil and subsoil were removed to an average depth of 400mm across the whole area and the 5m wide pipe trench was excavated through the centre. Part of the pipe trench excavated in this area was observed to a depth of 8m below the existing ground level, with groundwater visible in the base. No archaeological finds or features were exposed in Area 3.

Figure 5: Ground works in Area 3, stripped area and section of pipe trench.

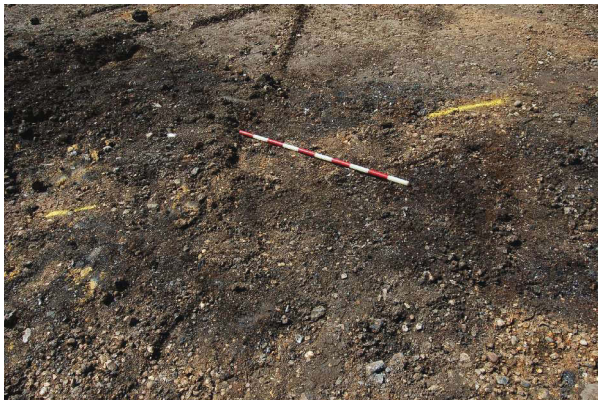
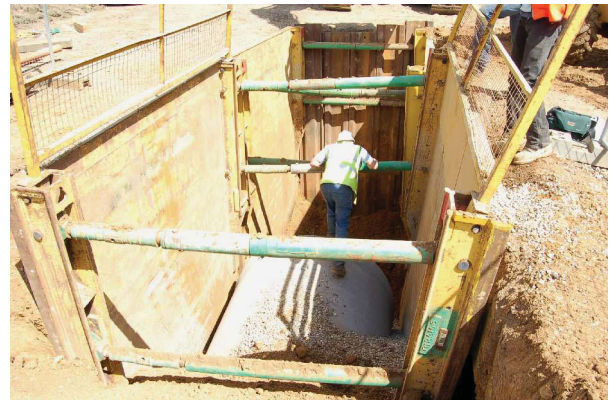
Area 4 measured approximately 135m by 40m and ran as a continuation of Area 3 within a separate compound. The same topsoil, subsoil and natural sequence was observed within this area but a further context has been applied to the surviving elements of concrete foundations representing a former swimming pool. Again, no archaeological finds or features were observed in this area, but numerous service cuts were visible following the stripping down to a natural to a depth of 350mm.

Figure 6: Modern dump material in Area 4 and section of pipe trench through natural gravels.

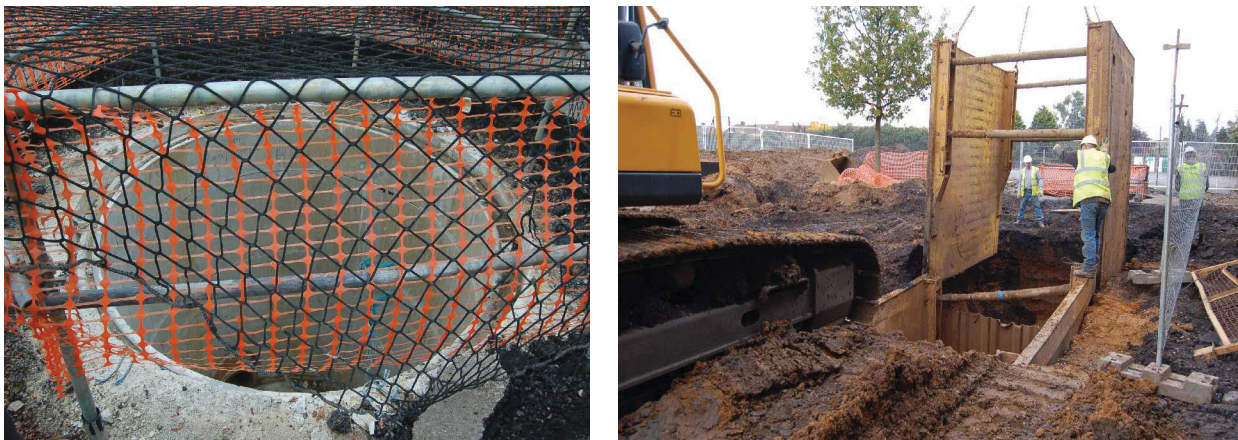
In this area a different deposit was observed underlying the topsoil and subsoil, namely a very dark grey sand and gravel deposit. This represents recent made ground and is presumably contemporary with the pre-war construction of the tennis courts. Area 5 was also the location of the ventilation column subject to a separate planning condition (Application No. 0296/07 - Condition 3; approved 16.03.2007). The excavation was monitored and the stripped area observed prior to work beginning. No archaeological finds or features were observed in the designated area so the construction of the ventilation shaft went ahead as planned (see location on Figure 2).

Figure 7: Ventilation column and ground works in Area 5.
