**TS BENBOW, 243 COMMONSIDE WEST, MITCHAM**

**AN ARCHAEOLOGICAL EVALUATION**

SITE CODE: CJM07

PLANNING APPLICATION No: 07/P1050

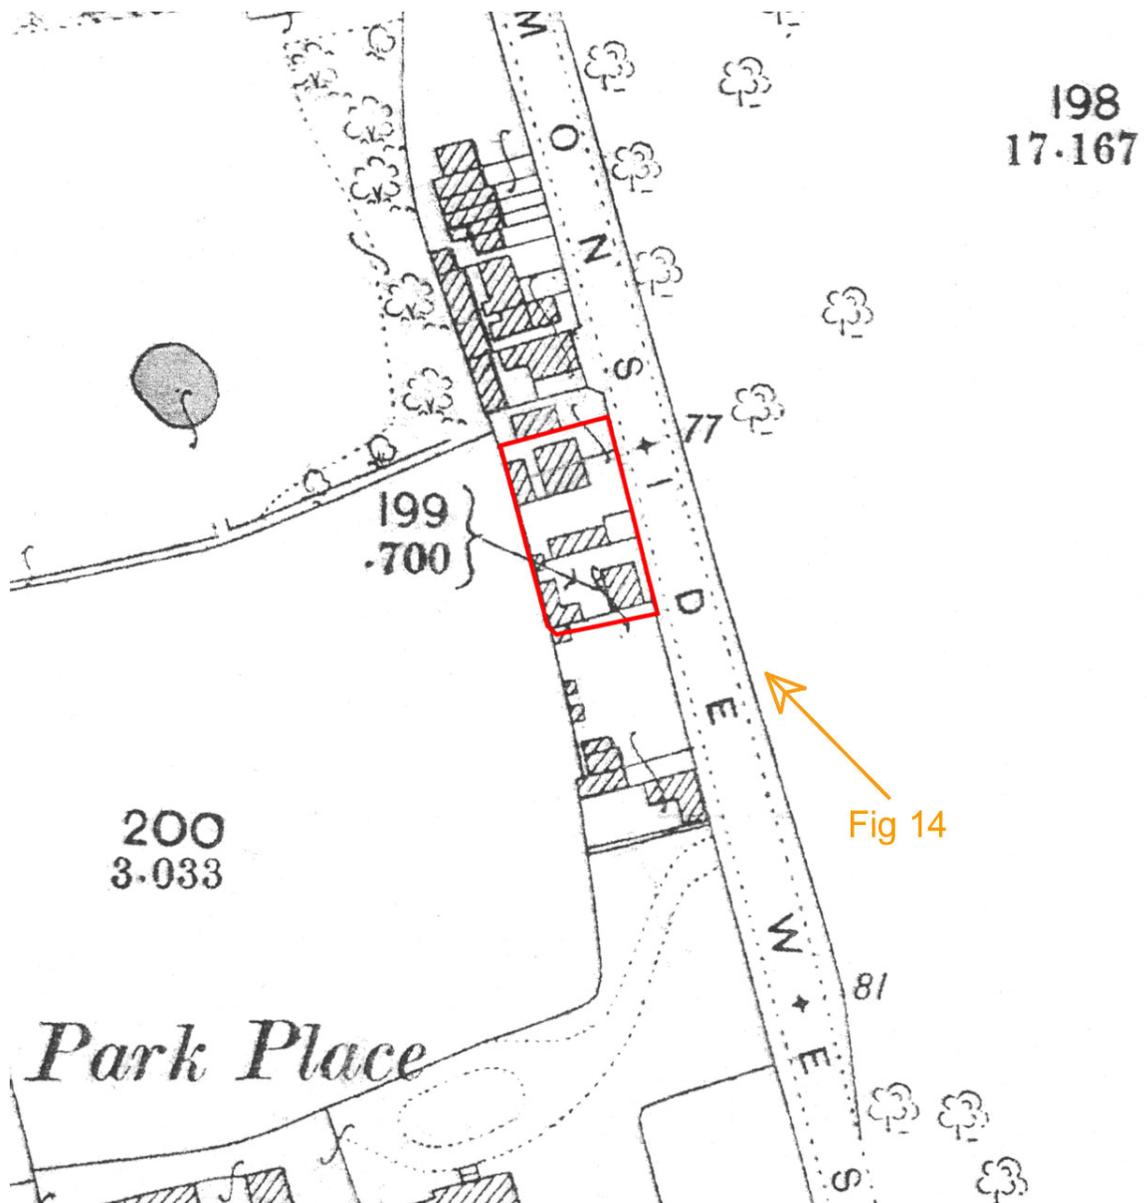
Fig 3 The site outline in relation to the Ordnance Survey 25-inch Second Edition map of 1895, showing the former cottages and other buildings and covering approximately the same area as Figure 1

The plan also shows the direction of view taken in Figure 14

**6.4.3** There was no sign of the east-west aligned building that is recorded in this area on mid 19<sup>th</sup> century and later maps (*cf.* Figures 3 & 6) – presumably due to the wartime or post-war truncation. However, it is reasonable to assume that the underlying deposit [1] is undisturbed. Moreover, the finds that were recovered from this context came exclusively from the area subsequently overlain by the east-west building. On this basis the earliest possible date for the construction must be in the 1720s, and probably later.

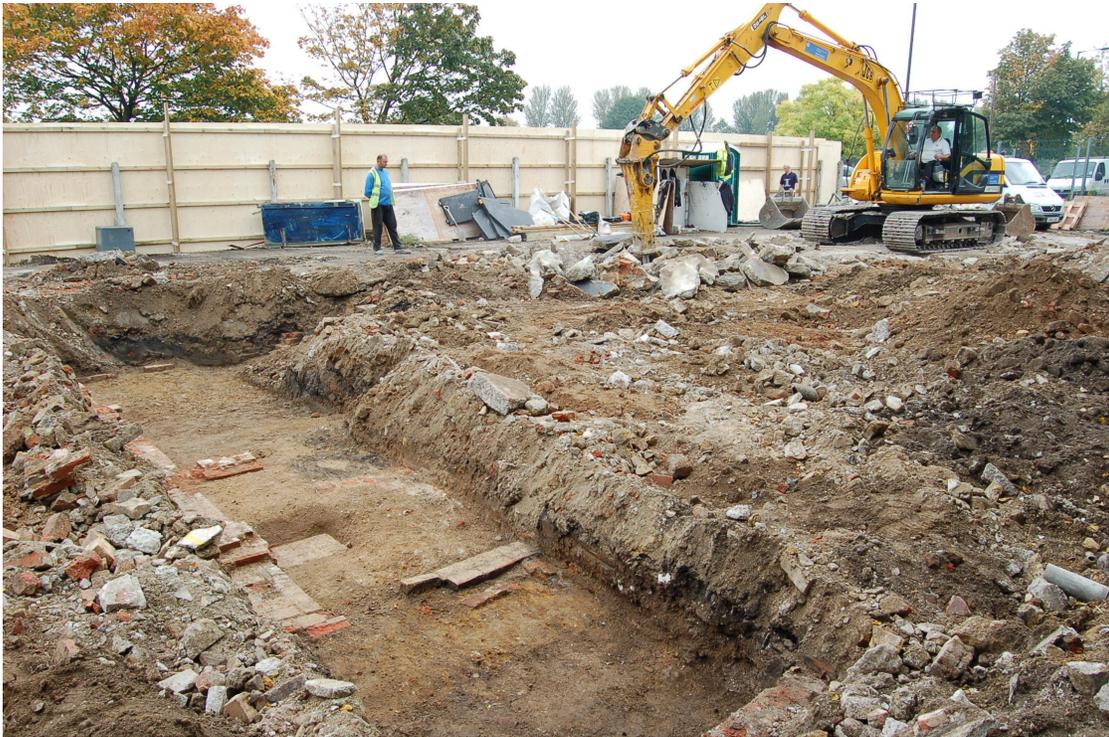
Fig 9 Detailed view of the rear fireplace base, looking north. The crushed rubble and burnt material in the foreground forms part of the primary floor make-up [13] (0.5m scale)

**6.3.3** Within the footprint of the building (and where not disturbed by later activity) the natural surface [14] was overlain by a compacted silty clay deposit with gravel, building rubble and charcoal inclusions [13], clearly shown in Figure 9. This appears to be a make-up layer for the internal floor, laid down after previous deposits had been removed to the level of natural and following construction of the brick wall bases. The extant thickness was up to 400mm, and the context contained occasional fragments of pottery and clay tobacco pipe that collectively suggest a later 18<sup>th</sup> or early 19<sup>th</sup> century date for the structure (*cf.* sections 7 & 8 below).

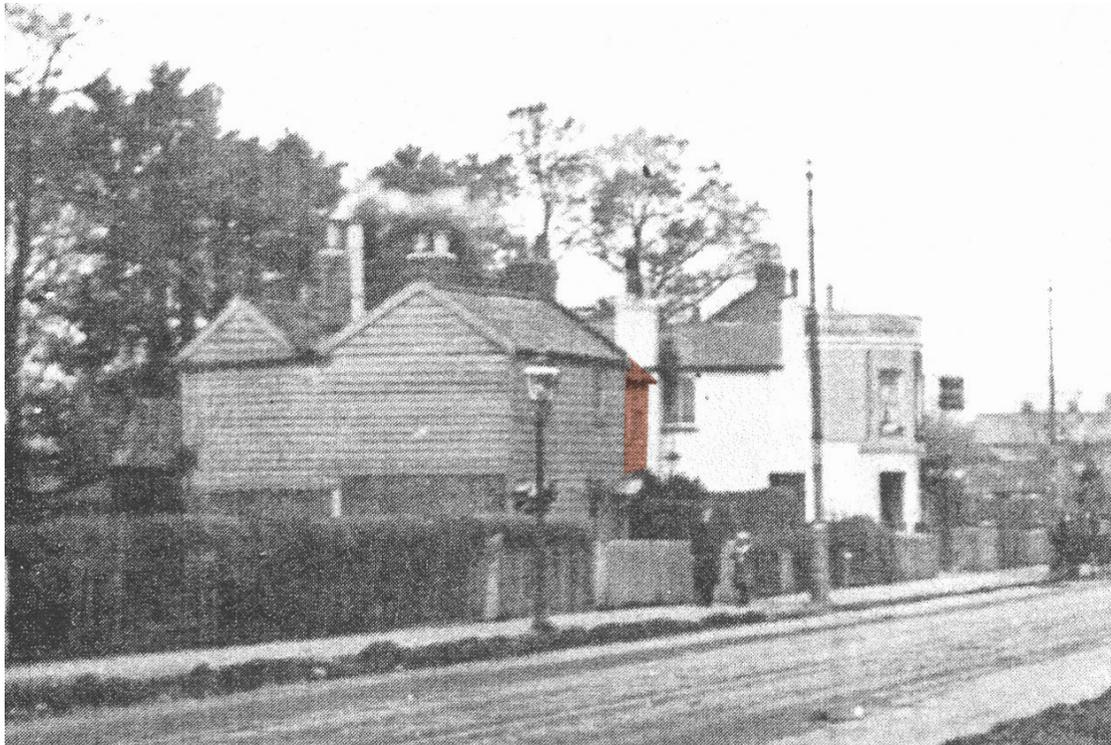
Fig 14 View of the site *c* 1910, looking northwest from the other side of Commonsie West (*cf.* Fig 3). The building recorded in Trench 1 is just visible in the centre of the frame (highlighted in red). To the extreme left is a single storey structure that probably crossed Trench 2, although not found in the investigation
