NEW RIVER, MYDDLETON ROAD, LONDON BOROUGH OF HARINGEY, N22

AN ARCHAEOLOGICAL WATCHING BRIEF AND LEVEL 2 HISTORIC BUILDING RECORD

SITE CODE: MDD18
NGR REF (APPROX. CENTRE): TQ 30575 91565

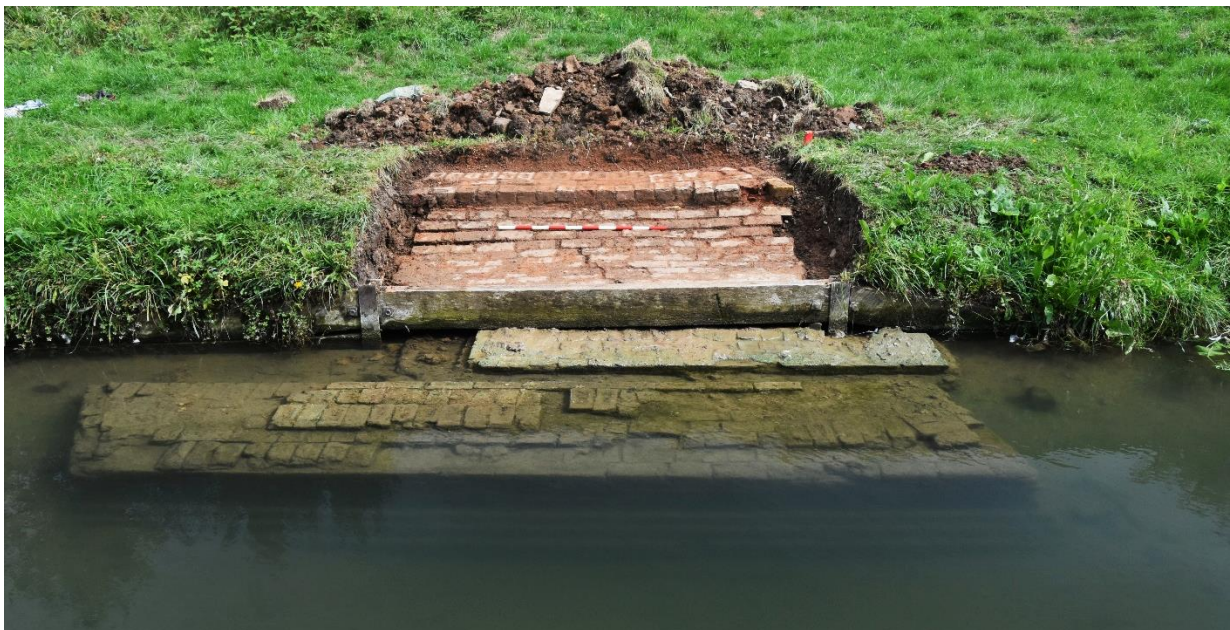
Figure 4: Overall view of footings on eastern bank. Looking E, scale 1m

7.2.1 The footings on the eastern bank comprised two parts, landward and waterside (figs. 4 & 5). The landward portion comprised two upper courses of red brick laid with headers to the E and W and a line of stretchers in the centre (fig. 6). It measured 0.66m E-W and 2.12m N-S. They were bonded with two types of mortar, an orange bricky mortar and an off-white sandy mortar, though the orange was more prevalent. The bricks were frogged and some stamped with 'S'. A line of three curved stretchers was visible at the southern end. Below the upper courses was a cambered slope down to the river comprising 10 rows of red bricks in a stretcher bond, laid on edge. This measured 0.76m E-W and 2.24m N-S. These bricks were also frogged and stamped with an 'S', and bonded with an orange mortar. The cambered section was bounded to the west by the wooden planks that could be seen supporting the banks along the length of the river section.

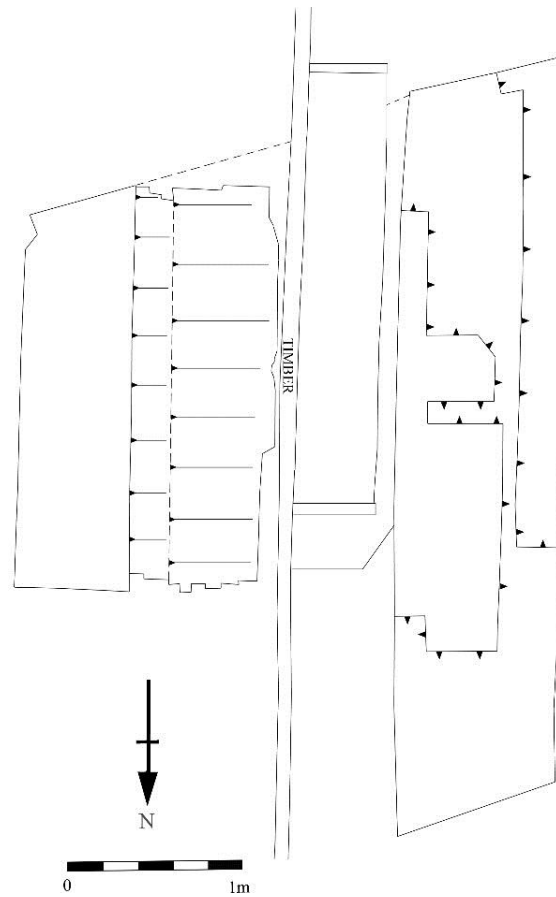
Figure 5: Plan of eastern bank. Original drawn at 1:20

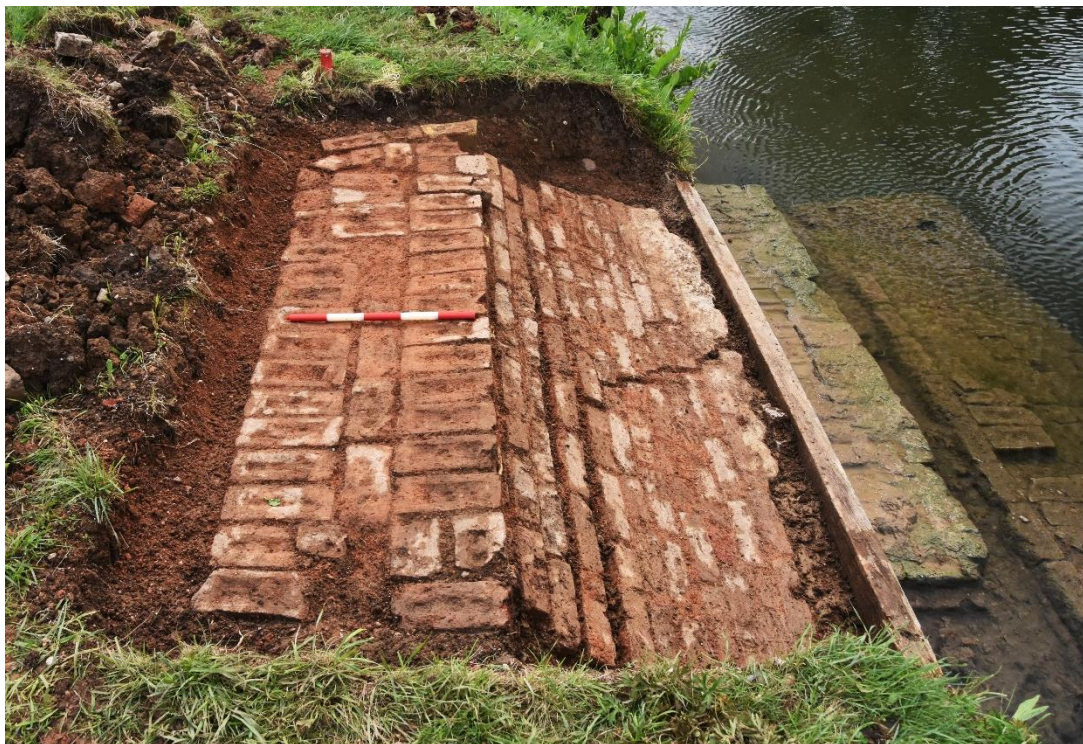
Figure 6: Landward portion of eastern footings. Looking S, scale 0.5m

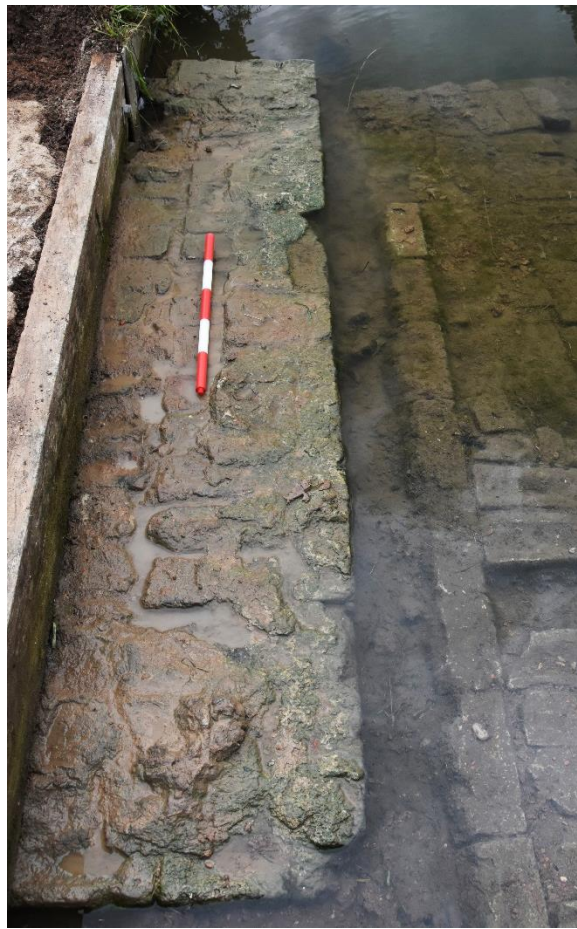
7.2.2 The waterside section appeared to have been laid in two phases, with an upper and lower block of bricks. As this section was underwater it was more difficult to record in detail. The upper block of red bricks were arranged in a mix of headers and stretchers, bonded with a thick, very compact white lime mortar (fig. 7). It measured 0.46m E-W and 2.58m N-S. These bricks were frogged, and the lower two courses were stepped out. Below this was a larger red brick platform, arranged with a mixture of headers and stretchers, and bonded by the same very compact, thick, white lime mortar. It measured 0.9m E-W and 4.12m N-S, and was approximately 0.85m tall measured from the base of the river (fig. 8). The edges of this earlier phase were angled NE-SW, similar to the alignment of the original bridge for Lascotts Road. The total number of courses was not visible, however the lower three were stepped out. The bricks were again frogged and at least one of the brick samples from the waterside section was stamped 'S', indicating that they were likely laid at the same time as the landward section.

Figure 7: Upper block of waterside bricks in eastern bank. Looking S, scale 0.5m

7.4.2 There is also little evidence of the replacement of this road bridge with a footbridge in the 1890s. It is possible that the apparent second phase of brickwork on the waterside of the eastern bank is related to this reconfiguration of the bridge but again it has not been verified. The slight overlap of this later phase of masonry displayed on the

southern side of the waterside would indicate that it was built later than the majority of the footings on this side- though for what reason is unknown.

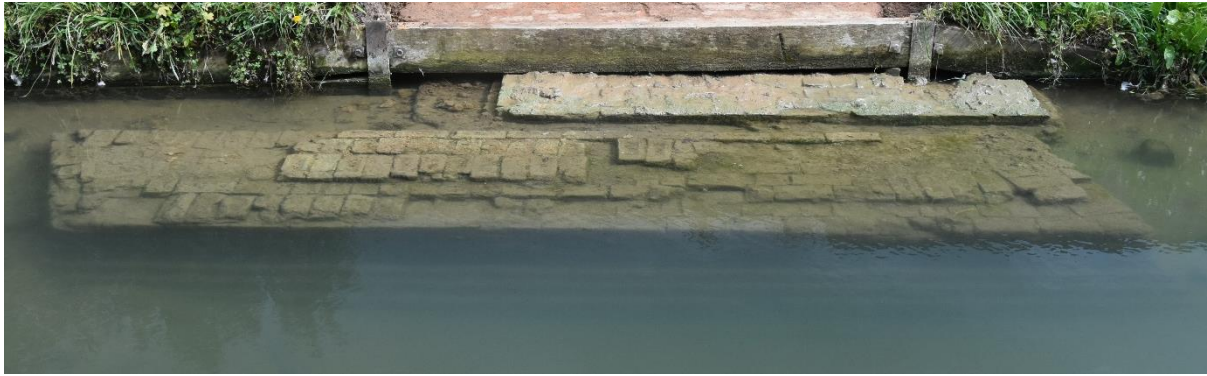
Figure 8: Lower block of waterside bricks in eastern bank. Looking E, no scale. Note three stepped courses visible at base of block.

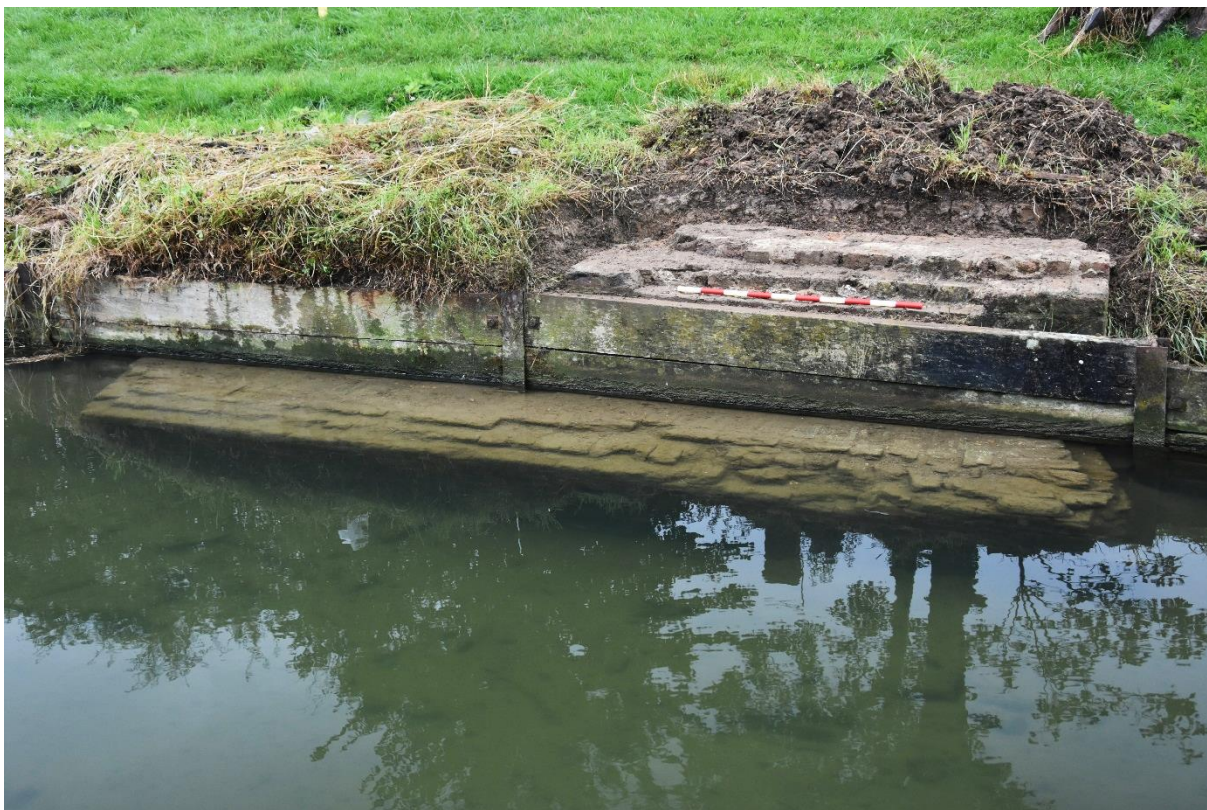
Figure 9: Overall view of footings on western bank. Looking SW, scale 1m

- 7.3.1** The footings on the western bank also comprised a landward section and a waterside section (figs. 9 & 10). The landside section comprised a rectangular block of red brick bonded with a very compact, thick off-white lime mortar in alternating stretchers and headers, though this was somewhat obscured by the mortar (fig. 11). There was evidence of the same orange mortar seen on the eastern bank on the brick samples, underlying the lime mortar. This upper section measured 0.76m N-S and 0.7m E-W with 7 visible courses, c.0.51m tall. The bricks were shallowly frogged as on the eastern bank, but there was no evidence of any maker's stamp. The block was bounded to the east by the timber wharfing along the riverbank and appeared to sit on the top of the waterside masonry.

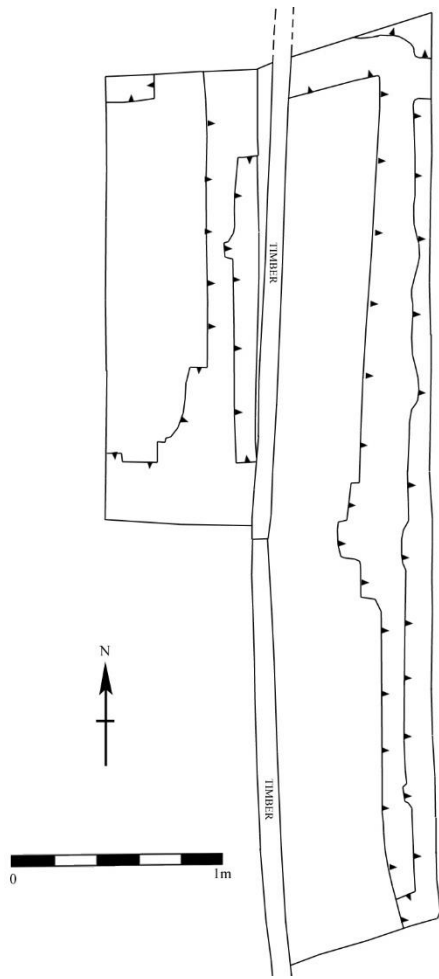
Figure 10: Plan of the western bank footings. Original drawn at 1:20

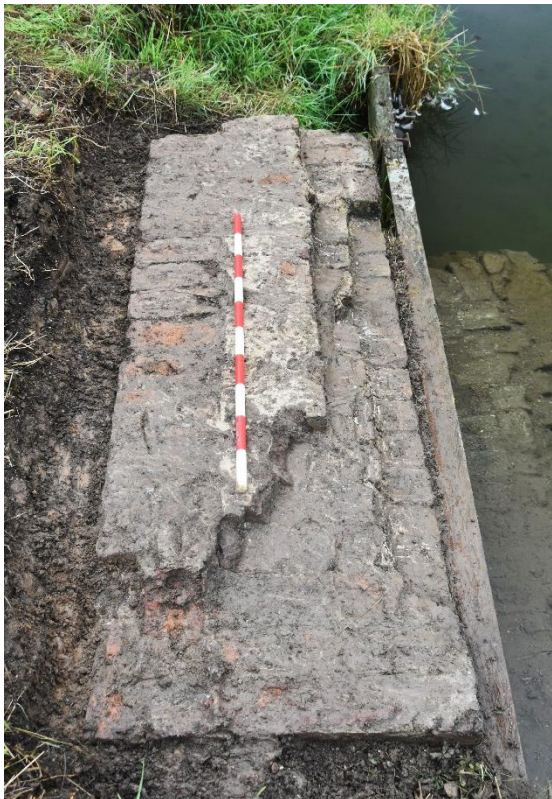
Figure 11: Landward masonry block on western bank. Looking N, scale 1m

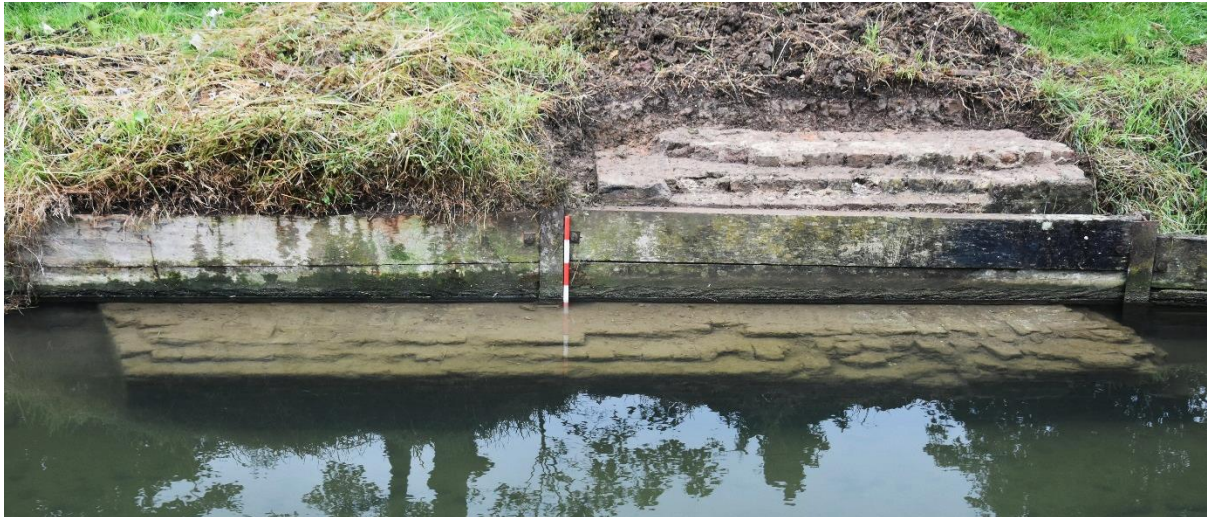
7.3.2 The waterside masonry on the western bank appeared to comprise a single phase of construction. It comprised red brick arranged in alternating headers and stretchers bonded with a thick, white to light-brown mortar with no evidence of the orange mortar seen elsewhere in the footings. It measured 4.26m N-S and 0.68m E-W with 7-8 visible courses, c. 0.65m tall. The masonry was shaped like a parallelogram, orientated NE-SW (fig. 12) along the same alignment as Lascotts Road and the waterside footings on the eastern bank. Some bricks in the upper courses were missing, and many had a coating of green algae on the outer faces. There was no evidence on this side that the bricks were stepped out at the base.

Figure 12: Waterside brick in western bank. Looking W, scale 0.5m

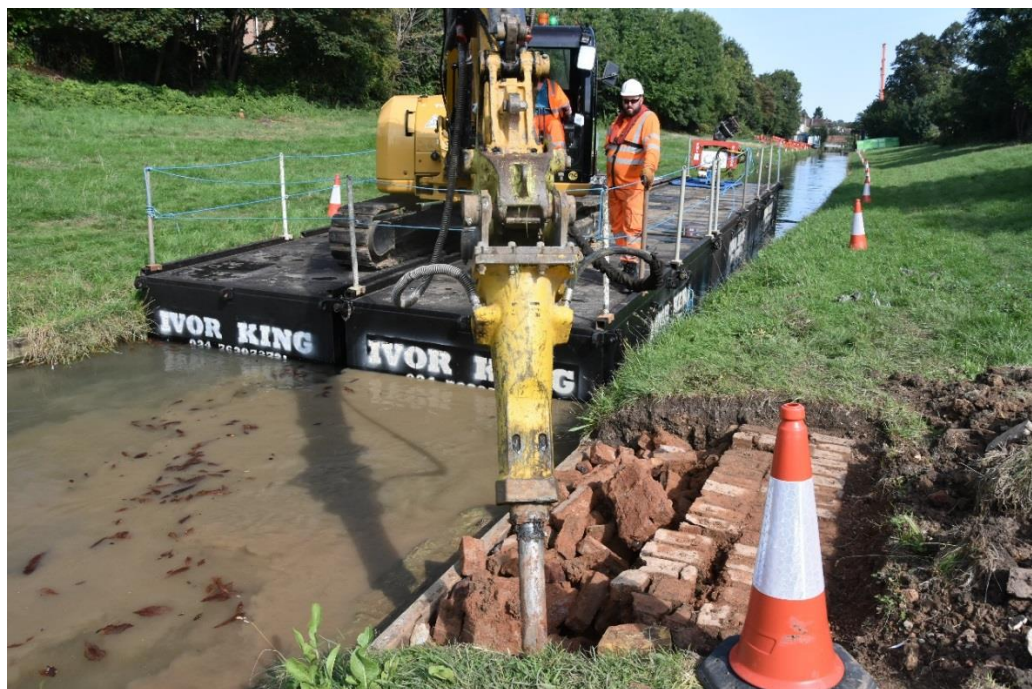
8.1 The footings were removed between 30th August and 9th October 2018. They were removed via machine fitted with a mechanical breaker to first break up the structure into more manageable chunks, which were then lifted out with a toothless bucket (fig. 13). The strength of the mortar used in some areas of the footings, particularly on the western bank and the waterside sections of both banks meant that this process took longer than initially thought. High noise levels which disturbed the bats living in the tunnel to the south also created delays during this process.

Figure 13: Working shot breaking up the landward section of the east bank. Facing NW, no scale.

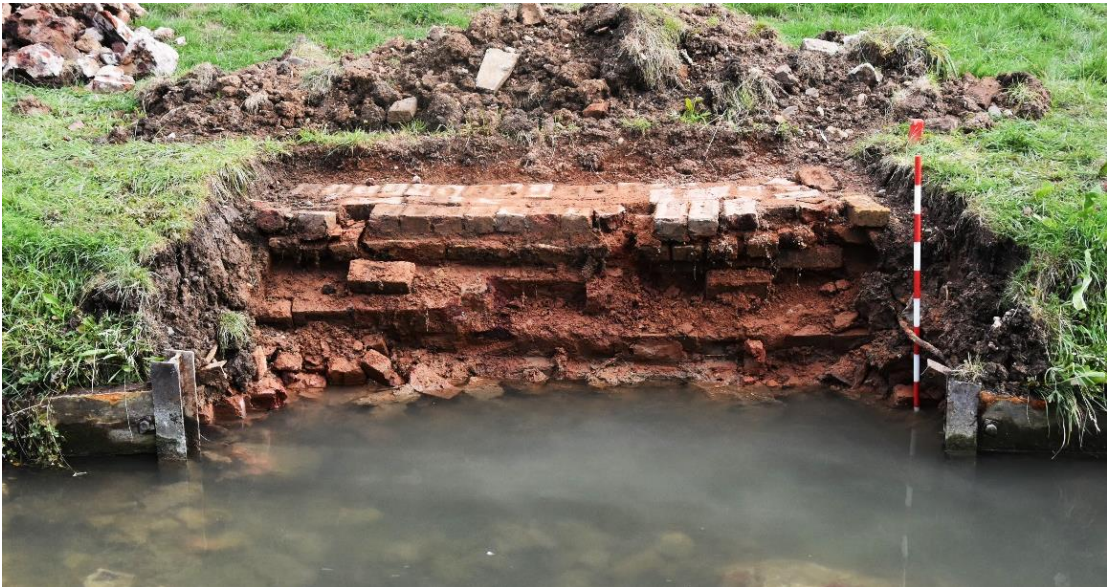
- 8.2.1 The eastern footings were removed first, with the landward portion broken out easily. This removal revealed that the cambered area was facing for additional courses of brick beneath the top section (fig. 14). The pontoon on which the machine sat and the breaking action stirred up a great deal of silt in the river, making it very difficult to see beneath the water. Nothing unexpected was revealed during the removal of the footings on the eastern bank.

Figure 14: Eastern footing, mid-removal. Facing E, scale 1m

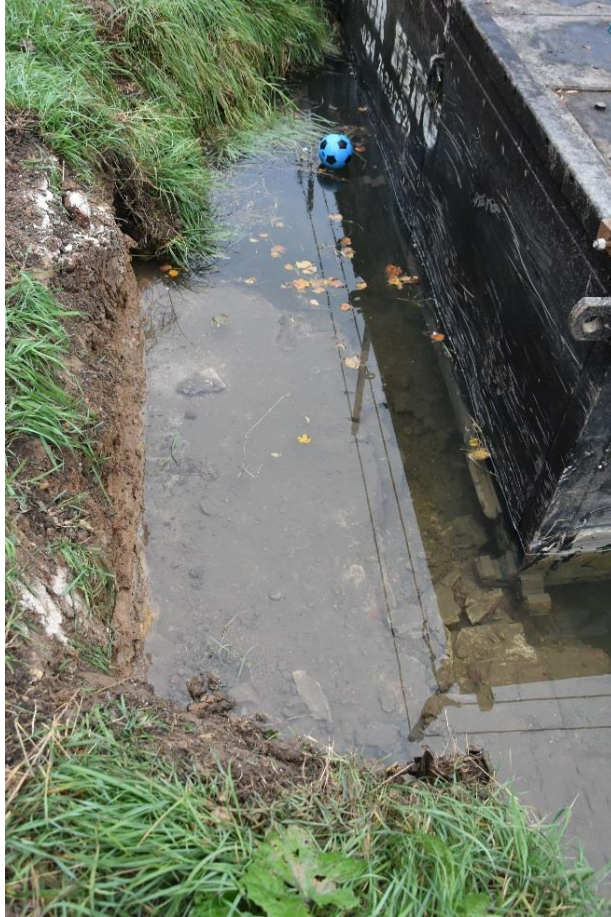
- 8.3.1 The landward brick structure on the western bank was very firmly mortared together. The mechanical breaker failed to break it up and it was lifted out in one piece. After its removal it became clear that the waterside structure continued beneath the landside masonry, and potentially into the riverbank itself (fig. 15).

Figure 15: Western footing, post landside portion removal. Looking N, no scale.

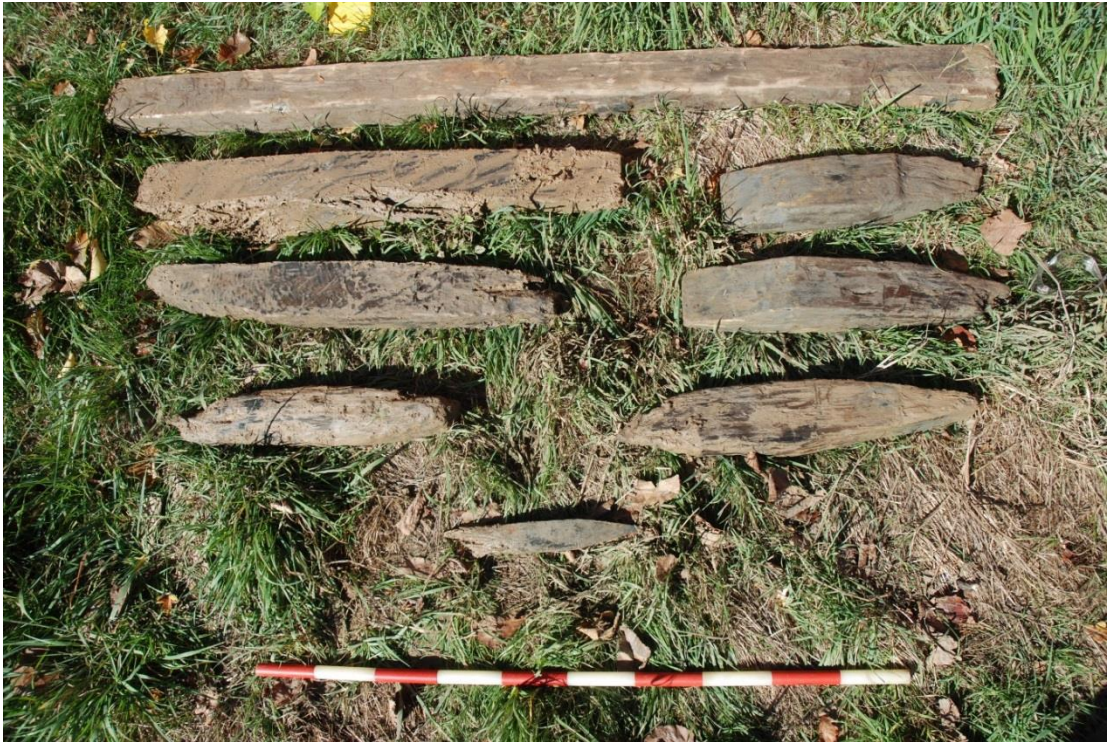
- 8.4** As the silt was stirred up in the river it was impossible to see the base, relying instead on what the machine brought up. Several medium and large timbers were encountered (fig. 16; Appendix III) though their origin and use cannot be identified. The materials list in the 1858, Contract 15 does not specify timbers, though mention is made of ‘lineal fixing only River Railing as before’, which may indicate the riverbank was fenced off and these timbers are remnants of that. The tapering ends of the majority of the timbers would imply that they were used as fence posts. It is also possible that they were employed as scaffolding during the construction of the bridge, and after completion were abandoned in the riverbed.

Figure 16: Timbers found in the New River. Scale 1m.

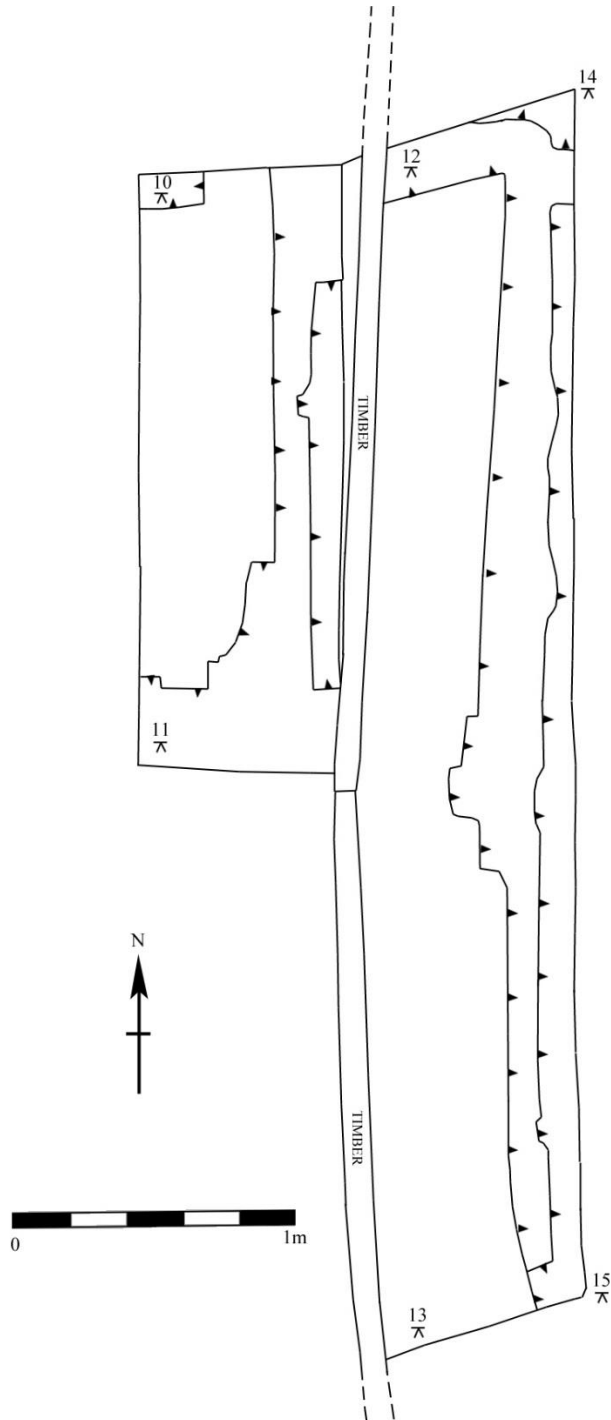
Bank	Number	Reduced mOD	Description
West	10	30.99	N end landward
	11	31.05	S end landward
	12	30.31	N end waterside
	13	30.35	S end waterside
	14	29.91	N end, base of waterside section
	15	30.15	S end, base of waterside section

Figure 18: Plan of west bank footings with location of levels

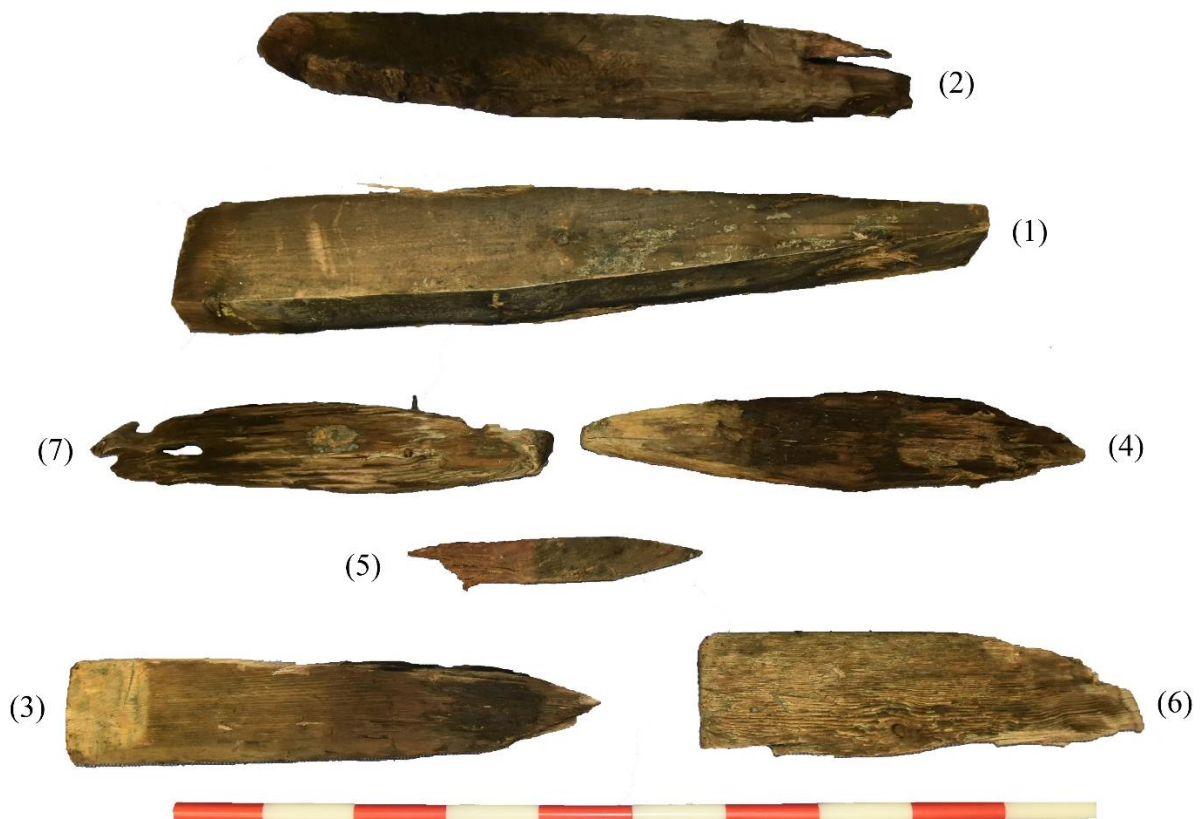
All the timbers bar one were cut from soft wood; timber 2 was made of oak, and some were better preserved than others. Several had nails or metal pins in them, and most were tapered at one end. The timbers were drawn and photographed, listed below. All drawings are not to scale and all measurements listed are in mm.

Figure 19: Timber group found in the riverbed. Numbers correspond to drawings below. Scale 1m
