ALDGATE HIGHWAY CHANGES AND PUBLIC REALM PROJECT, CITY OF LONDON EC3A

An Archaeological Assessment Report

Site code: DKE13

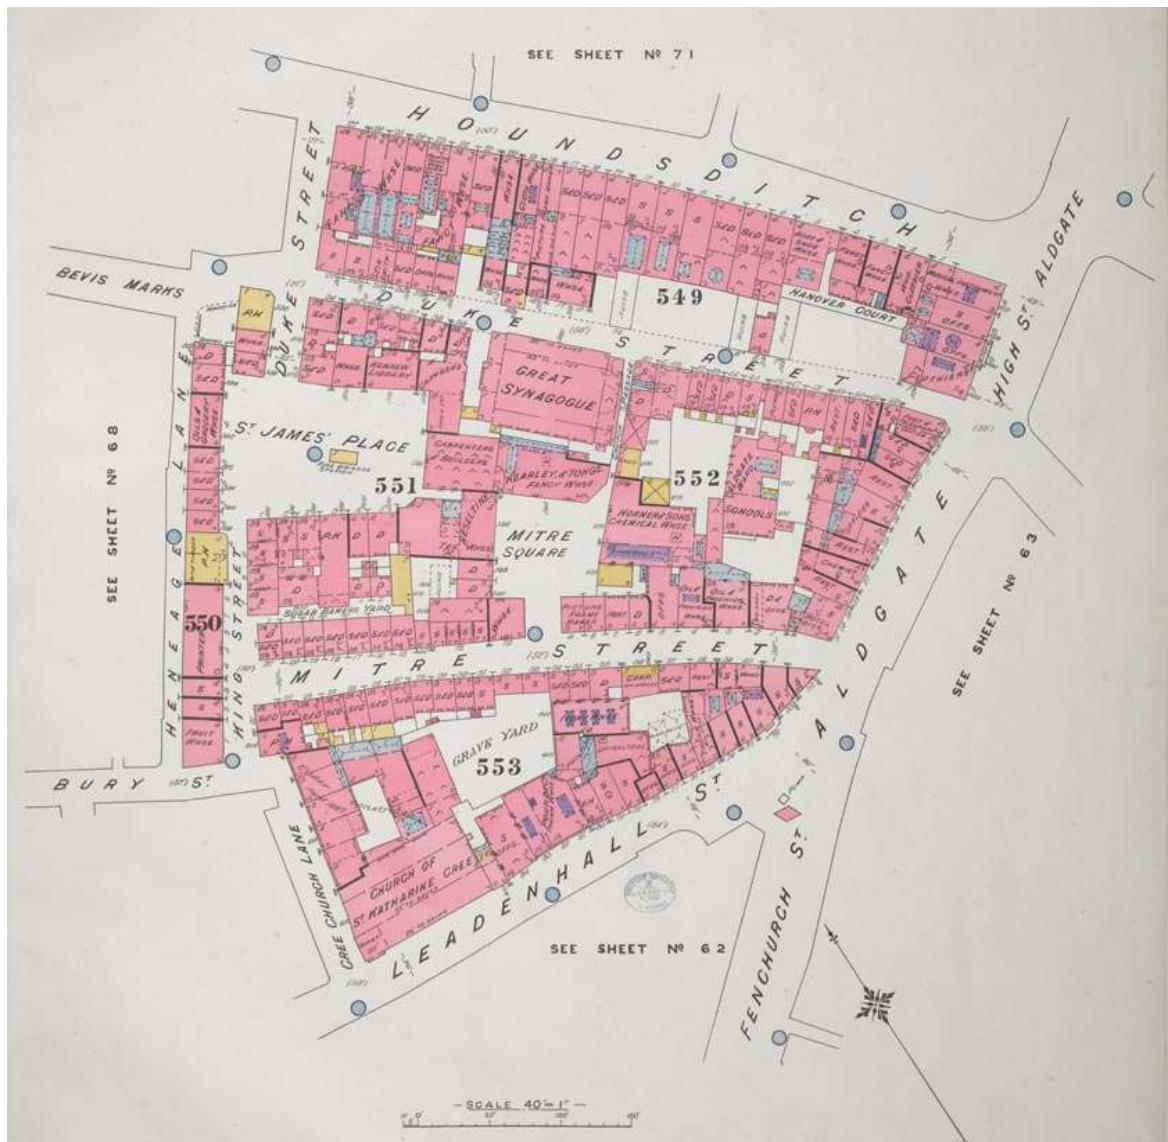
Figure 9: Extract from Goad's Insurance Plan vol.III sheet 69 (1887) showing the development between Houndsditch and Duke Street.

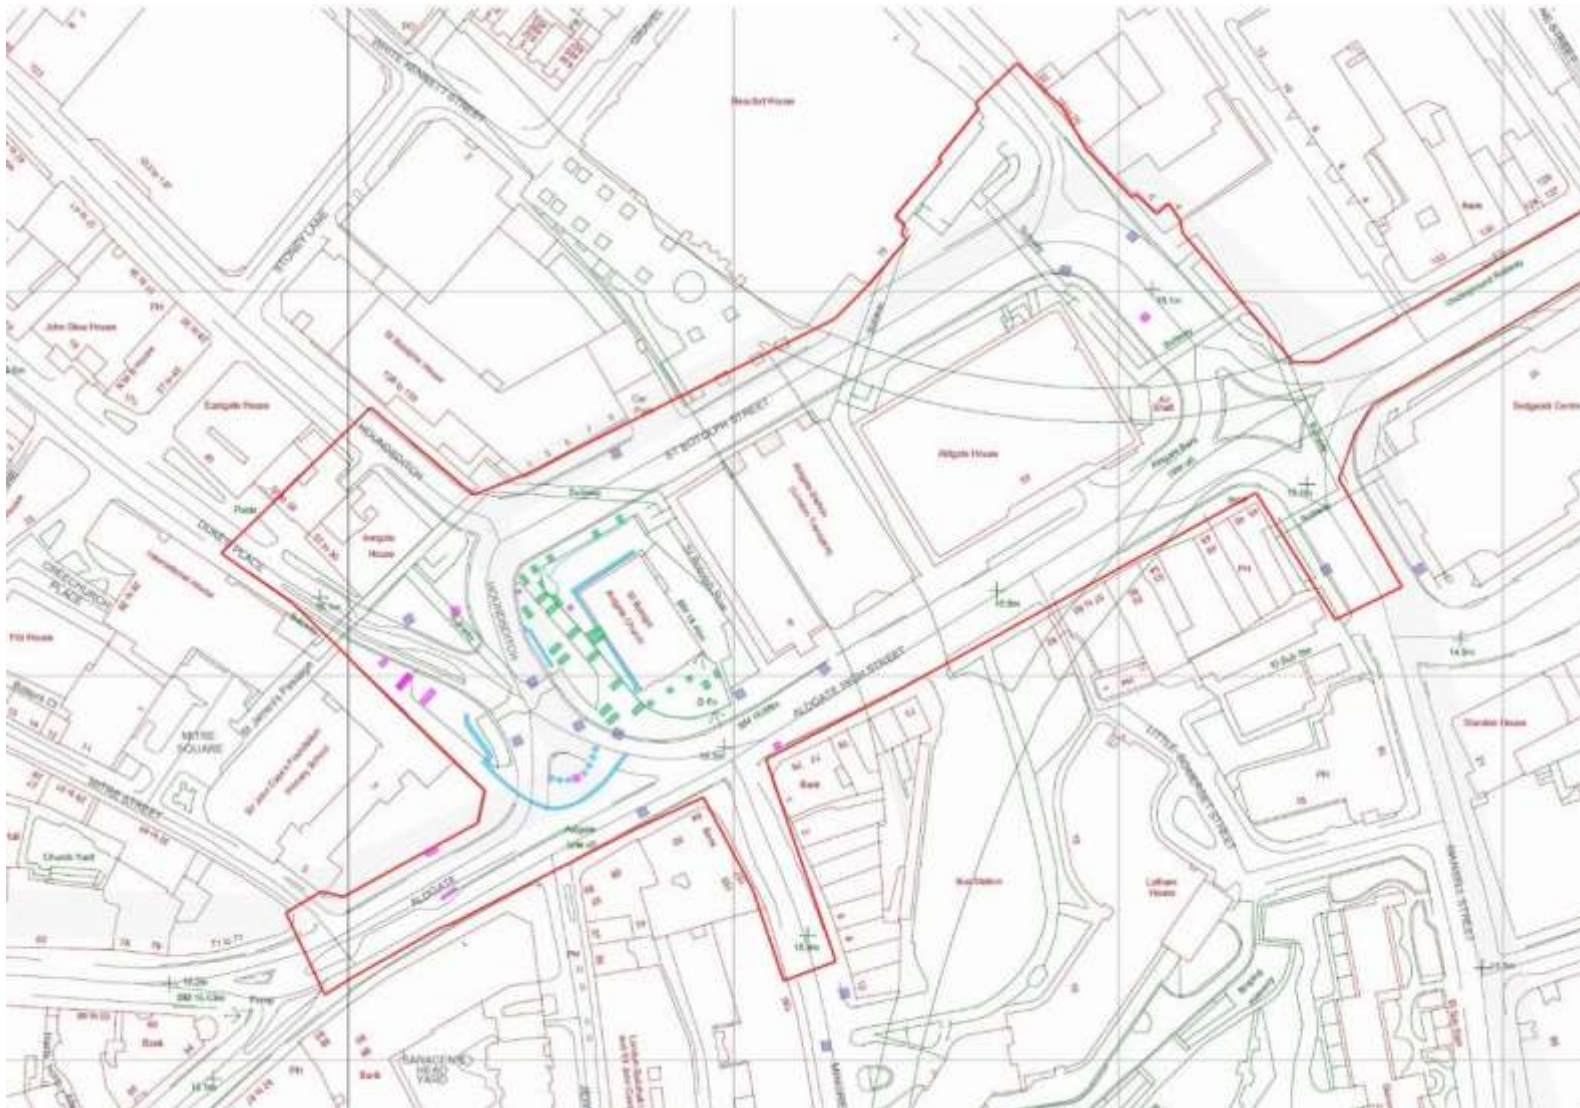
Figure 11: Plan showing the major groundworks undertaken between 2013 and 2018. Key: purple = dropshafts; pink = Compass Archaeology evaluation trenches; green = Trial pits; and blue = drainage / water works and landscaping. Many of the areas were re-excavated on several occasions.

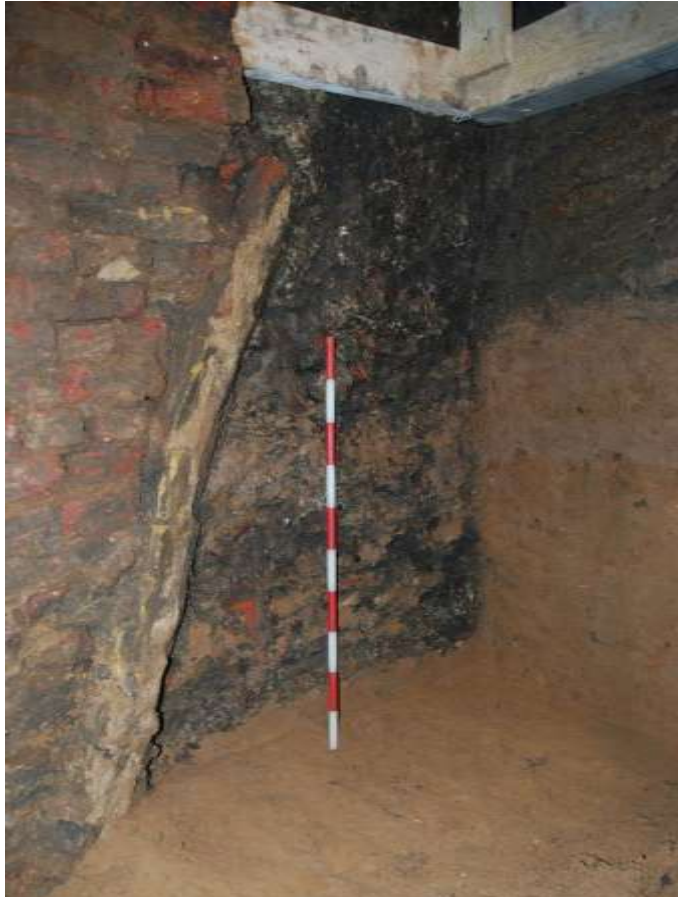
Figure 13: Dropshaft 3: natural brickearth (270) seen to the right of W[264] and concrete (283). Facing NW, scale 1m.

7.2.2 The natural geology comprised a sequence of mottled orange-brown brickearth (42), (77), (127), (246), and (274) over a thin interface of green-yellow sand (172) and (297), above well compacted sand and gravels (173), (270) (284) and (287) (figs.13-15).

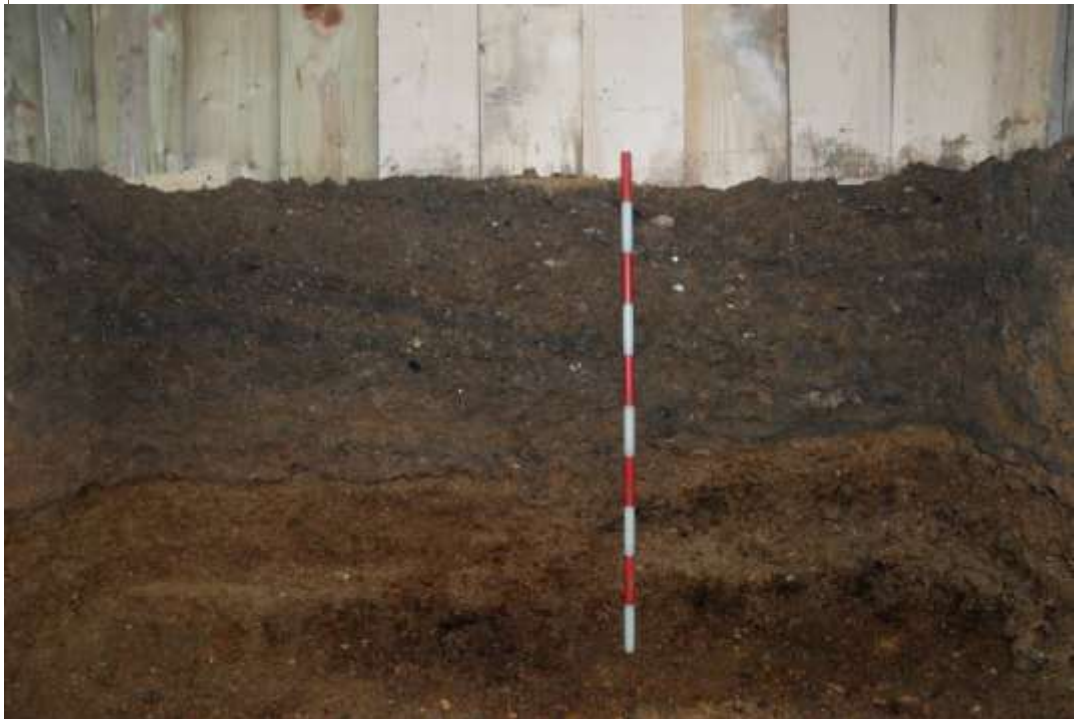
Figure 14: Dropshaft 5: Natural gravels (284) below (283), observed at the dropshaft base at c8.4mOD. Facing W, scale 1m.

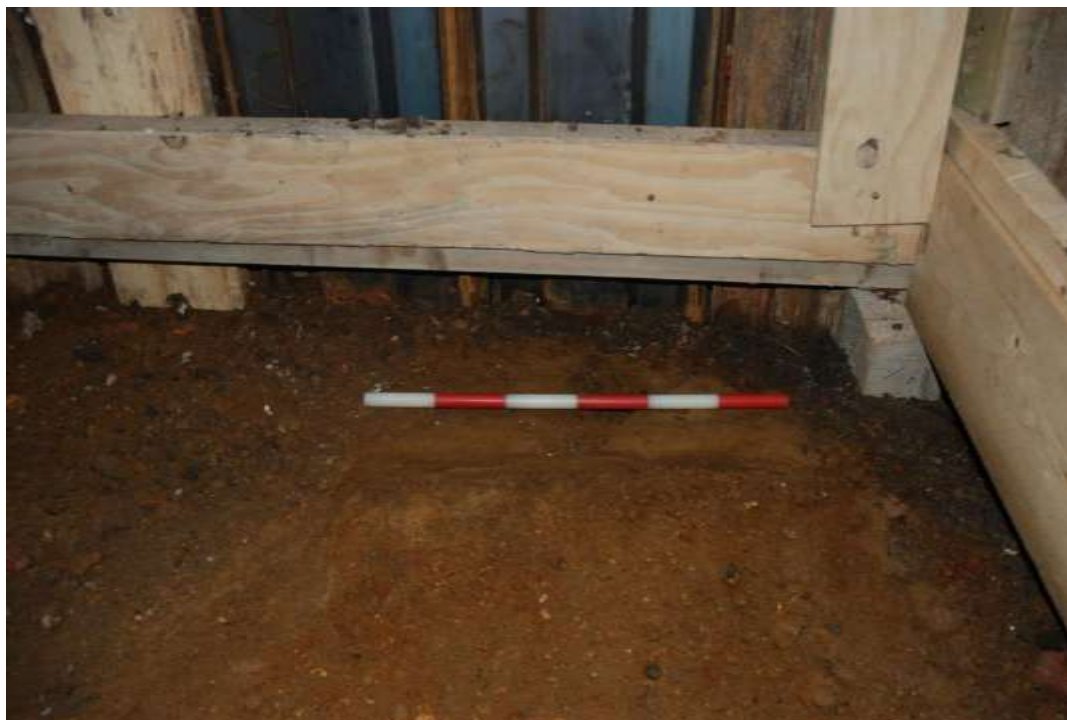
Figure 15: Dropshaft 16: Thin sequence showing natural sand (172) overlying natural orange gravels (173). Facing N, scale 0.5m.

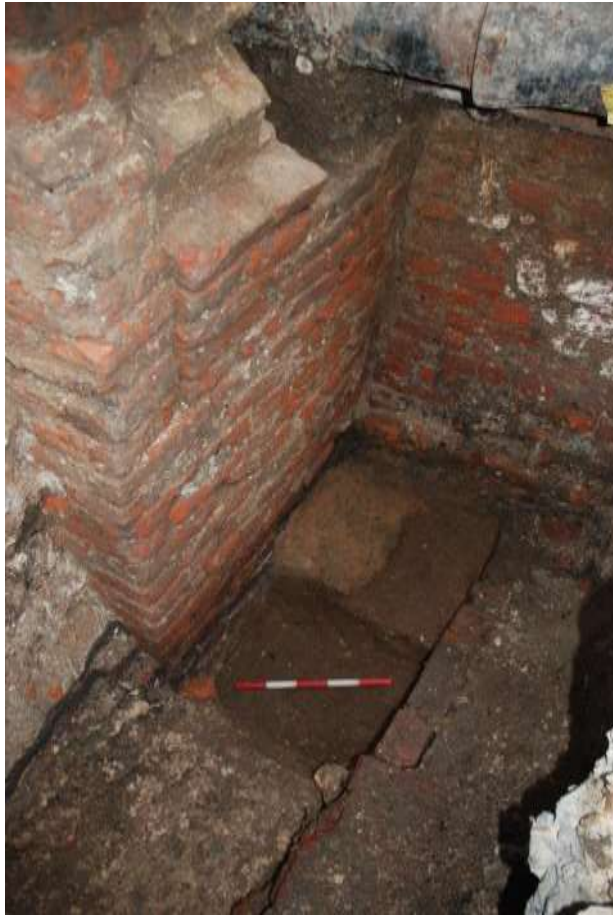
Figure 17: Remnants of the City wall [15] seen in the bottom left of frame. The scale rests within the robber / construction cut for the feature, and adjacent to Roman deposit (16), seen towards the corner of the post-medieval brick cellar. Facing SW, scale 0.5m.

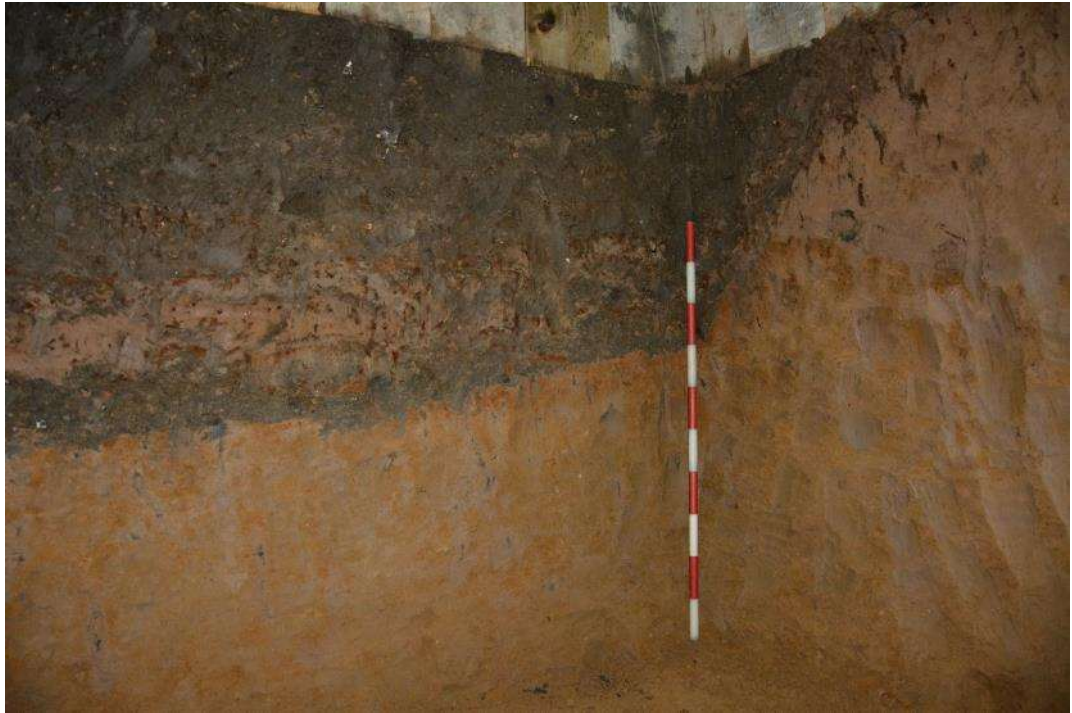
Figure 18: Dropshaft 11: Section of the eastern part of the Roman City ditch [39] / (40) and (41), cutting into the natural orange brickearth (42). Facing NW. Scale 1m.

- 7.3.3** The City wall was complemented by a section of the associated City ditch, observed in dropshaft 11, undertaken in January 2016. The feature comprised a linear cut [39] observed in plan and in the south, west and north sections at a depth of 4.25m (11.82mOD) (figs.18-19). The cut ran on a north-south alignment, with moderately steep east-west sloping sides terminating at a horizontal base. In total the observable section measured 0.6-0.8m in depth. The upper part of the ditch was filled by a relatively well compacted mid to dark grey silt abundant with small stones, charcoal flecks, gravel and occasional patches of redeposited brickearth (40), measuring 350-500mm in thickness. This overlay a band of mid to dark grey silt commingled with mottled orange redeposited brickearth containing frequent flecks of sand (41), measuring 200mm in thickness. The base of the ditch was encountered at 11.22mOD – 11.07mOD. Three fragments of Roman CBM were recovered from this context, two of which are taken to be fragments of tegula and imbrex roof tile².

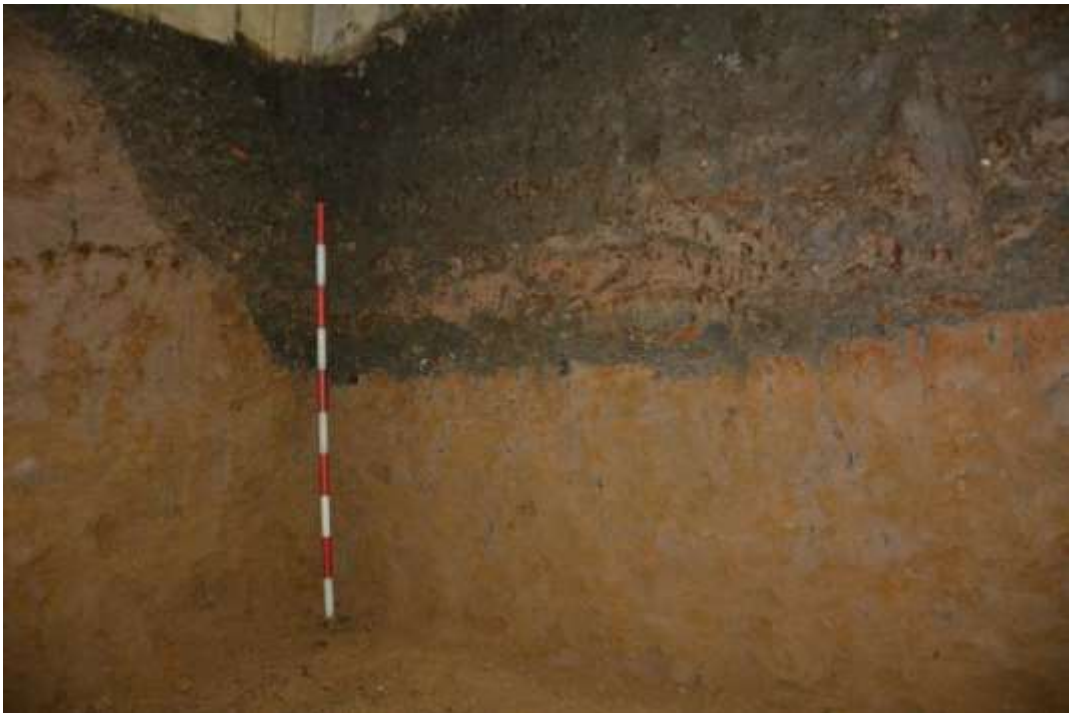
Figure 19: Dropshaft 11: Roman City ditch [39] / (40) and (41). The lighter band of redeposited brickearth (41) is visible to the right of the scale. Facing SW, scale 1m.

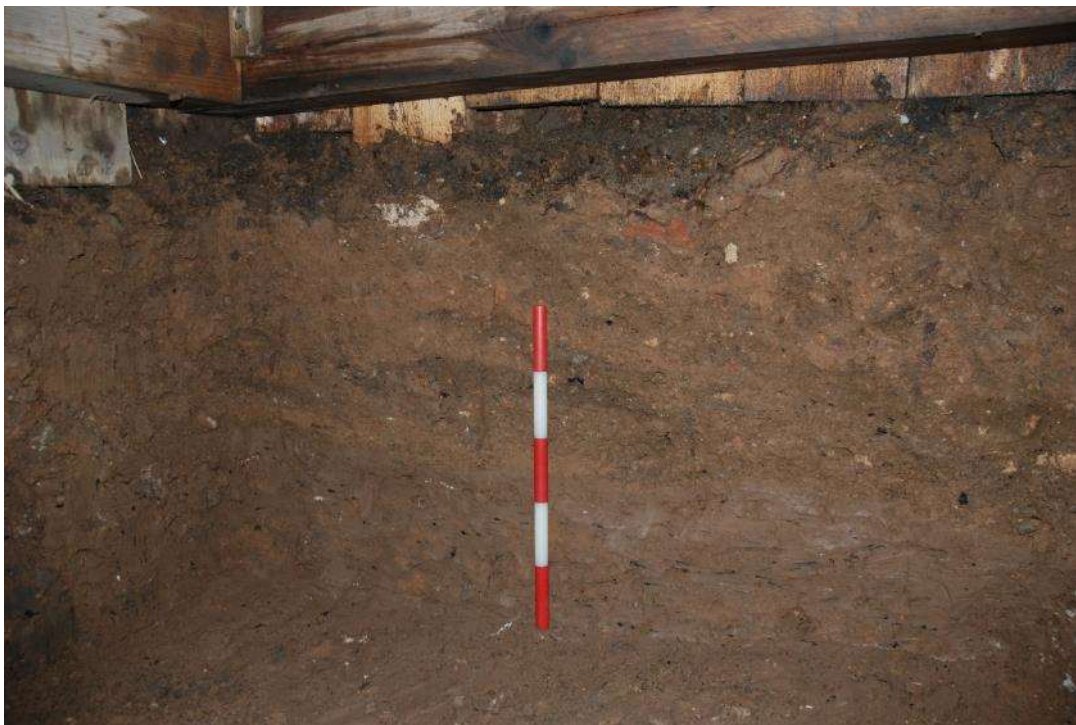
Figure 20: Dropshaft 1: Roman backfill layers (244) (top) and (245) (bottom). Facing approximately S, scale 0.5m

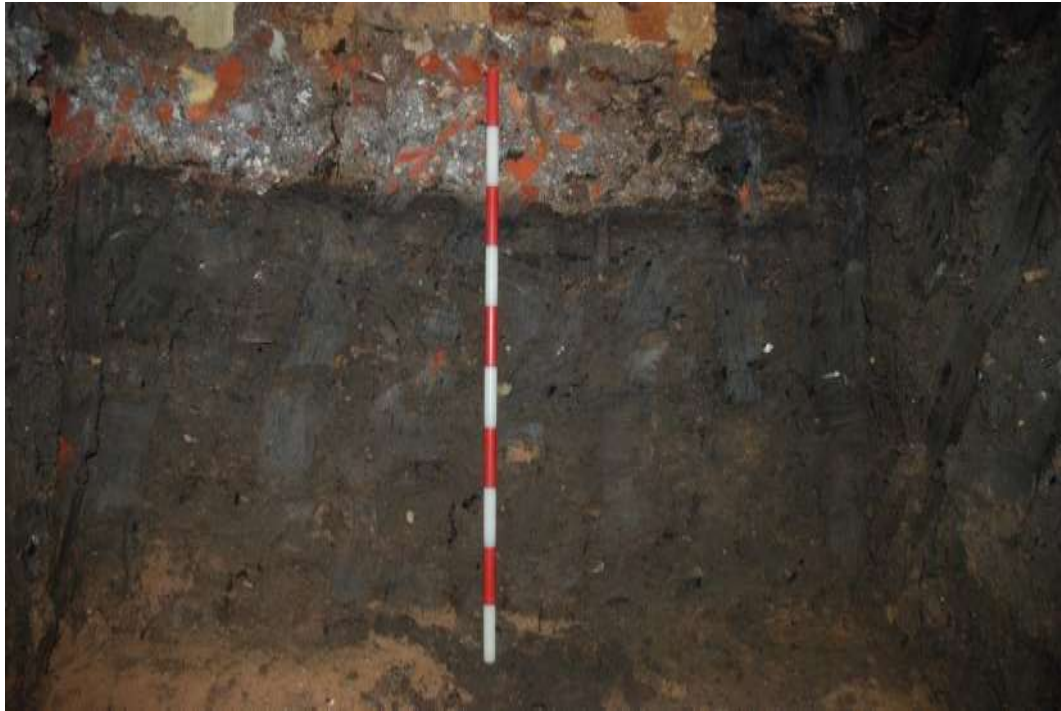
Figure 21: Dropshaft 4: Possible truncated pit [273] observed in the western section, filled by a dark brown silt with frequent charcoal flecks. Facing W, scale 1m.

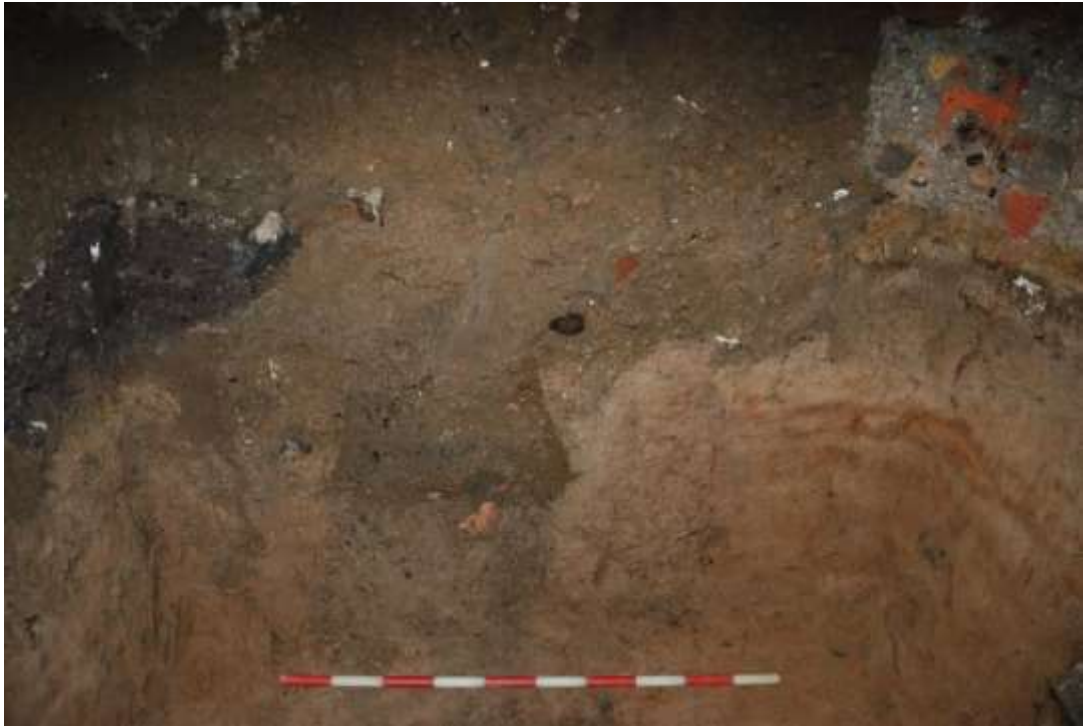
Figure 22: Dropshaft 15: Roman deposit (125) overlying and cutting into the natural brickearth (127), with a later pit [124] cutting into it, filled by dark brown-black silt (126), seen to the left of frame. Facing E, scale 1m.

- 7.3.8** Context (125), observed at a depth of 2.75m (13.25mOD) beneath a post-medieval floor in dropshaft 15, located adjacent to the Dorsett Hotel, comprised a greenish-grey silty layer abundant with charcoal flecks, stones, fragments of CBM and a substantial quantity of Roman pottery predominantly dated to the 1st and 2nd century AD. This was subsequently truncated by a later Roman pit [124], and backfilled with a very dark brown-black silt containing frequent flecks and fragments of charcoal and oyster shell (126), probably the discarded remains of a small cooking fire, overlain by a darker green-brown silt. Pottery from (126) dated predominantly to the 2nd to 4th centuries (fig.22). These intercutting pits demonstrate the area was used over a prolonged period, and revisited and repurposed as required.

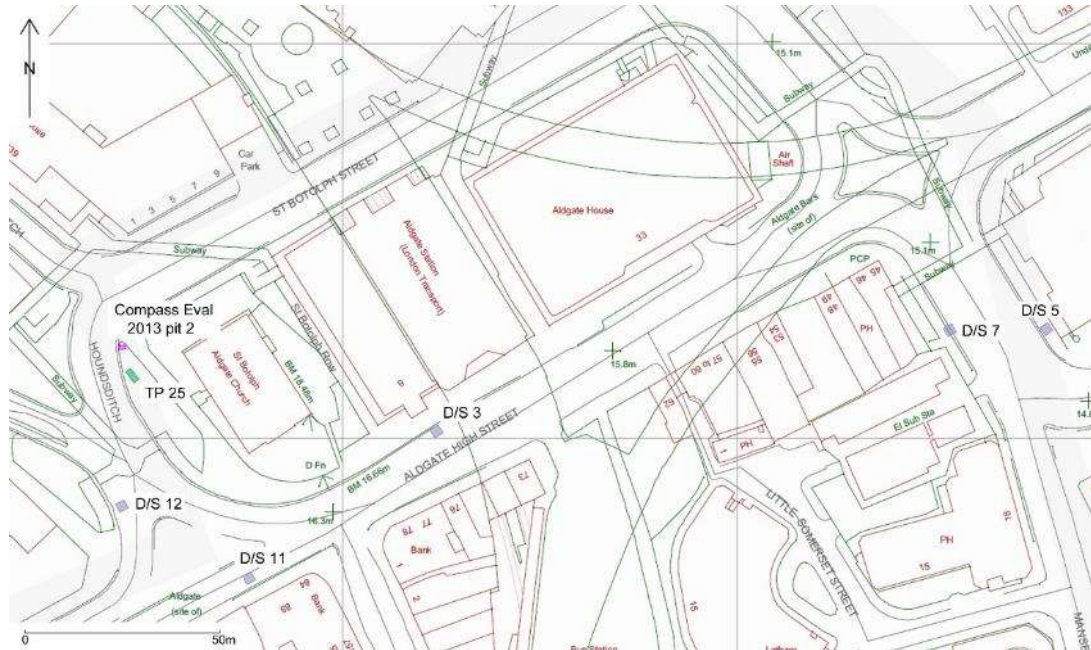
Figure 23: Plan of trenches in which medieval finds and features were encountered.

7.4.1 Following the withdrawal of a Roman presence in Britain in the 4th century AD the City ditch and wall continued to be maintained, although multiple recuts to create a wider, flatter profile indicate it was used less as a fortification, but more of a boundary / rubbish tip. Medieval finds and features of archaeological interest were recorded in seven trenches (fig.23).

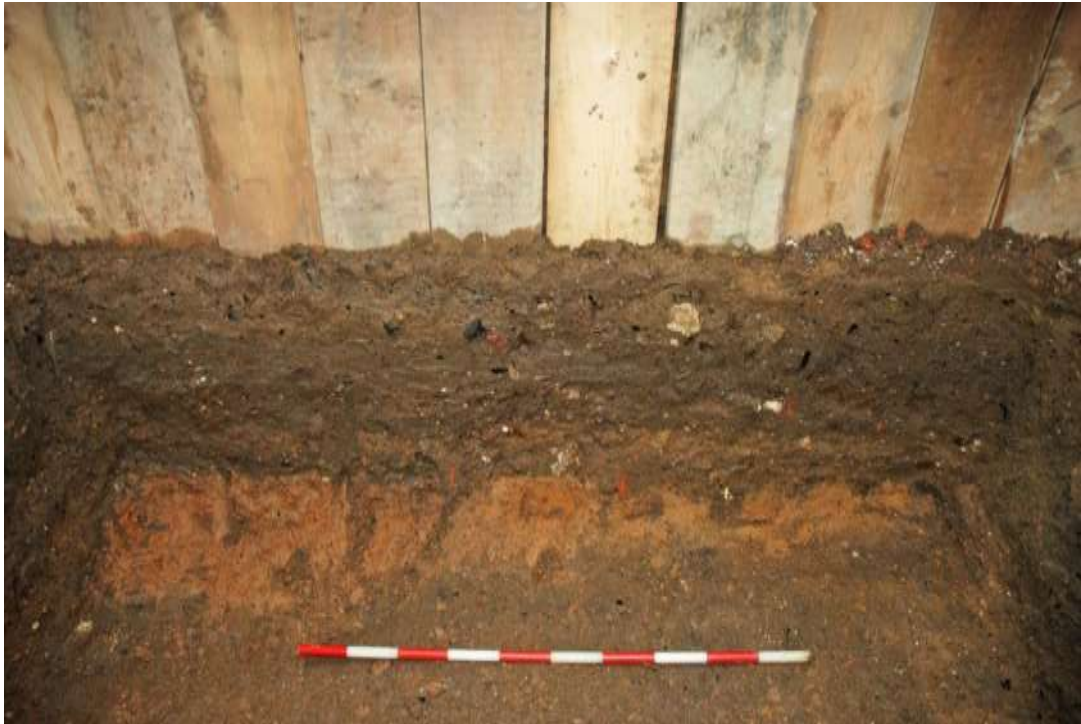
Figure 24: Dropshaft 12: City ditch [75] / (76) seen on the trench base cutting through the natural brickearth (77), overlain by later fills. Facing W, scale 1m.

7.4.2 The second section of City ditch, [75], observed in dropshaft 12 was filled by a homogenous deposit of moderately compact, wet, dark greenish silt containing infrequent small flecks of charcoal (76), recorded in plan at the level of excavation at 4.85m (10.96mOD) (fig.24). A quantity of animal bone was recovered, along with several fragments of pottery dated to the medieval period and a lead token. A residual Roman coin of Constantinian 'Fallen Horseman' type, dated cAD355-65 was also recovered³ (fig.25).

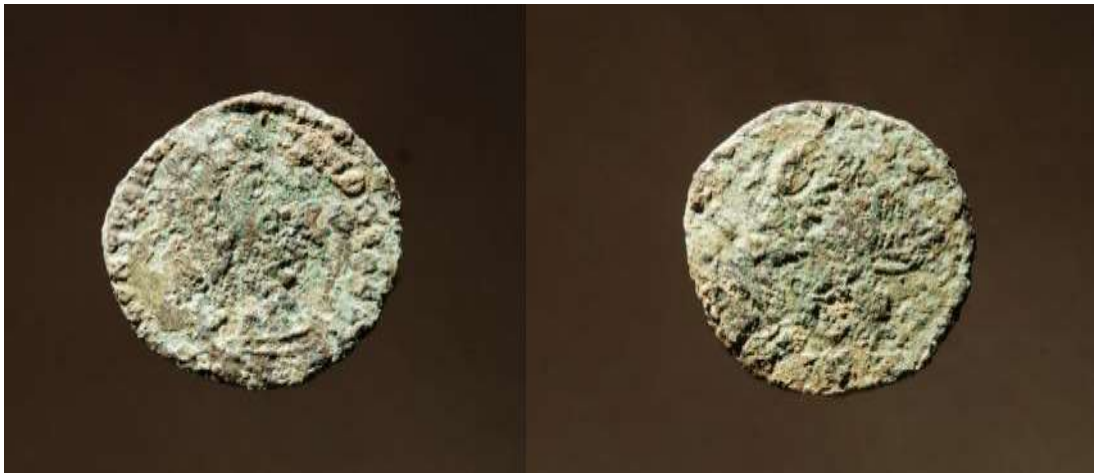
Figure 25: 'Fallen Horseman' Roman coin recovered from the ditch fill (76). No scale.

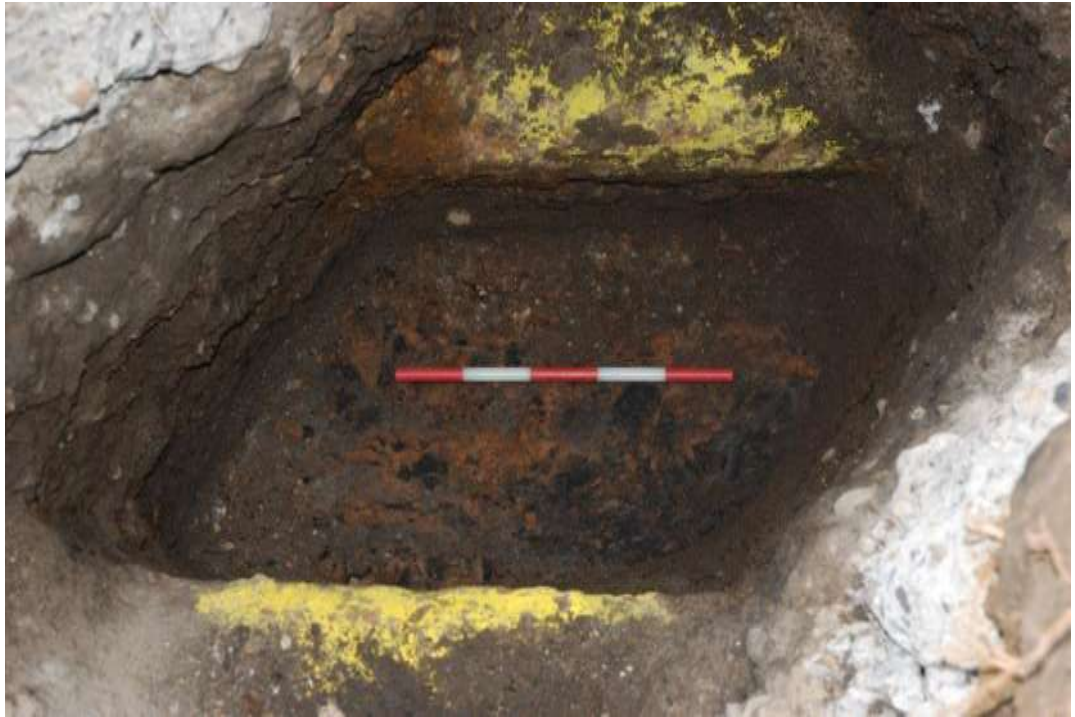
Figure 26: Probable road make up (18) overlain by a thin lens of gravel (19). Facing W, scale 0.5m.

- 7.4.3** A group of similar deposits were recorded on the eastern side of the Aldgate open space. Contexts (18), (38) and (238) comprised a well-compacted layer of burnt daub, charcoal and crushed CBM, varying in thickness between 200mm and 600mm. The layer had a relatively smooth and level upper surface, encountered across the site at a depth of 1.35-1.55m below ground level (14.72mOD-14.39mOD). Contexts (18) and (238) were overlain by a thin layer of compacted gravel, perhaps representing original metalling (figs.26-27).

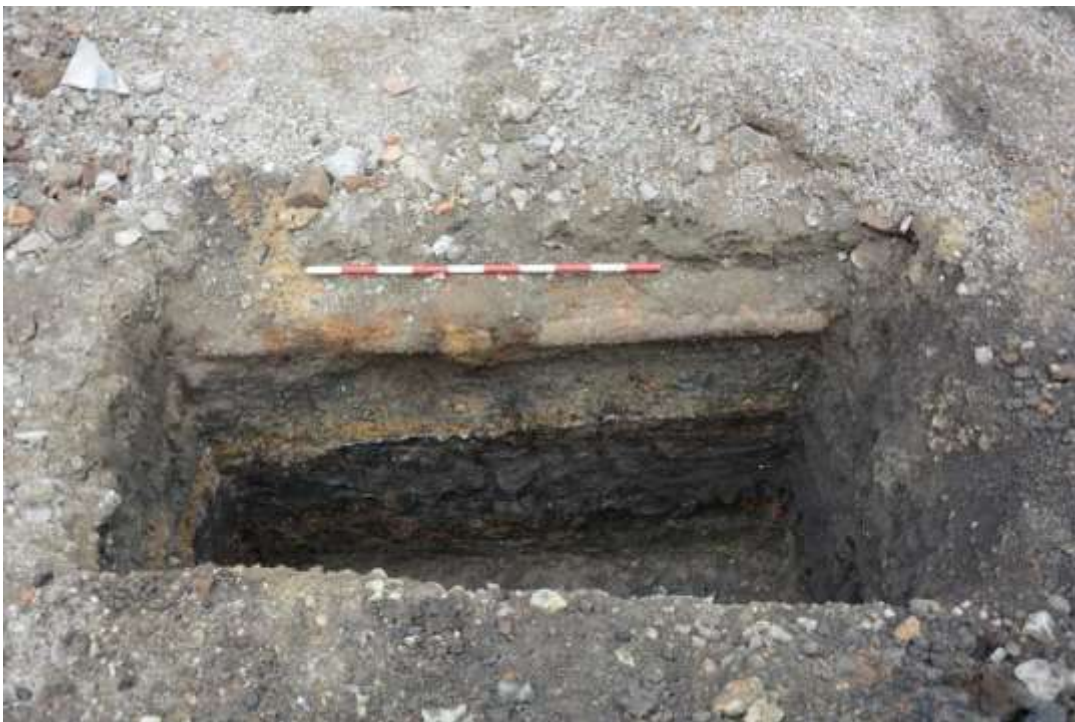
Figure 27: Section through the former road of Houndsditch (238) located to the west of St Botolph's Church. A thin lens of orange gravel, taken to be a metallised surface can be seen towards the left of the pit, over the blackened road make up. Facing E, scale 1m.

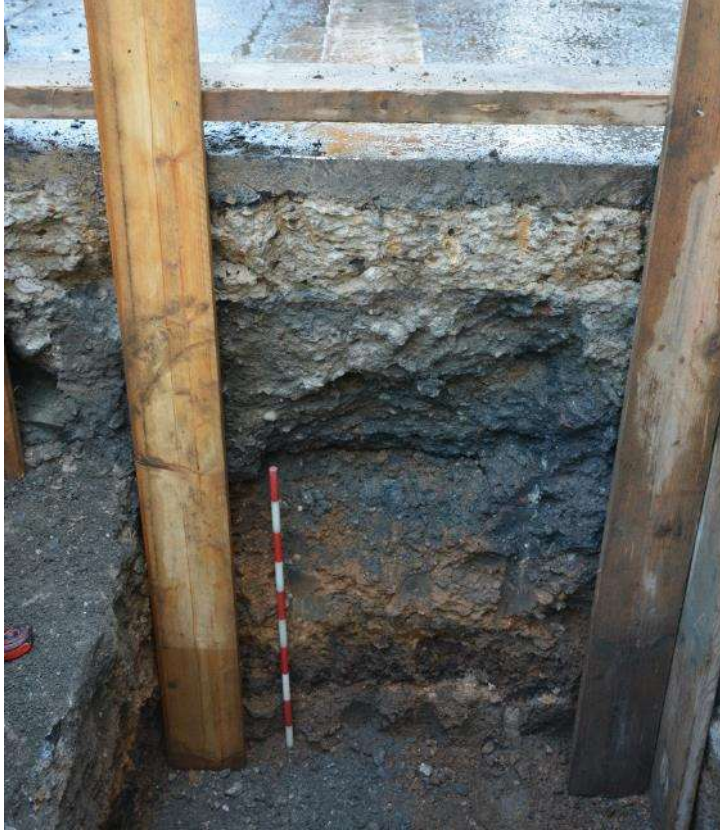
Figure 28: Dropshaft 11: A layer of burnt daub can be seen towards the limit of excavation, taken to be the continuation of the medieval Houndsditch. Facing E, scale 1m.

- 7.4.4** A more detailed section of this group was observed in dropshaft 11 at a depth of 1.35m (14.72mOD). The group (38) comprised 150mm of the compacted burnt daub layer over seven distinct bands of gravel of varying colour and composition. Each layer was level and uniform, varying in thickness between 100mm and 450mm in thickness, totalling 1.7m (figs.28-29).

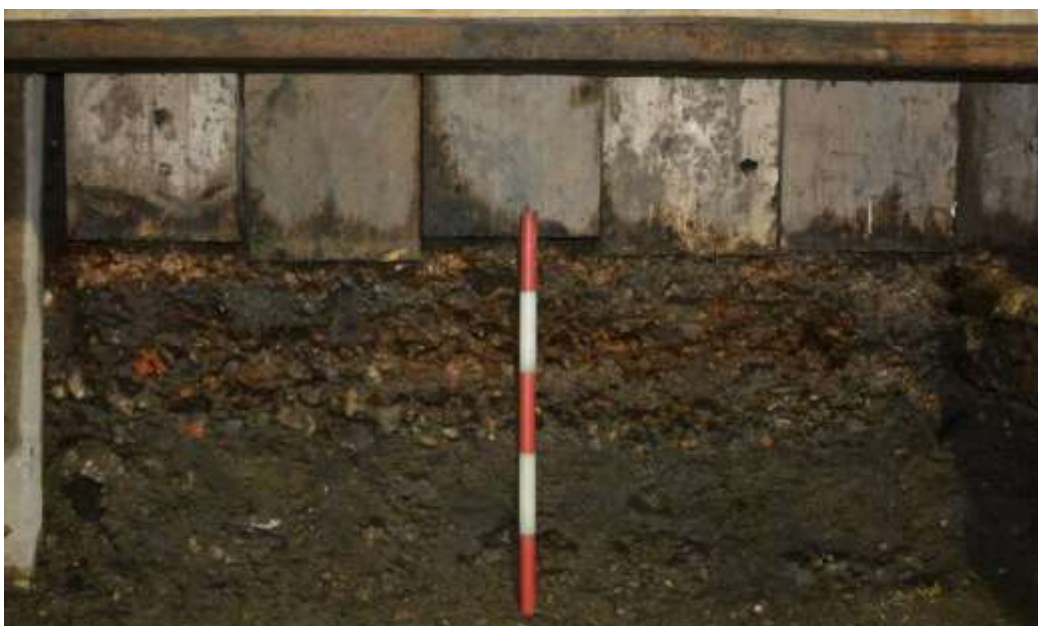
Figure 29: Dropshaft 11: Gravel bands seen at a depth of c2m. Facing E, scale 0.5m

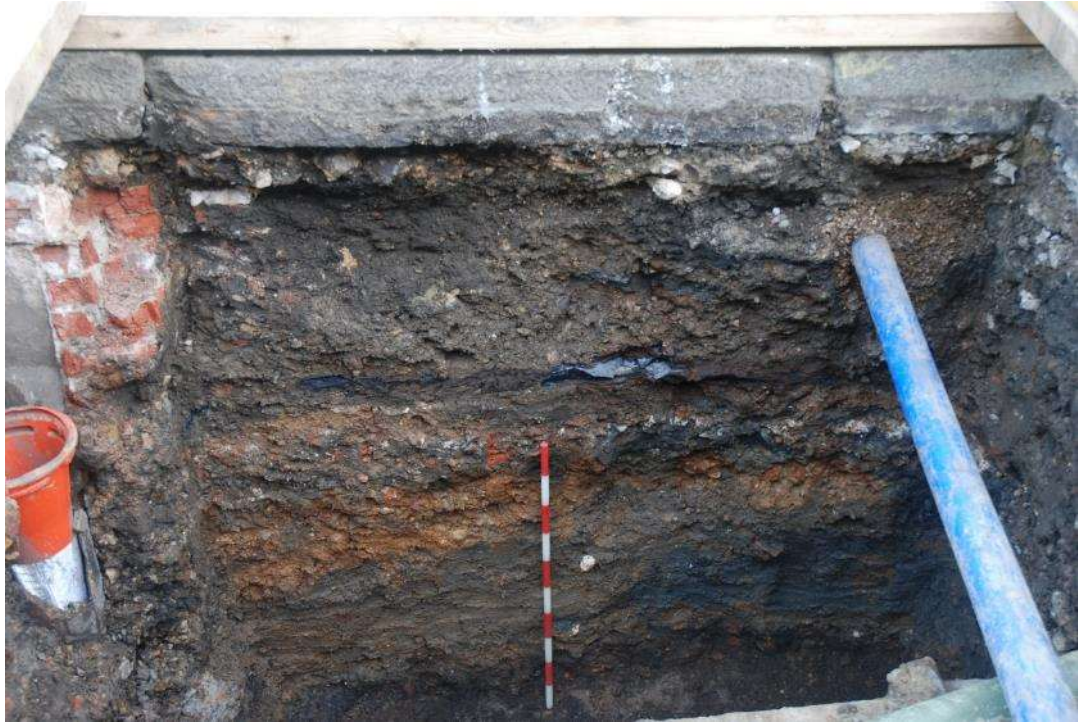
Figure 30: Dropshaft 3: upper part of the dropshaft showing a sequence of gravels and silts (262), (266), (267) and (269). The mottled black layer (268) seen at the base is likely to be a further continuation of the former line of Houndsditch. Facing S, scale 1m.

7.4.5 Several further medieval deposits were identified across the site including contexts (262)-(269), (281), (282), (294) and (295), which consisted of dark grey silty gravels (figs.30-31). The depths at which these layers were encountered varied across the central open space and wider Aldgate area, including St Botolph Street, Aldgate High Street and Minories, with some deposits being recording approximately 1.2m below ground level (c14.8mOD) and others at depths of 5.8m – 6.3m below ground level (c9.2-8.7mOD).

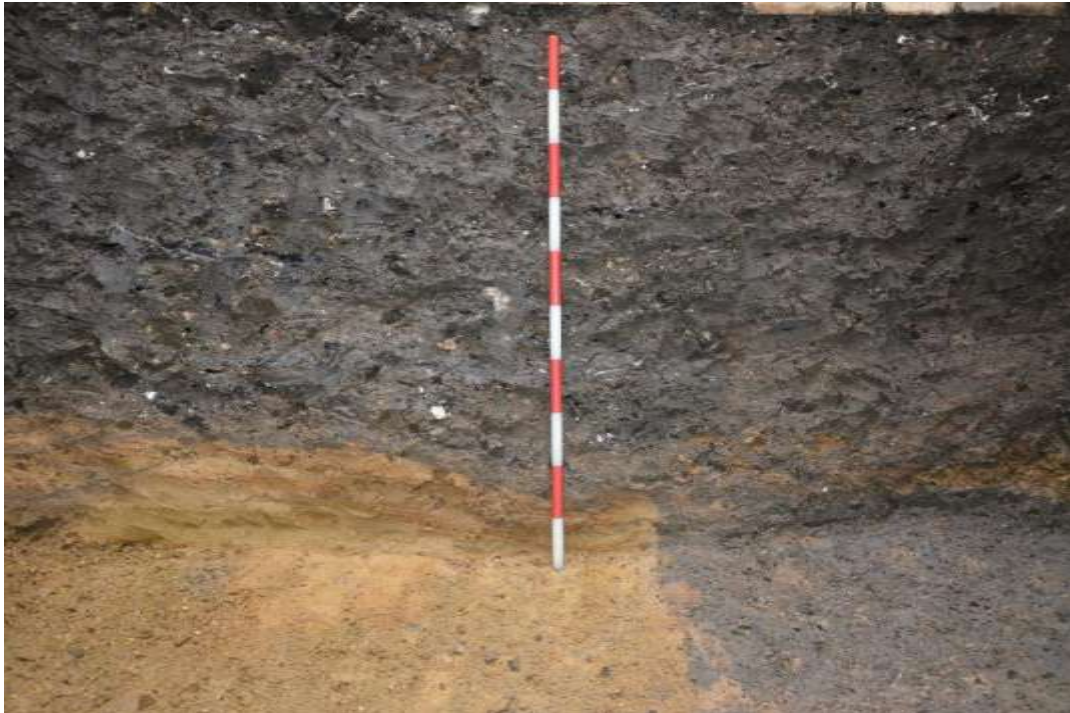
Figure 31: Dropshaft 7: Cut [296] and fill (295) of a pit, seen to the right of frame. The pit cuts into natural sand and gravel (297) and is overlain by a large homogenous deposit of dark grey silt (294). Facing N, scale 1m.

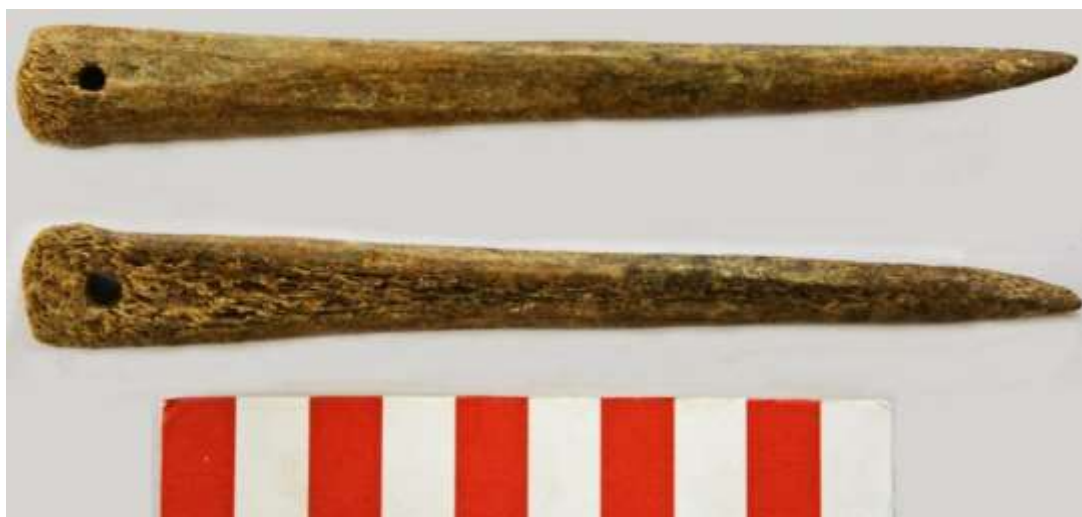
Figure 32: Bone awl or needle recovered from (context 282). Scale 10cm.

- 7.4.7** The finds recovered from the medieval contexts were primarily domestic in nature, comprising animal bone, oyster shell and pottery. Analysis of a sample of the animal bone demonstrated that approximately 50% of the assemblage were cattle, followed by sheep making up 43%, domestic fowl representing 4% and pig, 3%⁴. Evidence of butchery was present on 20% of the assemblage, indicating it was the result of food production processes and subsequent disposal, rather than natural death. One of two worked fragments of bone recovered from the site was found in context (282). A bone awl measuring 143mm in length was recovered (fig.32), however, the bone was not sharp enough to pierce anything substantial suggesting it may have been used for threading or knotting materials together, such as fishing nets.

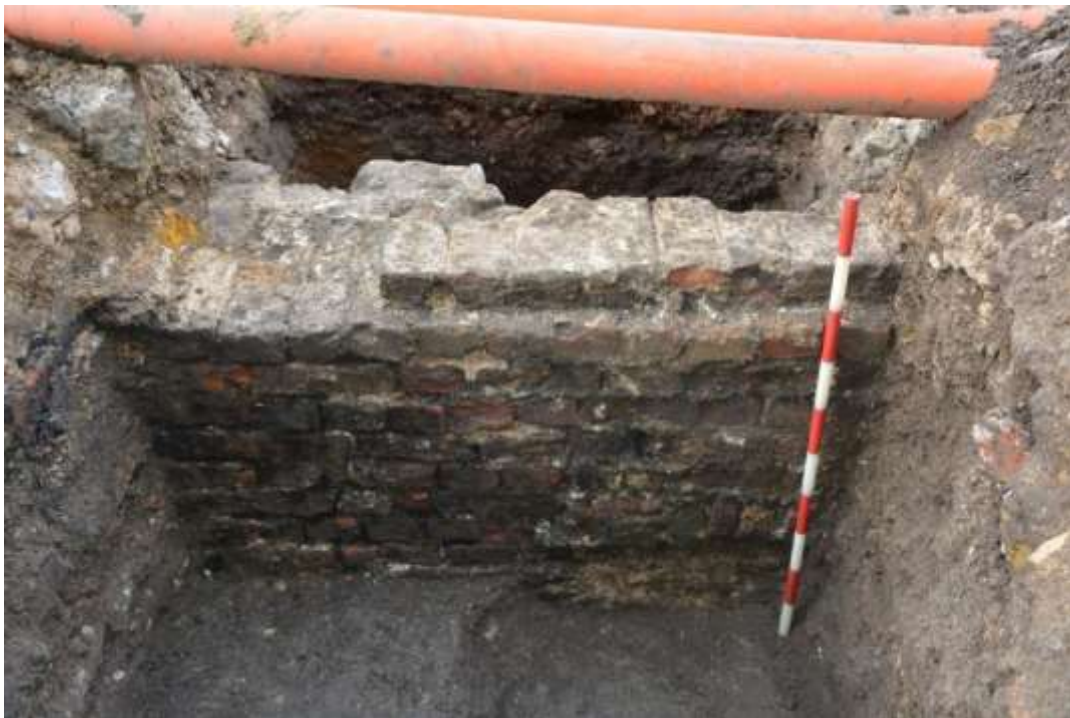
Figure 39: Wall [232] observed in TP12, one of twenty seven trial pits dug to the west of St Botolph's Church. A repair can be seen behind the scale. Facing W, scale 1m.

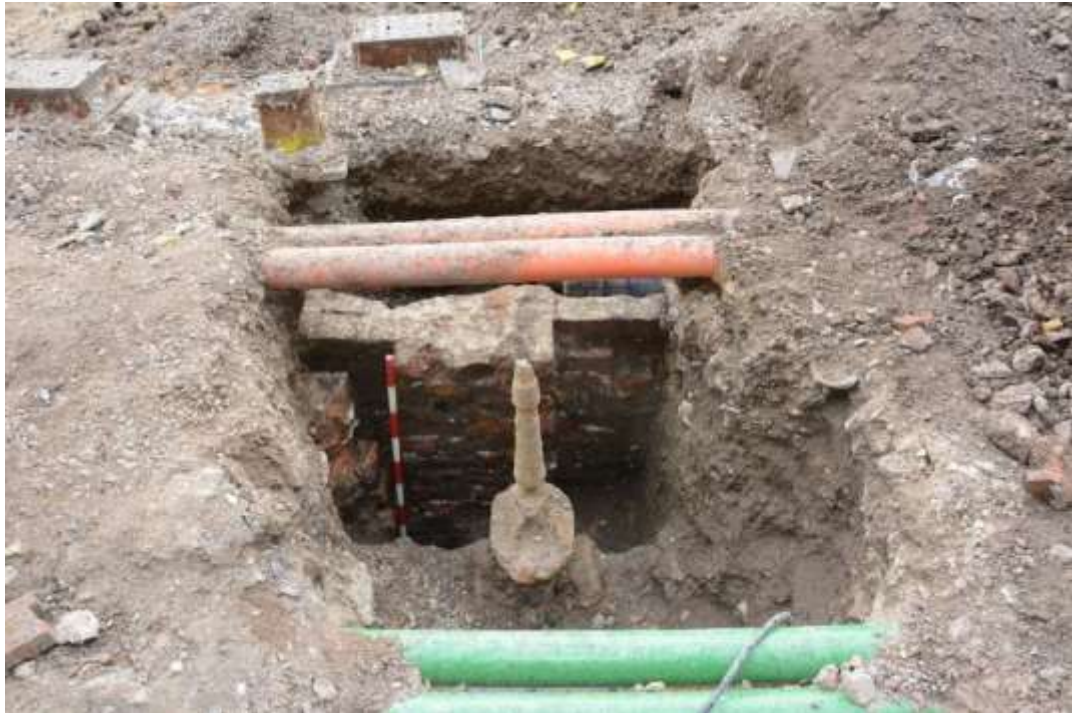
Figure 40: TP13: W[232] seen beneath modern services, with a buttress projecting eastwards. Facing W, scale 1m.

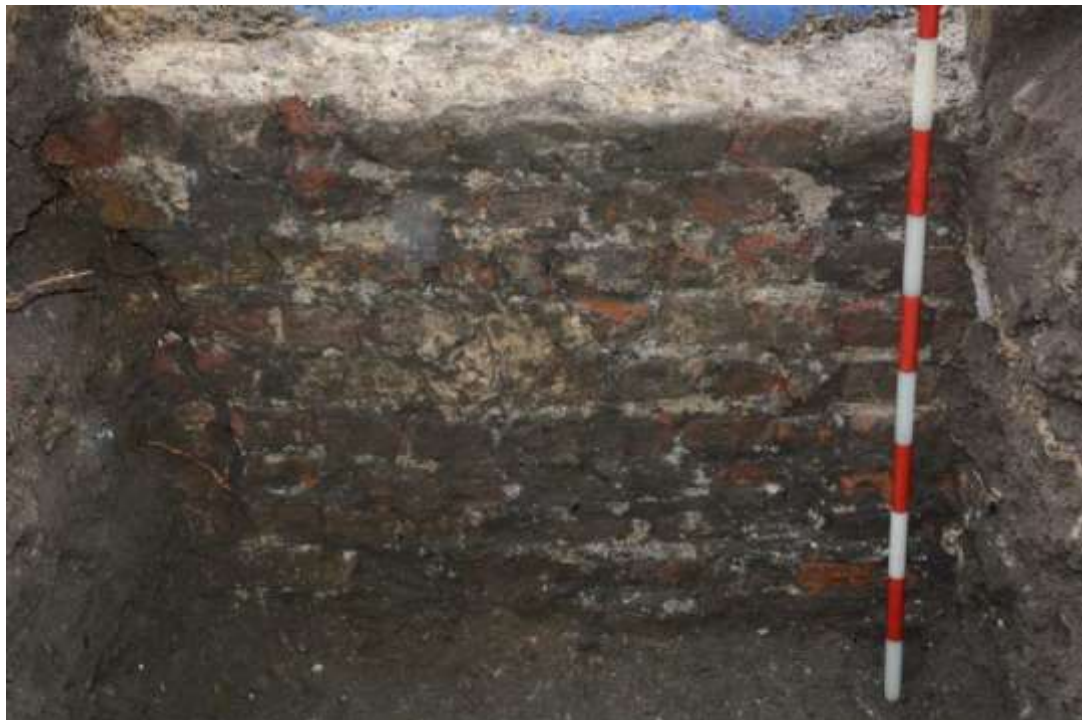
Figure 41: Wall W[232] observed in TP27. A rebuilt or blocked up rectangle can be seen to the left of the scale. The upper part of the wall has been truncated by modern services. Facing W. Scale 1m.

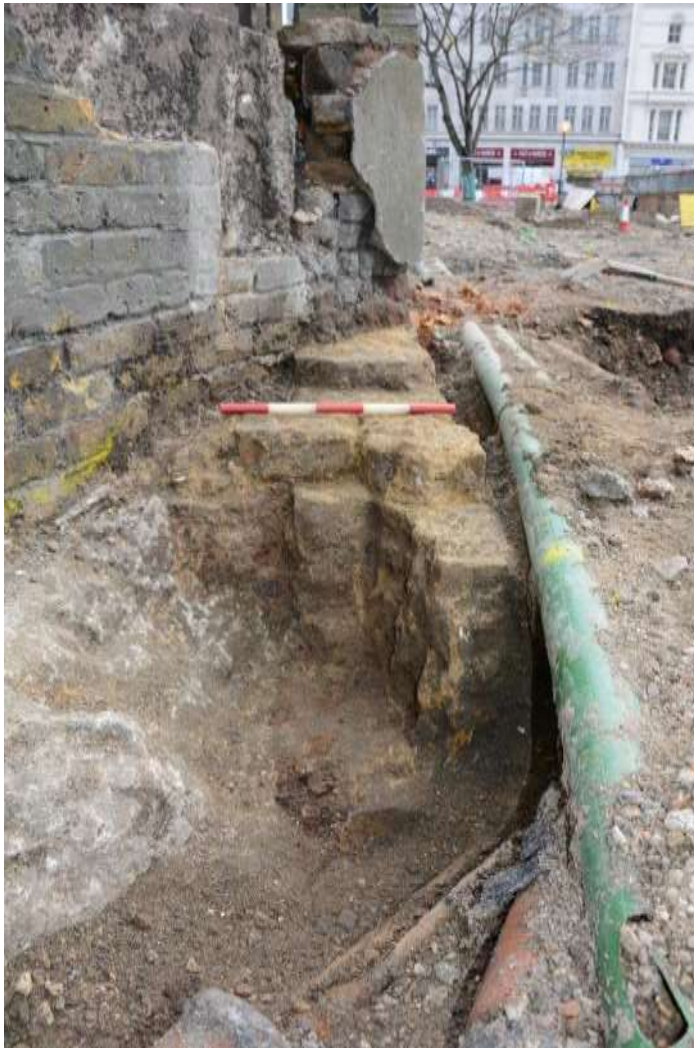
Figure 42: TP22: W[311] recorded at the northern end of the church boundary wall (prior to its rebuilding), demonstrating that the angled corner is a recent alteration to the churchyard. Facing S, scale 0.5m.

- 7.5.4.2** Analysis of brick samples taken from the wall indicate a date of 1750-1850. Cartographic sources indicate that the boundary changed in the early-1800s, to run parallel with the newly rebuilt church. The boundary wall described above is therefore taken to be associated with this alteration (see section 4.5 figs.5-10).
- 7.5.4.3** A further section of the modern church boundary wall was seen at its northern extent. A small section of red and yellow brickwork W[311] measuring 3.02m in length x 0.6m in width x 0.6m in height, running NW-SE was observed at the northern end of the wall. This brickwork is taken to be the 17th-19th century continuation of the boundary wall, which led to Church Row, prior to the 1960s-70s clearance and creation of the gyratory system and remodelling of the churchyard (fig.42).
