ALDGATE HIGHWAY CHANGES AND PUBLIC REALM PROJECT, CITY OF LONDON EC3A

An Archaeological Assessment Report

Site code: DKE13

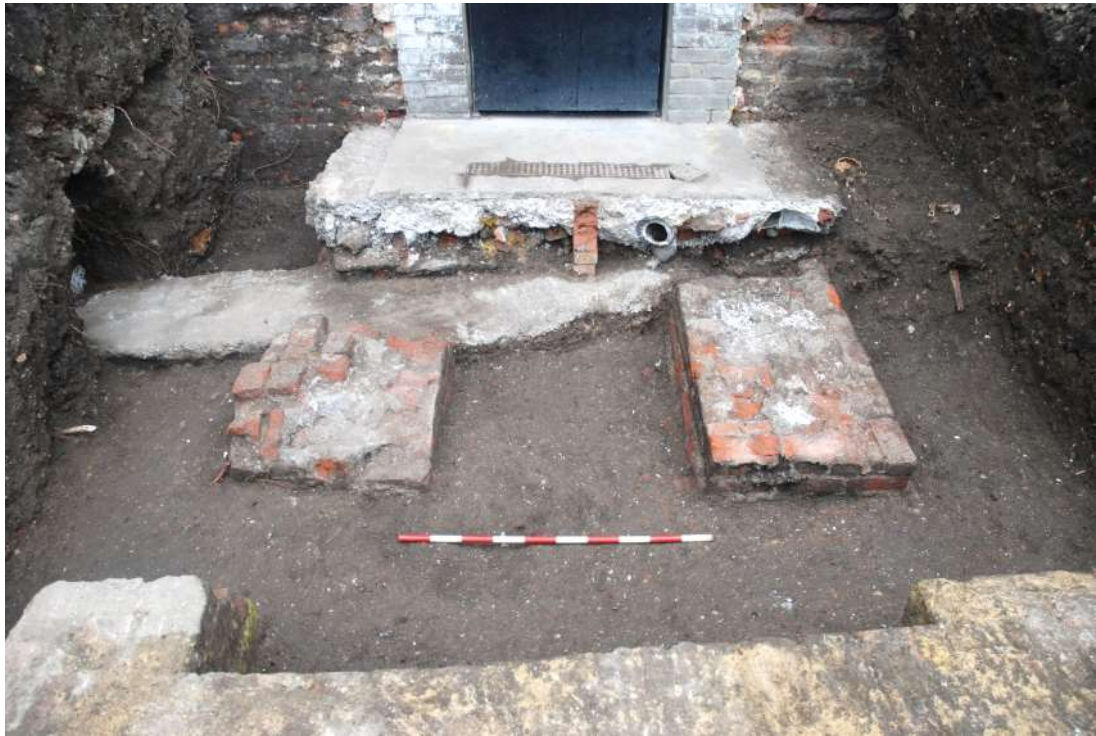
Figure 43: Brick pads W[64] and W[65] seen beneath the existing crypt entrance. The top of a burial can be seen to the right of the concrete step outside the door. The churchyard boundary wall can also be seen in the foreground. Facing E, scale 1m.

7.5.4.4 Further elements of the church were uncovered during groundworks immediately adjacent to the existing crypt entrance. Two brick structures W[64] and W[65], aligned east-west extending westwards from the western face of the church were recorded at a depth of 1.3m below ground level (14.89-14.82mOD). The structures comprised a chalk and stone core faced with red brick bonded with a gritty grey mortar. Three to four courses were visible above the level of excavation, however the feature is taken to be much truncated by later activity. Both blocks were similar in size, measuring 1.37m in length (E-W) x 0.74m in width x 0.30m in height, set 0.9m apart (figs.43-44).

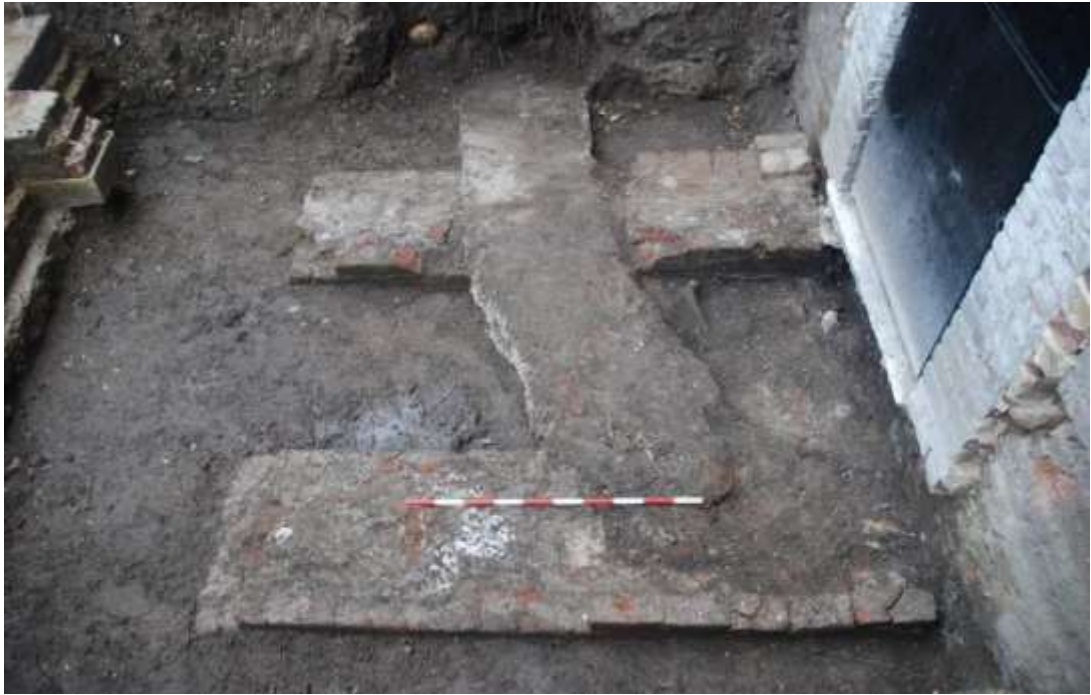
Figure 44: Continuation of the two brick pads following the removal of the concrete step. Some charnel material can be seen between the concrete drain base and crypt door, and also towards the top of frame. Facing N, scale 1m.

- 7.5.4.5** It is suggested that these structures are the remains of foundation blocks for a staircase leading to a now blocked up entrance to the church. This is consistent with a c1740 illustration of the church which shows a staircase leading between two small arched windows at the former ground level, now at first floor level (fig.45).

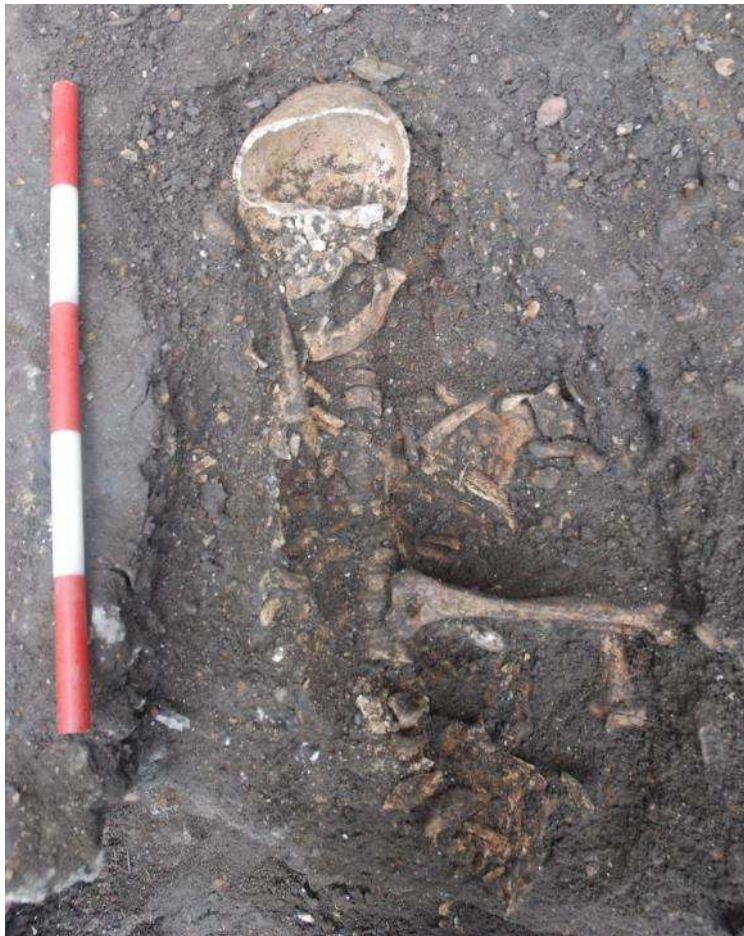
Figure 47: *In-situ* burial (skeleton 1) observed to the south of the crypt entrance. The burial was truncated at the pelvis by a modern drain. Facing E, scale 0.5m.

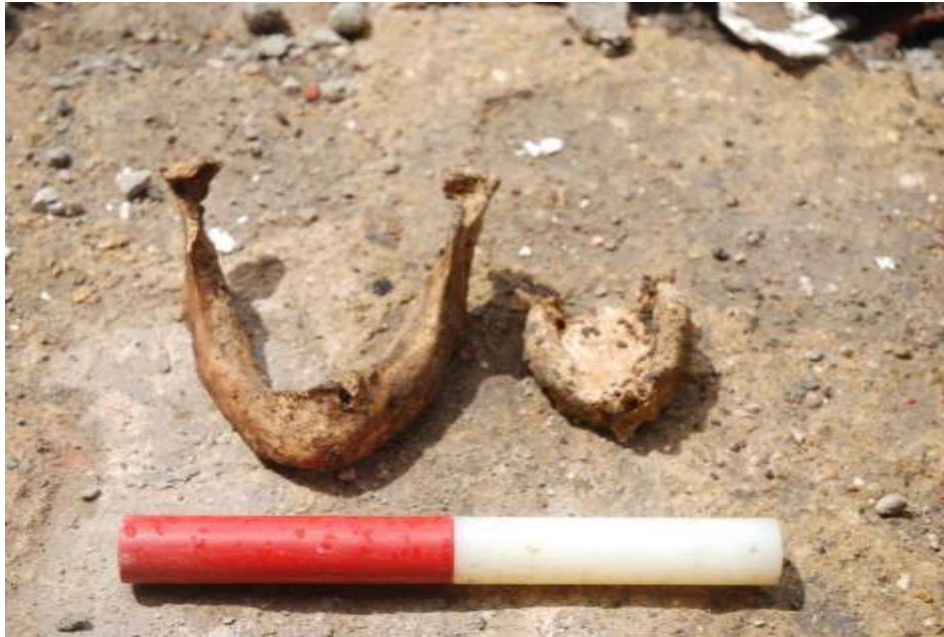
Figure 48: Edentulous mandible and maxilla from Skeleton 1. The degree of bone resorption indicates the individual was missing teeth for a considerable period of time. Scale 0.2m.

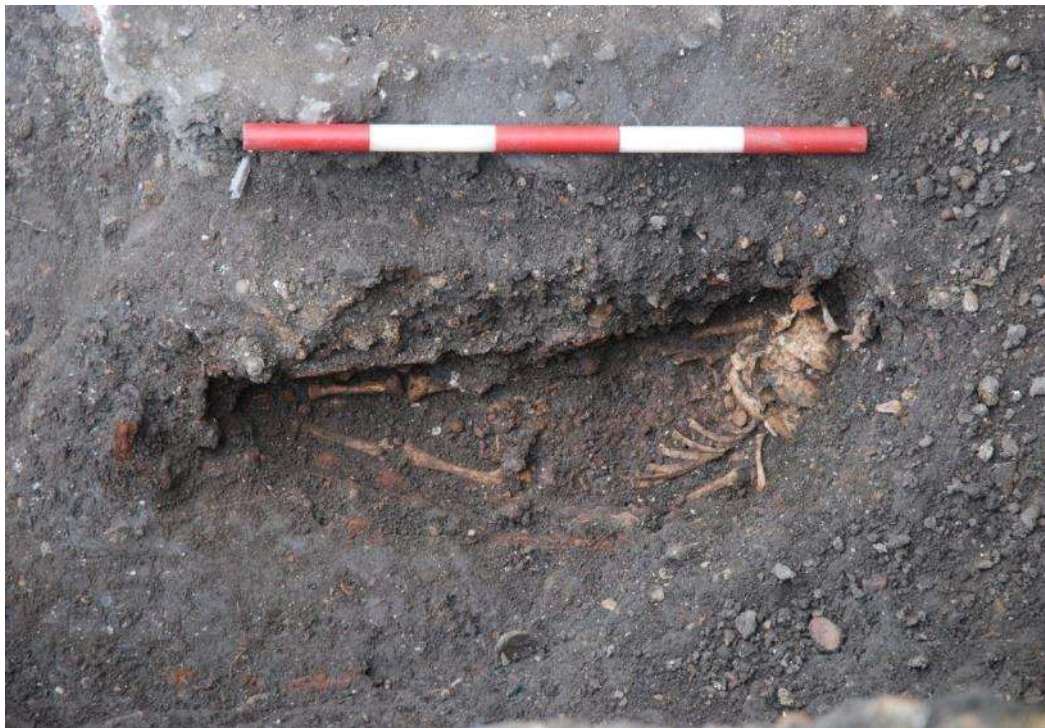
Figure 49: In-situ infant burial (skeleton 2), aligned east-west with the head at the eastern end. The remains of a wooden coffin can be seen, particularly below the left tibia and femur. Facing N, scale 0.5m.

7.5.4.6 To the north and south of these foundations a number of *in-situ* burials were exposed, along with a large quantity of disarticulated charnel deposited between the two pads. Twelve *in-situ* burials were recorded, encountered between 15.19mOD and 14.55mOD. The upper part of one adult was recorded, buried in a supine position with arms folded across the torso (fig.47). The skeleton was notable for its almost completely edentulous mandible and maxilla, and degree of wear on the bone as a result (fig.48). The remaining eleven burials belonged to infants and juveniles, ranging in age from 6 months \pm 3months to 6 years. Five of the burials were in wood and nail coffins, aligned east-west and stacked in very close proximity to each other. A significant degree of slumping and moving had occurred as a result of the wood rotting away (figs.49-53).

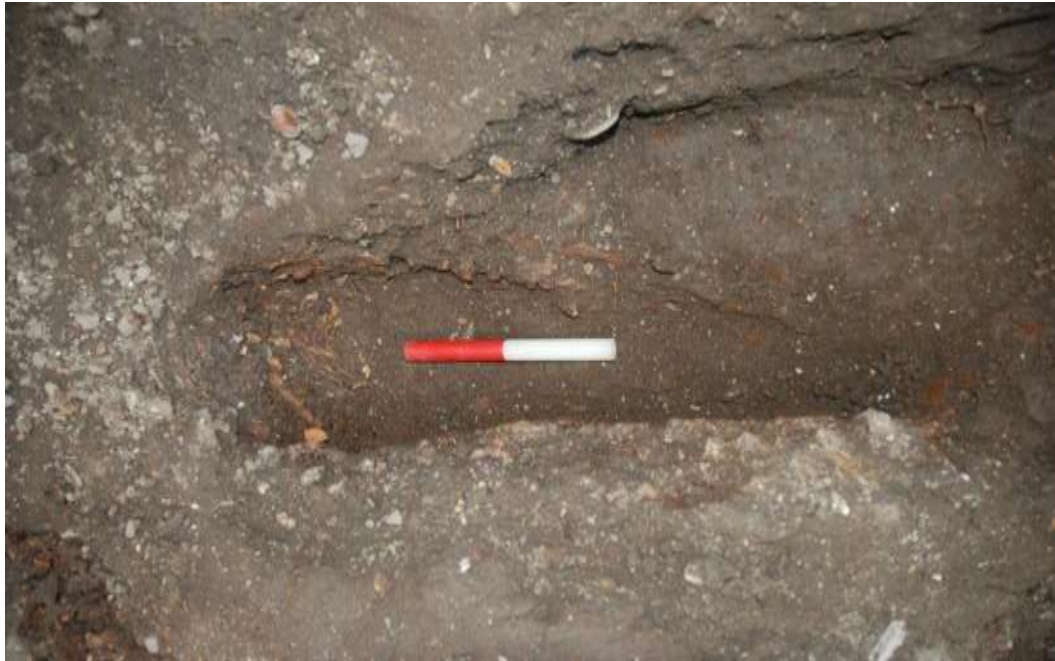
Figure 50: Partial remains of a second infant burial, comprising vertebrae, ribs, sternum and manubrium, right scapula and right humerus (skeleton 3). Recovered from immediately beneath the first infant burial (skeleton 2). Scale 0.2m.

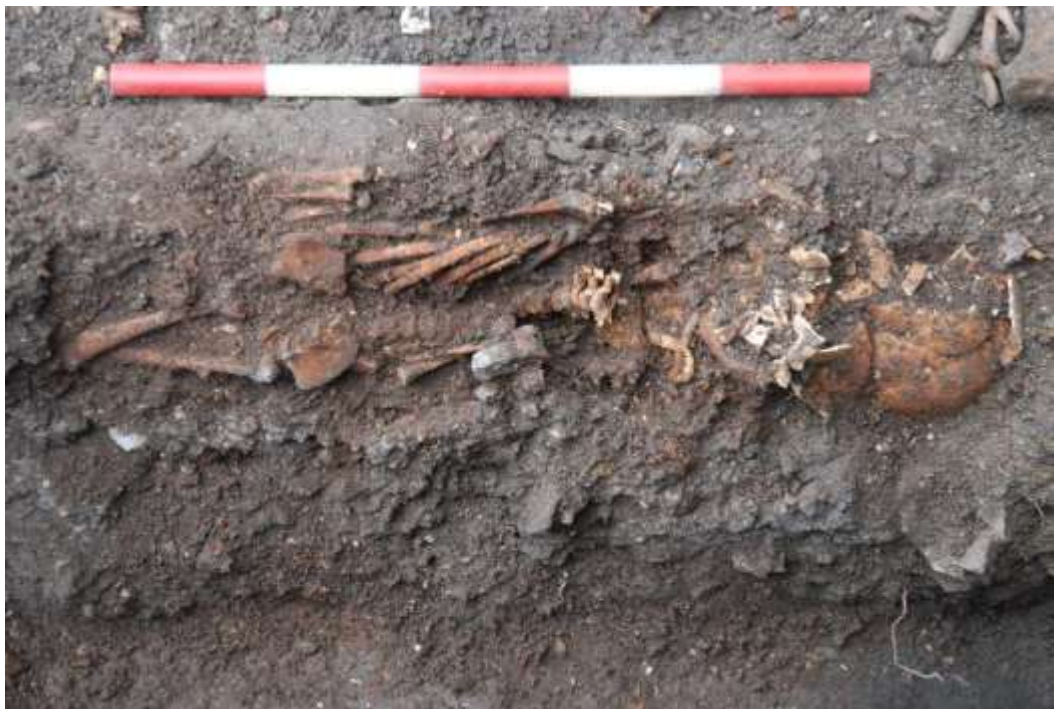
Figure 51: Infant burial (skeleton 8) found in-situ, lying on its right side facing northwards. Taken to be a result of slumping. Facing N, scale 0.5m.

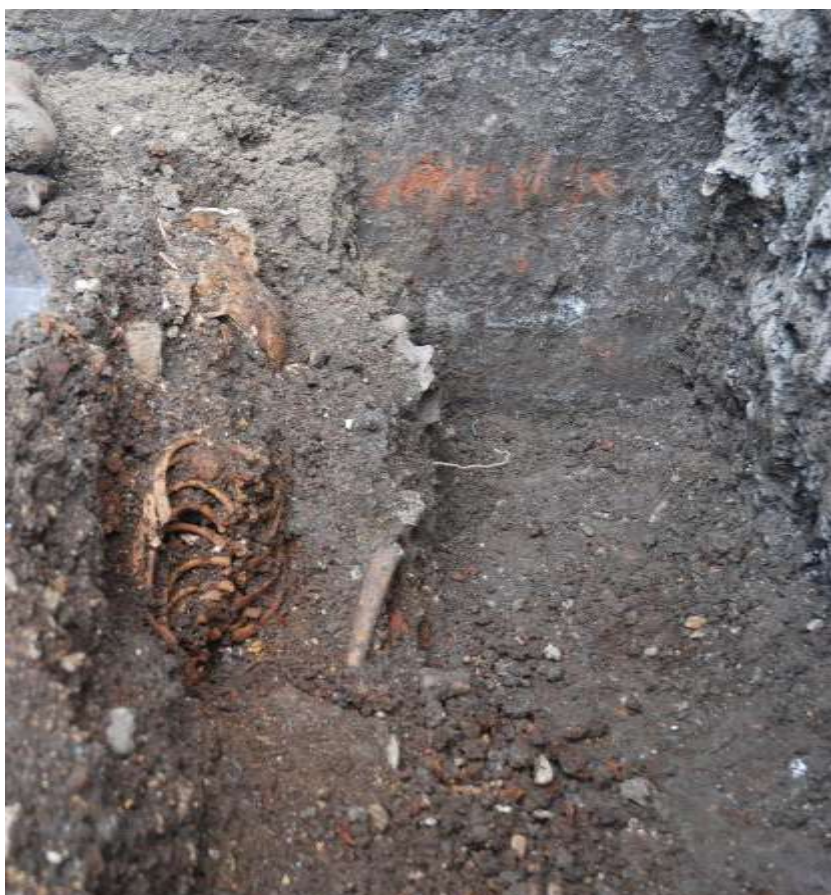
Figure 52: Working shot: Infant burial (skeleton 9) prior to removal. The remains were found sitting in an upright position. Facing E, no scale.

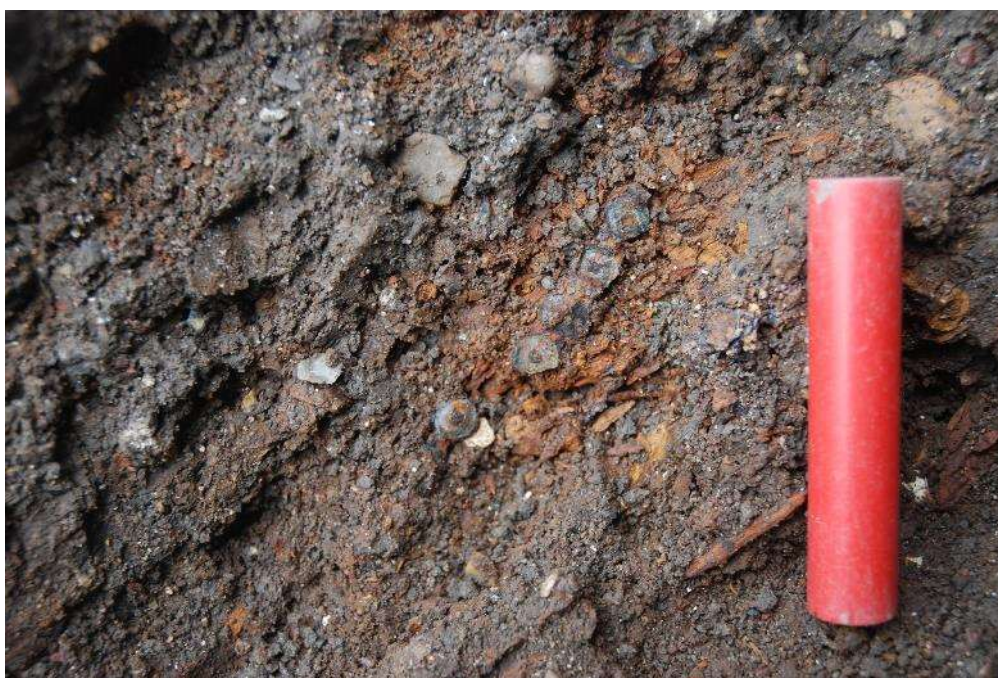
Figure 53: Detail of metal coffin tacks and remnants of wood recovered from the burial site. Facing N, scale 0.1m.

- 7.5.4.7** Some of the coffins survived in a moderate state of preservation and the outlines of several were still visible. The coffins were constructed from wood panels affixed with metal nails. Rows of metal tacks found *in-situ* suggest a degree of decoration on the outer surfaces although no clear patterns or motifs were visible.

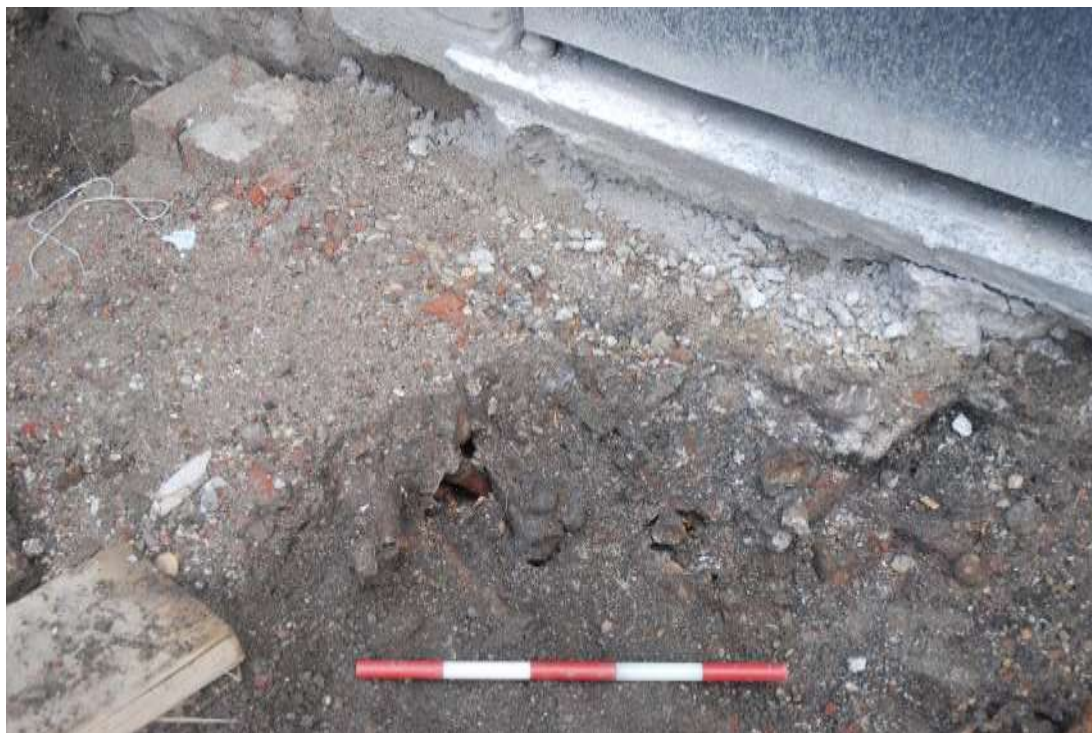
Figure 54: Charnel material beneath crypt door. The upper 0.5m of material was removed to enable the groundworks to be completed. Facing NE, scale 0.5m.

- 7.5.4.9** The charnel material was observed immediately beneath the existing entrance to the church crypt, between brick pads W[64] and W[65]. Approximately 0.5m of material was removed to reach an adequate level of excavation. Its deposition would suggest it is either the remains of a burial vault beneath the former staircase, dating from the 18th century, or a later 19th or 20th century clearance of a crypt, with the bones being tipped into the pit from the existing crypt door (fig.54).

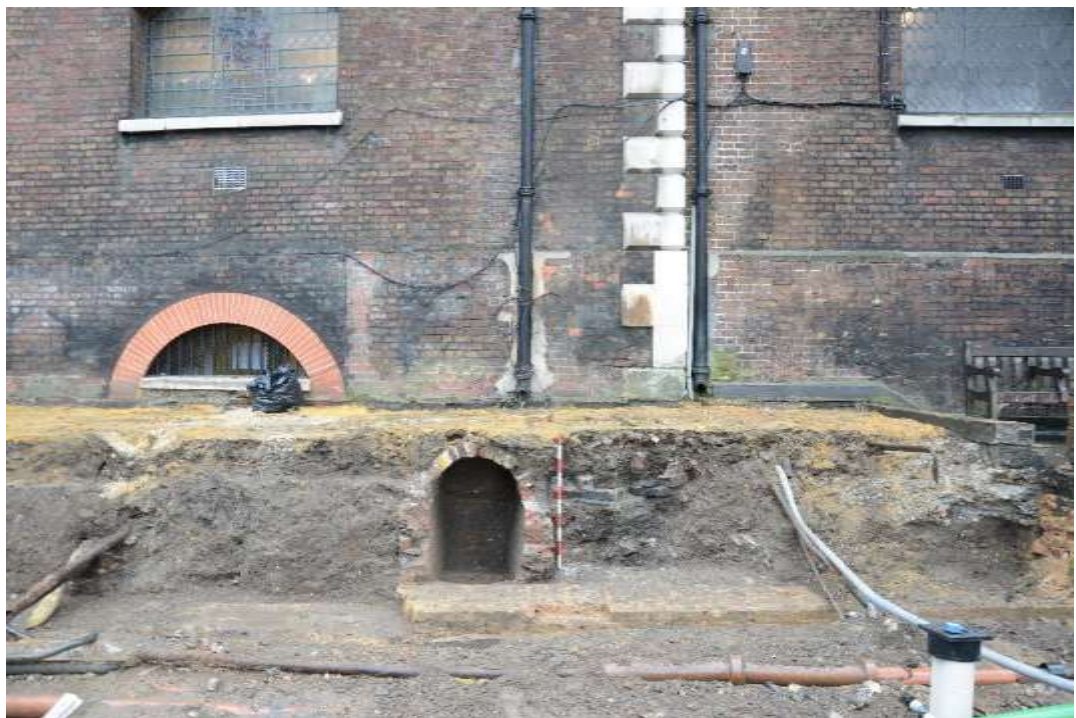
Figure 55: Burial vault W[44] encountered following the removal of the churchyard boundary wall. Facing E, scale 1m.

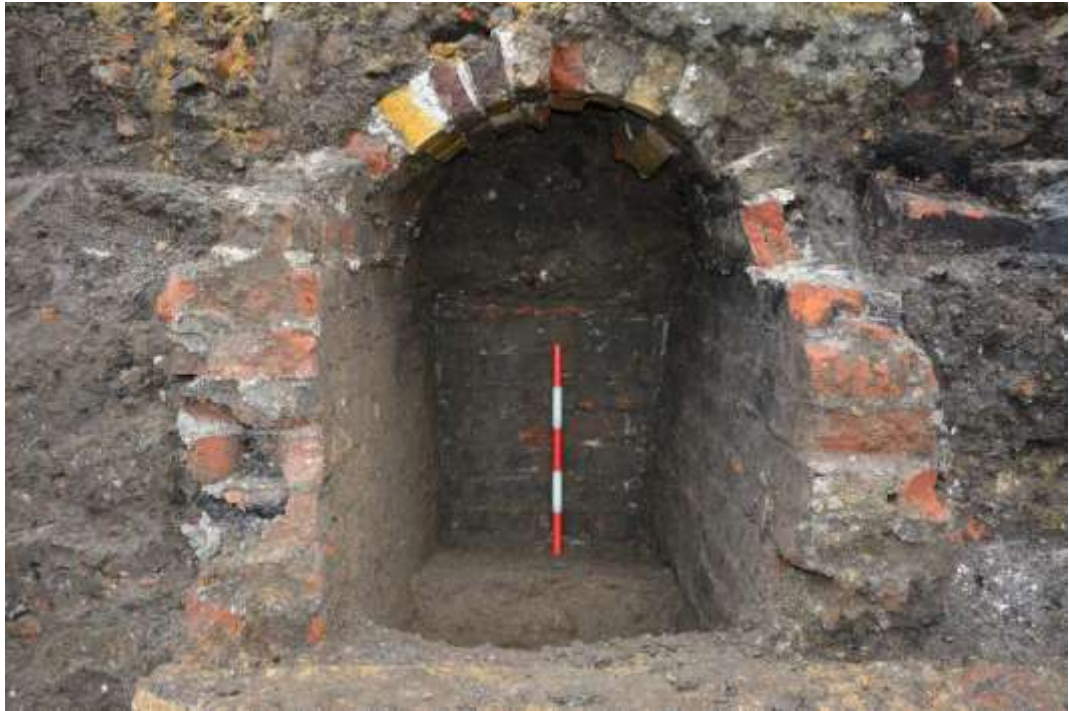
Figure 56: W[44] interior detail. Facing E, scale 0.5m.

7.5.4.11 A further two burial vaults / charnel pits were exposed during the removal of the existing churchyard wall. The first structure, W[44] comprised a red brick and yellow stock brick chamber with an arched roof. The vault measured at least 1.0m in height x 1.05m in width x 1.2m in depth (front to back), aligned east-west, encountered at 16.28mOD. The front had been truncated by the construction of the churchyard wall. The roof was partially collapsed and built from different brick types bonded with a messy mortar suggesting it had been repaired on at least one occasion (figs.55-56). The fill of the vault was a fairly loosely compact light to mid-brown soil containing frequent disarticulated human remains and some clay tobacco pipes. To the immediate south of the vault was a section of horizontally laid bricks and stone slabs, visible in the west facing section. The structure measured 1.3m in length x 0.12-0.34m in width, with the base being encountered at a depth of 0.45m below ground level (15.94mOD). A small headstone or marker had been re-used to create the base. The structure was interpreted as a drain, although its relationship with the vault is unclear (fig.57).

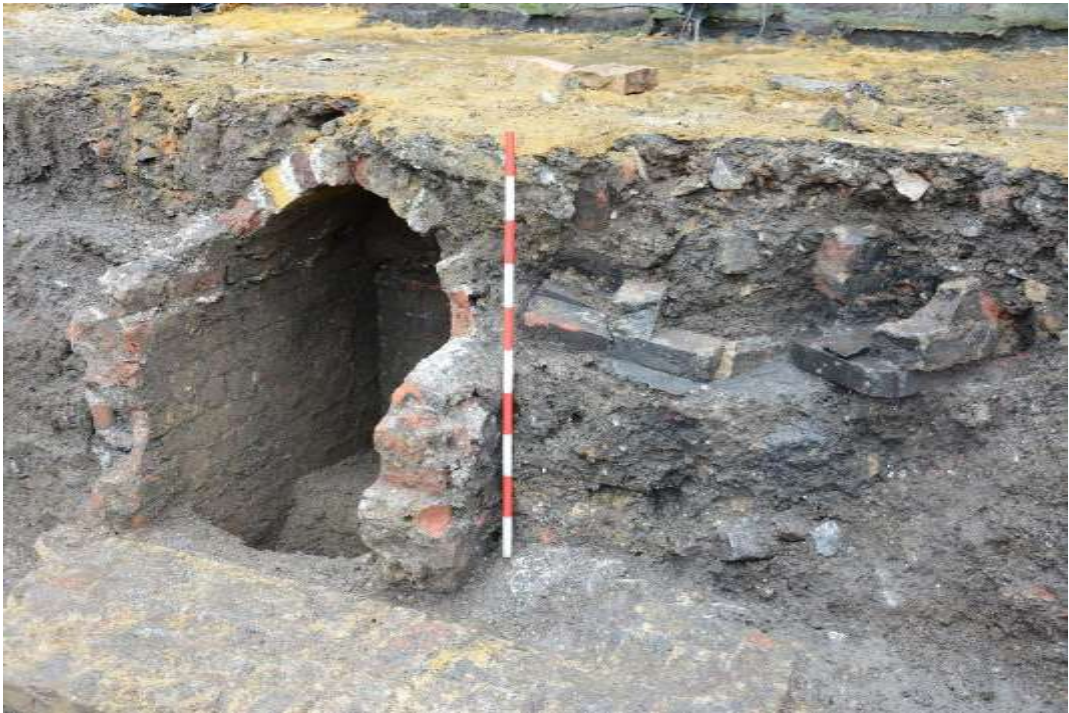
Figure 57: Vault and drain structure to south. The small headstone or grave marker can be seen towards the right of frame. Facing approximately ENE, scale 1m.

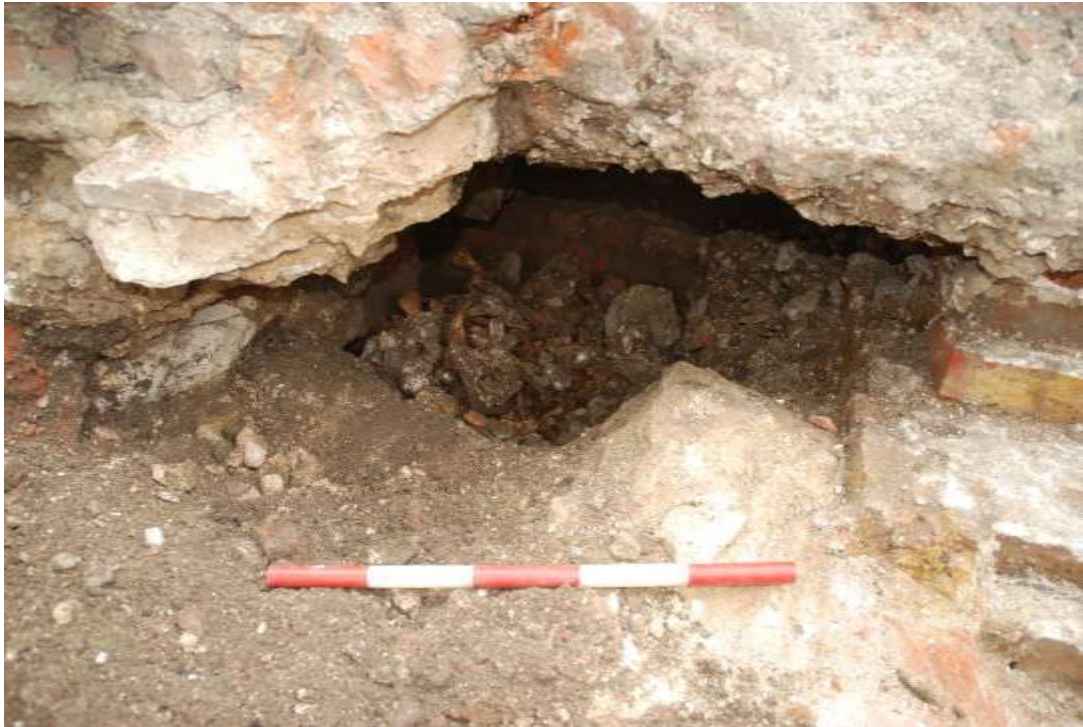
Figure 58: Interior of W[175], encountered at the south end of the churchyard boundary wall following its removal. Facing approximately E, scale 0.5m.

7.5.4.12 The upper part of a second burial vault was uncovered in June 2017, immediately beneath the western face of the steps leading between St Botolph Street and the church, at the southwestern corner of the church building. The visible section of the structure, W[175] comprised a brick arch measuring 1.46m in height x 1.97m in width, with an internal space of 0.92m. The maximum depth of the structure is unknown. The chamber was filled with disarticulated human remains and some sandy mid-brown soil (176) (fig.58).

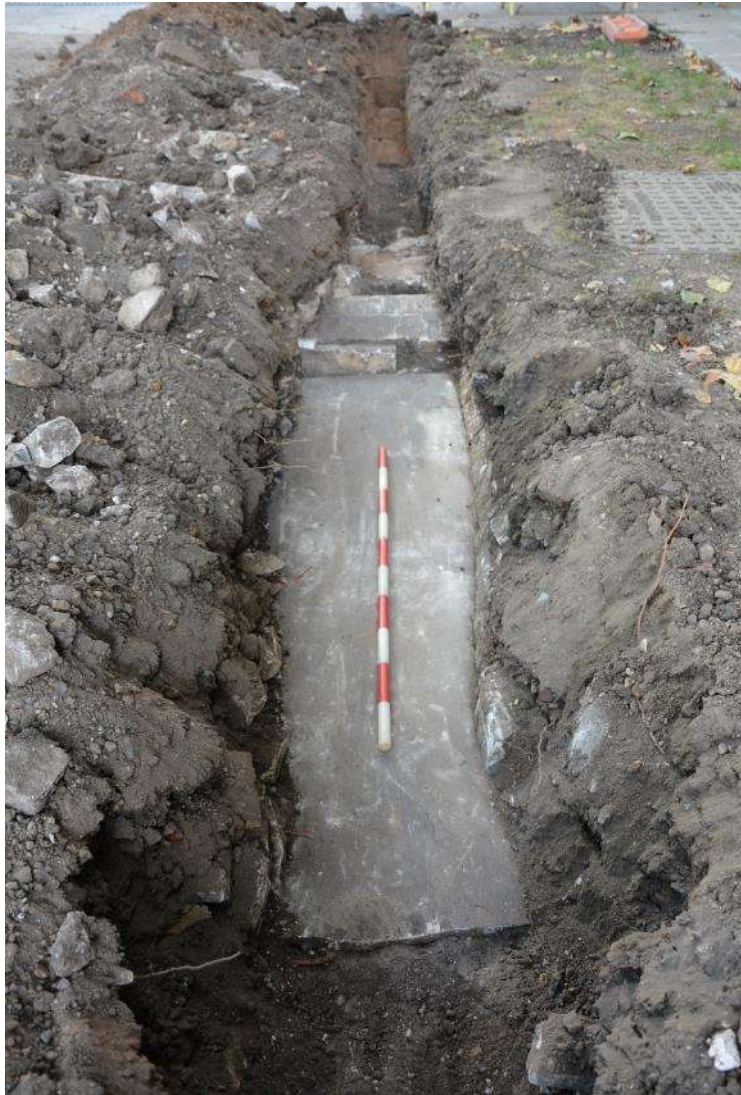
Figure 59: In-situ stone slabs exposed at the northern end of the church, buried beneath fragments of broken headstones. Facing E, scale 1m.

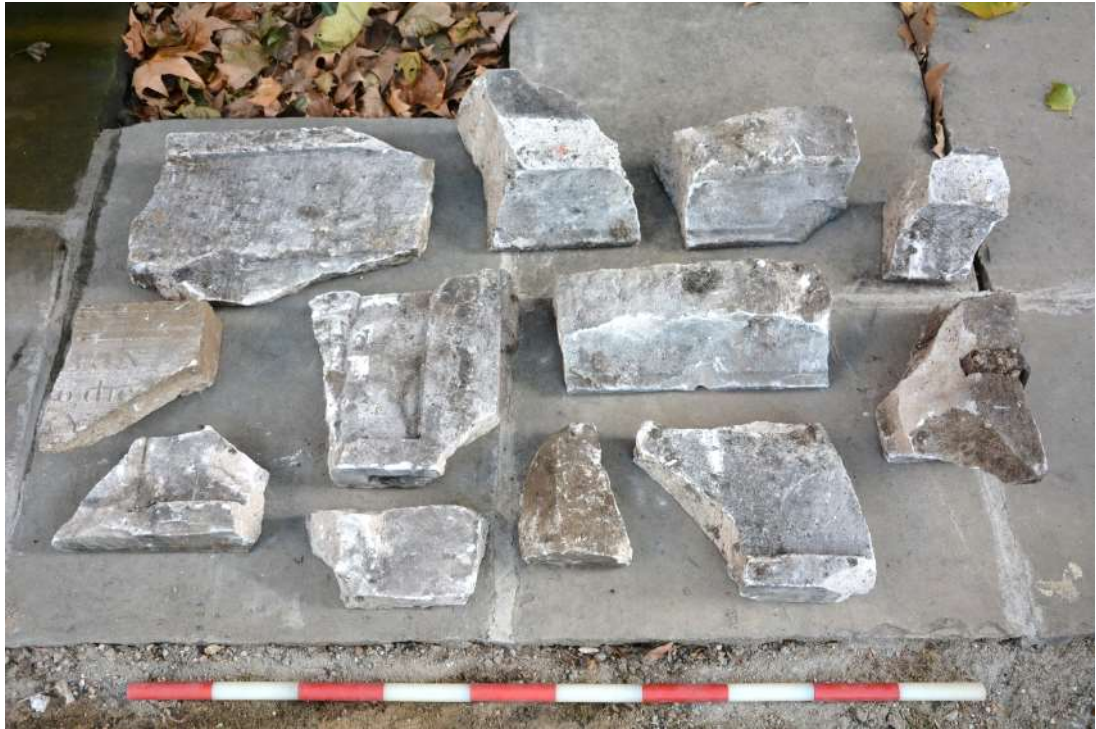
Figure 60: Examples of fragmentary furniture remains removed from the Fountaineers's ducting trenches. Scale 1m.

7.5.4.13 Further evidence of the former burial ground was recorded during drainage and landscaping works at the northern end of the site. Trenching undertaken to connect mains drains and to accommodate ducting for the water feature (completed by Fountaineers) exposed a thick layer of soil – taken to be made ground associated with the churchyard, containing numerous fragments of headstone / grave ornaments (figs.59-61), in addition to quantities of disarticulated human remains, phalanges in particular, which are often easy to miss during clearances.

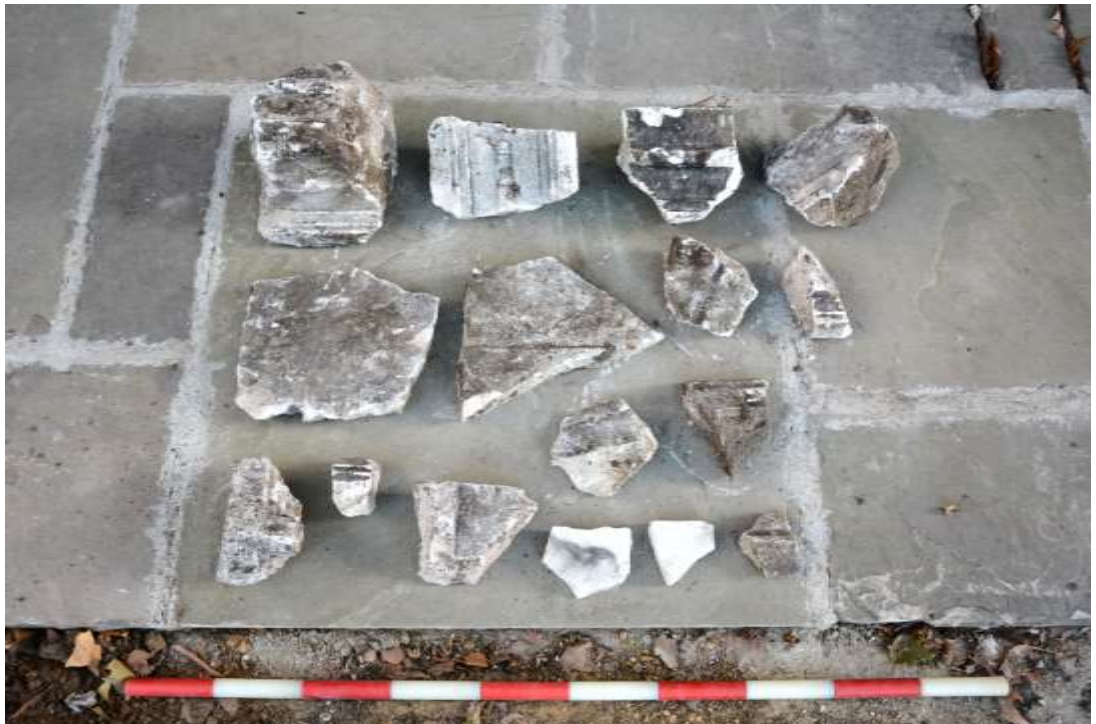
Figure 61: The collection was predominantly stone and comes from ledgers, slabs, vaults or tombs, rather than smaller, thinner headstones. The material was predominantly stone, with some fragments of white marble also observed. Scale 1m.

7.5.4.14 Much of the material is taken to have been dumped during the clearing and re-landscaping of the burial ground into a public park / churchyard in 1892.

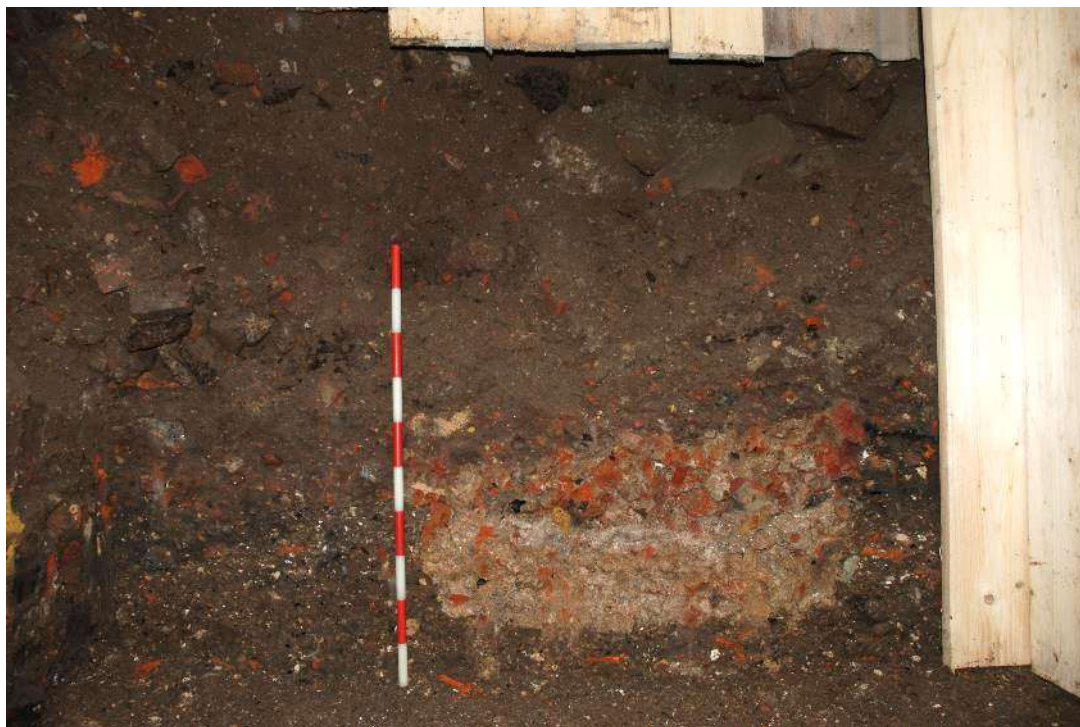
Figure 62: Post-medieval ditch fills seen to the left of the scale, truncated by the later brickwork. Facing S, scale 1m.

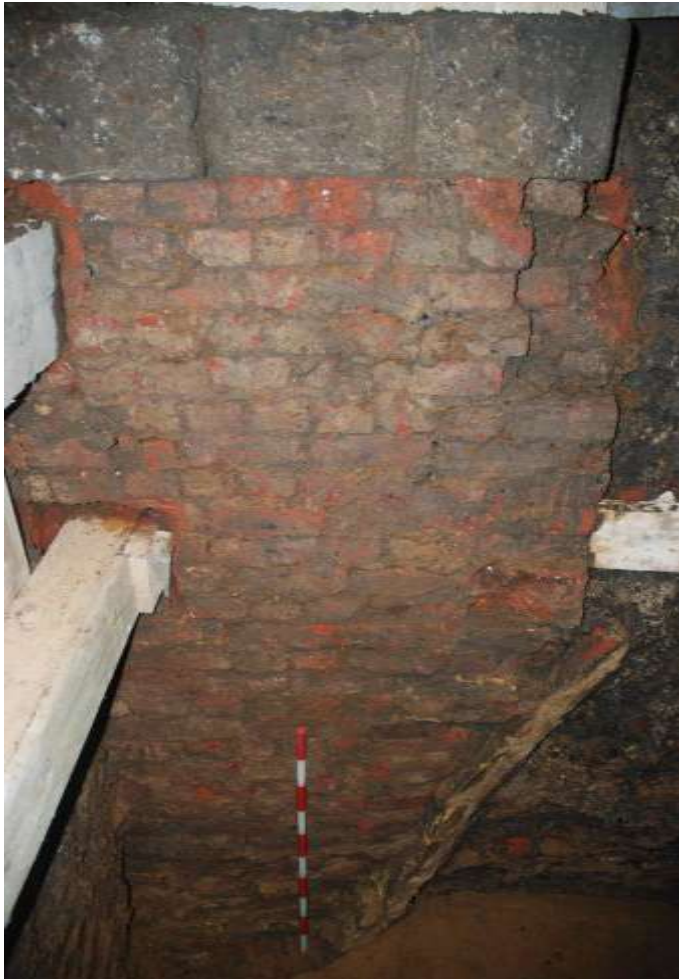
Figure 63: Brick wall W[264] topped by granite blocks. A timber beam appears to mark the extent of the structure, seen to the right of the scale. Facing W, scale 1m.

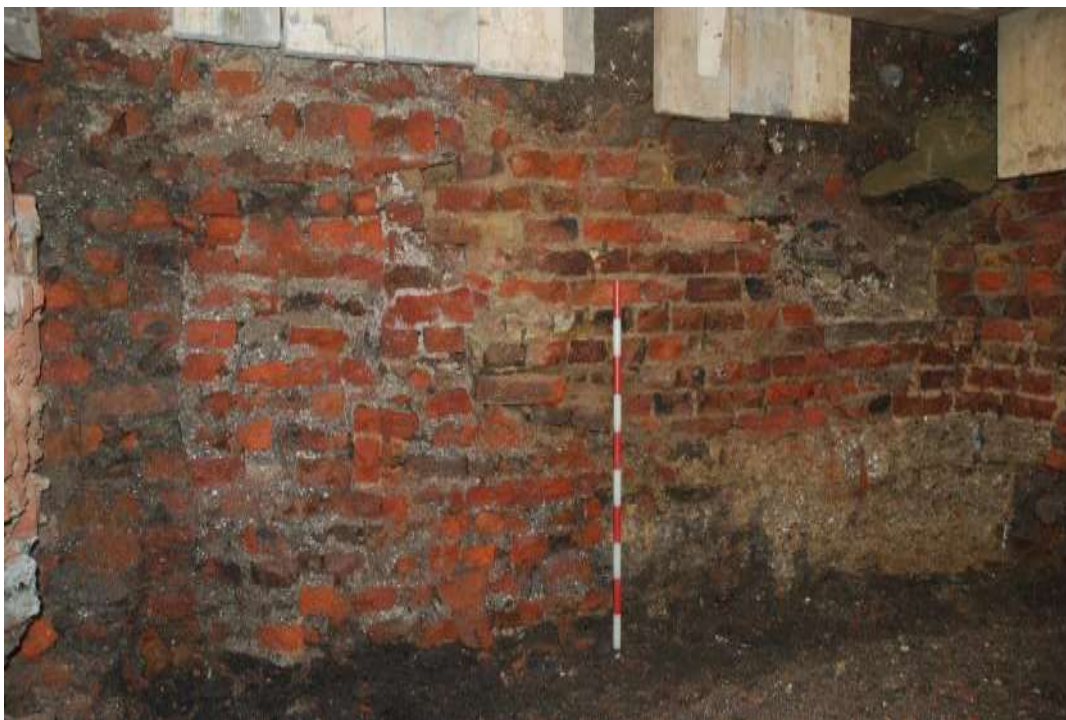
Figure 64: Wall W[279] observed in the north section, to the left of the scale, which was later cut by wall W[276] seen to the right of the scale with the concrete base and yellowish mortar. Taken to represent a sequence of post-medieval buildings in the area of the former Stern's Hotel and 17 Mansell Street, prior to modern redevelopment. Facing N, scale 1m.

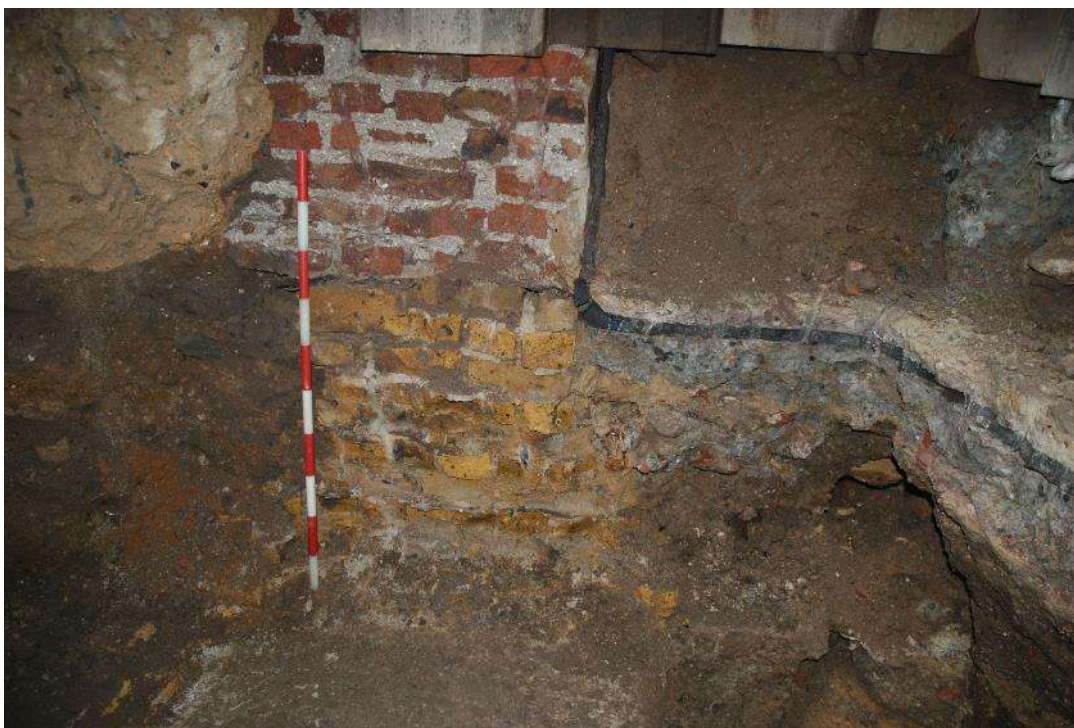
Figure 65: Dropshaft 13: E-W aligned wall W[189] and concrete floor S[194]. Taken to be part of a post-medieval basement belonging to a building fronting the former line of Houndsditch, facing St Botolph's Church. Facing W, scale 1m.

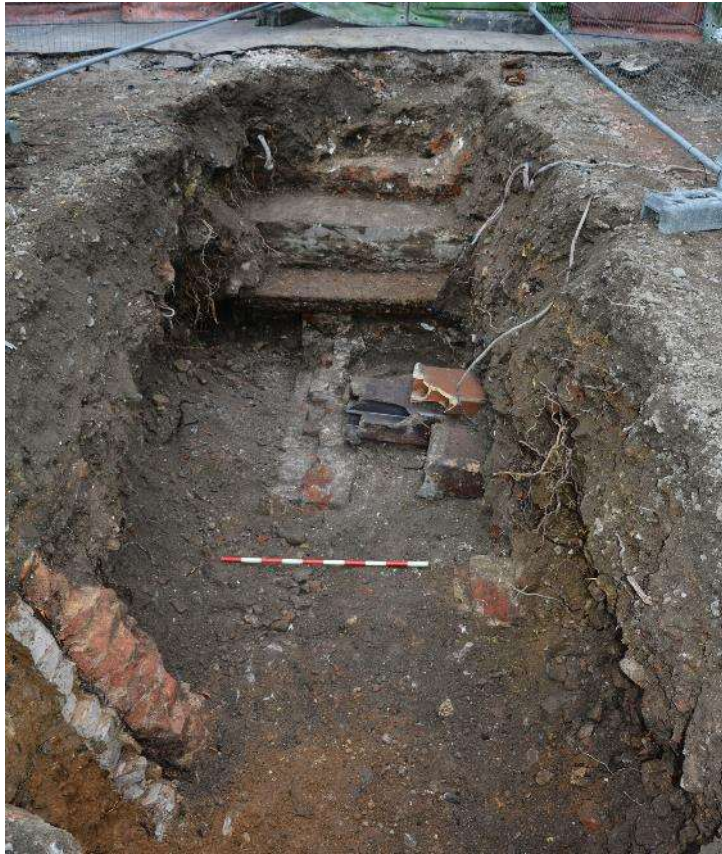
Figure 66: Compass Evaluation Trench 2 (November 2015), showing a series of post-medieval walls. W[209] can be seen running N-S towards the top of frame, W[204] E-W through the centre of the trench and a possible return, W[205] in the northern section to the right of the scale. Taken to be remnants of buildings fronting formerly fronting Duke's Place. Facing W, scale 1m.

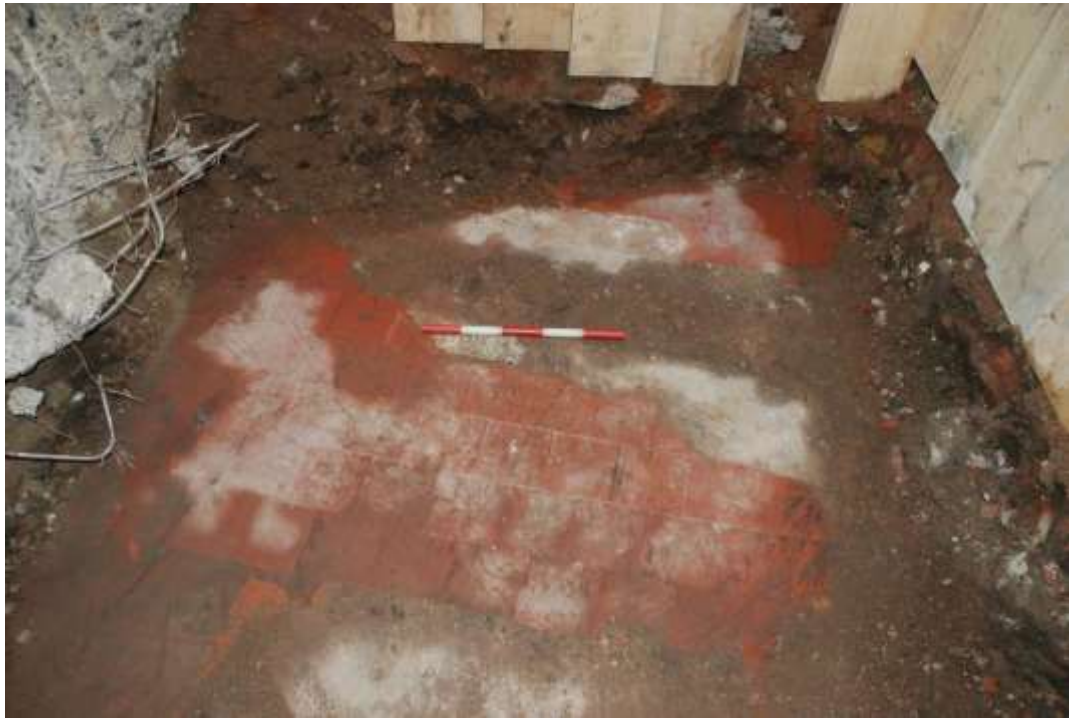
Figure 67: Dropshaft 5: Tile floor S[275] encountered at a depth of 2.60m (12.40mOD), sealing walls W[279] and W[276] in fig.64 above. Scale 0.5m

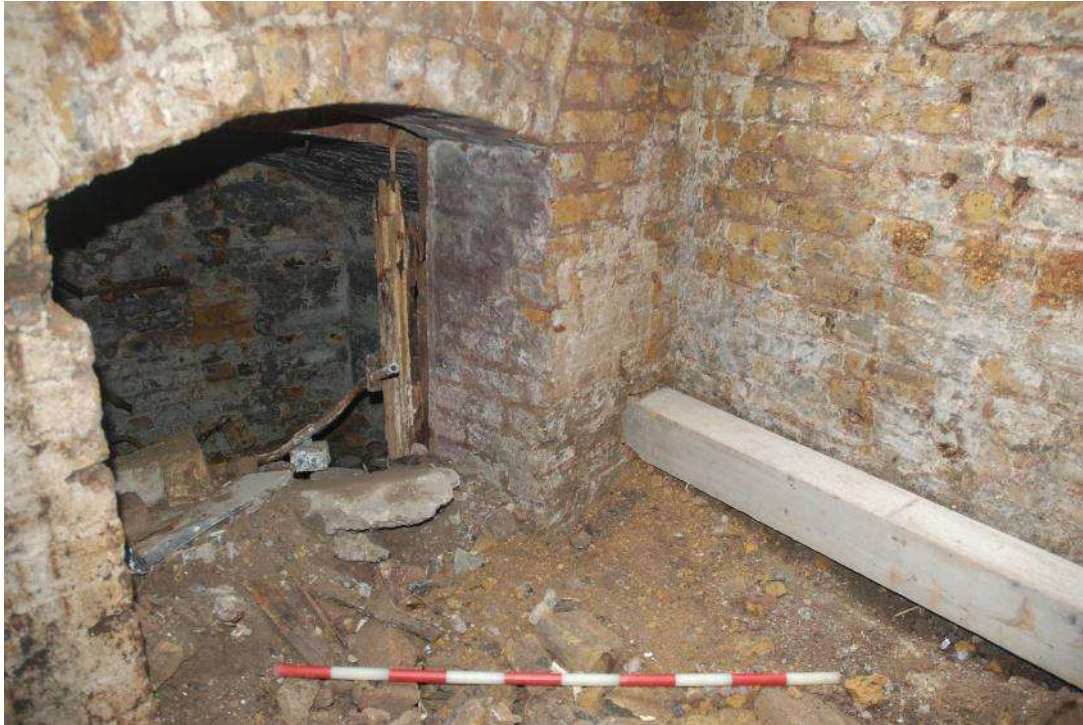
Figure 68: Dropshaft 15: Partially excavated basement W[115] looking into the coal cellar W[117]. A wooden shelf with cans and jars on is visible in the gap between the metal pipe and wooden doorframe. Facing SW, scale 1m.

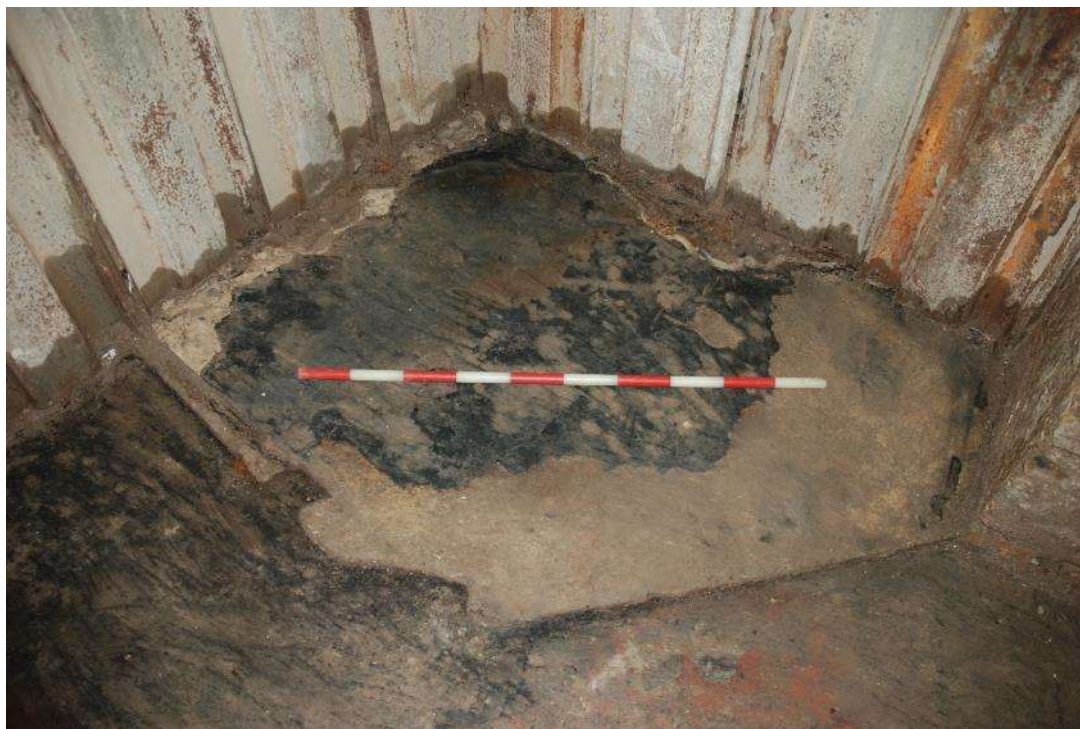
Figure 69: Dropshaft 15: Floor S[120], with division, separating an internal room from a corridor leading to the coal cellar (to the right of frame). Facing NE, scale 1m.

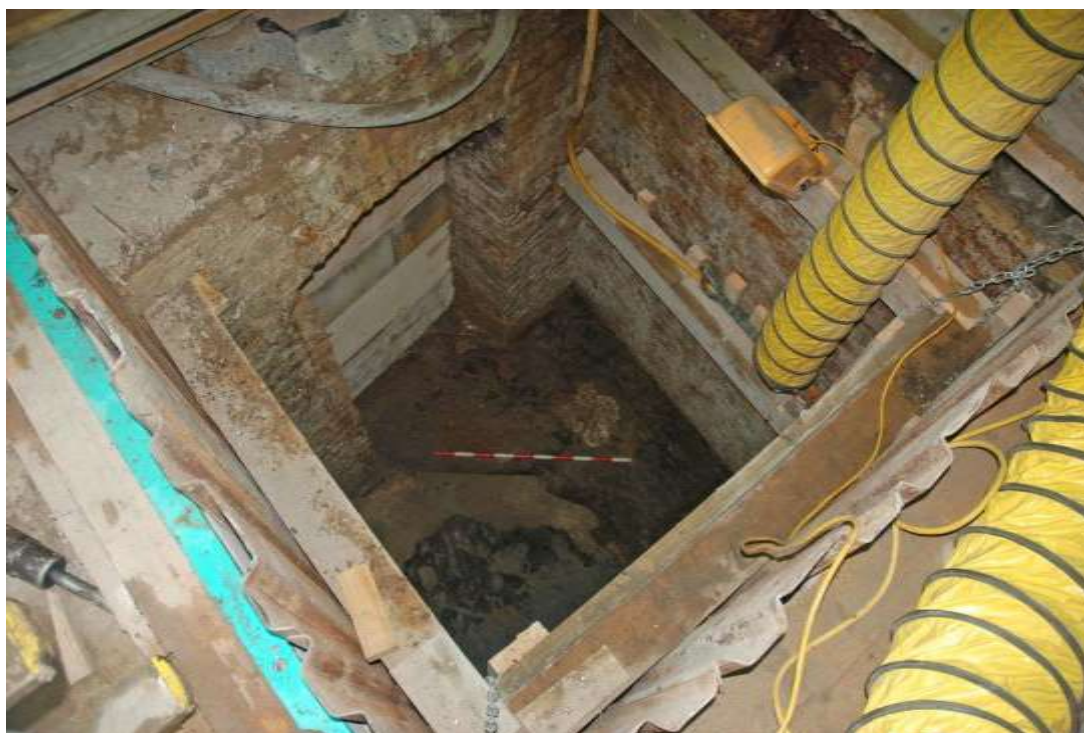
Figure 70: Dropshaft 15, excavated to floor level (13.90mOD), showing limewashed interior and access to coal cellar. Facing SW, scale 1m.

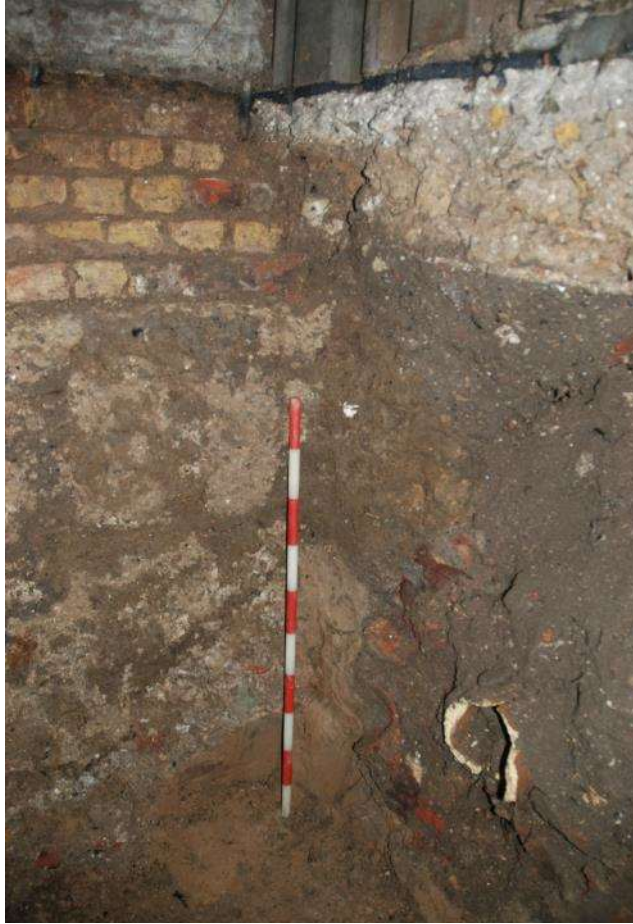
Figure 71: Dropshaft 15: Brick foundation courses below floor S[120], cutting to post-medieval drainage trenches, Roman deposits and natural brickearth. Facing NW, scale 1m.
