ALDGATE HIGHWAY CHANGES AND PUBLIC REALM PROJECT, CITY OF LONDON EC3A

An Archaeological Assessment Report

Site code: DKE13

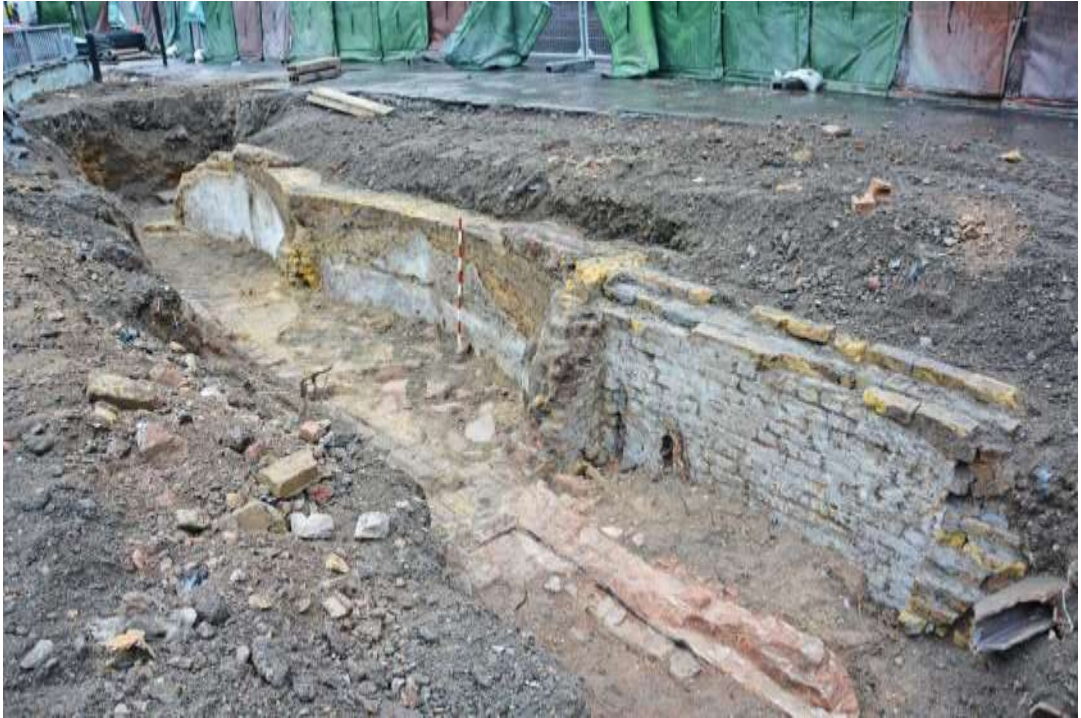
Figure 73: Row of coal cellars W[214] - W[219] observed on the western side of the central space. Taken to belong to buildings formerly fronting Duke's Place in the late-19th to early-20th century. Facing SSW, scale 1m.

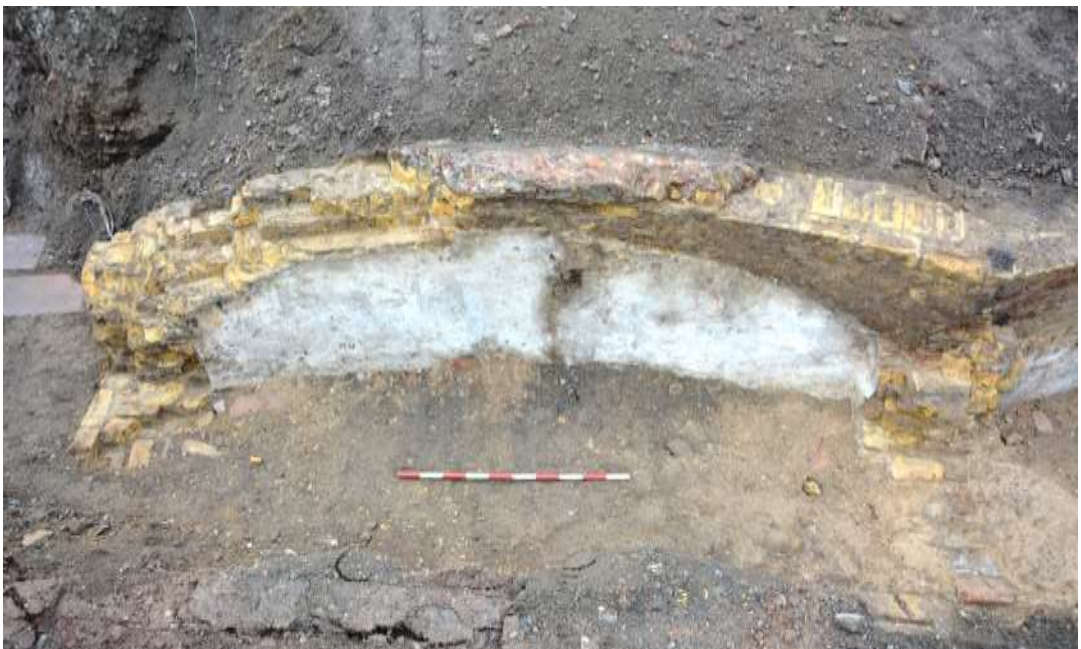
Figure 74: Southernmost cellar, with rendered interior indicating the structure had a vaulting roof. Facing SW, scale 1m.

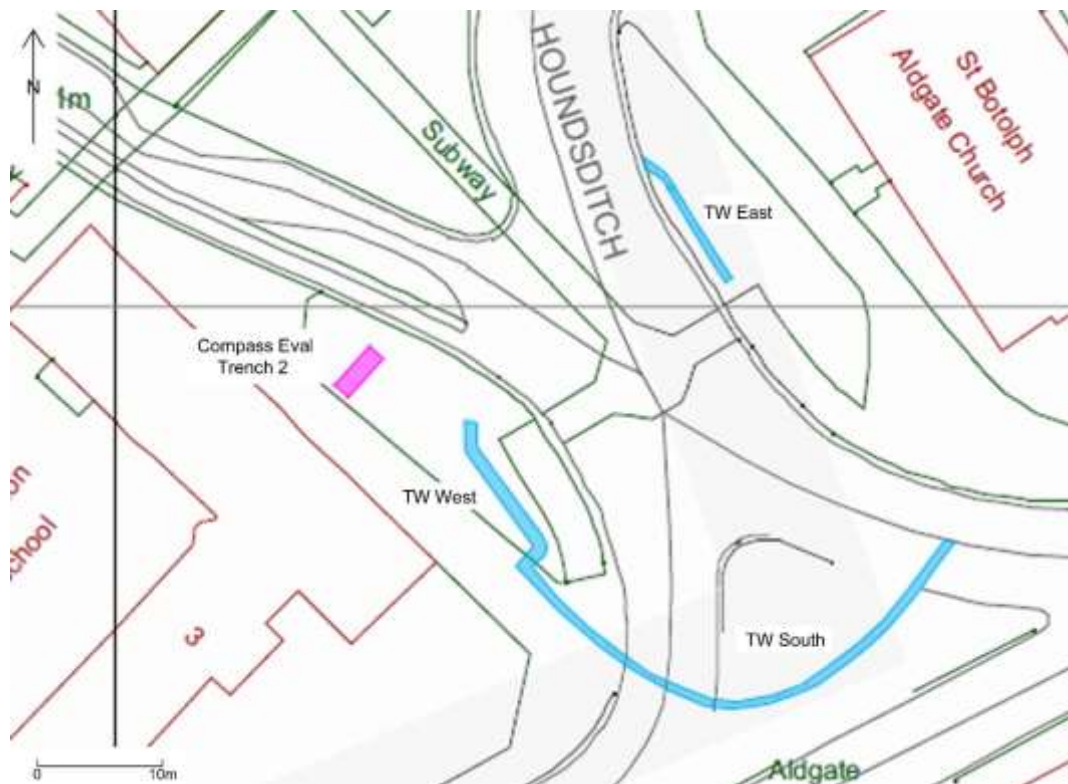
Figure 75: Plan showing the trenches in which modern archaeology was recorded.

7.6.1 During the Second World War the area was extensively damaged, particularly around Houndsditch, Jewry Street and to the east of Middlesex Street. Many of the buildings which fronted the former Duke's Place and Houndsditch were damaged beyond repair and cleared in the post-war period. The majority of the above ground structures were demolished and backfilled into their own basements, accounting for the large amounts of rubble observed throughout the investigation (fig.75).

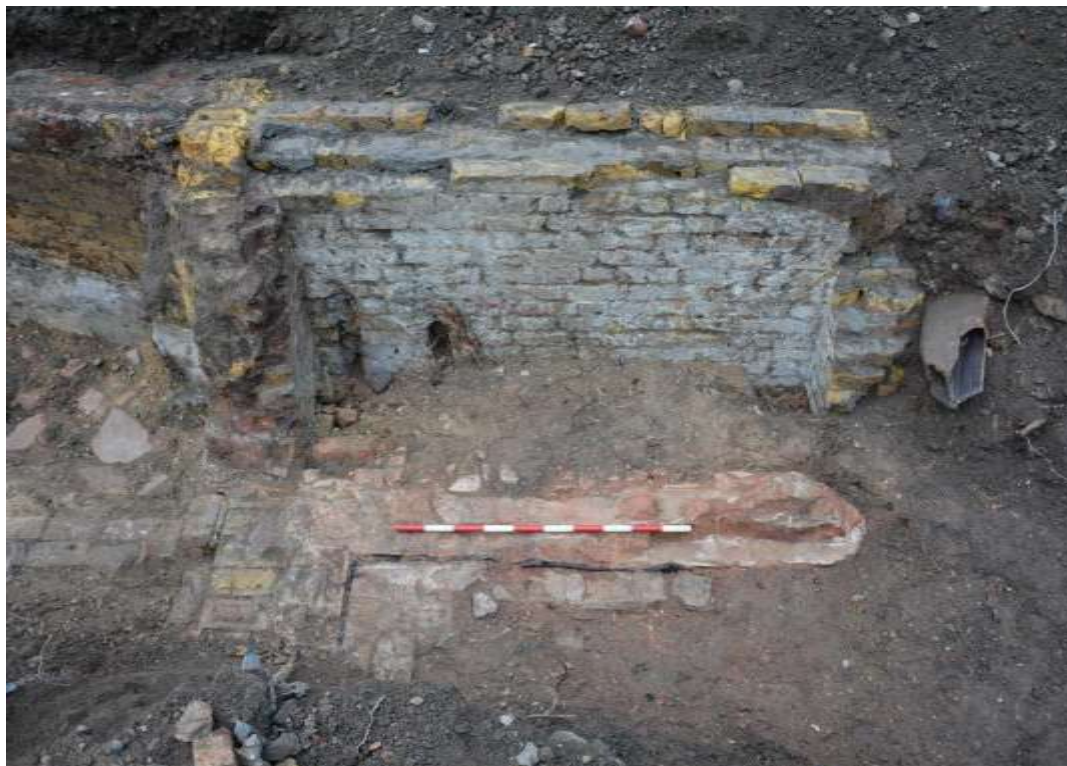
Figure 76: 1940s basement wall W[220] recorded in the eastern Thames Water re-routing trench (under scale) truncating the earlier 19th century yellow stock brick cellars. Facing SW, scale 1m.

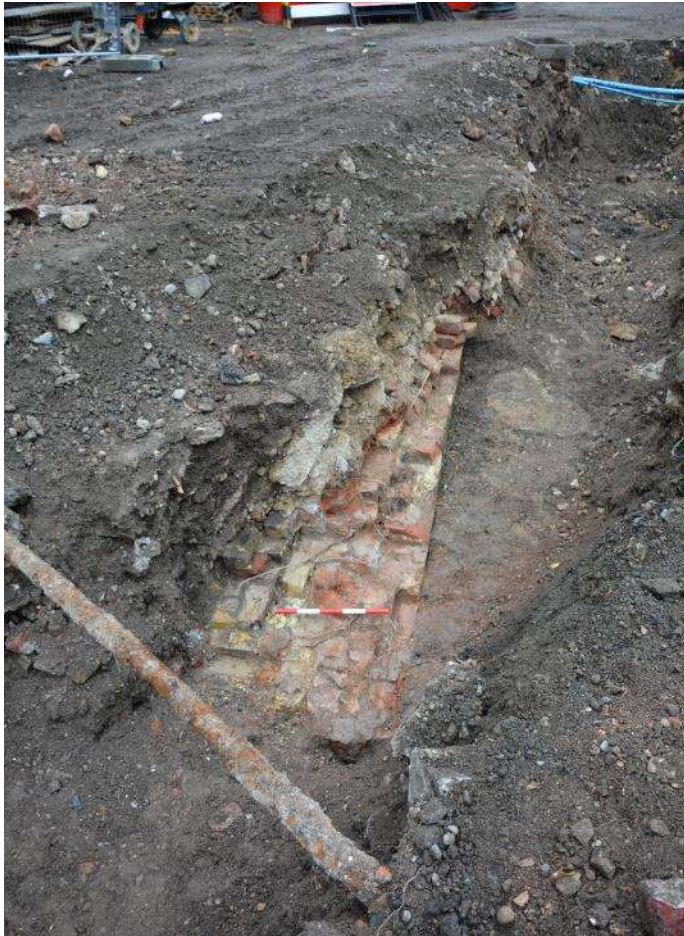
Figure 77: Continuation of W[220] seen towards the northern end of a Thames Water re-routing trench. Facing N, scale 0.5m.

7.6.2 The remains of a substantial 1940s-1950s building was recorded in two trenches undertaken between November 2015 and January 2017. The recorded sections, W[206], W[207], W[208] and W[220] consisted of pink brick walls bonded with a whitish grey to light pink mortar. One section of the structure was observed running north-south through the western side of the site, parallel to the Sir John Cass Foundation Primary School, and the second section was observed towards the northern end of the open space in the area of the pedestrian subway. The foundations were reinforced with cast iron girders set at even intervals, with the base encountered at a depth of approximately 10m below ground level (c6mOD) (fig.76-78).

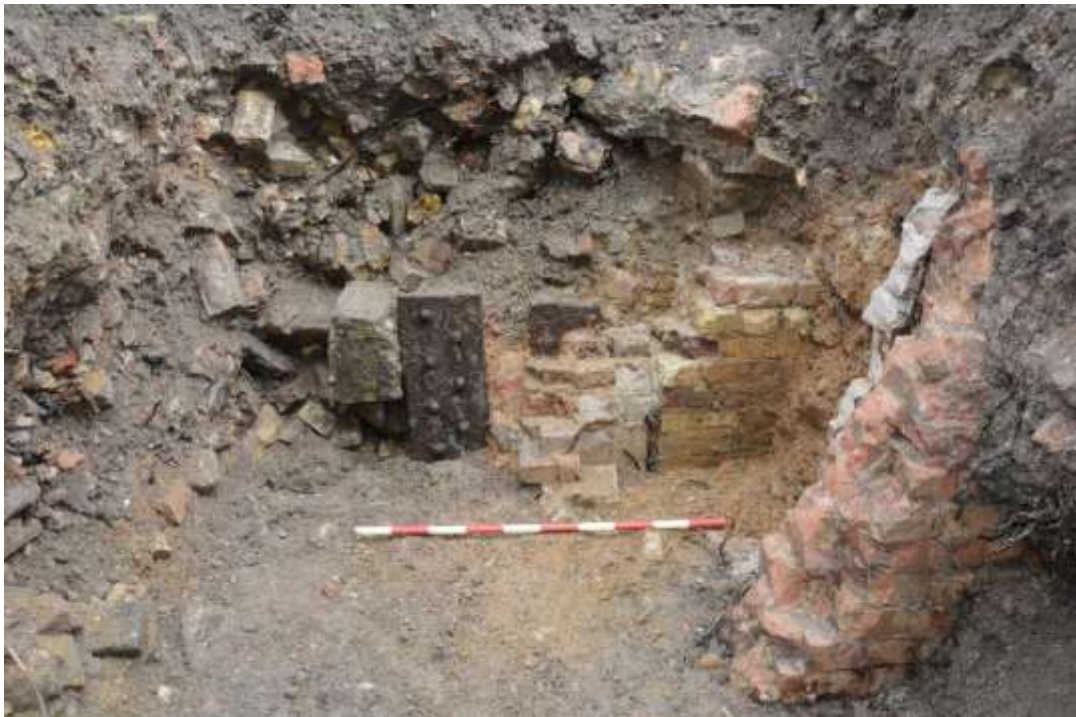
Figure 78: Compass Evaluation Trench 2 (November 2015): from L-R walls W[207], W[208] and W[206] recorded at the NE end of the trench. Facing NE, scale 1m.

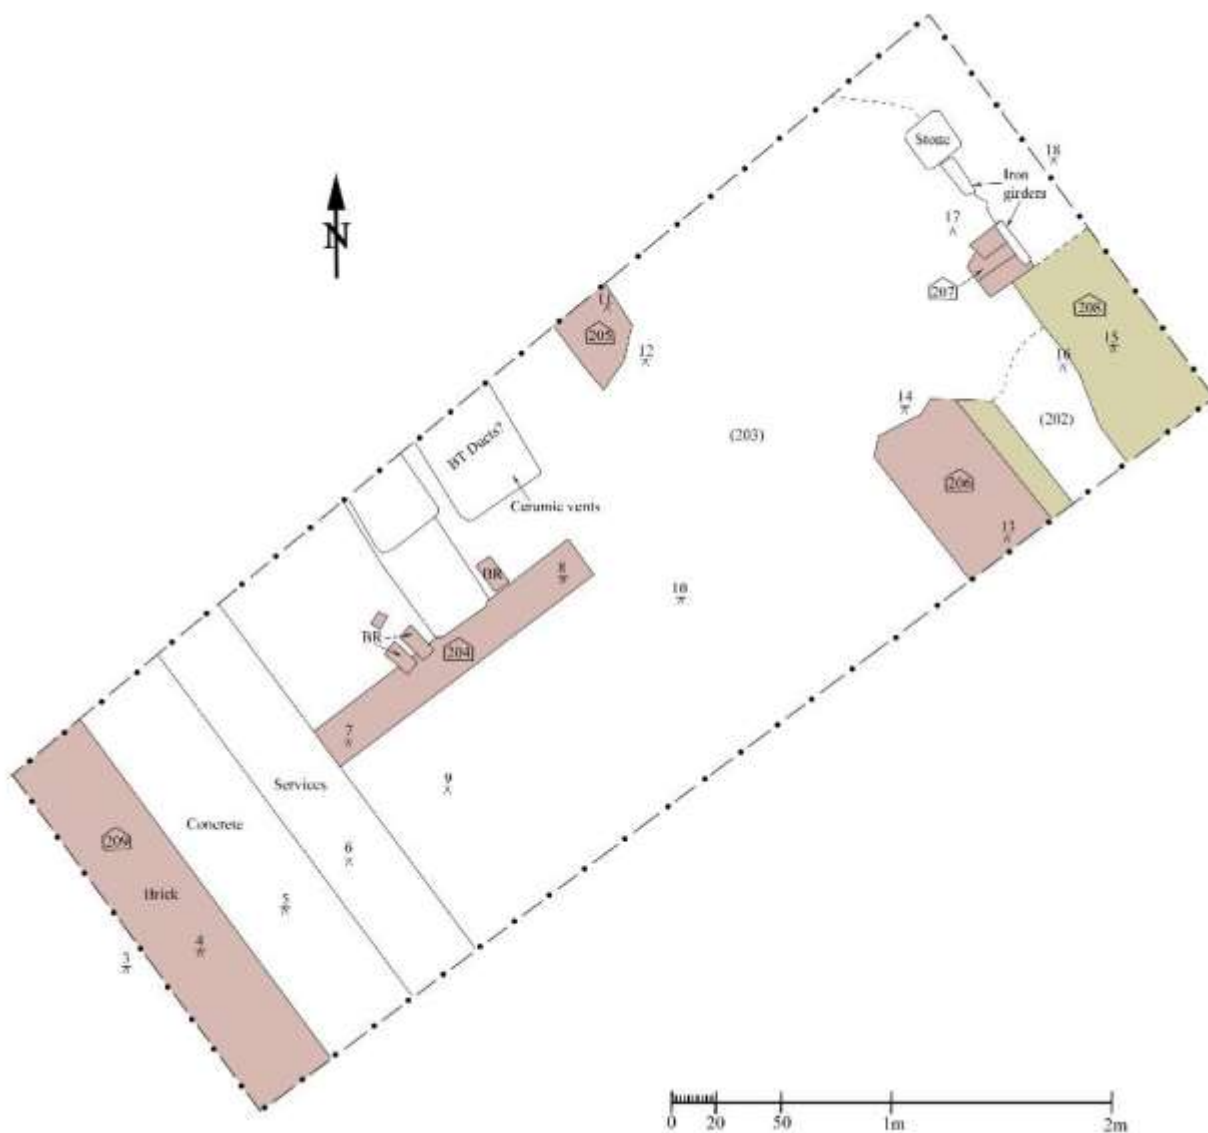
Figure 82: Plan of Compass Archaeology Evaluation Trench 2 (2015), showing post-medieval masonry W[209], W[204] and W[205] at the southwest end of the trench and the modern 1940s building, W[206], W[207] and W[208] at the northeast. Original drawn at 1:20.

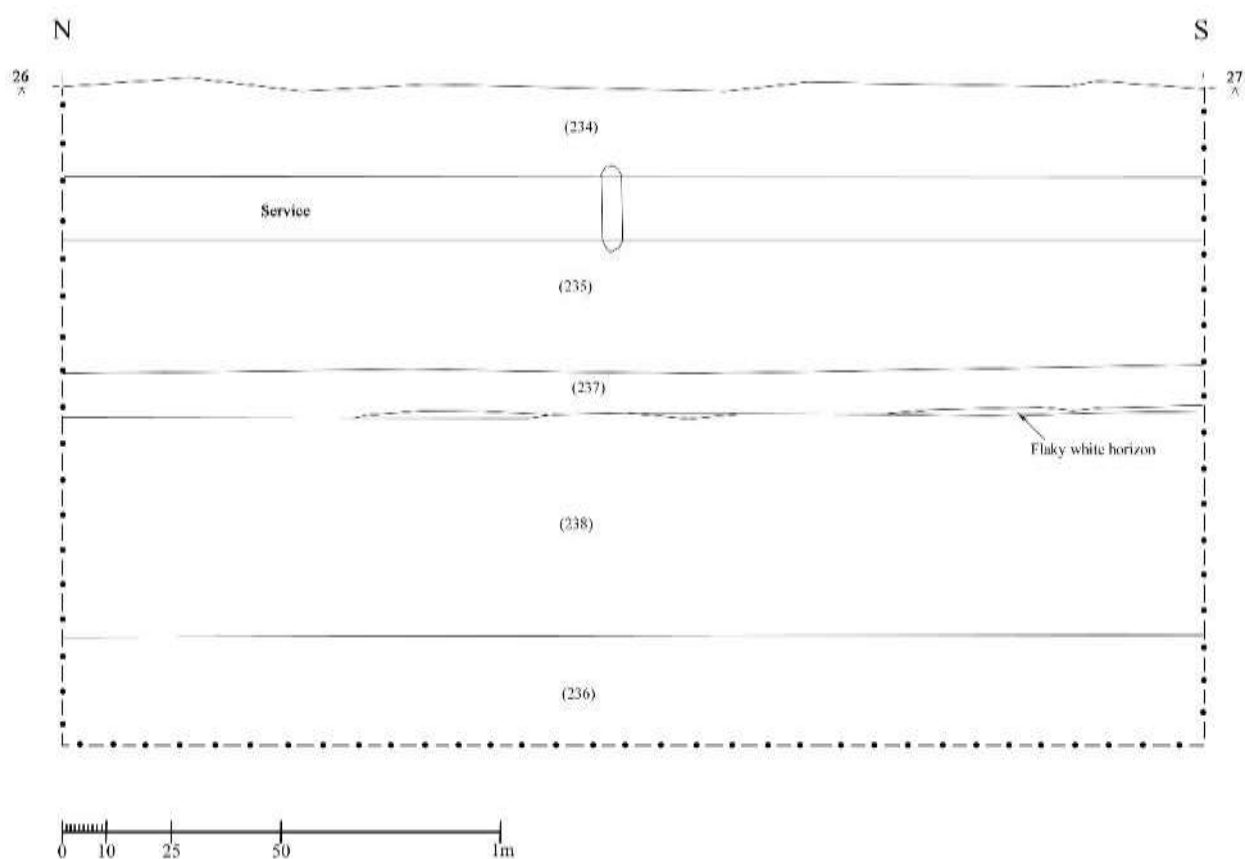
Figure 86: East facing section of TP25, with (238) taken to be the medieval incarnation of Houndsditch. Original drawn at 1:10.

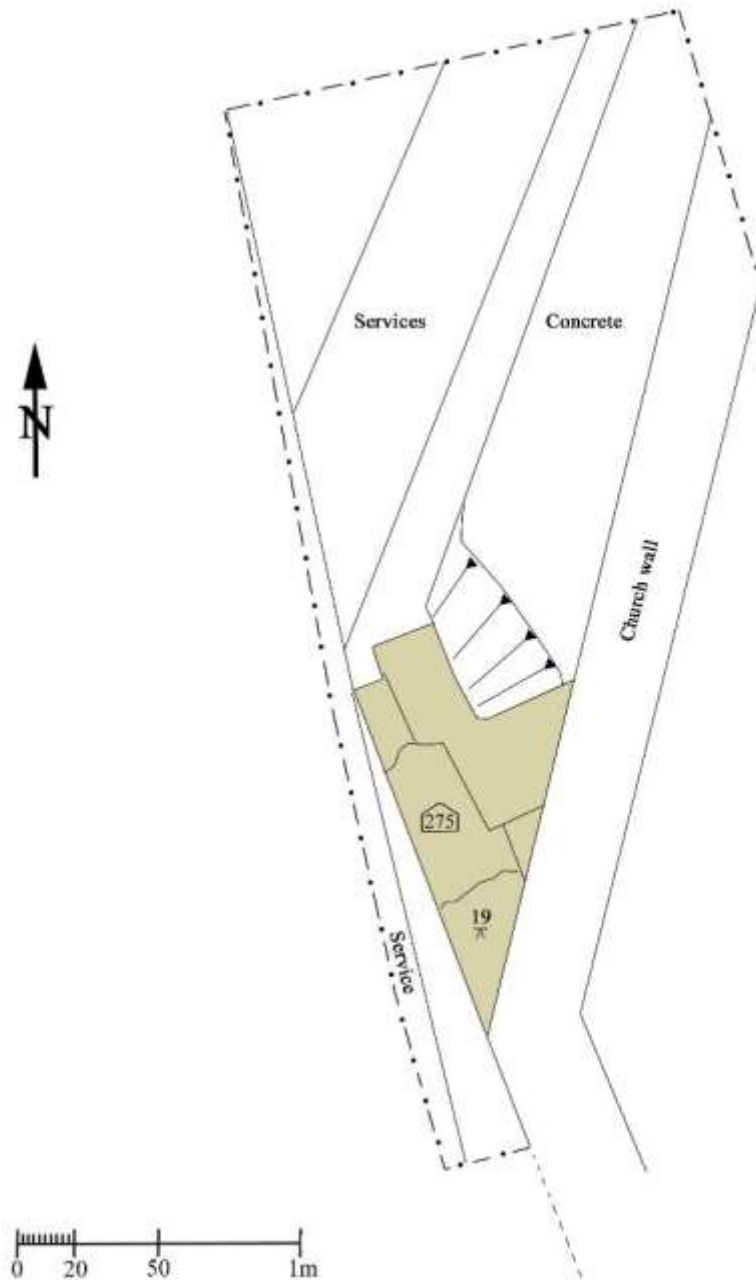
Figure 87: Plan of TP22, showing the previously line of the church boundary wall W[275].
Original drawn at 1:20.

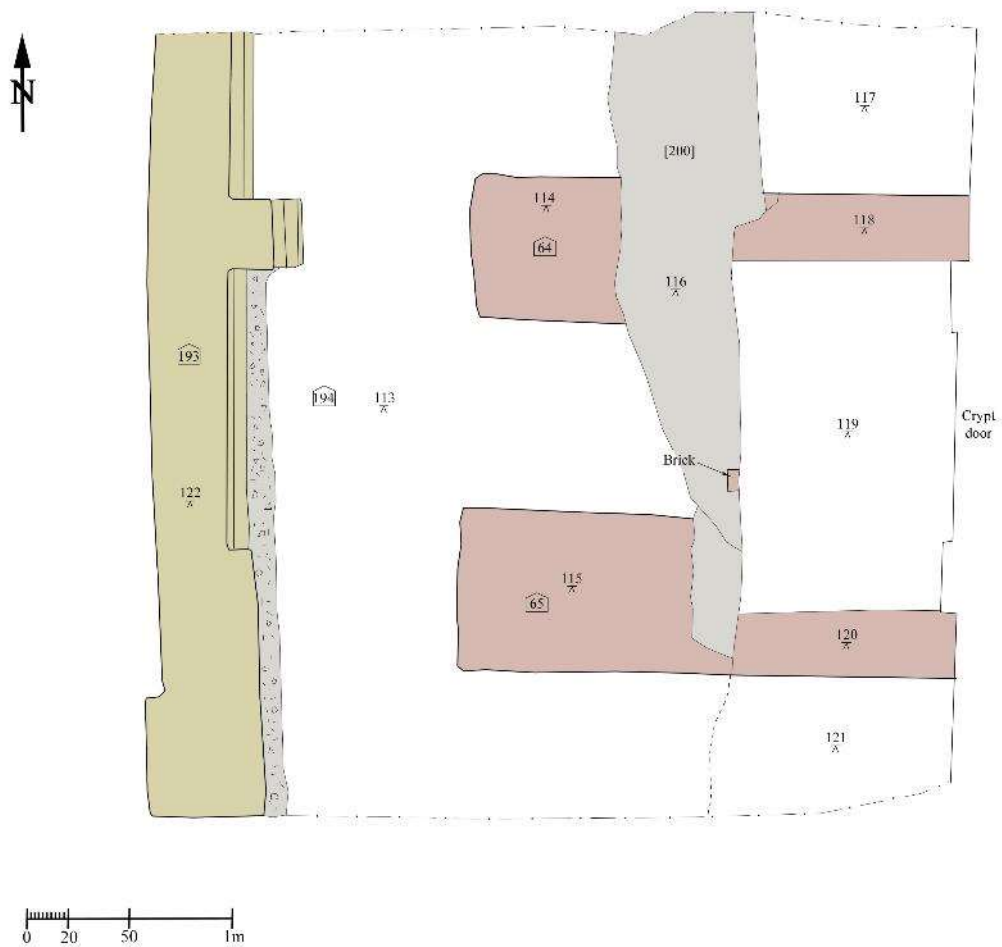
Figure 90: Plan of trench beneath crypt door, showing brick foundations W[64] and W[65] taken to be the base of a former staircase. The majority of the burials were recorded to the east of the concrete drain base [200]. Original drawn at 1:20.

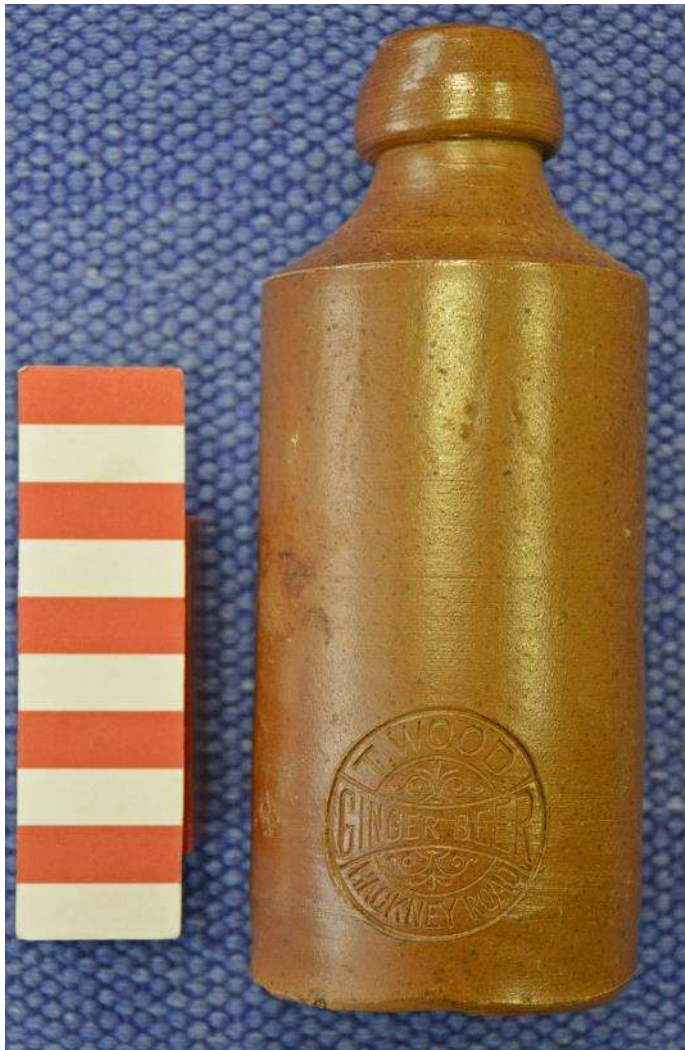
Figure 96: Stoneware Ginger Beer bottle recovered from context (288).
Scale 10cm.

Most of the 18th century and later material comprises domestic pottery. A complete stoneware bottle from context 288 is stamped “T. Wood Hackney Road Ginger Beer” (fig.96). An advertising poster for the company, which specialised in mineral waters, is in the British Library (Pressmark: Evan. 4303) and is dated to c.1885. It states that the company at that time had been “*Established upwards of half a century*”. Two further complete bottles and one missing its neck, along with a small jug missing its handle, occurred in context 275 (fig.97). One of the bottles was stamped “Metcalf” and the jug “W Ward Colourman Chandois Street” (*sic*). The latter sold artists’ supplies in Chandos Street in Covent Garden between 1773 and 1788. In addition to the pottery, a fragment of a tin-glazed wall-tile occurred in context 80.

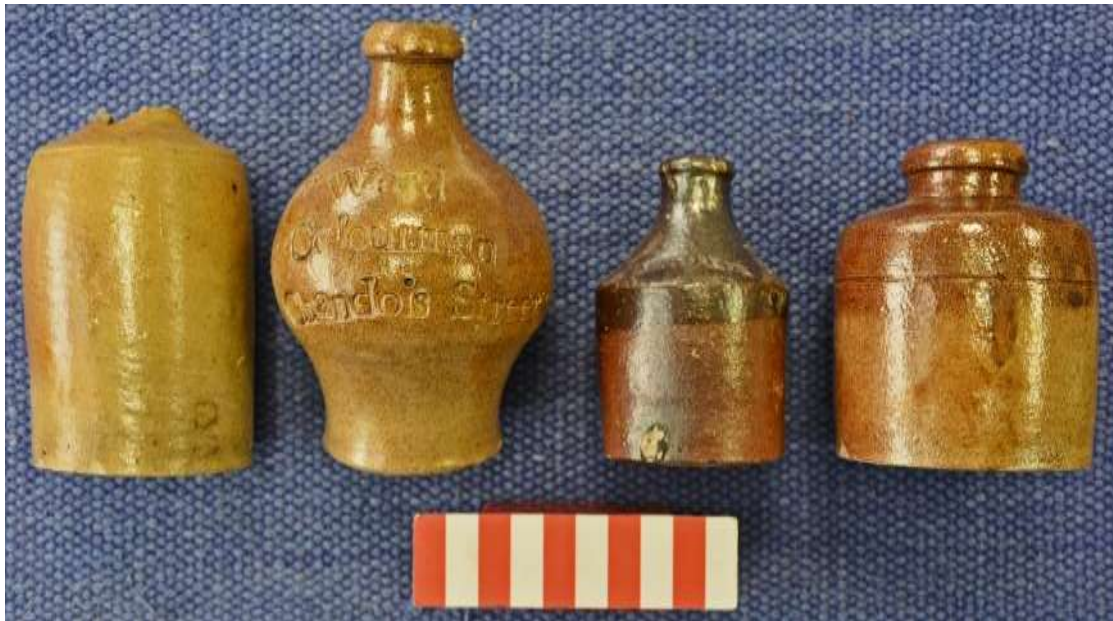
Figure 97: Assemblage of stoneware bottles recovered from context (275). Scale 10cm.

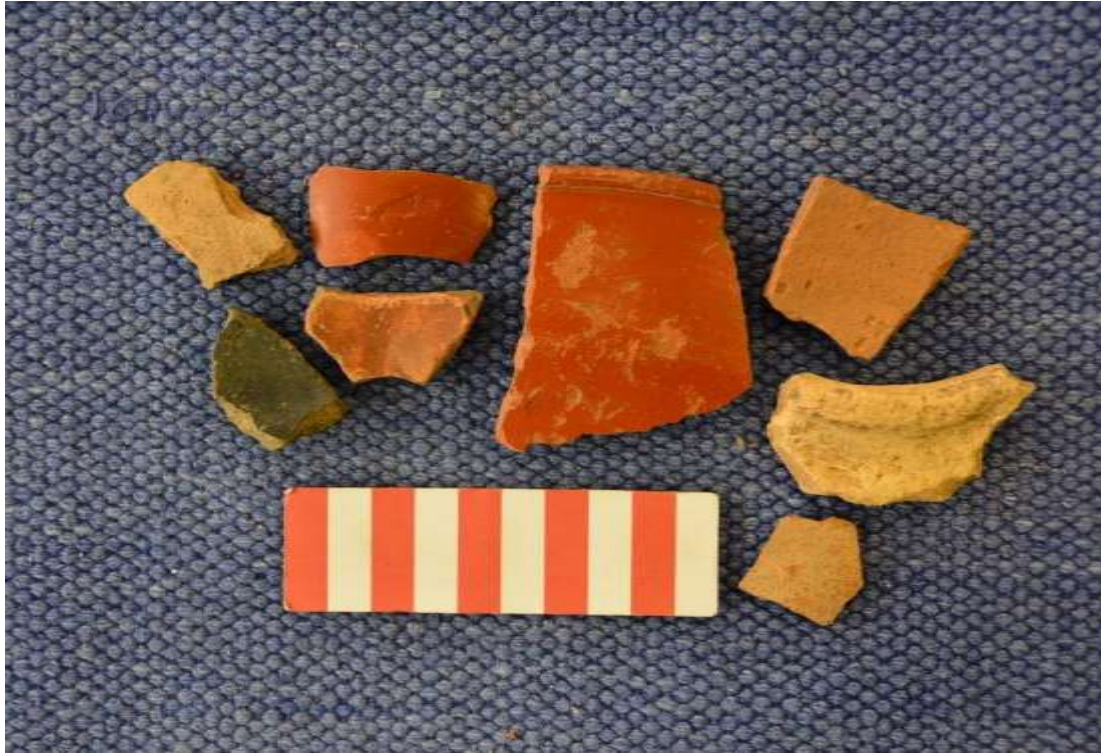
Figure 101: Fragments of Roman pottery recovered from context (80), including grey ware (bottom left), samian (centre) and Verulamium Region white ware (right). Scale 10cm.

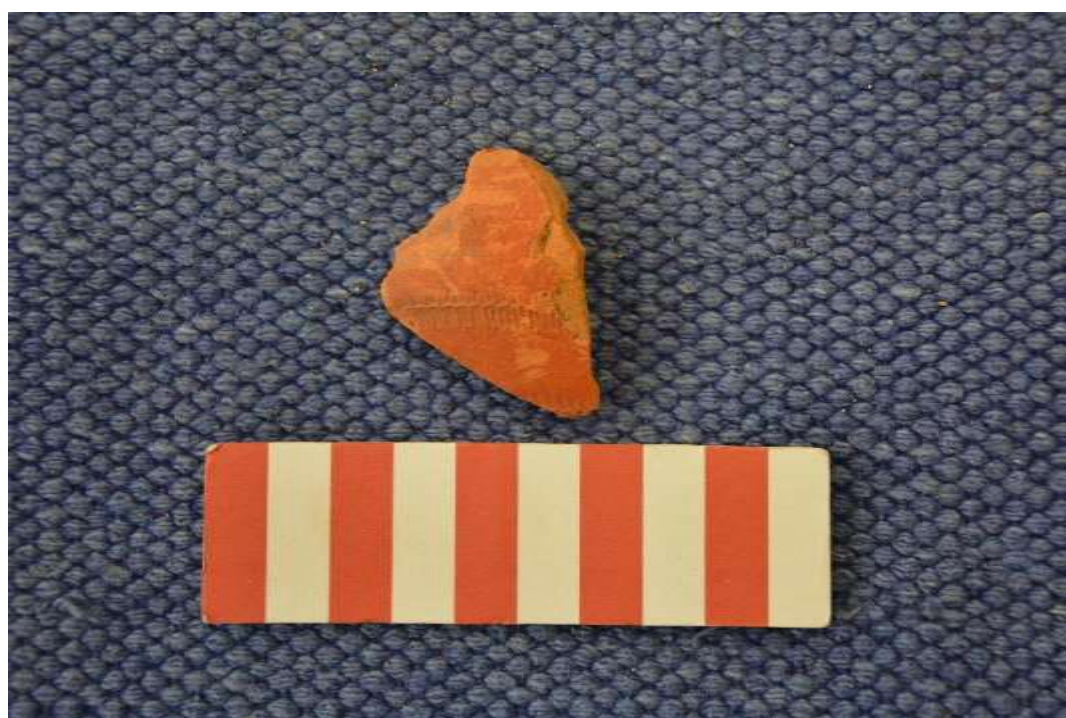
Figure 103: Fragment of a rouletted dish from context (81). Scale 10cm.

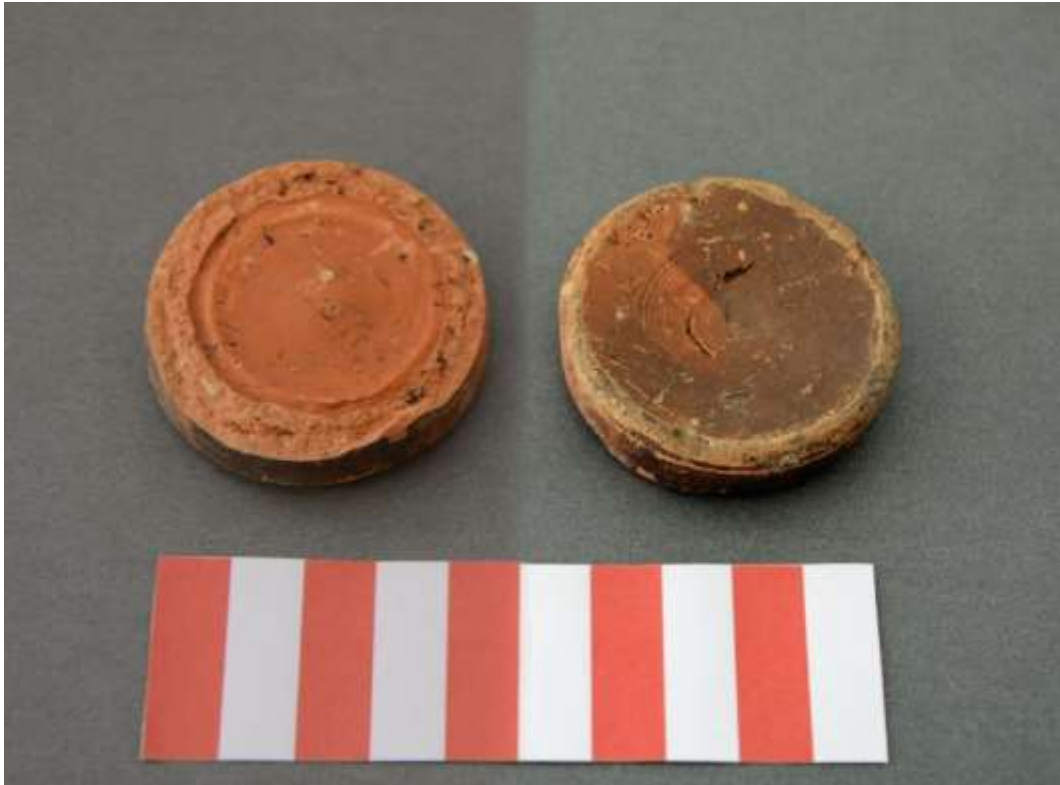
Figure 104: Base (interior and exterior) of a colour coated beaker from context (103). Its shape suggests it has been cut down and reused as a counter. Scale 10cm.

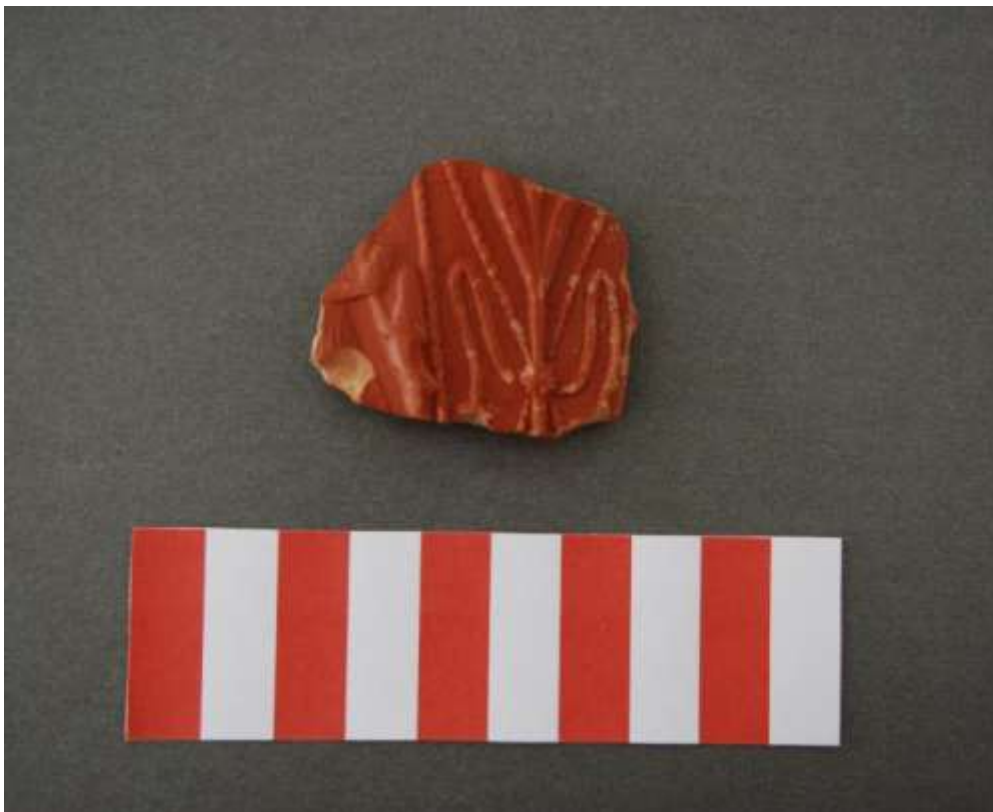
Figure 105: fragment of decorated samian from context (125), showing Diana holding a hare (left). Scale 10cm.

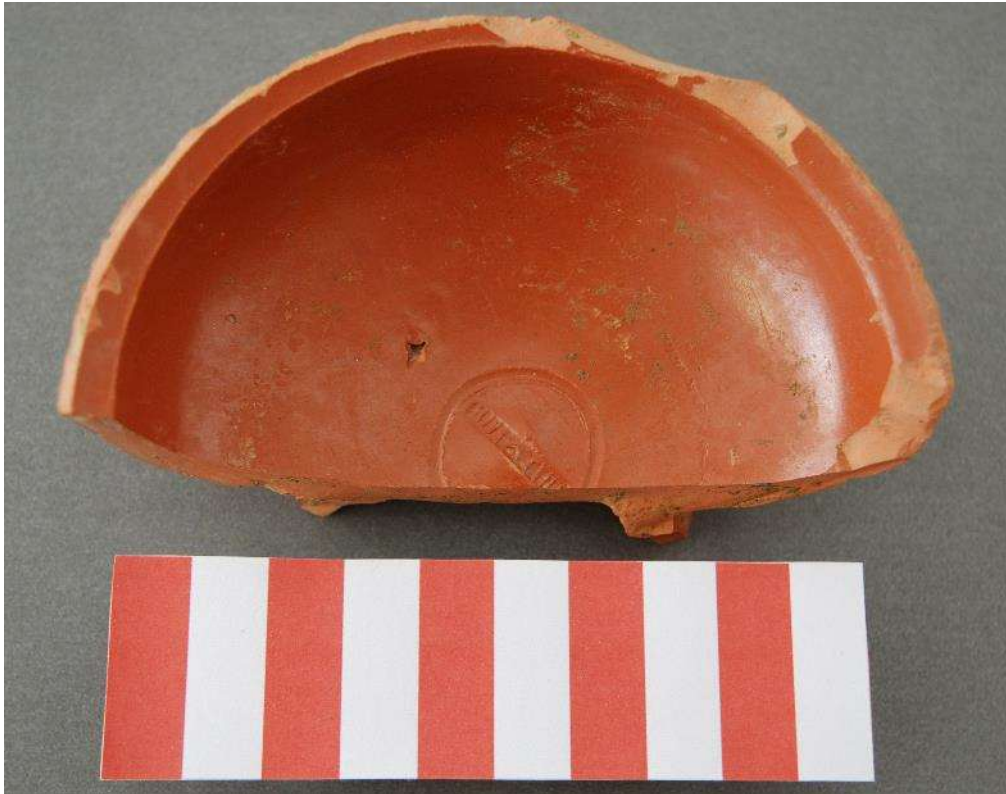
Figure 106: Samian cup from context (125), stamped by an illiterate potter. The lack of upper wall and rim indicates the vessel was cut down and reused. Scale 10cm.

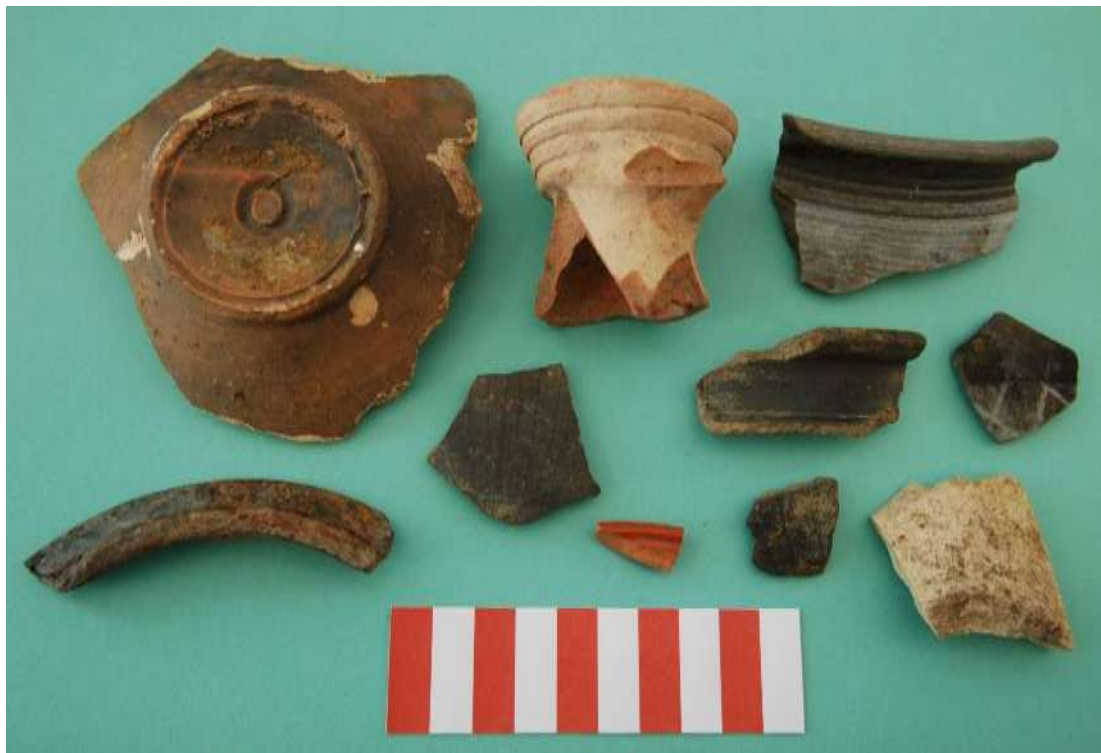
Figure 107: Assortment of wares and vessels recovered from context (125). Scale 10cm.

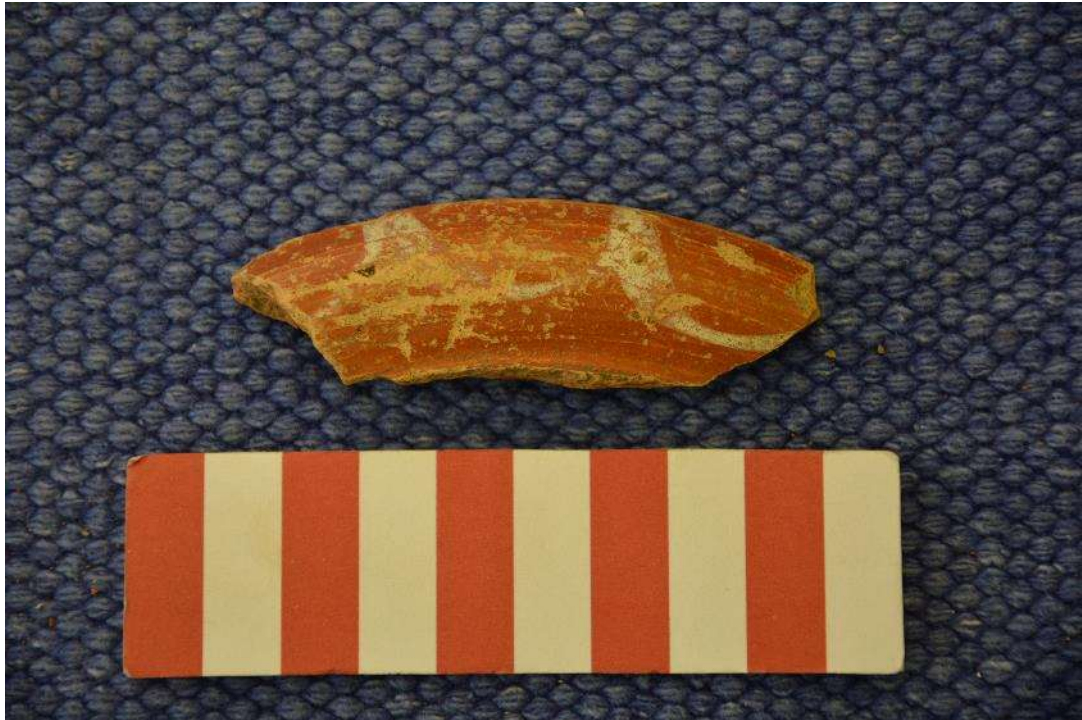
Figure 108: Fragment of Oxfordshire red/brown slipped ware from a flanged vessel, context (177). Scale 10cm.

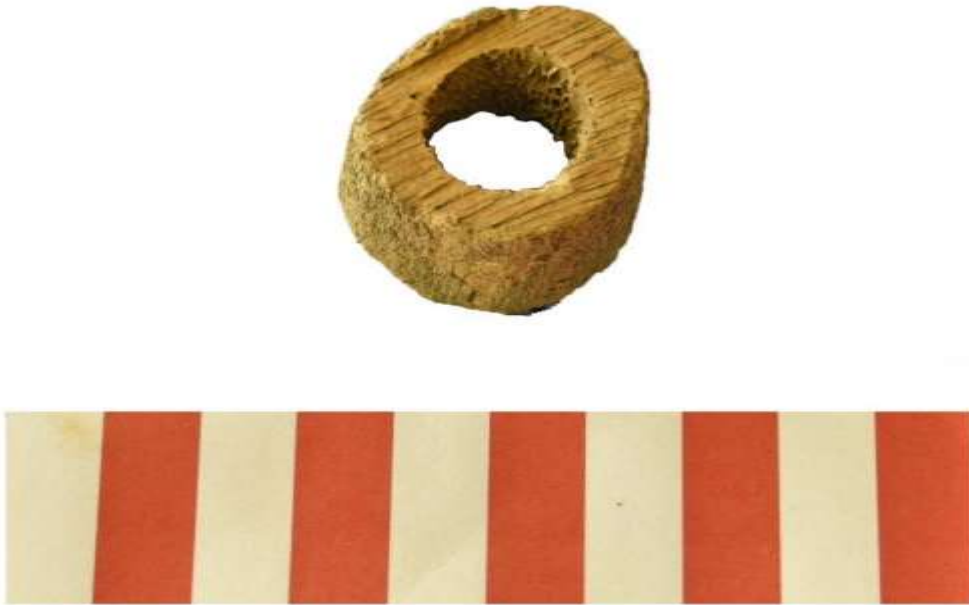
Figure 109: Worked bone from context (108). Scale 10cm.

Context (108) was a general backfill in the drainage for the church. The worked bone comprised a ring, sawn from the shaft of an unidentified long bone (fig.109). It measured 15mm wide with an exterior diameter of 32mm and an internal diameter of 20mm. Its use has not been identified.

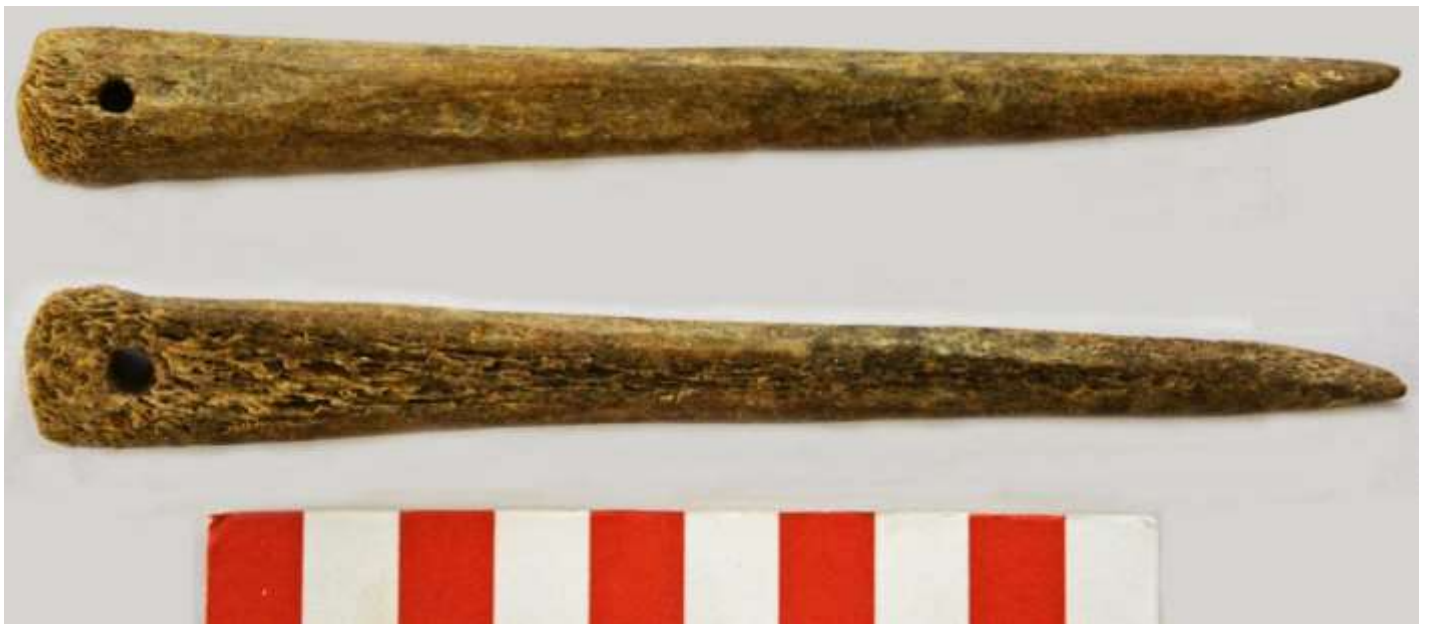
Figure 110: Worked bone from context (282). Scale 10cm.

Context (282) was visible in drop shaft 5, and comprised an early post-medieval fill of an extraction pit. The worked bone example was made from an unidentified bone from an unknown species. The bone was unidentifiable because it had been carved down into the shape of an awl or similar (fig.110). The bone measured 143mm long and 17mm wide at one end, tapering to 3.5mm at the other end. A hole was bored through the bone at the wider end. It was been interpreted as a potential awl or tool for knotting fishing nets. The hole may have been threaded in order to sew or knot together thick materials where the perforation was already present. The bone was not sharp enough to pierce anything substantial.

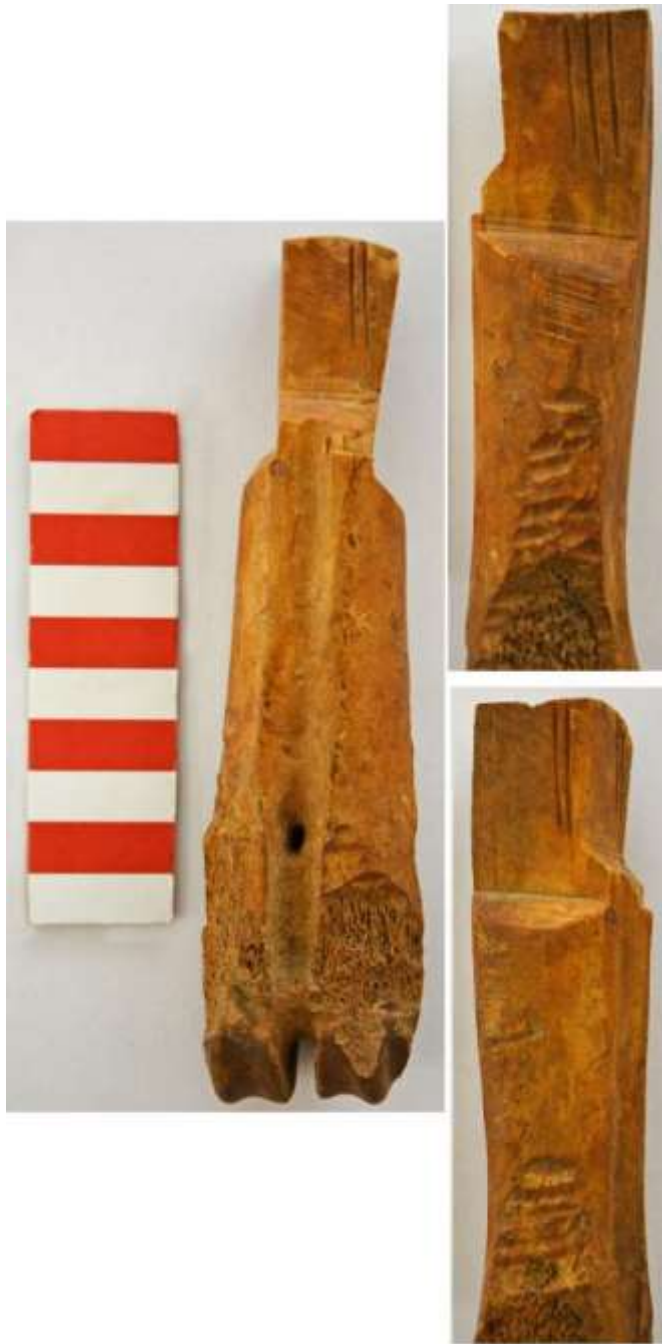
Figure 111: Worked bone from context (303). Front view (left), right side view (top right) and left side view (bottom right). Scale 10cm.

Context (303) was visible in drop shaft 8, and comprised an early-post medieval general made-ground backfill. The worked bone example was made from a cow metapodial. It is random in shape and seems to have been used for carving practice. The proximal end of shaft is shaped into rough square with 2/3 vertical cut marks on each face. At the base of the squared portion are horizontal cut marks of varying thickness. The distal end of the bone remains generally unmodified, though it has been narrowed (fig.111).

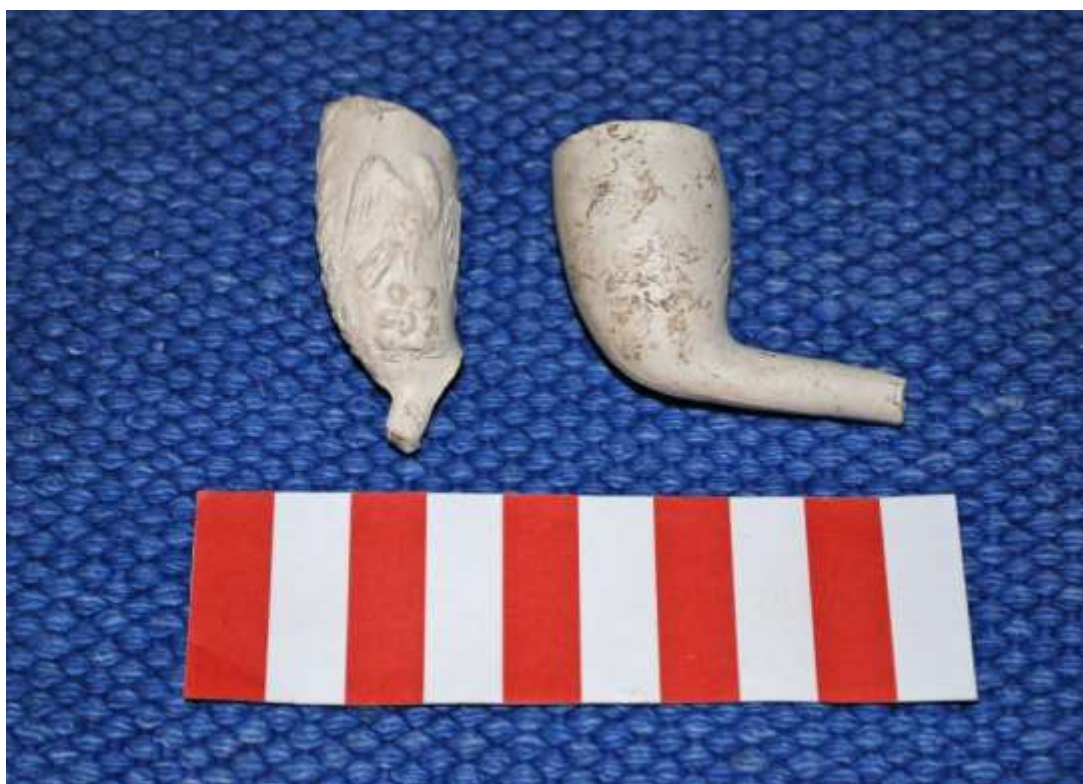
Figure 112: Bowls recovered from context (67), including one decorated with an eagle (left). Scale 10cm.

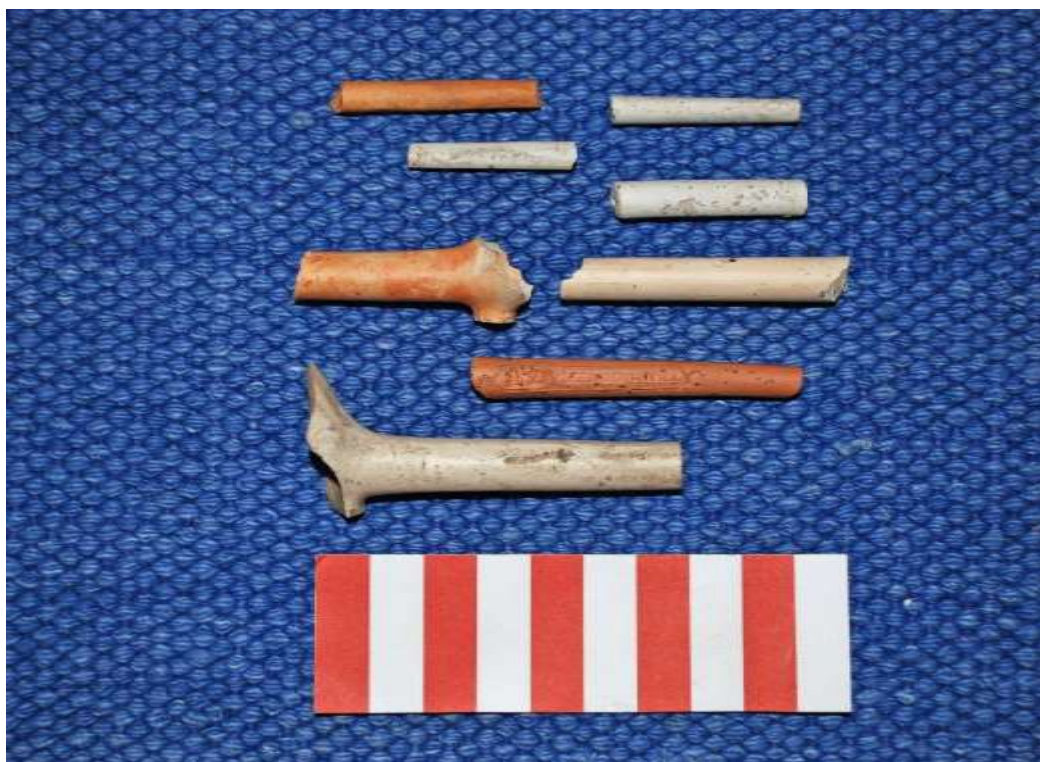
Figure 113: Glazed and unglazed stems recovered from context (233), including one unglazed stem stamped '12 McDOUGALL'. Scale 10cm.

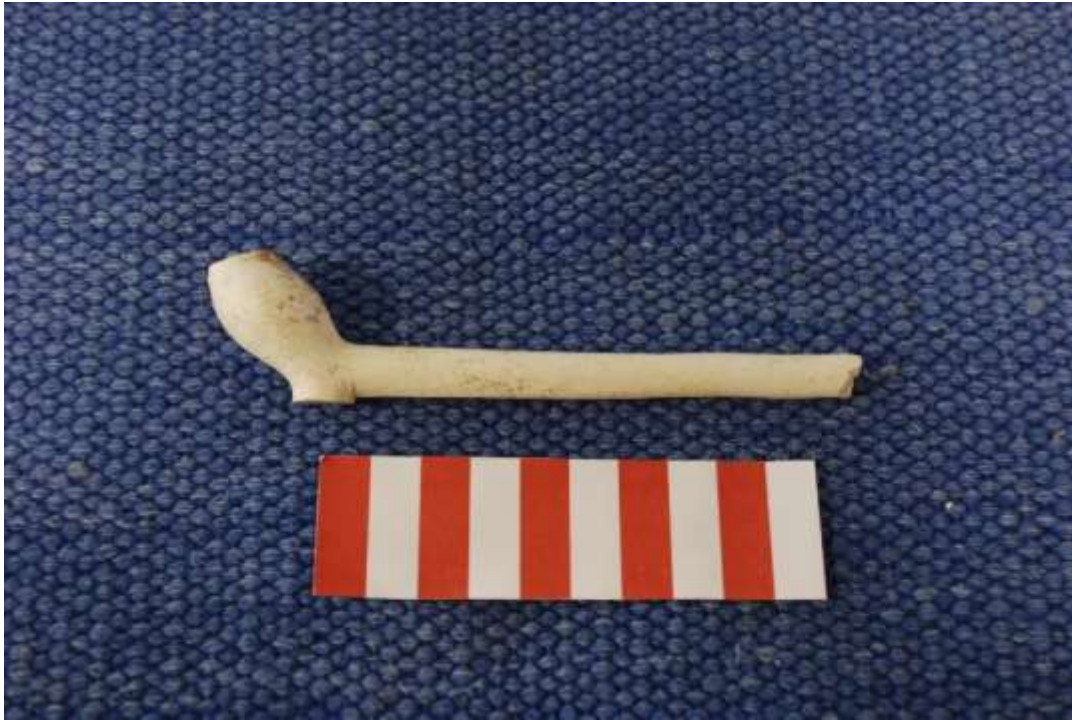
Figure 114: Bowl and partial stem recovered from context (281), dated 1610-1640. Scale 10cm.

(281)	Bowl and partial stem	5	1610-1640	1	28	14	102	9	4	Burning in bowl
-------	-----------------------	---	-----------	---	----	----	-----	---	---	-----------------
