ALDGATE HIGHWAY CHANGES AND PUBLIC REALM PROJECT, CITY OF LONDON EC3A

An Archaeological Assessment Report

Site code: DKE13

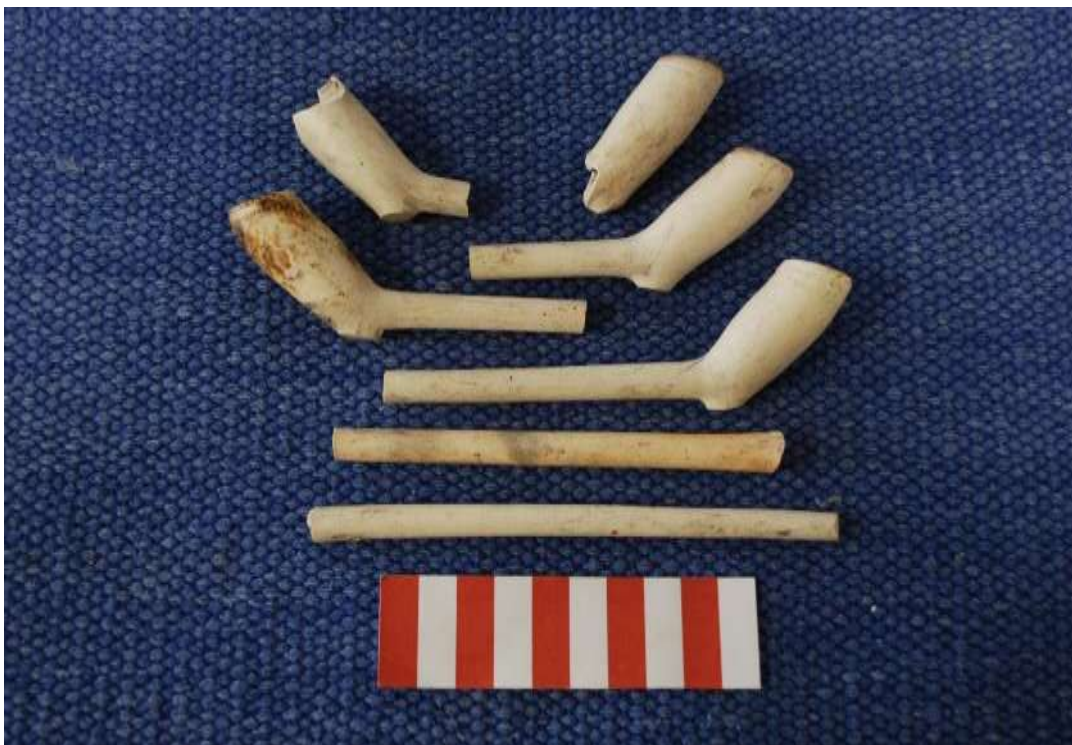
Figure 115: Bowls and stems recovered from context (242). Scale 10cm.

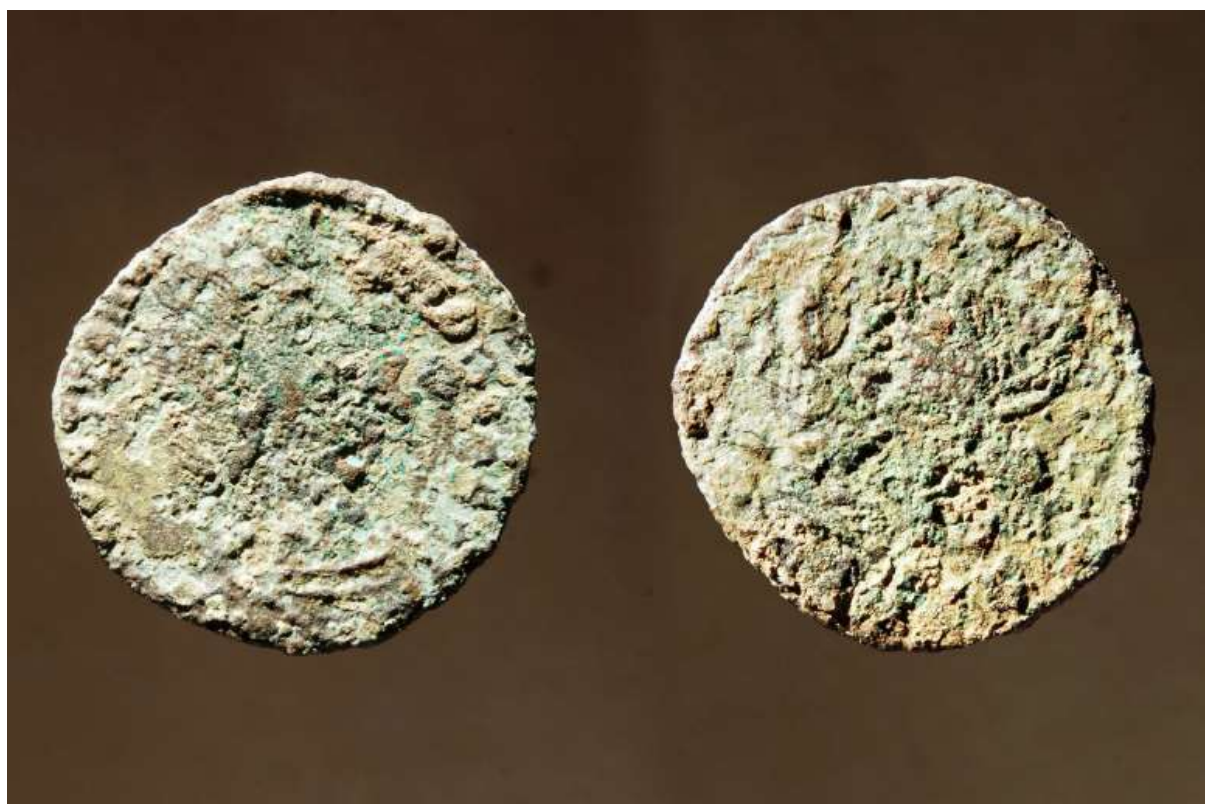
Figure 116: 'Fallen Horseman' Roman coin, recovered from dropshaft 12. No scale.

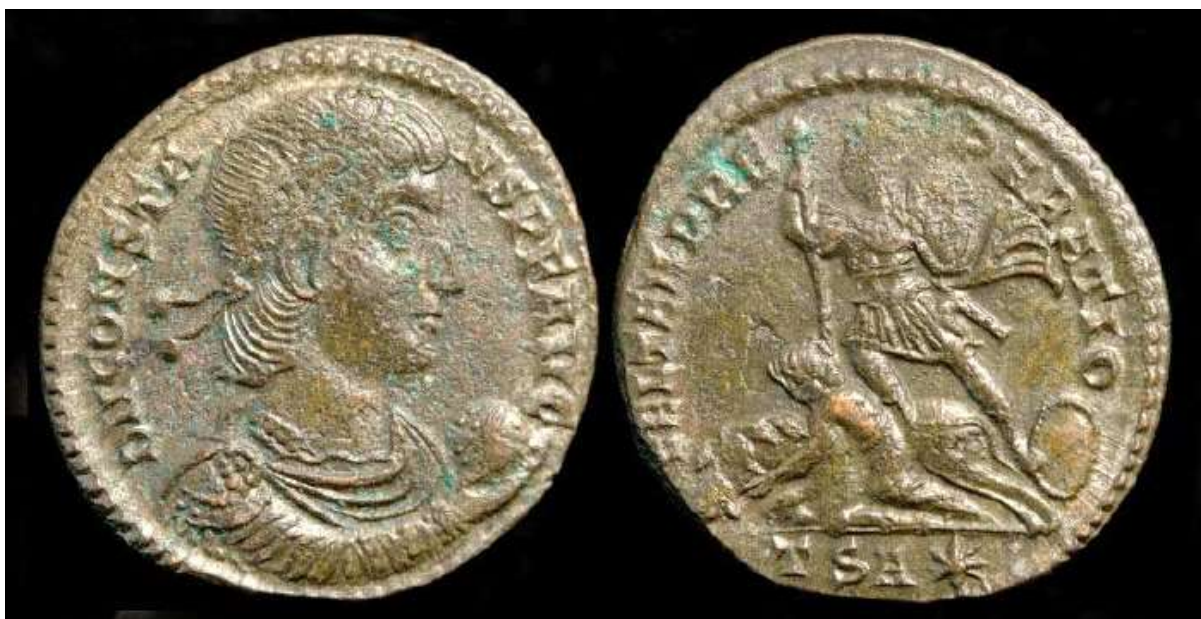
Figure 117: Comparative example of the coin recovered from dropshaft 12. No scale.
