# **WATER MAINS REPLACEMENT WORKS, SHOREHAM, KENT, TN14**

## **AN ARCHAEOLOGICAL WATCHING BRIEF**

SITE CODE: SHO18  
NGR REF (APPROX. CENTRE): TQ 52199 61574

January 2019

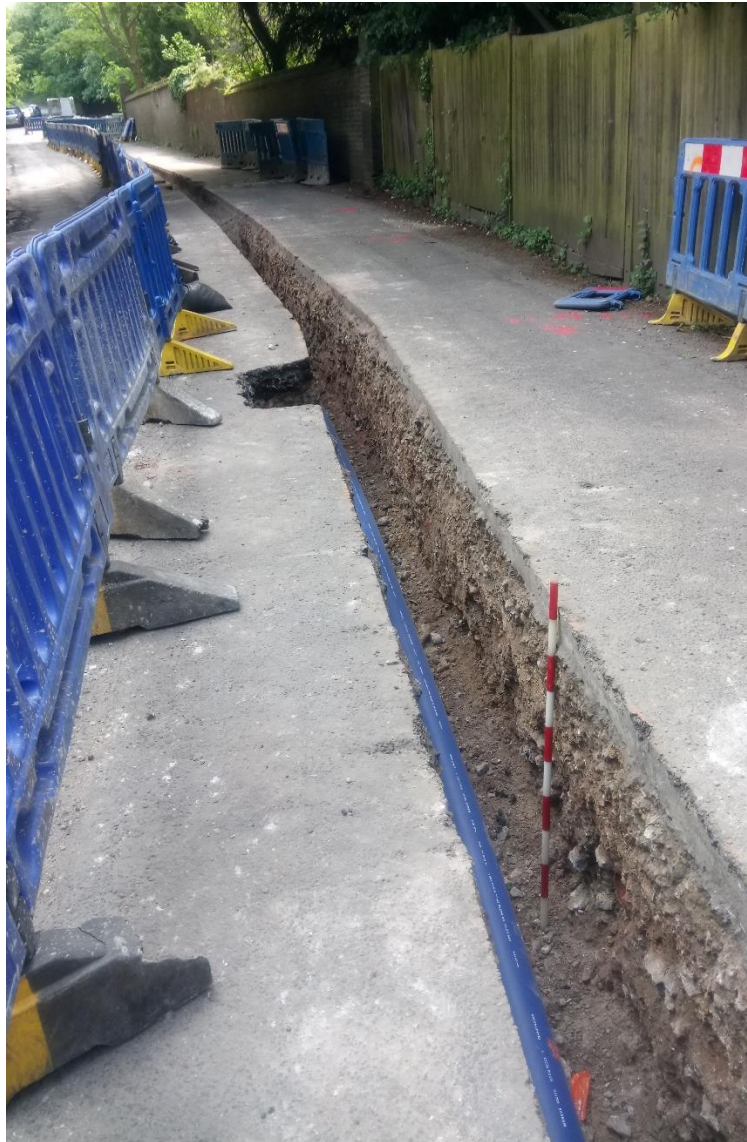
- 7.3.5** The stratigraphy seen here comprised tarmac, (1), 0.12m thick overlying a natural well-compacted, light grey flint gravel, (10), seen extending beyond the base of the trench (fig. 8). A small section of red and yellow brick fragments set in concrete were seen in the southern section of the trench in front of The Lodge (fig. 9). As the bricks were set in concrete retrieving a sample was not possible, and no other finds or features were recorded.

*Figure 8: Open cut section of trench, facing SE, scale 1m*

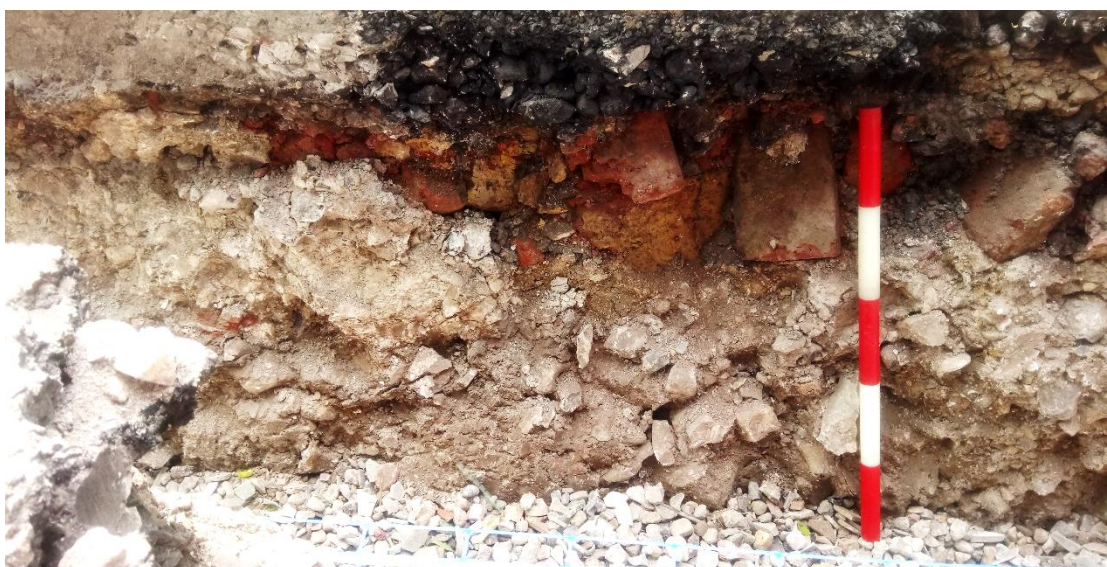
*Figure 9: Bricks in S section of open cut trench. Looking SSW, scale 0.5m*

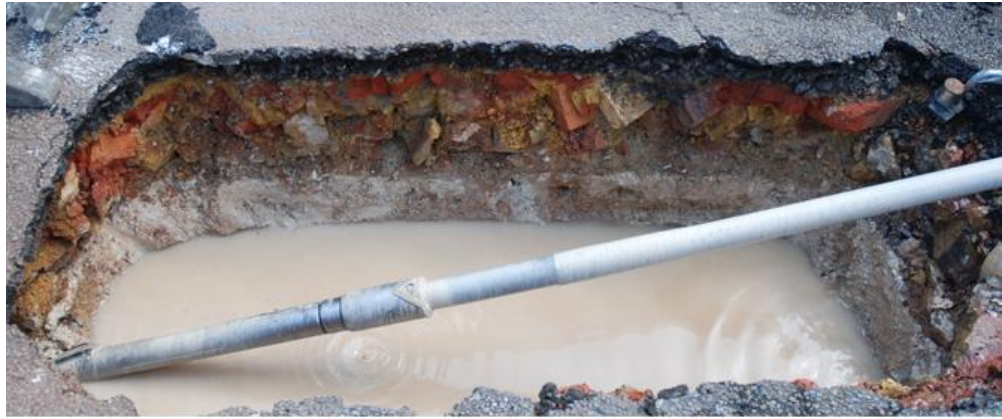
Figure 11: SW facing section, pit 28. Top: photograph, looking NE, no scale. Bottom: sample section, original drawn at 1:10.

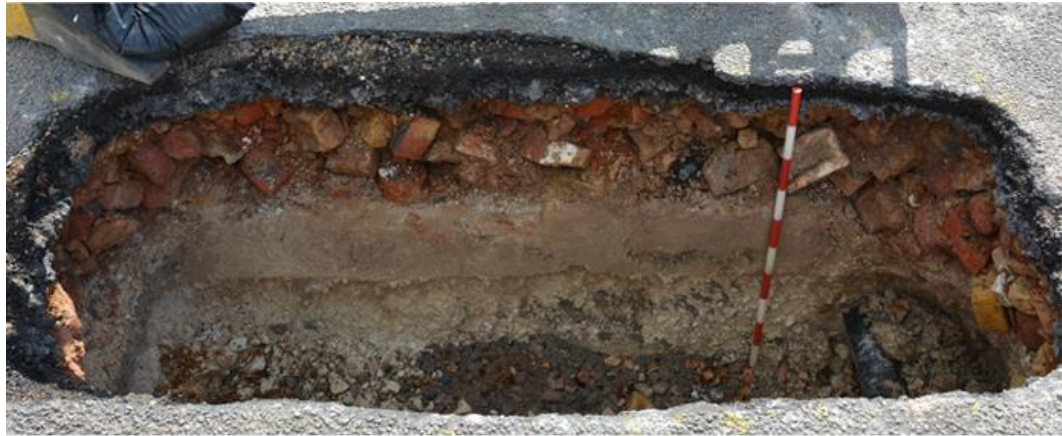
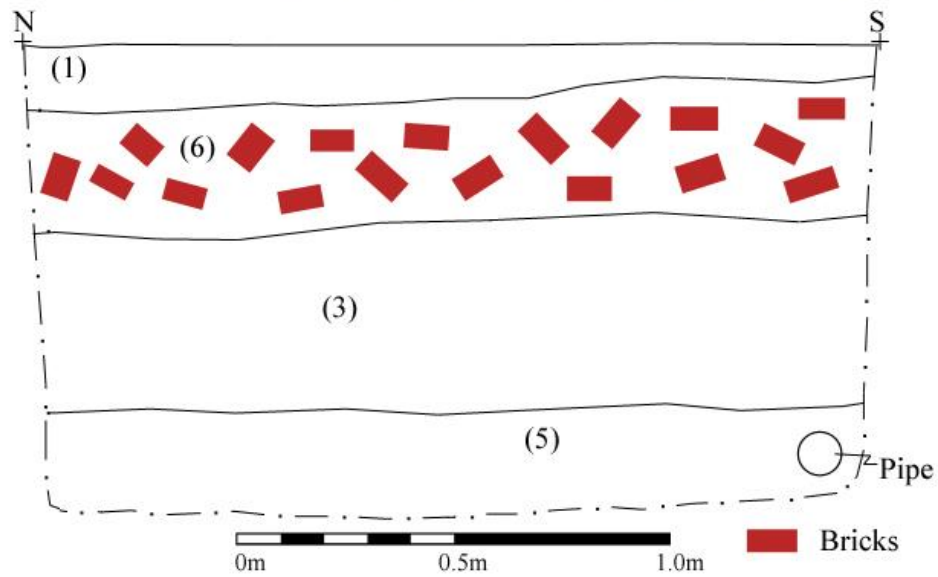
**7.4.2** The stratigraphy seen across Shoreham Place was similar, though some variation was recorded between trenches. In all instances the pits were overlain with tarmac, (1), 0.08-0.17m thick. In pits 14-18 and 25-33 the tarmac overlay a red brick and concrete rubble layer- (6), 0.2-0.5m thick (fig. 11). In pits 19 and 21-24 the tarmac overlay a mid-grey-brown gravelly silt (29), with a varying presence of modern made ground including pea gravel surrounding existing services. Underlying the sub-tarmac deposits was pale-brown reworked chalk (3), seen extending beyond the base of the pits. In pit 16 the natural white chalk, (5), was encountered at the base of the pit (fig. 12).

Figure 12: E facing section of pit 16. Top: Photograph, looking W, scale 1m. Bottom: sample section, original drawn at 1:10

**7.4.3** The archaeological sequence here comprised a modern road surface over a post-medieval made ground layer of brick rubble, potentially related to the demolition of Shoreham Place/Court. It is possible that the bricks, some being glazed and found with glazed tiles were remnants of the fountain that stood in the driveway of the estate house. Dates provided for the brick samples retrieved are mid-late 19<sup>th</sup> century though and therefore cannot be associated with the original construction of Shoreham Place in 1838. (Appendix II). It is possible that the fountain was a later addition to the grounds as the first map it appears on was produced in 1871, but this cannot be securely determined. No other archaeological finds or features were recorded in any of the pits on Shoreham Place.

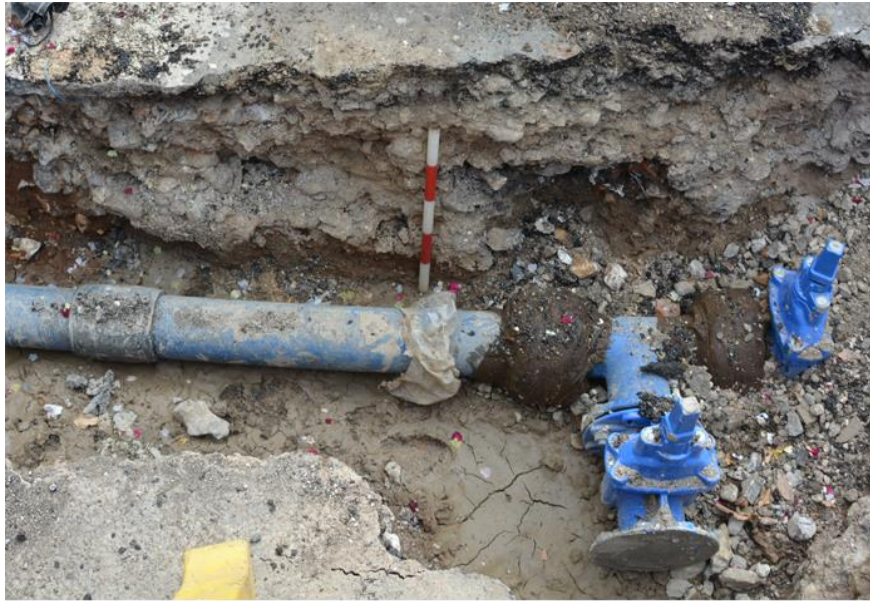
Figure 14: W facing section of pit 41. Top: Photograph looking E, scale 0.5m. Bottom: section, original drawn at 1:10.

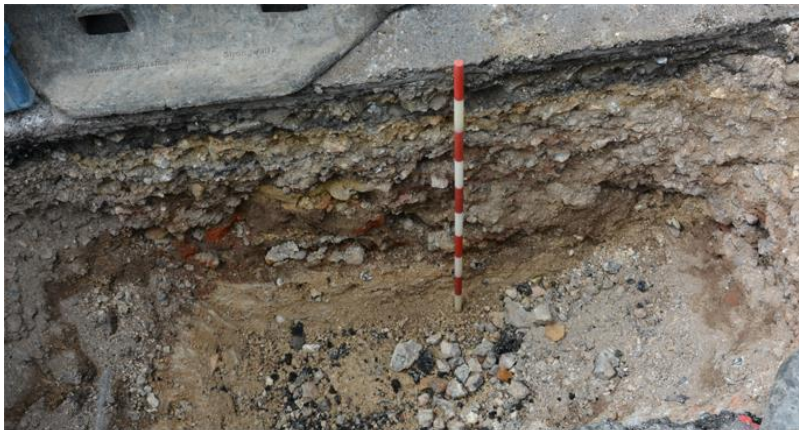
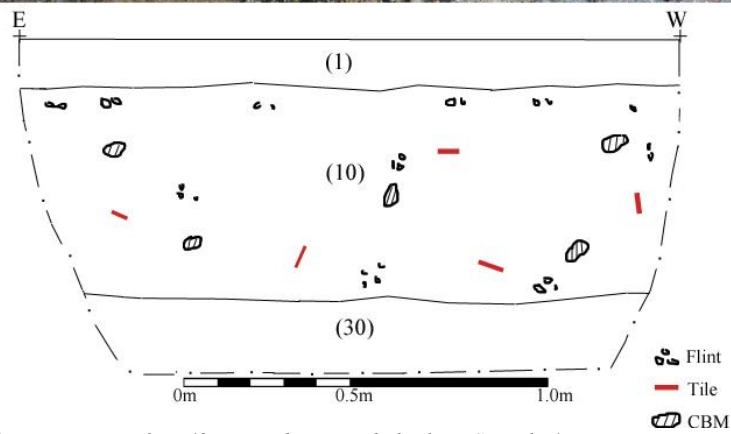
**7.5.3** Pit 42, excavated outside Waterfall Cottage also had grey, compact flint gravel, (10) underlying the tarmac. This deposit was a pale yellow towards the top, changing to grey c.0.1m down. (10) measured 0.62m thick and had occasional modern tile and CBM inclusions. This overlay a yellow silty clay, (30), seen extending beyond the base of the trench (fig. 15).

Figure 15: N facing section of pit 42. Top: photograph, looking S, scale 1m. Bottom: section, original drawn at 1:10

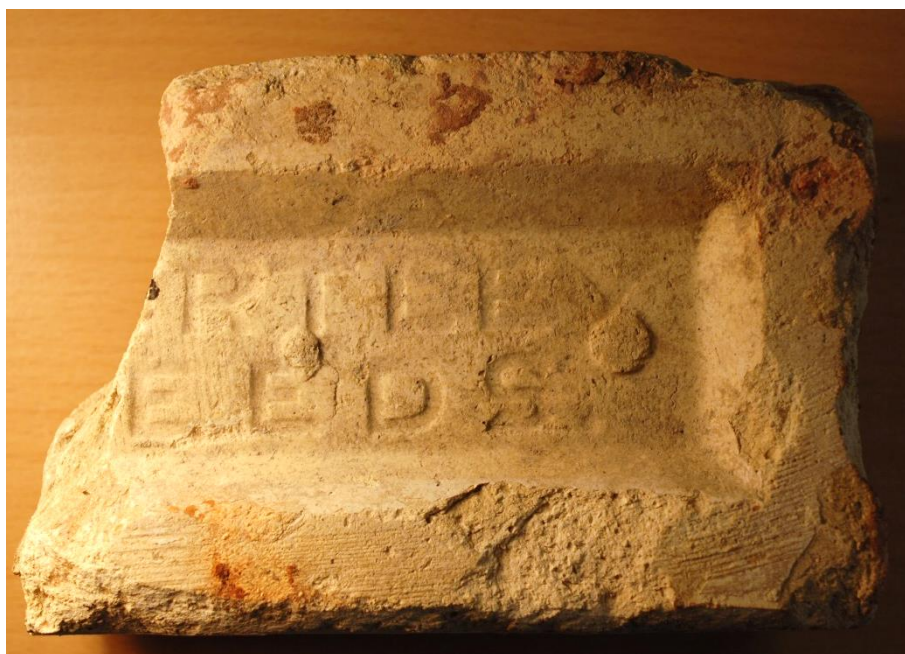
One brick, stamped “..RTLEY/ ...EEDS” (Wortley Leeds; fig. 27) with a white slip-glazed face on one side was recovered from pit 16 (fig. 28). It was made by Ingham, William & Sons: Wortley Fireclay Works, founded in 1825 the company manufactured most fireclay products, including firebricks, blast and other furnace lumps using fireclay, coal and ironstone extracted from its own property in Wortley. As well as producing firebricks and other industrial materials, they also manufactured bricks finished with a coloured glaze, sanitary fittings and baths and terracotta for building works and garden ornaments. After 1889 they formed part of the Leeds Fireclay Co.

*Figure 27: Brick from context (6), pit 16.*

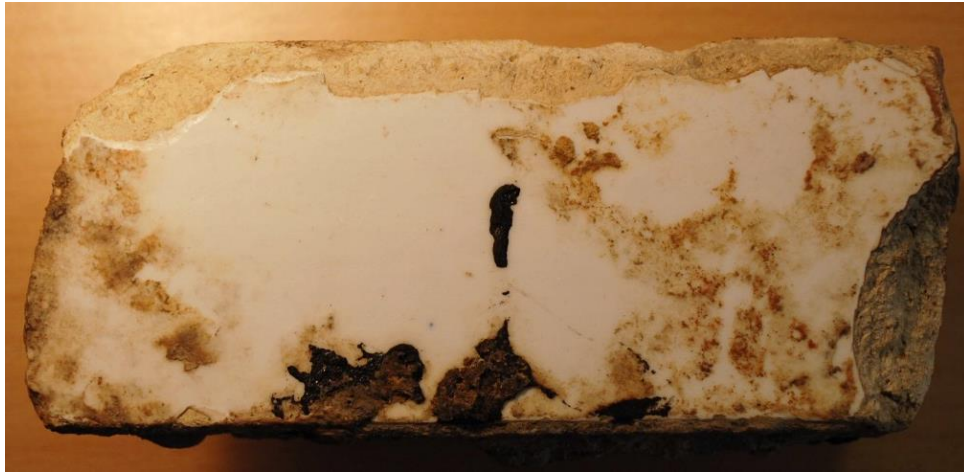
Figure 28: White slip-glazed face of brick from context (6), pit 16.
