THAMES WATER UTILITIES LTD
WATER MAINS REPLACEMENT WORKS

CAZENOVE ROAD AND NORTHWOLD ROAD AREA, E5 & N16
LONDON BOROUGH OF HACKNEY

AN ARCHAEOLOGICAL WATCHING BRIEF

December 2007

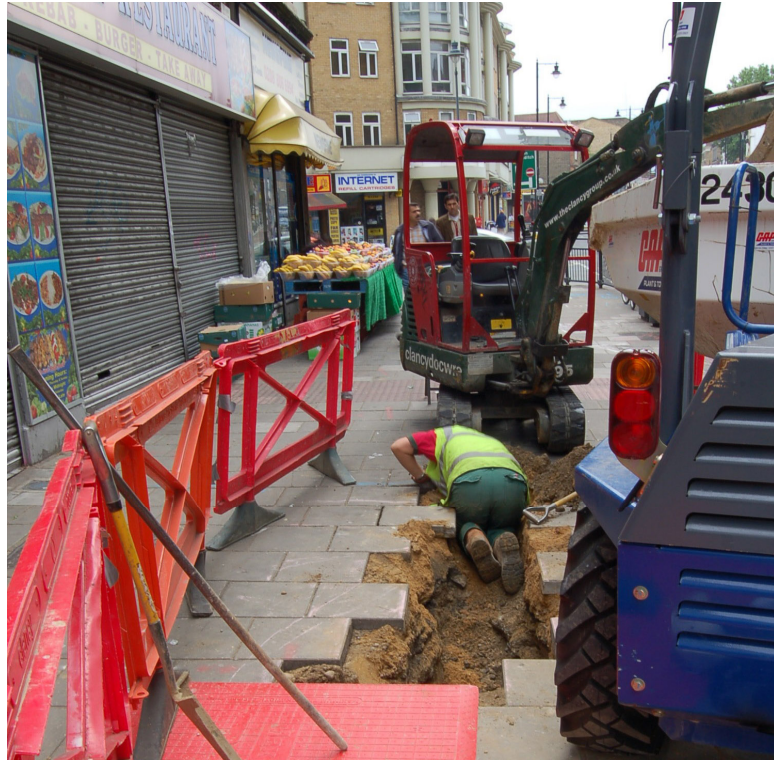
Figure 3: Trenching on Stamford Hill, looking south towards Cazenove Road junction.

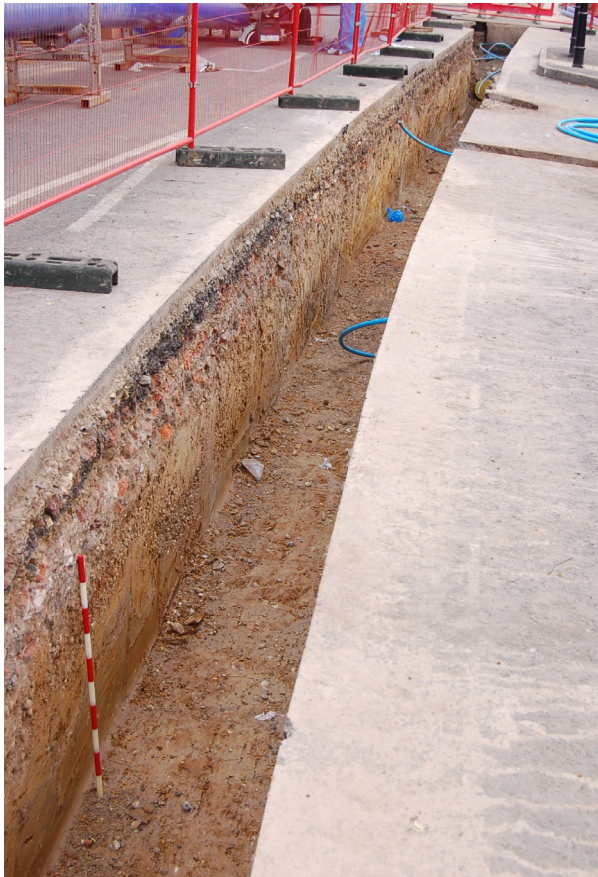
Figure 5: General views of the Cazenove Road works in the vicinity of the Osbaldeston Road and Kyverdale Road junctions

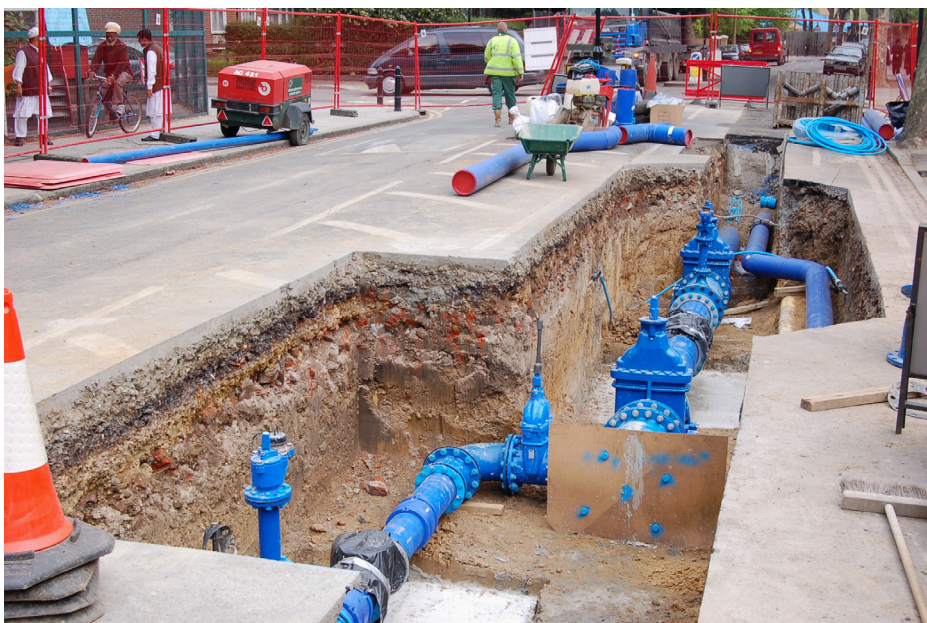
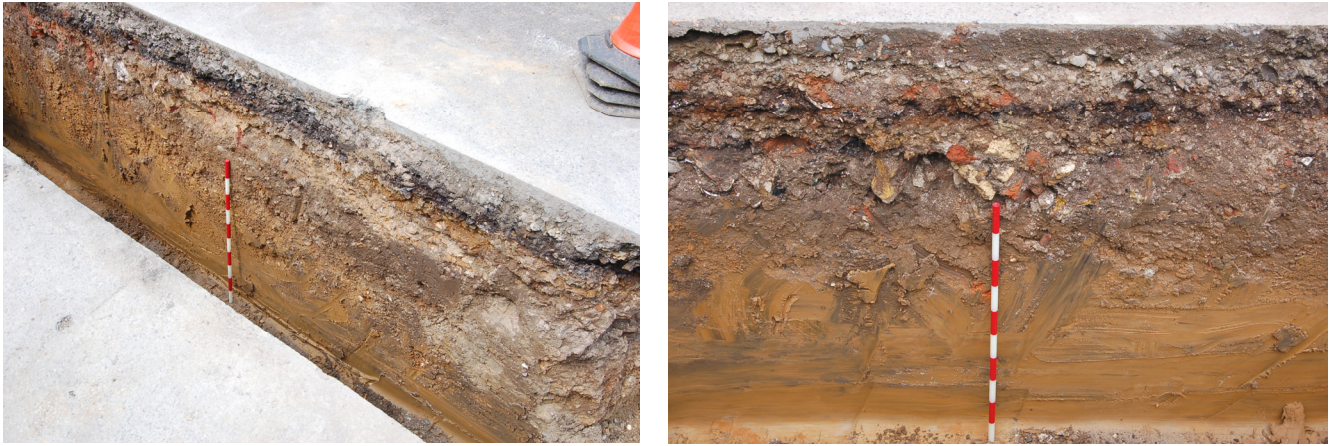
To the western end of Cazenove Road layers of rubble made-ground were observed below the concrete, consisting of red and yellow stock brick, pebbles and occasional ceramic inclusions within a silty matrix. These layers are probably related to the demolition of buildings in the latter part of the 19th century following the arrival of the Great Eastern Railway and the construction of more affordable houses. Natural clays and brickearths were observed in most trenches, between 0.6m and 1.2m below the existing ground levels and were truncated by made ground layers above.

Figure 6: Sample sections from Cazenove Road trenching to the west of Kyverdale Road, showing truncated natural brickearth deposits overlain by rubble made-ground and modern road make-up

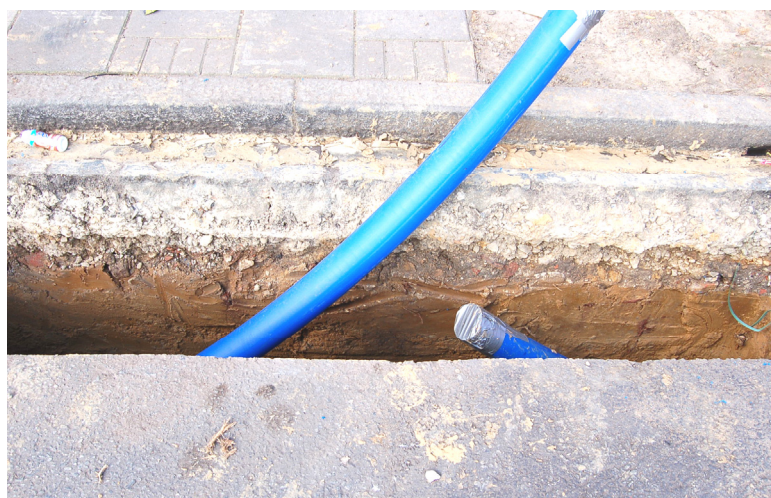
Figure 8: Cazenove Road west end - small pit west of Alkham Road showing natural brickearth immediately below modern road make-up

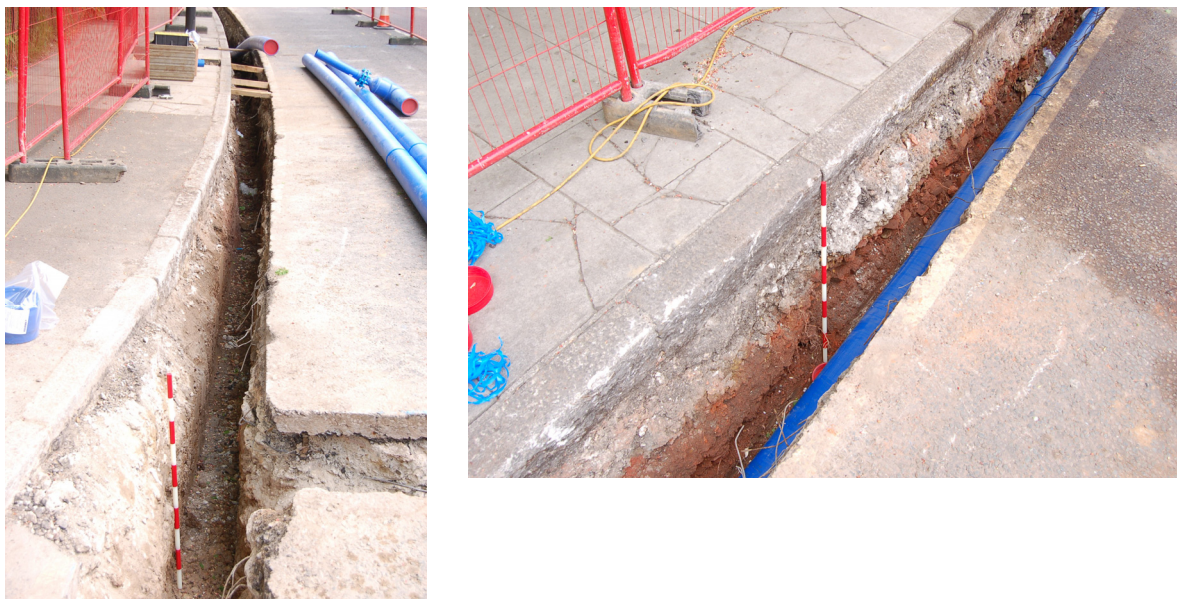
No archaeological finds of features were observed in trenching on Northwold Road – open cut excavations exposed modern road-make-up layers overlying made-ground, modern services and backfills and truncated natural deposits. Trenches on the north side of Northwold Road generally exposed similar brickearth and silty clay deposits as those exposed in trenching within the roads to the north; however, trenching further south exposed Hackney Gravel levels between 0.8m and 1.2m below the existing ground level. Again, these deposits appeared to be truncated, in some cases severely, by services and made-ground layers above. There was no evidence for deposits relating to the Hackney Brook.

Figure 10: Northwold Road: trenching between Fountayne and Durlston Road junctions

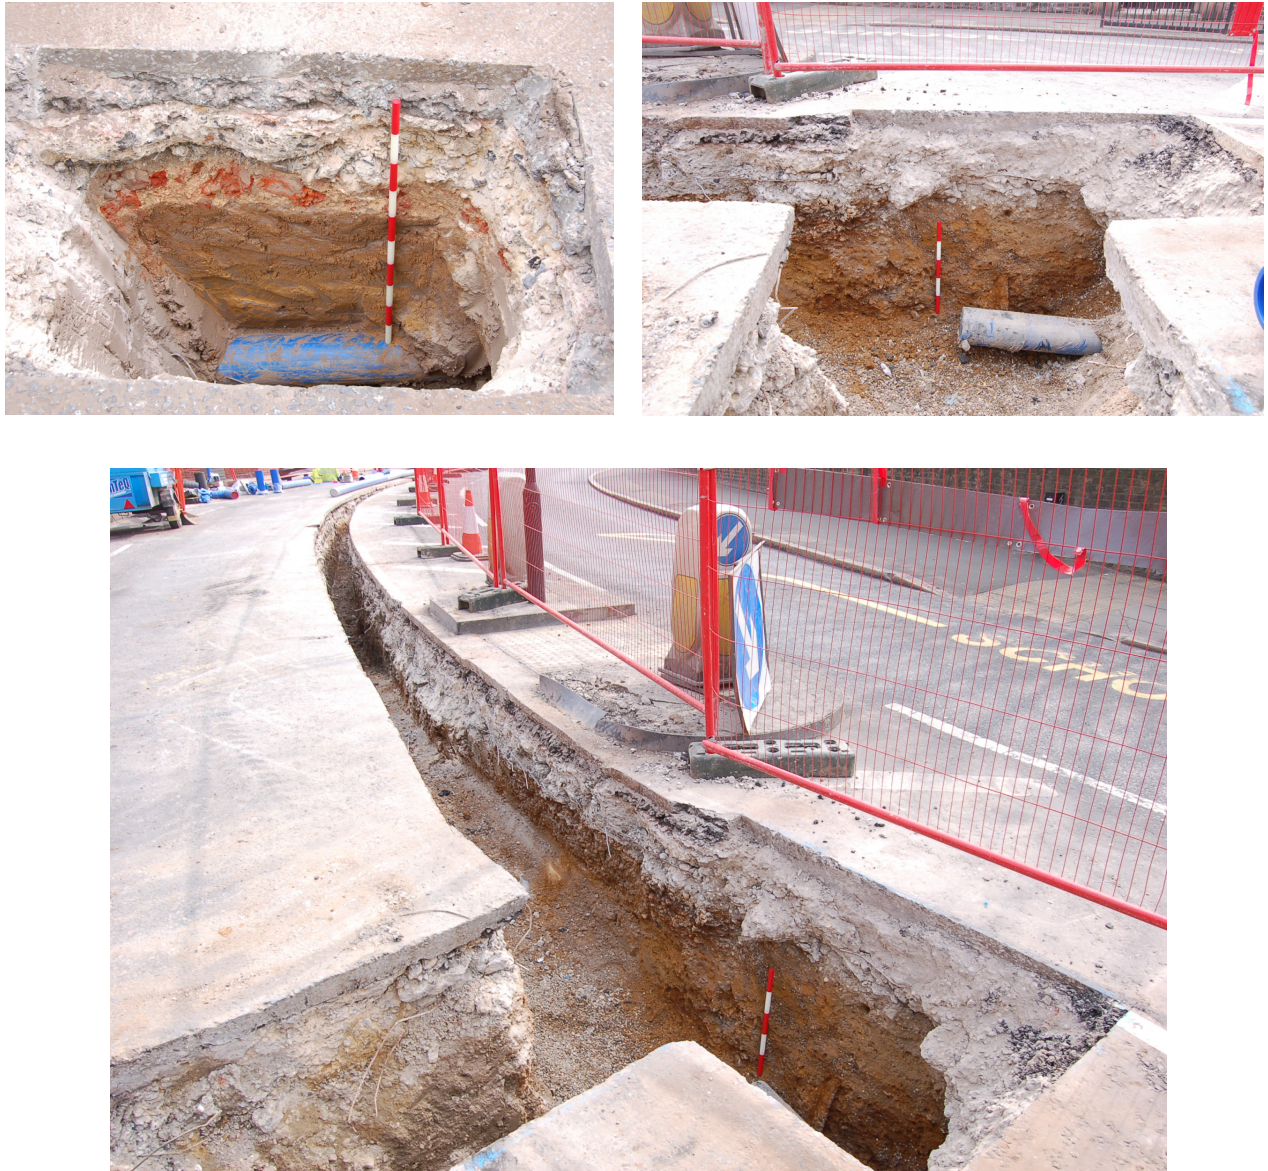
Figure 11: Trenching on Northwald Road, east of Kyverdale Road (top left) and east of Durlston Road. Sections show modern road-makeup layers overlying truncated natural deposits of silty clay and Hackney Gravels.

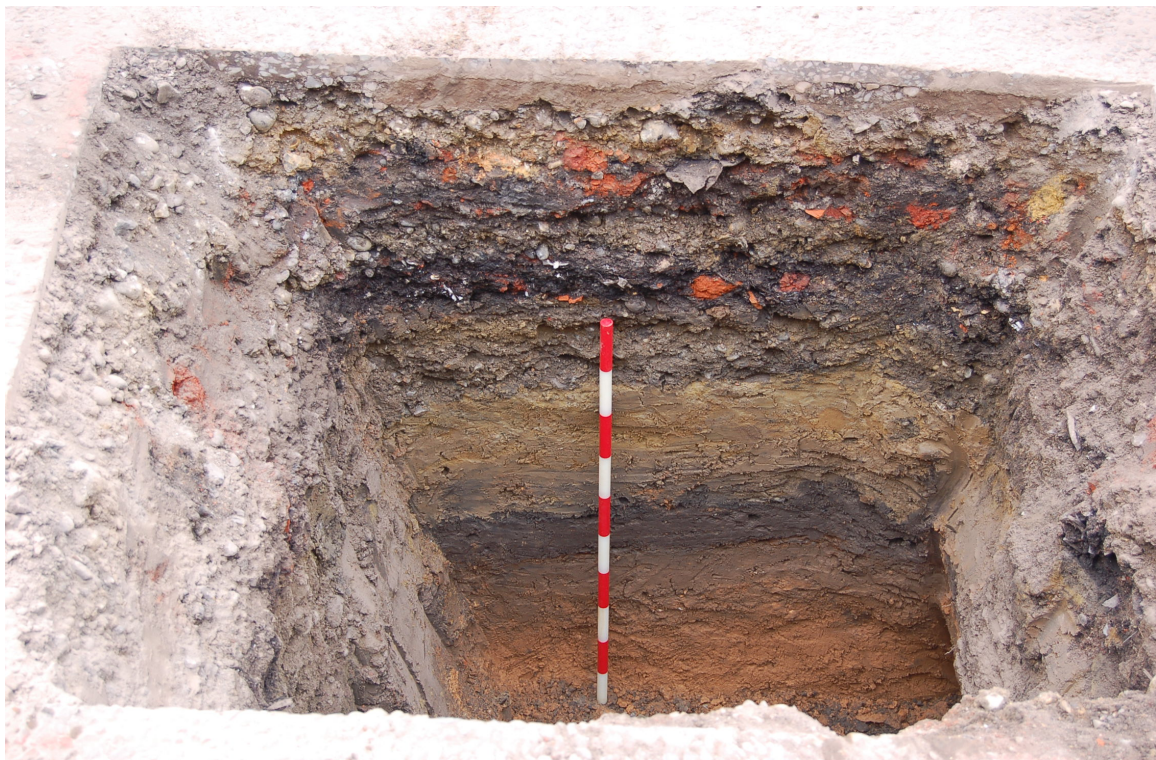
Natural deposits exposed at the base of the trench were overlain by an apparent buried soil-horizon (consisting of topsoil and subsoil), which was sealed by a yellowish sandy clay deposit. This latter deposit may represent hill-wash, or possibly dumping of redeposited natural. This deposit was then overlain by a series of gravel and rubble ground-makeup layers below the existing tarmac

ground-surface and shallow concrete base. The potential buried soil horizon contained fragments of ceramic building material (brick) and coal, and may well relate to the period of occupation prior to the 19th century demolition and redevelopment of the area.

Figure 13: Section of trenching near the northern end of Alkham Road, showing the natural silty clay with gravel and buried soil horizon overlain by modern makeup layers.

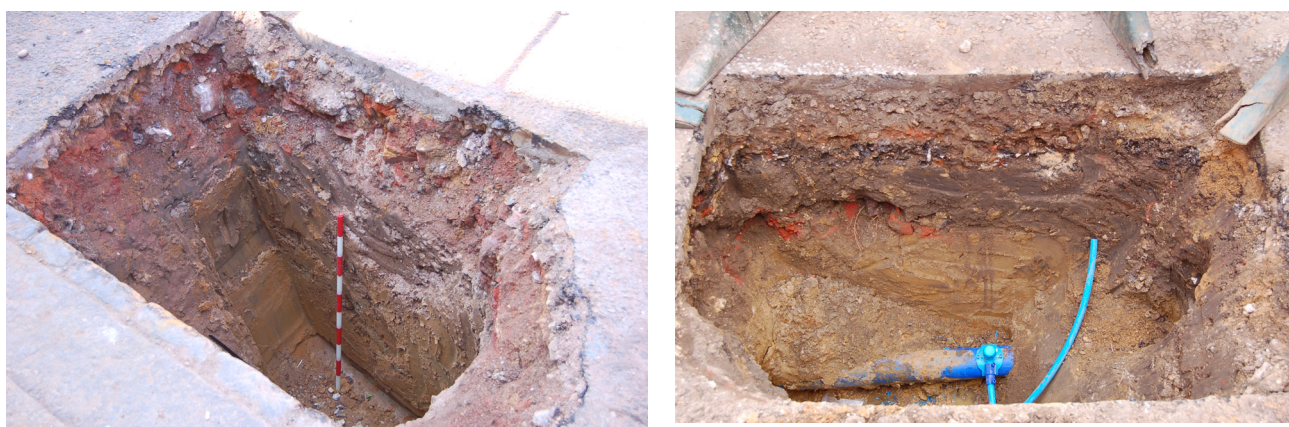
Figure 15: Trenching on Kyverdale Road, showing ground-makeup layers overlying truncated natural deposits.

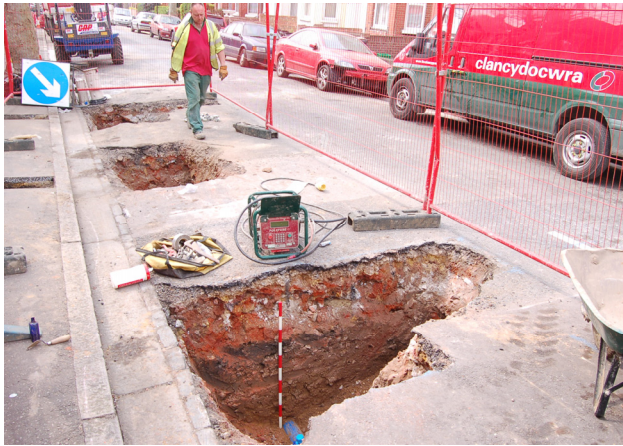
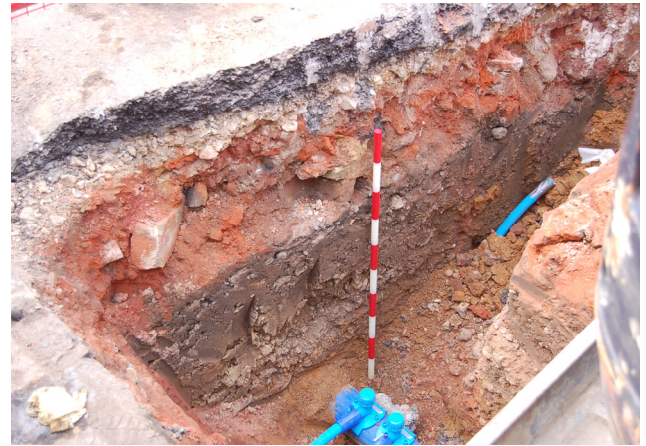
Figure 16: Trenching on Durlston Road, with compacted brick rubble road base overlying truncated sterile subsoil and natural deposits.

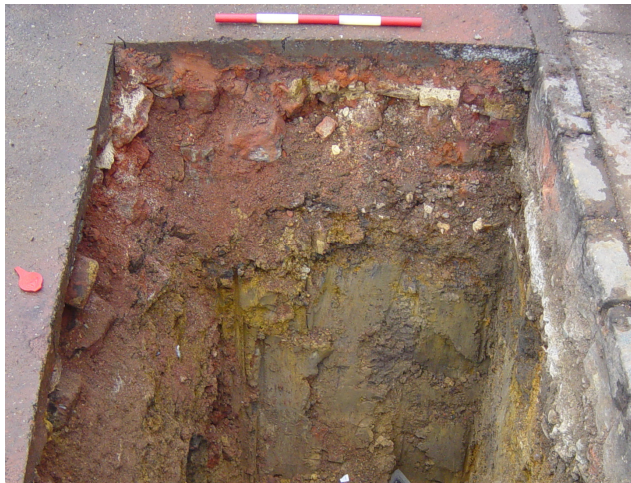
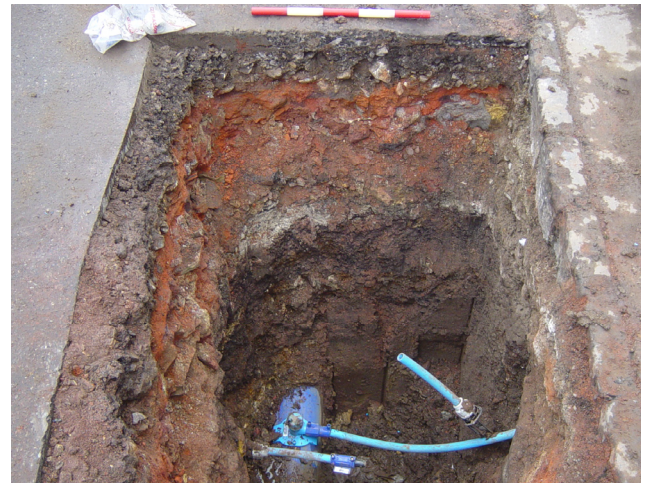
Figure 17: Trenching on Geldeston Road, showing a similar picture to that above
