**THAMES WATER MAINS REHABILITATION  
WORKS, FORTUNE GREEN ROAD, LONDON  
BOROUGH OF CAMDEN, NW6 1AA**

**An Archaeological Watching Brief**

Site code: LCF19  
Approximate site centre: NGR TQ 25289 85347  
Thames Water Scheme no.: 1362

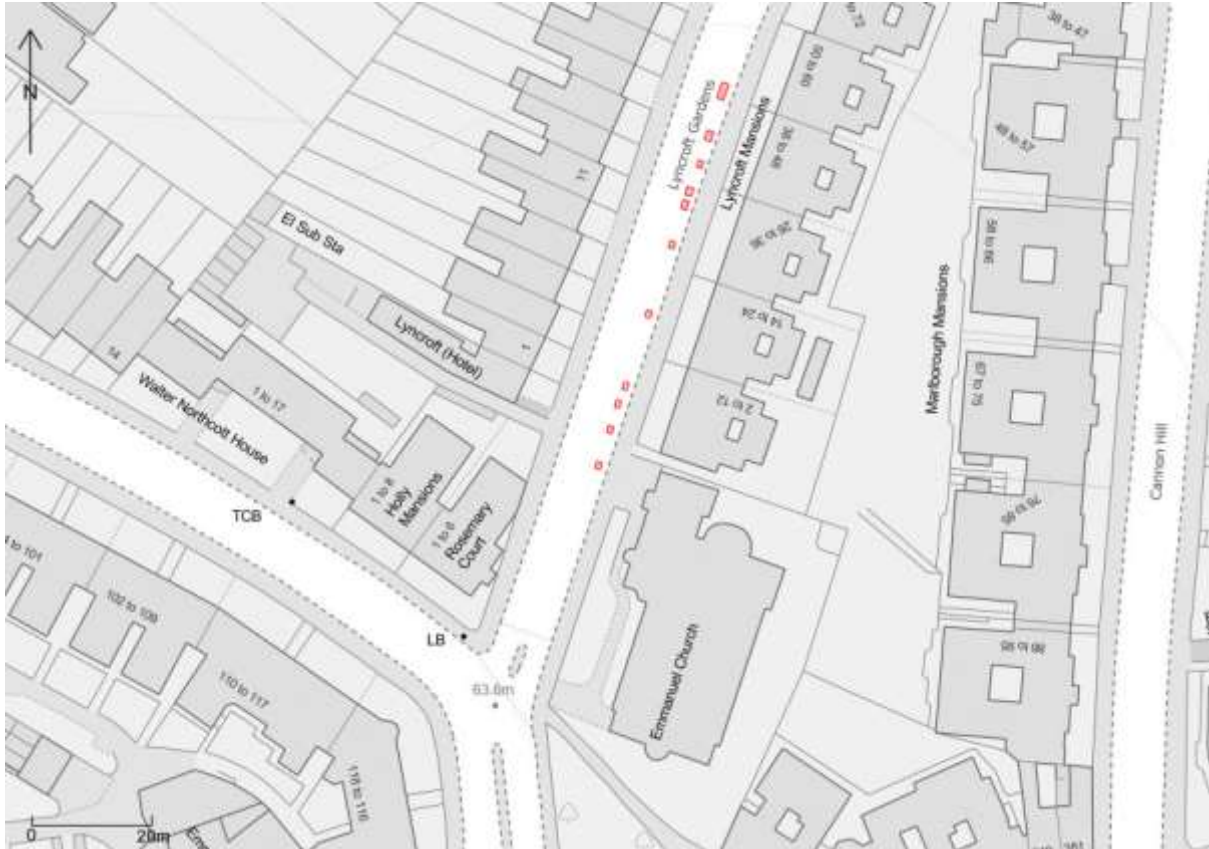
Figure 4: Plan showing the locations of the eleven trenches monitored during the watching brief (red).

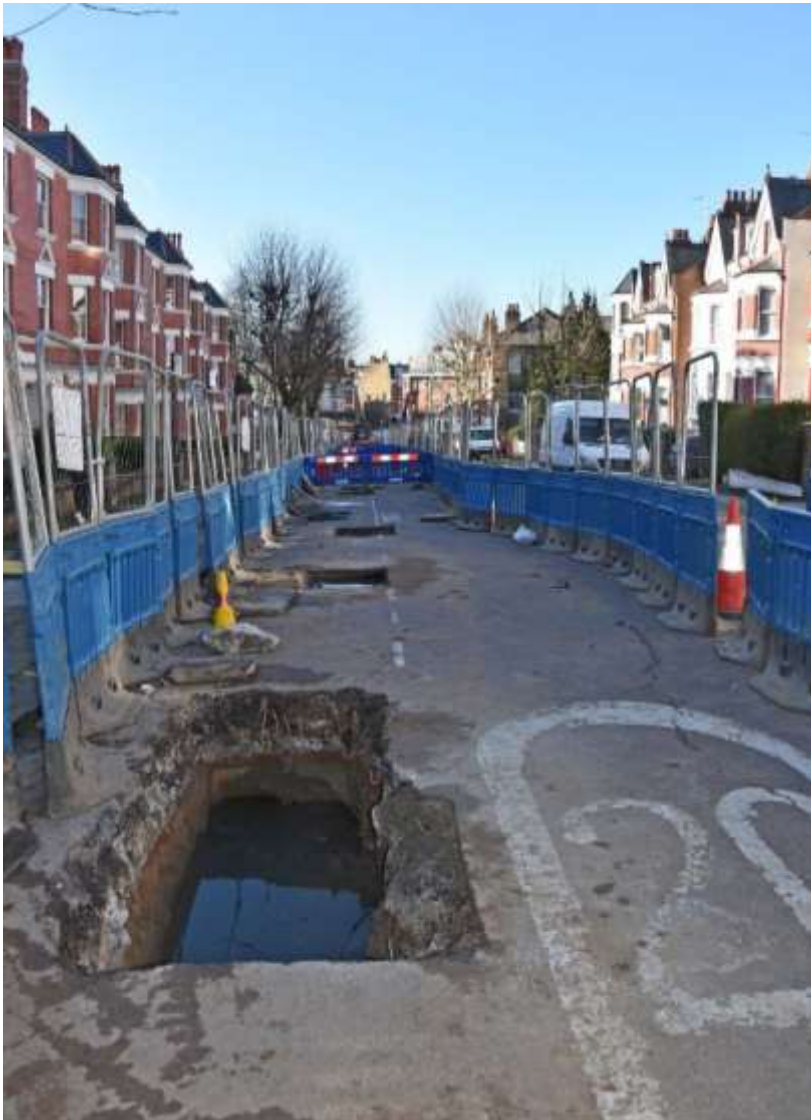
*Figure 5: Completed pits, looking towards Fortune Green Road. Facing SSW. No scale.*

- 5.3 The trenches measured between 0.7 and 3.0m in length x 1.0 – 1.3m in width, excavated to an average depth of 1.2m (c63.8-68.8mOD).

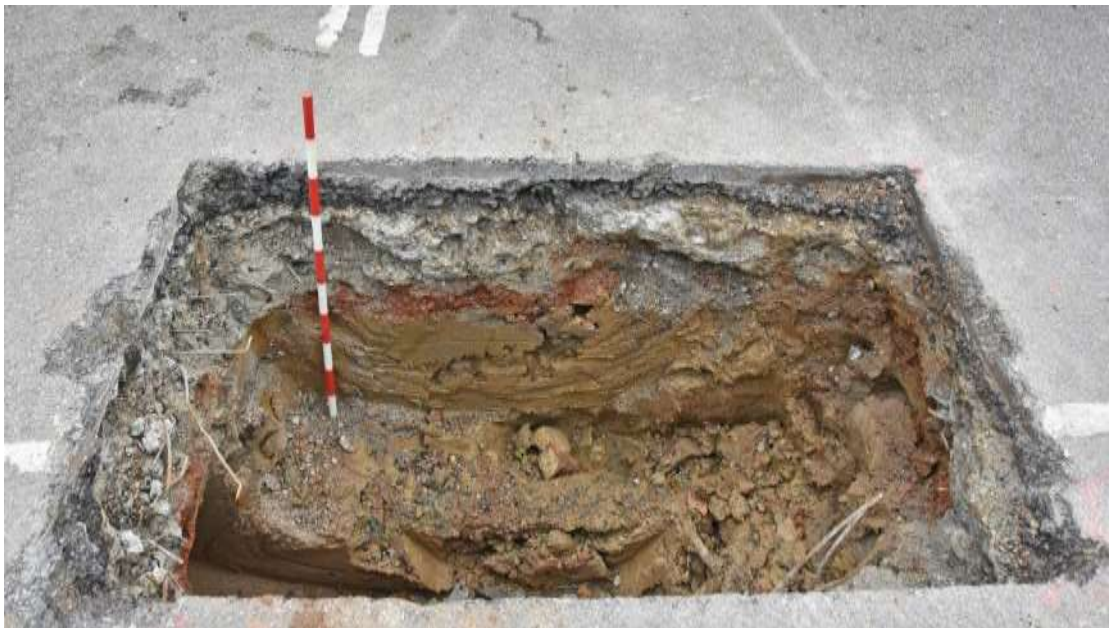
**5.4** The stratigraphy was relatively uniform throughout, comprising 120mm of well compacted black tarmac (1) above 240-250mm of reinforced concrete (2), overlying a thin lens of red brick rubble (3), measuring a maximum of 100mm in thickness. This lens was observed in all eleven trenches directly overlying a deposit of well compacted mid-brown orange clay with occasional stone inclusions (4), measuring a minimum of 0.5m in thickness continuing below the level of excavation. This clay is taken to be the natural geology (figs.6-8).

*Figure 6: Northwest facing section of a trial pit, showing modern made ground directly overlying the natural London Clay. Facing SE. Scale 1m.*

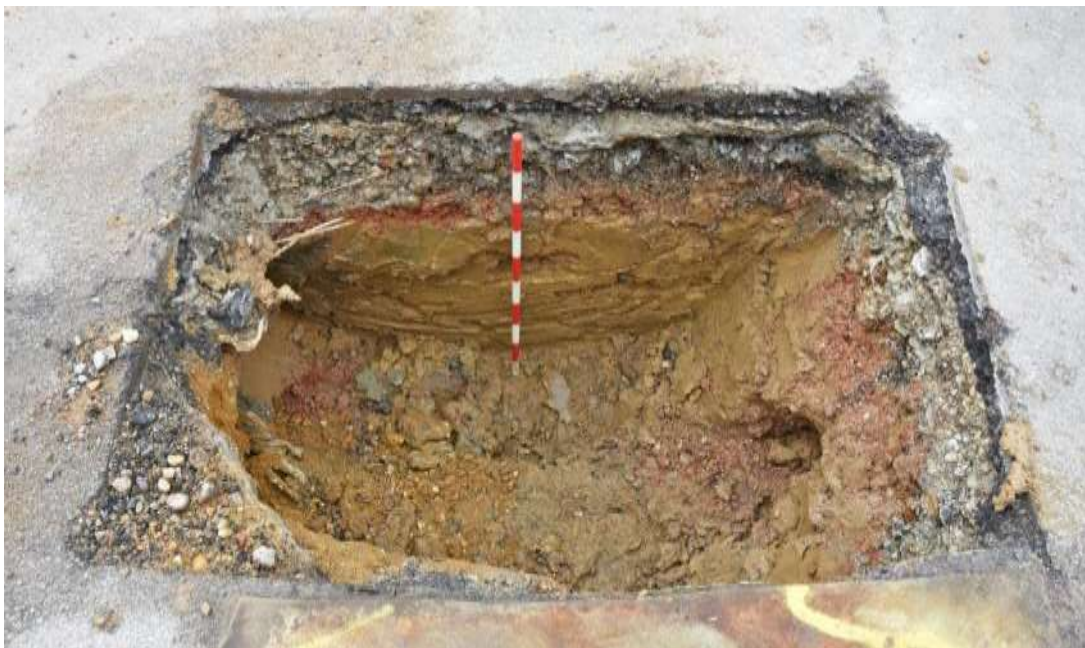
*Figure 7: The same stratigraphy was encountered towards the southern end of Lyncroft Gardens, comprising the existing road surface above reinforced concrete and rubble, overlying the natural geology. Facing NW. Scale 1m.*

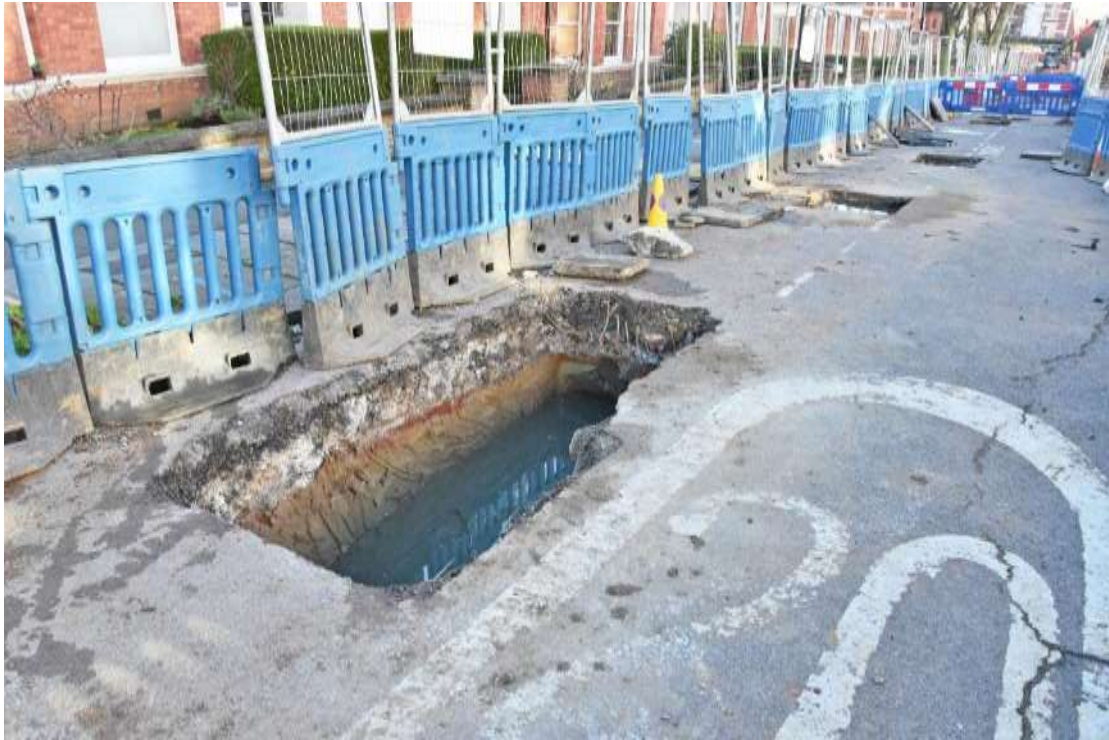
Figure 8: Overview of the works area, showing several flooding trial pits. The same stratigraphy comprising modern made ground over natural London Clay can be seen. Facing approximately S, towards Fortune Green Road.

**5.5** Several of the trenches were flooded so were unable to be fully recorded, however no features of archaeological interest were observed.
