GROUND INVESTIGATION WORKS AT HANCOCK ROAD, LONDON BOROUGH OF TOWER HAMLETS E3 3EG

An Archaeological Watching Brief

Site code: HCC19 NGR (centre): TQ 38002 83019

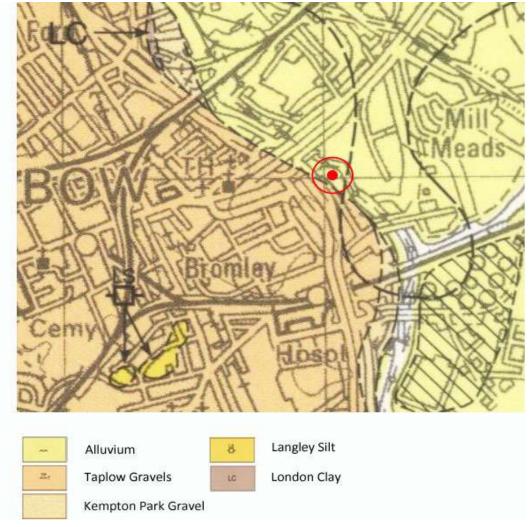
- 3.1 The site was located at the land at 3 Hancock Road, lying to the north-east of the A12 and the south-west of the River Lea.
- 3.2 According to the British Geological Survey (Sheet 256: *North London*) the site overlies a large area of alluvium which follows the course of the River Lea (fig.3). The area is bounded to the south by Taplow Gravels interspersed with pockets of Langley Silt and London Clay.
- 3.3 The site is relatively level, sitting at approximately 4.5mOD. The land lies on a terrace, dropping down from the west at c10mOD along the Blackwall Tunnel Approach, to the bank of the River Lea in the east, lying at 4.3mOD. There has been recent landscaping to the south with the creation of Ashley Court between 2014 and 2016 however the levels remained relatively unaltered.

Figure 3: Extract from the British Geological Survey, 1994, sheet 256 with the site marked in red.

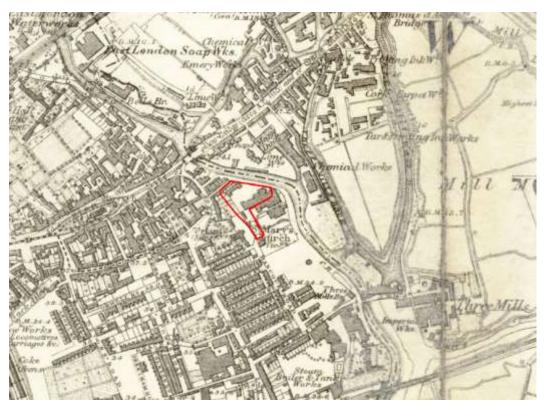
Figure 5: Extract from the Ordnance Survey 6-inch map (1863) with site outline marked in red.

By the 19th century the site itself was situated within a bustling riverside manufactory. The Bow area had been subject to intense development and occupation over the last century and very little of the religious and private estate remained. During the mid-19th much of the site was occupied by the Lloyd's Paper Mills, with a small area at the northern end occupied by residential housing – Ammiel Terrace and Ammiel Street (figs.5-6). By the late-19th / early-20th century a number of businesses had moved on to the premises and the site was occupied by the Ratner Safe Works, London General Omnibus Company's Depot, Albion Oil and Grease Works, a disused Soap Works and a Mineral Water Manufactory (which came within feet of St Mary's Church).

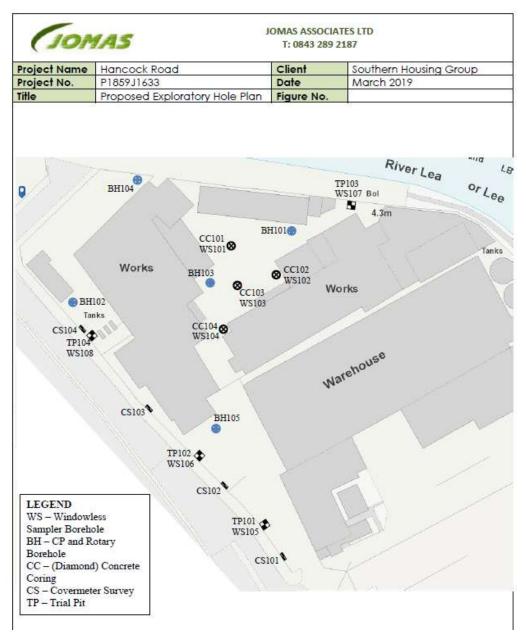
5.1 The groundworks entailed the completion of four trial pits, five boreholes and eight windowless sampler boreholes, also utilised for concrete coring sampling. The investigation works were situated across the site footprint in areas of open ground between the extant buildings (fig.7).

Figure 7: Plan showing the locations of boreholes and test pits undertaken. Drawing supplied by The Client (P1859J1633).

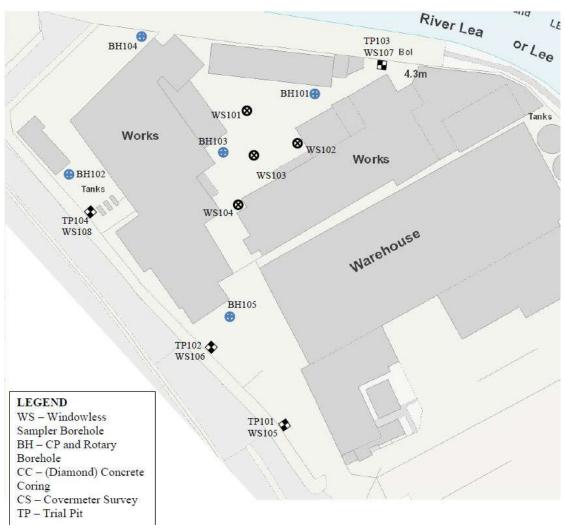
6.2.1 The archaeological watching brief took place during ground investigation works at Hancock Road, monitoring the completion of three hand excavated trial pits and a single borehole, undertaken between the 7th and 9th April 2019 (fig.8). A fourth trial pit was also recorded but not monitored.

Figure 8: Edited extract from Drawing no. P1859J1633 supplied by the Client, showing the location of works discussed below in Section 7.

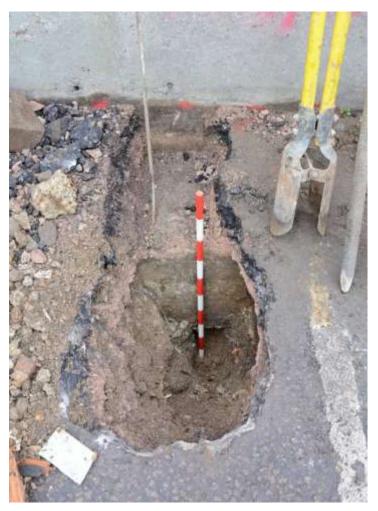
7.2.1 The first trial pit was situated in the southwestern corner of the site, immediately adjacent to the A12. The trench measured 1.1m in length x 0.5m in width x 1.0m in depth (fig.9).

Figure 9: TP101, showing modern backfill surrounding the wall foundation (behind scale). Facing SW. Scale 1m.

7.2.2 The stratigraphy comprised 100mm of well compacted black tarmac (1) above 130mm of loosely compacted MOT Type 1 (2). This existing car park surface and bedding overlay 600mm of modern made ground (3), consisting of a moderately compacted brown silty soil containing frequent stones and modern material including timber and tile. At a depth of 0.83m the material became slightly sandier (4), measuring at least 170mm in thickness, continuing below the level of excavation.

- **7.2.3** The works exposed the foundations of the wall separating the site from the Blackwall Tunnel Northern Approach, which extended north-eastwards into the trench by 0.45m and measured 0.6m in thickness, exposed at a depth of 0.2 below ground level.
- **7.2.4** No finds or features of archaeological interest were observed.

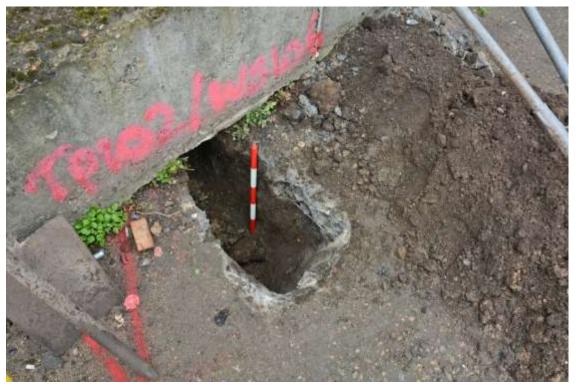
7.3.1 TP102 was situated along the western edge of the site, to the north of TP101. The trench was again undertaken to assess the foundations of the wall separating the site from the Blackwall Tunnel approach road. The trench measured 0.7m in length x 0.5m in width x 0.5m in depth (fig.10).

Figure 10: TP102, showing made ground below concrete. Facing NW. Scale 0.5m.

- **7.3.2** The stratigraphy comprised 150-200mm of coarse mix concrete (5) over at least 300mm of mid to dark brown moderately compacted soil (6) containing frequent small angular stones, taken to be made ground.
- **7.3.3** No below ground foundations for the approach road and wall were observed.
- **7.3.4** No finds or features of archaeological interest were recorded.

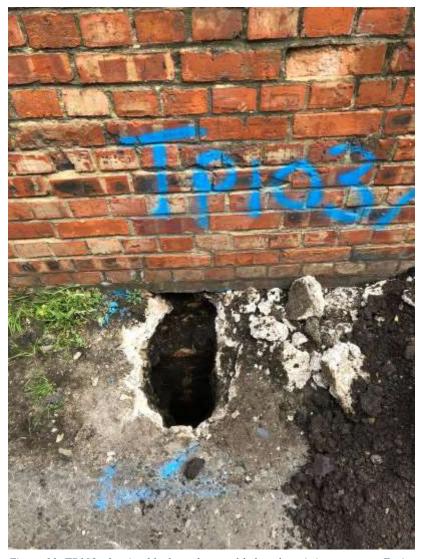
7.4.1 The third trial pit, TP103 was situated on the northern side of the site, adjacent to the boundary wall between the Hancock Road site and the River Lea footpath. The trench measured approximately 0.7m in length x 0.4m in width x 1.2m in depth (c3.1mOD) (fig.11).

Figure 11: TP103, showing black sandy gravel below the existing concrete. Facing NNE. No scale. Photograph supplied by JOMAS Associated Ltd.

- **7.4.2** The stratigraphy in the third trial pit comprised approximately 160mm of compact light grey concrete (7) above 1.04m of loose black very sandy gravel (8) consisting of fine-coarse angular to sub-rounded brick, concrete, flint, slate and clinker.
- **7.4.3** The darker composition and inclusions of post-medieval CBM suggests the material is possibly post-medieval in date, and more indicative of the ground make-up prior to modern disturbances, however no finds were recovered to confirm this.

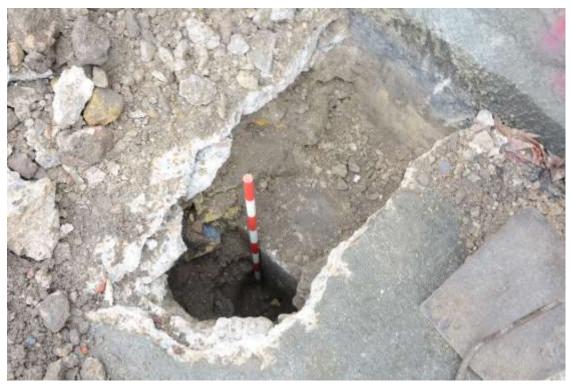
7.5.1 The final trial pit was situated towards the northwest corner of the site, immediately adjacent to an area formerly occupied by fuel tanks. The trench measured 1.1m in length x 0.4-0.5m in width x 1.0m in depth (fig.12).

Figure 12: TP104, showing modern backfill below concrete. Facing SW. Scale 1m.

- **7.5.2** The stratigraphy comprised 100mm of light grey concrete (9) overlying at least 900mm of loosely compacted brick and stone rubble within a sandy / mortar matrix (10).
- **7.5.3** The concrete foundation of the approach road was seen extending north-eastwards into the trench by approximately 0.7m and continued below the level of excavation.
- **7.5.4** The presence of plastic within the backfill (10) suggests it is recent in date. No finds or features of archaeological interest were observed.
