STRAWBERRY HILL HOUSE
TWICKENHAM, LONDON BOROUGH OF RICHMOND

AN ARCHAEOLOGICAL INVESTIGATION

SITE CODE: SWU07
SITE CENTRE NGR: TQ 1588 7230

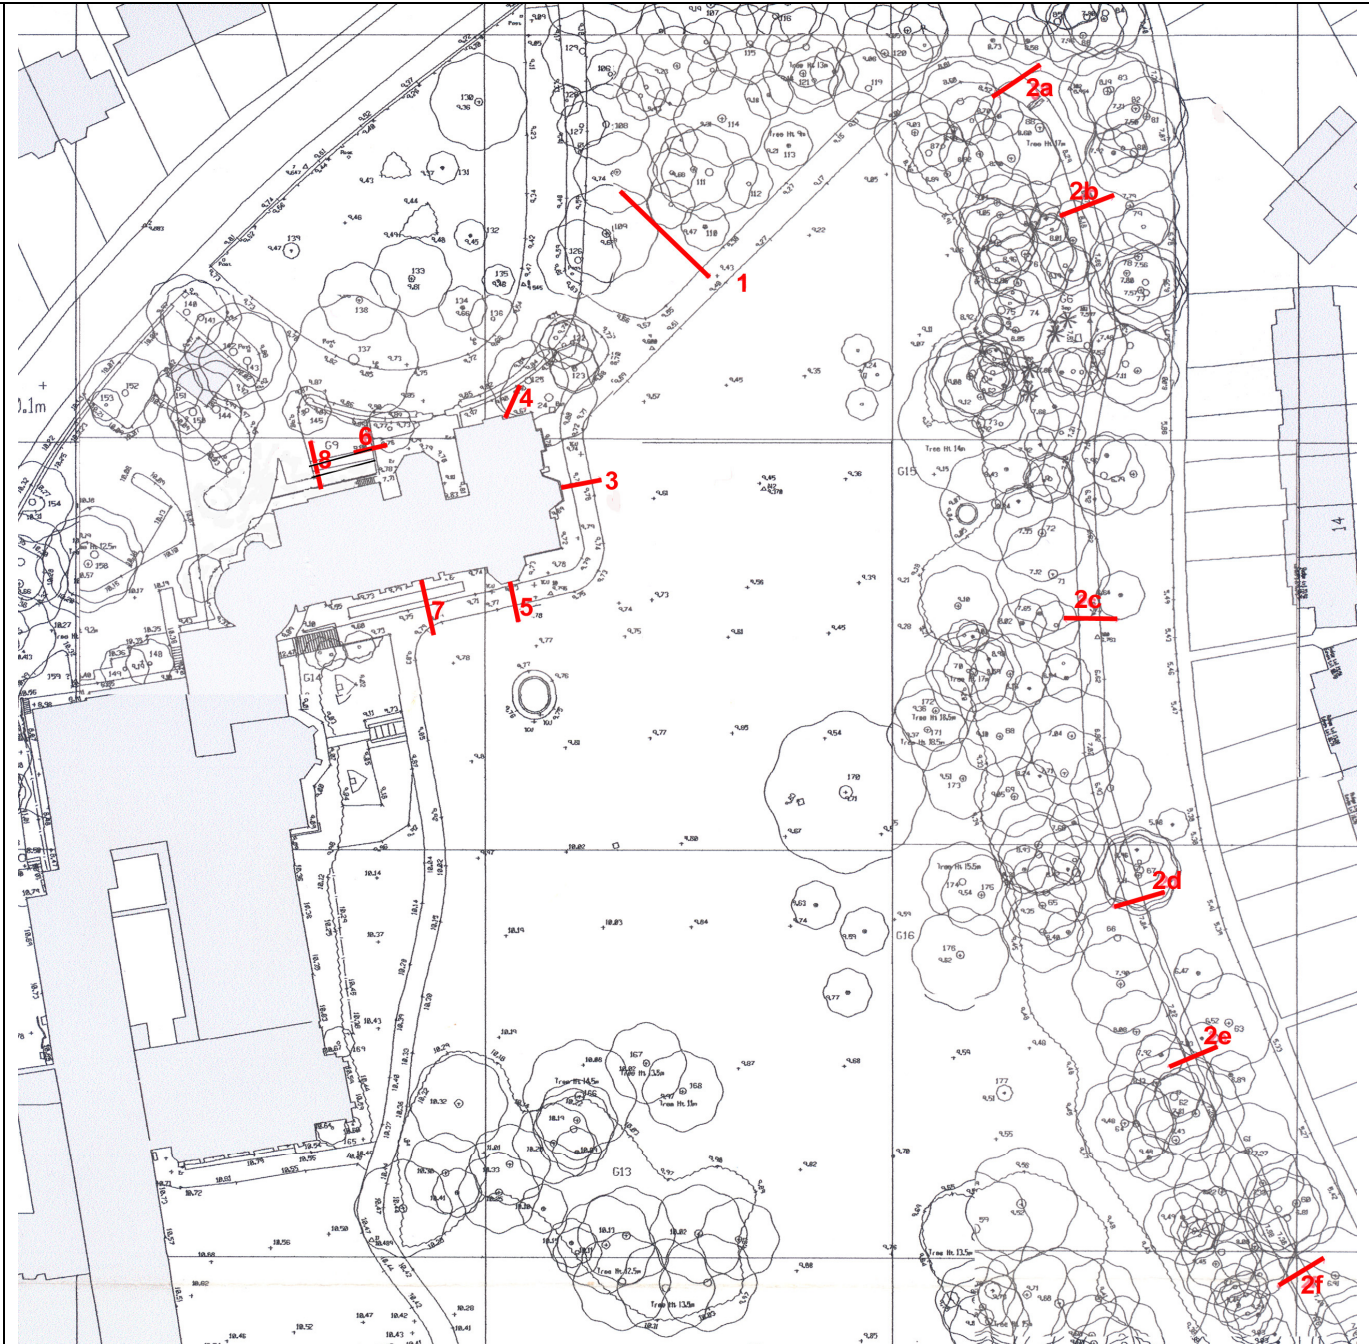
Figure 2:

Original trench layout, based on survey plan provided by Inskip and Jenkins Architects.

dimensions and layout of trenches during the course of the fieldwork and thus objectives were occasionally redefined. Figure 2 shows the original planned trench layout – changes to the layout and further objectives are discussed in more detail below.

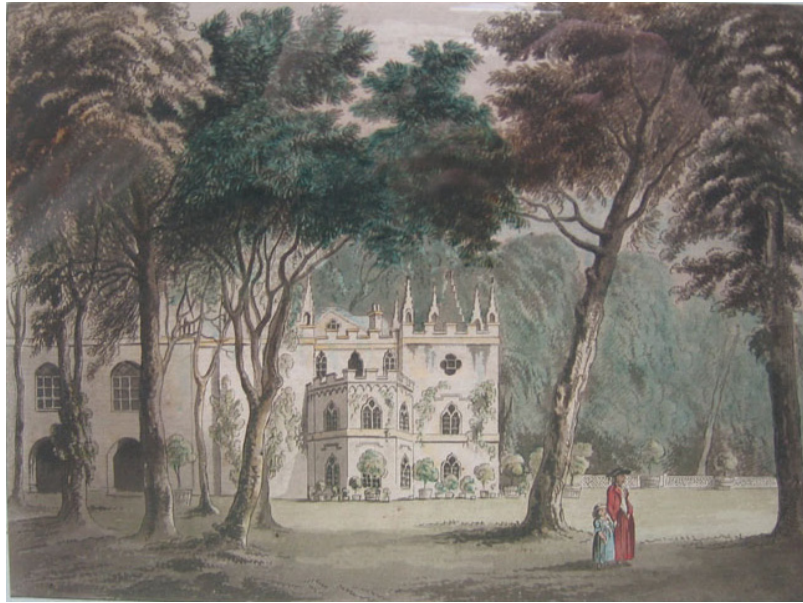
Figure 5: Illustration c.1780's, view north showing (on the right) forested area in front of road and trellis boundary wall. (Reproduced from Inskip and Jenkins 2006, Vol 2, part B, pp141)

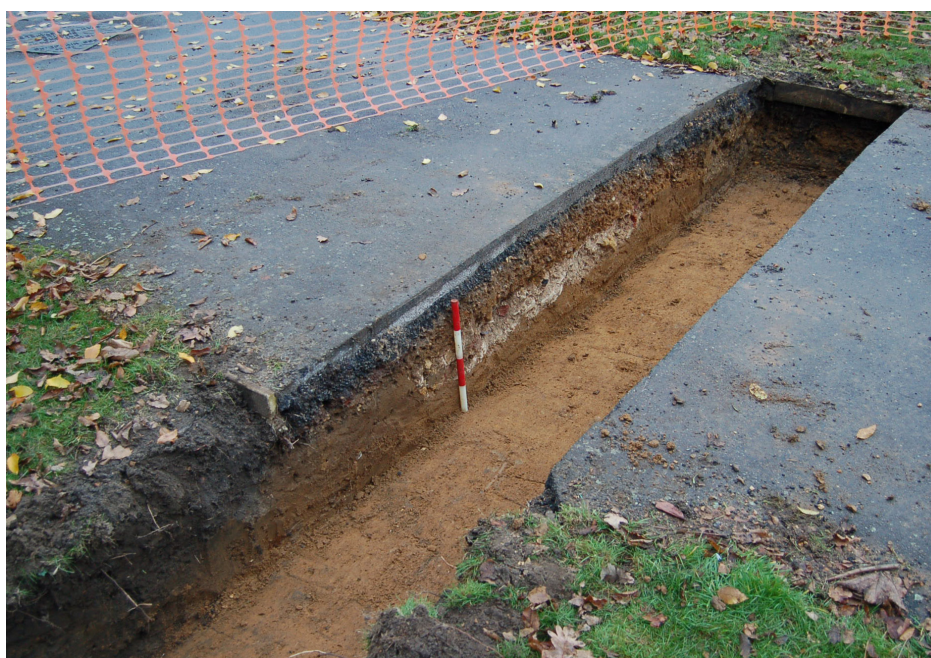
Figure 6: West facing section of Trench 1 showing existing tarmac path overlying remains of earlier late-19th century rubble path.

The existing top-soil [1] and subsoil [2] within the area were truncated to the south by the existing tarmac pathway [3] and associated make-up layers [4] [5]. Beneath the modern path makeup an earlier phase of path was observed (see Figures 6 and 7 below), constituting rubble within a linear, straight sided cut running on the same course as the existing pathway but substantially narrower (1.5m). The rubble fill layer [6] within the path cut [7] consisted of broken red and yellow brick, occasional slate fragments, frequent pieces of a coarse pale yellow mortar and white/grey concrete material. The material was clearly reused as path makeup – but the rubble condition with no apparent finished surface or compaction suggests the exposed contexts do not represent an *in-situ* path. The bricks within the fill [6] suggest an early 19th century date, but as the majority of pieces showed adhering mortar (suggesting reuse) a later date seems more applicable, combined with the presence of concrete materials the path was probably originally laid in the late 19th century. However, the final context as exposed in Trench 1 is later still, representing a dismantling or destruction of the path, probably in the 20th century prior to the laying of the existing tarmac surfaces. It may also be possible that contexts [5] [6] [7] represent deposits belonging to the same feature, an earlier wider gravel path dating to the later 19th century [5] with hardcore makeup beneath [6] [7]. Both conclusions are equally supported by the exposed stratigraphy.

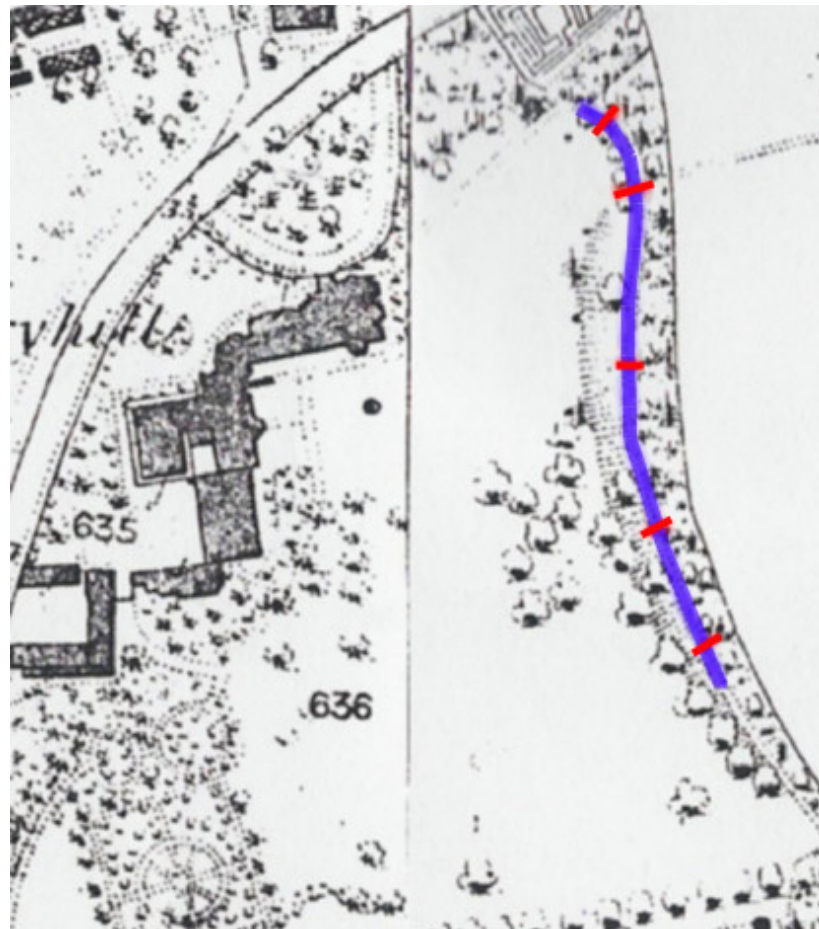
Figure 9: Extract from Ordnance Survey Map of 1863, showing location of pathway and trenches 2, 10, 11, 12 and 13.

The five trenches listed above were all located with the intention of targeting earlier phases of the perimeter path, currently running at the base of the wooded escarpment on the eastern edge of the study area. There is no specific depiction of this path on contemporary 18th century plans, the first definitive appearance being the Ordnance Survey map of 1863 (see below). The existing path, which appears to run on the same course as that depicted in 1863, has no obvious predecessor in terms of location or alignment on earlier plans.

Trenches 2 and 10-13 were designed to establish the presence and nature of this perimeter path in Walpole's period. A plan from 1791 indicates that the path lay within 'fields' to the east of the house. The same feature appears on a view in the 1780's of the approach to Strawberry Hill (Inskip and Jenkins, Vol 1, part B, pp31).

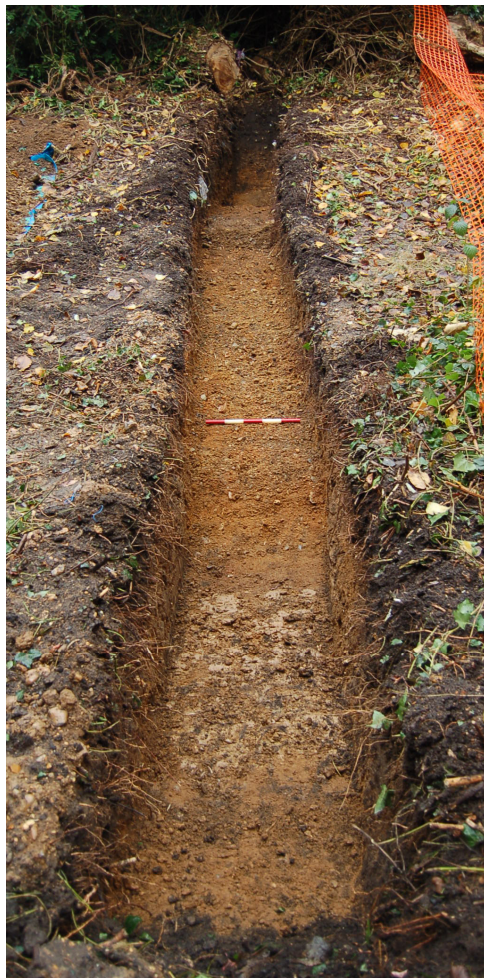
Figure 10: Trench 2, view east (0.5m scale) and 1m sample section.

layers of dumped sand and gravels [2] were exposed immediately below the existing topsoil [1], and extending beyond the limit of excavation at 1.2m below the existing ground surface (8.06m OD), suggest the occurrence of major groundwork and subsequent makeup within the area. No archaeological features were exposed for the full length of the trench, and the dump layers are clearly of relatively recent origin. Trench 13 (next trench south of Trench 2), exposed a very similar sequence of deposits with made-ground layers consisting of sand and gravels [7] continuing beyond the limit of excavation (7.51m OD). In both cases an armoured electrical cable was observed running north-south in approximate alignment with the path – it seems fairly obvious that recent groundworks and services have truncated any earlier evidence for the pathway.

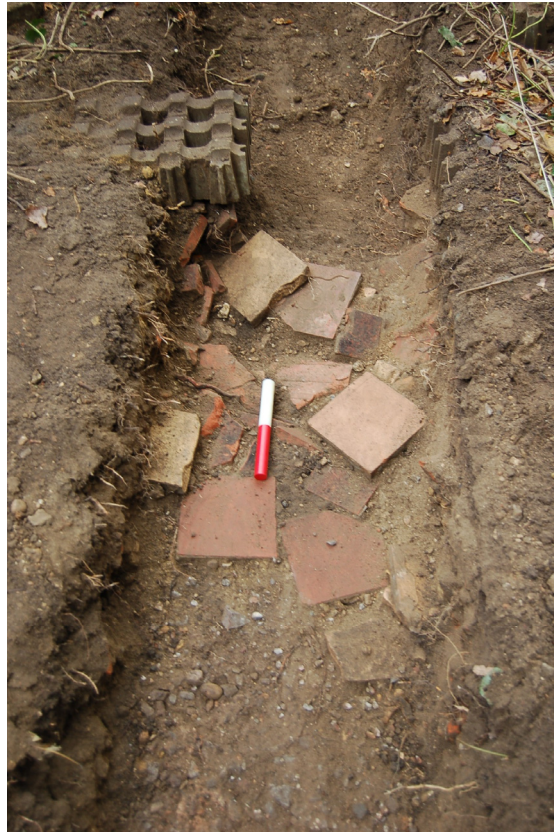
Figure 11: Concrete revetment and rubble makeup [7] in Trench 10 (0.2m scale).

with, or immediately post-dating the revetment itself. In Trench 10 these deposits [7] consisted of large quantities of brick and tile rubble, including reused ceramic floor tiles bearing the manufacturers mark 'Platt's' – these may relate to the Platt factory established in 1822, but their obvious reuse in this context places their presence in this deposit considerably later. In trench 11 the deposit [3] included less quantities of rubble and was more soily in composition, but nevertheless contained fragments of 19th century stock brick – again reused and found in association with 20th century material, and thus again considerably later than the bricks date of manufacture.

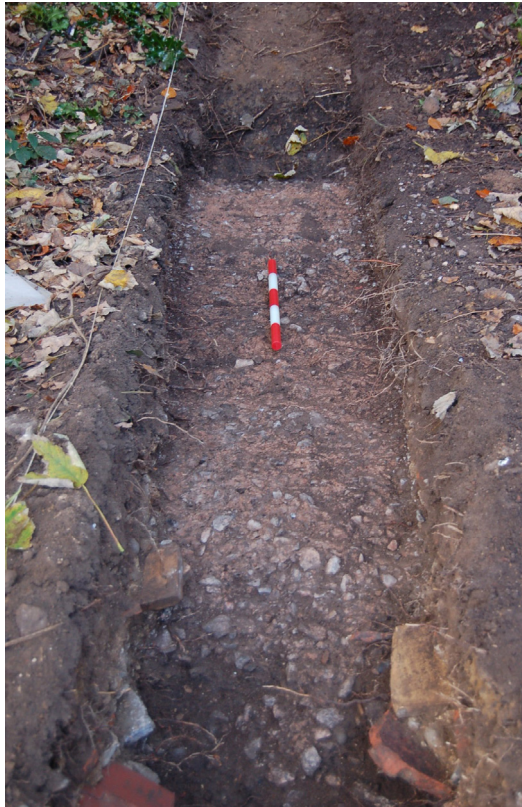
Figure 12: Compact pink gravel path in Trench 10 (0.5m scale).

Both trenches 10 and 11 exposed a path phase consisting of heavily indurated crushed pink MOT type 1 stone [10/5] [11/4]. Unfortunately, no dating evidence was retrieved from either example of this context but in Trench 10 this path was shown to overly a rubbish pit [9/8] containing 20th century moulded and previously used concrete bricks. While no secure date can be given, neither the rubbish pit nor the pink gravel path can be of any great age, and both probably represent post-war if not more recent activity. Again, both trenches exposed another phase of activity in the form of sandy yellow gravel within apparent linear cuts. In trench 10 this deposit [12] and cut [13] were truncated by the rubbish pit [9], but in trench 11 the sequence was better preserved exposing a cut [9] with two fill layers [7] and [8]. No datable material was recovered from either of these exposed sequences, nor did either example overly or truncate an earlier datable feature. Consequently, while it is likely that both examples represent phases of an earlier path, no definitive date can be given.

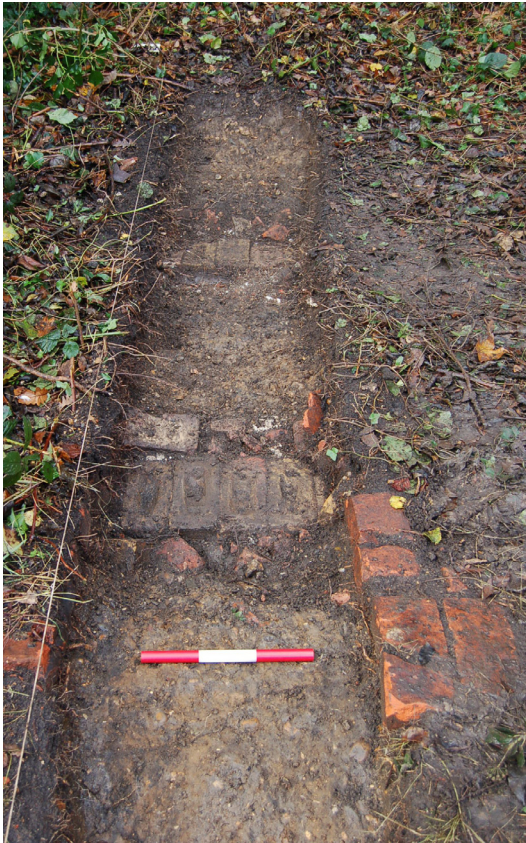
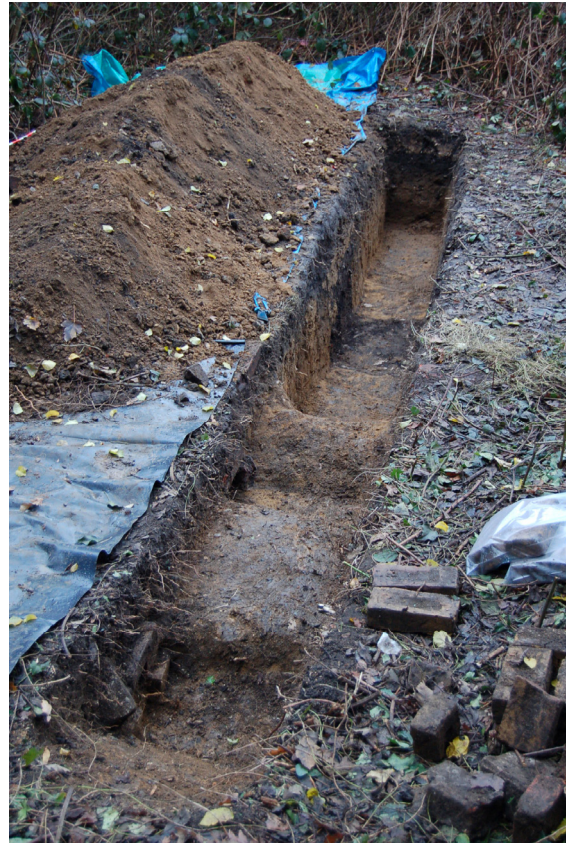
Figure 13: Trench 12 showing course of reused moulded red brick [1] in front of brick bases [2] [4], and two unexcavated construction cuts [3] [5] (left), and looking east fully excavated trench showing construction cuts [3] [5] and ditch feature [15] (right).

Trench 12 exposed a very different sequence to the other trenches, with a linear ditch feature [15] exposed running north-south and truncating the existing subsoil and natural. There was no evidence to suggest that this feature was historically significant, and the absence of formed subsoil overlying it suggests that it is of relatively recent date. To the west end of the trench two parallel cut foundation trenches [3] [5] were exposed, filled by similar sand and rubble deposits [8] [7] and containing courses of un-mortared yellow stock-brick. The bricks were fairly uniform in both cases, showing deeply pronounced frogs but one example appeared warped and two others showed evidence of cracking on firing - this may suggest that the bricks were seconds. Both parallel foundation cuts truncated the natural and were excavated in a manner so as to leave a baulk of natural gravels between them, they are clearly part of the same event but the nature of said event is by no means clear. No further datable evidence was retrieved from the features, but it can be noted that they post-date the mid 19th century, and may well represent some form of garden feature.

Just to the east of the brick bases and the highest level of excavation was a single un-mortared course of reused moulded bricks [1]. This is evidently quite a recent feature – the bricks themselves date to c.1900 – and may represent a localised area of paving in front of the structure that stood over the brick bases [2] and [4].

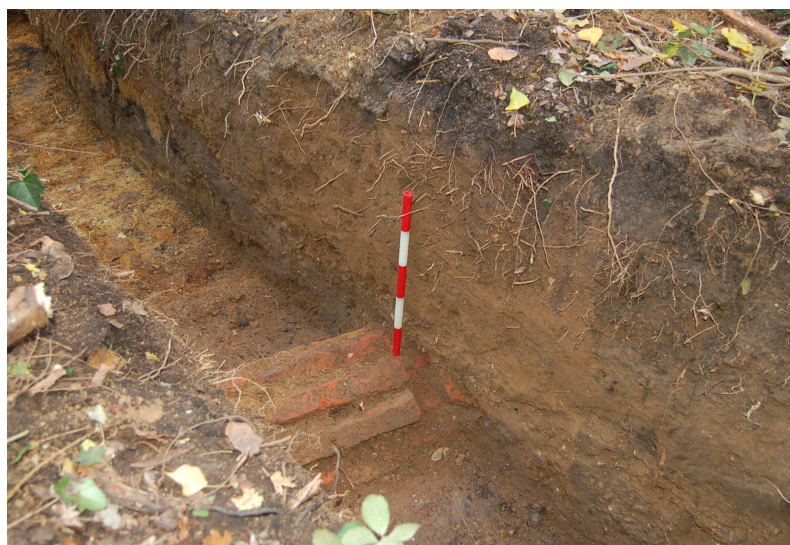
Figure 14: Brick built drain in Trench 13 (0.5m scale), view looking south-east.

While Trench 13 produced no evidence for earlier phases of the pathway, a brick-built arched drain [4] was exposed at the western end. Some of the bricks appear to be of 18th century date, but many of them were fragmented and heavily worn suggesting reuse, probably in the 19th century.

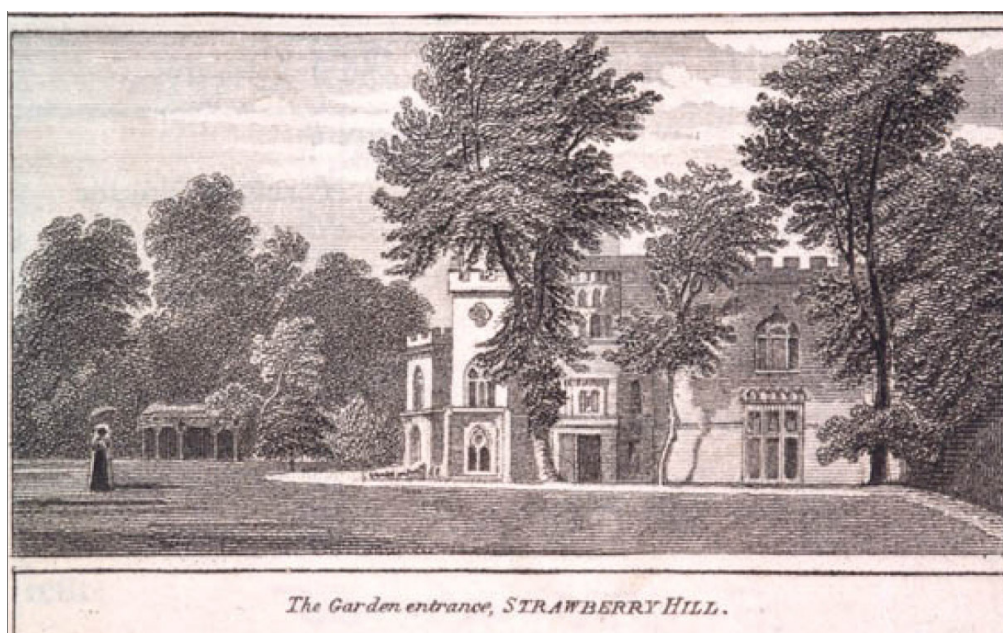
Figure 15: Unknown artist, c.1800. (Reproduced from Inskip and Jenkins 2006, Vol 1, Part C, p80)

Trench 3 was orientated east-west, projecting out on the south side of the door on the eastern face of the house. Due to the presence of concrete slabs sealing service drains, the trench was shifted south and excavation began approximately 1m from the existing property wall. This trench was located with the hope of identifying the location and nature of an earlier 18th century footpath relating to the east door and the rest of the house. Some contemporary illustrations present a depiction of this footpath, but while its existence is thus supported, very little useful detail can be discerned.

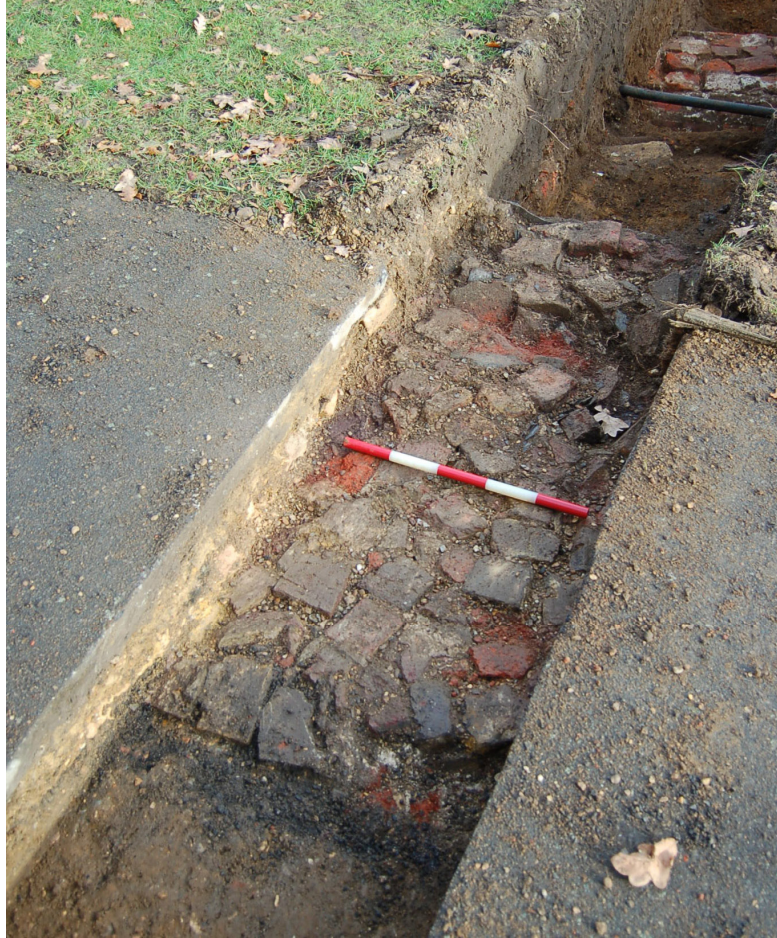
Figure 17: Trench 3, view north-east showing rubble path material [9] (0.5m scale)

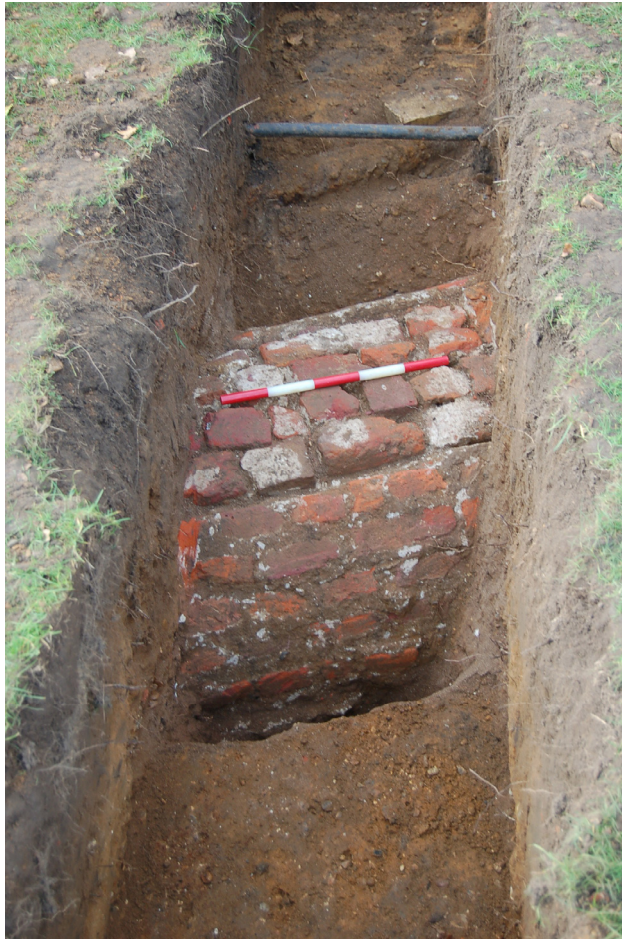
Figure 18: Brick built drain in Trench 3, view looking west (0.5m scale)

To the eastern end of Trench 3 a brick-built arched drain [5] was exposed at *c* 9.35m OD, cutting the natural gravels [12] within a wider sloped sided cut. As exposed, the drain was *c* 1.05m in with, with the cut extending some 0.4m either side. To the west the cut and subsequent fill sequence were truncated by modern services, while to the east the cut appeared to follow an initial gradual curve followed a near vertical drop and filled by two deposits, cutting the natural and subsoil. The bricks used within the drain itself were very abraded and frequently broken or fragmented, mostly made of a soft red fabric and unfrosted, and are probably 18th century in origin. However, the heavy abrasion on all surfaces, patches of exposed mortar, and use of broken bricks within the structure suggest they are reused, and thus that the drain itself post-dates the materials used in its construction. No further dating evidence was recovered from the fill layers, and thus a definitive date cannot be given. This type of arched top, steep sided drain is relatively common from the 18th century onwards, but in this case may well be of 19th century date.

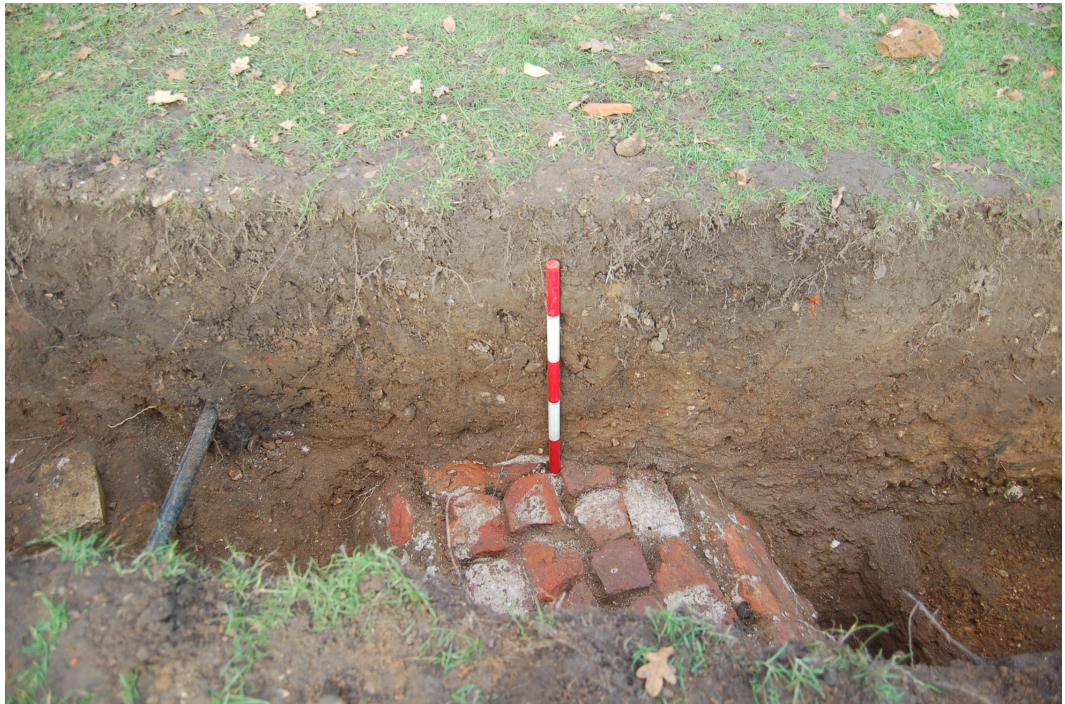
Figure 19: Brick built drain in Trench 3, showing cut and fill layers.

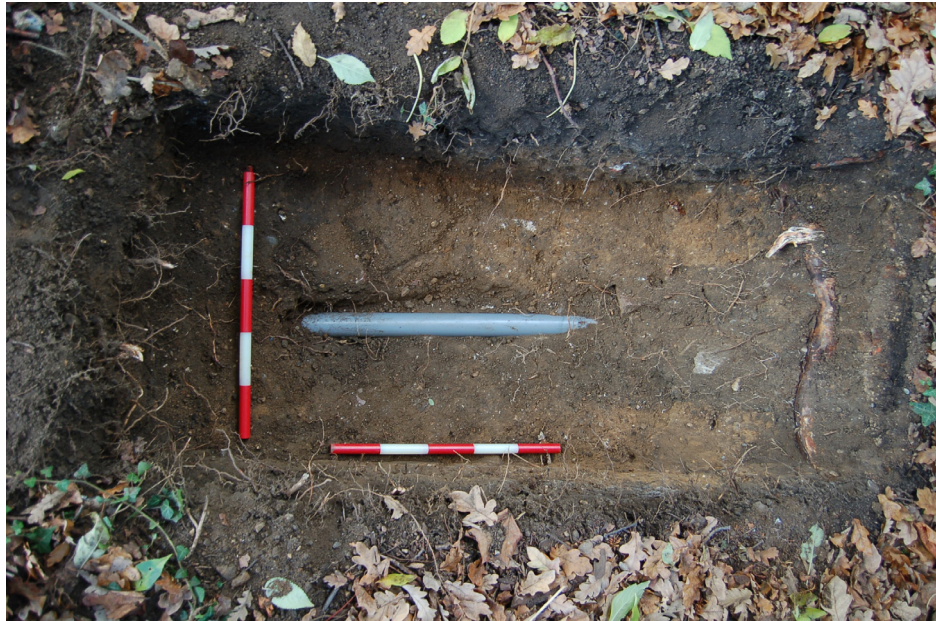
Figure 20: Trench 4, showing mains electricity cable within service cut through natural (0.5m scale).

A live mains electricity cable was encountered just 0.38m below the existing ground surface (9.84m OD), running down the centre of, and in alignment with the intended trench. Natural gravels were exposed either side of the service cut at c 9.8m OD, and existing topsoil and subsoil layers were removed in exposing the service. Due to proximity of other services, including water supply encountered in Trench 1 and a large concrete covered drain, there was no other feasible location of the trench within the designated area. Consequently, the trench was recorded and immediately backfilled without any further excavation.

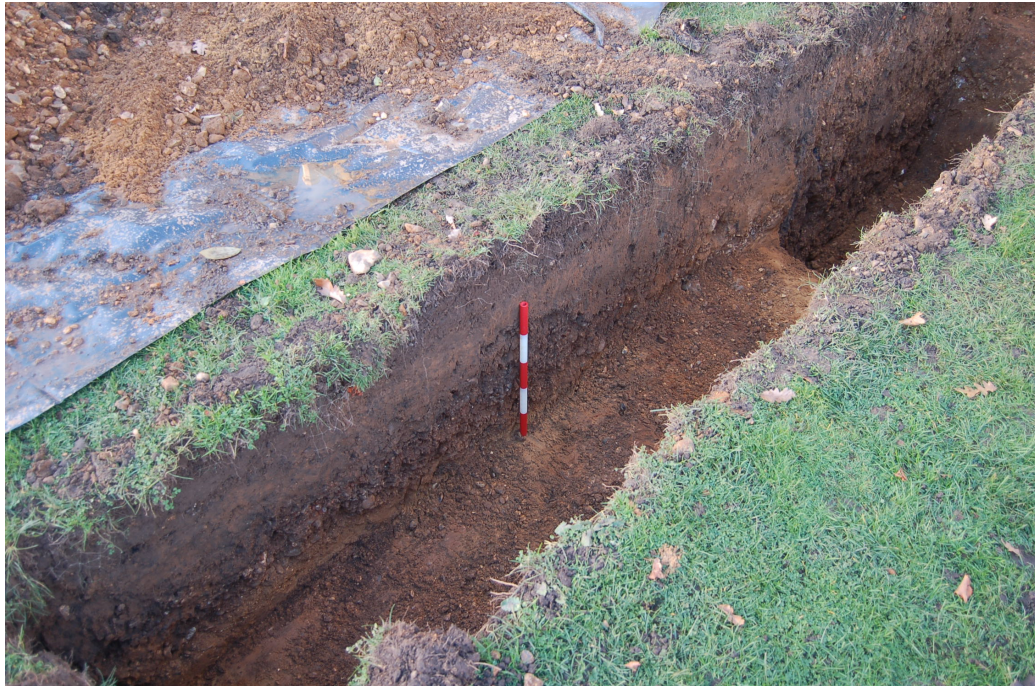
Figure 21: View north-west of Trench 5, showing slot into service backfill (0.5m scale).

No evidence for the historic path was observed in Trench 5. Excavation exposed a relatively simple sequence, including a large cut presumed to represent the existing drain located by manholes within the tarmac path. The cut [7] of this drain extended beyond the limits of excavation to the east and west on its linear axis, and in width to the south. A slot was dug into the fill [6] of this feature to establish depth, but the deposit continued beyond the 1.2m maximum excavation depth. The fill consisted of redeposited natural sand and gravel backfills with occasional lumps of tarmac suggesting a very recent date. A modern gas pipe was exposed very near the surface to the north of the trench, 1.7m south of the existing walls. The natural sequence consisted of a thin layer of silty sand brickearth [4] overlying compact sand and gravels [3].

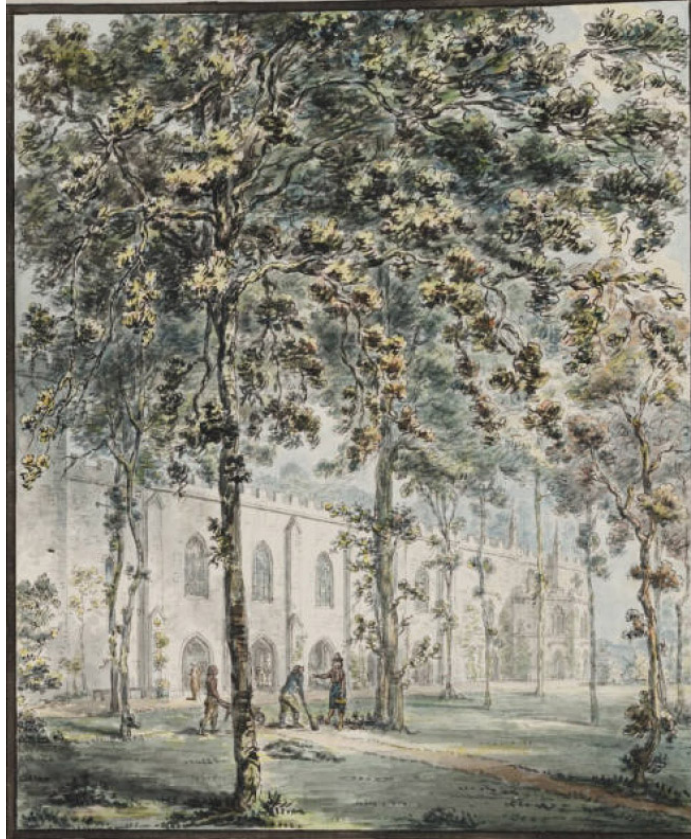
Figure 22: Illustration by John Carter *c* 1780's showing open cloisters, perimeter path and lightly wooden lawns (reproduced from Inskip and Jenkins 2006, Vol 2 Part B, p142).

Trench 7 was located projecting from the existing wall at what was originally the eastern most cloister opening on the south side of the house. Its location targeted any potential earlier remains and in particular the 18th century treatment of the area following the construction of the cloister between 1760-2, and before the subsequent alterations and blocking in after 1797. Earlier buildings stood on the site of the cloisters prior to their construction, which demolished following the final plans for this grander structure. During the phase *c.* 1760-1797, 18th century illustrations show the open cloisters with a perimeter path and opening onto lawns with occasional trees. No substantial structure seems to have existed outside the area of the cloisters, but it was hoped that 18th century ground levels, garden features or paths may be identified.

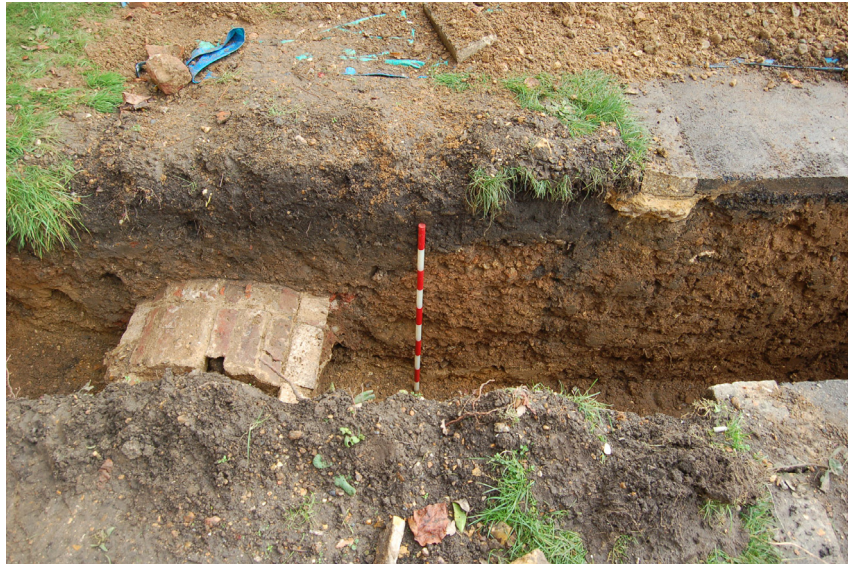
Figure 23: Trench 7 looking west. Arched brick drain [3] within linear cut, truncating redeposited gravel backfill (1m scale).

No evidence of 18th century activity was exposed in Trench 7 apart from a large construction cut and backfill [7] presumably associated with the 1760's construction of the cloisters themselves. This likely truncated any earlier features although it is possible that on the eastern side of the trench there were elements from the earlier *c.*1748 build. Backfill [7] was in turn cut by a brick built arched drain [3] running east-west within a wider linear cut [4]. The bricks used in the construction of this feature were very abraded and fragmentary, and some appeared to show warping during firing. Moreover, examination revealed two layers of mortar – a thin buff deposit overlain by the bonding material used in the drain. This all suggests that the bricks have been reused in this context, and while they may be 18th century originally the date of the drain itself is considerably later. This tallies with the assumption that the construction backfill (largely consisting of redeposited sands and gravels, with no datable recovered material) belongs to the mid 18th century construction of the cloisters and as the drain cuts this deposit it must therefore post-date it.

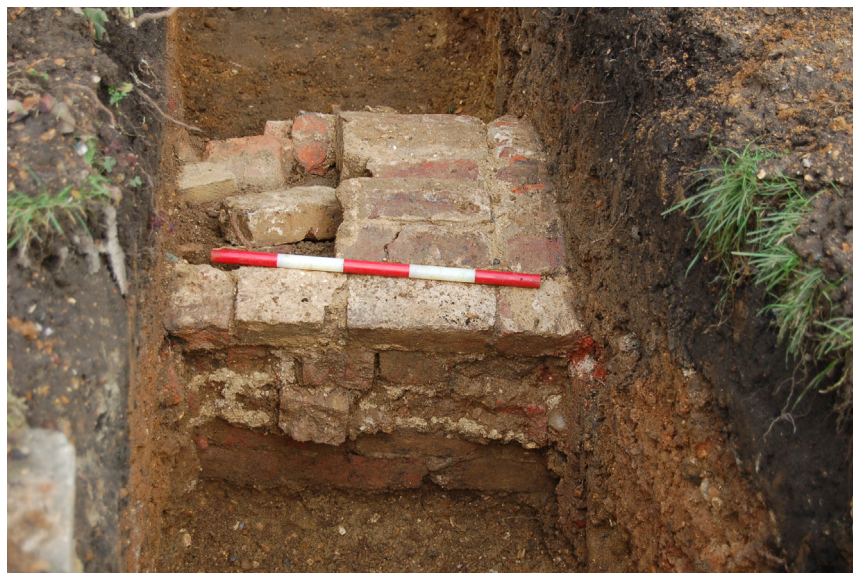
Figure 24: Brick drain in Trench 7 (0.5m scale)

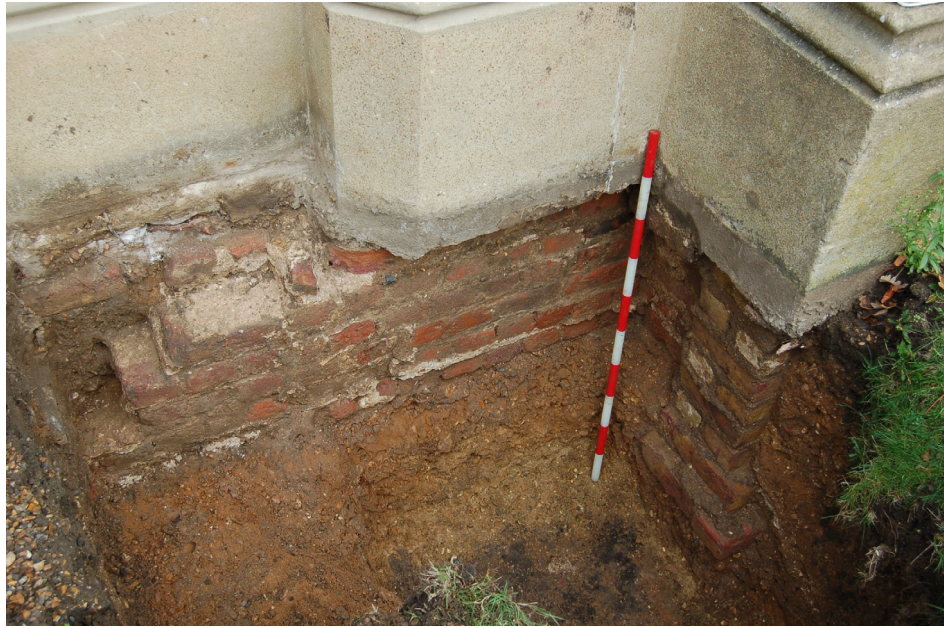
Figure 25: Photographed and drawn elevations of foundations exposed at the northern end of Trench 7.

At the north end of the trench the existing foundations of the house were exposed. The south face of the cloister wall showed brickwork continuing a further 0.52m below the initial ground level exposure, with the concrete render visible above ground level terminating 0.07m below ground level. A further 6 courses of bricks were observed, laid on-bed and bonded with grey/yellow chalky mortar with pebble inclusions. Below the final course of bricks (9.22m OD), natural [8] was observed consisting of relatively loose sand and gravels. The west face of the cloister pier on the east side of the trench showed a similar continuation of unfinished brickwork with no render. The foundation for the protruding column above ground consisted of a further 8 courses of brick, stepped towards the bottom to provide a wider plinth base (9.13m OD). It is possible that this outermost section, some 200-300mm wide relates to the earlier build of the eastern part of the house, *c.* 1748.

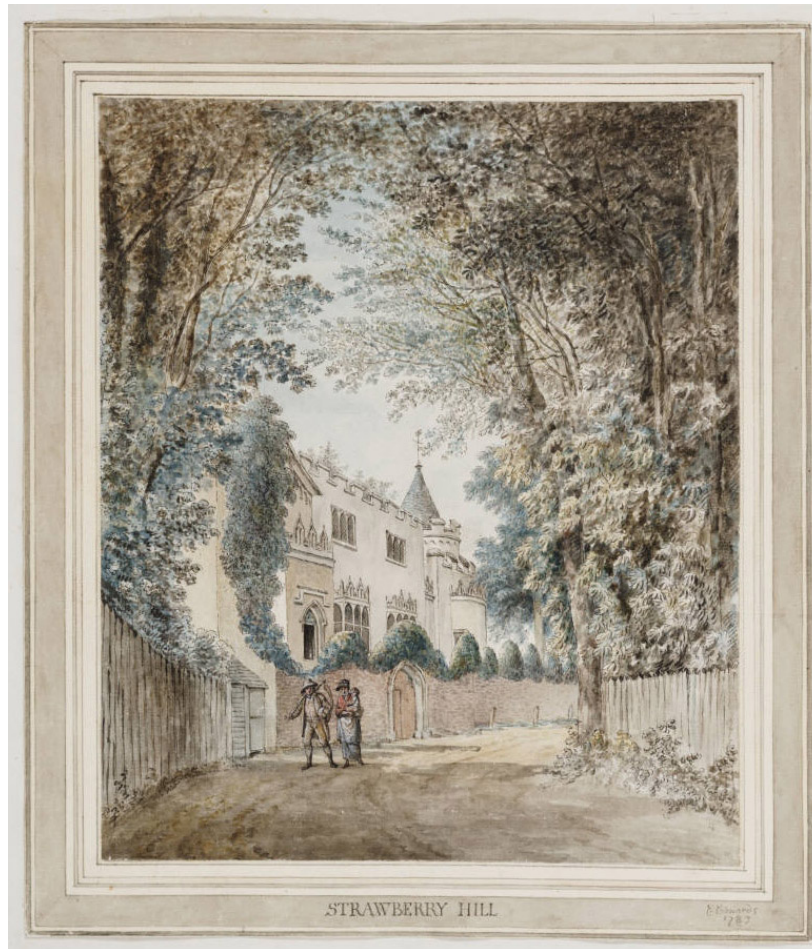
Figure 28: Illustration by Edwards from 1783 showing the north face of Strawberry Hill House and the wall of the Priors Garden (reproduced from Inskip and Jenkins 2006, Vol 1, Part B, p35).

Trench 8 was located on the north side of the house in the small lawn area in front of the existing kitchen. The trench was targeted at potential features relating to the 18th century Prior's Garden, including the paths and beds, as well as the northern boundary wall separating the garden from the contemporary road. Figure 27 below show a contemporary plan (1781) with the Prior's Garden wall highlighted in red, while Figure 28 shows a recent survey with the location of Trench 8 and the former position of the boundary wall highlighted.

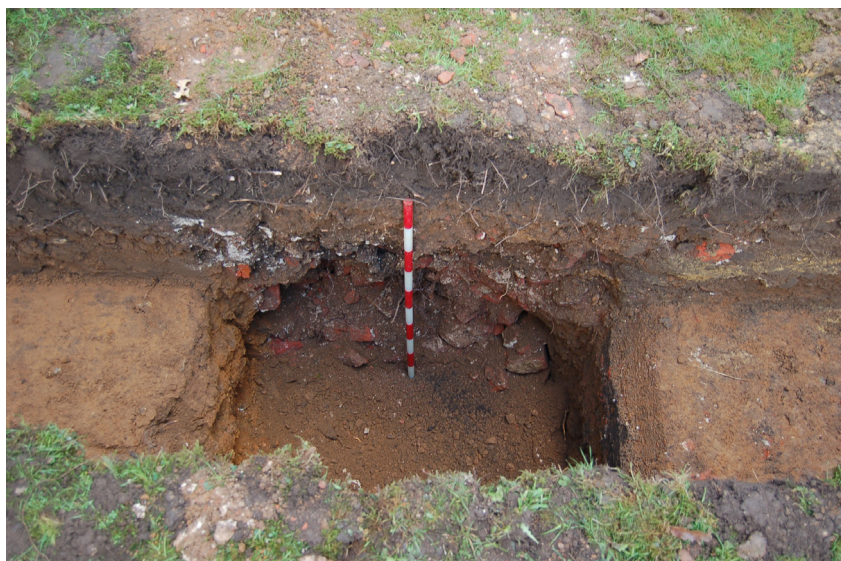
Figure 29: West facing section of Trench 8 showing partially excavated robber trench [4] backfilled with brick rubble. (1m scale).

No *in-situ* evidence of the 18th century features was exposed in Trench 8, but evidence for the wall bounding the Prior's Garden to the north was recorded in the form of a robber trench [4] backfilled with 18th century bricks, which presumably represents the demolition of this feature *c.* 1860, when the adjacent road was realigned and moved away from the House. Modern services were exposed in the south end of the trench, which well have truncated any surviving 18th century garden features. Natural gravels were exposed for the remaining area between 9.62m and 9.69m OD.

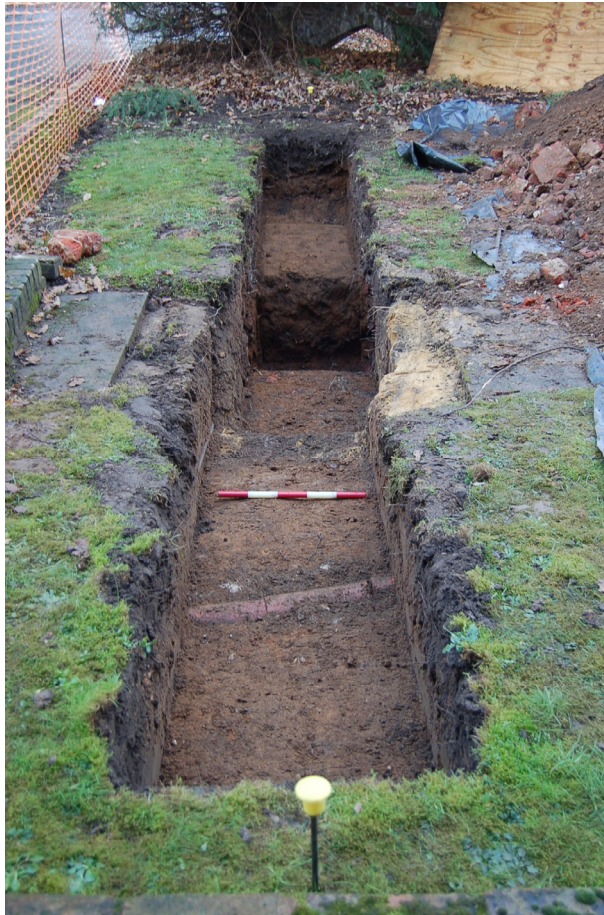
Figure 30: View north of Trench 8 showing services in foreground and robber trench to the north. (0.5m scale).

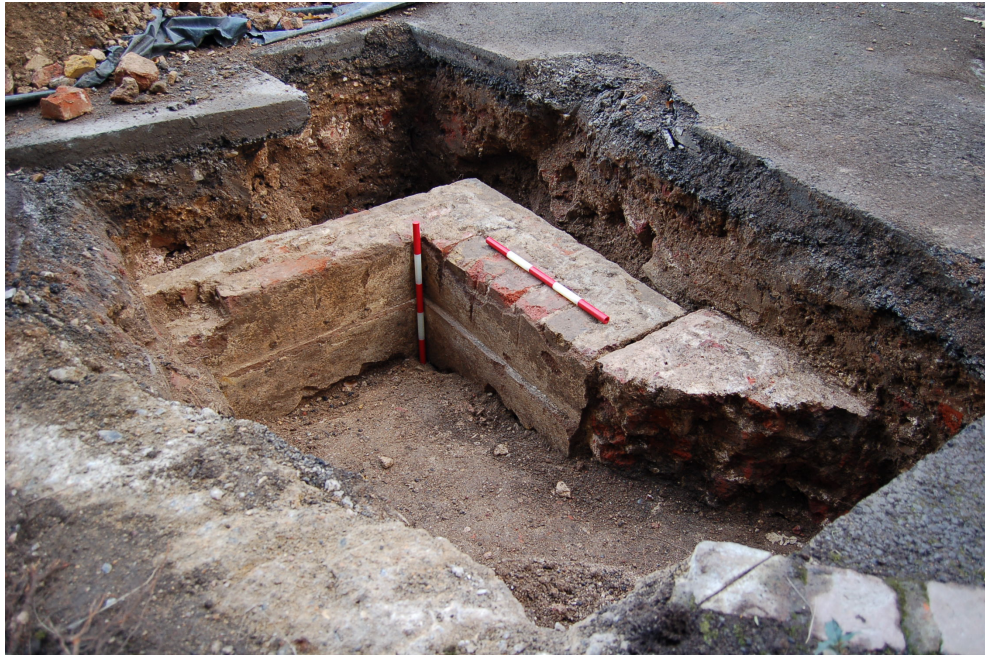
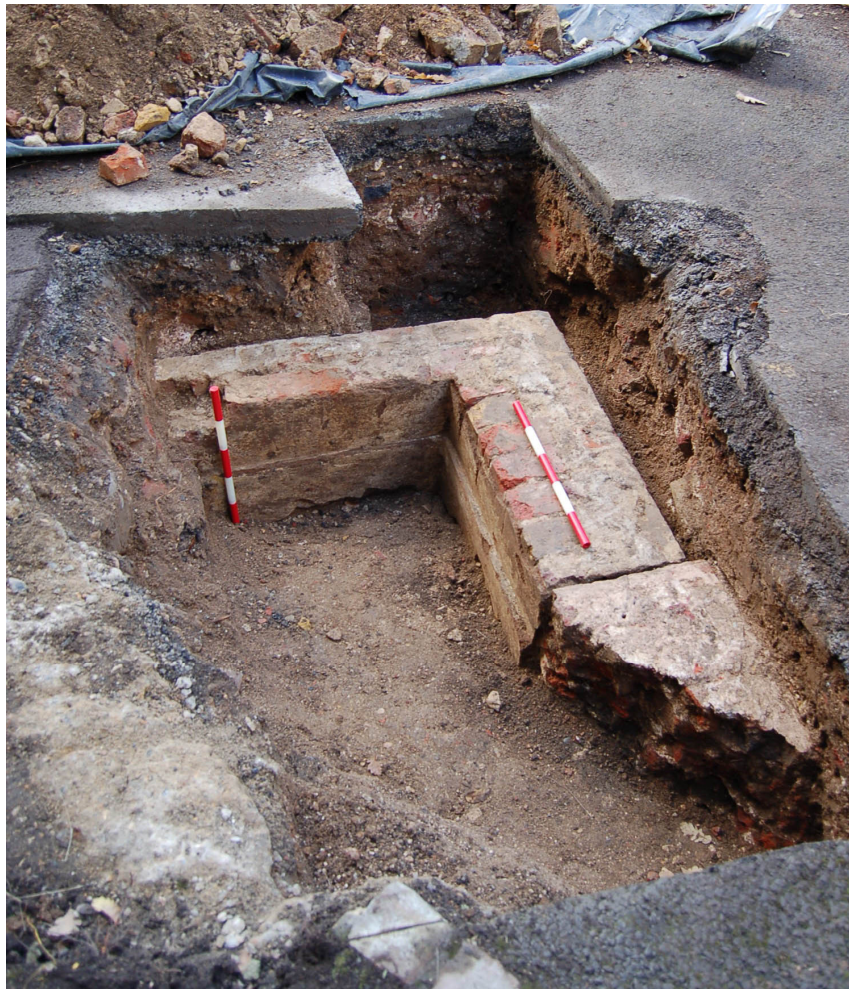
Figure 35: Trench 9 views north-west (top) and west (bottom) showing walls [4] and [5], backfill exposed in base of trench [3], and mortar render [6] on internal face.

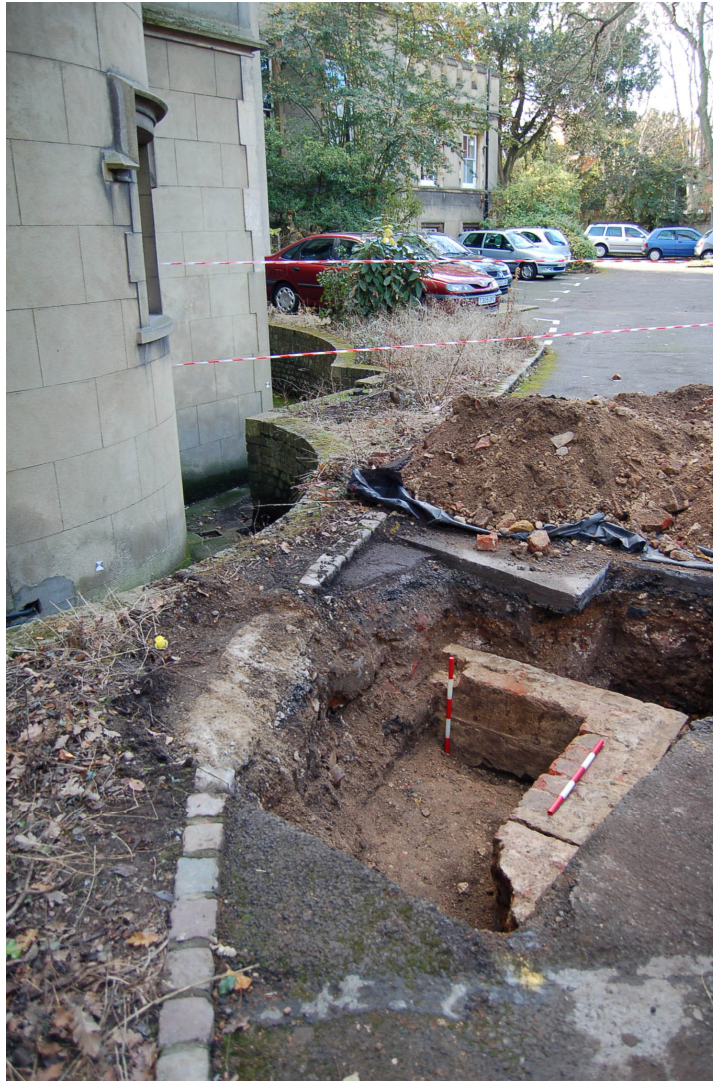
Figure 36: Trench 9, view south-west – showing relationship of walls [4] and [5] with existing building.

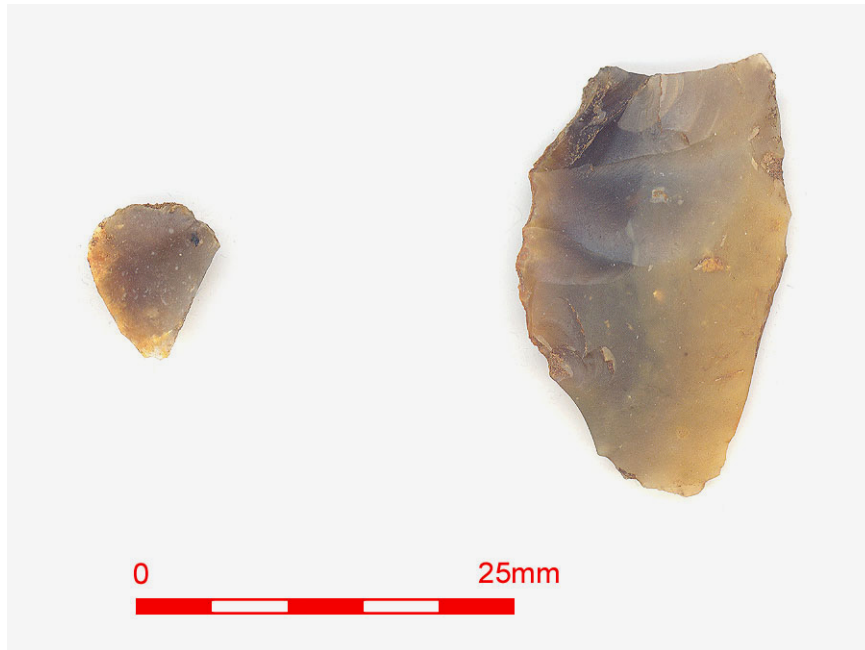
Fig 37: The flint finds from fill [10]. Shown at a scale of 2:1

1. Two potential worked flints were recovered from the fill [10] of a small pit in Trench 1, they are described as follows:
