KEW GUILD STUDENT VEGETABLE PLOTS

ROYAL BOTANIC GARDENS KEW

A PROGRAMME OF ARCHAEOLOGICAL RECORDING AND
PRESERVATION IN SITU

SITE CODE: RBG07

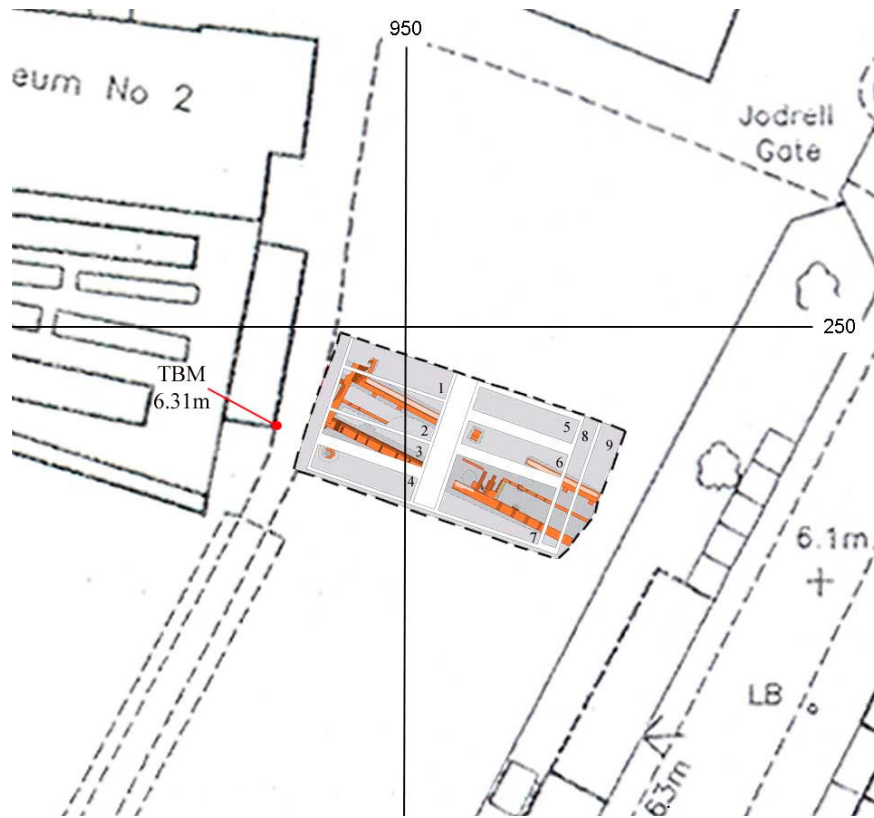
Fig 2 Site location, showing the newly discovered building outline in relation to the 1:1250 Ordnance Survey map. The area shown in orange represents the former building, the areas in grey show the individual Guild Student Plots, separated by the newly cast concrete baulks. The location of the OSBM on Kew Road (value 6.3m AOD) and the TBM on the corner of the adjacent glasshouse is also shown and the Bays are also numbered 1 to 9, following the reference system used throughout this report (*cf.* section 7).

The archaeological work revealed the foundations of a large rectangular garden building made of red brick with internal divisions (Fig 2). This building appears to be a large greenhouse or ‘forcing house’ and documentary evidence suggests that it may have been a peach house or vinery (see section 5.9). The presence of the building was previously unknown, but has now been traced through documentary and cartographic sources to be part of a large structure shown on maps dating from 1771. Further analysis indicates that the building is contemporary with the Georgian Grade II Listed School of Horticulture building (Museum No. 2), which stands a few metres to the east, and that both buildings were once part of the land held by the Earl of Essex, the Capel family (in the late 18th century¹). Both these buildings were constructed as part of the kitchen gardens for the Capel’s residence at Kew Farm (later the White House) on Kew Green. The School of Horticulture was also a garden building and before being assimilated into Kew Gardens was a gardener’s residence and a fruit store.

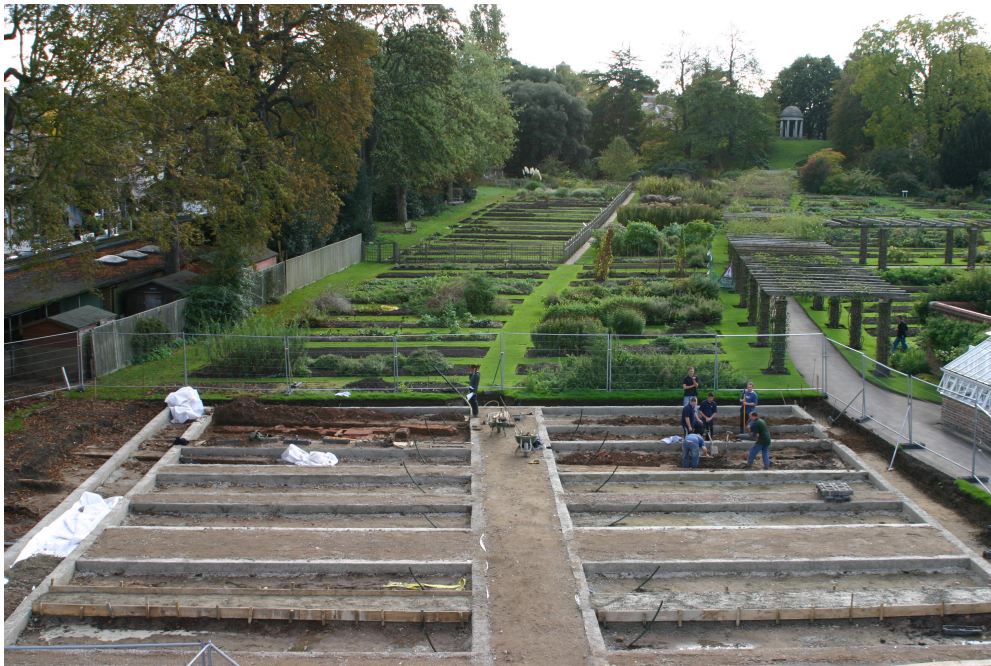
Fig 3 General view of the Kew Guild Student Vegetable Plots looking south. The excavation area can be seen with Bays 1 to 4 to the right (figures standing) and Bays 5 to 7 to the left of the wheel barrows and Bays 8 and 9 on the far left of the image (with two large pieces of white geotextile membrane). © John Lonsdale, Royal Botanic Gardens Kew.

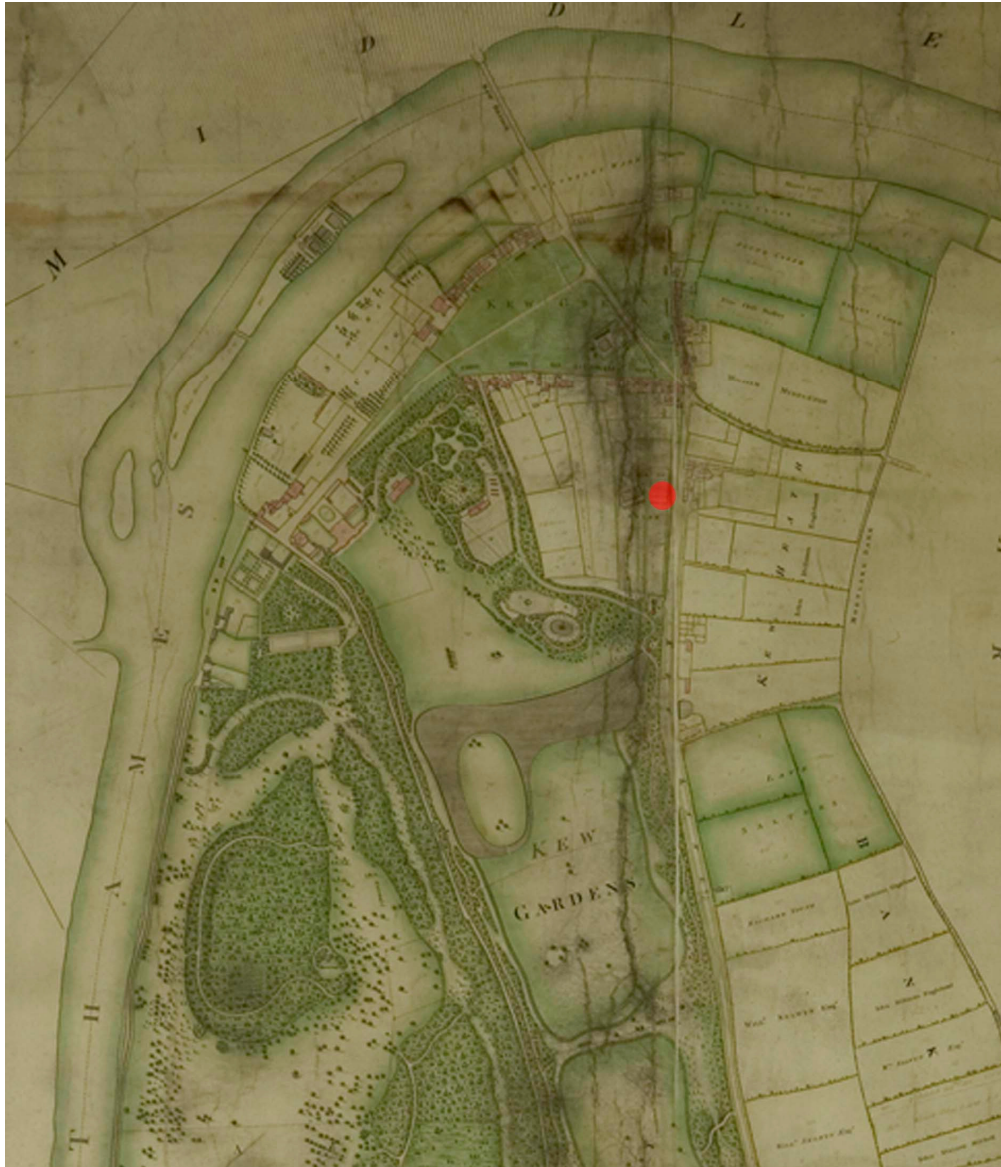
Fig 5 Extract from the much larger 'Plan of the Royal Manor of Richmond, otherwise West Sheen, in the County of Surrey' dated 1771. This map was kindly provided by the RBG Kew Archives and is a digital copy of the 1771 original plan from the Royal Library Windsor Castle (Neg. E9037, Order no. 328/92) that was 'taken under the direction of Peter Burrell Esq. His Majesty's Surveyor-General by Thomas Richardson'. The larger plan shows Kew Gardens, New Menagerie, Kew Heath, Thames, Kew Green and plots of land surrounding Kew (marked with the names of the

owners). Unfortunately there is no scale. The site is shown in red and is located in still broadly undeveloped land in comparison to the newly laid out Kew Gardens (Kew Park) to the south and east. Reproduced with kind permission of the Archives, RBG Kew.

5.7 The 1771 Burrell and Richardson map is extremely interesting as it shows the results of the intensive developments at Kew Park in the intervening years between this map and the Rocque survey of 1746 (Fig 5). More importantly when the site area is viewed in detail it can be seen that a long narrow building now occupies the site area and other large buildings are located near by (Fig 6). The plot of land is labelled Earl of Essex in reference to the land ownership and clearly lacks the detail of the formal Kew Gardens (also leased) to the west and south suggesting a different purpose of lesser importance. The buildings are not labelled in the key, unlike those within Kew Gardens and so are deemed less significant. It is apparent that the larger rectangular building to the north west of the study area conforms to the layout of the building now known as the School of Horticulture and that the area highlighted in red is extremely similar in plan to the brickwork structure discovered at the New Student Guild Plots (*cf.* Fig 2).

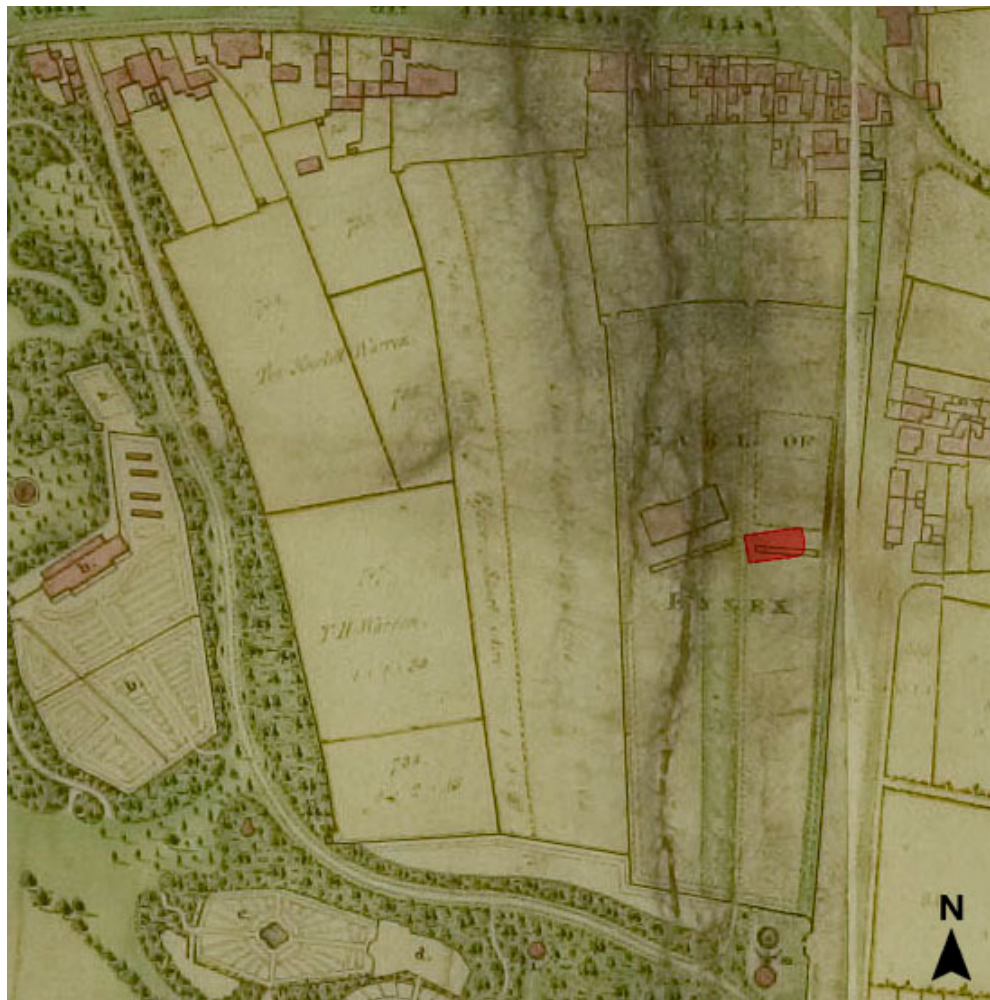
Fig. 6 Detail of Burrell and Richardson's 'Plan of the Royal Manor of Richmond, otherwise West Sheen, in the County of Surrey, 1771' see Fig 4 for larger extract of

this plan. The distinctive floor plan of the School of Horticulture building can be seen as a central plan with two wings. Reproduced with kind permission of the Archives, RBG Kew.

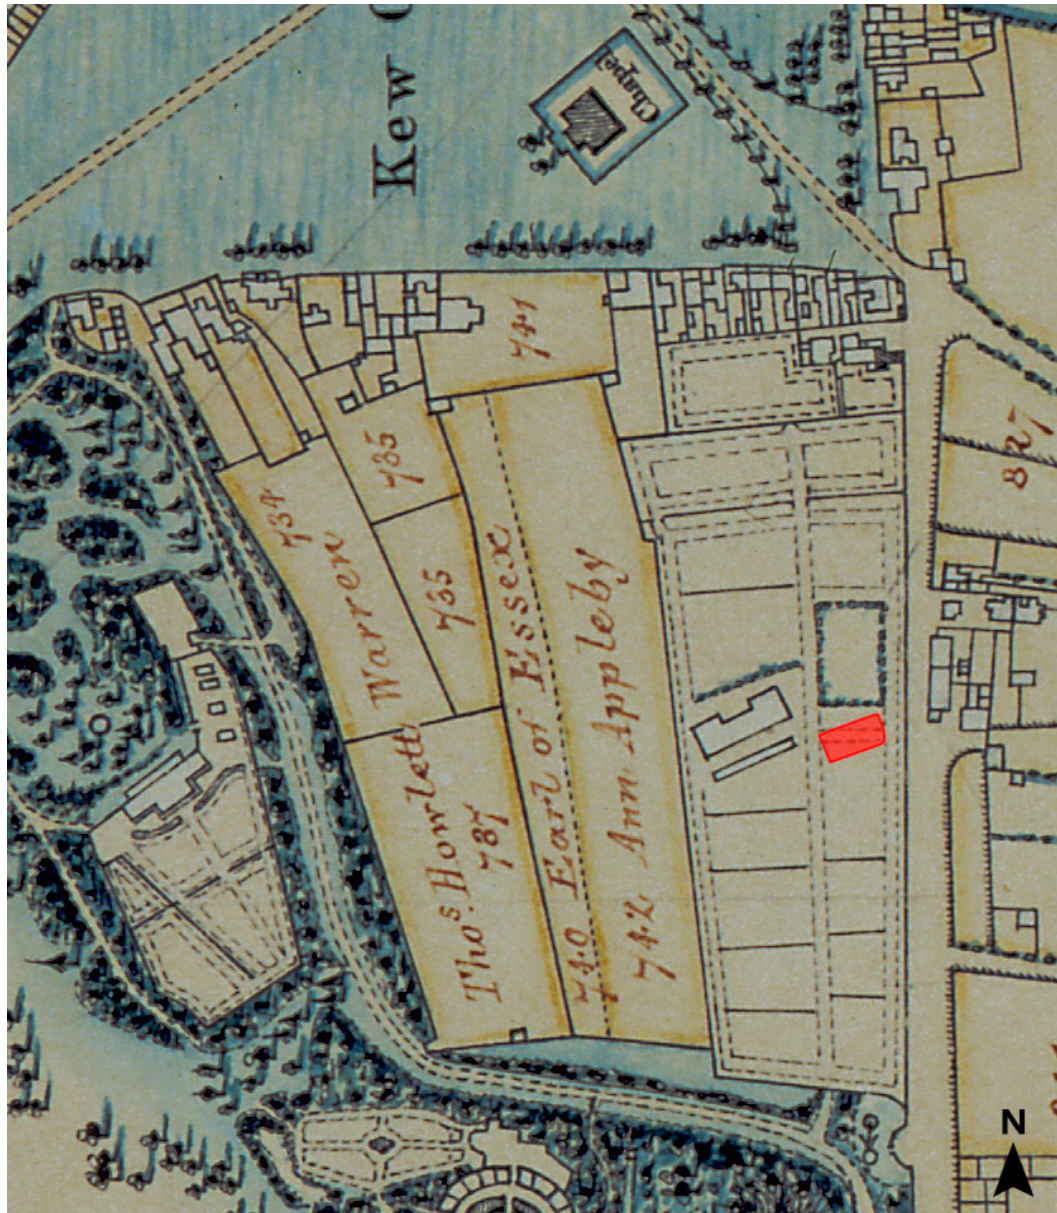
Fig. 7 Extract from the Burrell (Royal Surveyor General) and Richardson's (illustrator) 'Plan of the Royal Manor of Richmond, otherwise West Sheen, in the County of Surrey, 1771'. Reproduced with kind permission of the Archives, RBG Kew.

- 5.8 A second map, carrying the same title, and by the same cartographers was also produced in 1771 and the relevant extract is shown below in Fig 7. Their similarity suggests that the two versions were either produced for two distinct purposes but this is not stated, or that one is an earlier draft version of the other.

- 5.9 This version of the 1771 survey has a marked difference to that in Figs 5 and 6, in that the building in the study area is not so clearly defined, although the dashed area

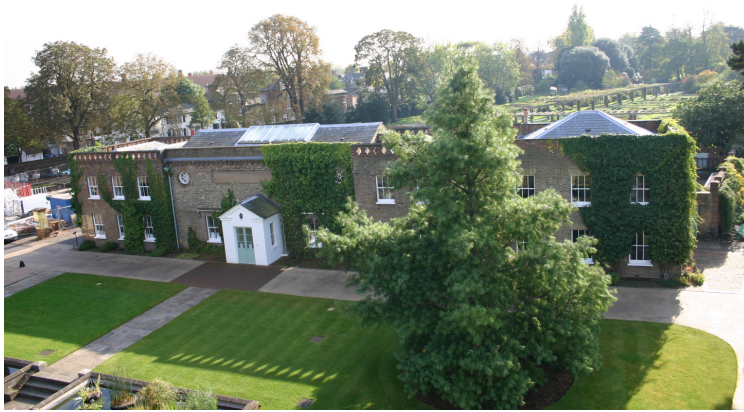
Fig 16 The Georgian Grade II Listed former fruit store building, view looking southeast. Restoration works in the 1960s replastered much of the brickwork (much in cement) and the original flush pointing style (possibly ‘penny point’) cannot be seen. © John Lonsdale, RBG Kew.

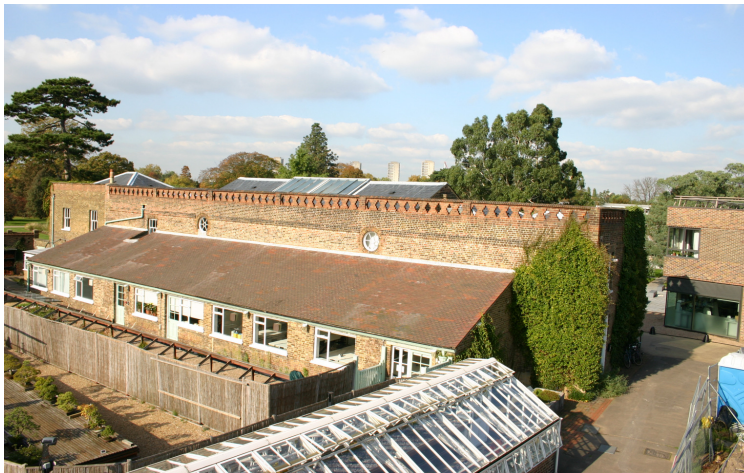
Fig 17 The rear of the Museum No. 2 building, view looking northwest, the red brick parapet has obviously been rebuilt at some stage © John Lonsdale, RBG Kew.

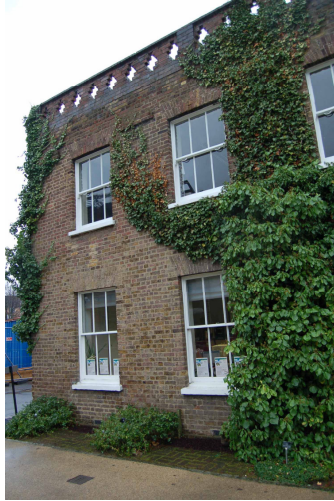
Fig 18 The north east corner of the Museum No. 2 building, looking southeast. The dark London stock brick courses can be seen.

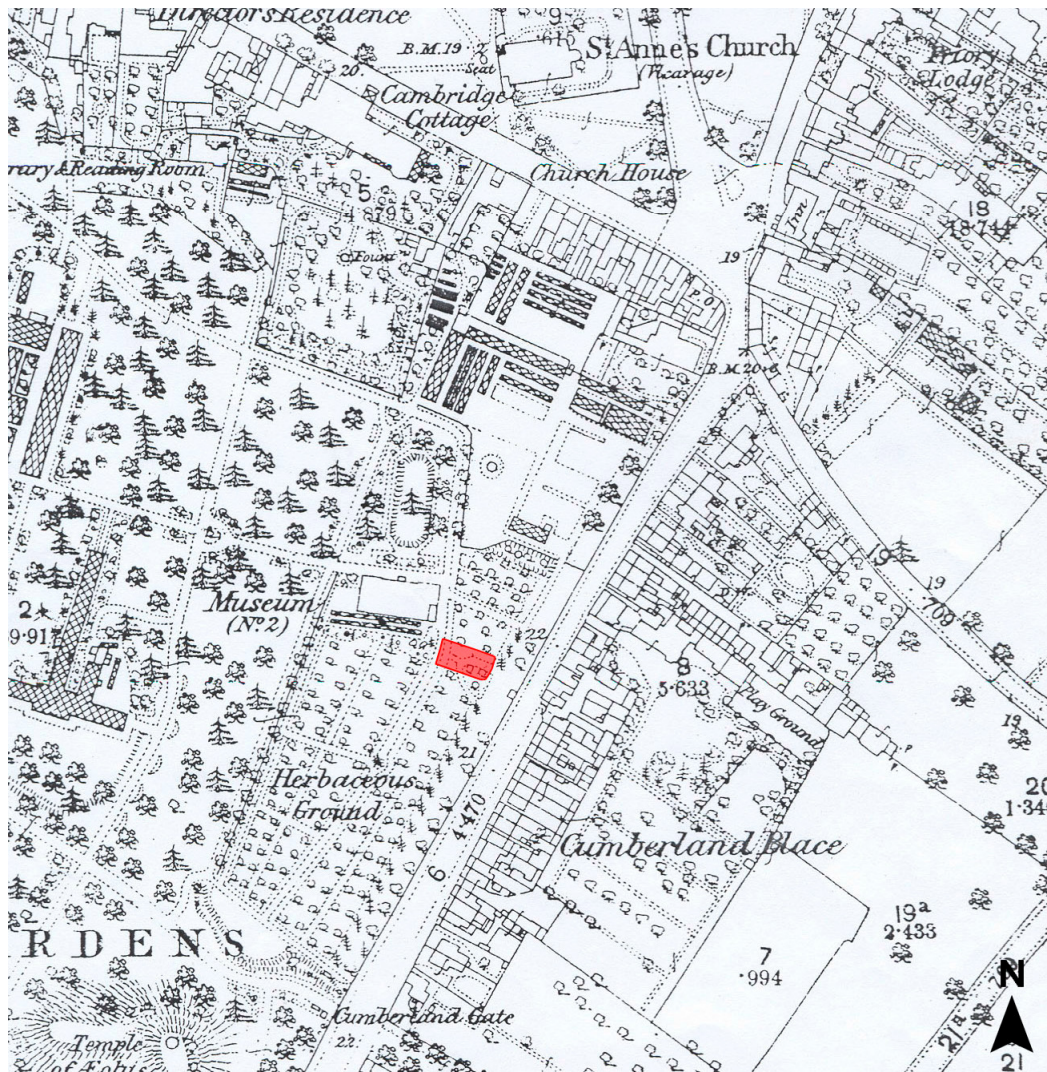
Fig. 19 Extract from the 1884 Ordnance Survey series.

5.25 The 1884 OS map shows no building in the study area; given the accuracy of the Ordnance Survey series by this date, and the historical records, it is evident by 1884 the buildings previously occupying the site, were demolished, probably as part of the works associated with the creation of the Herbaceous Ground Museum (Museum No. 2 after 1857). It is also possible that 18th century bricks from the demolition of the structures that once stood on the study site were reused in the rebuilding of the fruit store to form the museum as the elevations of the museum show contemporary materials were generally used. The site area is now part of the Herbaceous Ground and the former fruit store has been altered in accordance with Decimus Burton's designs as the shape is now rectangular rather than like an 'U'. The central portico juts out from the two storey ranges at either end, the central range projecting slightly forward as was indicated in Fig 15. There also appear to be a two long and narrow buildings adjoining to the southern wall of the museum, for which no function is given, but they are no doubt the forerunners of the glasshouses that survive to this day.

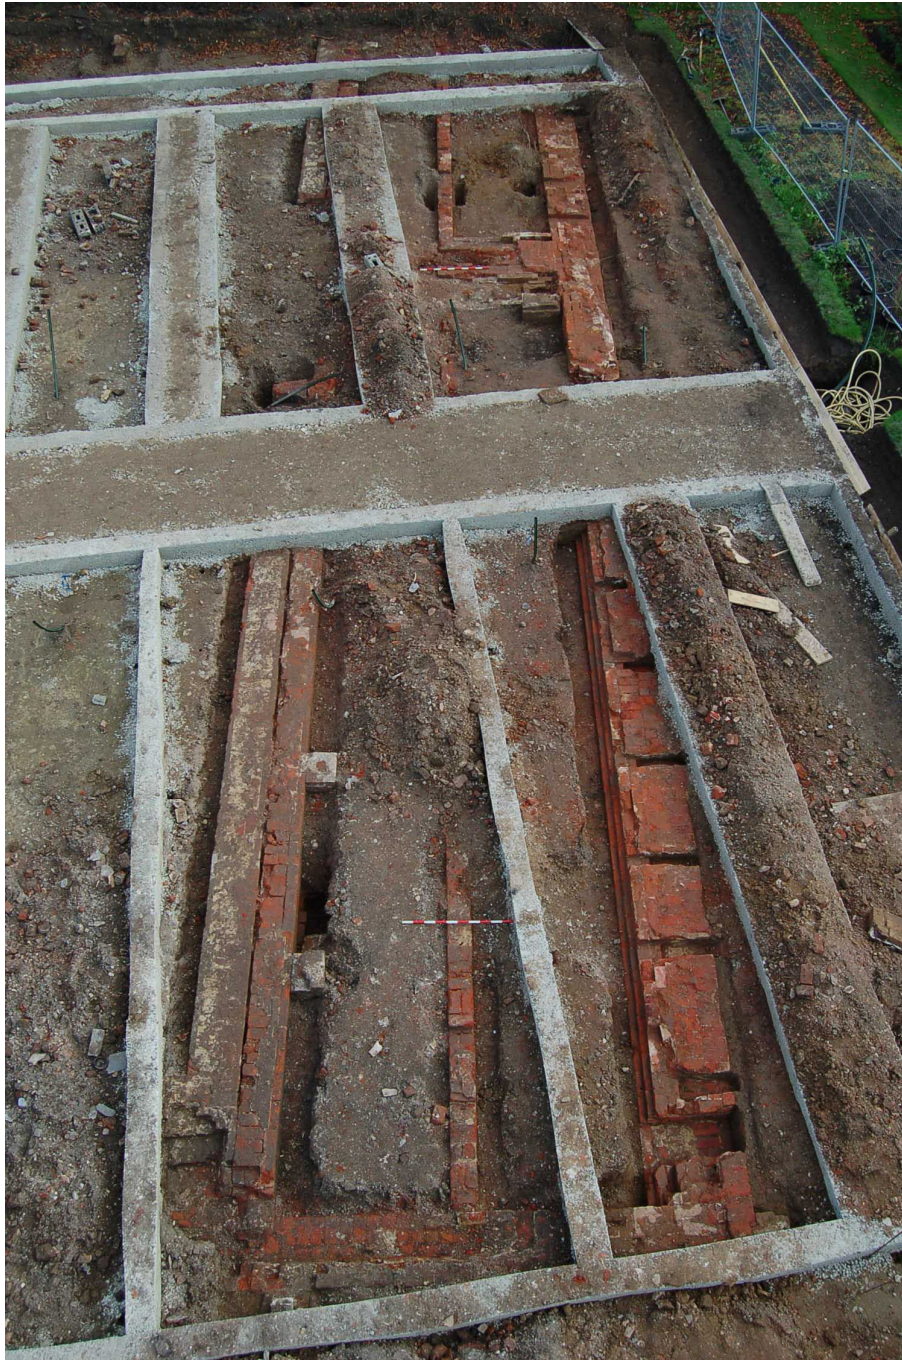
Fig 22 Aerial view of the excavation area, looking east. Bays 1 to 4 are in the foreground and Bays 5 to 9 in the distance. The principal features can be identified by comparison of this figure to Fig 21 and by using the list of contexts in section 7.4.

7.2.2 In Bay 7 Foundation [001] survived to a maximum of seven courses in height and was more substantial than the parallel east-west wall bases, being some 550mm thick and having three definite stepped foundations. The foundation had numerous cavities built into its length at irregular distances (*cf.* Fig 22)³¹. It is not known at what depth the

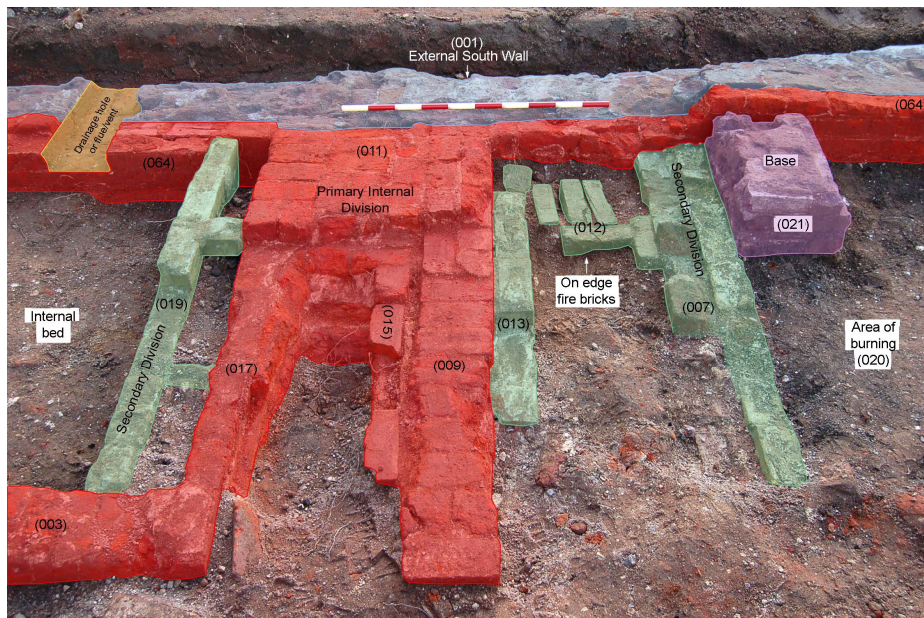
Fig 23 Detail of central deposits in Bay 7, showing in red the more major structures adjacent to main wall foundation [001] (at the top of the picture with the scale lying on

top), later features are shown in green possibly relating to a later phase of works for a area of central heating or division and finally, in purple, one of the five small brick pad bases found internally in the large structure.

- 7.2.6** The central brick structures were not fully excavated and preserved *in situ* so their intricate stratigraphic relationships and functions cannot be determined. What can be said is that the area had obviously been rebuilt and altered at subsequent stages and that a significant amount of burnt residue was present in the surrounding area [020], [016]. There appears to have been some heating element associated with this configuration of brick structures that may relate to the internal cavities in foundation [001] and in the internal division [003]. Two principal phases could be determined as the brick fabrics and sizes were of two generally distinct types, although the sample bricks from wall [015] were slightly smaller and perhaps part of a separate batch.

010	7	Shallow linear cut for wall division [009]	Cut for wall base [009]
011	7	Complex area of level (+5.95m OD) red brickwork located adjacent to and abutting [001] but possibly contemporary with [001]. Physically overlies internal walls [009], [015], [017] and stratigraphically [003]. Very compact cream white sandy mortar bond, measuring 700mm E-W by 600mm N-S. Earlier than adjacent walls [013], [007] and [019].	Flat area of horizontal brickwork, abutting but potentially contiguous with [001], [064], see Fig 23.

012	7	Five slumped or displaced frogged burnt bricks (exposed faces turned brown by burning), set on edge on a loose sandy bond in the area north of [001], between [007] and [013]. Brick dimensions 232mm x 103mm x 67mm.	Area of firebricks set on edge near area of complex brickwork and burnt soil deposits. Function unknown, but possibly relating to the area of burning to the north and possibly part of a stove or furnace for the greenhouse, cf. Fig 23

015	7	Loosely mortared red brick internal N-S wall division, one footer thick and up to 900mm visible, possibly extends under [011], only seen in plan (one course). Pinkish mortar with flint inclusions very friable almost sand like. Probably contiguous with wall [009] and [011] but using different materials.	Narrow internal division wall, later than main structure but using smaller hand made bricks 230mm x 100mm x 40mm. See Fig 23

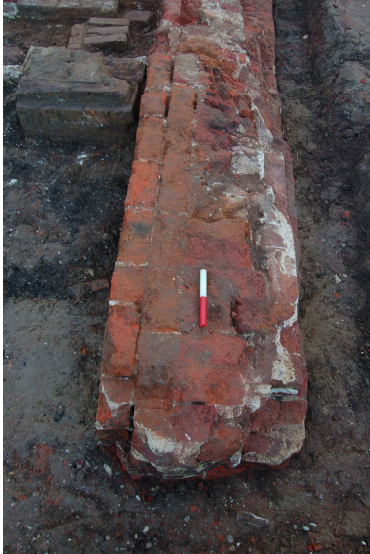
Context	Bay no.	Description	Interpretation
+	All	Mixed deposits; generally darker brown-grey soil with variable amounts of building rubble.	Recently disturbed made ground overlying principal features.
001	3 as [055] 7 8 9	Solidly mortared E-W red brick wall foundation (<i>c</i> 550mm thick) with ten drainage or heating holes (teeth) evident along the length of the foundation (including [055]) at irregular intervals, but generally about 1m apart. Extends for 7.8m in Bay 7 and a further 2.10m in Bays 8 & 9, where it continues beyond the edge of excavation. Becoming foundation [55] in Bay 3 and extending here for another <i>c</i> 8m. With the areas truncated by the modern concrete this gives a total length of this wall base as <i>c</i> 21.1m (approx 69 ft). Generally up to four courses (270mm) extant (now preserved <i>in situ</i>). English bond with a compact cream/yellow lime mortar with flush jointing. Whitewashed drainage holes (possible flues) evident along the length of the wall footing (cf. Fig 21). Small trial trench excavated to base of footing revealing the wall base to survive to a depth of <i>c</i> 630mm deep (at least seven courses). Top of wall base at highest point +6.05m OD and at base of wall footing at +5.15m OD. See also context [064].	Very substantial wall footing for southern exterior wall of large red brick 18 th century greenhouse. <i>Right: View of truncated end of [001] from west end of Bay 7 looking east. Base [021] to left.</i>

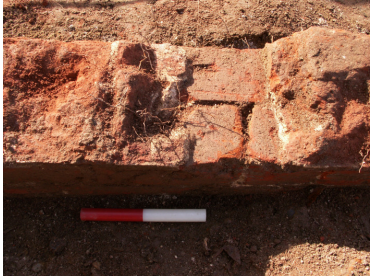
003	7	Very solidly mortared narrow E-W red brick internal division wall foundation across bays 7, 8 and 9 and becomes [005] and [048]. One stretcher wide (103mm) and steps out in a single footer ½ brick step at depth of 240mm from top +5.73mOD. Five irregular teeth holes evident in top surviving course (highest point +5.97), possibly for drainage or for heat circulation. English bond with thick cream yellow and grey patchy mortar with large flint inclusions, only chippable with point of trowel. This wall runs parallel to and is approximately 1.4m (4ft7”) away from wall [025] and approximately 1.5m. (4ft11”) away from wall base [011].	Narrower wall base or internal division within the 18 th century greenhouse, for internal bays or raised beds.

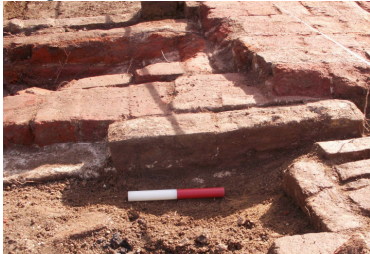
005	7	Continuation of internal E-W wall division [003], but further west in Bay 3, truncated to east and west by modern disturbance.	Continuation of central dividing wall [003]
006	7	Cut for wall foundation [005]	Foundation cut for wall [005]
007	7	Compactly mortared red and yellow frogged stock brick N-S internal wall division, running between and abutting walls [001] and [005], one stretcher (213mm) wide and extends for 1.55m. English bond in plan, very white thick mortar. Only seen in plan, but a small amount of whitewash visible in east face. Later than [011] and similar in appearance (although wider than) to [013]. Top of wall at +5.92m OD.	Small secondary phase internal wall or frame division. Not fully excavated as preserved <i>in situ</i> . Related to several contexts connected with the area of burning.
008	7	Shallow linear cut for wall footing [007]	Shallow cut for wall base [007]
009	7	Compactly mortared red brick internal N-S wall division, one stretcher thick (210mm) and up to 1.58m long, with three courses visible, similar to but earlier than [007] to west. Relates to nearby contexts, being earlier than [011] (stratigraphically, but all these contexts are broadly contiguous), contiguous with [015] and [017]. The northern end of the wall survives to +5.88mOD and appears to have a stopped end and the southern end disappears beneath [011] at +5.95m OD. Preserved <i>in situ</i> and not disturbed.	Small internal wall or frame division. <i>Below: Wall [009] visible behind small wall [015] in forefront, clearly overlain by brick structure [011] to right of image.</i>

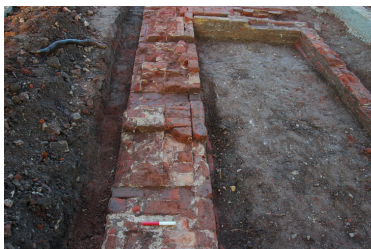
013	7	Small section of narrow red and yellow frogged brick internal N-S wall division, one footer thick and only a few bricks surviving so coursing not determined, appears to be 1.10m N-S. White sandy loose crumbly mortar. Adjacent and to the east of internal wall [009] at +5.90m OD.	Small internal wall, obviously later than adjacent wall [009]. Similar in appearance to parallel wall [007], cf. Fig 23
014	7	Mixed mid brown silty soil deposit, frequent inclusions of modern demolition rubble. In plan 4m E-W by 1.5m N-S. Intrusive elements including concrete, but probably in origin a bed or surface inside the green house. No significant evidence of burning, survives at +5.77mOD. Preserved <i>in situ</i> so not fully excavated. <i>Right: [014] visible between wall [001] to left and [003] to right and with internal partition [019] running between at the top of the image.</i>	Originally an internal cultivated soil deposit or formation deposit now disturbed.

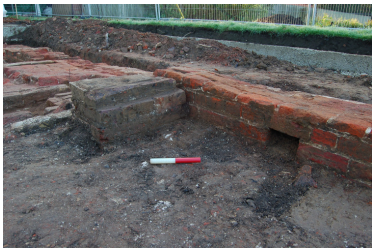
021	7	Rectangular/square freestanding dark purple frogged brick pad base. Solidly mortared and independent of all surrounding walls, measures 300mm E-W by 500mm N-S and three courses visible. Shallow foundations and abutting wall [001]. Similar structures survived in Bays 2, 3, 8 and 9 again on the northern (interior) side of exterior wall [055] in Bay 3 and to the southern side (interior) of exterior wall [037] (Bay 2) and [025] Bays 8 and 9. Survives to a height of +6.09m OD. Not spaced parallel to each other so not pairs of bases.	Internal base or pad for an upright support. <i>Below: base [021] with wall base [001] to right of image.</i>

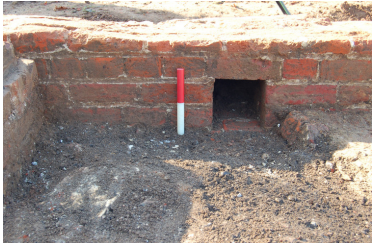
022	7	Moist compact mid grey/brown fine clean silty clay, some modern intrusive inclusions but becoming cleaner at depth. Extends to base of footings on southern side of wall [001].	Natural sub-soil deposit, through which wall [001] was constructed
023	7	Fill of small tooth in brick walls [001] and [064] a fine clean silty clay with small mollusc clusters. Analysis of mollusc sample from this apparent drainage feature showed the mollusc like samples to be the eggs of one of three species of shelled slug <i>Testacella</i> . All eat earthworms and can burrow deep in cultivated soil, none are aquatic and the sample was probably quite recent ³⁵ .	Silted up fill of small drainage tooth [024] in wall [001]. <i>Below after excavation and also showing [018] sooty soil deposit.</i>

024	7	Small structural hole through wall foundation [001], [064], narrower than other holes in this wall base 170mm N-S x 630mm E-W (two courses 170mm) high. See image above for [023].	Structural void or tooth through wall, see image above, probably for drainage as not generally large enough to be training roots through. Also, probably too small and too deep for a stoke hole.

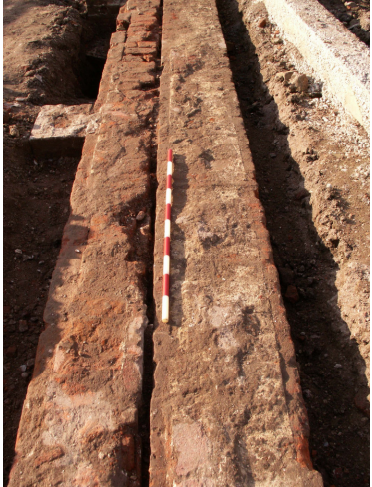
<p><i>Above: showing relationships of wall [025] left and wall [028] right, as seen in Bay 2 looking west (as walls [037] and [039] here).</i></p>

028	6,7,8	<p>Compactly mortared E-W major dark red brick external wall foundation running across Bays 6, 8 and 9 and also connecting with and becoming [030] to the west in Bay 6 and continuing as [039] in Bay 2. Measures a total length (including [030] and [039]) of approximately 21m (over 68ft) E-W and is 450mm wide N-S, depth to base of footing is 550mm with one half step visible at +5.17mOD. English bond with a thick grey/cream lime mortar in a neat flush jointing, but hard to be certain as whitewashed on northern face. The appearance of the southern side not visible as the wall abuts wall [025]. No teeth or voids visible in this wall and possibly evidence of a northern return in Bay 2. Survives in Bays 6, 7 and 8 at general level of +5.97m OD and extant for three courses.</p> <p>Runs parallel and to north of wall [025] and probably replaces [025] as a load-bearing wall. See images to right and for [039].</p>	<p>Very substantial wall footing for northern exterior wall of large red brick rectangular structure.</p>

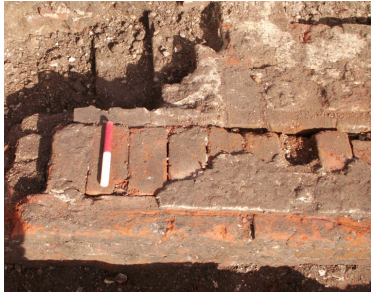
035	8	Very compactly mortared small square freestanding dark red brick base, one of four such surviving bases located to the south (interior) of E-W wall [025]/[037]. Base measures 380mm E-W by 300mm N-S and survives to +5.91m OD. Very compact grey/brown mortar with faint charcoal flecks. The other three are [041], [043] in Bay 2 and [065] in Bay 9.	One of four small square freestanding bases to south of wall [025]/[037].
036	2	Very compact cream/grey mortar scar visible on the top of wall foundation [037] at +5.95m OD and centrally placed on wall, measuring 190mm N-S by length of wall in Bay 2 of 2.54m E-W. Same as [027] and [030]. Forms a crust c. 10mm deep. <i>Right: detail of surviving mortar scar, visible along the central area of wall [037] in patches.</i>

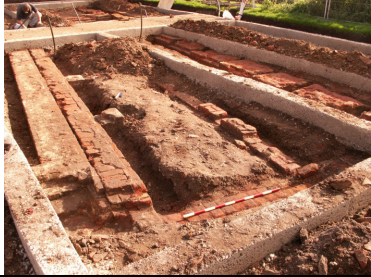
037	2	Very compactly mortared major red brick external E-W foundation, 330mm wide crossing Bays 6, 8 and 9 and becoming foundation [025] in Bays 8 and 9 and also surviving as small section [033] in Bay 6. Variation on English bond in places with a thick (10mm) grey/cream lime mortar, but only external (southern) face is whitewashed or lime washed. Does not appear to have penny point jointing and no voids evident as on other bases. Survives to height of +5.95m OD at highest point in Bay 2.	Continuation of wall base [025] in Bay 2. <i>Below: general view of Bay 2, looking east, with wall foundation [039] to left of image parallel to wall [037] adjacent to right.</i>

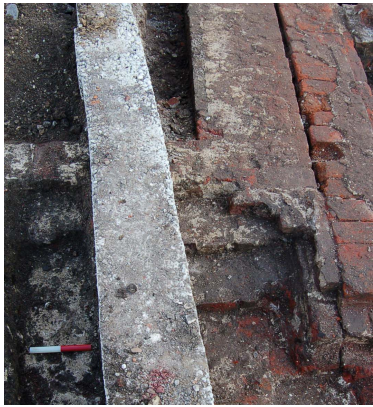
039	2	<p>Compactly mortared E-W major red brick external wall foundation running across Bay 2 and also connecting with and becoming [030] to the east in Bay 6 and continuing as [028] in Bays 6,8,9. Measures a total length (including [030] and [028]) of approximately 21m (over 68ft) E-W and is 450mm wide N-S, depth to base of footing is 550mm with one half step visible at +5.17mOD. English bond with a thick cream grey lime mortar in generally a flush jointing, but hard to be certain as whitewashed on northern face. The appearance of the southern side not visible as the wall abuts wall [037]. No teeth or voids visible in this wall and possibly evidence of a northern return in Bay 2. Survives in Bay 2 at general level of +5.95m OD and survives for at least seven courses.</p> <p>Runs parallel and to north of wall [025] and probably replaces [025] as a load-bearing wall. See images to right and for [039].</p>	<p>Continuation of wall [028], possibly with north-south return at far western end.</p> <p><i>Below: Wall [039] with [037] to right, looking east, showing possible northern return of [039] cut by central white modern concrete footing.</i></p>

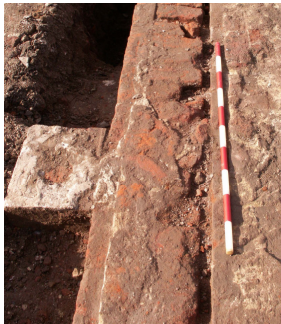
040	2	Cut for [039]	
041	2	<p>Small square freestanding dark red/purple brick base, one of four such bases located to the south (interior) of E-W wall [025]/[037]. Other three area [035], [043] and [065] measures 360mm E-W by 290mm N-S and survives to +5.91m OD and three courses deep (220mm). Thick very compact crusty white/cream mortar with faint charcoal flecks, small circular area of mortar missing in centre of base, perhaps suggesting a circular perhaps metal upright stood on this base (see context [052] for this mortar scar).</p> <p><i>Right: view looking east of square freestanding base [041] to south of wall [037]</i></p>	<p>One of four small square freestanding bases to south of wall [025]/[037].</p>

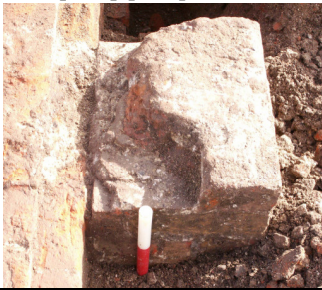
043	2	Small square freestanding dark red/purple brick base, one of four such bases located to the south (interior) of E-W wall [025]/[037]. (cf. [041]. Measures 360mm E-W by 310mm N-S and survives to +6m OD. White/cream mortar with faint charcoal flecks. Four courses visible, with thick mortar crust surviving on top of base [053].	One of four small square freestanding bases to south of wall [025]/[037].

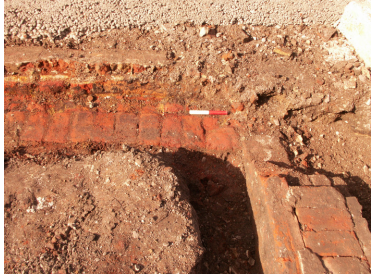
050	1,2	<p>Within a complex area of disturbed brickwork at western end of Bay 3 is a loosely mortared E-W red (in places bright red) brick wall foundation (c 550mm thick E-W) and in other places looking completely contiguous with wall footing [055]. Extends for 5m N-S in Bays 1-3 continuing beyond the edge of excavation in Bay 3. Generally up to four courses (270mm) extant (preserved <i>in situ</i>). English bond with a yellow sandy friable loose mortar with generally flush jointing. Top of wall base at highest point +6.05m OD and at base of wall footing at +5.15m OD.</p> <p>The areas of very bright red brick appear in the northwest corner of Bay 2 where significant residues of burnt material were found.</p>	<p>Appears to be the western end of large rectangular greenhouse structure.</p> <p><i>Below [050] looking west at west end of Bay 3 at junction with [037].</i></p>

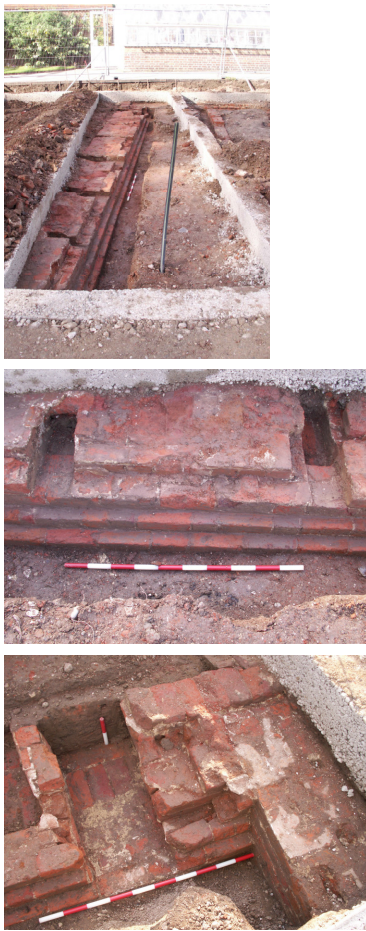
056	3	<p>Cut for [055] apparently trench built, clean silty sub soil evident at depth of +5.87m OD which is about depth of top stepped footing of wall [055].</p>	
057	3	<p>Large deep void at western end of wall base [055] integral part of wall construction and contiguous with main construction phase. Appears to be a large drain (too small for a root hole) and was filled with clean silty alluvium [058].</p> <p><i>Right: Detail of drain [057].</i></p>

- 7.3.5** In wall foundation [055] in Bay 3 numerous large cavities were evident, many of which had whitewashed interiors. Also integral to this foundation was a large deep cavity possibly a drain or water feature at the western end [057] as the surface had been whitewashed and there was no evidence of burning. This is possibly linked to the well or soakaway [063] to the south in Bay 4. It is also possible that this feature is a stoke hole as shown on Burton's plans of the fruit store (Fig 15), which has a similar feature at each end of the southern walls, although it appears that the stoke hole in the fruit store may have been up to 3ft wide.
