**KING SOLOMON ACADEMY (THE FORMER
NORTH WESTMINSTER COMMUNITY
SCHOOL) PENFOLD STREET, NW1 6RX**

AN ARCHAEOLOGICAL EVALUATION

**SITE CODE: KSM08
SITE CENTRE: TQ 2713 8189**

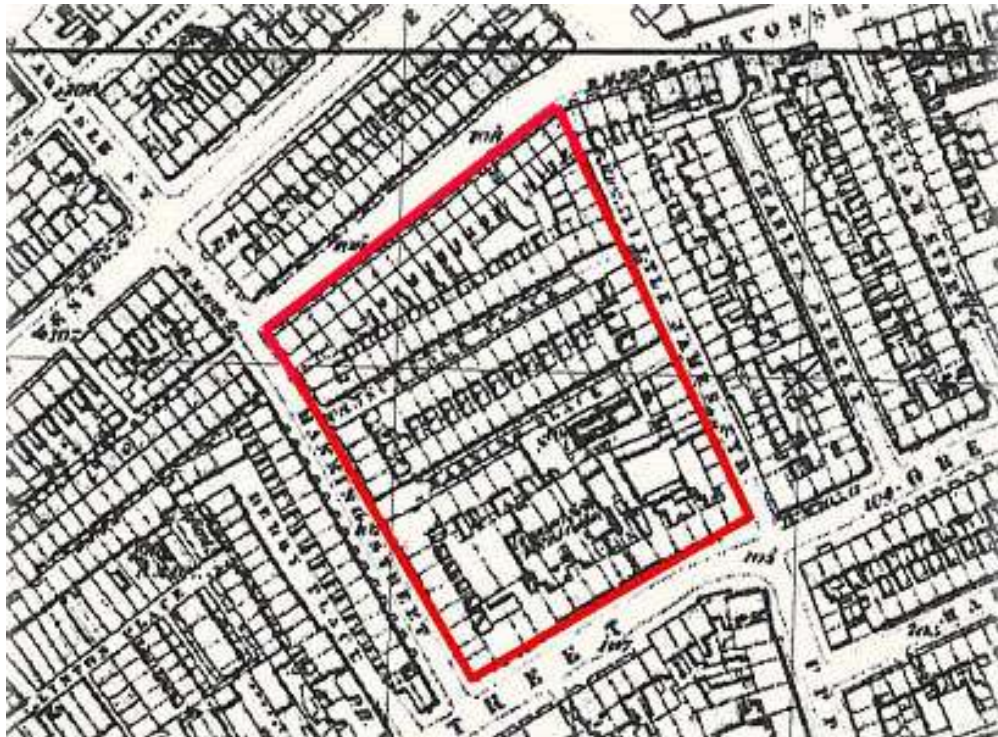
Figure 4: Extract from OS published 1869 1:2500 map.

The contemporary Ordnance Survey maps detailed in Figures 4 and 5 above, while showing no detail as to the layout of individual properties, give a general impression of the nature of the tenement buildings. They appear typical of buildings of this period, consisting of a more substantial structure facing onto the road (in this case onto Ashmill Street and probably two storeys) that housed the halls and parlours, with a rear, narrower structure at the back of the property that would have contained the kitchen and scullery and may well have been single storey only. This typical plan (suggested in Figure 10 below) would have formed the general layout of a series of similar terraced buildings. The structural features exposed in Trench 1 appear to fit this pattern, but suggest the trench was placed over two adjacent properties. Figure 10 below details the suggested layout described above, with a simplified extract from the 1896 OS map, overlain with the outline of Trench 1 and the exposed walls. Based on these observations, it appears that the exposed wall [7] is the part of the rear structure shared between two adjoining terraced properties. The junction between walls [11] and [12] represents the internal division of the front and rear parts of the property, while the northeast-southwest stretch of wall [11] represents the continuation of the main front structure facing onto the rear yard. Wall [18] is structurally more substantial and represents the main side wall in the front part of the property, its size may well indicate that it supported an upper storey. The plans suggest that wall [16] and plinth [9] represent internal features. The concrete slabs [6] and [8] represent the floor surfaces of the rear sections of two adjacent properties – the fact that no such surface appears in the front part of the building indicates that an alternative method was employed, probably a suspended floor, laid on the ground makeup represented by deposit [5]. The drainage features exposed beneath [8] may also explain why concrete was employed in the rear, providing further protection for the below-ground services.

The features exposed in Trench 2 are clearly of mid-late 19th origin, and as with Trench 1 a basic understanding of the areas development during this period is an advantage. Figures 4, 5 and 6 show the changing appearance of the study area between the mid-19th century and the clearance of the site for the Rutherford School c.1960. The area in which Trench 2 was located is shown to have residential properties similar to those discussed in regard to the results of Trench 1, but there are two specific features to note. The Church of St Barnabas appears on the OS map of 1869 and is known to have stood on the site since 1863 (consecrated 1865), before disappearing from the record in the 1870's. It is likely that the church was a temporary structure, supported by the reference to '*St Barnabas's Church (iron)*' (Compass Archaeology:2006). By 1874 the church is no longer present on the site, and a new building – the Bell Street School – has been constructed, although the maps indicate that the latter was not built over the footprint of the former.

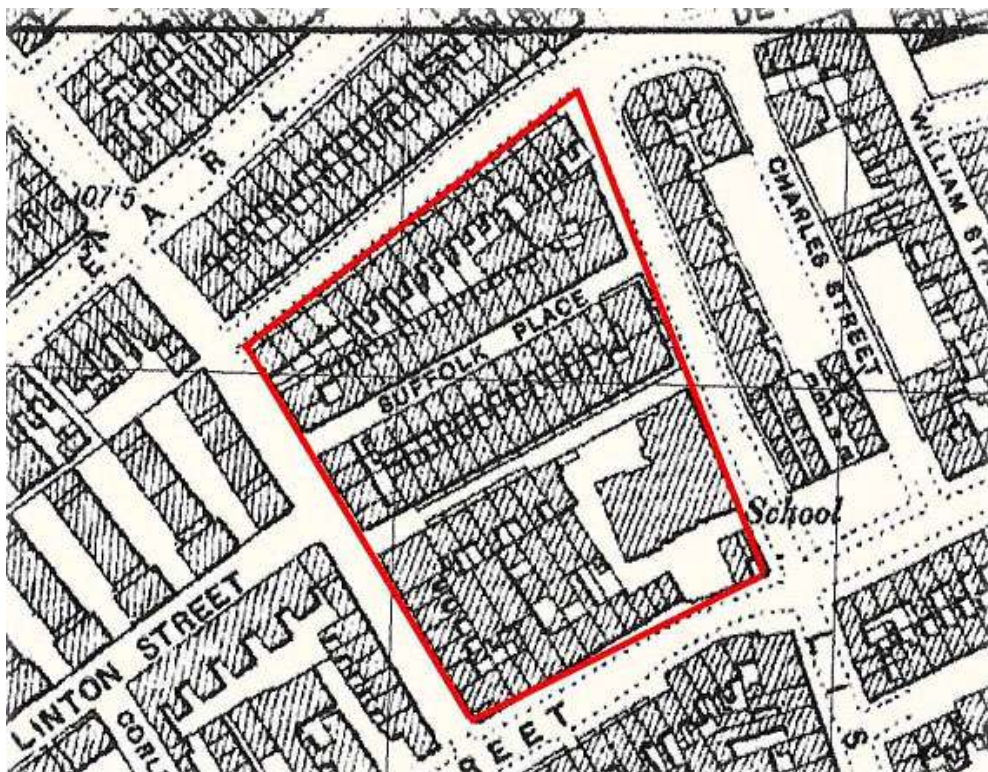
Figure 5: Extract from the OS 1896 series

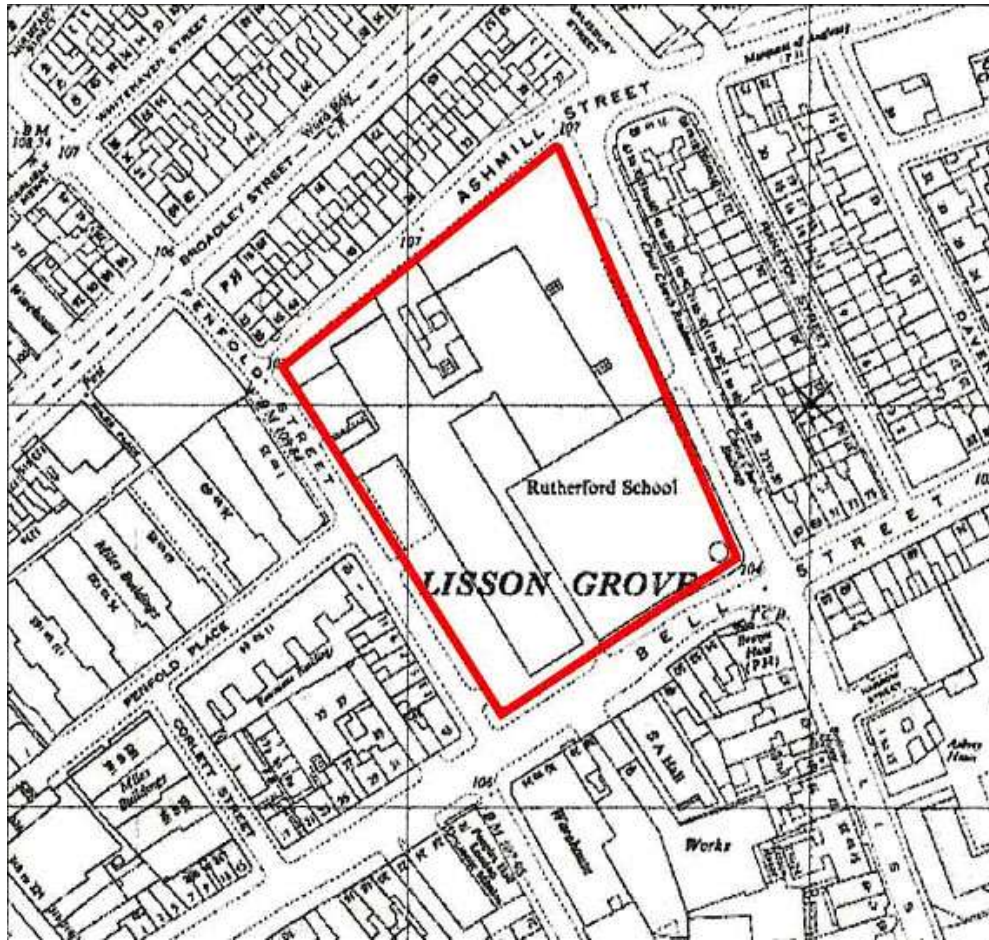
Figure 6: The OS 1962 series, showing the newly constructed school

The overall historic development of the area is discussed in depth within the Desktop and Archaeological Impact Assessment (Compass Archaeology 2006), but for the purposes of clarification a brief summary of the relevant period is presented below. From 1800 onwards the study area was rapidly redeveloped, spurred on dramatically by the arrival of the railways from c.1836. In the early part of the 19th century the northern part of the site consisted of terraced housing of a relatively upmarket nature – largely due to the proximity of the site to Regents Park and other fashionable areas. However, from 1860 onwards the City of London saw a massive programme of redevelopment, including a new sewer system and travel infrastructure – as a consequence vast numbers of people migrated to the suburbs and the richer occupants of the study area in the first half of the century were rapidly replaced with a poorer crowd. Lisson Grove in particular became a notorious slum, and much of the area was crowded with denser and more affordable housing. Contemporary maps from this period show rows of terraced properties on the relevant areas of the study site, and from 1896 two roughly east-west roads and a school building (Bell Street School constructed 1874) are shown (see Figures 4 and 5 below). The site then remained relatively unchanged until after the Second World War, when a number of schools were constructed in the area to compensate for the 'baby-boom'. In 1958, the study site was cleared of the Victorian tenement buildings to make way for the Rutherford School, designed by Leonard Manasseh and partners (see Figure 6).

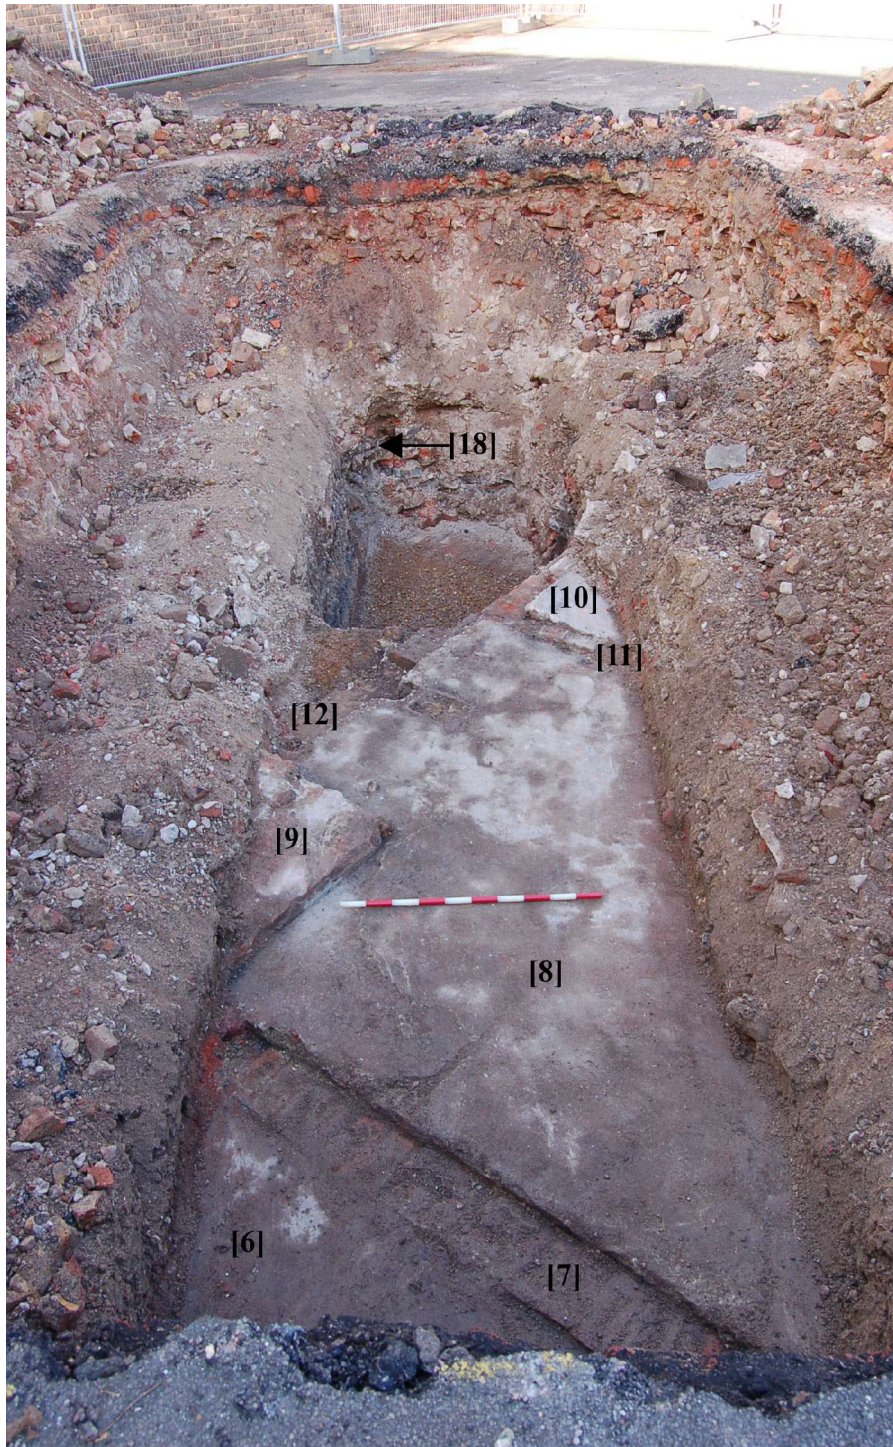
Figure 8: Trench 1, view north showing the series of walls and concrete slabs. (Scale 1m)

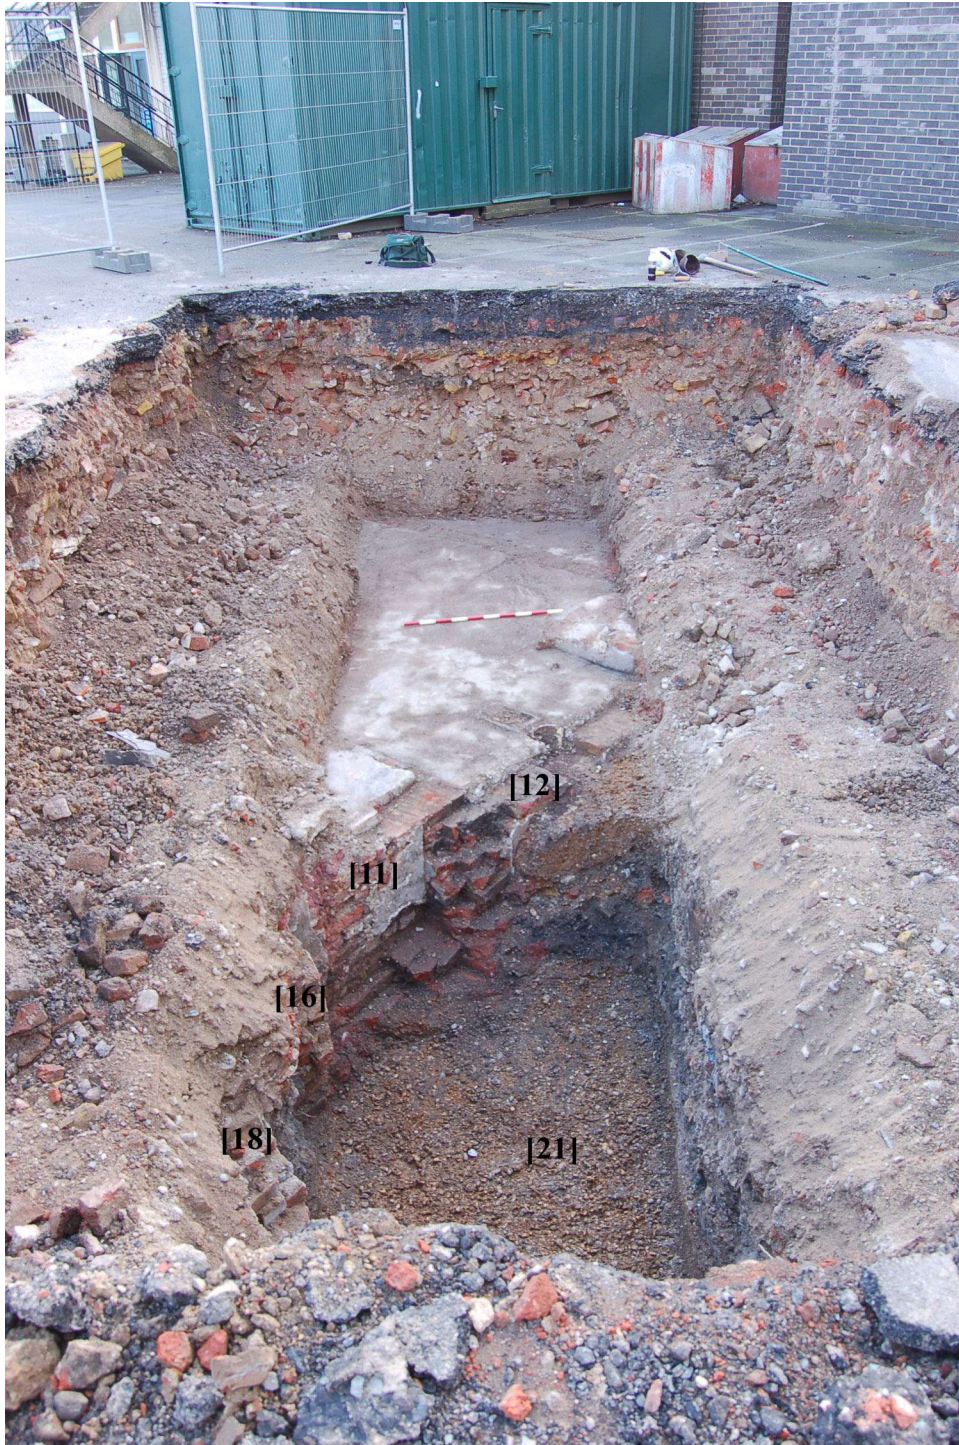
Figure 9: Trench 1 view south showing the series of walls and concrete slabs with natural gravels exposed in the base.

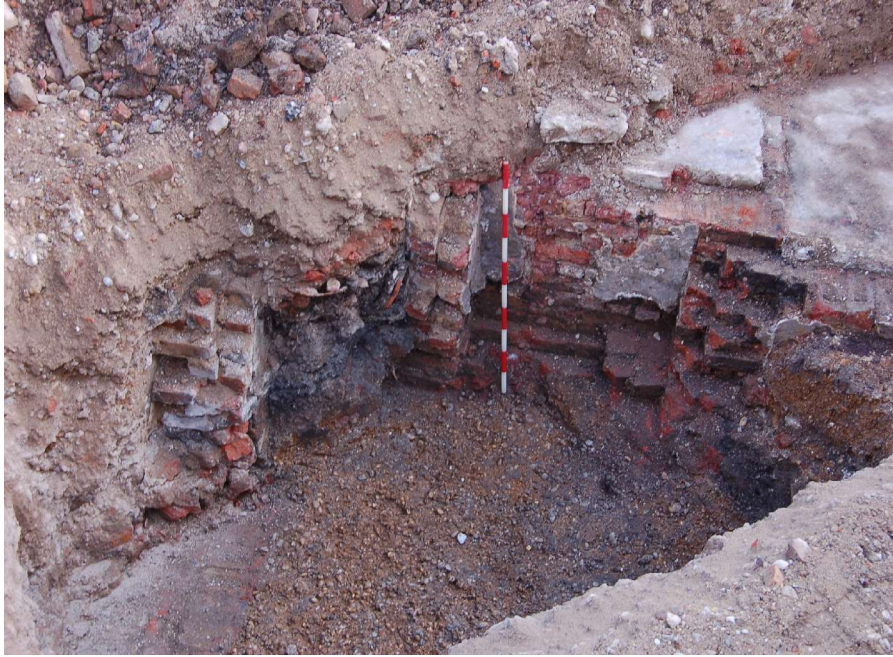
Figure 12: Trench 1 view southeast showing walls [18] [16] [12] [11] and natural gravels [21].

Figures 11 - 13 below show photographic and drawn details of the exposed features.

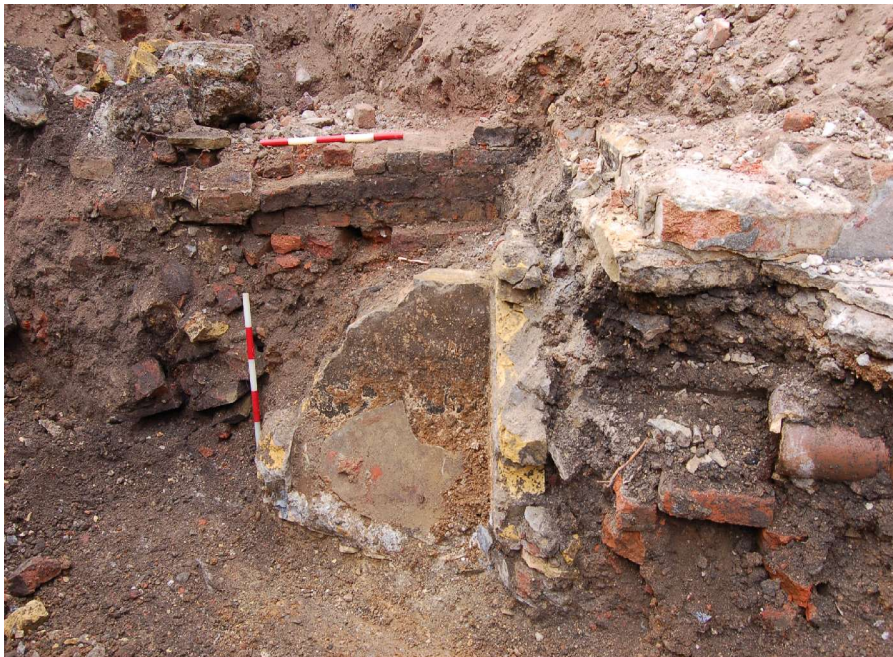
Figure 13: Trench 1 view southwest showing drain chamber [25], ceramic drain [27] and deposit [24] below concrete slab [8] and wall [7].

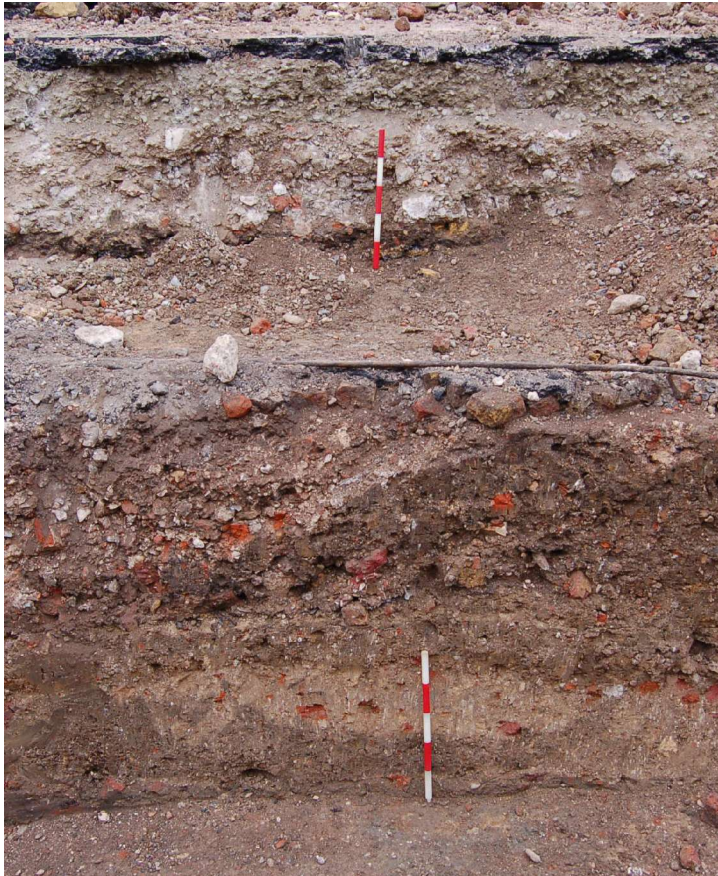
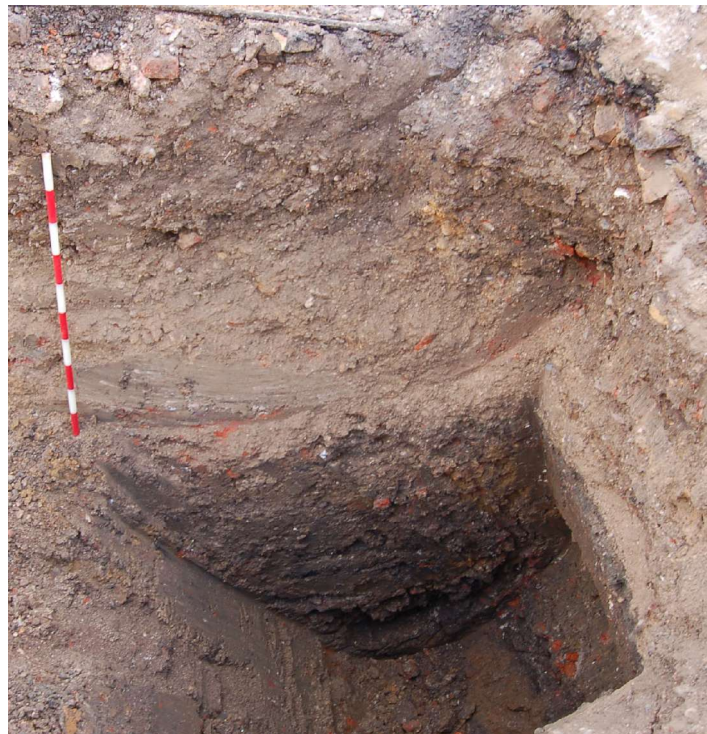
Figure 16: North facing section of Trench 2 and north facing of machine slot.

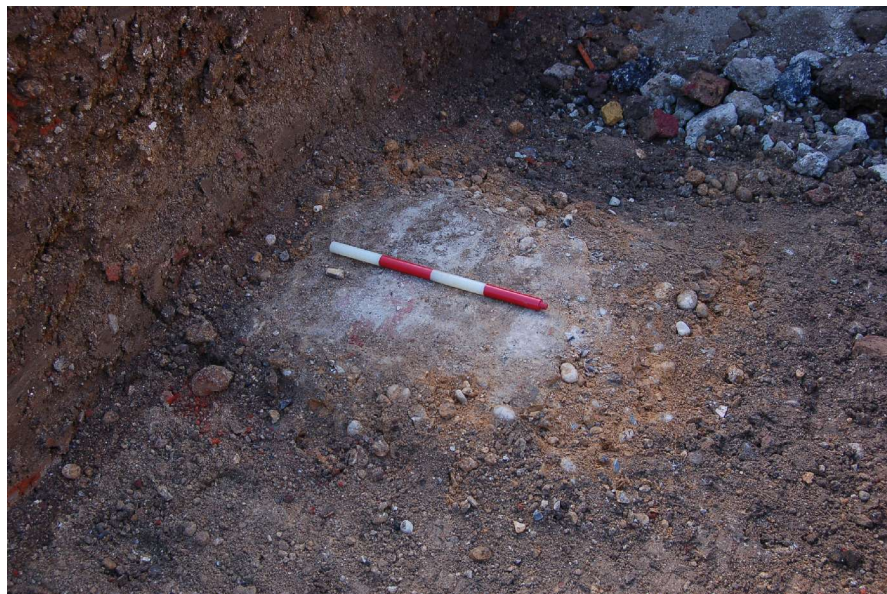
Figure 18: Concrete and brick foundation in Trench 2.
