**THAMES WATER UTILITIES LTD**  
**WATER MAINS REPLACEMENT WORKS**  
**LAND EAST OF CHURCH ROAD, BIGGIN HILL**  
**LONDON BOROUGH OF BROMLEY**

**AN ARCHAEOLOGICAL WATCHING BRIEF**

**April 2008**

SITE CODE: CBX 08

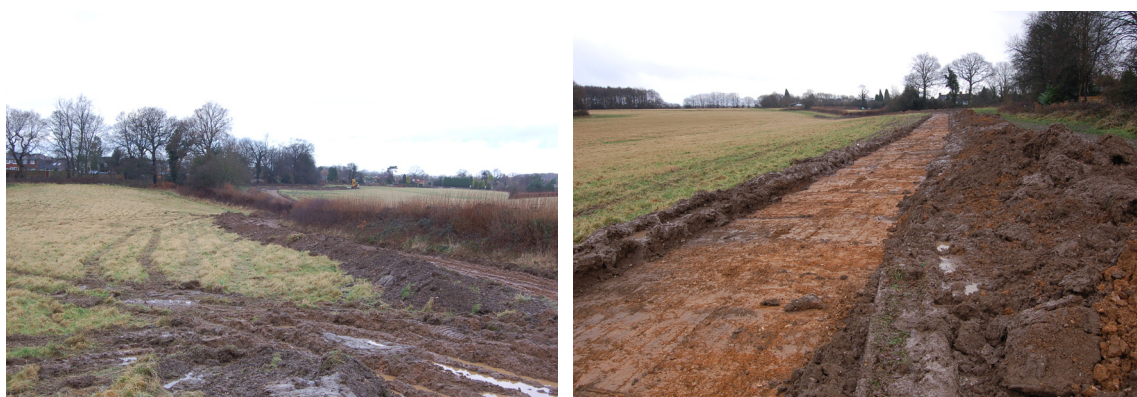
Fig 4. (right) A view of the Access Road from Main Road and (left) the Access Road from the main watermain route.

In order to access the area of trenching between the rear of No57 and 59 Old Tye Avenue and the west boundary of Cherry Lodge Golf Course, an access road was dug running from Main Road (A233) in a northerly direction parallel to Aperfield Road and was 692m in length. This included an area with a diameter of 12m for storing materials and equipment sited next to Main Road. Dug to a depth of 300mm and approximately 2.5m wide, the road uncovered natural yellow brown clay at a depth of 260-410mm exposing large flint nodules within this context. Above the natural was a dark brown humic layer of topsoil underneath the turf. There were no retained finds from this area, although occasional fragments of ceramic building material were noted within the soil horizon.

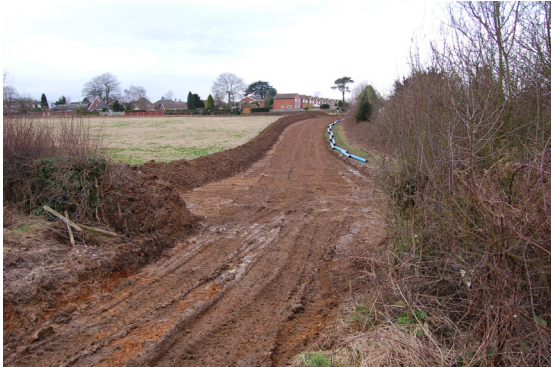
Fig 5. The west section of the easement strip with a view of the Access Road in the background (running parallel to the residential area).

track. It was 1.6m deep (measured from the original level of the turf) and 1m wide. The yellow brown natural sandy clay deposit occurred at 220mm depth below the existing ground surface with large flint nodules present towards the upper horizon of the natural, gradually thinning after 900mm. At the exit of the Access Road, there were areas of possible dumping, metal scrap was detected by the metal detector and in two specific areas immediately opposite the entrance to the access road, was soil, stained and with CBM (ceramic building material) inclusions and charcoal flecking. These features can be seen to have derived from agricultural activity.

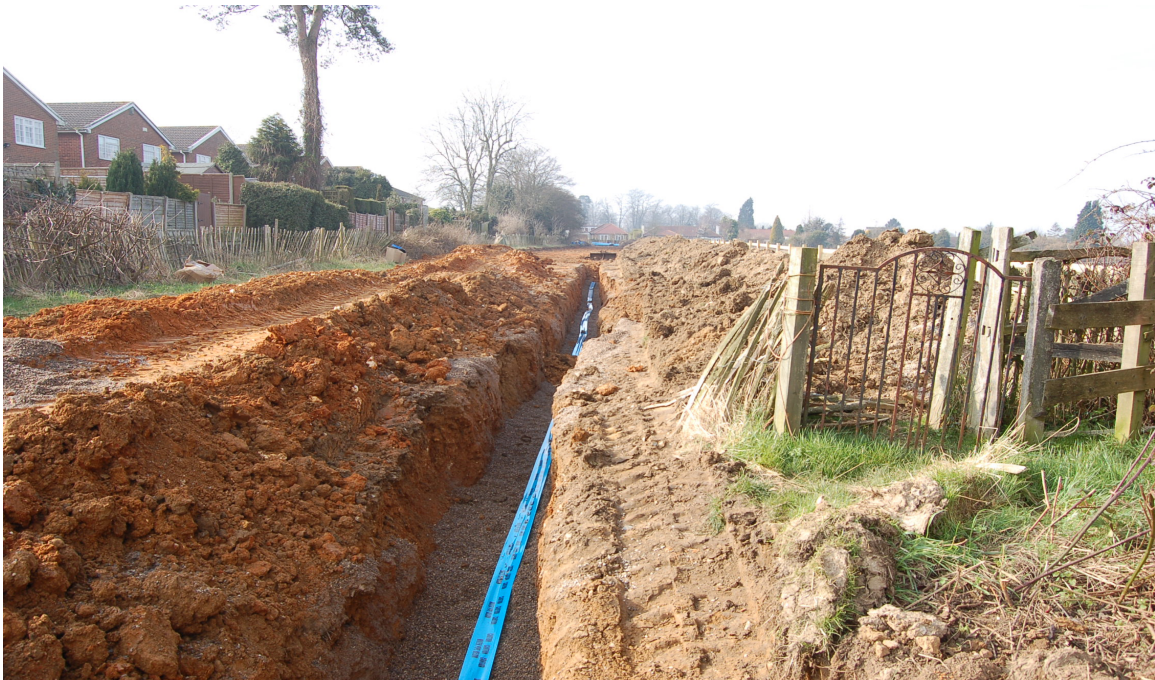
Fig 6. The watermain lying within its trench at the junction between the Access Road and the easement track.

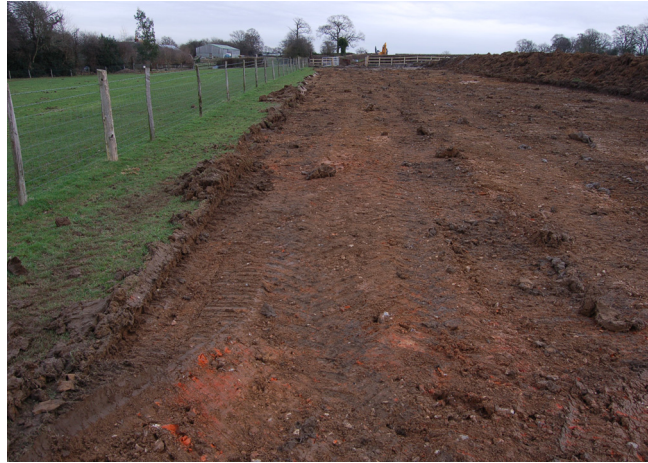
Fig 7. View of the mid section easement track. Residual brick rubble can be seen within the natural in the foreground.

The middle section of the route of the pipe trench ran from the Brickyard Farm fields to the golf course for a distance of 563m. Stripping of this area was uneven and the subsoil and topsoil was not completely removed. As a consequence, the depth of the easement track varied greatly from 150mm to 400mm. The width too varied as access

through the hedgerows between the fields meant that the trench was occasionally forced to a width of 2.35m although generally it was 12.5m wide. Towards the crest of the hill the topsoil and subsoil became shallower. Within the surface of the natural, some CBM rubble and flecking was observed, which may relate to the gravel pit that appears on the 2<sup>nd</sup> edition 1897 OS map. This gravel pit is found within a farm called Brickyard Farm and adjacent

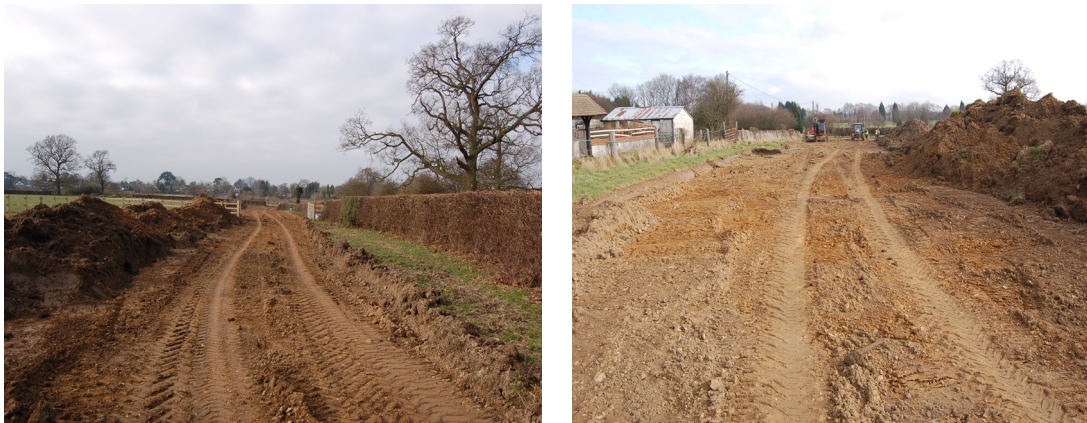
Fig 8. (right) a view towards the Brickyard Farm looking towards the west, (left) the mid section of the easement track, looking towards the Cherry Lodge Golf Course.

to a clay pit. Furthermore, there is an area described as “waste (Brick Yard Kiln)” on the Cudham Tithe map of 1843-1844. Since there was no modern waste within these areas of disturbance, modern agricultural interference can be ruled out and a date of mid 19<sup>th</sup> to early 20<sup>th</sup> century can be given for the areas of disturbance. It was also from this area the majority of the finds from the metal detector were found.

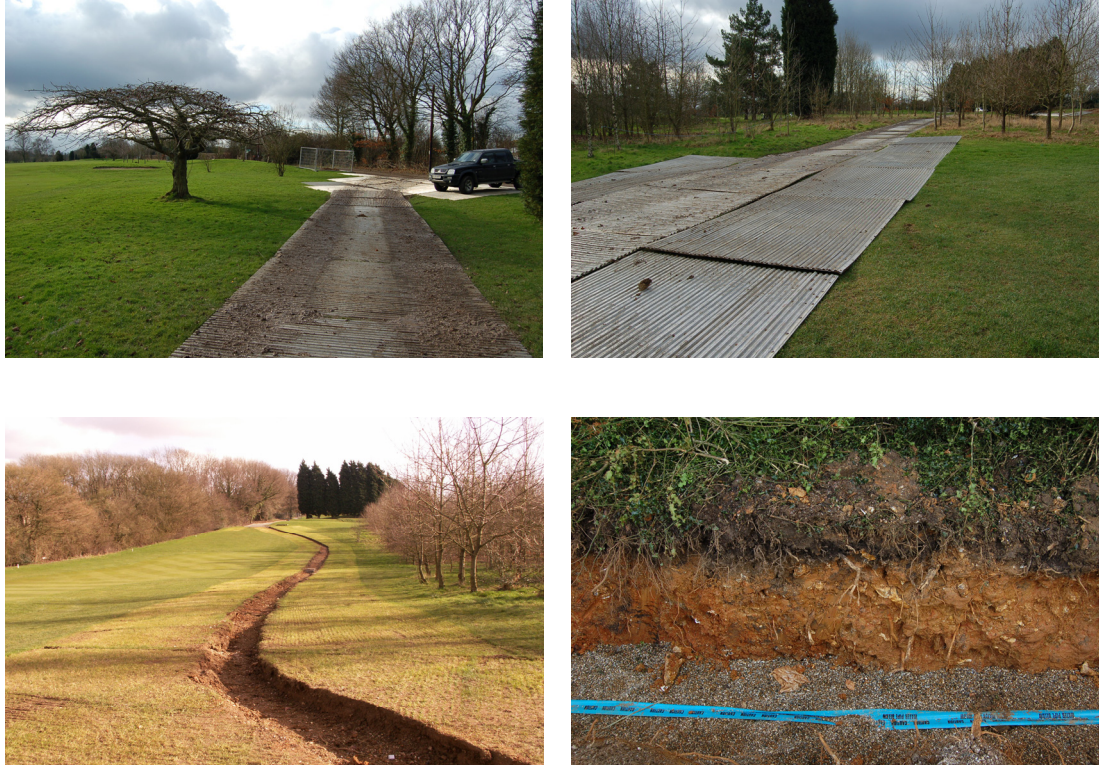
Fig 9. (clockwise from top left) View of the golf course towards the west of the watermain route; a view from the middle of the watermain route through the golf course, Looking towards Littlewood Farm; Representative section from the trench through the golf course; View of the pipeline heading towards the eastern section of the watermain route.

800mm wide and 1.8m deep. A rich humic topsoil lay above an orange brown sandy clay natural soil, the topsoil was 220mm deep gradually merging with the natural soil beneath it. Flint nodules were present in the upper regions of the natural gradually becoming less apparent towards the bottom of the trench. Throughout the golf course there were no finds or features of archaeological significance.

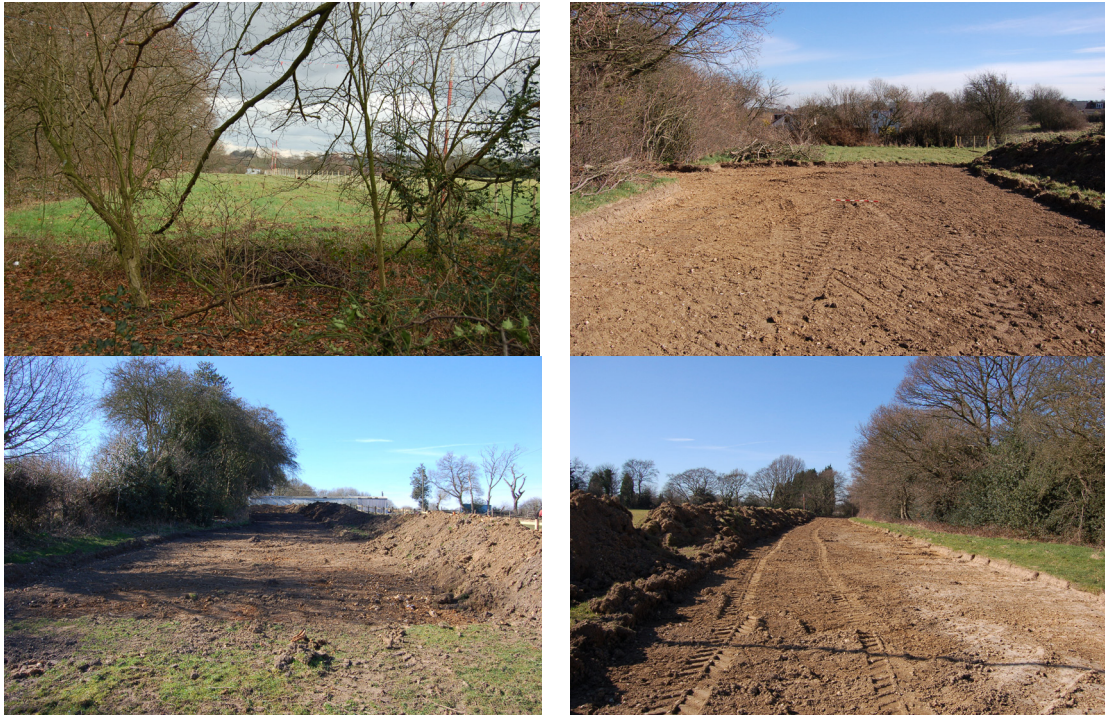
Fig 10. (clockwise from top left) View of the east section of stripping through the hedge boundary (golf course side); Looking east over the easement strip before it turns into Smallfields Farm; View of the easement strip, the golf course is beyond the hedge in the background; The final section of the easement strip as it terminates at Smallfield Farm.

The easterly section of trenching ran along two fields of Smallfields Farm, the first stretch ran east for 290m before it turned north and then east again for 48m giving it a total east to west length of 285m. The total width once stripped was 12.5m and it was stripped to a depth of 230mm but did not expose the natural beneath the topsoil throughout most of the stripped area. The natural was exposed in some areas at a depth of 210mm, however. Where it was uncovered, flint nodules were again prevalent. Throughout this area there were no finds or features of archaeological significance observed, although some metal finds and coins were recovered.
