MAIDSTONE MUSEUM & BENTLIF ART GALLERY

EAST WING DEVELOPMENT

AN ARCHAEOLOGICAL WATCHING BRIEF

SITE CODE: MMM 08

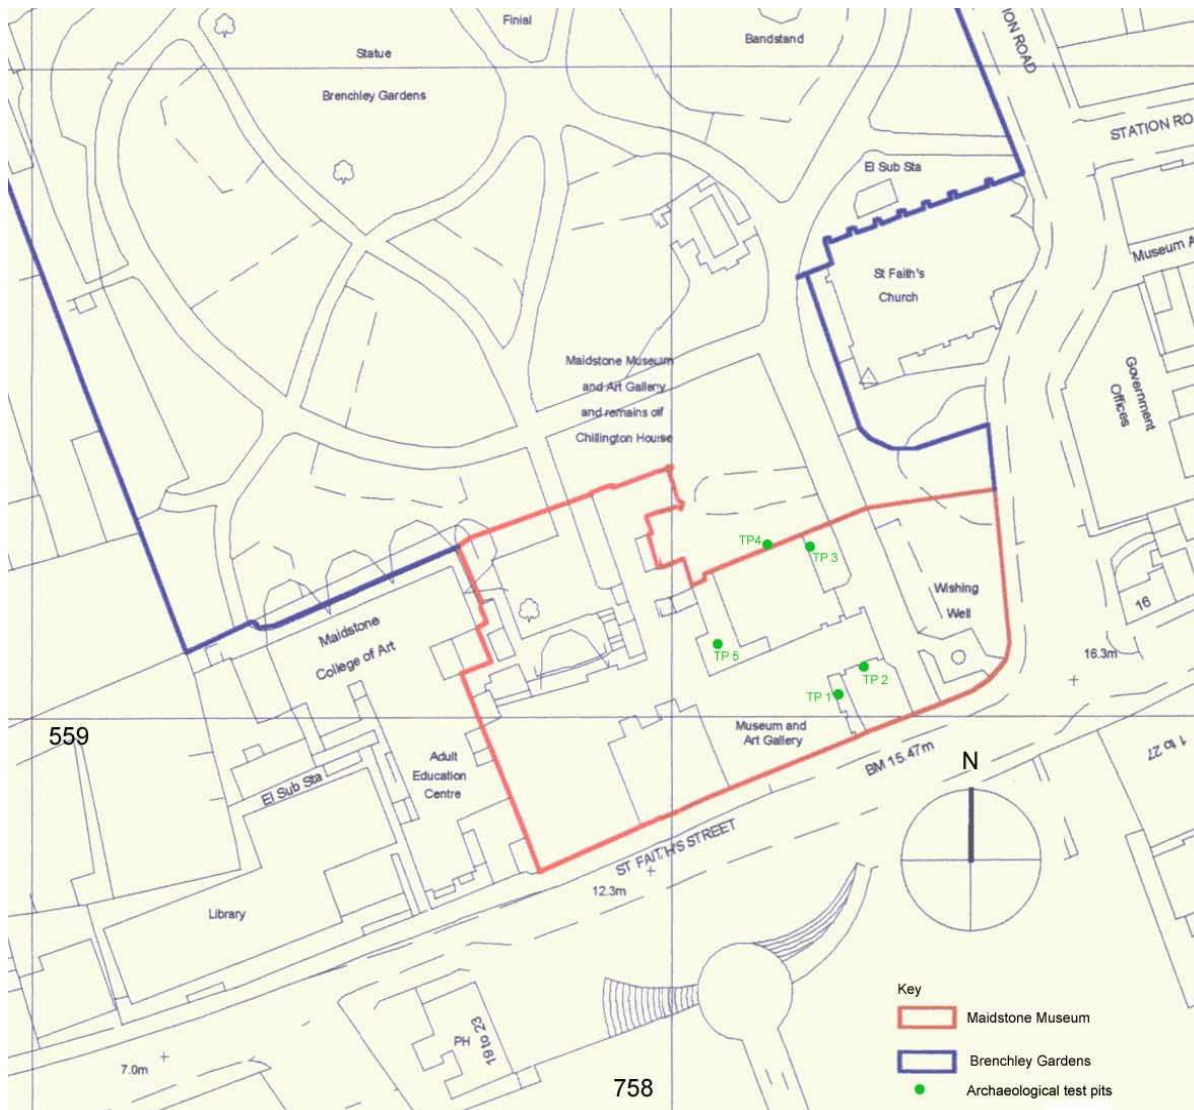
Figure 1: Site location, showing the geotechnical trial pits marked in green in relation to the current Ordnance Survey map.

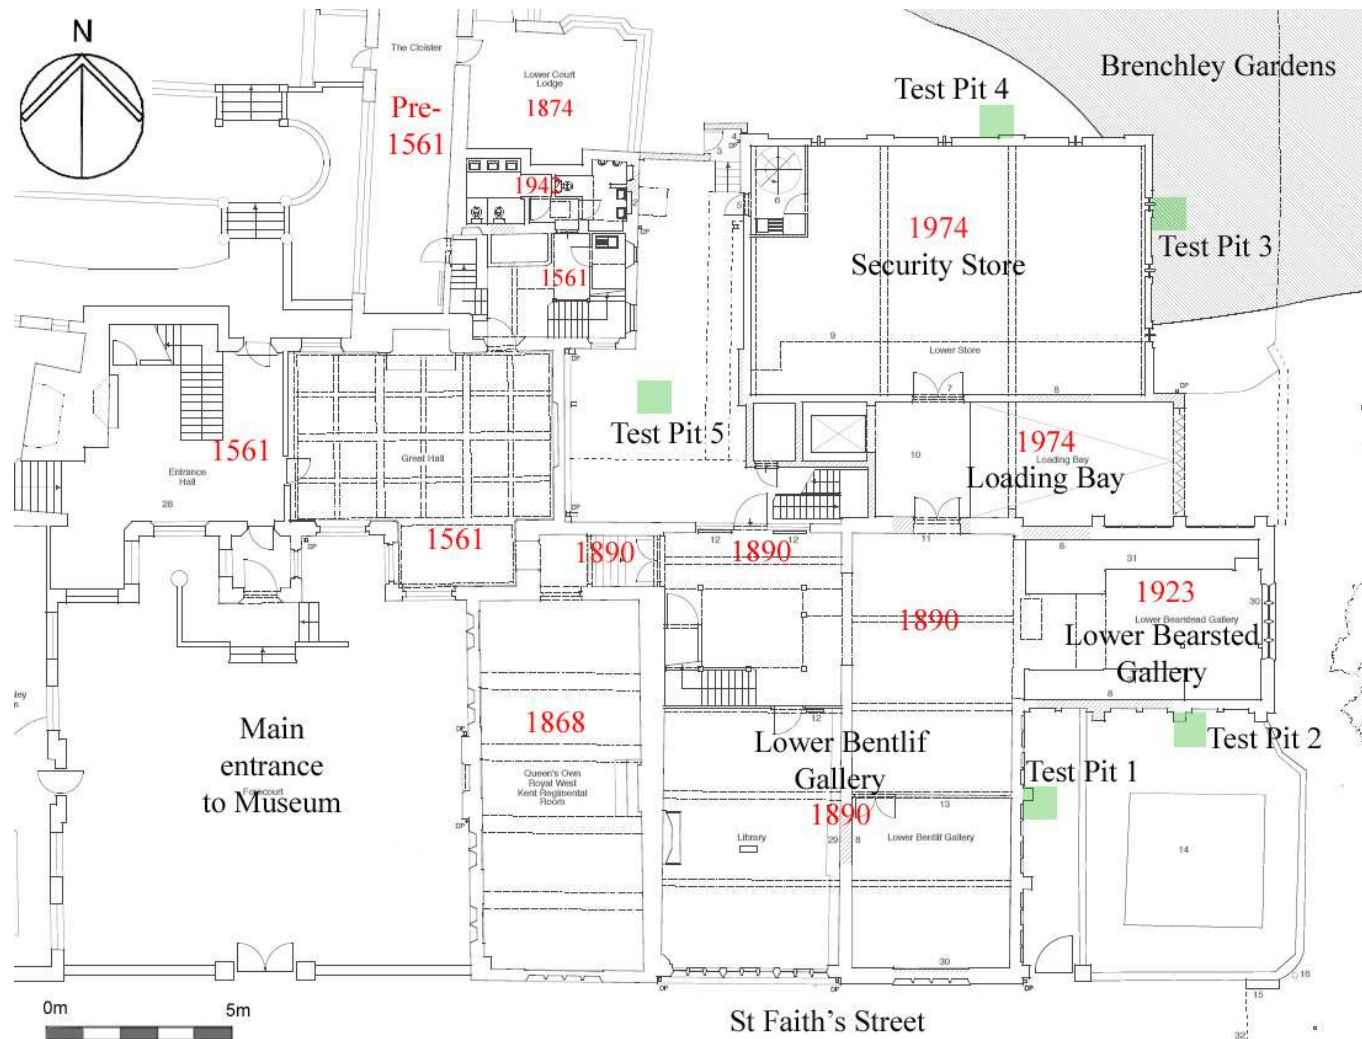
Figure 2 Site location plan showing the locations of the geotechnical test pits 1 to 5 (green) in relation to the historical elements of the buildings (dating phases shown in red). TPs 3 and 4 were enlarged by machine on the 7th and 8th April 2008, as it was necessary to dig to a greater depth to confirm the depth of the foundations of the 1974 Security Store building.

The groundworks comprised the excavation of five test-pits for geotechnical purposes around the outside of the present museum buildings in order to expose their foundation depths. The location and extent of the test-pits is shown on Figure 2.

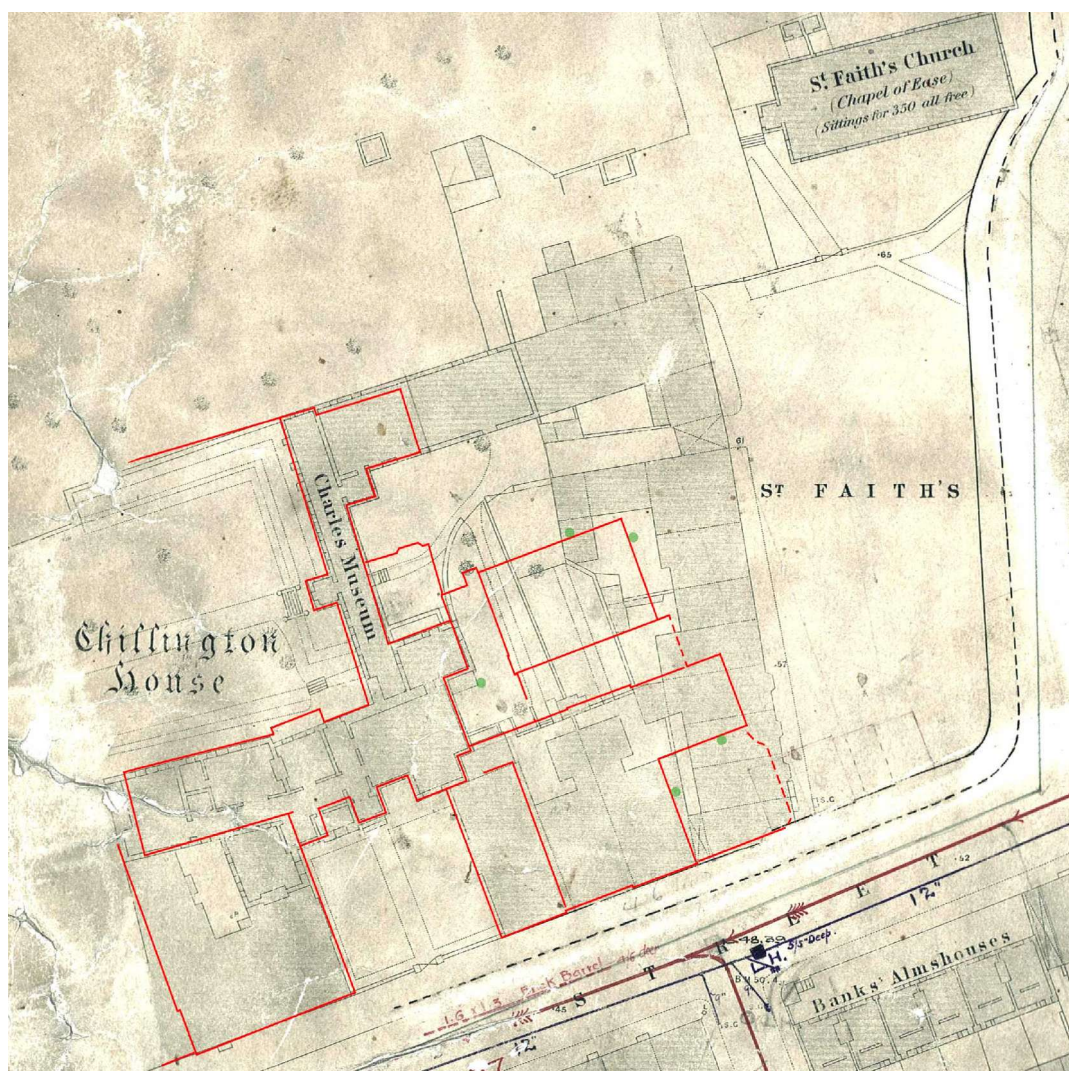
Fig 3 Extract from the 1867 Ordnance Survey series. The red lines show the current layout of the modern buildings and the green dots are the Test Pit locations overlain onto the Victorian tenements. These fronted onto St Faith's Green to the east and St Faith's Street to the south and extending west to the 1868 Queen's Own Royal West Kent Regimental Room, completed 1868⁰.

The Museum site lies on gently sloping land that falls to the south from the higher ground at St Faith's Church. The line of St Faith's Street also follows a gentle slope down to the west towards the River Medway. According to the maps of the British Geological Survey, the site lies on Atherfield Clay. It was considered that the site had potential for archaeological remains, particularly those of Roman date for which there are a number of local references. In later periods the area appears to have lain within open arable land, and certainly appears as such on 19th century maps. Areas of the site were also occupied by Victorian tenements, prior to the foundation of Brenchley Gardens (*c.f.* Figure 3).

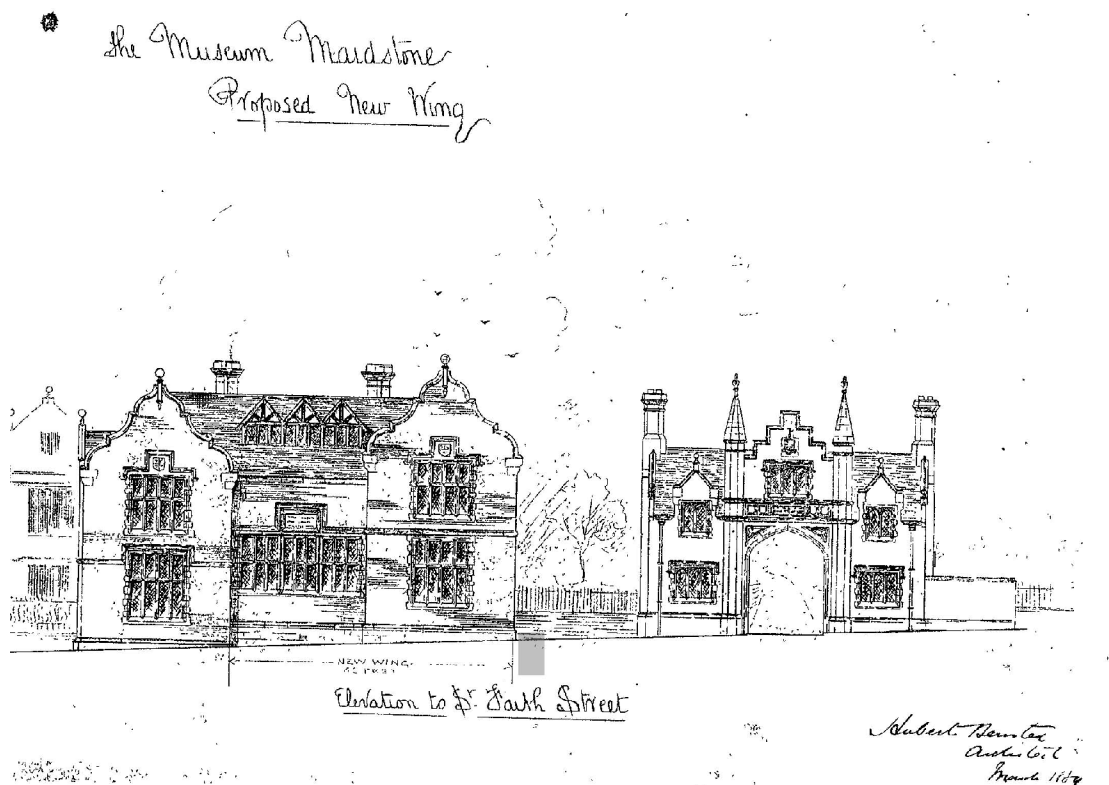
Fig 4 Illustration dated 1889 showing the relationship of the 1890 Lower Bentlif Gallery (annotated New Wing) and the now demolished 1870's Gatehouse (right), the small rectangle marked in grey shows the approximate location of TP 1 (obviously set back 6m from the street frontage). © Maidstone Museum.

It was anticipated that the areas of Test Pits 1 and 2 would have been severely disturbed by WWII bombing, as it was known that the 1870s Gatehouse (Figure 4) was badly damaged during the war and had to be demolished. The evidence from TP 2 does suggest that the area had been completely remodelled since the construction of the Lower Bearsted Gallery in 1923 and the levelling of the area after the demolition of the Gatehouse. In TP 2 masonry blocks, most probably originating from the Gatehouse, were discovered lining the northern edge of the test pit at a depth of *c* 200mm below the current ground surface (+15.35m OD, *c.f.* Figures 5, 12 and 13).

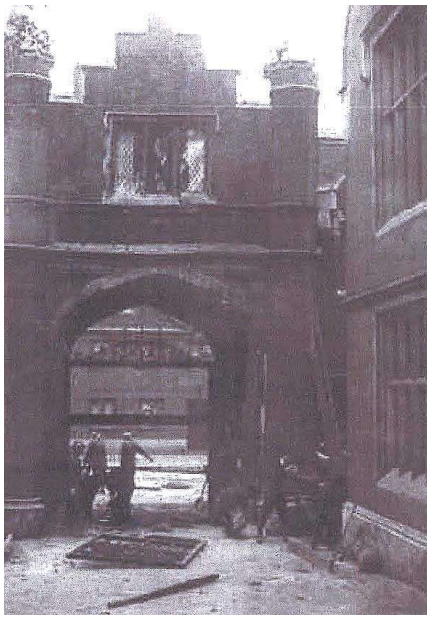
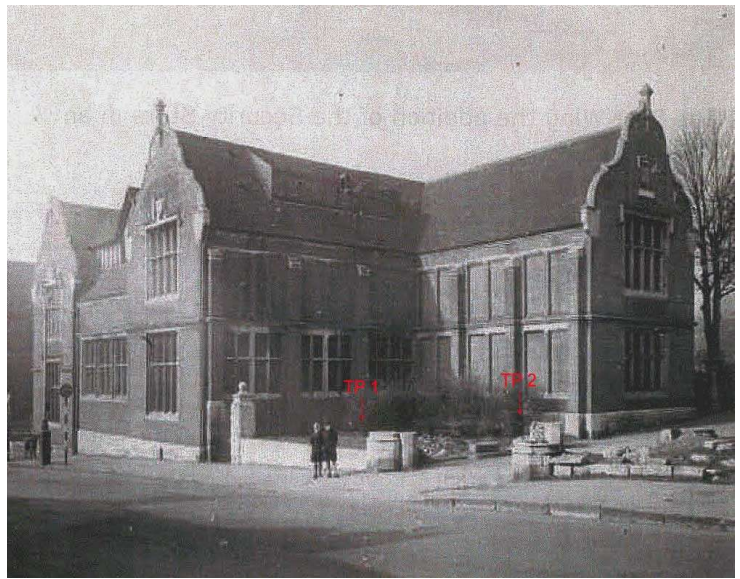
Fig 5 Left: Museum archive photograph of the Gatehouse after bombing in 1940-41, and, Right: after demolition (later 1940s) with the locations of TPs 1 and 2 marked; masonry blocks similar to those discovered in TP 2 can be seen lying to the right of the image. © Maidstone Museum.

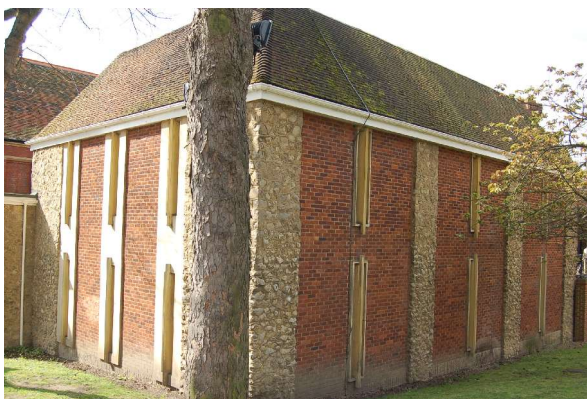
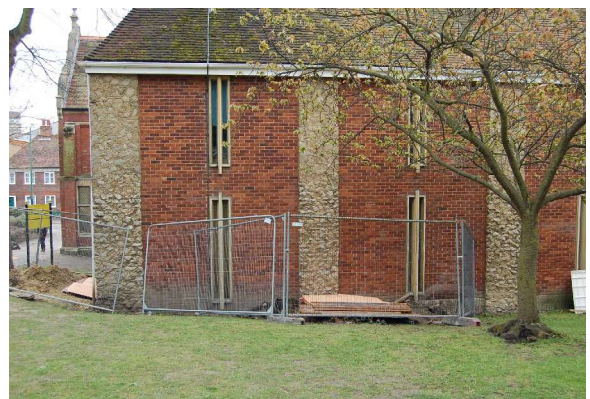
Fig 6 (left and right) Views of the 1974 Security Store and the locations of TP 3 and 4 (*c.f.* Fig 2). Left: pre-excavation of TP 3 and 4 and Right: post-excavation of TP 3 and 4 (under orange covers). The image on the right shows how the ground slopes down to the store and the natural line of the slope has been truncated (*c.f.* Figs 7 and 8 below).

The general areas of TP 3 and 4 have obviously also been truncated by levelling works for the construction of the 1974 Security Store and loading dock building. This is evident from archive photographs of the store area prior to the 1974 construction (*c.f.* Figures 7 and 8) in comparison with photographs after the store is in place (Figure 6). The store building was the first significant extension to the Museum to be built in the 'Modern Style'. It uses complimentary materials of ragstone and red brick, although this extension uses an English Garden Wall bond and the Victorian buildings are all in a Flemish bond. The store was designed by the local architect, Dennis Darbison, and although a modern extension it does balance with the earlier buildings, but also unfortunately blocks views of the most historic parts of the building (dating from 1561) that are evident behind the store in the Godiva Courtyard.

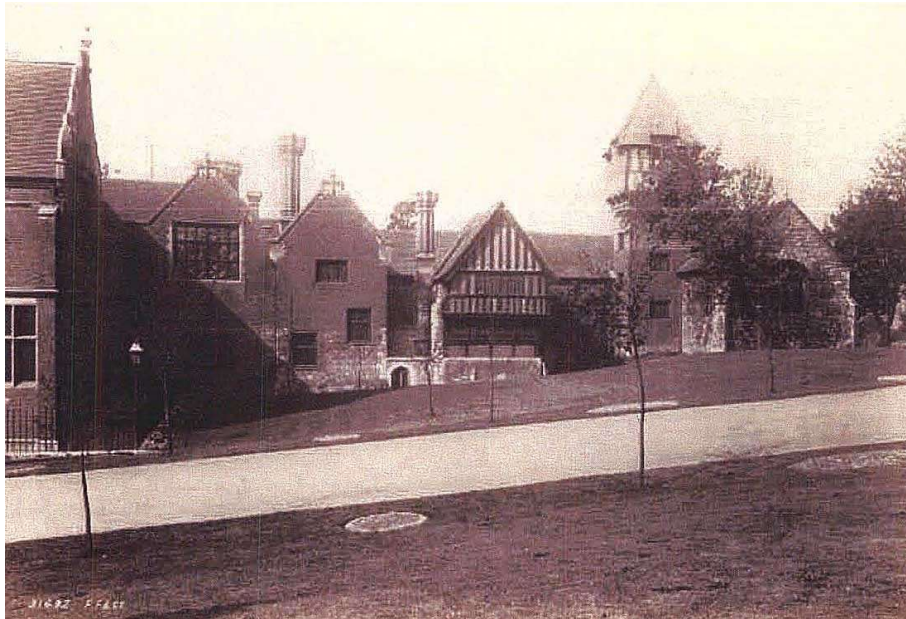
Fig 7 Image of the Security Store area pre-1974, showing the original (but apparently somewhat artificially mounded) topography of the area in contrast to the truncation following the construction of the store (*c.f.* Fig 6 above). However, the line of the roadway still remains roughly the same. © Maidstone Museum.

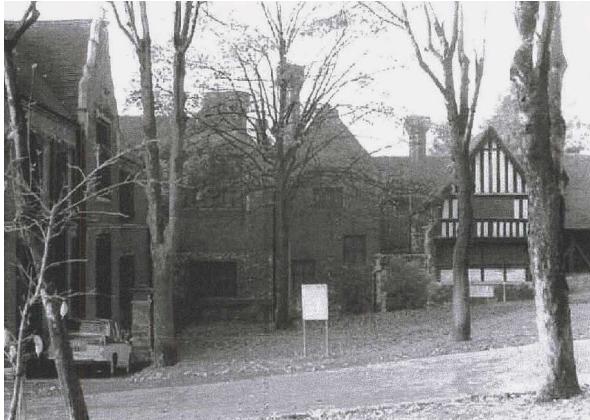
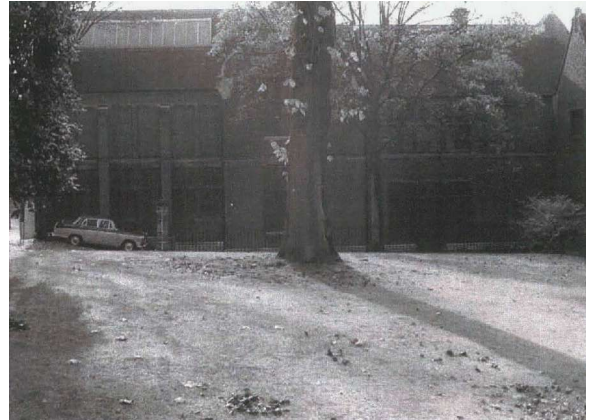
Fig 8 Additional images of the areas of TP 3 and 4 pre-1974, showing how the natural slope has been truncated. © Maidstone Museum.

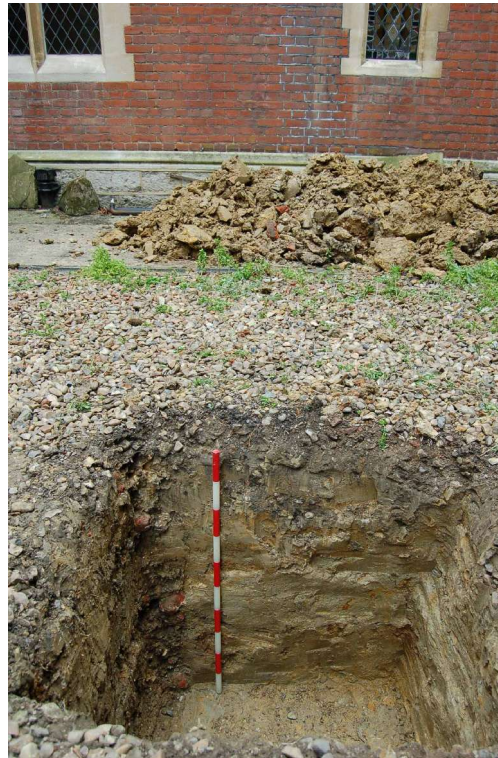
Fig 9 View of TP 5 looking south towards the north wall of the 1890 Lower Bentlif Gallery (where it extends west behind the 1868 gable end of the Queen's Own Royal West Kent Regimental Room). Natural clay can be seen surviving below the gravel covering of the Godiva Courtyard at +14.75m OD.

Test Pit 5 promised the most potential for the preservation of archaeological remains and potentially those associated with the evolution of the historic buildings on the site. Unfortunately, TP 5 did not produce any archaeological features or finds and had been slightly truncated to the east by the cut and fills of a modern drain.

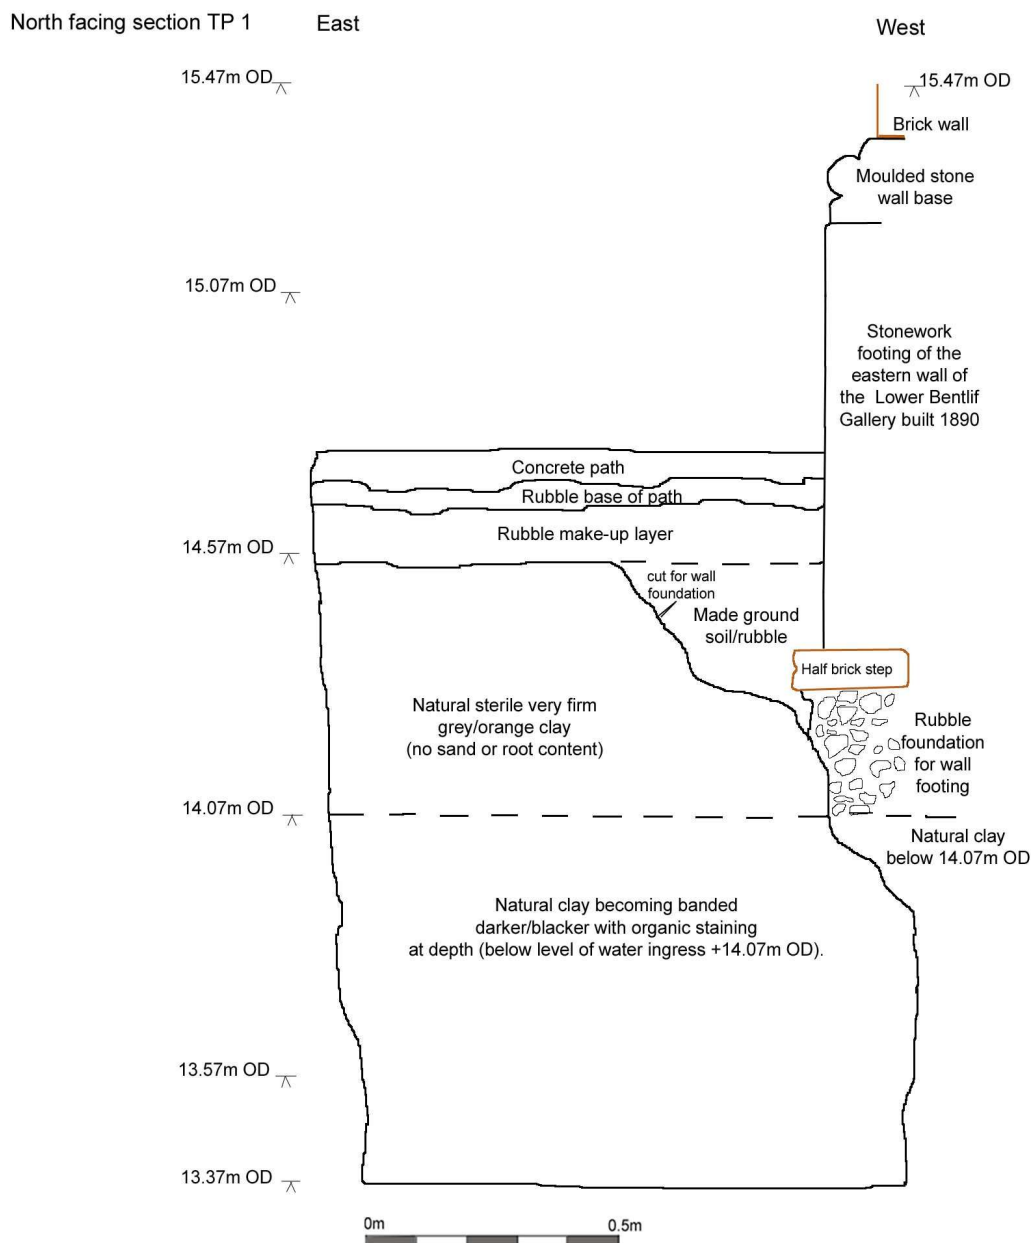
The stratigraphic profile was of the concrete path on a rubble base, overlying levelling layers to a depth of 0.2m, overlying a 0.35m wide construction cut for the Lower Bentrif Gallery foundation construction trench. The construction cut was filled with made ground and rubble. The stonework base for the gallery rested on a single footer course of red brick, projecting half a brick out from the base of the footing at 14.07m OD. This brick course rested on a rubble base (see Figure 10). The construction trench for the gallery cut natural sterile clay across the rest of the trench at a maximum survival height of +14.57m OD. The natural clay became darker and banded at depth, changing from a mid brown/orange to a grey clay and containing organic staining below the level of water ingress at the base of the brick and rubble base footing at 14.07m OD.

Fig 11 Section through Test Pit 1 showing the south elevation (north facing section)

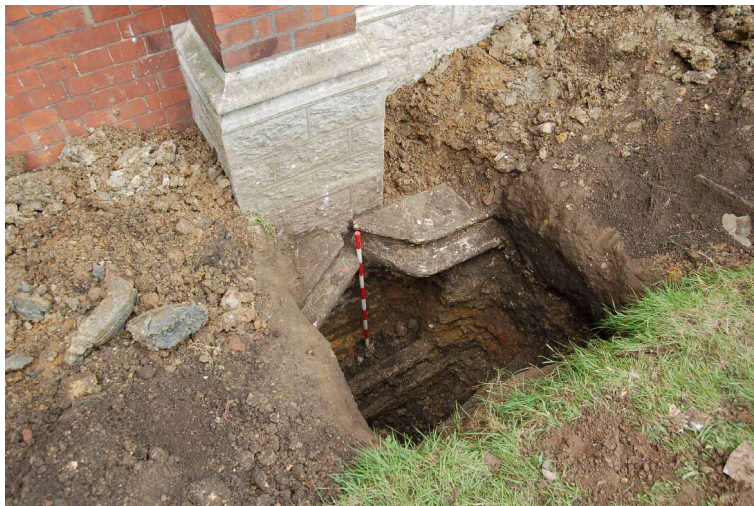
In the upper made ground layers at *c* 15.35m OD two large masonry blocks were uncovered. These were made of Kentish ragstone and were very similar in design to elements of the 1870's Gatehouse decorative masonry (*c.f.* Figure 5). It is probable that masonry salvaged from the demolition of the Gatehouse was stacked against the south wall of the Lower Bearstead Gallery and had gradually become covered over, especially when the raised flowerbed was constructed.

Fig 12 Oblique view of Test Pit 2 looking northeast and showing the large masonry blocks uncovered in the watching brief.

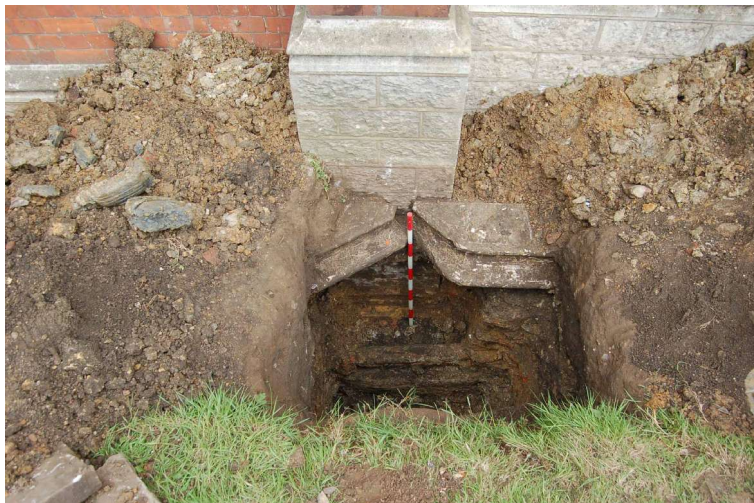
The stratigraphic profile of TP 2 was different to all the other TPs and natural clay was not encountered. The whole trench was composed of recent made ground deposits relating to two east-west running service pipes (see section drawing Figure 14 for details of the made ground deposits). The Lower Bearstead Gallery foundation construction

Fig 13 Detail of Test Pit 2 looking down from the raised flowerbed (approximately north). The service pipes can be seen crossing the TP at depth.

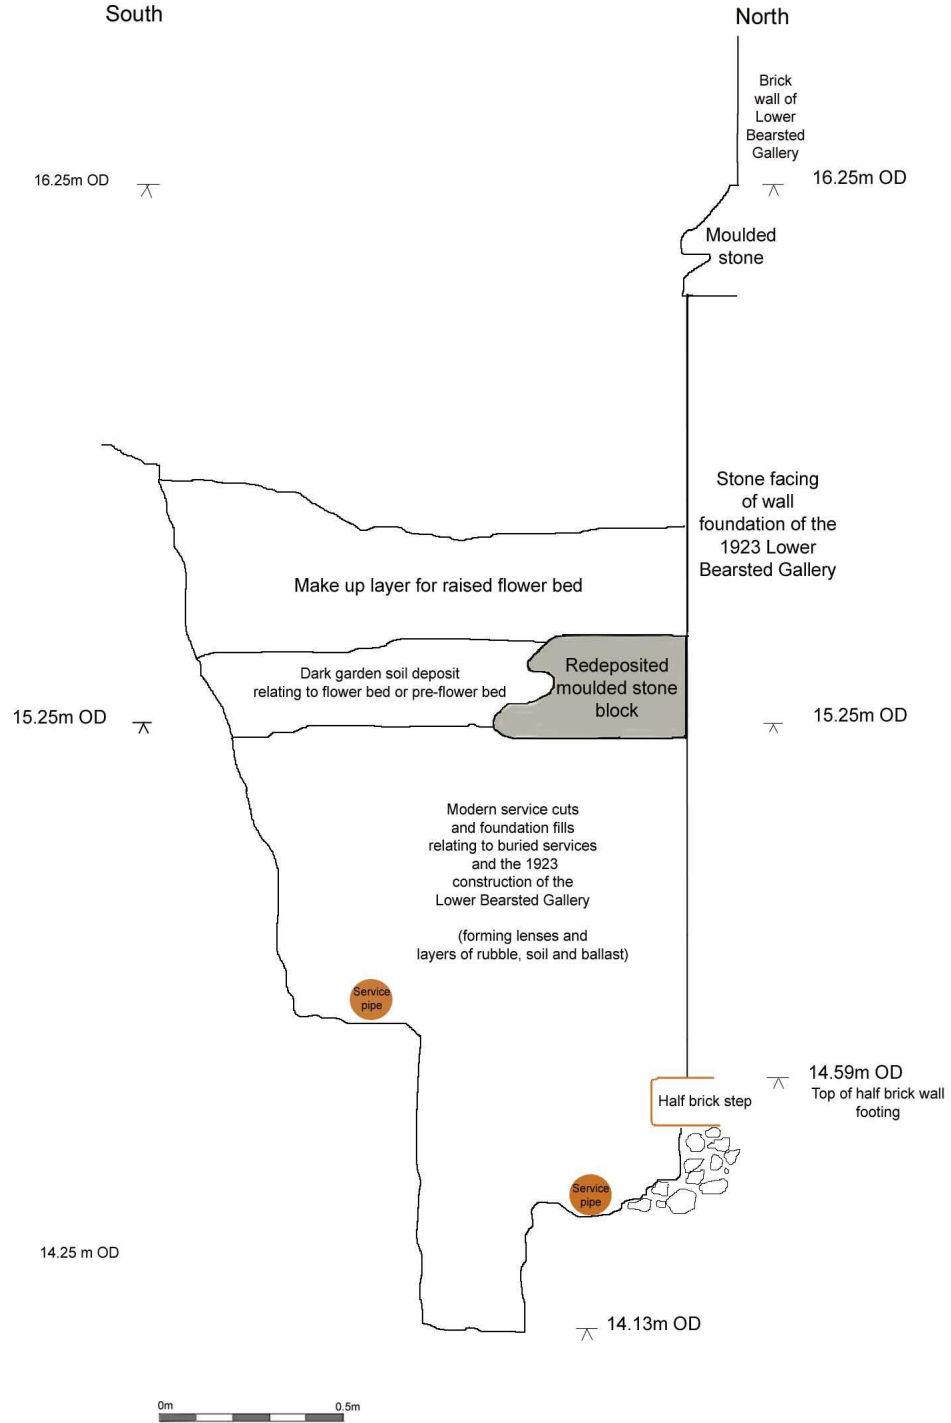
East facing section TP2
South

trench was also exposed and a half brick footer course similar to TP 1 (but obviously of a later date) was recorded at +14.59m OD, approximately 0.5m higher than the Lower Bently Gallery and reflecting the upward slope of St Faith's Street to the east and St Faith's Church to the north.

Fig 14 Section through Test Pit 2, showing the western elevation (east facing section).

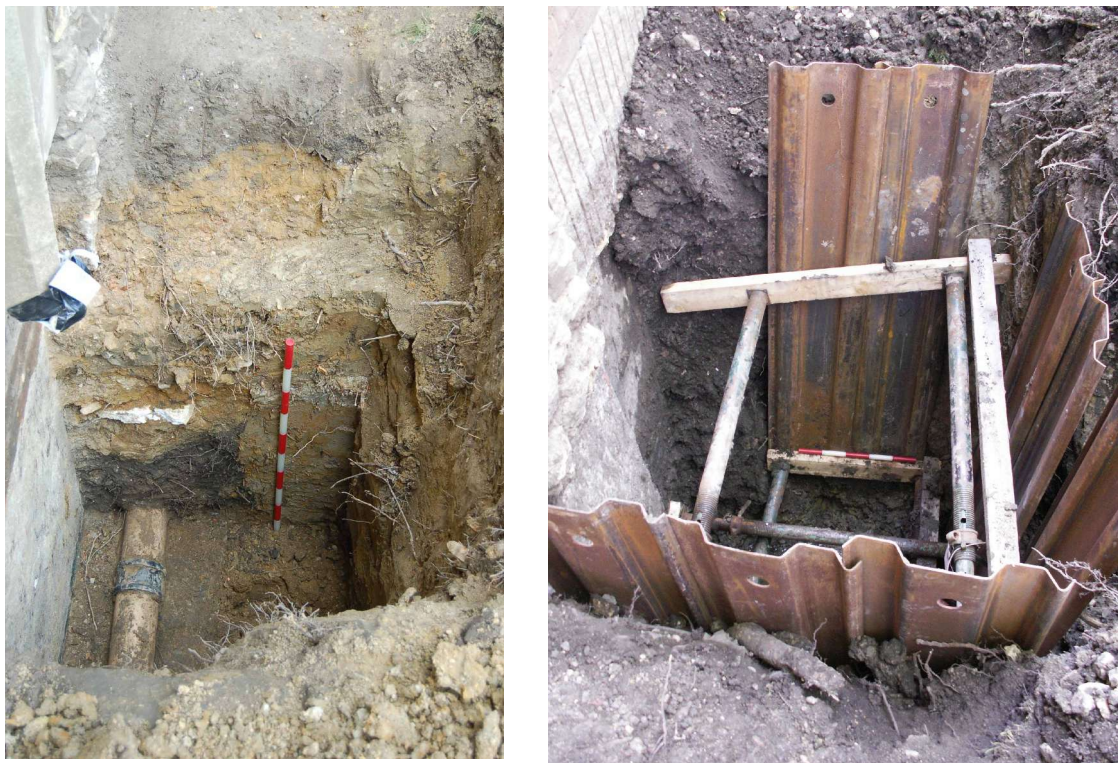
The stratigraphic profile was redeposited top soil over a layer of builders sand 0.15m thick over a large construction cut running alongside the the wall and extending up to 0.55m south of the wall. The cut was backfilled with recent made ground and 1970's construction debris including large (up to 300mm in length) fragments of polystyrene. At the base of the TP was a 1970s service pipe in a silty soil matrix overlying a ledge of concrete *c* 0.06m thick.

To the east of the construction cut the surface of the natural clay was exposed at +16.5m OD and the natural in this TP was again a sterile mottled grey/orange clay, but in this TP having some fine sand content and having frequent roots throughout the deposit. A small lense of mottled chalky clay was recorded in the south facing section (*c.f.* Figure 16) at a depth of 0.9m (+15.79m OD) but this was also sterile and most probably represents a natural formation in the clay or may be a result of tree root action. When the TP was extended the clay geology changed becoming much sandier below 2m.

Fig 15 Test Pit 3, looking north. Right: the initial hand excavation TP and left the second phase after machine excavation. The same large fragment of polystyrene can be seen to the left of both images in the construction cut for the service pipe/construction of the Store building.

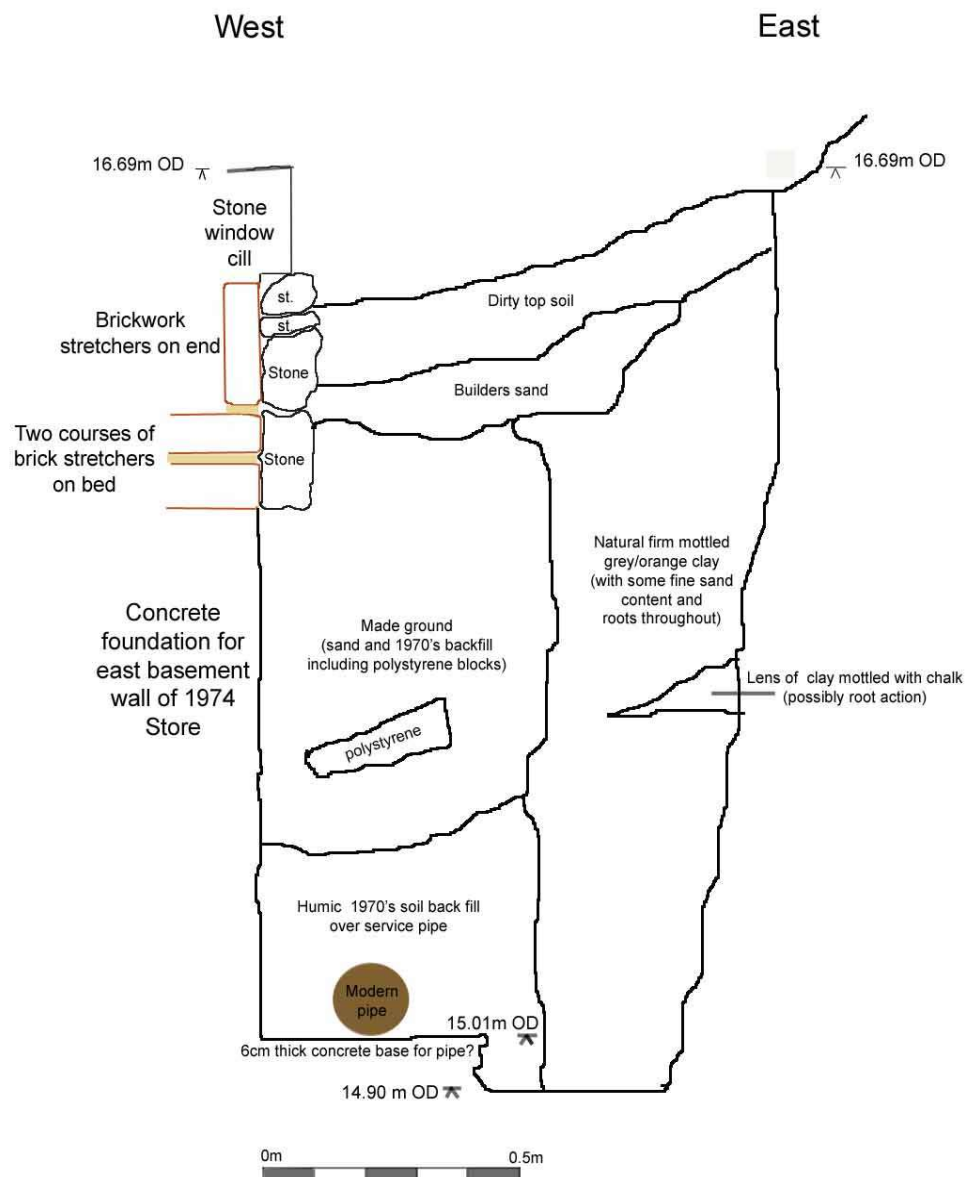
South facing section TP 3

Fig 16 The South facing section (northern elevation) of Test Pit 3

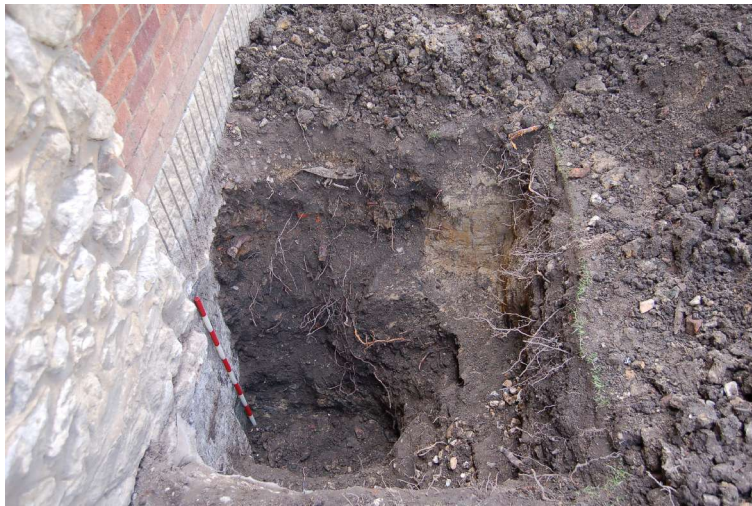
The stratigraphic profile was of recent made ground (including deep lenses of imported rounded and angular pebbles) extending to *c* 2.5m in depth. Natural clay was visible in the northern face of the TP and was exposed at a height of 16.30m OD. However, the general area of the TP showed a considerable depth of recent made ground indicating that the southern area of the Security Store site had been extensively truncated during construction of the Store in 1974.

Fig 17 Above: Test Pit 4 looking west and showing made ground deposits.

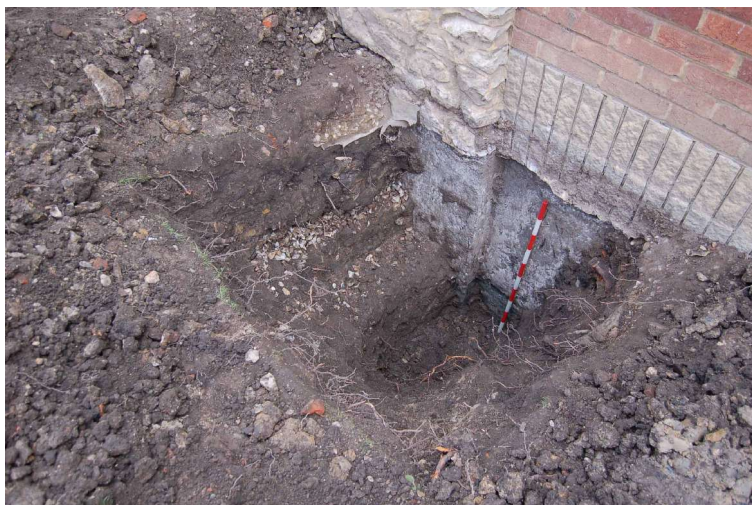
Fig 18 Left: similar view of TP4, but looking approximately south.

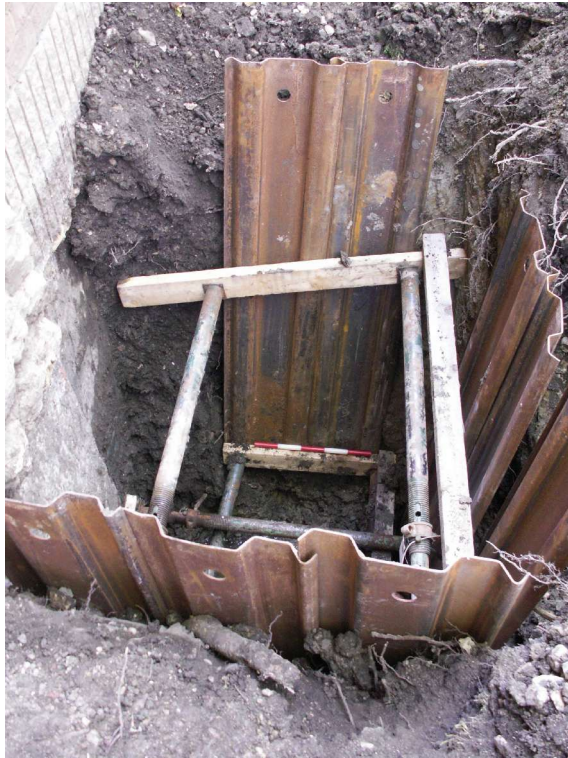
Fig 19 Test Pit 4 looking west and showing made ground deposits after machine extension.

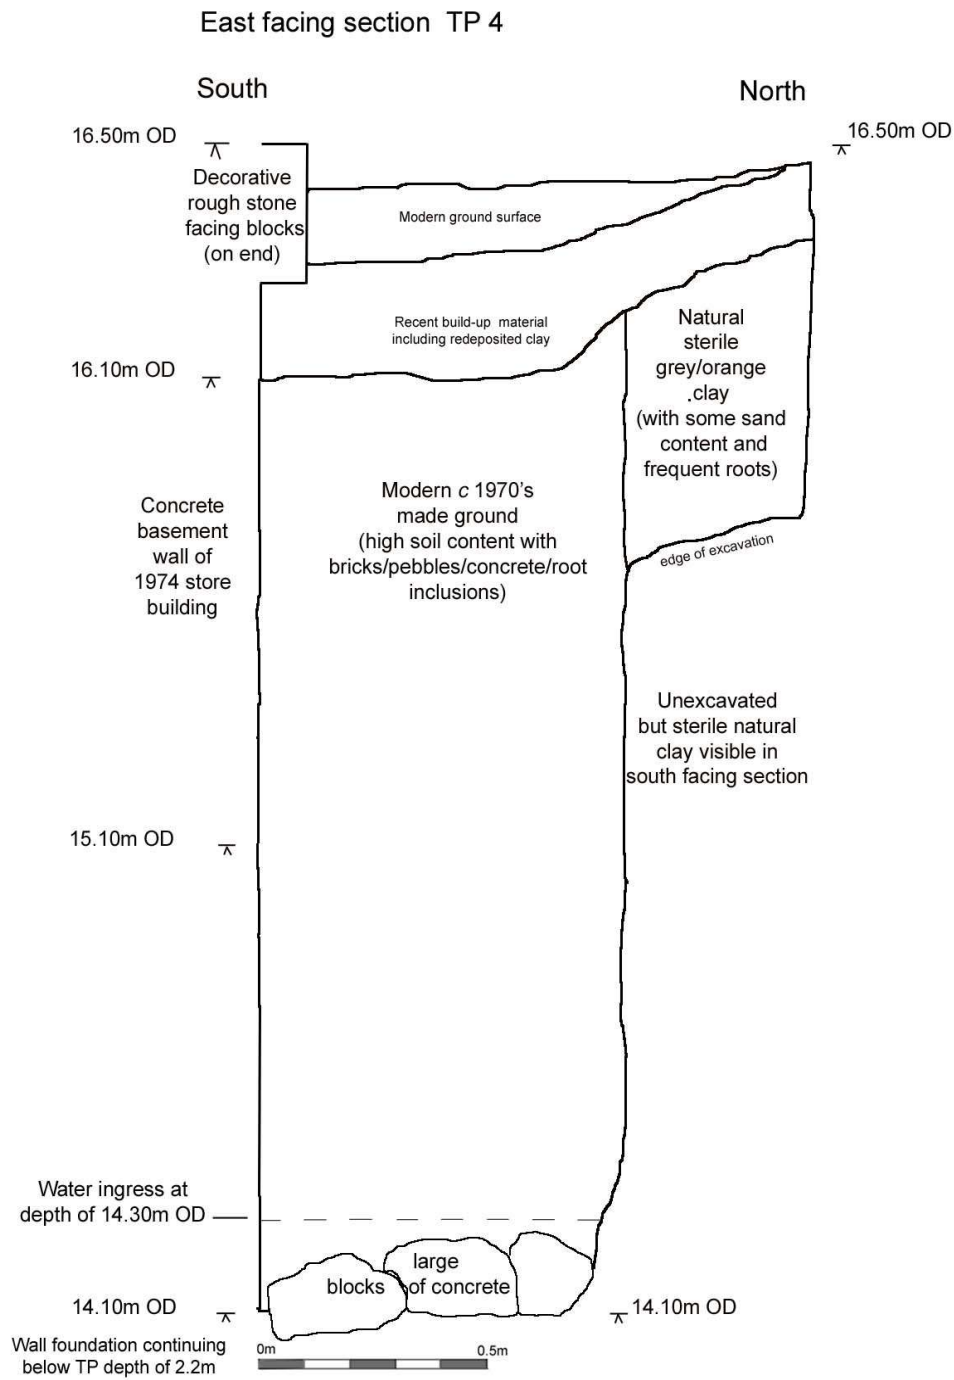
Fig 20 Section through Test Pit 4

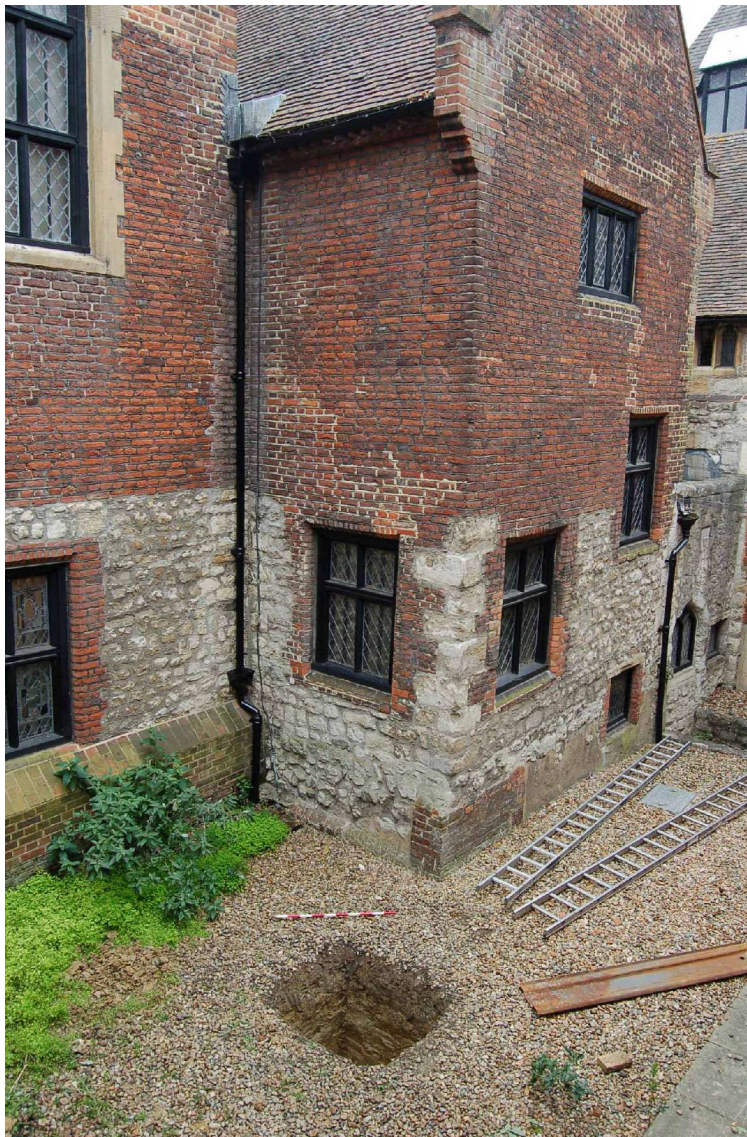
The stratigraphic profile was of the Courtyard pebble surfacing overlying the construction cut for the modern drain (*c.f.* Figure 21 and 22). The cut was filled with modern made ground including a large piece of machine made glazed ceramic sewer pipe at the base of the TP 5. The natural sterile clay was encountered at 300mm depth below the courtyard ground surface at +14.55m OD.

Fig 21 Overhead view showing the location of TP5, looking northwest.

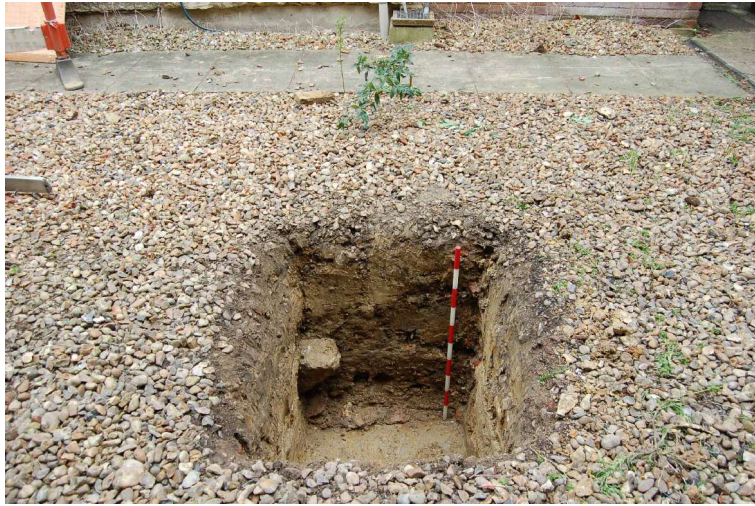
Fig 22 View of TP5 looking east and showing the fill of the modern drain in the west facing section. The large piece of ragstone in the TP (left of scale) has been redeposited in the modern drain cut.

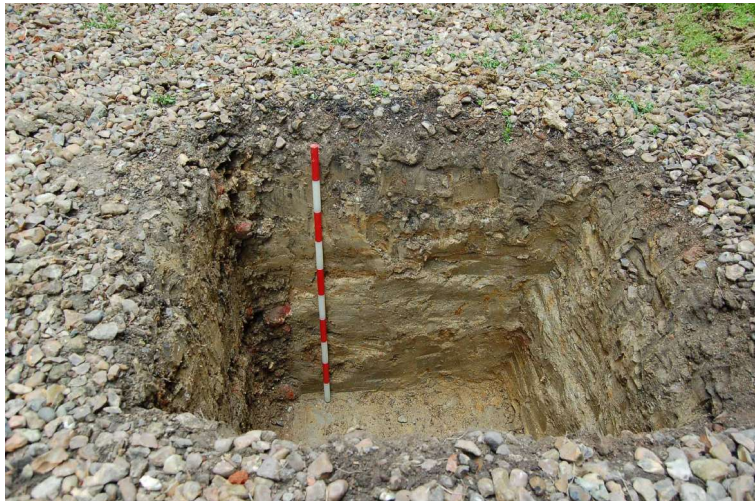
Fig 23 View of TP5 looking south with the fill of the modern drain visible to the left of the scale (see drawn section Fig 23).

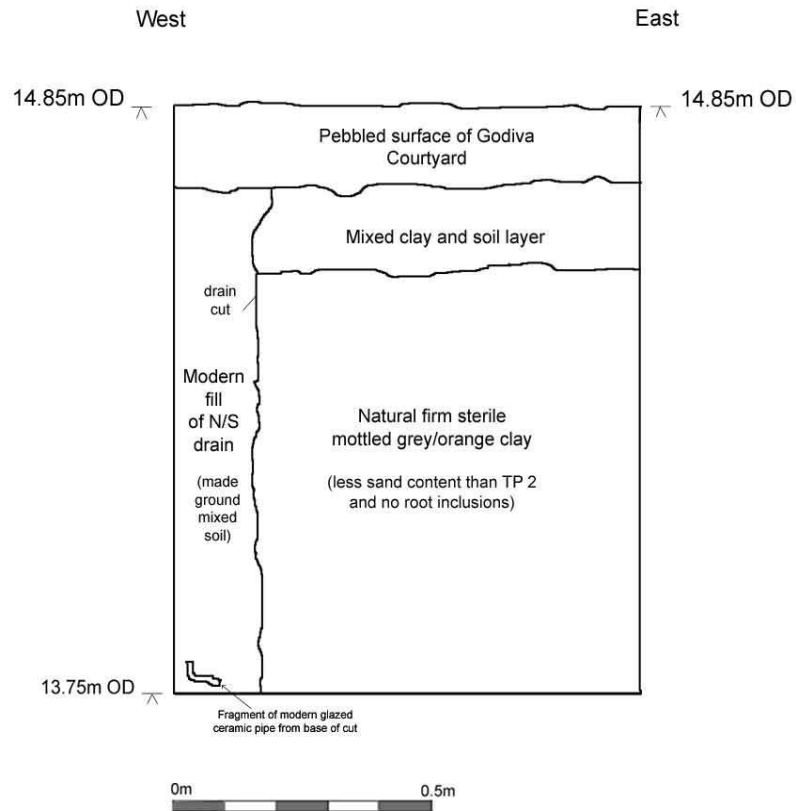
North facing section TP 5

Fig 24 North facing Section (south elevation) of TP5.
