**THE CROSSING POINT OF A THAMES WATER  
PIPELINE ACROSS THE M11 AT GREAT  
HALLINGBURY, ESSEX**

**AN ARCHAEOLOGICAL EVALUATION**

**May 2008**

SITE CODE: GHM08

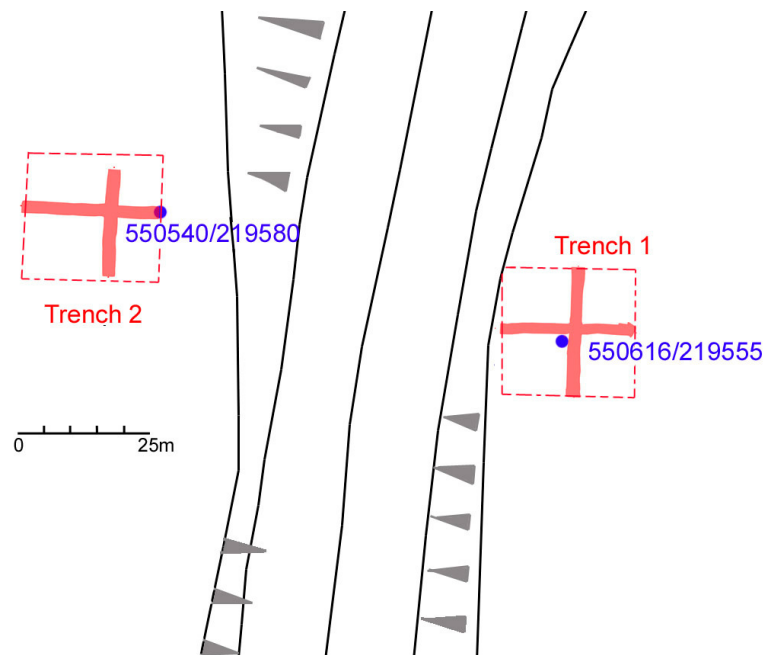
**Figure 3:** Trench Locations based on Ordnance Survey 1:1250 map extract.

6.1 The evaluation groundworks involved the machine stripping of two sets of two trenches in a cross pattern, one set on each side of the M11 motorway at the access points for the proposed pipe line (see Figure 1 above). The long axis for each of the two trenches was set at 25m, while each trench measured 2m in width. The first pair of trenches (grouped as Trench 1) was situated on the east side of the motorway, approximately centred as NGR 550616/219555. The second pair of trenches (grouped as Trench 2) was situated on the west side of the motorway and extended west from NGR 550540/219580 – see Figure 3 below.

The Archaeological Evaluation consisted of the excavation of two areas (each area involving 2 x 25m trenches at 2m width, excavated in a cross pattern – see Figure 3 below) either side of the M11 motorway at the crossing point with the new Thames Water Pipeline. Due to the nature of the exposed deposits and features the results of the two areas will be discussed separately below. All trenches were excavated using a 360° tracked mechanical excavator fitted with a flat-bladed 2m bucket, operating under constant supervision by a banksman from McNicholas Construction Ltd and a suitably experienced archaeologist.

Trench 2 was excavated on the west side of the M11 motorway, located with reference to NGR 550540/219580 (see Figure 3). An Ordnance Datum height was provided at the existing ground level of this point, recorded as 69.63m OD. This level was used to derive all other heights taken across the excavated area.

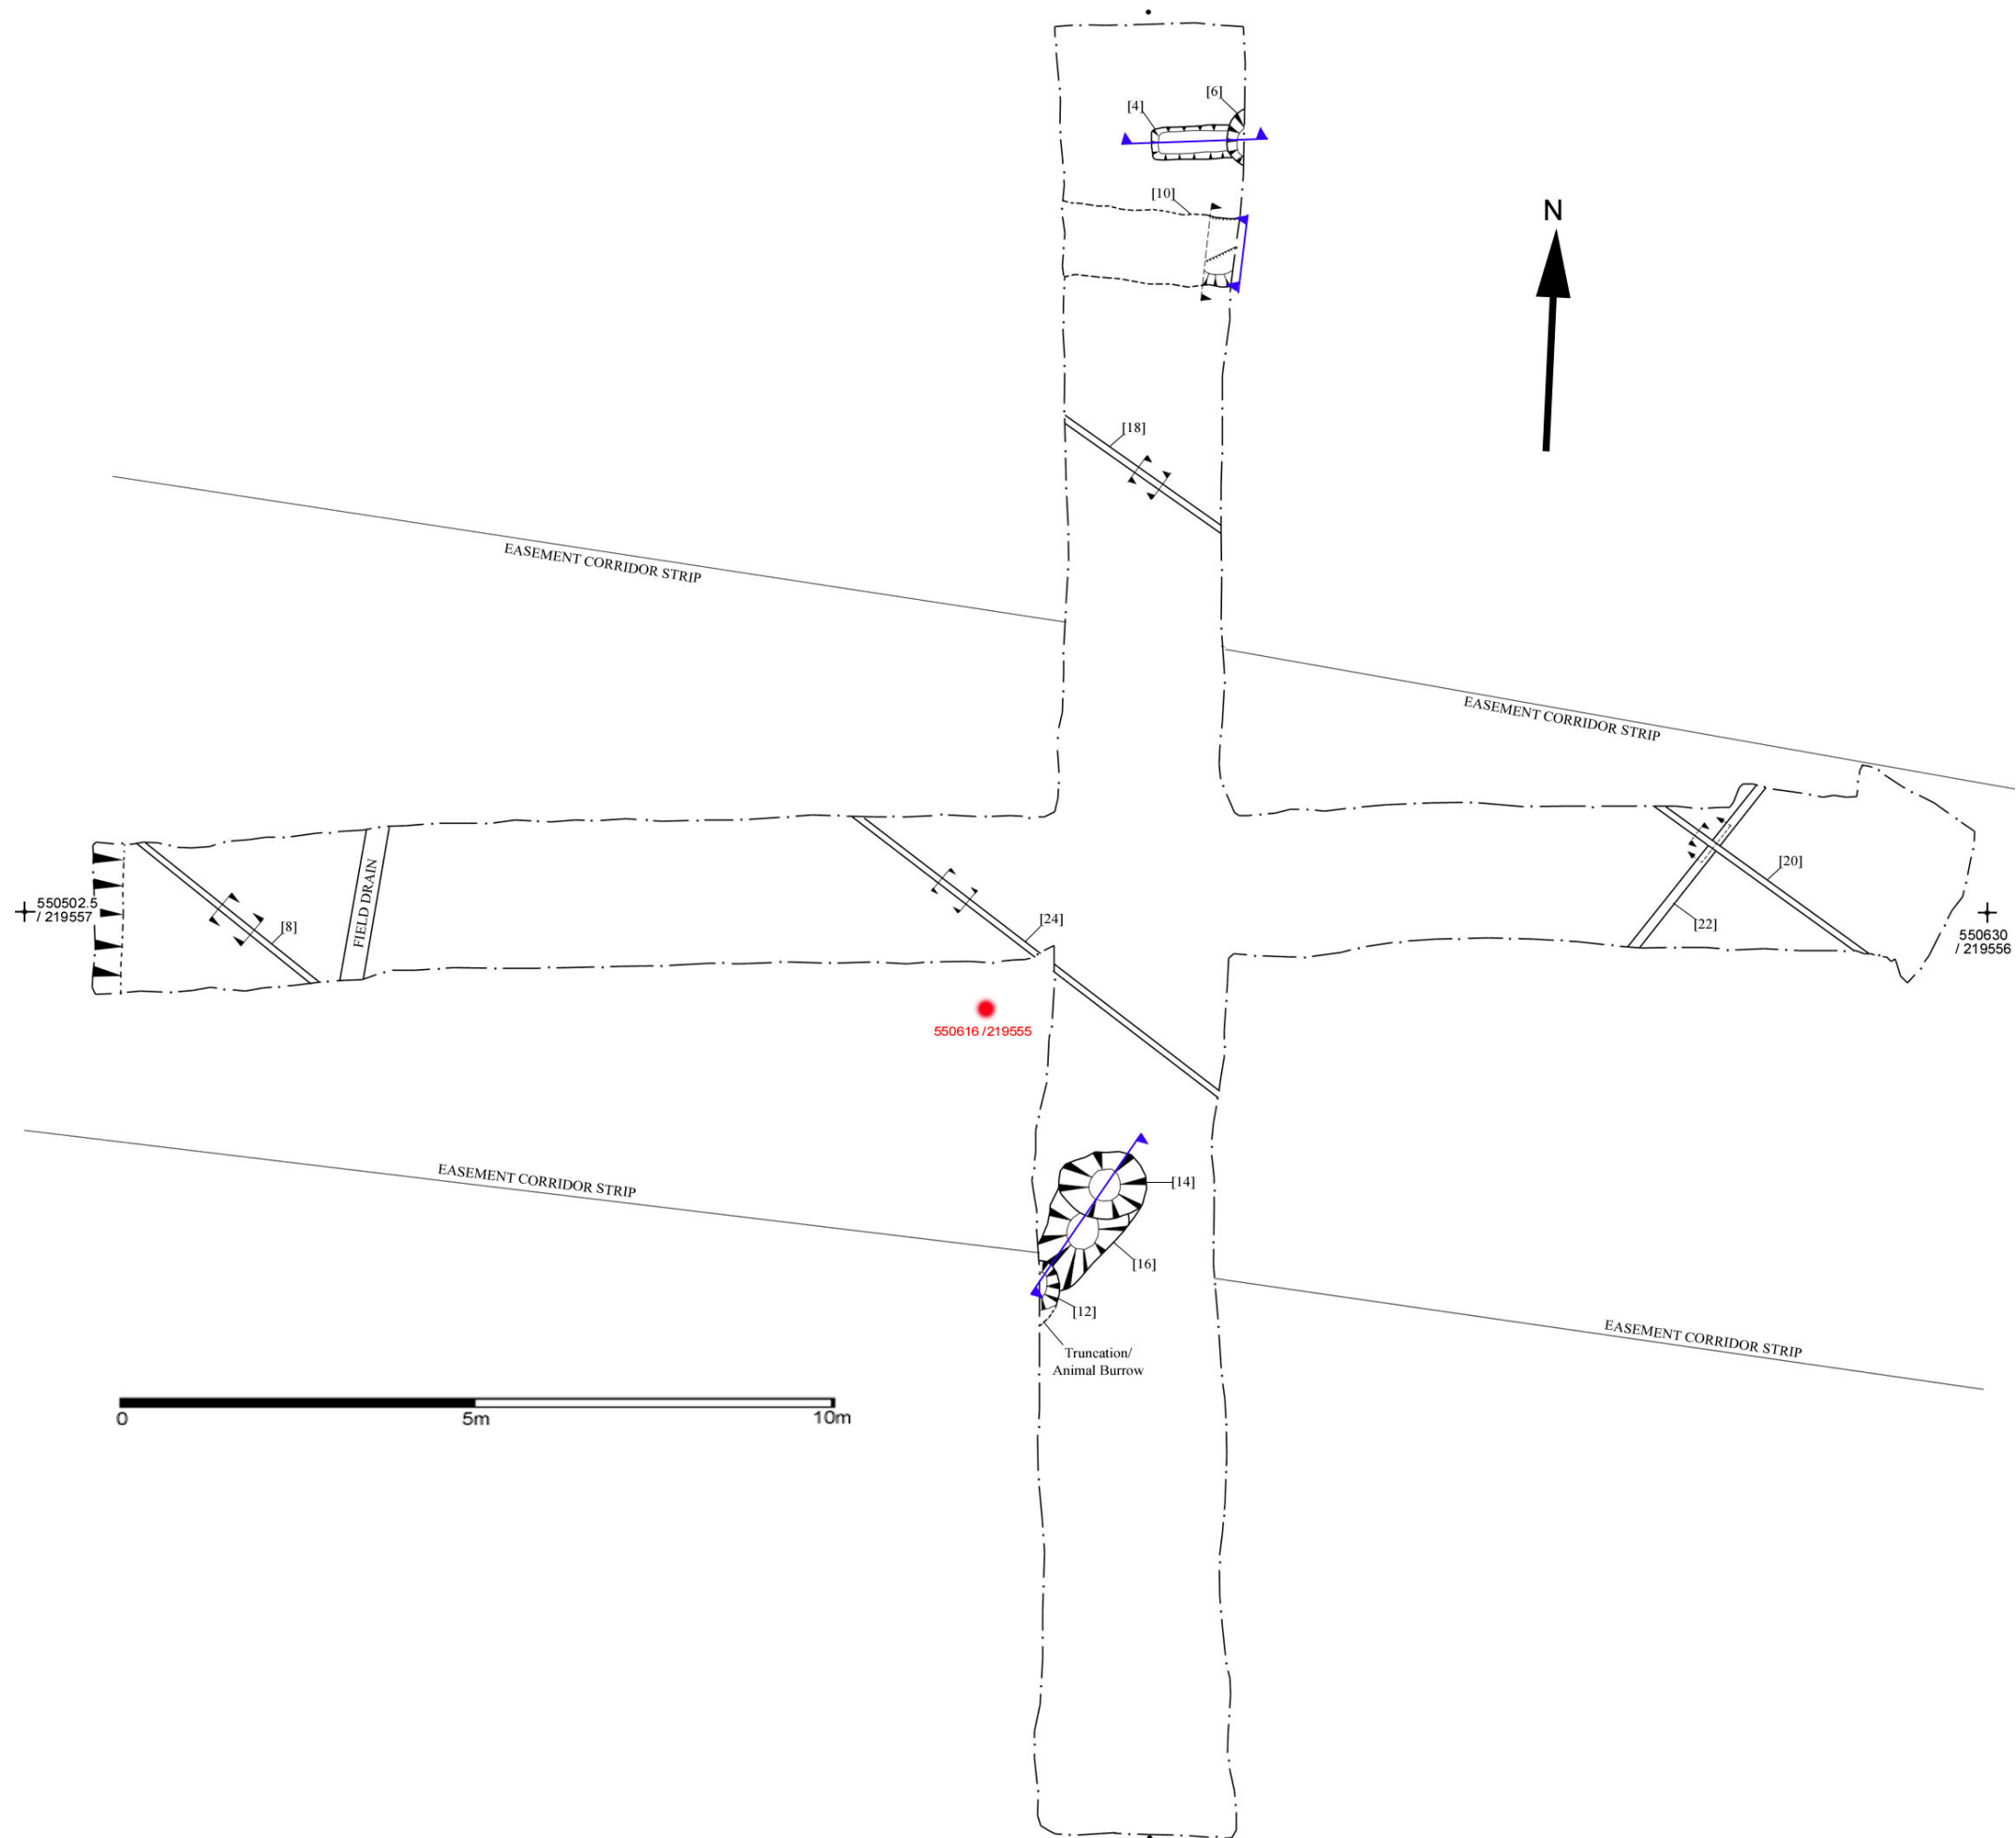
Figure 5 Plan of Trench 1 showing features cutting into the natural deposit and the location of illustrated sections

Figure 5 (above) shows the exposed features cutting into the natural deposit [25]. The features can be grouped into two units – initially the series of regular linear cuts thought to be plough furrows, and secondly 6 heavily truncated and somewhat ephemeral cut features of probable prehistoric date.

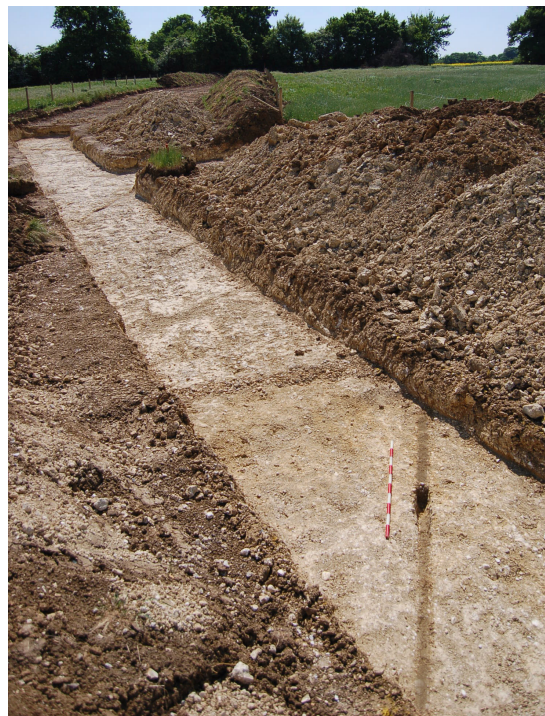
**Figure 6:** View southeast of Trench 1 showing plough furrow [8] (1m scale).

A series of linear, regular cut features [8] [18] [20] & [24] were observed running on the same angle and orientation on a northwest – southeast axis. Cuts [18] [20] are considered to be the same feature exposed in the north and east lengths of trench respectively, with the adjoining section continuing beneath the unexcavated baulk. The continuation of cut [8] beneath the baulk and into the southern length of the trench was not exposed. Whether this implies the terminus of the feature beneath the unexcavated area, or simply a greater degree of disturbance and truncation to the south is unclear. The very regular appearance of these features and broadly similar dimensions (with only depth showing real variation) suggests they are machine cut. Furthermore, the three individual linears – [8] to the west, [24] in the centre and [18] [20] to the east – are evenly spaced with an interval of some 6.3m. It is likely these features represent a series of regular plough furrows, but the absence of finds recovered from the fills [7] [17] [19] & [23] leave them undated.

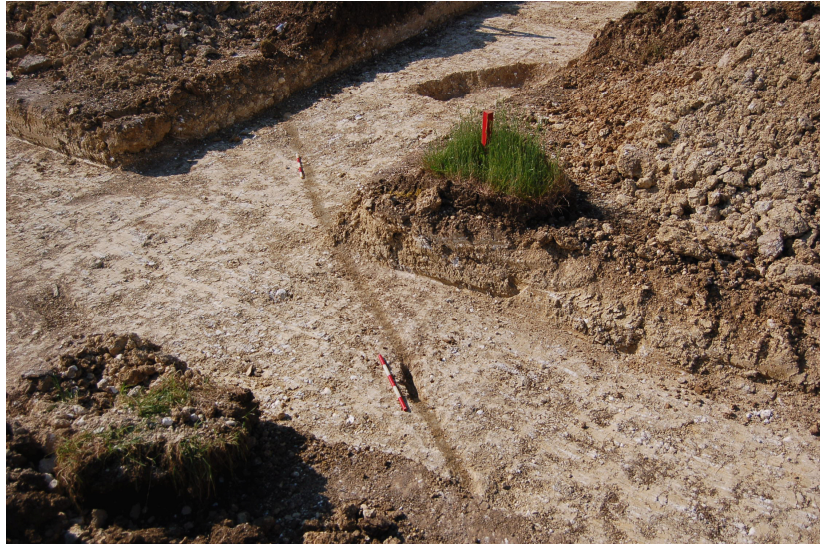
**Figure 7:** View southeast of Trench 1 showing plough furrow [24] (0.5m scale).

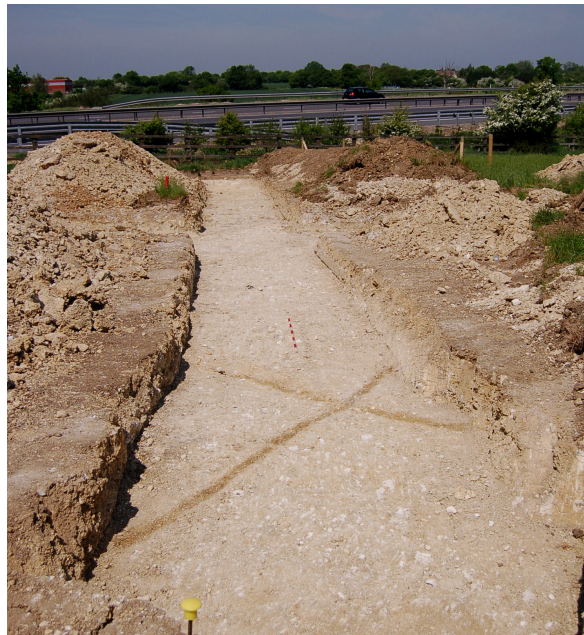
**Figure 8:** View west towards the M11 of Trench 1, showing plough furrow [20] and linear feature [22] (1m scale).

Furrow [20] was shown to cut a further narrow linear [22], which ran virtually perpendicular to [20] on a northeast-southwest orientation. Linear [22] was of a similar depth to the probable plough furrows elsewhere, but slightly wider at 0.18m and filled by a very different deposit [21] of yellow/orange sand and gravel. Again, no finds material was recovered from the excavated section and the feature is thus not datable – although it must pre-date furrow [20] which cuts through it and is itself presumably contemporary with cuts [8] [18] and [24]. It is possible, given the nature of the cut, that linear [22] represents an earlier phase of plough furrow.

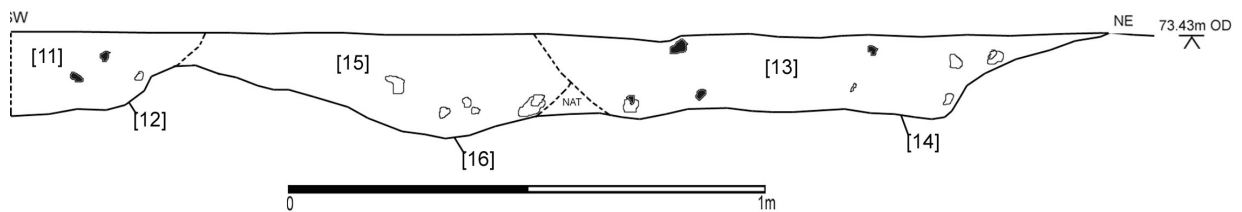
**Figure 9:** Section A – through pits [12] [14] [16].

In the southern length of Trench 1 a series of three probable intercutting pits was observed. The earliest of these, pit [16] was irregularly shaped measuring 0.95m (NE-SW) by 0.9m (NW-SE) and 0.21m in depth. It was truncated to the northeast and southwest by the later cuts of pits [12] and [14]. Pit [14] was roughly circular in plan, again very shallow at 0.17m. To the southwest, extending into the baulk, pit [12] was the smallest of the group at 0.5m by 0.25m and 0.19m in depth. [12] was truncated to the south by an animal burrow, obscuring the southern extent of the cut – see Figure 9 and 10 below. All three pits were very shallow indicating heavy truncation, probably through ploughing. The fills [11] [13] [15] were very similar, consisting of mid-brown grey silty clay with chalk pieces and fragments of thermally shattered flint. A single piece of worked flint was recovered from fills [13]+[15] (not separated) which was identified as a Mesolithic or Neolithic blade worked in banded flint, measuring 41mm in length – see Figure 11.

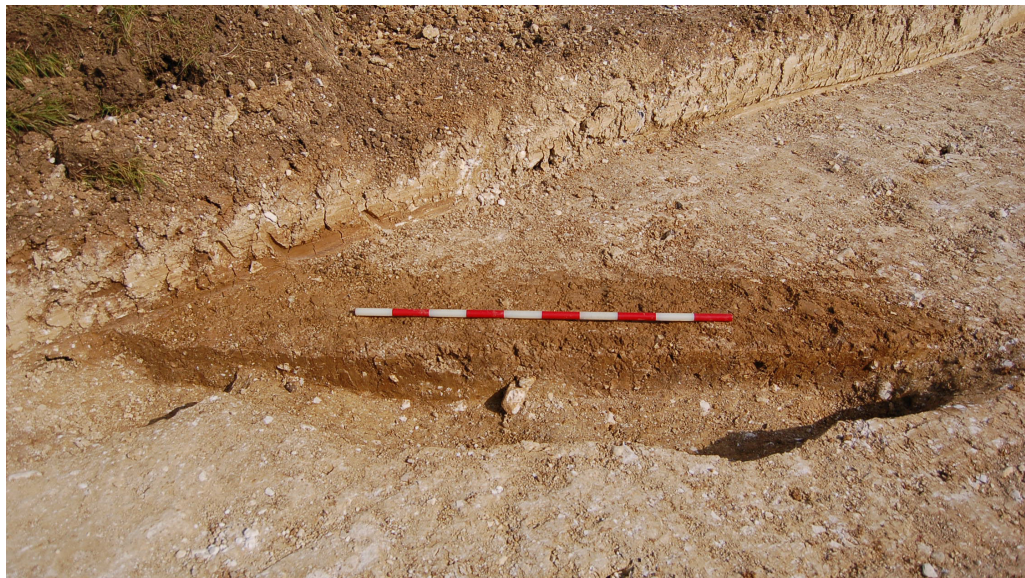
**Figure 10:** Southeast facing section of pits [12] [14] [16] (1m scale).

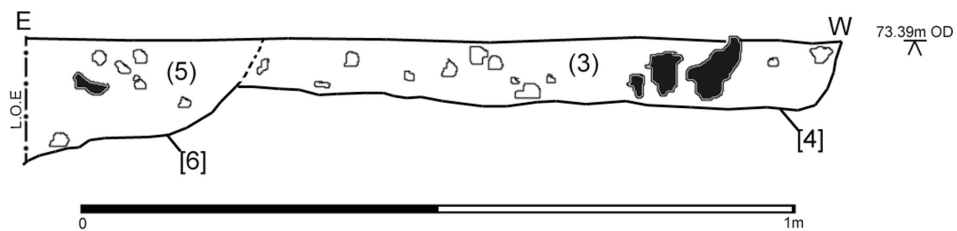
**Figure 13:** Section B: through linear feature [4] cut by [6].

Cut [4] was a narrow (0.4m) linear feature orientated east-west and exposed for 1.15m to its eastern end where it was truncated by a circular cut [6]. Cut [6] and presumably the continuation of linear [4] extended beyond the limit of excavation to the east. Both features were very shallow, probably heavily truncated through ploughing as with the pit sequence [12] [14] [16] described above. Fills [3] [5] were very similar, consisting of mid-brownish/orange clay with silt and sand, occasional chalk inclusions and frequent thermally shattered flint flakes. One such example was identified as showing signs of probable reuse or modification, likely by human activity but possibly through natural processes (see Figure 12 below). The heavy degree of truncation and lack of further finds evidence makes secure identification and dating of these features problematic. Both features are probably prehistoric, perhaps contemporary with the pit sequence observed to the south – linear [4] may represent a small ditch or gully, later cut by the small circular feature [6], possibly a small pit or post-hole.

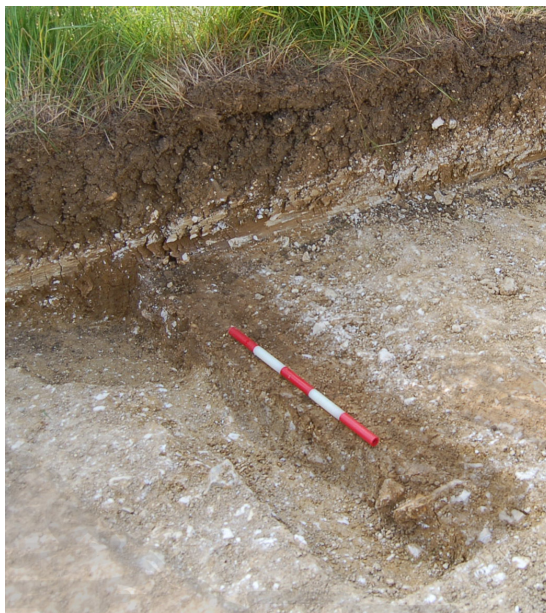
**Figure 14:** North facing section of features [4] and [6] (0.5m scale).

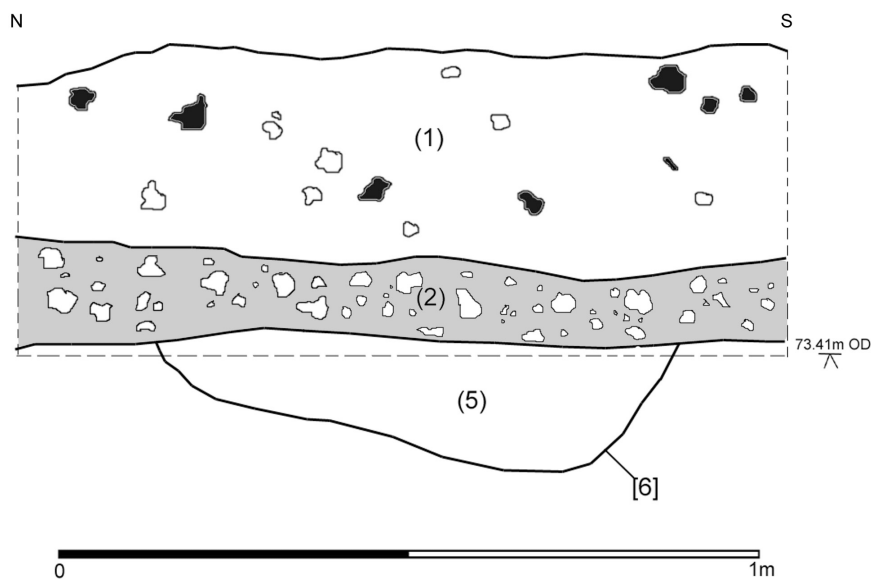
**Figure 15:** Section C: showing feature [6] with overlying topsoil and subsoil.

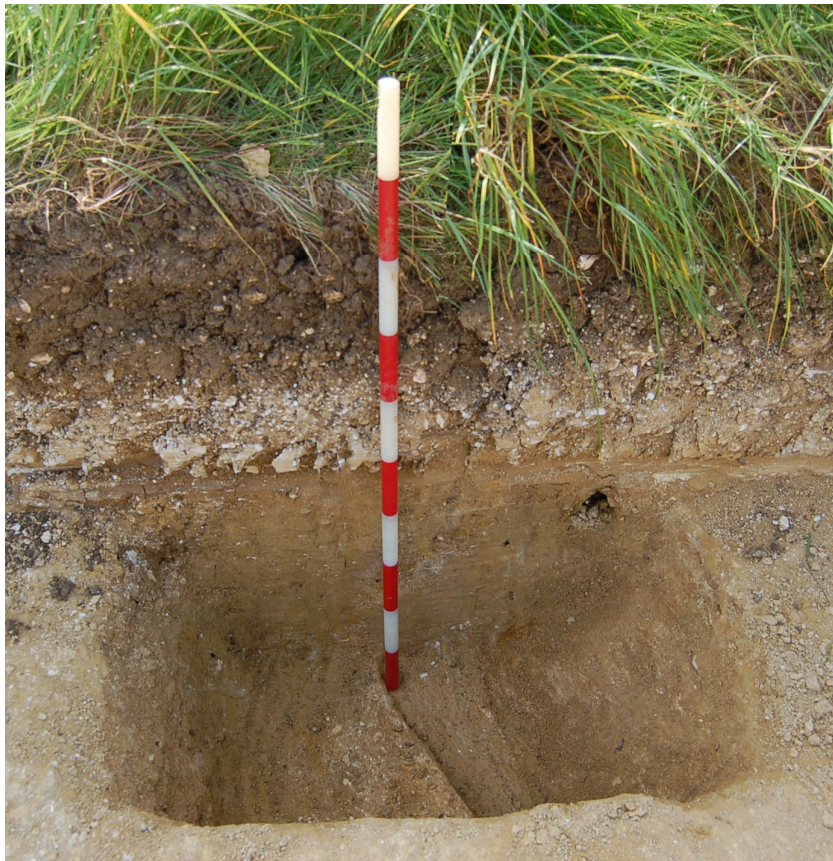
**Figure 16:** West facing section of possible linear feature [10] with topsoil [1] and subsoil [2] – 1m scale.

Cut [10] was an irregularly edged linear feature orientated east-west and extending beyond the limits of excavation in both directions. Fill [9] consisted of a very sandy deposit, yellow/orange in colour and barring small areas of chalk flecking, completely sterile of inclusions. The cut was significantly deeper than other features exposed in trench 1, extending some 0.4m into the natural deposit. A small step was exposed in the base of the cut, which may represent the remnants of a re-cut, suggesting the feature is a partially truncated ditch or gully. However, the lack of inclusions, dissimilarity with the other exposed features and composition of fill [9] may indicate that the feature is natural sediment within a very mixed wider natural deposit. As the feature was only exposed in a very small area, and sampled with a small section, further identification is not possible.

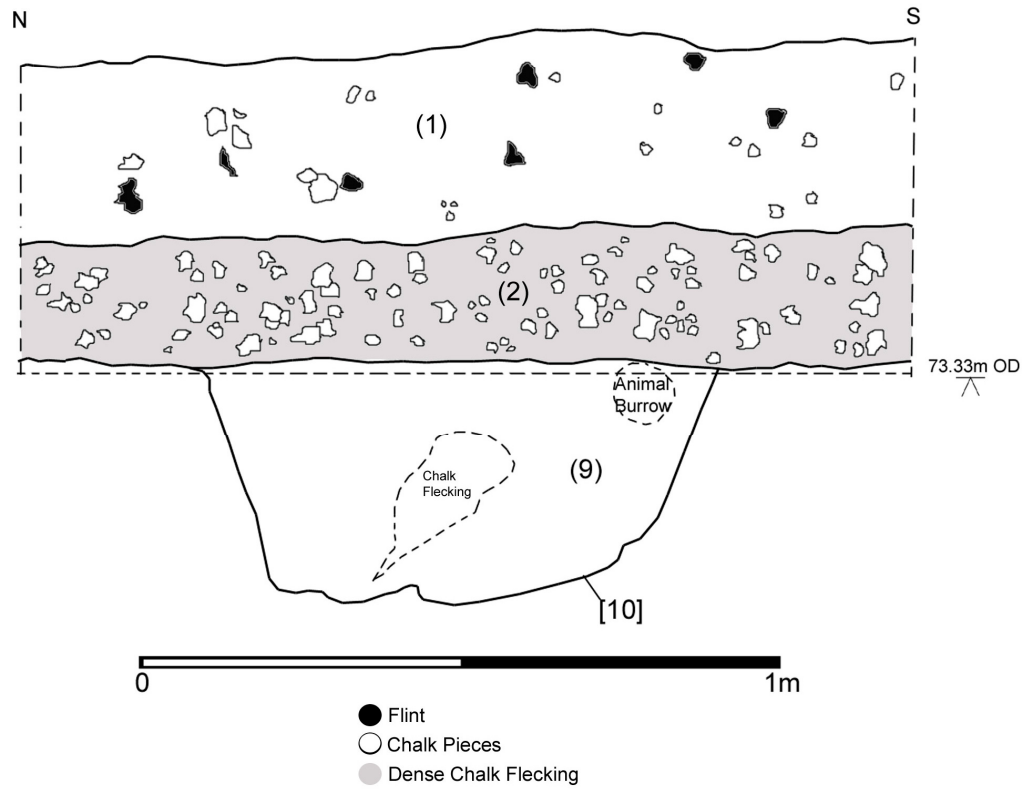
**Figure 17:** Section D – through feature [10] and baulk.

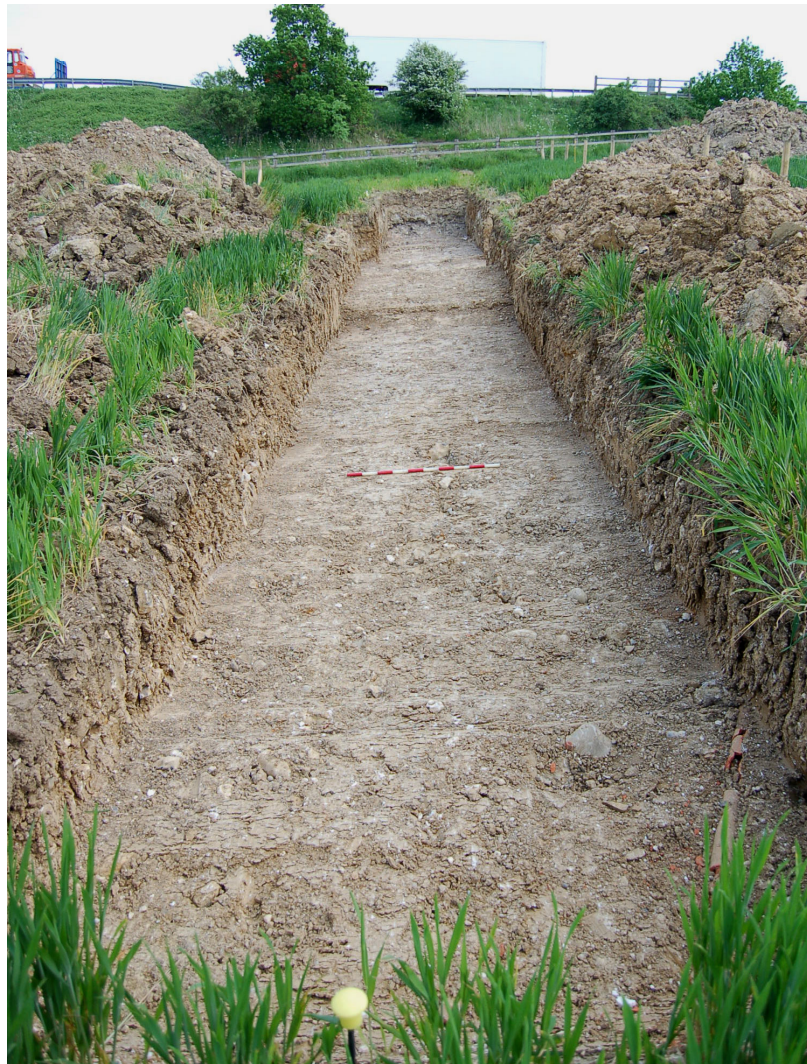
**Figure 19:** Trench 2, looking east towards the M11 motorway (1m scale)

No archaeological finds or features were exposed in Trench 2, deposits consisted of the existing topsoil [26] and subsoil [27] overlying a very mixed natural [28] between 67.28m and 69.07m OD. The latter deposit was very different to that exposed on the east side of the motorway [25], containing considerably less chalk but with higher quantities of flint including very large nodules up to 450mm in length. This type of sediment is likely to represent material laid down by glacial activity, but appears to be heavily truncated. The extent of ground works undertaken during the M11 construction works is unknown, but the difference in ground level between the two sites (some

4.25m) considering the distance apart (approximately 75m) may indicate some significant reduction. This is borne out by the depth of subsoil (0.65m) and the mixed nature of this deposit, combined with the presence of frequent ceramic land-drains and a large plastic-corrugated drain at the maximum depth of excavation (see Figure 22 below), which indicates a reduction in natural ground level and subsequent makeup. It is likely then that any archaeological remains were consequently destroyed, hardly surprising considering the proximity to the motorway and the sharp drop in ground level observable between the excavation site and road. At the south end of the trench a large area of darker material was observed, but was not in any observable cut was considered to be a natural variation in the deposit [28].

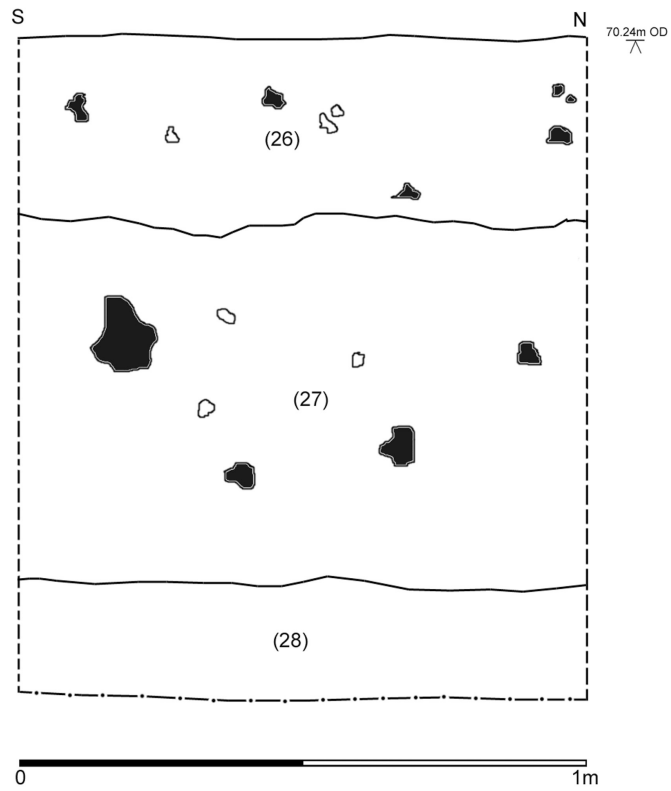
**Figure 21:** Section E: 1m sample section of Trench 2.

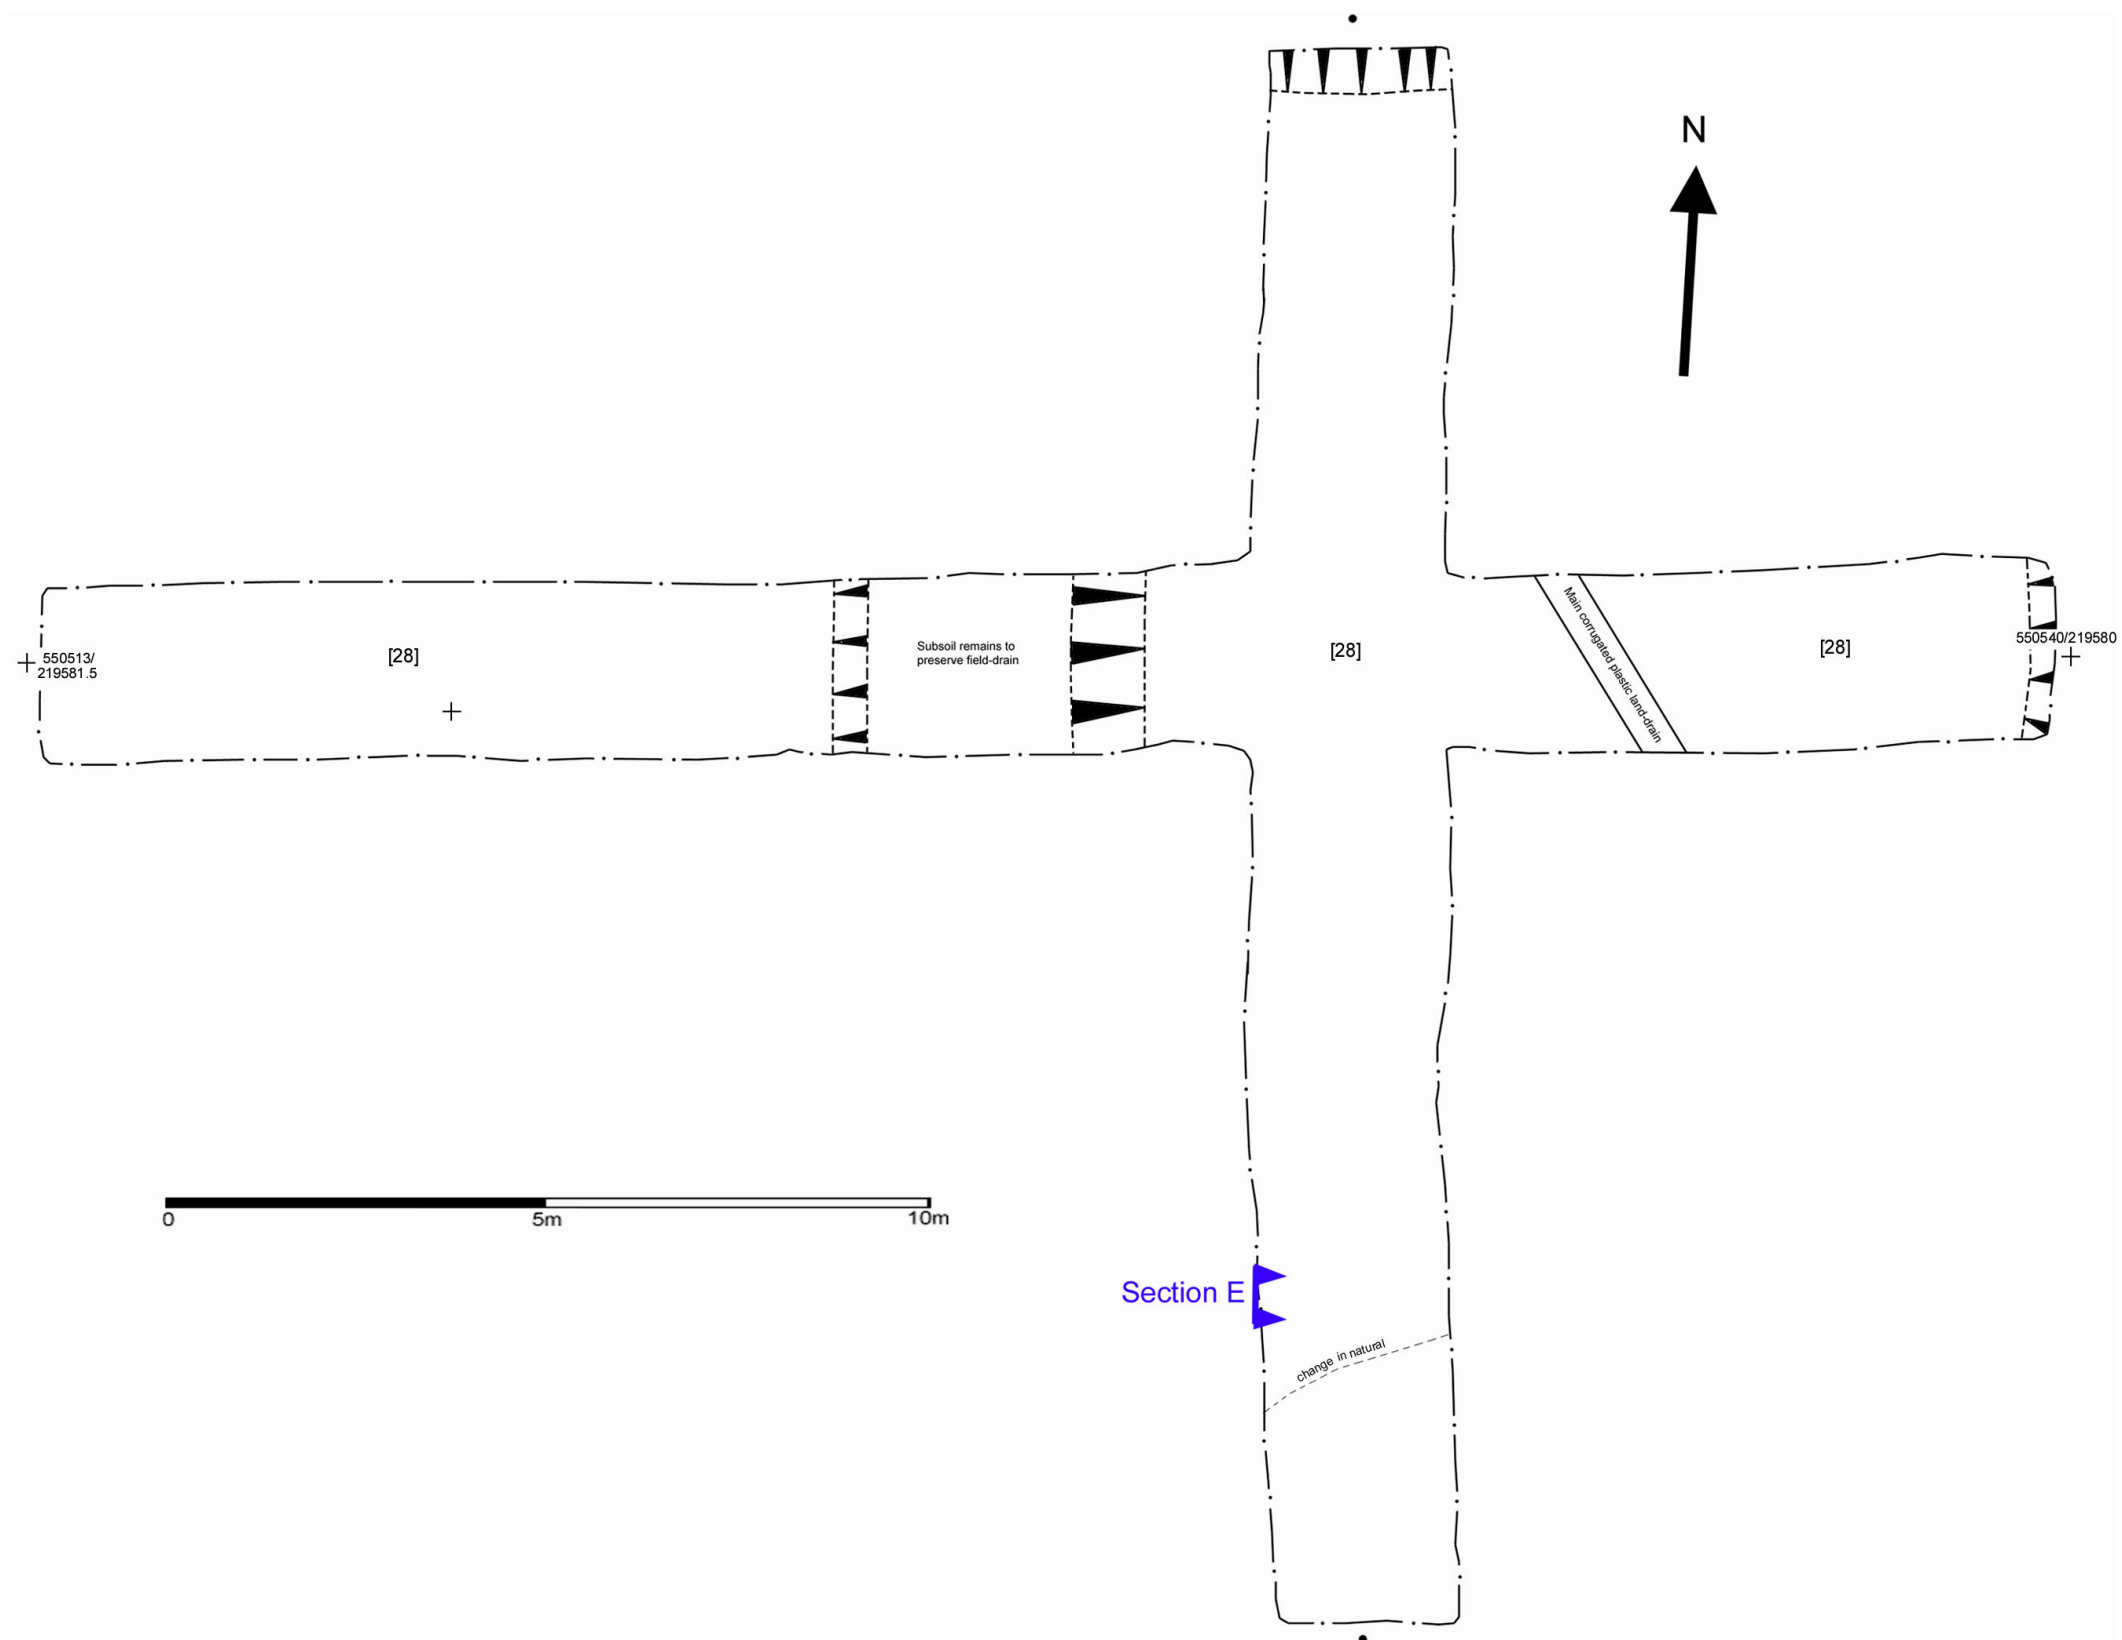
Figure 22 Plan of Trench 2, showing features cutting into the natural deposit and the location of illustrated section
