## THAMES WATER UTILITIES LTD WATER MAINS REPLACEMENT WORKS

# DEPTFORD AND ST. JOHNS (NORTH) LONDON BOROUGHS OF GREENWICH AND LEWISHAM

AN ARCHAEOLOGICAL WATCHING BRIEF

SITE CODE: DSJ 06

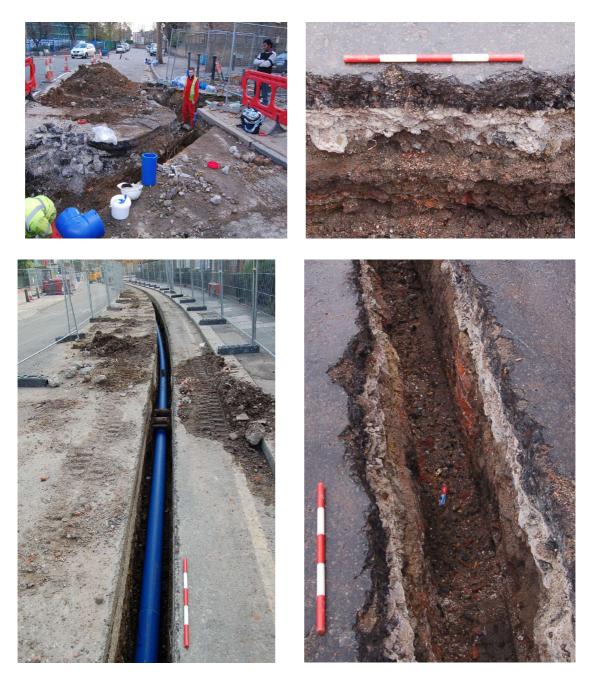
In the east and west facing sections, red brick wall bases (likely to be either earlier basements or coal cellars at this depth) could be seen in the trench towards its southern end (opposite the building line of No. 4 Brookmill Road). At least 7 courses of red bricks were exposed and were bonded with a light grey soft mortar; the wall bases were less than 0.5m wide. It seems most likely this *in situ* brickwork represented the remains of former buildings along Brookmill Road before the street line was widened to its present size. Stanford's 1862 Library Map of London and its Suburbs clearly shows the street (then Mill Lane) as narrow compared to other roads in the area. It is lined with buildings on both sides, whose footprint would now extend into the modern highway. Whilst it is not possible to date the structures (due to such a small exposed section and the tightly bonded brickwork preventing brick sampling), a reference does exist for the clearing of buildings along this road at the end of the 19<sup>th</sup> century<sup>2</sup>.

Fig. 2 Views of the trenching in Brookmill Road. *Top left:* monitoring works just north of Admiral Street, looking south. *Top right:* west-facing section in the northern part of the street. *Lower left:* long section of open cut trench in Brookmill Road, looking south. *Lower right:* part of an *in situ* brickwork wall base exposed in section

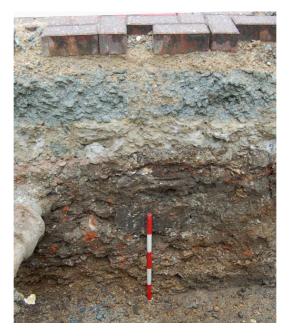
Much of the excavated area in Deptford Broadway and New Cross Road showed massive disturbance by large old services crossing and running through the trenches. Where the area has been less disturbed a dark silt comprised the majority of the deposits observed; this contained occasional post-medieval ceramic building material but was not closely dated.

Fig. 3 The northwest-facing section for the trench outside Nos. 48-50 Deptford Broadway (scale 0.5m)

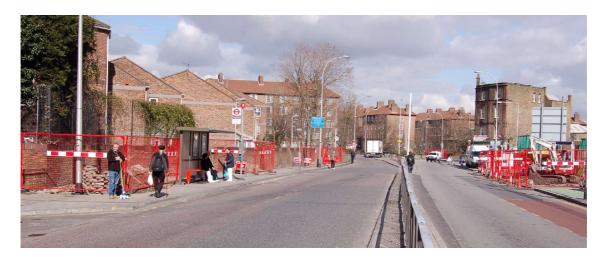
A later visit monitored a long trench cut located on the eastern side of the road, about 1m out from kerb. This ran from just south of Lewisham College entrance to the corner of Deptford Bridge. The total overall length of open cut was approximately 100m long, and it was c 0.33m wide. At the northern end a compact gravely brown silty soil was overlain by brick rubble, and was cut by a modern frogged brick wall base (crossing the base of the trench obliquely southwest to northeast). In this area trench was c 1.1m deep.

Fig. 4 General shot of groundworks on either side of the Deptford Church Street carriageway; the 100m long trench to the east having been partly reinstated by the time this photograph was taken. Looking north towards the roundabout and junction with Creekside/ Reginald Road.

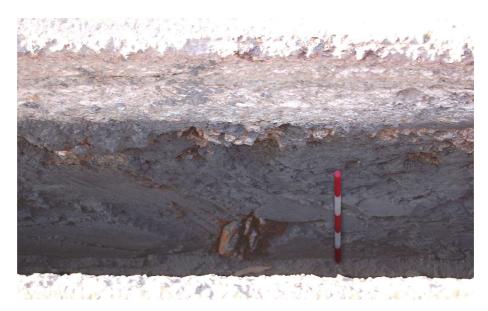
To the south, around one-third of the way along the trench from the northern end the lower deposits became darker and more silty. The firm and homogeneous dark grey sandy silt, which was not bottomed even at the trench's deepest point (1.4m), was some 380mm to 600mm below the present surface, overlain by modern disturbance and road make-up layers. The silt contained a couple of small and partially decayed timber posts or stakes (*cf.* figure 5 below), but no other material.

Fig. 5 View of alluvial deposits exposed in section on the eastside of Deptford Church Street. The deposits here contained a single decayed timber (at centre base) but were otherwise sterile and directly overlain by modern rubble/ road make-up.

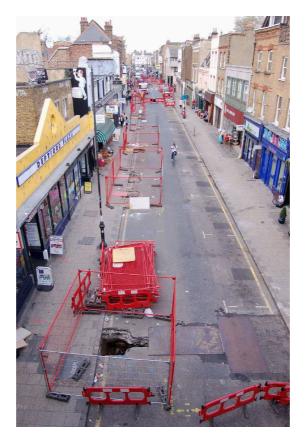
Fig. 6 Looking north from the railway bridge up Deptford High Street at groundworks on either side of the carriageway; on the eastern side foreground including a number of backfilled pits. Almost all the excavations were 0.8m to 1.0m deep, and all exposed modern made ground/backfill with the previous services below present road make-up. Earlier deposits and/or natural deposits were not apparent.

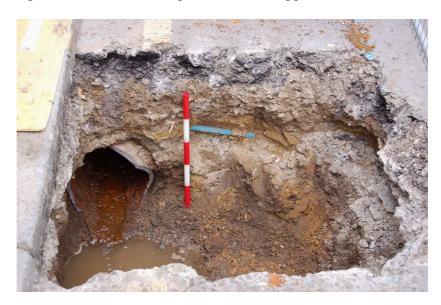
Fig. 7 Pit in the western carriageway outside No. 157 Deptford High Street, showing road make-up, made ground deposits and (to left of the 0.5m scale) the former cast iron water mains now cut and awaiting insertion of the new pipe.

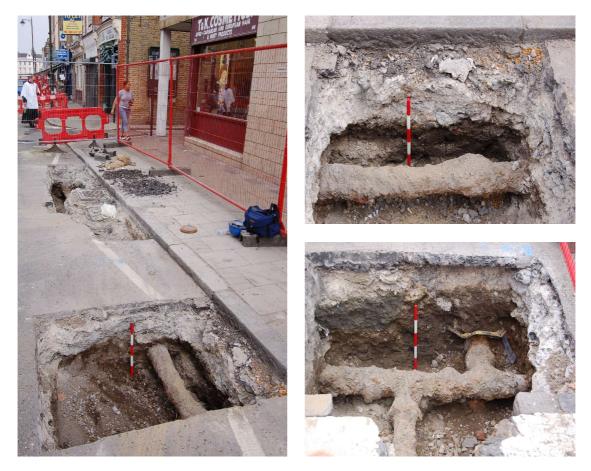
Fig. 8 Excavations on the eastern side of the road adjacent to Nos. 162-164 High Street.

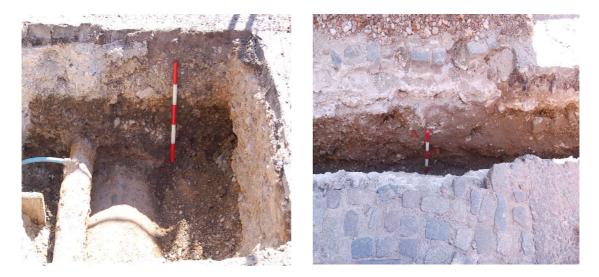
Fig. 9 *Left:* pit in the eastern carriageway outside No. 200 Deptford High Street, with a very large pipe visible at the base of the trench, and *right:* a narrow trench to the north dug eastwards into Lamerton Street.

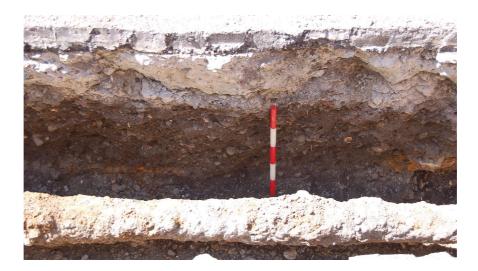
Fig.10 East-facing section outside No. 212 Deptford High Street, with a corroded cast iron pipe exposed in the foreground. A further iron pipe is visible in section either side of the 0.5m scale

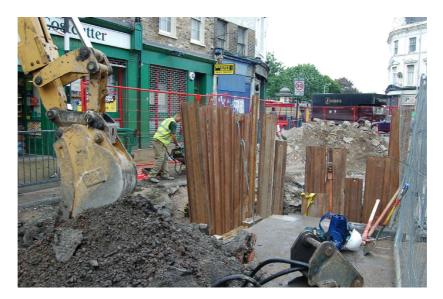
At the northern end of Deptford High Street further larger, irregularly shaped pits and areas of open cut were observed (figure 11). The largest of these reached a vast depth of 5.4m. This revealed successive layers of made ground, and at the base of the trench probable natural clay and gravels were observed, although these may have been disturbed or redeposited. In addition, Morrison site contractors reported encountering a large oyster shell concentration just south of the centre of the junction with Creek Road.

Fig.11 Monitoring groundworks at the northern end of Deptford High Street (just to the north of figure 10), looking north-west.

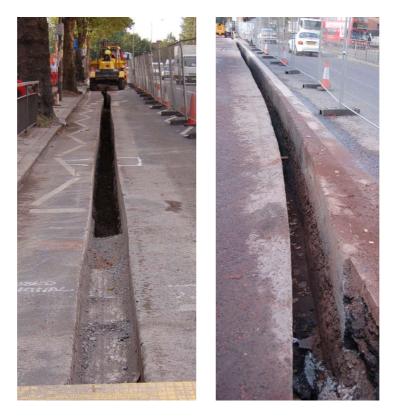
Trenching was observed along the entire length of the relevant section of Creek Road over the course of the watching brief. Initially a long section of open cut ran along the southern carriageway about 1.2m out from the kerb. This started in the east at the junction with Creekside, and ran almost continuously to the junction with Deptford High Street (with a few breaks of unopened areas). This long narrow trench revealed no archaeological features or finds below the modern road make up.

Fig. 12 Views of trenching in the southern carriageway of Creek Road. Looking west.

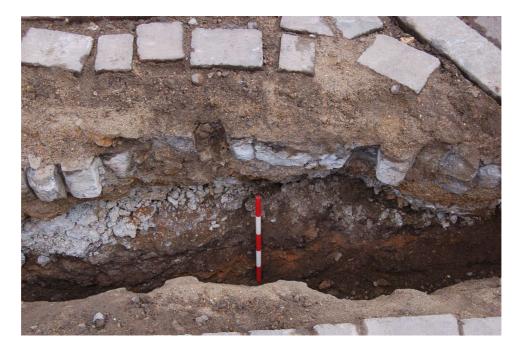
The present ground surface of brick paving in sand bedding (and concrete) overlaid a former cobbled surface of granite setts. Below these were multiple layers of concrete. The last 300-400m of the trench was made up of mixed soily rubble with crushed red CBM inclusions, which probably represents made ground deposited prior to the construction of the former cobbled area.

Fig. 13 The north facing section in the triangle of open paved area on the north side of Creek Road, just east of the Deptford High Street junction.
