**LAND TO THE REAR OF 12-26 CRAYFORD HIGH STREET**

**CRAYFORD, DA1**

**ARCHAEOLOGICAL OBSERVATION AND RECORDING**

SITE CODE: CFZ 08

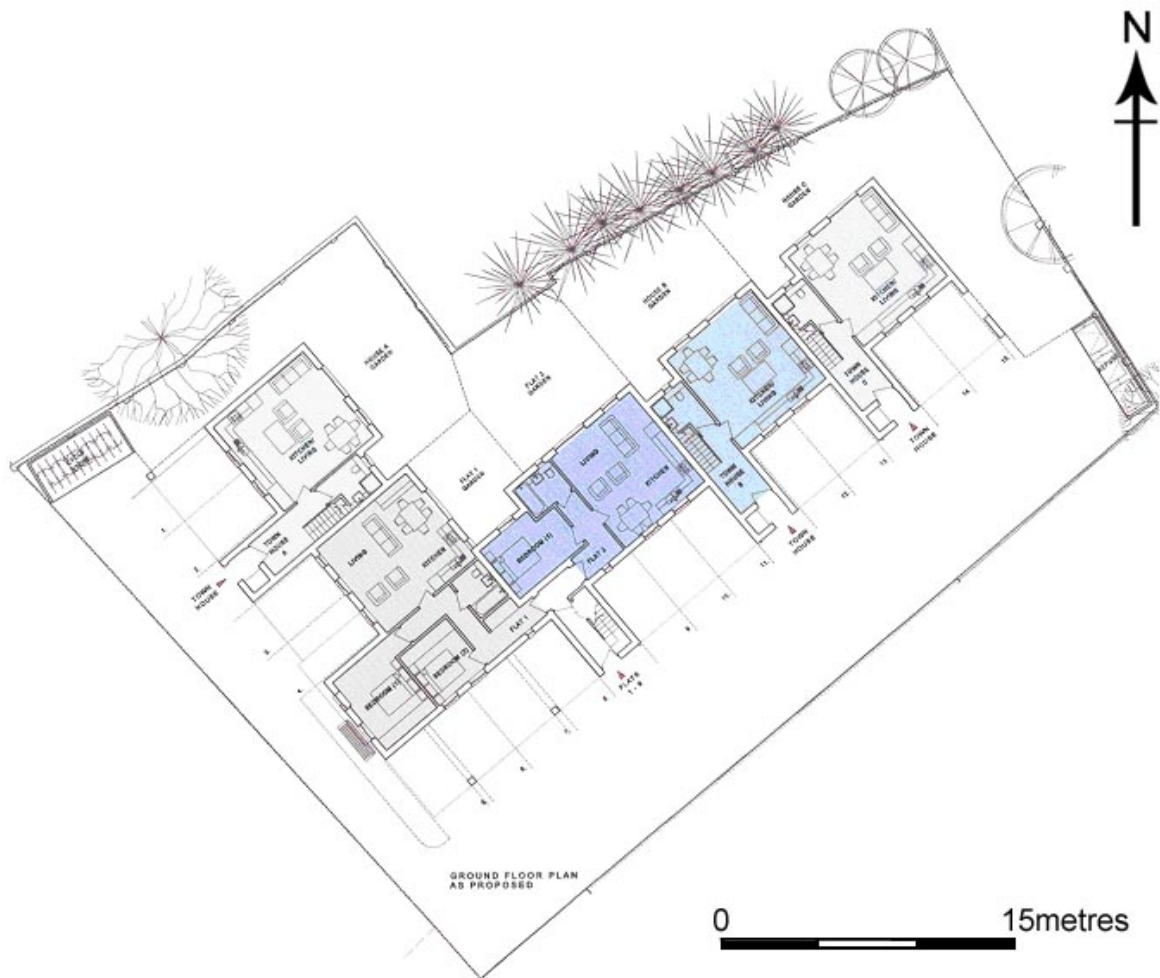
Fig. 2 Ground floor plan of proposed development

Adapted from a planning application drawing by Neal Tuson Architects, No. 223.P02 (E)

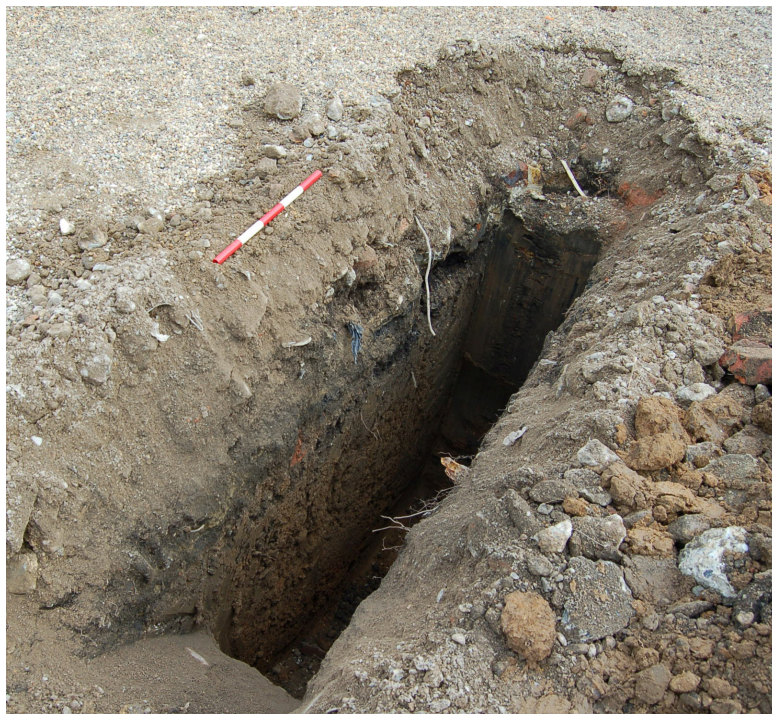
Beneath the shingle/ gravel yard surface a modern made ground deposit of pale brown rubble was observed (at least 0.5m thick). Below this was a black-dark grey sandy/ash deposit with frequent charcoal and small stones. This deposit was 150mm thick at the maximum point at the eastern end. The eastern half of

the north facing section had a thin (80mm thick) layer of pale fine-medium sand. Below this was a dark grey sandy deposit that had occasional ceramic building material (CBM) fragments and small stones; this layer was just 150mm thick. This overlaid a similar but thicker (300mm) deposit, which was distinguished by its inclusions of CBM fragments, occasional flint nodules, rusted metal fragments, and what appeared to be slag or bone (health and safety issues prevented pit access to examine further). At the base of the trench a natural mid-light brown (increasingly orange with depth) soft sandy silt with gravels was observed.

This sequence of deposits was interpreted to represent a series of former construction surfaces, made ground deposits and dumped burnt material showing repeated developments on the site in its recent history. These overlaid natural alluvial silts and gravels related to the nearby river Cray.

*Fig. 4 The north facing section of test pit 1 (scale 0.5m)*

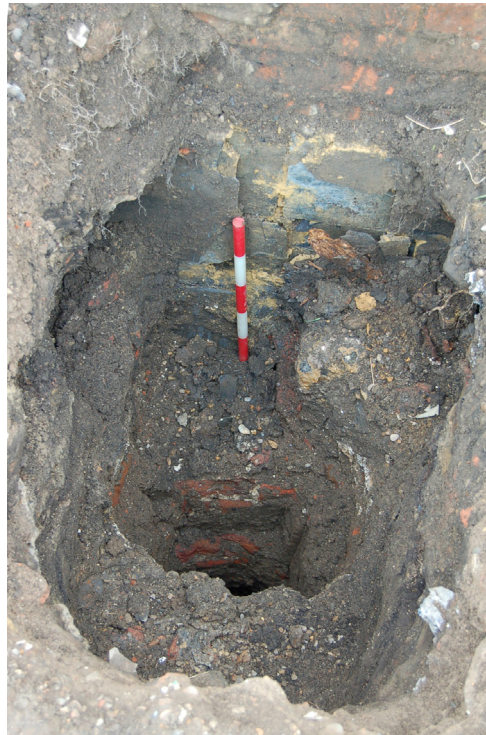
Test pit 2 was located on the northeast-southwest aligned site boundary wall in the south of the site. It was positioned right against this wall and was situated 16.5m along its length measuring from the eastern corner of the site. The small pit measured just 950mm in length (east-west) by 650-700mm, but had a depth of 1.9m at the deepest point. This hand dug pit revealed several layers of made ground material with a concrete base observed at a depth of 300mm. Below this was a 500mm thick dark grey sandy silt with occasional CBM (red and yellow stock bricks), glass, and pot sherds. Beneath this was a layer of soft white mortar with *in situ* brick (the exposed section being northwest facing) work below to a depth of 1.70m, which jugged out 3-400mm from the boundary wall. The red handmade bricks were tightly mortared with a white, charcoal flecked

mortar. This brickwork most likely represented either earlier wall foundations or a former cellar of 19<sup>th</sup> century date and was considered to be of low significance.

*Fig. 5 The northwest facing section of test pit 2, with the in situ brick work visible below the scale (scale: 0.5m)*

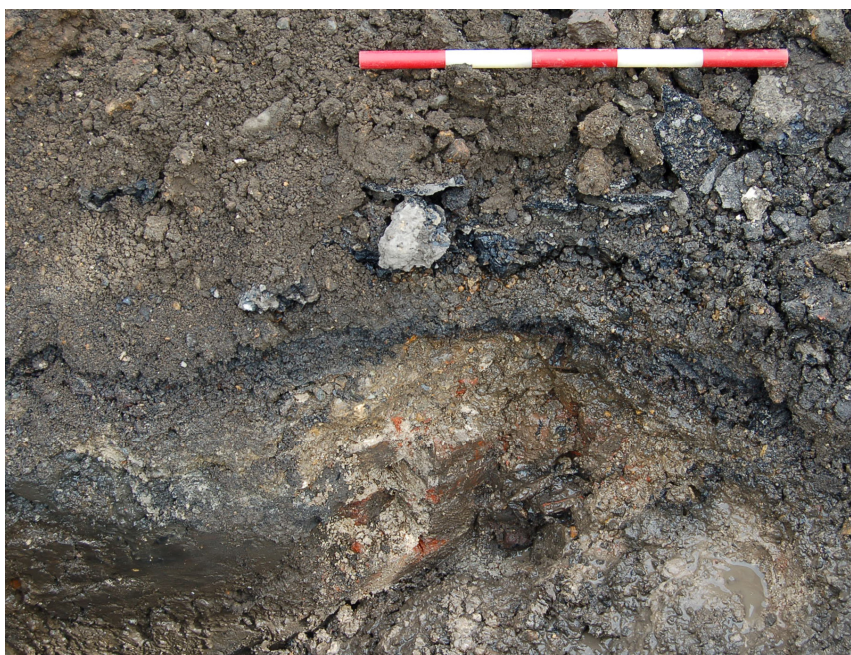
The upper 250mm of deposits consisted entirely of repeated layers of tarmac and tarmac base. Below which was a dirty deposit of dark grey gritty material interpreted to be a backfill or made ground deposit. Comprised largely of coarse sandy silt, with CBM and pottery inclusions, this deposit was up to 700mm thick. At the very base of the trench natural mid-light orange brown sandy silt which was increasingly clean and sandy with depth. Just 300mm of this deposit was exposed, but it most likely continues beyond the limit of excavation. Four courses of white mortared red brickwork were exposed *in situ* in the west facing section, at a slightly different alignment to the trench. This brickwork most likely represents former cellars or wall foundations from the 19<sup>th</sup> buildings known to previously exist on the site.

*Fig. 6 The west facing section of test pit 5, showing the in situ brick work observed at the southern end of the trench*

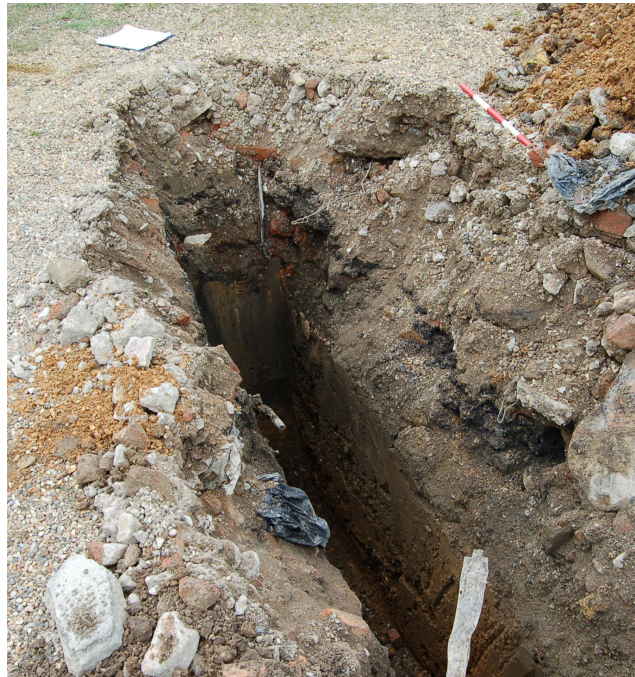
Test pit 6 was located at the rear of the Bexley Business Centre building towards the approximate middle of the site as shown in figure 3. The trench was 2.5m in length (approximately north to south) but just 0.5m in width. A maximum depth of 2.1m was recorded. The pit revealed a simple sequence of deposits of modern rubble made ground over broken tarmac base at a depth of 750mm, with further similar rubble below (but with notably fewer large brick fragments, in the dry coarse sandy matrix) to a depth of 1.3m. Below these deposits was a

natural mid brown clean silty clay, and beyond the upper 400mm, the deposit became orange with frequent gravels extending beyond the limit of excavation.

*Fig. 7 The east facing section of test pit 6, please note that for health and safety access reasons the test pit could not be examined from within the trench (scale: 0.5m)*

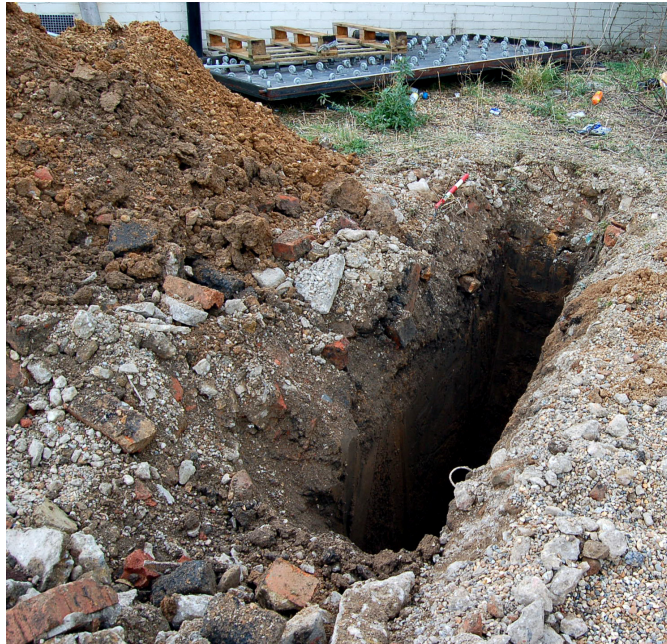
Test pit 7 was also at the rear of No.14B Crayford High Street, but further to the north than test pit 6. This trench measured 2.8m east to west by 550mm wide, with an average depth of 2.1m. Deposits encountered were very similar to those seen in test pit 6, with the upper 400mm of deposits comprising modern made ground rubble, with a dirty and mixed dark grey-brown silt below with occasional pot, CBM and chalk lumps. This deposit blended with the underlying soft mid orange-brown silt, which became increasingly gravely and sandy towards the base of the trench.

*Fig. 8 The north facing section of test pit 7, please note that for health and safety access reasons the test pit could not be examined from within the trench (scale: 0.5m)*

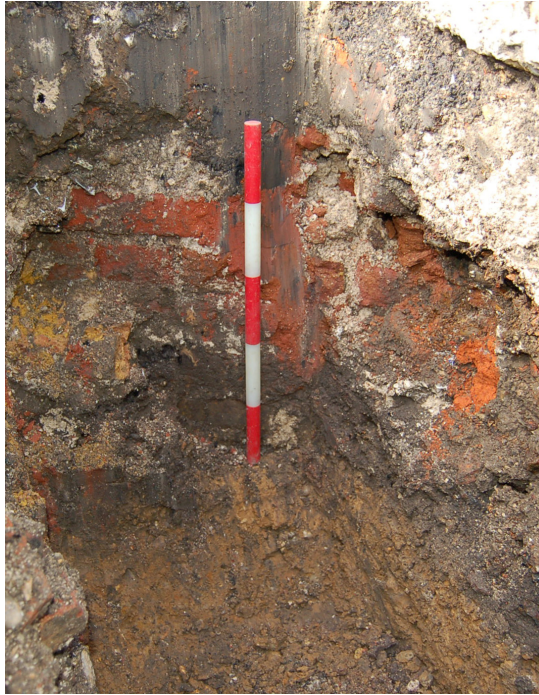
This test pit was located further to the south of test pit 5, just outside the entrance to No. 14B Crayford High Street. The test pit measured approximately 2.2m east to west, by 0.5m north to south. The pit had a maximum depth at the mid point of 1.15m. Tarmac and tarmac base comprised the upper 150mm of deposits, with a concrete base below to a depth of 550mm. Below this, at the western end, in the east facing section were several courses of *in situ* brickwork (five courses exposed). The upper three courses were made of red bricks, with yellow stock bricks below. As with other recorded brickwork on the site, the brickwork was not thought to be of any great significance or antiquity and most likely represents former building foundations or cellars. At the base of the trench yellow-orange sandy clay was observed, which was thought to be the brickworks' construction cut backfill.

*Fig. 9 The east facing section of test pit 8 showing the in situ brickwork (scale: 0.5m)*

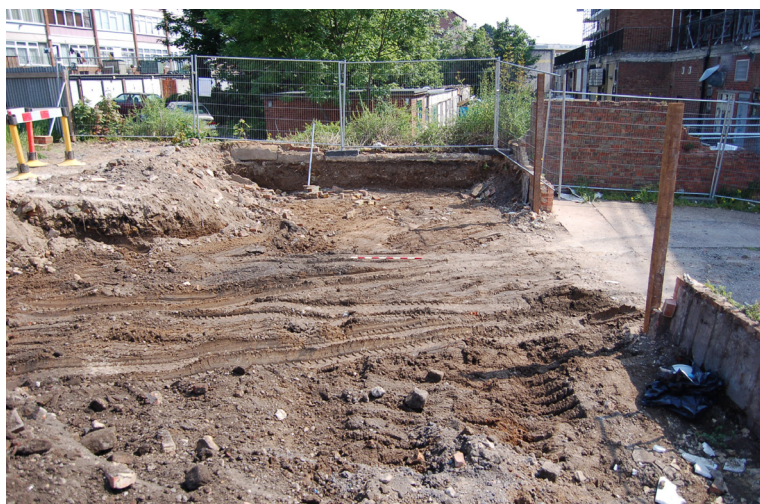
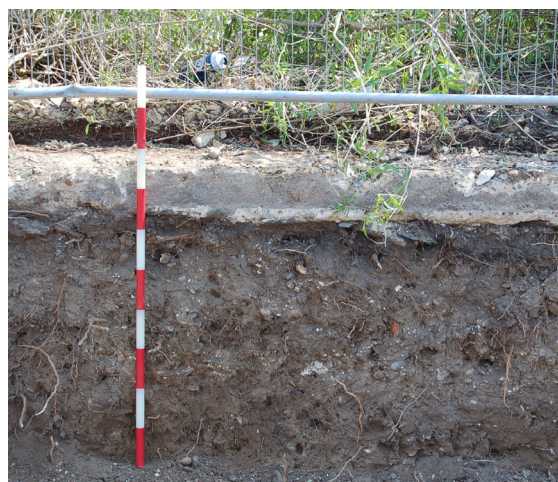
An area measuring 11m by 7m was stripped in the eastern corner of the site to a depth of approximately 1m below the present gravel car park surface. A sandy dark brown-black made ground deposit was revealed. This contained frequent CBM, wood and concrete inclusions suggesting a very recent origin, perhaps from when the Bexley Business Centre was built in the later part of the 20<sup>th</sup> century.

*Fig. 10 The stripped area in the eastern corner of the site. Left: view of the stripped site access route, looking west. Right: the west facing section showing the modern made ground. (scale: 1m)*

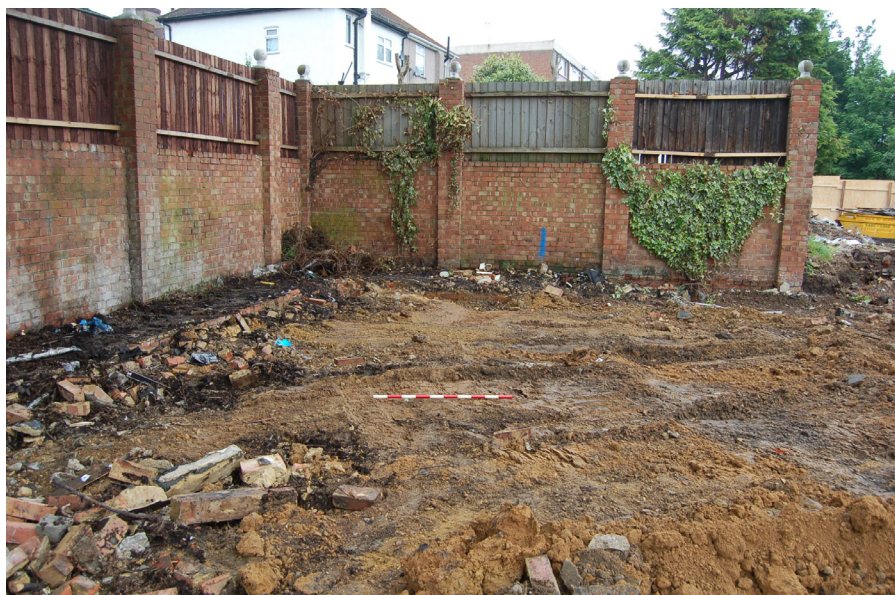
On a later site visit, stripping of the southern area of the site for the new roadway was carried out under archaeological supervision to a depth of 0.4m. The stripped area was 4.5m wide, and ran the southern length of the site. The stripping revealed made ground overlying humic topsoil. The cut of a single modern feature was revealed. Below this was a rich orange brown silty alluvium, which was sterile of inclusions with the exceptions of pebbles and thermally struck flints. A similar sequence was encountered in the northwestern part of the site.

*Fig. 11 The stripped area in the northwest corner of the site below the made ground (scale: 1m)*
