**THE THRIVE BATTERSEA GARDEN PROJECT,
BATTERSEA PARK,
ALBERT BRIDGE ROAD, SW11

AN ARCHAEOLOGICAL WATCHING BRIEF**

July 2008

SITE CODE: TVB 08

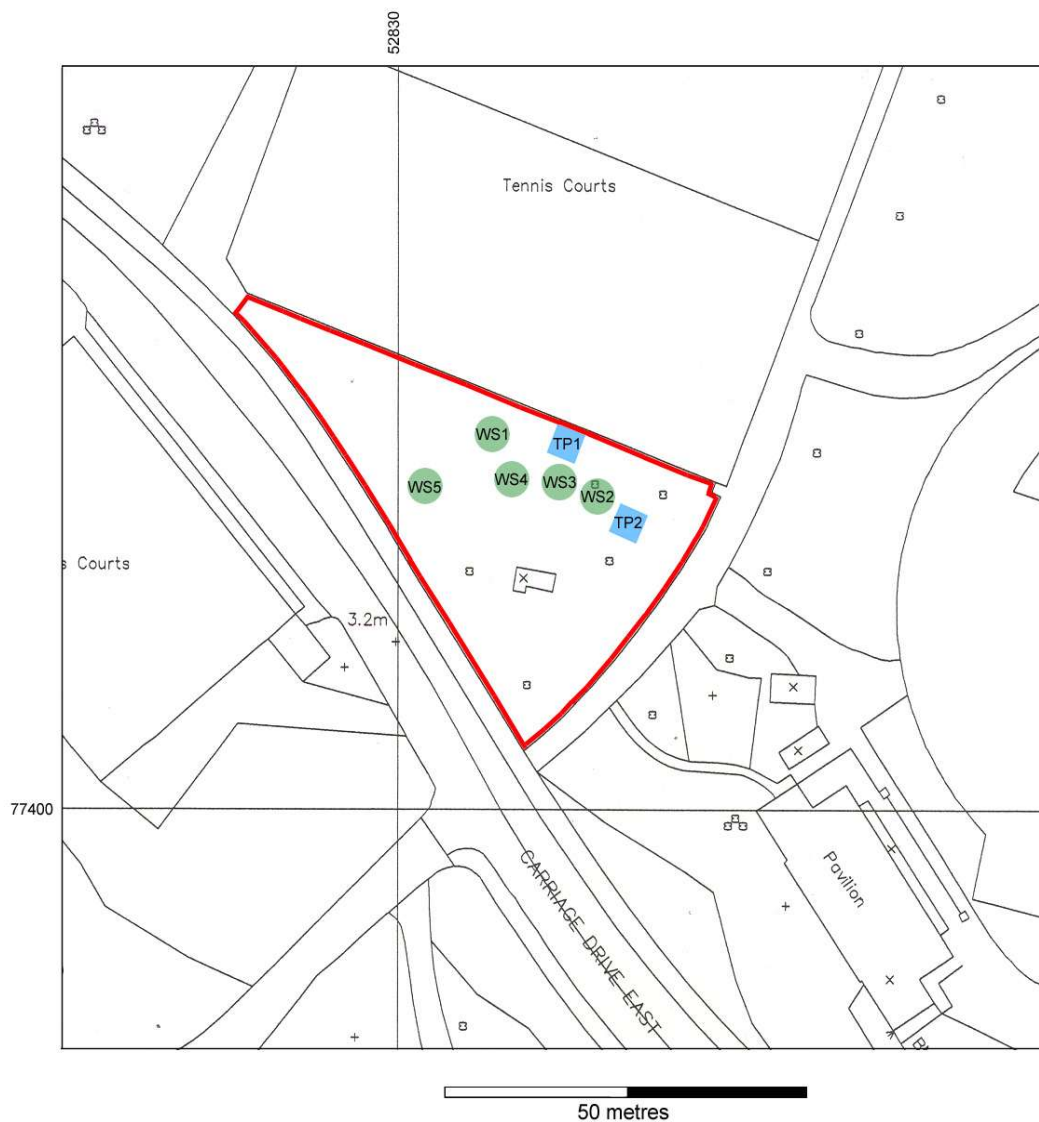
Figure 3 Site plan showing the approximate location of the two test pits (blue) and the five window samples (green). The size of the TPs and WSs is obviously shown at a larger scale for identification purposes.

The watching brief took place during investigative groundworks carried out by AP Geotechnics. The geotechnical groundworks involved the excavation of two hand-dug test pits and the drilling of five window sample boreholes, the locations of which are shown in figure 3. All the geotechnical works were observed for potential archaeological deposits and features. A further objective of the window sampling was to ascertain the nature and depth of natural deposits across the site.

The project involved the monitoring of investigative groundworks carried out by AP Geotechnics. The geotechnical groundworks involved the excavation of two hand-dug test pits and the drilling of five window sample boreholes, the locations of which are shown in figure 3.

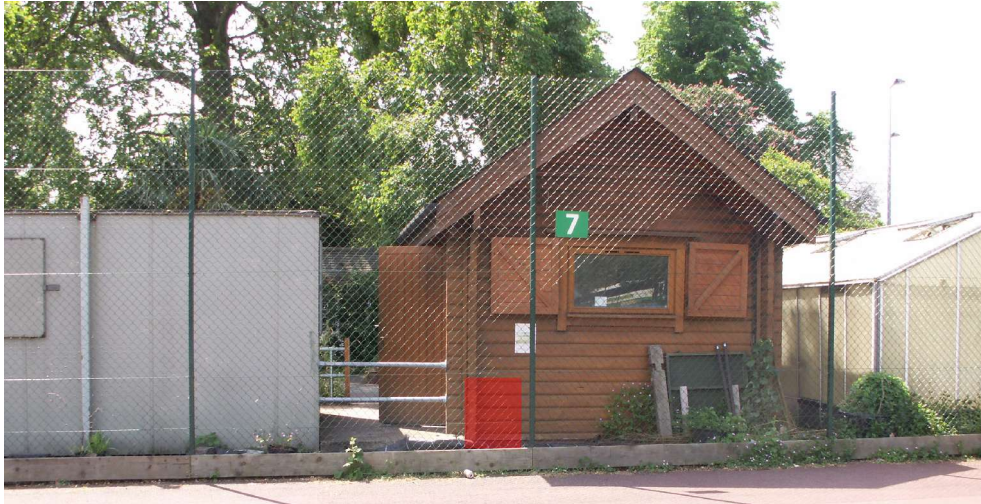
Figure 4 General view of the location of Test Pit 1 (shown highlighted in red), looking southwest from the centre of the tennis courts to the north of the site.

Test Pit 1 was located to the rear of the wooden kitchen and toilet block building, centrally placed on the northern boundary of the site (*cf* figures 3 and 4). The test pit measured 0.56m NW-SE x 0.6m NE-SW and was hand excavated to a depth of 1.2m deep. The test pit was located between the rear of the wooden kitchen building and the fence of the tennis court.

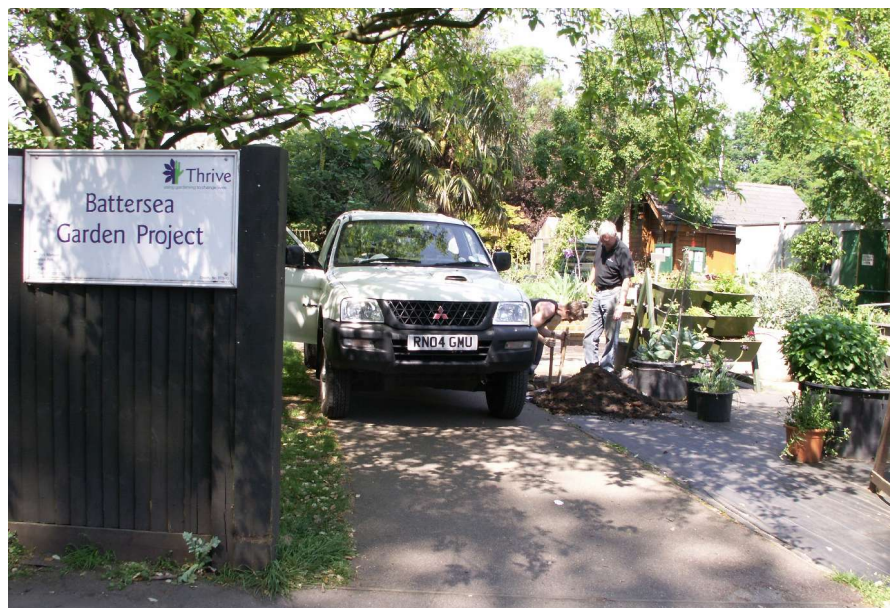
Figure 5 Entrance to the Thrive Battersea Garden Project, showing the excavation of test-pit 2 to the right of the image.

Test Pit 2 was located just to the east of the entrance to the Thrive Battersea Garden Project site (*cf* figures 3 and 5). The test pit measured 0.38m NE-SW x 0.48m NW-SE and was hand excavated to a depth of 1.2m. The test pit was located in the south-west corner of a flower bed by the main entrance.

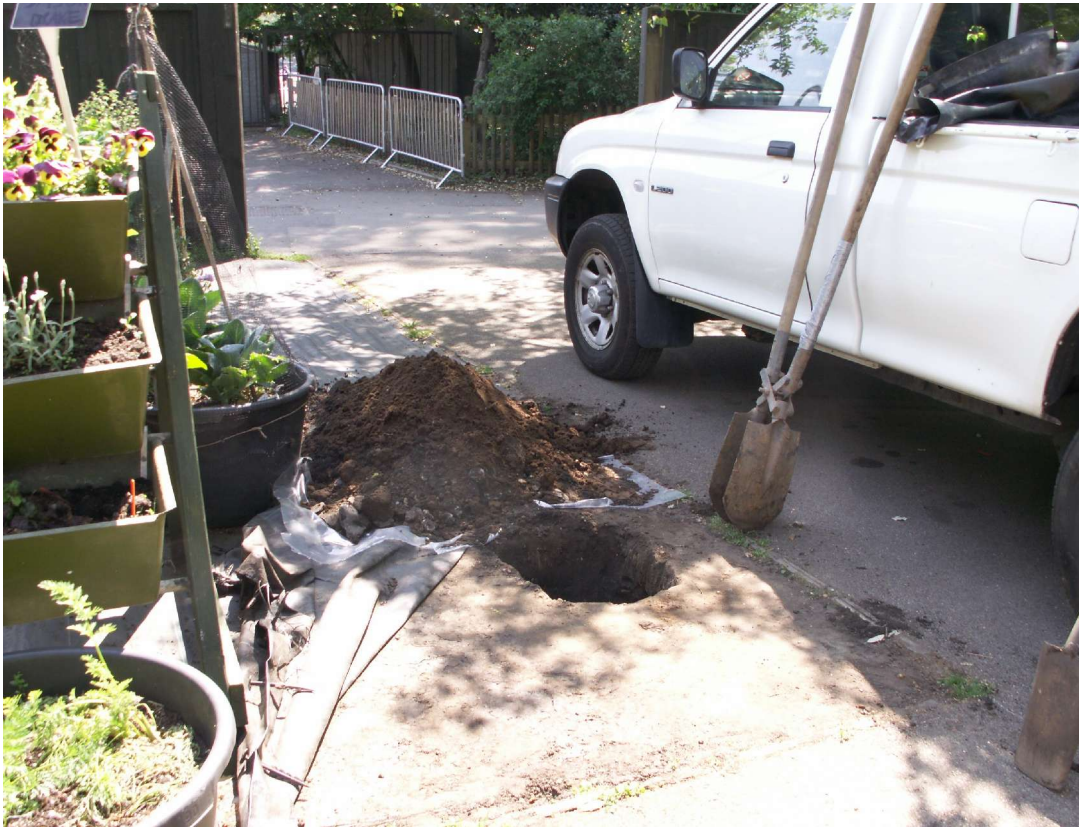
Figure 6 Detail of the area of Test Pit 2.

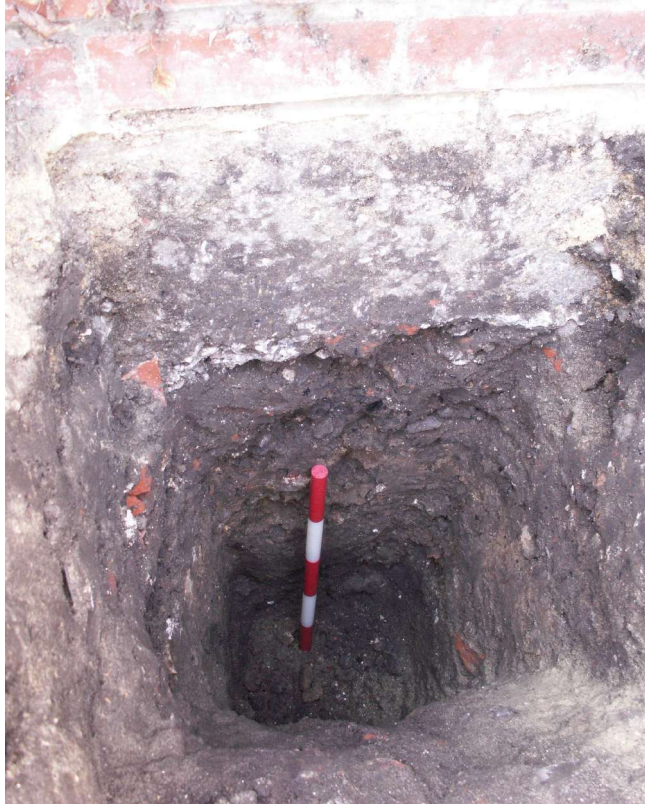
Figure 7 Deposits in Test Pit 1 after full excavation to a depth of 1.2m (scale 0.5m).

Figures 7 and 8 show general views of the excavated test pits and demonstrate their narrow width, allowing for economical excavation of the underlying deposits. As shown in the summary table above, made ground was excavated to 1.2m below ground level, TP 2 appeared to indicate the surface of a sandier silt deposit, possibly the brickearth shown on the geological map (Figure 2).

The deposits exposed in both test pits are consistent with the geological map (South London Sheet 270, figure 2), which shows 19th century made ground along the north and east region of Battersea Park. The test pits both revealed made ground to a depth of 1.2m (c. +2m OD). The shallow depth of excavation (just 1.2m) revealed only made ground in the form of a dark brown humic garden soil deposit with frequent inclusions of small concrete and CBM fragments, pebbles, gravel and sand and occasional inclusions of shell, bone and clay tobacco pipe stem (undateable). No archaeological deposits were found in either test pit.

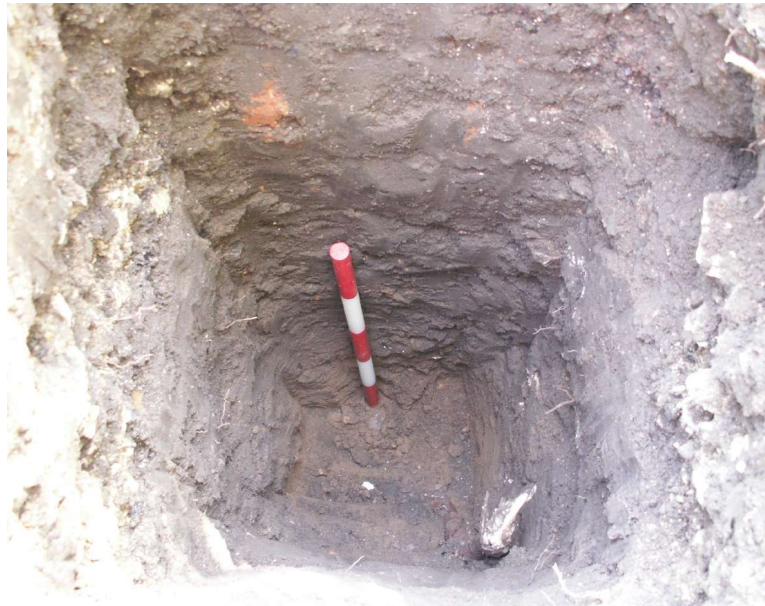
Figure 8 View of deposits in test pit 2 after full excavation (scale 0.5m).

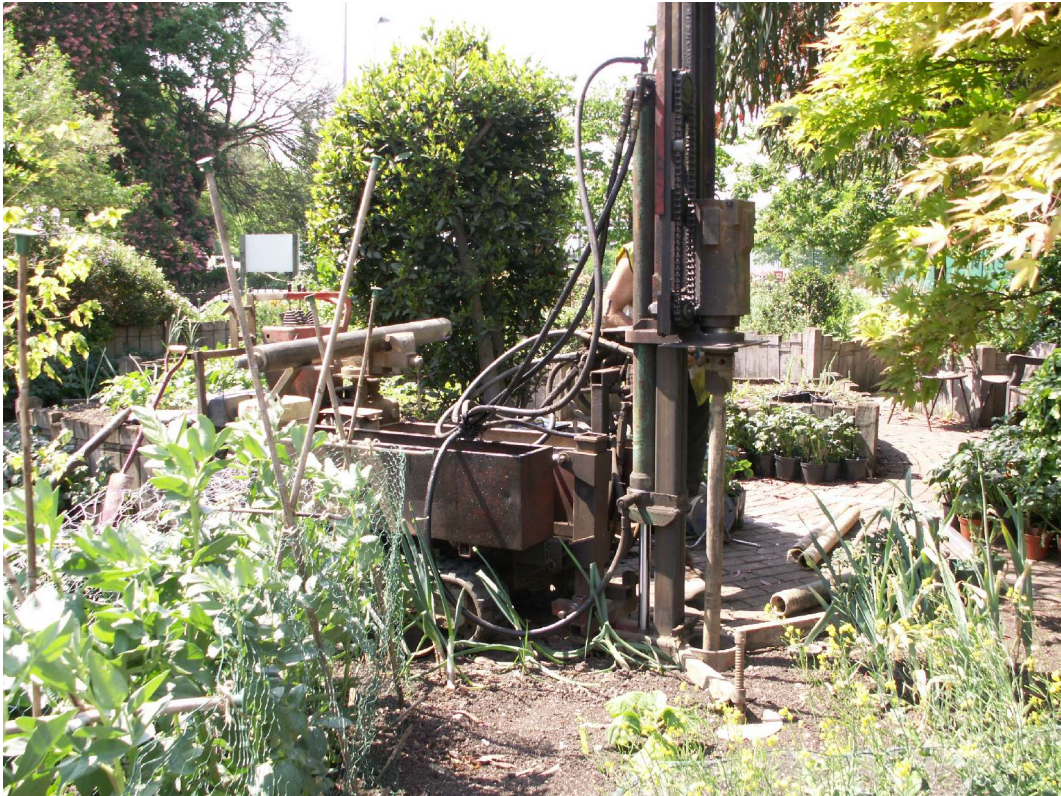
Figure 9 General view showing the extraction of window samples in the centre of the site (WS 4).

The summary table above shows that no significant archaeological deposits were recovered in any of the five window samples. 19th century made ground was observed in all five of the window samples: at depths of 1.9m below ground level in WS1; 1.5m in WS2; 1.9m in WS3; 1.9m in WS4 and 2m in WS5. These depths are broadly consistent with the levels of made ground excavated in both test pits. Dense orange natural gravel was observed below the made ground in all the samples. It is possible that the brown clay recorded at a depth of *c* 1.5m below current ground surface (approximately +1.7m OD) in WS4 and WS5 may represent a truncated band of the Langley Silt brickearth surviving in a small area of the truncated gravel surface, but this cannot be proven and this could equally represent a further deposit of imported made ground.

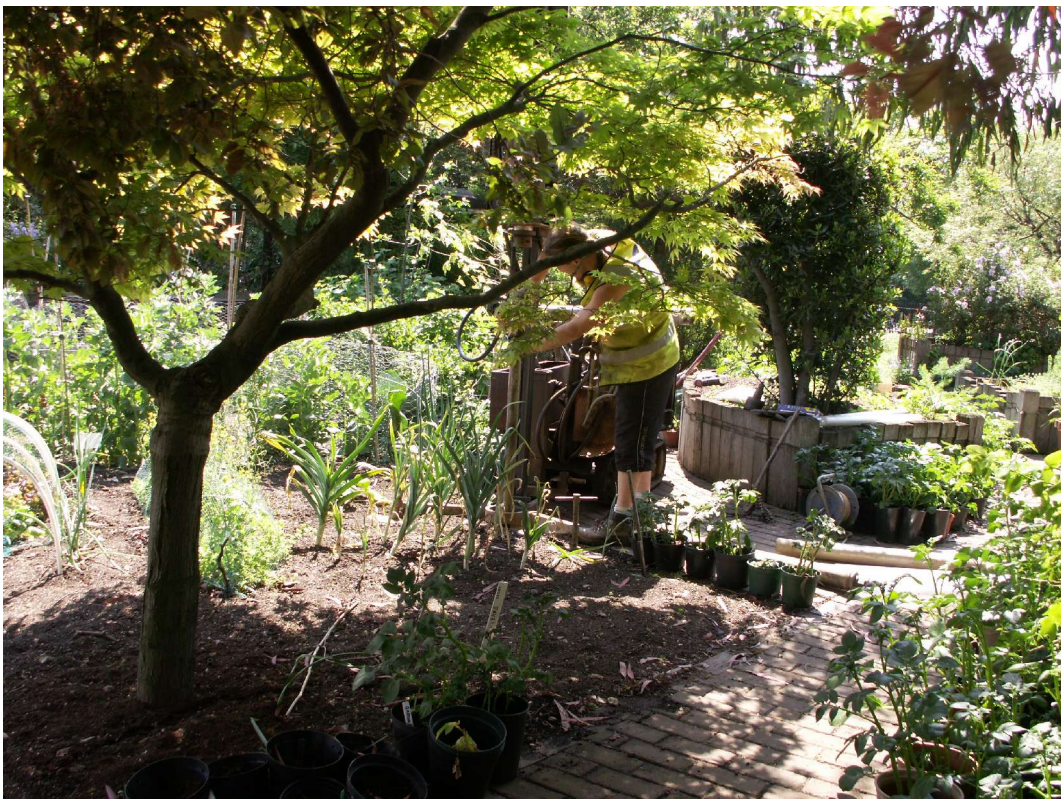
Figure 10 Similar view showing the extraction of WS 4.
