**THAMES WATER ENGINEERING WORKS IN STOCKLEY
PARK, 89 CG – CORWELL LANE, UXBRIDGE, UB8**

AN ARCHAEOLOGICAL WATCHING BRIEF

July 2008

SITE CODE: SKX 08

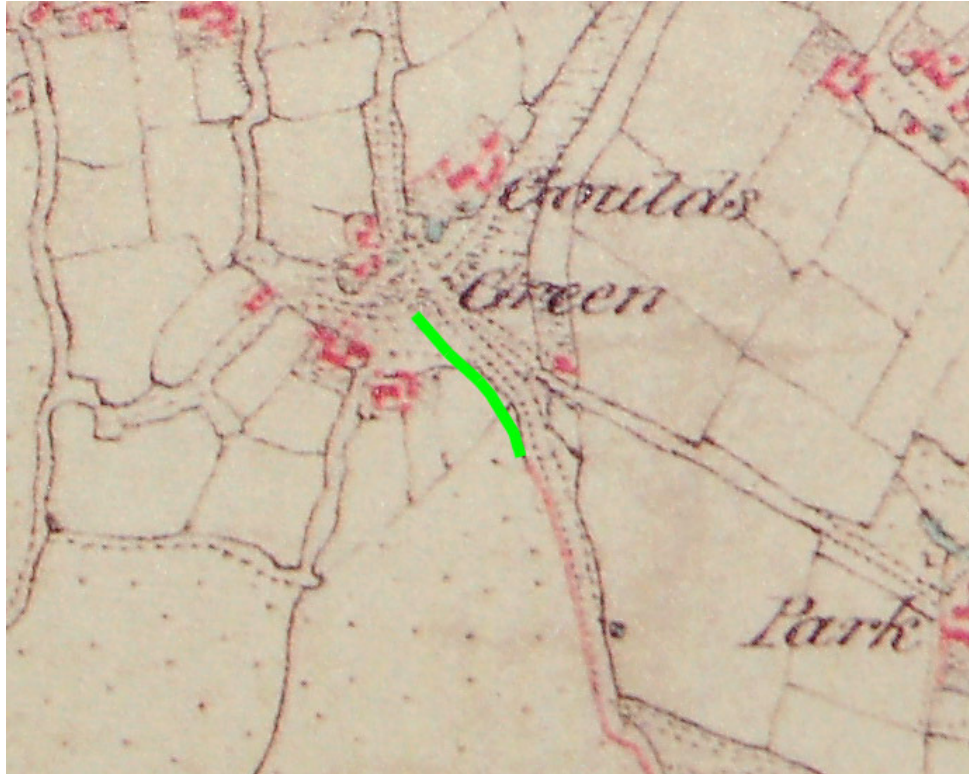
Fig 2: 1806 Ordnance Survey map with the trench route marked in green.

3.2 There does not appear to be much evidence for subsequent (Roman to medieval) activity in the immediate vicinity. Historic maps show the small settlement of Goulds Green immediately to the north, with Harlington Road representing the historic route to Harlington and Cranford (*cf.* Figure 2). The 1806 map also shows that the present site area in Stockley Park lay within open land, although it does indicate a couple of field boundaries crossing the proposed pipe route.

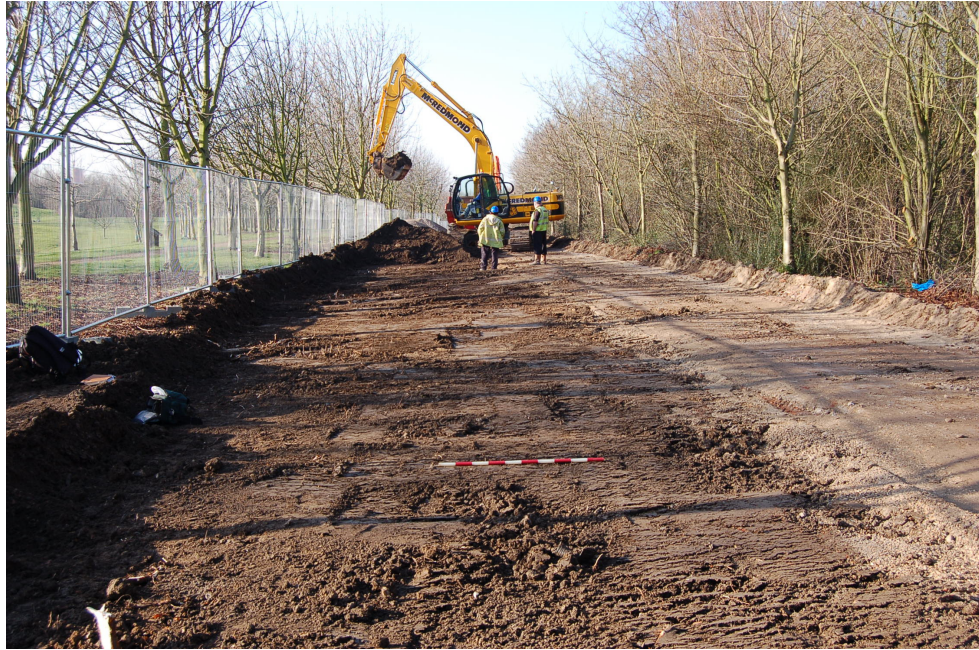
Fig 4: General view looking northwest from the area of manhole No.10.

The topsoil stripping works took place along the course of the 'horse ride', which runs along the northeast side of Stockley Park and ends at the entrance onto Goulds Green, near the junction with Harlington Road. The area that was initially stripped was 380m in length and 9m wide. The sewer ran south from the junction between Goulds Green and Harlington Road, south into Stockley Park and then turned southeast along the horse ride that runs parallel to Harlington Road before turning east across the road and ending at manhole No.11 in the grounds of Wood End Juniors and Infants School.

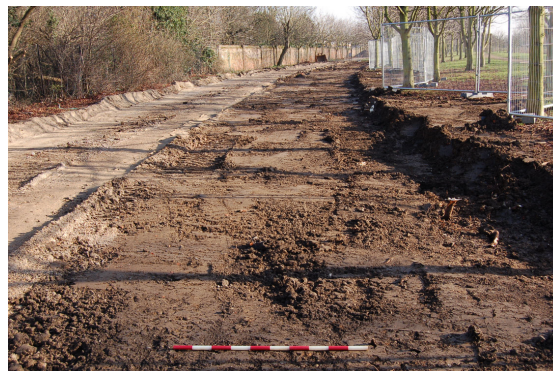
Preliminary stripping of the horse ride revealed a rich friable mid brown organic topsoil which was recorded to a depth of 0.2m, beneath which lay a mid brown silty clay with occasional charcoal flecking, modern pottery and flint nodules, moderate CBM (ceramic building material) fragments and frequent small stones and plastic debitage. An irregular brick spread was observed at some points where the depth increased slightly although it did not exceed 0.5m. This

Fig 5: General view looking southeast of the 'horse ride' after the completion of the preliminary topsoil stripping.

spread was not structural, but forms part of the on-site dumping that was recorded throughout the site.

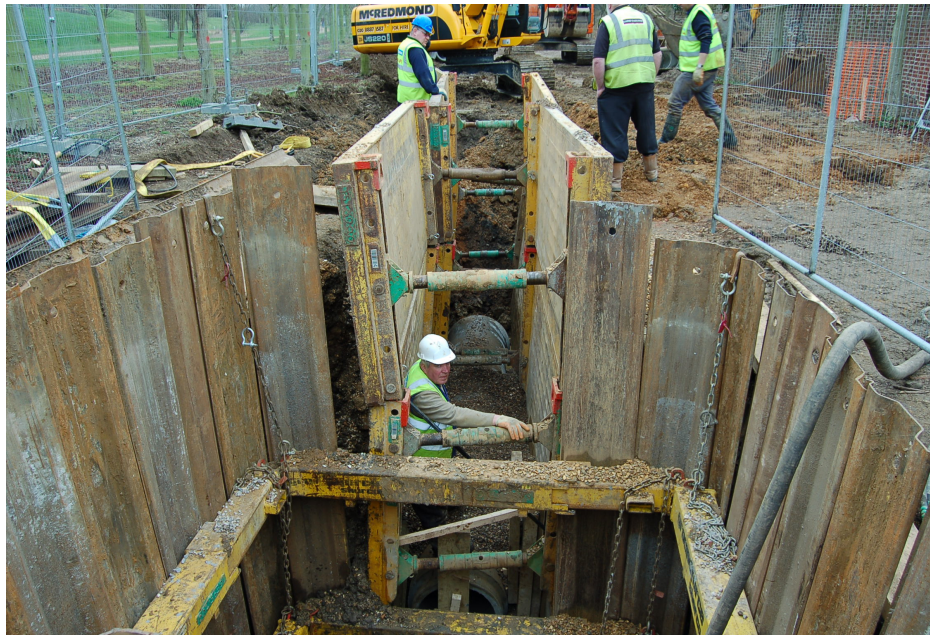
Open cut trenching commenced from the southern end of the horse ride at manhole No.10 (see Fig 3). Construction of the manholes involved excavation of a trench, 3m wide and 4m long on a northeast to southwest alignment, these trenches were then monitored for any archaeological finds or features. A mid brown silty clay deposit with broken brick rubble, CBM and flint gravel inclusions was observed to a depth of 0.55m. This deposit overlay 0.75m of greyish-metallic blue clay dumped landfill deposits. Its colour reflects chemical leaching within the soil as a result of the dumping which took place over time within this area. A variety of dumped materials were observed within this deposit including wooden boards, plastic, modern pottery and broken brick rubble. The grey clay deposit overlay 0.8m of brownish yellow natural clay with flint gravel inclusions to a depth of 2.9m.

Fig 6: Two trench boxes north of manhole No.10 with the shored up manhole trench in the foreground.

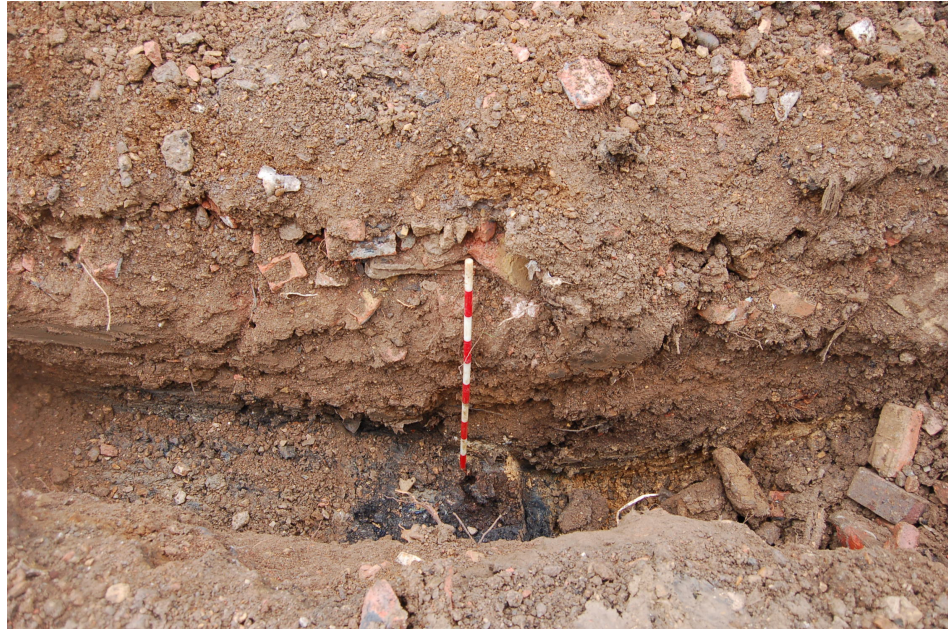
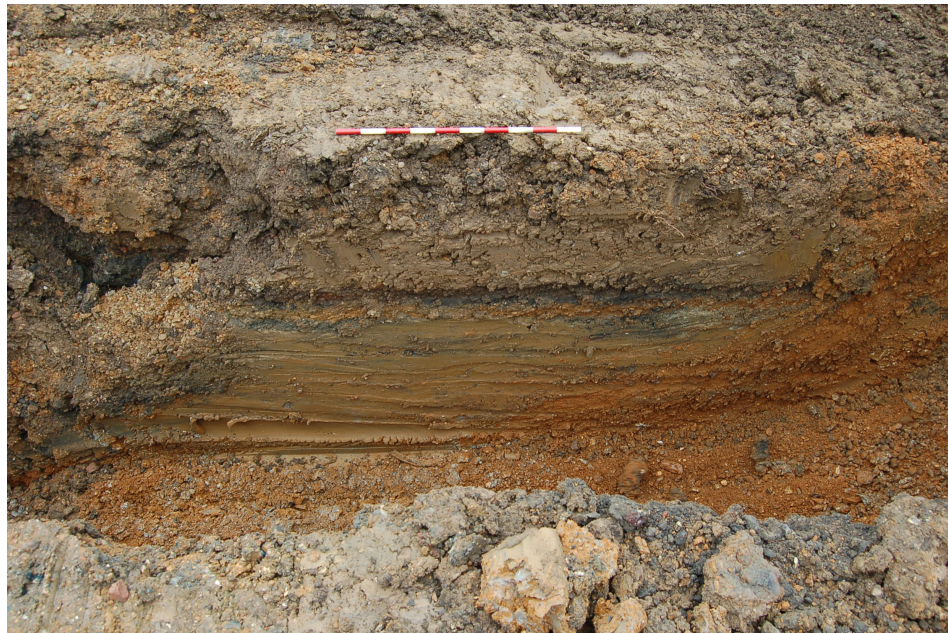
Extending northwest from manhole No.10 the pipe trench was also excavated to a depth of 3m. The same stratigraphic sequence was observed within all the sections of pipe trench that were monitored. However, as trenching progressed northwards the stratigraphic sequence changed and the upper deposits became increasingly truncated. Between manholes No.7 and 8, the upper deposit had completely disappeared leaving only a grey clay deposit with blue mottling and wood and brick inclusions. Beneath this deposit, at 1.6m lay a yellow natural soil with flint inclusions, which was recorded to the base of the trench, 3m below the current ground level.

Figs 7 & 8: East facing section of the north end of the pipe trench, showing the dumped deposits of brick, wood and other refuse material (top) and northeast facing section of the pipe trench from the area around manhole No.8 (bottom).

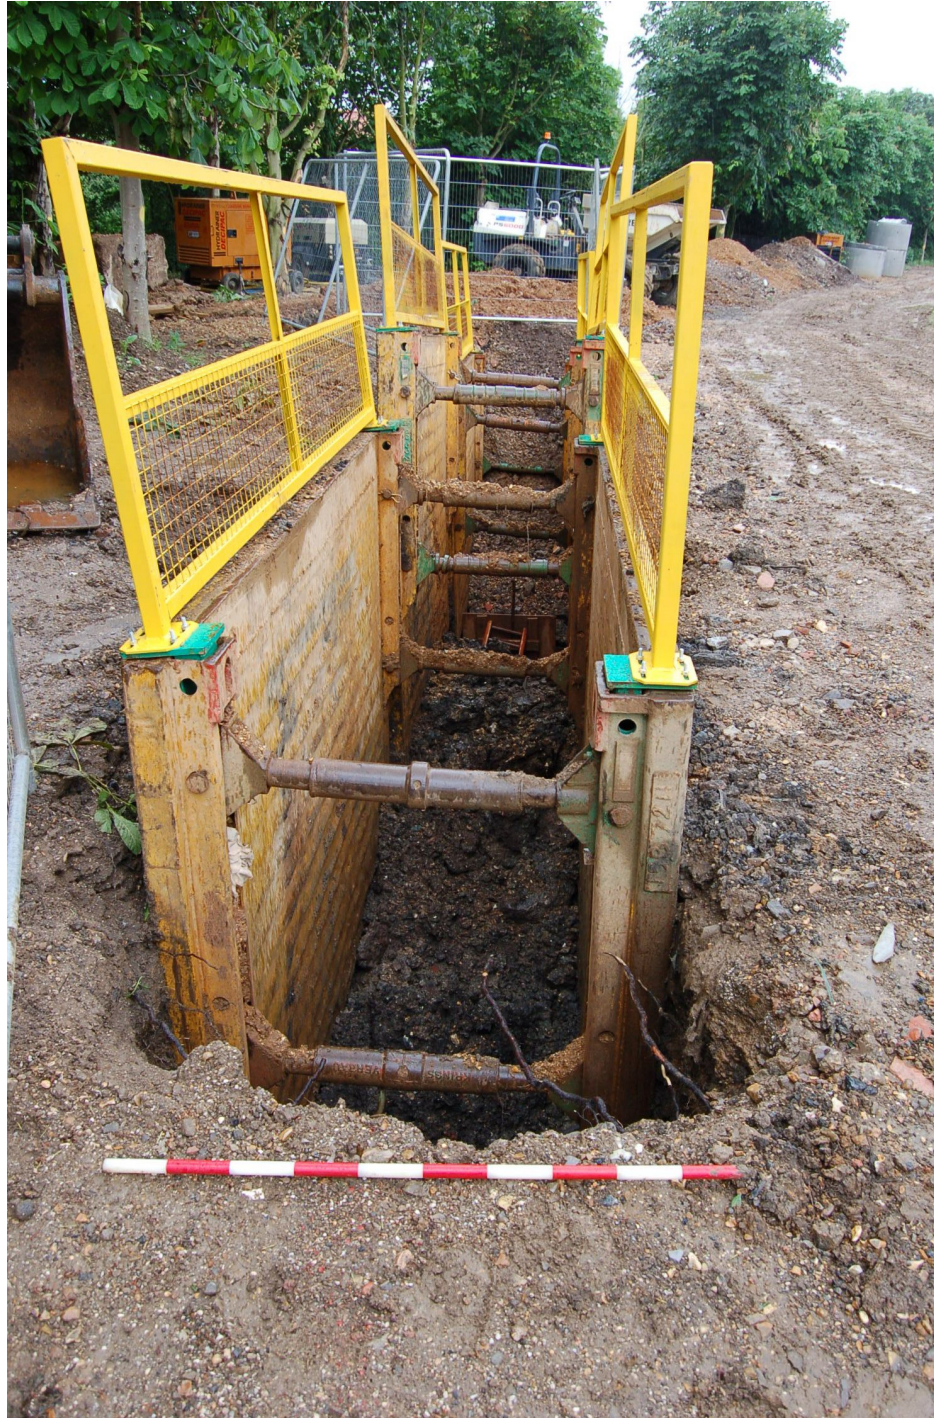
Towards the northernmost area of trenching, at the site entrance, trenching became shallower. Manhole No.6 was situated immediately south of the northernmost end of the pipe trench, where it turns north towards the junction of Goulds Green and Harlington Road (*cf.* figure 3) and was recorded as measuring 3m in length and 2m in width and excavated to a depth of 3m (*cf.* figure 9). At the apex of the aforementioned corner was the site of manhole No.5 (*cf.* figure 3). Stratigraphically, this area of excavation differed to previous areas and was made up of a brown grey deposit of sand and gravel, beneath which a mixed made ground deposit was visible, made up of broken

Fig 9: Area of open cut trenching between manhole No.5 and 6 from the northwest.

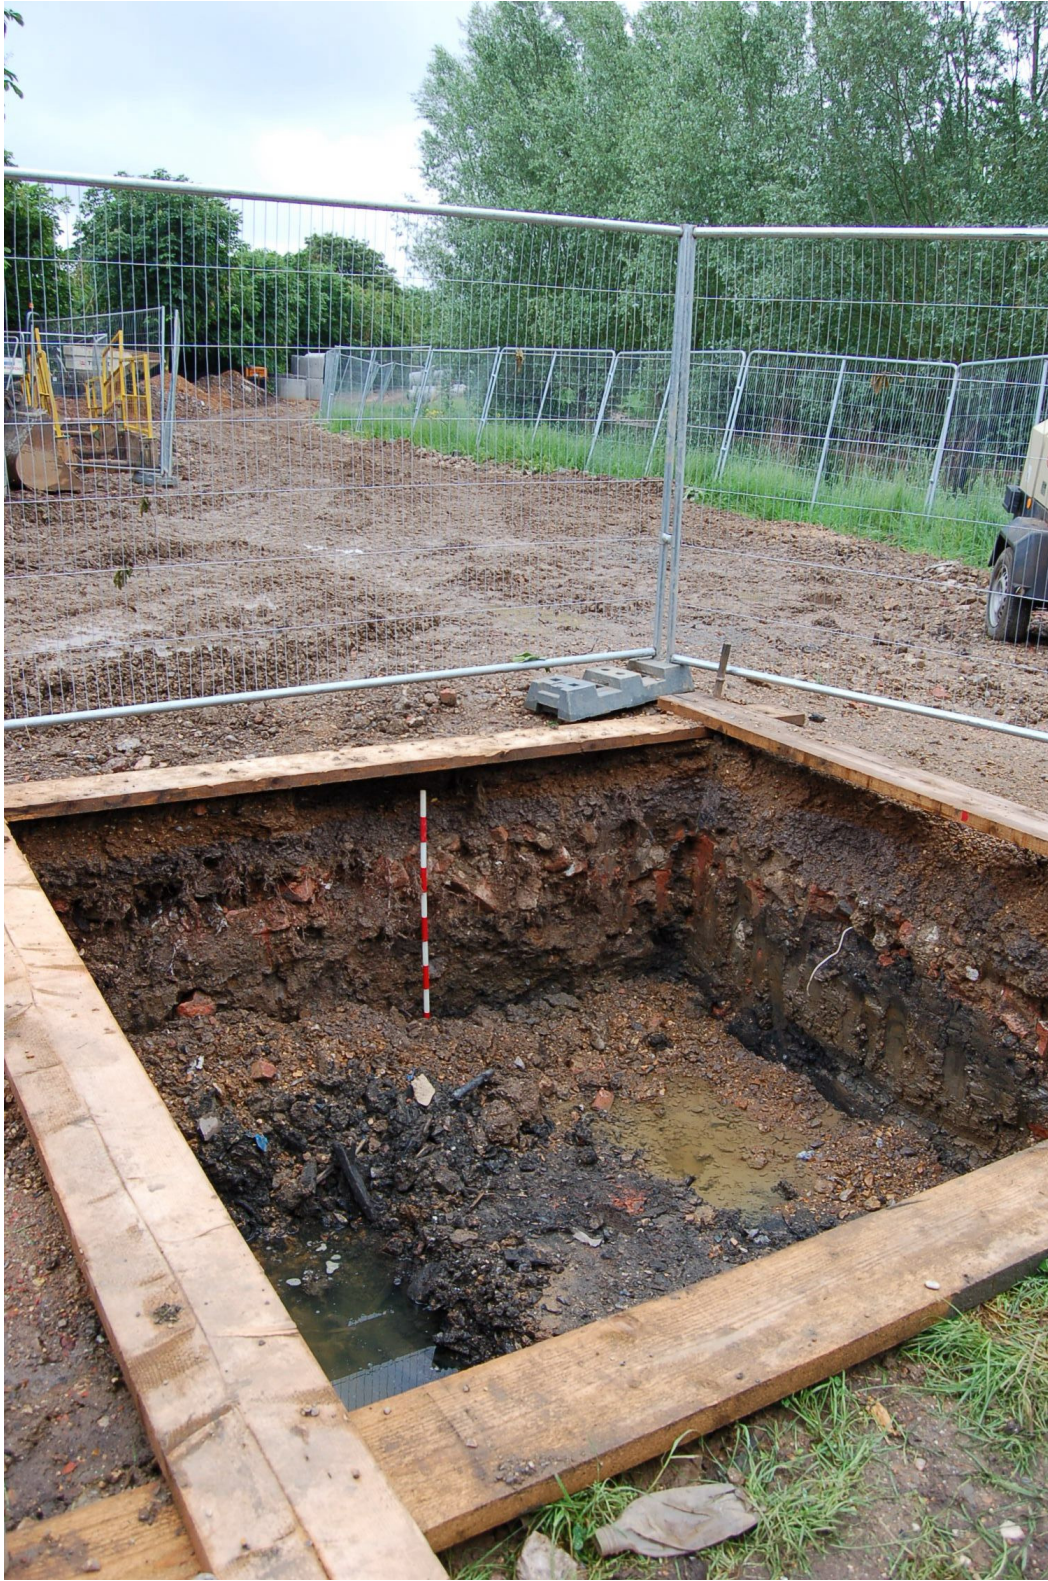
brick rubble. At the base of the trench lay a light brown clay deposit with black mottling through it and wood and modern pottery inclusions. This trench was recorded as being 2m wide by 3m in length. However, unlike the previous manhole trenches, manhole No.5 was only excavated to a depth of 1.2m and natural gravel was not encountered (*cf.* figure 10).

Fig 10: View of manhole No.5 looking south.
