**LAND AT ST MARY'S PRIMARY SCHOOL, CHURCH  
LANE, CHESSINGTON, KT9 2DH**

**ROYAL BOROUGH OF KINGSTON UPON THAMES**

**AN ARCHAEOLOGICAL EVALUATION**

SITE CODE: MYS08

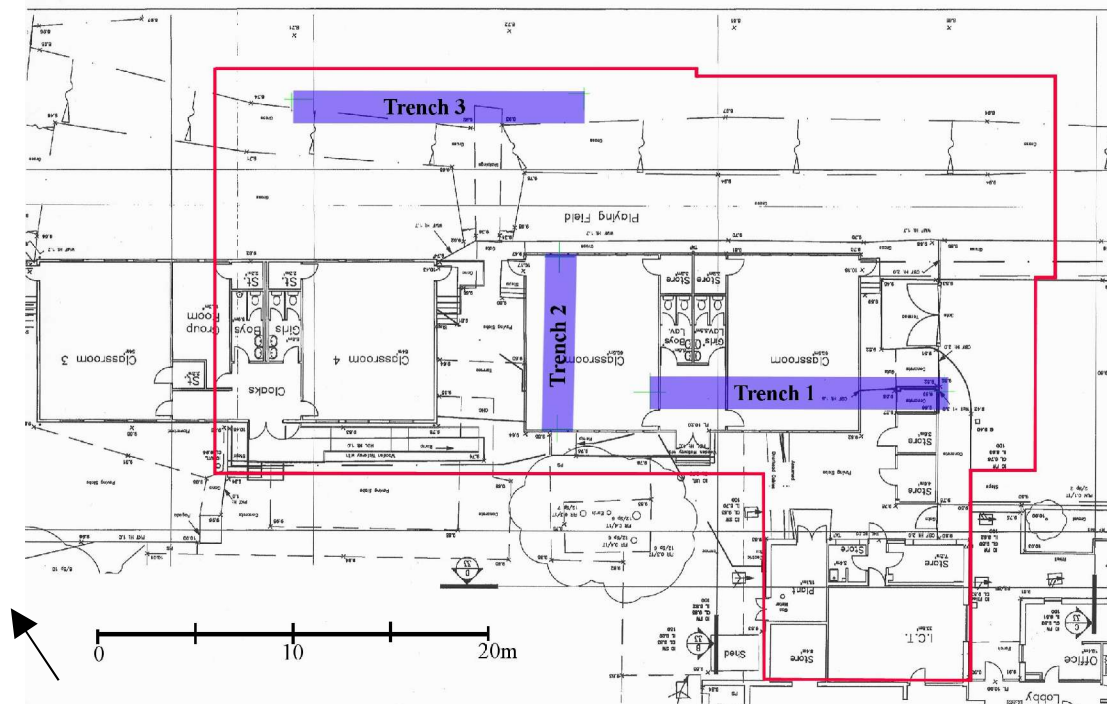
**Figure 2:** Trench locations in relation to the existing site survey, with the outline of the new build footprint shown in red.

*NB: plan reorientated approximately to northeast: based on original drawing by DHP Property Consultants, No. 3599-A-G1-001.*

The archaeological evaluation consisted of the machine clearance of three trial trenches located within the area of redevelopment as shown in Figure 2 (below). Two of the trenches measured *c.* 14m by 1.8m, and the third 10m by 1.8m (a total of just under 70 square metres).

The archaeological evaluation consisted of the excavation of three trial trenches within the area of the proposed redevelopment (see Figure 2 below). Initial excavation was carried out with a mechanical excavator under archaeological supervision. All trenches were excavated down to the level of natural sandy clay or subsoil, and natural was recorded between 49.60m and 50.19m OD. The results of the archaeological evaluation are described in detail below.

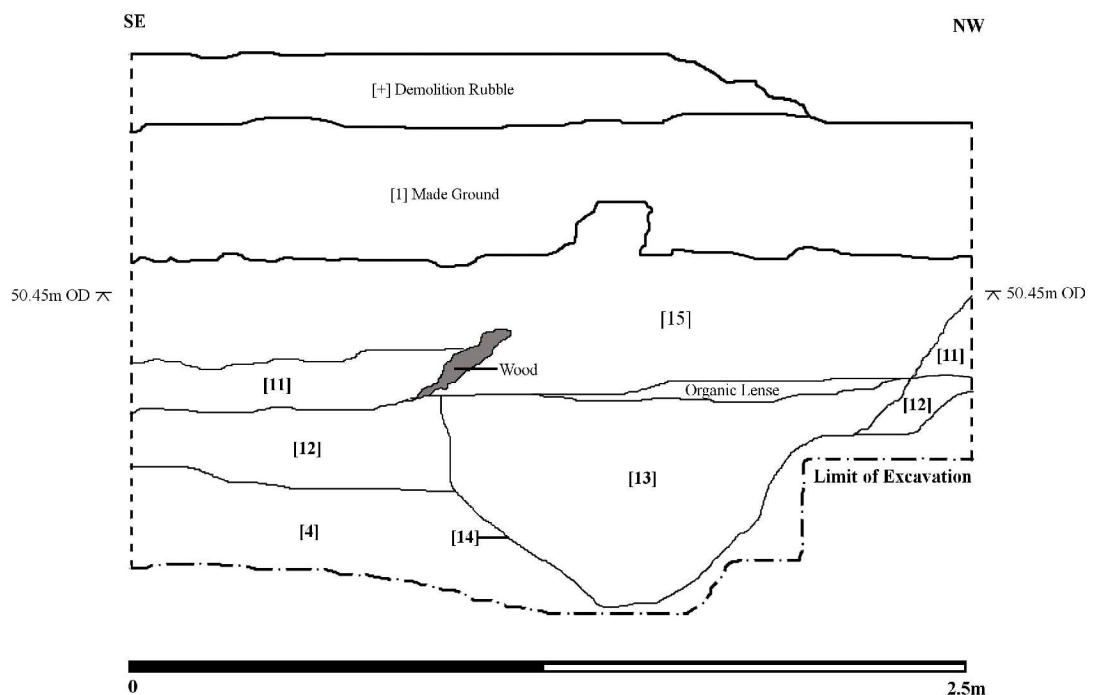
**Figure 3:** Southwest section of Trench 1 (see also Fig 5).

Trench 1 showed a heavy degree of truncation across the excavation area due to soil stripping/ground reduction and subsequent dumping of *c.*0.8m of made-ground, represented by building rubble [1] and dark-organic material [15]. These deposits were overlain by modern demolition rubble [1], the material accumulated from the recent building works. Contexts [1] and [15] are thought to represent the construction works relating to the present school building *c.*1975 and truncated the underlying deposits down to the level of natural subsoil [11]. This deposit consisted of fine silt and clay very similar in consistency and composition to the underlying deposit [12], both of which represent the naturally accumulated subsoil deposit truncated by the overlying made-ground. The majority of the trench exposed these deposits overlying the natural sandy clay [4] at a level of 50.00m to 50.19m OD.

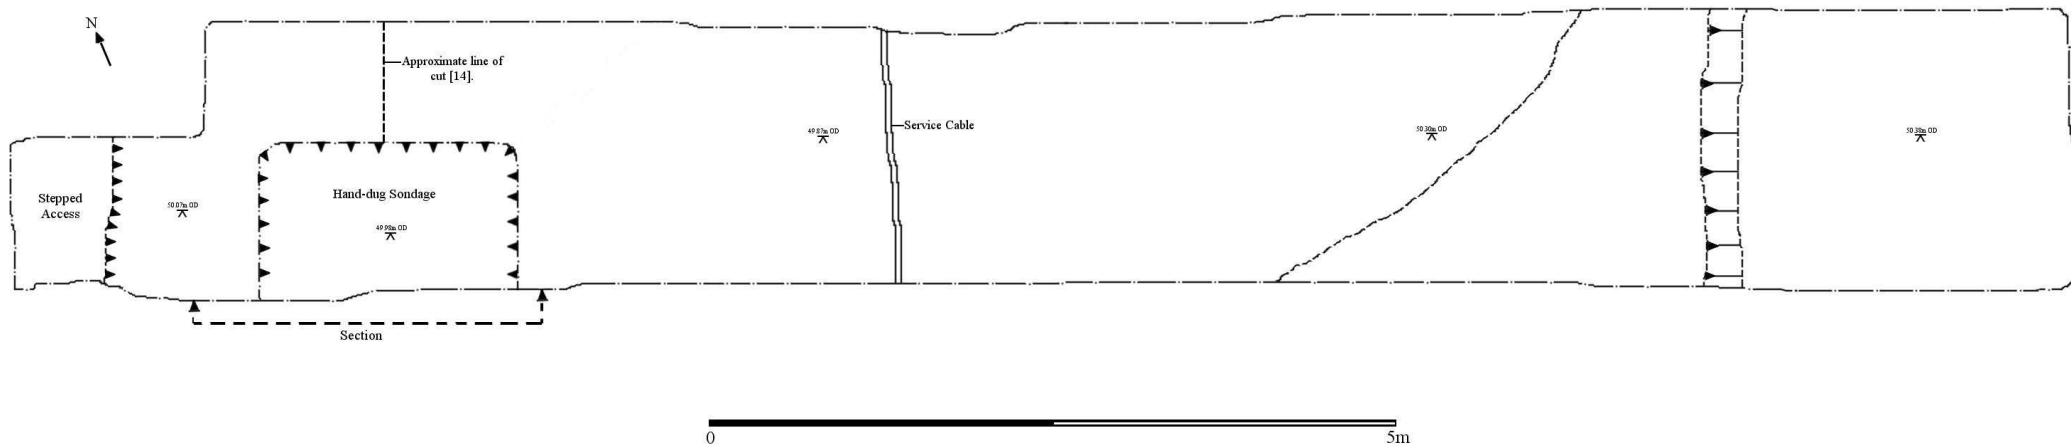
**Figure 4: Plan of Trench 1.**

At the west end of Trench 1 a linear feature [14] was exposed running approximately northeast to southwest as shown in Figure 4 above. The feature was relatively unclear in plan, but showed up in section as a steep sided ditch feature filled with a very fine dark brown organic silt [13], approximately 1.3m in width at the maximum measurement and 0.65m in depth, although presumably truncated by the overlying made-ground deposits. A hand-excavated sondage was dug to establish the nature of this feature as shown in Figures 3 and 4. Unfortunately, no dating material was recovered from the fill of this feature and the deposit was generally very sterile with few inclusions. However, when located on earlier historic maps the linear feature appears to align with a field boundary shown on the 25inch Ordnance Survey map of 1866, which retains its position on the maps until 1932. This feature is also shown, albeit less accurately, on the Chessington Tithe map of 1839.

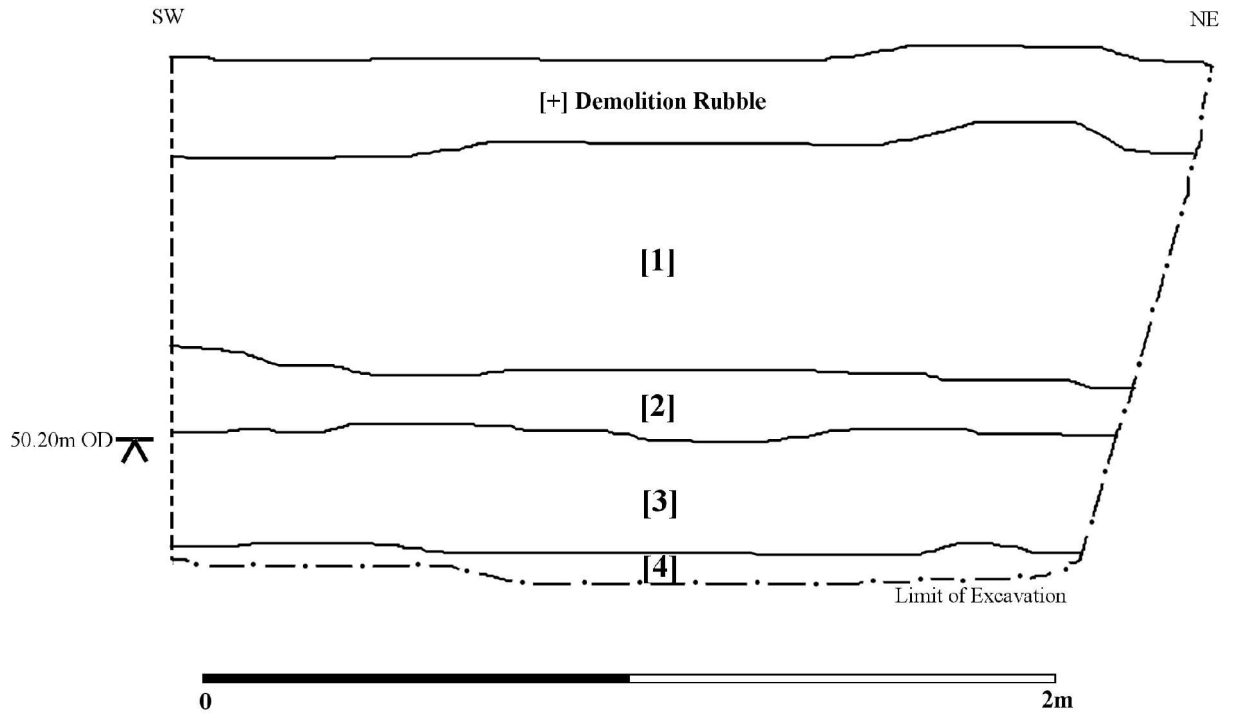
**Figure 10:** Section of Trench 2.

Trench 2 lay in the centre of the site and was excavated down to the level of truncated natural clay between 49.81m and 50.03m OD. The trench exposed a heavy degree of truncation due to previous soil stripping/ground reduction and subsequent dumping of made-ground layers [+] and [1]. Towards the northern end a probable buried soil horizon [2] was exposed in section some 0.7m below the existing ground surface. This deposit in turn overlay weathered natural subsoil [3] and natural sandy clay [4]. No archaeological finds or features were recovered during the excavation of Trench 2. Figures 10 – 12 show the recorded section and photographic record of Trench 2.

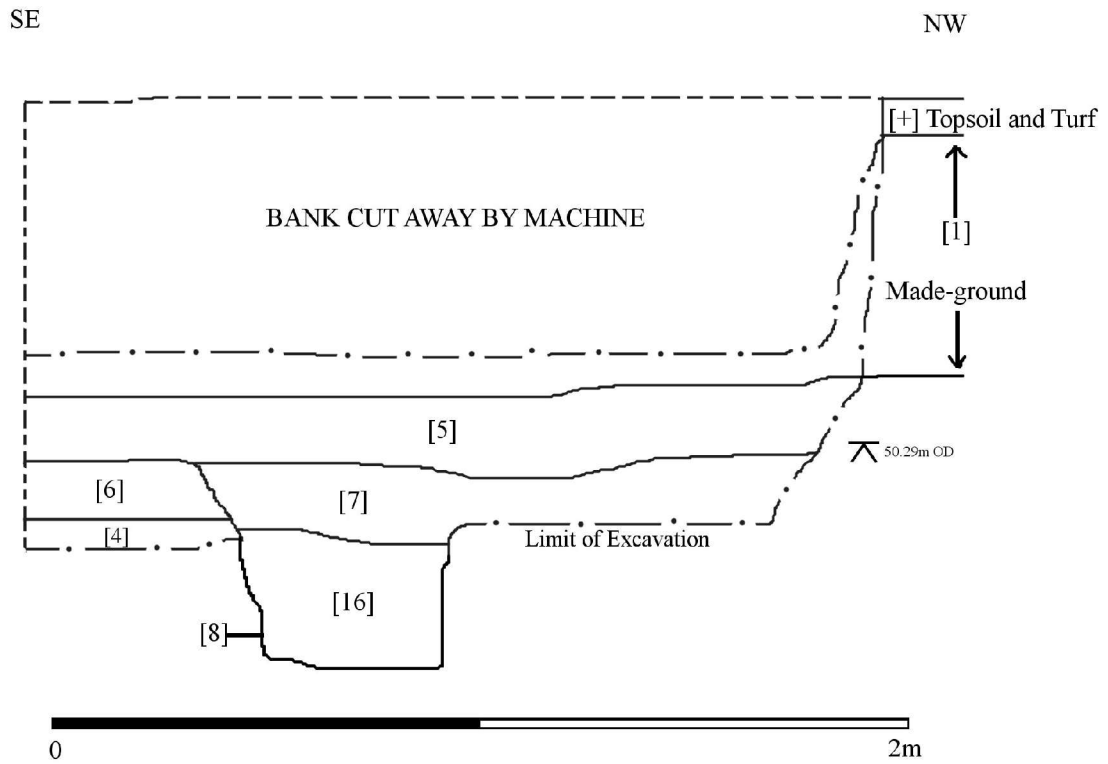
**Figure 13:** Section of Trench 3.

Trench 1 exposed modern topsoil and turf [+] overlying a mixed made-ground deposit [1] of *c.*1975 to a depth of some 0.7m below the existing ground surface. These deposits represent dumping subsequent to ground reduction, and appear to have truncated the underlying deposits down to the level of and into a buried soil horizon [5]. This deposit in turn sealed the weathered subsoil [6] overlying natural clay [4] between 49.60m and 49.67m OD.

Cutting the natural subsoil [6] was a small feature some 0.45m deep assigned cut [8] and similar silt and sand fill deposits [16] and [7] – the lower of these including very occasional ceramic flecks. A slot was excavated into this deposit to establish its nature suggested a natural deposition of silt within the subsoil deposit, the feature perhaps originating as a tree-throw.

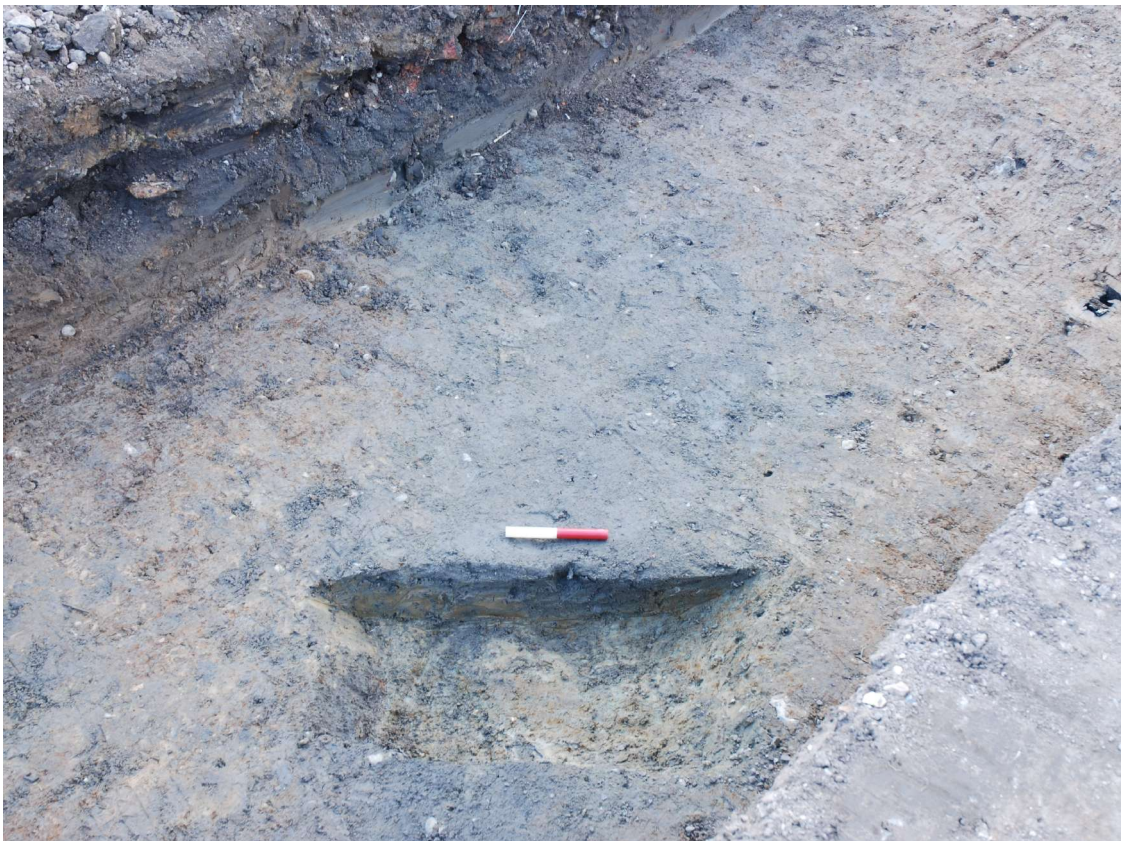
**Figure 15:** Trench 3 looking west, and showing a section through the partly excavated feature [10] (0.2m scale)

At the northeast end of Trench 3 a linear feature [10] feature was exposed orientated approximately east-west. The feature was filled with a fine silty sand deposit [9] and measured some 3.0m+ in length by 0.8m in width, and was excavated to a depth of some 0.13m. The fill was quite sterile, producing occasional gravel fragments but no finds. It is possible that the feature represents a natural anomaly in the surface of the natural clay, with the accumulation of leached alluvial material or chemical staining. However, while context [10] is not so much a defined cut but a limit of the deposit [9] the feature may represent a faint scar cutting the natural from an earlier historic field boundary. There is no evidence for such a boundary on the available cartographic sources from the Chessington Parish Tithe map of 1839 onwards but there may have existed such a feature prior to this date. Unfortunately, the lack of dating evidence and degree of truncation from overlying deposits make it difficult to determine the nature of the feature whether natural or man-made.
