**THAMES WATER ENGINEERING WORKS OPPOSITE
Nº. 2 STATION ROAD
SOUTH WIMBLEDON, SW19 2LP
LONDON BOROUGH OF MERTON
AN ARCHAEOLOGICAL WATCHING BRIEF**

SITE CODE: TZE 08

This report describes the results of an archaeological watching brief undertaken during Thames Water repair works on a 42" trunk main in the carriageway opposite No. 2 Station Road, South Wimbledon, London Borough of Merton. The document forms a response to recommendations made by the Greater London Archaeological Advisory Service (GLAAS), English Heritage, for a watching brief to take place during the excavation of a single trench dug as part of the maintenance works. The work took place from 24th to 27th November 2008.

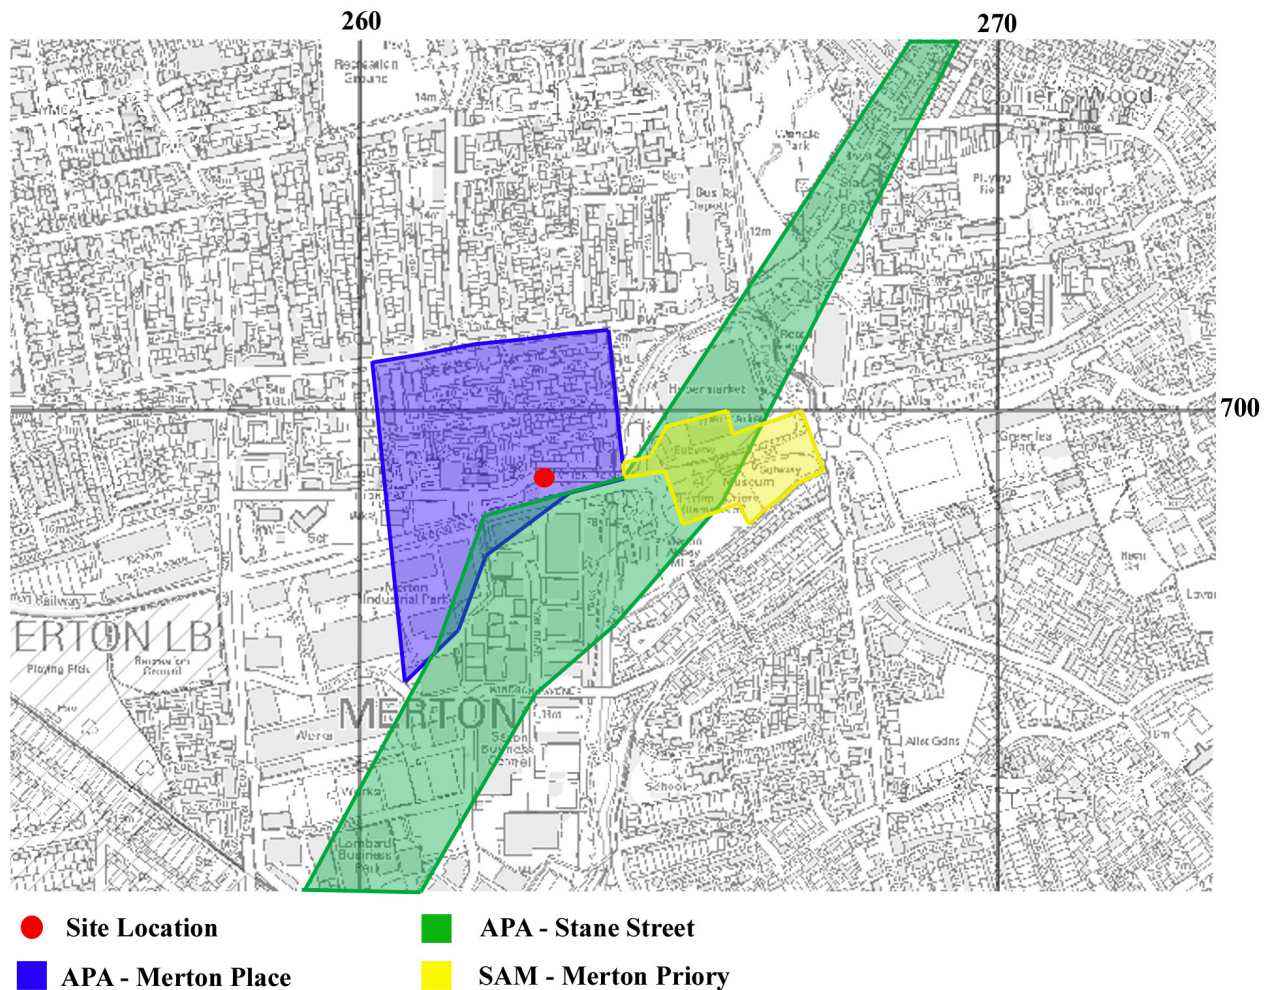
Fig 2: The site location, Borough-defined Areas of Archaeological Priority and Merton Priory Scheduled Ancient Monument, in relation to the Ordnance Survey 1:10 000 map.

The site lies within, and in close proximity to, areas of archaeological priority as defined by the London Borough of Merton Unitary Development Plan, and just to the west of a Scheduled Ancient Monument defined by English Heritage. Figure 2 shows the site location in relation to these areas, the details of which are reproduced below:

The most significant aspect of Roman occupation in the vicinity is the alignment of the major thoroughfare known as Stane Street. The road alignment and the immediate hinterland are identified as an Archaeological Priority Area by the Borough UDP (see 4.1 and Figure 2 above). The closest evidence for the road itself was found during excavations on land bordered by High Street Colliers Wood, Christchurch Road and The Pickle in 1998, some 400m to the northeast (CCC97). The road was exposed as layers of gravel, flint and sand, its upper level at 10.47m to 10.71m OD and with a ditch containing 1st to 3rd century pottery. It formed a more or less flat surface approximately 16m in width with raised banks, and although different from typical ‘cambered’ construction this may indicate a causeway through low-lying areas close to the river.

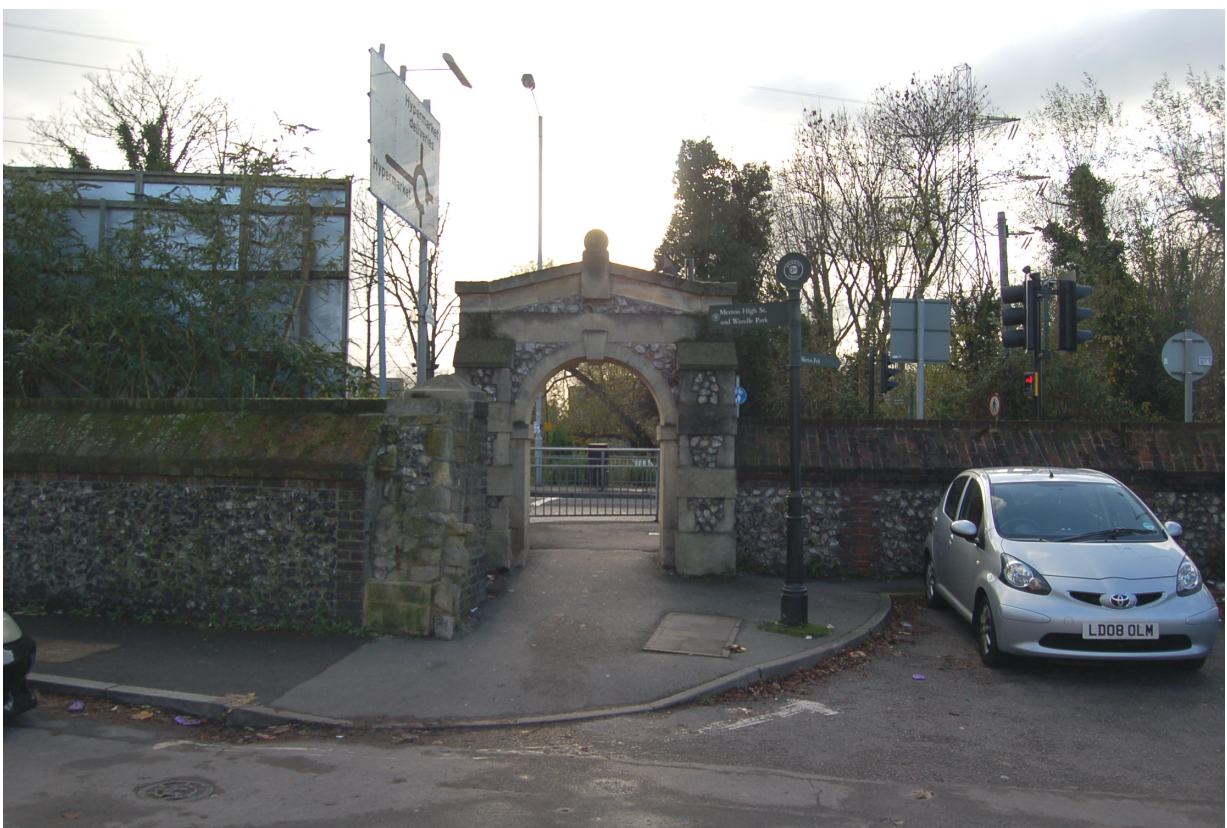
Fig 4: View of the ‘Norman-Jacobean’ gateway on the south side of Station Road: it was rebuilt in its current location during the construction of the A24.

itself may have originated as a medieval track approaching the priory, with its own lining wall. However, there is no secure date for the remains and they may be significantly later, possibly associated with the 18th century Merton Estate (see below). The ‘Gateway’ also shown on the 1866 map to the east of the present site is annotated in Heales as ‘*Doorway in 17th Century Wall*’ (Figure 4).

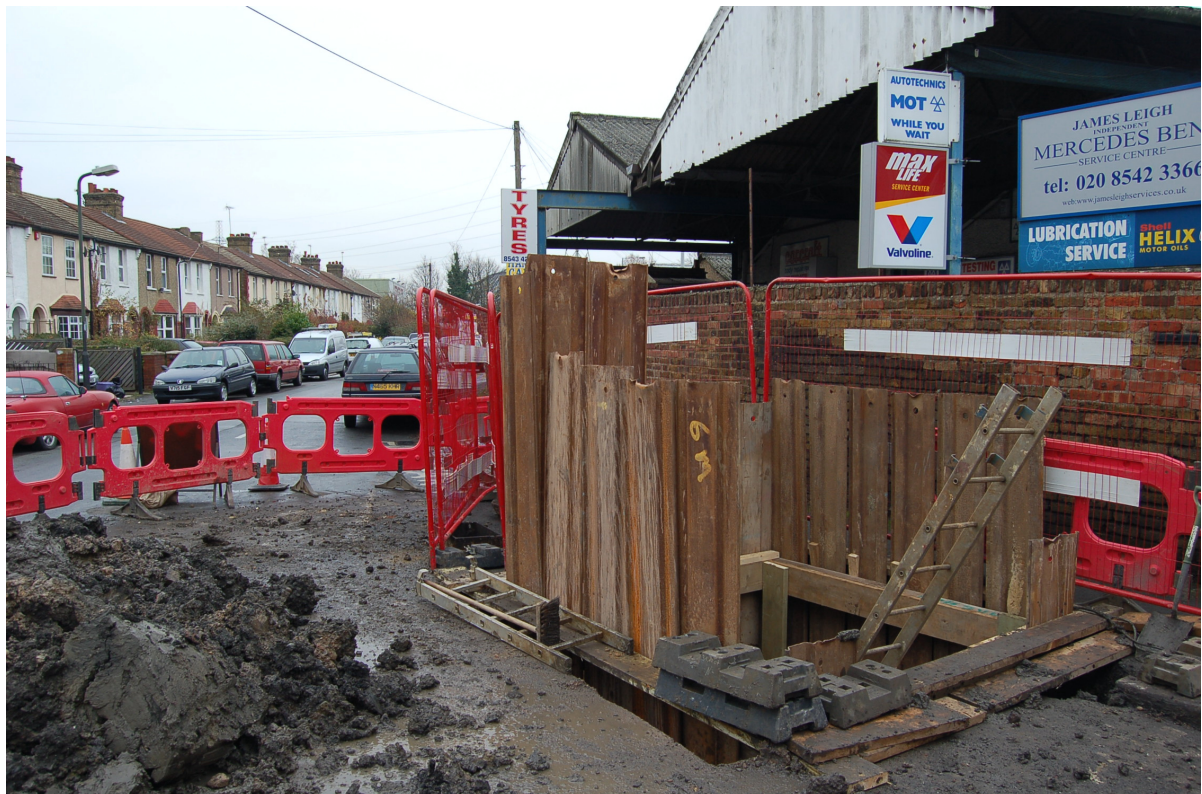
Fig 5: View looking east along the south side of Station Road, with the groundworks in the foreground.

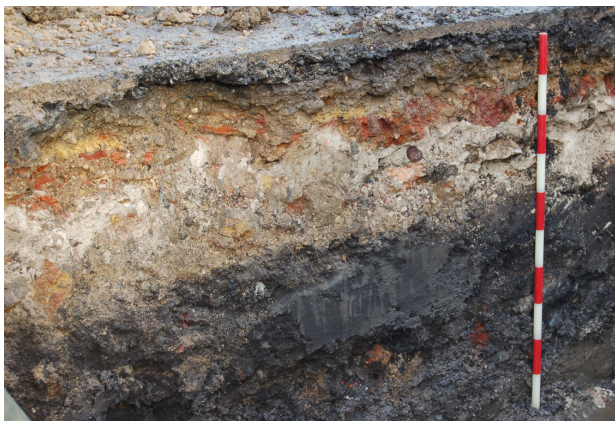
Fig 6: An oblique view of the south-facing section showing the possible earlier road surface beneath the tarmac and the underlying silty alluvial deposit.

The trench measured *c* 3.2m x 2.8m in plan, on an approximate northeast-southwest alignment running into the southern pavement. To the north, tarmac overlay a thin deposit of sand and shingle while to the south, tarmac overlay a sand bedding. Directly below this sandy deposit was the backfill for a ceramic storm water drain that lay at a depth of about 0.85m, and which cut into the upper fills of the 42'' trunk main. Immediately to the north of this the present road make-up overlay a possible previous road surface, which was observed at a depth of 0.22m and which now acted as the base for the road above. This deposit consisted mainly of red and yellow stock brick with inclusions of chalk and gravel, and presumably dates to the late 19th century.

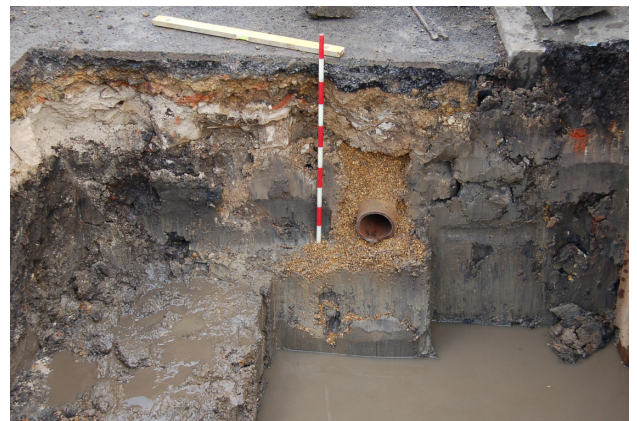
Fig 7: The west-facing section showing the storm water drain and associated sandy fill, cut into the backfill of the larger and much deeper trunk main (scale 1m).

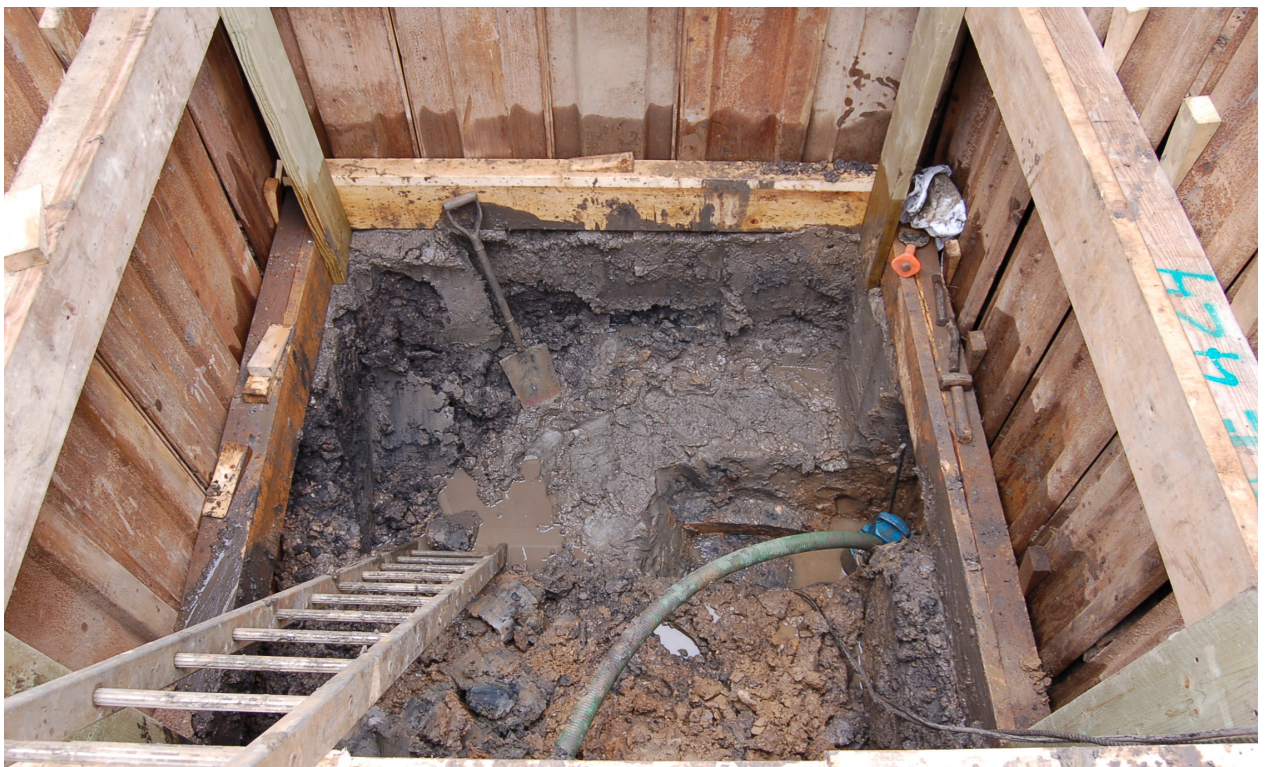
Fig 8: The trench after initially exposing the water main, seen here to the right of the picture.

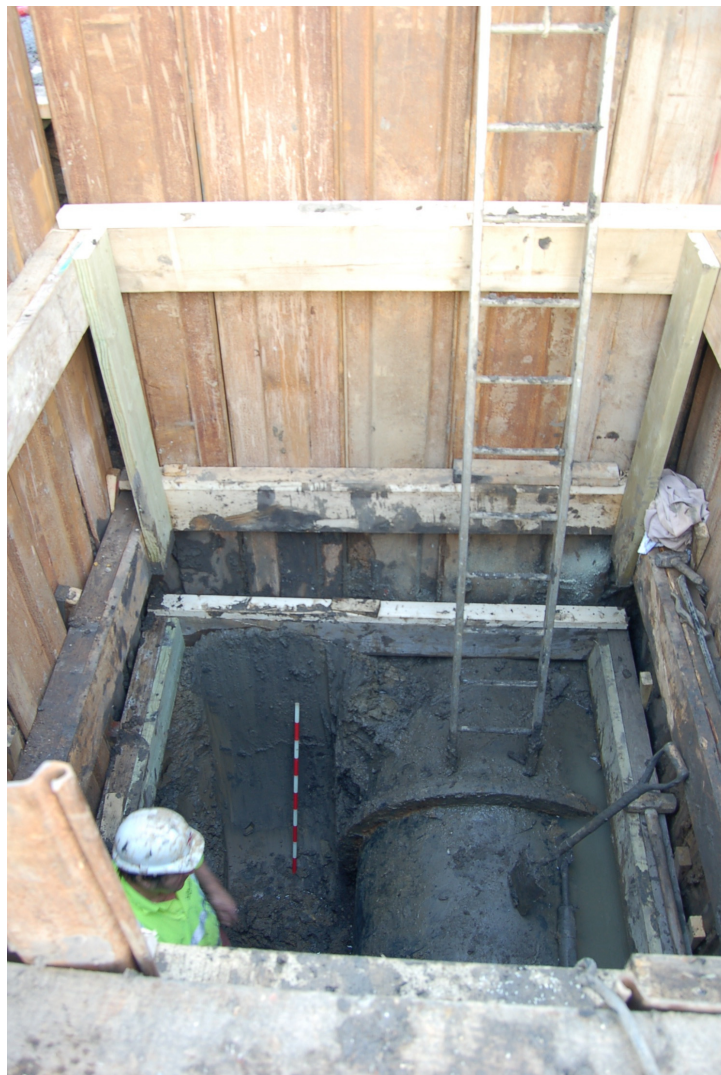
Fig 9: A post-excavation picture showing the exposed 42'' trunk main (*1m scale*).

The natural deposit of firm sterile clay may also represent an alluvial deposit. It was observed continuing to the base of the trench, at *c* 3.24m below the existing road

surface. Despite its proximity to the trench, no evidence was found during the watching brief for the continuation of the historic wall or for the possibly associated arches or recesses that appear on the 1866 OS map. However, any remains may well have been cleared from this area during the excavations for the trunk water main, which occupied all but the northern part of the trench to a depth well below the natural ground surface.
