**THAMES WATER ENGINEERING WORKS
ADJACENT TO N°. 86 LEADENHALL STREET, EC3A**

AN ARCHAEOLOGICAL WATCHING BRIEF

**SITE CODE: TZF 08
SITE CENTRE NGR: TQ 33380 81127**

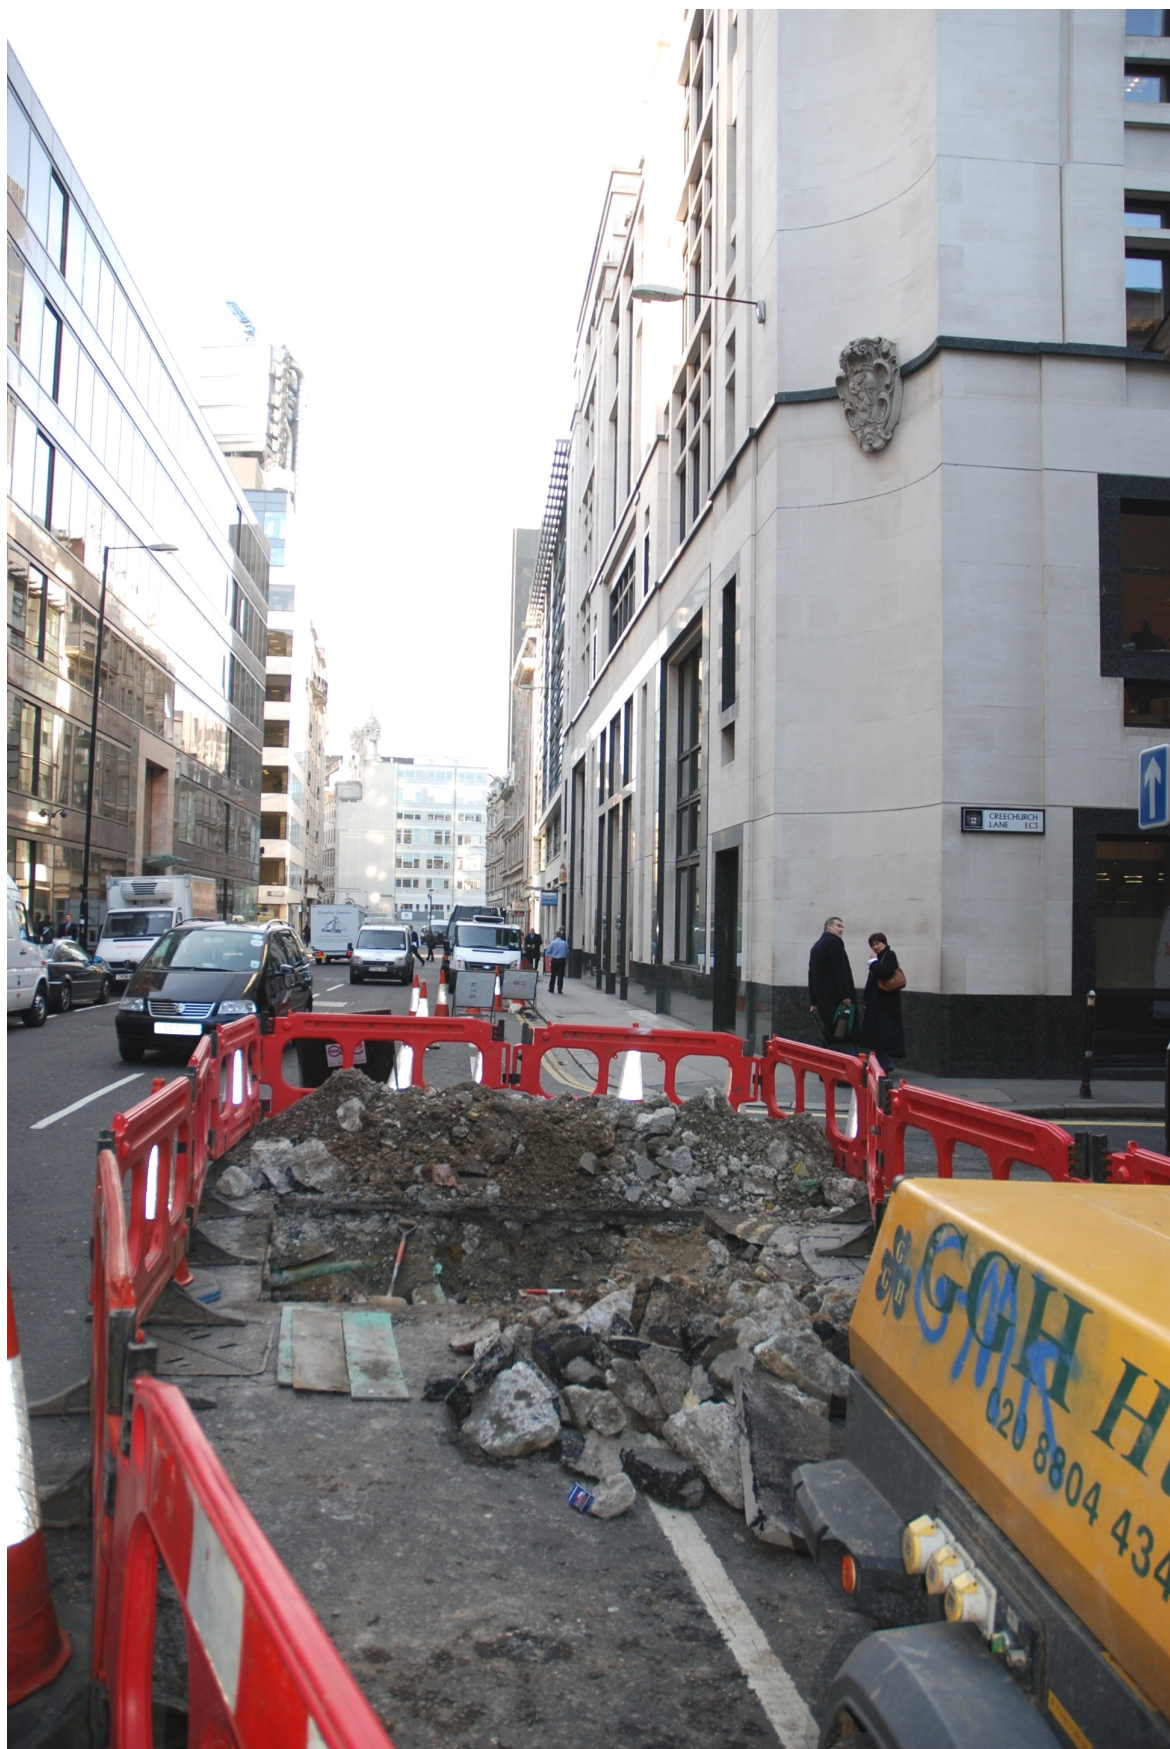
Fig 1: A view looking west down Leadenhall Street with the trench in the foreground.

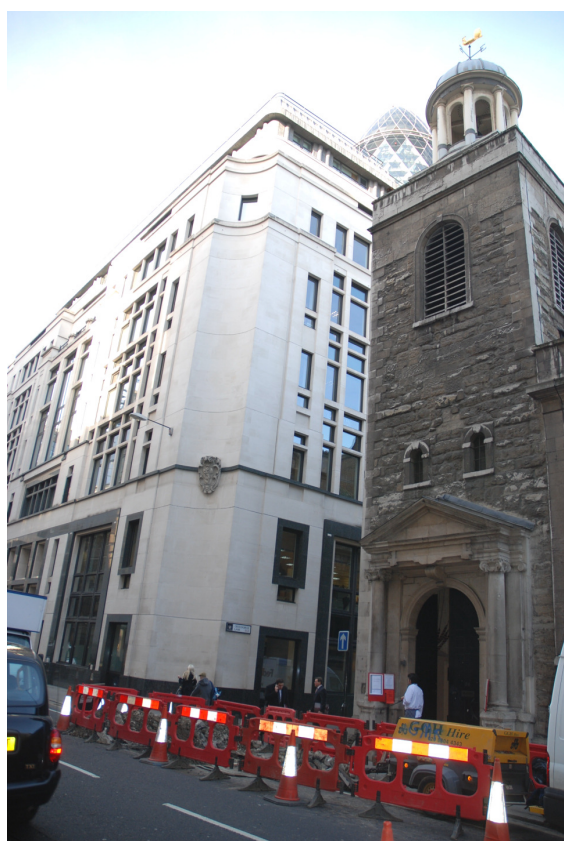
Fig 2: An overview of the site showing its relation to Creechurch Lane and Leadenhall Street. The Church of St Katherine Cree stands to the right of the picture, with the trench just to the south

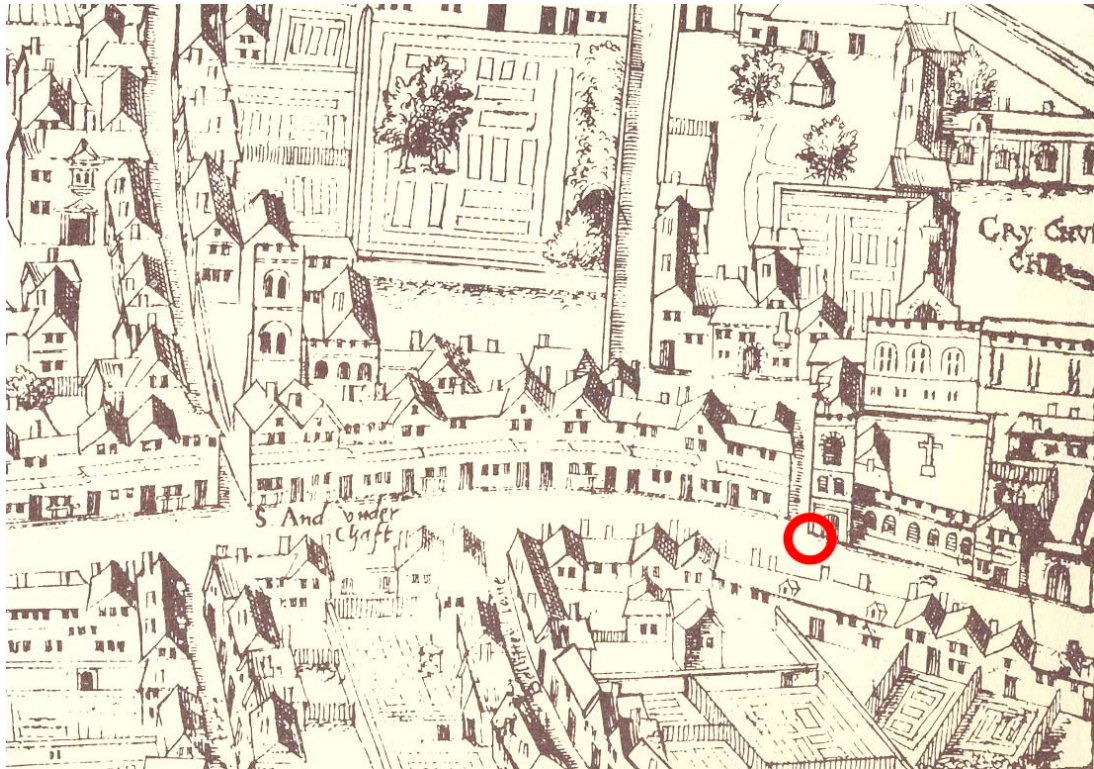
Fig 4: Approximate site location in relation to the Copperplate Map of c. 1553-59.

The Copperplate Map, c 1553-59 (Fig 4)

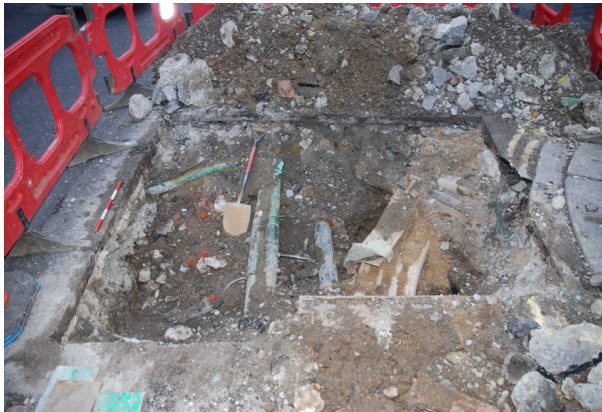
Fig 6: View orientated west at the top of the picture, showing the trench during excavation (*0.5m scale*).

The initial excavation consisted of a single trench measuring 2.6m x 1.9m, later extended to 2.8m x 1.9m in order to access the trunk main through the large number of services that lay above it. Initial monitoring of the site revealed road makeup layers, tarmac and concrete hardcore to a depth of 0.38m. Beneath the road makeup were various sandy backfill deposits, heavily reworked with gravel and concrete rubble inclusions prevalent throughout the trench. The trench was on average 0.74m deep, although around the actual water main excavation reached a maximum of 1.31m below the present ground surface. No finds or features of archaeological significance were uncovered during the course of excavation.

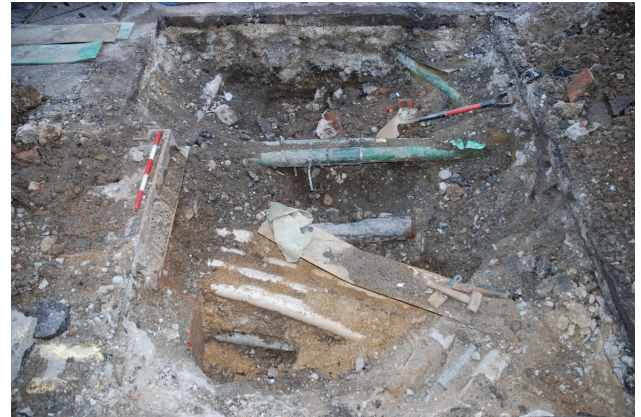
Fig 7: This picture is orientated to the south, the trunk main lying beneath the services that are visible in the foreground.

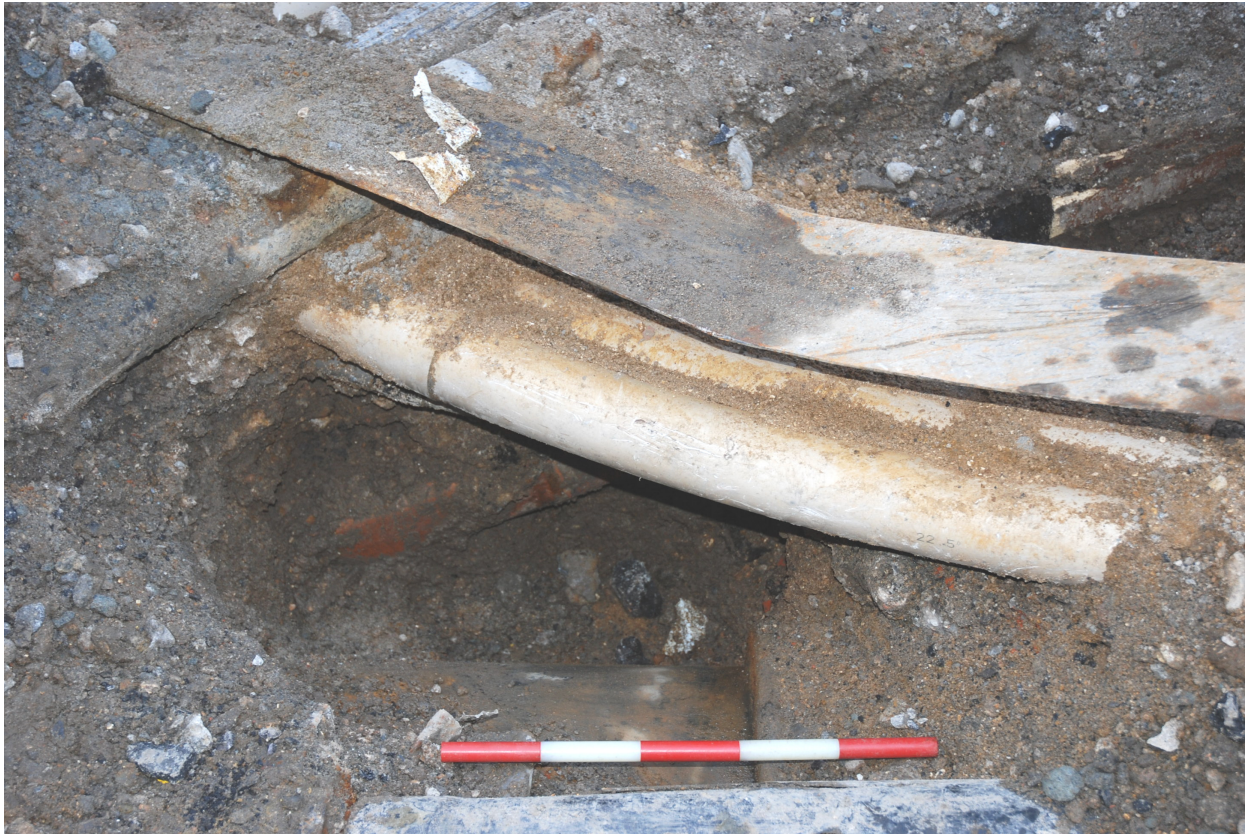
Fig 8: Detail of the northern part of the trench looking north: the trunk main lies at the base of the picture, and was the only area excavated to a depth of 1.31m (0.5m scale).

No significant archaeological deposits or remains were found in the trench, due mainly to the shallow depth of the water main (c 1.3m). Nor was any earlier residual /redeposited material seen, although elsewhere significant remains – particularly masonry – have occasionally been found to survive at a high level. However, it was also clear that the trench area had been heavily truncated and reworked during the 20th century, as evidenced by the large number of pipes and other services.
