BREAKSPEAR HOUSE
BREAKSPEAR ROAD NORTH
HAREFIELD UB9 6NA
LONDON BOROUGH OF HILLINGDON
AN ARCHAEOLOGICAL FIELD EVALUATION

AN ARCHAEOLOGICAL FIELD EVALUATION

PLANNING APPLICATION REFERENCE: 7610/APP/2008/1012 (Condition 23)

SITE CODE: BZH09

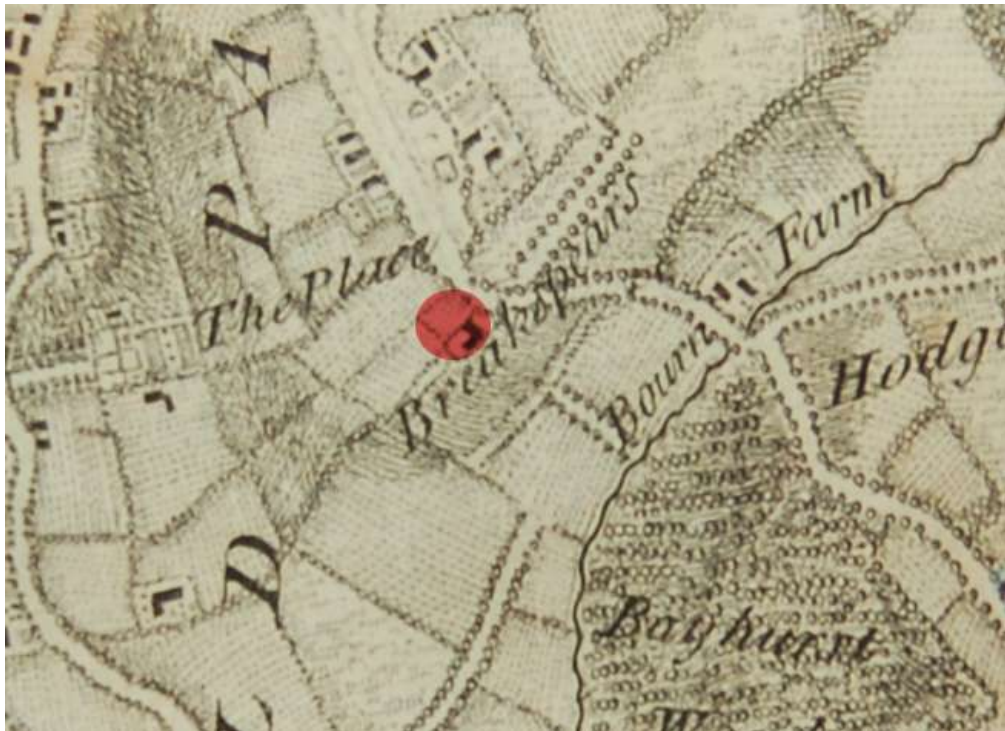
The first detailed survey of Middlesex is Rocque's *Map of the County of Middlesex*, published c 1754 (Fig. 3). This gives a good picture of the historic settlement pattern, and although the map base is not totally accurate the site is shown as a reasonably sized estate in a rural setting. At this time Breakspears was occupied by Robert Ashby: the estate is clearly marked and named and the house appears to be quite accurately drawn when compared to the more detailed survey of 1771 (Fig 4). However, there are more substantial buildings at Knightscode (the large estate to the north, not shown here) as well as several buildings around *The Place* and to the east at *Bourn Farm*. The L-shaped Breakspear House itself was modest in comparison to the large structure that stands on the site today. The extensive avenue of trees projecting from the front entrance can be seen and this obviously was a formally planted vista or walk. Other formal planting and ponds are not shown, although some of the mature trees now standing on the site probably date to the middle of the 18th century.

Fig. 3: Map of the County of Middlesex by John Rocque (1754) with the location of the Breakspear Estate shown in red © Guildhall Library.

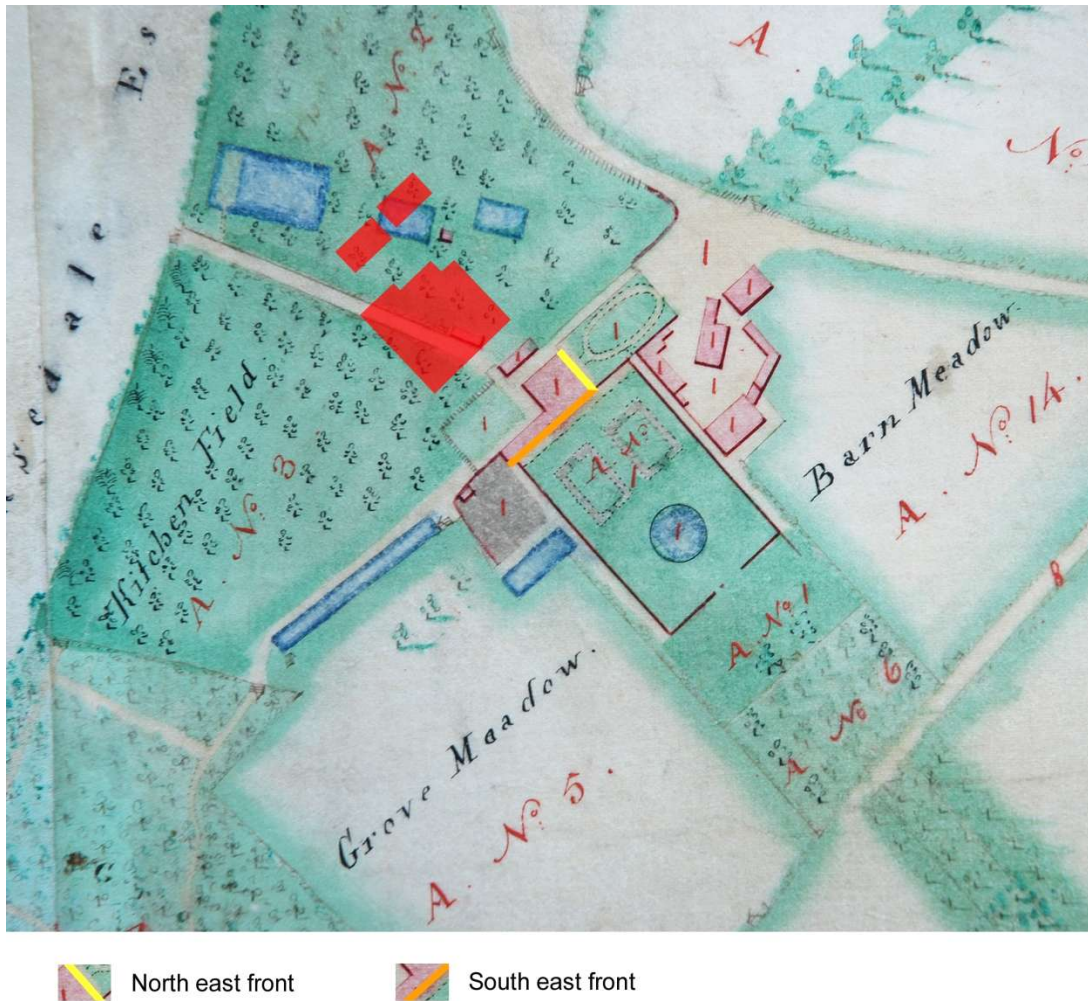
Fig. 4: Extract from the 1771 Plan of the Estate of Joseph Partridge, with new build areas and underground car park area are highlighted in red (©London Metropolitan Archive).

The above plan shows in detail the configuration of the buildings then on the site, with the main house as an L-shaped building in the centre of the image; the long southeastern extension being a service wing. The proposed new build areas lie to the west and northwest. Formal and kitchen gardens (and probably orchards) are laid out around the house, with what appears to be a walled garden just to the southwest, and the home farm is established to the east. There is an oval carriage drive to the northeast, and elsewhere six large ponds. The Dovecote can be seen between the two smaller ponds at the top of the image.

The trenches were located to optimise the potential of archaeological deposits and features as indicated by the historic map record (*cf.* Figs 4, 8 & 10). These included the site of the 19th century stable block and carriage house, but also some earlier structures plus boundary and path lines, and in the walled garden a large pond feature.

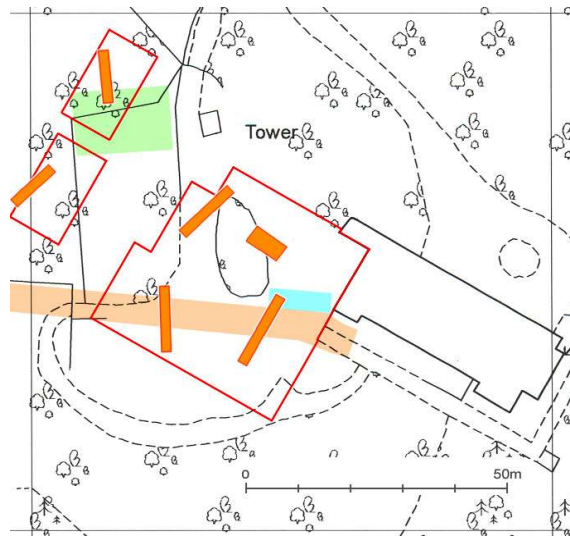
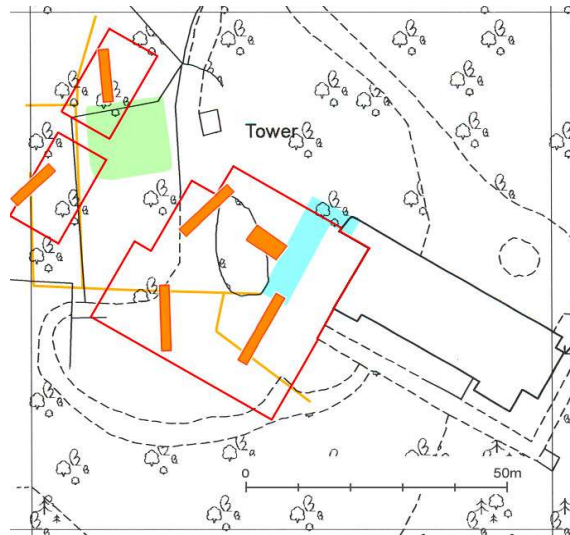
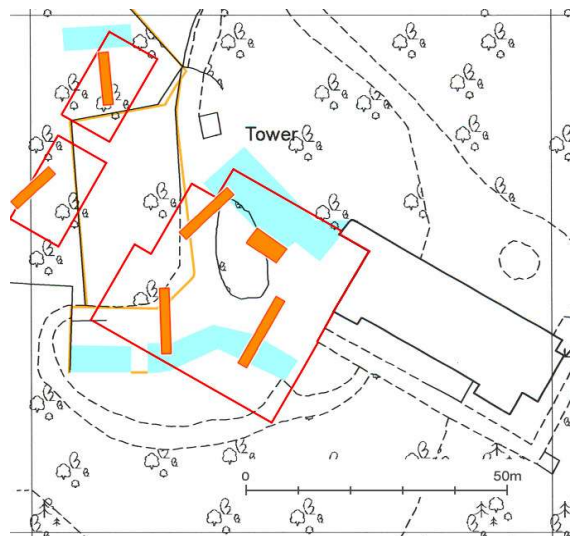
Fig. 10: Evaluation trench layout (in orange) with features taken from historical maps superimposed, and showing potential archaeological signatures to be encountered.

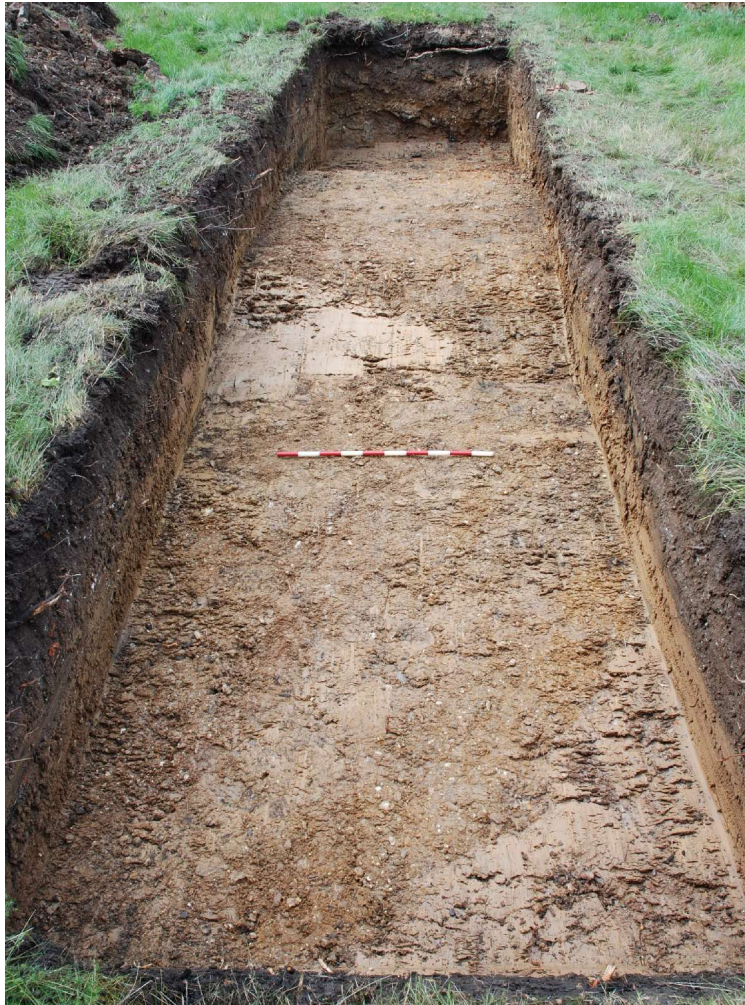
The natural deposit in Trench 1 [7] generally comprised a firm mid brownish yellow silty clay, with variable quantities of medium-fine pebbles/gravel and occasional pockets of coarse sand or more homogeneous clay (the latter visible just above and to the left of the scale in Fig. 12. This layer presumably represents the Glacial deposits and undifferentiated Head that is identified by the Geological Survey (*cf.* Fig. 2)

Fig. 12: Overview of Trench 1 looking southwest (*scale 1m*)

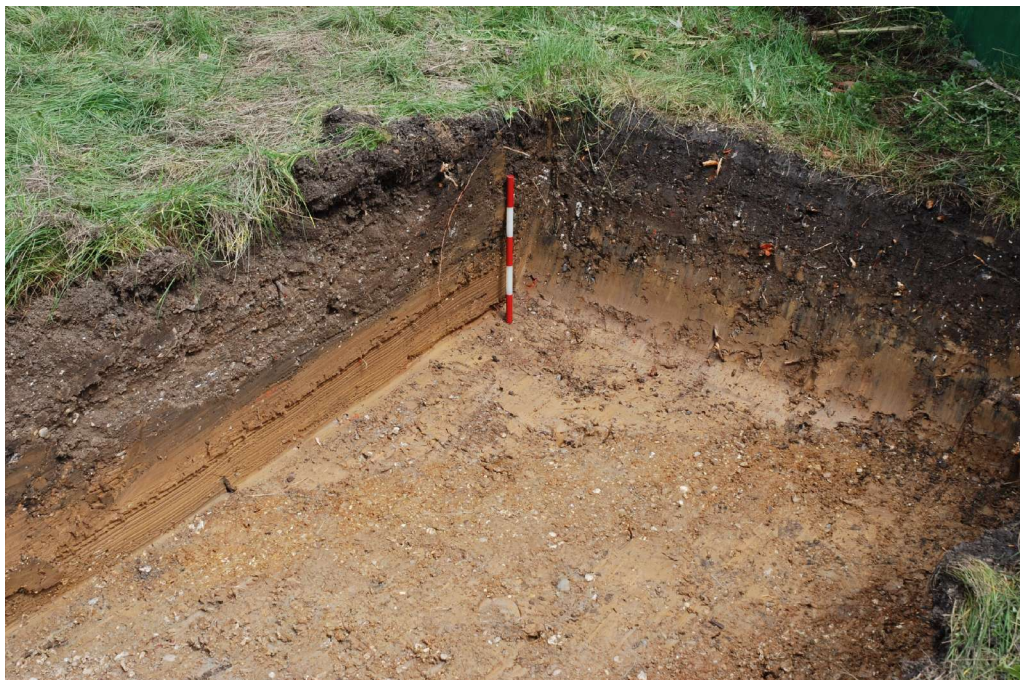
Fig. 13: The northern corner of Trench 1, showing the line of the cut feature (20), with solid clay infill [18] directly below the 0.5m scale

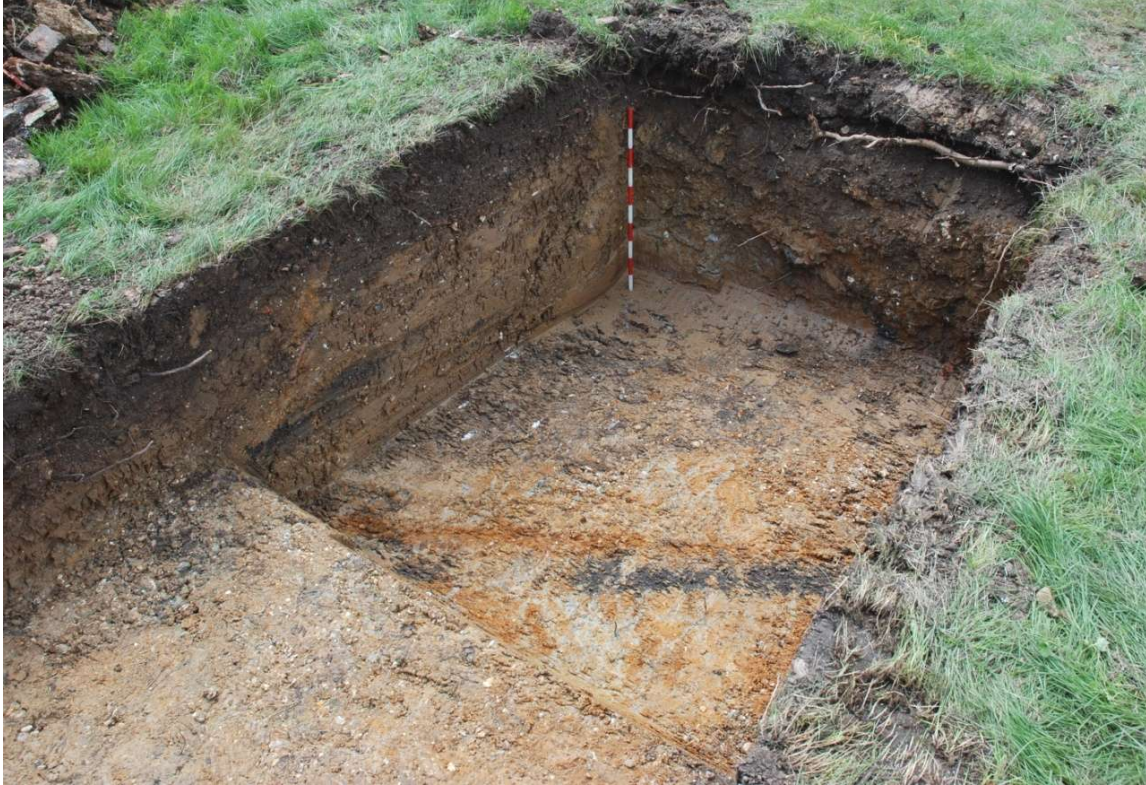
Fig. 14: View of the southern corner of Trench 1, with the east-west aligned iron pipe [19] in the foreground and unexcavated linear feature (32) to the rear (*scale 1 m*)

Immediately adjacent to and to the south of the pipe [19] an earlier east-west cut into the natural deposit was observed. The surviving edges of this feature (32) were quite clear, with a fill [31] of mainly medium brown sandy silty-clay. At its uppermost surviving level – below a reworked soil horizon and truncated to the north by [19] – (32) was at least 1.6m wide and some 1.3m deep (Fig. 15). This feature is difficult to interpret due to the small area of horizontal exposure (some 2m to 3m overall) but appears to have been some form of ditch or artificial water course, although there was no silting at the base. The fill was relatively clean, but produced one small sherd of plain white earthenware of 19th century date (REFW; Appendix II. 1). There was also a small assemblage of ceramic building material of broadly post-medieval date (Appendix I) – fragments of floor tile and vitrified brick, and a number of pieces of roof tile. Fill [31] can therefore be dated to the first half of the 19th century – as it is also cut by the pipe trench [19] – although the associated feature may well be earlier.

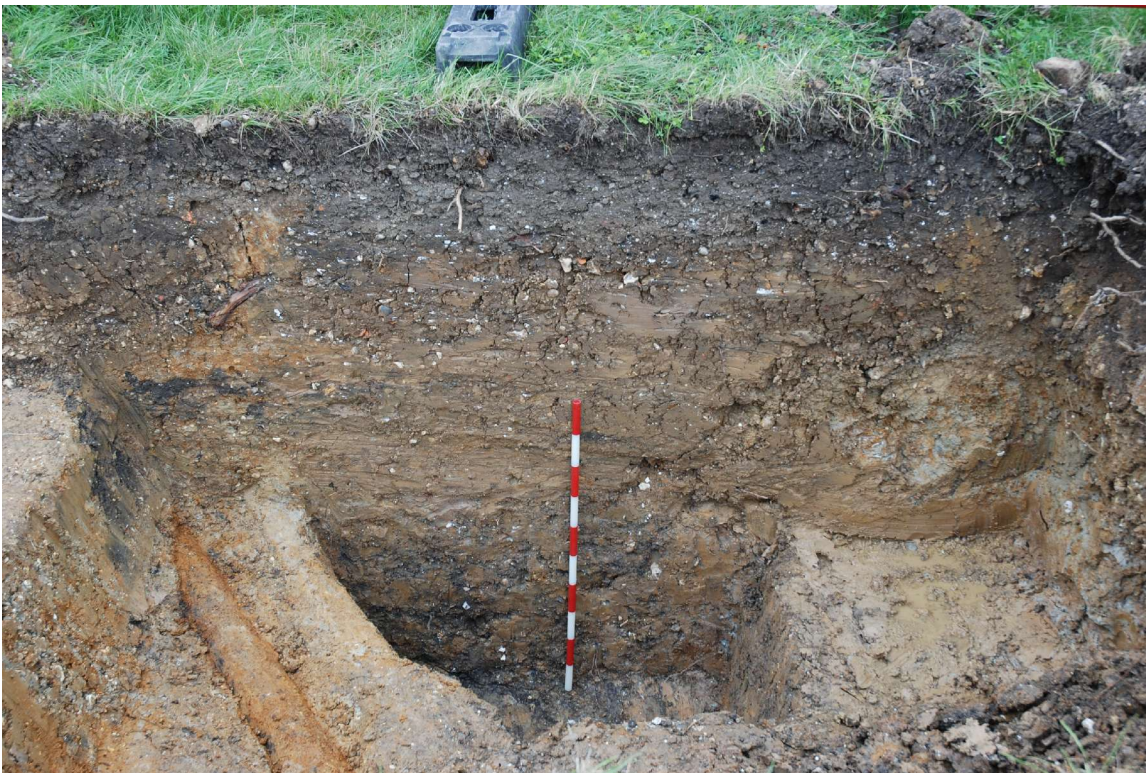
Fig 15: The southeastern section of Trench 1, showing the excavated slot through the probable ditch (32) with exposed fill [31] behind the 1m scale. To the left is the later cast iron pipe and associated fill [19]

Two further features found in Trench 1 – within the area of the former walled garden – also relate to activity on the estate. The function and date of feature (20) is unknown (other than post-medieval), but the cut (32) was evidently some form of drainage ditch or water channel, and was backfilled in the first half of the 19th century.

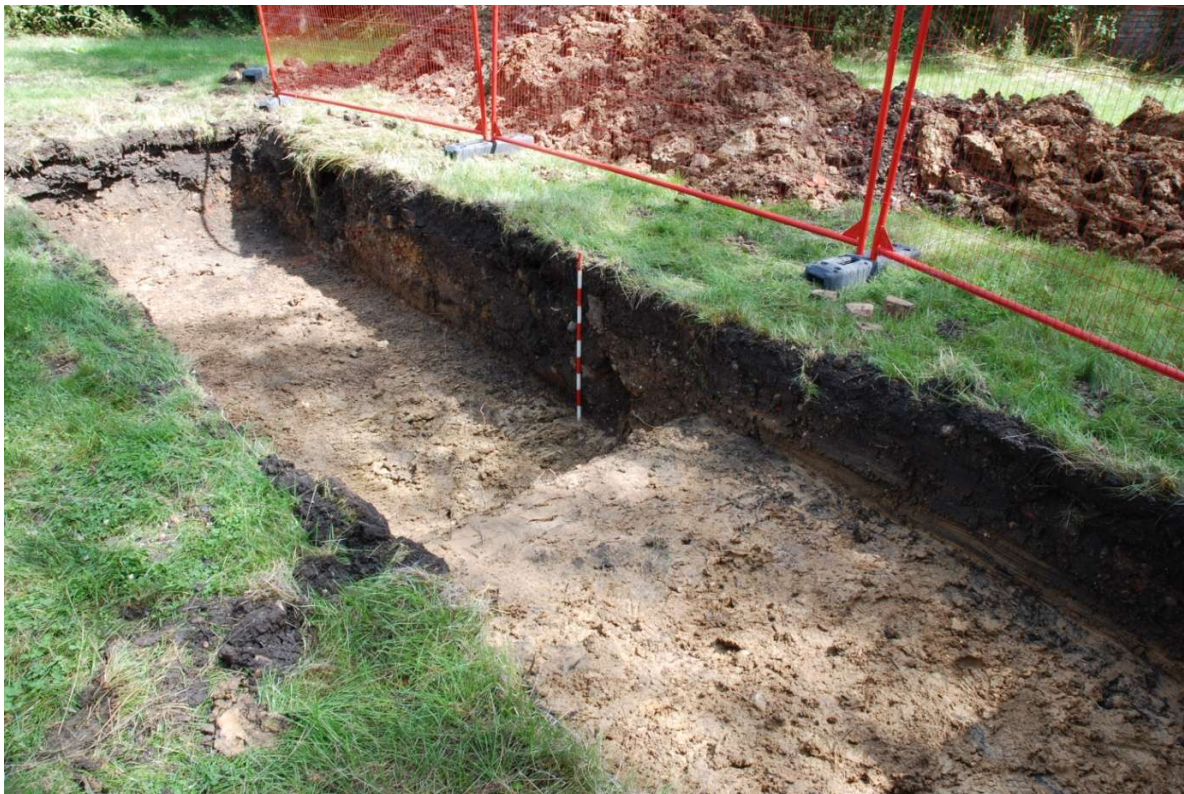
The topsoil in this trench was superficially comparable to that in Trench 1, and of similar depth (*c* 0.25m – 0.3m), although here it did not merge into the underlying natural. Instead, it overlay a deposit of demolition material, fragmentary brickwork and iron piping, which itself overlay and was cut into the natural silty clays – as clearly seen in Fig. 17 overleaf. The Ordnance Survey record shows that three east-west aligned glasshouses were constructed in the area between the late 1890s and 1914, with the two largest (which completely covered the northern two-thirds of the trench) still present in 1934. The soil here is thus of a recent origin, most if not all having been imported or re-deposited after the latter date.

No sub-surface archaeological features were otherwise encountered in this trench, and there was no sign of the apparently rectangular pond that is indicated on the Estate Plan of 1771.

Fig. 16: Overview of Trench 2 looking northeast (*scale 1 m*).

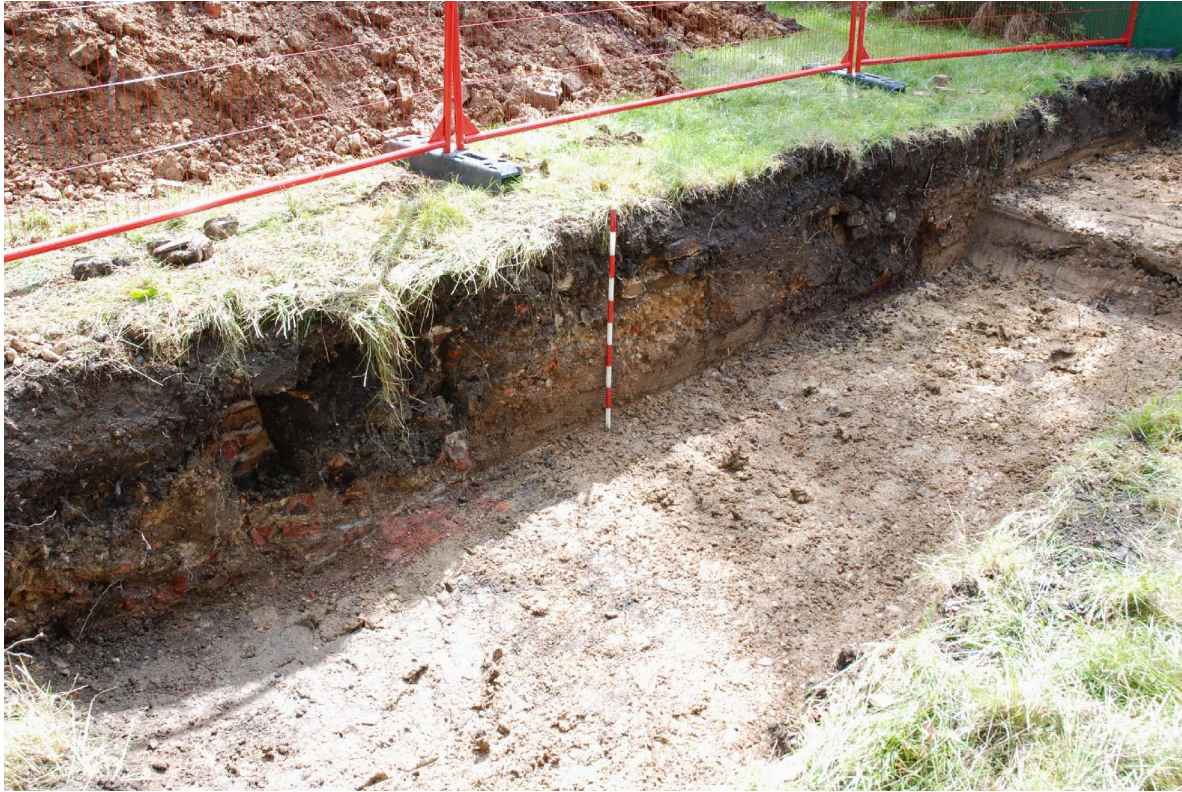
Fig. 17: Overview of Trench 2 looking northwest (*scale 1 m*).

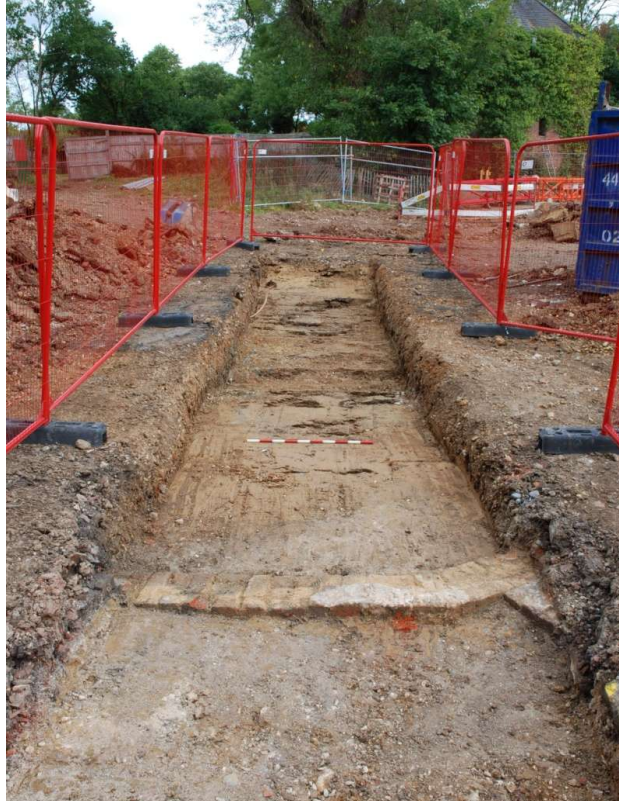
This trench was located within the impact area of the new build (Units 1-4) and underground car park. It was 12m long (north-south) by 2.3m wide and was excavated to an average depth of 0.3m to 0.5 m. Brick building remains were encountered in the southern part of the trench, being situated relatively close (>0.3m) to the modern surface (*cf.* Figs. 18 & 19). Otherwise the stratigraphic situation in this trench, as in trenches 4 to 6, was very straightforward. The present surface was made up of very recent levelling /demolition material, *c.* 0.2m to 0.3m thick, overlying compacted made ground and gravel of probable mid 19th century date. The underlying natural [7] consisted of a firm, mid brownish yellow silty clay, with pockets of coarse sand which included rounded pebbles and angular gravel.

Fig. 18: Overview of Trench 3 looking north (*scale 1m*).

All features found in this trench relate to known uses of the site during the mid-late 19th century. Any earlier surfaces and/or soil horizons had clearly been truncated to the level of natural by the development of the coach house and adjacent yard. In particular, there was no sign of the broad path or track that appears to cross the area on the 1771 Estate Plan (Figs. 4 & 10).

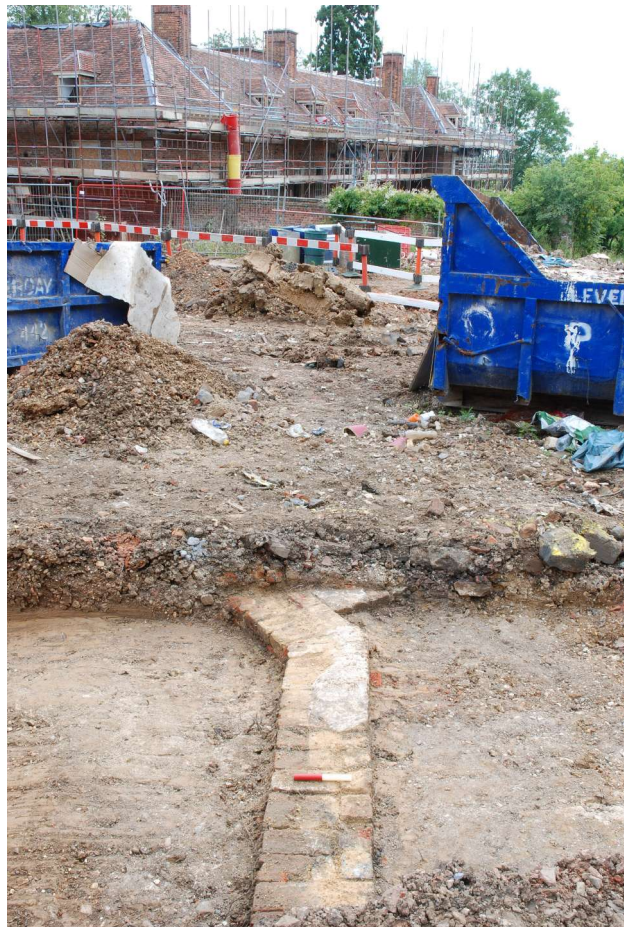
Thus the date of the wall [15] – and associated coach house – can be placed with some confidence in the period *c* 1850-1865. To the south [15] was abutted by the smaller and shallower wall base [12], of which a short length (0.46m) was exposed within the trench. This presumably marks an internal sub-division of the coach house, although as it is not directly bonded into [15] may represent a later alteration to the building rather than a contemporary feature.

Fig. 19: Trench 3, view looking east along the line of wall [15] (*scale 0.2m*)

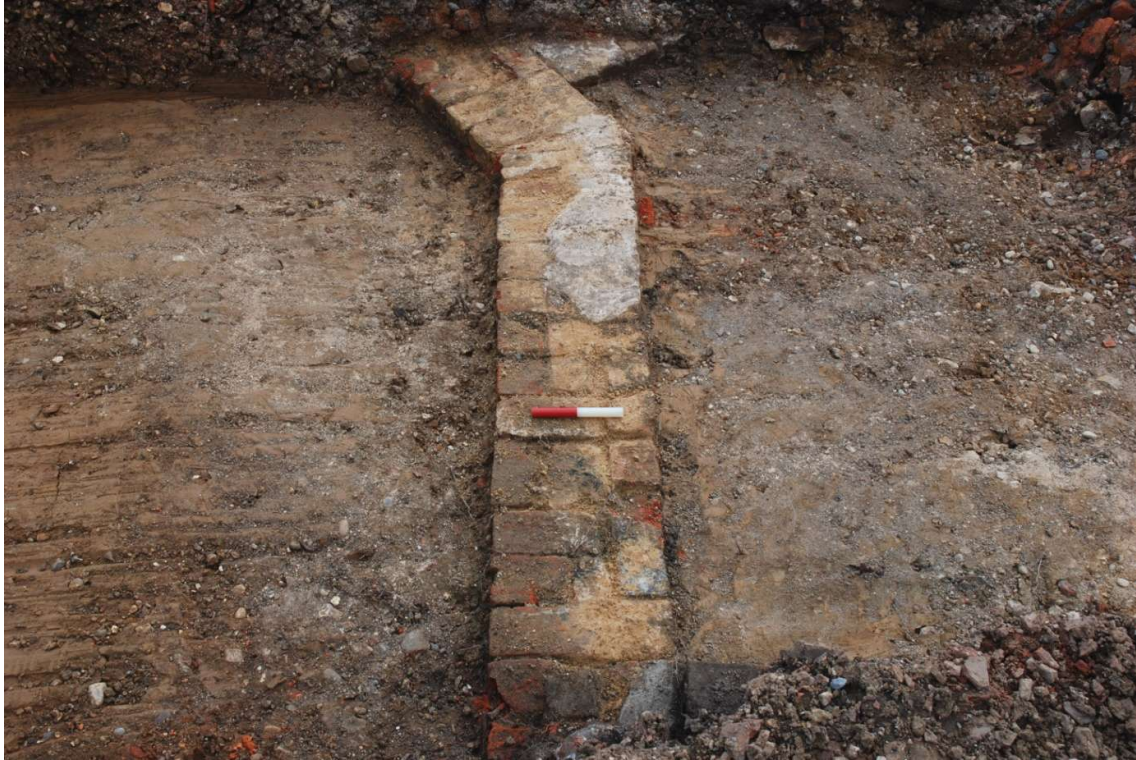
Fig. 21: Trench 3. Detailed view of brick wall base [15] looking east, with internal wall [12] in the background and running into unexcavated section (*scale 0.2 m*).

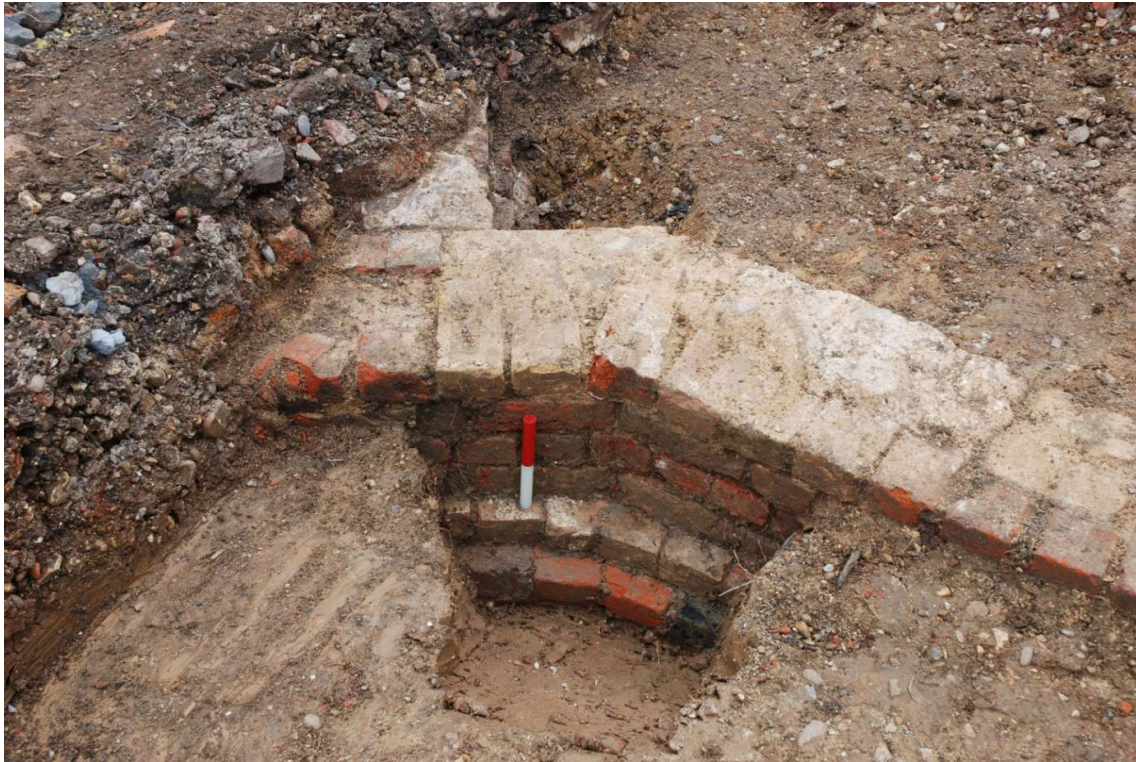
Fig. 22: Trench 3. Detailed view of brick wall base [15], showing stepped lower two courses (*scale 0.2 m*). Abutting the rear of [15] is wall [12], representing a subdivision within the building – and also stepped out at its base although only 3 courses deep.

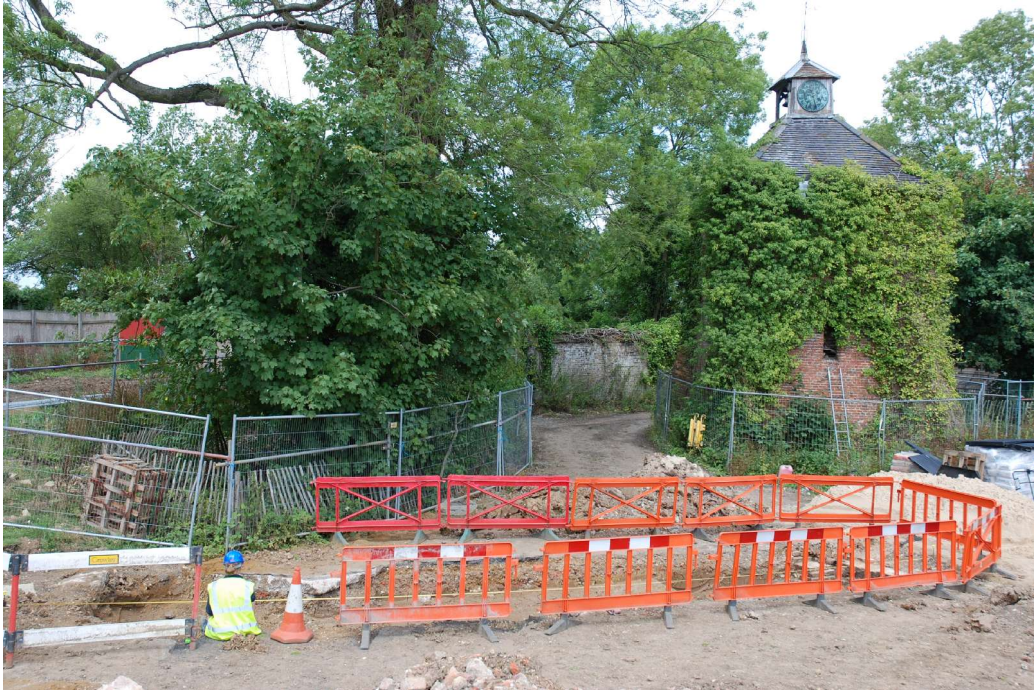
Trench 4 measured 12.2m in length (NE-SW) by approximately 2.3 m in width. It was excavated by machine to an average depth of between 0.3m to 0.6m. Archaeological features were encountered in the northeastern part of the trench, consisting of a brick wall base and associated drainage works (Figs. 23 & 24). The brickwork was capped by modern levelling and demolition rubble, whilst elsewhere this surface deposit overlay compact gravelly made ground. The underlying natural was very similar to that encountered in Trench 3, *etc.*, (context [7]), with a trench for the wall foundation [11] and a further cut for the ceramic drainpipe [9] having been dug into this.

Fig. 24: General view looking northwest across Trench 4, with the Dovecote to rear right

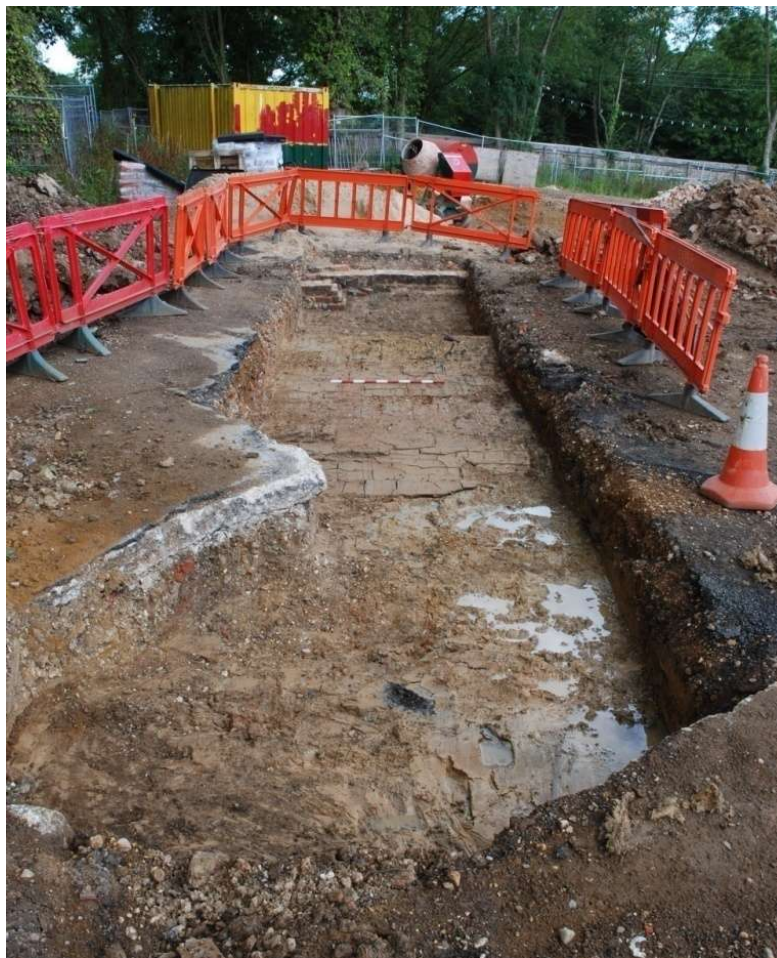
Fig. 25: Overview of Trench 4 from the southwestern end (*scale 1 m*).

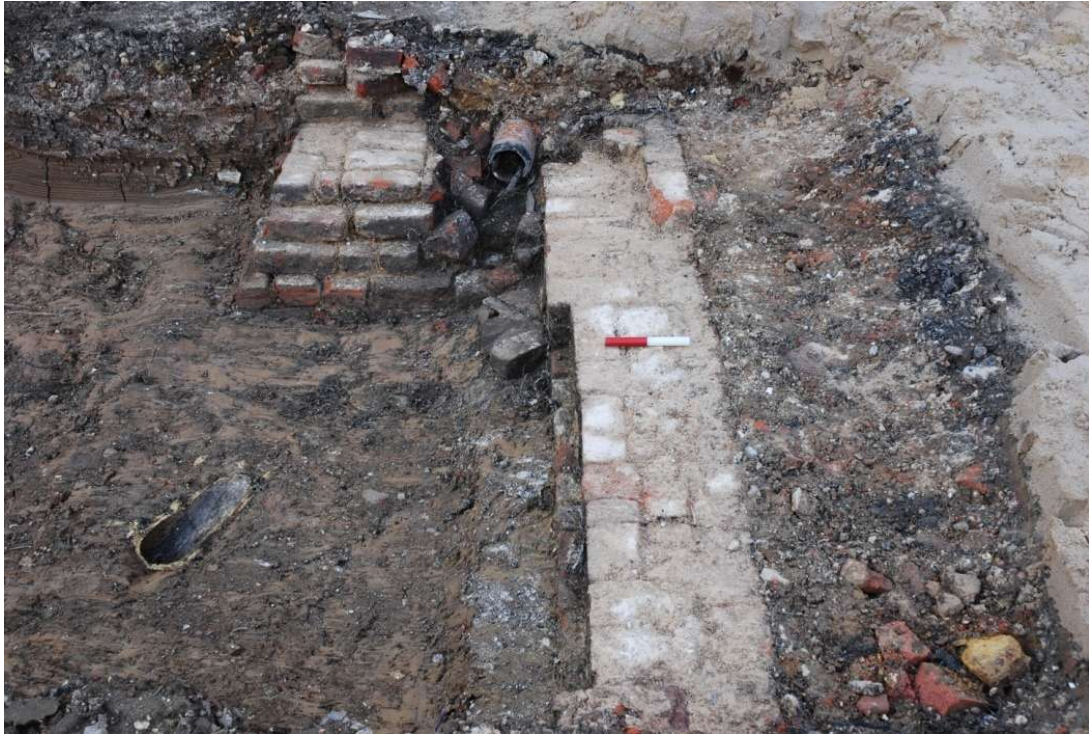
Fig. 26: Trench 4, view northwest along the brick wall base [10] that formed the front wall of the stable block, plus the remains of drain [9] (*scale 0.2 m*). The drainpipe cut into the brickwork near the top of the picture is a later and apparently unrelated feature

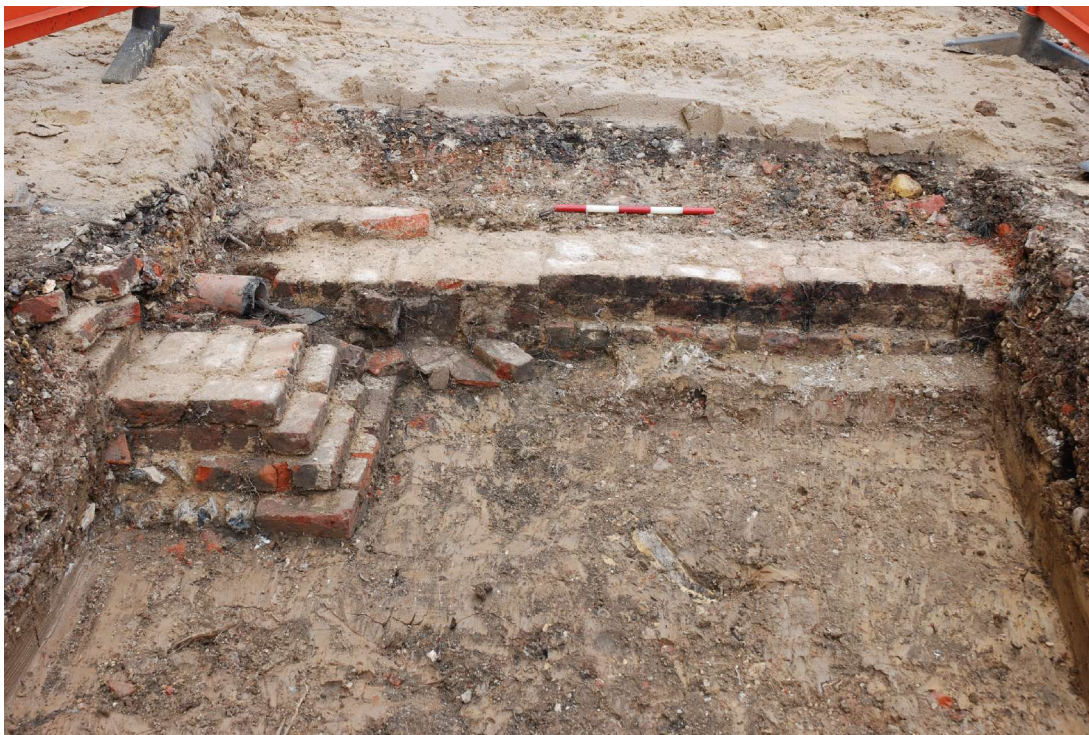
Fig. 27: Trench 4, showing the external (southwest) face of the brick wall [10] plus step out towards the northwest corner of the original building (*scale 0.5m*)

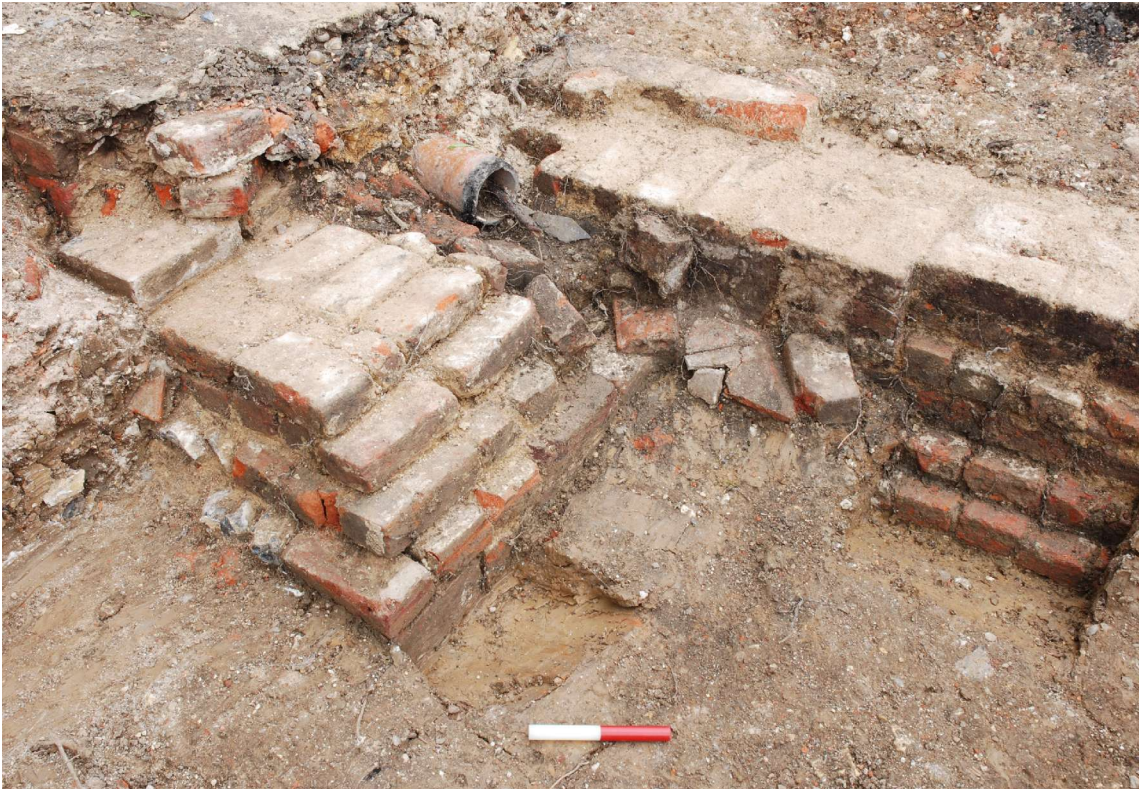
Fig. 28: Trench 4. Detail of the northwest end of the exposed wall base [10] (scale 0.2m)

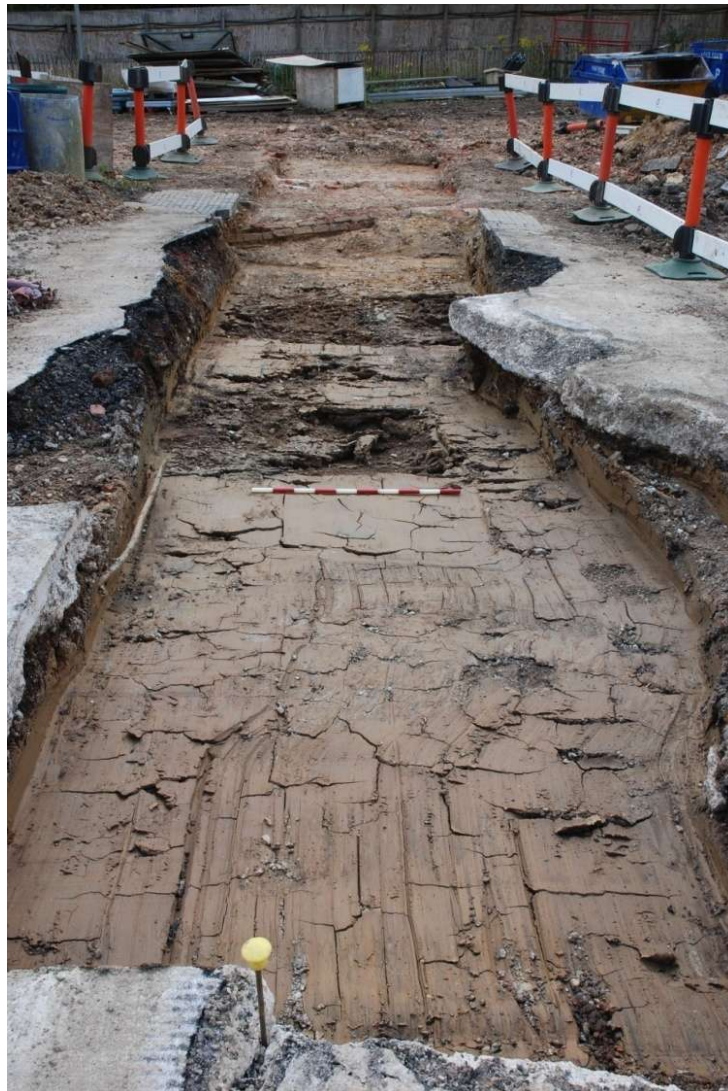
To the north and in the centre of the trench the modern surface was concrete, with recent levelling and earlier (?mid 19th century) block paving to the south. As in trenches 3 and 4 there was an underlying layer of compact made ground and gravel, probably also of 19th century date, and thence a similarly truncated natural deposit (context [7]) – a silty clay with occasional sandy and gravelly inclusions (*cf.* Fig. 30). The following features and remains were recorded:

Fig. 30: Overview of Trench 5, looking southeast and showing exposed natural clays in foreground (*scale 1 m*).

Trench 5 did not reveal any other features predating the mid 19th century. In particular, there was no sign of the broad path that appears to cross the area on the 1771 Estate Plan, or of the two phases of building at the northern end of the trench shown then and in 1813 (*cf.* Figs. 4 & 10).

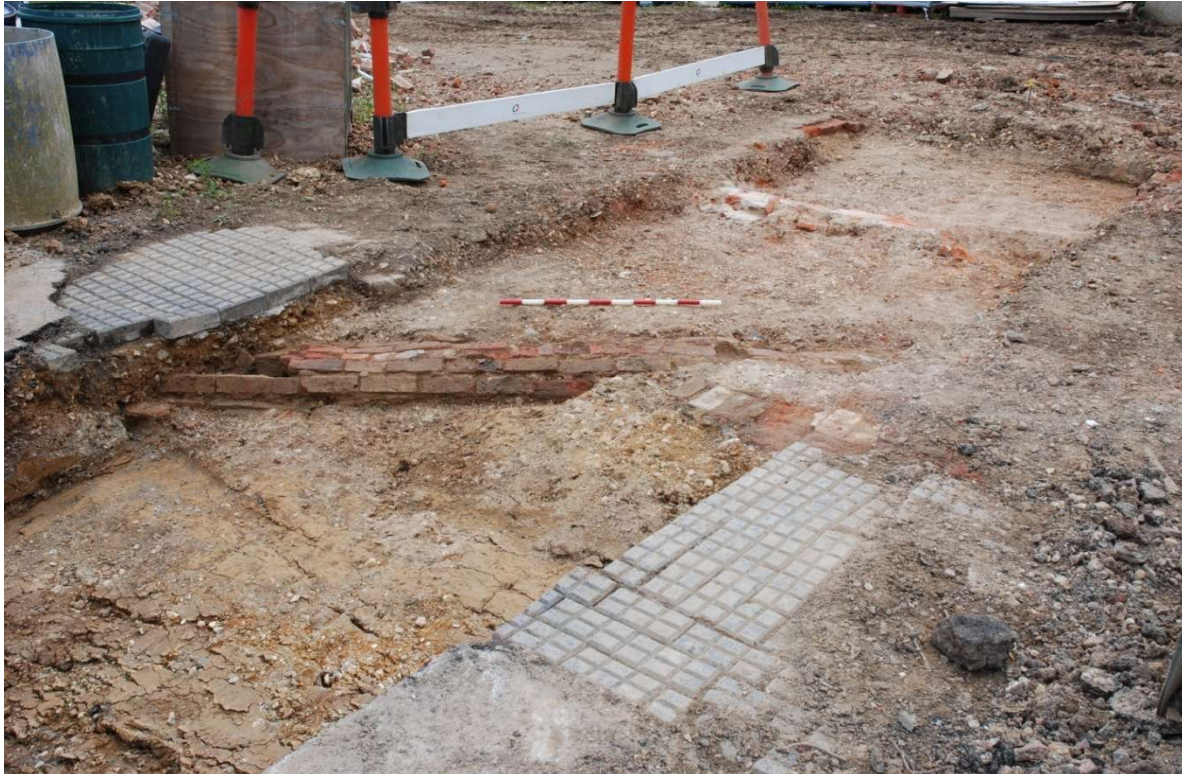
Fig. 32: View of the southern part of Trench 5, showing barrel vaulted drain [28], coach house wall bases [21] and [26] and earlier brick rubble base [24] (*scale 1 m*). The stable pavers on either side of the trench would have formed a continuous surface to the north of the coach house

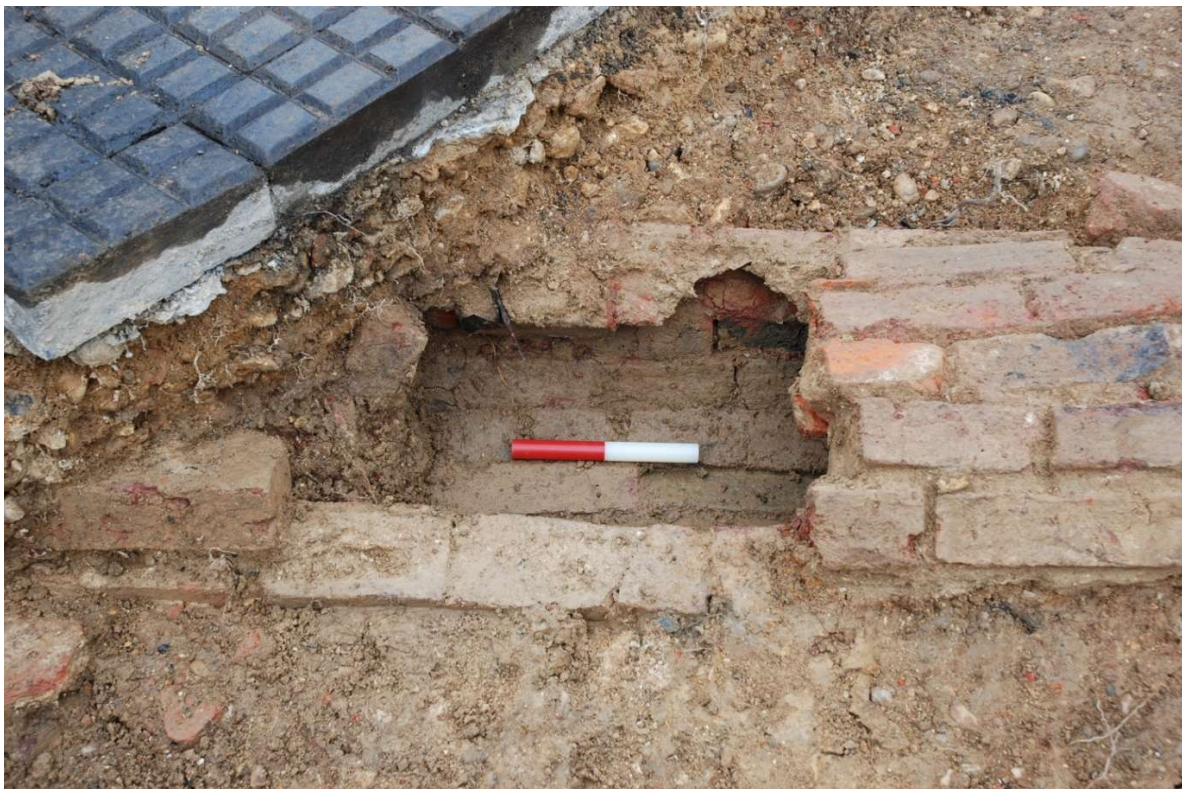
Fig. 33: Trench 5, detail of barrel vaulted drain [28] after removal of fill (*scale 0.2 m*).

Three of the bricks noted above (& one in particular) had been roughly cut or trimmed on one face to a voussoir shape, obviously to fit within the arch of the drain. The overall date of the construction is 1780 or later, but is not likely to be after than 1850 given the rapid introduction of stoneware pipes from this date. On this basis [28] probably also predates the overlying coach house construction (walls [26], [15] in Trench 3, *etc.*).

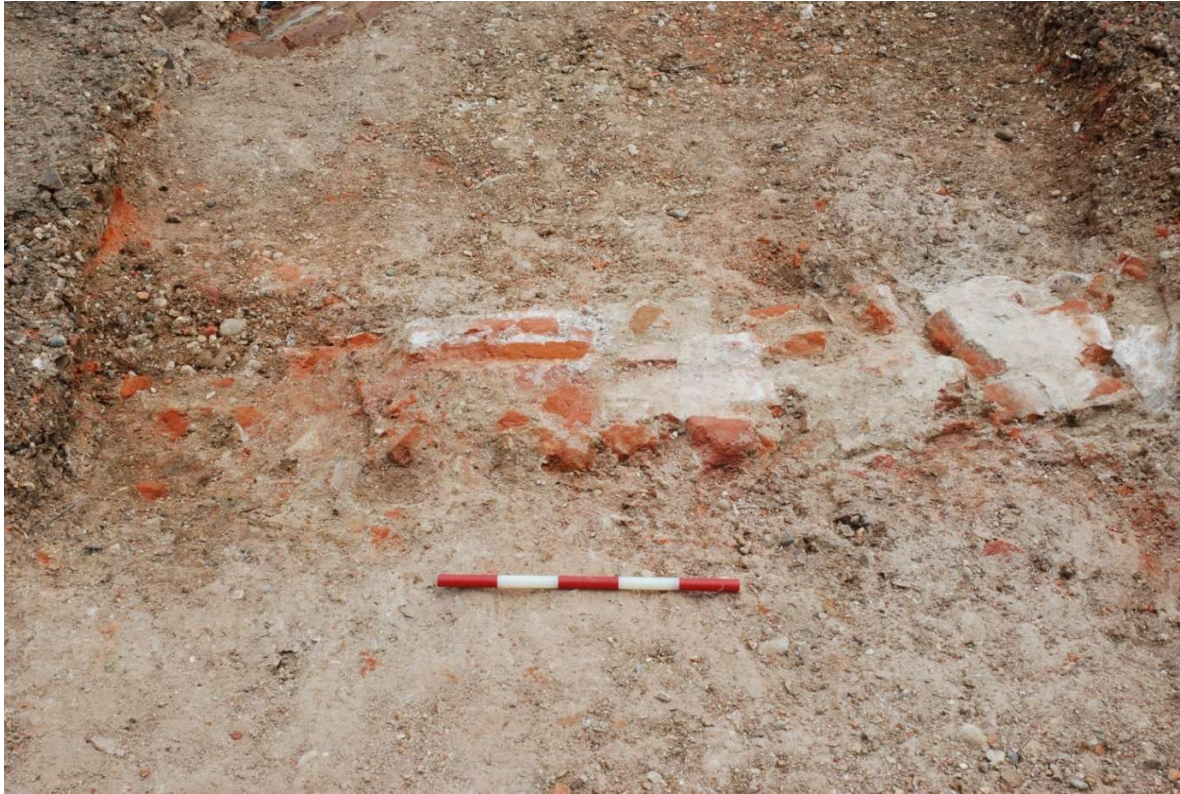
Fig. 34: Trench 5. Detail of rubble brick wall base [24], looking northeast (*scale 0.5 m*).

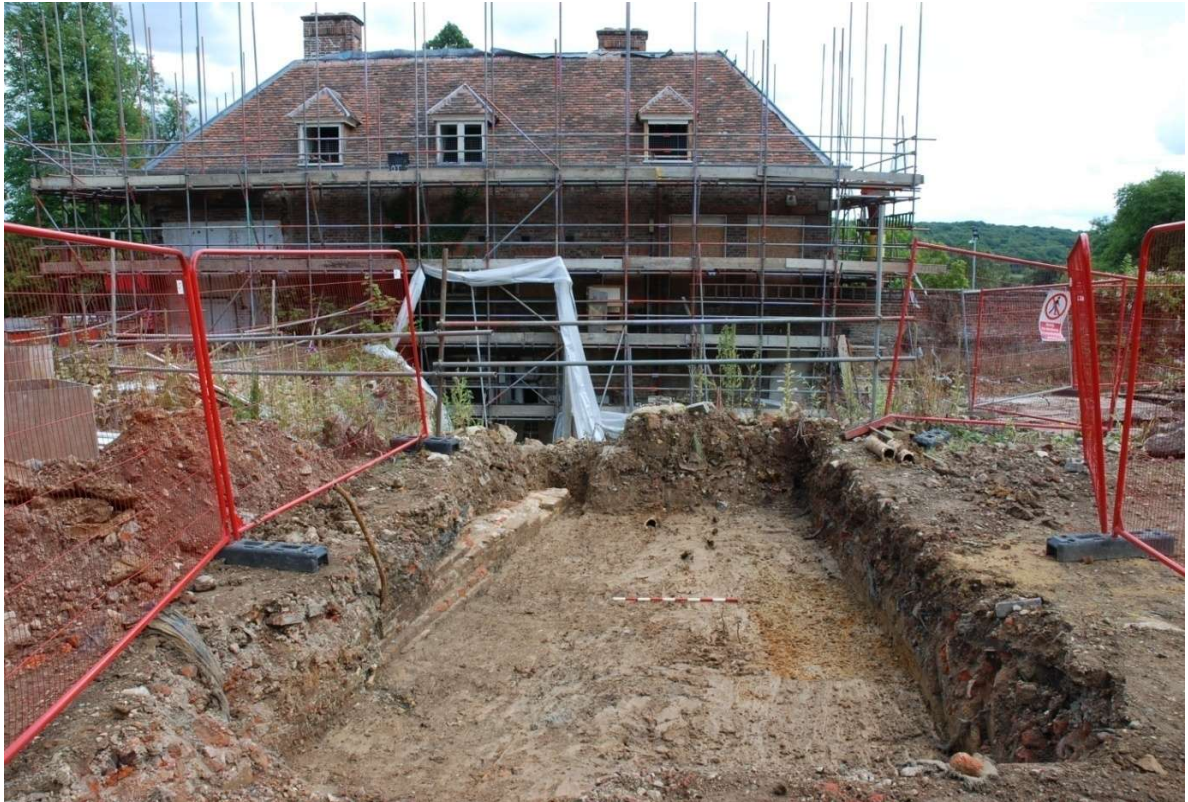
Fig. 36: Overview of Trench 6 looking southeast, with the brick wall base [2] to the left of the 1m scale
